DOT MITIGATION STEWARDSHIP INSPECTION REPORT

COUNTY Macon	Division 14	# ACRES 38.93
-----------------	----------------	------------------

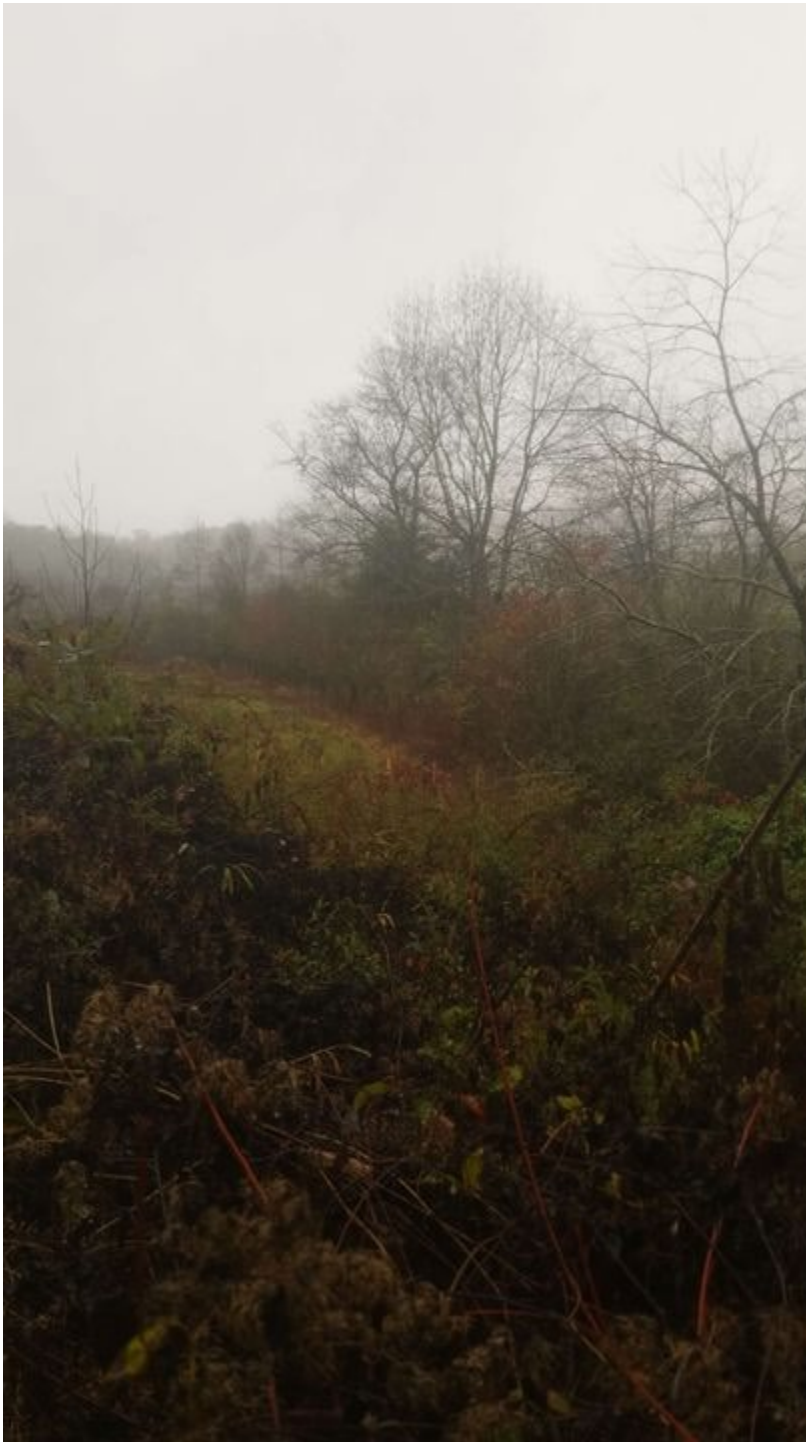
Date & Time: November 14, 2024 9:23 AM

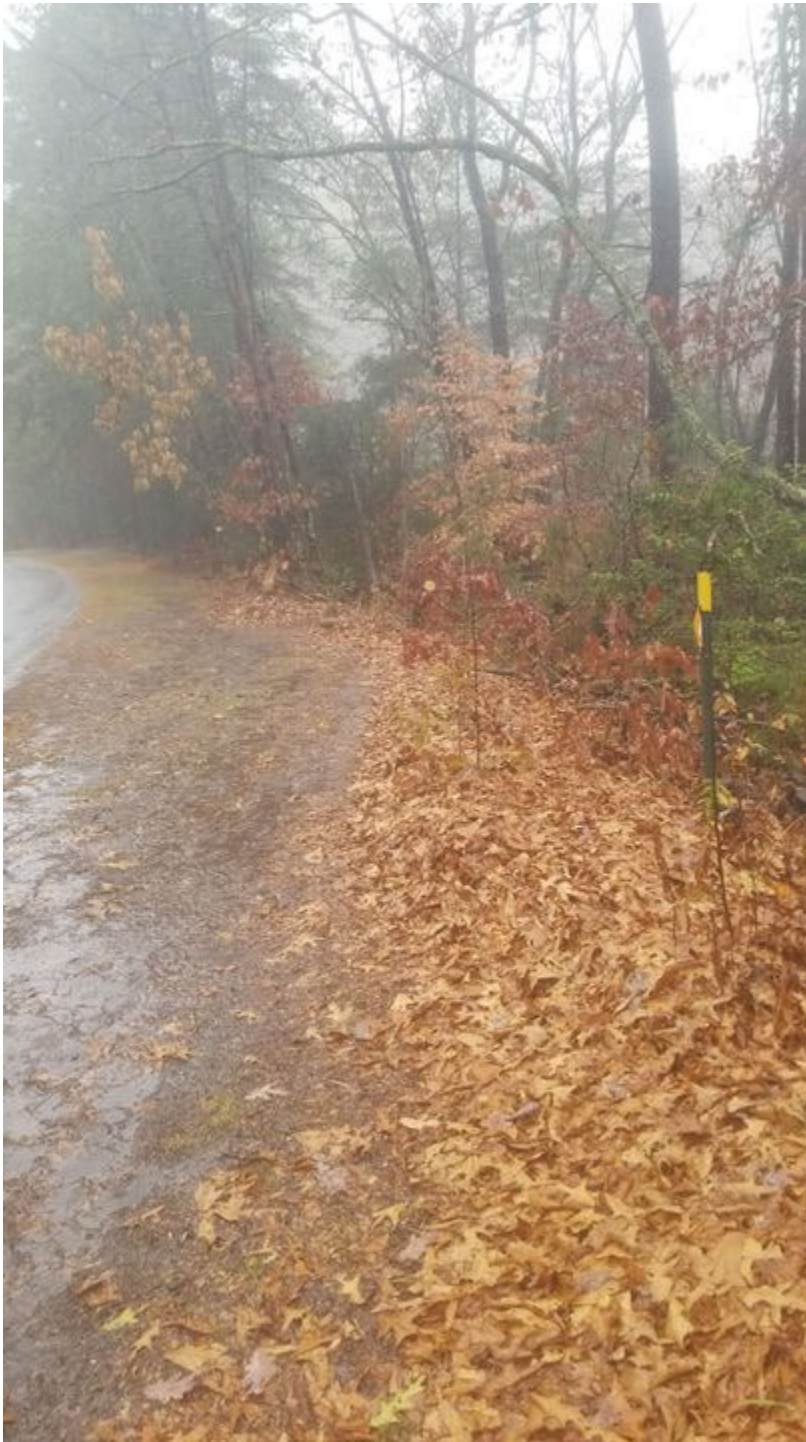
Date & Time: November 14, 2024 9:25 AM
Location: 35.197207, -83.328999
Photo Direction: Southwest
