# **Superstreet Benefits and Capacities**

**Final Report**

Project: 2009 – 06

December, 2010

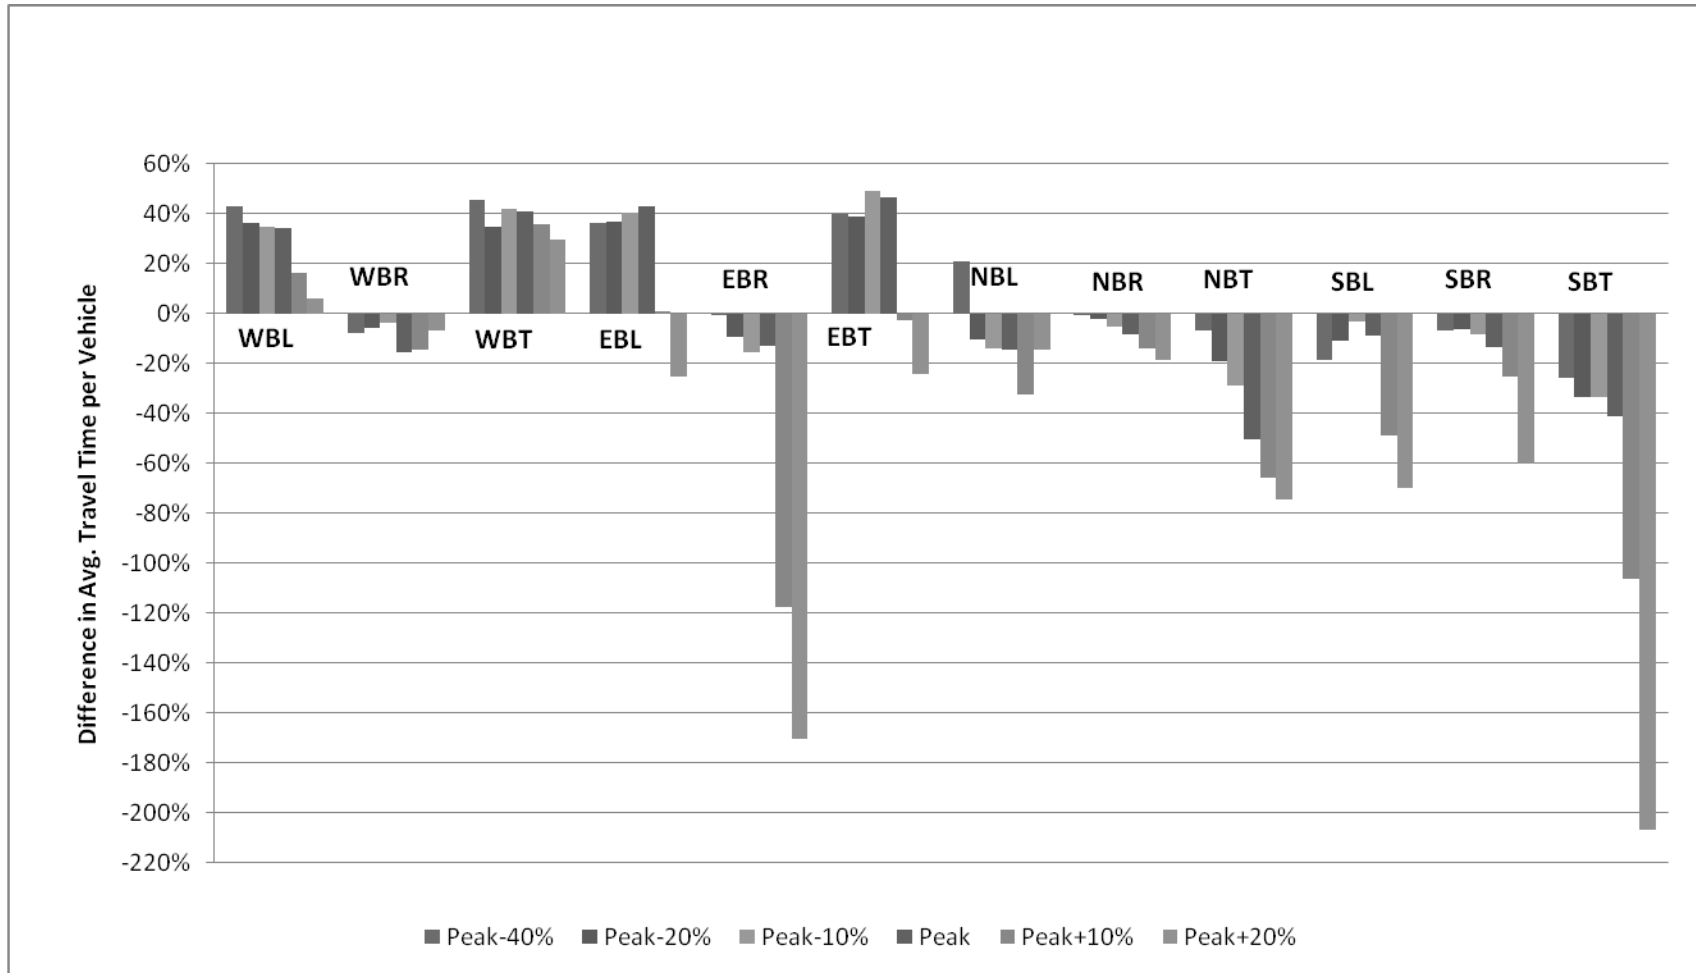
**Figure 2.13. Comparison of Travel Times by Movement – US-17 @ Plouf/Poole**

The US-17 corridor saw similar effects as the Chapel Hill and Wilmington superstreets with travel time steadily improving as demand increased. At the peak+10% and peak+20% levels, the major through movements had large travel time savings over the conventional, reaching up to over 100% and even 200% in some cases. This is an indication that the conventional intersections were most likely overloaded and failing.

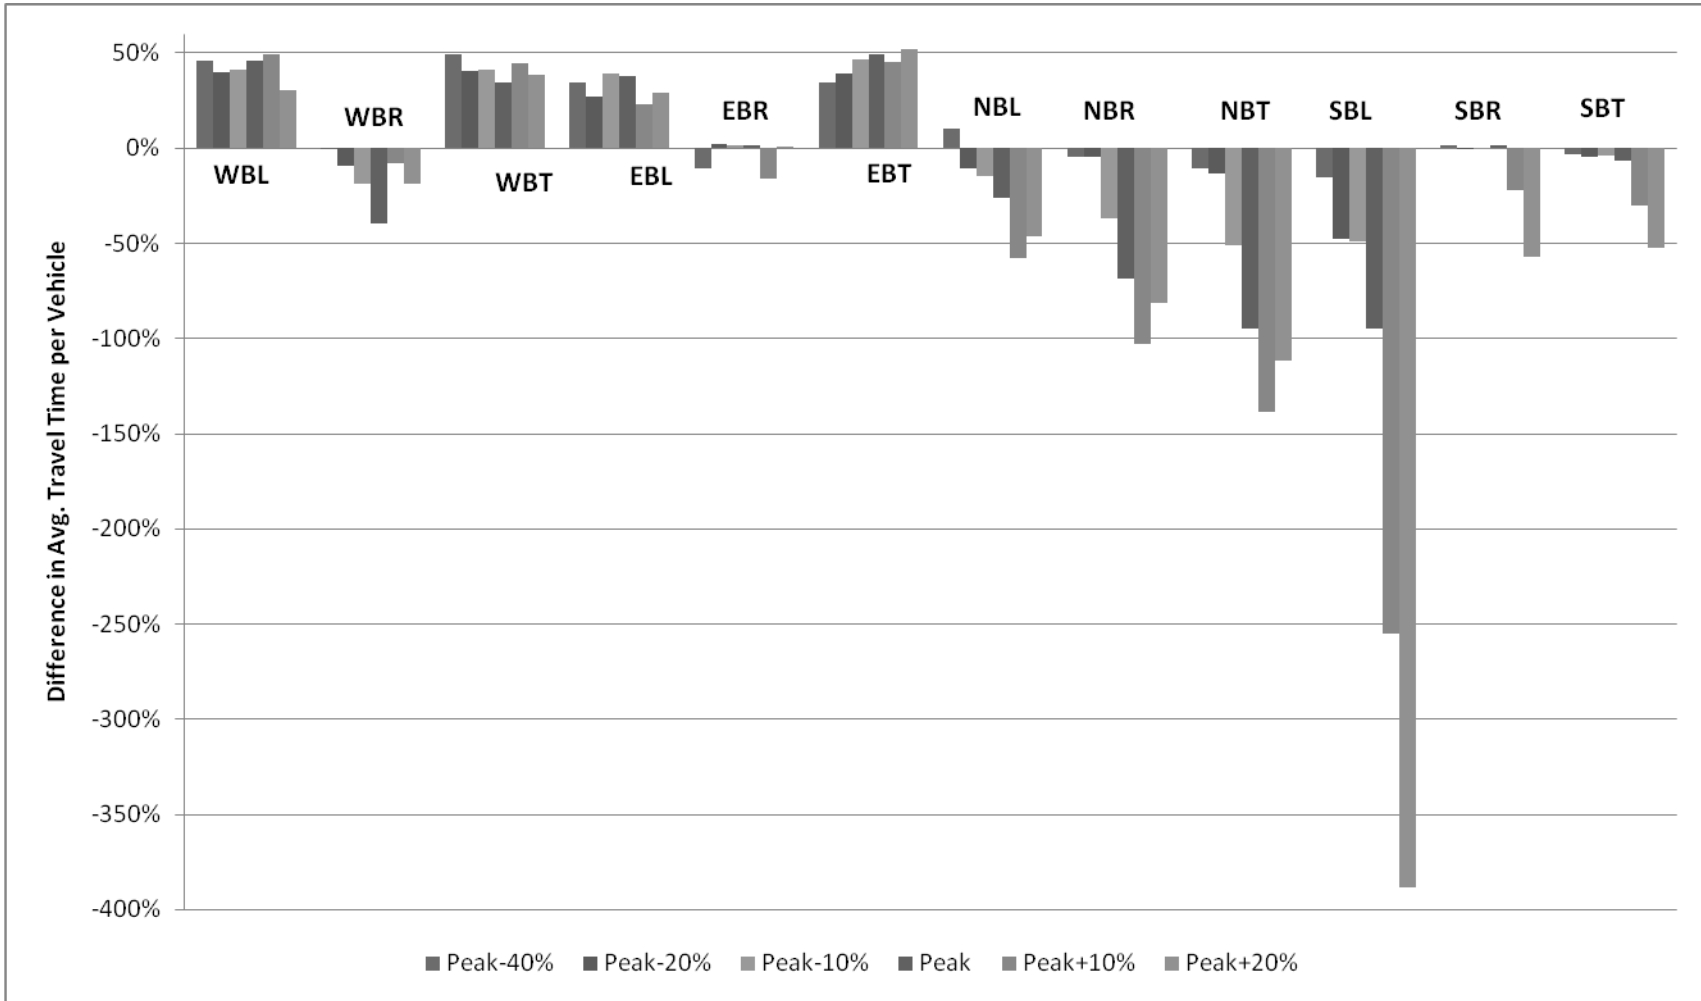
**Figure 2.14. Comparison of Travel Times by Movement – US-17 @ Walmart/Gregory**

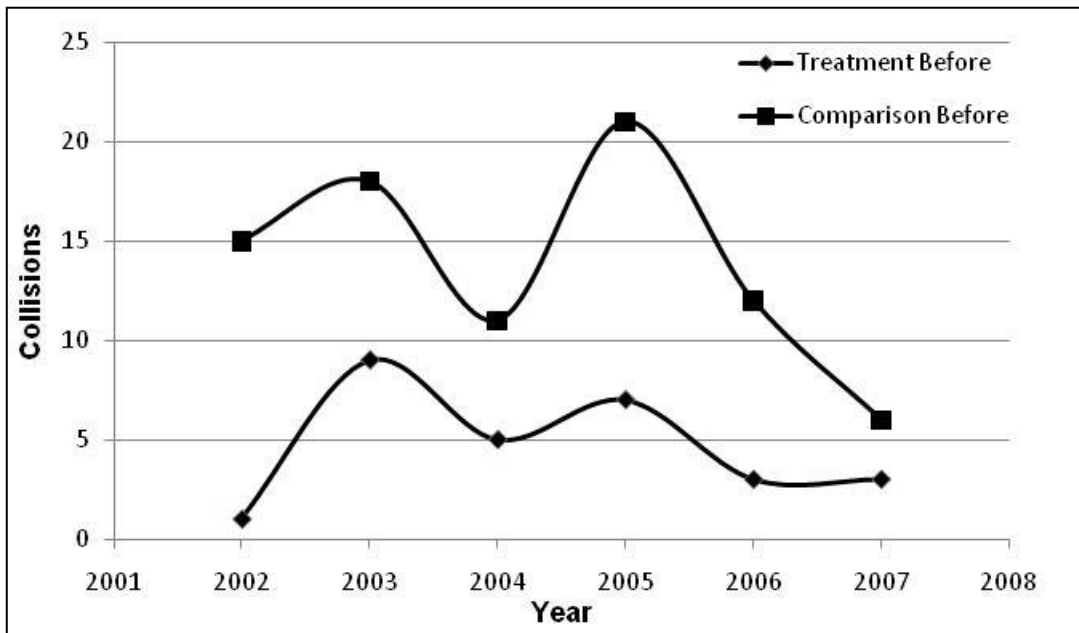
Figure 3.1 shows a plot of the total before collisions for US-74/441 and Barkers Creek Road/Wilmon Road and its comparison sites as an example to show if the collisions in both groups had similar trends. Figure 3.2 shows the total crashes for the signalized set of superstreets and their comparison sites in the before period using one start date. Similar to Figure 3.2, Figure 3.3 shows the crashes for the unsignalized set.

Figure 3.1. US-74/441 and Barkers Creek Road/Wilmont Road Collisions in the Before Period

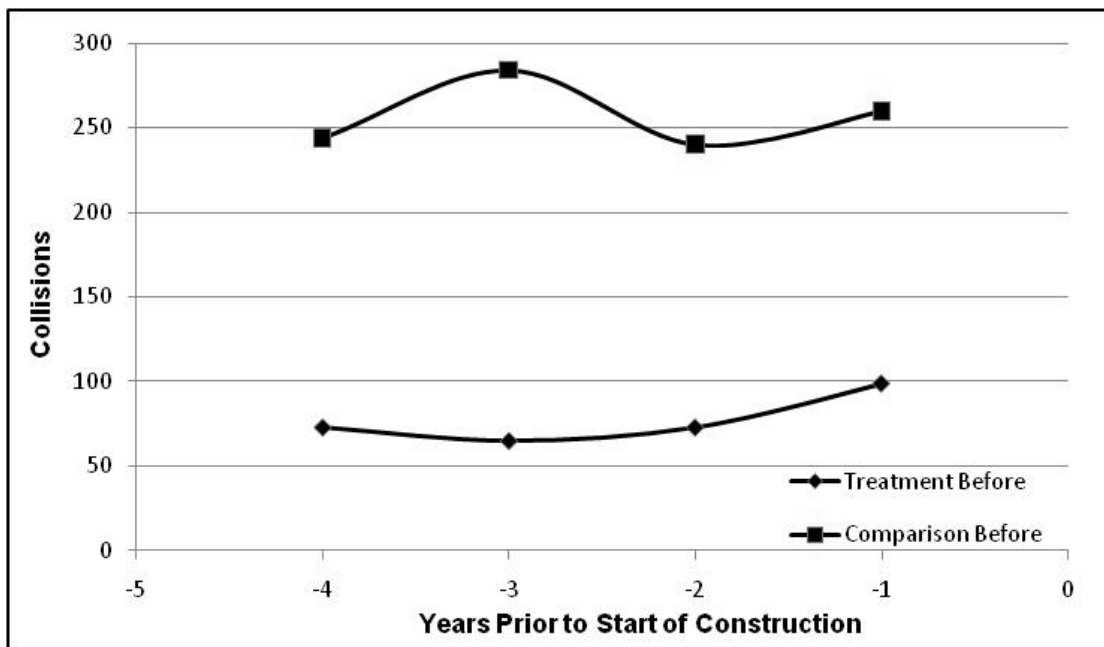
Figure 3.2. Signalized Superstreet and Comparison Site Collisions in the Before Period

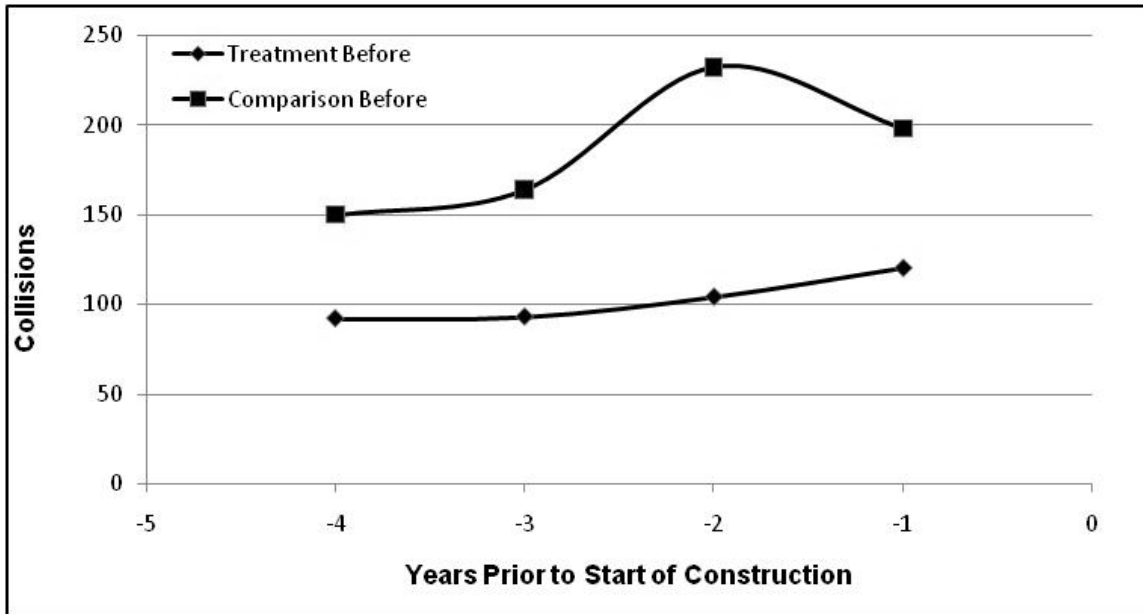
**Figure 3.3. Unsignalized Superstreet and Comparison Site Collisions in the Before Period**

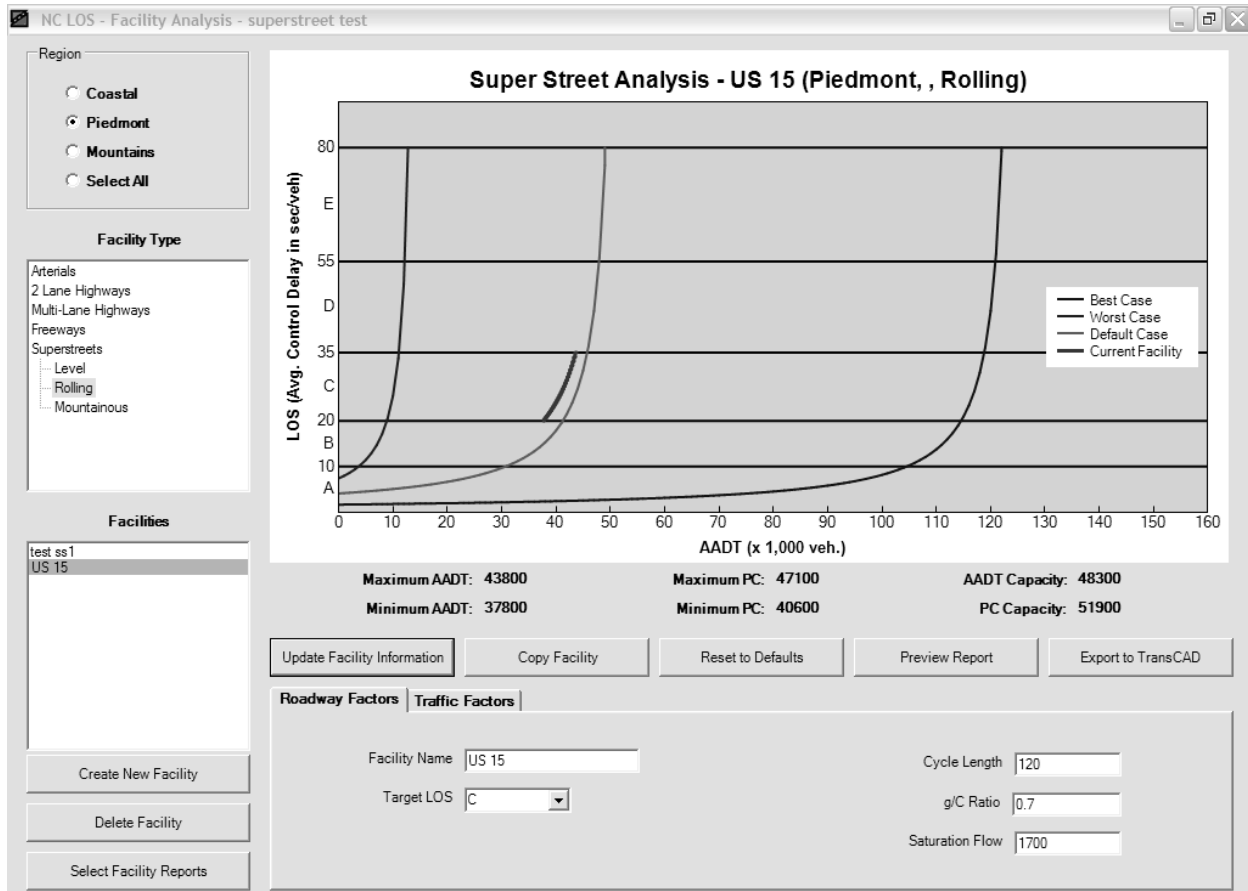
The screen shot on the previous page shows the display graph along with the roadway factor inputs (target LOS, cycle length, g/C ratio, and saturation flow rate). LOS C was selected and a plot of the LOS C range for AADT is shown in the graph with corresponding AADT values displayed just below the graph, including volumes for capacity (veh/day) and in passenger cars per day.
