STATE OF NORTH CAROLINA DEPARTMENT OF TRANSPORTATION

TIP NO: HB-0039 WBS: 50603.1.1

DESCRIPTION: Replace Bridge # 13 over Cape Fear River on US 421

SUBJECT: GeoEnvironmental Phase I Report

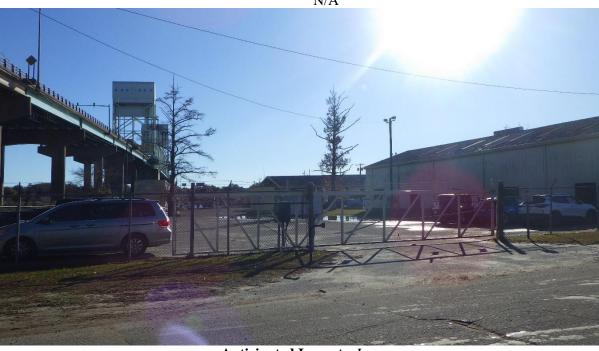
(01) Property Name:

Anticipated Impacts: Low

This site is currently the Engineer Yard owned by the US Army Corp of Engineer. The site is used as a repair and storage/maintenance facility. It is located on the east side of Battleship Rd at US 17 Business on the west of the Cape Fear River. In 1996 petroleum contaminated soil and groundwater was encountered while excavating for a new boat slip. Approximately 1000 tons of contaminated soil and 7300 gallons of contaminated water were removed from the site. Source of the contamination appeared to be from localized spills occurring from past operations at Eagle Island.

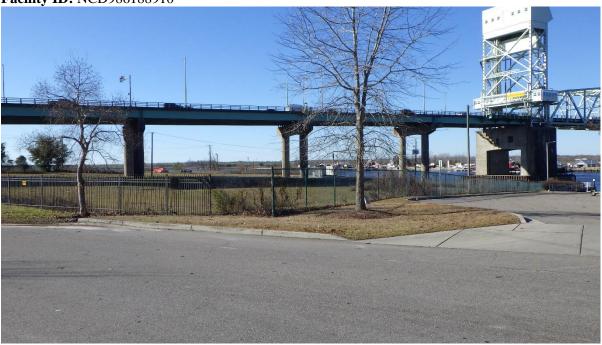
(02) Property Name:

Anticipated Impacts: Low-Medium

This parcel is currently a vacant lot. It is the former location of the Wilmington Manufactured Gas Plant. The site is listed as an Inactive Hazardous Waste Site under the Superfund Section. According to DEQ online reports, Bi-Annual groundwater sampling is currently on going. For the exception of one monitoring well the area of groundwater sampling appears to be outside the proposed study area.

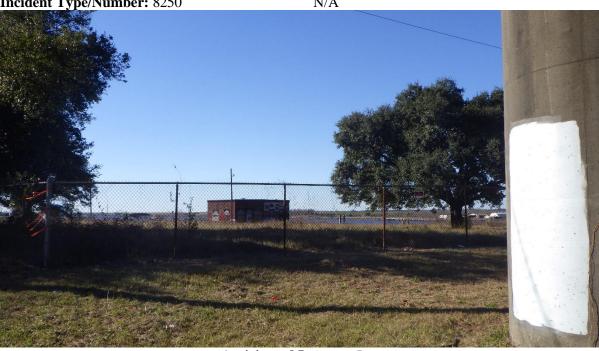
(03) Property Name:

Anticipated Impacts: Low

This parcel is currently a vacant lot. It was acquired by NCDOT as an advanced acquisition in May 2023. According to the October 20, 2022, Phase II Environmental Site Assessment provided by the former property minor soil and groundwater contamination is present at the property.

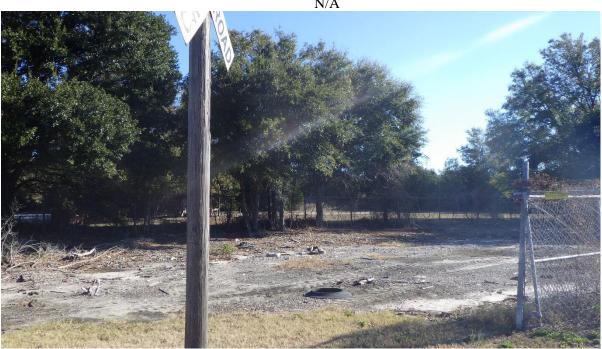
(04) Property Name:

Anticipated Impacts: Low-Medium

This vacant lot is part of the former Oil Refinery that operated at 801 Surry St from the 1970s to the mid-1990s. The facility was declared a superfund site in the mid-1990s. In 1997 the US EPA took over cleanup. The site was cleaned up and approximately 50,000 cubic yards of contaminated soil was removed. The area within the study area appears to be where the former office building was located. This site was identified as site 1 in the 2018 U-5734 GeoEnvironmental Phase I report.

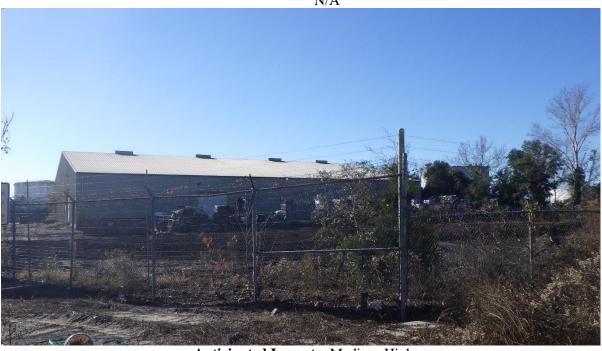
(05) Property Name:

Anticipated Impacts: Medium-High

This active Metal Recycling facility is located in the northwest quadrant of S. Front St and Wright St. The site is being cleaned up and is scheduled to permanently close December 22, 2023. The Facility is listed in the DEQ Waste management Superfund - Inactive hazardous site database. The facility is not listed in the UST Section Registry and there are no known incidents associated with it. This site was identified as site # 2 in the 2018 U-5734 GeoEnvironmental Phase I report.

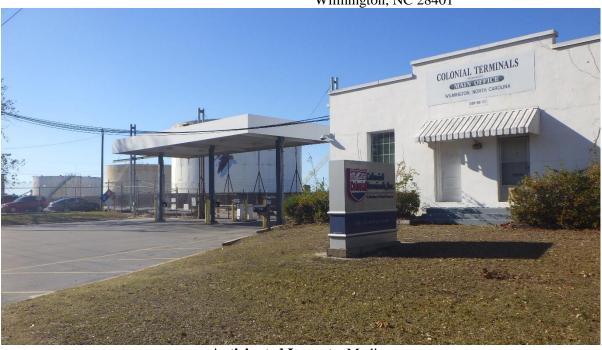
(06) Property Name:

Anticipated Impacts: Medium

This site currently operates as Colonial Fuels bulk storage facility. It is located on the southwest quadrant of S. Front St and Wright St. The facility occupies approximately 33 acres. The Facility is listed in the DEQ Waste management Superfund - Inactive hazardous site database. It is listed as a large quantity generator. There are numerous bulk storage ASTs on the property and several incidents are associated with the site. According to the UST Section Registry there is one current 1000-gallon oil/water separator. One tank was closed in 1955, two in 1976, one in 1978 and one in 1994. There were several monitoring wells observed during the site investigation. This site was identified as site # 4 in the 2018 U-5734 GeoEnvironmental Phase I report.

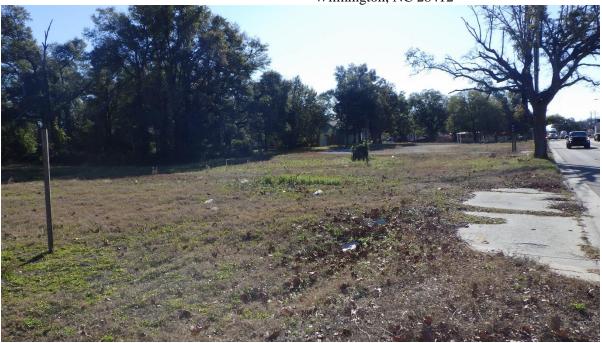
(07) Property Name: DTS LLC Property 102 Wright St Wilmington, NC 28401

Anticipated Impacts: Low

This site is currently a vacant lot. It is located on the east side of S. Front between Wright St and Meares St. It is the former location of Springer Eubanks Bulk Plant. According to the UST Section Registry four (4) tanks were removed in 1993. Incident # 19136 is associated with this facility and was closed out in 2004. There is a possible old pump island located in the middle of the gravel lot. No monitoring wells were observed during the site investigation. This site was identified as site # 3 & 5 in the 2018 U-5734 GeoEnvironmental Phase report. This property (parcel 019_U-5734) was investigated in August 2023 for advanced ROW acquisition. NO USTs or contamination were identified.

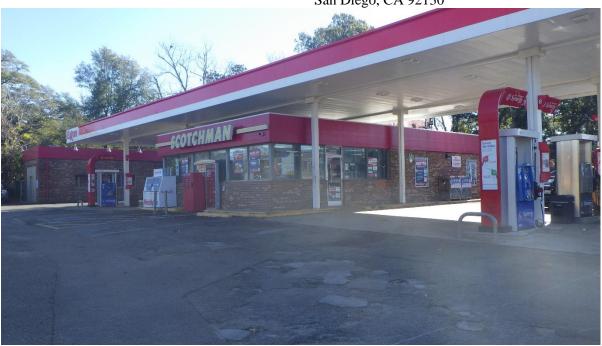
(08) Property Name:

Anticipated Impacts: Low

This site currently operates as a convenience store/gas station. It is located on the southeast quadrant of S. 3rd St and Dawson St. According to the UST Section Registry there are four USTs currently in use. Incident #'s 14965 and 48249 are associated with this site and both have been closed out. Four monitoring wells that appeared to be abandoned were observed during the site investigation. There is a "Notice of Residual Petroleum" attached to the property deed.

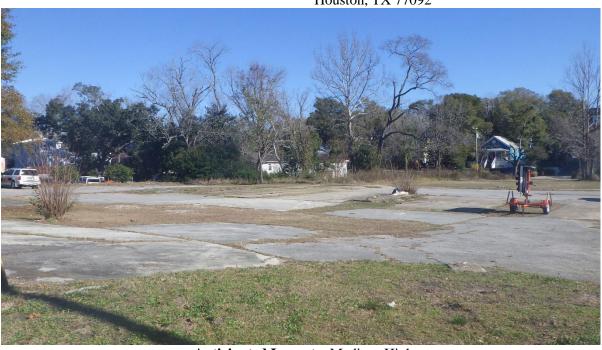
(09) Property Name:

Anticipated Impacts: Medium-High

This site is currently a vacant lot. It is the former location of Exxon # 4-3957. It is located on the northeast quadrant of S. 3rd St and Wooster St. According to the UST Section Registry seven USTs were removed in 1993. Incident # 10031 is associated with this site and was closed out in 1998. The site was turned over to Inactive Hazardous Waste Section for the Tetrachloroethane (PCE) contaminated groundwater identified in a 1998 phase II investigation. The source of PCE contaminated groundwater is unknown and may be from an off-site source. In October 2021 the current property owner submitted Brownfields Property application and Consent Fee. On February 9, 2022 DEQ issued a Letter of Eligibility. A 2022 Phase II conducted for the prospective developer identified PCE and Vinyl chloride above DEQ 2L standards but below the Non-Residential groundwater screening levels in one groundwater sample. No monitoring wells were observed during the site investigation.
