North Carolina Department of Transportation
Materials and Tests Unit – Product Evaluation Program
Innovative Technologies and Products Awareness Report
January 6th, 2021

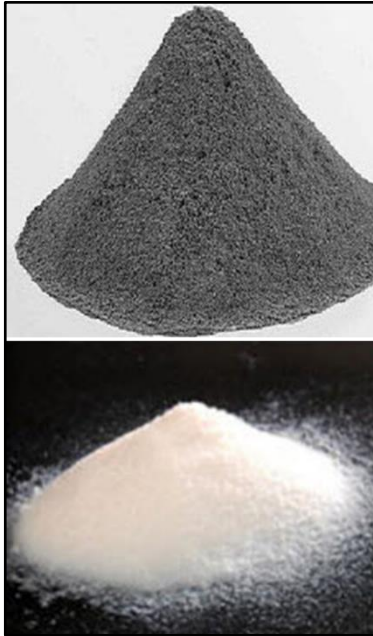
*Samples of Silica Fume – images
from R-E-D website*

RED 104OG and 104OGA are Silica Fume products manufactured by Reliable, Efficient, Dependable (R-E-D) Industrial Products out of Burnsville, Mississippi and Montgomery, Alabama. They are currently approved for use on the Approved Products List (APL) as NP19-8575 (RED 104OG), and NP19-8576 (104OGA). Silica Fume products are mainly used as a pozzolanic material in high performance concrete applications, and where greater resistance to chloride penetration is needed, such as parking structures, bridges, and bridge decks. These products enhance the concrete's compressive strength and durability, while reducing permeability, porosity, viscosity, and the set time of cement-based materials. Both products are comprised of 100% recycled materials using off gases from silicon metal and ferrosilicon alloy production high in SiO₂ to produce a value-added product from a waste stream. For more information, please visit: www.redindustrialproducts.com

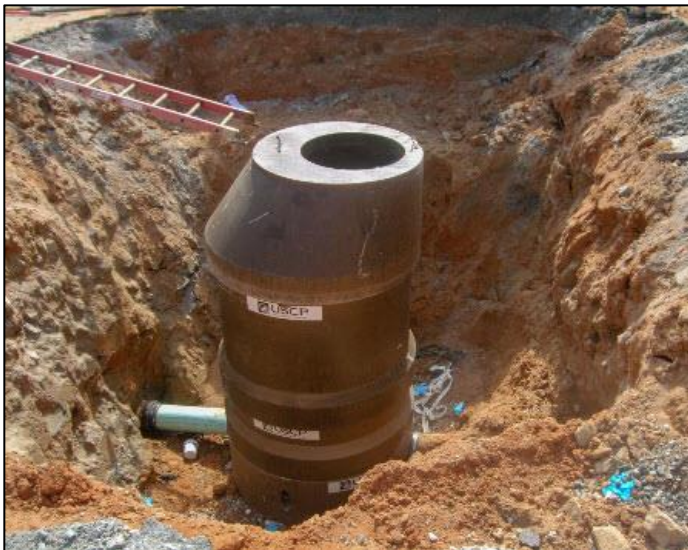
*Installation of USCP Steel Reinforced Polymer
Manhole – photograph from USCP website*

The USCP Steel Reinforced Polymer Manhole is manufactured by U.S. Composite Pipe, Inc. out of Alvarado, Texas. It is currently listed as under evaluation on the APL as NP19-8573. Polymer concrete manholes are used in corrosive environments without the need for a coating or liner to protect them. They can be installed in field conditions with a pH range of 1 to 13, and have a typical design compressive strength of 9,000 psi. The USCP Steel Reinforced Polymer Manhole is available in a range of diameters from 48" to 192". They can be field cored should additional lines be needed later, and the tops are HS-20 rated. For more information, please visit: www.uscompositепipe.com/manholes/
