NCDOT Traffic Safety Unit Programs

Safety Edge Implementation Study

NCDOT completed a study of the constructability and durability of resurfacing with safety edge. Safety edge has been placed on hundreds of miles of roadway in North Carolina since 2008.

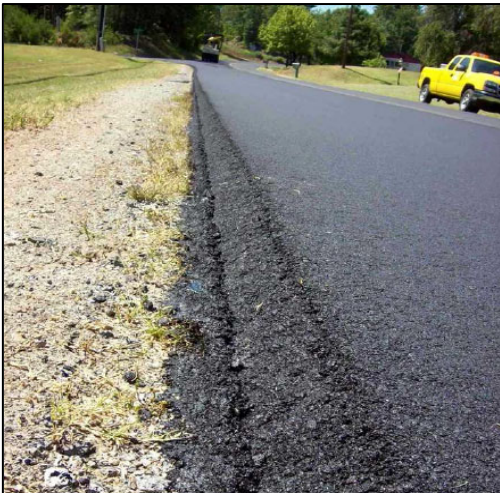
SR 1611 in Burke County: Resurfacing With Safety Edge

When applied correctly during resurfacing, safety edge provides a 30 degree pavement edge, rather than the standard pavement edge that is approximately 45-60 degrees with a non-shaped and non-formed edge that crumbles and breaks off leaving a potential 90 degree pavement edge. Because it minimizes the slope of the exposed pavement edge, safety edge may reduce crashes where the shoulder drop off was a contributing factor in the crash at no additional cost to paving projects.

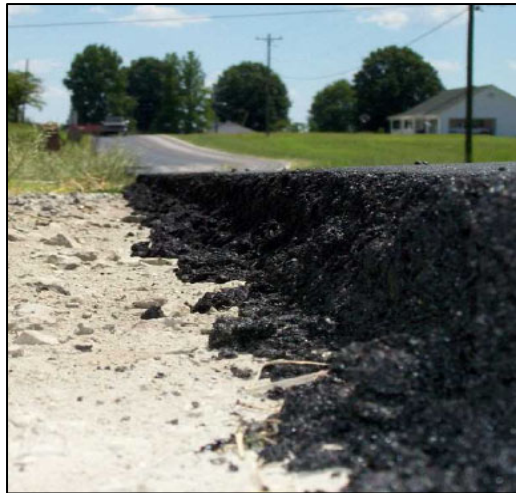
SR 1611 in Burke County: Resurfacing Without Safety Edge

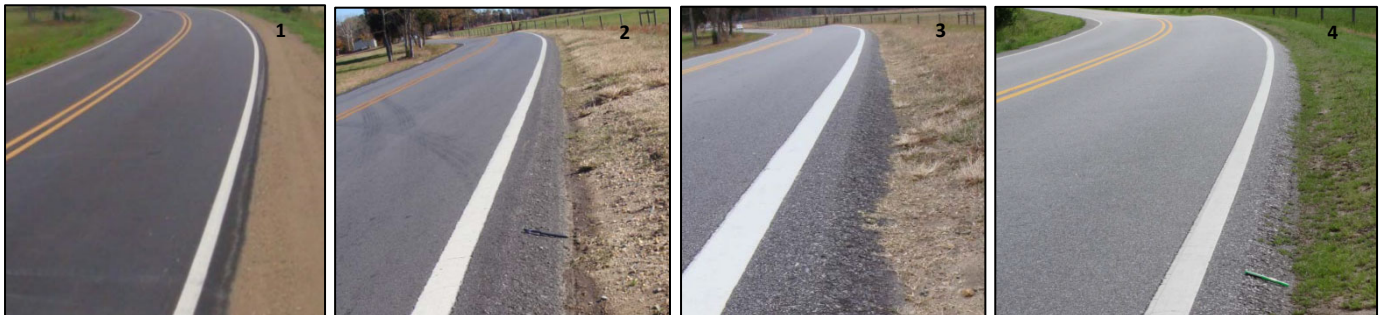
SR 1007 in Johnston County (1) initially after the shoulders were pulled, and at (2) 13 months, (3) 19 months, and (4) 37 months after resurfacing.

The results show that safety edge is constructible, and seems to hold up well over time. Pilot locations in Johnston and Iredell Counties were observed for up to 3 years to monitor how well the pavement edge holds up over time. Below are photos of a successful application at varying periods post-installation.
