NC DEPARTMENT OF TRANSPORTATION  
DIVISION OF HIGHWAYS  
BRIDGE MANAGEMENT UNIT

# BRIDGE INSPECTION REPORT

INSPECTION TYPE: Damage Inspection Report

COUNTY CATAWBA BRIDGE NUMBER 170142 INSPECTION CYCLE 0 YRS  
ROUTE SR1692 ACROSS US321 M.P. 0

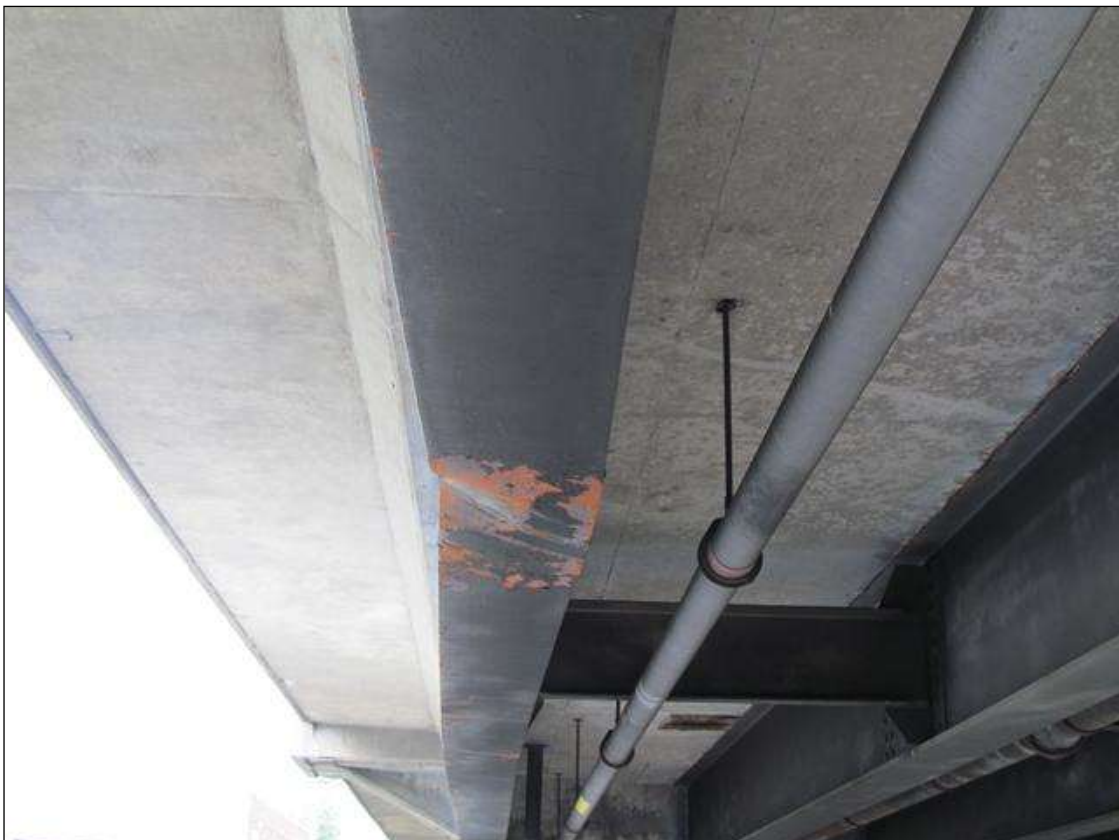
BEAM 6 OUT OF PLUMB

LOOKING AT BEAM 6

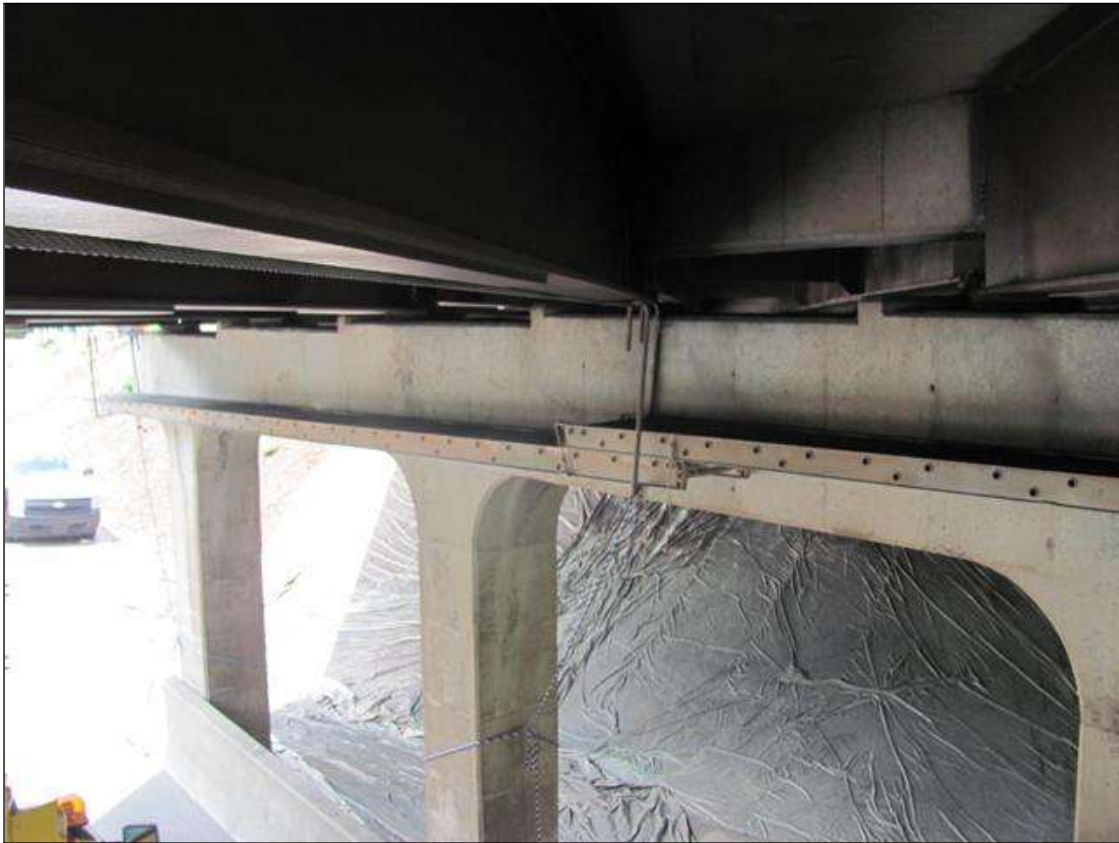
IMPACT ON GIRDER # 7 WAS 23'-11" FROM THE FACE OF BENT 1

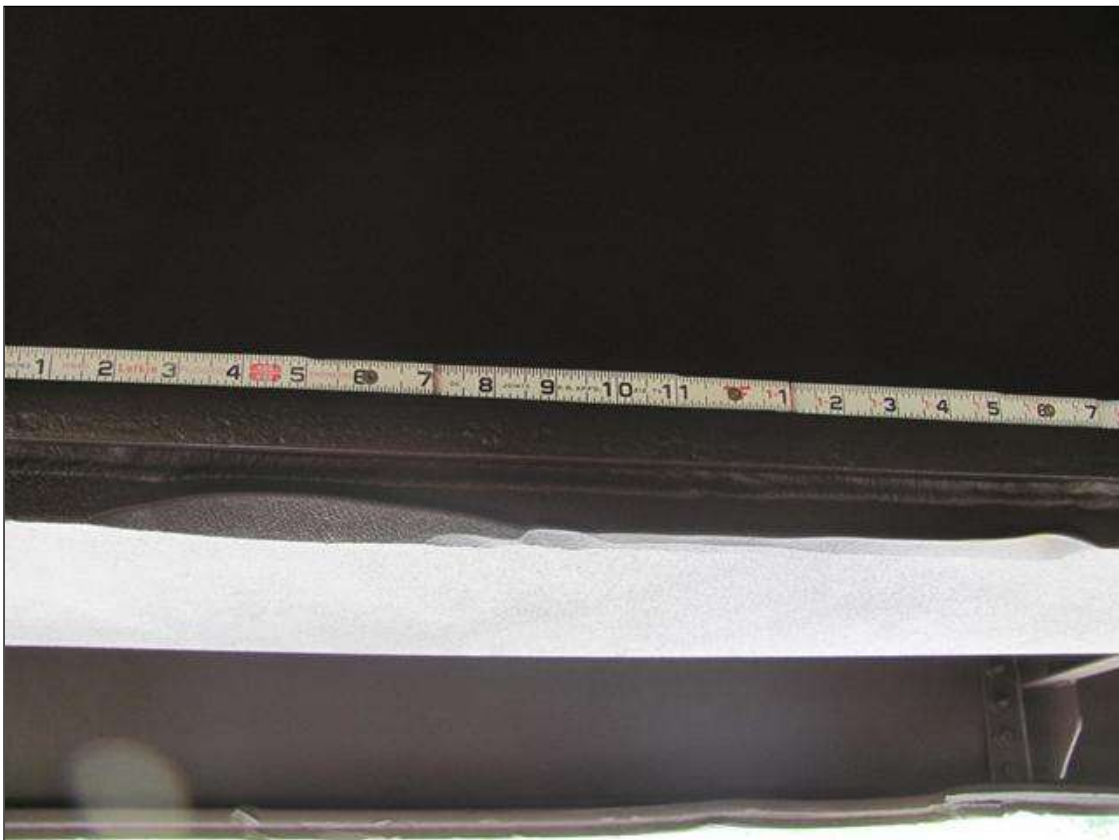
INDENTION ( 1'-7" X 1/16" ) IN COVER PLATE @ 19'-4" FROM THE FACE OF BENT 1. GIRDER 8

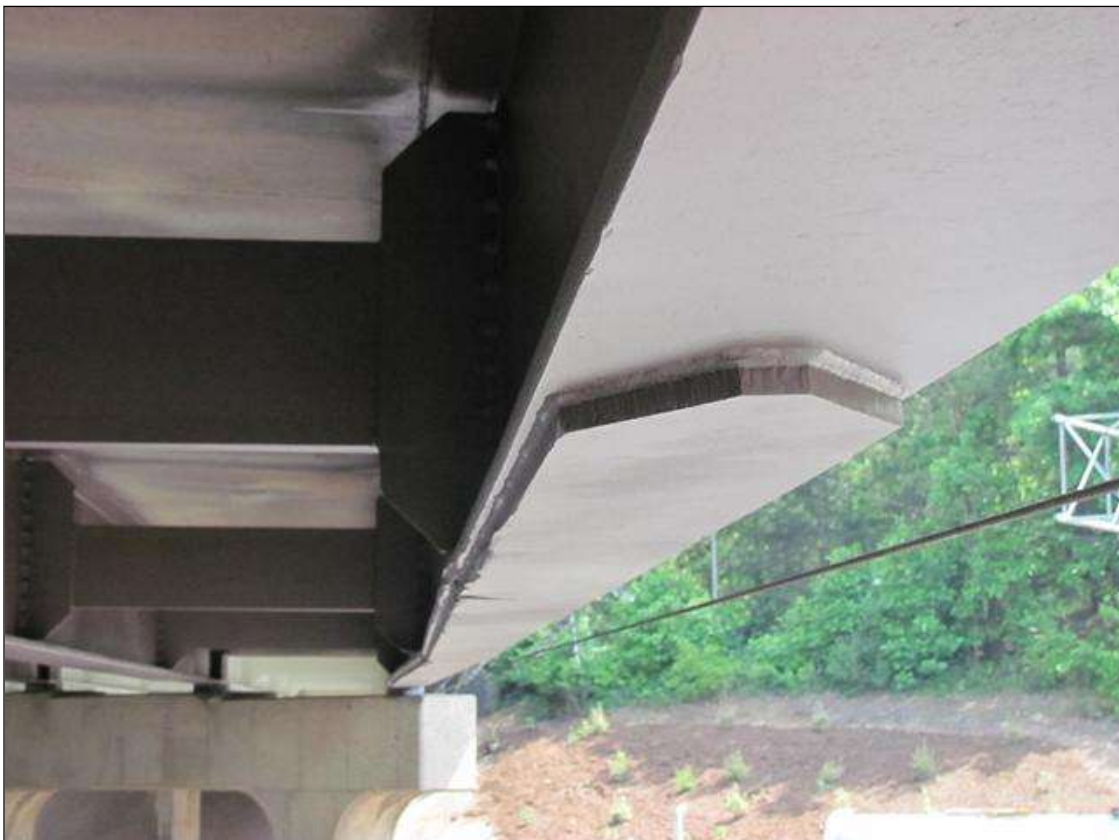
DIAPHRAGM BOLTS ARE LOOSE. FOUR HAVE NO WASHERS. GIRDER 10

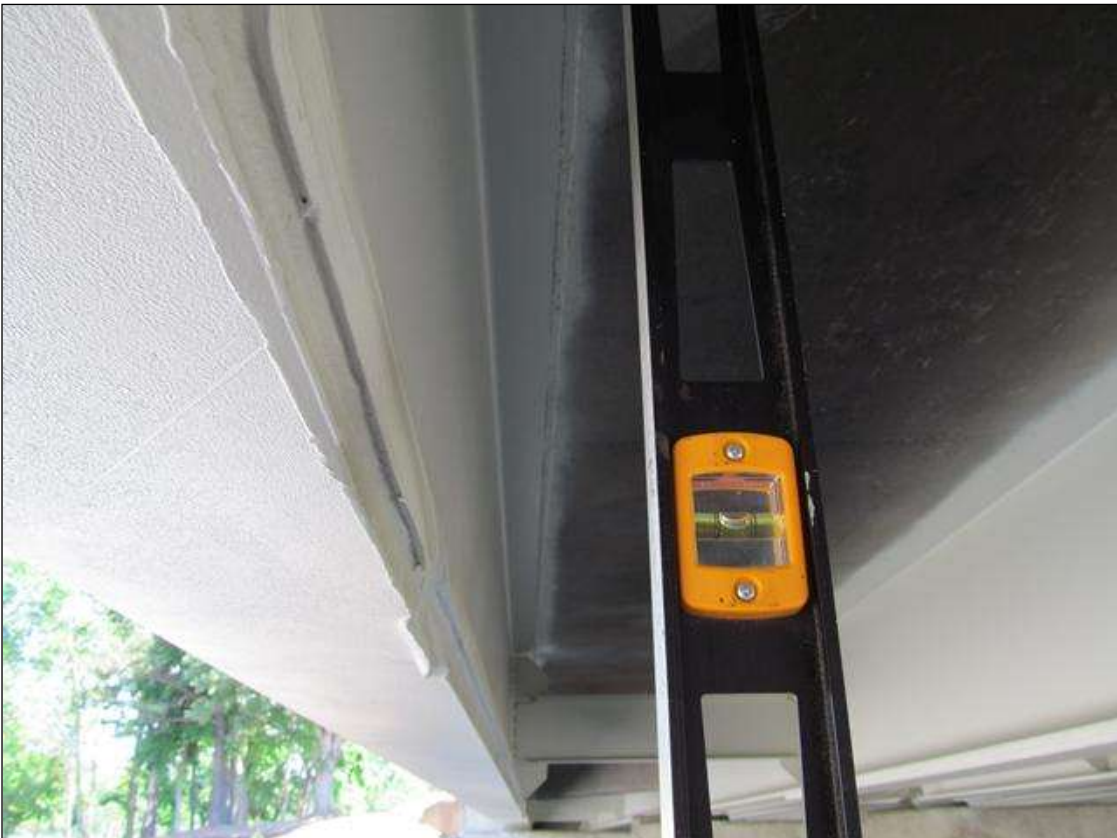
GIRDER 10 IS OUT OF PLUMB ( 4 1/4" ) @ 37'-5" FROM THE FACE OF BENT 1

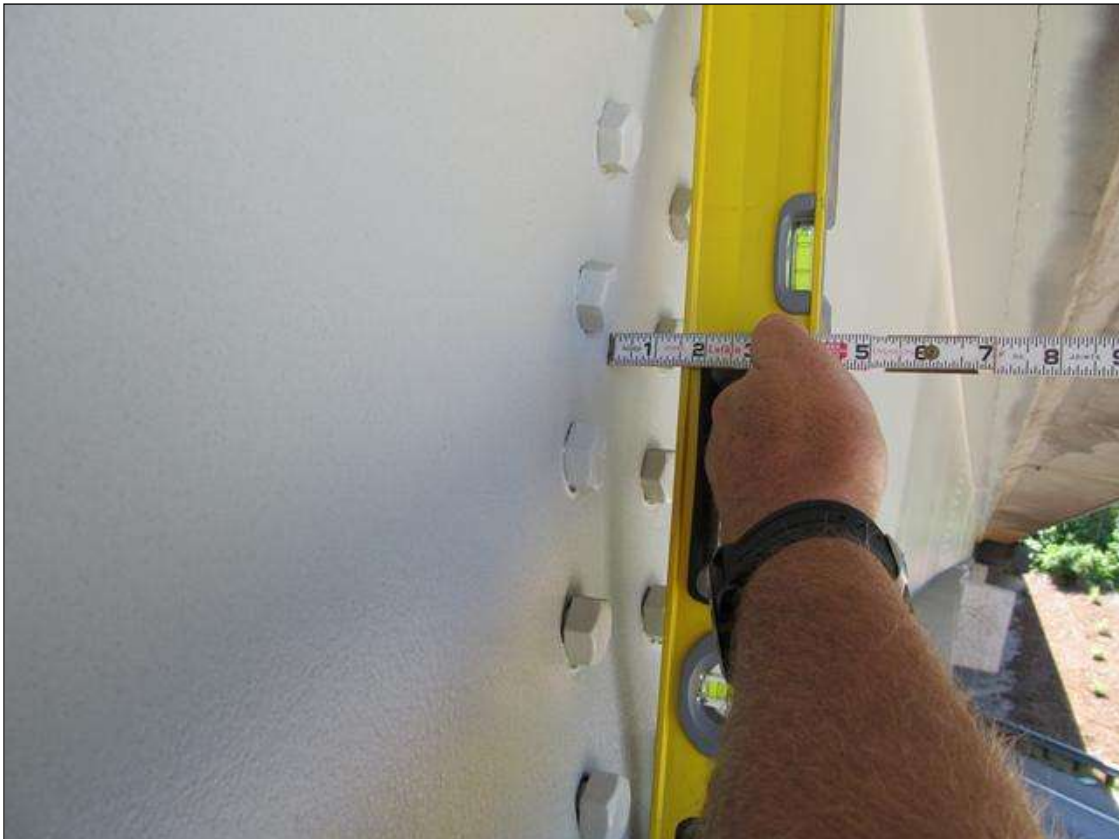
1 1/2" BOW IN GIRDER 10 WEB @ 39'-11" FROM THE FACE OF BENT 1

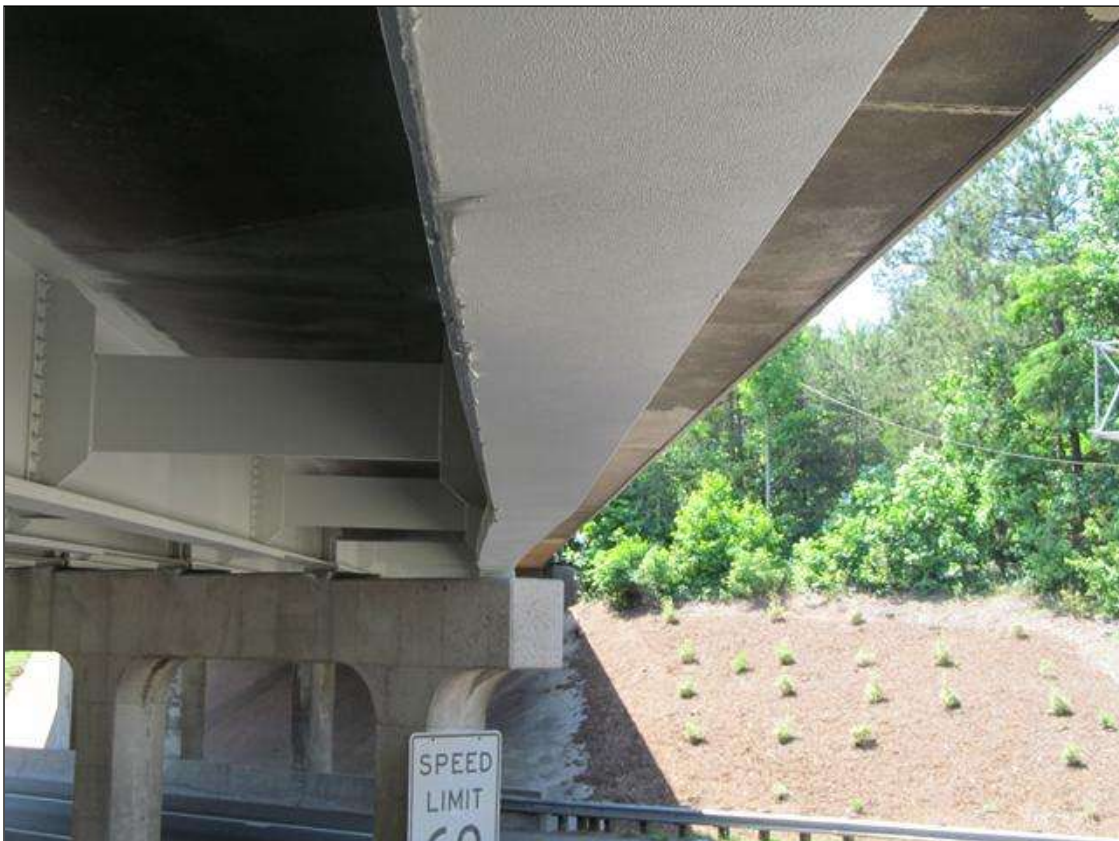
14 DIAPHRAGM BOLTS WITHOUT WASHERS AND 8 WITH WASHERS @ 39'-11" FROM THE FACE OF BENT 1.  
GIRDER 10

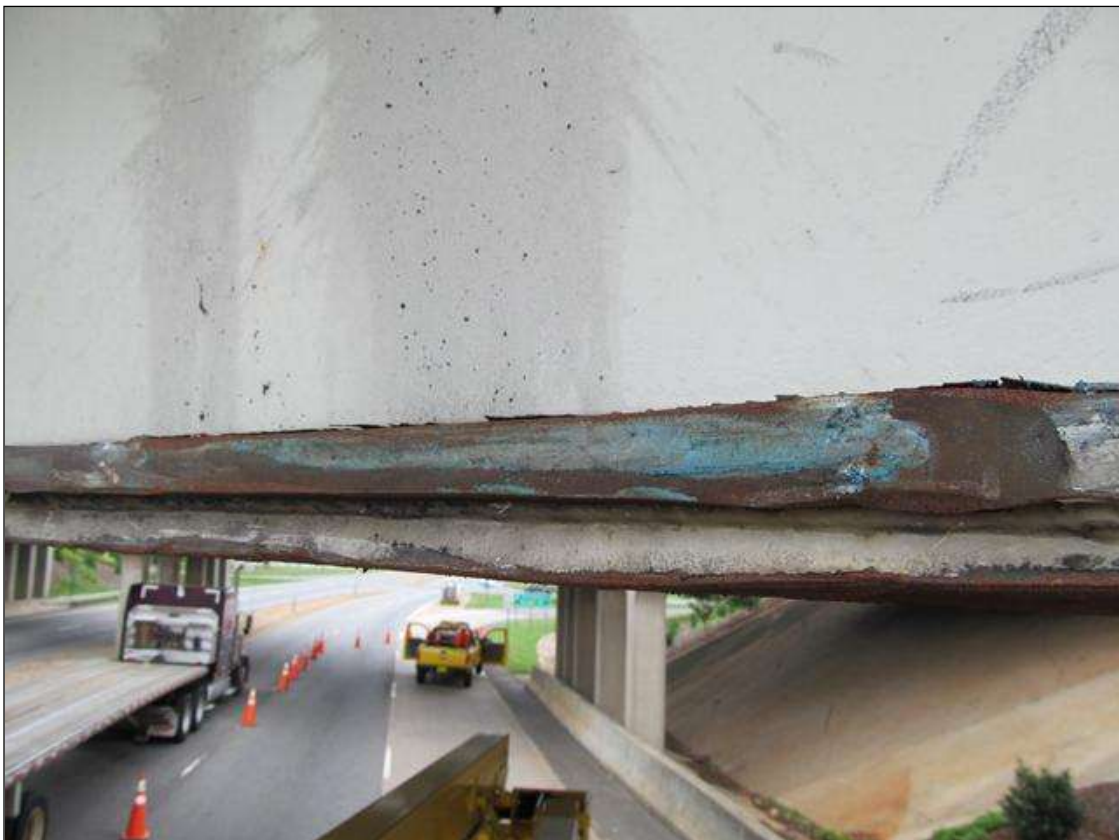
AN INDENTION IN FLANGE FROM 33'-10" TO 24'-4" FROM THE FACE OF BENT 3. BEAM 4,

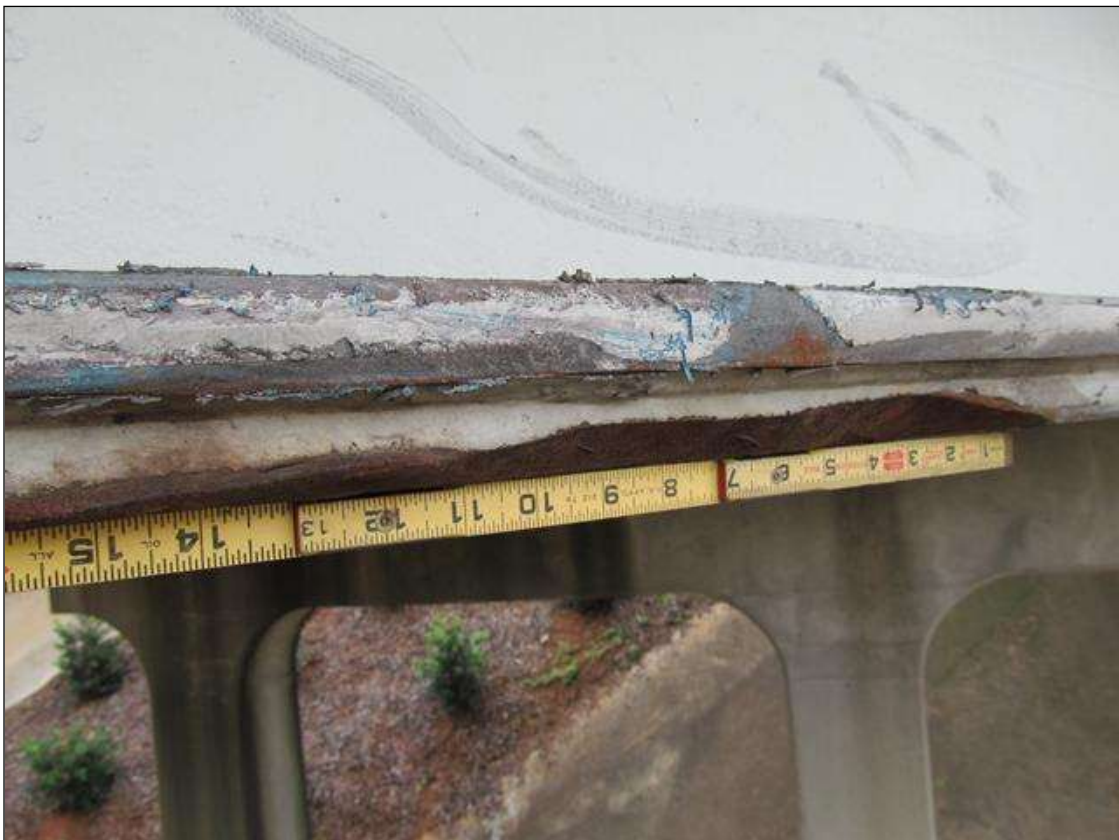
INDENTION ( 48" X 3/4" ) IN COVER PLATE @ 23'-0" FROM THE FACE OF BENT 3. BEAM 4,

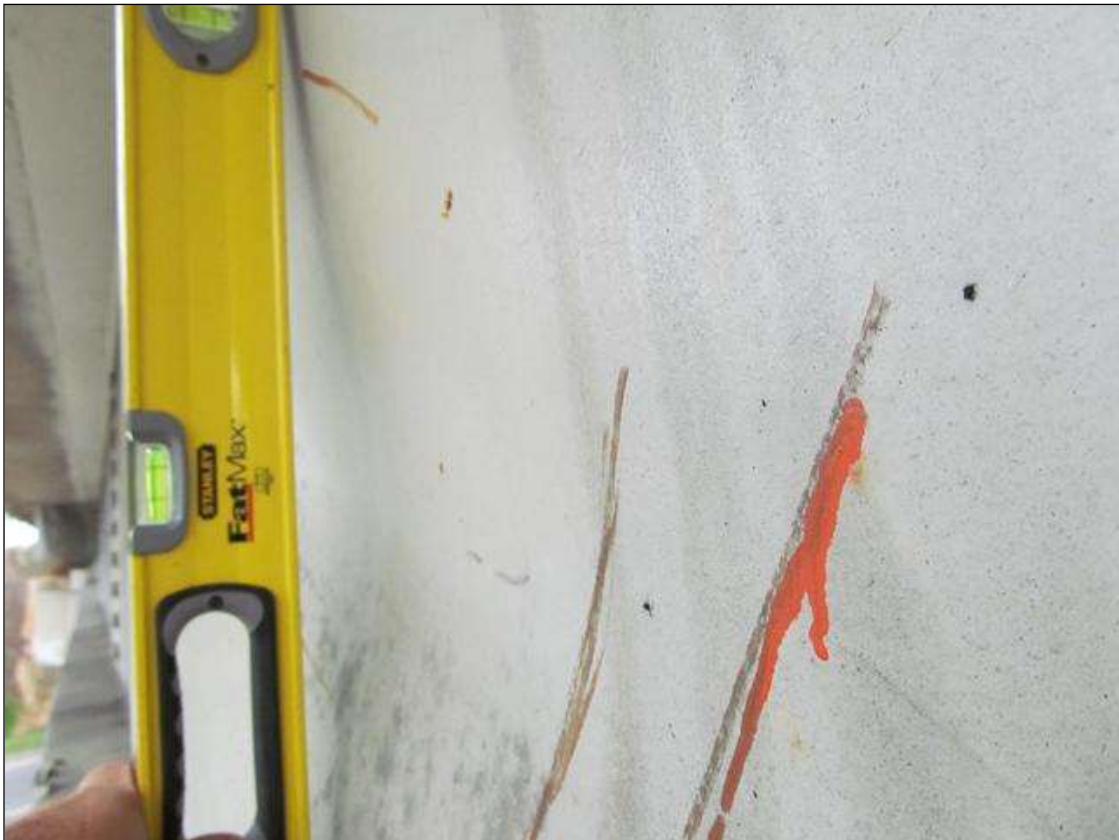
WEB OF BEAM 4 IS BENT (  $1 \frac{1}{2}$ " ) INWARD @ 30'-4" FROM THE FACE OF BENT 3. BEAM 4, SPAN 3

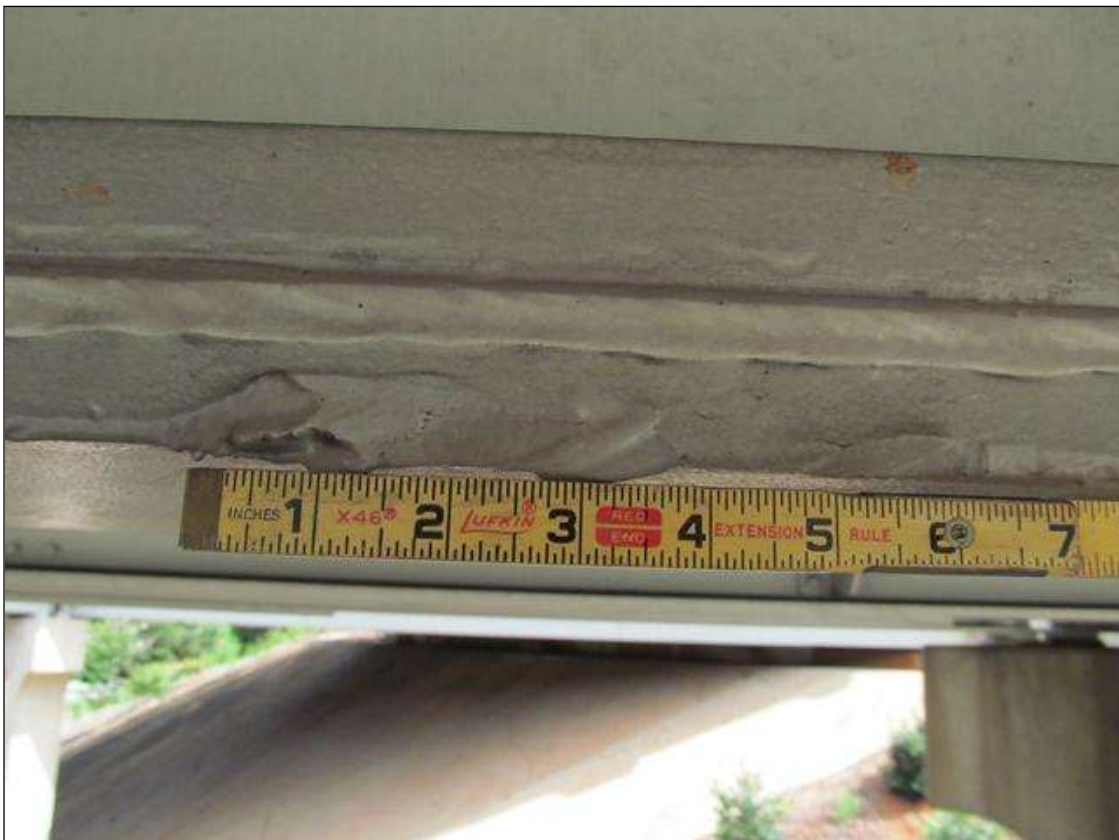
INDENTATION ( 6" X 1/4" ) IN COVER PLATE @ 23'-2" FROM THE FACE OF BENT 3. BEAM 3, SPAN 3

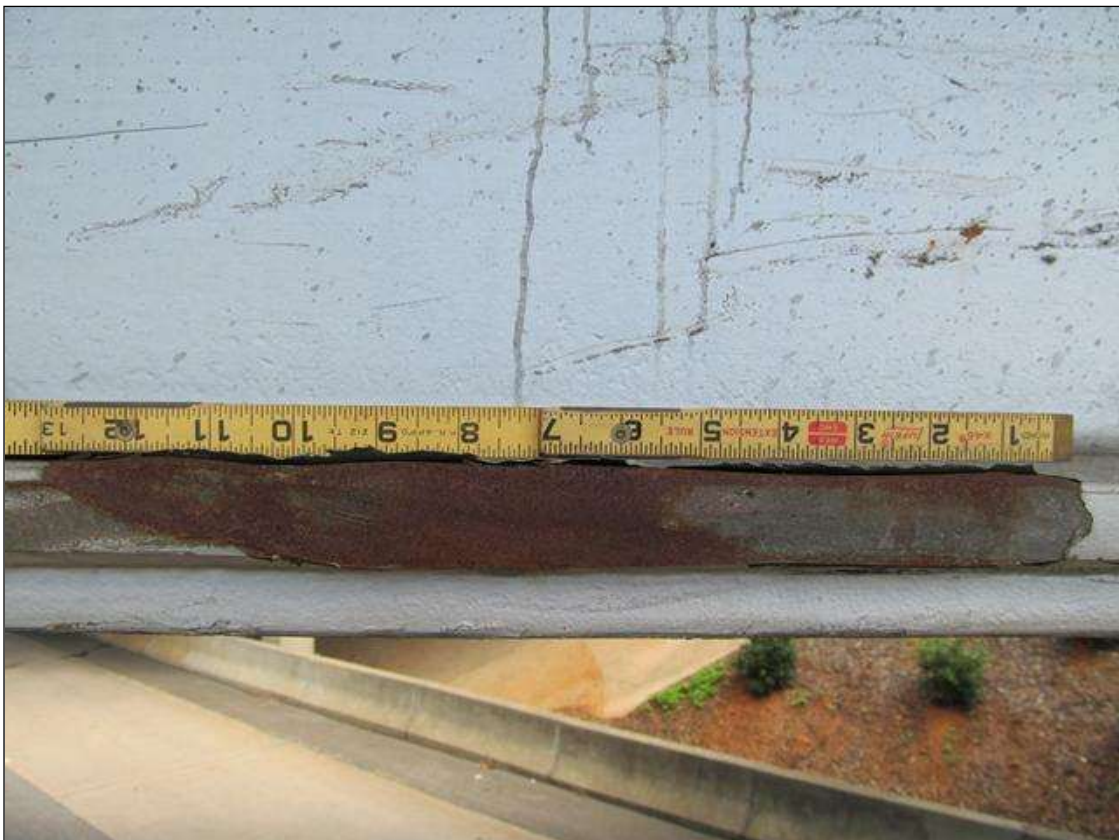
INDENTATION ( 13" X 1/4" ) IN FLANGE ON BEAM 4 @ 21'-2" FROM THE FACE OF BENT 2. BEAM 4, SPAN 3

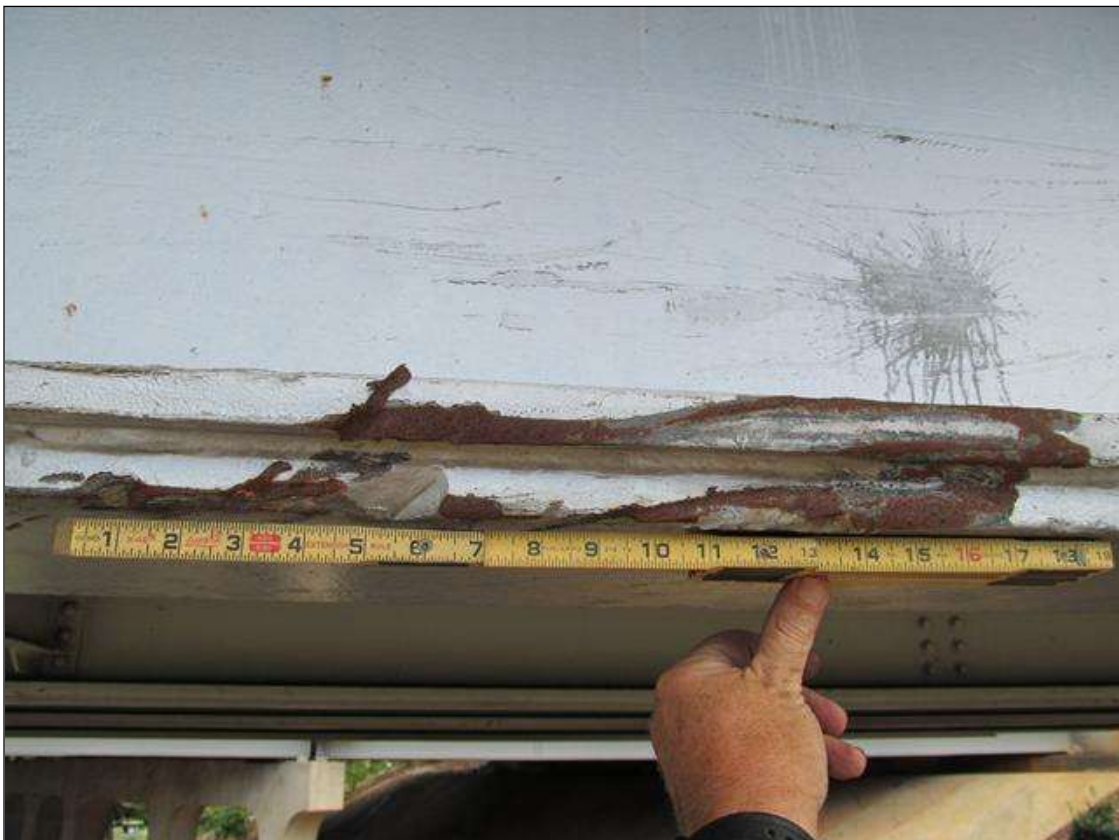
INDENTIONS IN FLANGE AND COVER PLATE @ 16'-2" FROM THE FACE OF BENT 2. BEAM 4, SPAN 3

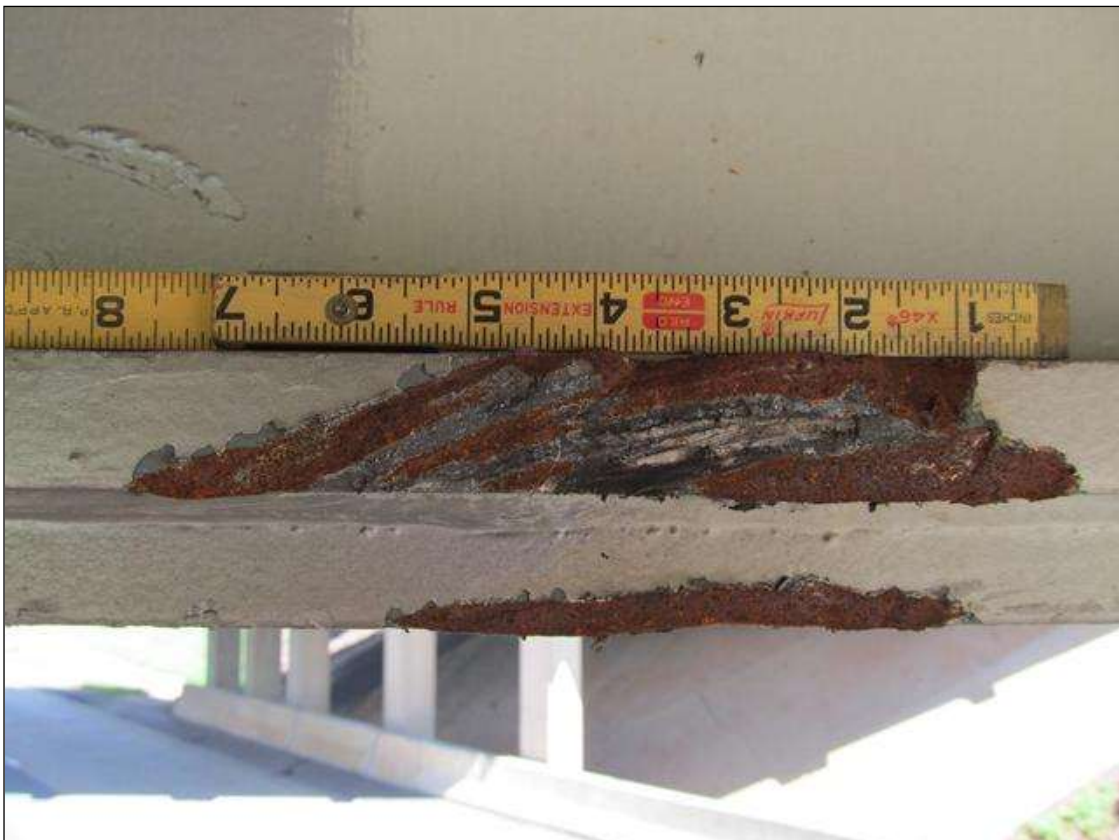
INDENTION IN FLANGE ( 8" X 1/4" ) AND COVER PLATE ( 5" X 1/16" ) @ 14'-5" FROM THE FACE OF BENT 2.  
BEAM 3, SPAN 3

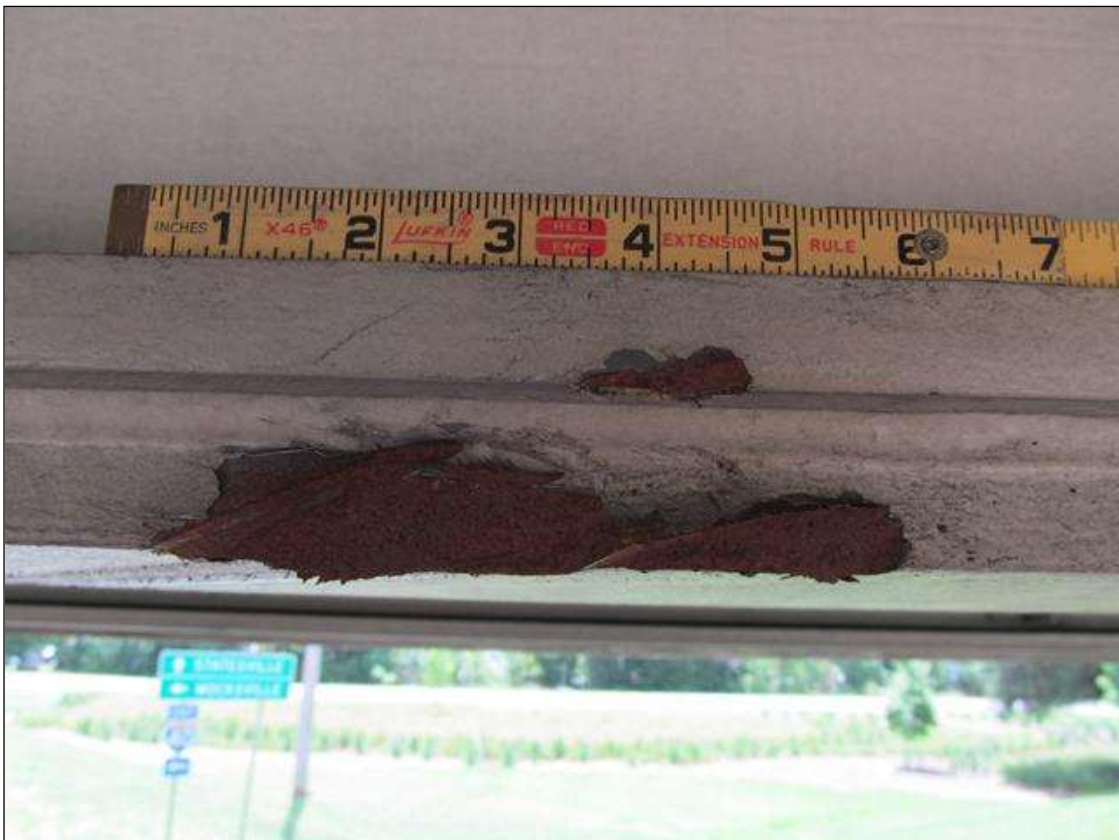
POINT OF IMPACT ON BEAM 2 @ 21'-6" FROM THE FACE OF BENT 2. BEAM 2, SPAN 2

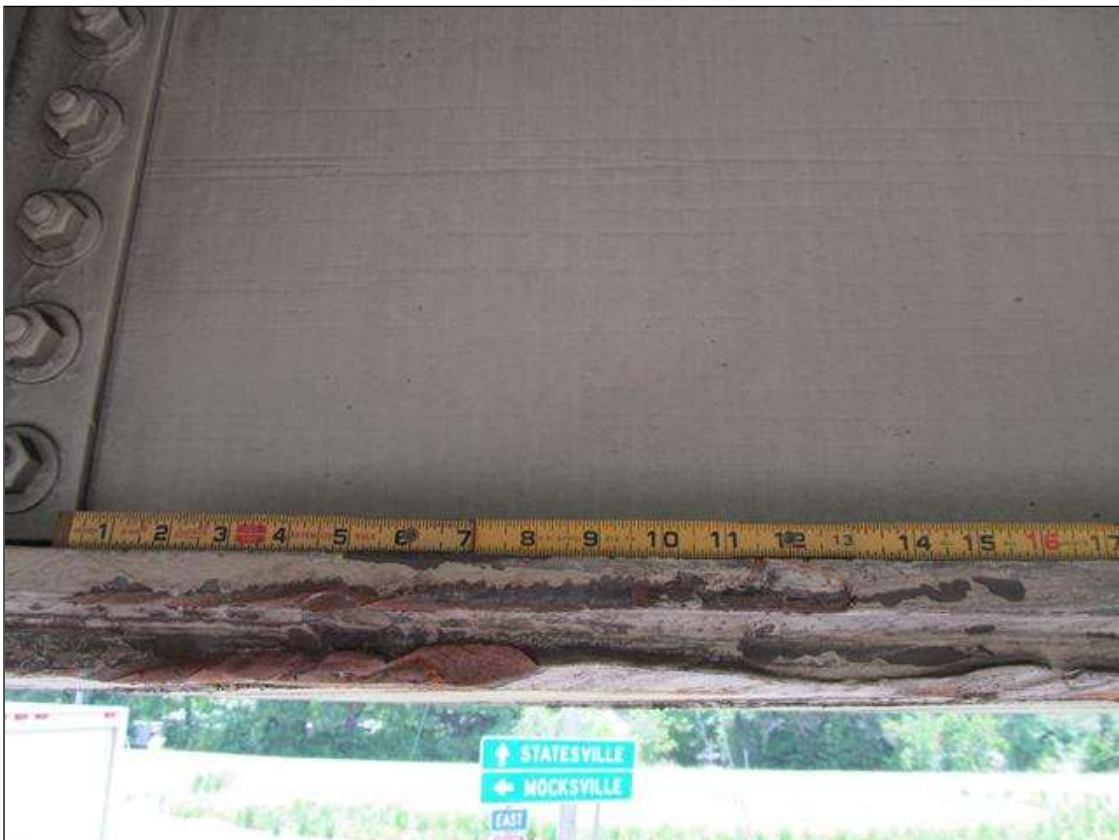
POINT OF IMPACT ON BEAM 4 @ 19'-1" FROM THE FACE OF BENT 2. BEAM 4, SPAN 2
