NC DEPARTMENT OF TRANSPORTATION
 DIVISION OF HIGHWAYS
 STRUCTURE MANAGEMENT UNIT

Structure Safety Report

Supplemental Element Inspection

DIVISION: 13 COUNTY: BUNCOMBE STRUCTURE NUMBER: 100387 FREQUENCY: None

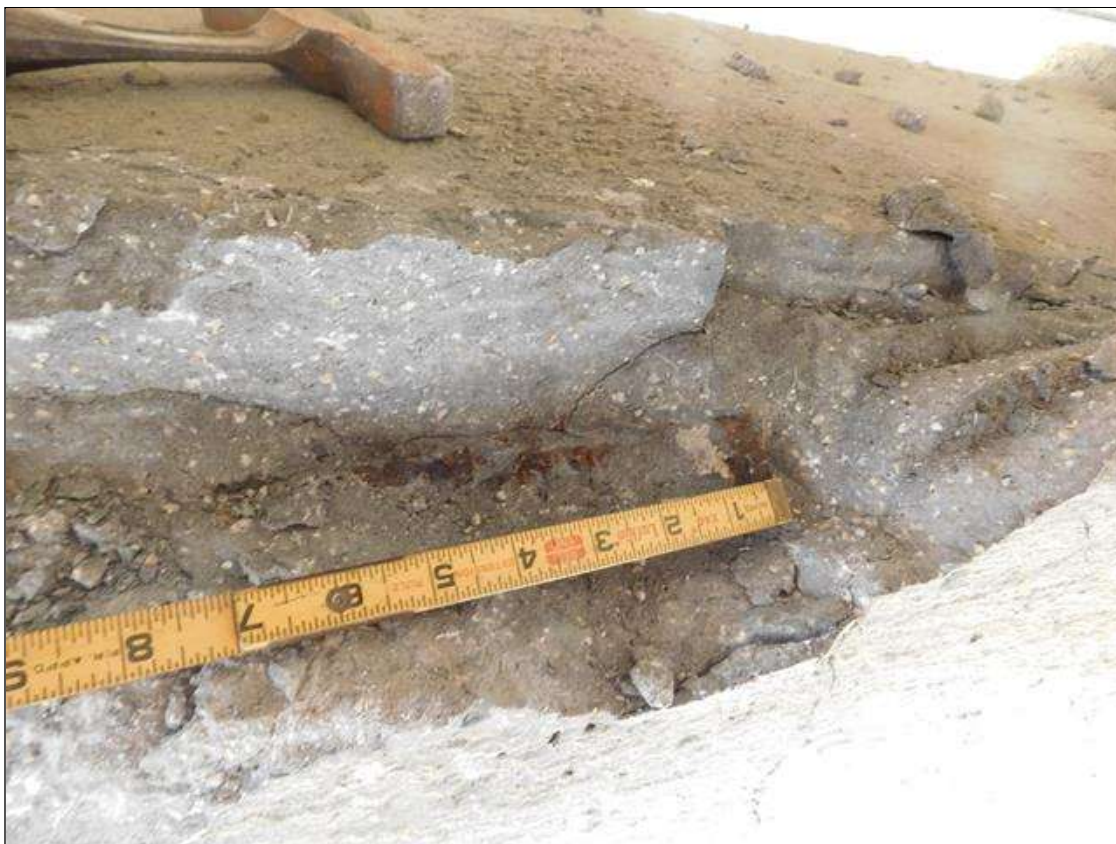
INT. BENT 1 CAP SPALL 26" LONG X 9" HIGH X 5" DEEP AT 8'-6" FROM EAST END BAY 3 WITH 1 REINFORCING BAR EXPOSED (PAR)

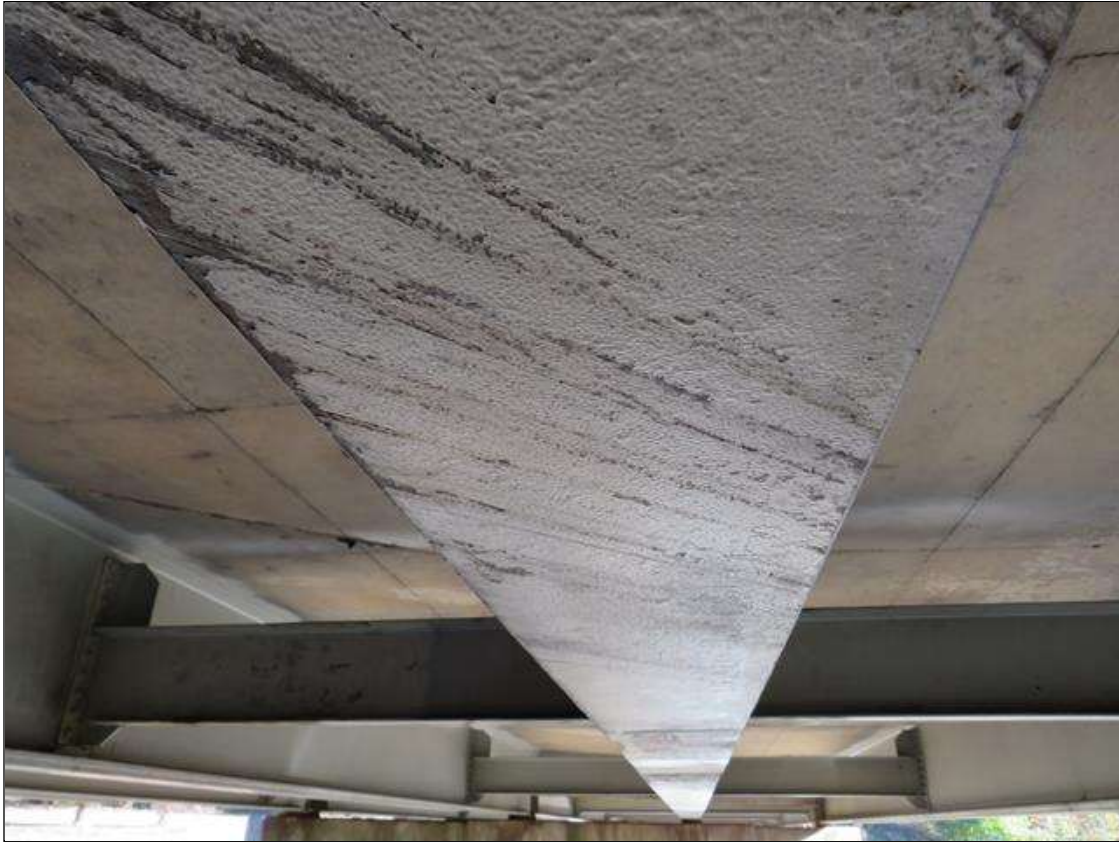
Span 2 Beam 3: SUPPLEMENTAL INSPECTION 2021: Point of impact on beam 3 West approach slab 26'-1" from face of bent 1. Beam 1 is out of plumb 2 1/2" +/- in the direction of traffic and a indentation in cover plate 3" X 1/2" and a 2" X 1/2" in the impact area.

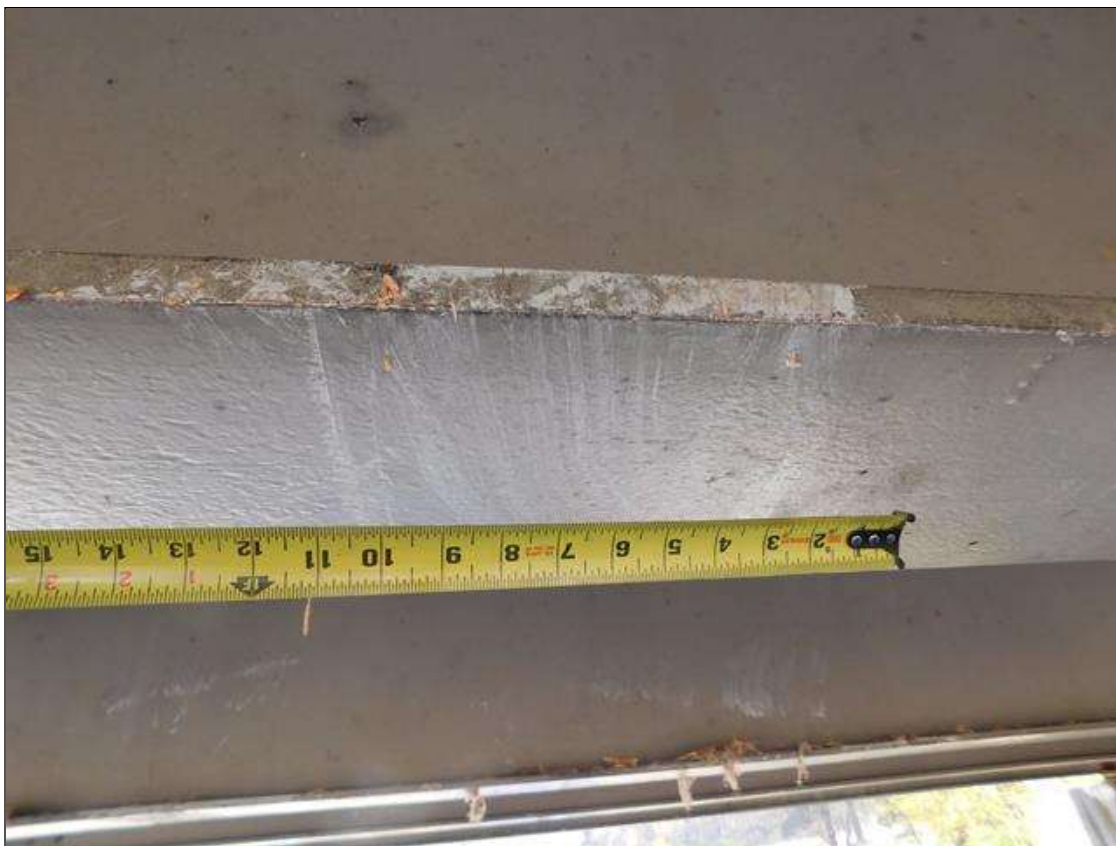
Span 2 Beam 2: SCATTERED SCRAPES TO BOTTOM FLANGE THROUGHOUT BEAM 2

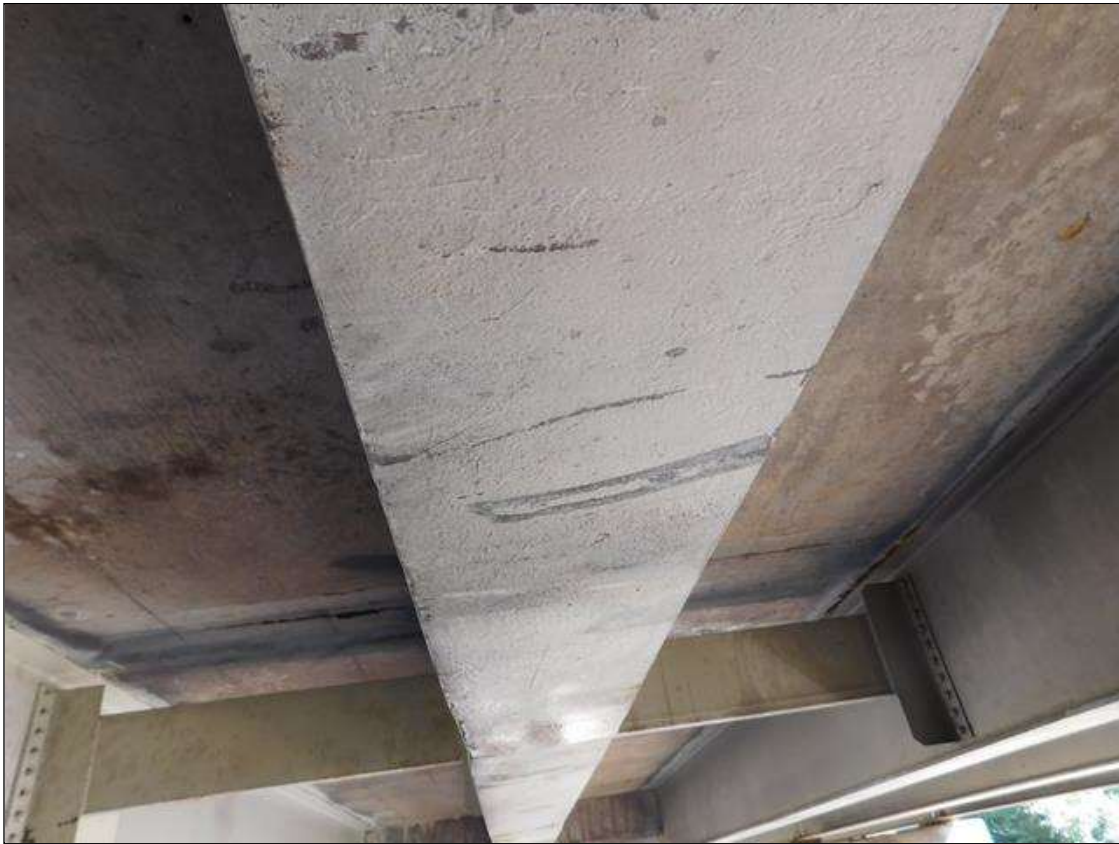
Span 2 Beam 2: SUPPLEMENTAL INSPECTION 2021: POINT OF IMPACT 8" LONG WITH A 1/2" DEEP GOUGE AT 18'-8" FROM INT. BENT 2 , WITH BEAM BEING SWEEPED EASTWARD 1/2". SCATTERED SCRAPES ALONG THE BEAM (PAR) THERE IS A BENT UP SECTION ON THE WEST BOTTOM FLANGE 4" LONG X 1" HIGH AT 20' OUT FROM INT. BENT 1 (PAR)

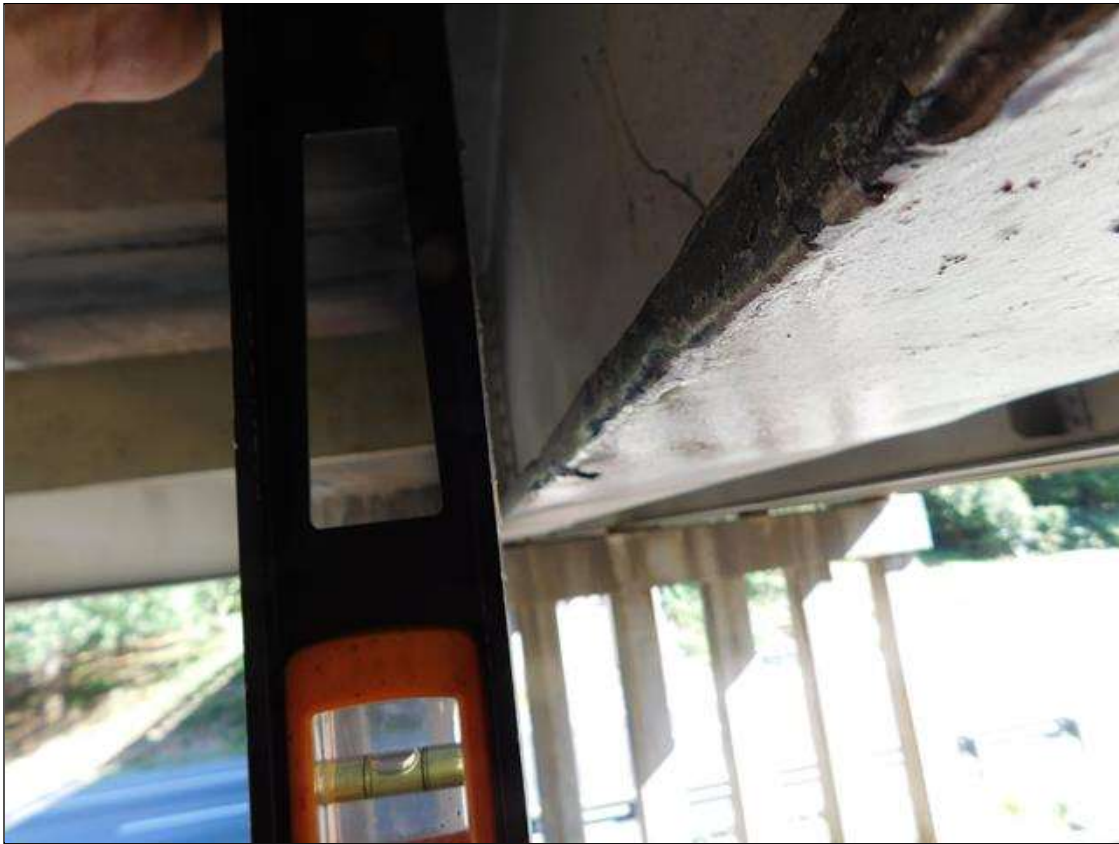
Span 2 Beam 2: SUPPLEMENTAL INSPECTION 2021: POINT OF IMPACT 8" LONG WITH A 1/2" DEEP GOUGE AT 18'-8" FROM INT. BENT 2 , WITH BEAM BEING SWEEPED EASTWARD 1/2". SCATTERED SCRAPES ALONG THE BEAM (PAR) THERE IS A BENT UP SECTION ON THE WEST BOTTOM FLANGE 4" LONG X 1" HIGH AT 20' OUT FROM INT. BENT 1 (PAR)

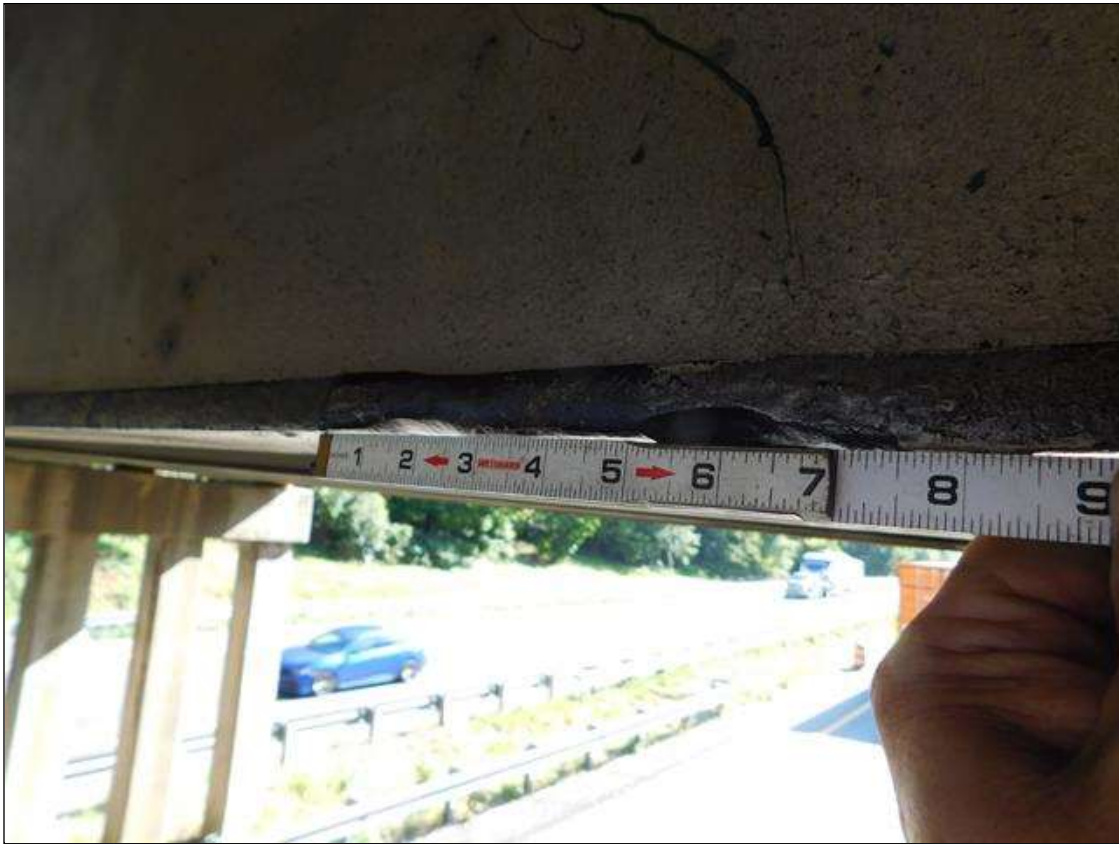
Span 2 Beam 2: SUPPLEMENTAL INSPECTION 2021: POINT OF IMPACT 8" LONG WITH A 1/2" DEEP GOUGE AT 18'-8" FROM INT. BENT 2 , WITH BEAM BEING SWEEPED EASTWARD 1/2". SCATTERED SCRAPES ALONG THE BEAM (PAR) THERE IS A BENT UP SECTION ON THE WEST BOTTOM FLANGE 4" LONG X 1" HIGH AT 20' OUT FROM INT. BENT 1(PAR)

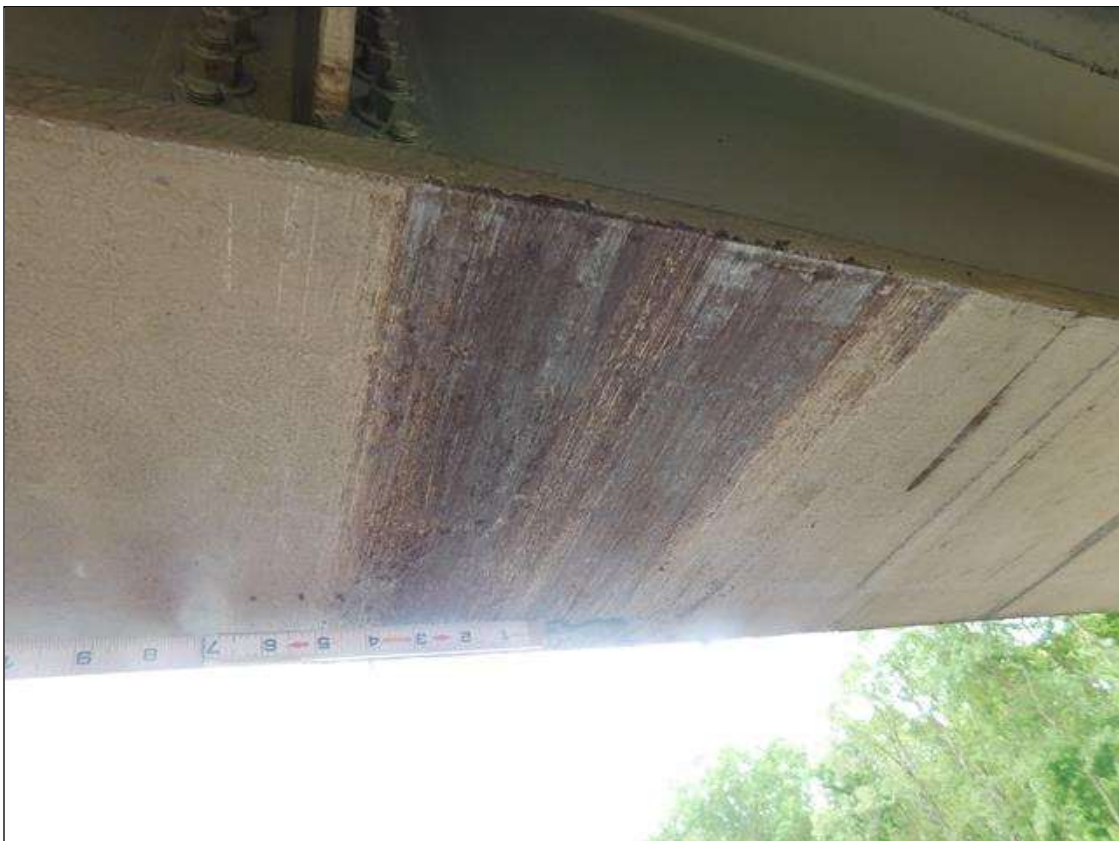
Span 3 Beam 5: BEAM 5 SPAN 3 HAS SCRAPES ON BOTTOM FLANGE AT 16.5' FROM INTERIOR BENT 3 FOR A TOTAL LENGTH OF 1'. INDENTATION AT 16.417' FROM INTERIOR BENT 3, 1" LONG BY 1/4" DEEP

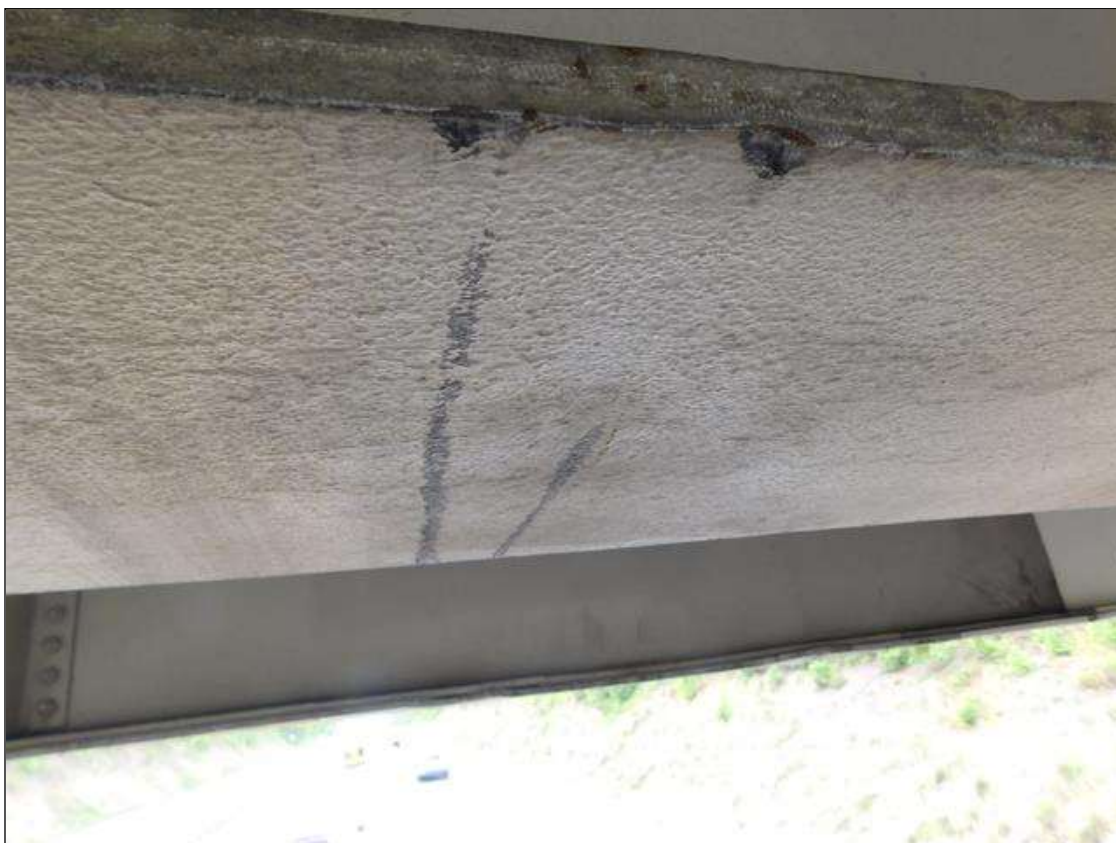
Span 3 Beam 2: BEAM 2 SPAN 3 DEFLECTED UPWARD 1/2" AT 19.5" FROM INTERIOR BENT 2 FOR A LENGTH OF 4', WITH SCRAPES ON BOTTOM FLANGE

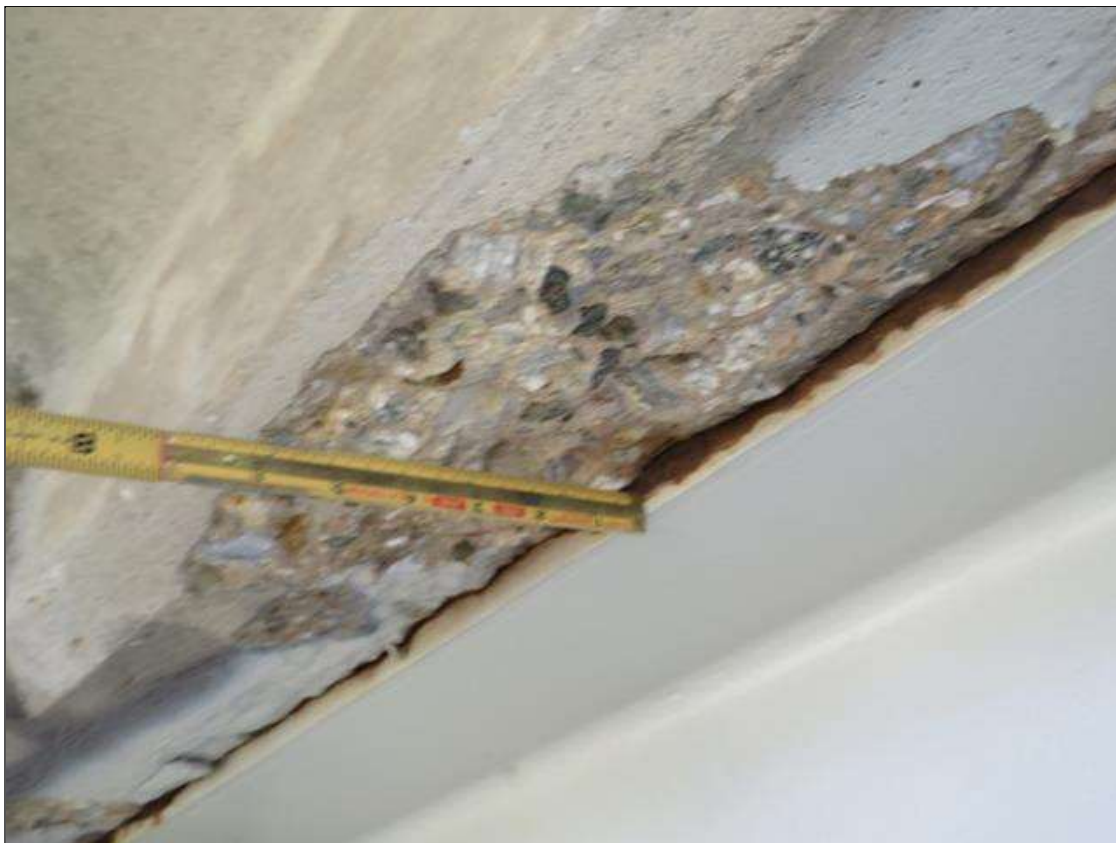
Span 3 Deck: SUPPLEMENTAL INSPECTION IMPACT DAMAGE 2022. spalling up to 12" WIDE X 1" deep, full length, underside of deck along both sides of beam 1.

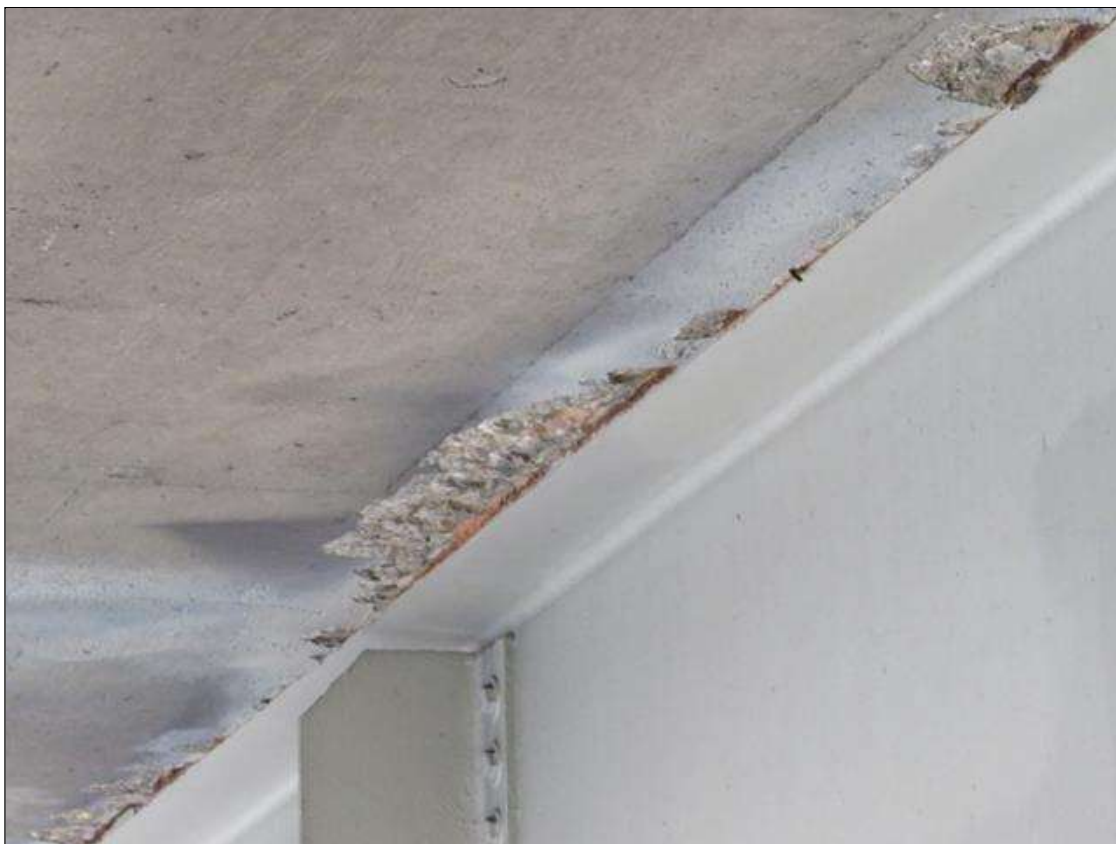
Span 3 Deck: SUPPLEMENTAL INSPECTION IMPACT DAMAGE 2022.: full length x up to 1/2in deep surface spalling, in underside of deck, along edges of beam 3.

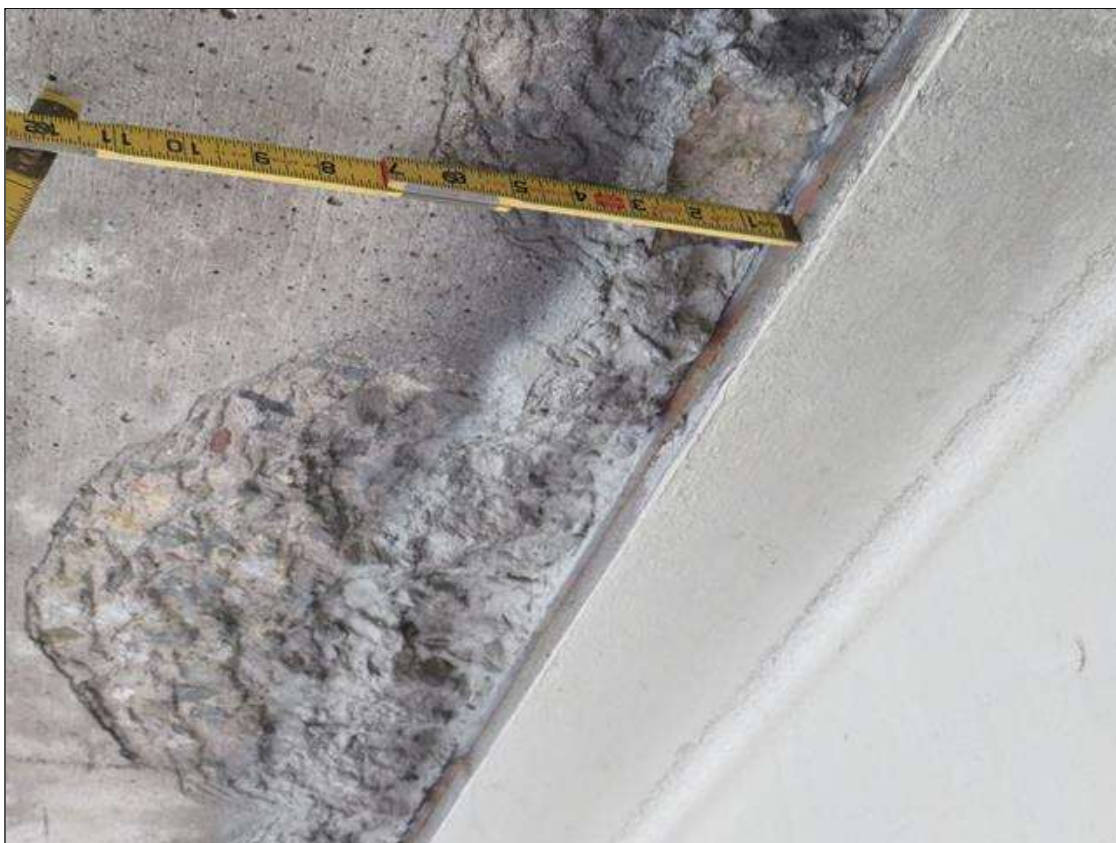
Span 3 Deck: SUPPLEMENTAL INSPECTION IMPACT DAMAGE 2022.surface spalling up to 1/2in deep, full length, underside of deck along both sides of beam 2.

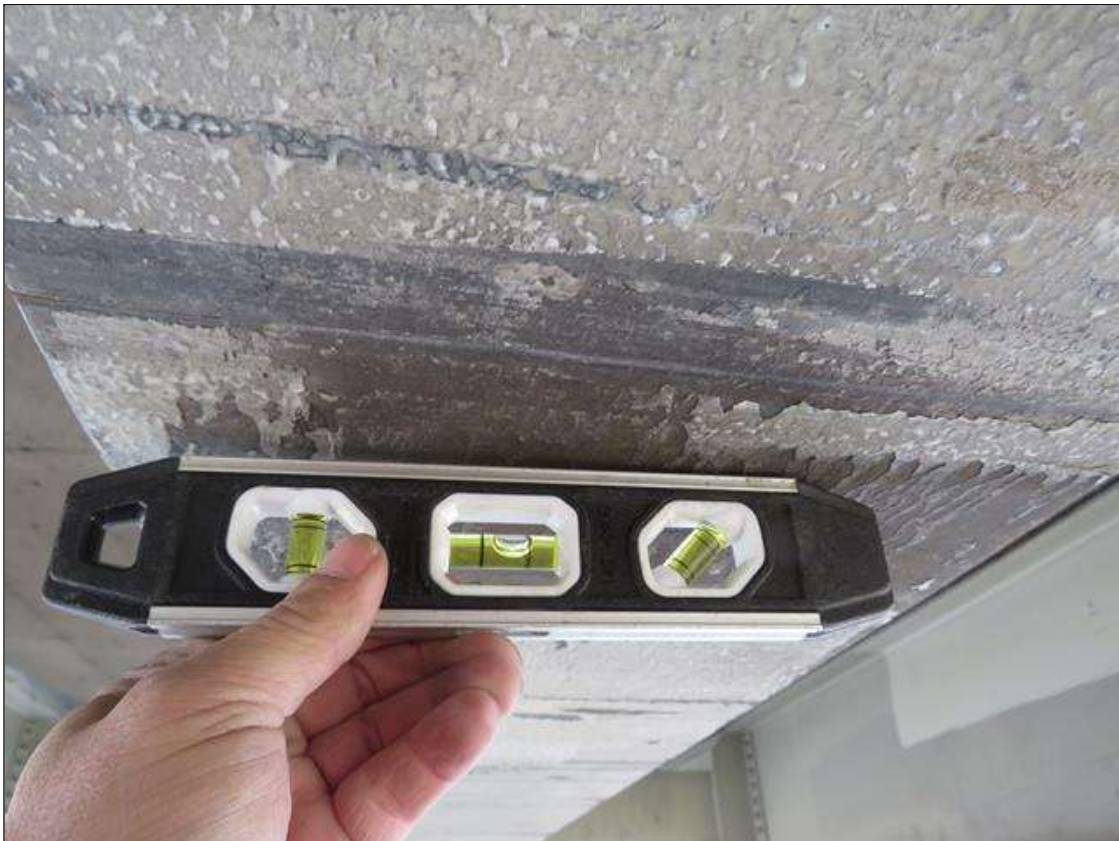
Span 3 Beam 2: SUPPLEMENTAL INSPECTION IMPACT DAMAGE 2022.: beam 2 span 3 deflected upward 1/2in at 19.5in from bent 2 for a length of 4ft, with scrapes on bottom flange

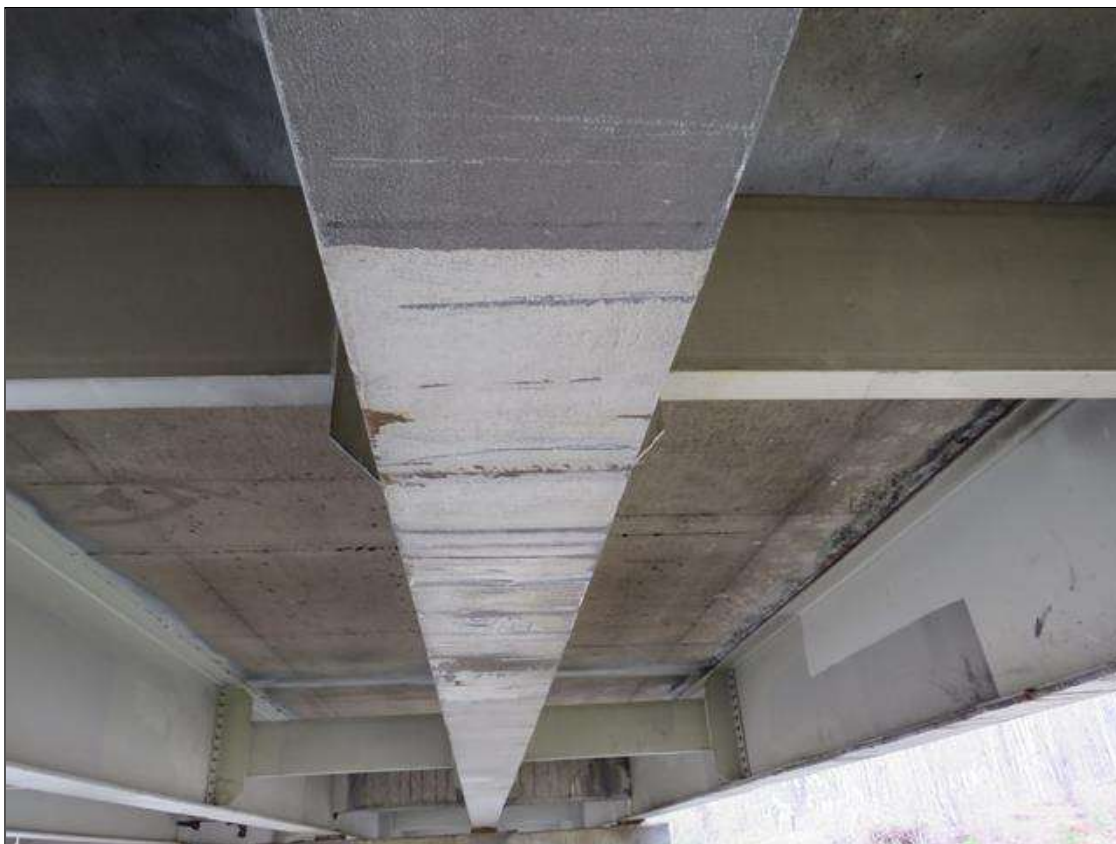
Span 3 Beam 2: SUPPLEMENTAL INSPECTION IMPACT DAMAGE 2022.: beam 2 span 3 deflected upward 1/2in at 19.5in from bent 2 for a length of 4ft, with scrapes on bottom flange

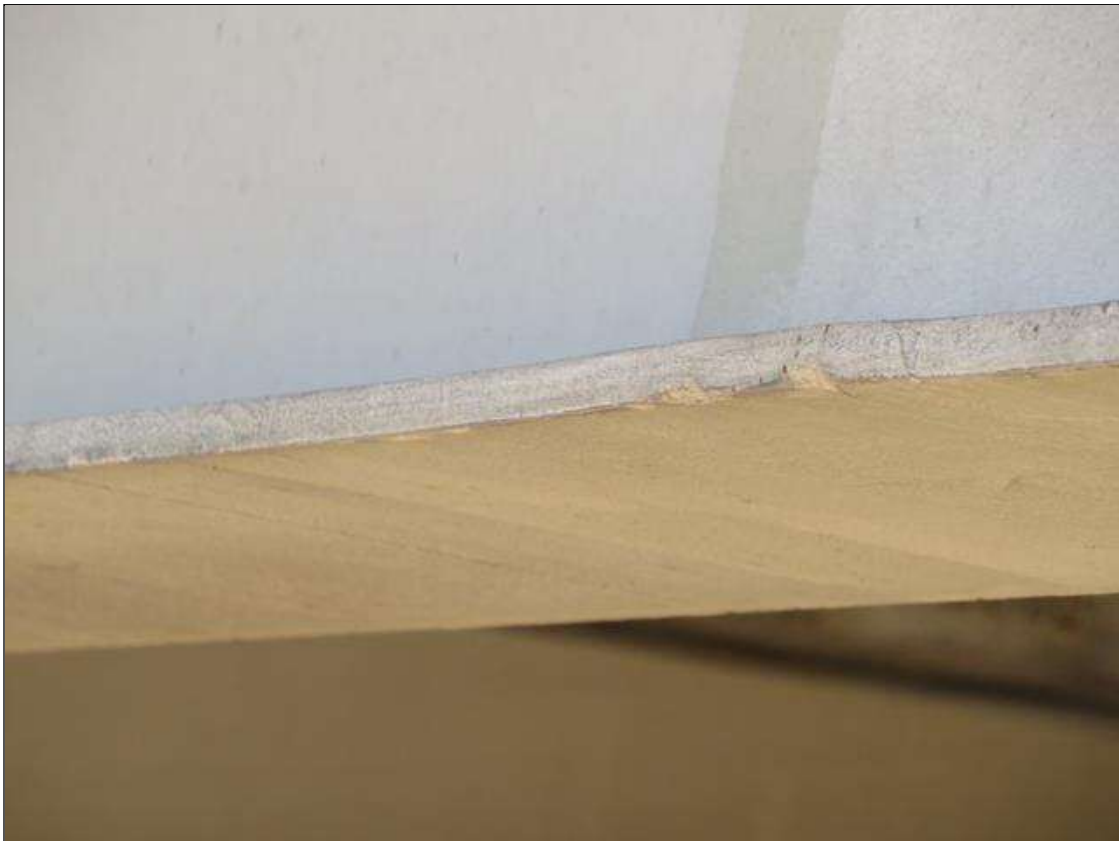
Span 3 Beam 5: SUPPLEMENTAL INSPECTION IMPACT DAMAGE 2022.: two 1/4in deep indentions in bottom flange of beam 5 span 3 at 16.5ft from bent 2 for a length of 1ft . SCATTERED SCRAPES

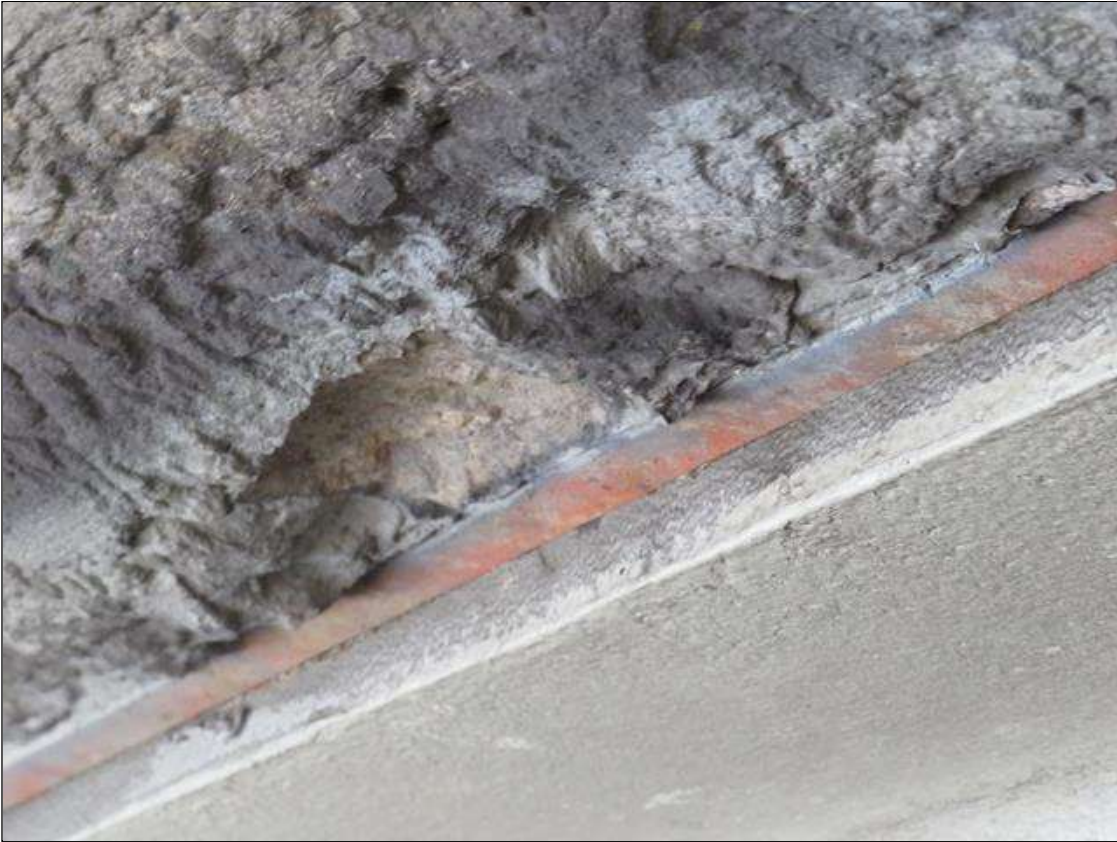
Span 3 Beam 1: SUPPLEMENTAL INSPECTION IMPACT DAMAGE 2022.: POINT OF IMPACT 9' LONG WITH SCATTERED 1" DEEP INDENTIONS THROUGH OUT BOTTOM FLANGE , AT 12'-9" OUT FROM INT. BENT 3 . BEAM 1 DEFLECTION 1" TO THE WEST. TOP FLANGE PULLED LOOSE FROM BEAM EAST SIDE FOR A LENGTH OF 30' X 3/4" .,EAST SIDE OF BOTTOM FLANGE BENT UPWARD 1/2in. SCATTERED SCRAPES ALONG BOTTOM FLANGE AND WEB(PAR) . SCATTERED OLD SCRAPES AND INDENTIONS ALONG BOTTOM FLANGE .

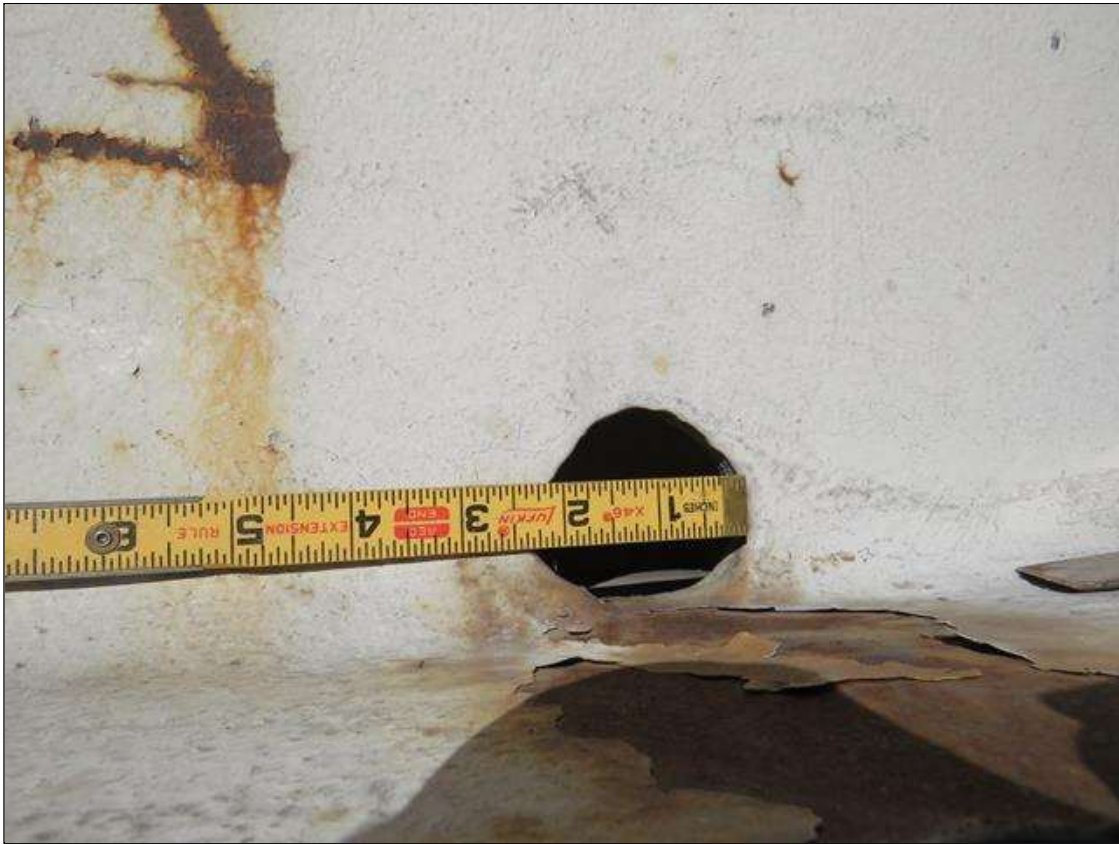
Span 3 Beam 11: SUPPLEMENTAL INSPECTION IMPACT DAMAGE 2021 area of previous impact damage, distortion of bottom flange vertical up to 2" lateral up to 1/2" with broken cover plate weld [10" long]. new area of impact damage 6" long x 2" high at 13'-5" out from int. bent 3 . with the bottom cover plate being broken loose from bottom flange 10" long x 2" deep . there are also two older 1/2" indentions in the same area . Beam 11 is swept westward up to 1 1/2". (par) there is a 2" diameter torch cut hole at both ends of of the 6' length .

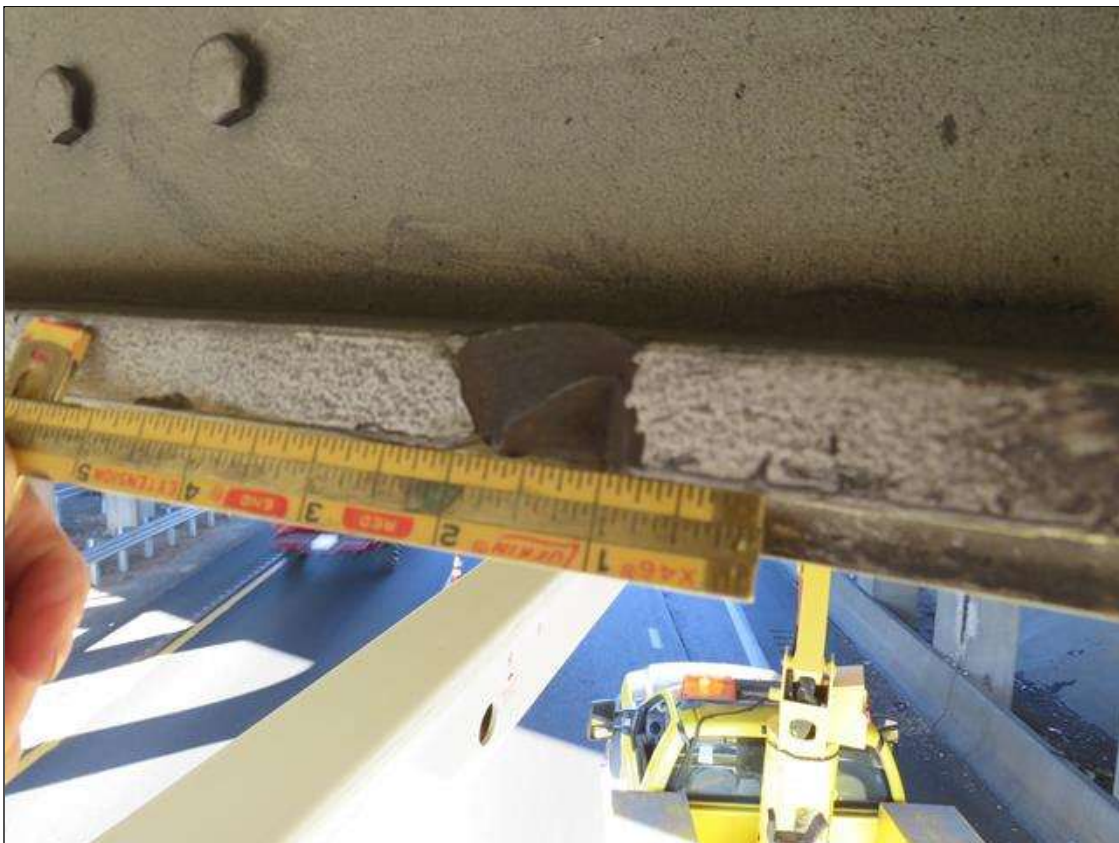
Span 3 Beam 10: SUPPLEMENTAL INSPECTION IMPACT DAMAGE 2021: 1 indentation 1" long x 1/2" deep at 18'-8" from int. bent 3 . scattered scrapes along the web .

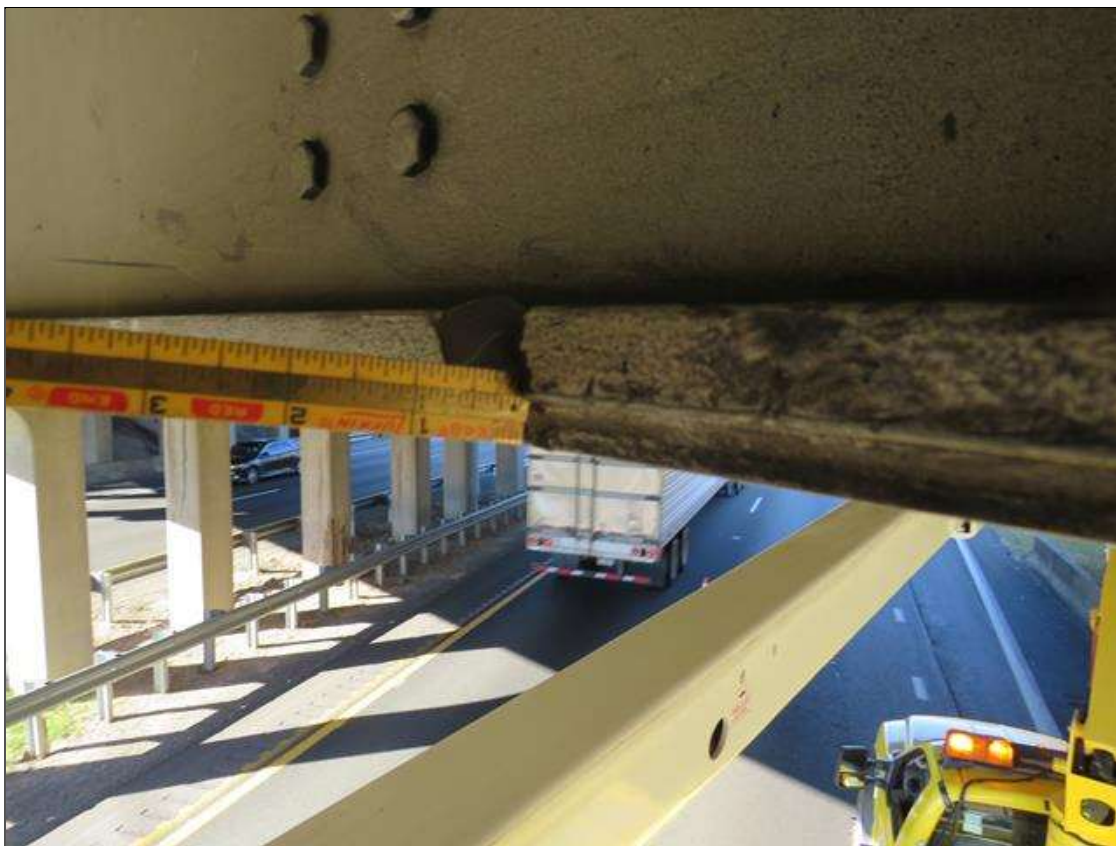
Span 3 Beam 10: SUPPLEMENTAL INSPECTION IMPACT DAMAGE 2021: 1 indentation 1" long x 1/2" deep at 18'-8" from int. bent 3 . scattered scrapes along the web .

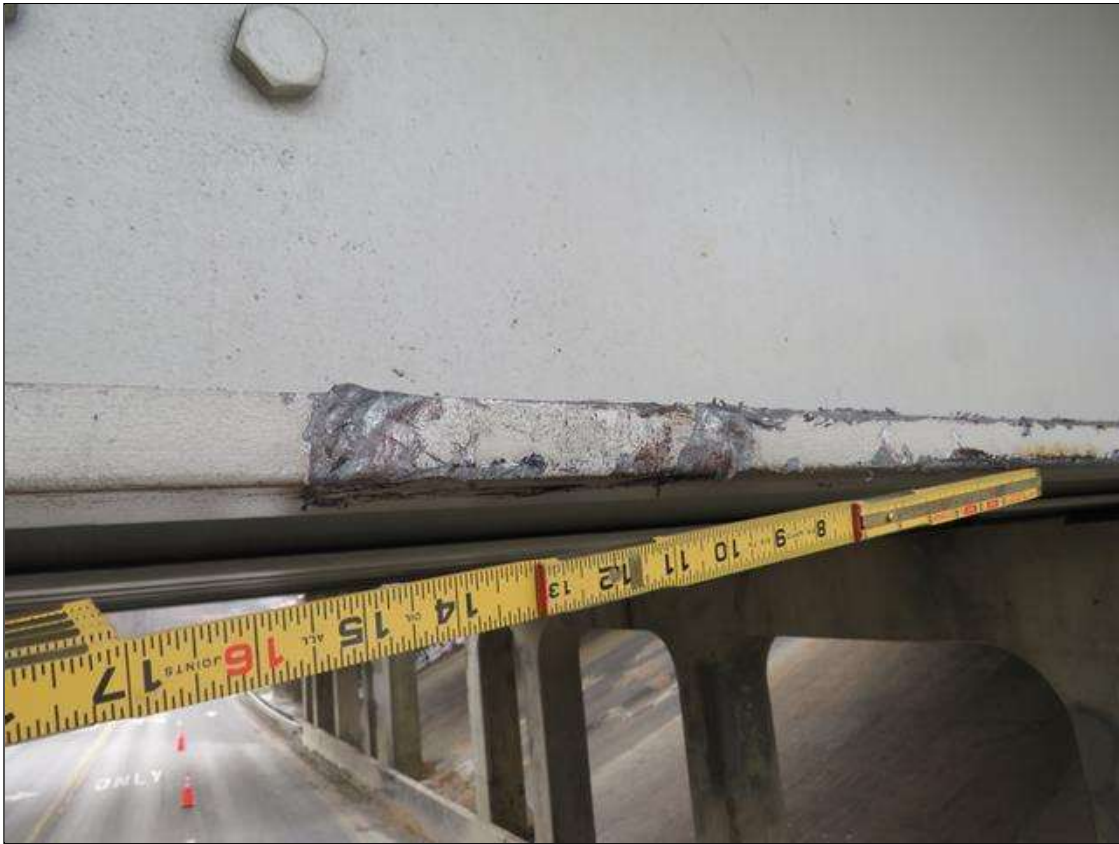
Span 2 Beam 1: SUPPLEMENTAL INSPECTION IMPACT DAMAGE 2022: SPAN 2 BEAM 1 ,BEAM SWEEP SOUTHWARD UP TO 3" X 25' LONG . (POI)8' OUT FROM INT. BENT 1 WITH A LENGTH OF 10' . 1 INDENTION 1/8" DEEP X 3" LONG AT 10' OUT FROM INT. BENT 1. WITH 2 OTHER INDENTIONS AT 16'-7" OUT FROM INT. BENT 1 , 22" LONG 1/4" WIDE X 1/16" DEEP AND 1/2" LONG X 1/4" DEEP . BOTTOM FLANGE OF BEAM BOWED UPWARD 1/2" . ANCHOR BOLT 1 LEFT SIDE BEAM 1 BENT WESTWARD . SCATTERED SCRAPES BEAM 1 BOTTOM FLANGE . (PAR)

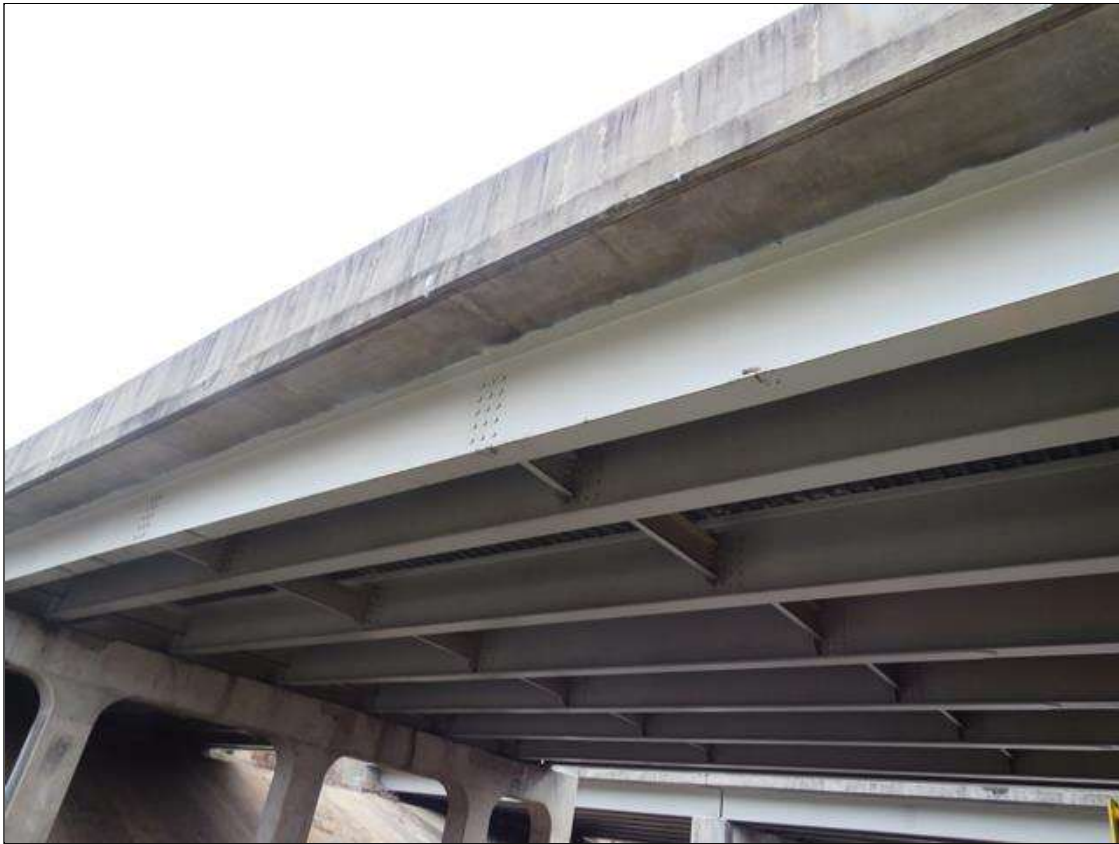
Span 2 Beam 1: SUPPLEMENTAL INSPECTION IMPACT DAMAGE 2022: SPAN 2 BEAM 1 ,BEAM SWEEP SOUTHWARD UP TO 3" X 25' LONG . (POI)8' OUT FROM INT. BENT 1 WITH A LENGTH OF 10' . 1 INDENTION 1/8" DEEP X 3" LONG AT 10' OUT FROM INT. BENT 1. WITH 2 OTHER INDENTIONS AT 16'-7" OUT FROM INT. BENT 1 , 22" LONG 1/4" WIDE X 1/16" DEEP AND 1/2" LONG X 1/4" DEEP . BOTTOM FLANGE OF BEAM BOWED UPWARD 1/2" . ANCHOR BOLT 1 LEFT SIDE BEAM 1 BENT WESTWARD . SCATTERED SCRAPES BEAM 1 BOTTOM FLANGE . (PAR)

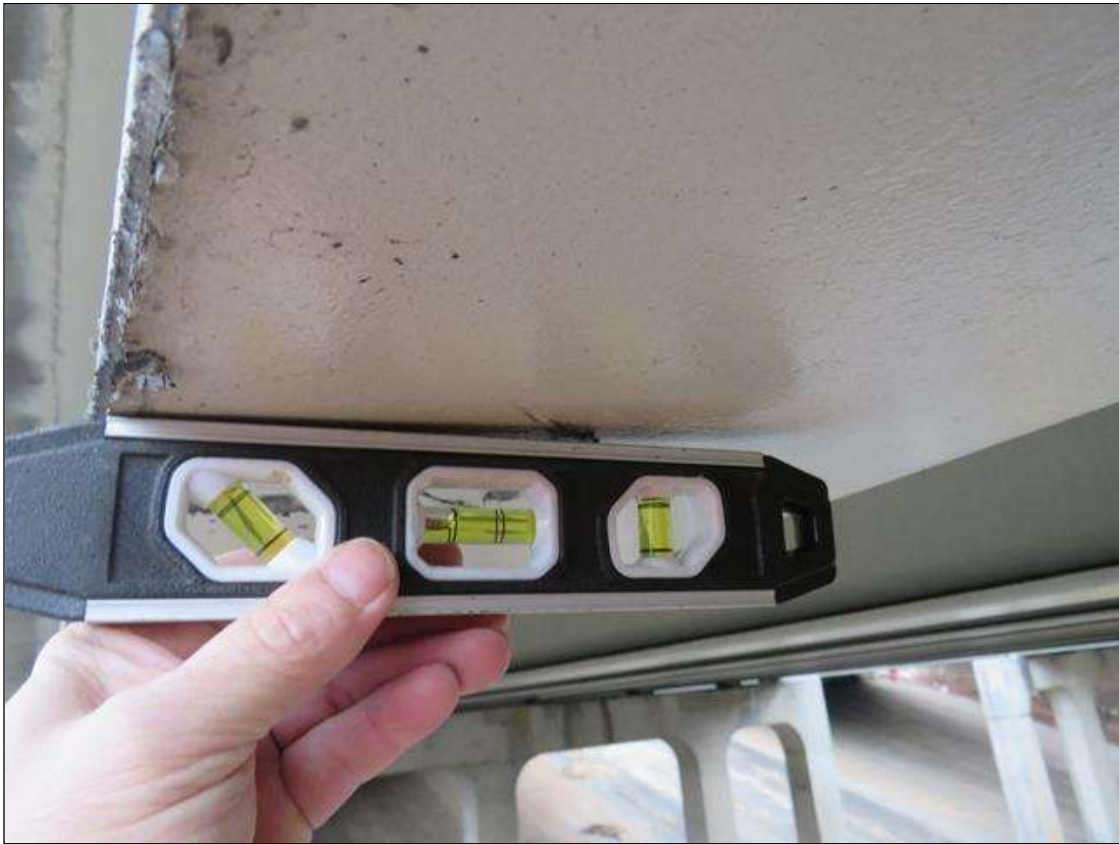
Span 2 Beam 1: SUPPLEMENTAL INSPECTION IMPACT DAMAGE 2022: SPAN 2 BEAM 1 ,BEAM SWEEP SOUTHWARD UP TO 3" X 25' LONG . (POI)8' OUT FROM INT. BENT 1 WITH A LENGTH OF 10' . 1 INDENTION 1/8" DEEP X 3" LONG AT 10' OUT FROM INT. BENT 1. WITH 2 OTHER INDENTIONS AT 16'-7" OUT FROM INT. BENT 1 , 22" LONG 1/4" WIDE X 1/16" DEEP AND 1/2" LONG X 1/4" DEEP . BOTTOM FLANGE OF BEAM BOWED UPWARD 1/2" . ANCHOR BOLT 1 LEFT SIDE BEAM 1 BENT WESTWARD . SCATTERED SCRAPES BEAM 1 BOTTOM FLANGE . (PAR)

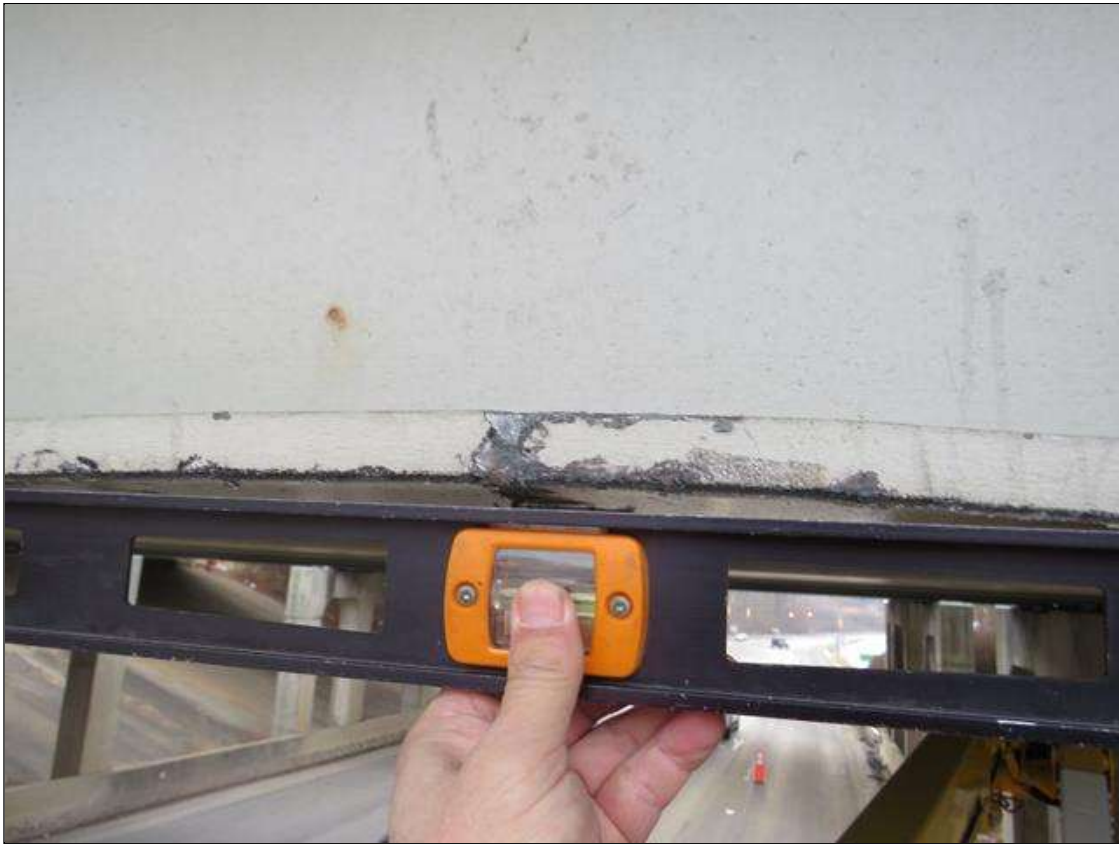
Span 2 Beam 1: SUPPLEMENTAL INSPECTION IMPACT DAMAGE 2022: SPAN 2 BEAM 1 ,BEAM SWEEP SOUTHWARD UP TO 3" X 25' LONG . (POI)8' OUT FROM INT. BENT 1 WITH A LENGTH OF 10' . 1 INDENTION 1/8" DEEP X 3" LONG AT 10' OUT FROM INT. BENT 1. WITH 2 OTHER INDENTIONS AT 16'-7" OUT FROM INT. BENT 1 , 22" LONG 1/4" WIDE X 1/16" DEEP AND 1/2" LONG X 1/4" DEEP . BOTTOM FLANGE OF BEAM BOWED UPWARD 1/2" . ANCHOR BOLT 1 LEFT SIDE BEAM 1 BENT WESTWARD . SCATTERED SCRAPES BEAM 1 BOTTOM FLANGE . (PAR)
