NC DEPARTMENT OF TRANSPORTATION
 DIVISION OF HIGHWAYS
 STRUCTURE MANAGEMENT UNIT

Structure Safety Report

Supplemental Element Inspection

DIVISION: 13 COUNTY: BUNCOMBE STRUCTURE NUMBER: 100387 FREQUENCY: None

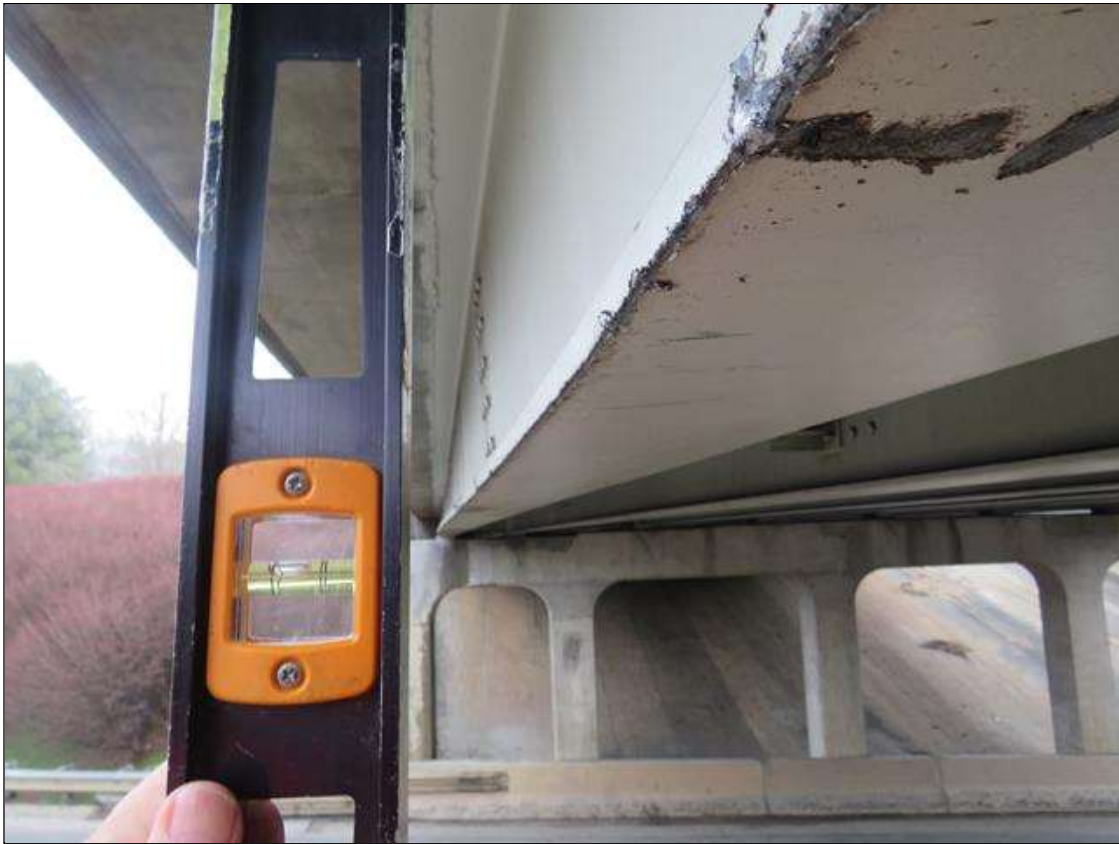
Span 2 Beam 1: SUPPLEMENTAL INSPECTION IMPACT DAMAGE 2022: SPAN 2 BEAM 1 ,BEAM SWEEP SOUTHWARD UP TO 3" X 25' LONG . (POI)8' OUT FROM INT. BENT 1 WITH A LENGTH OF 10' . 1 INDENTION 1/8" DEEP X 3" LONG AT 10' OUT FROM INT. BENT 1. WITH 2 OTHER INDENTIONS AT 16'-7" OUT FROM INT. BENT 1 , 22" LONG 1/4" WIDE X 1/16" DEEP AND 1/2" LONG X 1/4" DEEP . BOTTOM FLANGE OF BEAM BOWED UPWARD 1/2" . ANCHOR BOLT 1 LEFT SIDE BEAM 1 BENT WESTWARD . SCATTERED SCRAPES BEAM 1 BOTTOM FLANGE . (PAR)

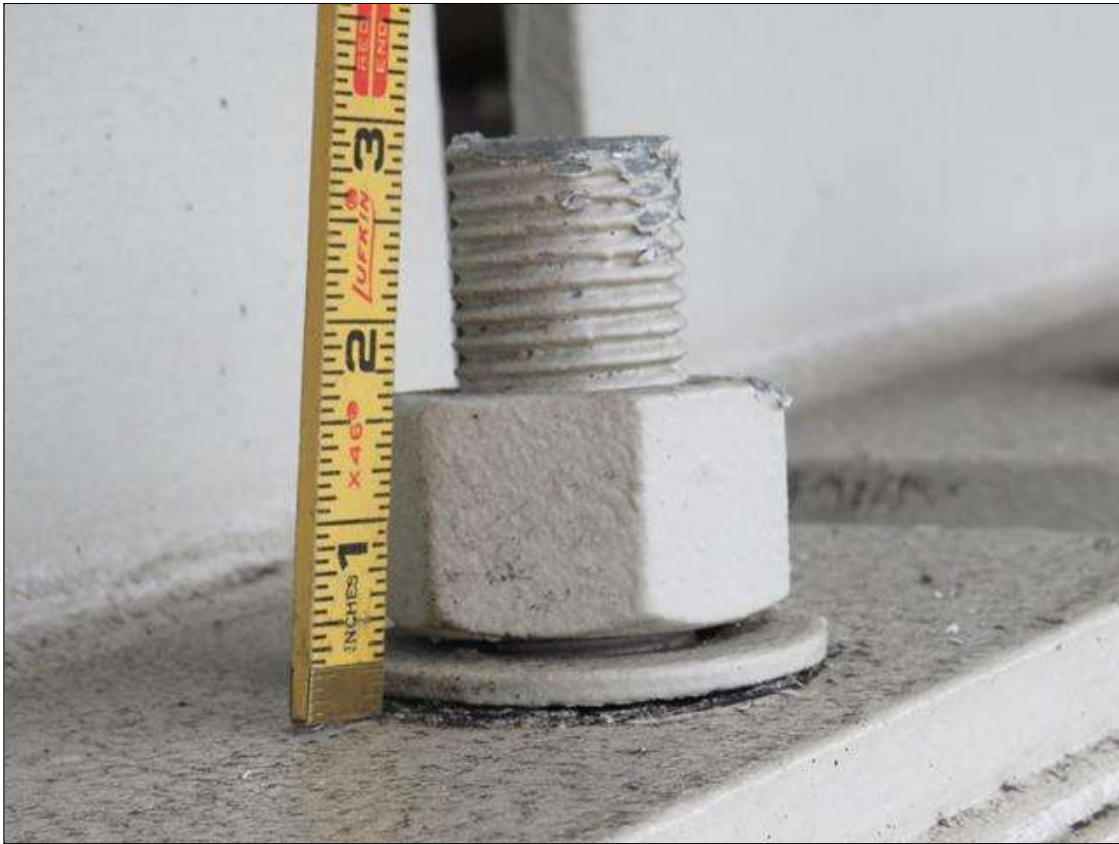
Span 2 Beam 1: SUPPLEMENTAL INSPECTION IMPACT DAMAGE 2022: SPAN 2 BEAM 1 ,BEAM SWEEP SOUTHWARD UP TO 3" X 25' LONG . (POI)8' OUT FROM INT. BENT 1 WITH A LENGTH OF 10' . 1 INDENTION 1/8" DEEP X 3" LONG AT 10' OUT FROM INT. BENT 1. WITH 2 OTHER INDENTIONS AT 16'-7" OUT FROM INT. BENT 1 , 22" LONG 1/4" WIDE X 1/16" DEEP AND 1/2" LONG X 1/4" DEEP . BOTTOM FLANGE OF BEAM BOWED UPWARD 1/2" . ANCHOR BOLT 1 LEFT SIDE BEAM 1 BENT WESTWARD . SCATTERED SCRAPES BEAM 1 BOTTOM FLANGE . (PAR)
