# Retaining Wall Inventory and Assessment System

**NCDOT Project 2014-10**

**FHWA/NC/2014-10**

**September 2015**

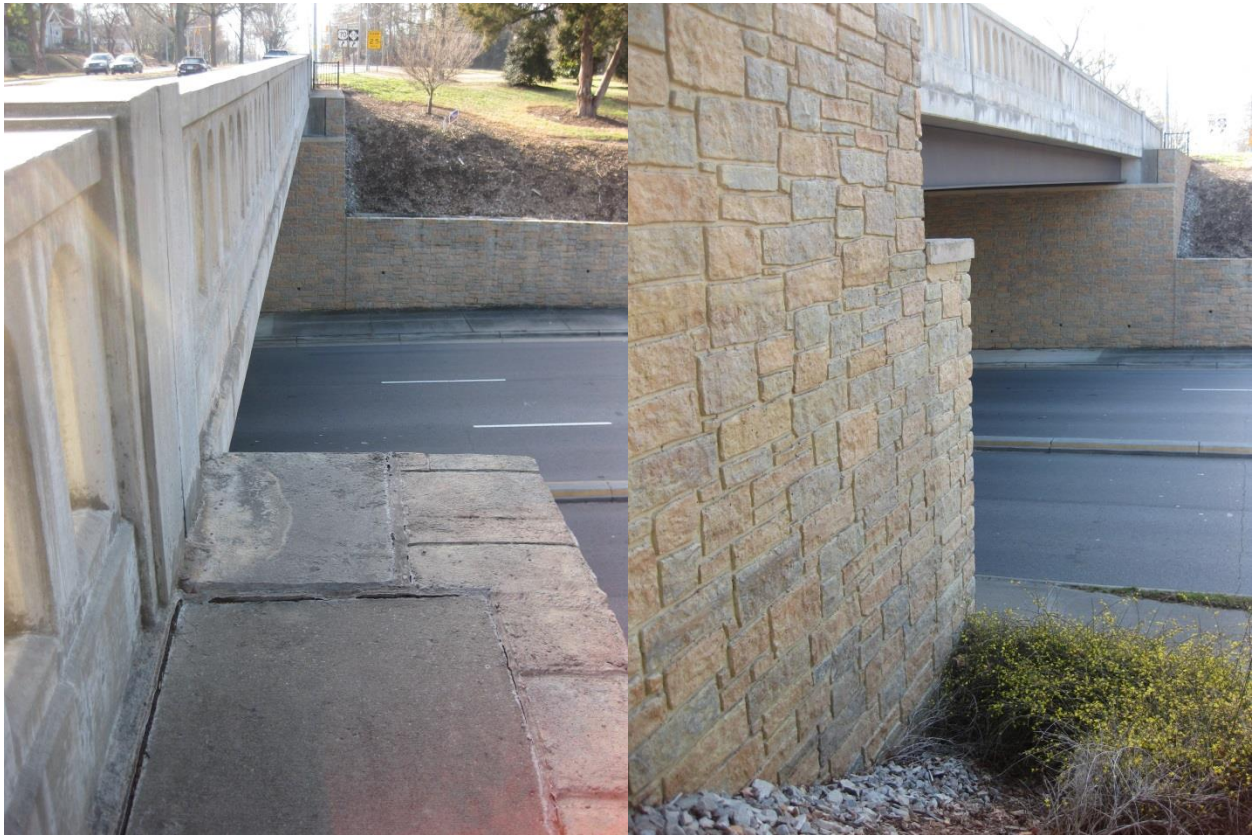
**Figure 1. Glenwood over Wade bridge and MSE abutment (SB)**

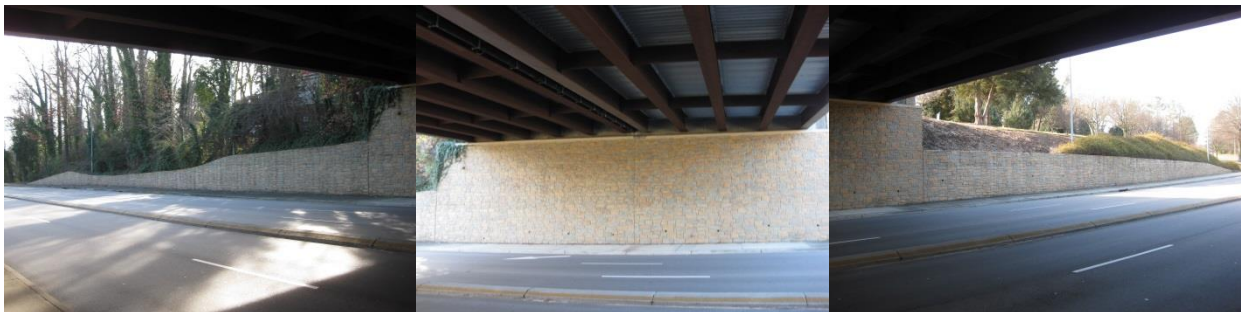
**Figure 2. Southern Glenwood approach with tieback abutment and H-pile with CIP facing wing walls**

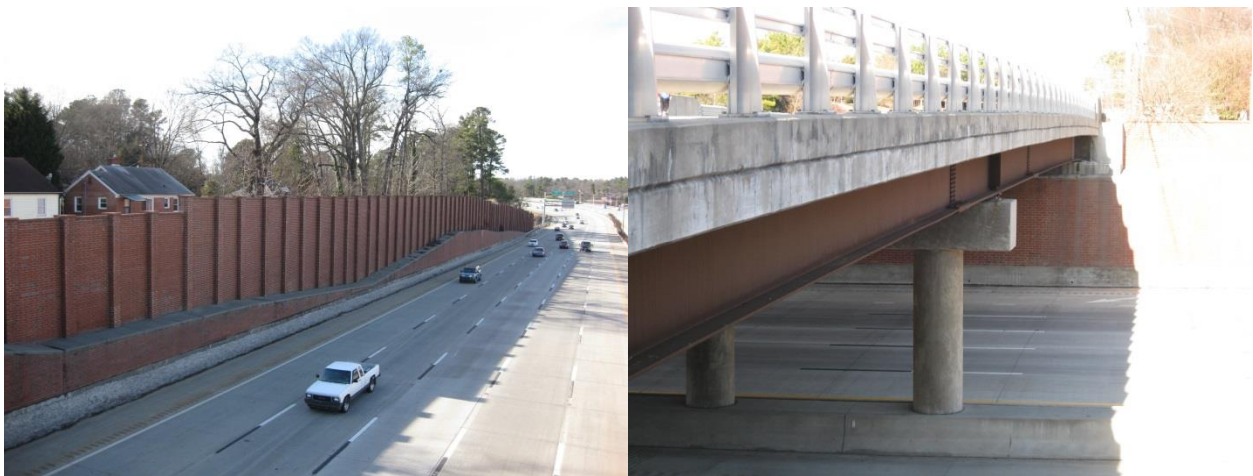
**Figure 2. Soil nail wall and bridge abutment on I-85 (Durham, NC)**

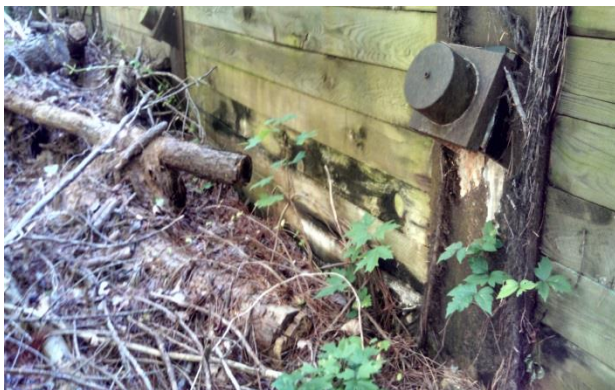
**Figure 3: Wide gaps between several timber lagging units.**

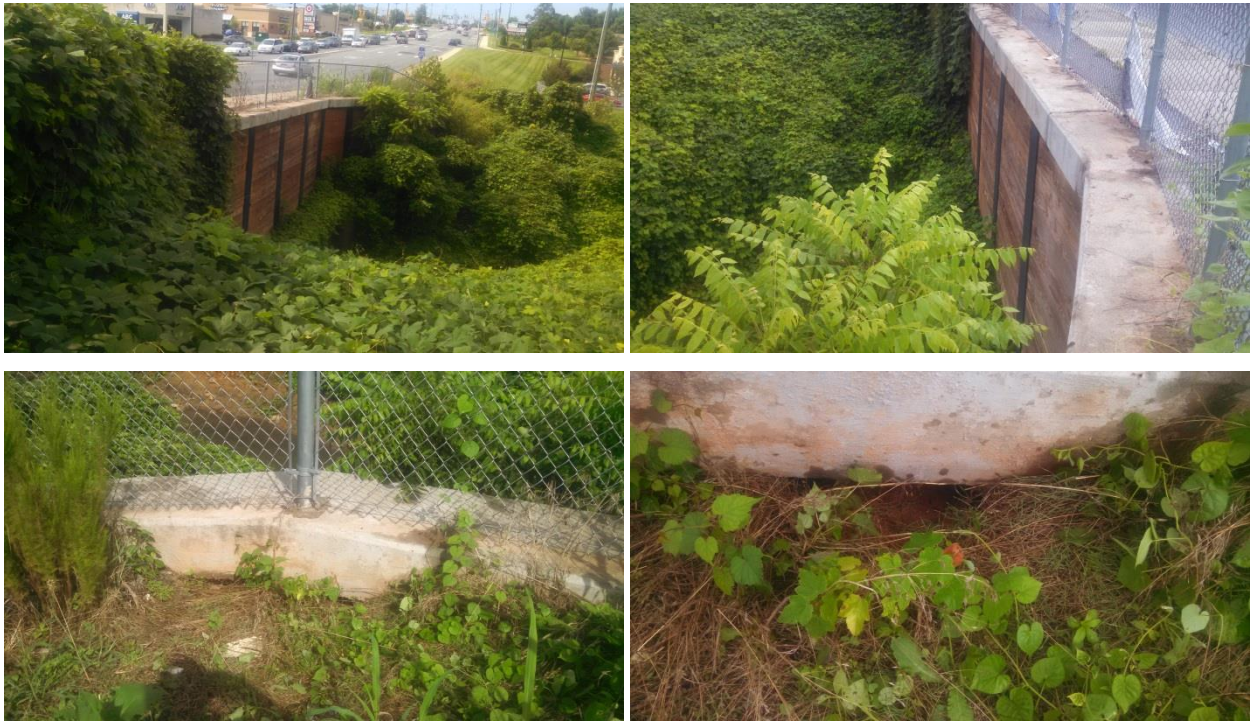
**Figure 7. Cantilever Wall with timber lagging near 404 Cox Road (Gastonia, NC).**

Some evidence of material loss behind the wall under the concrete coping was identified.
