**ANNUAL REPORT FOR 2003**

**Paint Fork Creek Stream Mitigation Site (Brigmon Site)  
Madison County  
WBS Element 32573.4.1  
TIP No. A-10WM**

Prepared By:  
Office of Natural Environment & Roadside Environmental Unit  
North Carolina Department of Transportation  
December 2003

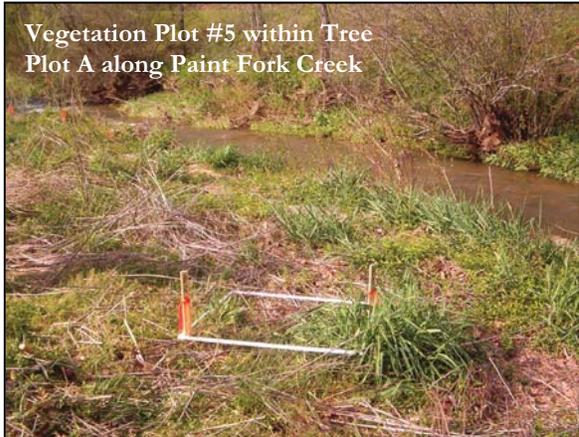
Plot 5. Canary grass, fescue, meadowrue, and henbit were observed in and immediately adjacent to the plot. No other woody stems were noted within five feet of the vegetation plot.

Vegetation Plot #5 within Tree Plot A along Paint Fork Creek
