NC DEPARTMENT OF TRANSPORTATION
DIVISION OF HIGHWAYS
STRUCTURE MANAGEMENT UNIT

Structure Safety Report

Routine Element Inspection - Contract

FEATURE INTERSECTED: ALLIGATOR RIVER

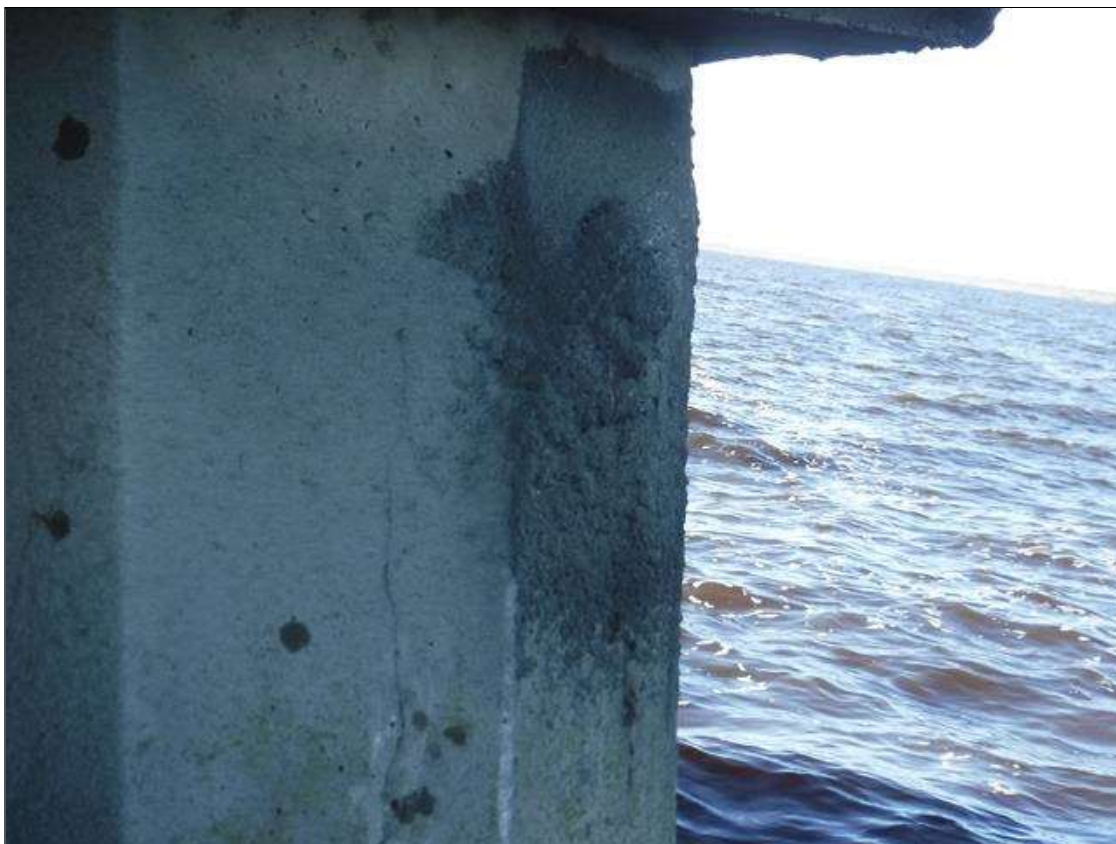
Bent 9 Saved Pile 2: 1' X 1' PATCHED AREA, NORTH FACE, 1' FROM BOTTOM OF CAP.

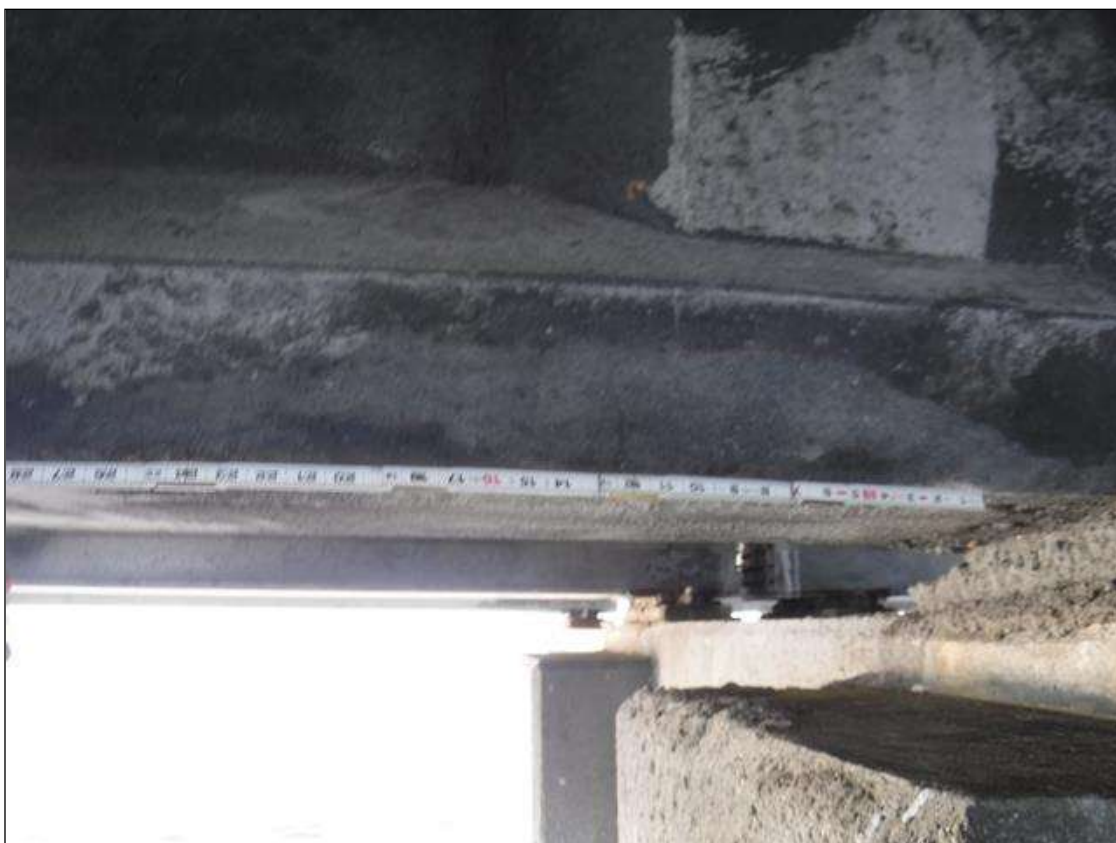
Span 10 Beam 2: (2) UP TO 24" X 6" X 12" CORNER PATCHED AREAS, NORTH AND SOUTH FACES, AT BENT 9.

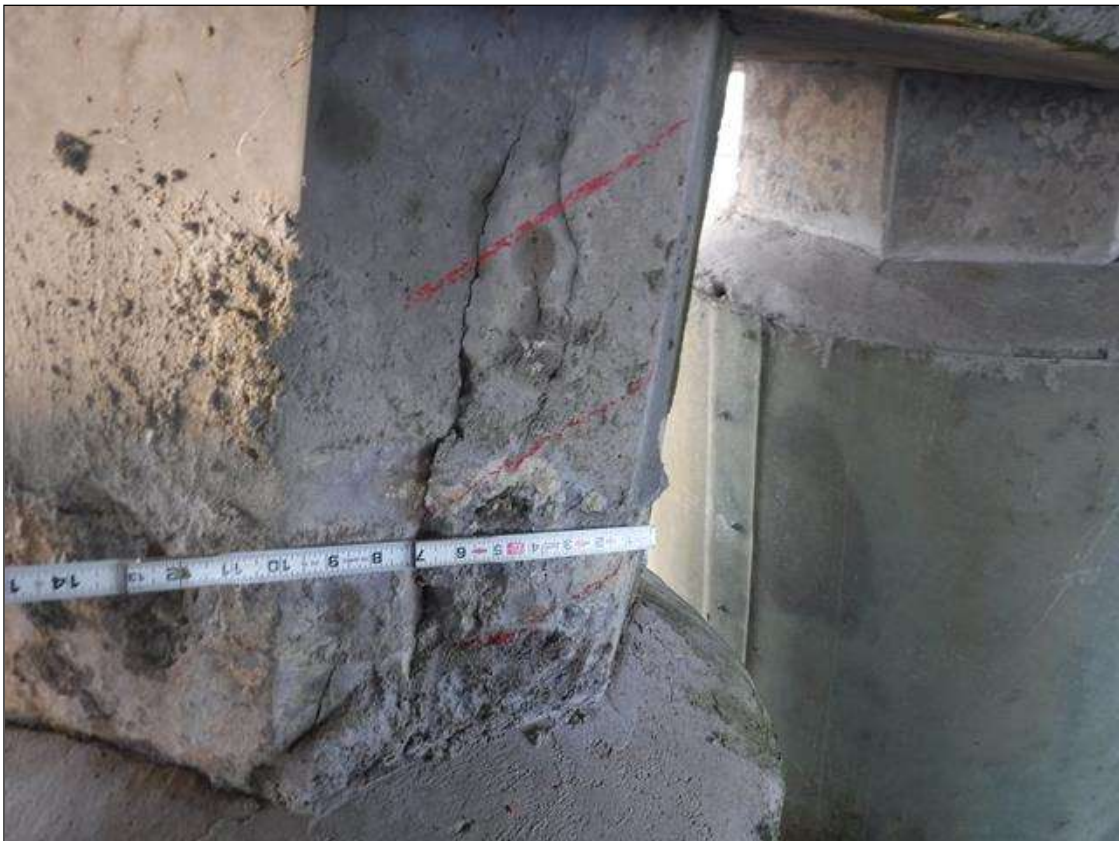
Bent 9 Saved Pile 5: 18" X 8" DELAMINATION ON NORTH FACE BEOW BOTTOM OF CAP, SOUTH FACE SIMILAR

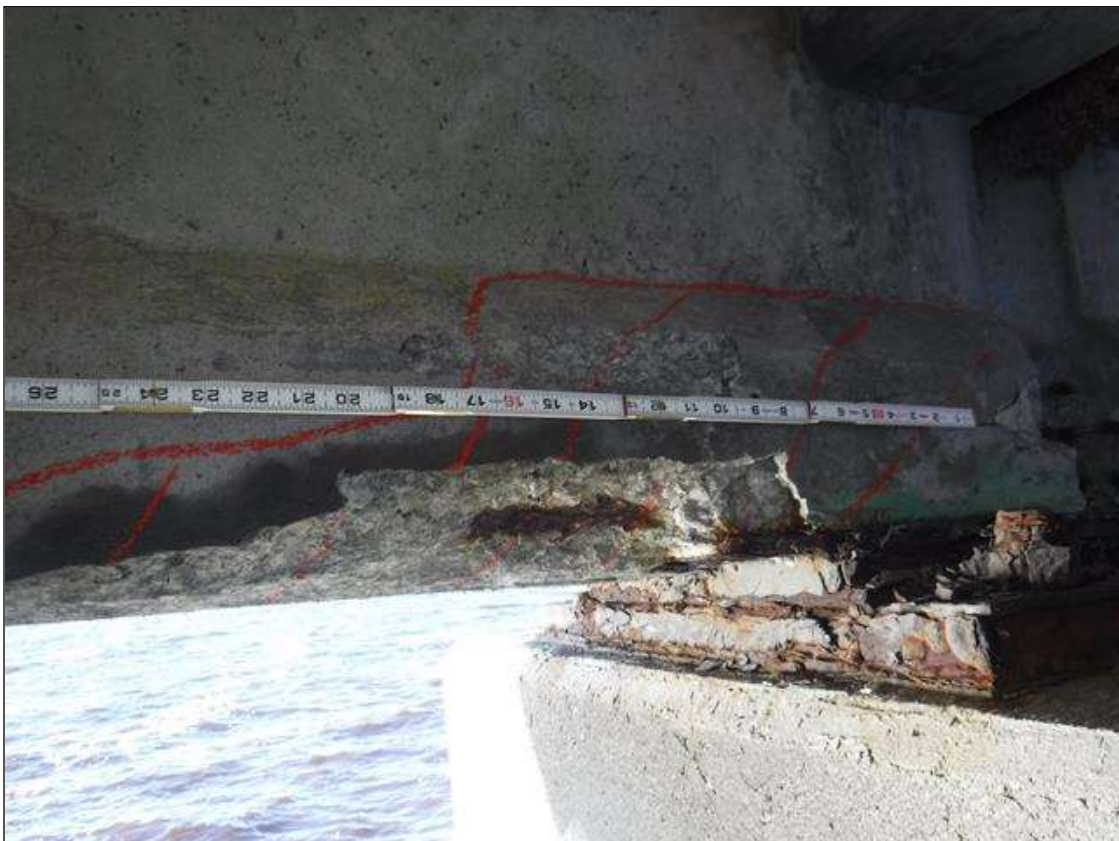
Span 10 Beam 4: (PAR) SPALL WITH EXPOSED STRAND IN GIRDER IN BOTTOM BULB OVER BENT 9 BEARING. AREA IS 10" TALL, 34" LONG, AND 6" DEEP.

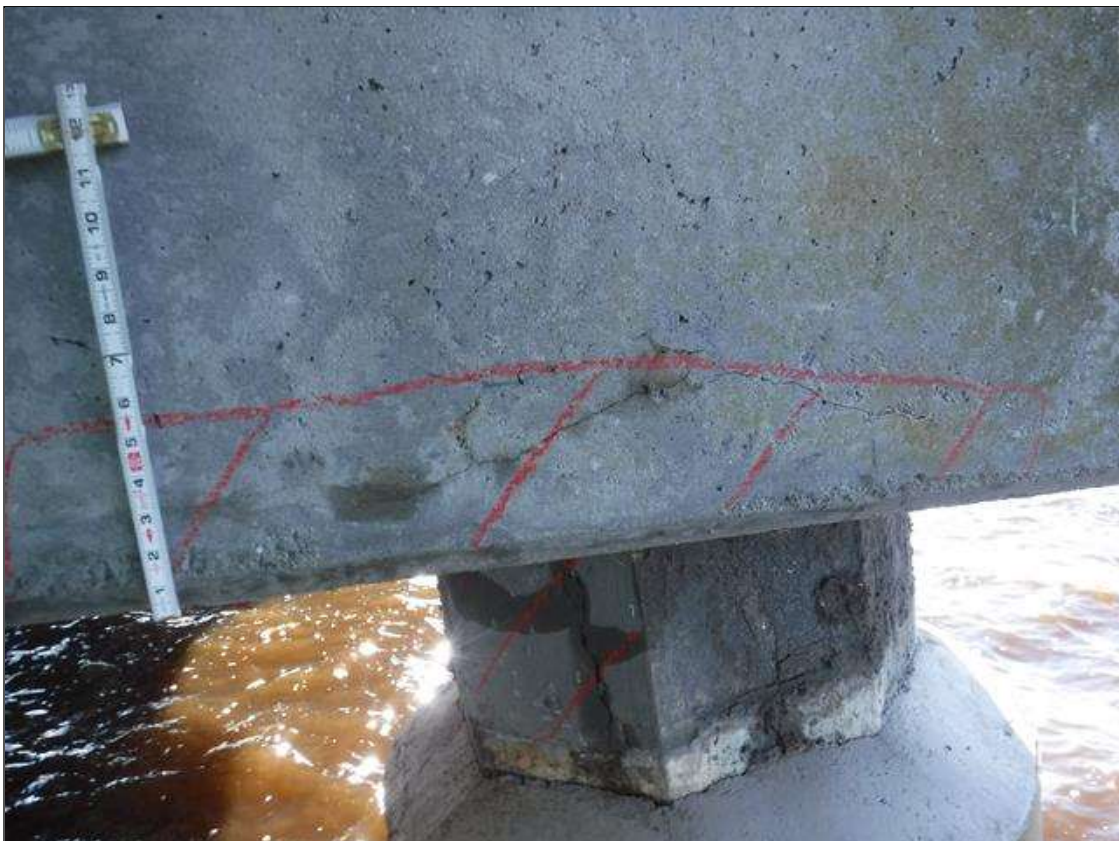
Bent 9 Cap 1: 3' X 8" DELAMINATION, WEST FACE, ABOVE PILE 4.

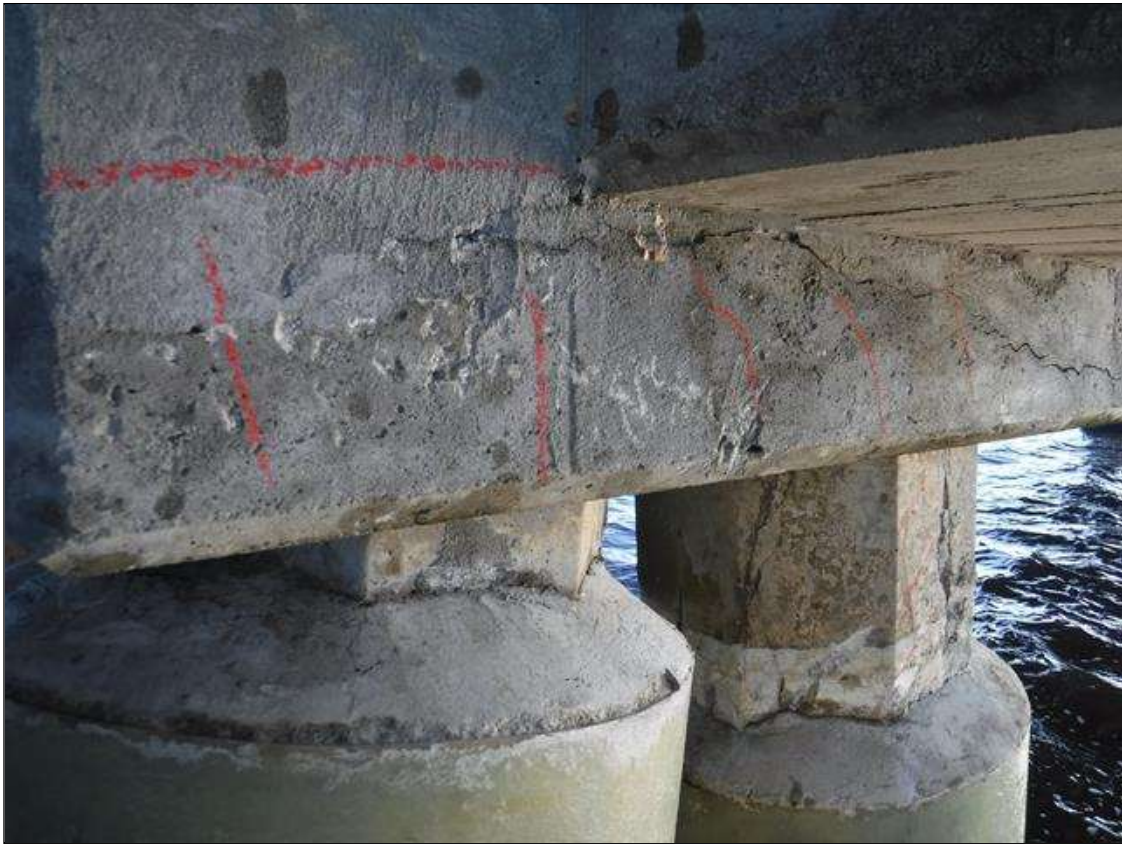
Bent 9 Cap 1: 5' X 8" DELAMINATION, SOUTH FACE OF PILE 4 AND 5 BLOCK-OUT.

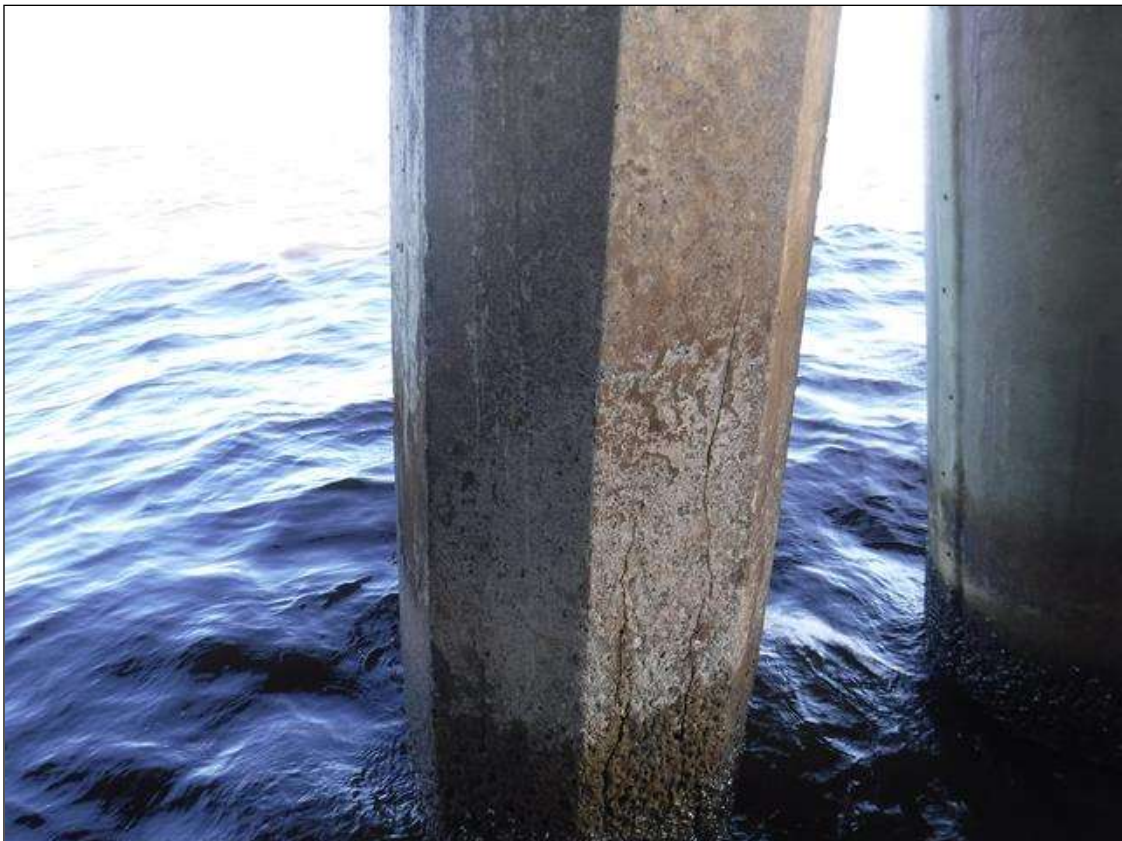
Bent 9 Saved Pile 2: (PAR) HAIRLINE TO 1/16" CRACKS, 3' BELOW CAP, DOWN 4', MULTIPLE FACES. SCALING TO 1" DEEP FROM WATERLINE TO MUDLINE.

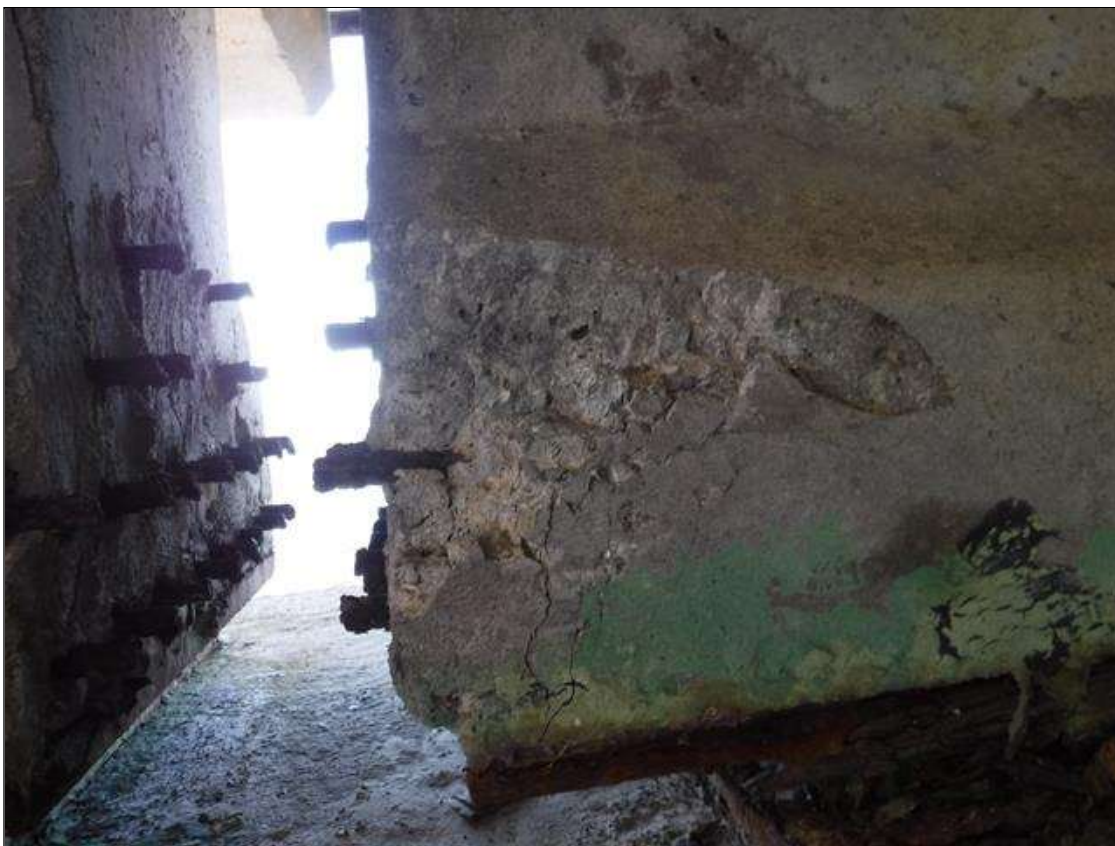
Span 9 Beam 4: (PAR) 6" X 4" X 2" SPALL, WITH EXPOSED STRAND, NORTH FACE, AT BENT 9.

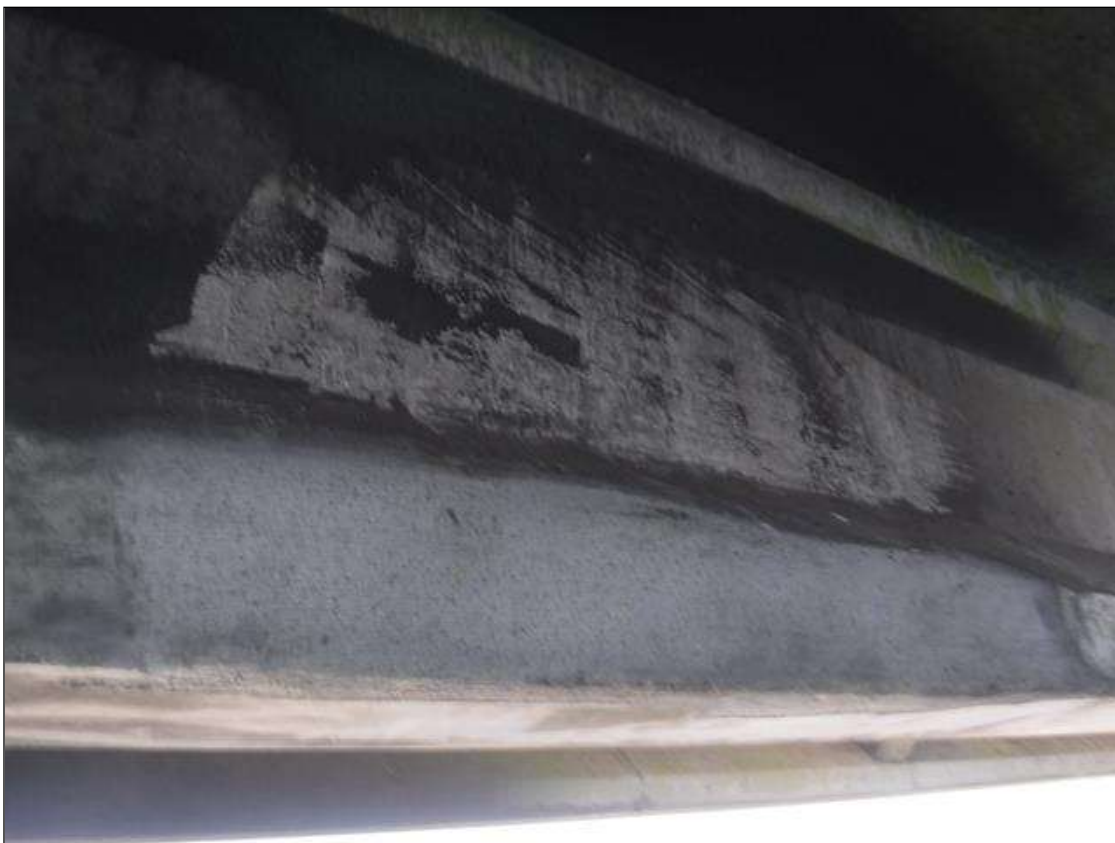
Span 9 Beam 3: 5' OF PATCHED AREA IN BOTTOM BULB OF GIRDER, 20' FROM BENT 9.

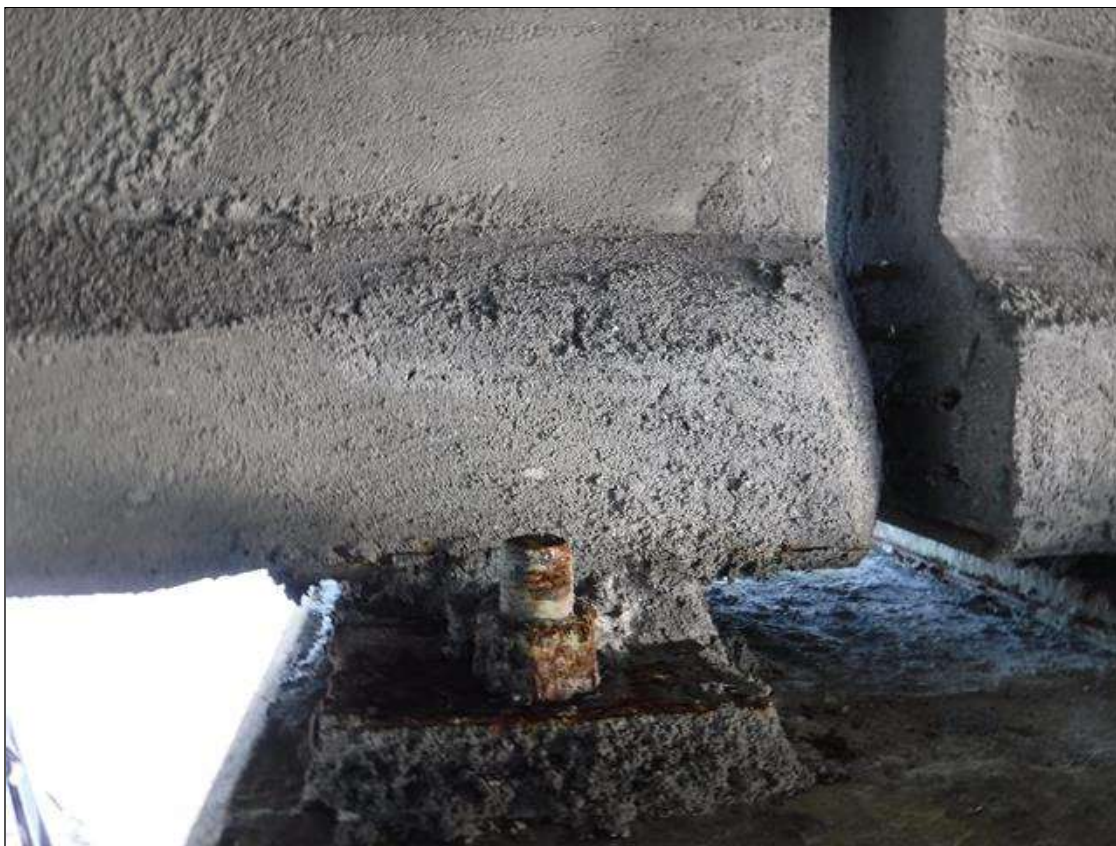
Span 10 Beam 1: PATCHED AREA IN GIRDER IN BOTTOM BULB OVER BENT 10 BEARING SOUTH FACE.

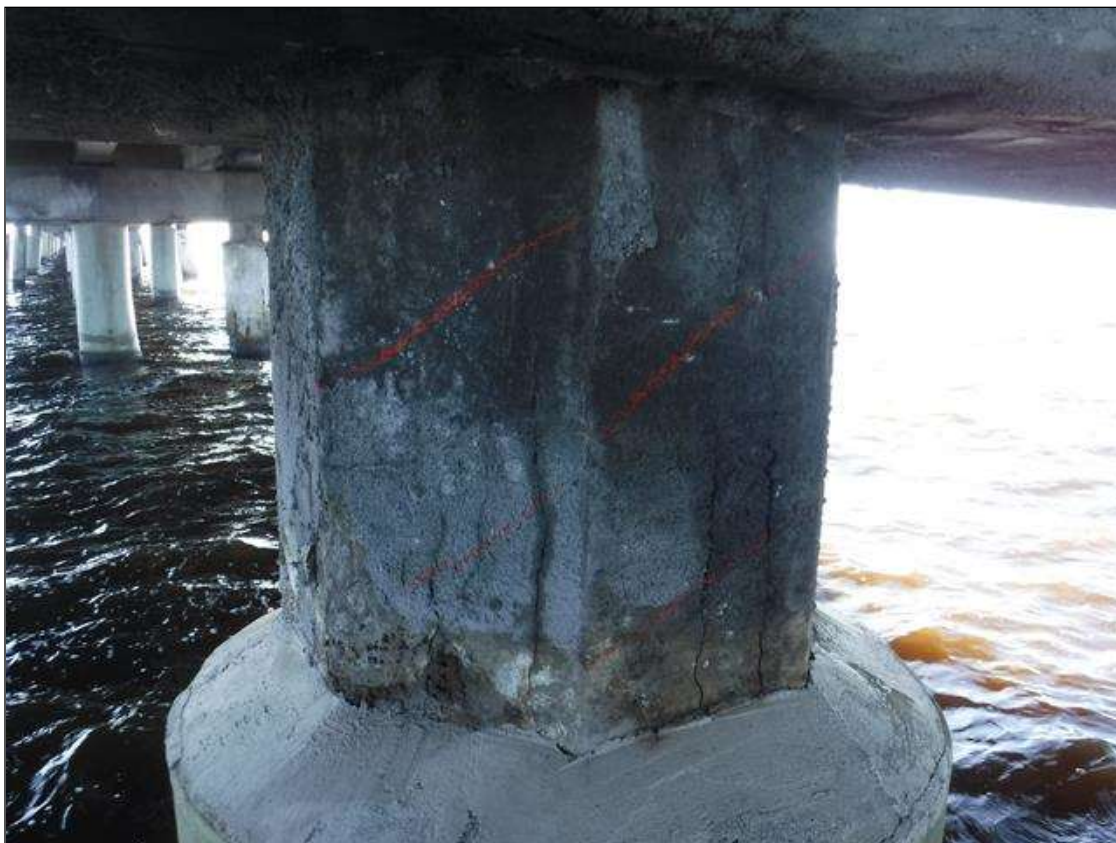
Bent 10 Saved Pile 2: 2' X 3' DELAMINATION, WEST FACE, BEGINNING AT TOP OF PILE.

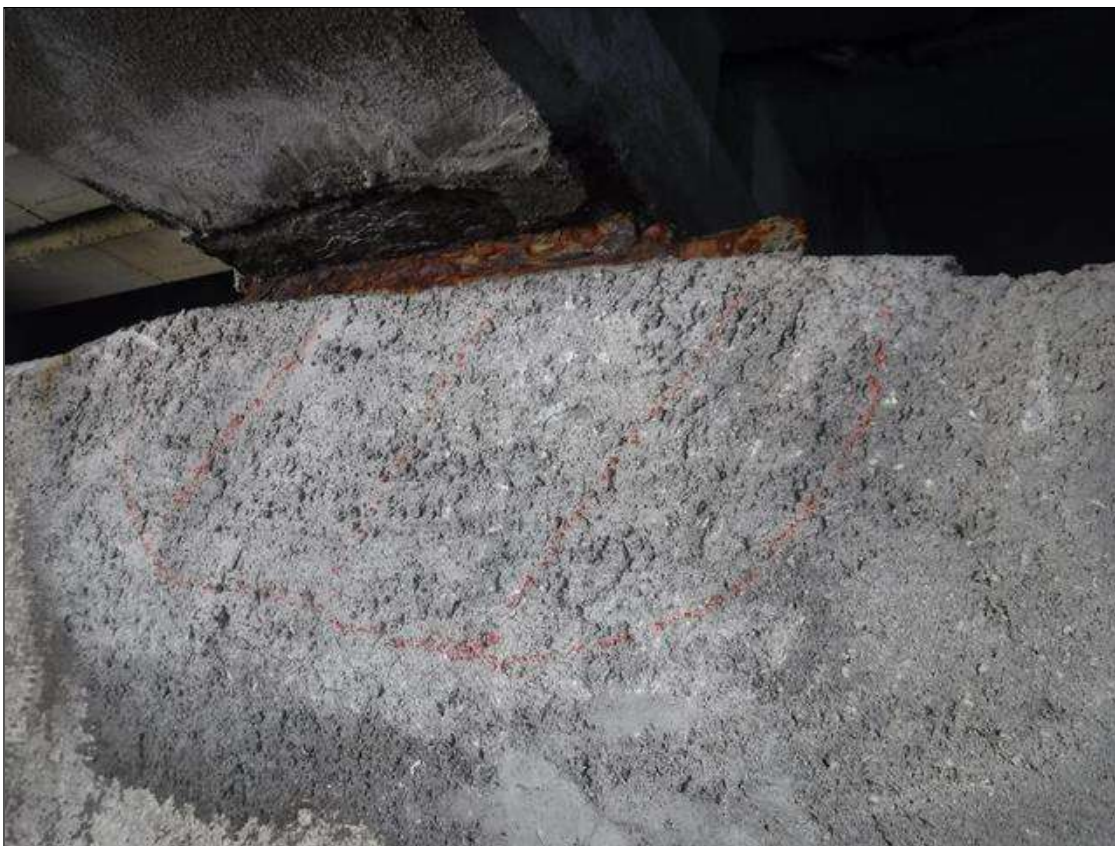
Bent 10 Cap 1: 2' X 1' FAILED PATCHED AREA BELOW BEAM 2

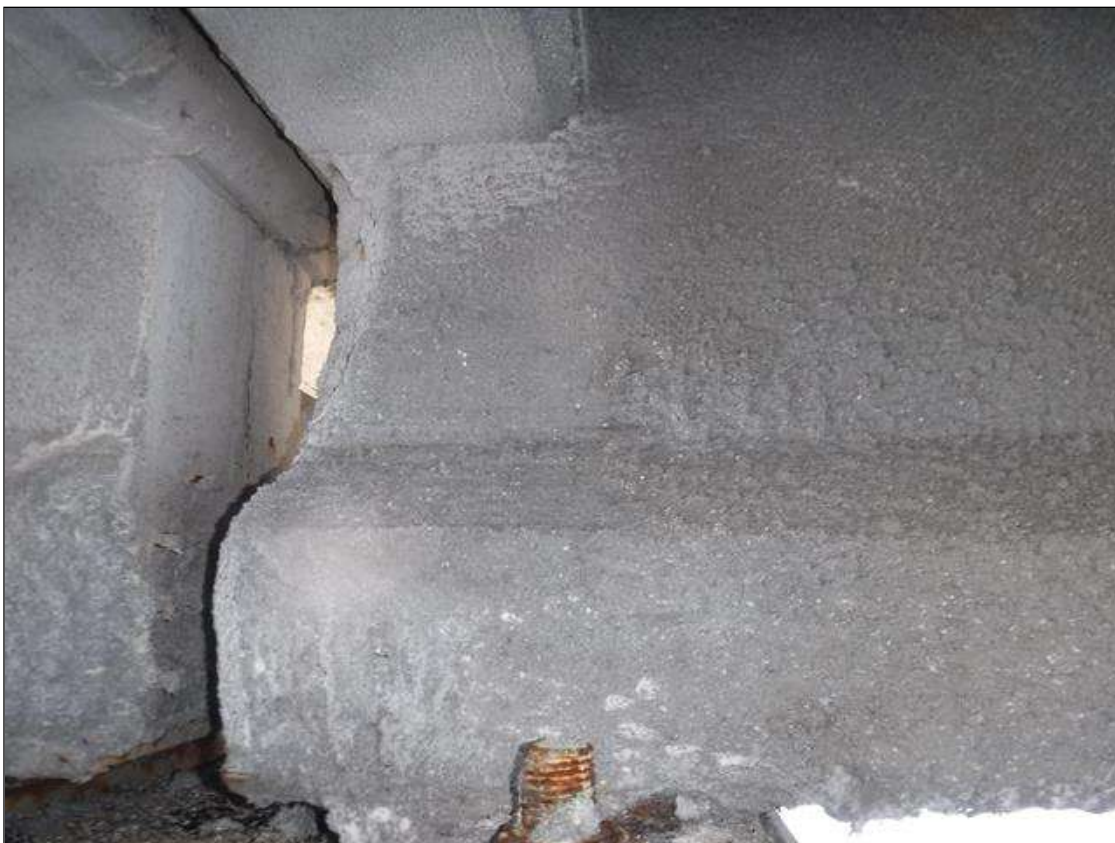
Span 11 Beam 2: 12" TALL, 6" LONG PATCHED AREA ON BOTH SIDES OF GIRDER AT BENT 11.

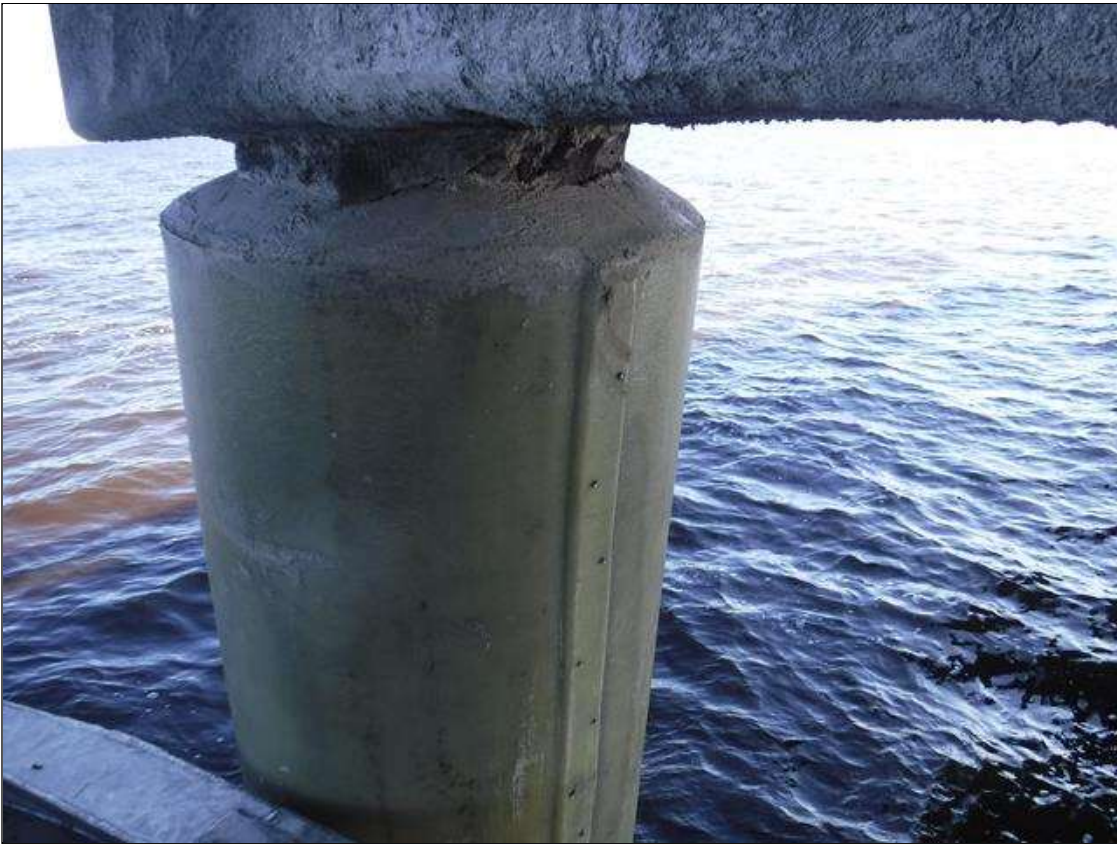
Bent 11 Saved Pile 1: PILE REPAIRED WITH 3' DIAMETER CONCRETE JACKET STARTING 6" BELOW BOTTOM OF CAP

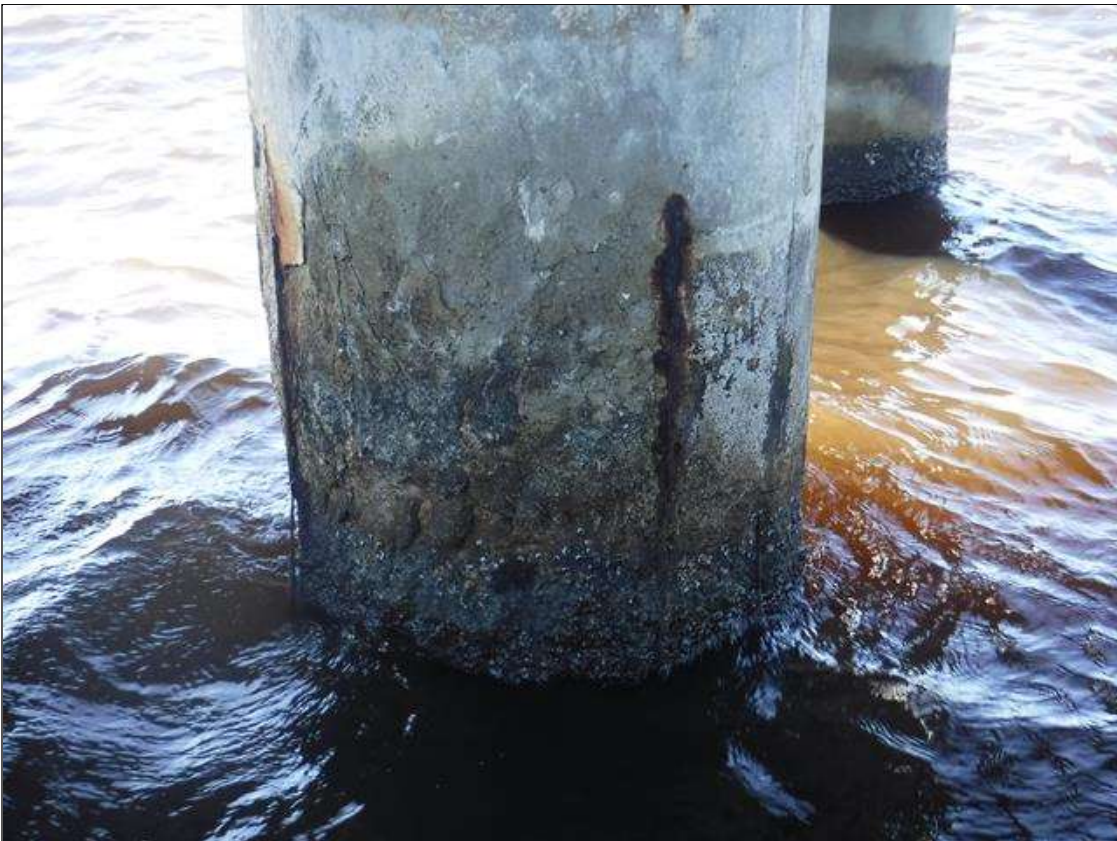
Bent 11 Saved Pile 3: (PAR) 4' X 2' X UP TO 1.5" SPALL ON PILE JACKET, WITH EXPOSED REINFORCING WITH COMPLETE SECTION LOSS, NORTH FACE, 5' FROM BOTTOM OF CAP.

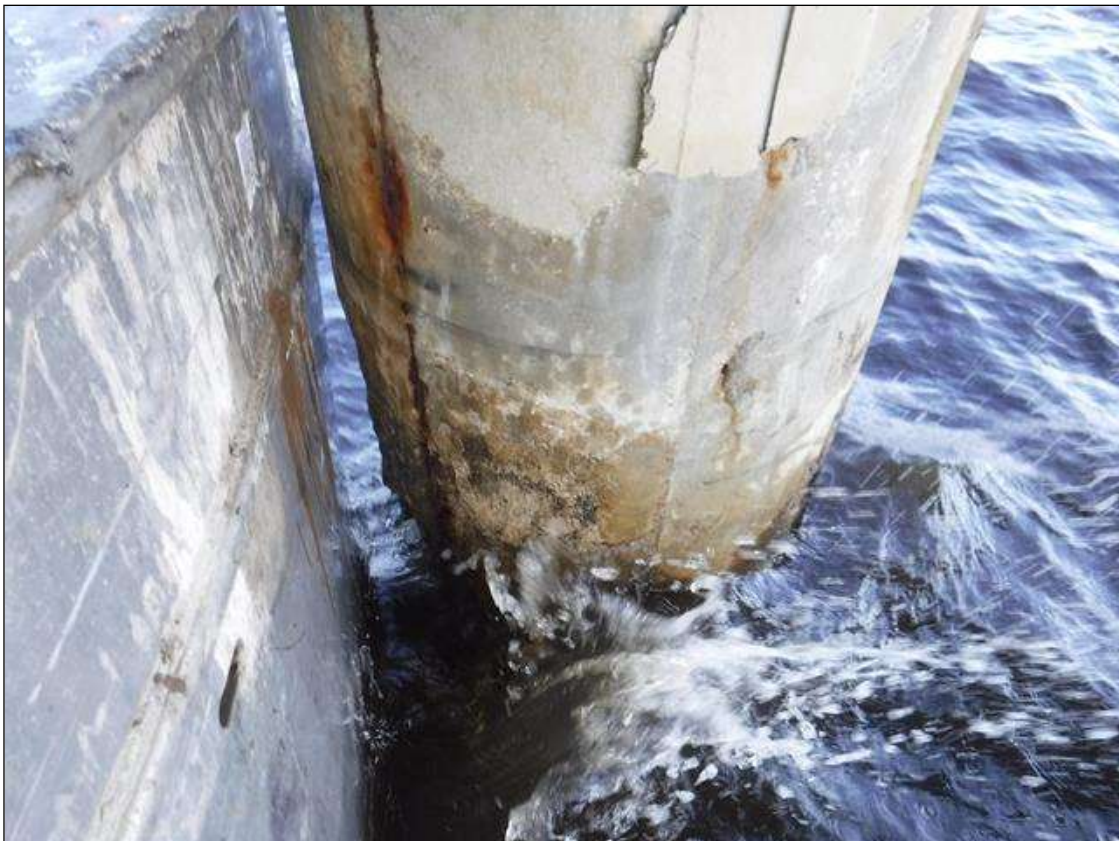
Bent 12 Saved Pile 1: (PAR) 3' X 2' X UP TO 2" SPALL ON PILE JACKET, WITH EXPOSED REINFORCING WITH COMPLETE SECTION LOSS, NORTH FACE, 5' FROM BOTTOM OF CAP AND EXTENDING BELOW WATERLINE.

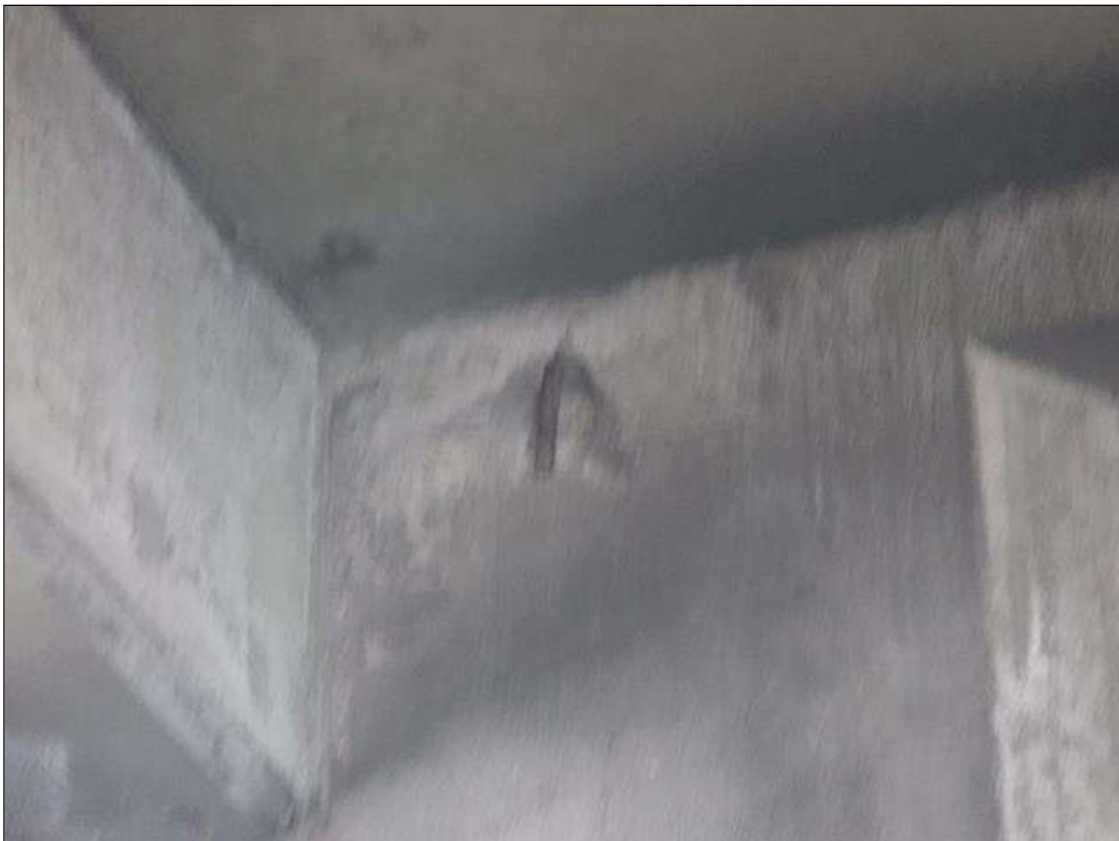
Span 13 Beam 3: 6" X 6" X 2" SPALL, WITH EXPOSED REINFORCING, TOP OF NORTH FACE, AT BENT 13.

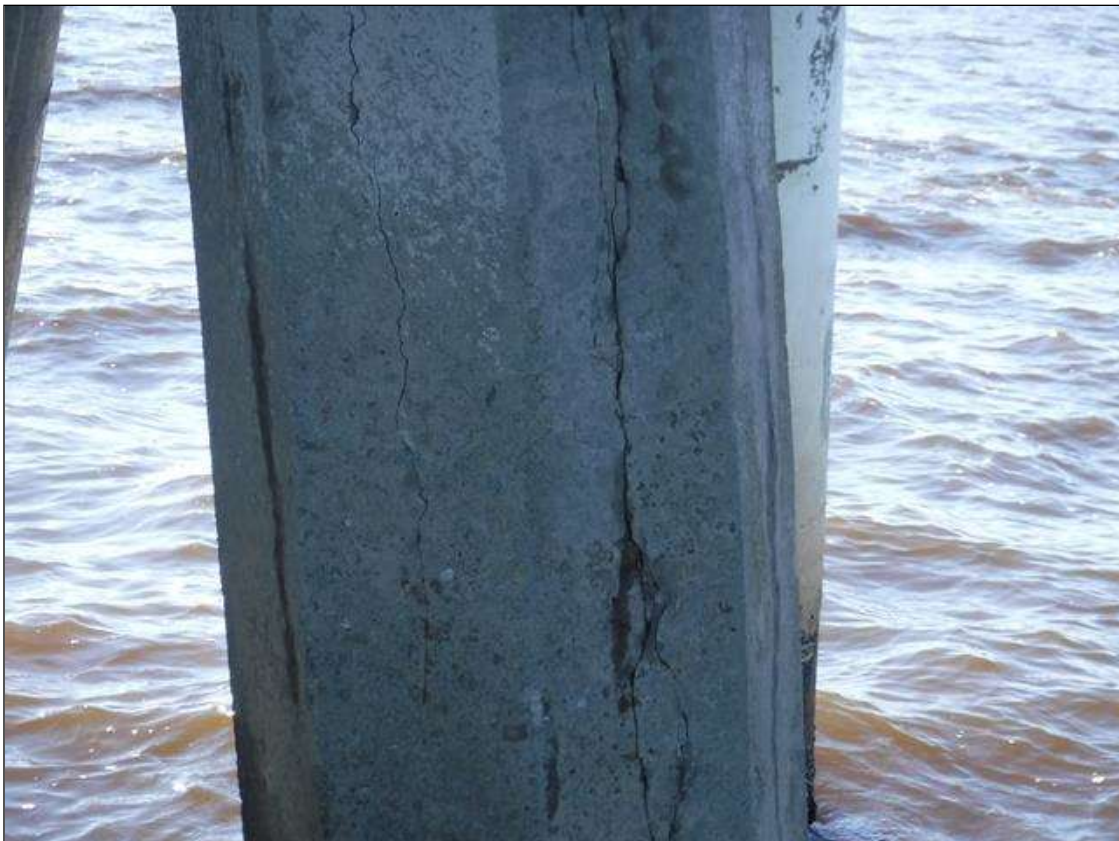
Bent 13 Saved Pile 4: (PAR) HAIRLINE TO 1/8" CRACKS, FROM BOTTOM OF CAP DOWN 8', MULTIPLE FACES. SCALING TO 1" DEEP FROM WATERLINE TO MUDLINE.

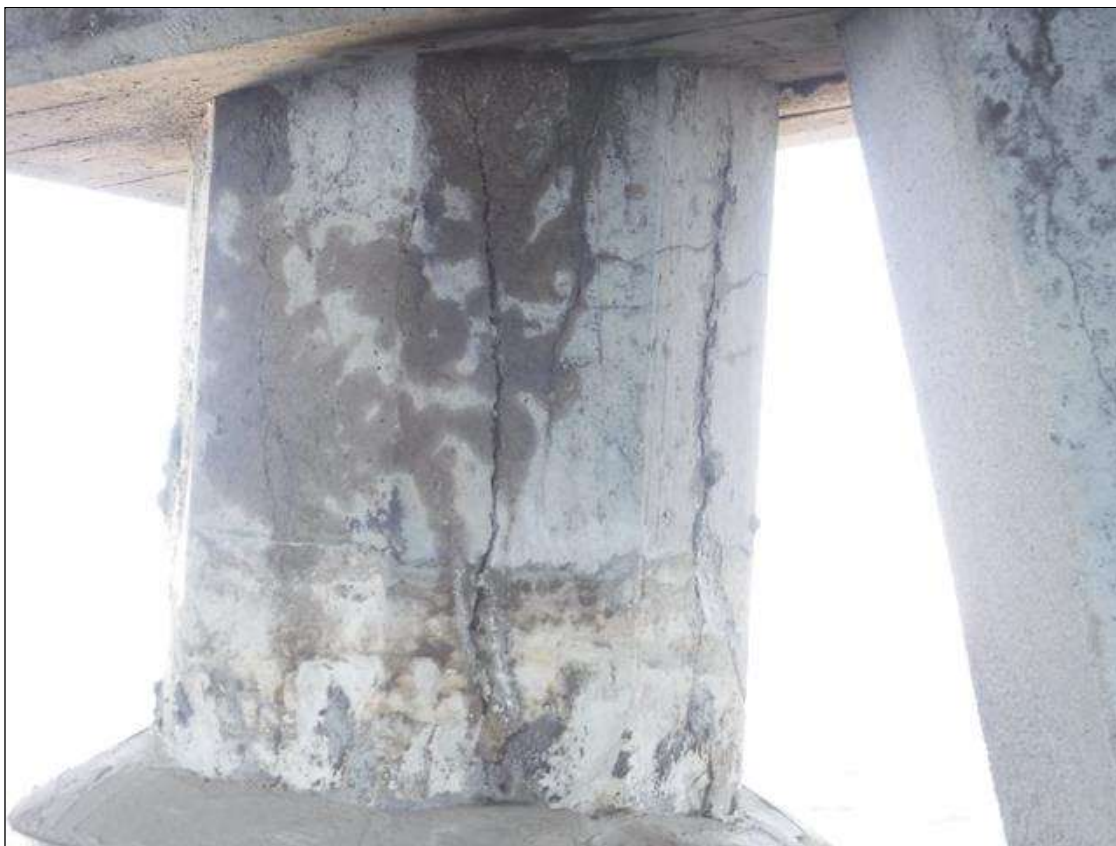
Bent 13 Saved Pile 5: (PAR) 3' X 1' DELAMINATION, WEST FACE, BEGINNING AT BOTTOM OF CAP TO TOP OF PILE JACKET

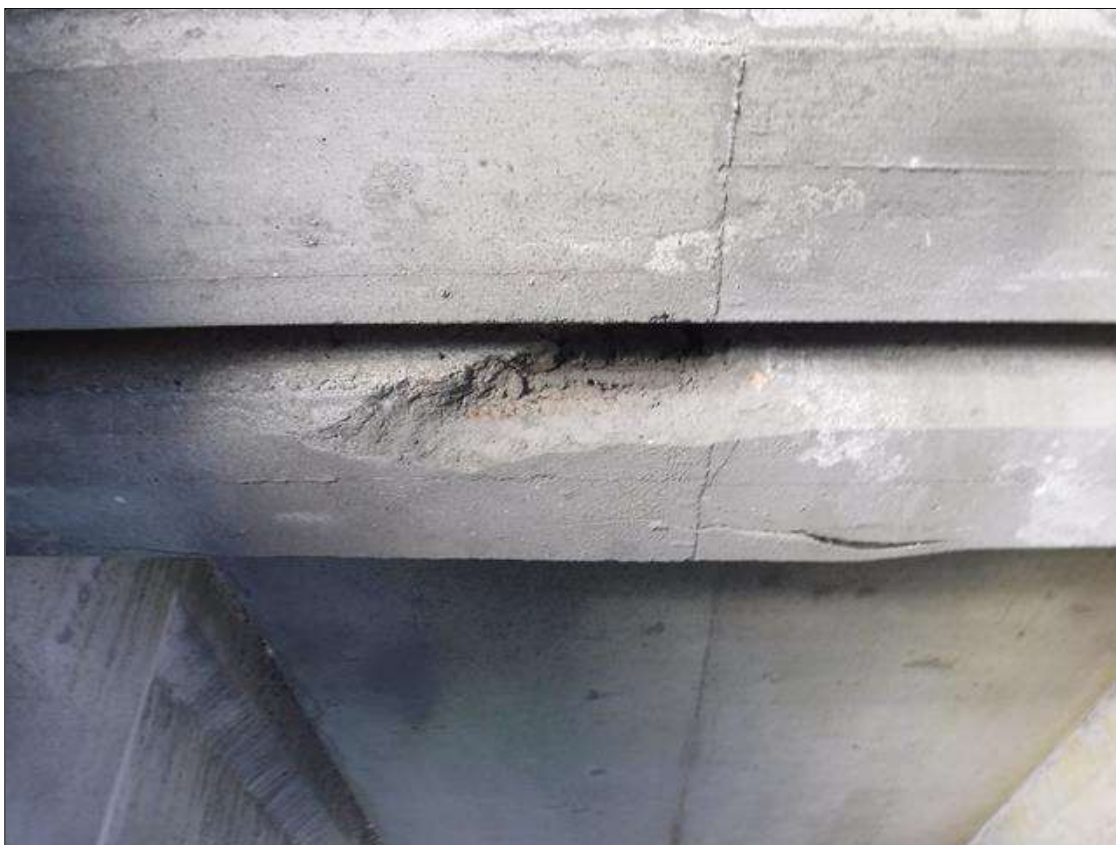
Span 13 Beam 1: 18" X 6" X 3" DEEP SPALL IN BENT 13 DIAPHRAGM

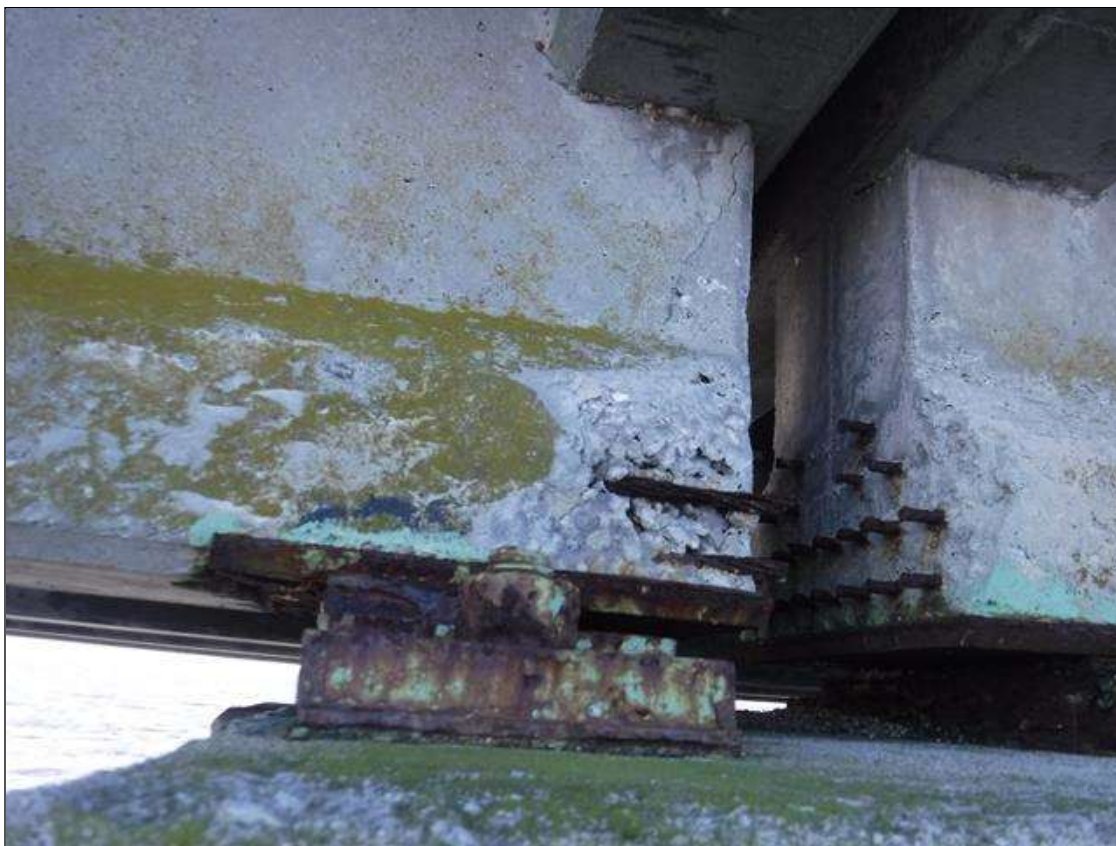
Span 14 Beam 1: (PAR) 8" X 8" X 2" SPALL, WITH EXPOSED PRESTRESSING STRAND, NORTH FACE, AT BENT 13.

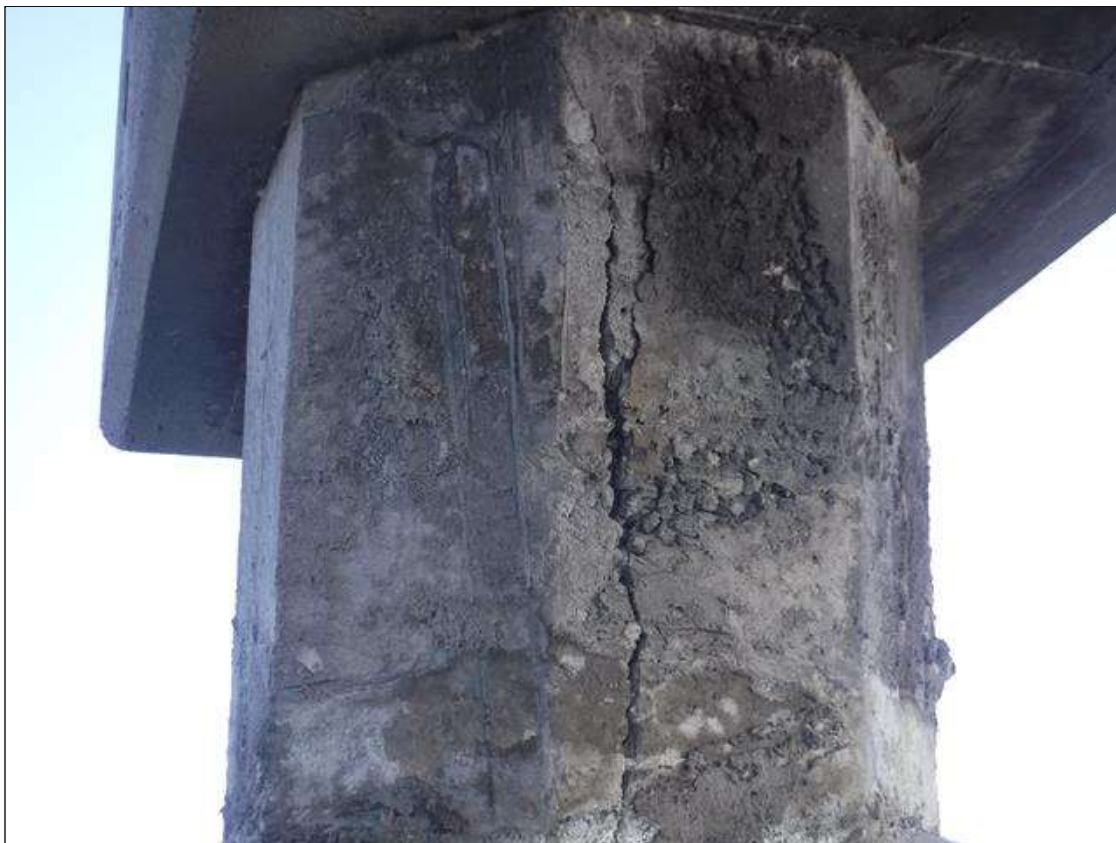
Bent 14 Saved Pile 1: 2' X 1' DELAMINATION ON SOUTH FACE AT BOTTOM OF CAP

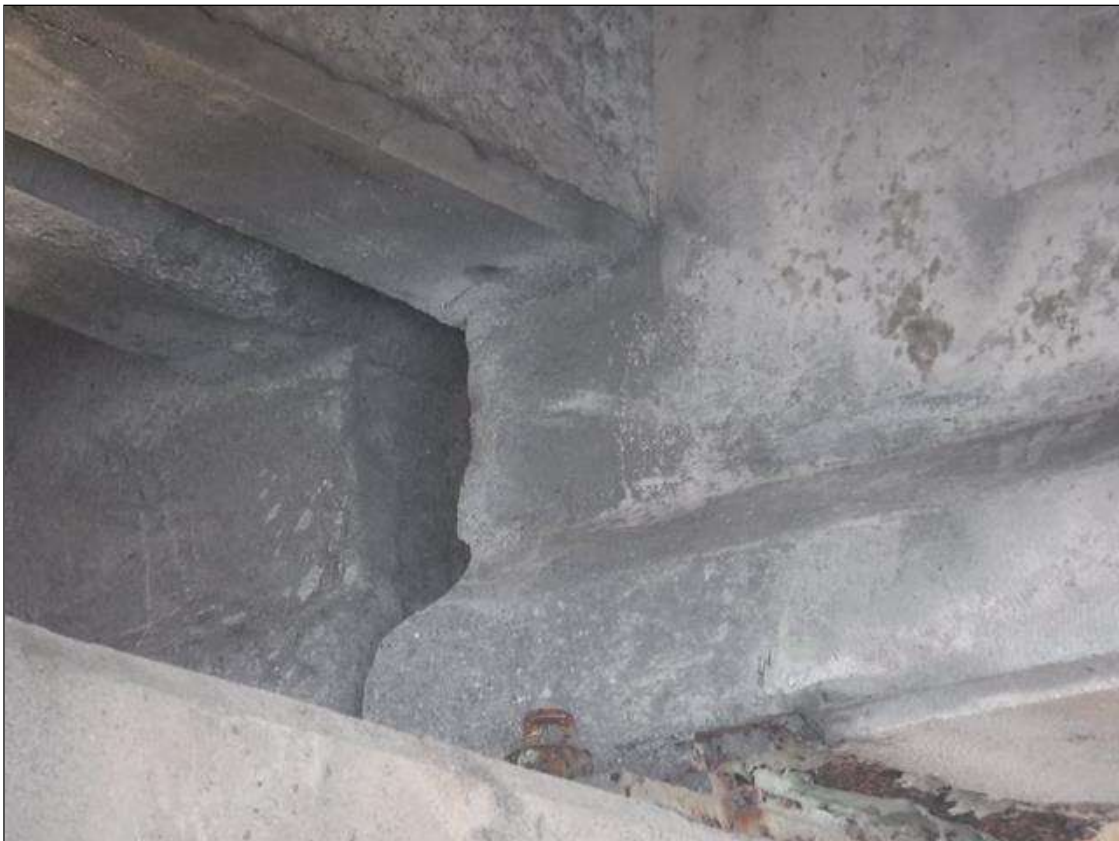
Span 15 Beam 3: (2) UP TO 12" X 18" PATCHED AREAS, NORTH AND SOUTH FACES, AT BENT 15.

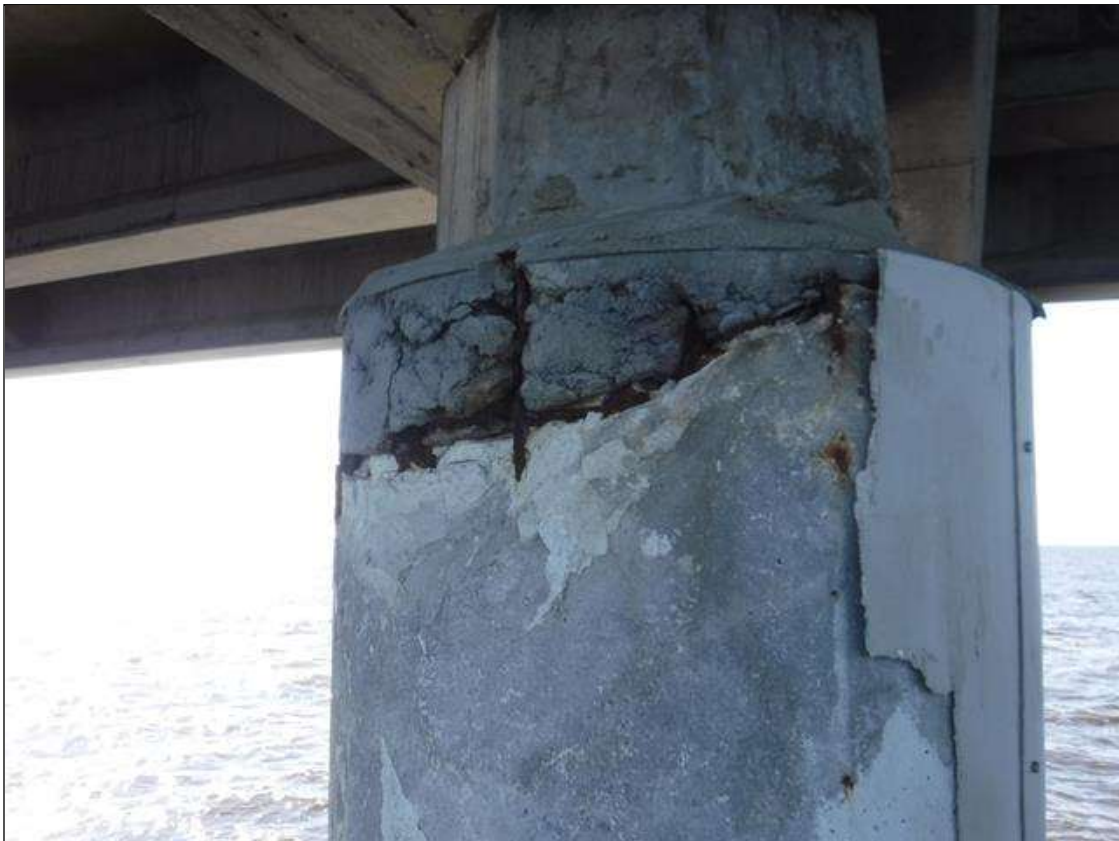
Bent 15 Saved Pile 2: (PAR) 6" X 12" X UP TO 1/2" SPALL WITH EXPOSED REBAR, REBAR HAS 50% SECTION LOSS, NORTH FACE, 2' FROM BOTTOM OF CAP.
