NC DEPARTMENT OF TRANSPORTATION
DIVISION OF HIGHWAYS
STRUCTURE MANAGEMENT UNIT

Structure Safety Report

Routine Element Inspection - Contract

FEATURE INTERSECTED: ALLIGATOR RIVER

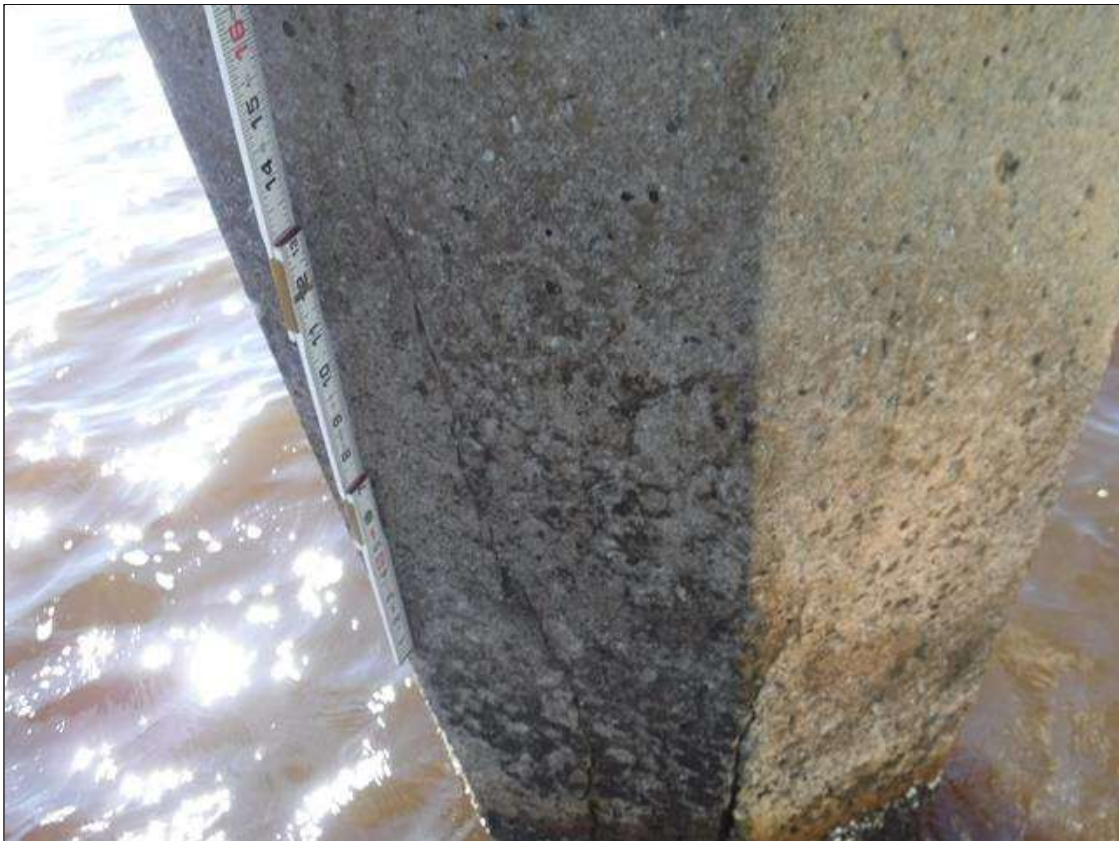
Bent 15 Saved Pile 4: (PAR) HAIRLINE TO 1/4" CRACKS, 10' BELOW CAP, DOWN 6', MULTIPLE FACES. SCALING TO 1" DEEP FROM WATERLINE TO MUDLINE.

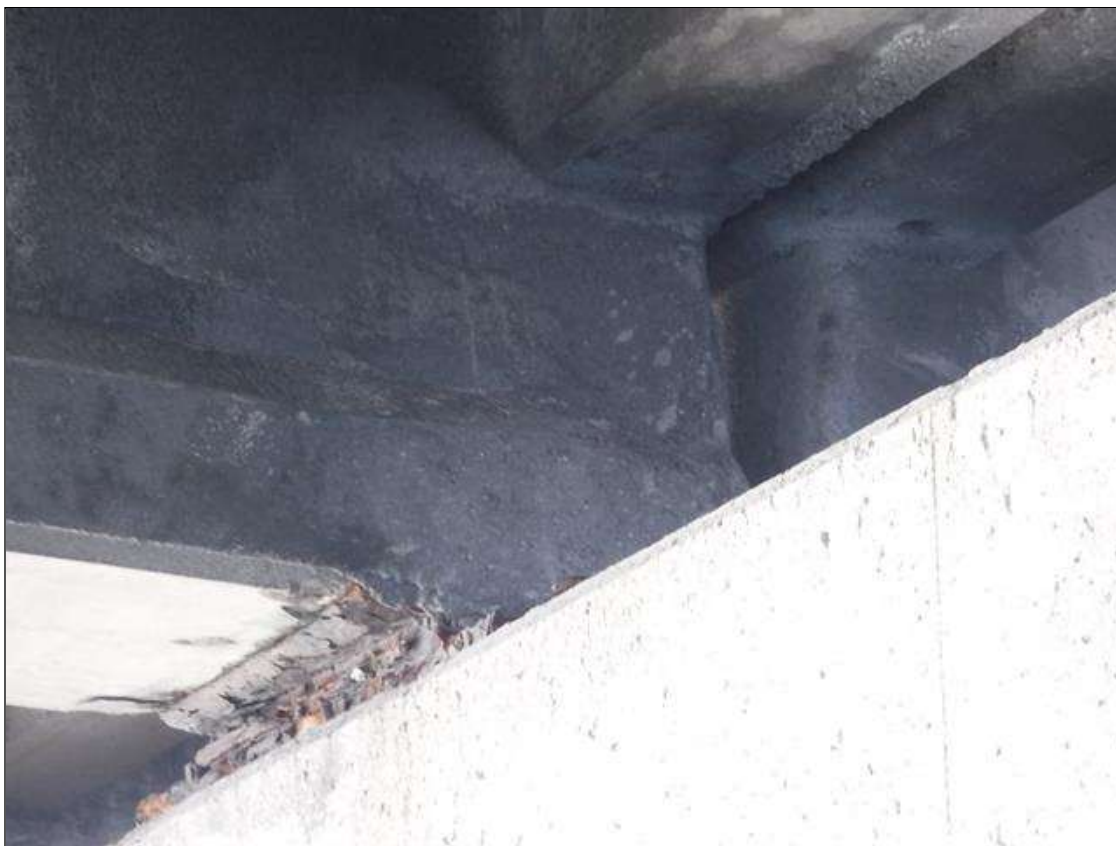
Span 16 Beam 3: (2) UP TO 18" X 12" PATCHED AREAS, NORTH AND SOUTH FACES, AT BENT 15.

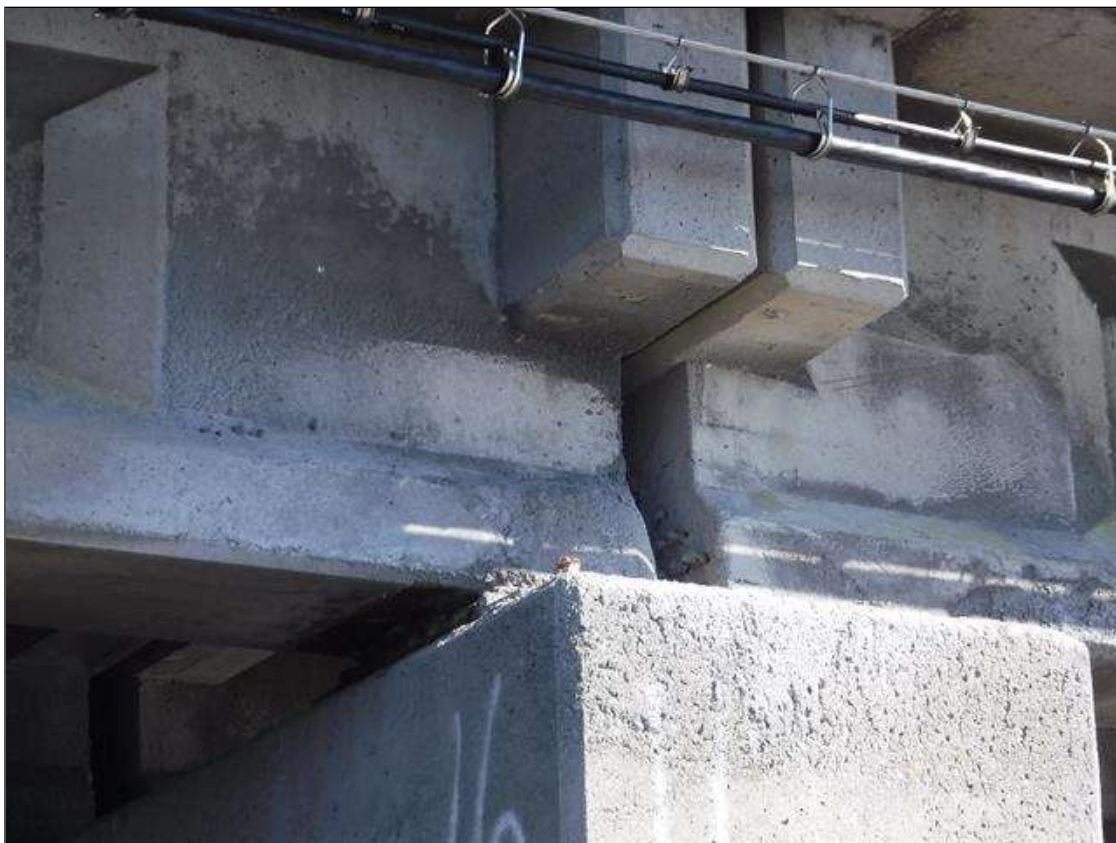
Span 16 Beam 4: 16" TALL X 12" LONG PATCHED AREA AT BENT 16 ON EXTERIOR SIDE.

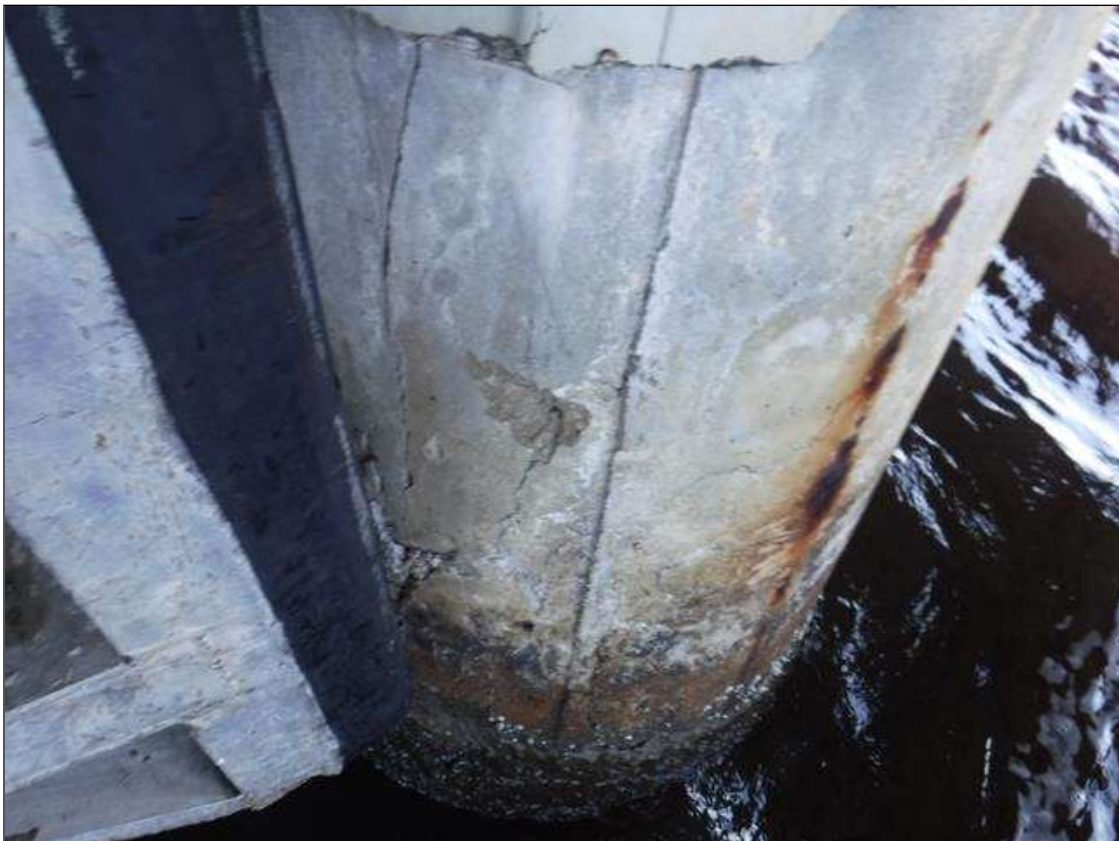
Bent 17 Saved Pile 2: JACKETED. SCALING TO 1" WITH LOOSE AGGREGATE FROM BOTTOM OF JACKET TO MUDLINE.

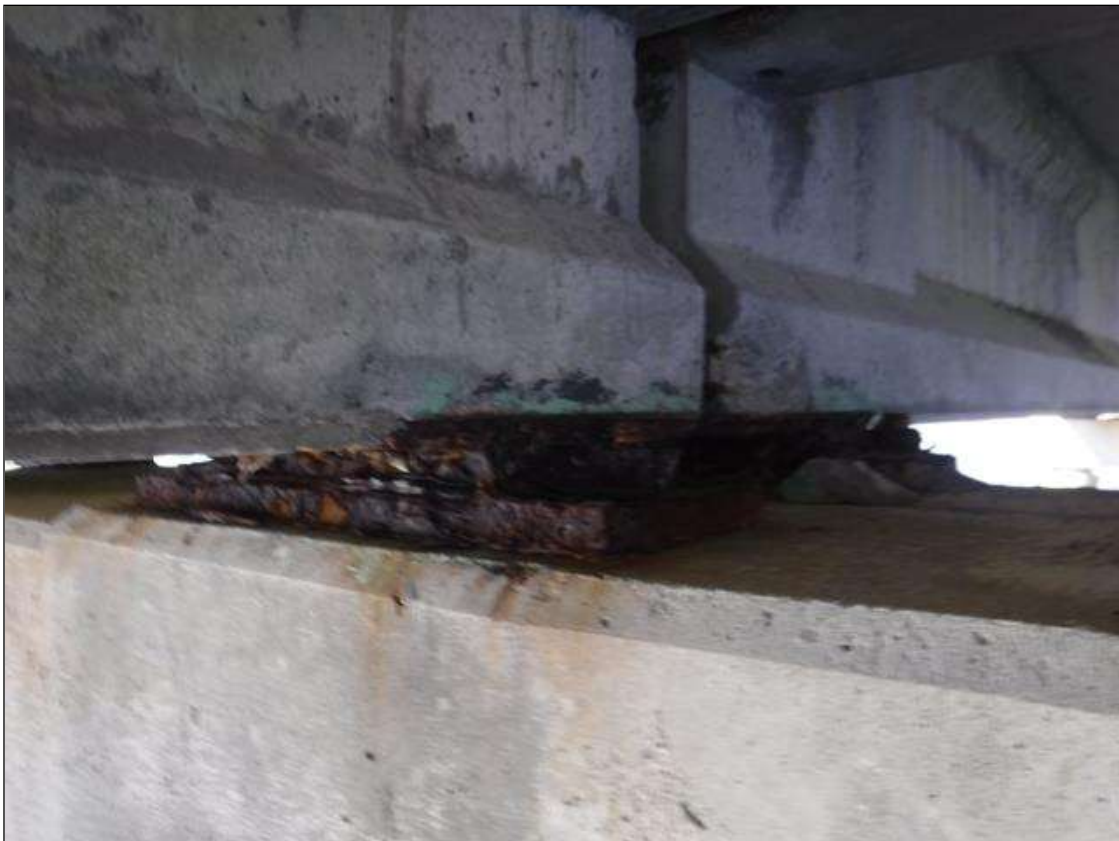
Span 19 Beam 3 Near Bearing: CORROSION WITH LESS THAN 1/16" LOSS. (2" REMAINING).

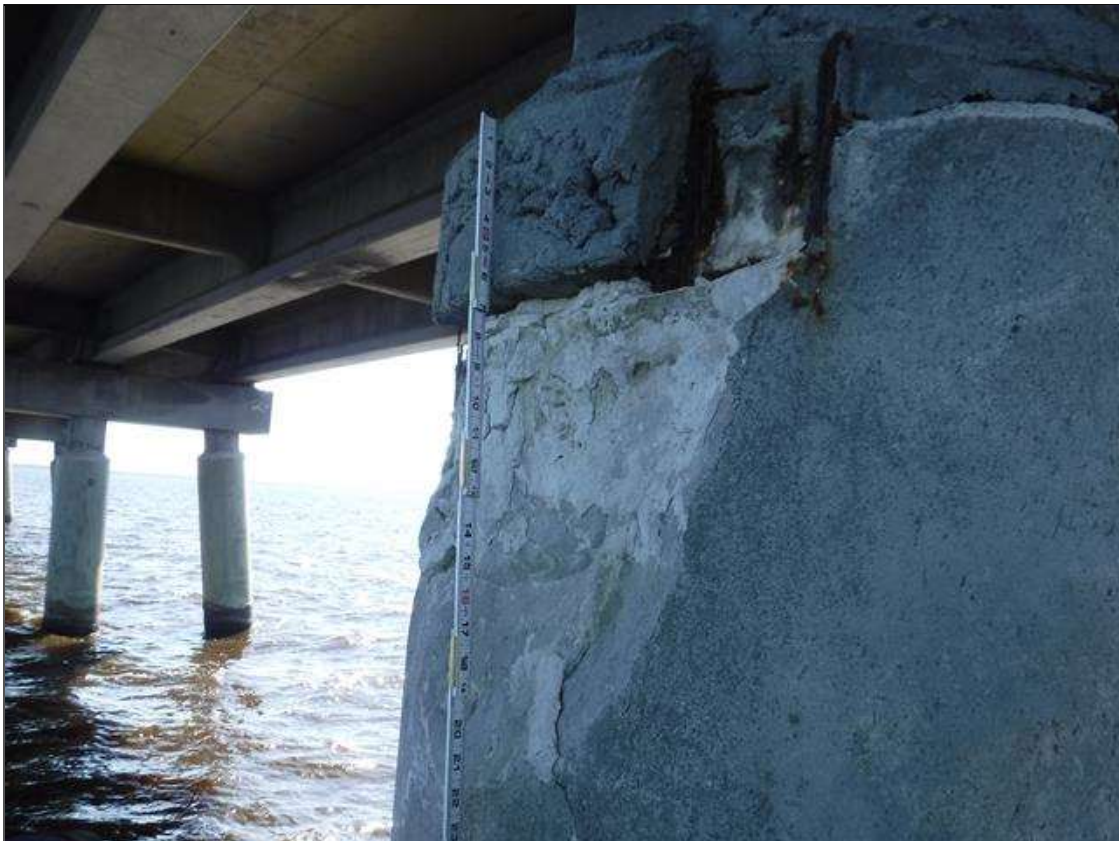
Bent 19 Saved Pile 2: (PAR) 2' X 18" X UP TO 1" DEEP SPALL WITH EXPOSED REBAR ON NORTH FACE, 2' FROM BOTTOM OF CAP. REBAR HAS COMPLETE SECTION LOSS.

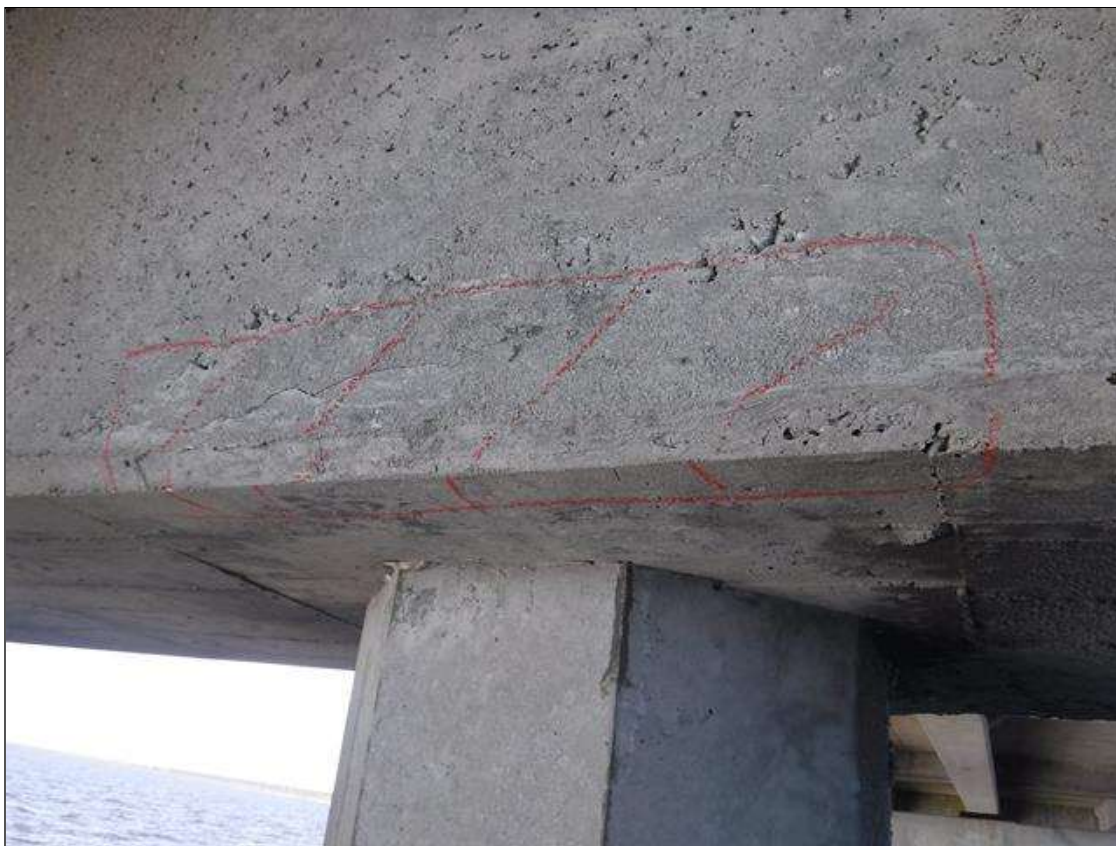
Bent 19 Cap 1: 48" X 12" X 12" CORNER FAILED PATCHED AREA, BOTTOM OF EAST FACE, BENEATH BEAM 2.

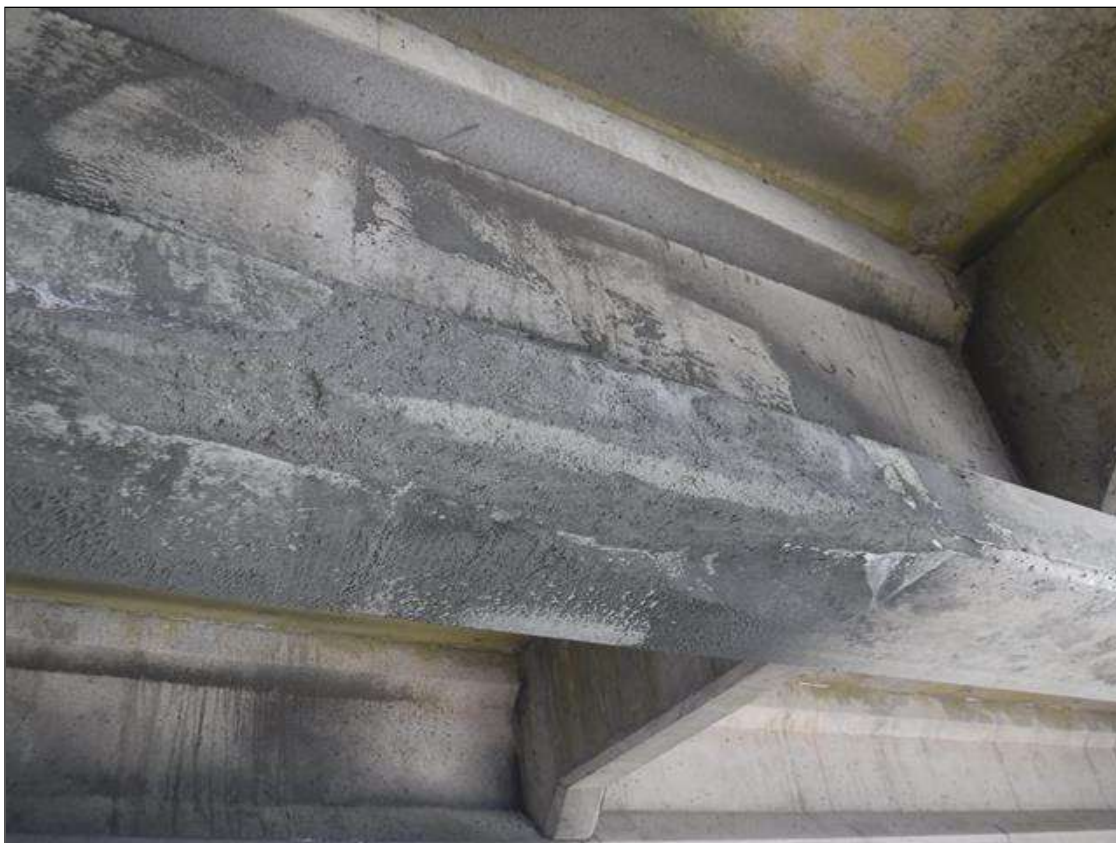
Span 20 Beam 3: 4' LONG X 12" TALL PATCHED AREA AT MIDPOINT OF SPAN.

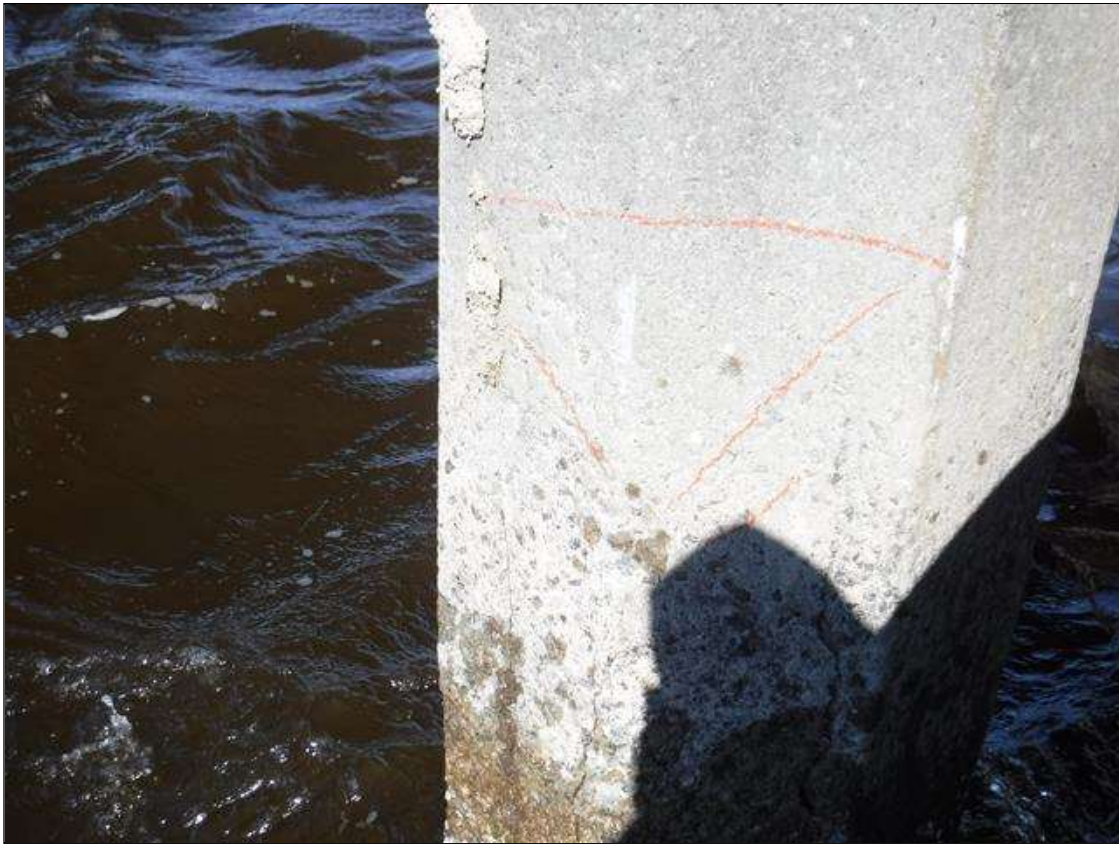
Bent 19 Saved Pile 4: 2' X 1' DELAMINATION, SOUTH FACE, 8' FROM BOTTOM OF CAP.

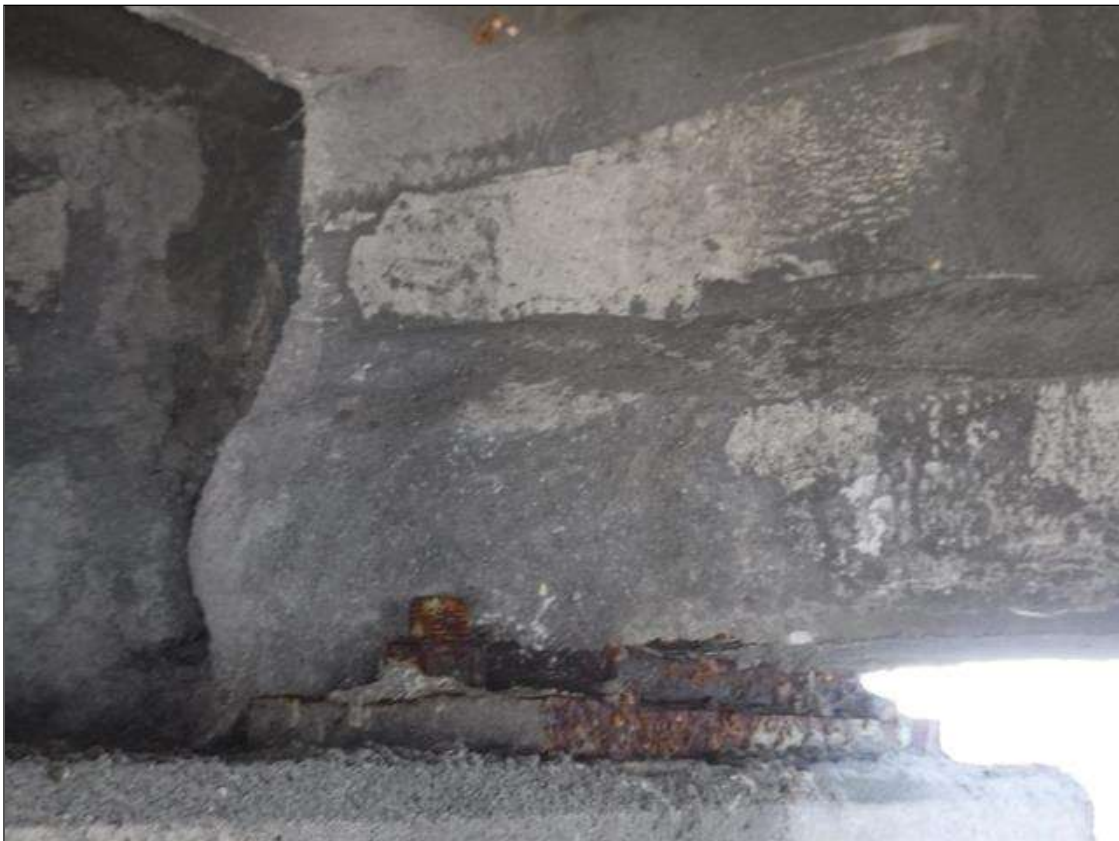
Span 21 Beam 1: (2) UP TO 24" X 12" PATCHED AREAS, NORTH AND SOUTH FACES, AT BENT 20.

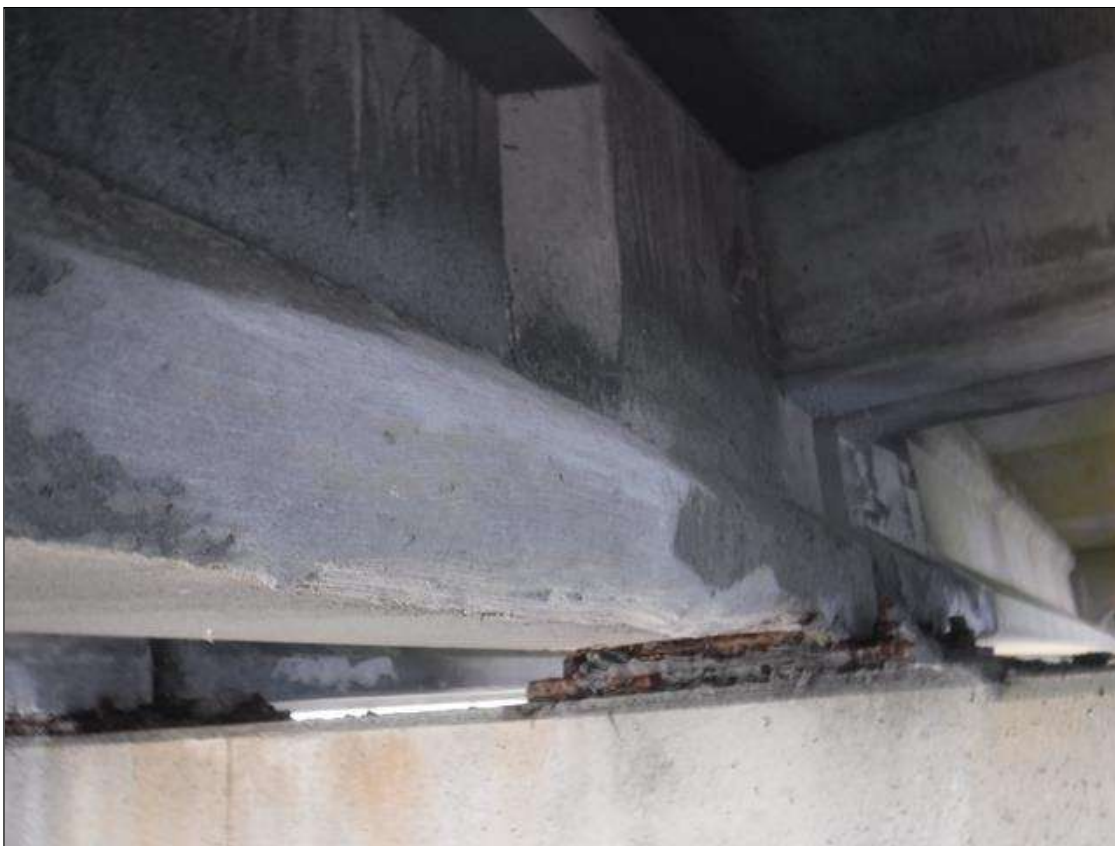
Span 21 Beam 2: 5' X 12" PATCH ON BOTTOM FLANGE, NORTH FACE, AT BENT 20.

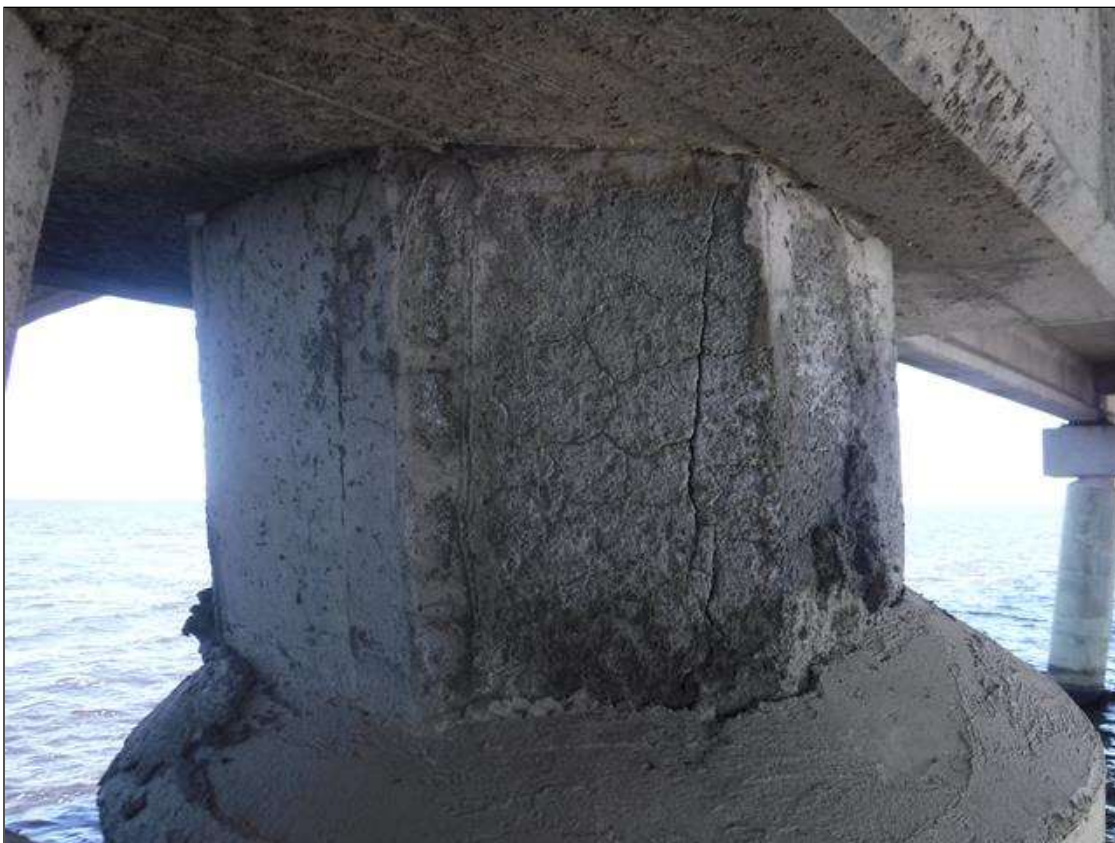
Bent 21 Saved Pile 3: 2' X 1' WIDE DELAMINATION ON SOUTHWEST FACE BELOW CAP

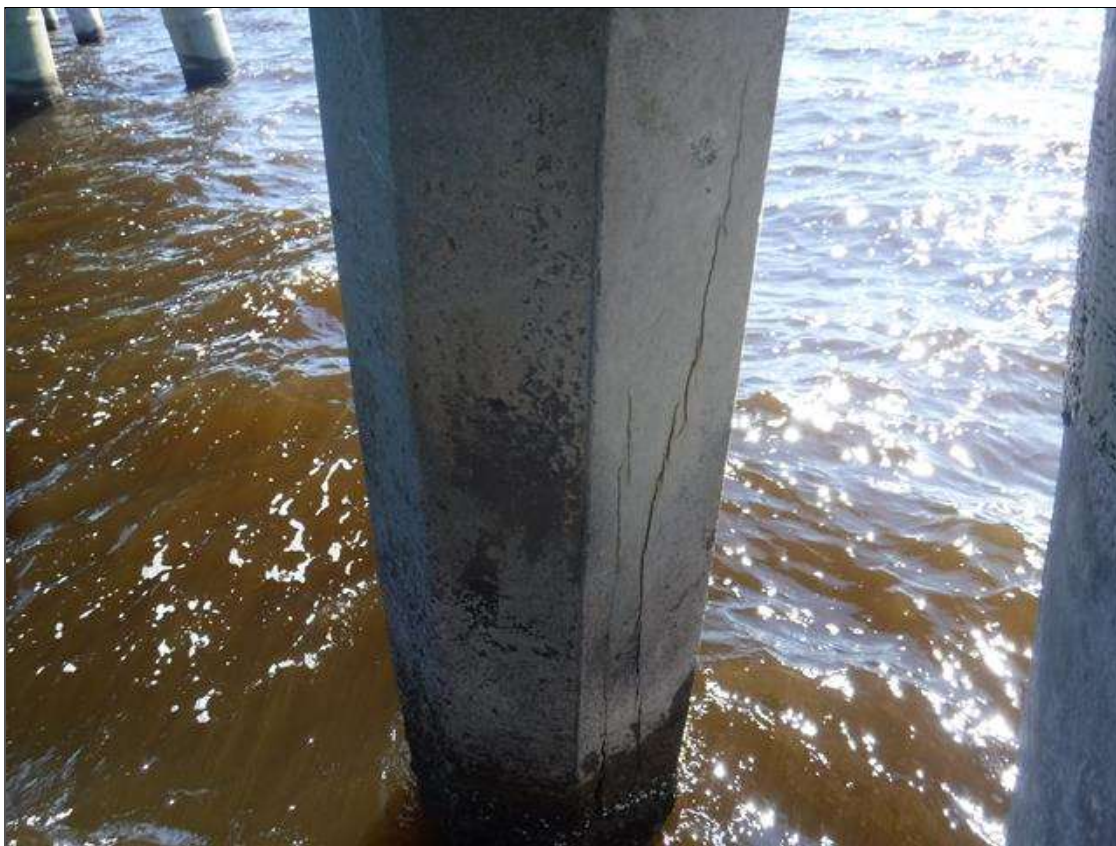
Bent 21 Saved Pile 5: 3' X 1' DELAMINATION, WEST FACE, 8' FROM BOTTOM OF CAP.

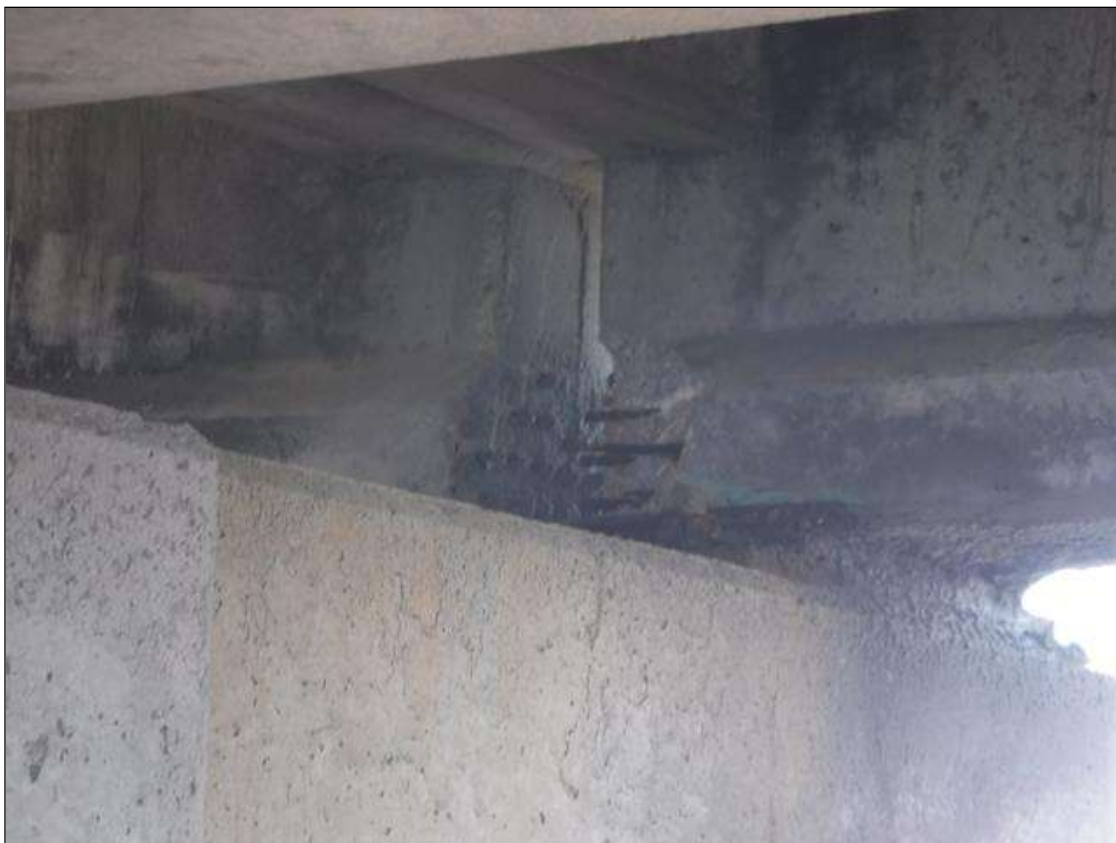
Span 21 Beam 4: (PAR) 12" X 12" X 6" SPALL, WITH EXPOSED PRESTRESSING STRAND, NORTH FACE, AT BENT 21.

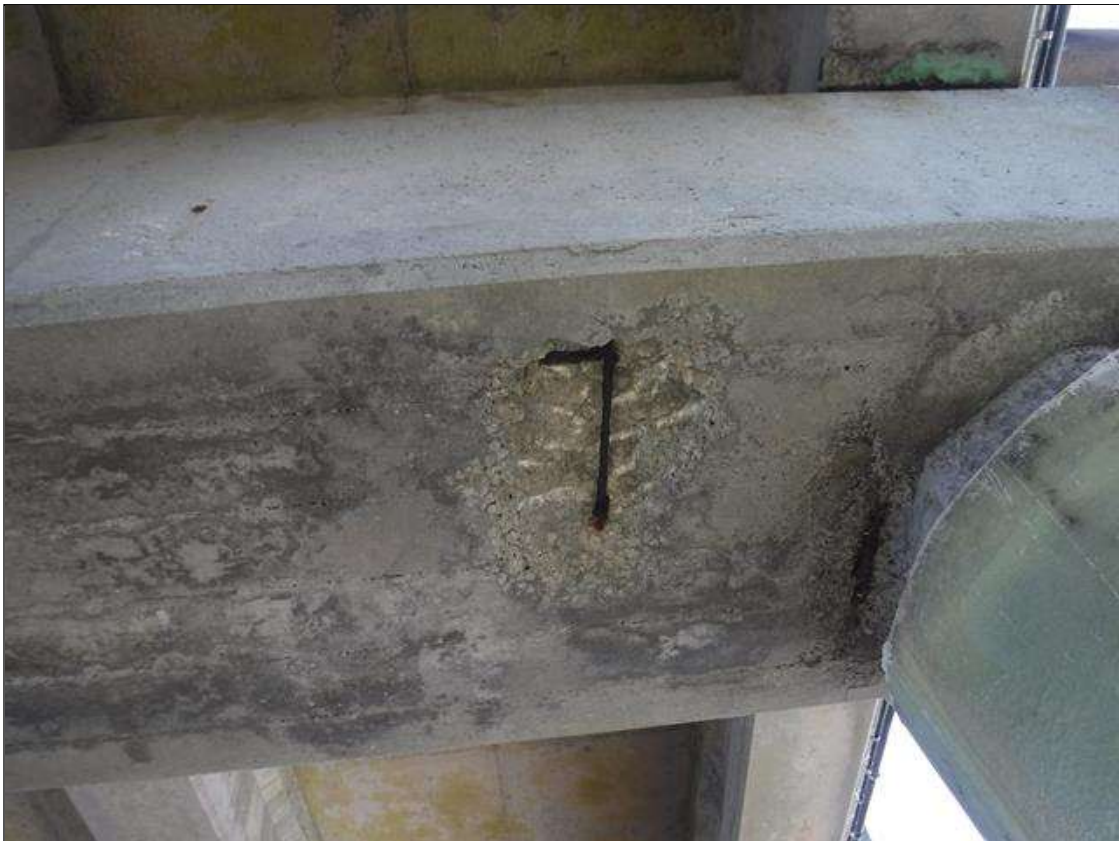
Bent 22 Cap 1: (PAR) 12" X 24" X 6" SPALL, WITH EXPOSED PRIMARY REINFORCING, BOTTOM FACE, BETWEEN BEAMS 3 AND 4. REBAR HAS 10% SECTION LOSS

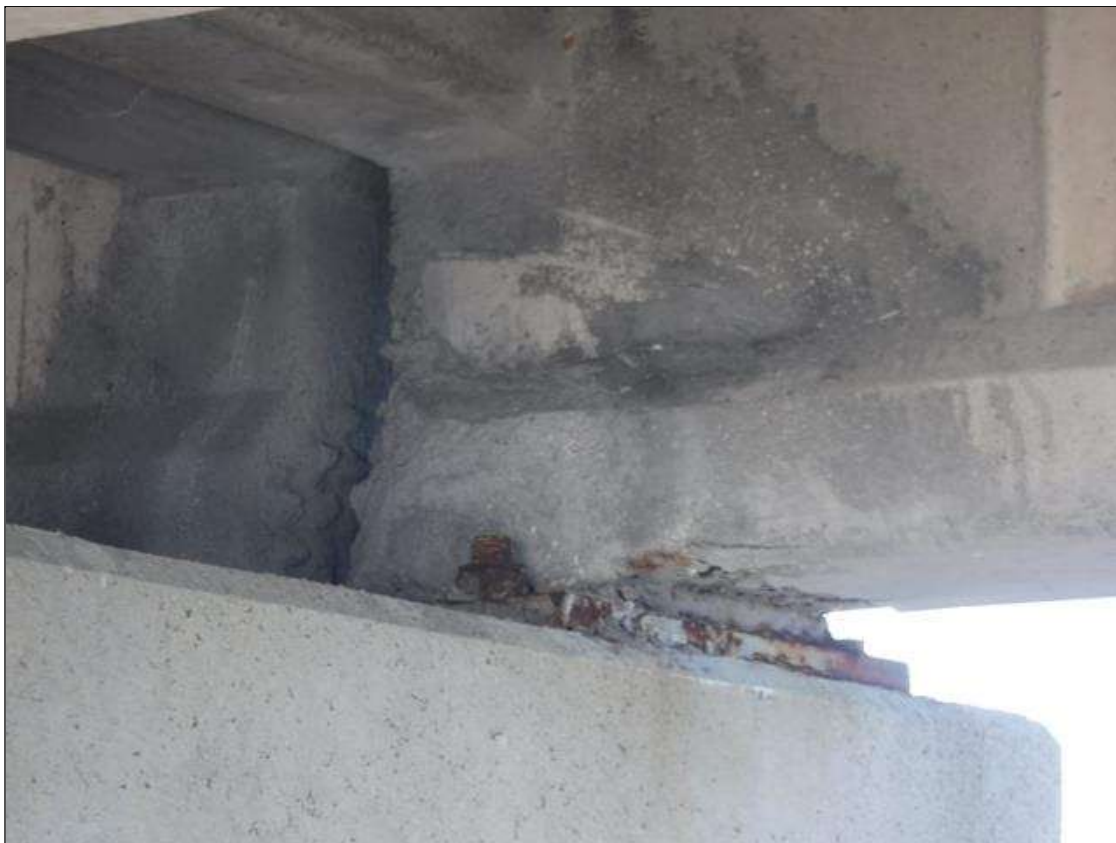
Bent 22 Cap 1: (PAR) 12" X 24" X 4" SPALL, WITH EXPOSED REINFORCING, BOTTOM FACE, BENEATH BEAM 4.
REBAR HAS 10% SECTION LOSS

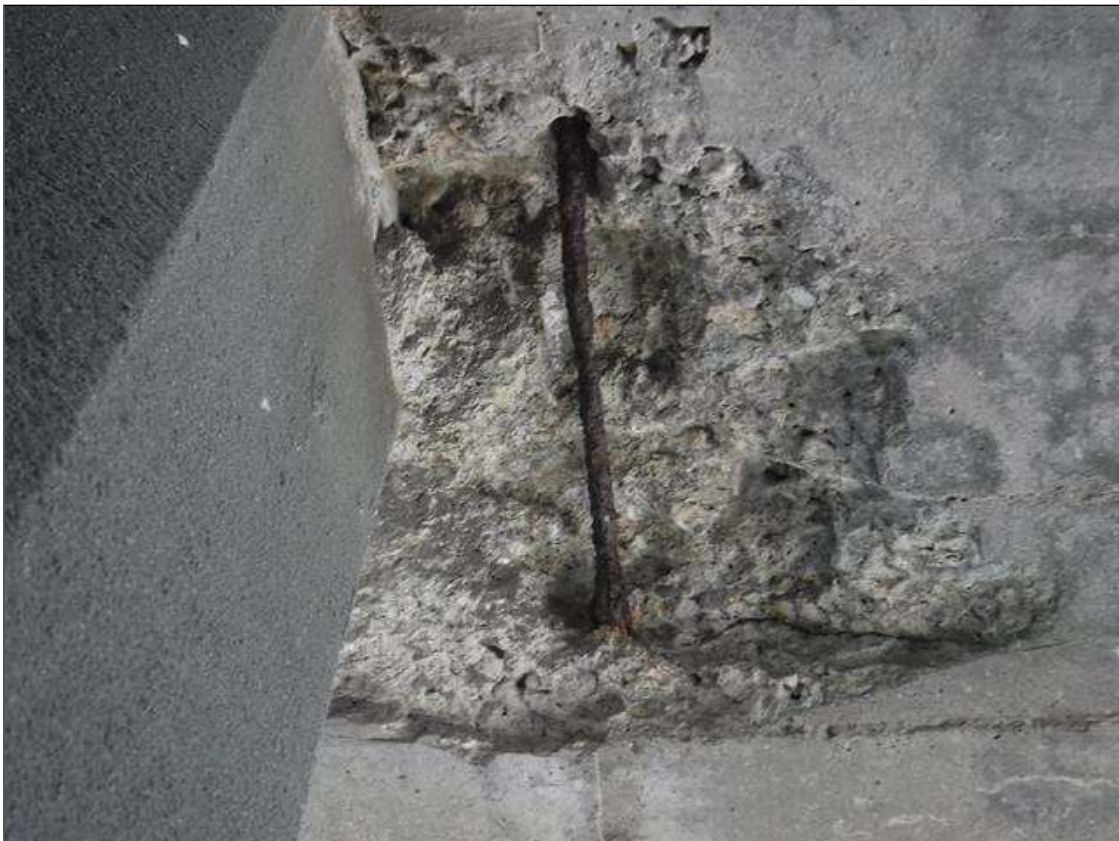
Span 23 Beam 4: 2' X 10" X 1" DEEP SPALL WITH EXPOSED REBAR ON BENT 22 DIAPHRAGM

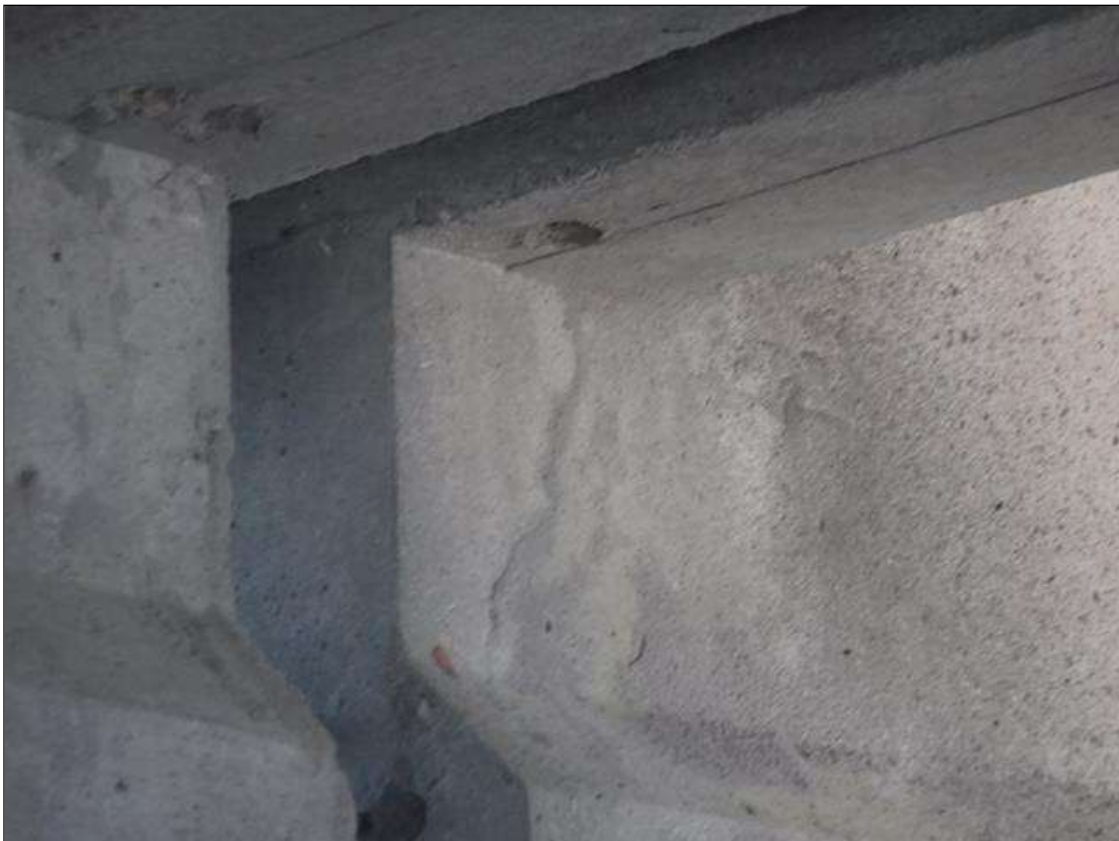
Span 23 Beam 4: 30" X 12" PATCHED AREA ON NORTH FACE, AT BENT 23.

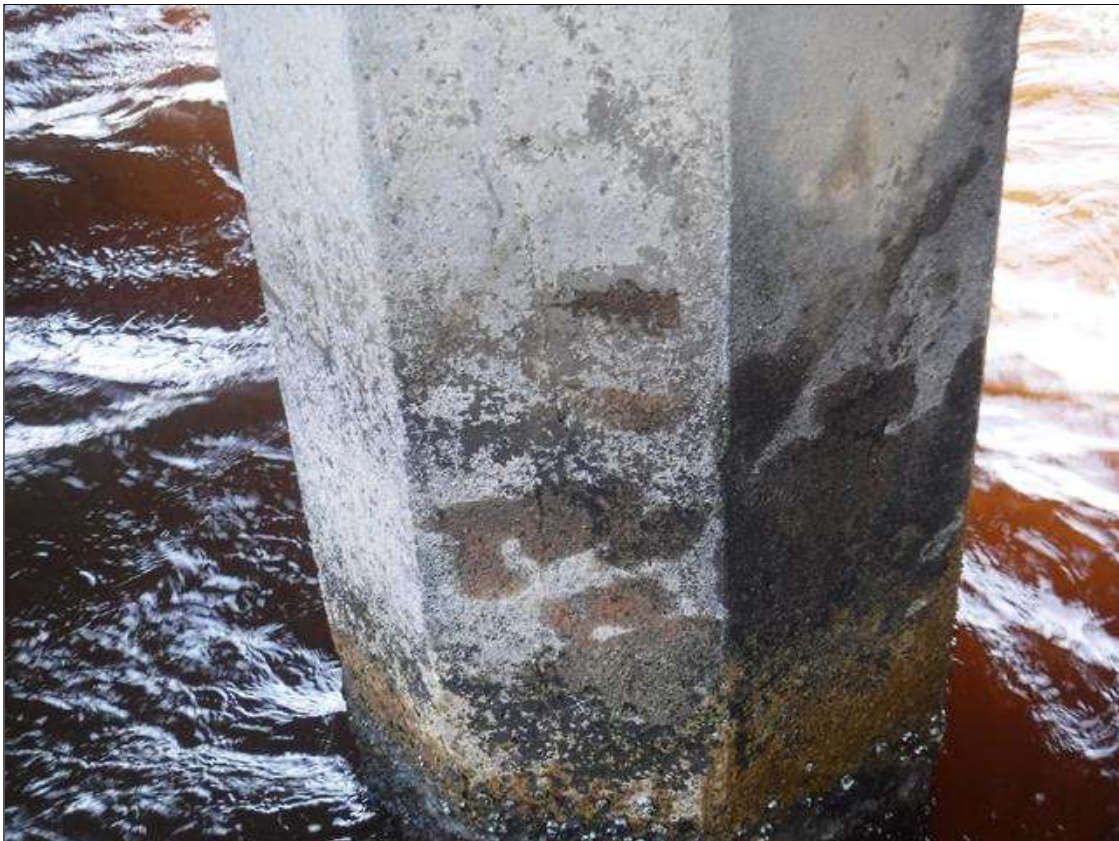
Bent 25 Saved Pile 2: 2' X 8" DELAMINATION, SOUTH FACE, BEGINNING 8' FROM BOTTOM OF CAP AND EXTENDING BELOW WATERLINE.

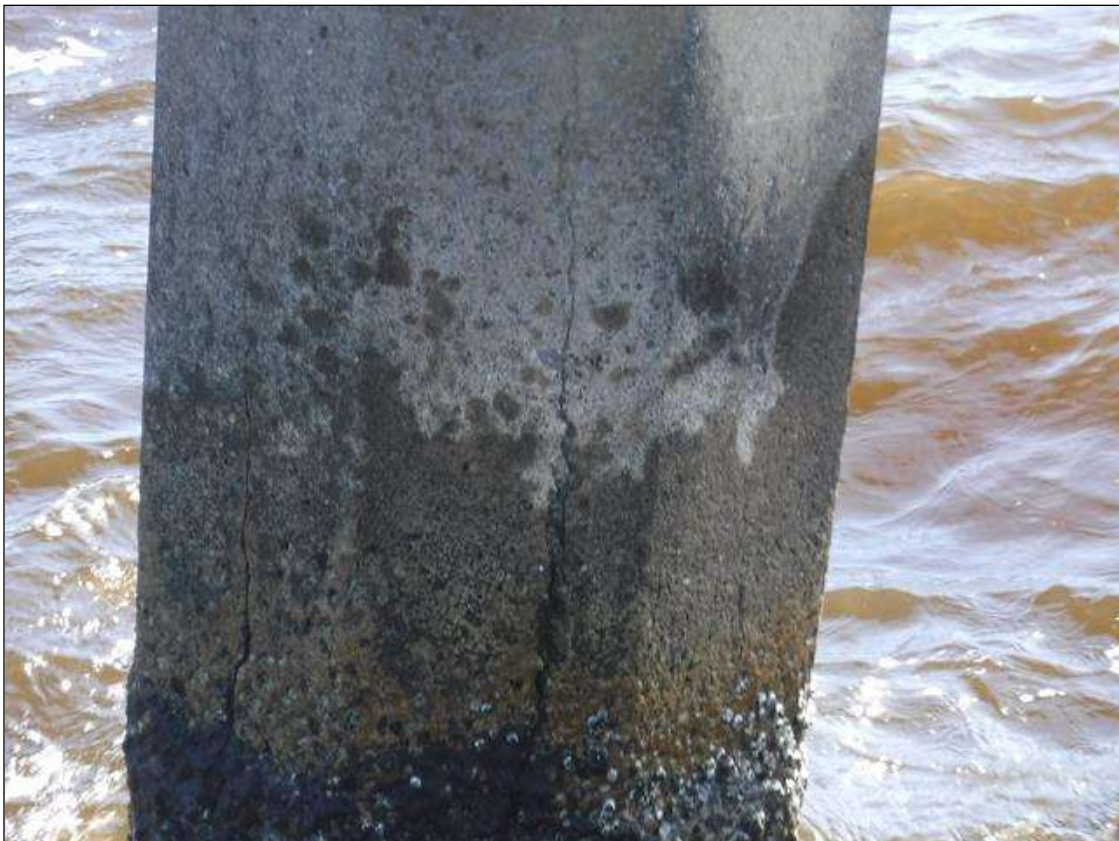
Bent 28 Saved Pile 2: 2' X 1' DELAMINATION, SOUTH FACE, 8' FROM BOTTOM OF CAP.

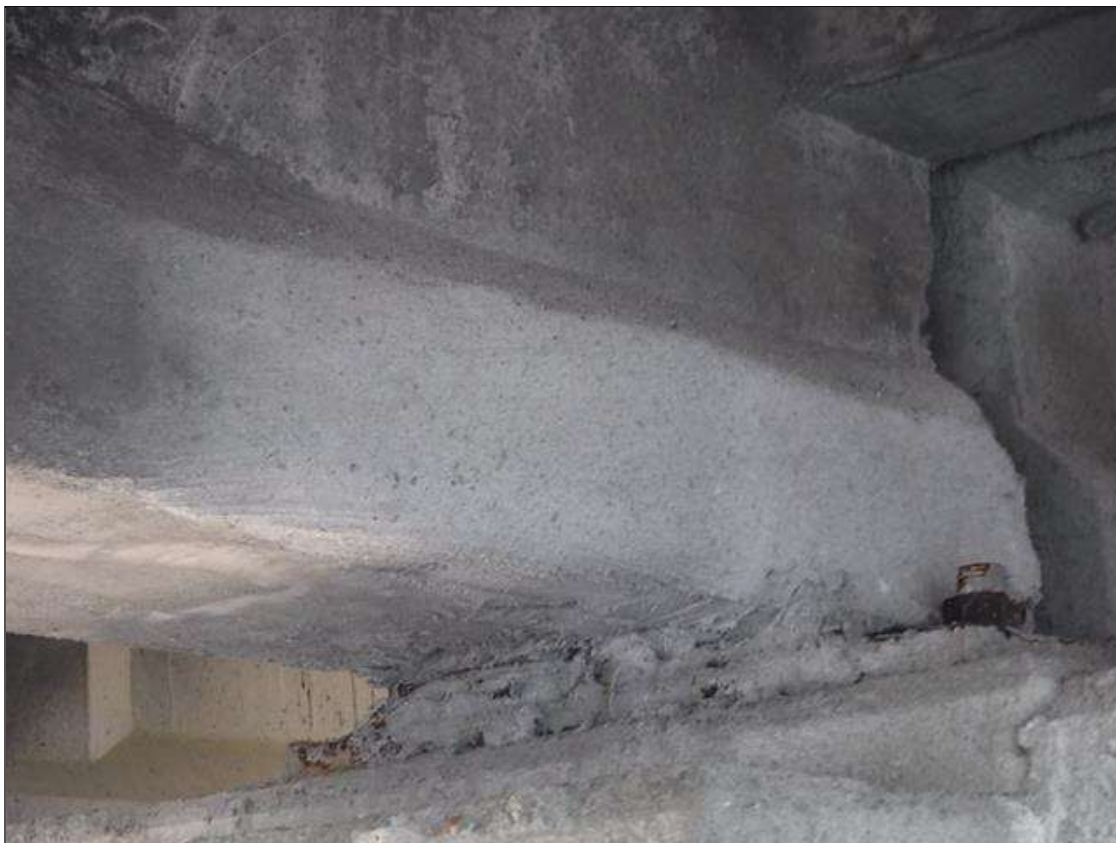
Bent 29 Cap 1: (PAR) 4" LONG, 16" WIDE, AND 3" DEEP SPALL WITH EXPOSED REBAR ON NORTH FCE ABOVE PILE 5. REBAR HAS 15% SECTION LOSS

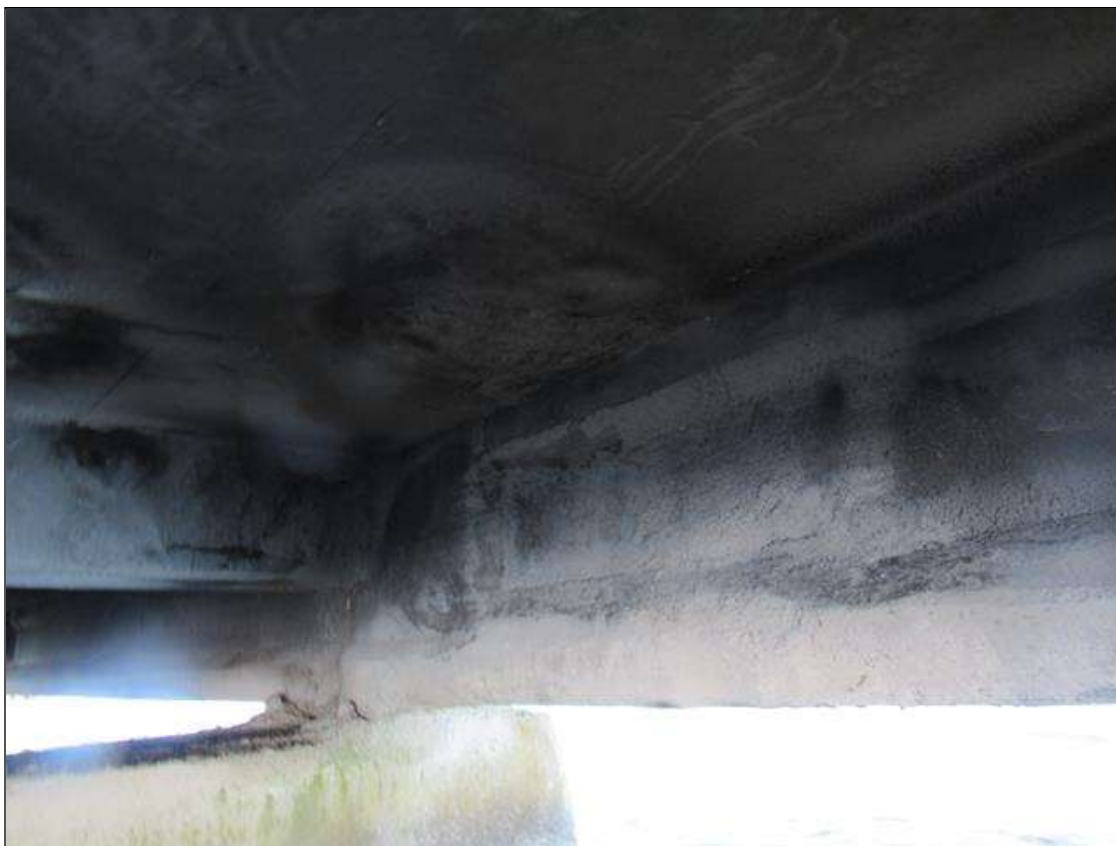
Span 30 Beam 2: 3' X 1' PATCHED AREA ON NORTH FACE AT BENT 29.

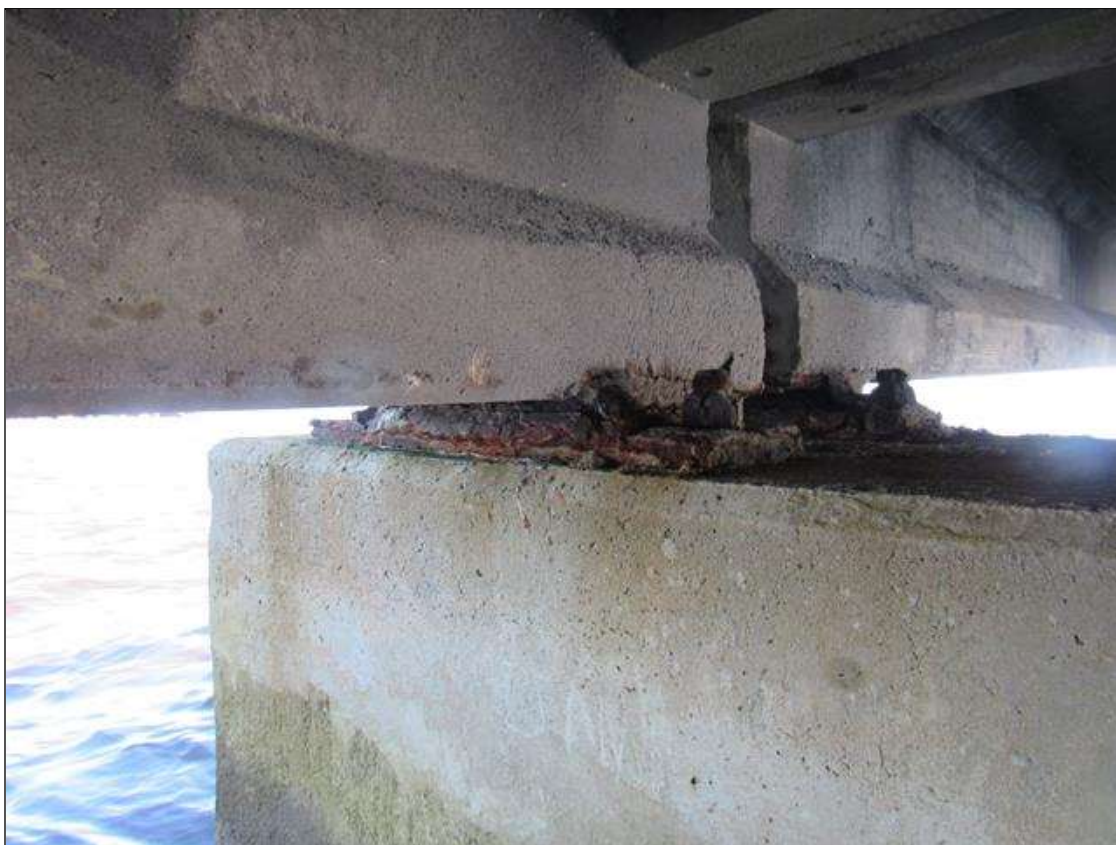
Span 3 Beam 1: 12' X UP TO 32" PATCHED AREAS, AT RANDOM THROUGHOUT, NORTH AND SOUTH FACES, BEGINNING AT BENT 2.

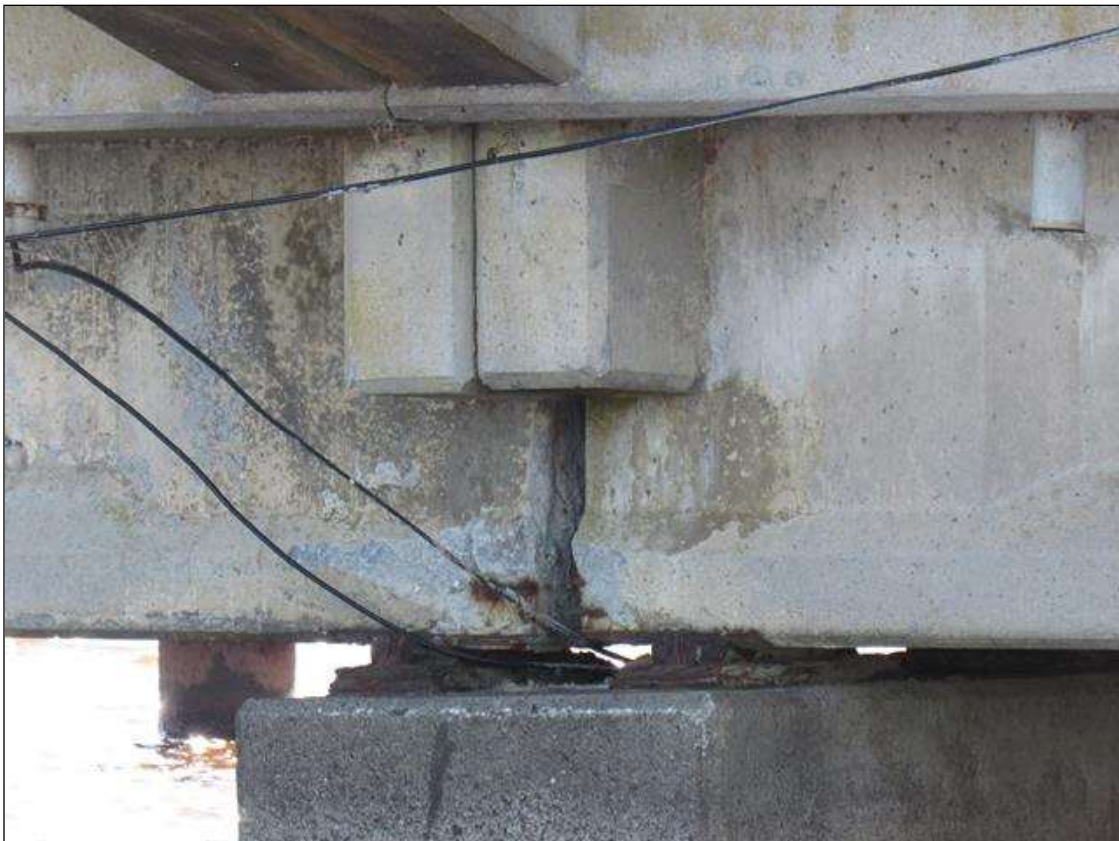
Span 3 Beam 2: (PAR) 3' X UP TO 0.031" LONGITUDINAL CRACK, BOTTOM FACE, 15' FROM BENT 2.
