NC DEPARTMENT OF TRANSPORTATION
DIVISION OF HIGHWAYS
STRUCTURE MANAGEMENT UNIT

Structure Safety Report

Routine Element Inspection - Contract

FEATURE INTERSECTED: ALLIGATOR RIVER

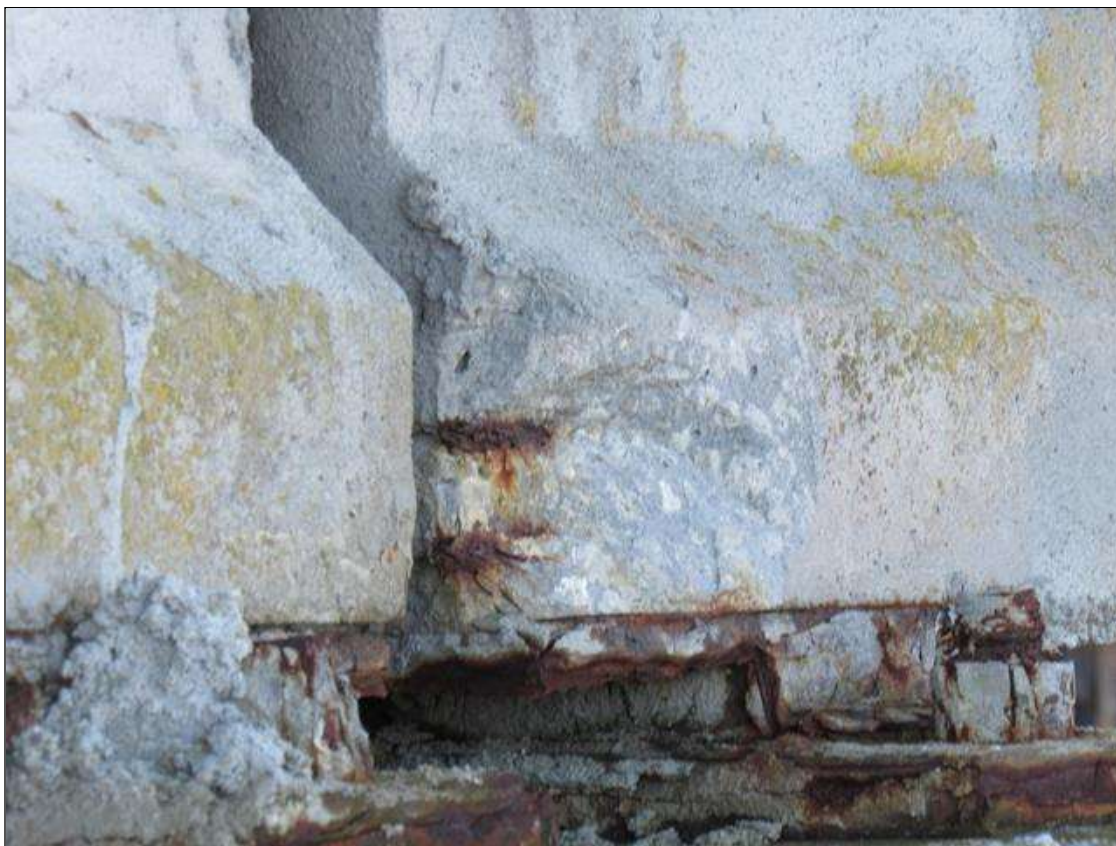
Span 2 Beam 1: (PAR) 18" X 8" X 2" SPALL, WITH EXPOSED STRAND, NORTH FACE, AT BENT 1.

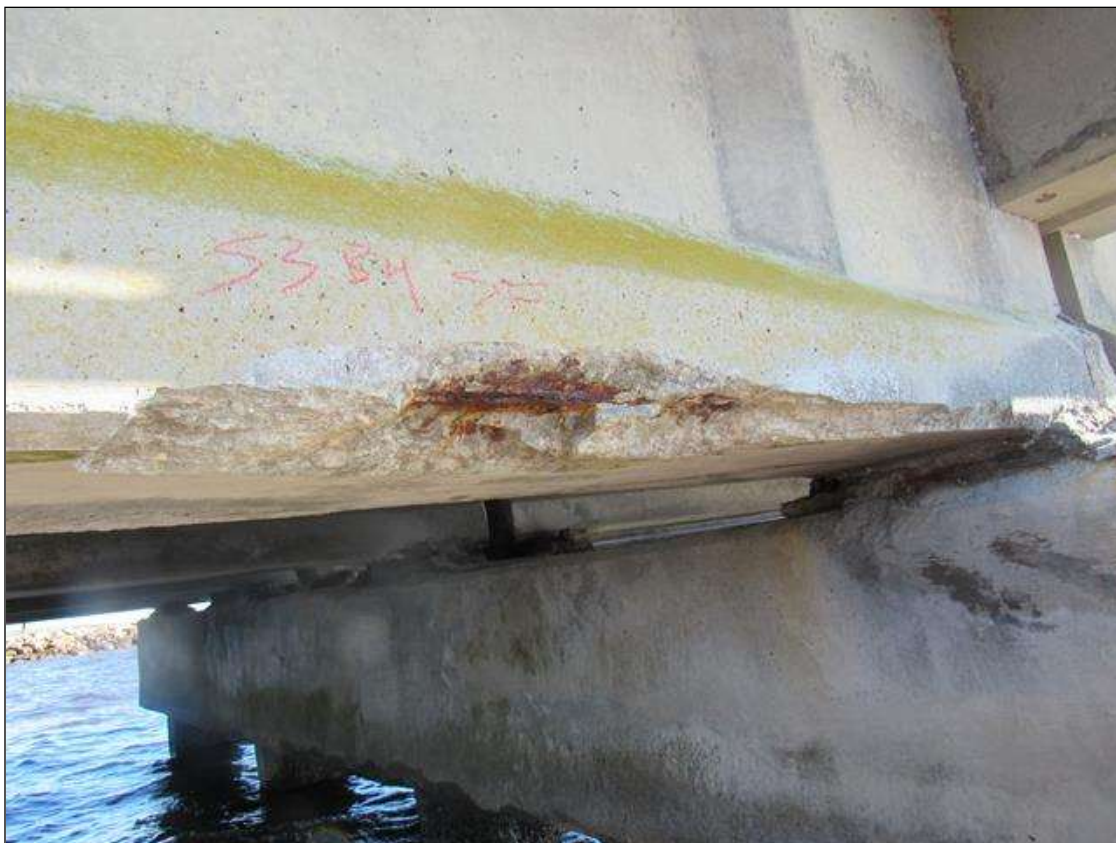
Span 2 Beam 1: (PAR) 8" X 6" X 1" SPALL WITH EXPOSED STRAND, NORTH FACE, AT BENT 2

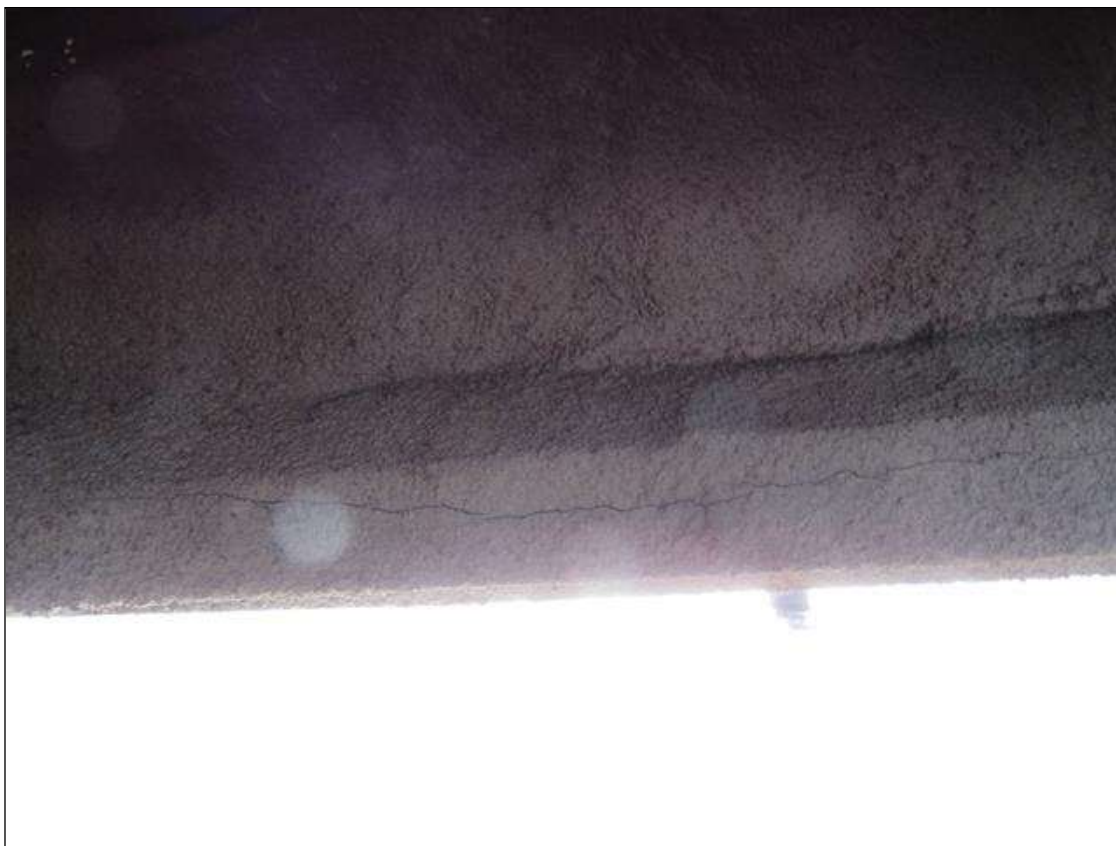
Span 3 Beam 4: (PAR) 48" X 8" X 2" SPALL, WITH EXPOSED STRAND, BOTTOM FACE, 3' FROM BENT 3.

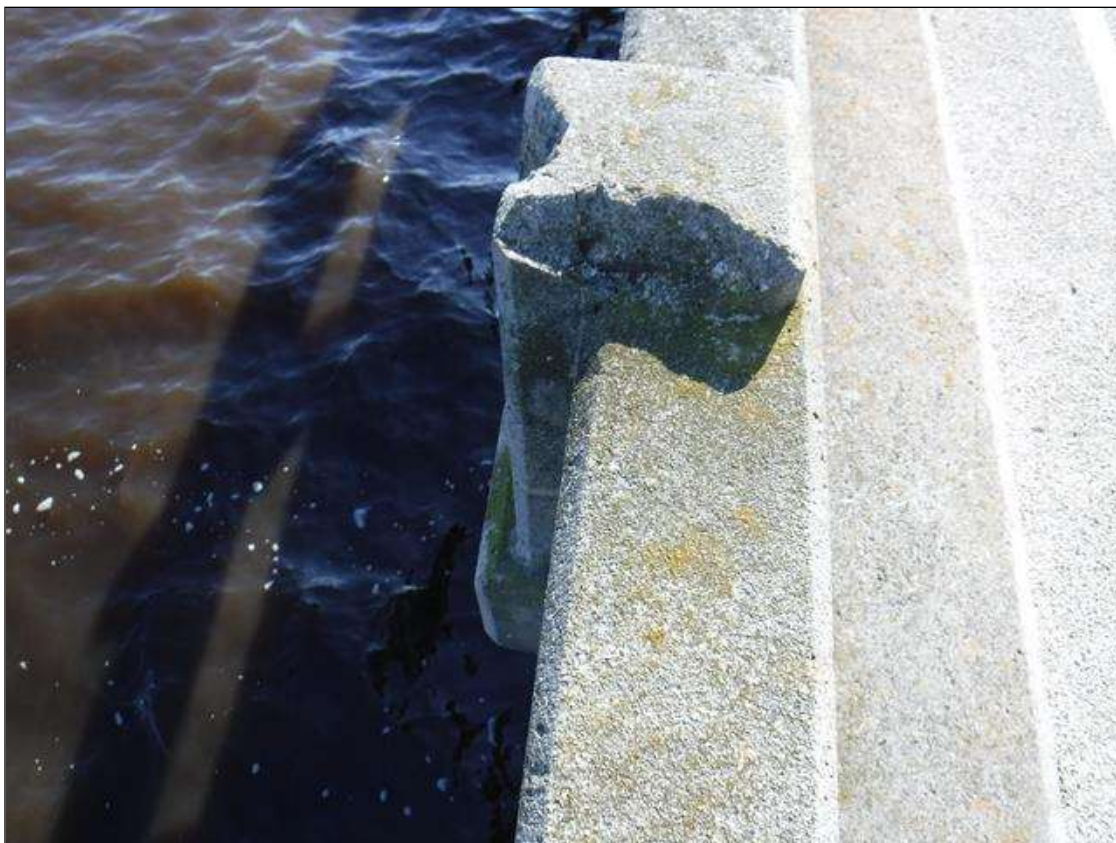
Span 1 Left Bridge Rail: 3' OF DAMAGE TO LEFT RAIL ATTACHMENT

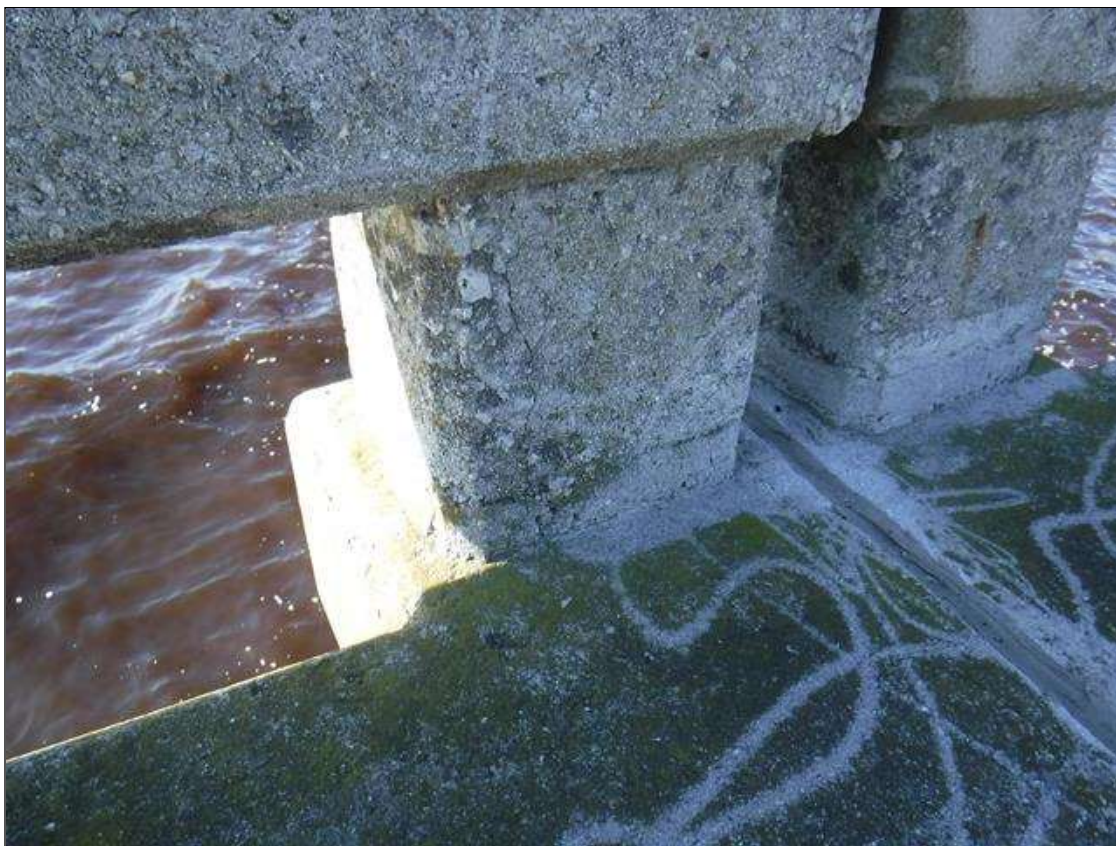
Span 2 Left Bridge Rail: 8" X 8" X UP TO 3" SPALL, WITH EXPOSED REINFORCING, NORTHWEST CORNER, 8TH RAIL POST FROM BENT 1.

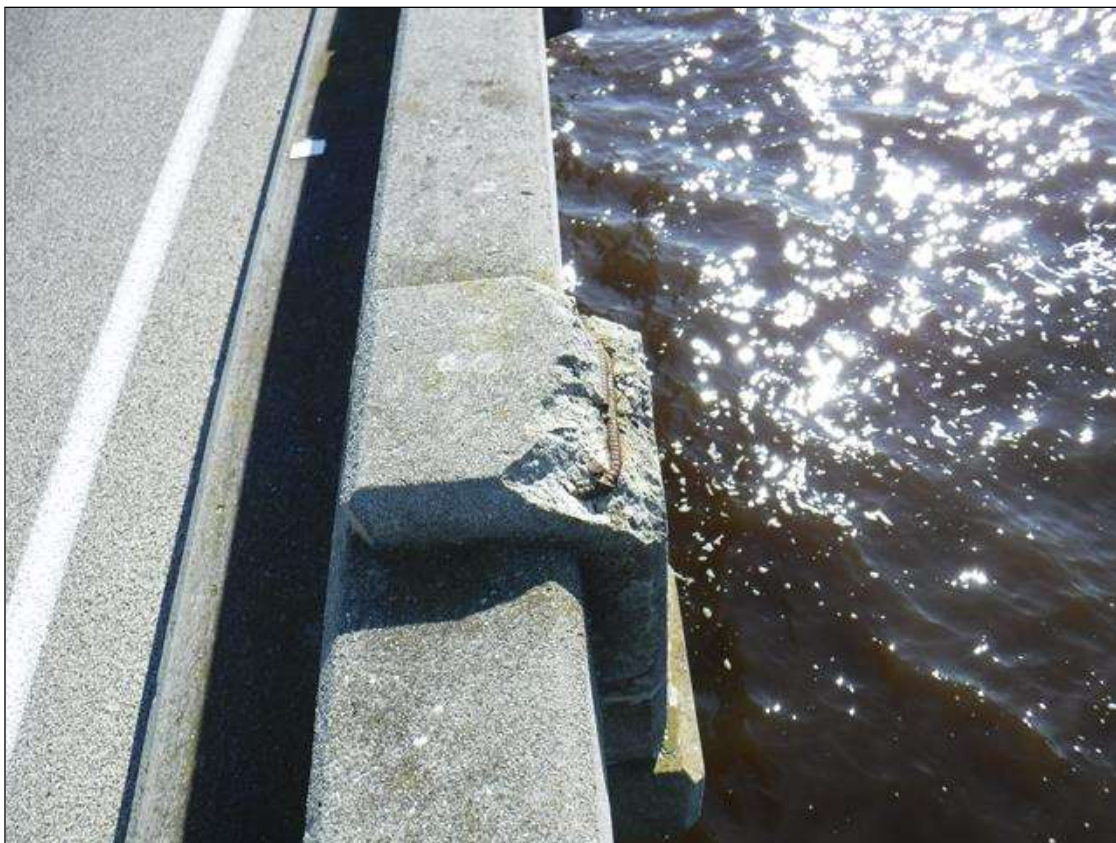
Span 3 Right Bridge Rail: 8" X UP TO 1/32" VERTICAL CRACK, NORTH FACE, RAIL POST AT BENT 2.

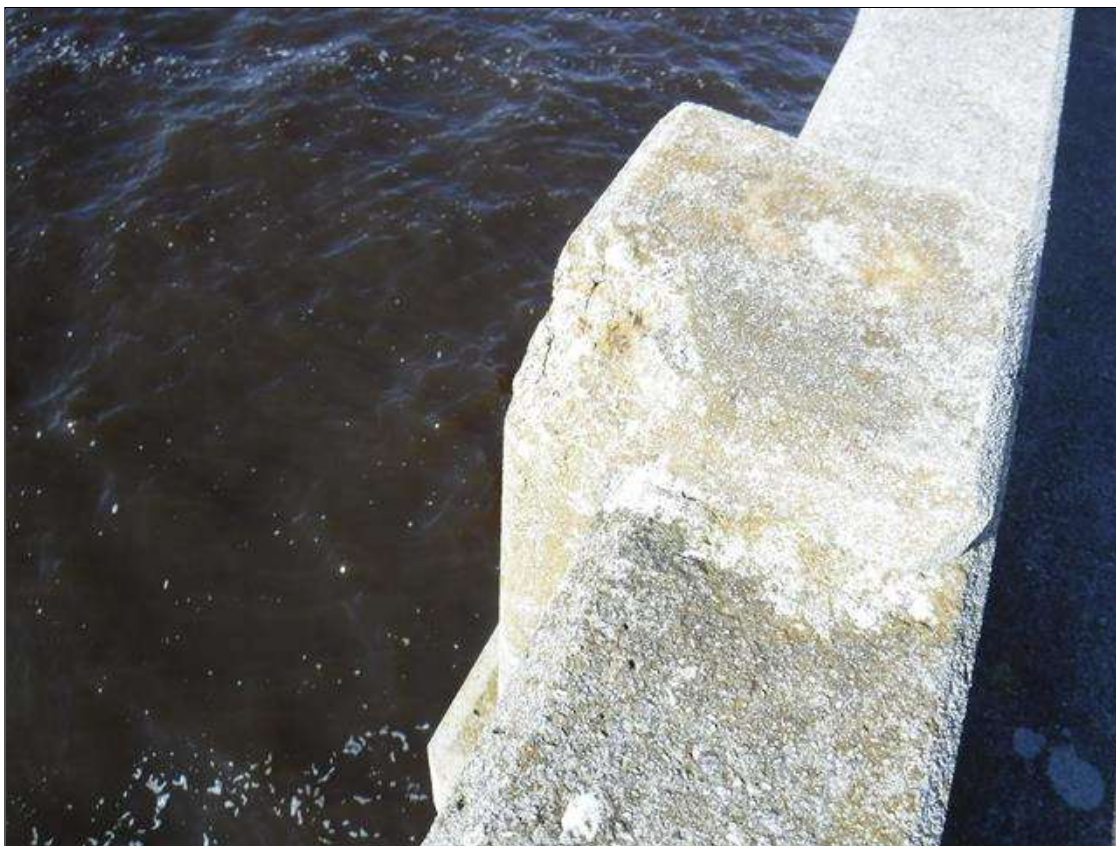
Span 8 Right Bridge Rail: 10" X 3" X UP TO 3" SPALL, WITH EXPOSED REINFORCING, SOUTH CORNER, 2ND RAIL POST FROM BENT 7.

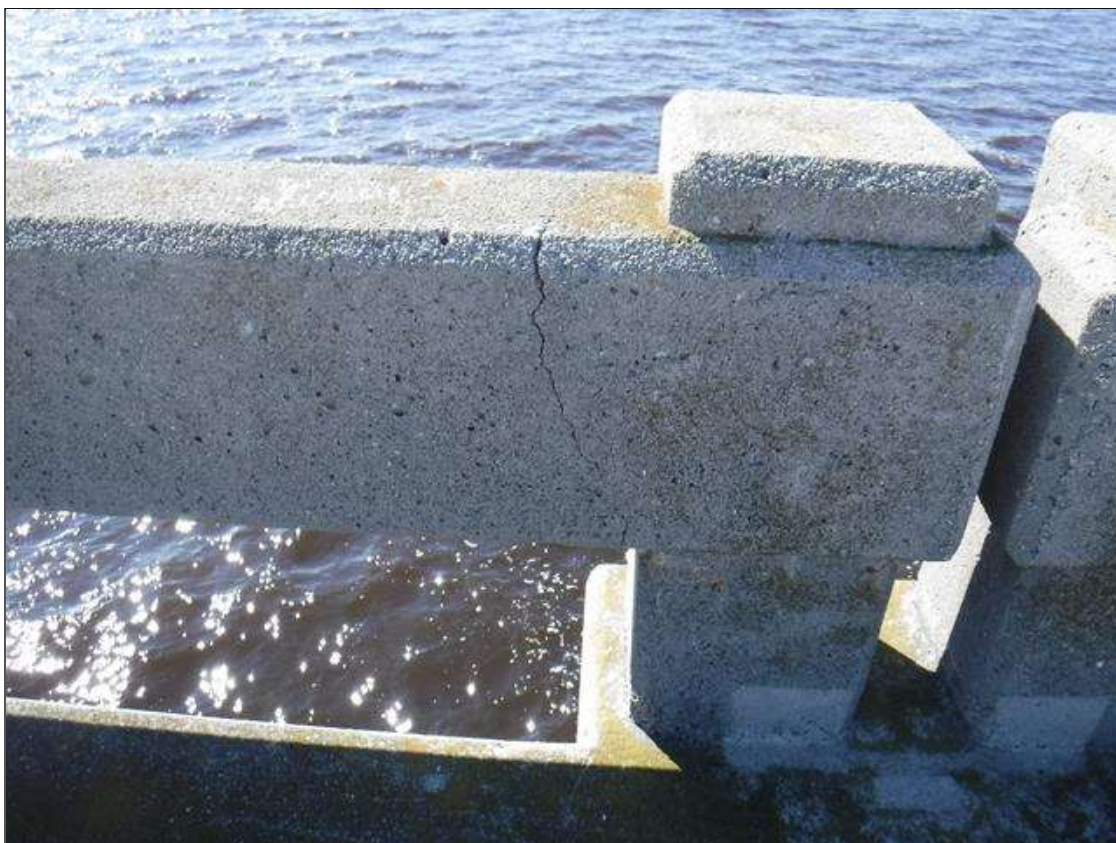
Span 15 Right Bridge Rail: (2) UP TO 6" X 4" X 3" SPALLS, WITH EXPOSED REINFORCING, AT RANDOM THROUGHOUT TOP OF RAIL POSTS.

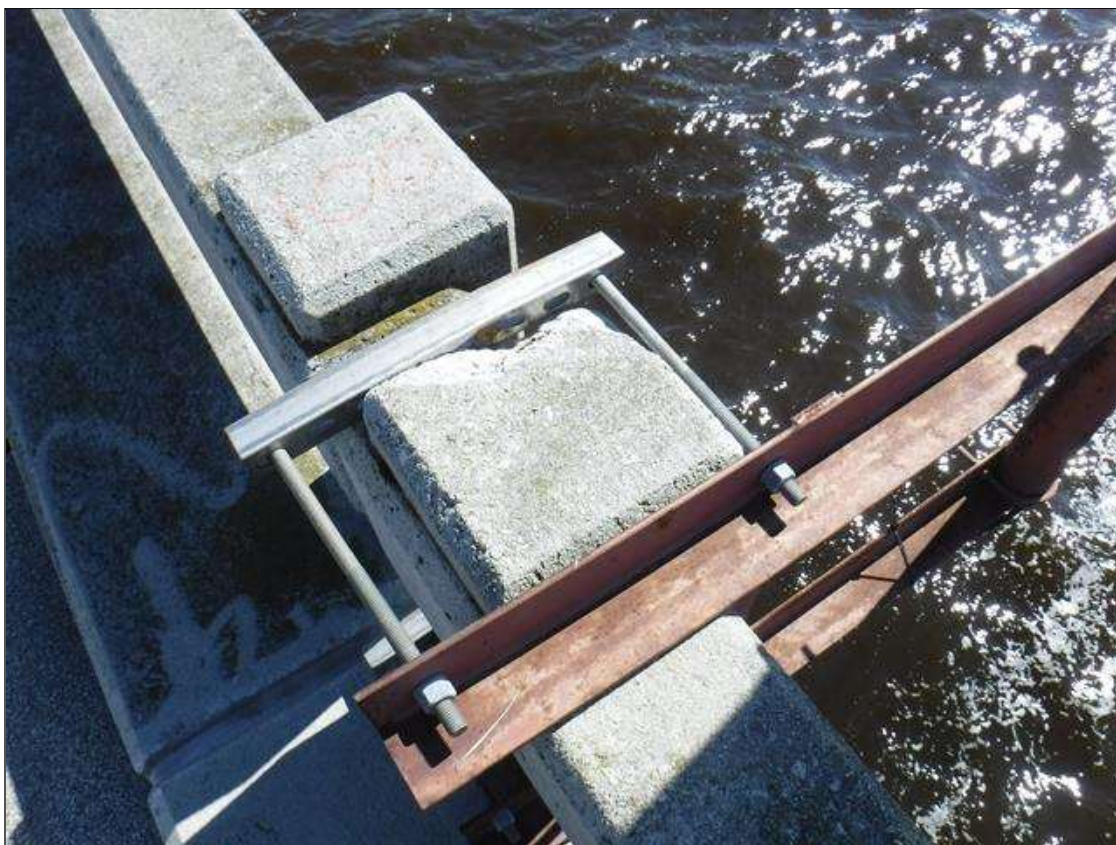
Span 55 Right Bridge Rail: (6) UP TO 3" X 6" X 3" SPALLS, AT RANDOM THROUGHOUT TOP OF RAIL POSTS, POSTS 4 AND 5 SHOWN

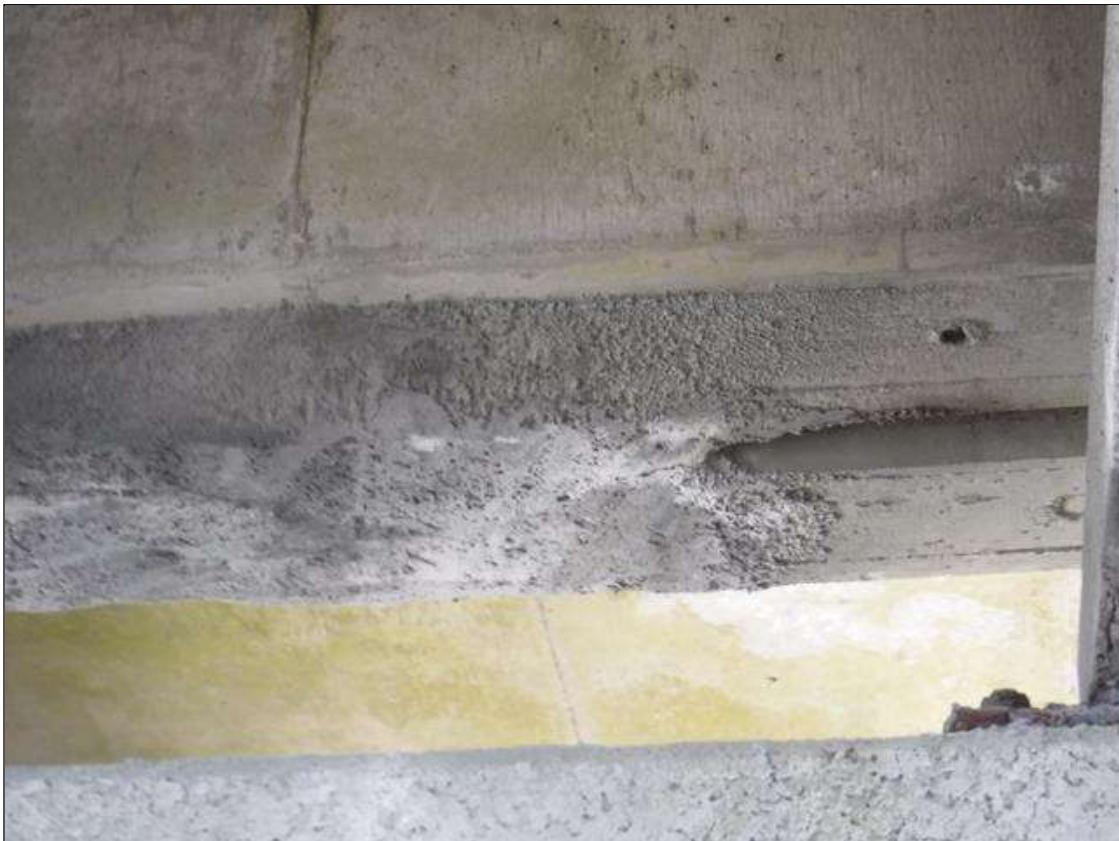
Span 100 Left Bridge Rail: 2' x 3" x 2" DEEP SPALL WITH DELAMINATION, TOP NORTH CORNER, 3' FROM BENT 100.

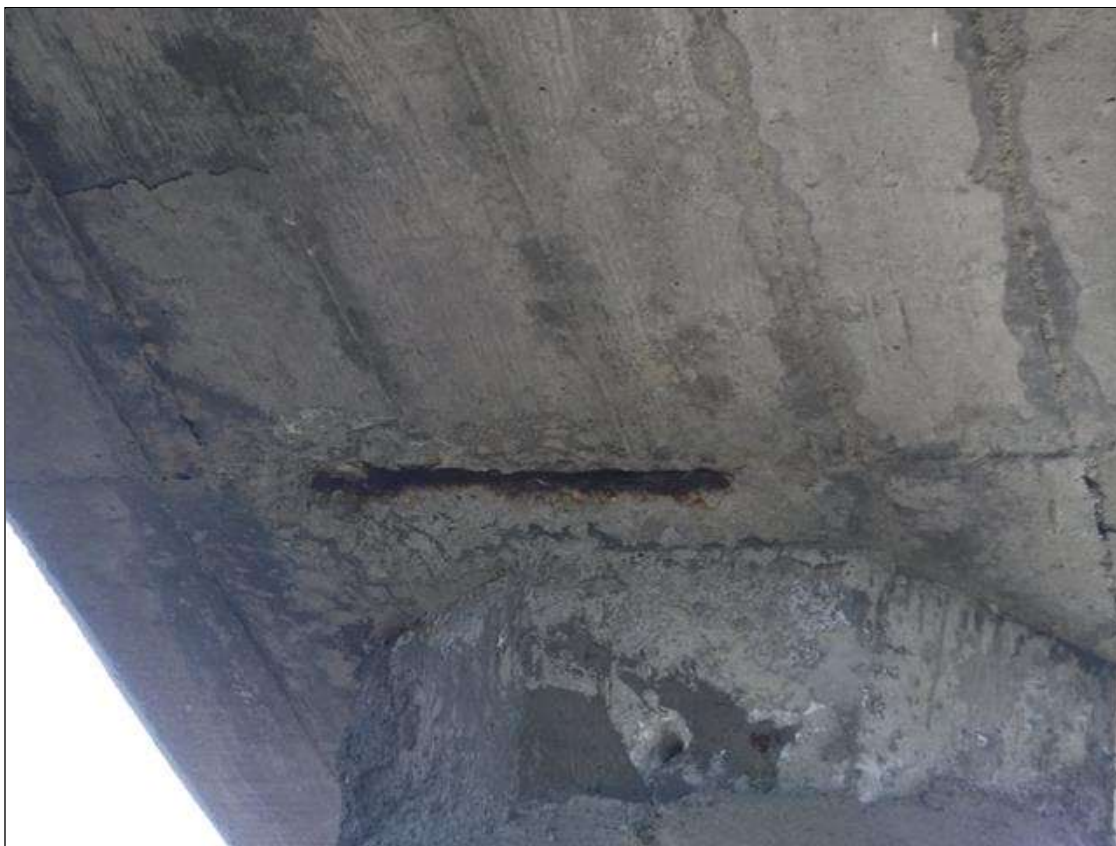
Span 118 Beam 3: 5' X UP TO 1' PATCHED AREA, WEST FACE OF BENT 118 DIAPHRAGM, BETWEEN BEAMS 2 AND 3.

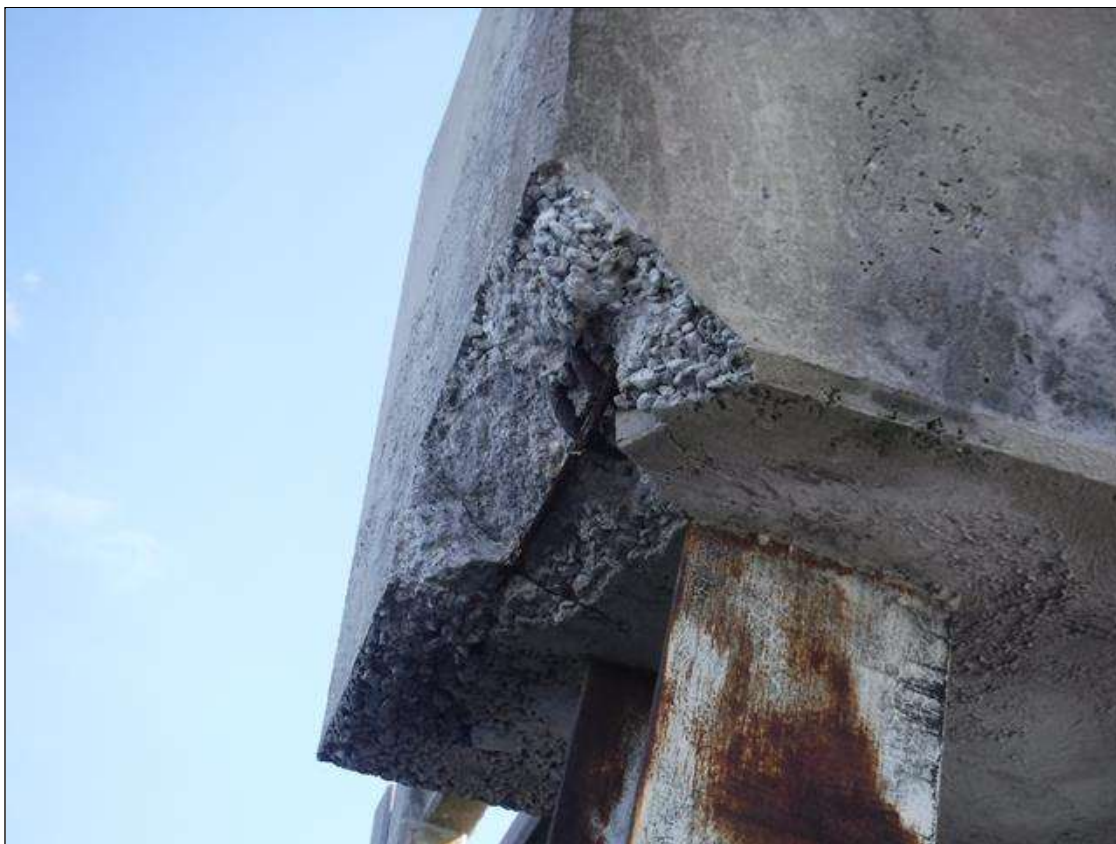
Bent 118 Pile 2: 2' X 2' DELAMINATION, SOUTH FACE, 6' FROM BOTTOM OF CAP.

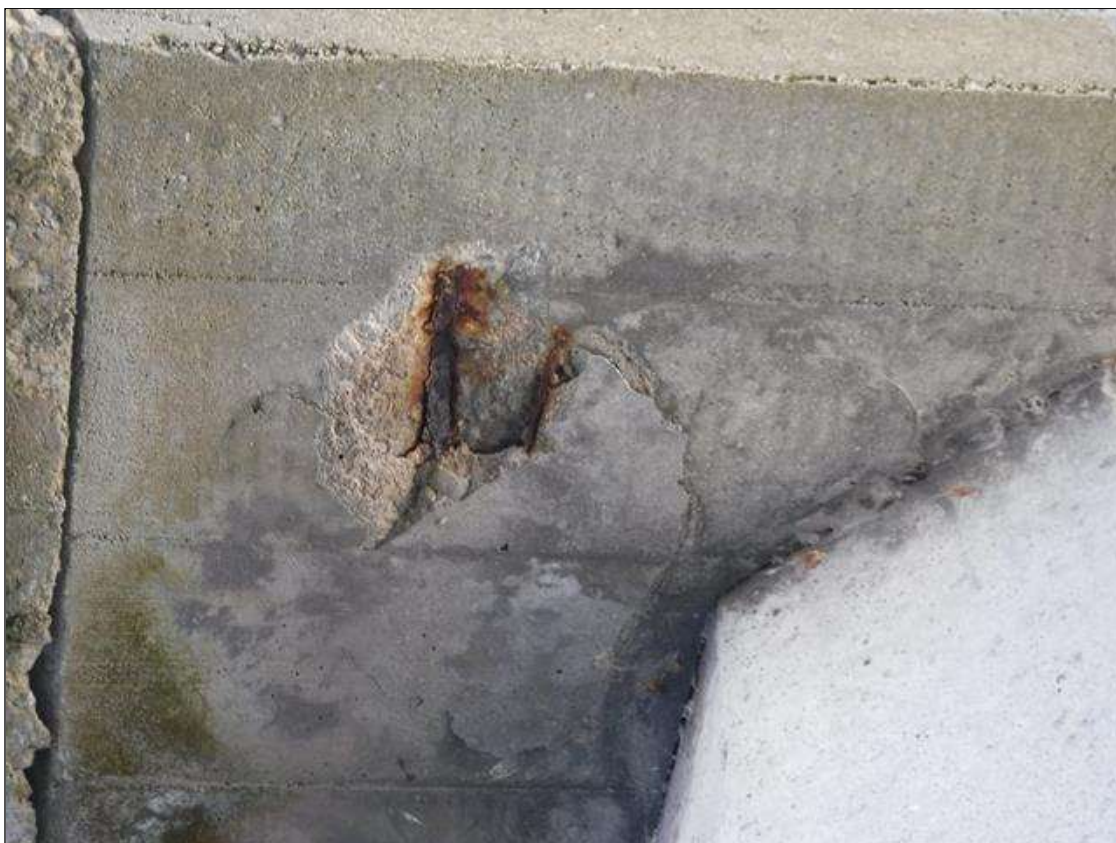
Bent 120 Cap 1: 24" X 8" X 8" EDGE SPALL, WITH EXPOSED PRIMARY REINFORCING, BOTTOM OF NORTH FACE.

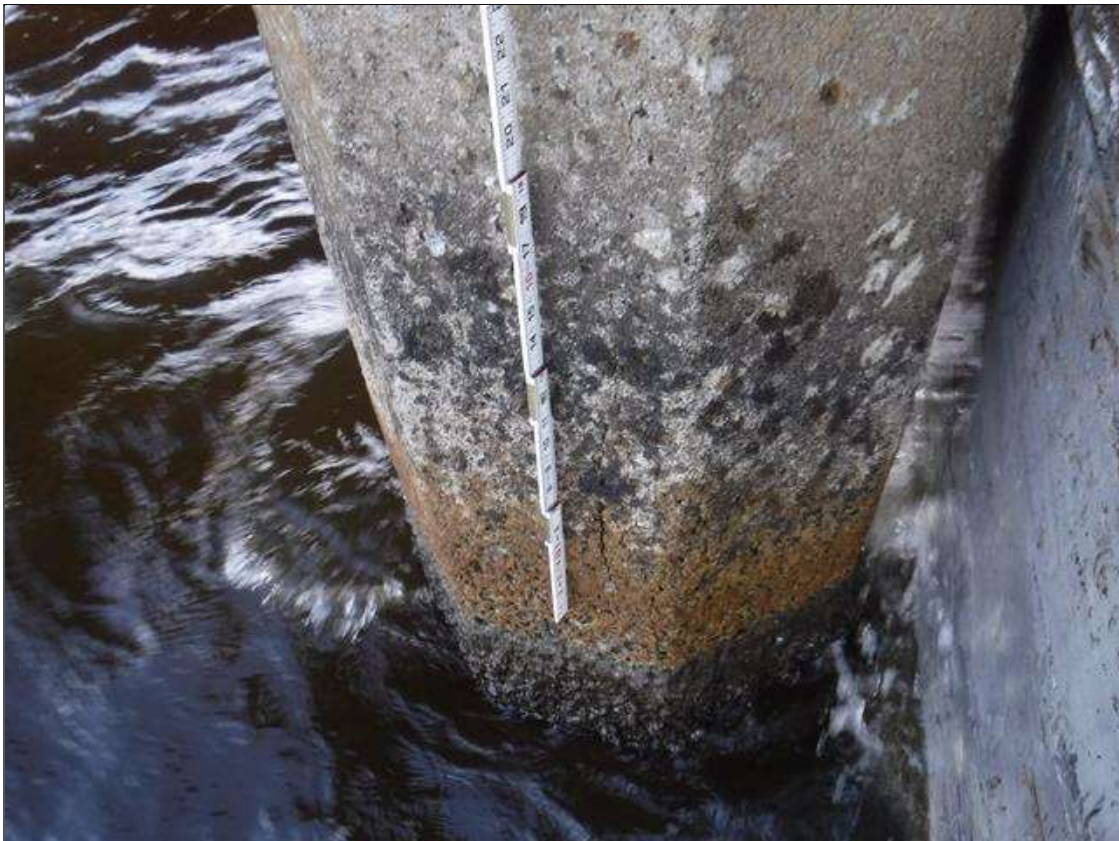
Bent 120 Saved Pile 1: (PAR) 2" X 1" AREA OF CORROSION WITH SECTION LOSS ON NEAR RIGHT FLANGE, 0.26" REMAINING FLANGE THICKNESS MEASURED ABOVE CONCRETE JACKET

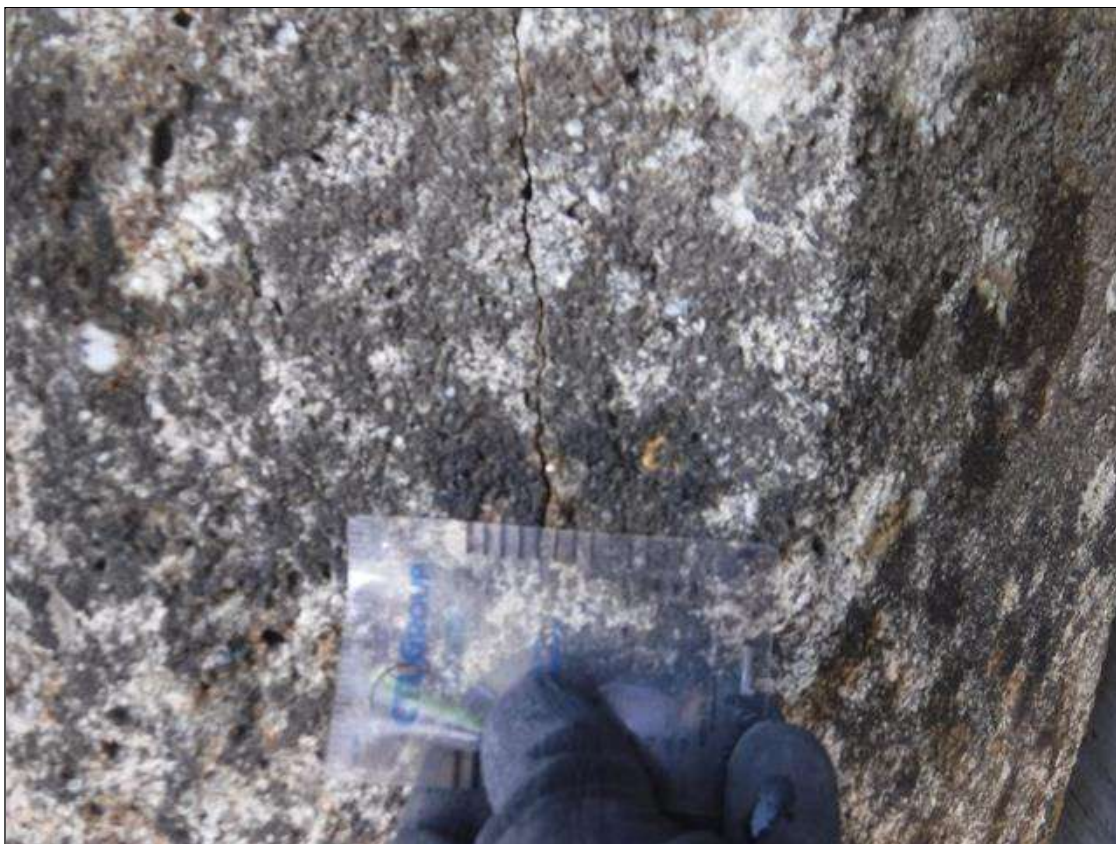
Bent 120 Saved Pile 2: 3' X 1' DELAMINATION, NORTH FACE, 9' FROM BOTTOM OF CAP, EXTENDING BELOW WATERLINE.

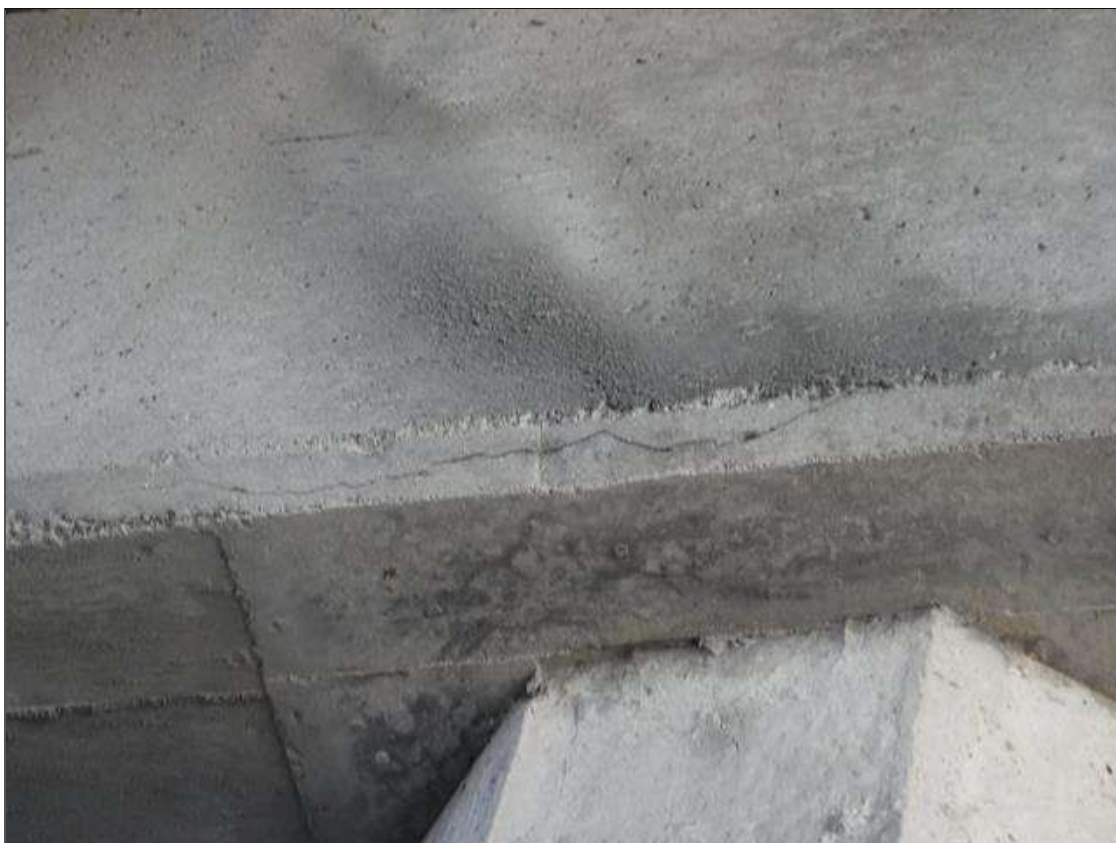
Bent 120 Saved Pile 2: (PAR) UP TO 12' X 0.03" VERTICAL CRACKS, AT RANDOM THROUGHOUT, EXTENDING BELOW WATERLINE.

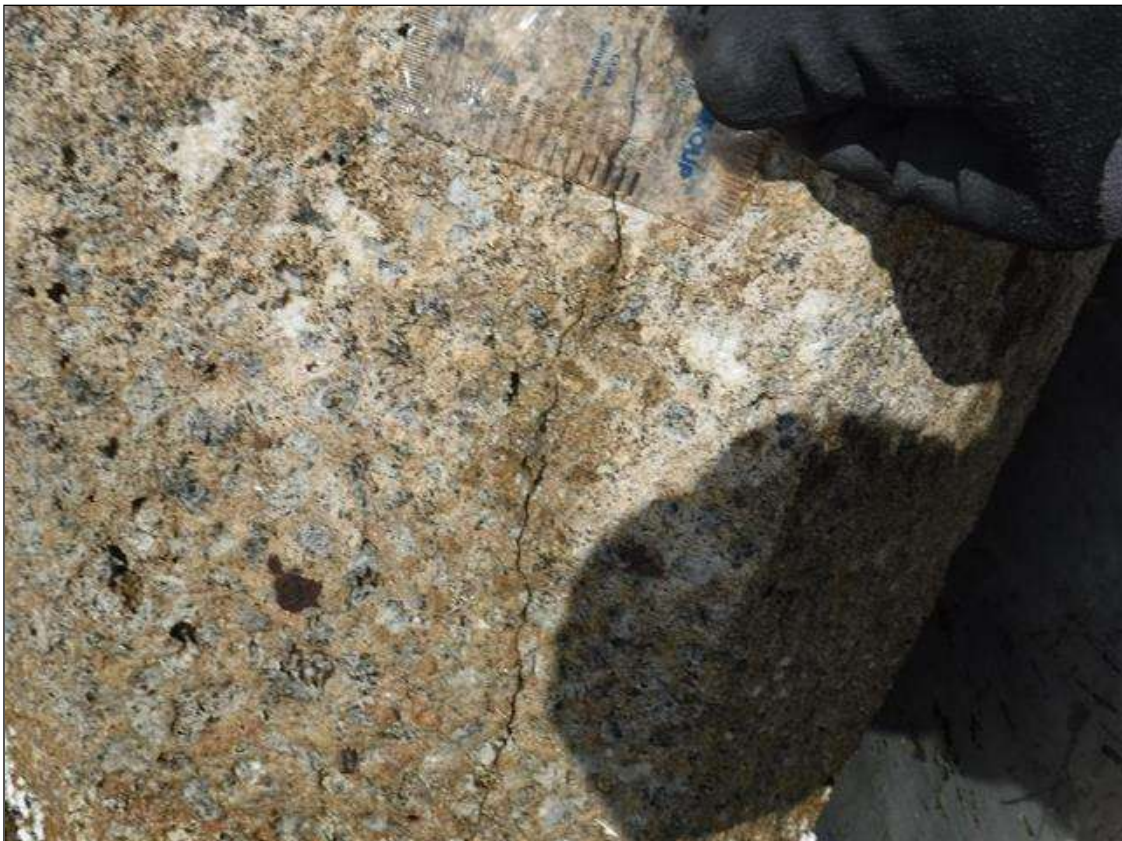
Bent 121 Pile 3: UP TO 6" X 4" X 3" SPALLS, TOP OF PILE JACKET.

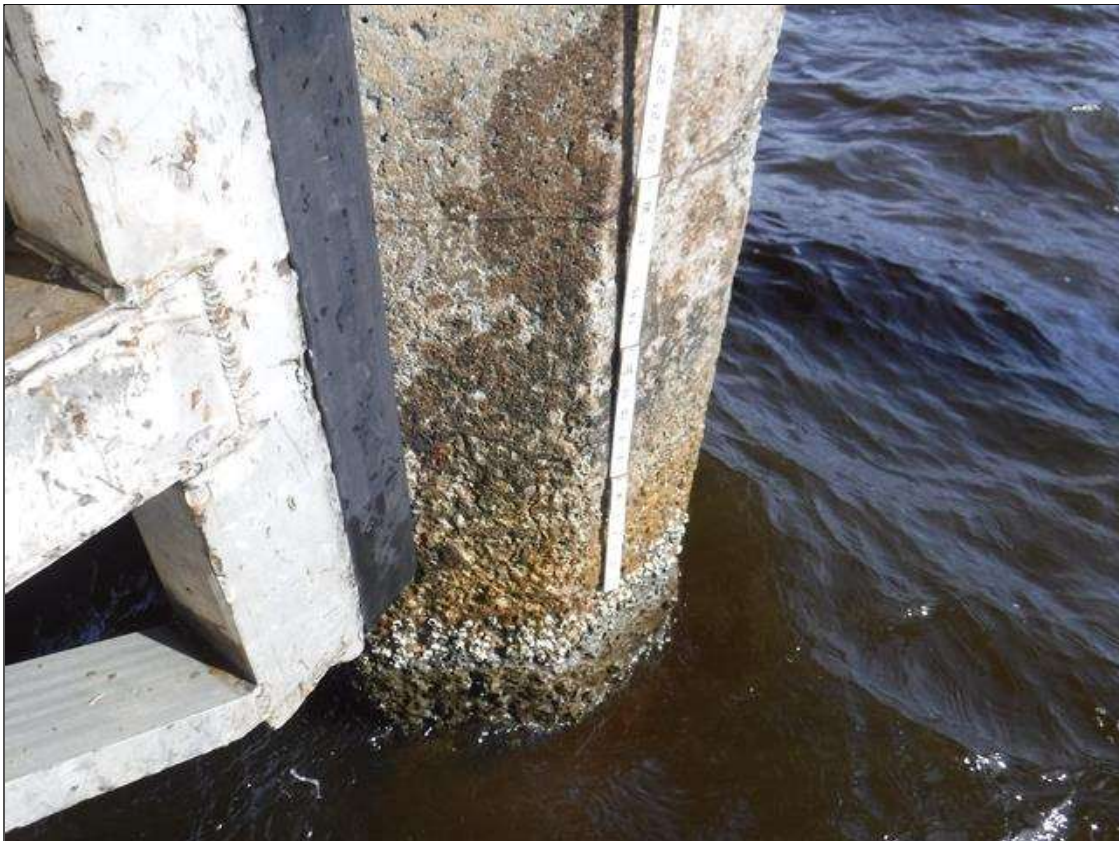
Bent 124 Pile 3: (PAR) UP TO 6' X 0.031" VERTICAL CRACKS, NORTH FACE, BEGINNING 3' FROM BOTTOM OF CAP, EXTENDING BELOW WATERLINE.

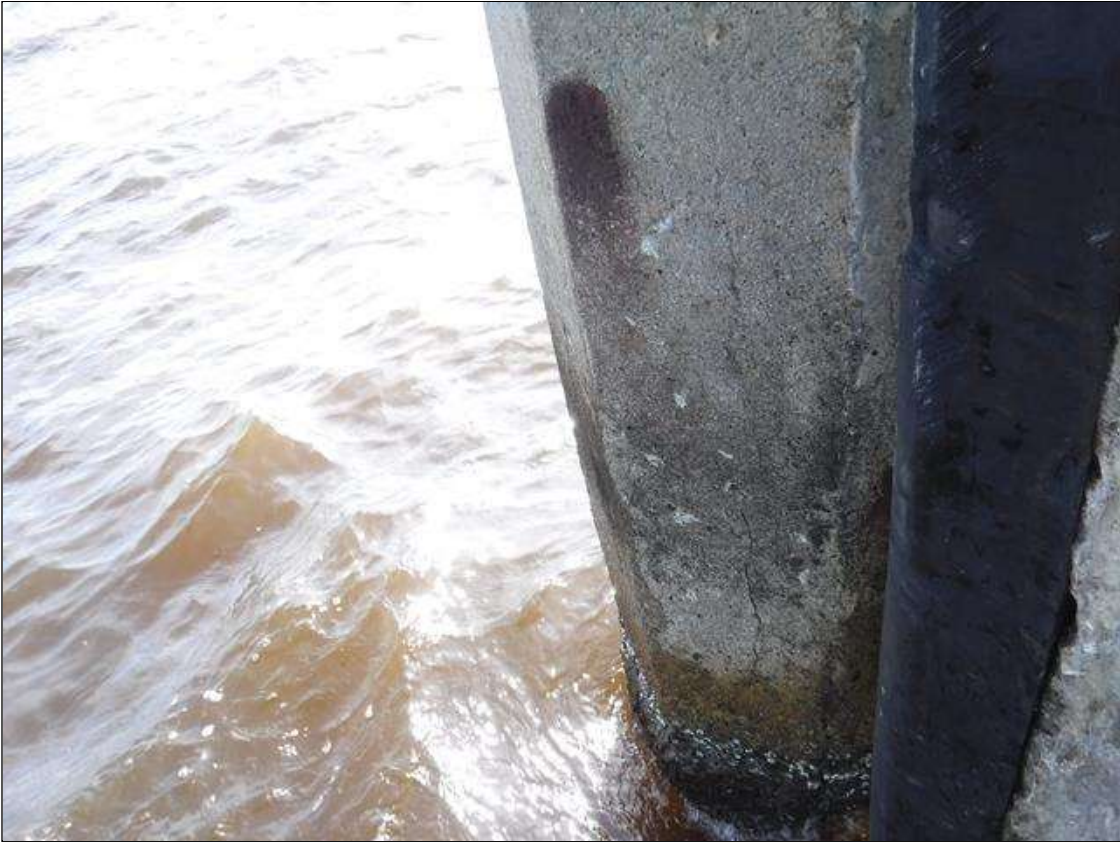
Bent 126 Cap 1: 3' X 18" PATCHED AREA, EAST FACE, ABOVE PILE 3

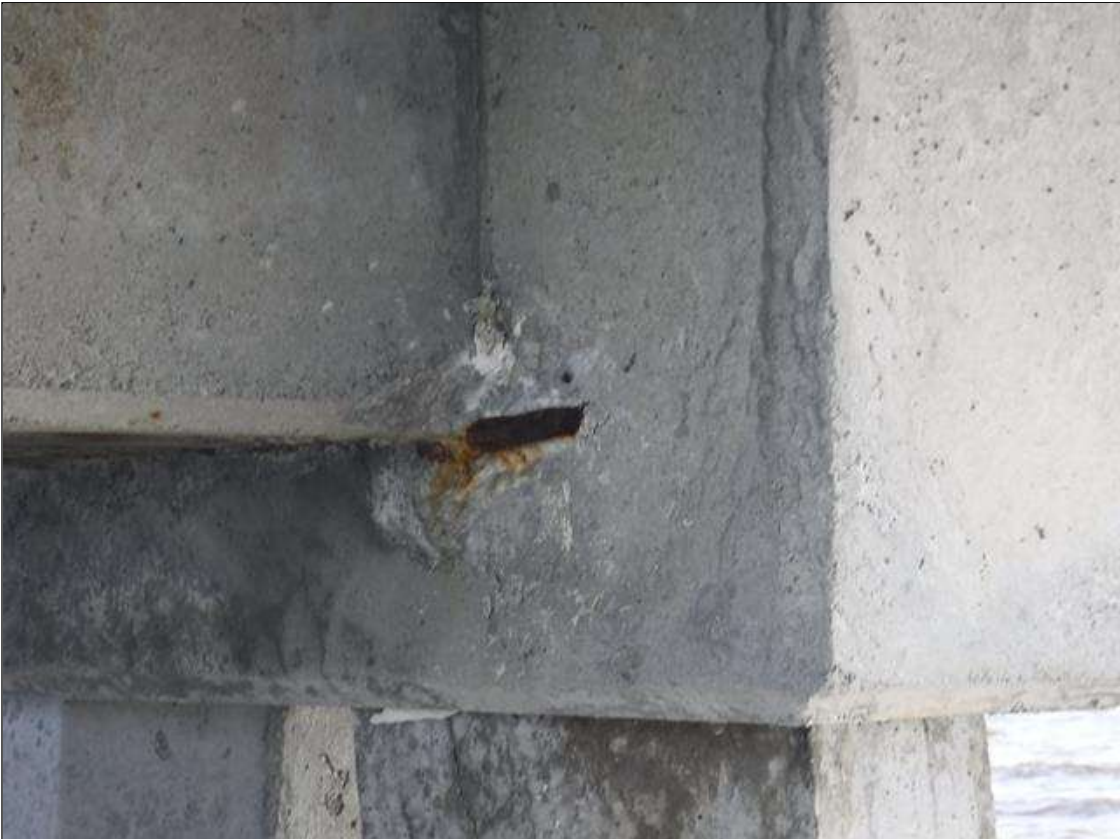
Bent 126 Pile 4: 3' X 1' DELAMINATION, EAST FACE, 8' FROM BOTTOM OF CAP, EXTENDING BELOW WATERLINE.

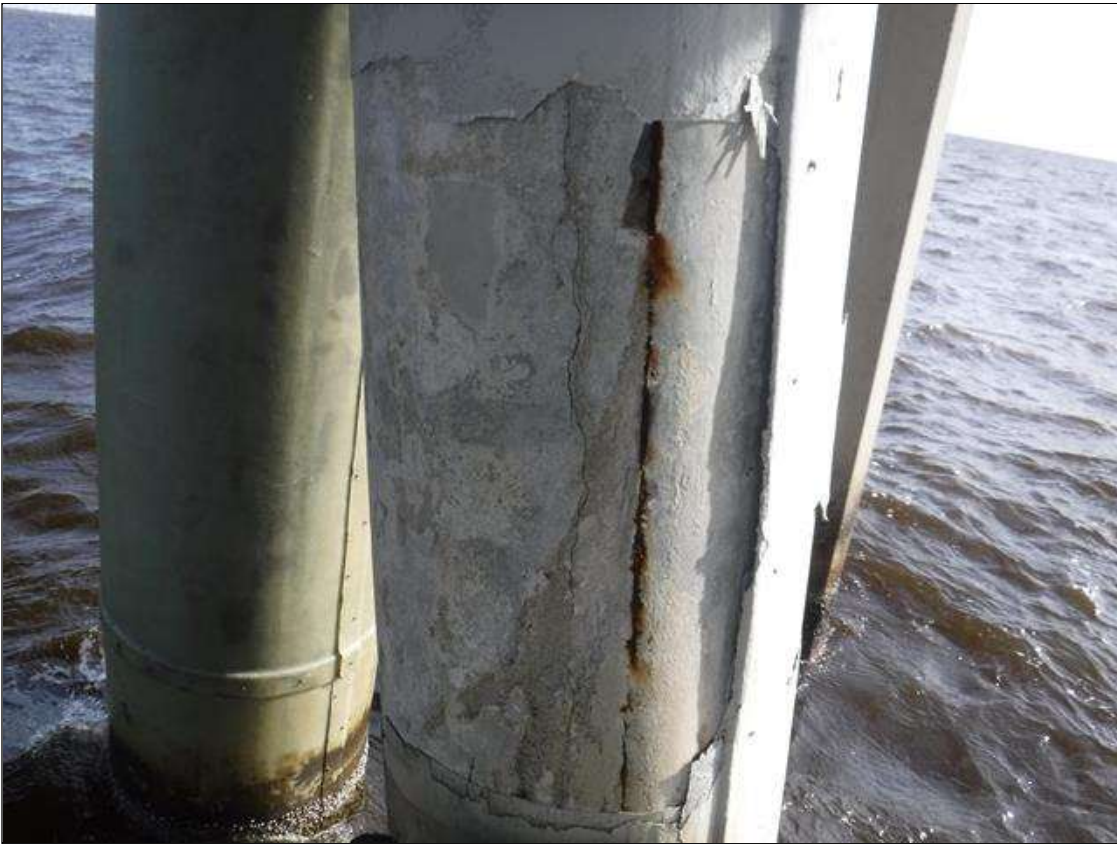
Bent 127 Pile 2: PILE HAS BEEN JACKETED, BEGINNING 1' FROM BOTTOM OF CAP, WITH PILE JACKET MISSING, AT RANDOM THROUGHOUT, EXTENDING BELOW WATERLINE, WITH 18" X 12" X 2" SPALL, WITH EXPOSED REBAR, EAST FACE, 5' FROM BOTTOM OF CAP.

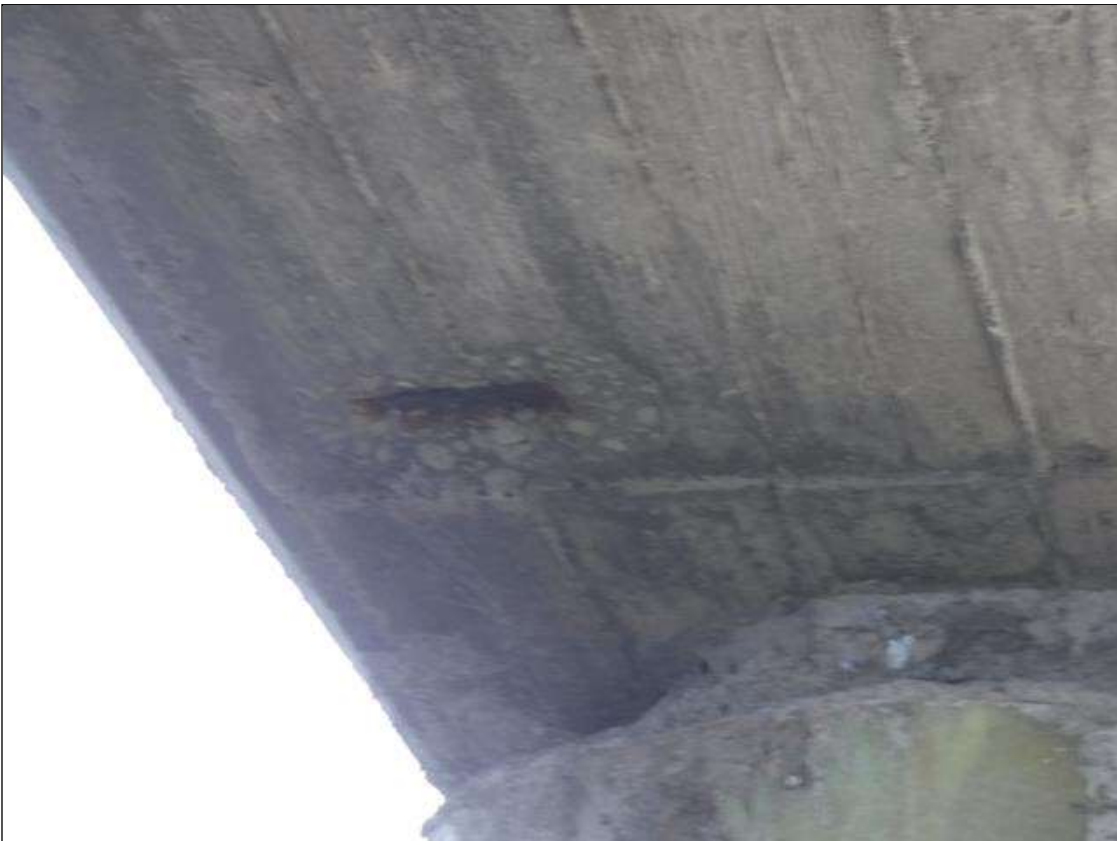
Bent 127 Pile 4: PILE HAS BEEN JACKETED, BEGINNING 1' FROM BOTTOM OF CAP, WITH PILE JACKET MISSING, AT RANDOM THROUGHOUT, EXTENDING BELOW WATERLINE, WITH EXPOSED REINFORCING.

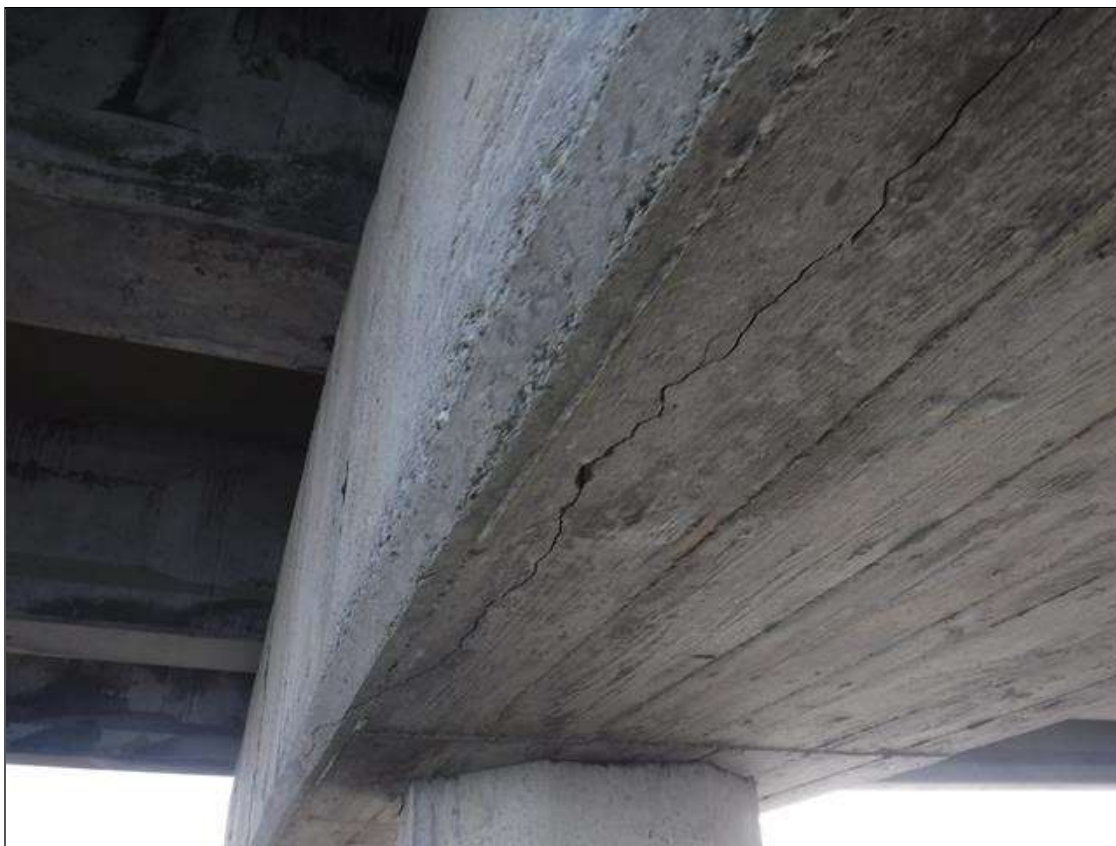
Bent 128 Cap 1: 8" X 4" X 1/2" SPALL, WITH EXPOSED REINFORCING, BOTTOM FACE, NEAR PILE 4.

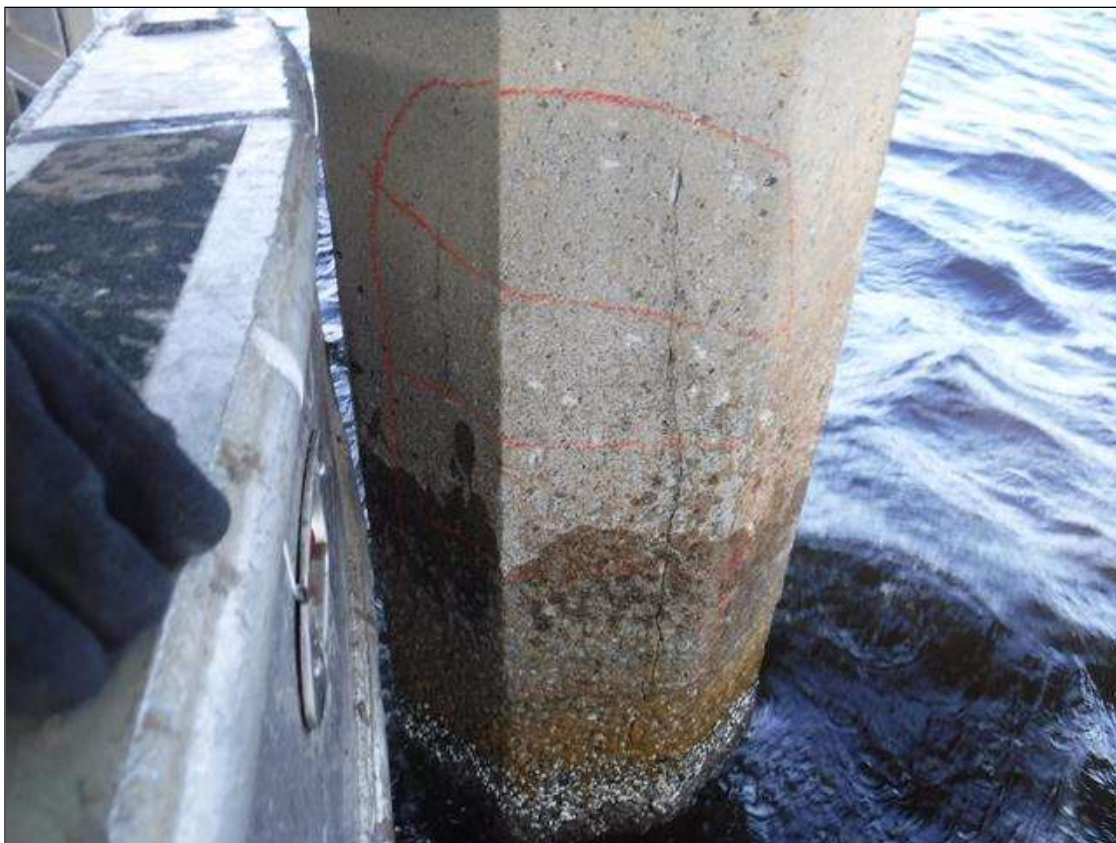
Bent 128 Cap 1: 6' X 1/16" CRACK ON EAST BOTTOM FACE BETWEEN PILES 1 AND 2
