NC DEPARTMENT OF TRANSPORTATION
DIVISION OF HIGHWAYS
STRUCTURE MANAGEMENT UNIT

Structure Safety Report

Routine Element Inspection - Contract

FEATURE INTERSECTED: ALLIGATOR RIVER

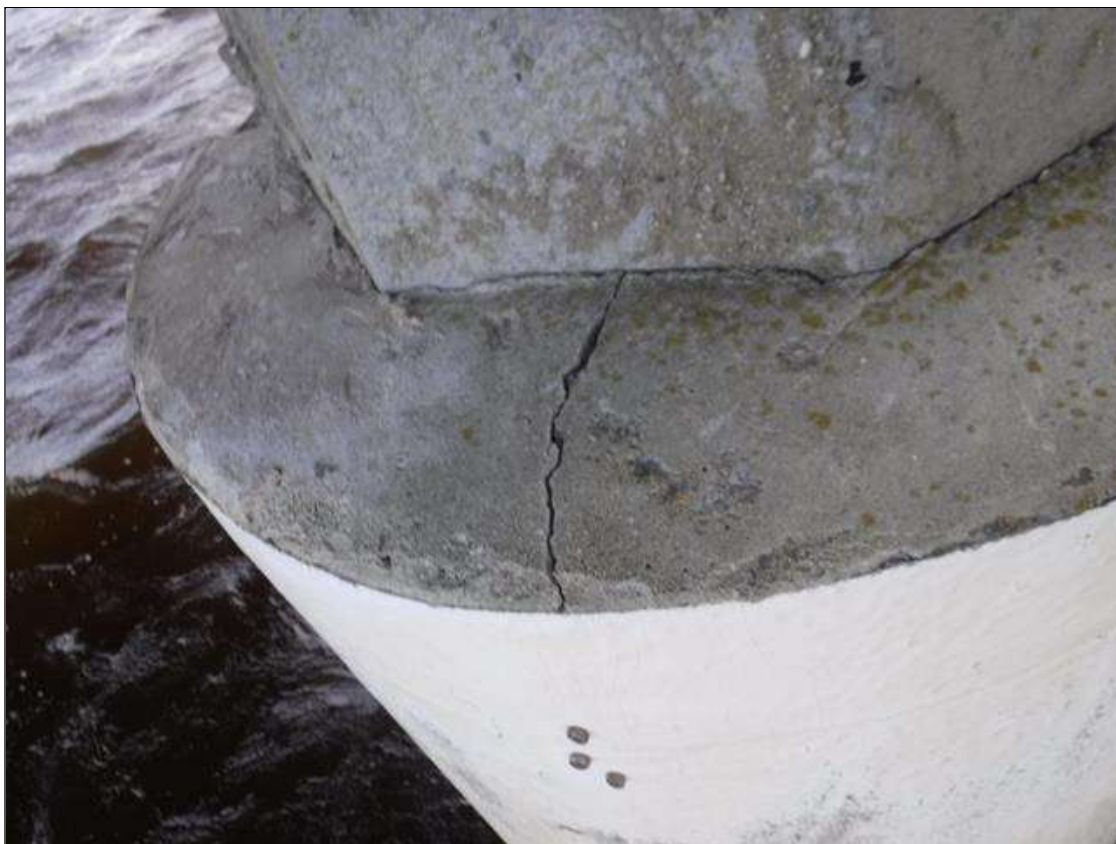
Bent 128 Pile 2: 3' X 2' DELAMINATION, SOUTH FACE, 8' FROM BOTTOM OF CAP, EXTENDING BELOW WATERLINE.

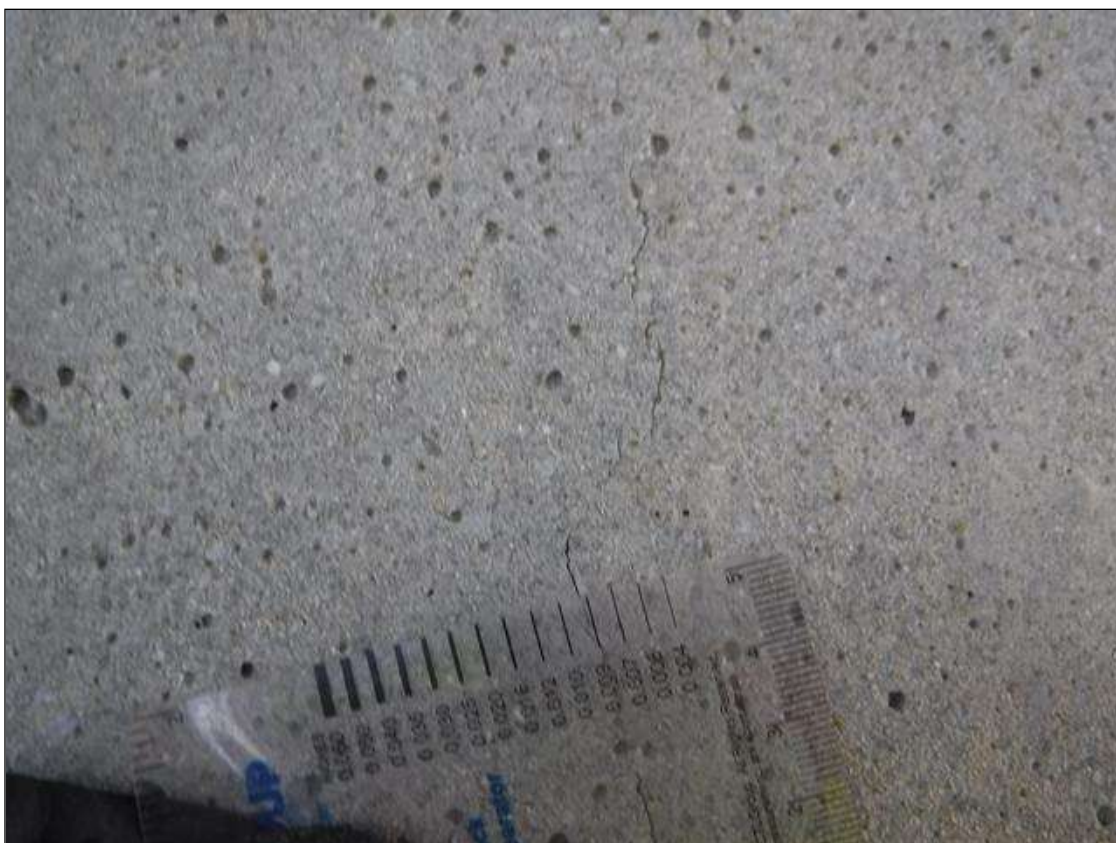
Bent 130 Pile 2: CRACKED DELAMINATION AT RANDOM THROUGHOUT, TOP OF PILE JACKET.

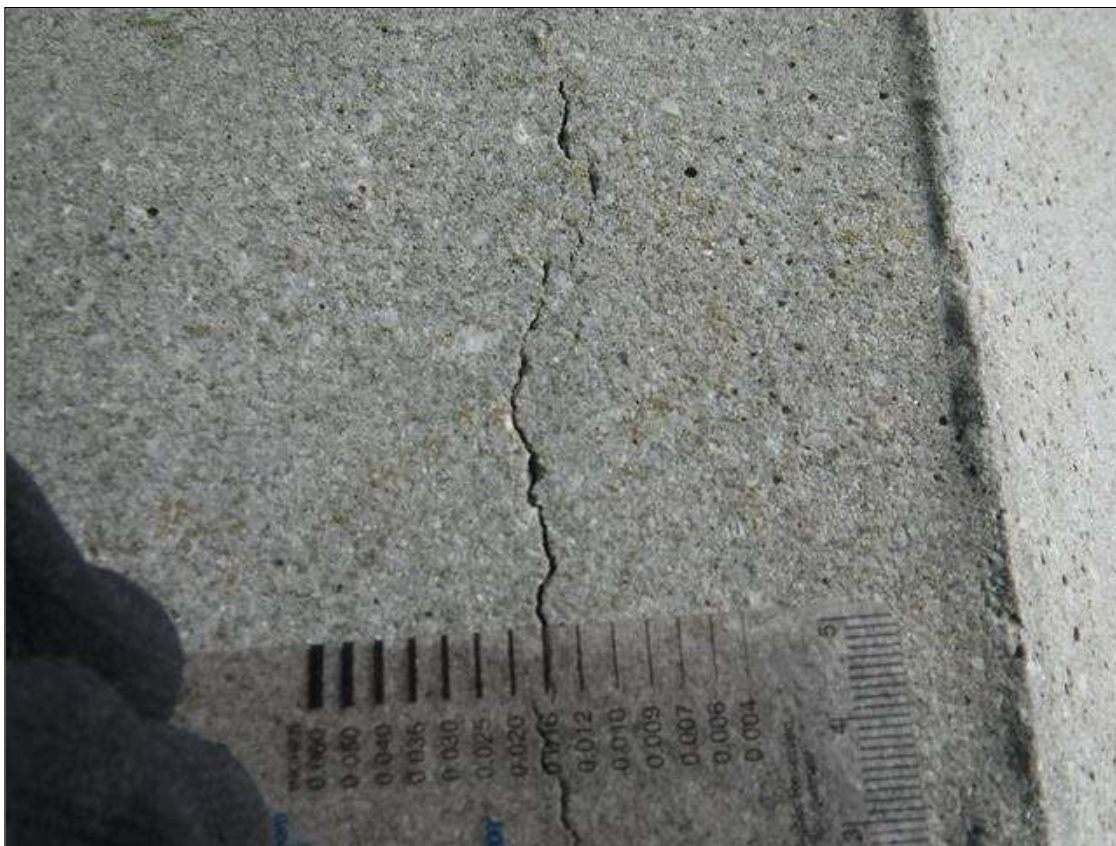
Bent 130 Pile 3: UP TO 3' X 0.009" VERTICAL CRACKS, AT RANDOM THROUGHOUT.

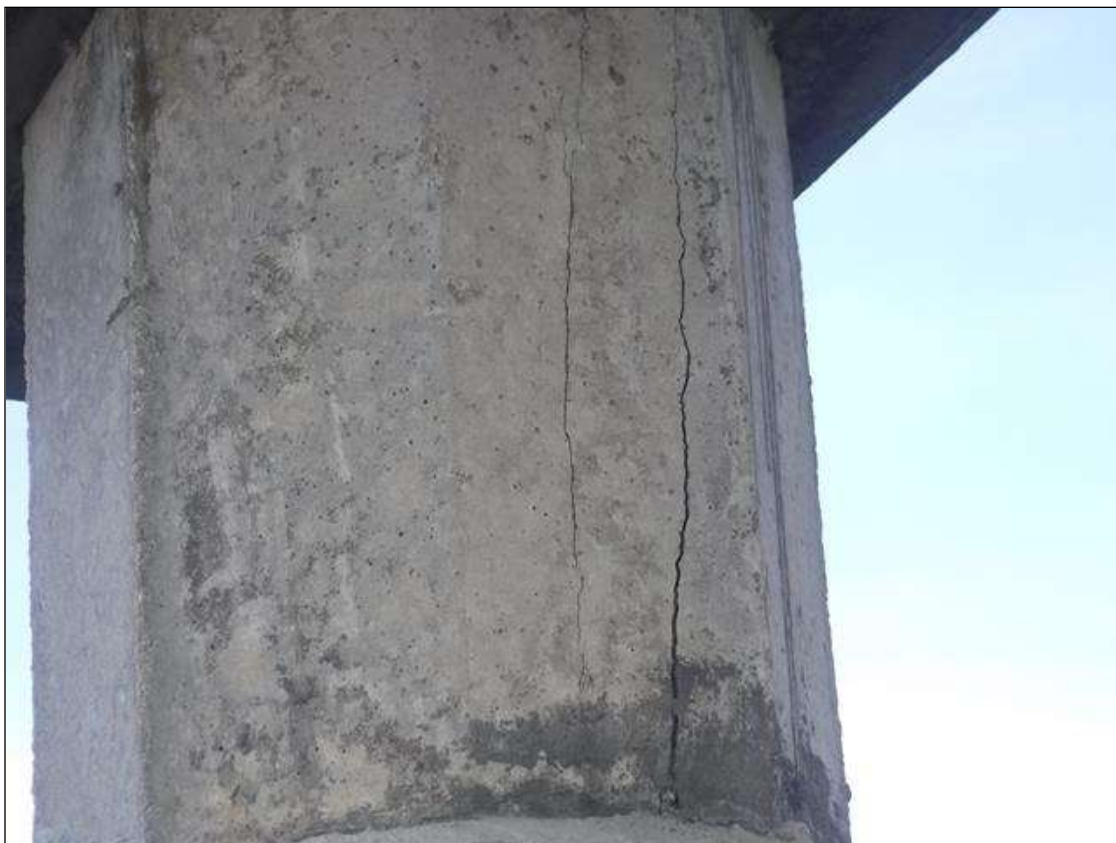
Bent 130 Pile 4: (PAR) UP TO 3' X 0.016" VERTICAL CRACKS, AT RANDOM THROUGHOUT.

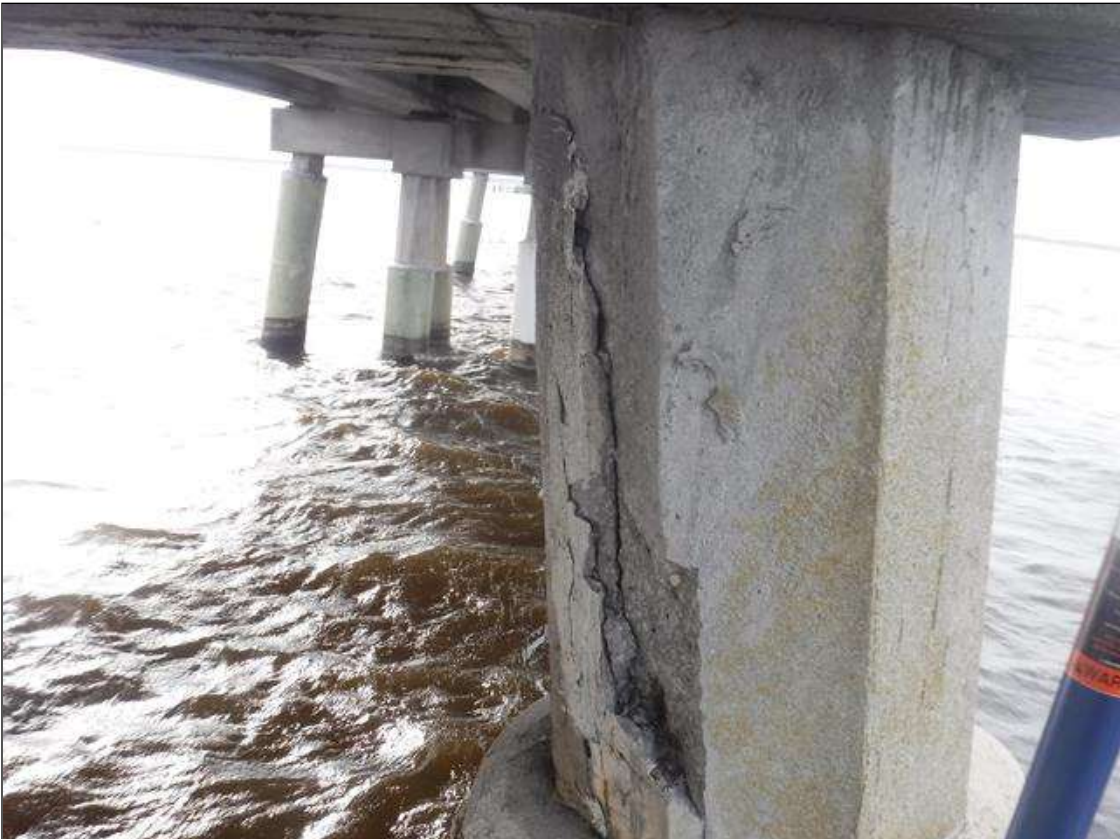
Bent 131 Pile 4: (PAR) UP TO 3' X 0.0625" VERTICAL CRACKS, AT RANDOM THROUGHOUT WEST FACE.

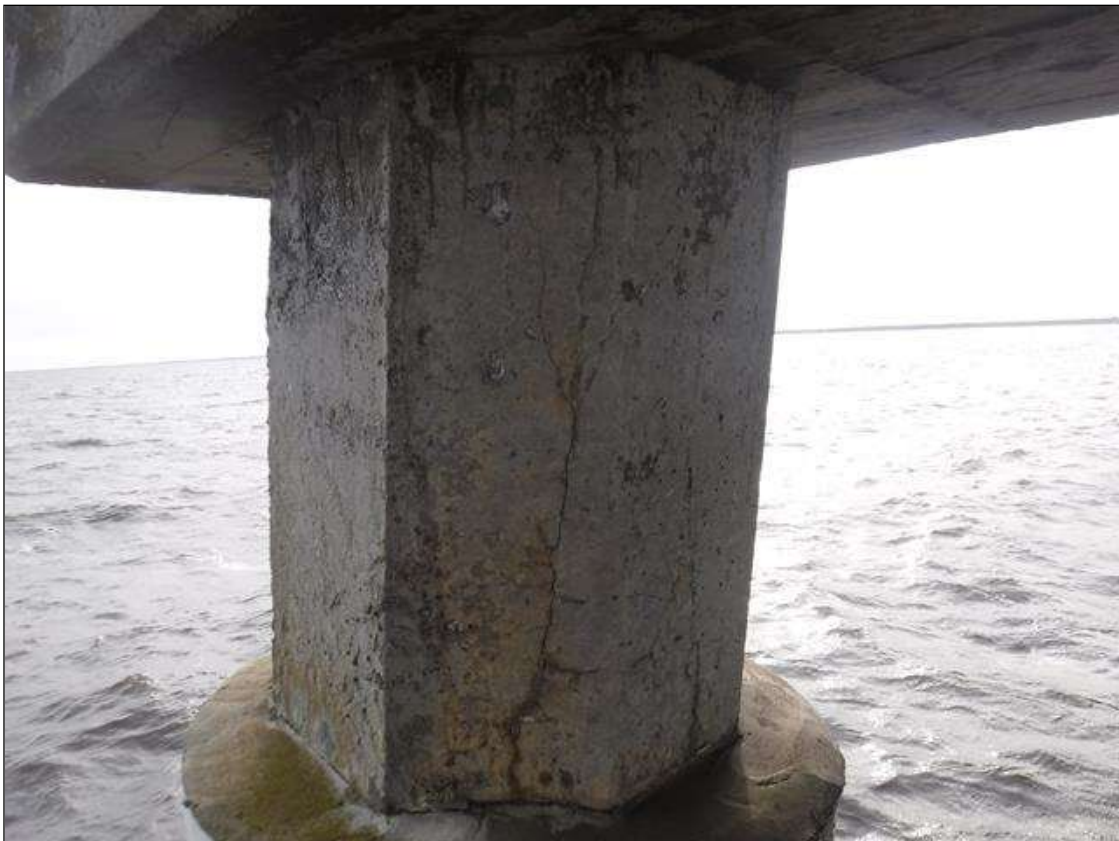
Bent 136 Saved Pile 3: 32" LONG X 0.006" HORIZONTAL CRACK ON EAST FACE 11" FROM TOP

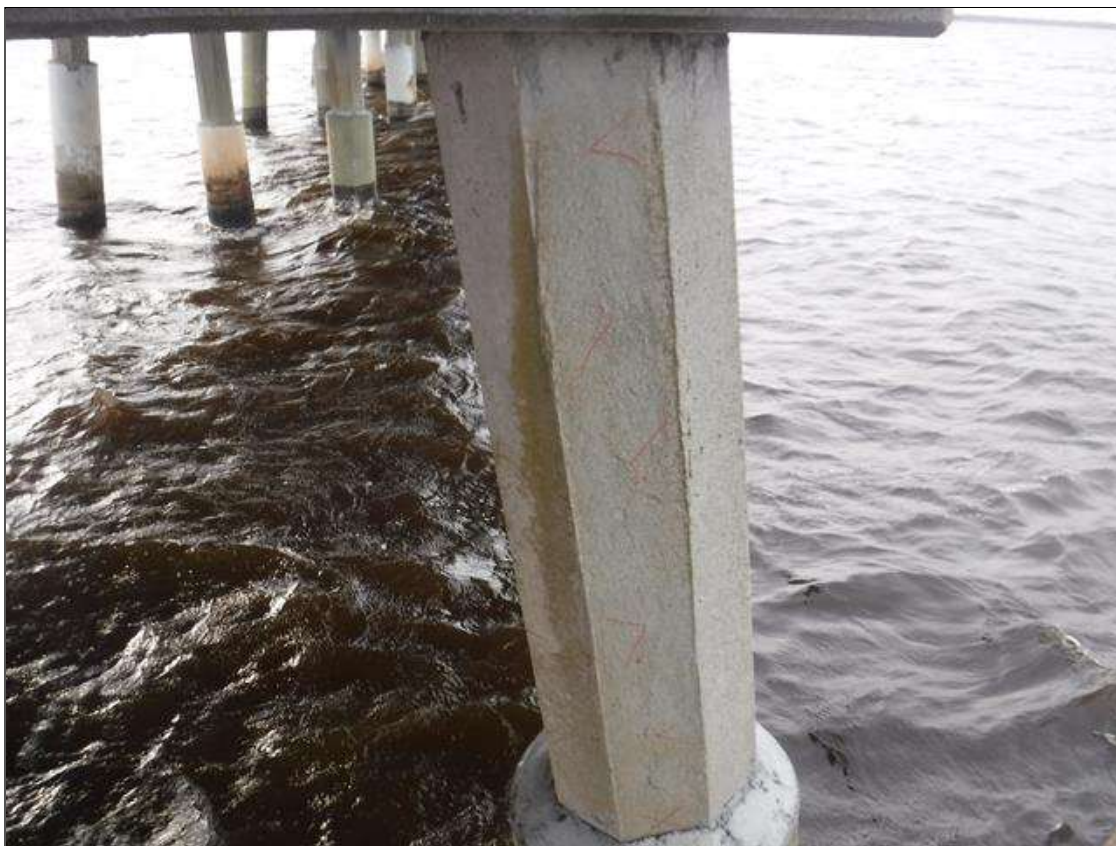
Bent 136 Saved Pile 4: 2' LONG X 0.006" VERTICAL CRACK ON EAST FACE

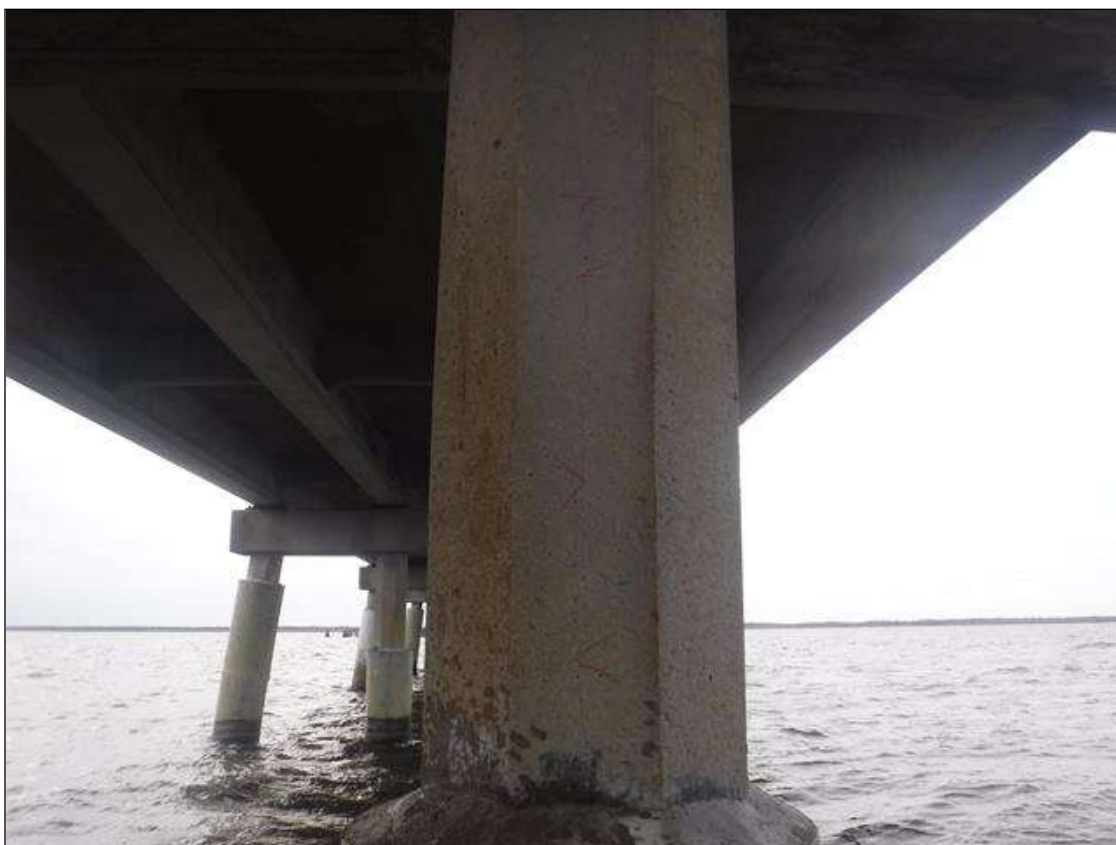
Bent 137 Pile 1: (PAR) 6' X UP TO 0.031" VERTICAL CRACK ON EAST FACE, BEGINNING AT BOTTOM OF CAP.

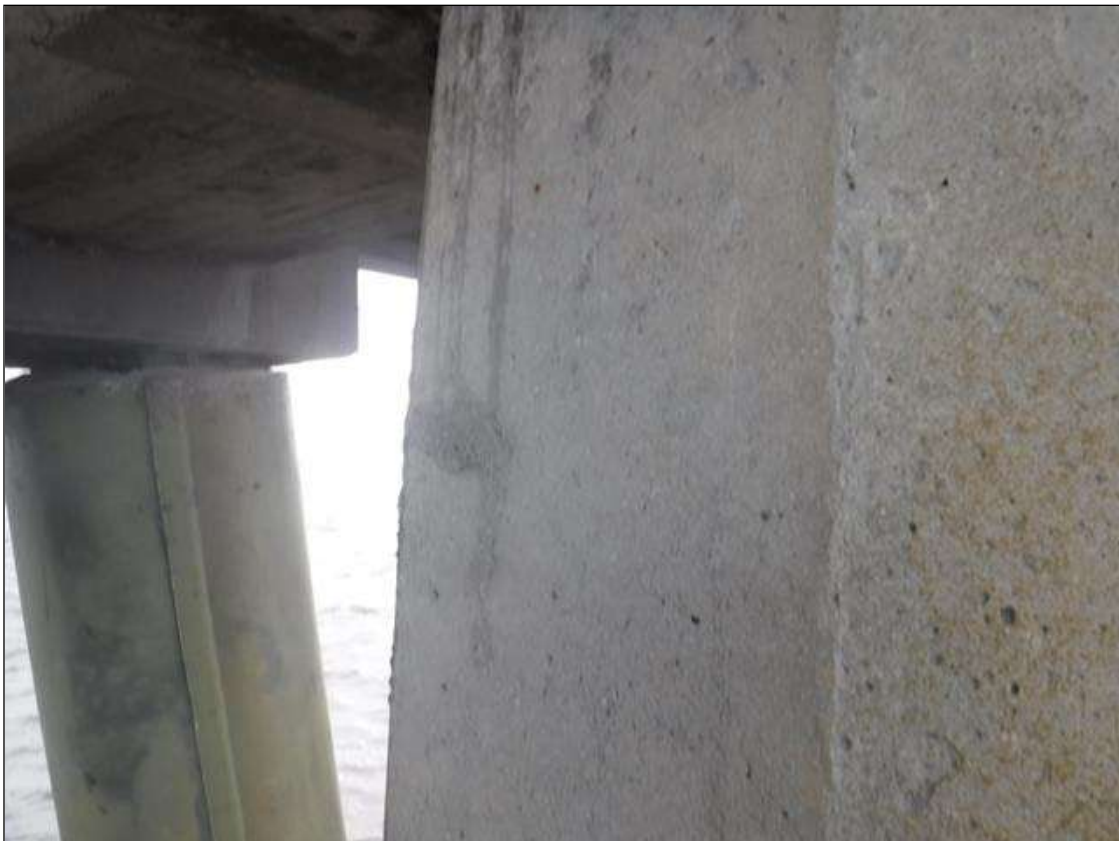
Bent 139 Pile 1: UP TO 2' X 0.009" VERTICAL CRACKS, AT RANDOM THROUGHOUT.

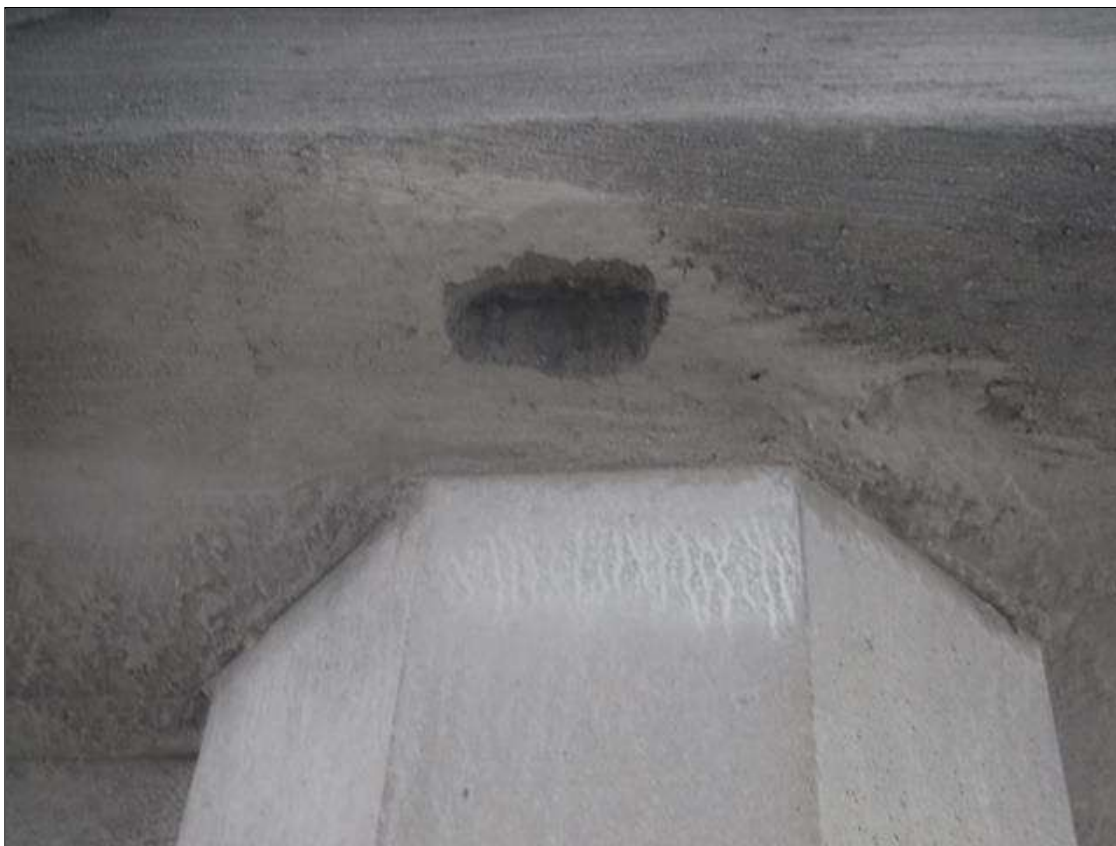
Bent 139 Pile 3: UP TO 2' X 0.009" VERTICAL CRACKS, AT RANDOM THROUGHOUT.

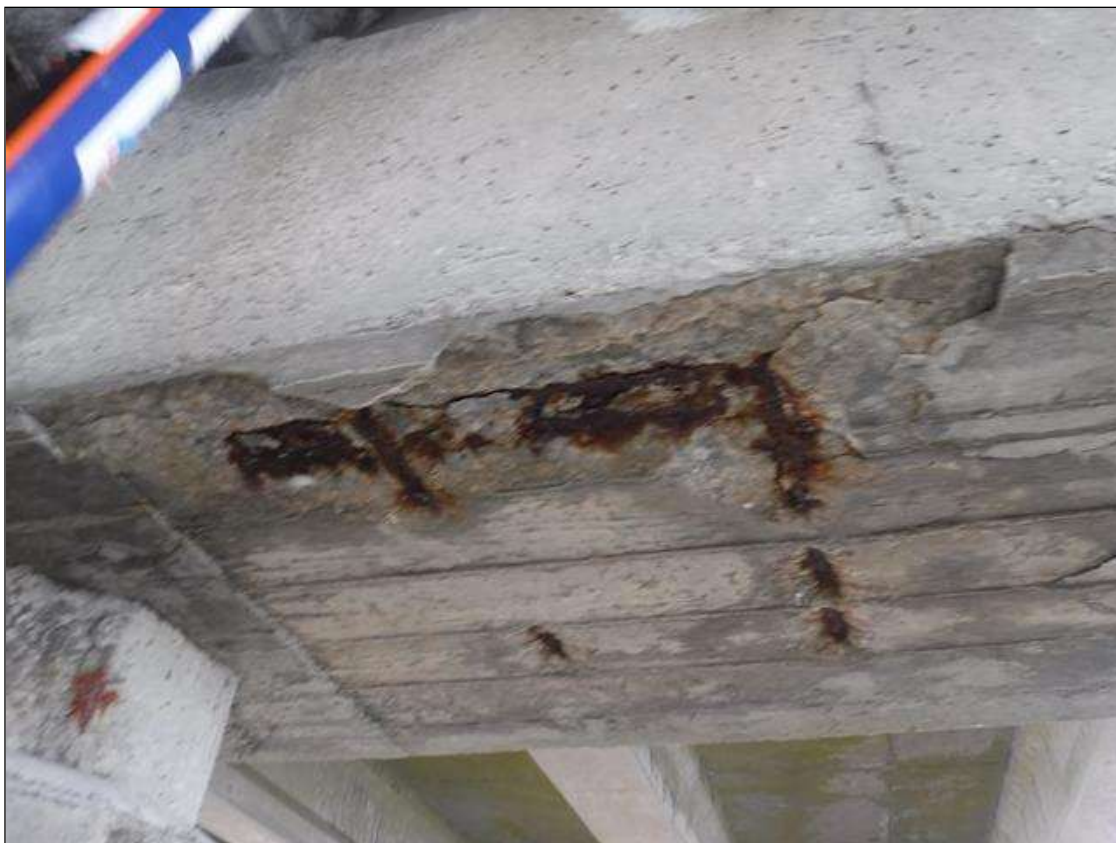
Bent 141 Cap 1: 6" DIAMETER X 2" DEEP SPALL WITH EXPOSED REBAR IN BOTTOM OF CAP EAST OF PILE 2

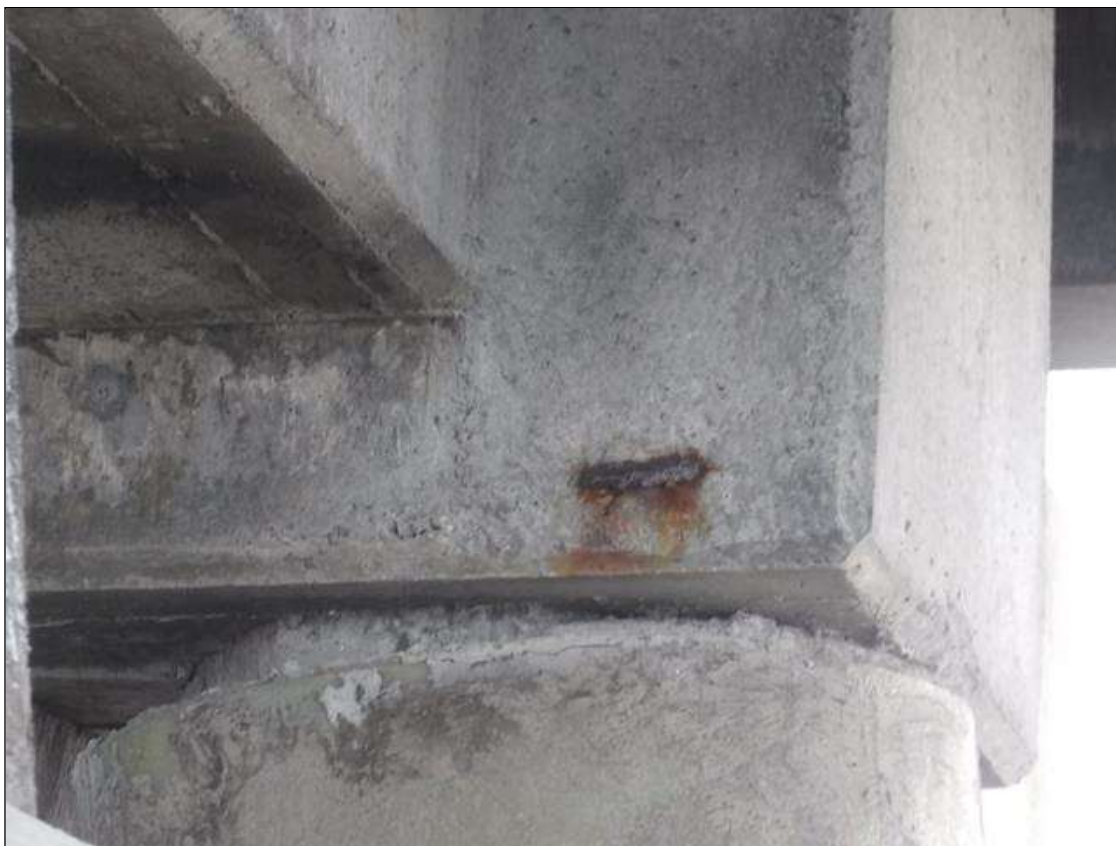
Bent 144 Cap 1: (PAR) 3' X 2" DEEP SPALL IN BOTTOM OF CAP WITH EXPOSED REBAR, REBAR HAS 10% SECTION LOSS

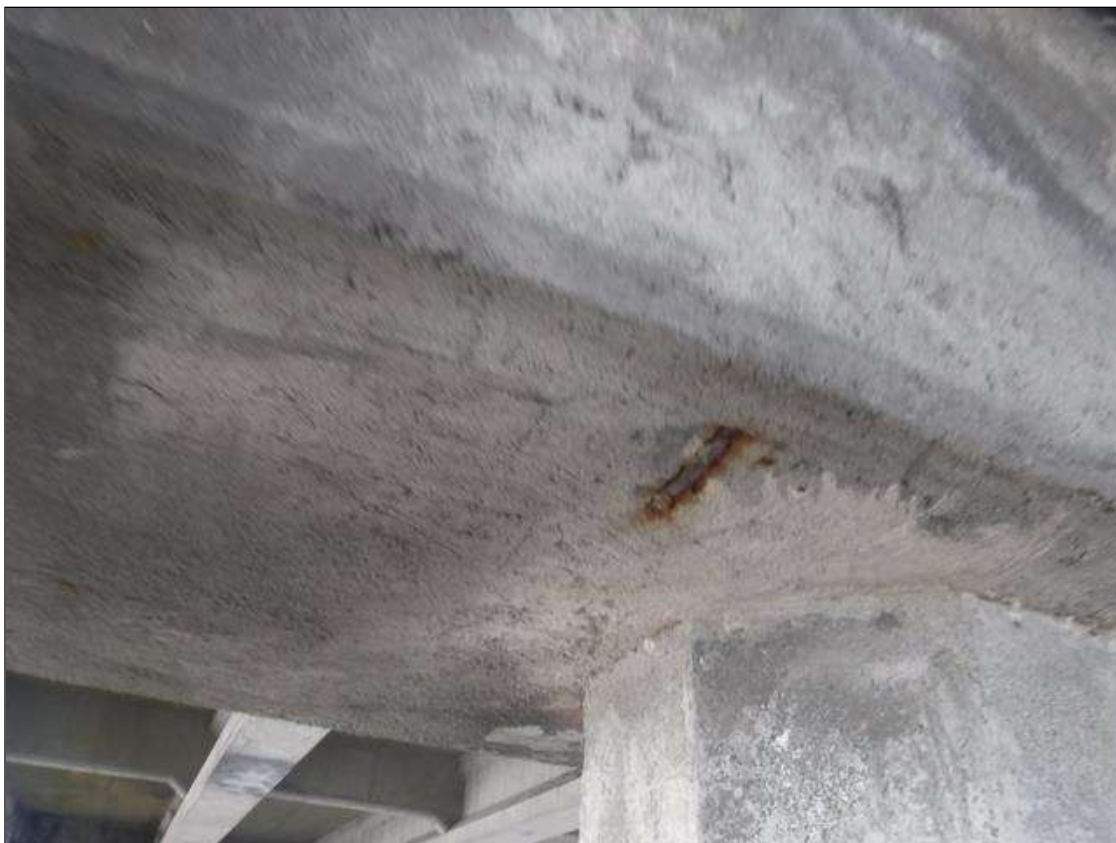
Bent 147 Cap 1: 8" X 4" X 1" SPALL, WITH EXPOSED REINFORCING, NORTH FACE OF PILE 4 BLOCK-OUT.

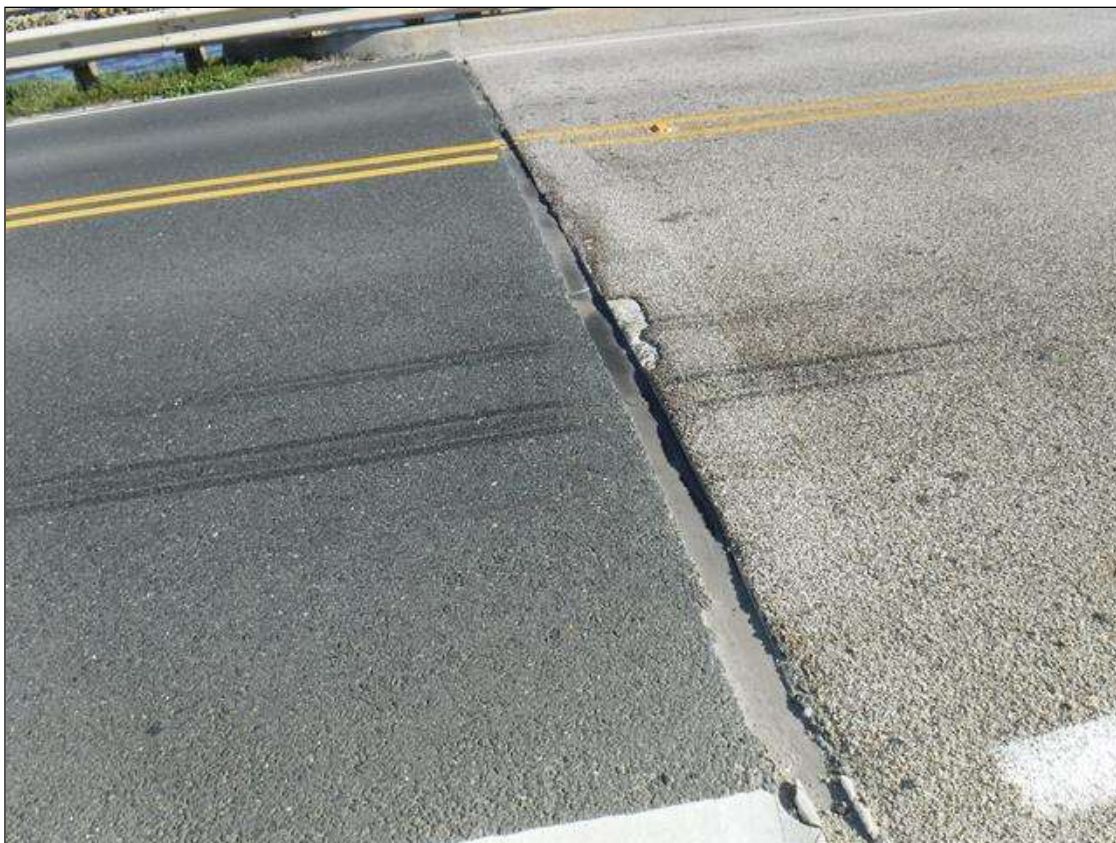
1/2" SETTLEMENT IN JOINT BETWEEN NEAR APPROACH AND SPAN 1, 3' FROM RIGHT LANE

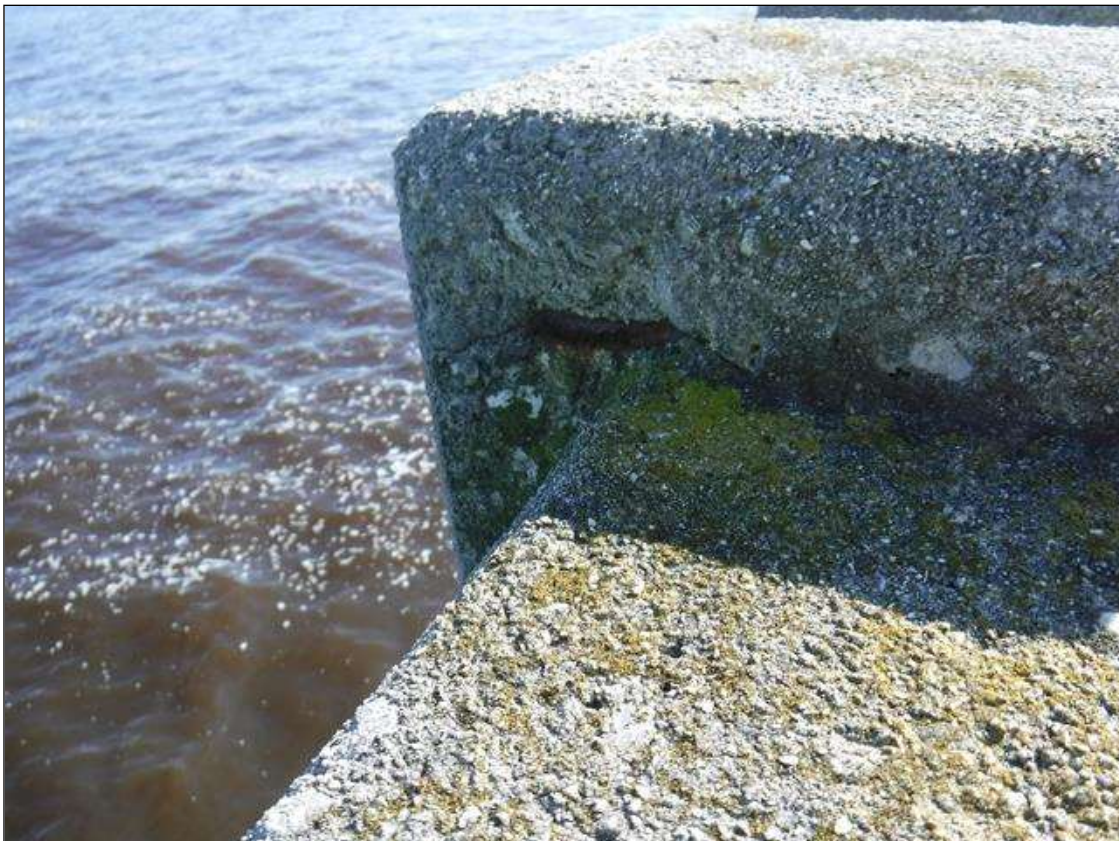
Span 1 Right Bridge Rail: 3 1/2" X 5" X 2" SPALL ON RIGHT FACE LOCATED AT NEAR RIGHT END POST

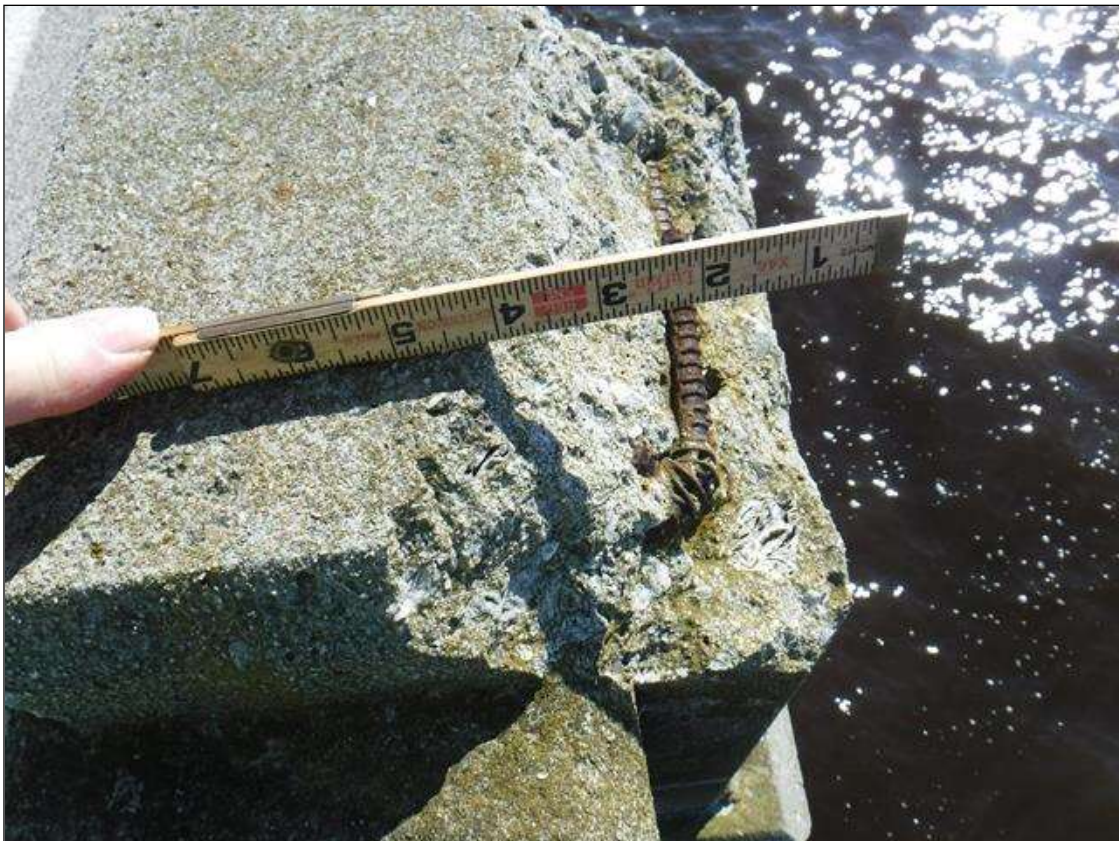
Span 18 Left Bridge Rail: 2 1/2" X 4" X 1 1/2" SPALL ON TOP FACE LOCATED FIRST POST AT BENT 17

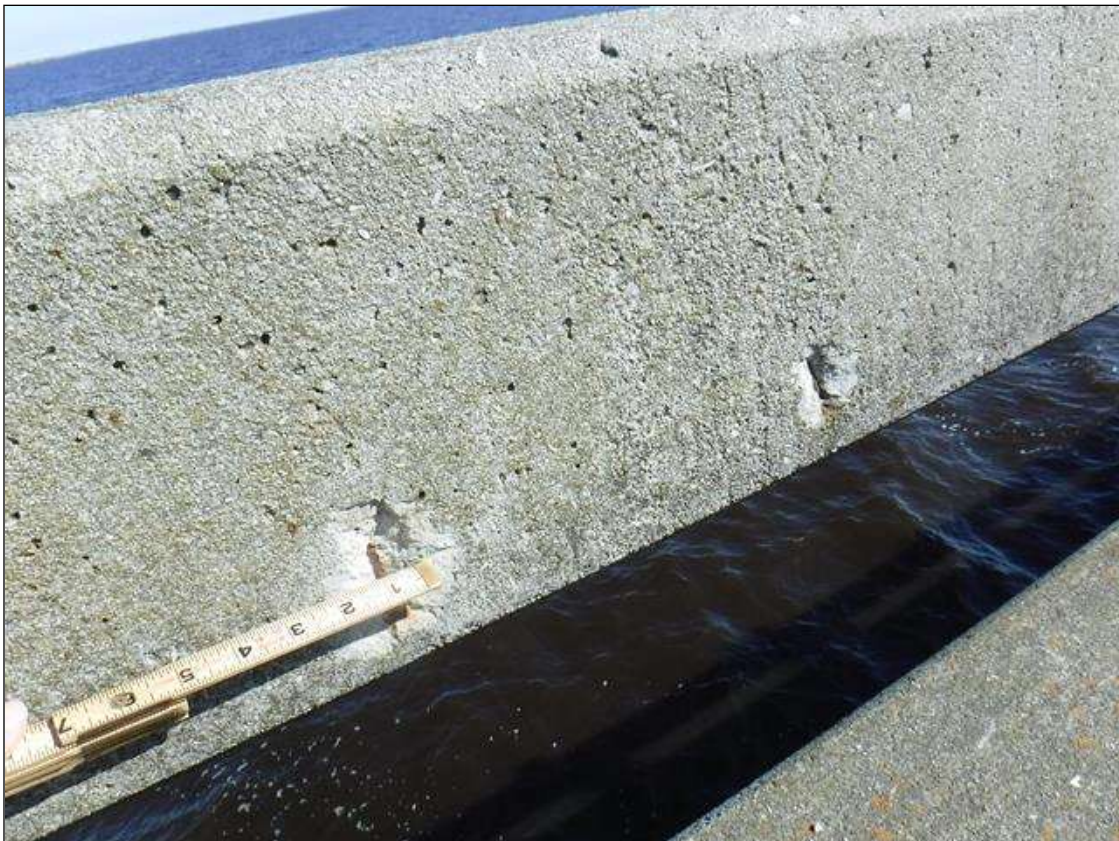
Span 31 Left Bridge Rail: 3" DIAMETER SPALL ON NEAR FACE LOCATED 5TH POST FROM BENT 30

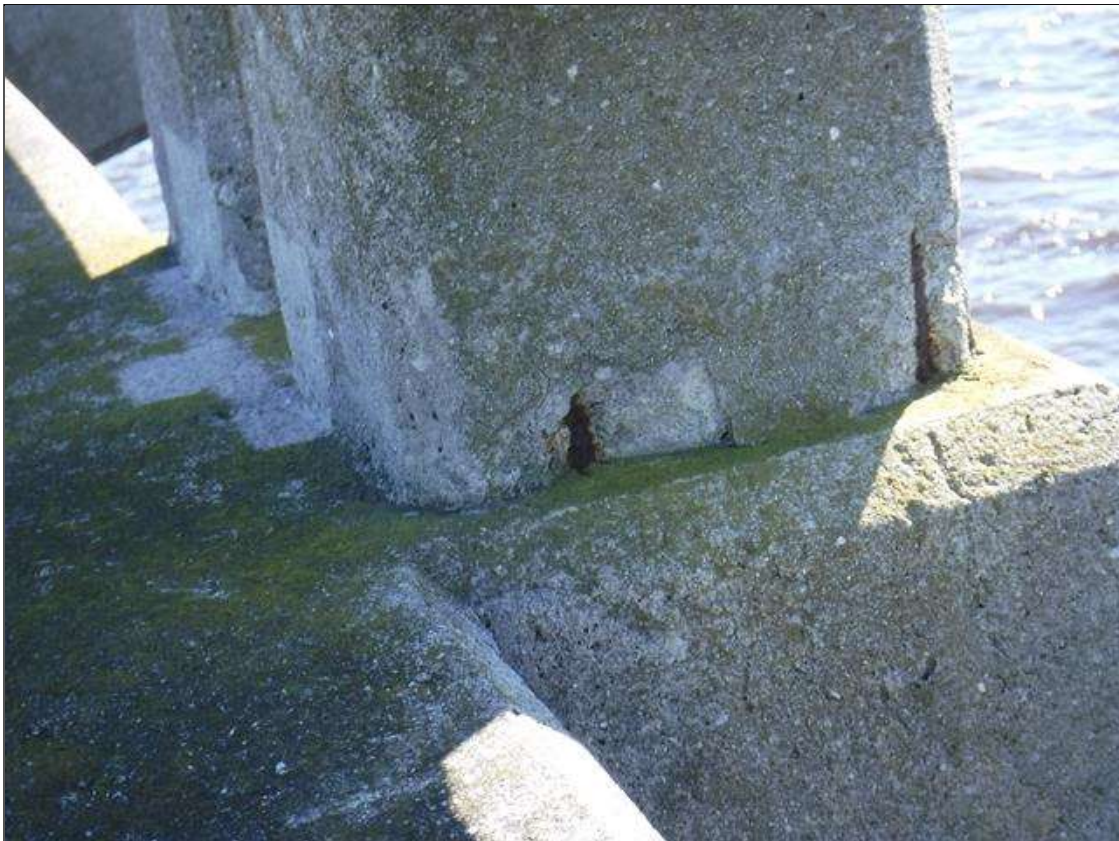
Span 49 Left Bridge Rail: 5" X 1" X 1/2" SPALL WITH EXPOSED REBAR ON RIGHT FACE LOCATED 2' FROM BENT
48

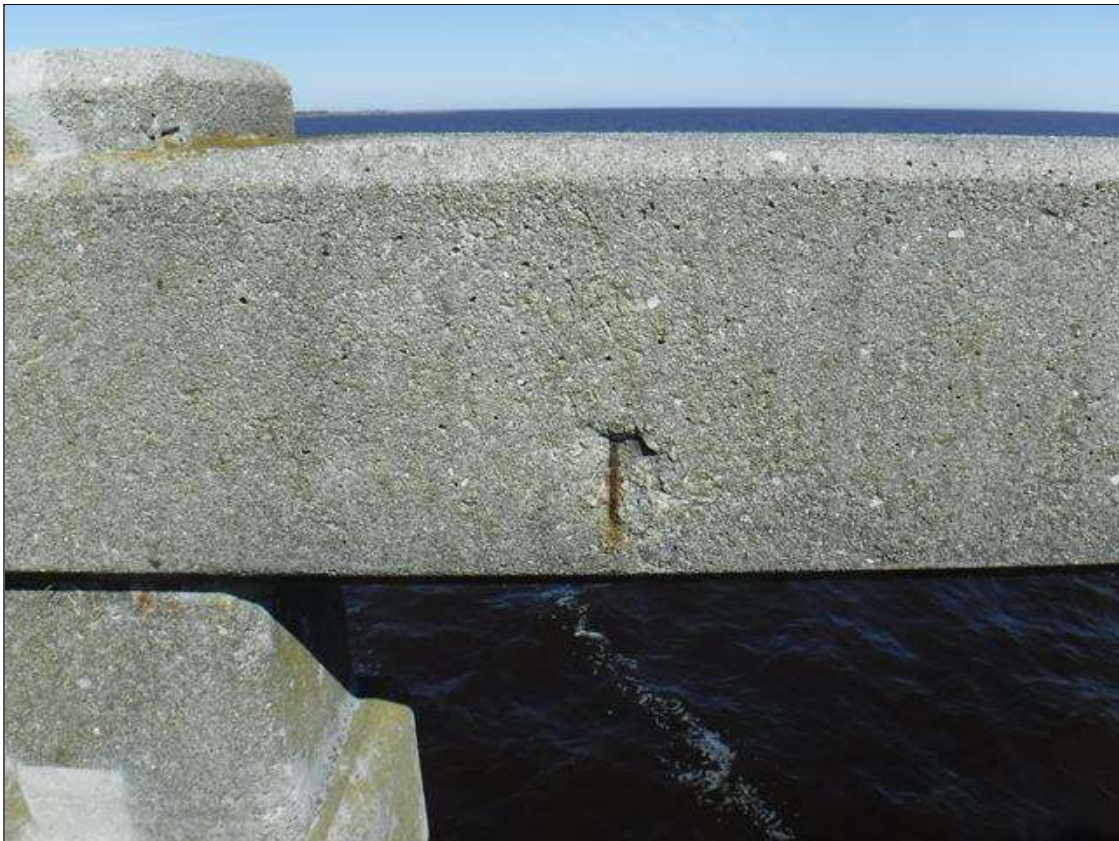
Span 66 Left Bridge Rail: 3" X 3" X 2" SPALL WITH EXPOSED REBAR AT BOTTOM RIGHT CORNER LOCATED AT POST 4

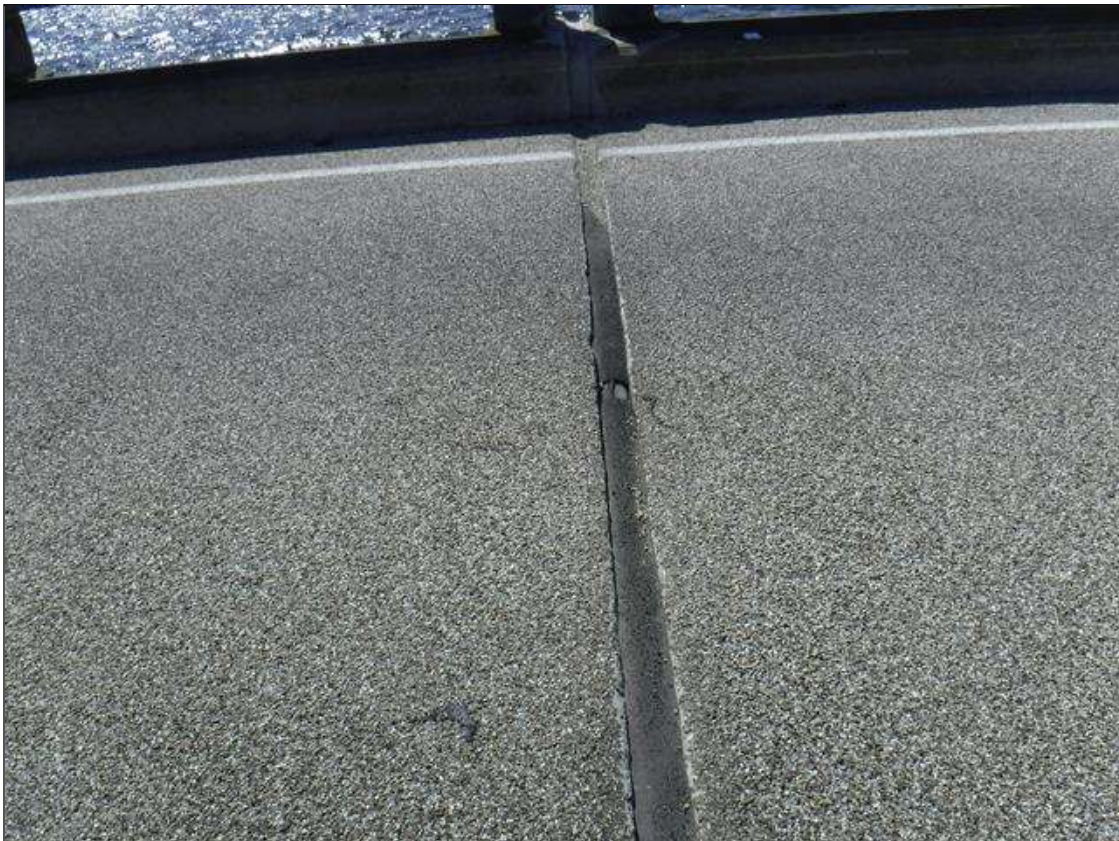
Span 82 Right Bridge Rail: 4" X 2 1/2" X 5" SPALL WITH EXPOSED REBAR AT BOTTOM LEFT CORNER LOCATED AT POST 1

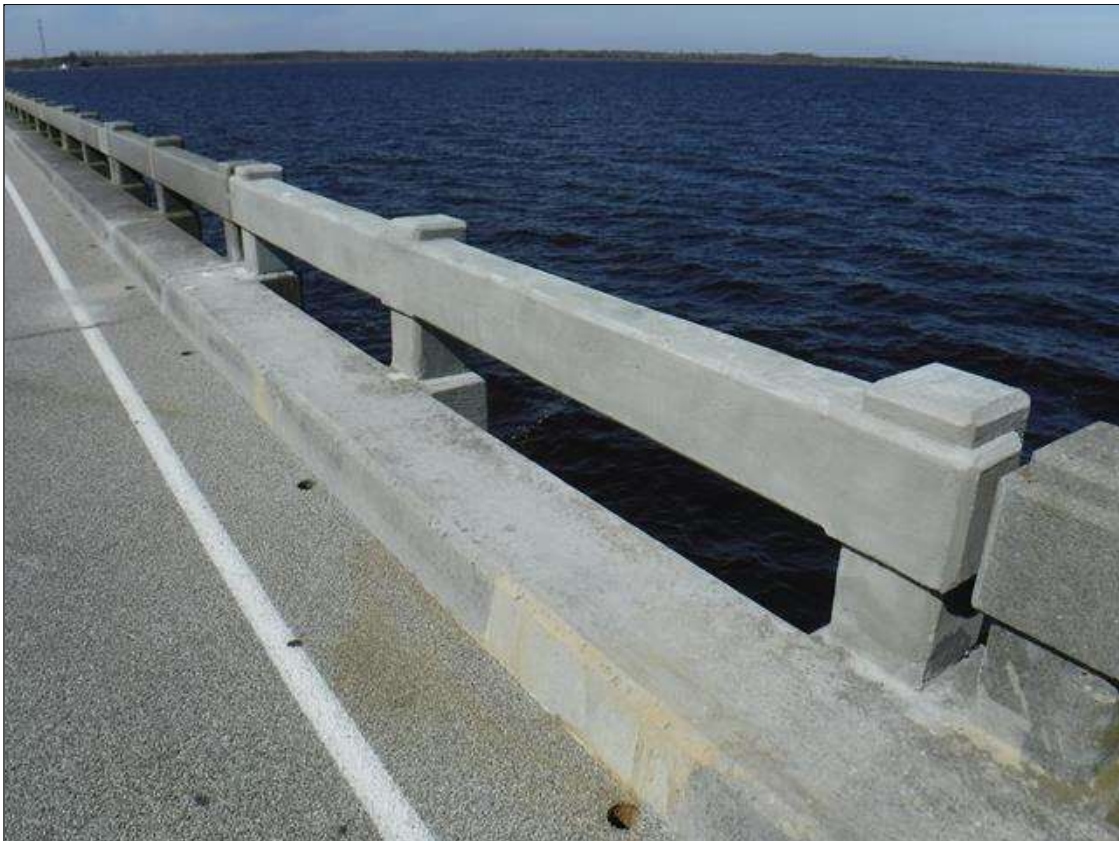
Span 84 Right Bridge Rail: 2" X 2" X 3/4" SPALL WITH EXPOSED REBAR AT BOTTOM LEFT CORNER LOCATED ON POST 6

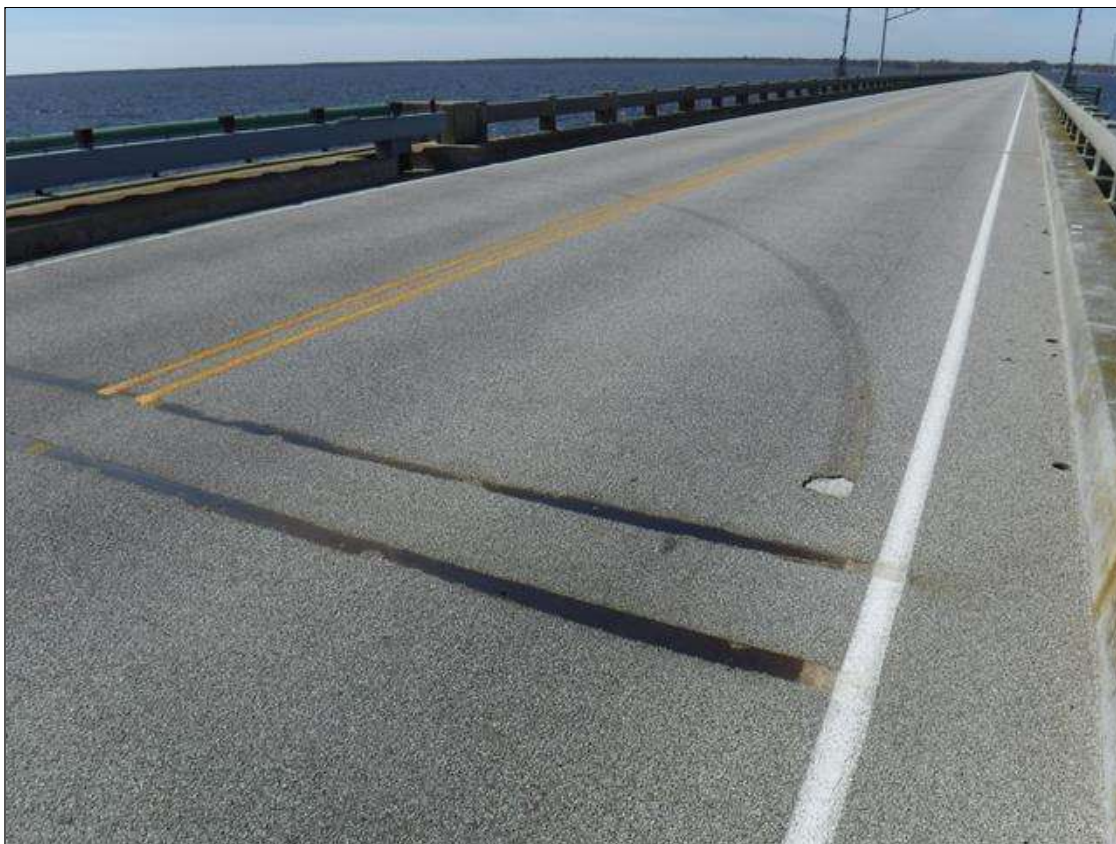
Span 89 Left Bridge Rail: 12' PATCHED LENGTH OF RAIL LOCATED IN FIRST SECTION OF RAIL FROM POST 1 TO POST3

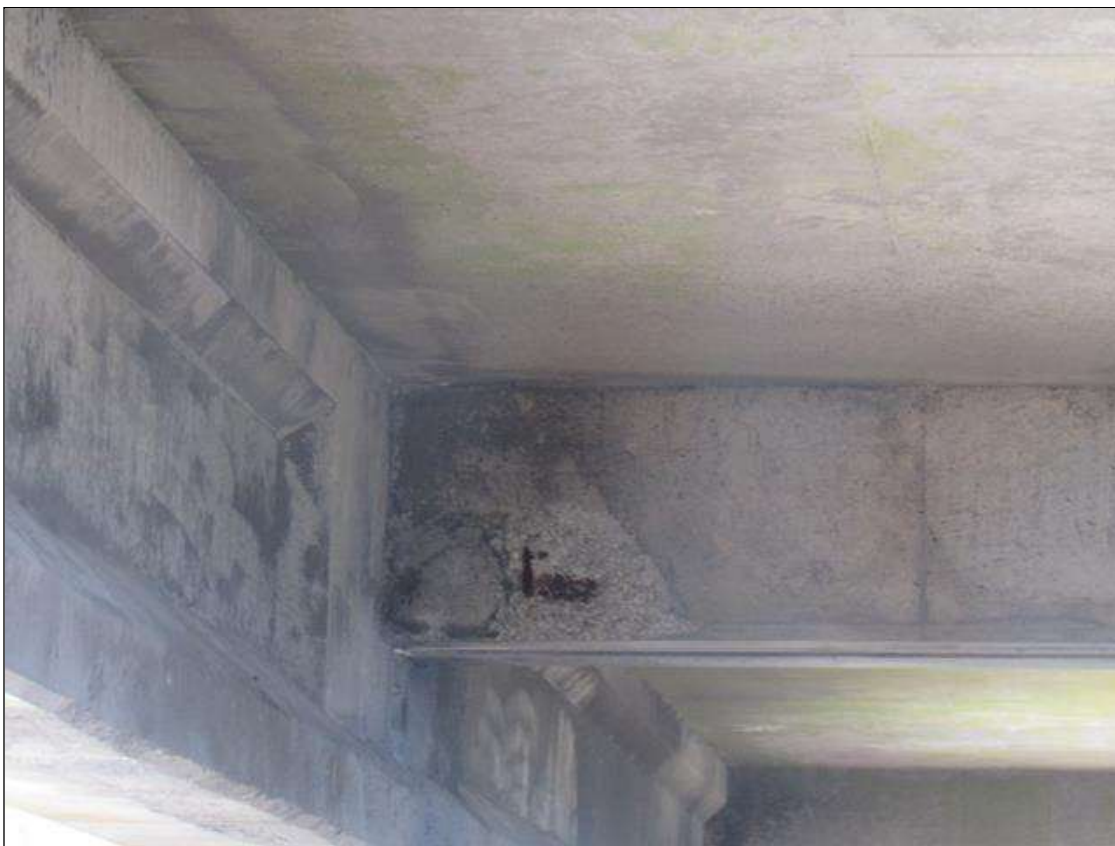
Span 5 Beam 4: 2' X 1' SPALLED PATCHED AREA, WITH EXPOSED REINFORCING, EAST FACE OF BENT 4 DIAPHRAGM, BETWEEN BEAMS 3 AND 4.

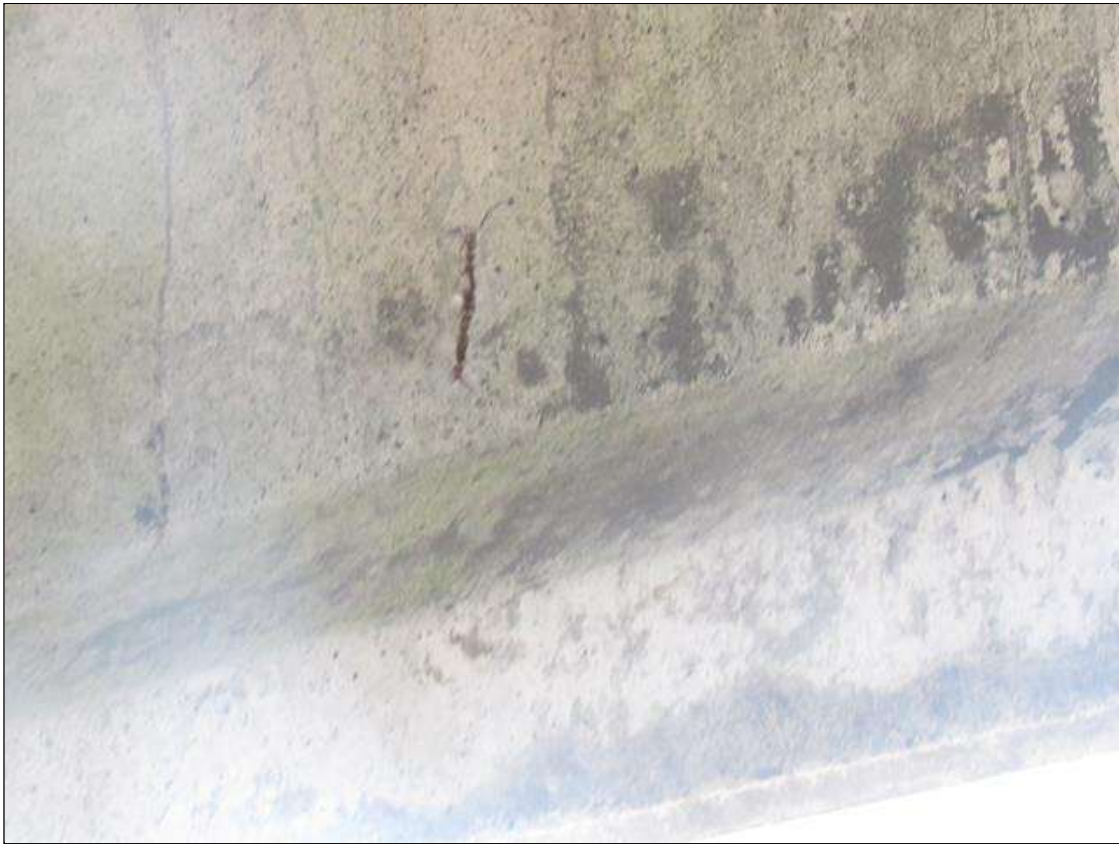
Span 6 Beam 4: 1" X 6" X 1/2" SPALL, WITH EXPOSED REINFORCING, NORTH FACE, 3' FROM BENT 6.
