NC DEPARTMENT OF TRANSPORTATION
DIVISION OF HIGHWAYS
STRUCTURE MANAGEMENT UNIT

Structure Safety Report

Routine Element Inspection - Contract

FEATURE INTERSECTED: ALLIGATOR RIVER

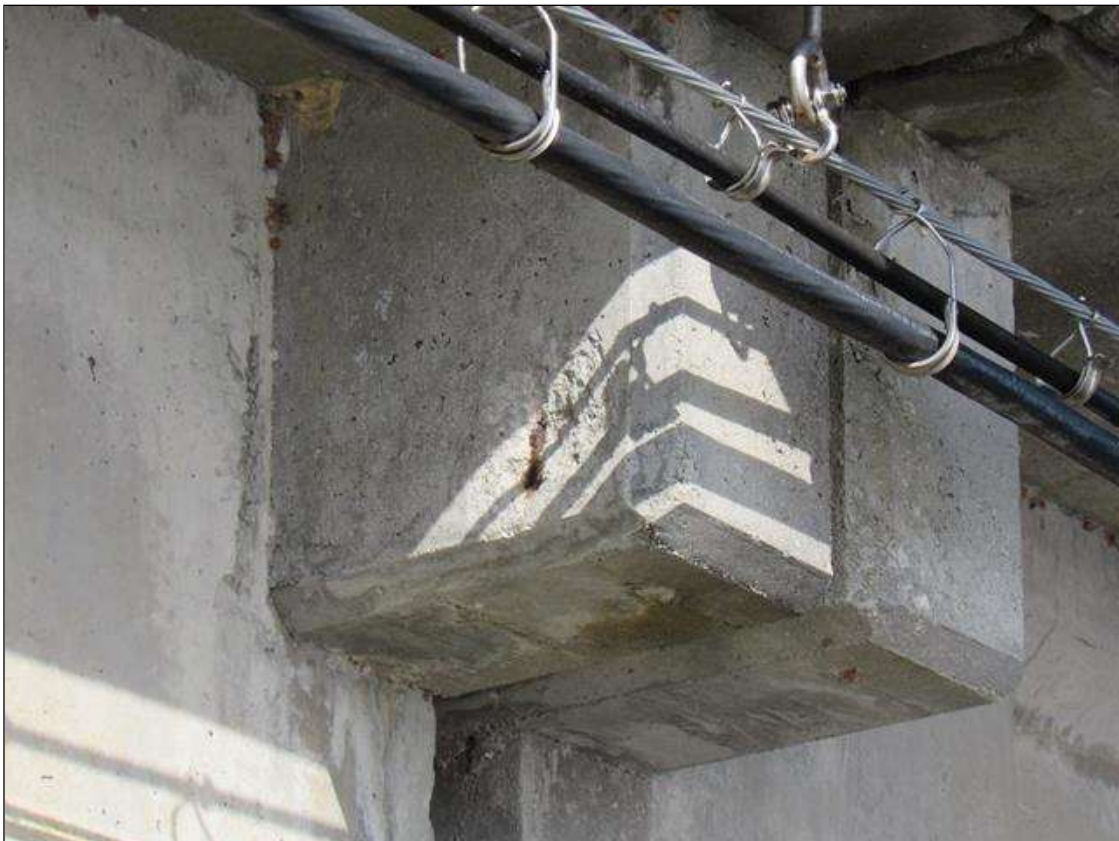
Span 6 Beam 4: 6" X 6" X 1" SPALL, WITH EXPOSED REINFORCING, WEST FACE OF BENT 6 SOUTH OVERHANG DIAPHRAGM.

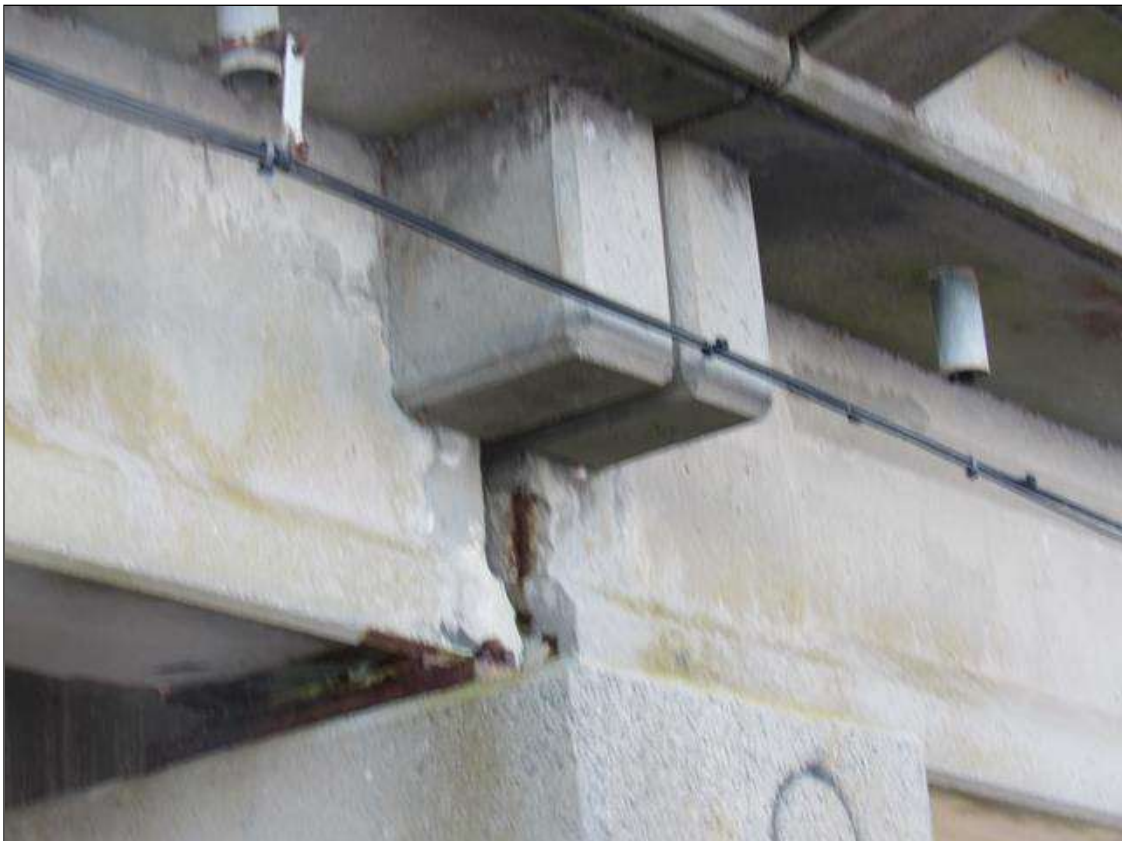
Span 8 Beam 1: 3" X 8" X 3" SPALL WITH EXPOSED REINFORCING, NORTH FACE, AT BENT 8.

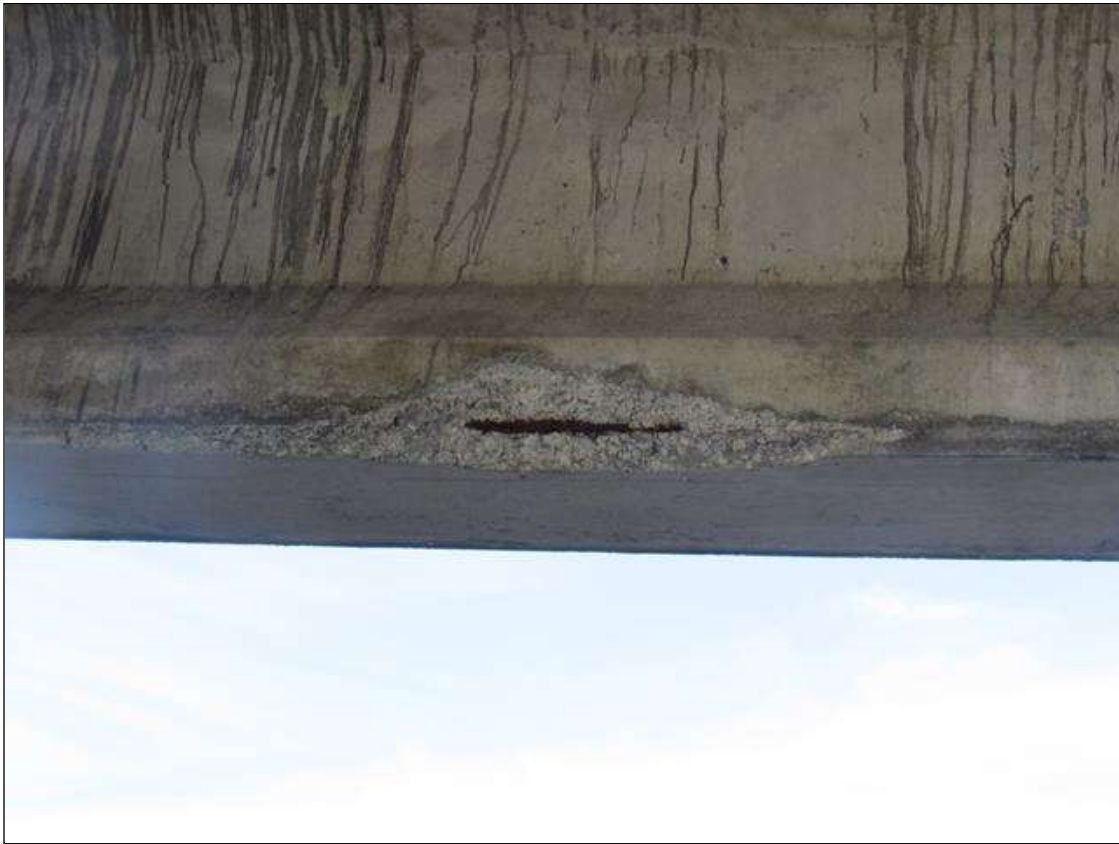
Span 8 Beam 1: (PAR) 42" X 4" X 4" EDGE SPALL WITH EXPOSED STRAND BOTTOM SOUTH CORNER, 20' FROM BENT 7.

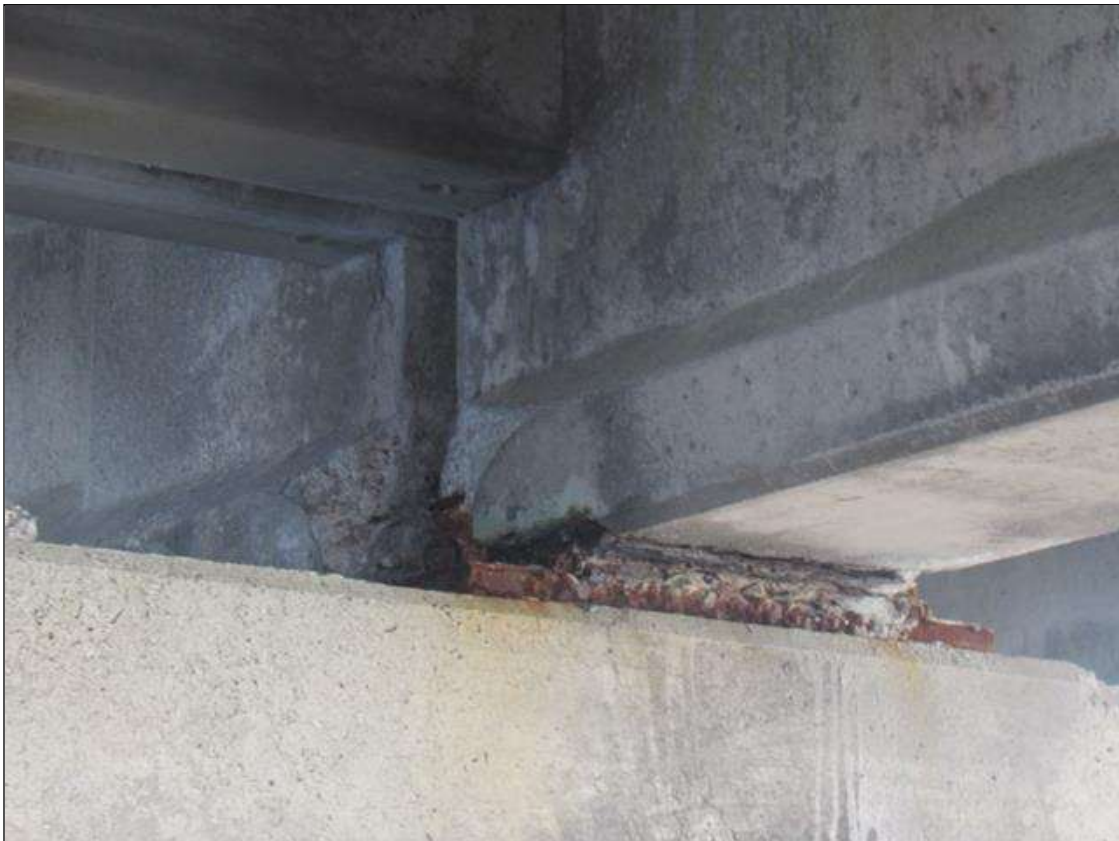
Span 8 Beam 3: (PAR) 6" X 10" X 3" SPALL WITH EXPOSED STRAND, NORTH FACE, AT BENT 7.

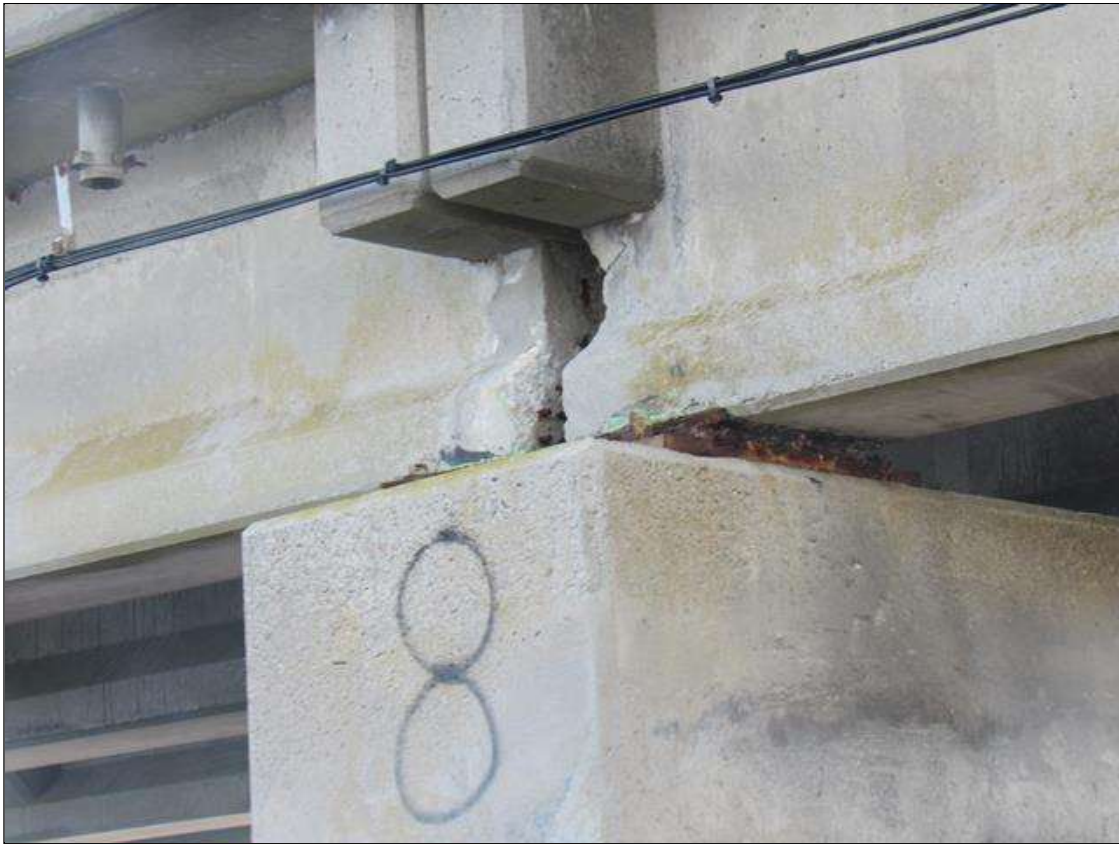
Span 9 Beam 1: (PAR) 12" X 6" X UP TO 3" DEEP SPALL WITH EXPOSED STRAND, WEST FACE, AT BENT 8.

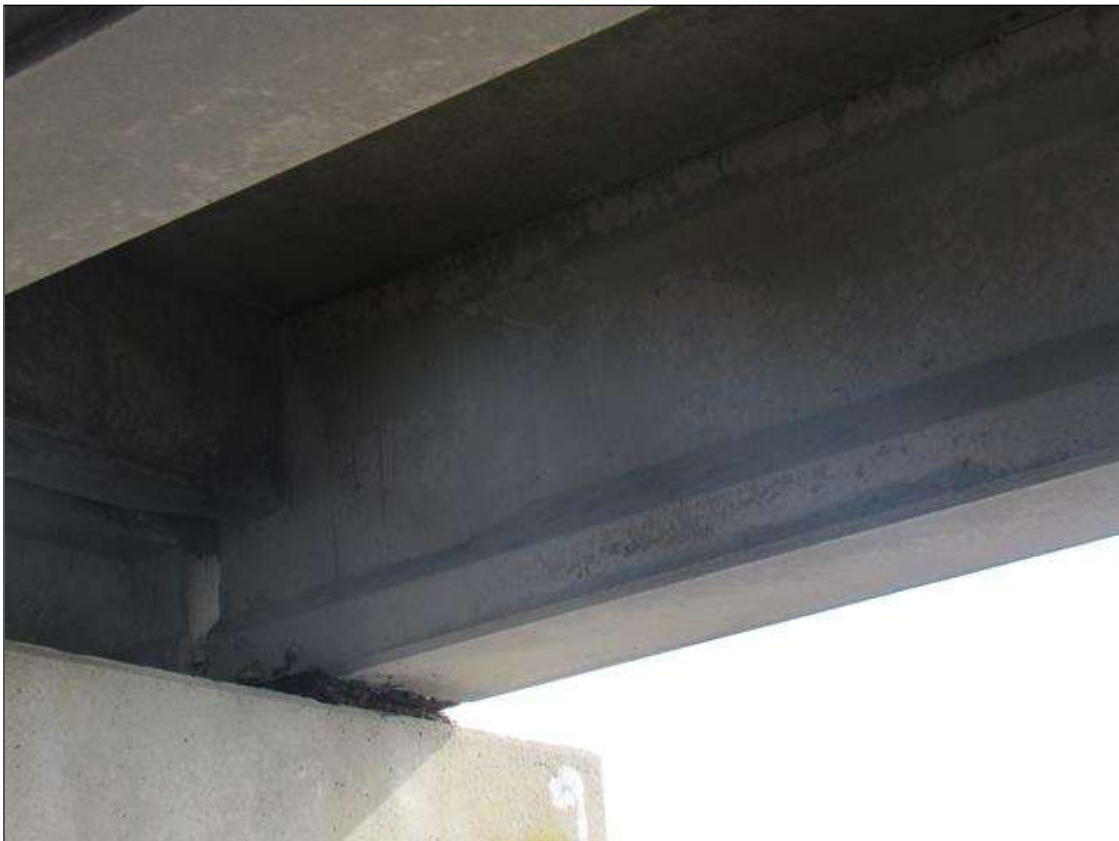
Span 9 Beam 4: (PAR) 6" X 4" X 2" SPALL WITH EXPOSED STRAND, NORTH FACE, AT BENT 9.

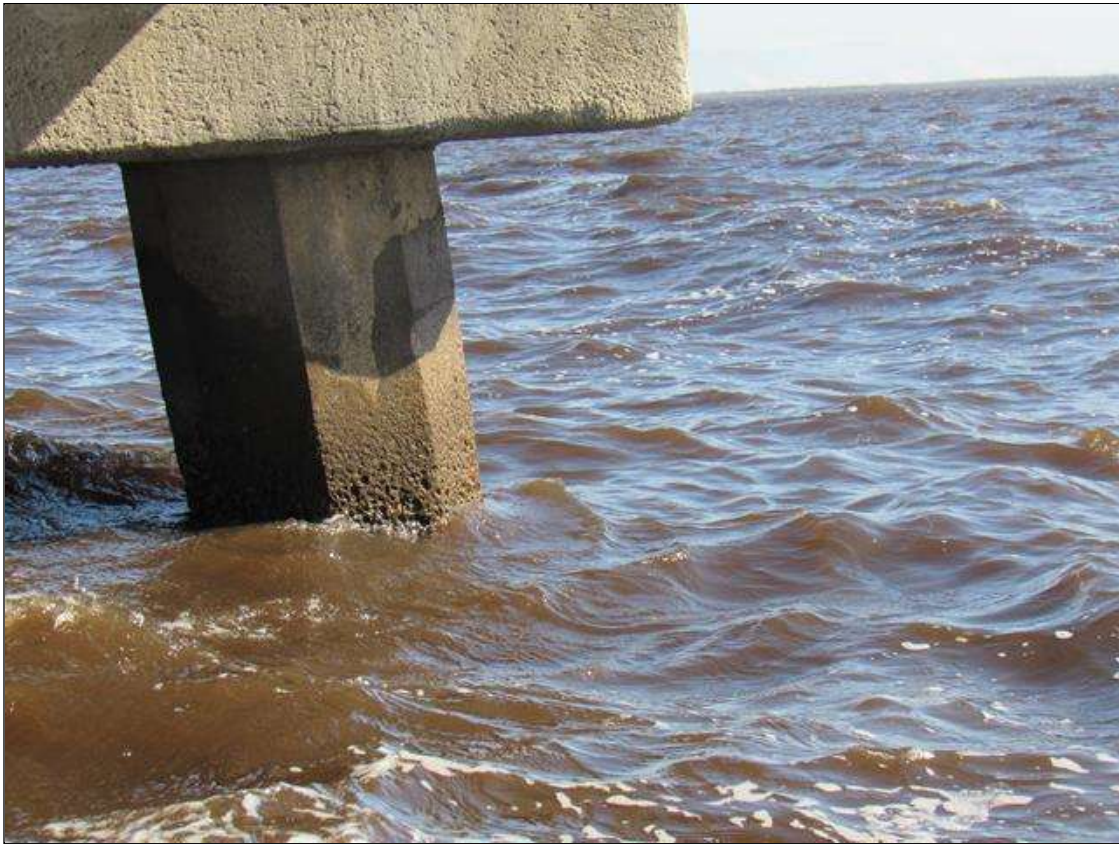
Bent 5 Saved Pile 6: SCALING TO 1" WITH LOOSE AGGREGATE FROM WATERLINE TO MUDLINE

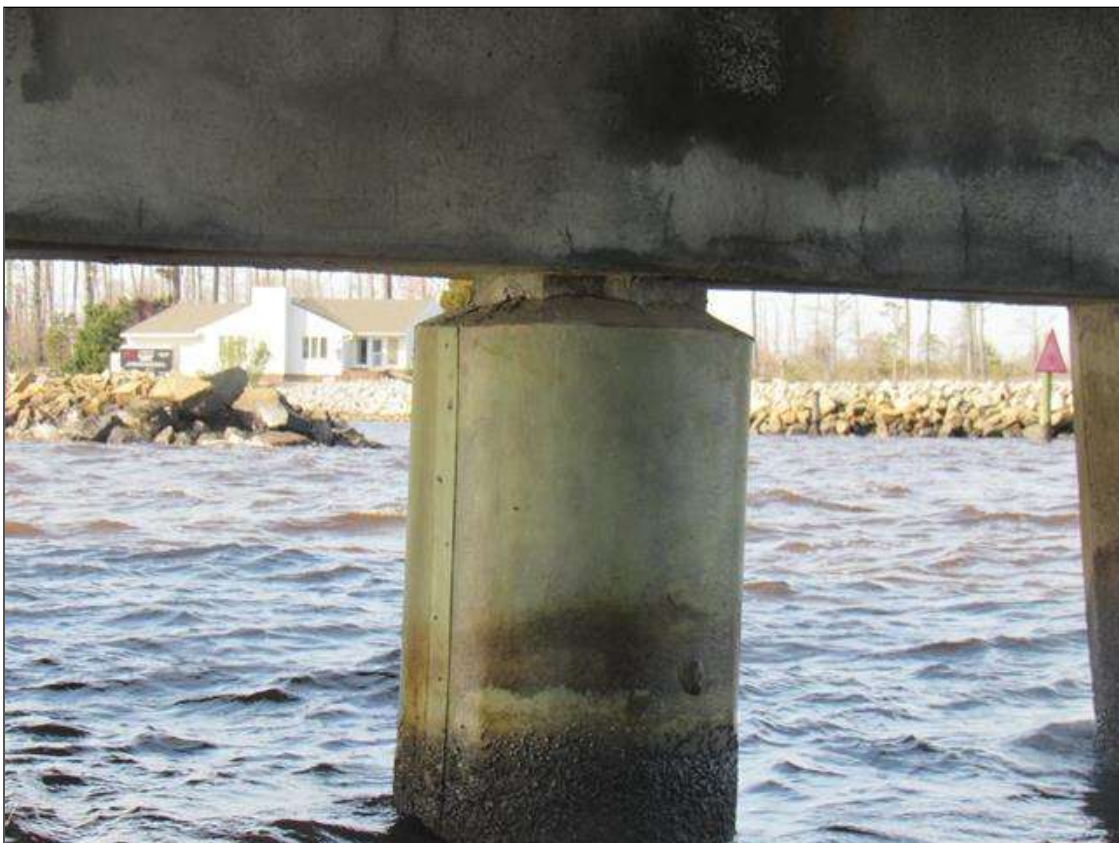
Bent 7 Saved Pile 2: PILE REPAIRED WITH 3' DIAMETER CONCRETE JACKET

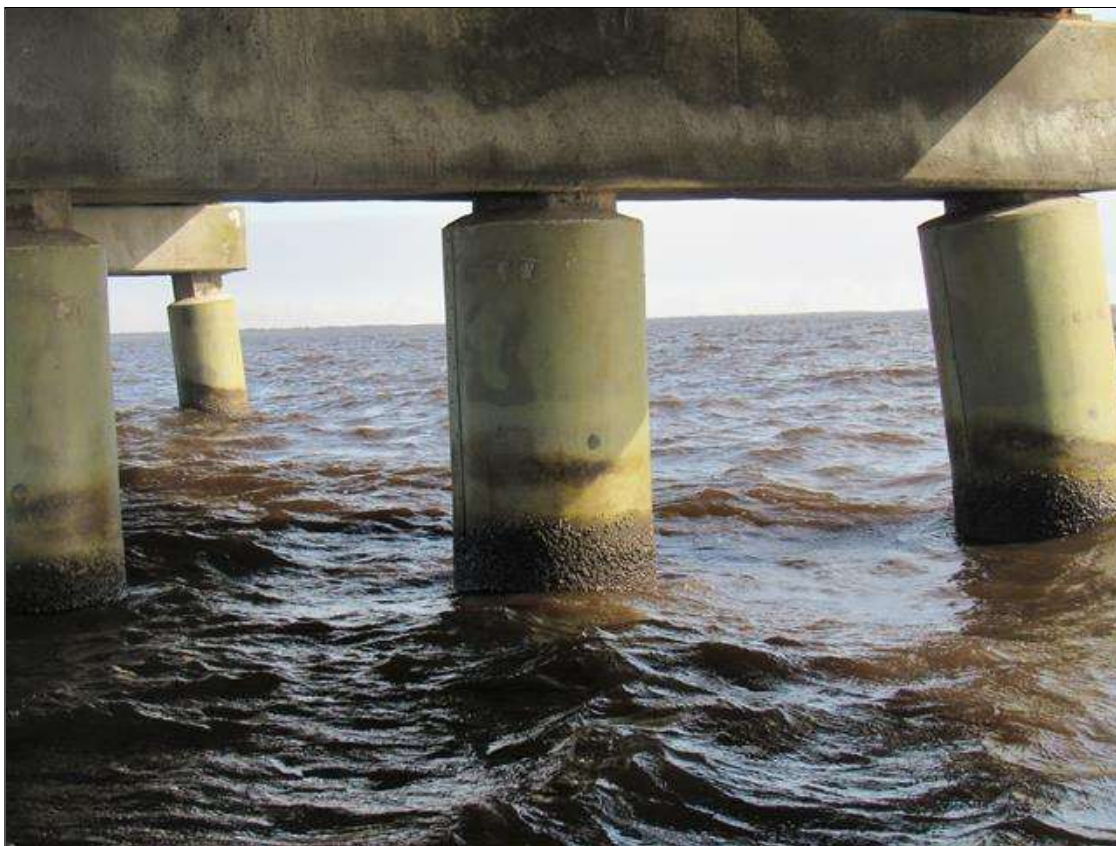
Bent 8 Saved Pile 3: PILE REPAIRED WITH 3' DIAMETER CONCRETE JACKET, OTHER PILES SIMILAR

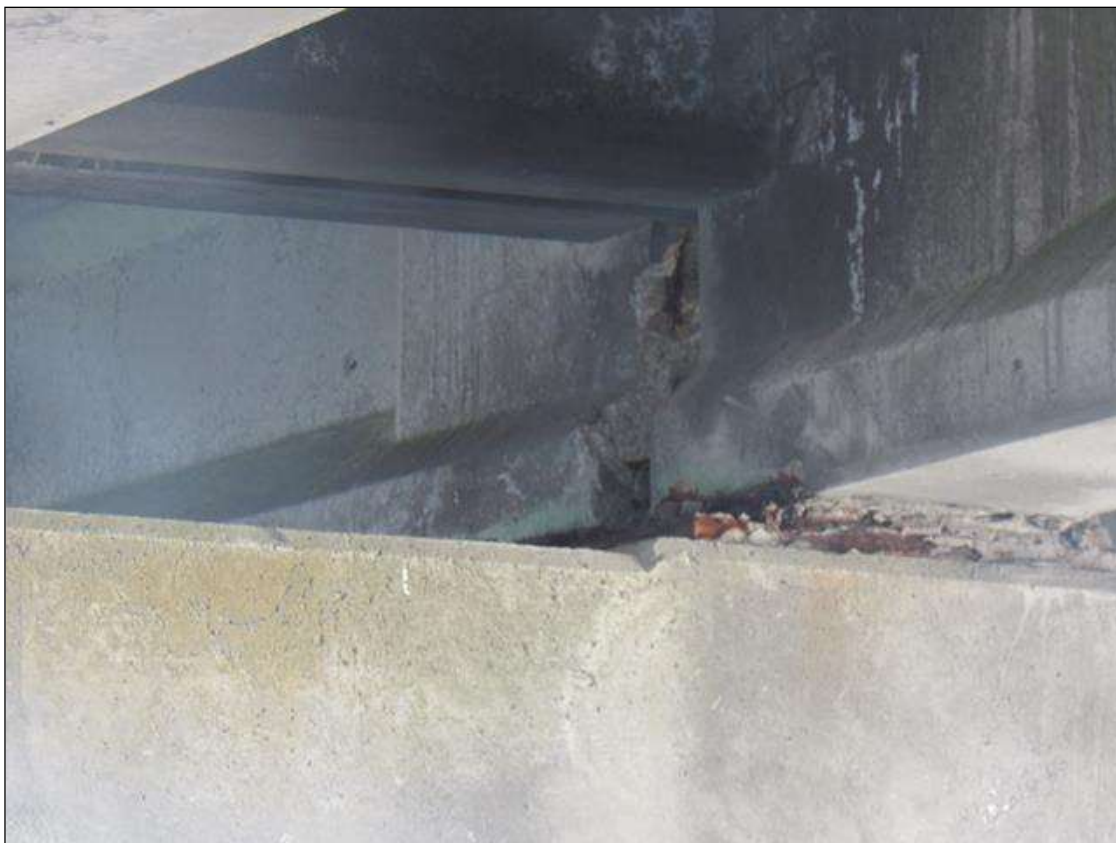
Span 8 Beam 3: (PAR) 6" X 10" X 3" SPALL WITH EXPOSED STRAND, NORTH FACE, AT BENT 7.

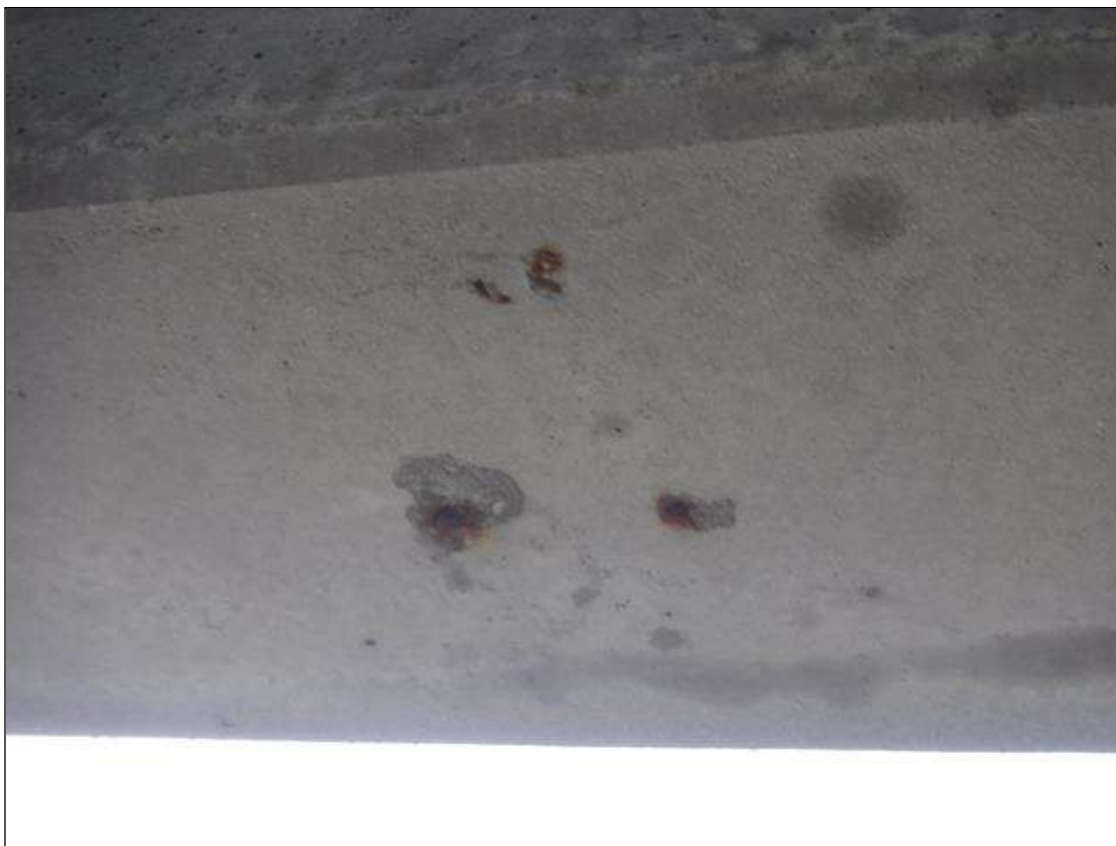
Span 151 Beam 4: (2) UP TO 3" DIAMETER X 1/2" SPALLS, WITH EXPOSED REINFORCING, BOTTOM FACE, 2' FROM BENT 150.

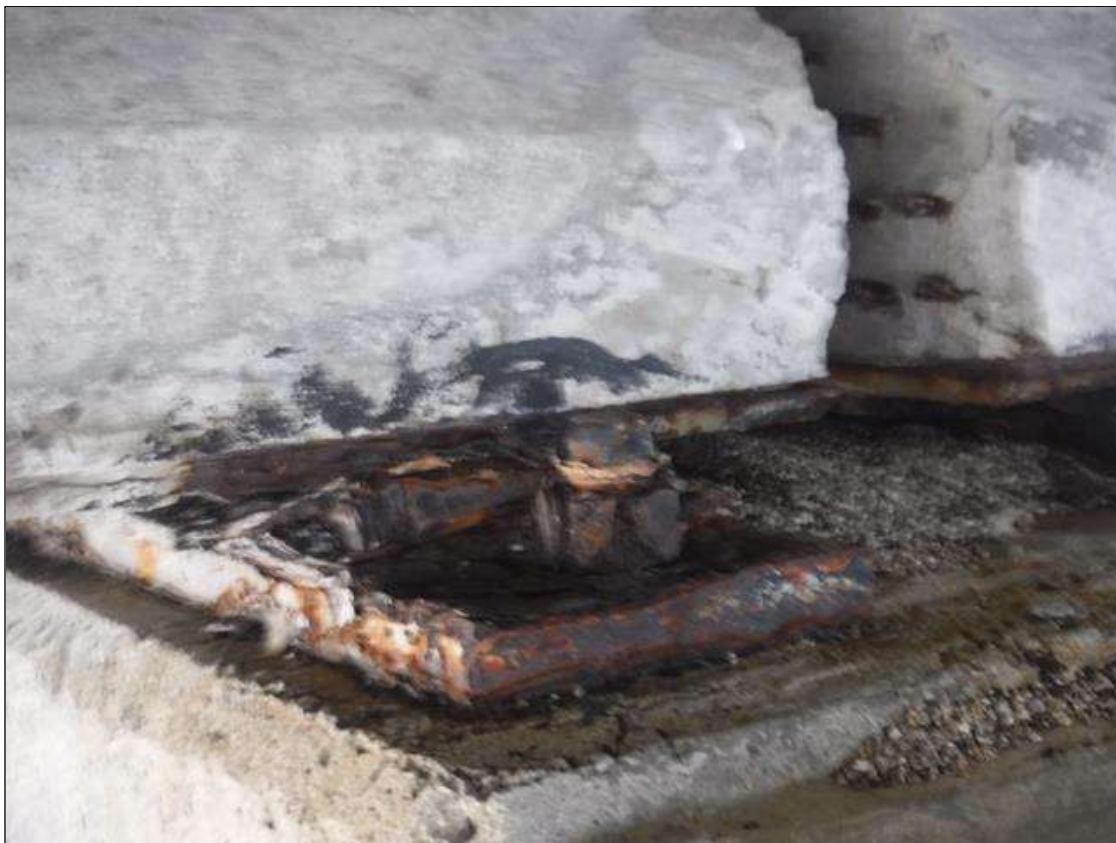
Span 151 Beam 2 Near Bearing: CORROSION WITH LESS THAN 1/16" LOSS. (2" REMAINING).

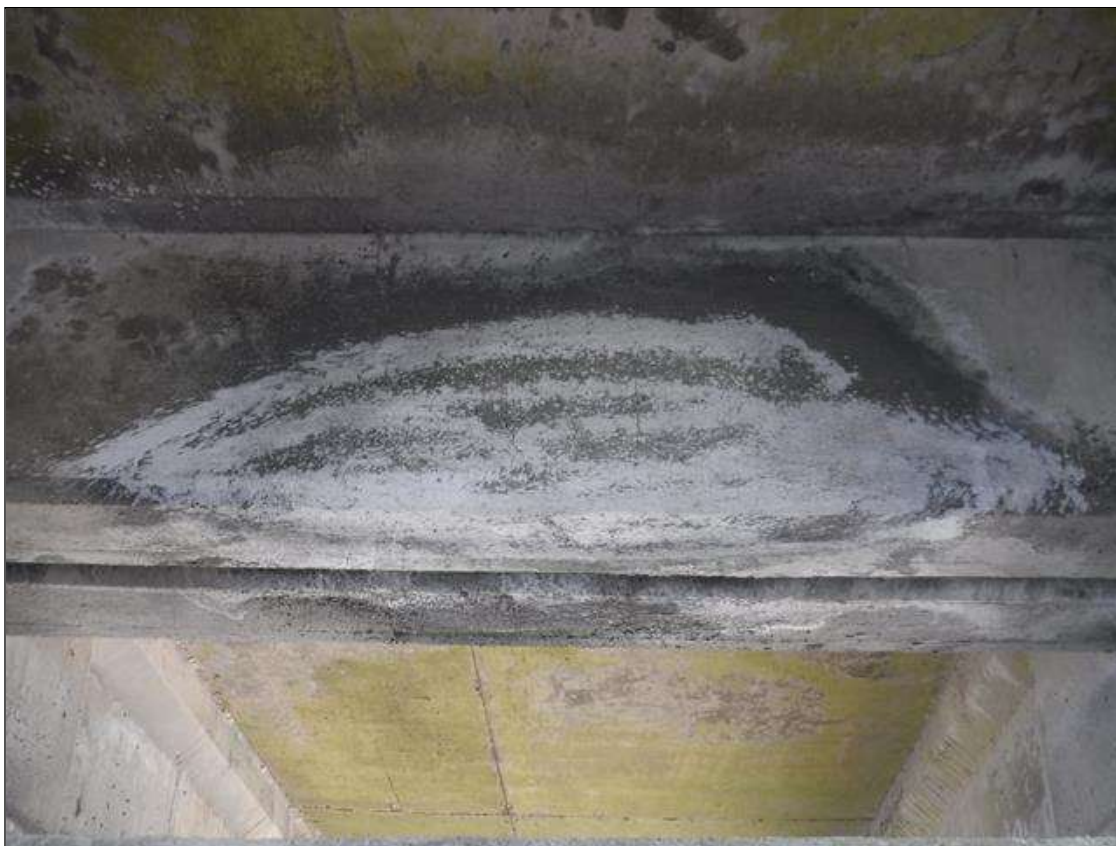
Span 152 Beam 3: 5' X UP TO 1' X 10" CRACKED PATCHED AREA UP TO 1/16", END DIAPHRAGM, BETWEEN BEAMS 3 AND 4, AT BENT 152.

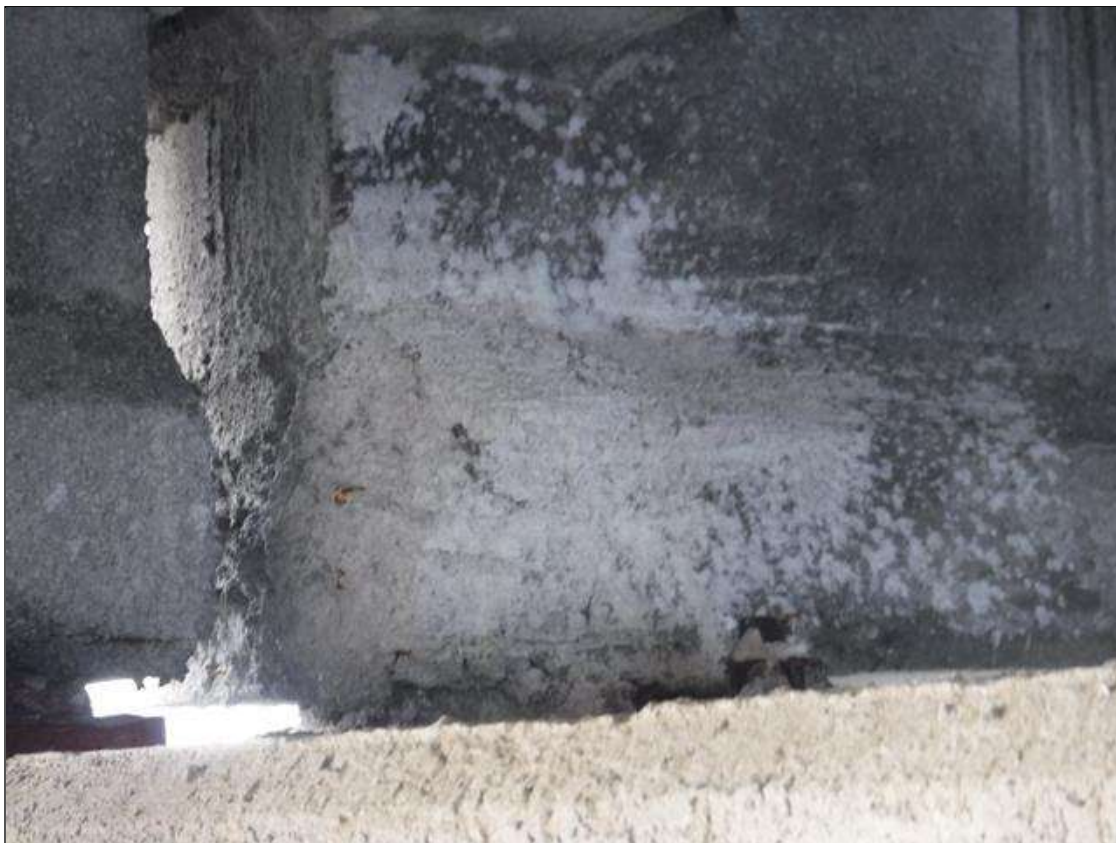
Span 153 Beam 4: 12" X 12" PATCHED AREA ON NORTH FACE AT BENT 153

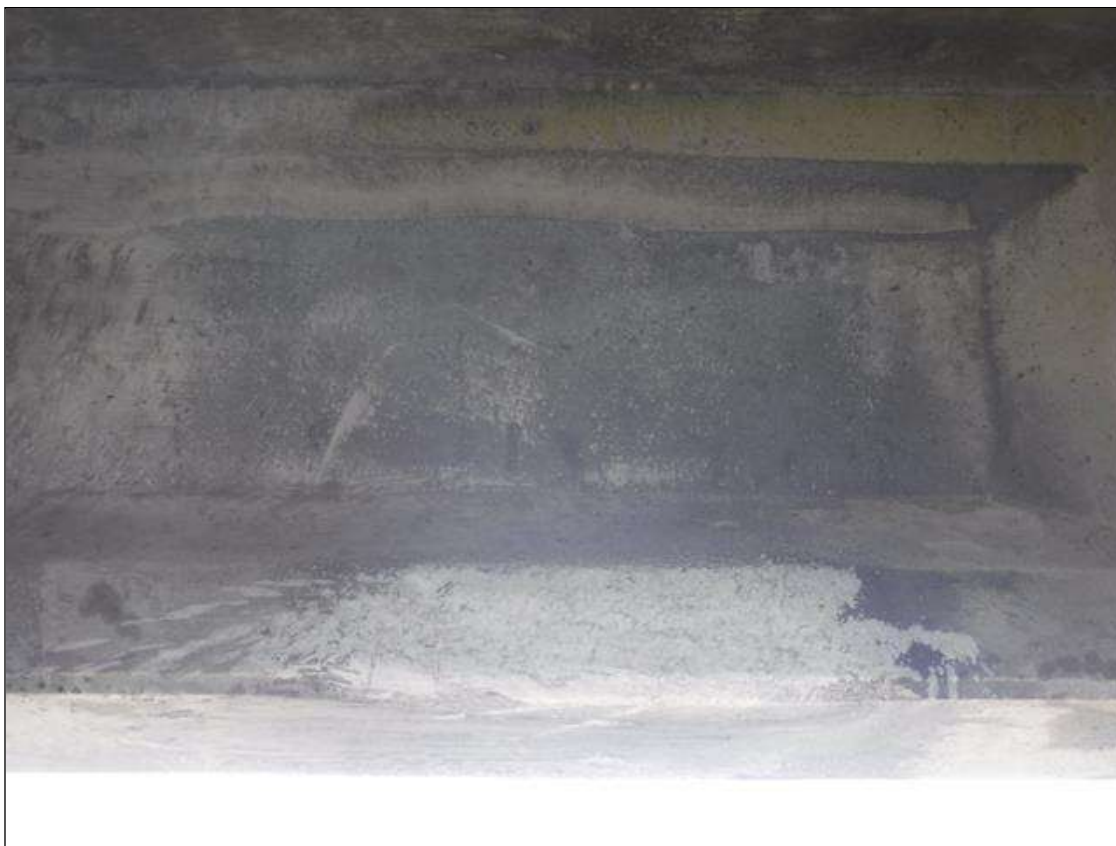
Span 154 Beam 4: 3' X UP TO 1' X 4" CRACKED PATCHED AREA UP TO 0.031", NORTH FACE, 3' FROM BENT 153

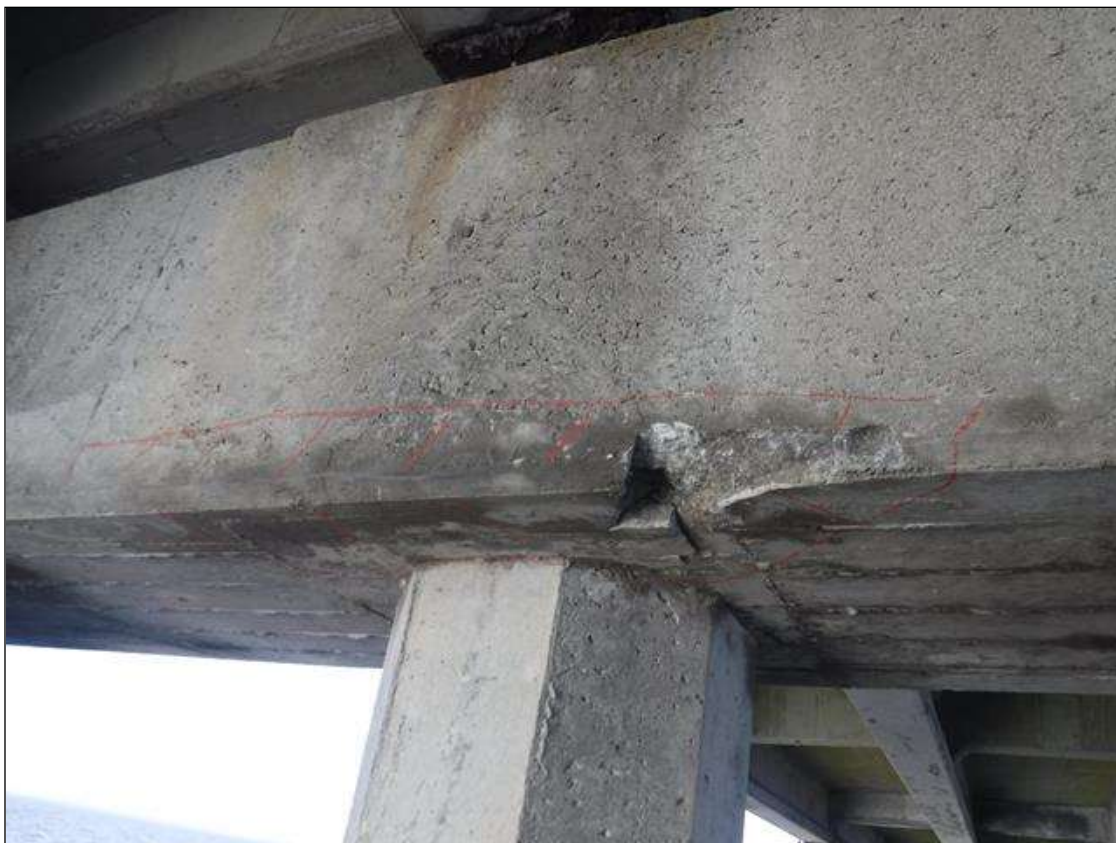
Bent 153 Cap 1: 4' LONG X 6" HIGH X 1' DEEP DELAMINATION WITH SPALL ON EAST FACE ABOVE PILE 3

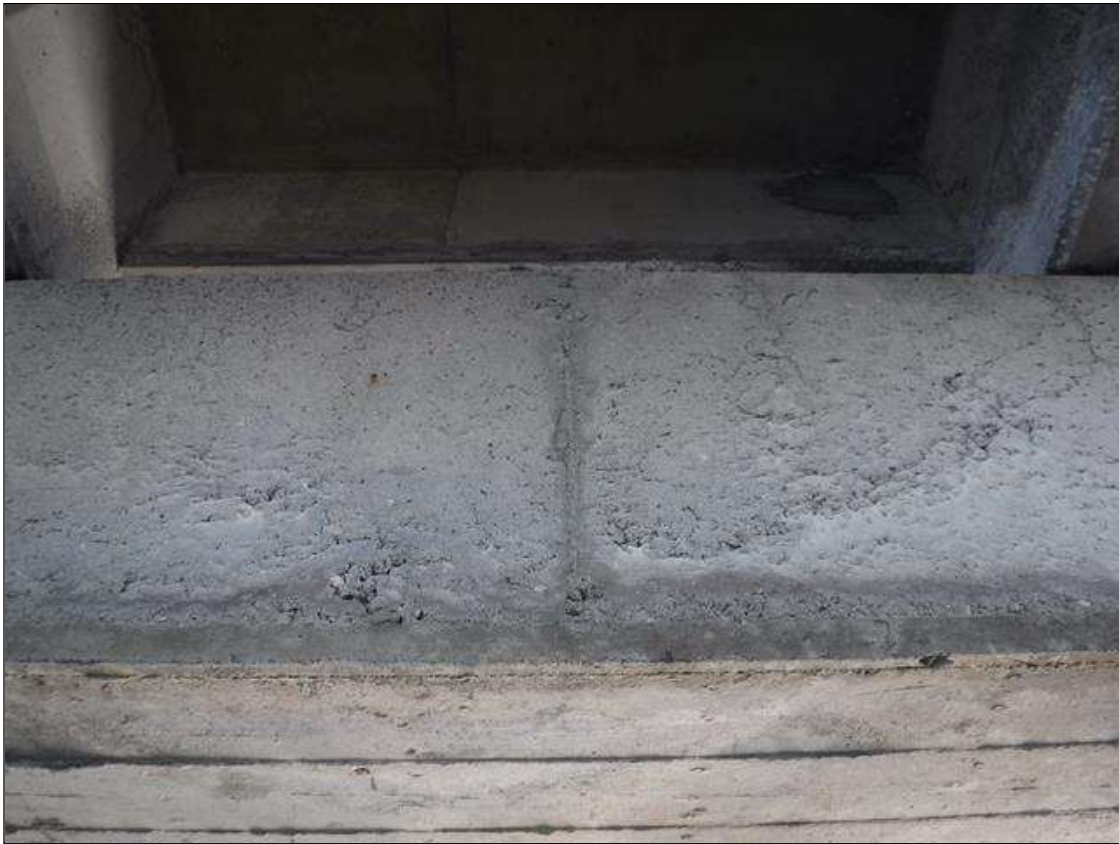
Bent 154 Cap 1: 7' X 3' AREA OF HONEYCOMBING, WEST FACE, BETWEEN BEAMS 2 AND 3.

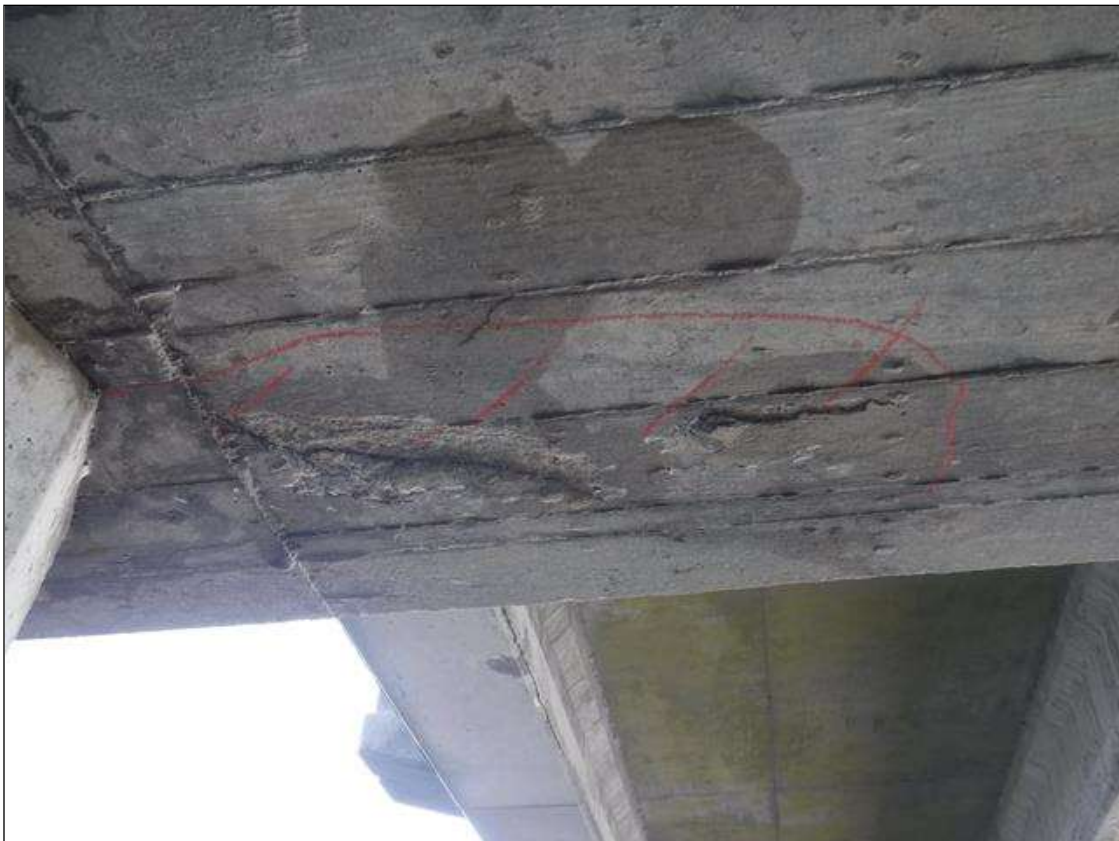
Bent 154 Cap 1: 3' X 12" AREA OF DELAMINATION ON BOTTOM OF CAP, AT PILE 1.

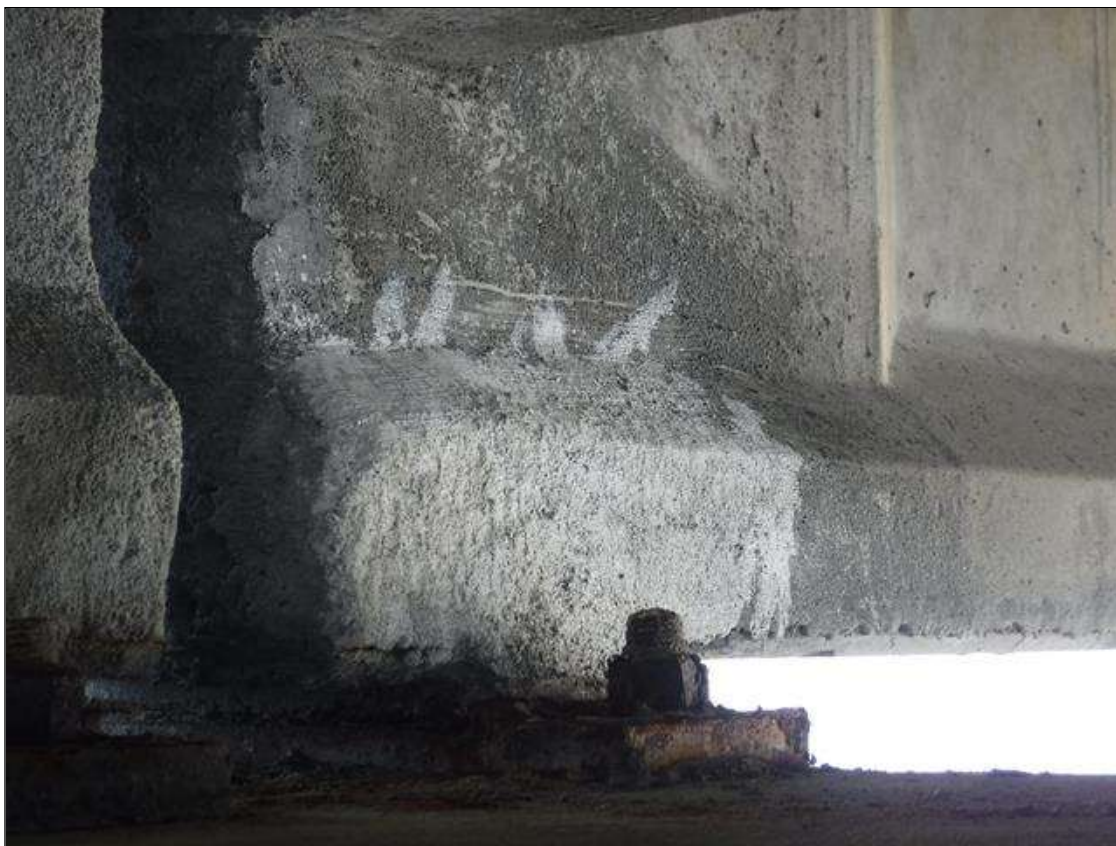
Span 155 Beam 1: 1' X 1' PATCHED AREA, SOUTH FACE, AT BENT 154.

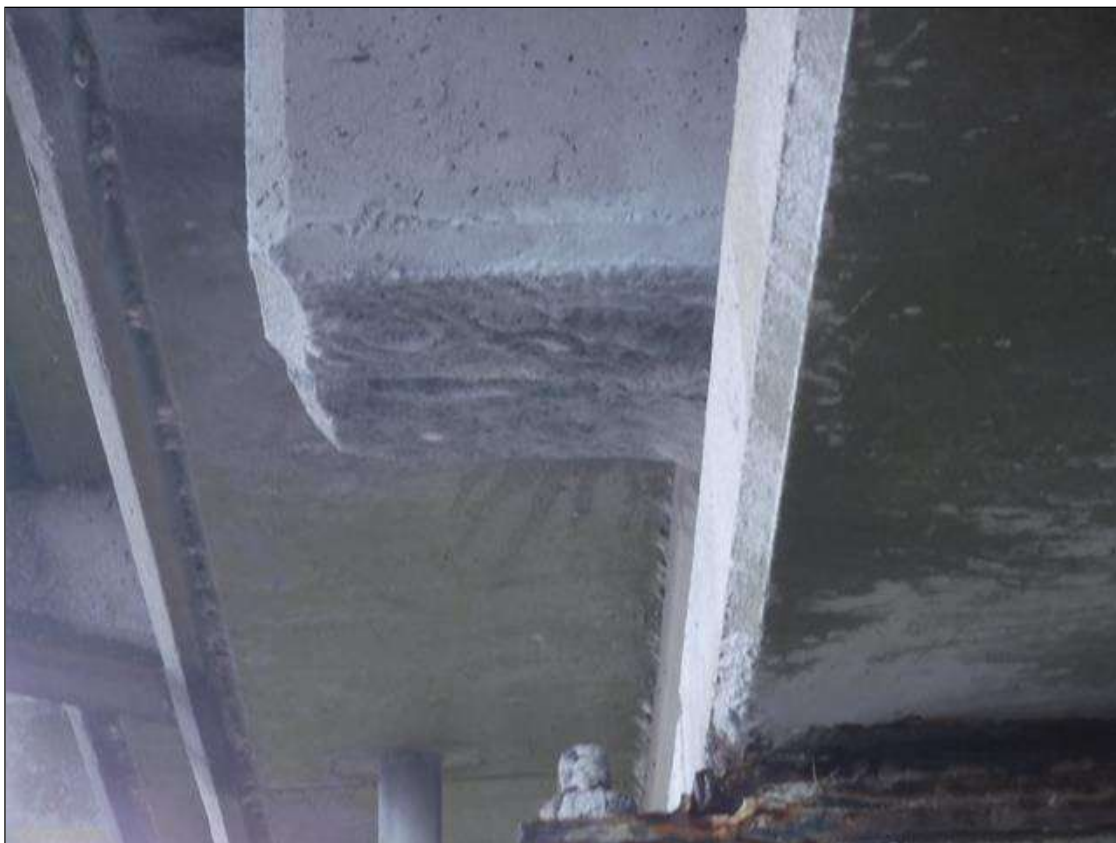
Span 156 Beam 1: 1' X UP TO 1' PATCHED AREA, END DIAPHRAGM, NORTH OVERHANG, AT BENT 155.

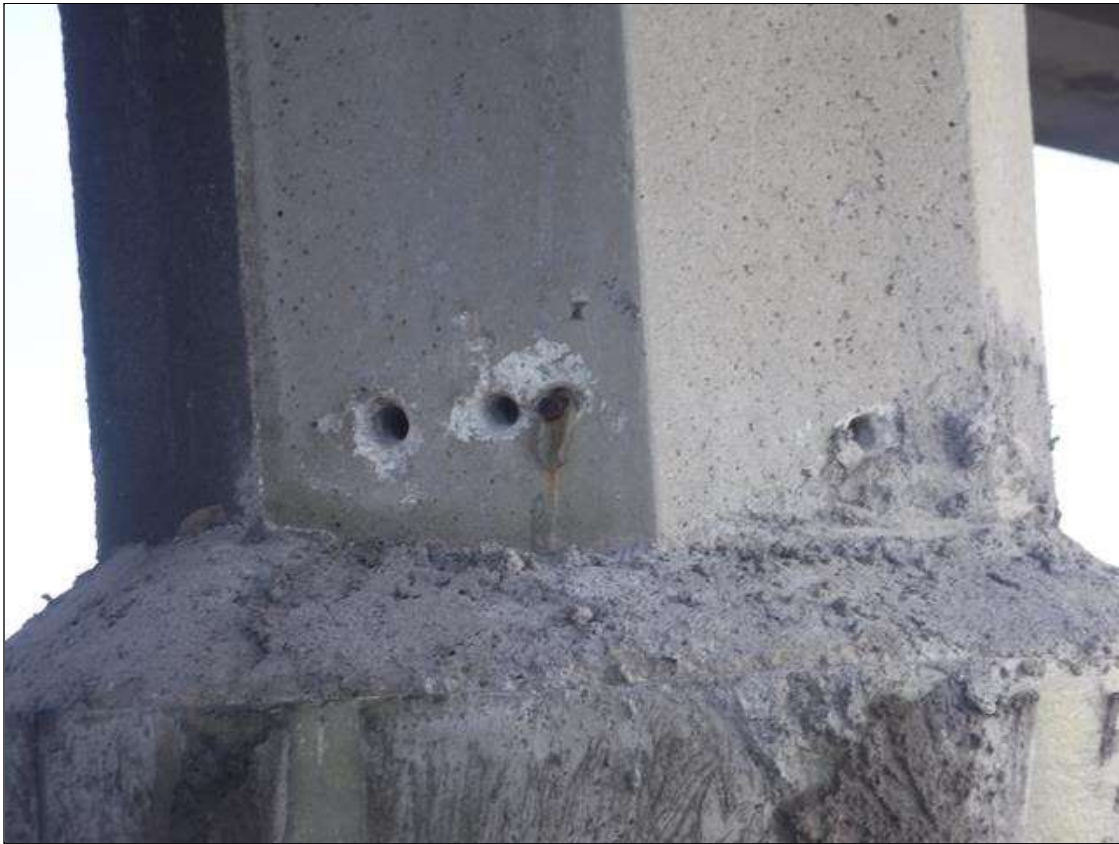
Bent 155 Saved Pile 5: (3) 1/2" DIAMETER HOLES, WITH EXPOSED STRANDS, SOUTH FACE, 2' FROM BOTTOM OF CAP.

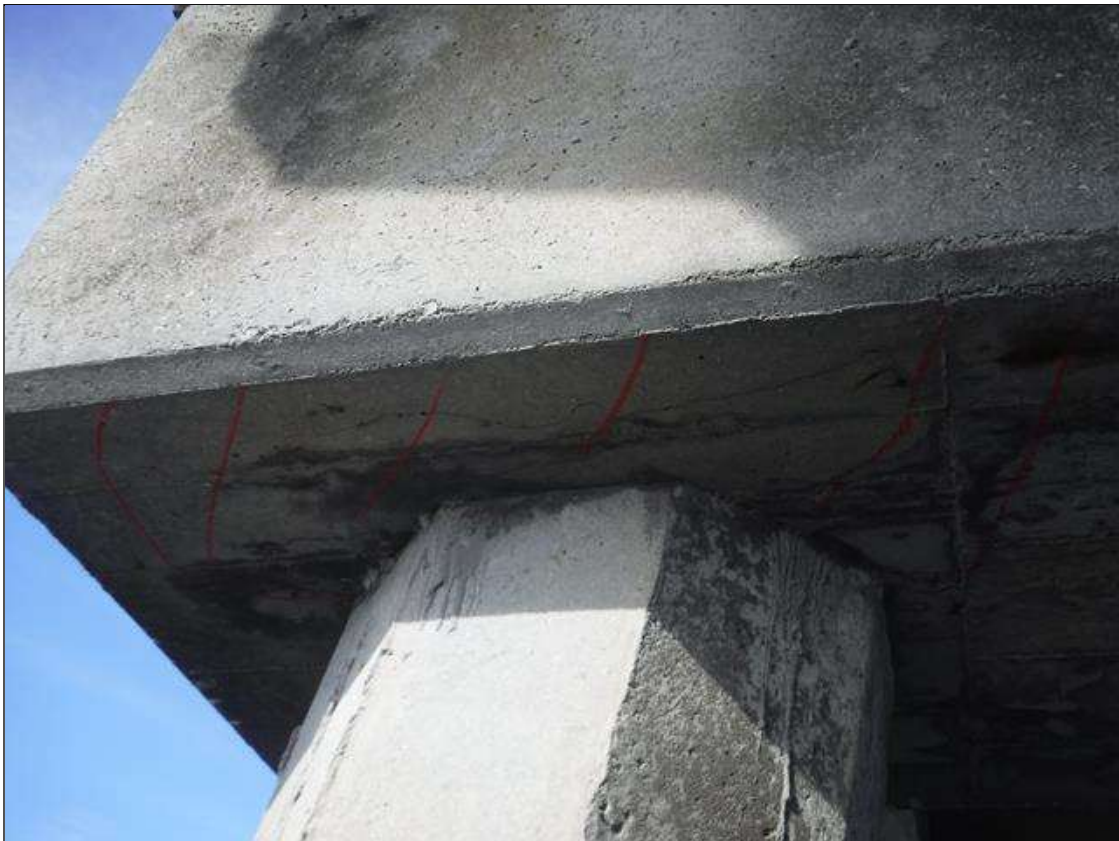
Bent 157 Cap 1: 4' X 18" DELAMINATION ON BOTTOM OF CAP AT PILE 4

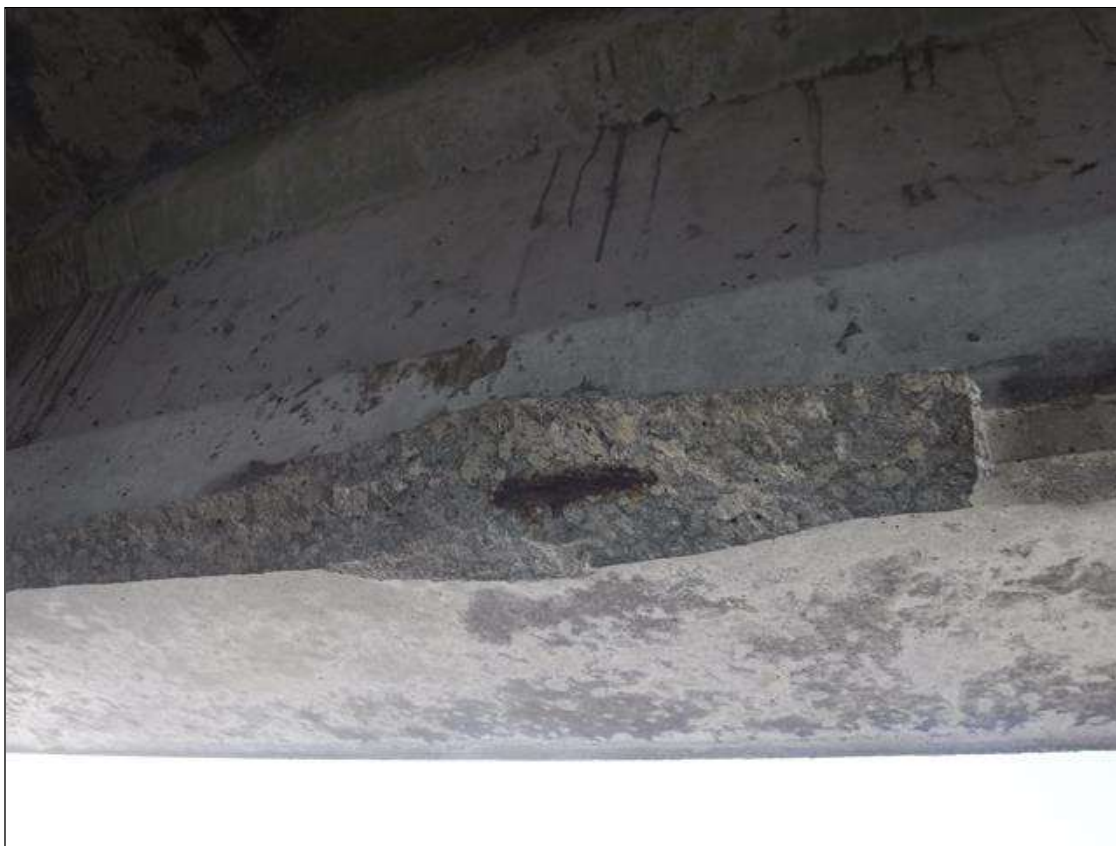
Span 158 Beam 4: (PAR) 3' X 6" X 2" DEEP SPALL WITH EXPOSED STRAND ON BOTTOM LEFT FLANGE 12' FROM BENT 157

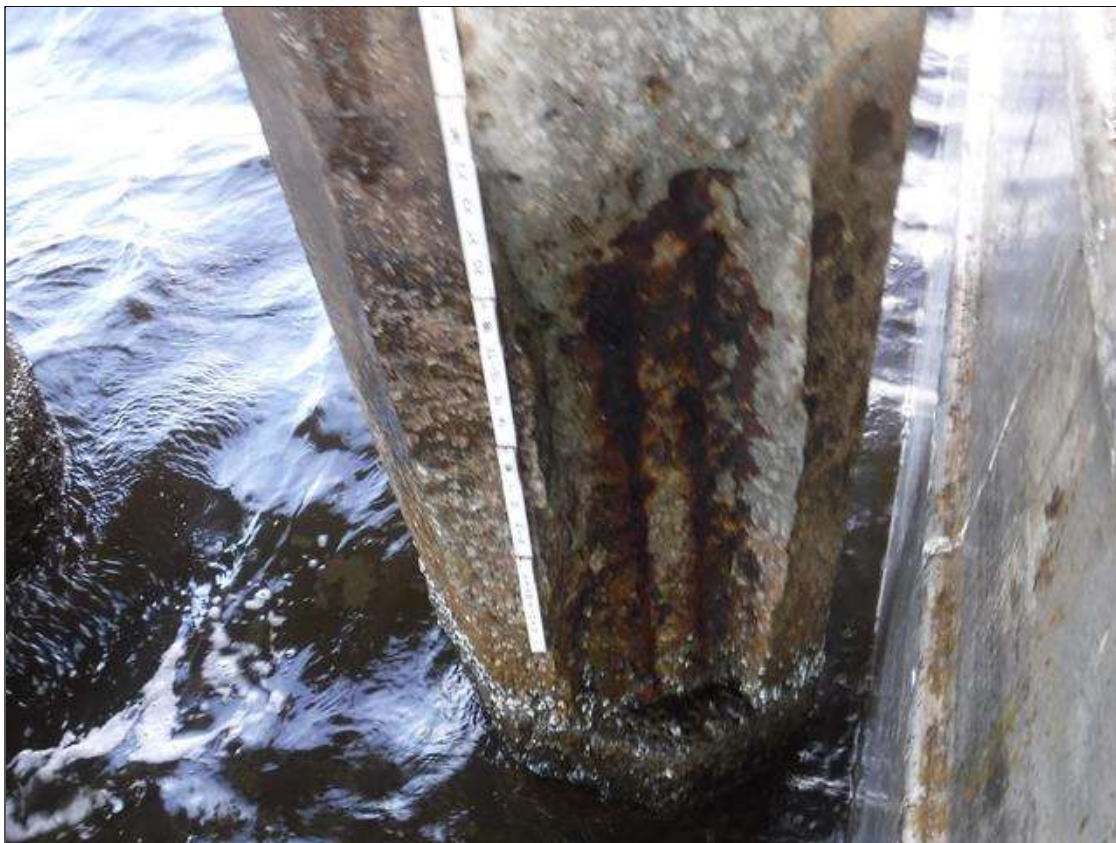
Bent 159 Pile 3: (PAR) 6' X UP TO 1' X 2.5" SPALL, WITH EXPOSED STRAND, SOUTH FACE, STARTING 4' FROM BOTTOM OF CAP.
