NC DEPARTMENT OF TRANSPORTATION
DIVISION OF HIGHWAYS
STRUCTURE MANAGEMENT UNIT

Structure Safety Report

Routine Element Inspection - Contract

FEATURE INTERSECTED: ALLIGATOR RIVER

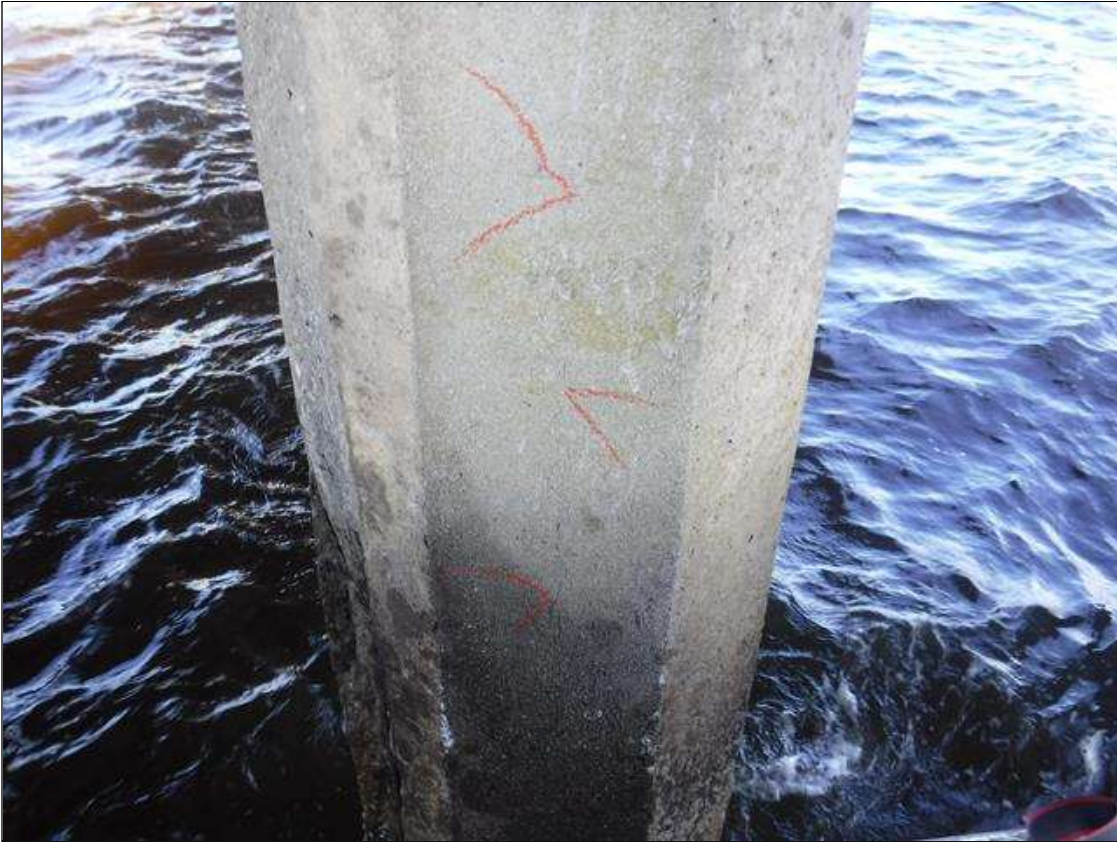
Bent 159 Pile 3: HAIRLINE CRACKS, 6' BELOW CAP, DOWN 10', MULTIPLE FACES. SCALING TO 1" DEEP WITH LOOSE AGGREGATE FROM WATERLINE TO MUDLINE.

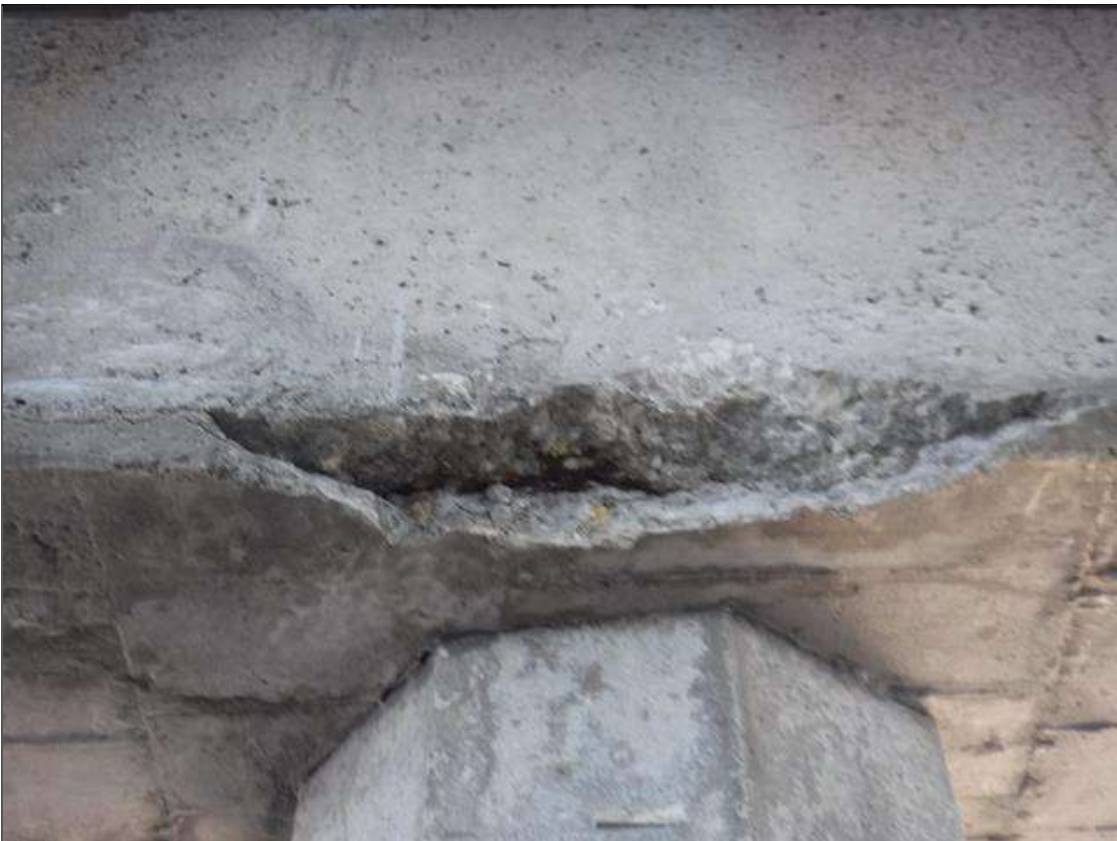
Bent 160 Cap 1: 3' X UP TO 5" X 5" SPALL, WITH EXPOSED PRIMARY REINFORCING, BOTTOM OF WEST FACE, ABOVE PILE 2.

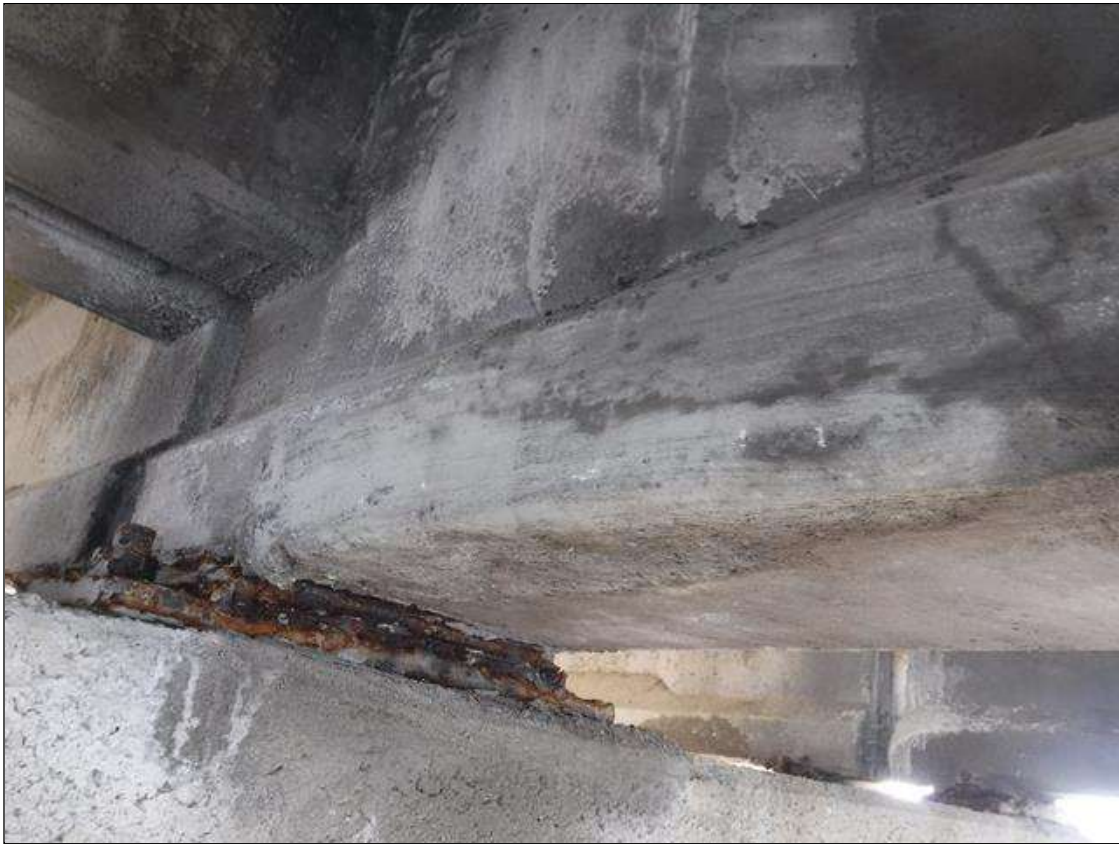
Span 160 Beam 3: 24" LONG X 7" TALL PATCHED AREA ON NORTH FACE AT BENT 160

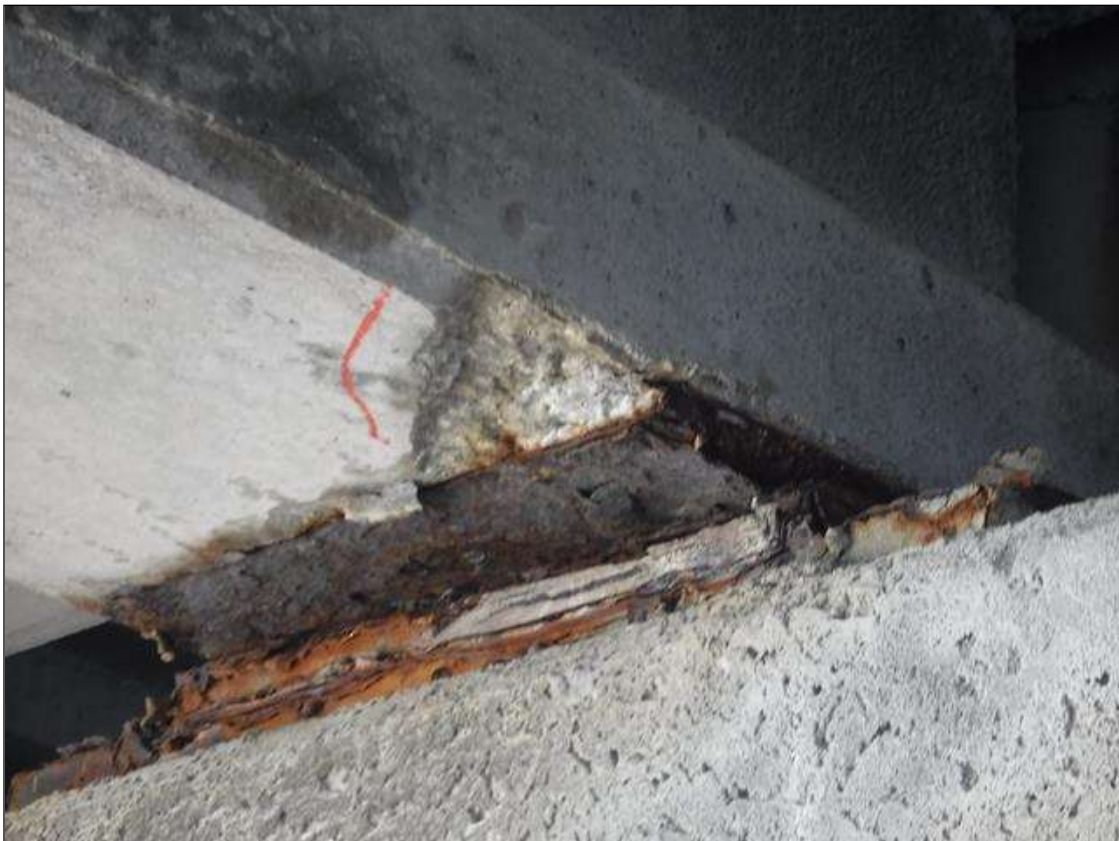
Span 161 Beam 3: 6" DIAMETER X 3/4" DEEP SPALL IN BOTTOM FACE AT BENT 160

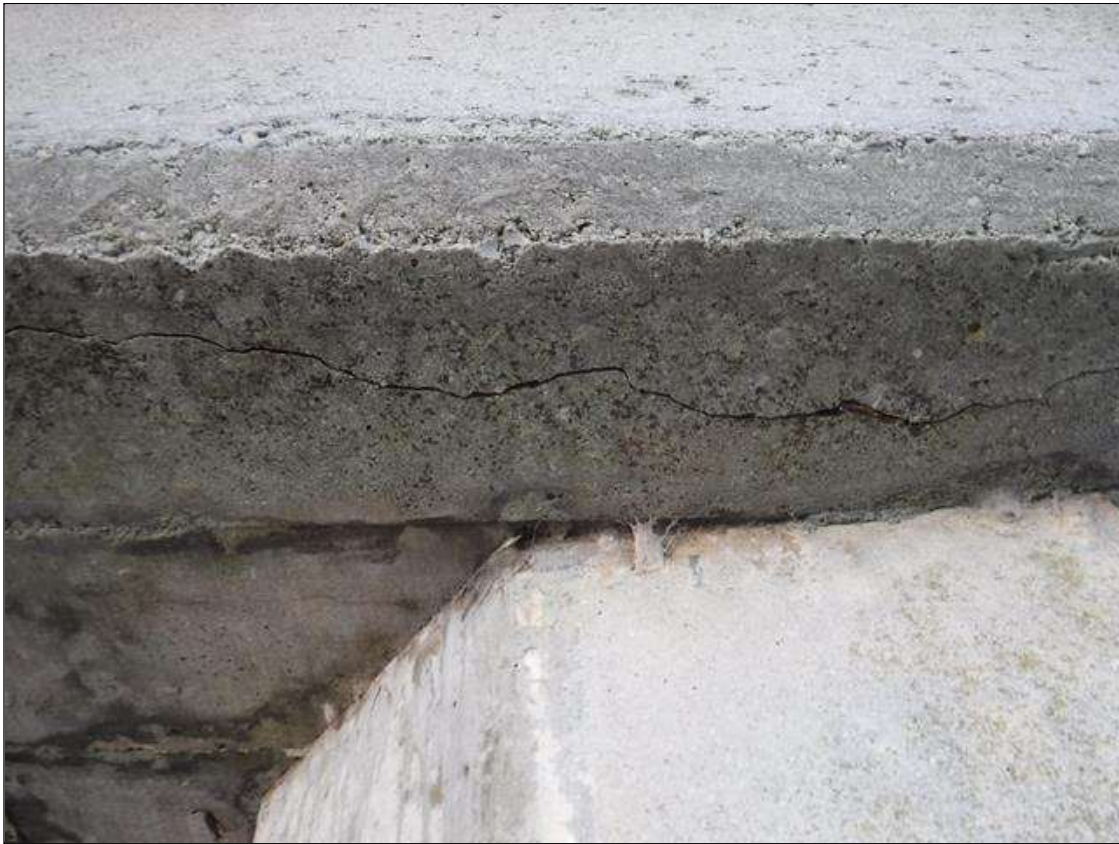
Bent 160 Cap 1: 10' LONG X 1/16" LONGITUDINAL CRACK ON BOTTOM EAST FACE OF CAP AT PILE 1

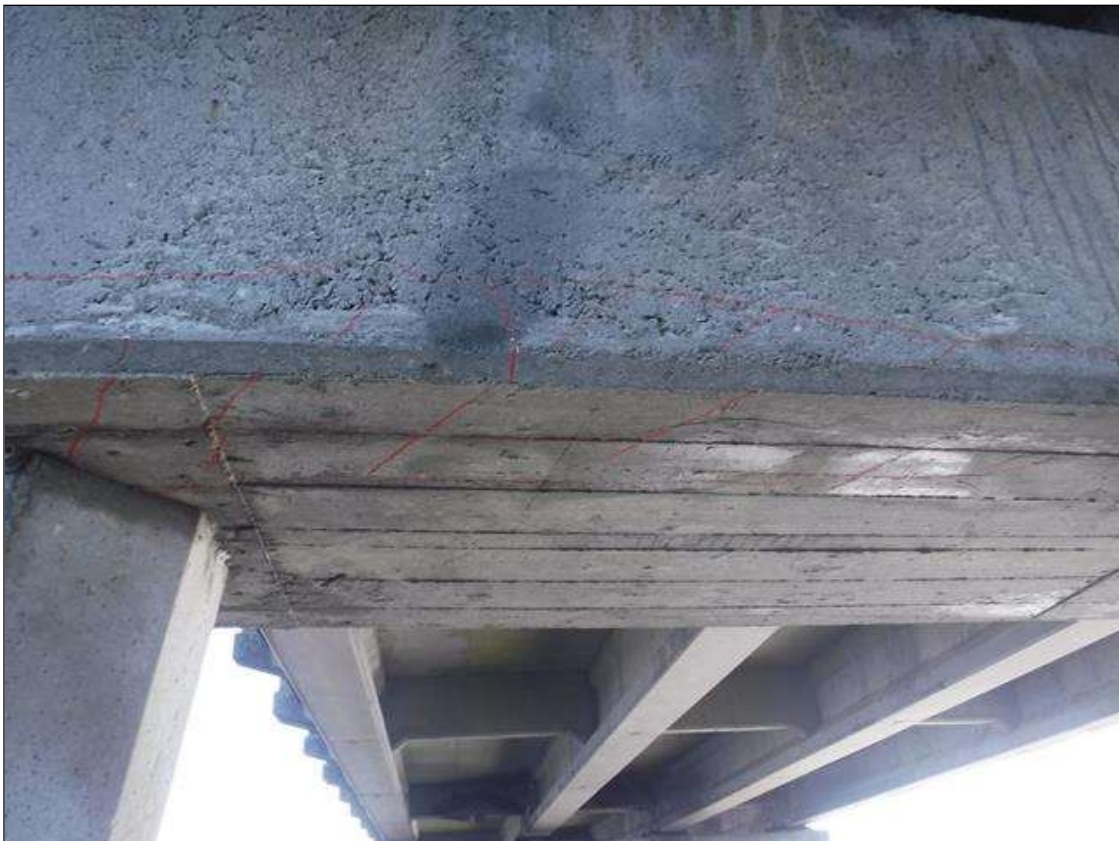
Bent 161 Cap 1: 6' LONG X 6" HIGH X 18" DEEP DELAMINATION AND SPALL ON BOTTOM WEST OF CAP, STARTING 1' FROM NORTH FACE.

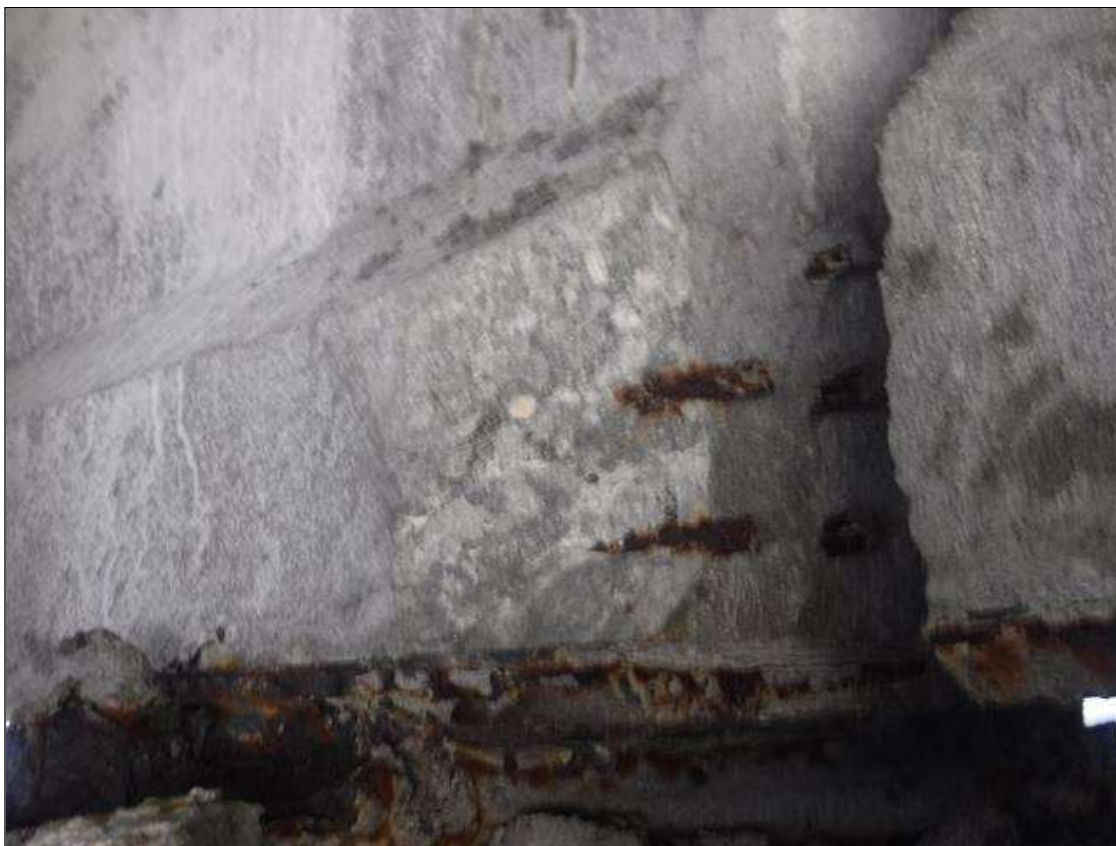
Span 161 Beam 3: (PAR) 10" X 10" X 1" DEEP SPALL WITH EXPOSED STRAND ON SOUTH FACE AT BENT 161

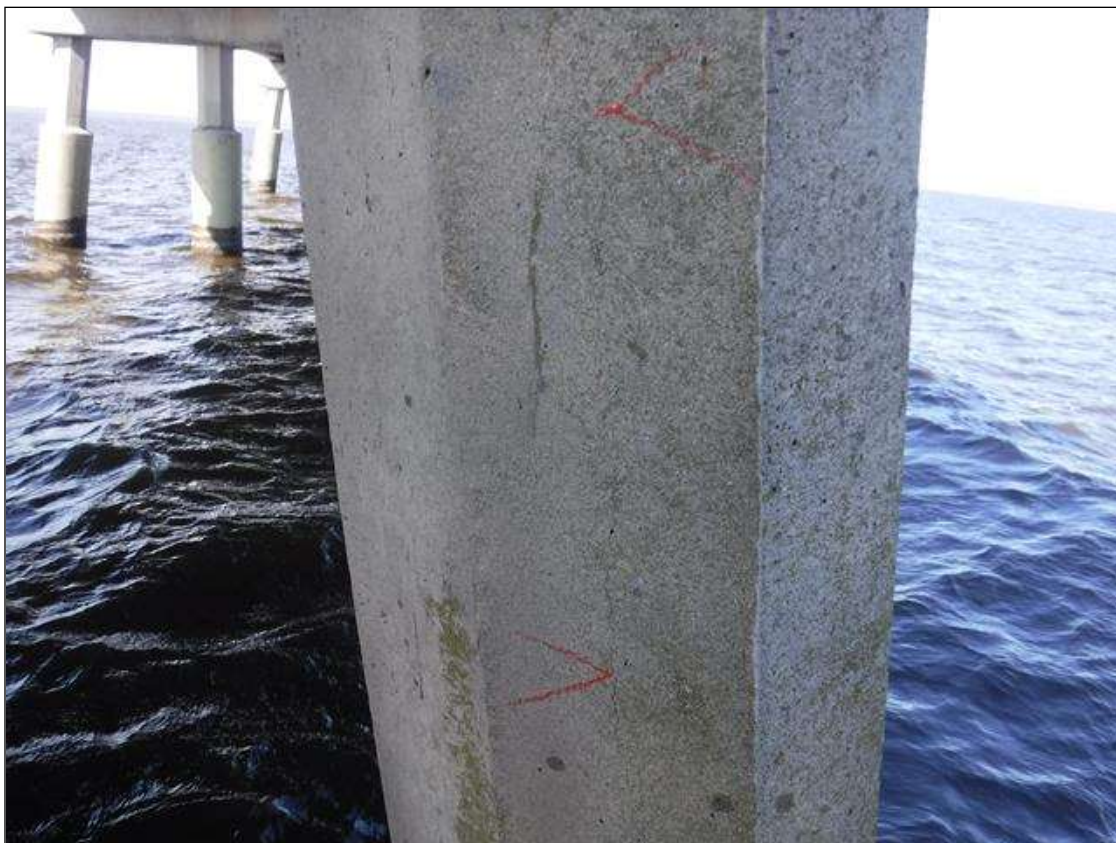
Bent 162 Pile 1: 10' LONG X 0.006" WIDE VERTICAL CRACK ON EAST FACE

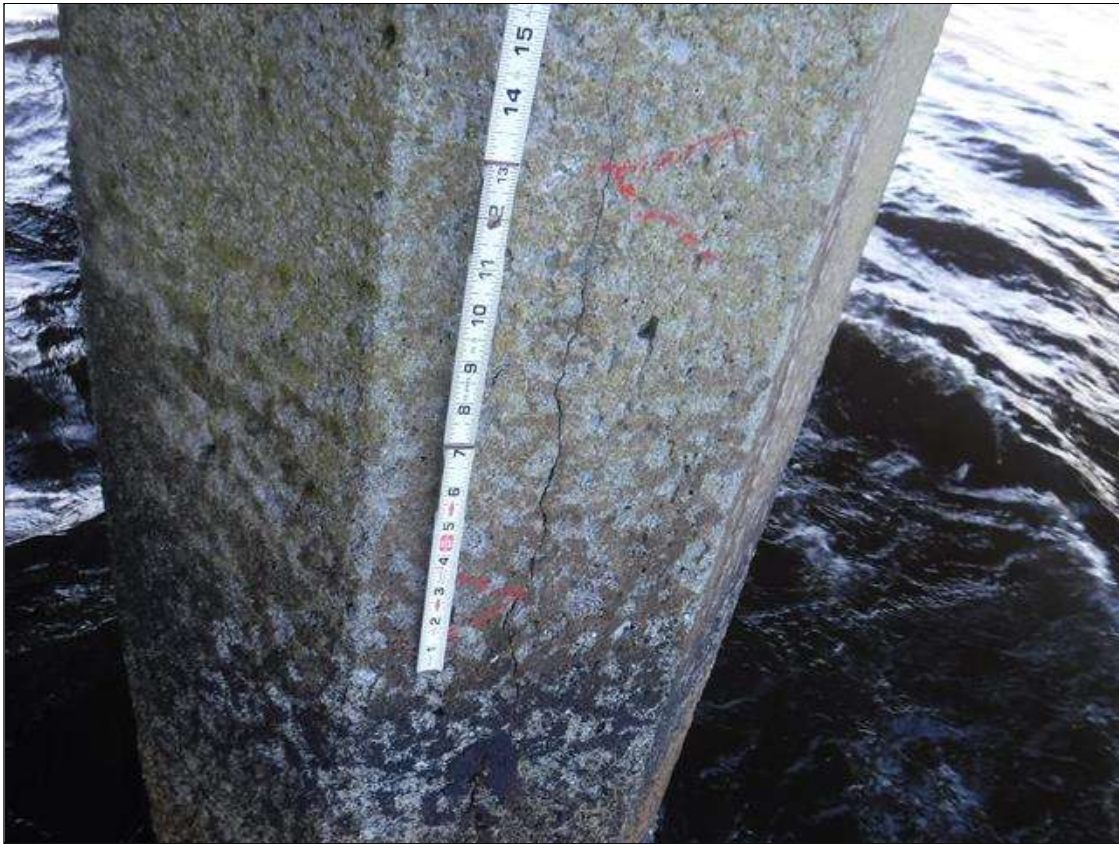
Bent 162 Pile 1: (PAR) 3' LONG X 0.06" VERTICAL CRACK ON NORTH FACE 8' BELOW CAP

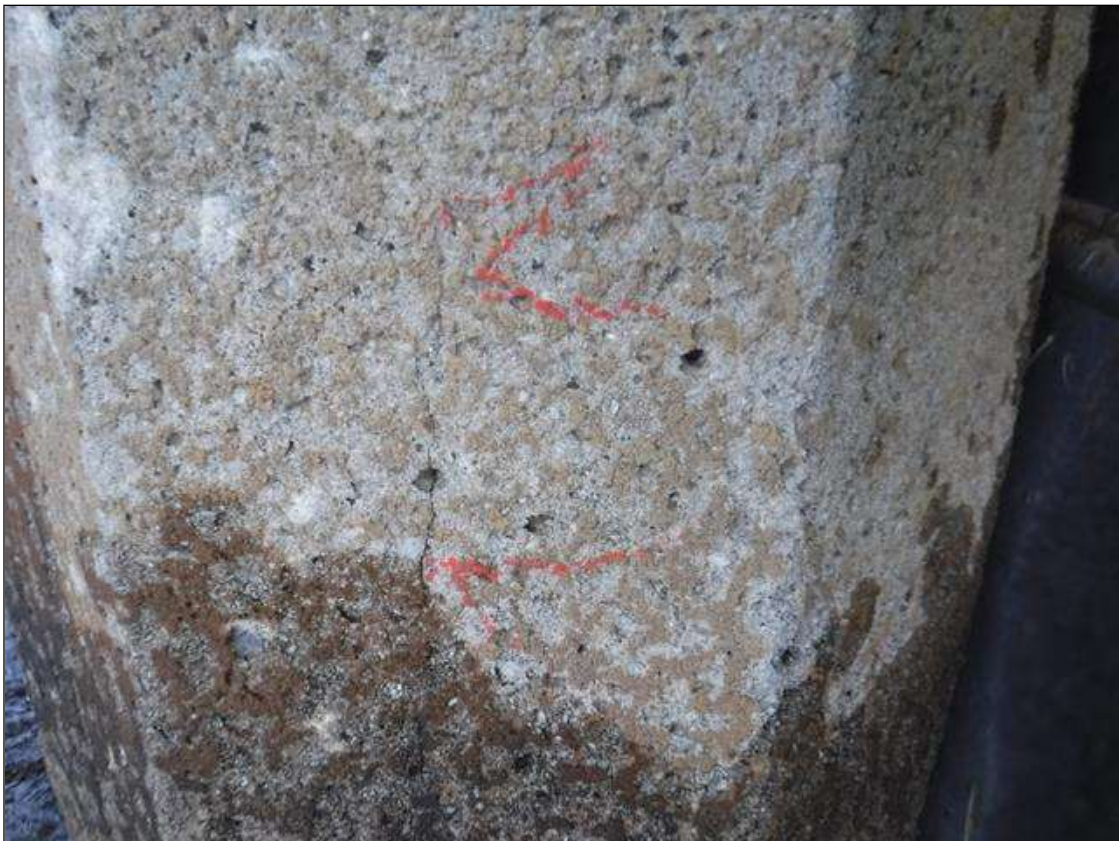
Bent 162 Pile 4: (PAR) HAIRLINE TO 1/16" CRACKS, 6' BELOW CAP, DOWN 10', MULTIPLE FACES. SCALING TO 1" DEEP WITH LOOSE AGGREGATE FROM WATERLINE TO MUDLINE.

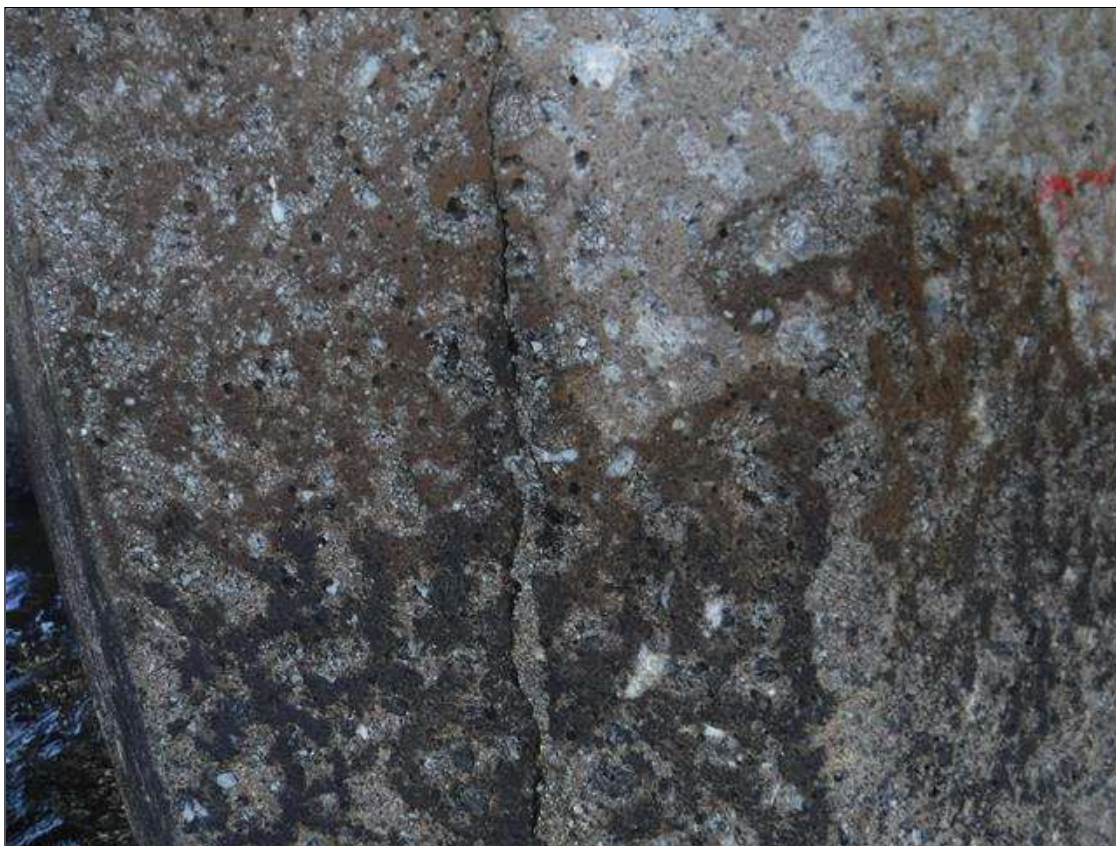
Bent 162 Pile 4: (PAR) 2' X UP TO 0.04" VERTICAL CRACK, SOUTH FACE, 9' FROM BOTTOM OF CAP, WITH ADJACENT 1' X 2' DELAMINATION.

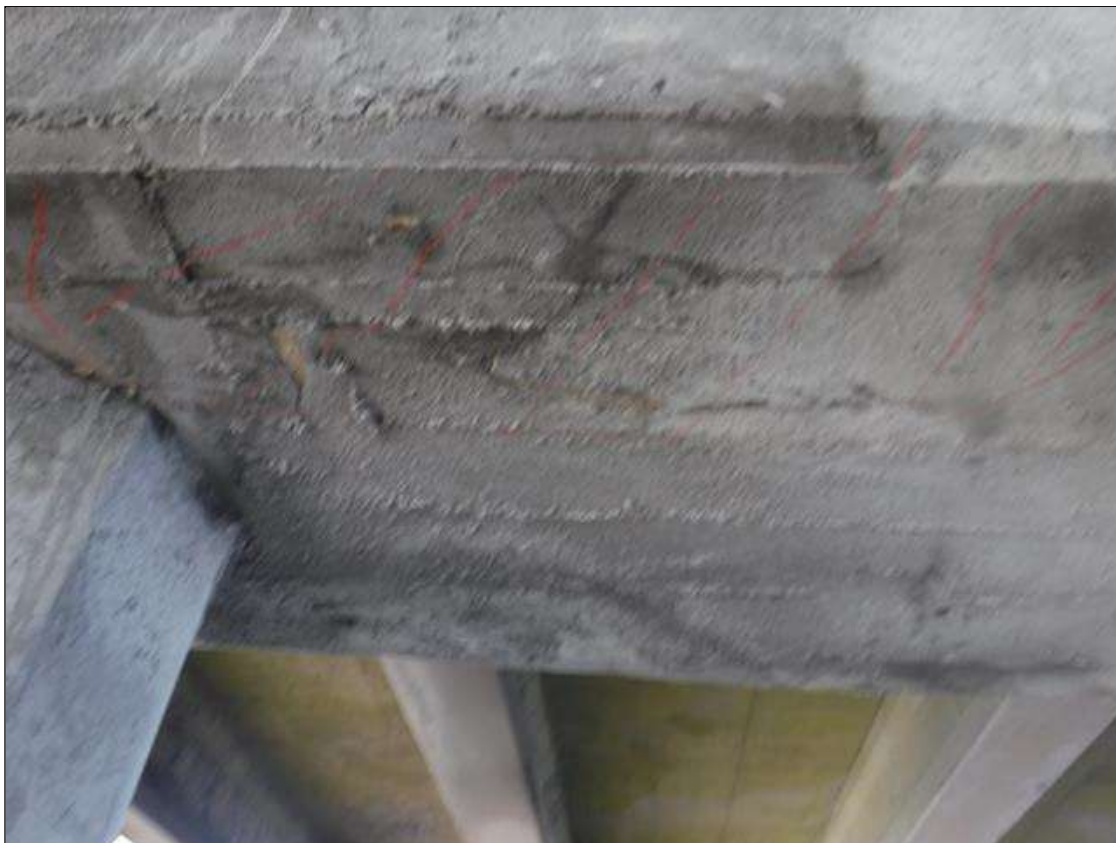
Bent 164 Cap 1: 4' X 1' DELAMINATION ON BOTTOM OF CAP BETWEEN PILES 2 AND 3

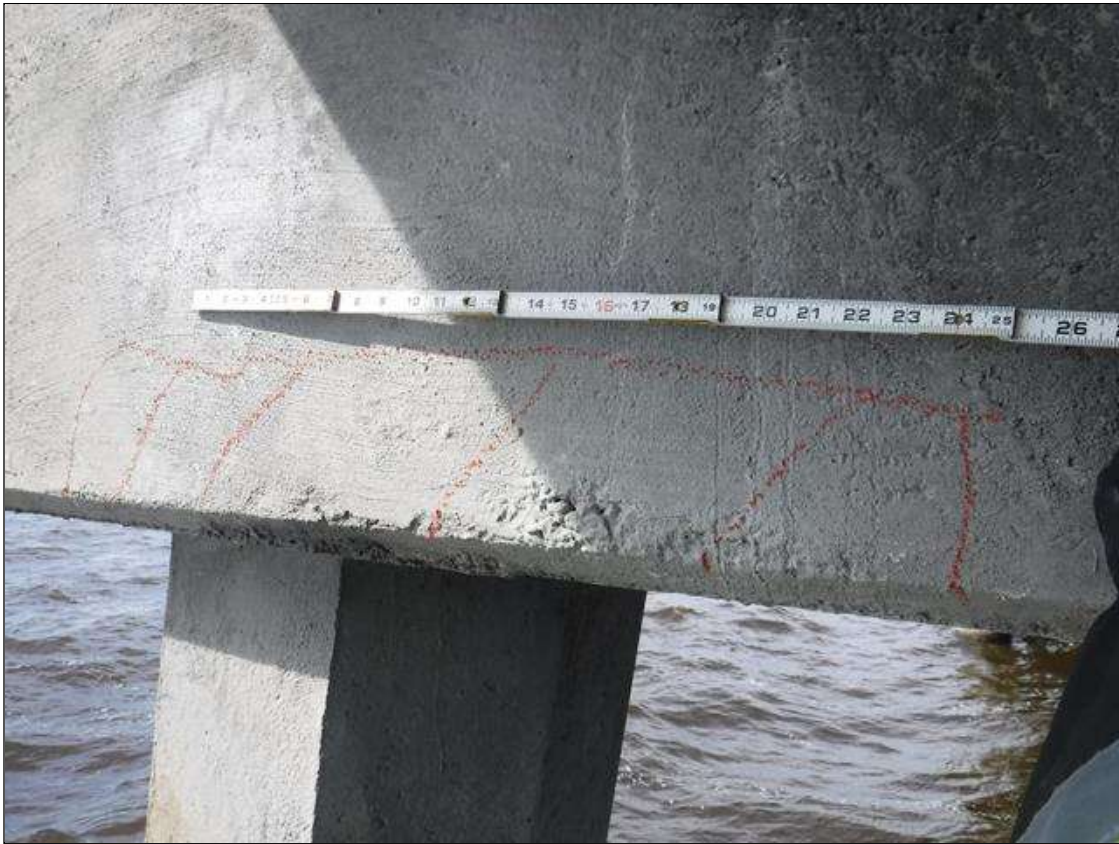
Bent 164 Cap 1: 28" X 6" DELAMINATION IN EAST FACE OVER PILE 4.

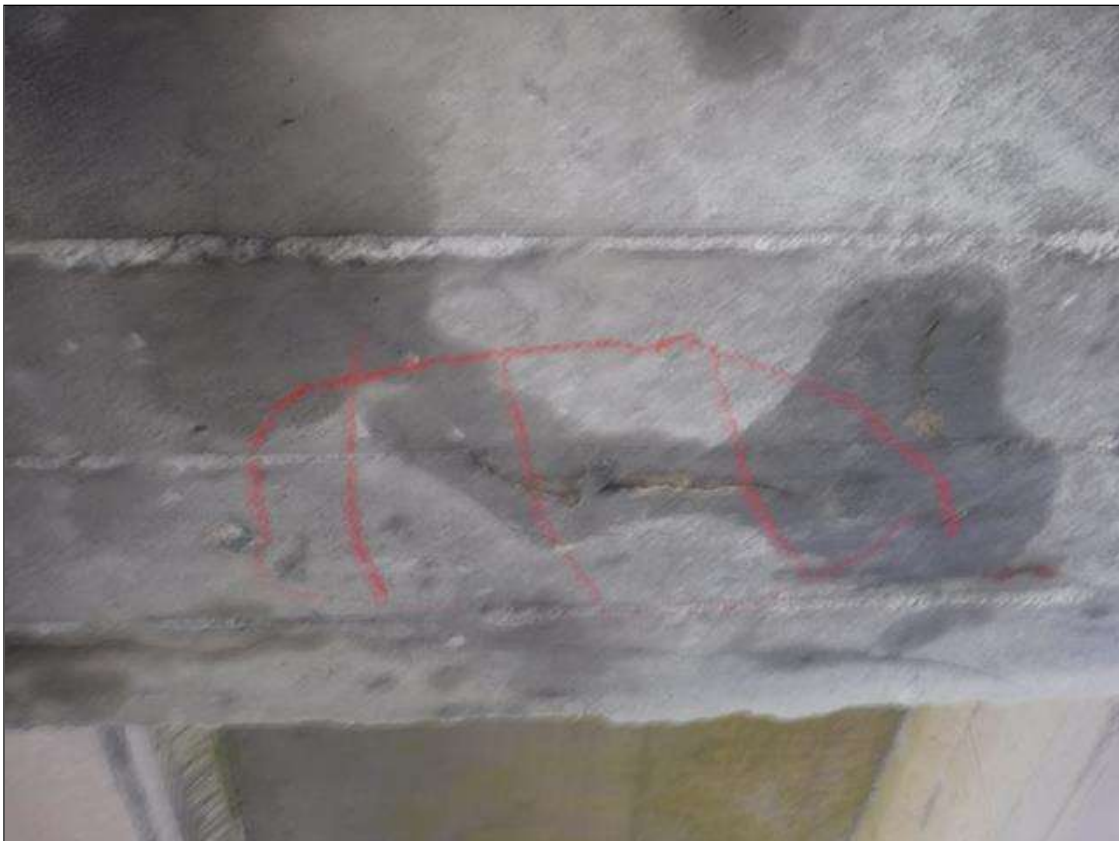
Bent 164 Cap 1: 7' X UP TO 1/32" LONGITUDINAL CRACK WITH 1' DIAMETER DELAMINATION ON BOTTOM OF CAP, BETWEEN BEAMS 1 AND 2.

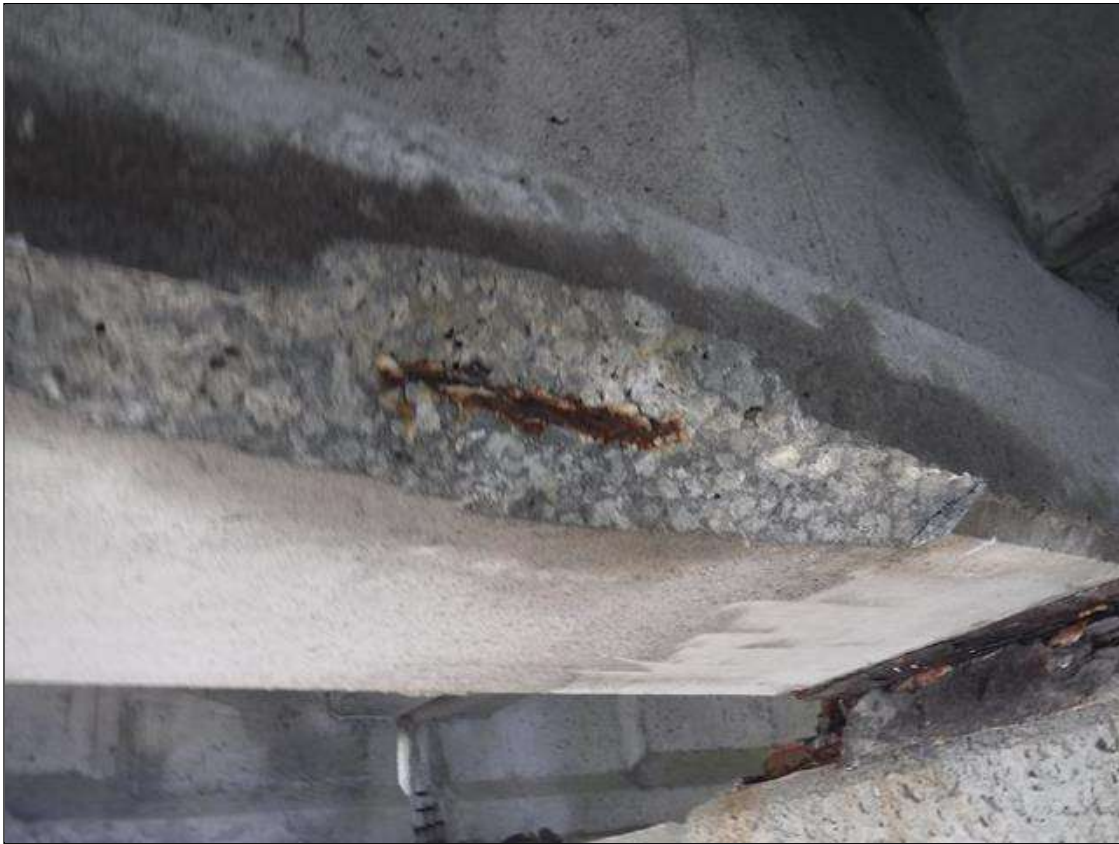
Span 166 Beam 3: (PAR) 2' X 6" X 2" DEEP SPALL WITH EXPOSED STRAND ON BOTTOM FLANGE 2' FROM BENT 165. STRAND HAS 10% SECTION LOSS

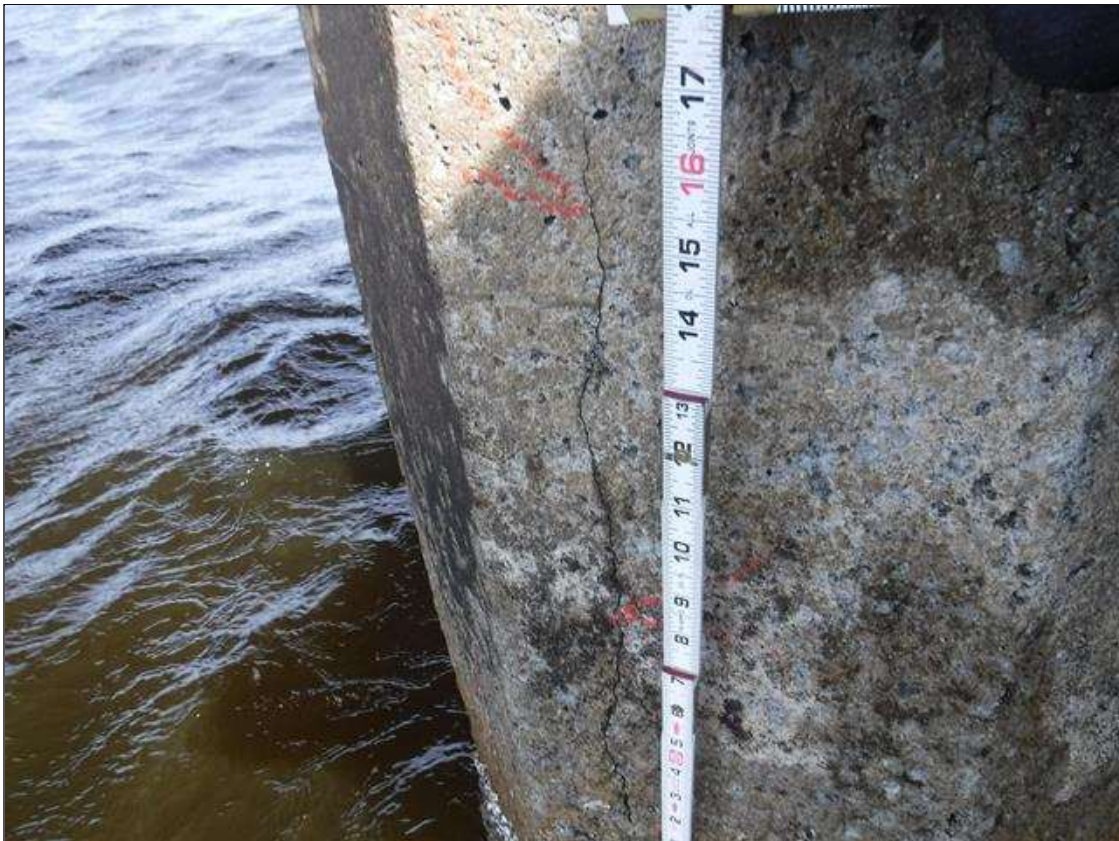
Bent 165 Pile 3: (PAR) HAIRLINE TO 1/8" CRACKS, 6' BELOW CAP, DOWN 10', MULTIPLE FACES. SCALING TO 1' DEEP WITH LOOSE AGGREGATE FROM WATERLINE TO MUDLINE.

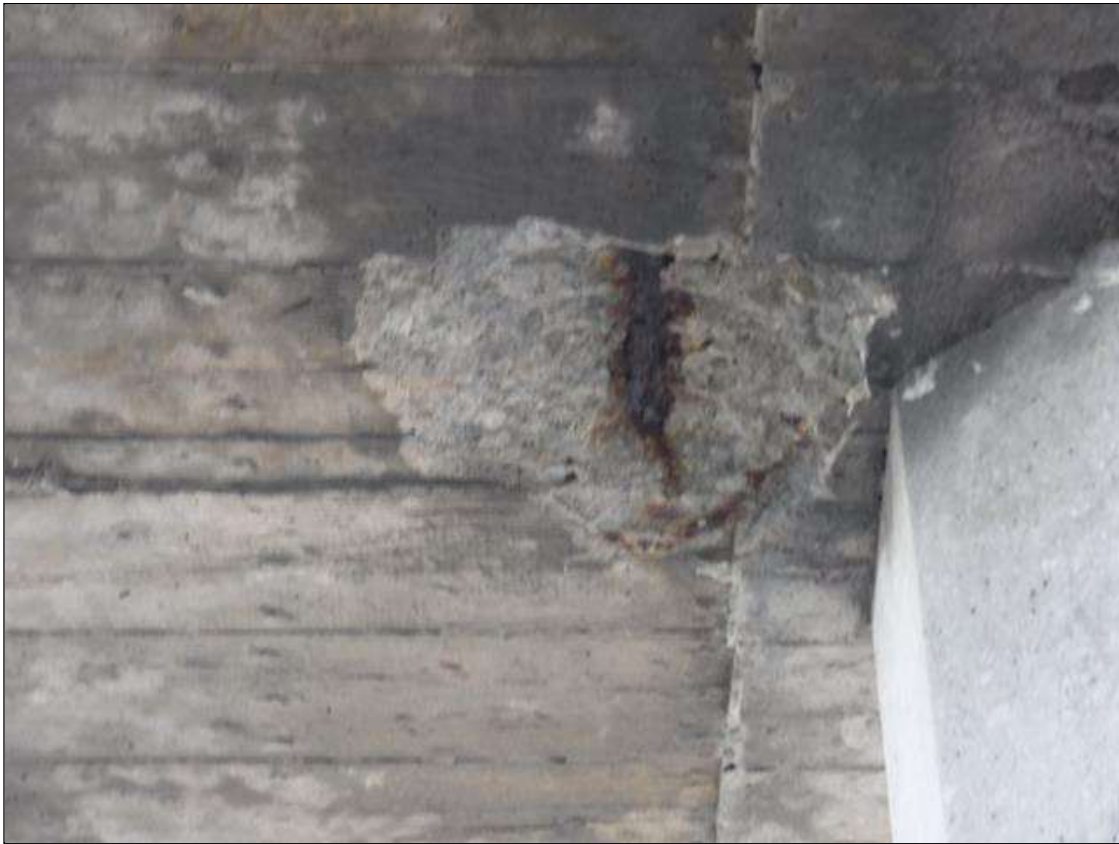
Bent 166 Cap 1: (PAR) 1' X 1' X 1" SPALL, WITH EXPOSED PRIMARY REINFORCEMENT, BOTTOM OF CAP, NORTH OF PILE 2. REBAR HAS 10% SECTION LOSS

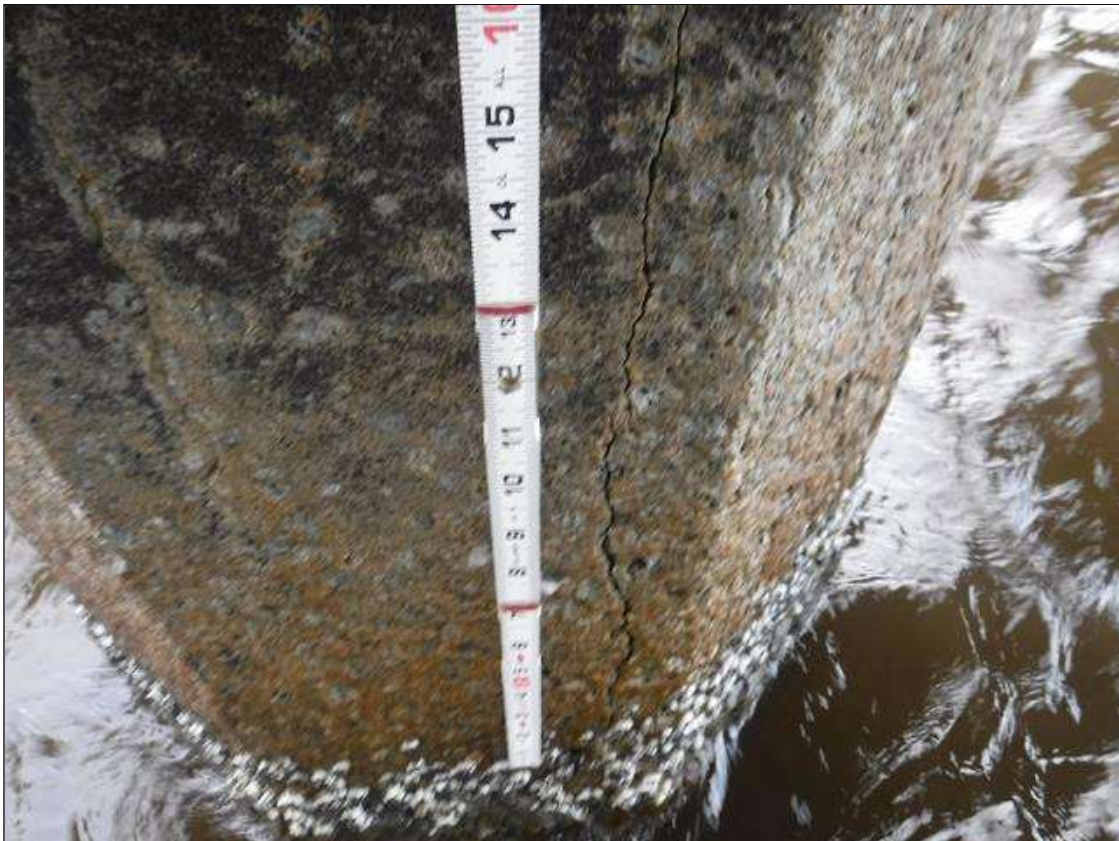
Bent 166 Pile 1: (PAR) HAIRLINE TO 1/16" CRACKS, 6' BELOW CAP, DOWN 10', MULTIPLE FACES. SCALING TO 1" DEEP WITH LOOSE AGGREGATE FROM WATERLINE TO MUDLINE.

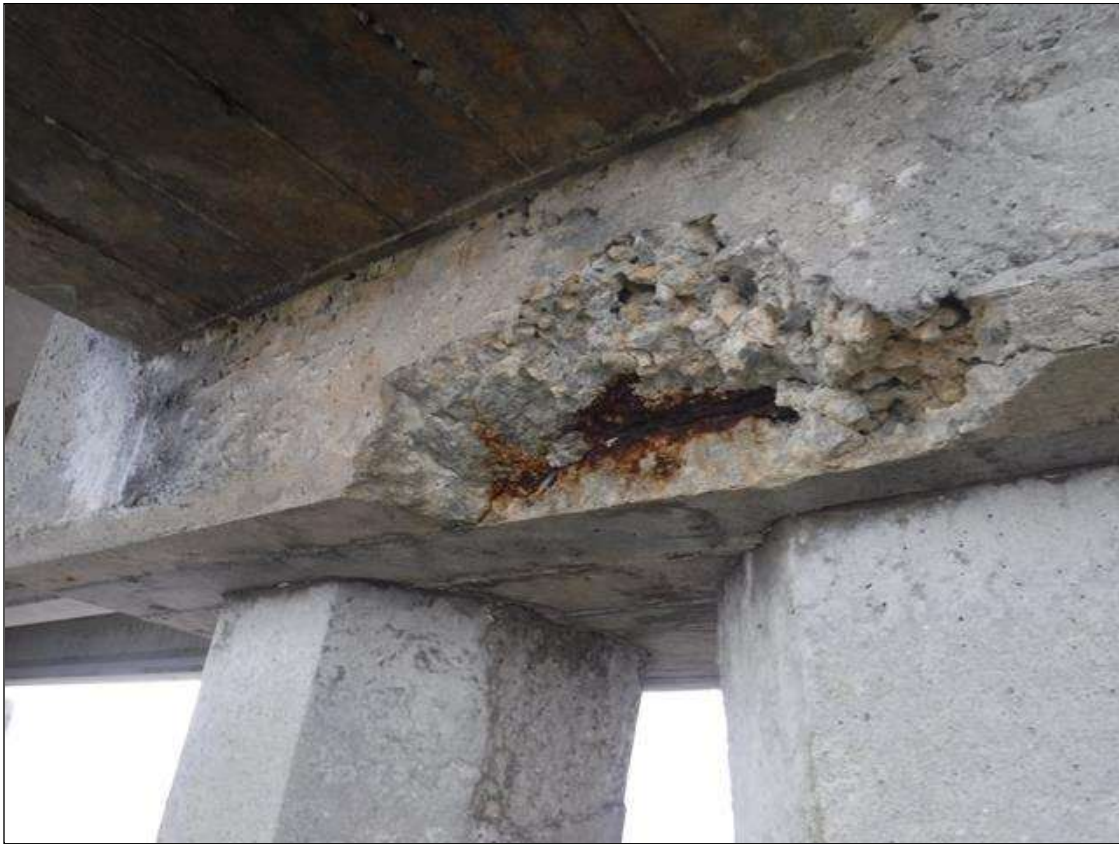
Bent 167 Cap 1: (PAR) 6" DEEP X UP TO 8" X 22" SPALL, WITH EXPOSED REINFORCING, BOTTOM OF CAP, NORTH OF PILES 2 AND 3. REBAR HAS 10% SECTION LOSS

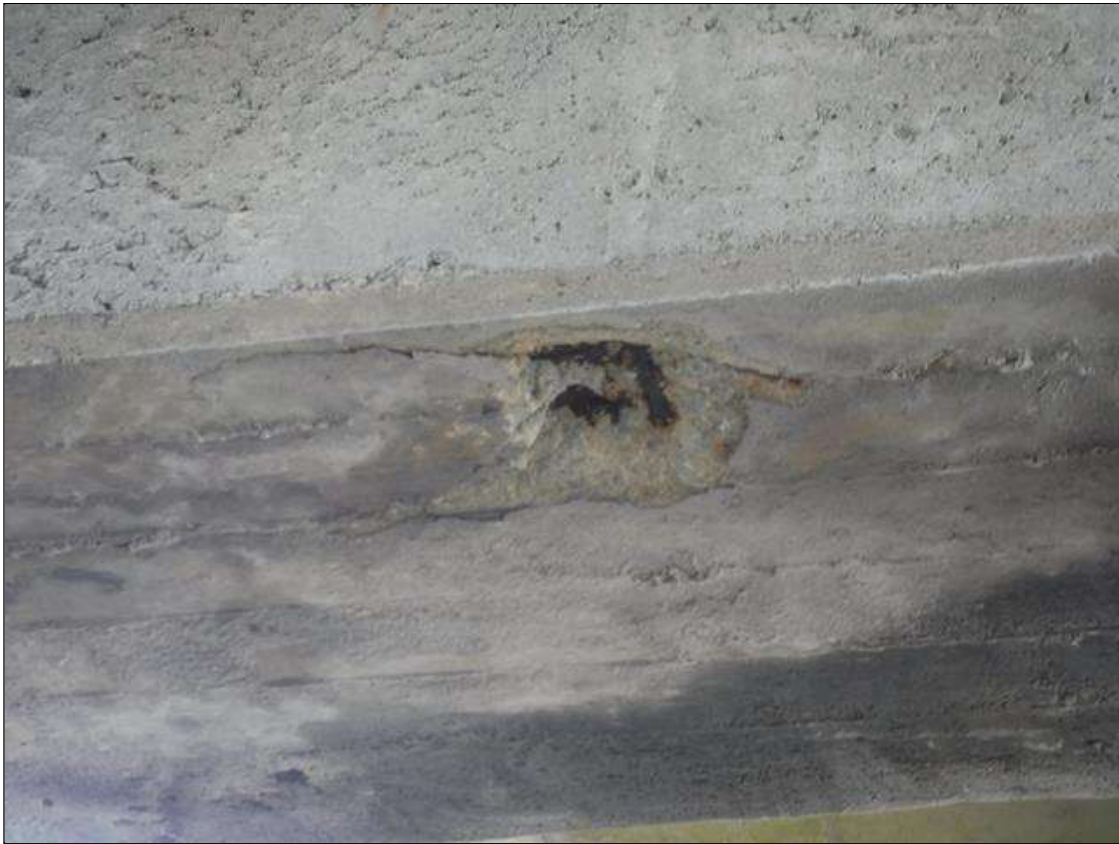
Bent 169 Cap 1: (PAR) 10" X UP TO 10" X 1.5" DEEP SPALL, WITH EXPOSED PRIMARY REINFORCING, BOTTOM OF CAP, BETWEEN COLUMNS 1 AND 2, WITH ADJACENT 6' X 10" DELAMINATION. REINFORCEMENT HAS 10% SECTION LOSS

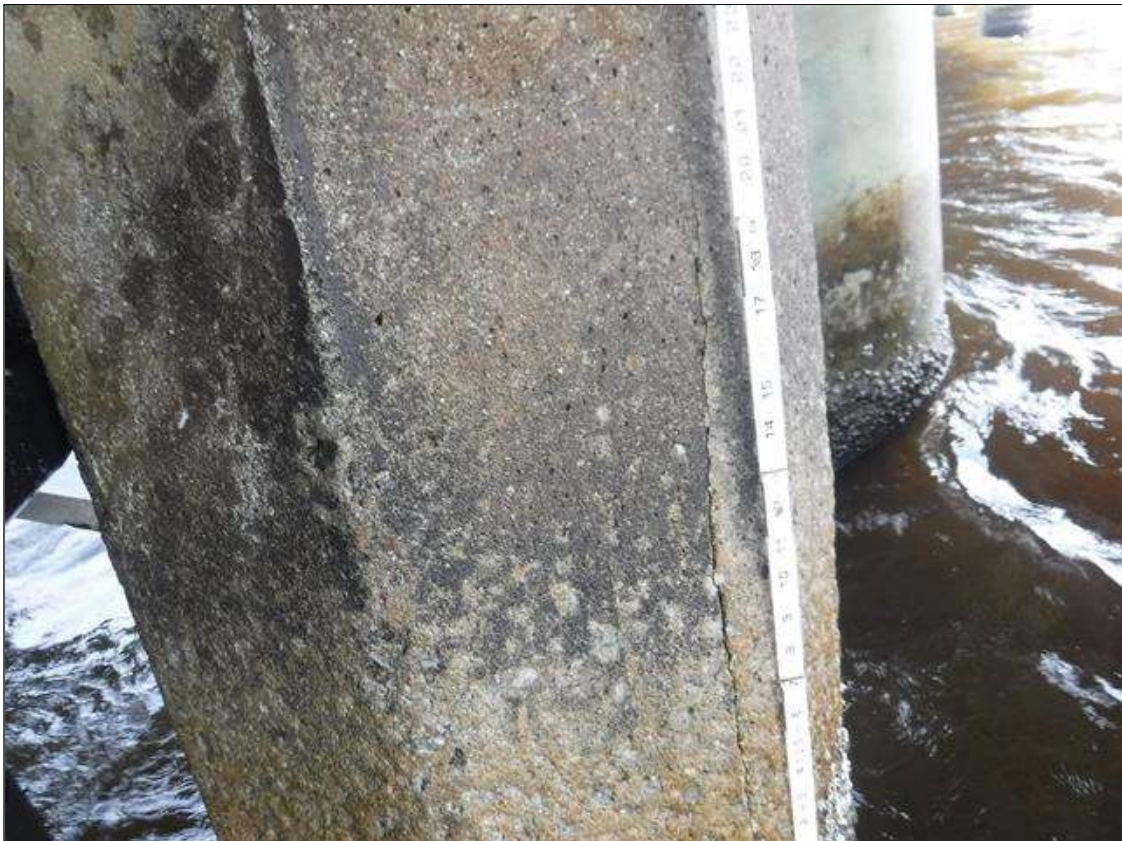
Bent 171 Pile 2: (PAR) 3' X 0.03" VERTICAL CRACK, WEST FACE, BEGINNING 7' FROM BOTTOM OF CAP.

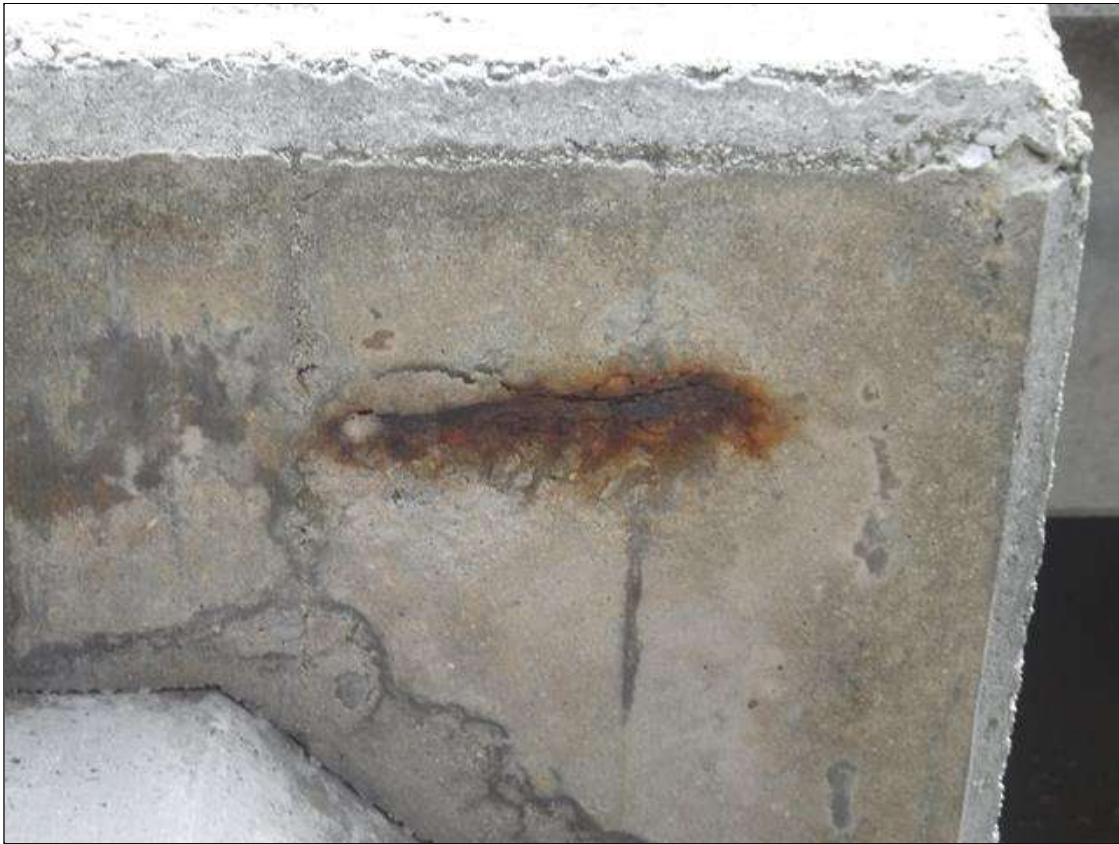
Bent 171 Cap 1: SPALL WITH EXPOSED REBAR IN BOTTOM OF RIGHT OVERHANG. AREA IS 4" LONG, 7" WIDE, AND 1.5" DEEP.

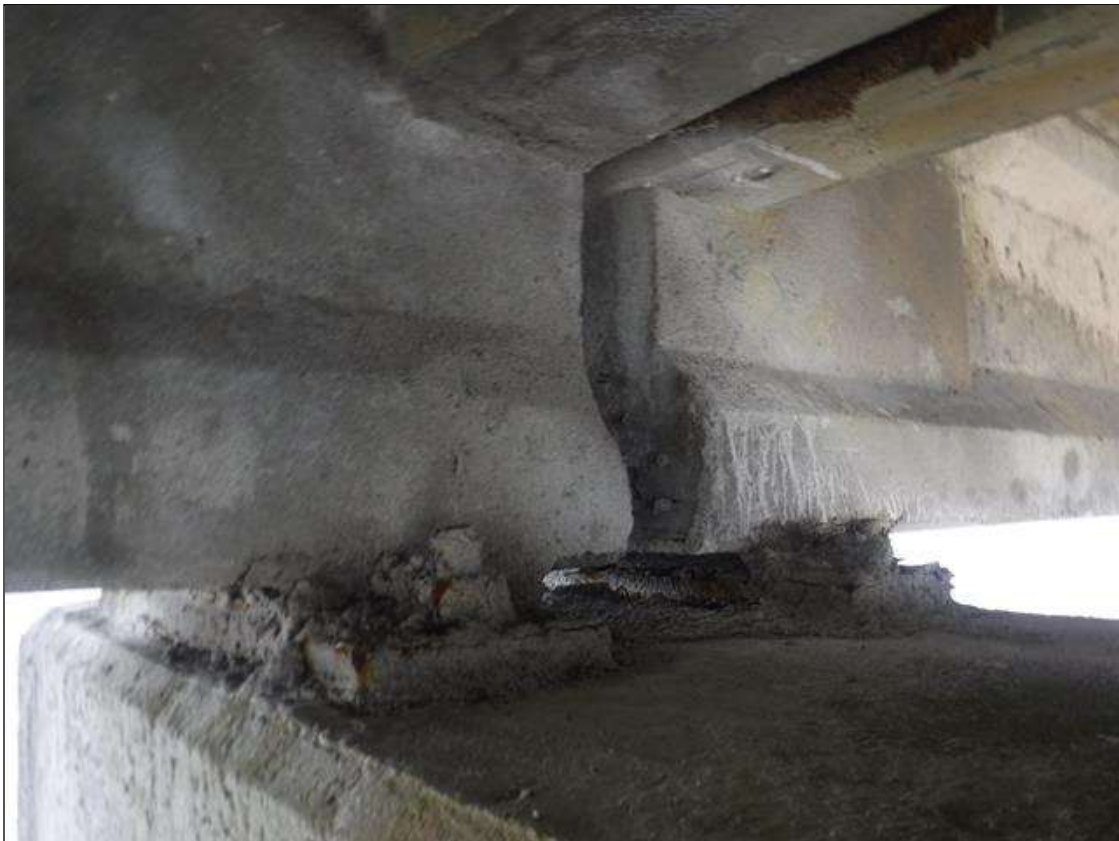
Span 172 Beam 1: 12" X 12" PATCHED AREA ON SOUTH FACE AT BENT 172.
