NC DEPARTMENT OF TRANSPORTATION
DIVISION OF HIGHWAYS
STRUCTURE MANAGEMENT UNIT

Structure Safety Report

Routine Element Inspection - Contract

FEATURE INTERSECTED: ALLIGATOR RIVER

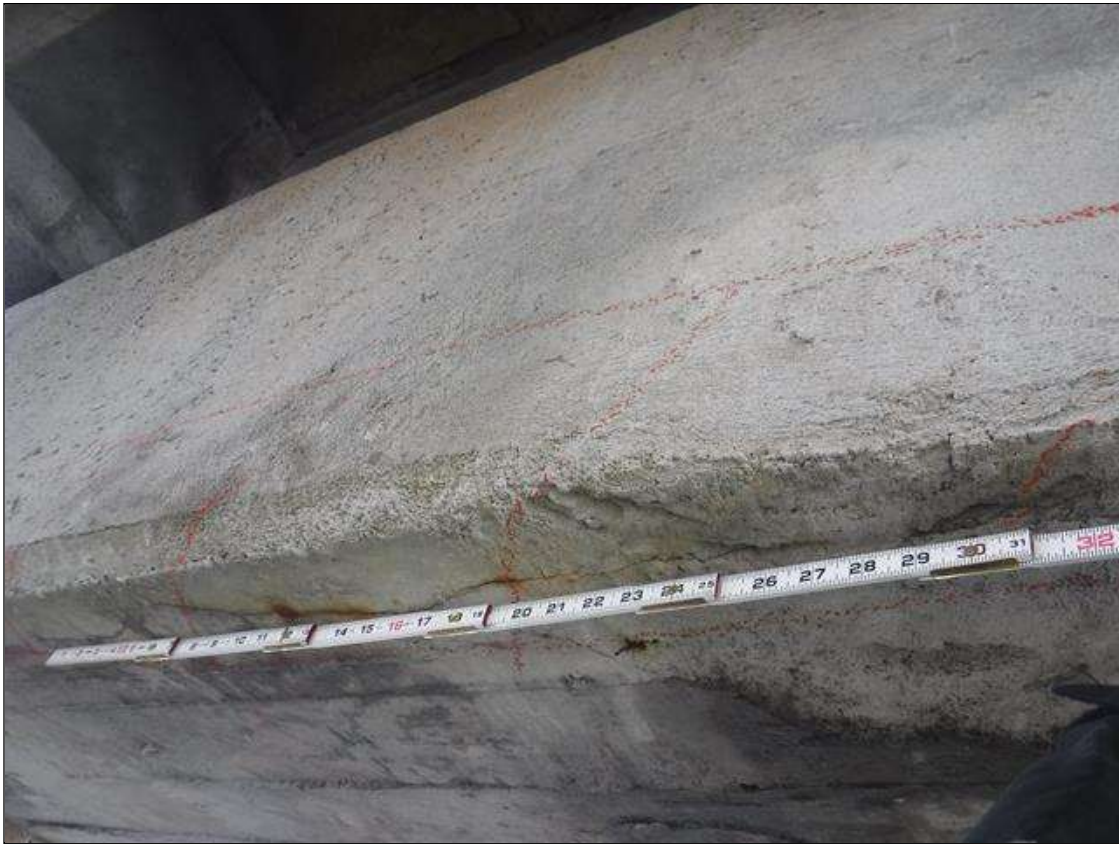
Bent 172 Cap 1: 40" X 6" HIGH X 6" DEEP DELAMINATION ON WEST BOTTOM CORNER BETWEEN BEAMS 1 AND 2

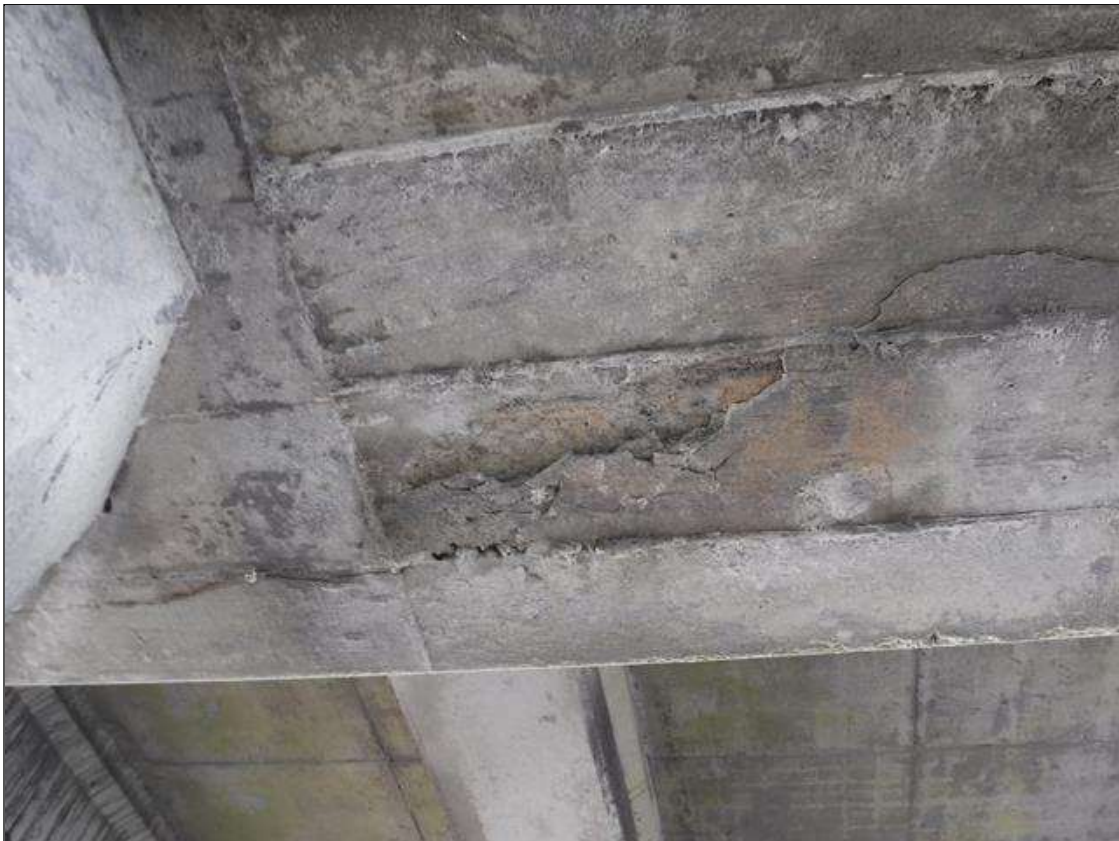
Bent 173 Cap 1: 8" X 2" X 1/2" SPALL, BOTTOM FACE, BETWEEN PILES 1 AND 2, NEAR PILE 2.

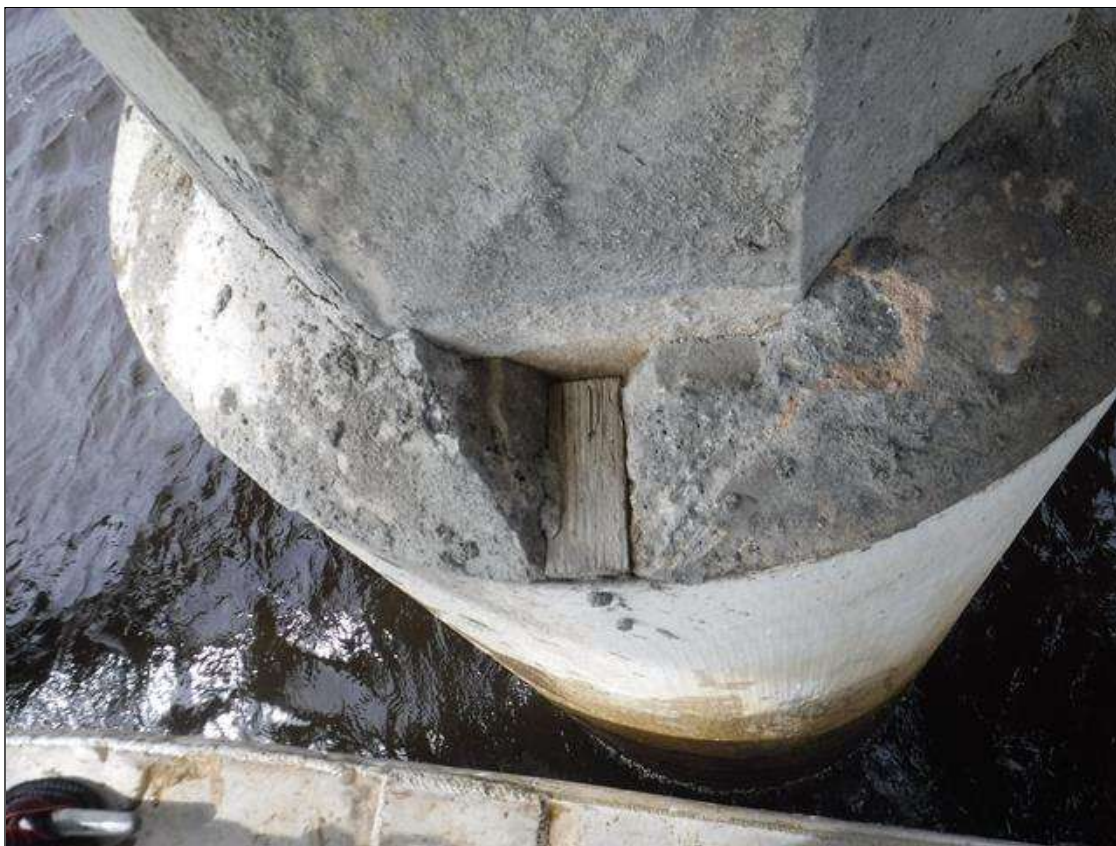
Bent 173 Pile 3: (2) UP TO 8" X 5" X 3" SPALLS, EAST AND WEST FACES, TOP OF PILE JACKET.

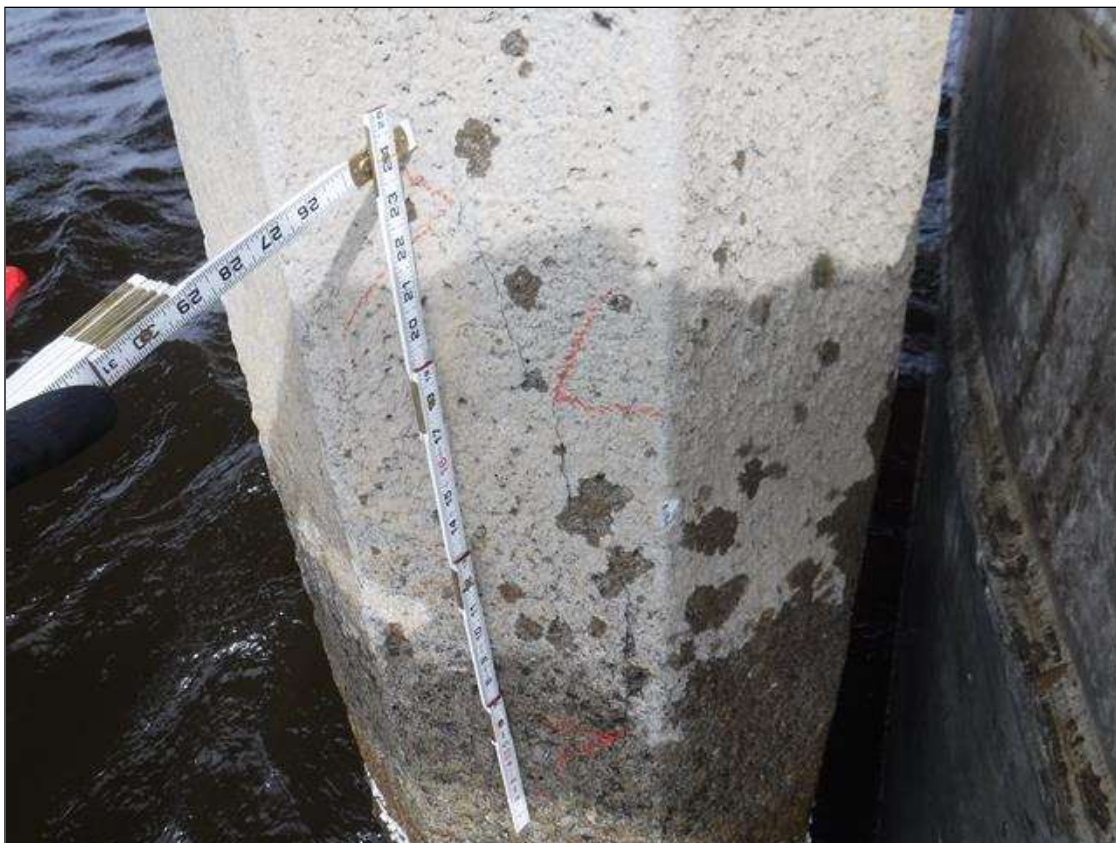
Bent 173 Pile 4: (PAR) (2) UP TO 6' X 0.063" VERTICAL CRACKS, SOUTH FACE, BEGINNING 8' FROM BOTTOM OF CAP.

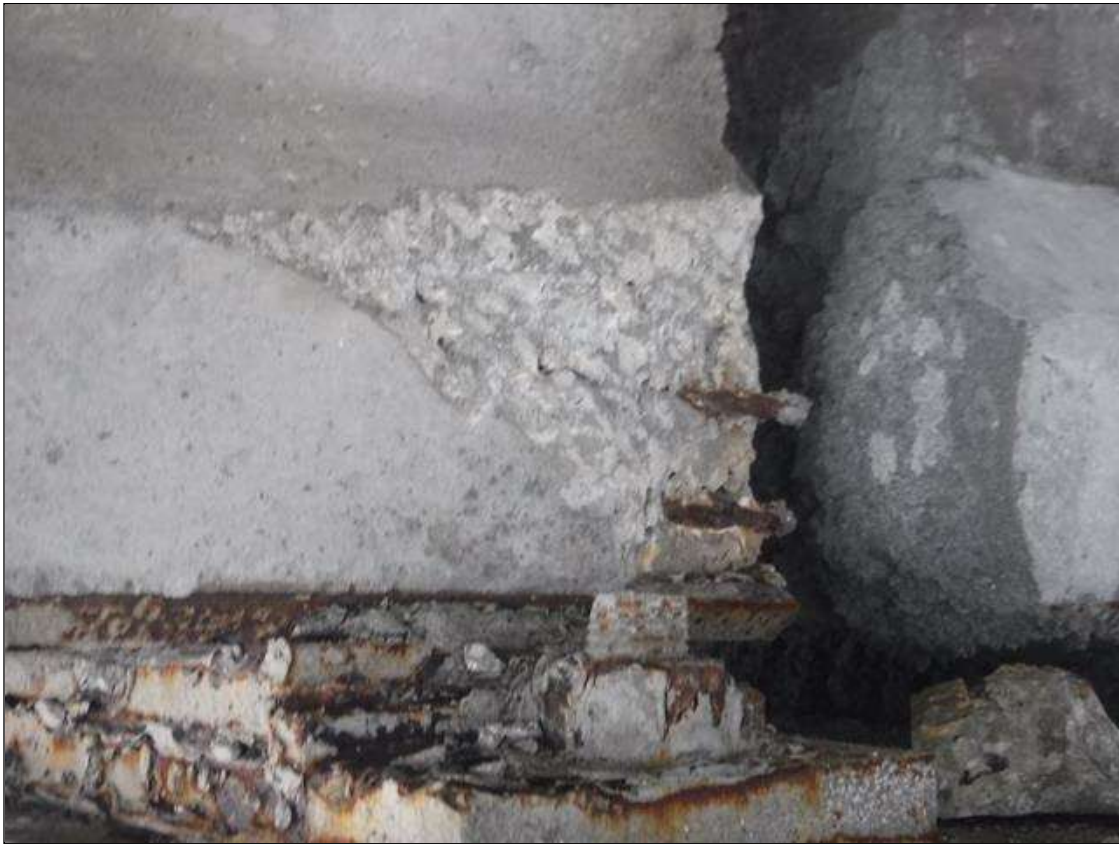
Span 175 Beam 2: (PAR) 12" X 10" X 1" DEEP SPALL WITH EXPOSED STRANDS ON NORTH FACE AT BENT 174

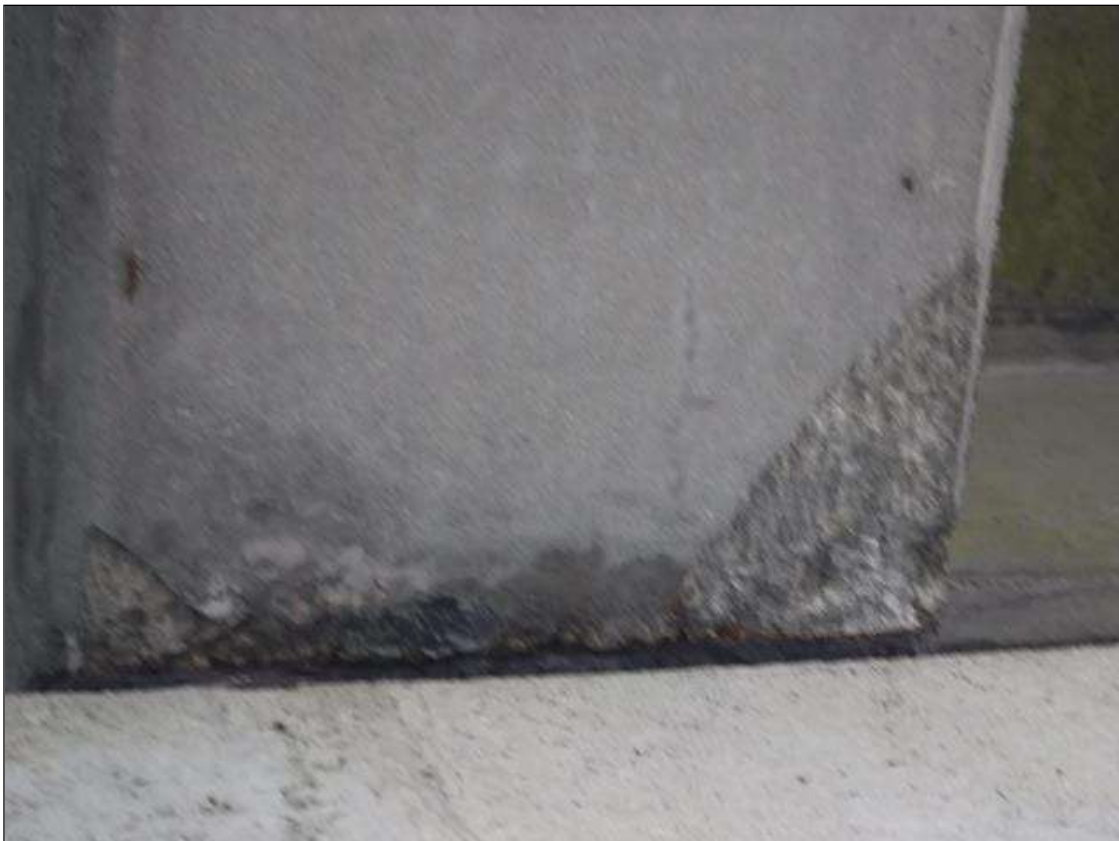
Span 174 Beam 3: 6" X 6" X 1" SPALL, BOTTOM OF BEAM, AT BENT 174.

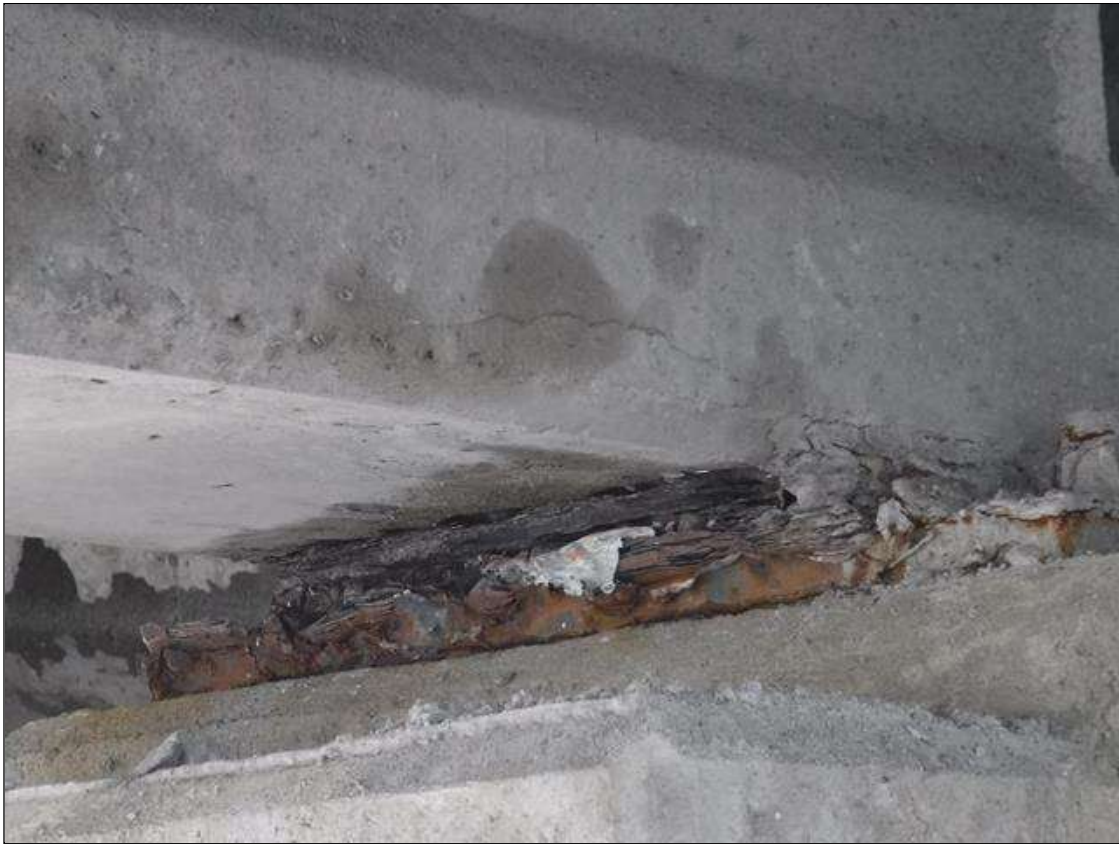
Span 176 Beam 3: 18" HAIRLINE CRACK IN BOTTOM NORTH FACE AT BENT 175

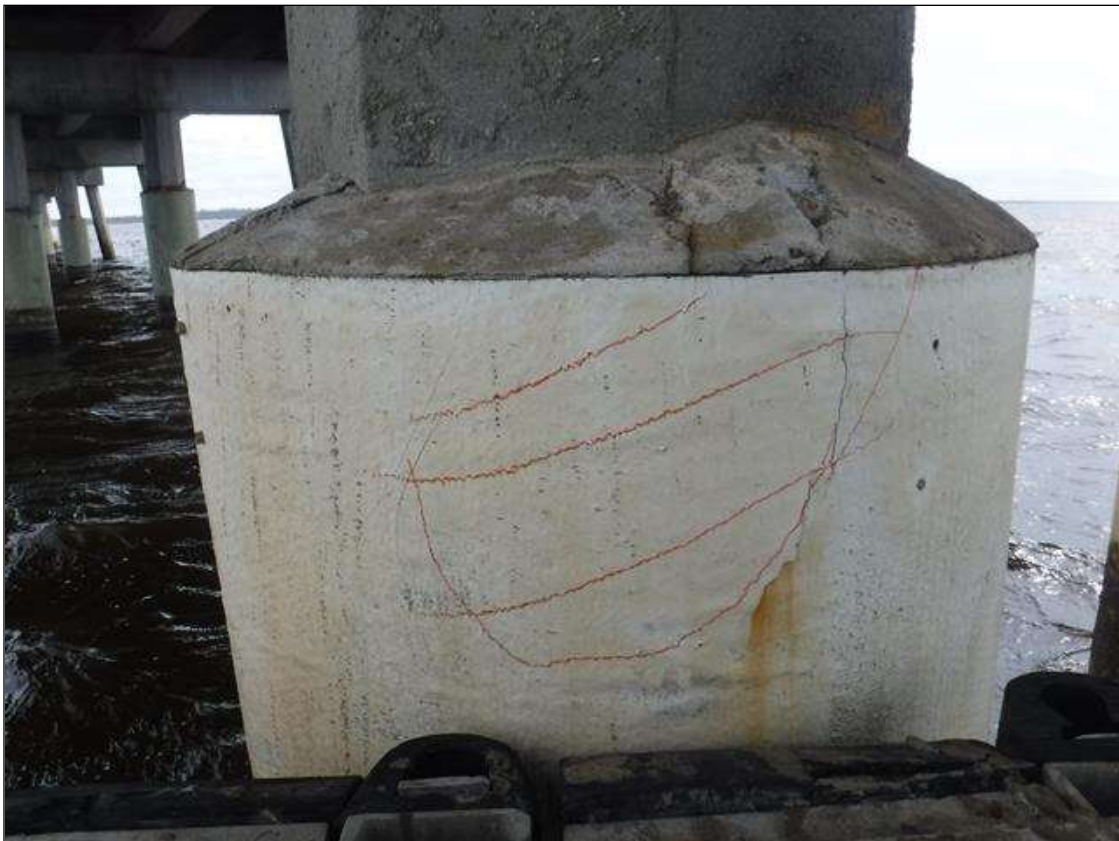
Bent 176 Pile 2: 12" X 5" DELAMINATION, WEST FACE ON TOP OF PILE JACKET, 5.25' FROM BOTTOM OF CAP.

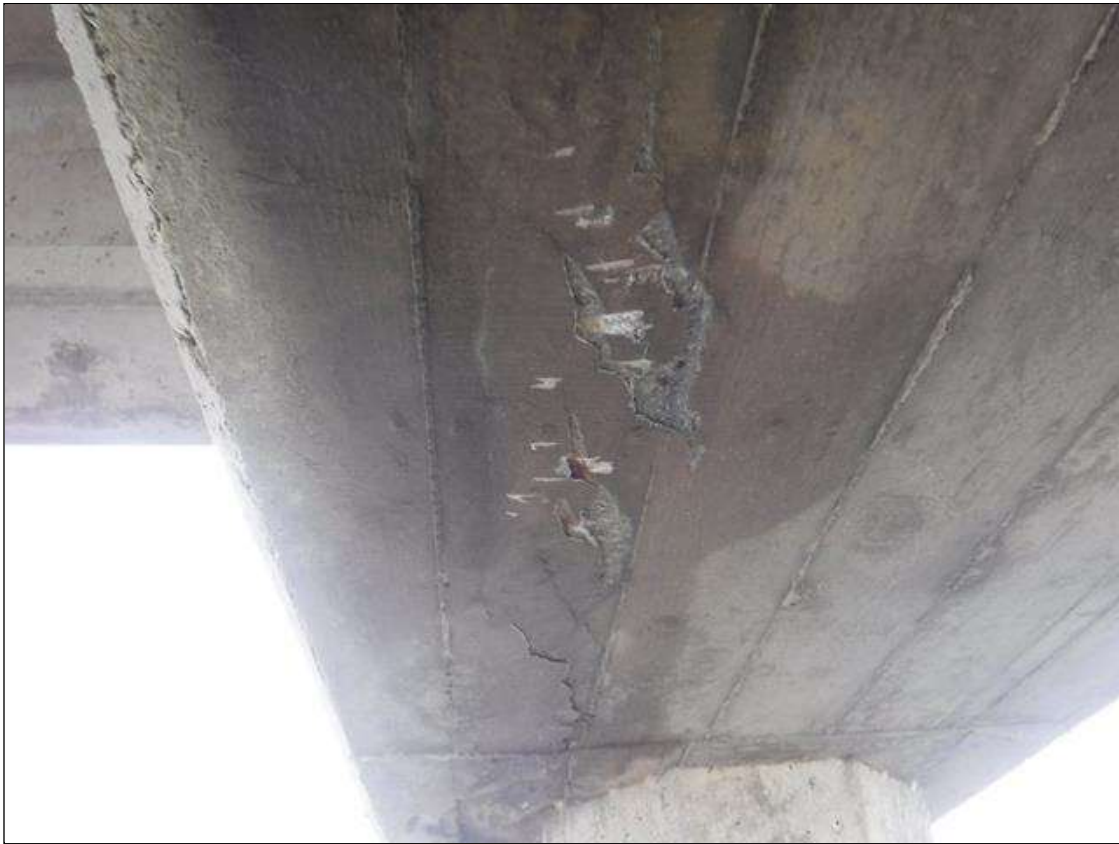
Bent 176 Cap 1: 3' X 1' DELAMINATION, BOTTOM FACE, BETWEEN BEAMS 1 AND 2

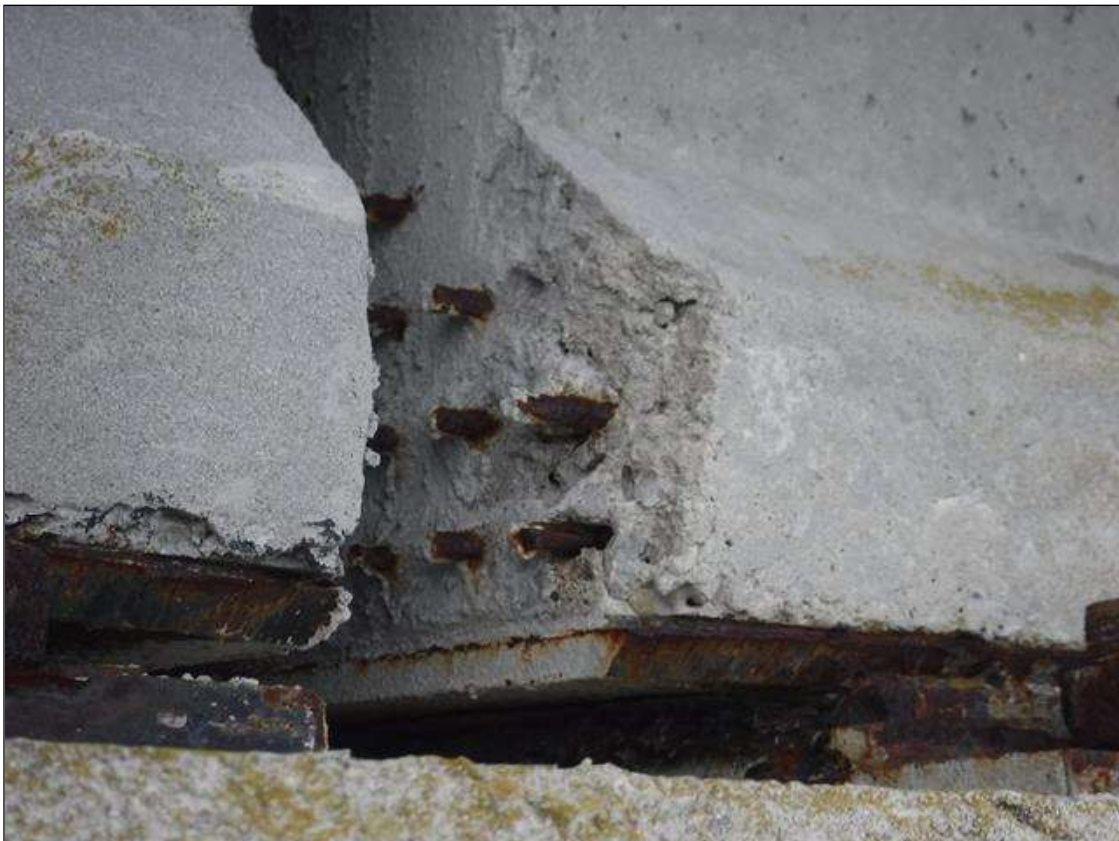
Span 179 Beam 1: (PAR) 6" X 6" SPALL WITH EXPOSED STRAND, NORTH FACE, AT BENT 178.

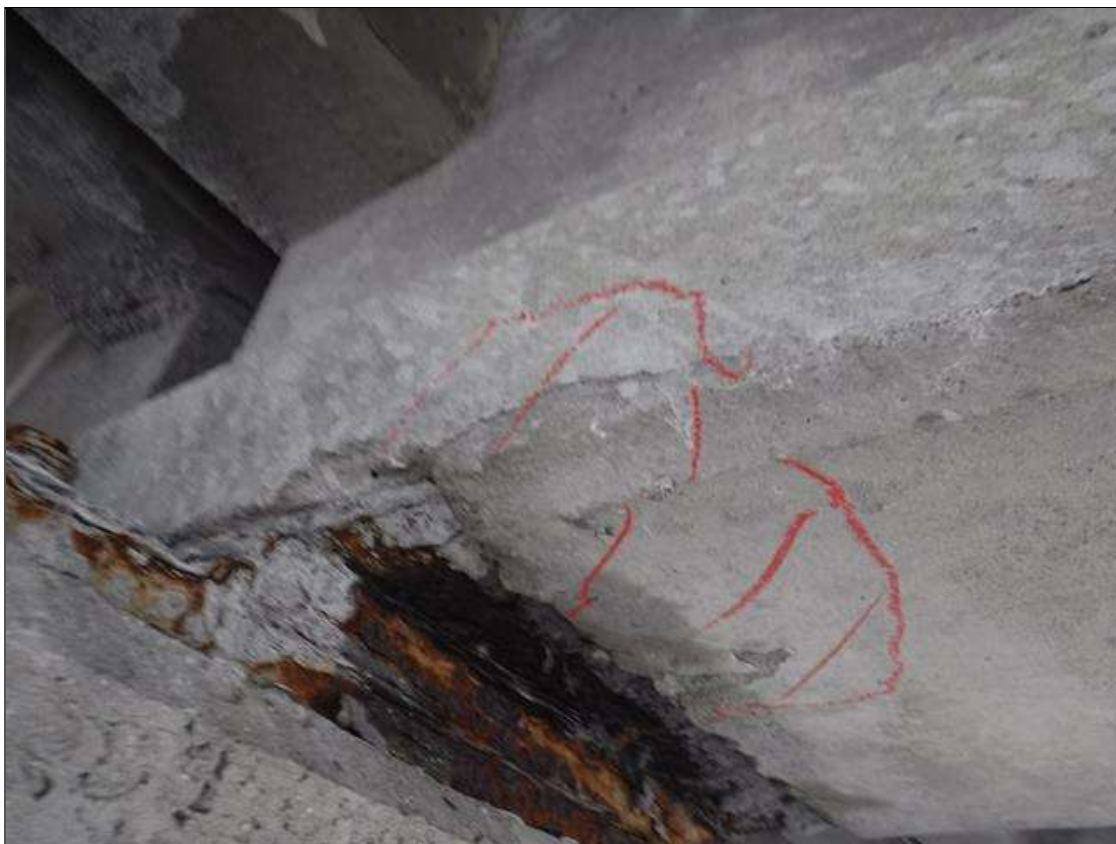
Span 179 Beam 2: 10" X 10" X 4" DELAMINATION ON BOTTOM FLANGE SOUTH FACE AT BENT 178

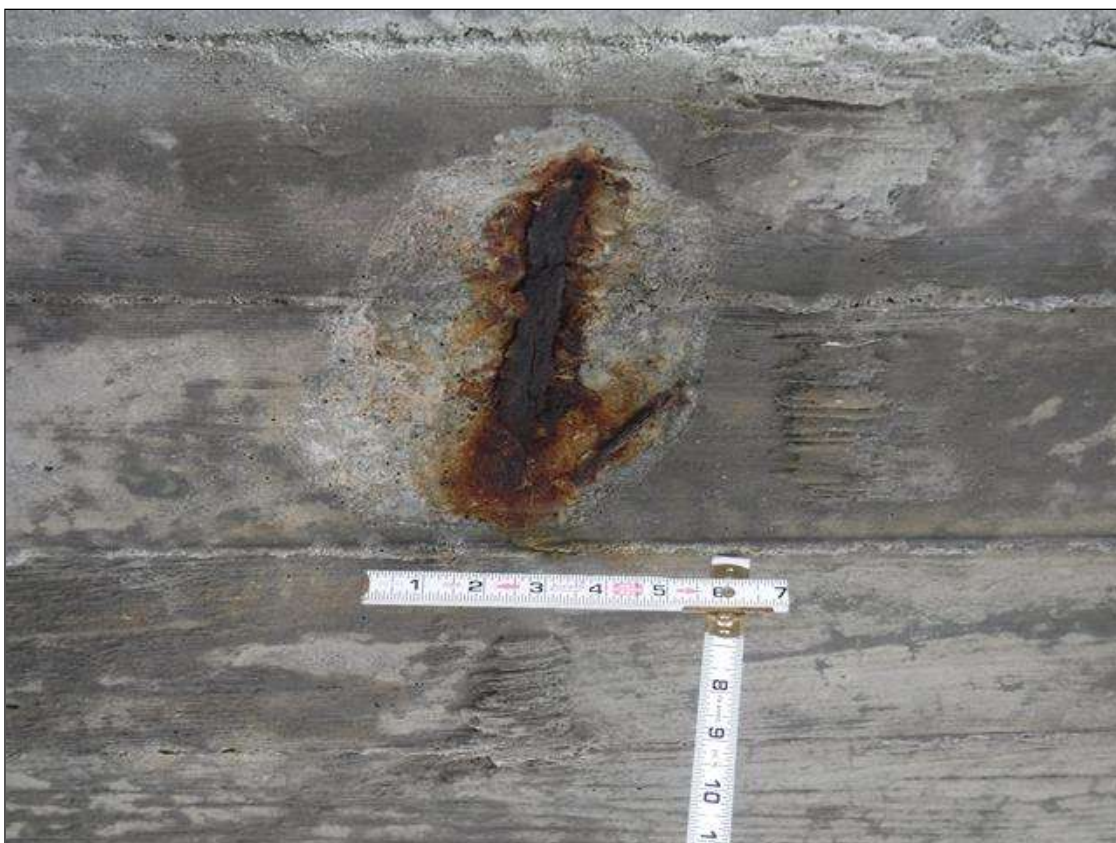
Bent 179 Cap 1: 8" X 5" X 1/4" SPALL, WITH EXPOSED REINFORCING, BOTTOM FACE, AT MID SPAN.

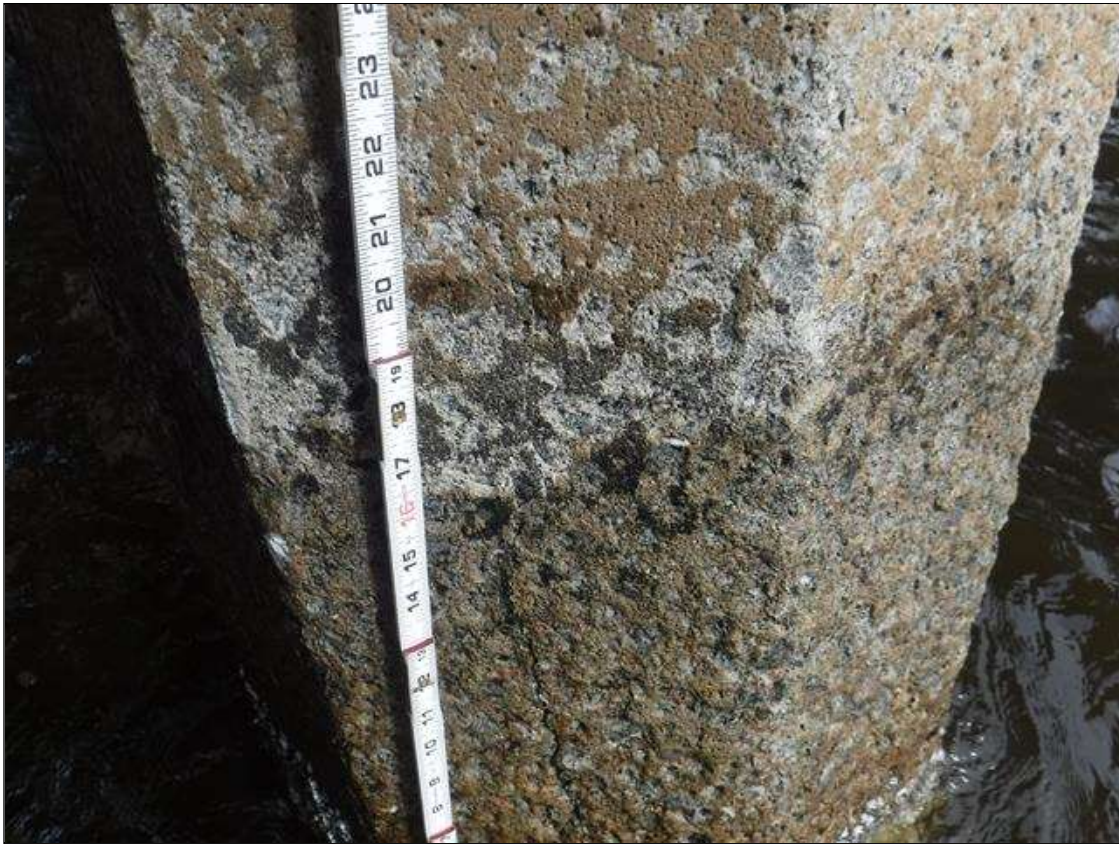
Bent 179 Pile 6: (PAR) HAIRLINE TO 1/4" CRACKS, 8' BELOW CAP, DOWN 4' , MULTIPLE FACES. SCALING TO 1" DEEP WITH LOOSE AGGREGATE FROM WATERLINE TO MUDLINE.

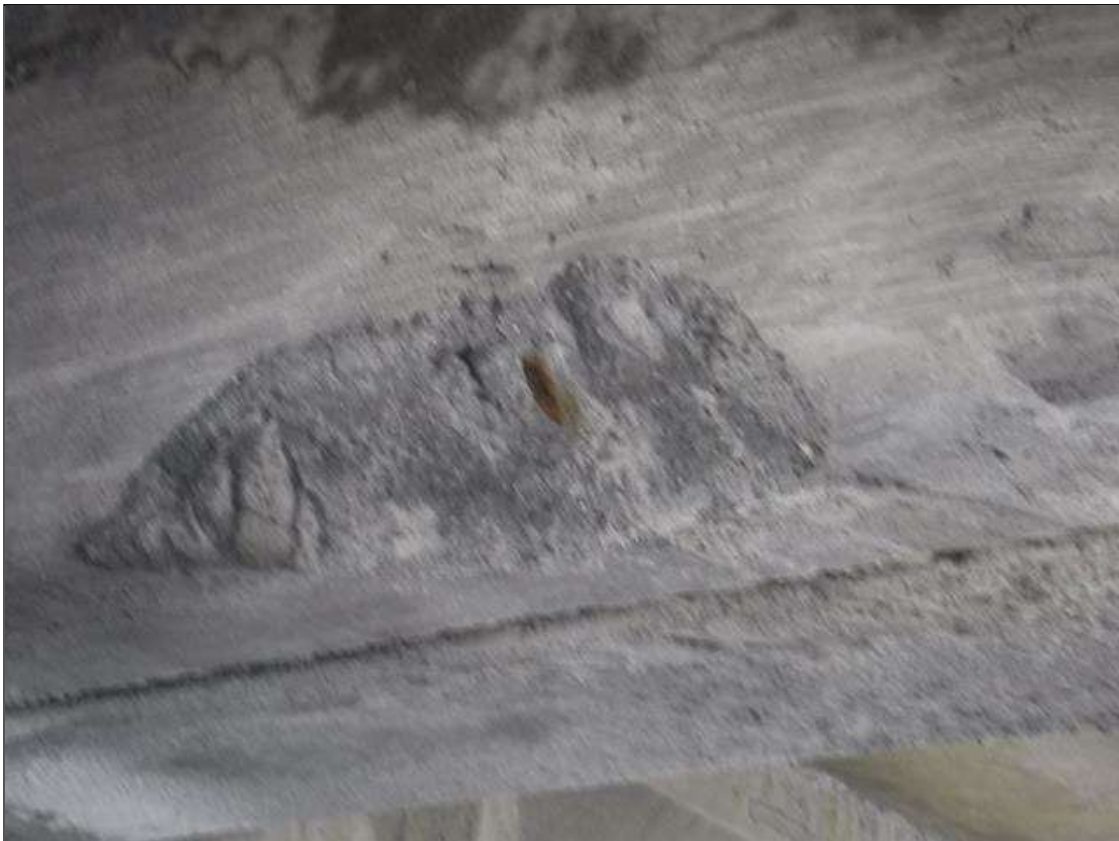
Span 181 Beam 3: 48" X 8" X 12" FAILED CORNER PATCHED AREA, WITH EXPOSED REINFORCING, END DIAPHRAGM, BETWEEN BEAMS 2 AND 3, EAST FACE, AT BENT 180.

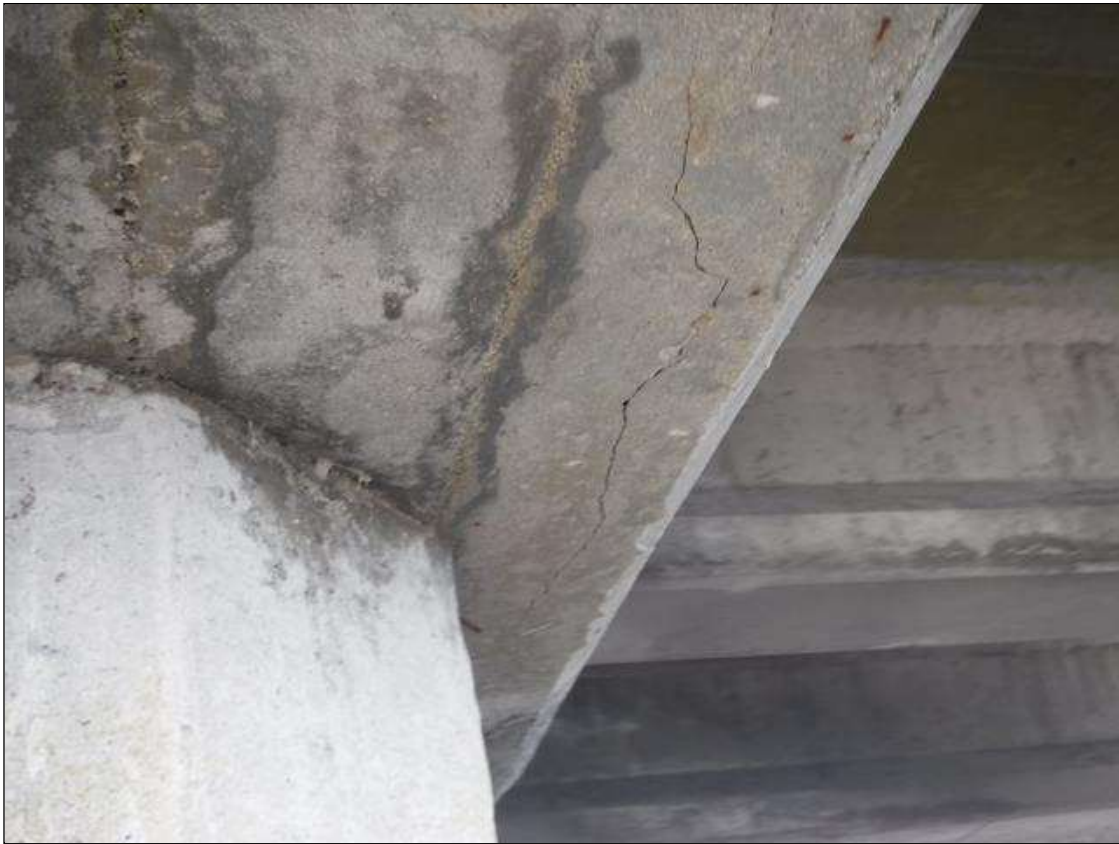
Bent 181 Cap 1: 3' LONG X 1/16" CRACK IN BOTTOM FACE EAST OF PILE 4

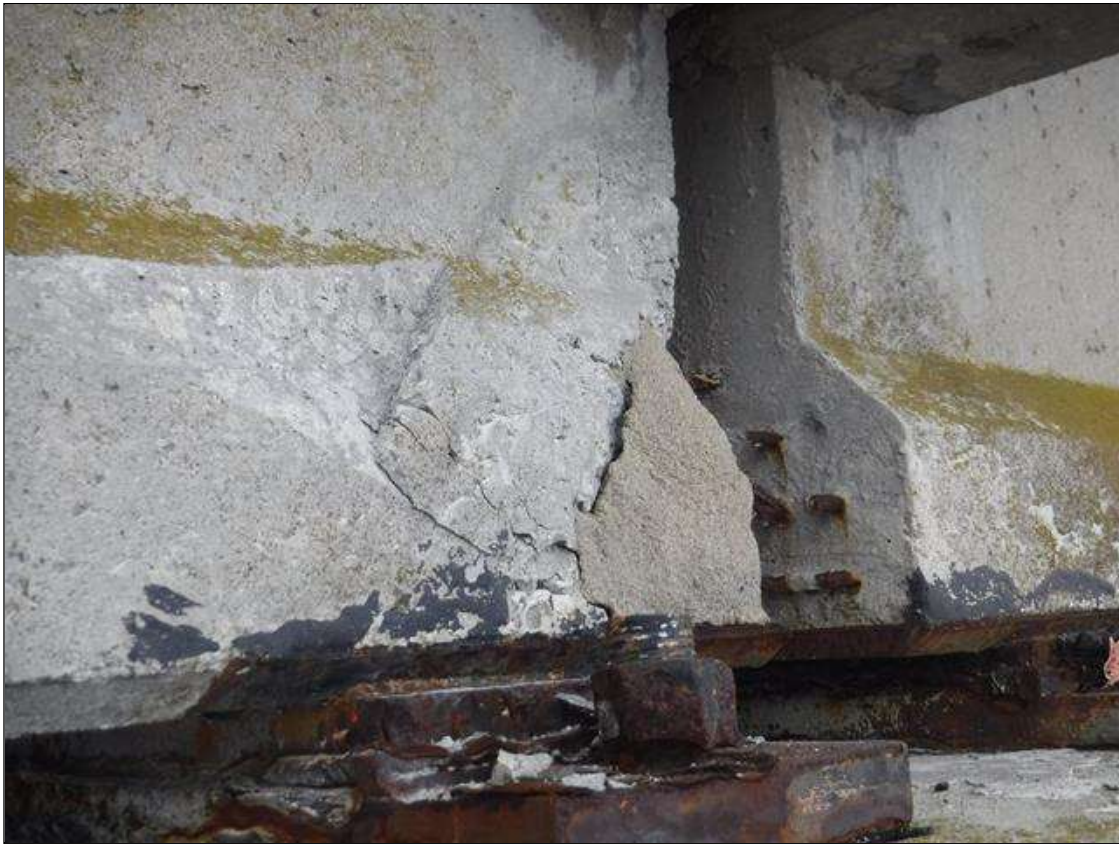
Span 182 Beam 1: (PAR) 18" X 10" X 5" SPALL, WITH EXPOSED PRESTRESSING, NORTH FACE, AT BENT 181.

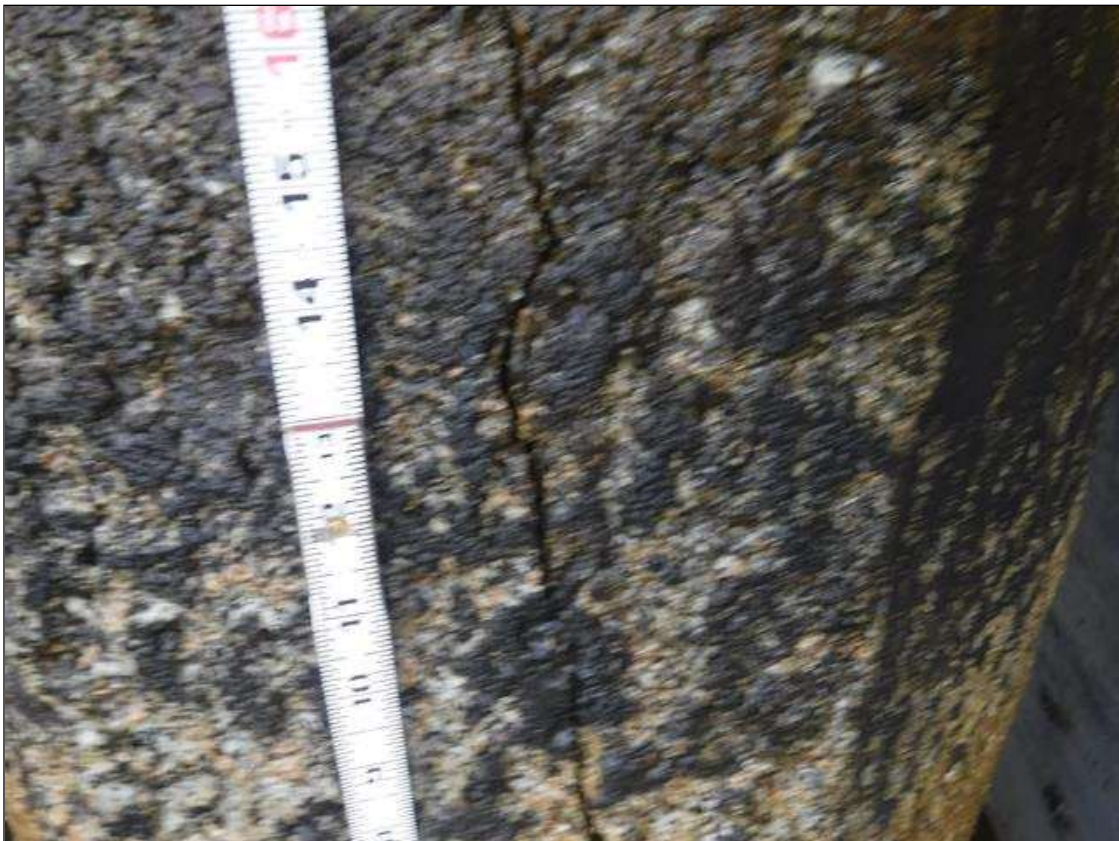
Bent 183 Pile 1: (PAR) HAIRLINE TO 1/8" CRACKS, 8' BELOW CAP, DOWN 4', MULTIPLE FACES. SCALING TO 1" DEEP WITH LOOSE AGGREGATE FROM WATERLINE TO MUDLINE.

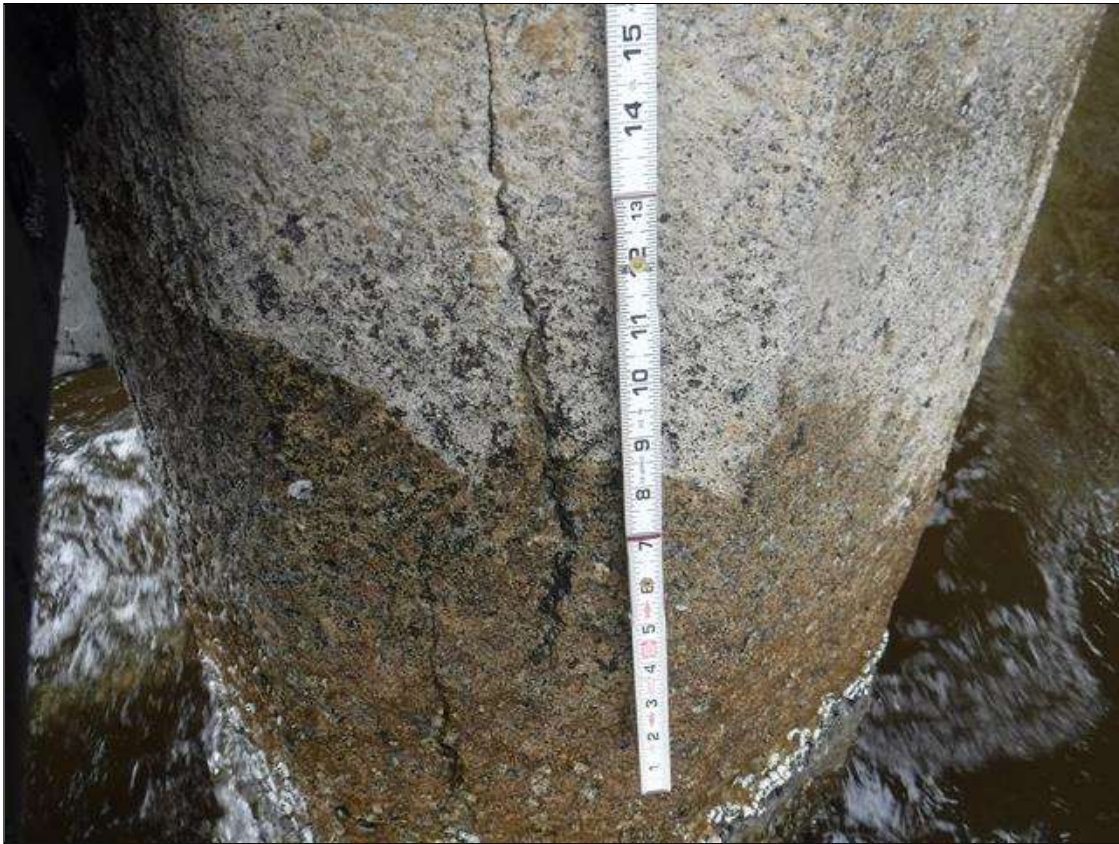
Bent 183 Pile 6: (PAR) HAIRLINE TO 1/8" CRACKS, 8' BELOW CAP, DOWN 4', MULTIPLE FACES. SCALING TO 1" DEEP WITH LOOSE AGGREGATE FROM WATERLINE TO MUDLINE.

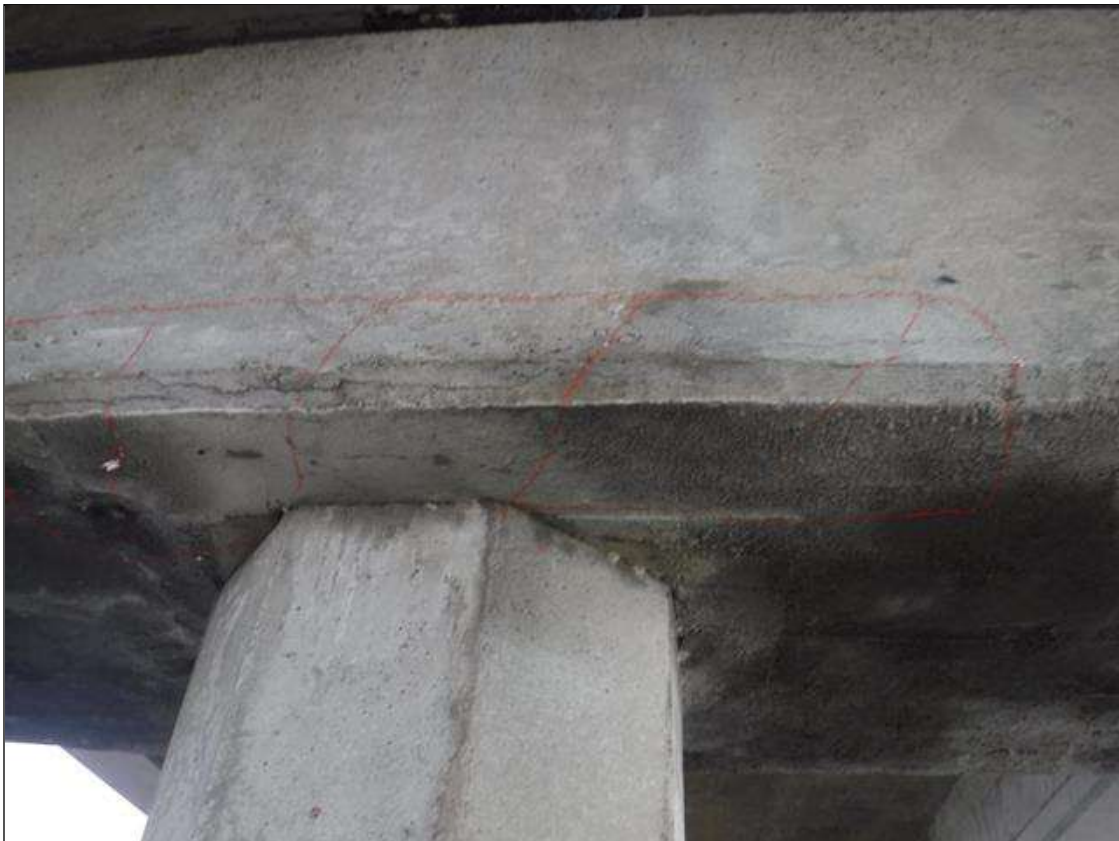
Bent 185 Cap 1: 3' X 6" HIGH X 8" DEEP DELAMINATION ON BOTTOM AND WEST FACE AT PILE 2

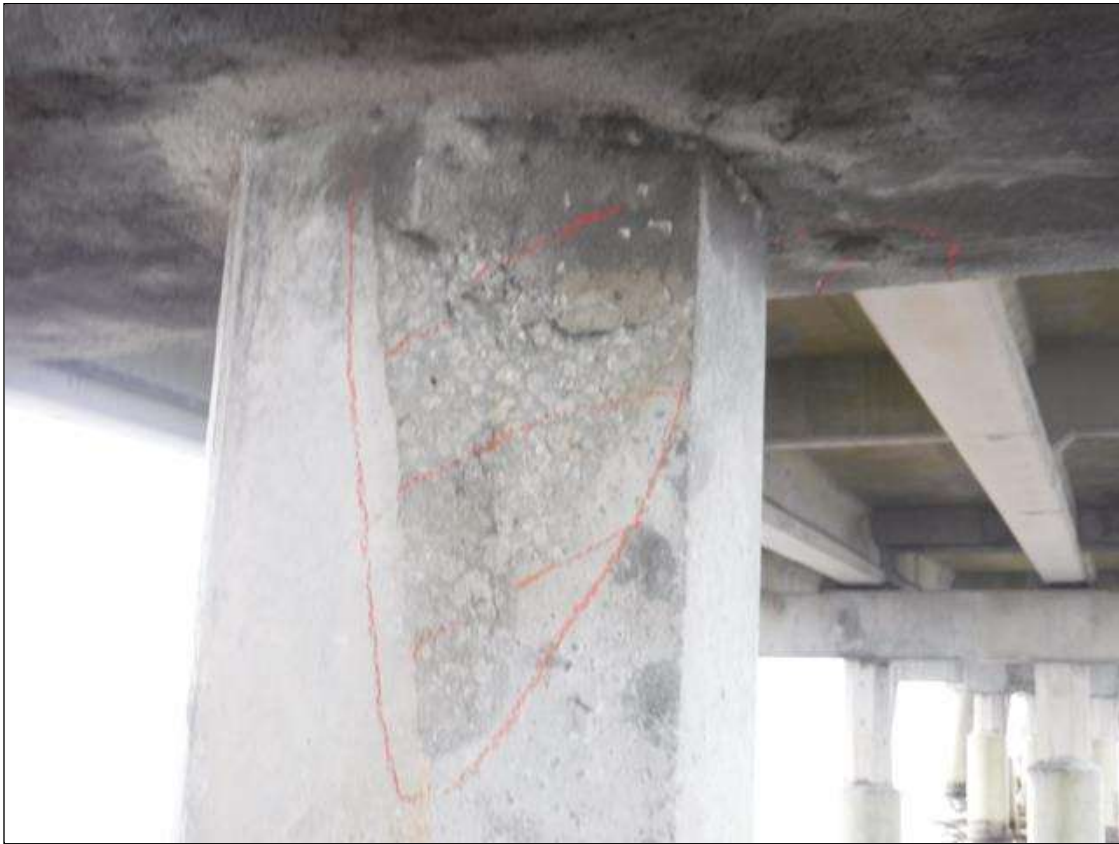
Bent 185 Pile 2: 24" X 12" X 2" SPALL, EAST FACE, BEGINNING FROM BOTTOM OF CAP.

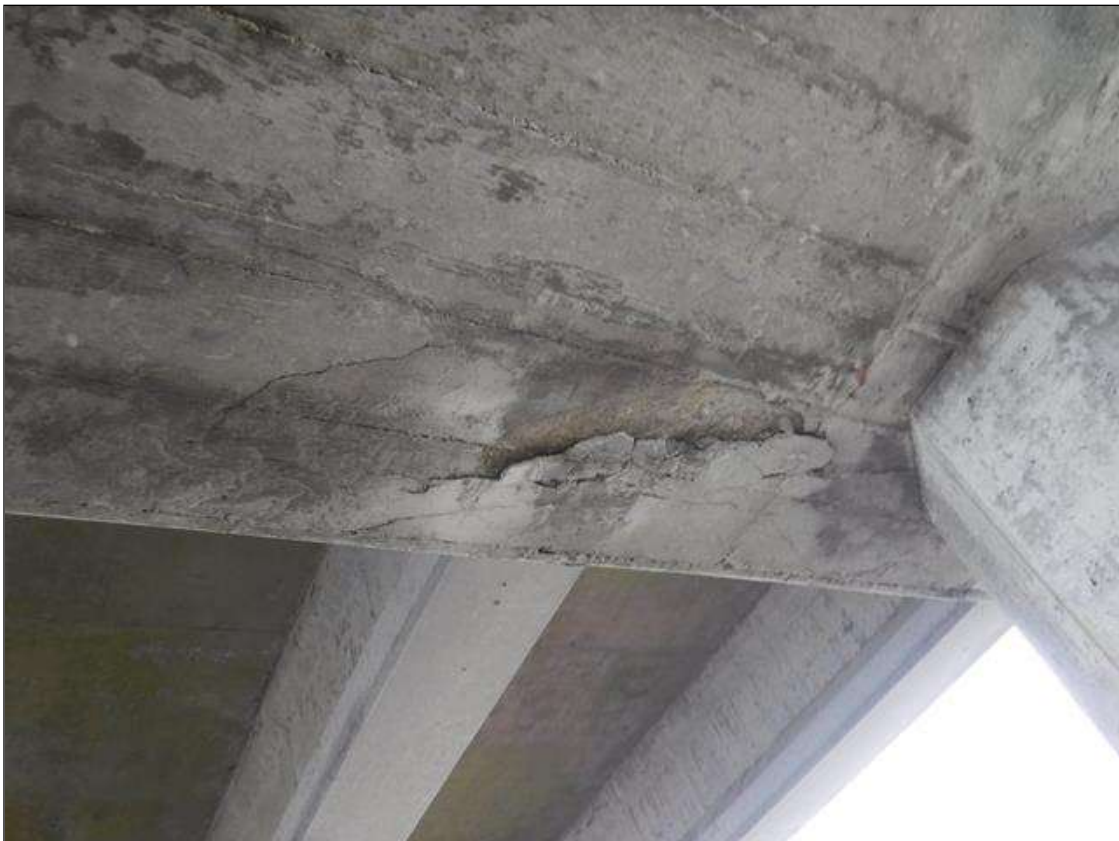
Bent 186 Cap 1: 3' OF DELAMINATION IN BOTTOM OF CAP ON EAST SIDE AT PILE 3.

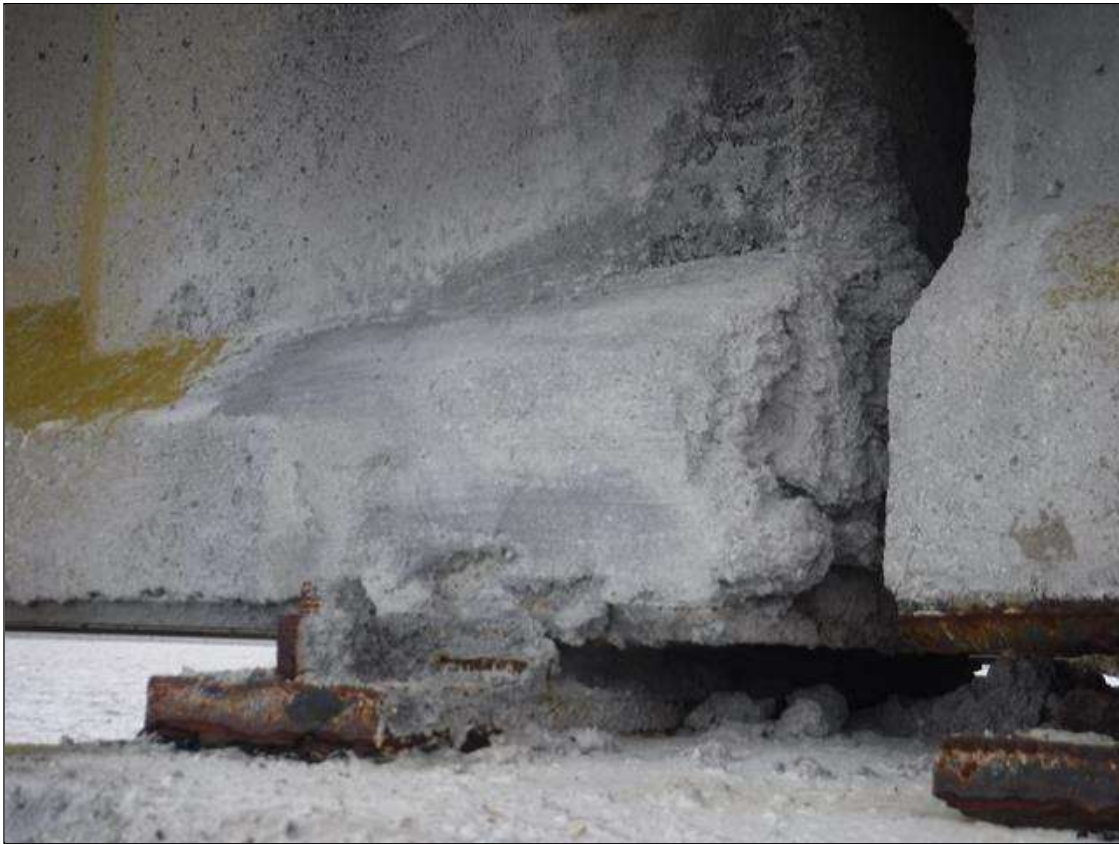
Span 188 Beam 1: 12" X 12" PATCHED AREA, NORTH FACE, AT BENT 187.

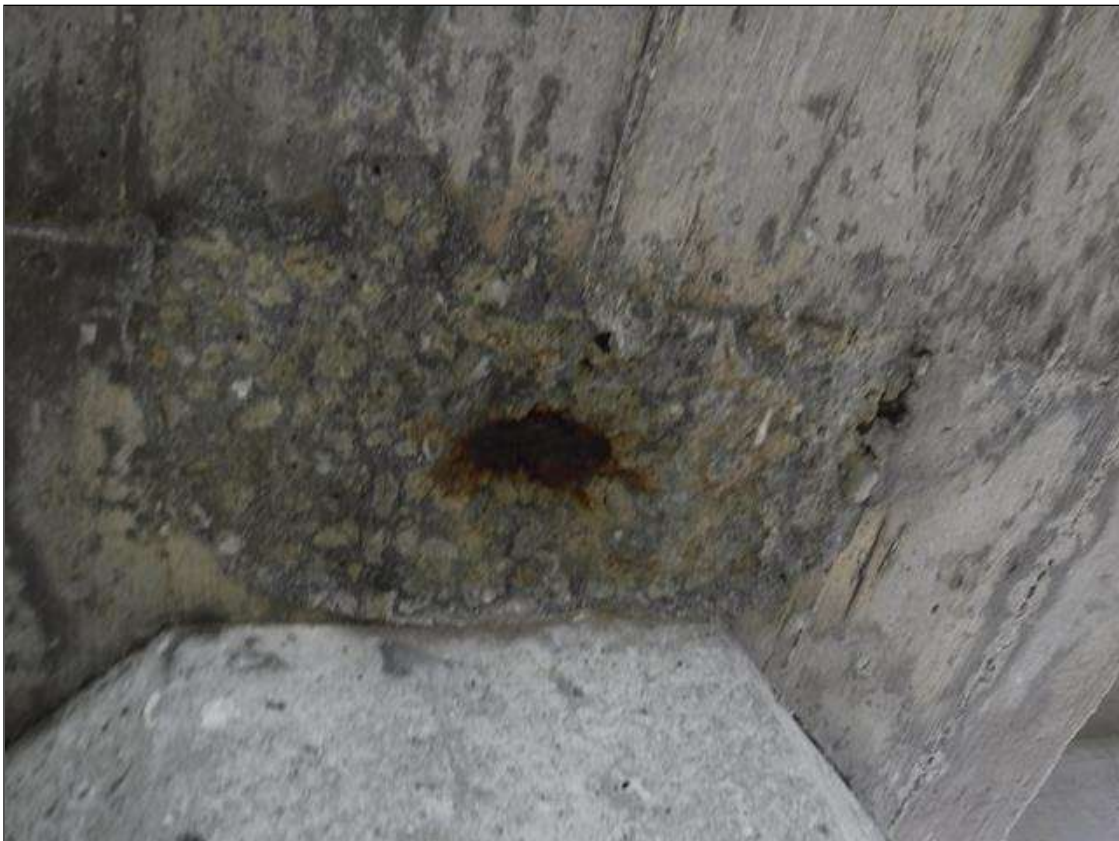
Bent 188 Cap 1: 6" X 12" X 1/2" SPALL, WITH EXPOSED REINFORCING, BOTTOM FACE, BETWEEN BEAMS 2 AND 3, AT BENT 188.

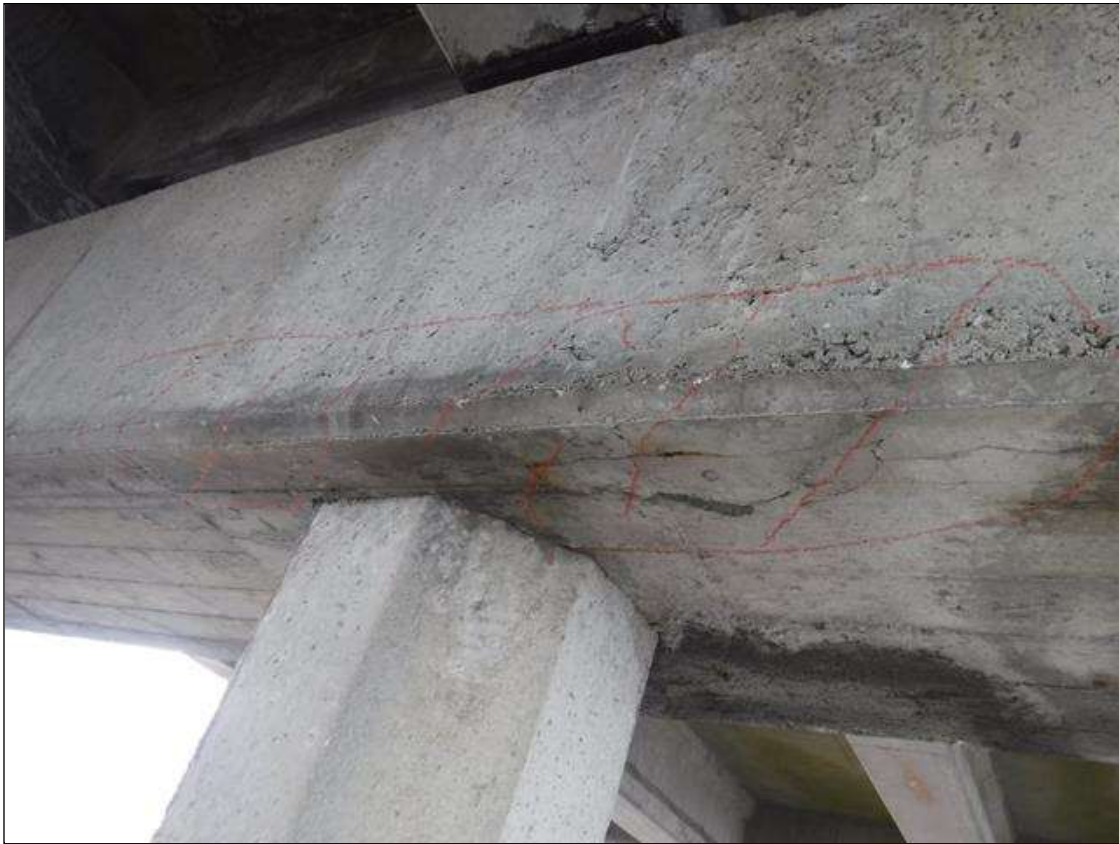
Bent 188 Cap 1: 6' X 8" X 12" DEEP DELAMINATION ON BOTTOM AND EAST FACE AT PILE
