NC DEPARTMENT OF TRANSPORTATION
DIVISION OF HIGHWAYS
STRUCTURE MANAGEMENT UNIT

Structure Safety Report

Routine Element Inspection - Contract

FEATURE INTERSECTED: ALLIGATOR RIVER

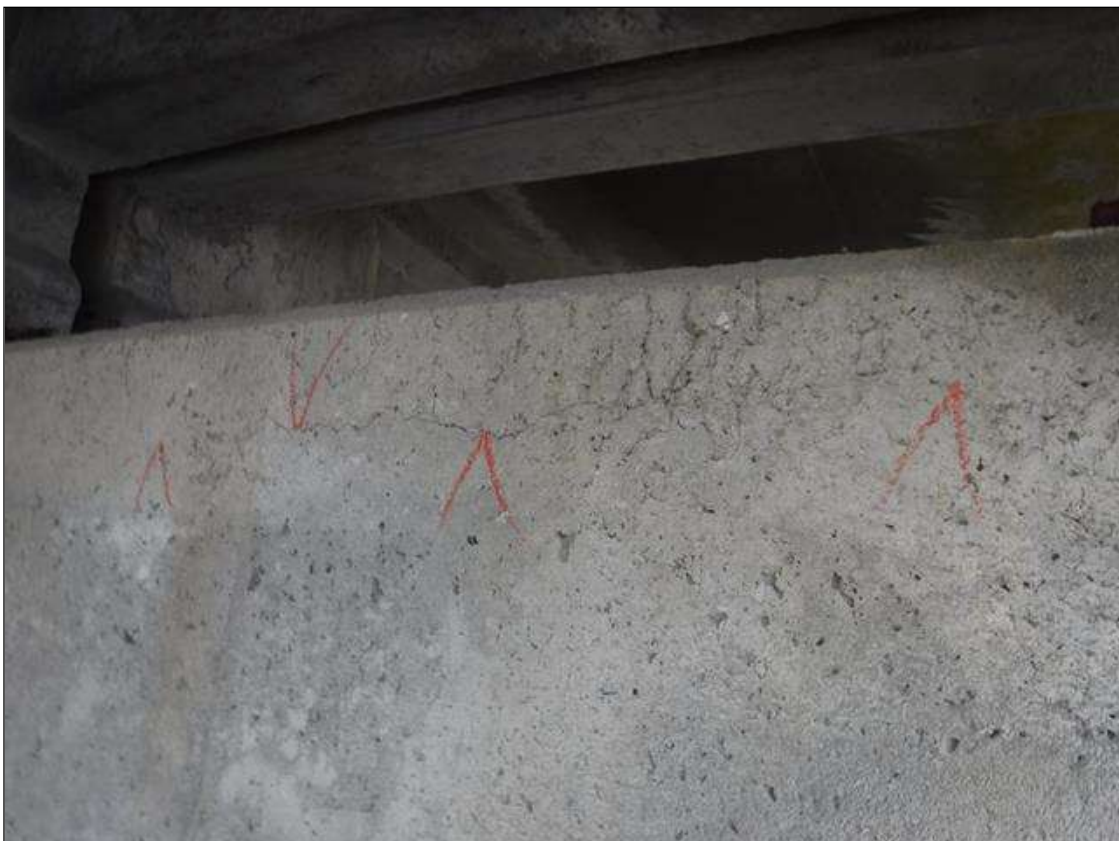
Bent 189 Cap 1: 3' HAIRLINE CRACK ON EAST FACE BETWEEN BEAM 1 AND 2

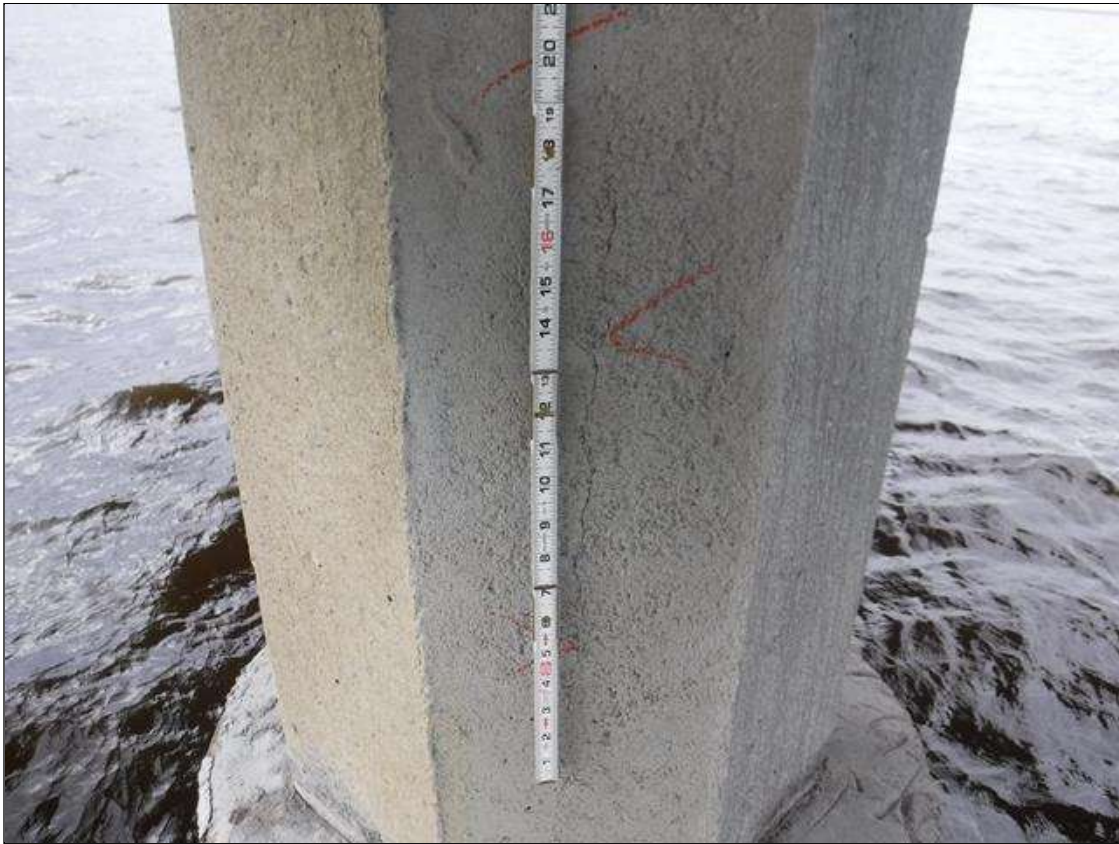
Bent 190 Pile 3: UP TO 5' X 0.009" VERTICAL CRACK ON EAST FACE

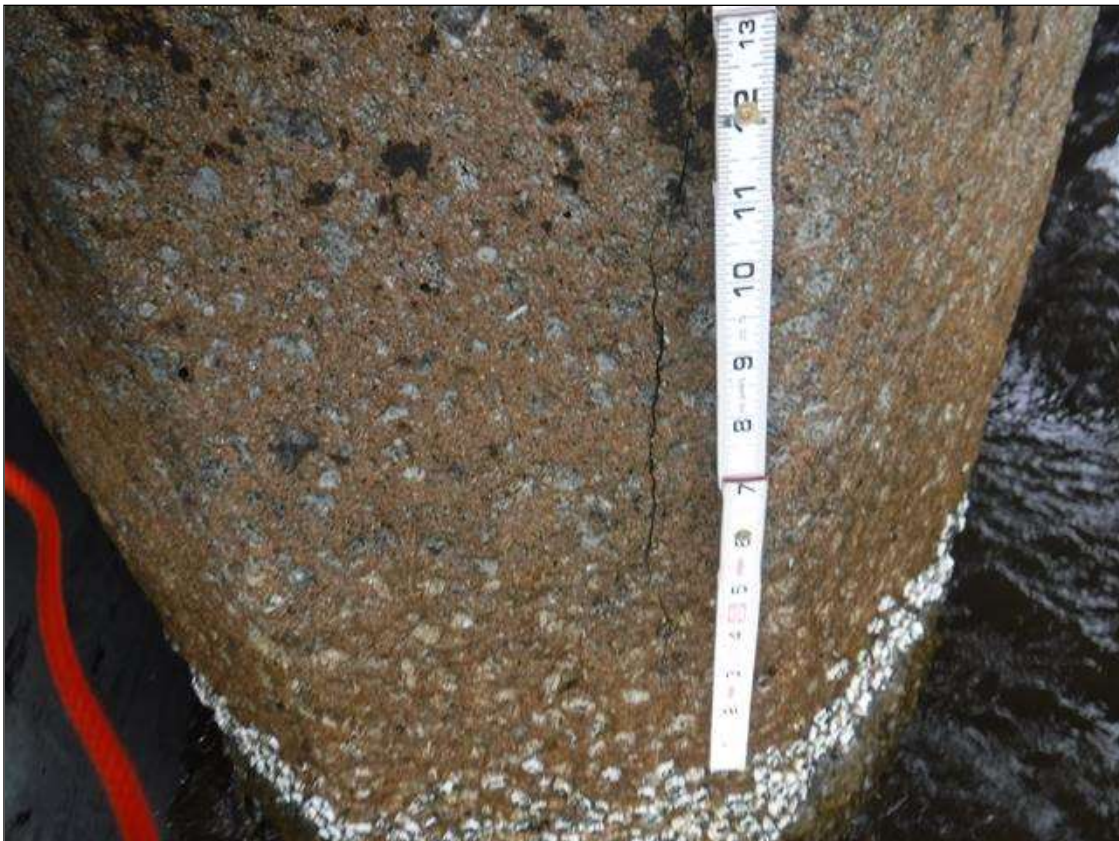
Bent 191 Pile 4: (PAR) HAIRLINE TO 1/8" CRACKS, 8' BELOW CAP, DOWN 4' , MULTIPLE FACES. SCALING TO 1" DEEP WITH LOOSE AGGREGATE FROM WATERLINE TO MUDLINE.

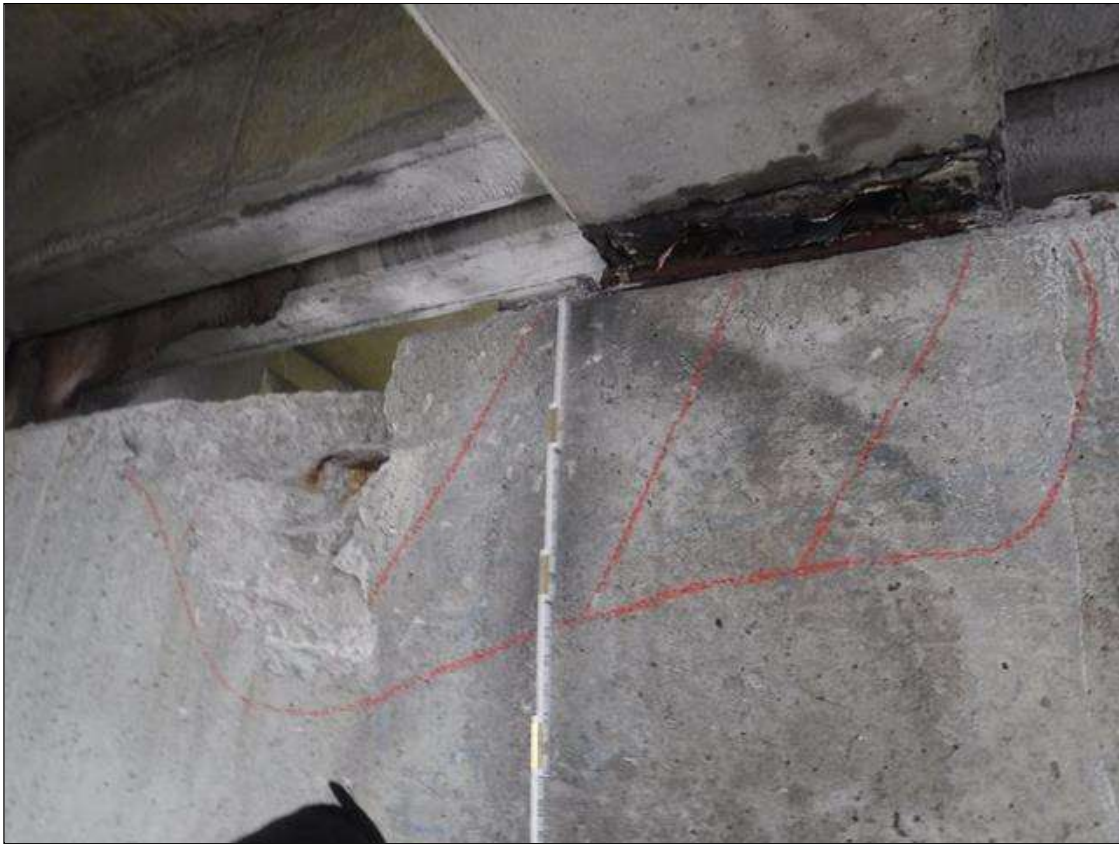
Bent 192 Cap 1: (PAR) 4' X 2' DELAMINATION WITH 18" DIAMETER X 6" DEEP SPALL WITH EXPOSED REBAR IN EAST FACE BELOW BEAM 3

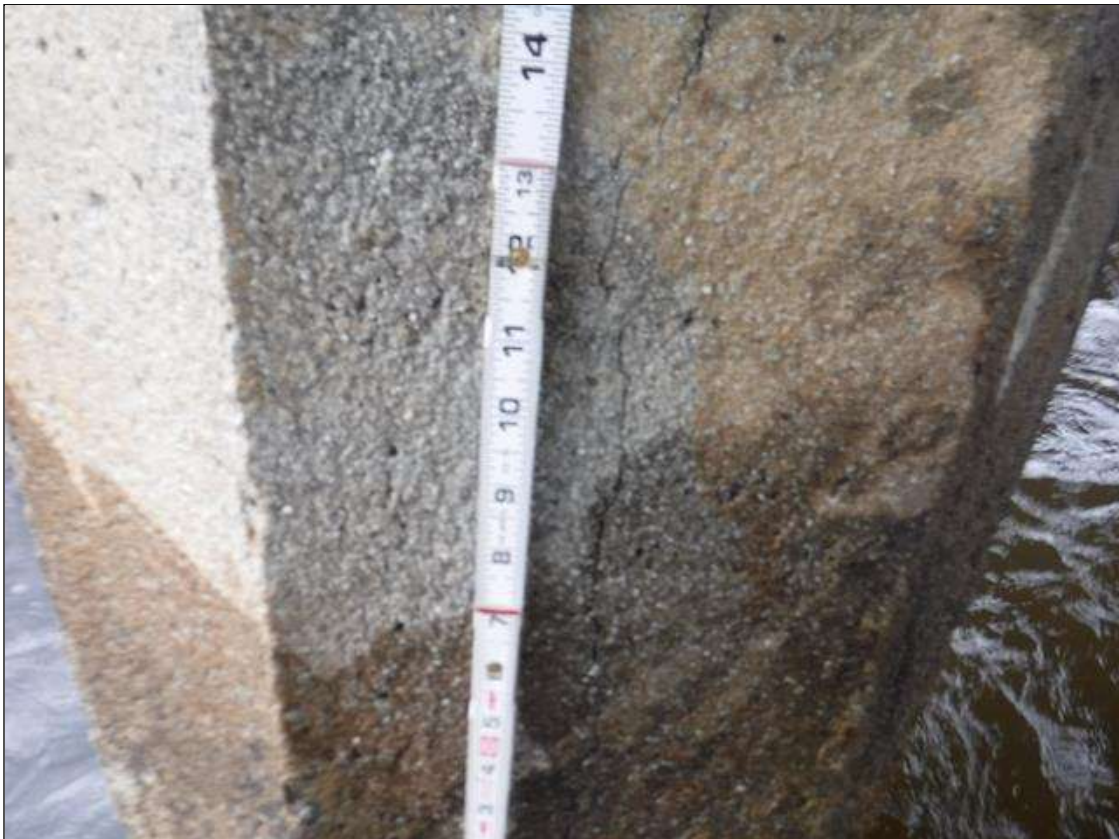
Bent 192 Pile 4: (PAR) HAIRLINE TO 1/8" CRACKS, 8' BELOW CAP, DOWN 4', MULTIPLE FACES. SCALING TO 1" DEEP WITH LOOSE AGGREGATE FROM WATERLINE TO MUDLINE.

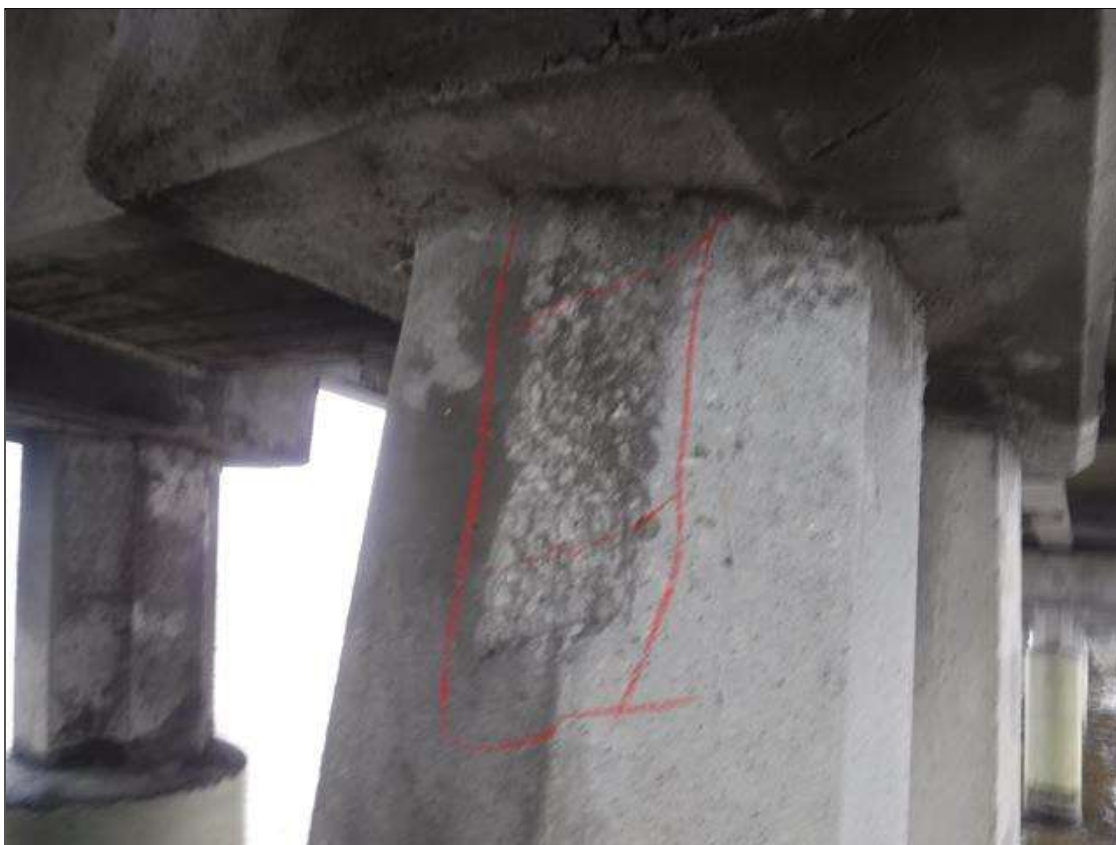
Bent 194 Pile 3: 3' X 1' DELAMINATION, EAST FACE, 7' BELOW BOTTOM OF CAP, EXTENDING BELOW WATERLINE.

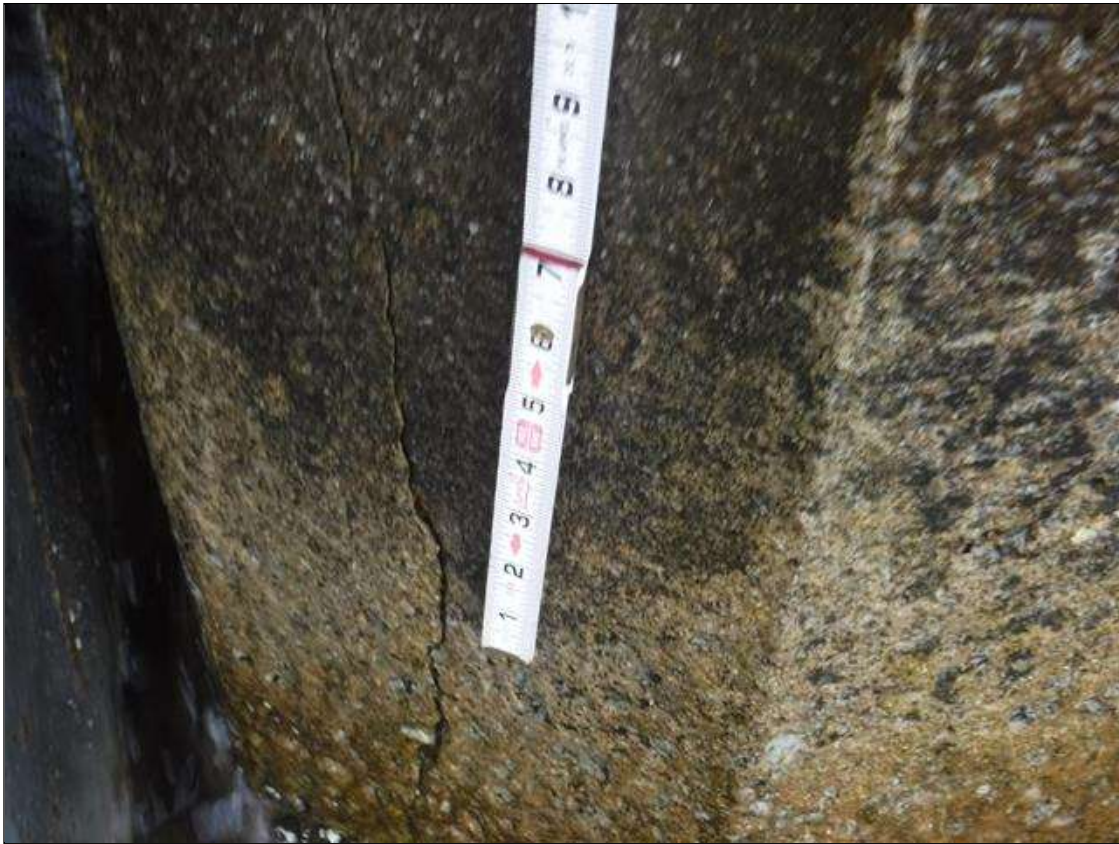
Bent 195 Pile 4: 16" X 6" X 1" SPALL, WEST FACE, AT BOTTOM OF CAP.

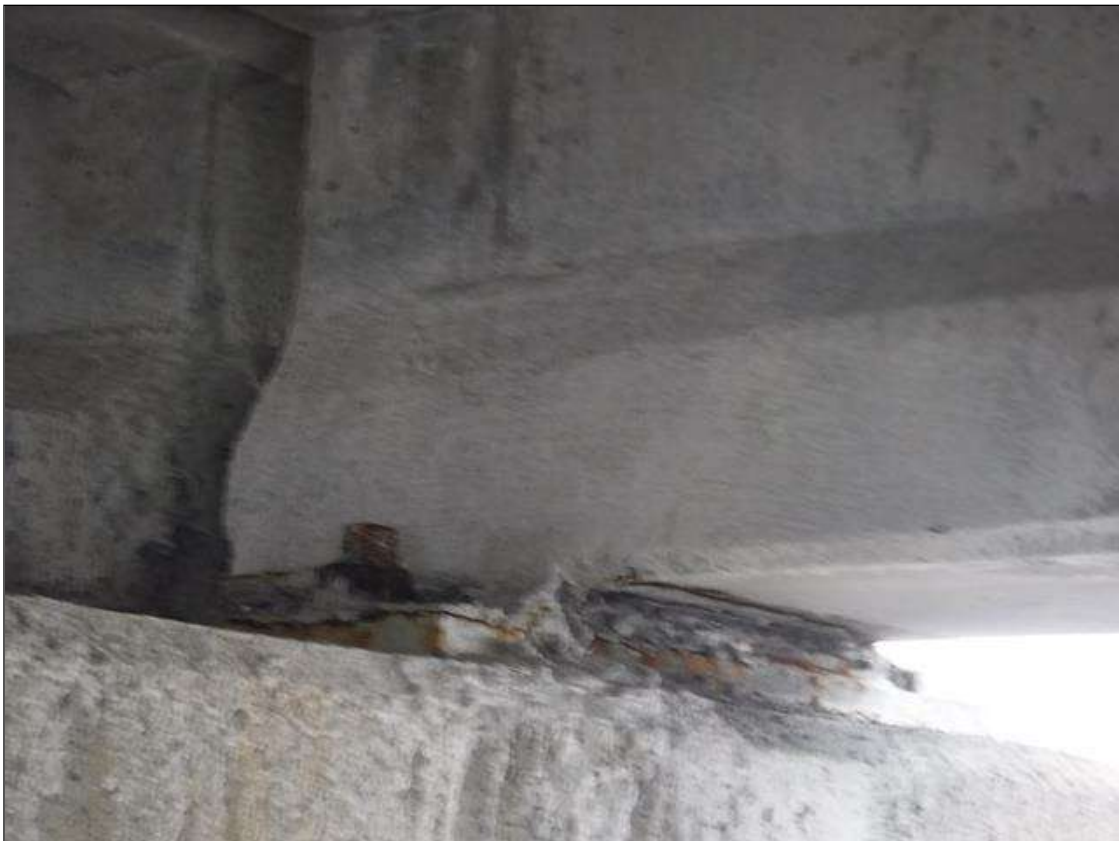
Bent 196 Pile 2: (PAR) 3' LONG X 0.06" WIDE CRACK IN EAST 8' BELOW CAP

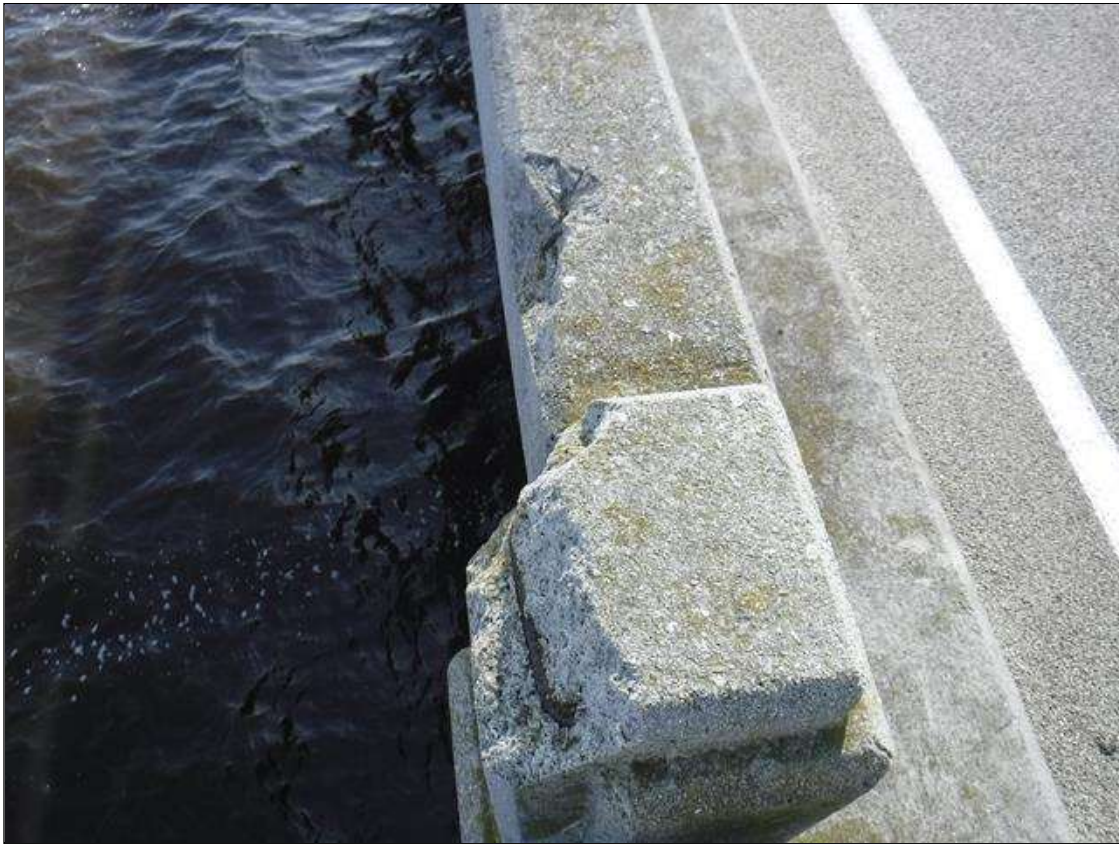
Span 199 Beam 4: 16" TALL X 16" LONG PATCHED AREA ON NORTH FACE AT BENT 199.

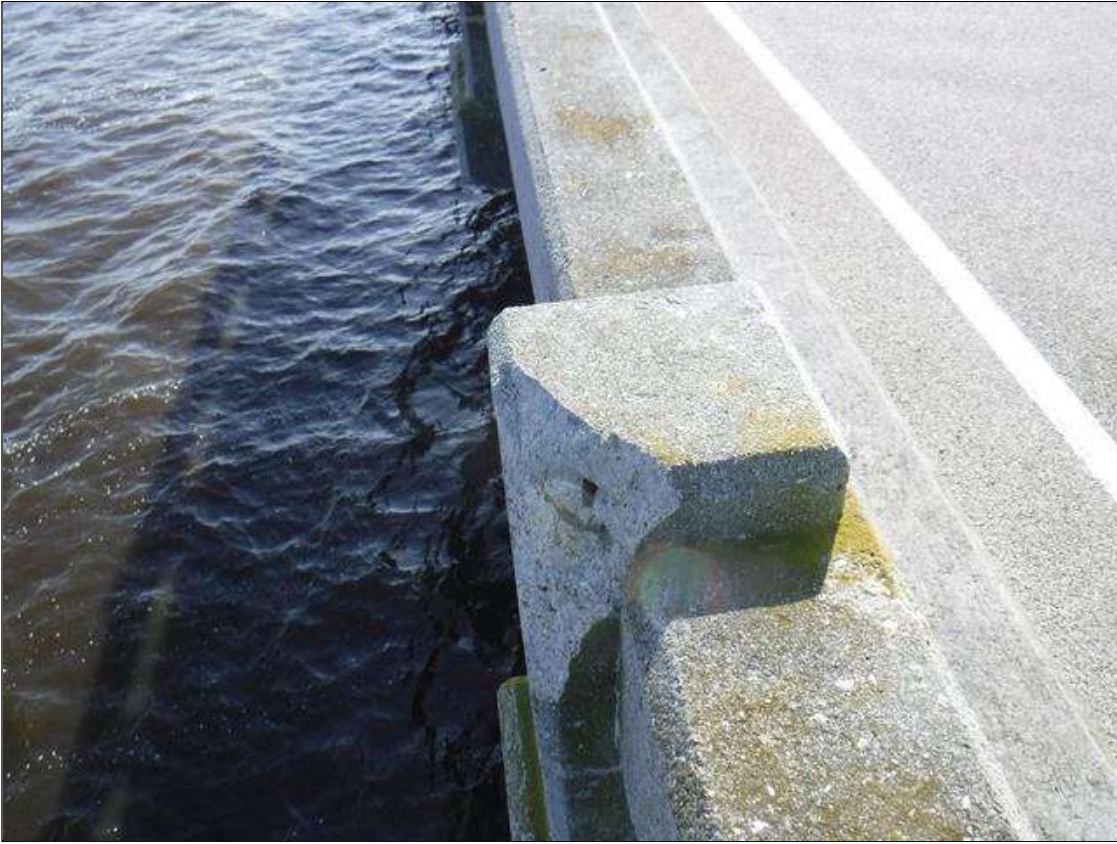
Span 137 Left Bridge Rail: 2' X 4" X 11" SPALL WITH EXPOSED REBAR AT TOP LEFT CORNER LOCATED ON POST 7 AND RAIL

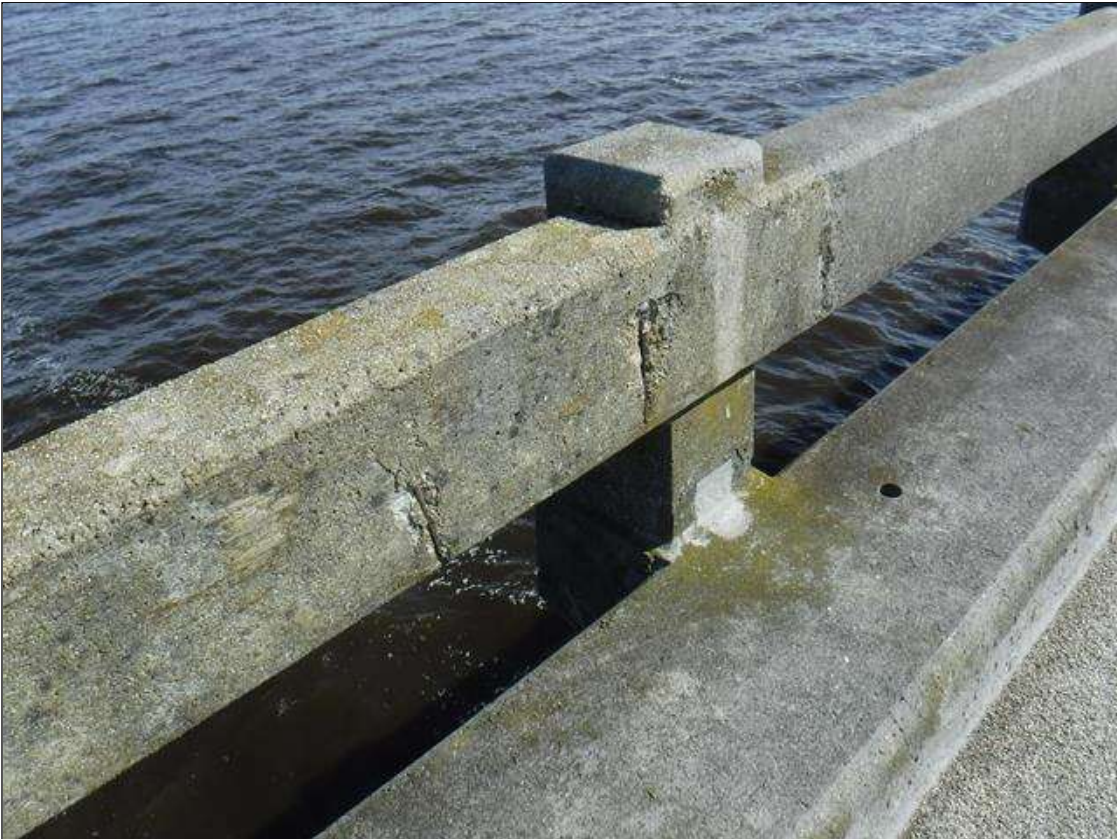
Span 143 Left Bridge Rail: 8" X 6" X 12" SPALL WITH EXPOSED REBAR AT TOP LEFT CORNER LOCATED ON POST 2

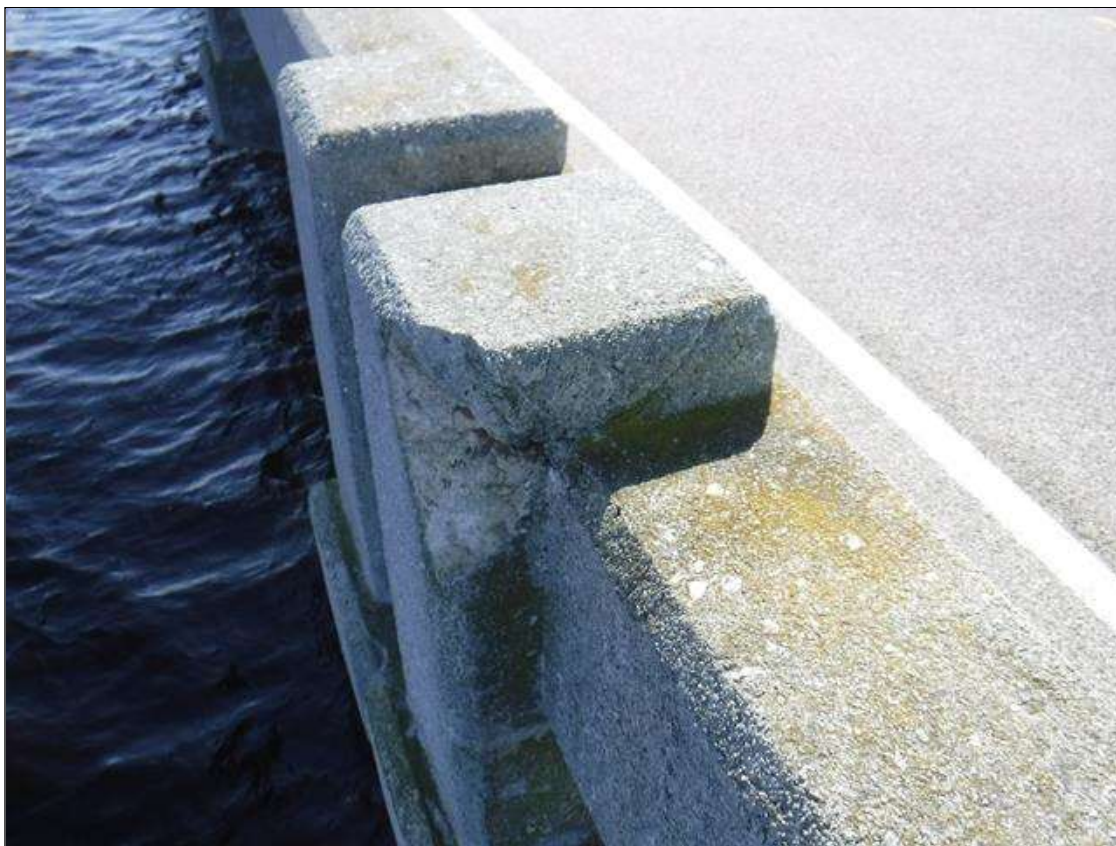
Span 150 Left Bridge Rail: (3) UP TO 8" X 4" X 1/2" SPALLS WITH EXPOSED REBAR ON RIGHT FACE LOCATED ON RAIL AT POST 5

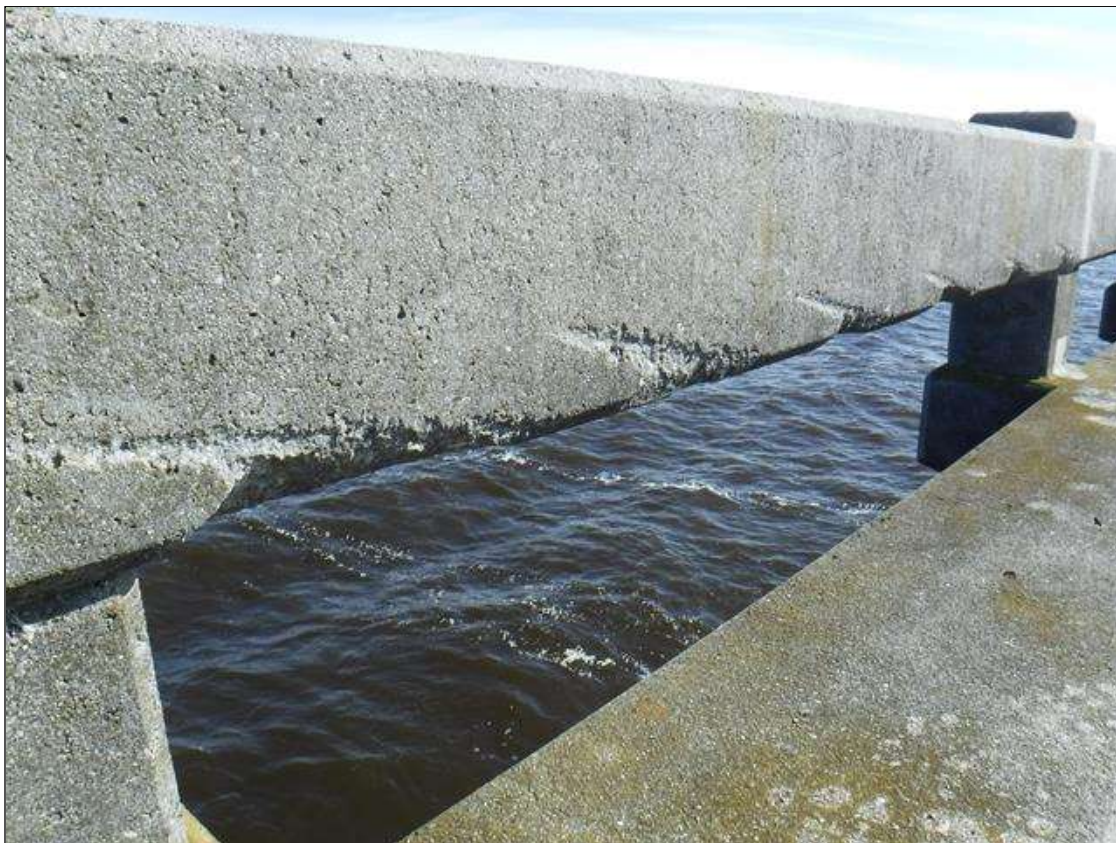
Span 154 Left Bridge Rail: 8" X 5" X 7" SPALL WITH EXPOSED REBAR AT TOP LEFT CORNER LOCATED ON POST 6

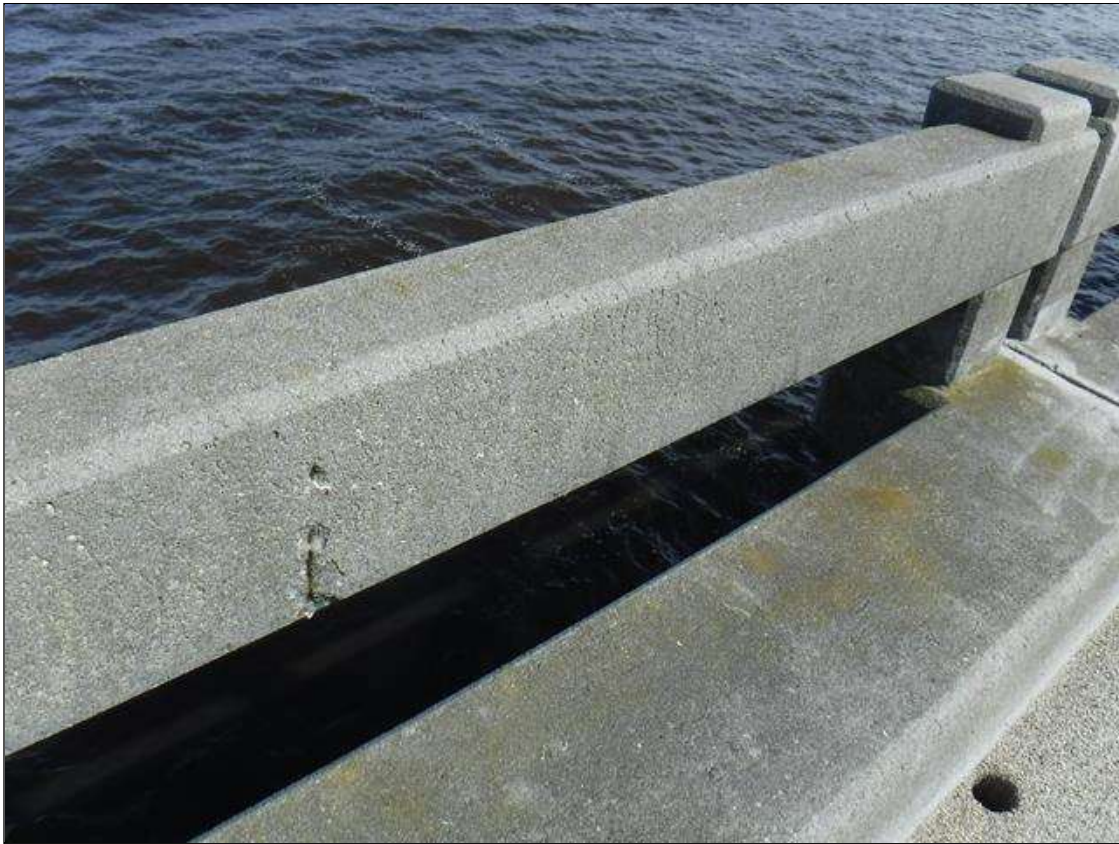
Span 191 Left Bridge Rail: 4" DIAMETER X 1" DEEP SPALL ON LEFT FACE LOCATED ON RAILING 1' PAST POST 5

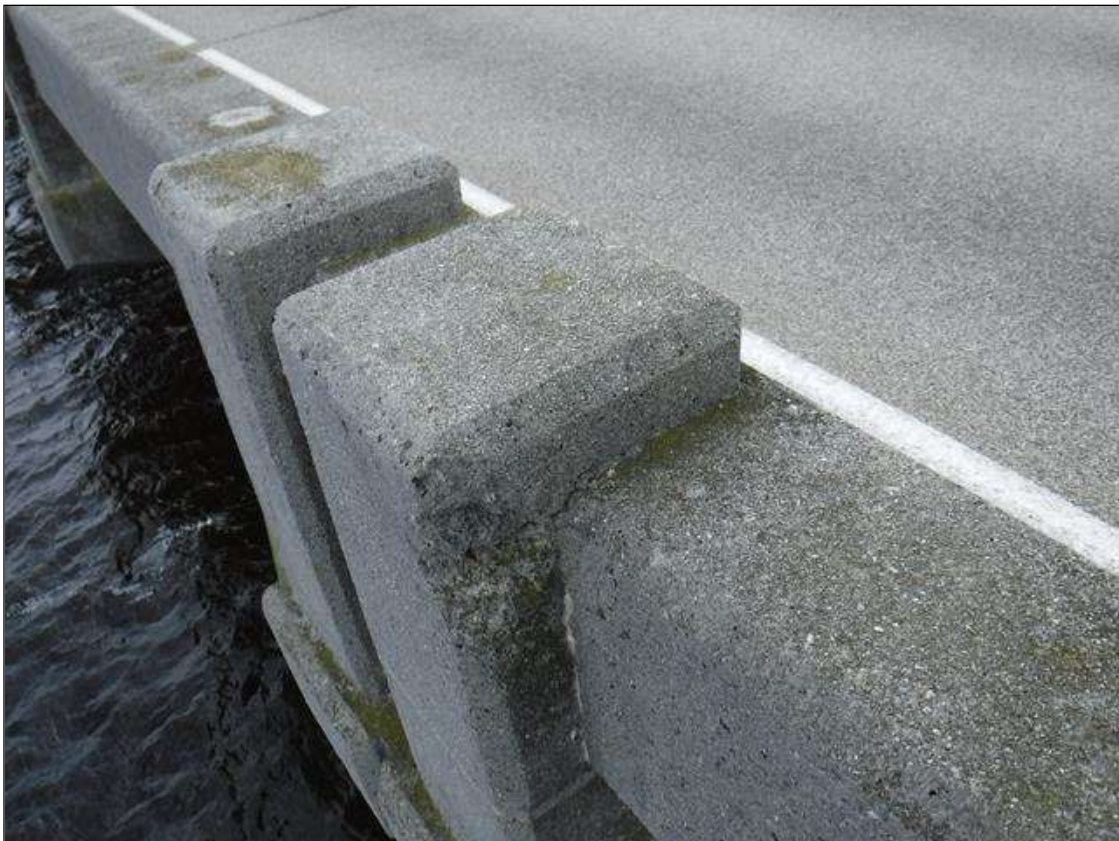
Span 191 Left Bridge Rail: 9" X 2" X 1/2" SPALL ON RIGHT FACE LOCATED ON RAILING 30" FROM POST 8

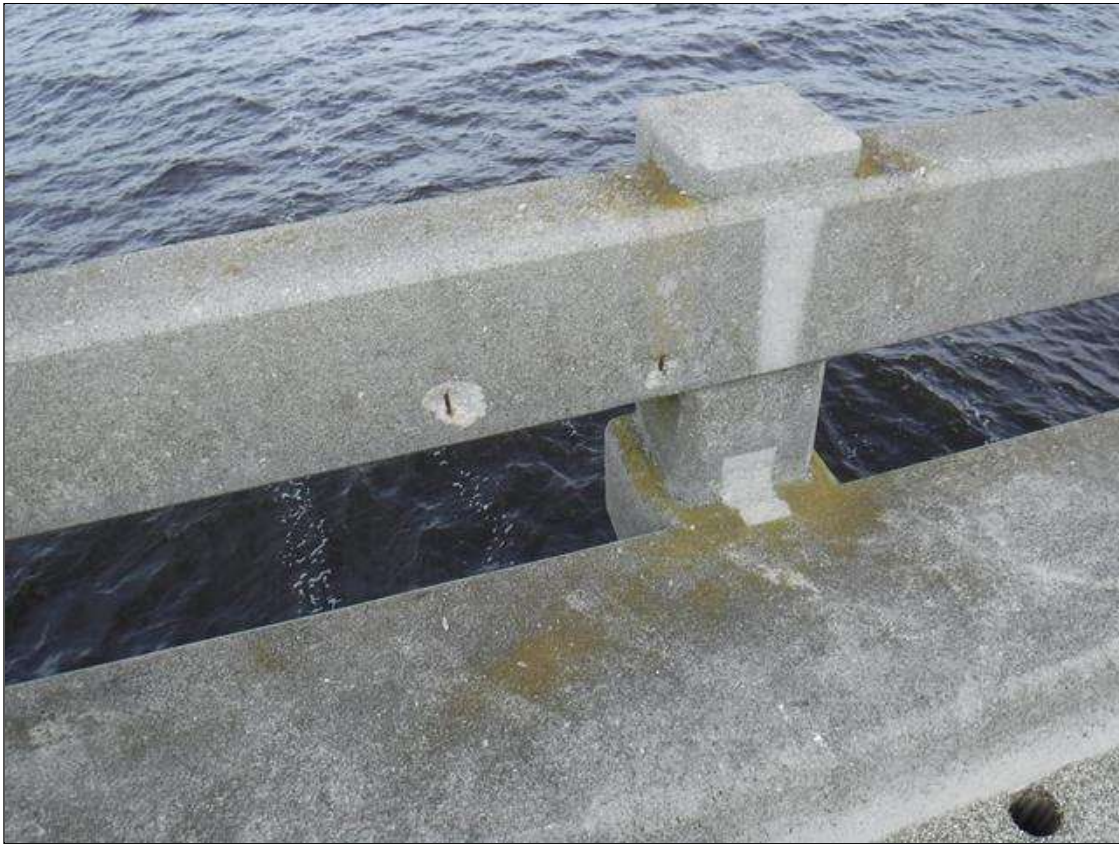
Span 191 Left Bridge Rail: 6" X 3" X 2" SPALL AT TOP LEFT CORNER LOCATED ON POST 6

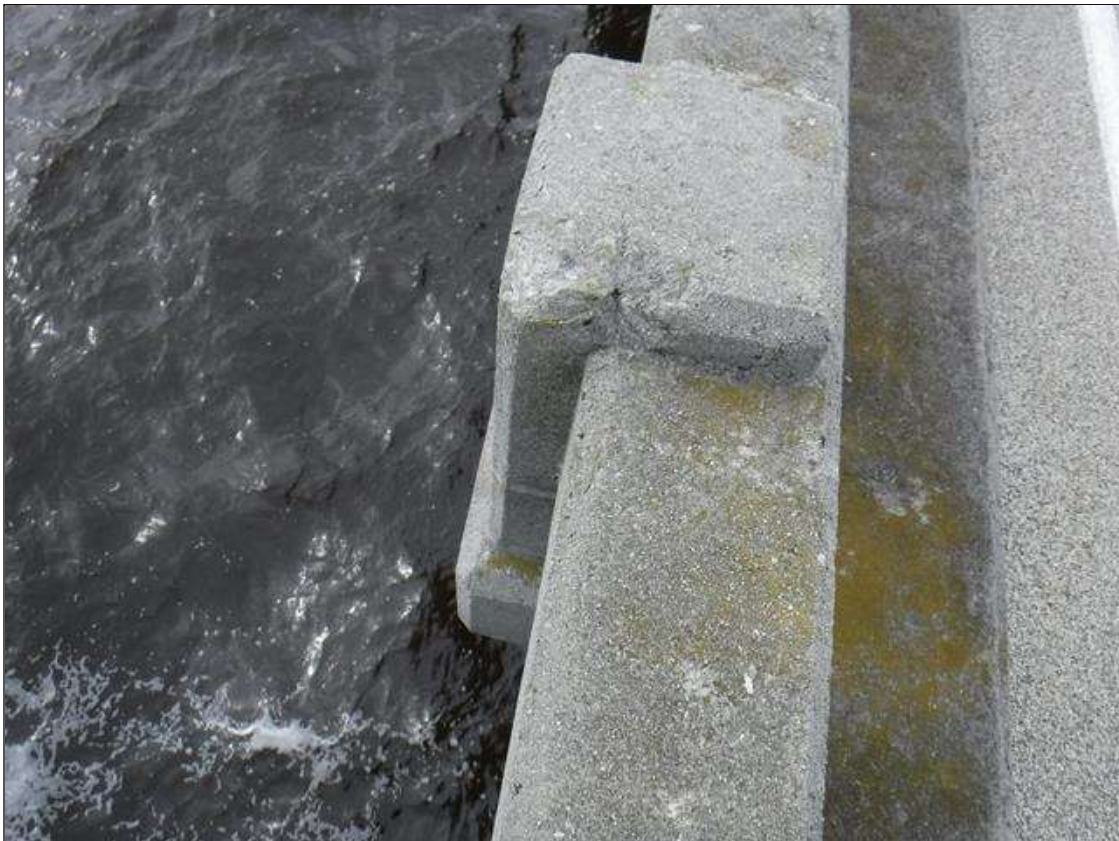
Span 191 Left Bridge Rail: (2) 4" DIAMETER SPALLS WITH EXPOSED REBAR ON RIGHT FACE LOCATED 2' BEFORE POST 2

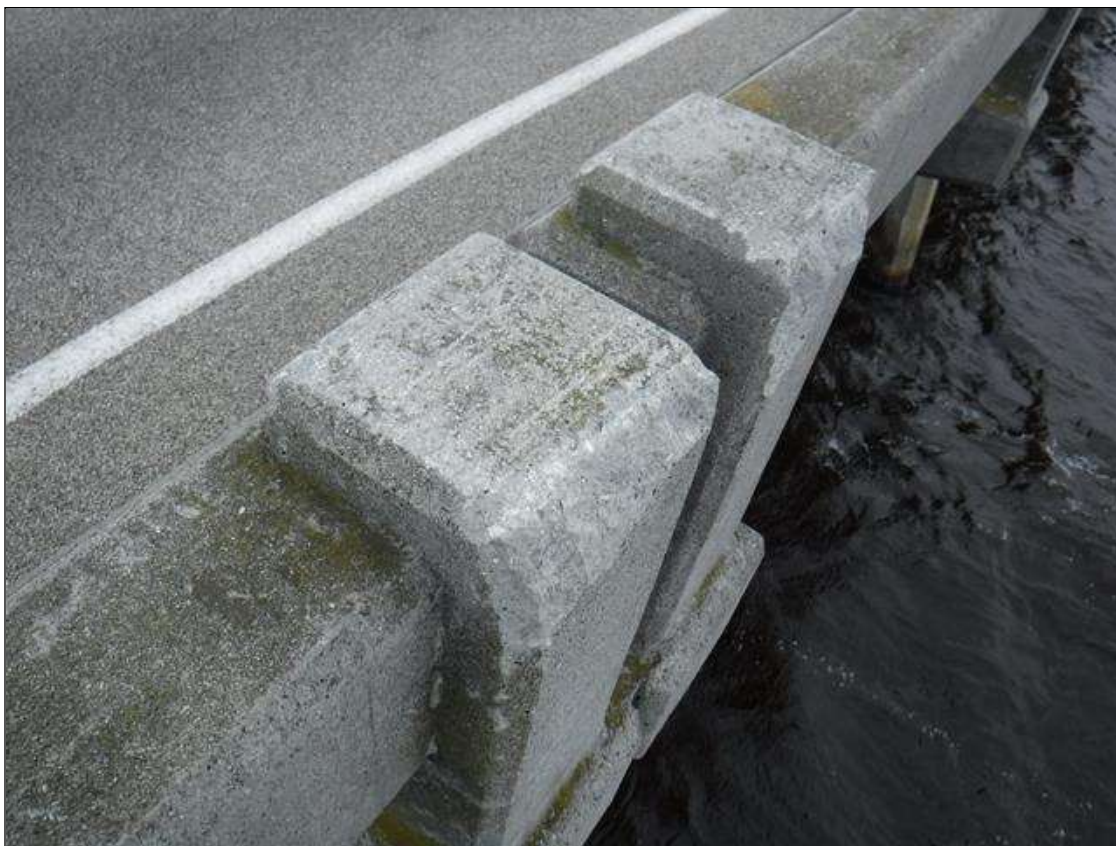
Span 218 Right Bridge Rail: 6" X 3" X 3" SPALL AT TOP RIGHT CORNER LOCATED ON POST 5

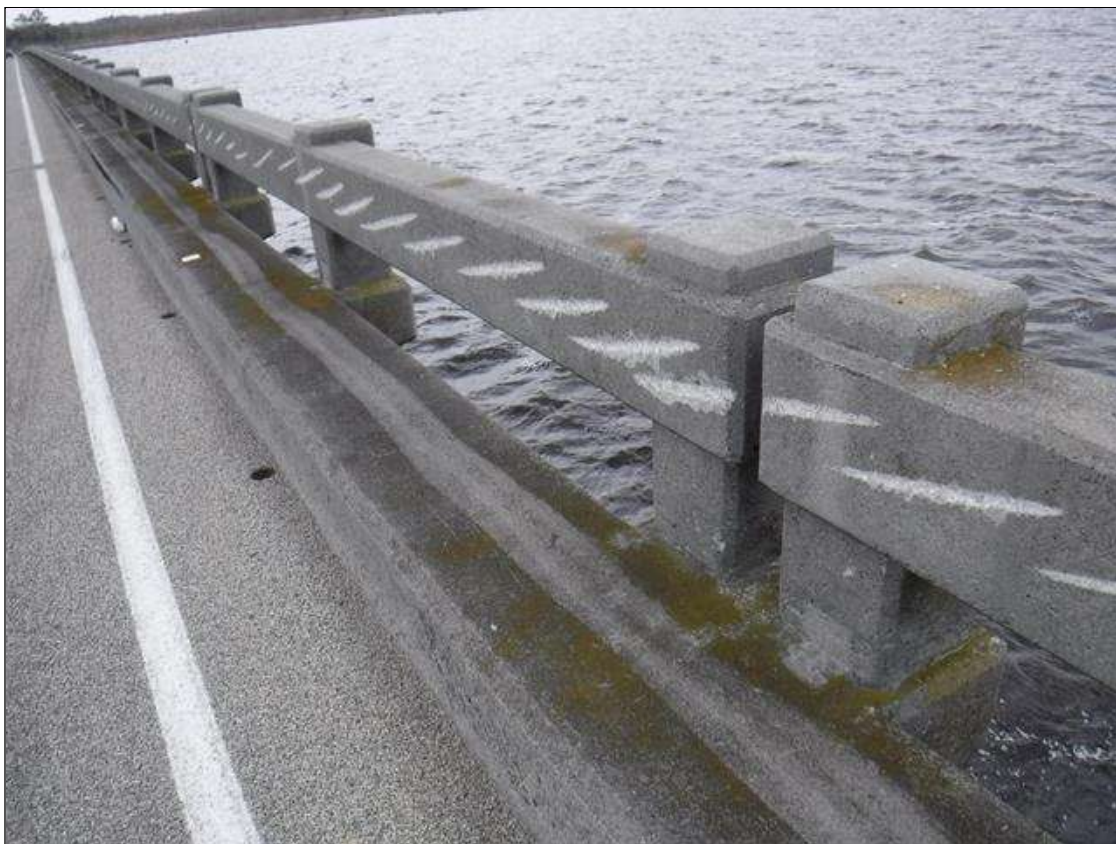
Expansion Joint 246 : FULL LENGTH SEAL DAMAGE WITH LOSS OF ADHESION LOCATED AT BENT 246

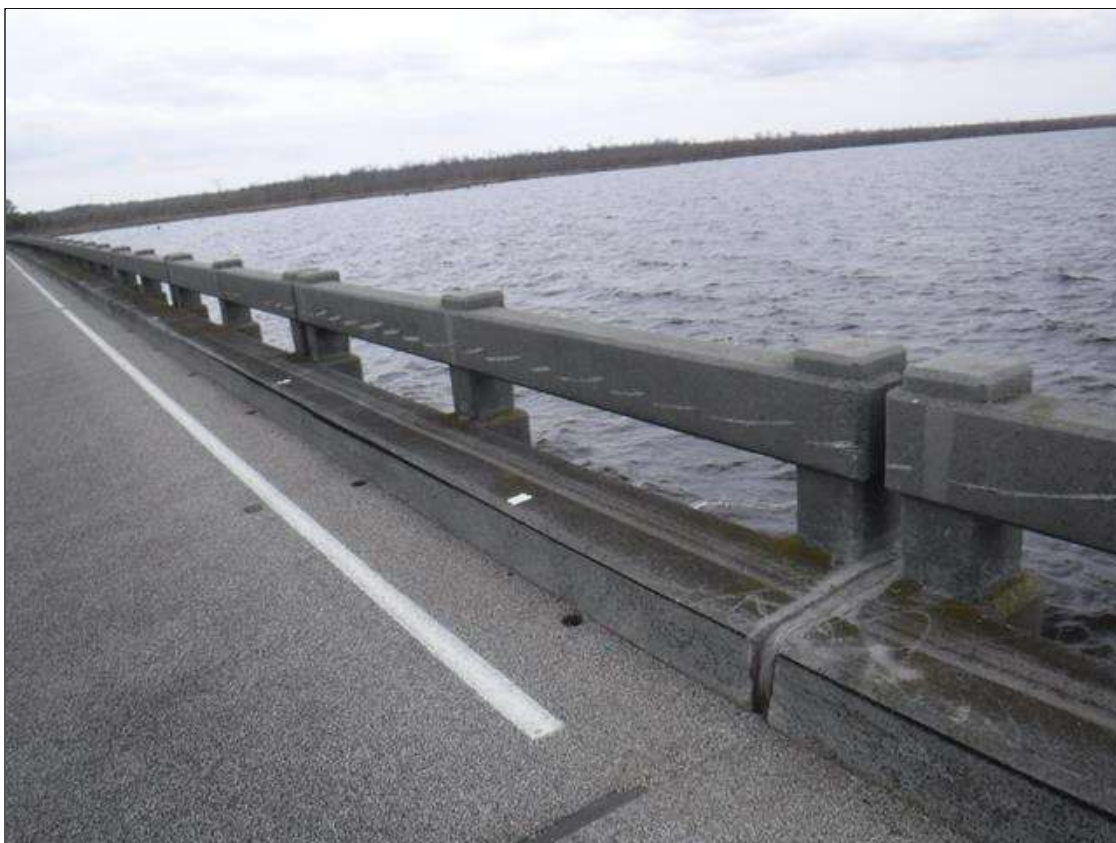
Span 258 Right Bridge Rail: 42' OF SCRAPES AND GAUGES CAUSED BY IMPACT DAMAGE ON LEFT FACE
LOCATED ALONG RAIL

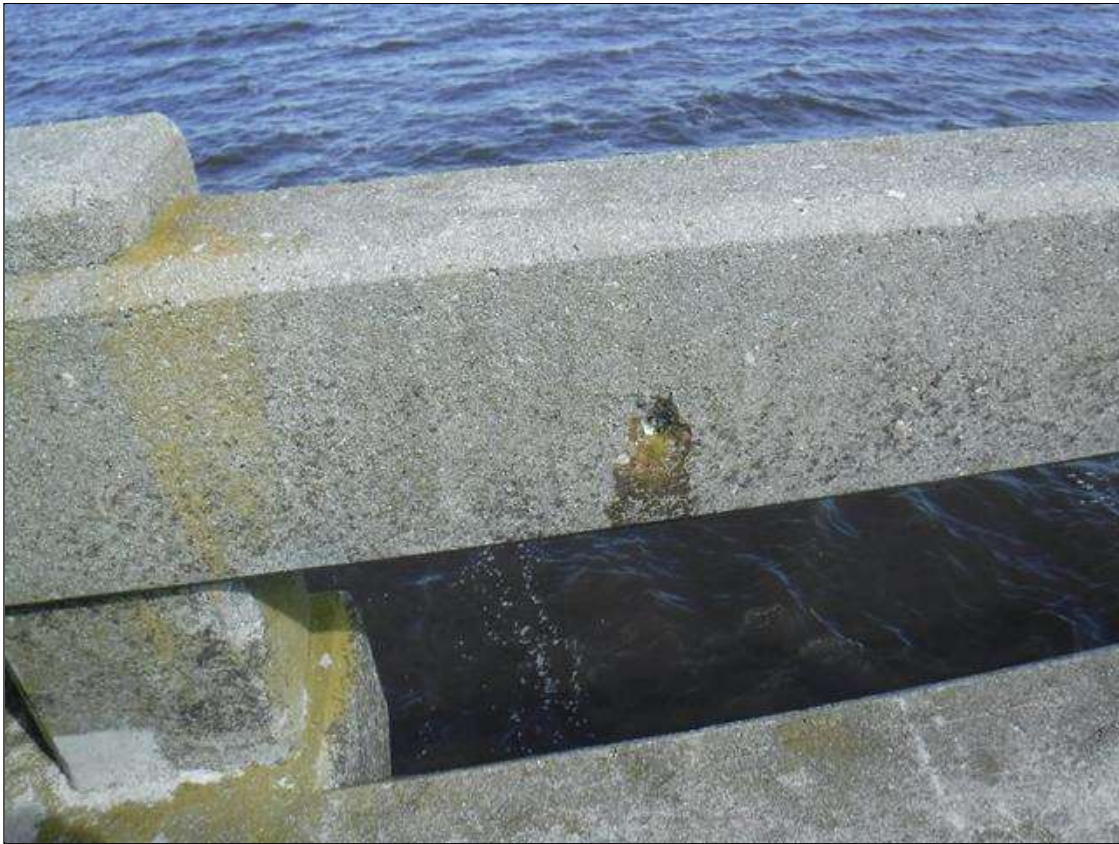
Span 259 Left Bridge Rail: 24' OF SCRAPES AND GAUGES CAUSED BY IMPACT DAMAGE ON LEFT FACE
LOCATED ALONG RAIL

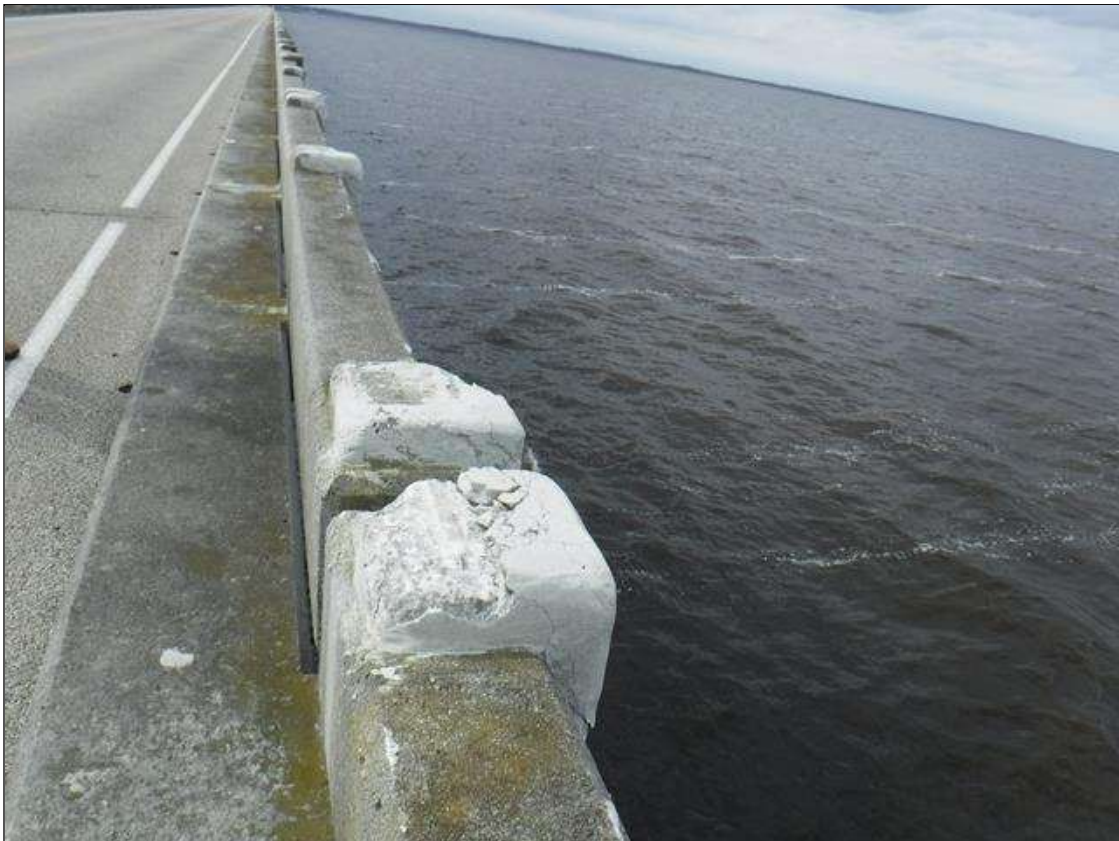
Span 180 Left Bridge Rail: 4" X 6" FAILED PATCHED AREA, SOUTH FACE, BETWEEN RAIL POSTS 7 AND 8 FROM BENT 179.

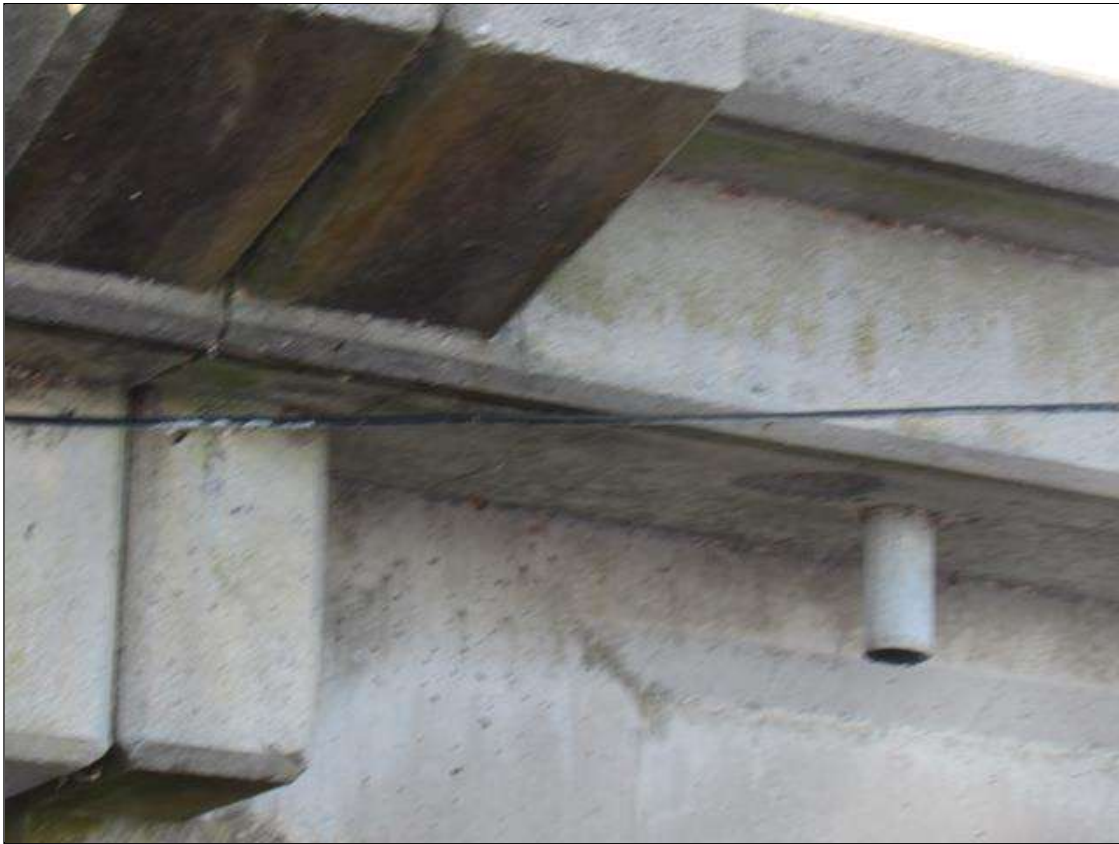
Span 242 Left Bridge Rail: (8) UP TO 10" X 10" CRACKED PATCHED AREAS, WITH UP TO 6" X 6" X 4" SPALLS, SOME WITH EXPOSED REINFORCING, AT RANDOM THROUGHOUT TOP OF RAIL POSTS.

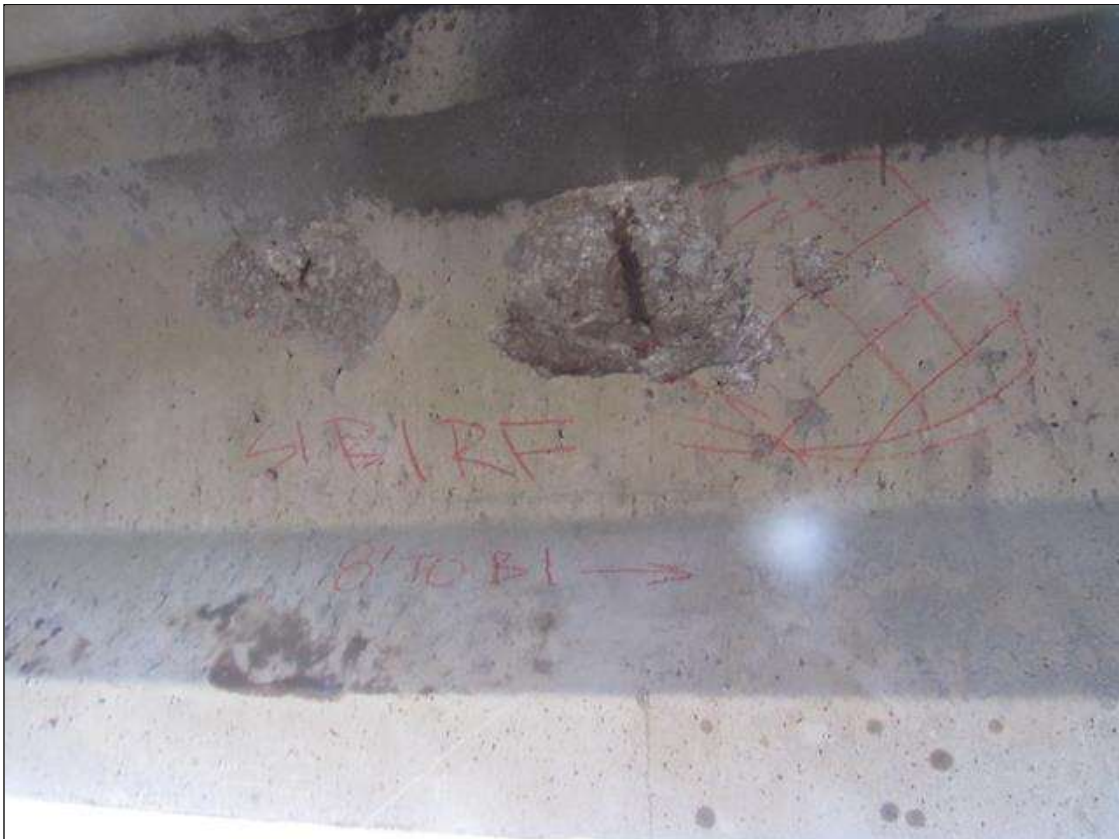
Span 1 Deck: 8" DIAMETER X 1" SPALL, WITH EXPOSED REINFORCING, DECK UNDERSIDE, NORTH OVERHANG, 3' FROM BENT 1.
