NC DEPARTMENT OF TRANSPORTATION
DIVISION OF HIGHWAYS
STRUCTURE MANAGEMENT UNIT

Structure Safety Report

Routine Element Inspection - Contract

FEATURE INTERSECTED: ALLIGATOR RIVER

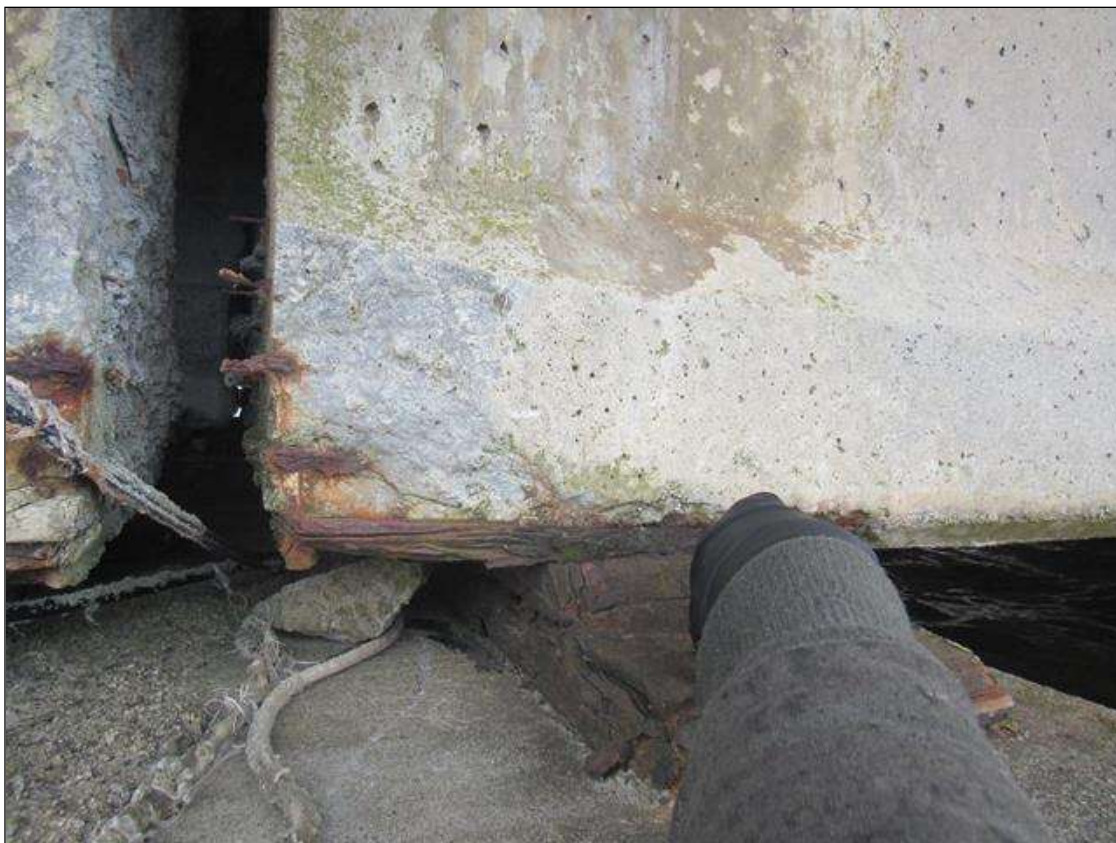
Span 1 Beam 2: 8" X 8" X 1" SPALL, WITH EXPOSED REINFORCING, SOUTH FACE, 16" FROM END BENT 1.

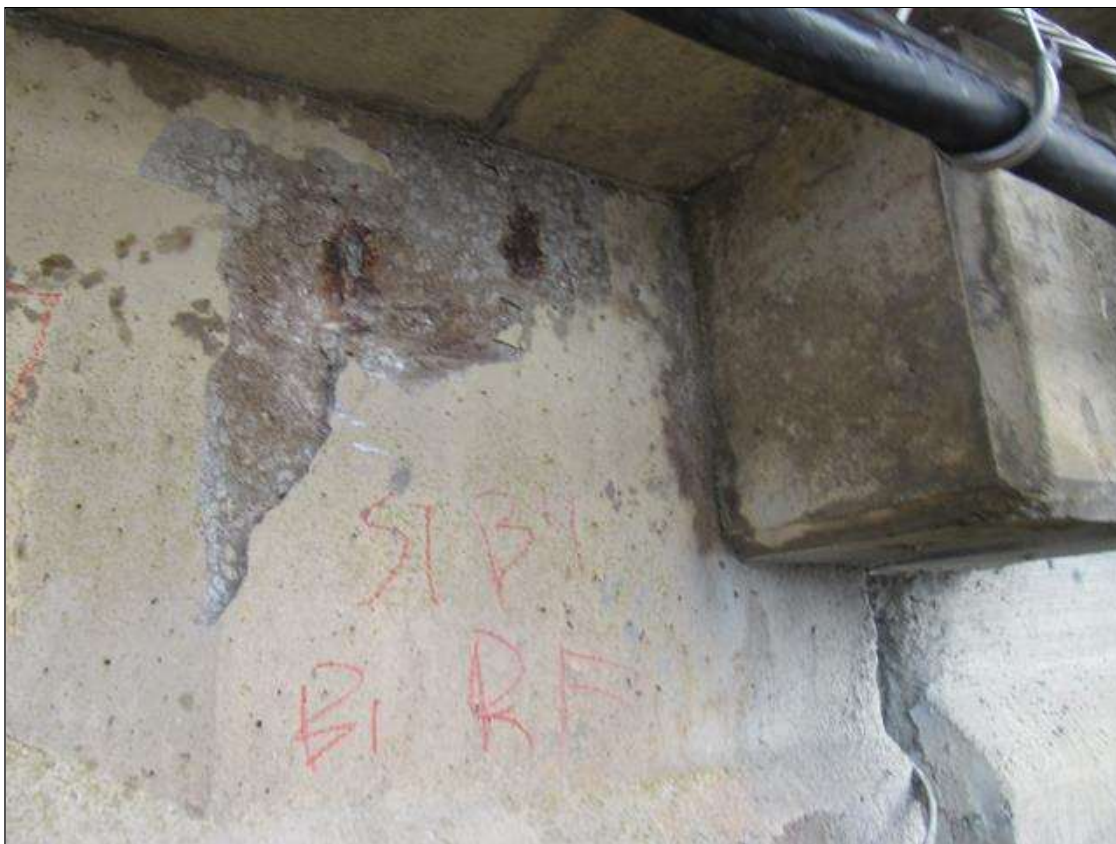
Span 1 Beam 1: (PAR) 8" x 8" x 2" DEEP SPALL (2) EXPOSED PRESTRESSED STRANDS ON RIGHT FACE
LOCATED 8' FROM BENT 1

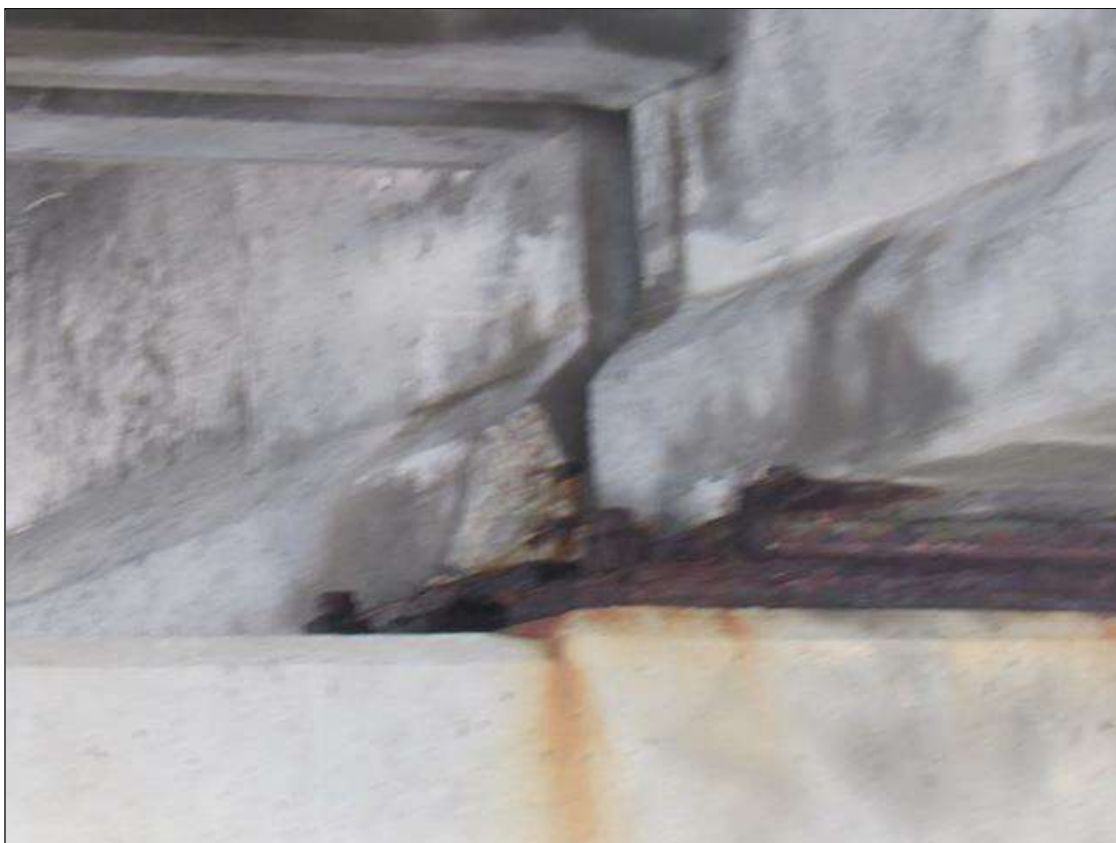
Span 1 Beam 4: 21" X 19" SURFACE SPALL WITH (2) UP TO 4" LONG EXPOSED REBARS, SOUTH FACE, 3' FROM BENT 1.

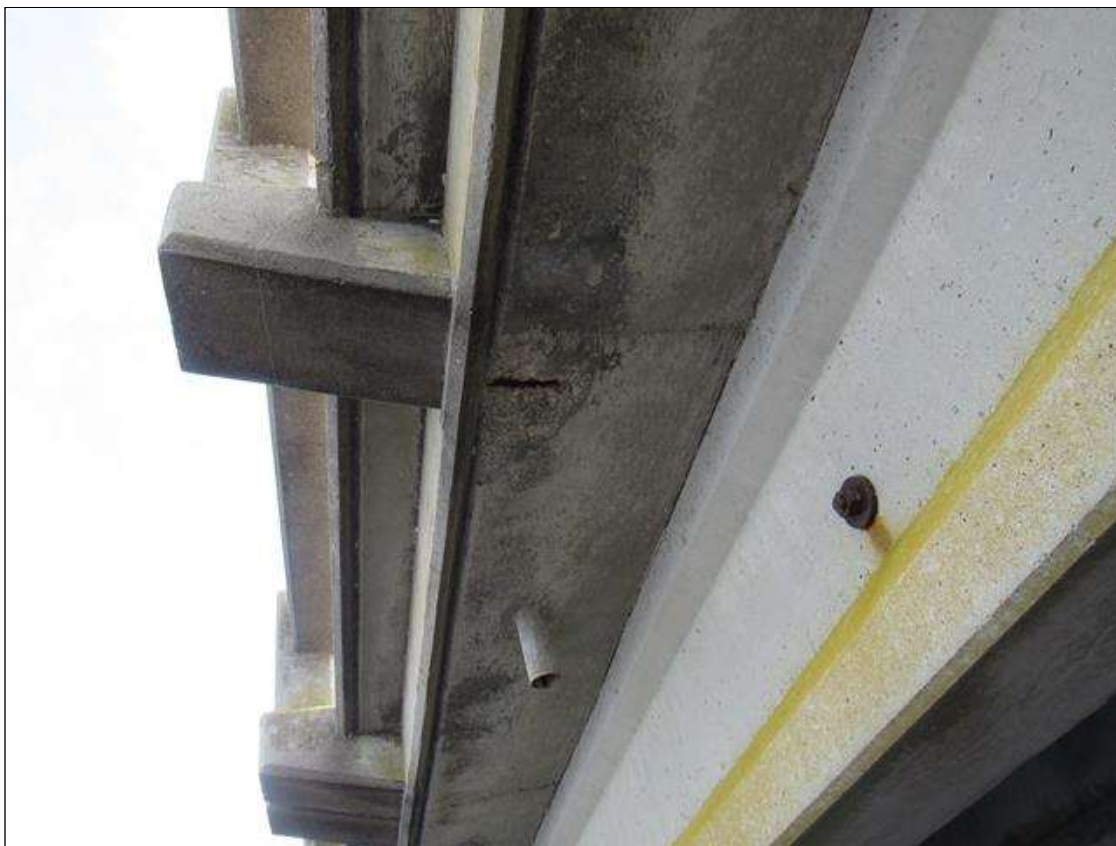
Span 274 Beam 2: (PAR) 6" X 6" X 1" SPALL, WITH EXPOSED STRAND, NORTH FACE, AT BENT 273.

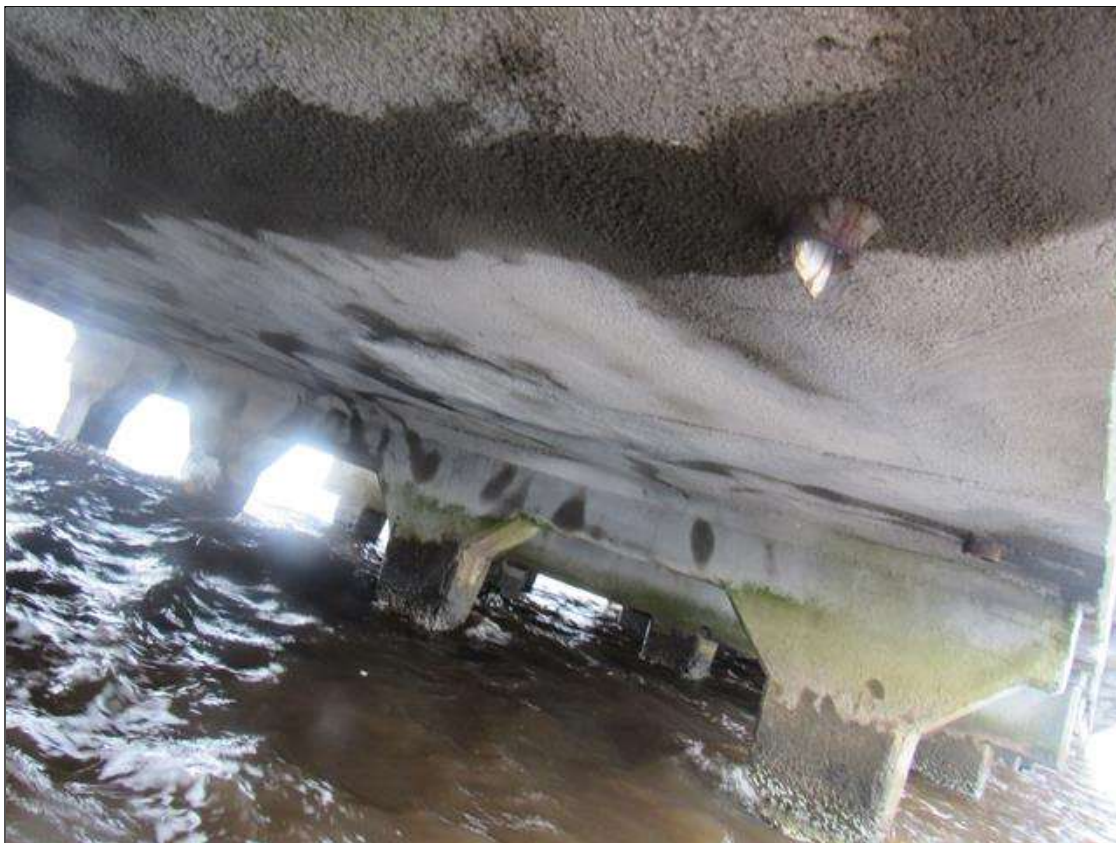
Span 276 Deck: 18" X 10" X 1" SPALL WITH EXPOSED REINFORCING, DECK UNDERSIDE, NORTH OVERHANG, NEAR MIDSPAN.

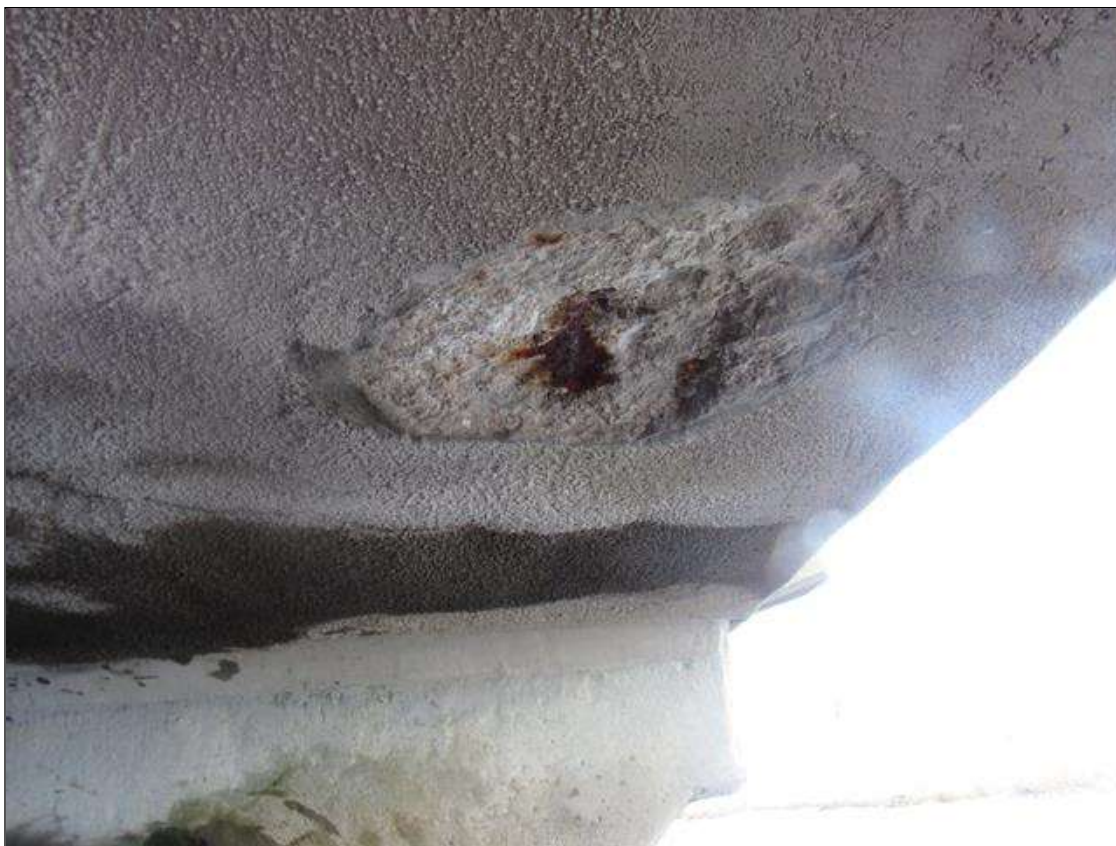
Span 291 Deck: 180 SF OF PATCHED AREA, AT RANDOM THROUGHOUT DECK UNDERSIDE.

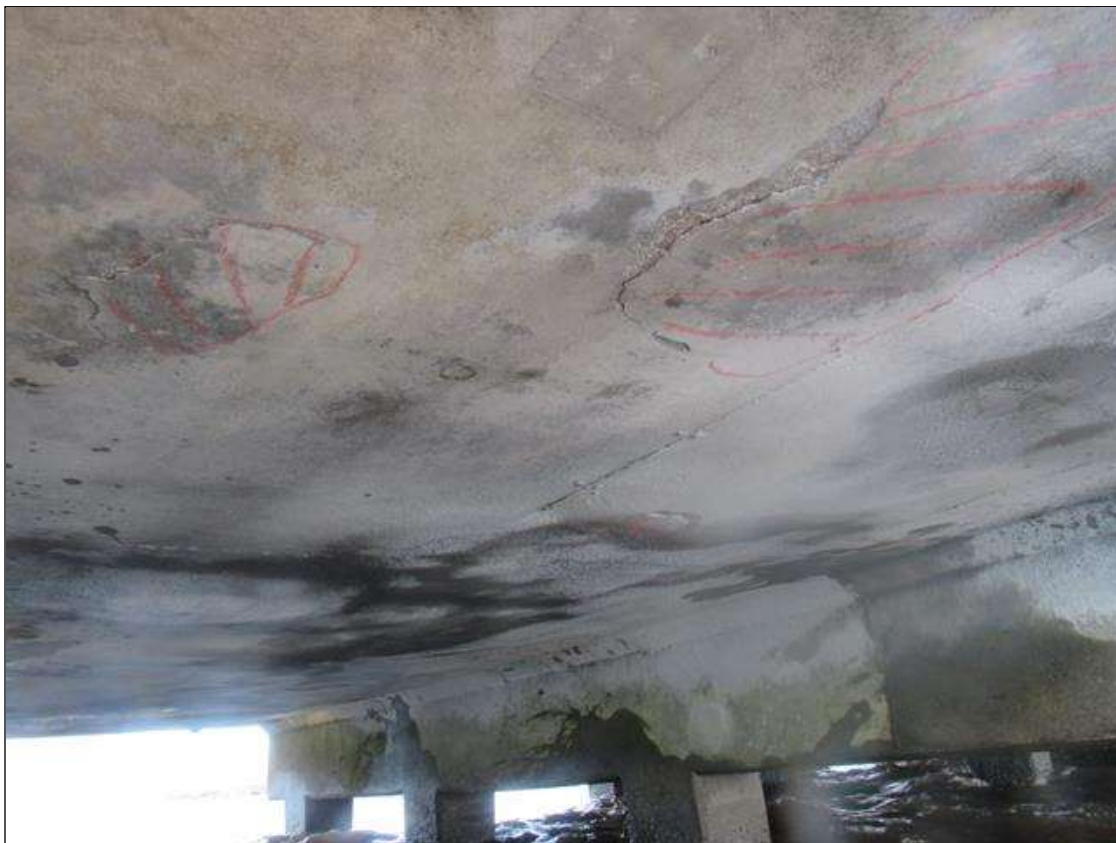
Span 294 Deck: 16" DIAMETER X 2" SPALL, WITH EXPOSED REINFORCING, DECK UNDERSIDE, 2' FROM SOUTH FACE, NEAR MIDSPAN.

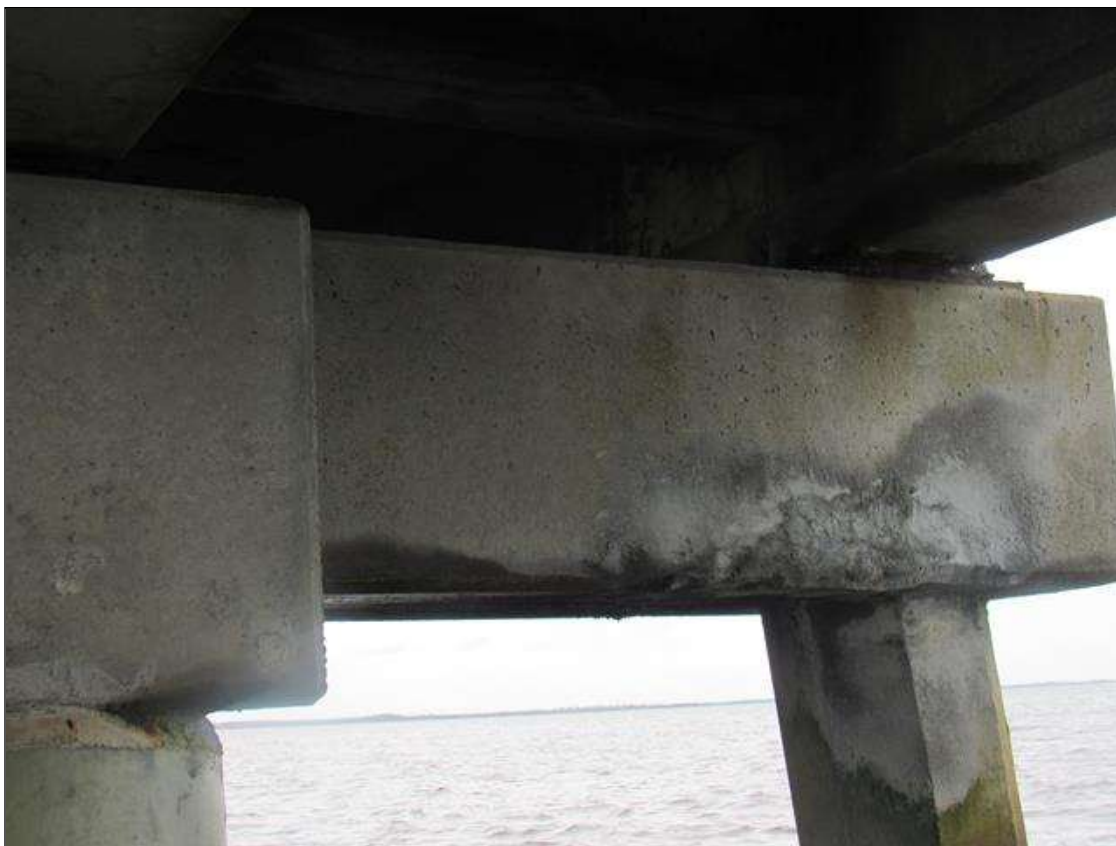
Span 295 Deck: (3) UP TO 14" X 20" DELAMINATIONS, AT NEAR RIGHT EDGE OF DECK UNDERSIDE.

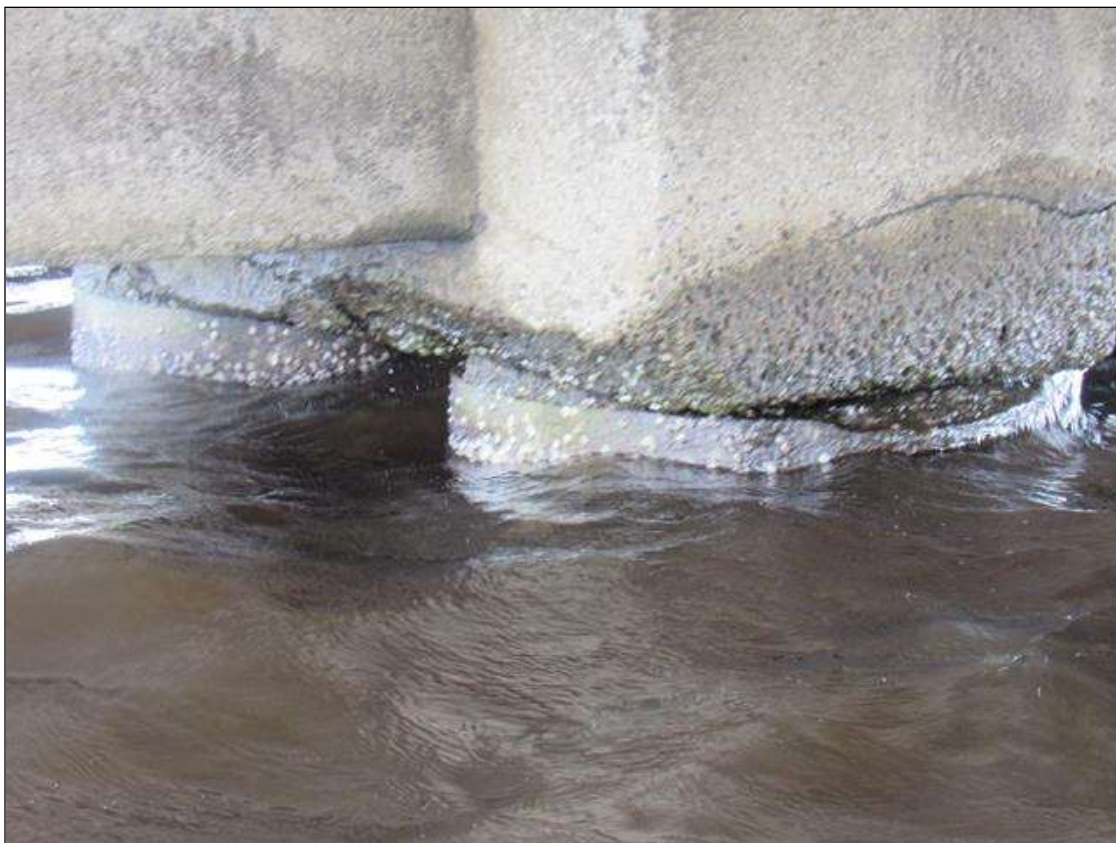
Bent 271 Cap 1: 4' X 6" PATCHED AREA, EAST FACE, BETWEEN BEAMS 1 AND 2.

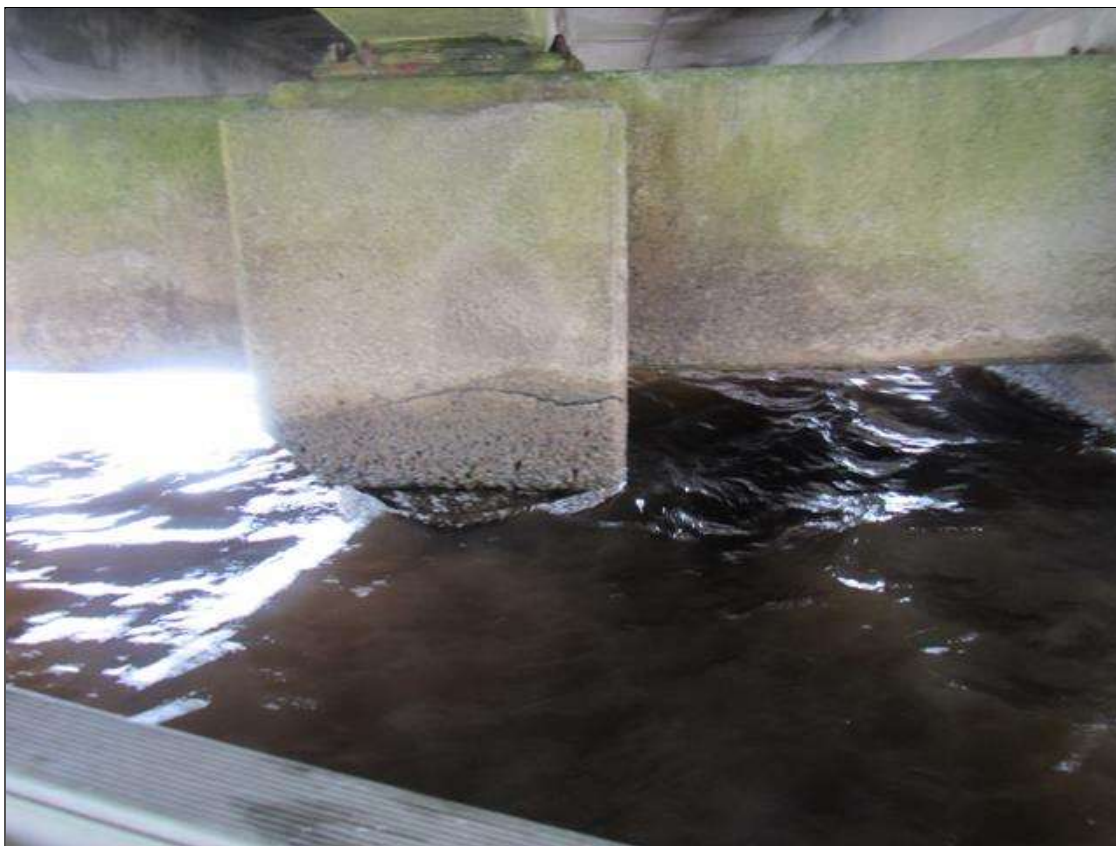
Bent 275 Cap 1: 5' X UP TO 6" X 6" SPALL, WITH EXPOSED REINFORCING, NORTH FACE OF PILE 2 BLOCK-OUT.

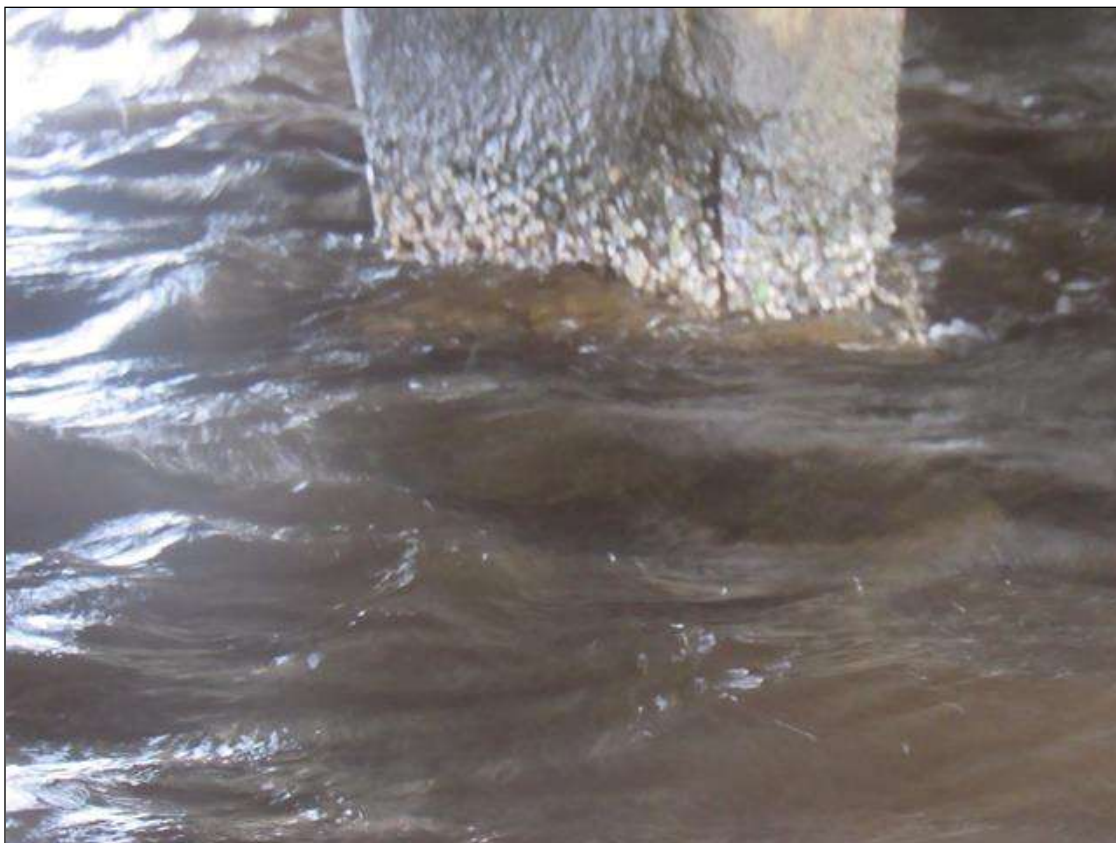
Bent 275 Cap 1: 3' X 8" DELAMINATION, WEST FACE, PILE 2 BLOCK-OUT.

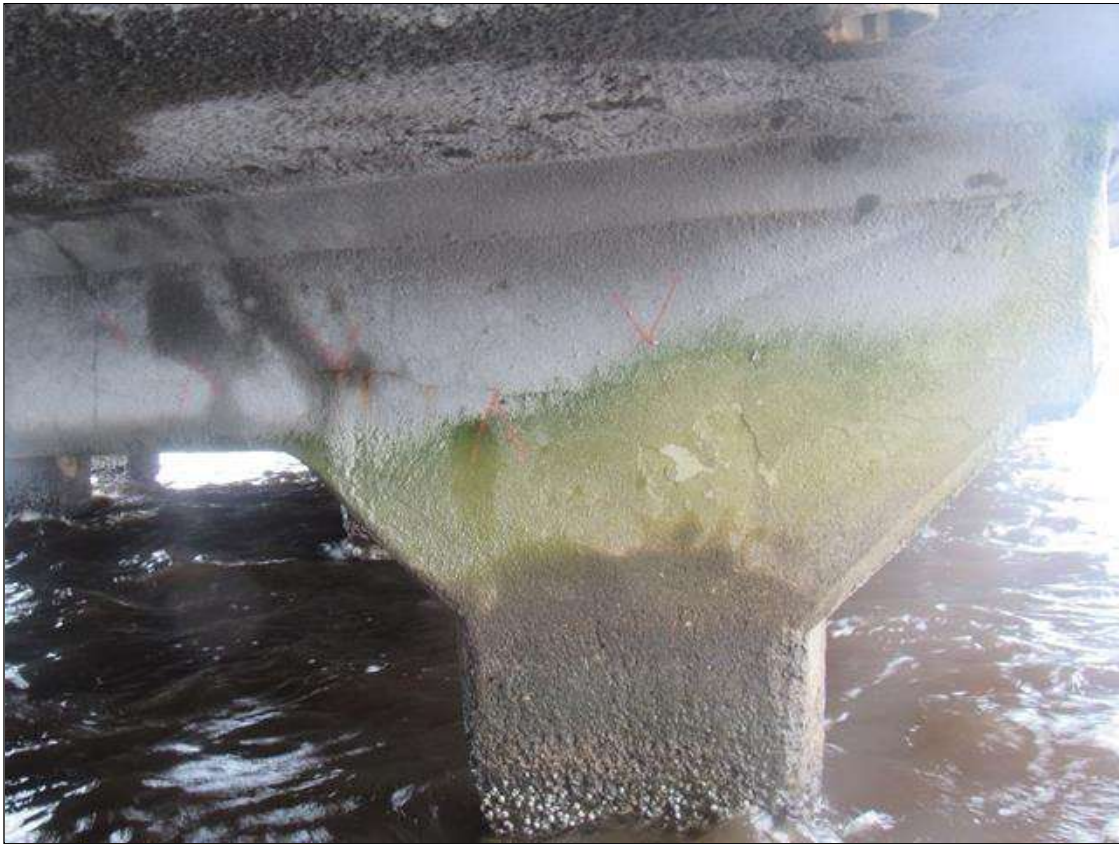
Bent 290 Pile 2: (PAR) 8" X 3" X 3" SPALL, WITH EXPOSED PRIMARY REBAR, NORTHEAST CORNER, 2' FROM BOTTOM OF CAP. REBAR HAS 10% SECTION LOSS

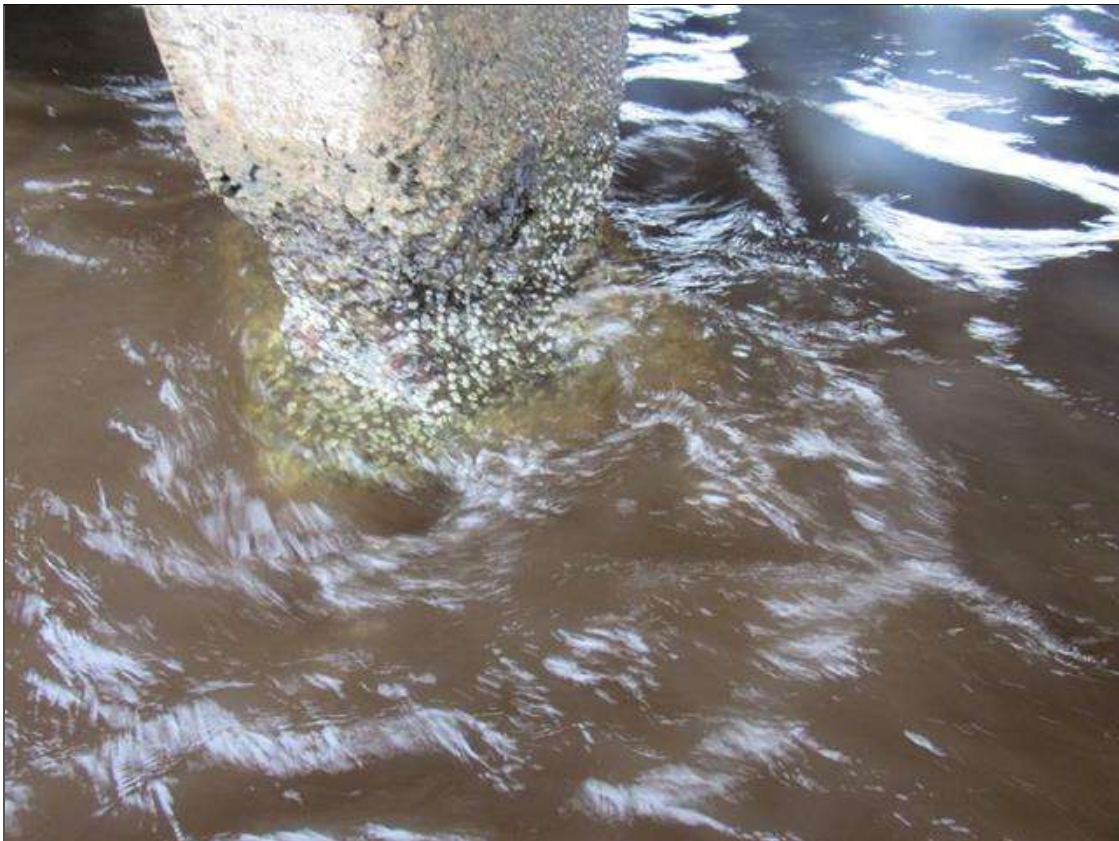
Bent 291 Cap 1: 4' OF UP TO 1/16" LONGITUDINAL CRACKS, AT RANDOM THROUGHOUT, EAST AND WEST FACES.

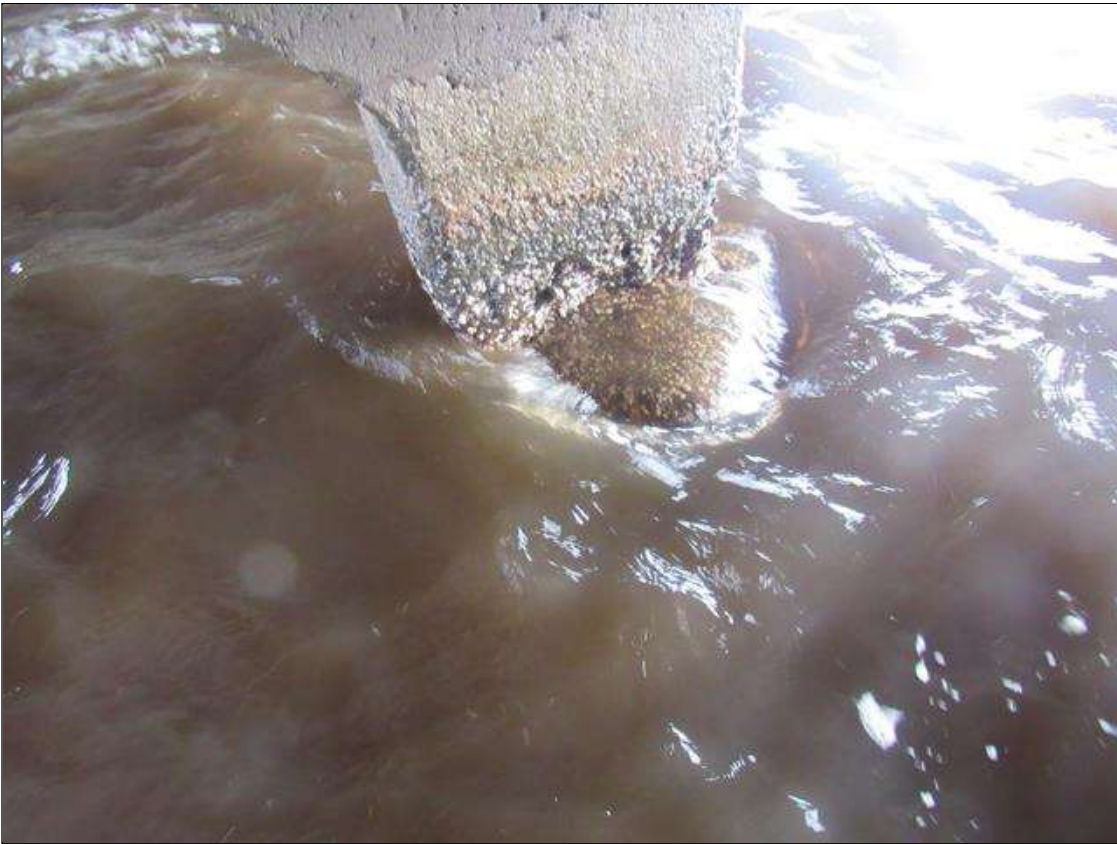
Bent 292 Pile 2: (PAR) SCALING AROUND BASE OF COLUMN AND TOP OF FOOTING 3" - 6" DEEP X 8" HIGH X 360*, EXPOSED REBAR WITH 25% SECTION LOSS.

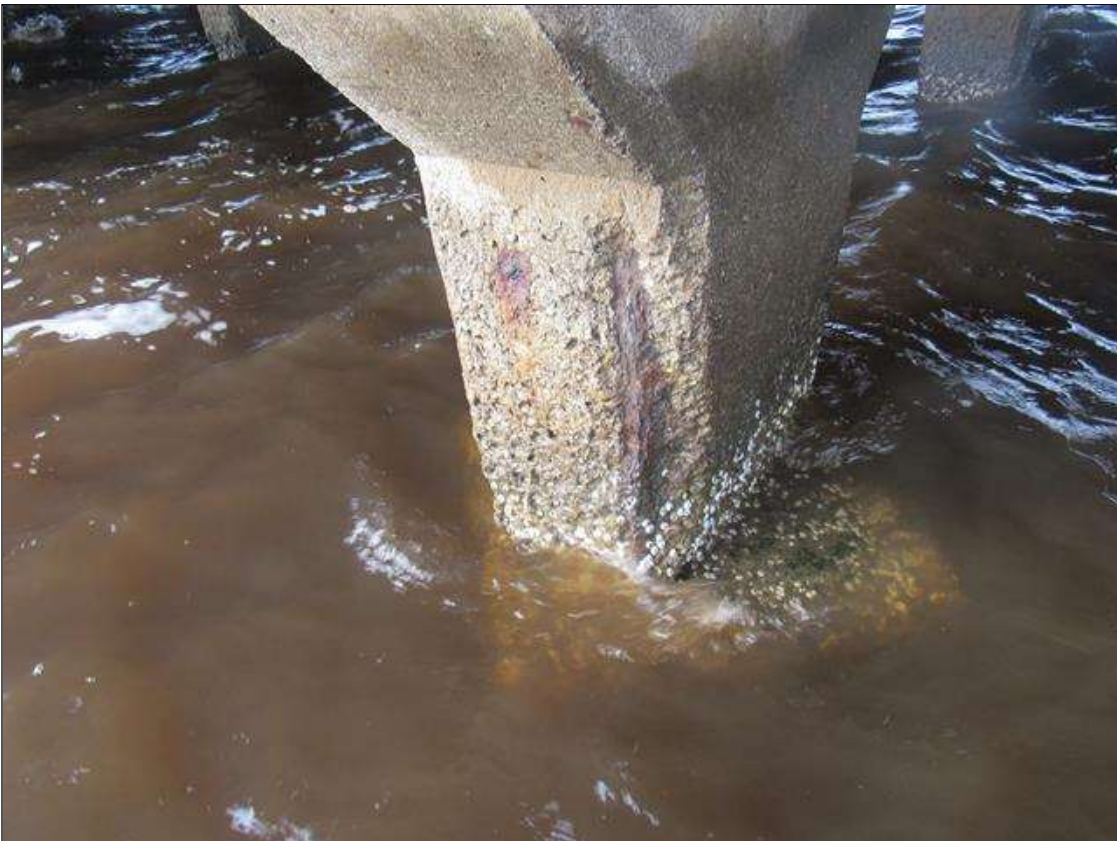
Bent 292 Pile 3: (PAR) 6" X 20" X 6" SPALL, WITH EXPOSED PRIMARY REBAR, WEST FACE, 2' FROM BOTTOM OF CAP. REBAR HAS 10% SECTION LOSS

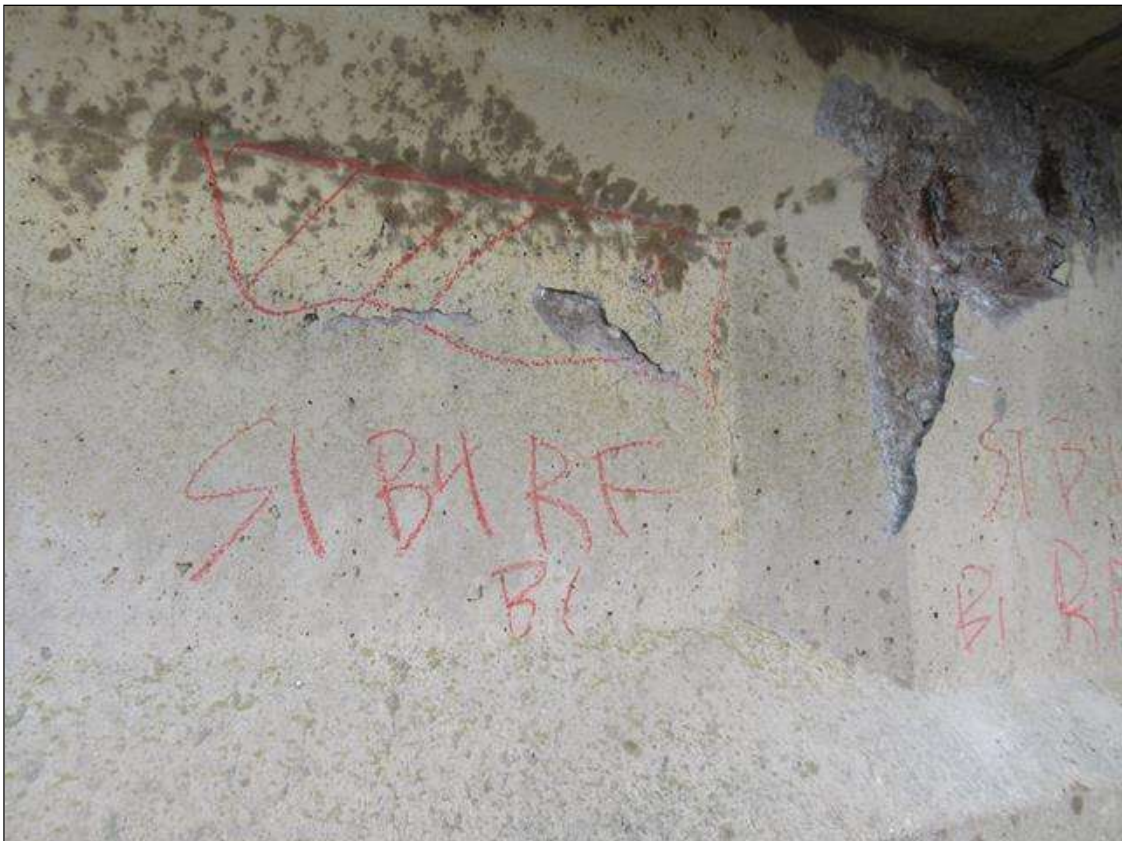
Span 1 Beam 2: 12" DIAMETER DELAMINATION ON RIGHT FACE LOCATED AT END BENT 1

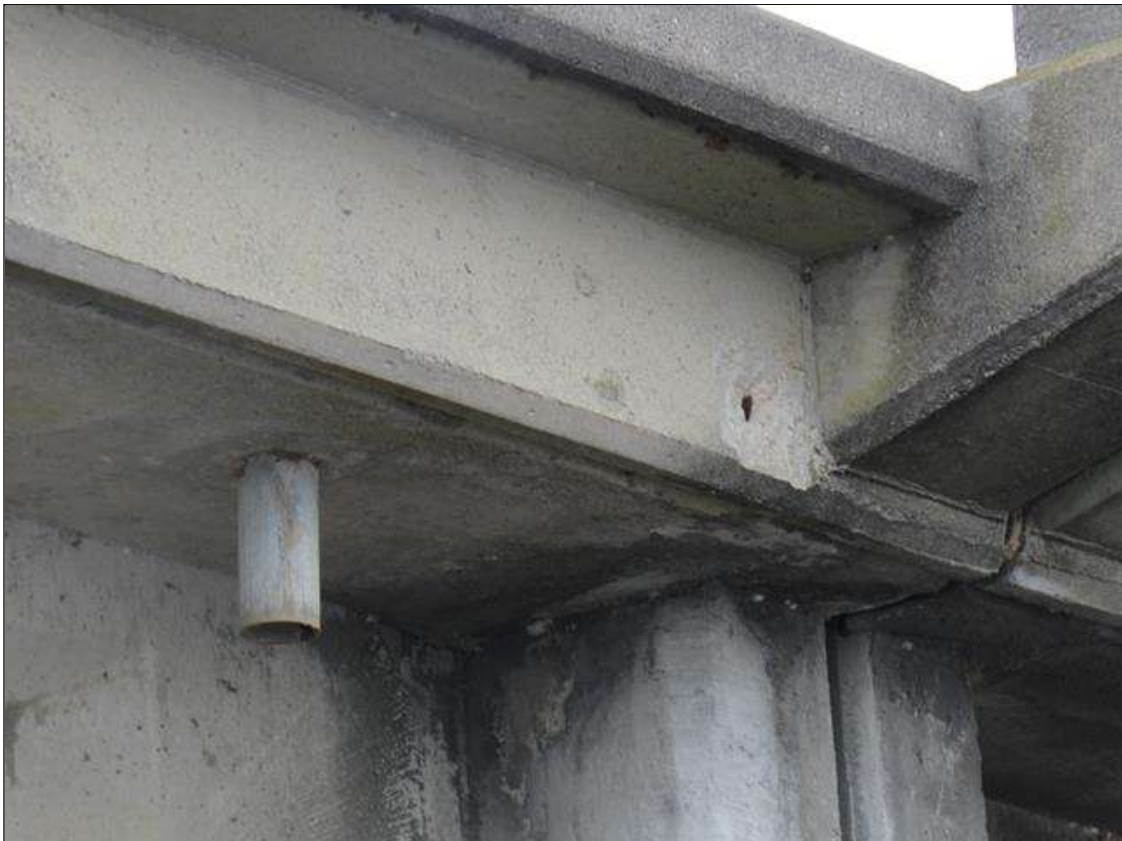
Span 1 Deck: 12" DIAPHRAGM FAILED PATCHED AREA ON UNDERSIDE OF DECK LOCATED 4' FROM END BENT 1 IN BAY 2

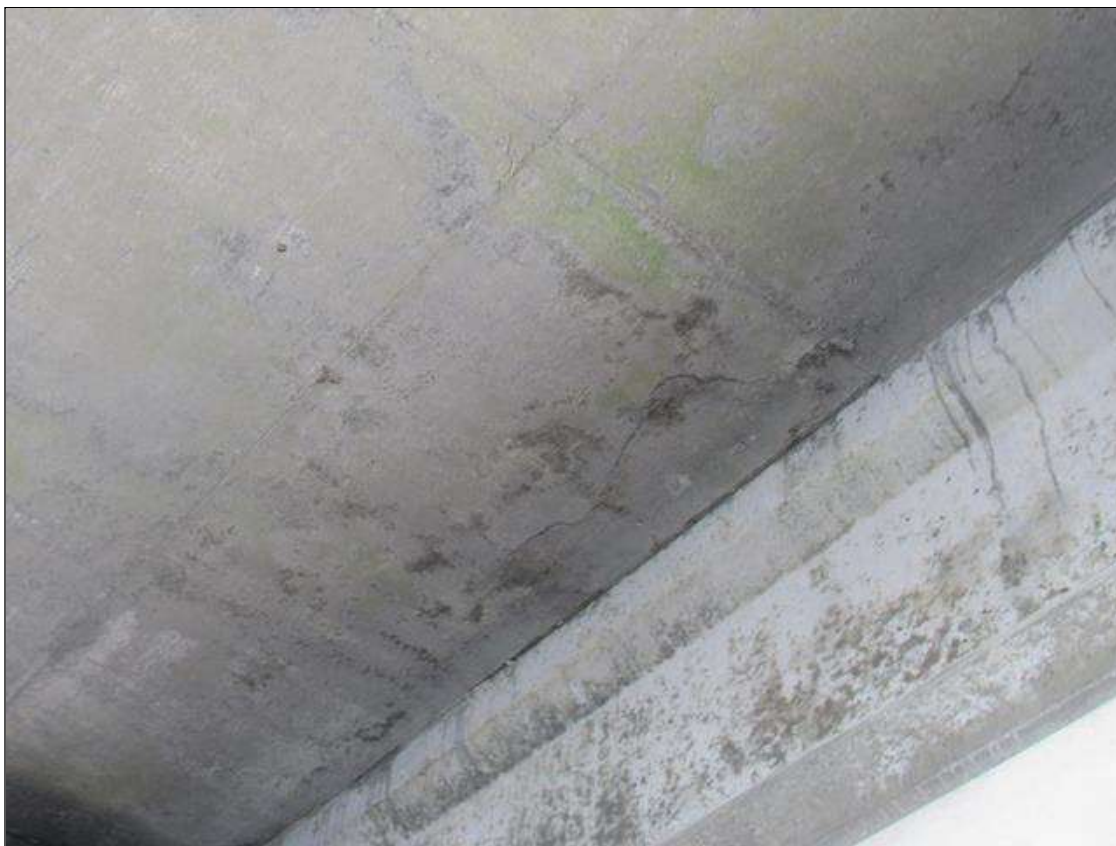
Span 267 Deck: 8" DIAMETER SPALL WTH EXPOSED REBAR ON UNDERSIDE OF DECK LOCATED ABOVE BENT

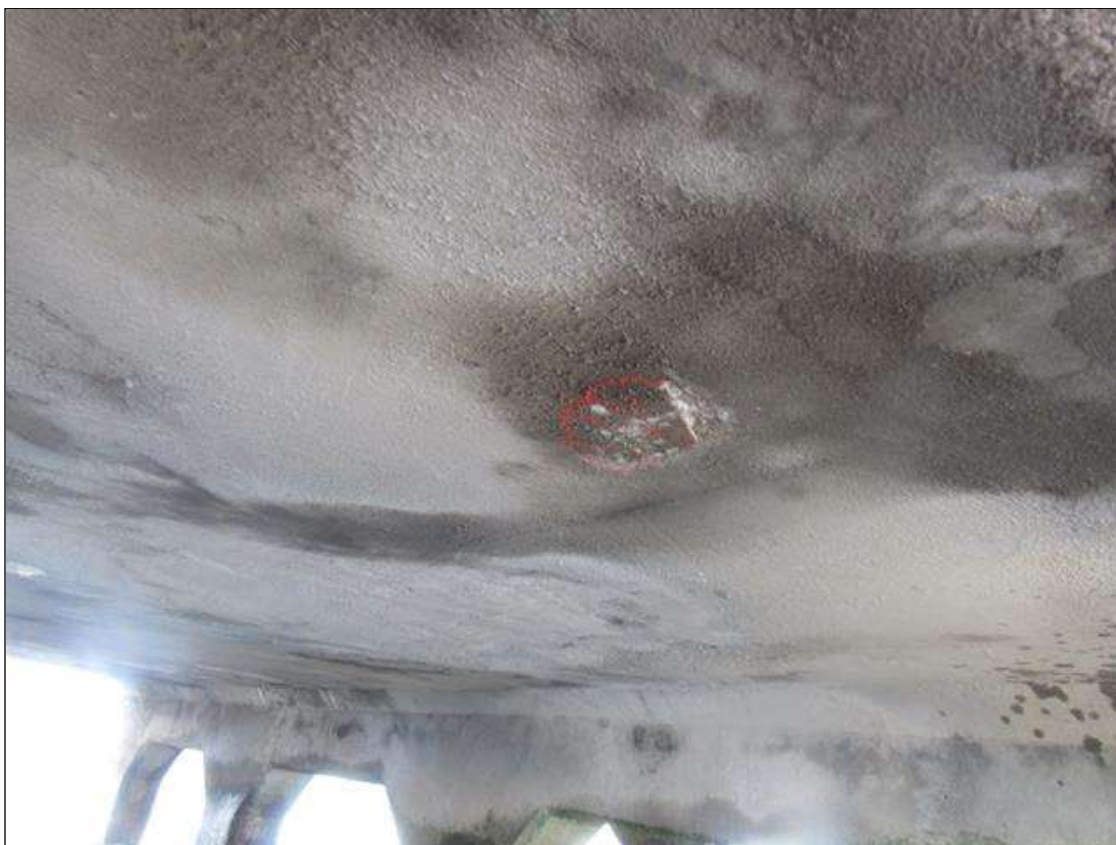
Span 269 Deck: 4' X UP TO 18" DELAMINATION ON UNDERSIDE OF DECK LOCATED LEFT OF BEAM 3, 6' FROM SPAN 270

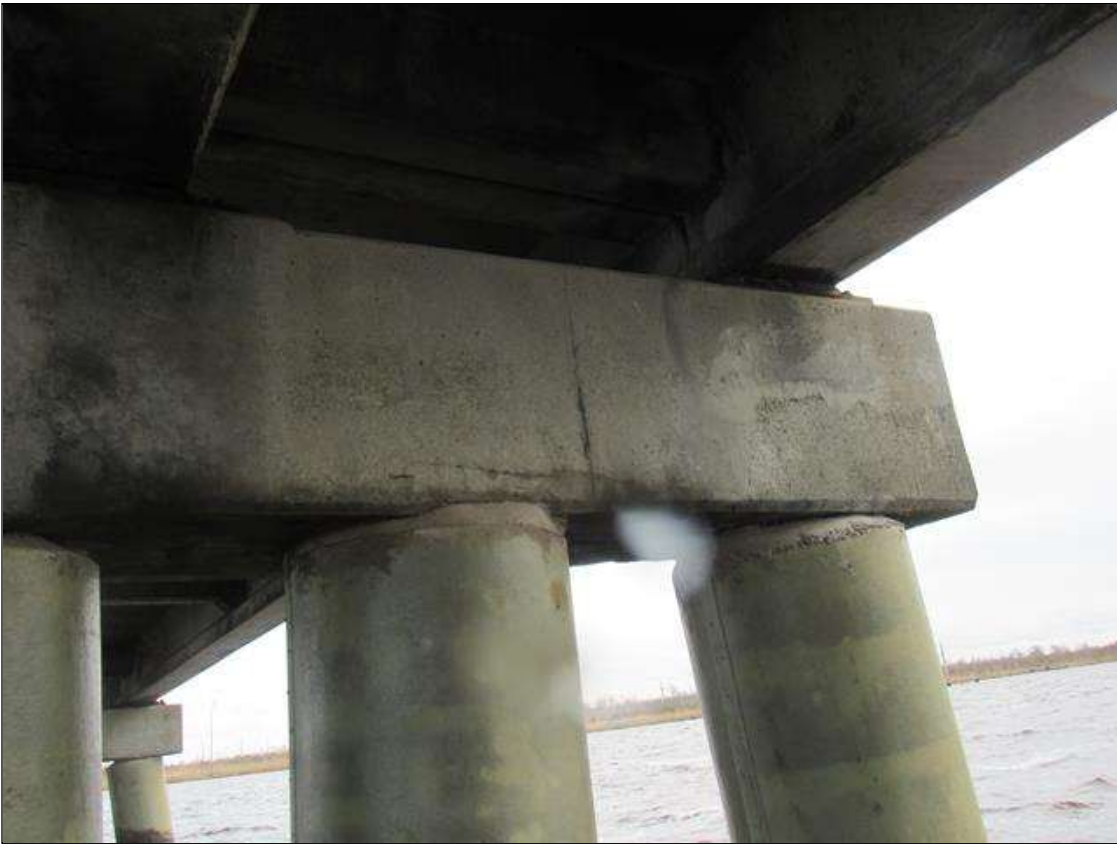
Span 295 Deck: 8" DIAMETER DELAMINATION ON BOTTOM FACE LOCATED 3' FROM LEFT EDGE AT MIDSPAN

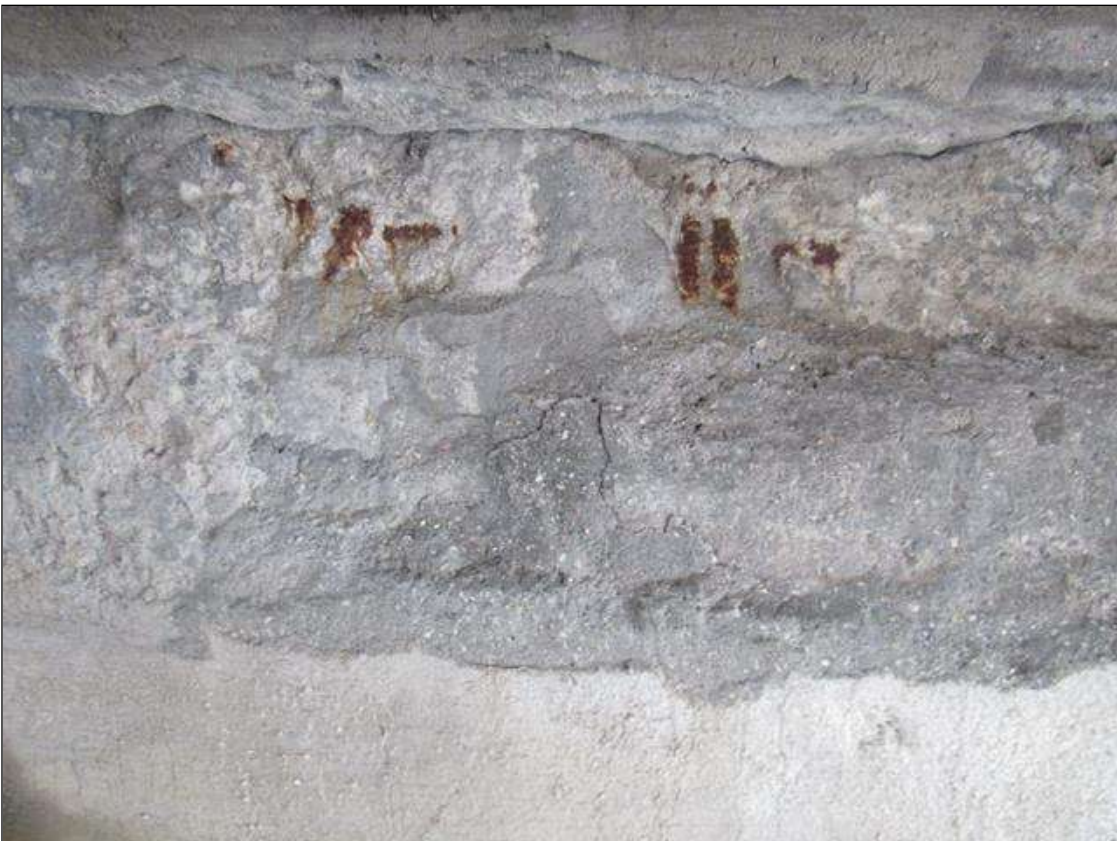
Bent 269 Cap 1: 3' LONG HORIZONTAL CRACK UP TO 1/16" WIDE ON NEAR FACE LOCATED ABOVE PILE 5

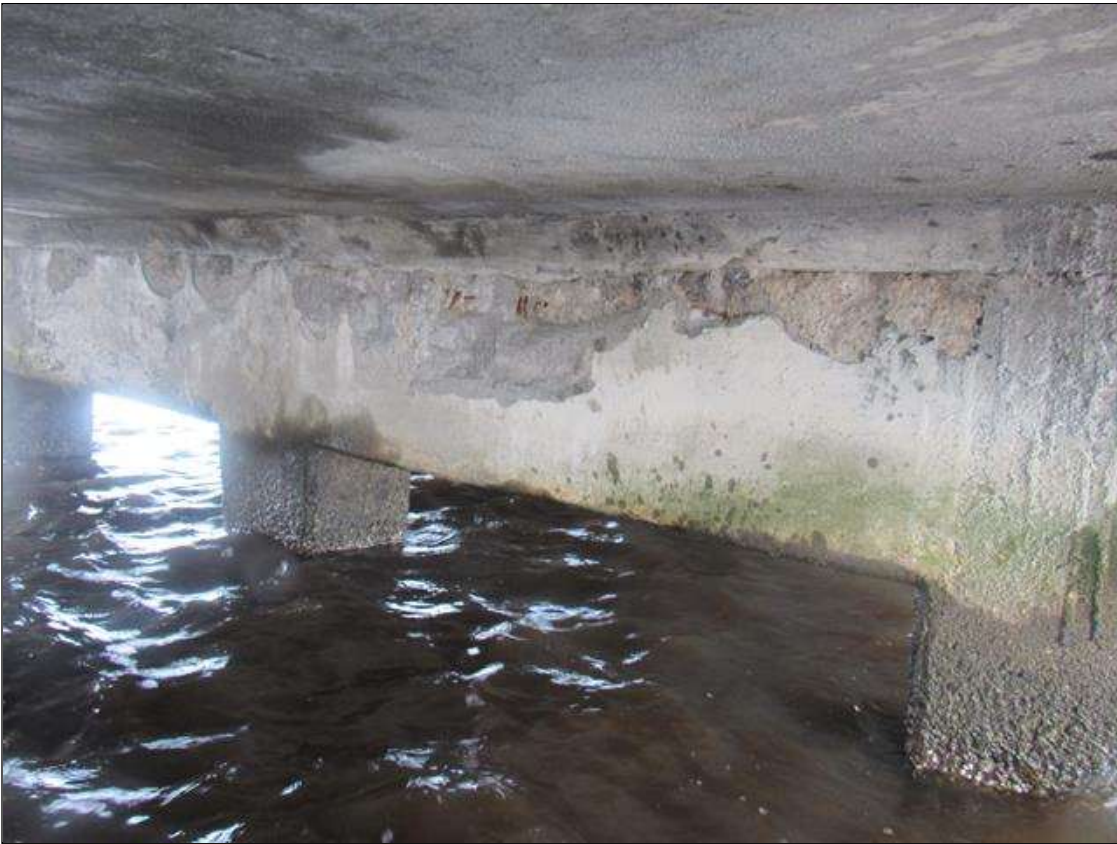
Bent 295 Cap 1: (PAR) 12' X UP TO 14" HIGH X 5" DEEP SPALL WITH EXPOSED REBAR ON EAST FACE LOCATED BETWEEN PILES 1 AND 3. LOSS OF UP TO 5" OF BEARING AREA FOR SLAB

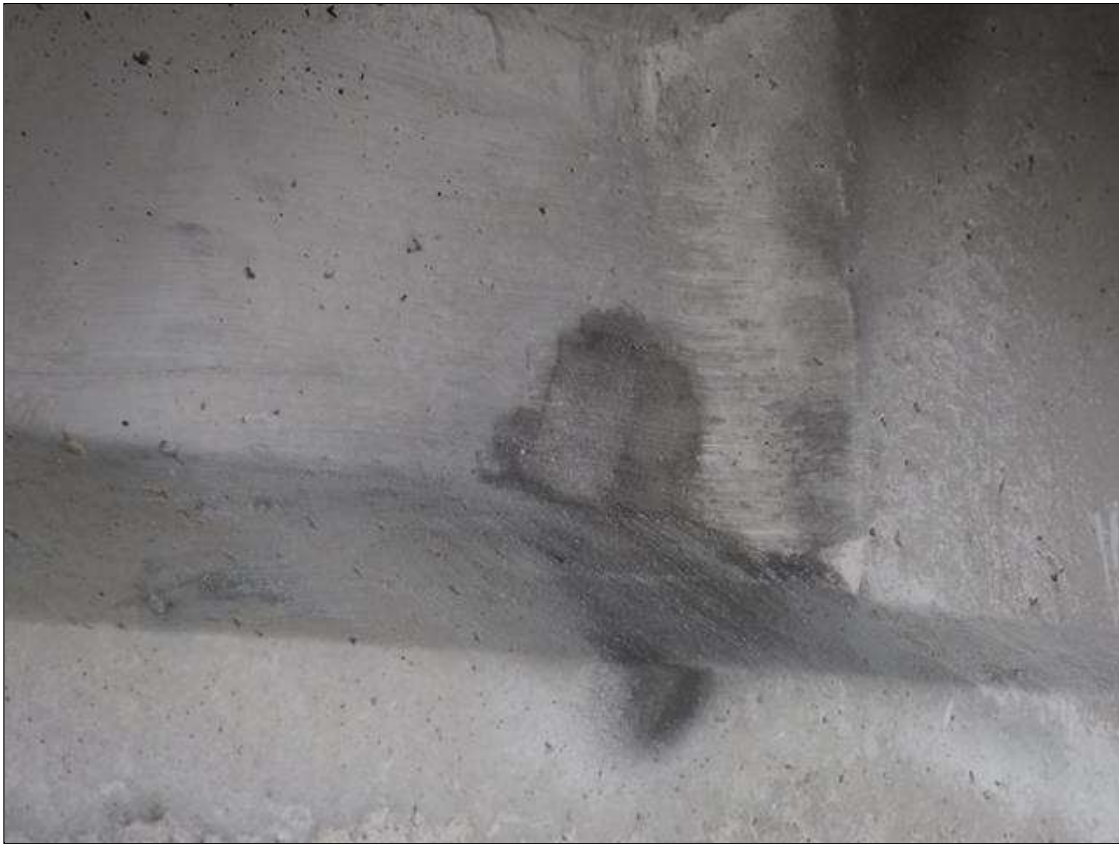
Span 203 Beam 1: 3" X 4" X 1/2" SPALL, WITH EXPOSED REINFORCING, NORTH FACE, AT BENT 202.

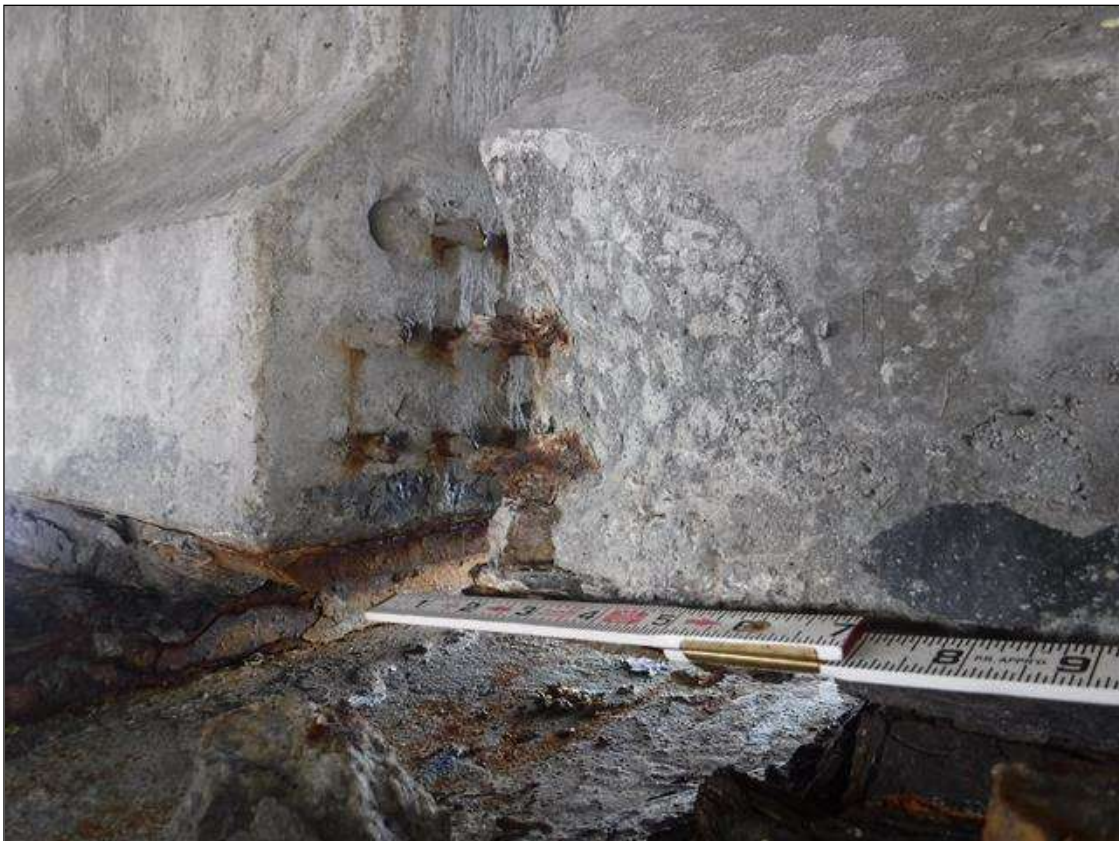
Span 204 Beam 2: 6" X 6" PATCHED AREA ON NORTH FACE IN WEB, 1' FROM BENT 203.
