NC DEPARTMENT OF TRANSPORTATION
DIVISION OF HIGHWAYS
STRUCTURE MANAGEMENT UNIT

Structure Safety Report

Routine Element Inspection - Contract

FEATURE INTERSECTED: ALLIGATOR RIVER

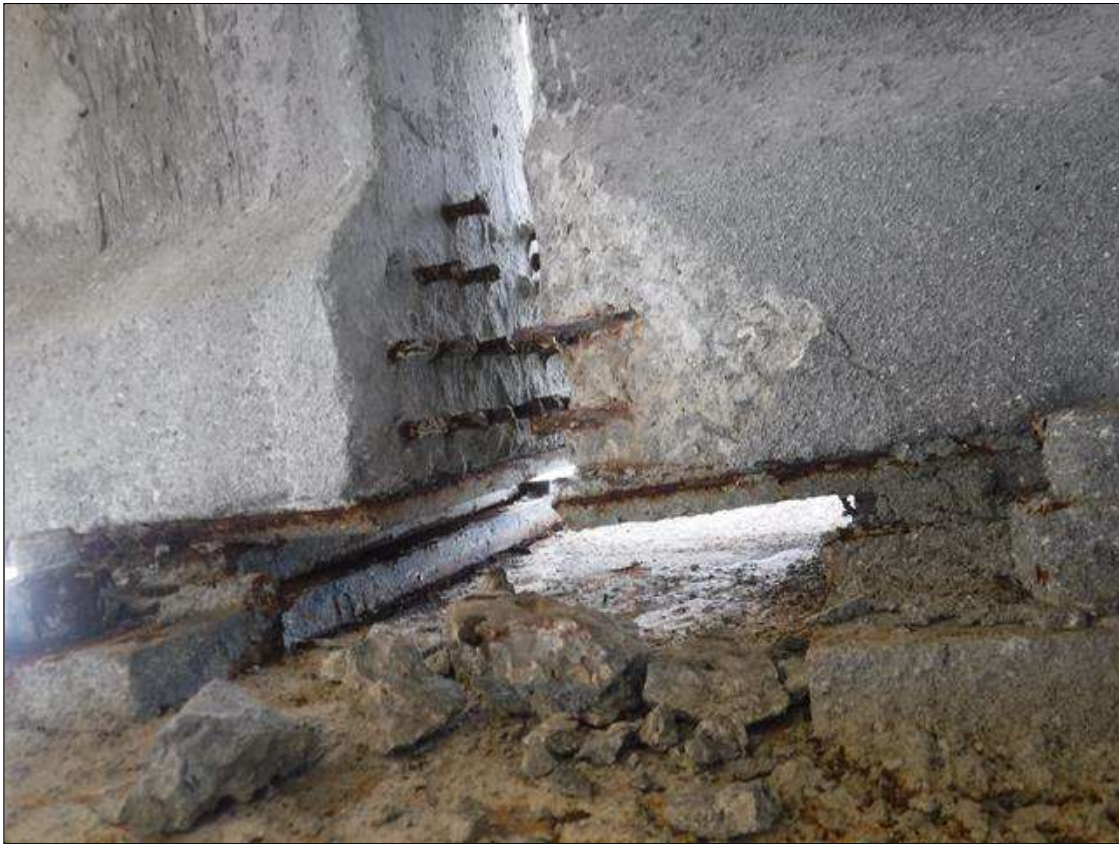
Span 205 Beam 1: (PAR) 6" X 6" X 2" DEEP SPALL WITH EXPOSED STRANDS IN BOTTOM FLANGE, SOUTH FACE AT BENT 204

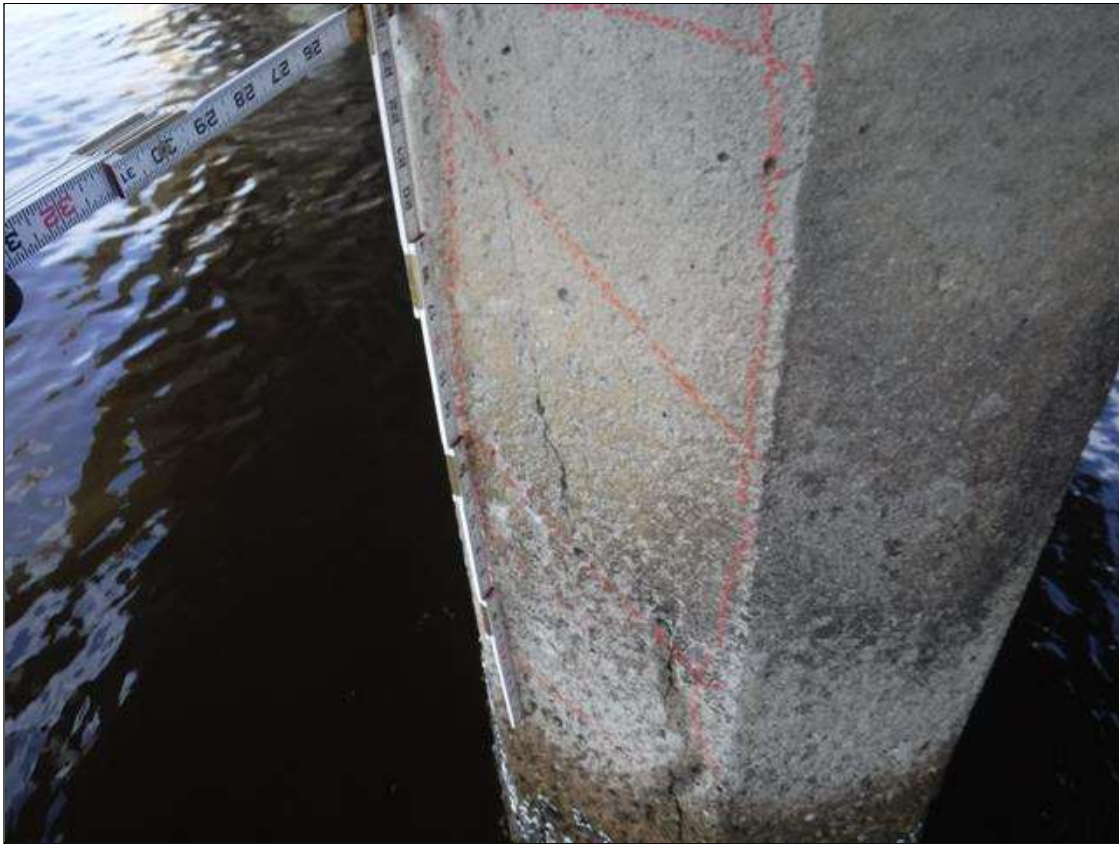
Bent 204 Pile 3: (PAR) HAIRLINE TO 1/8" CRACKS, 8' BELOW CAP, DOWN 4', MULTIPLE FACES. SCALING TO 1" DEEP WITH LOOSE AGGREGATE FROM WATERLINE TO MUDLINE.

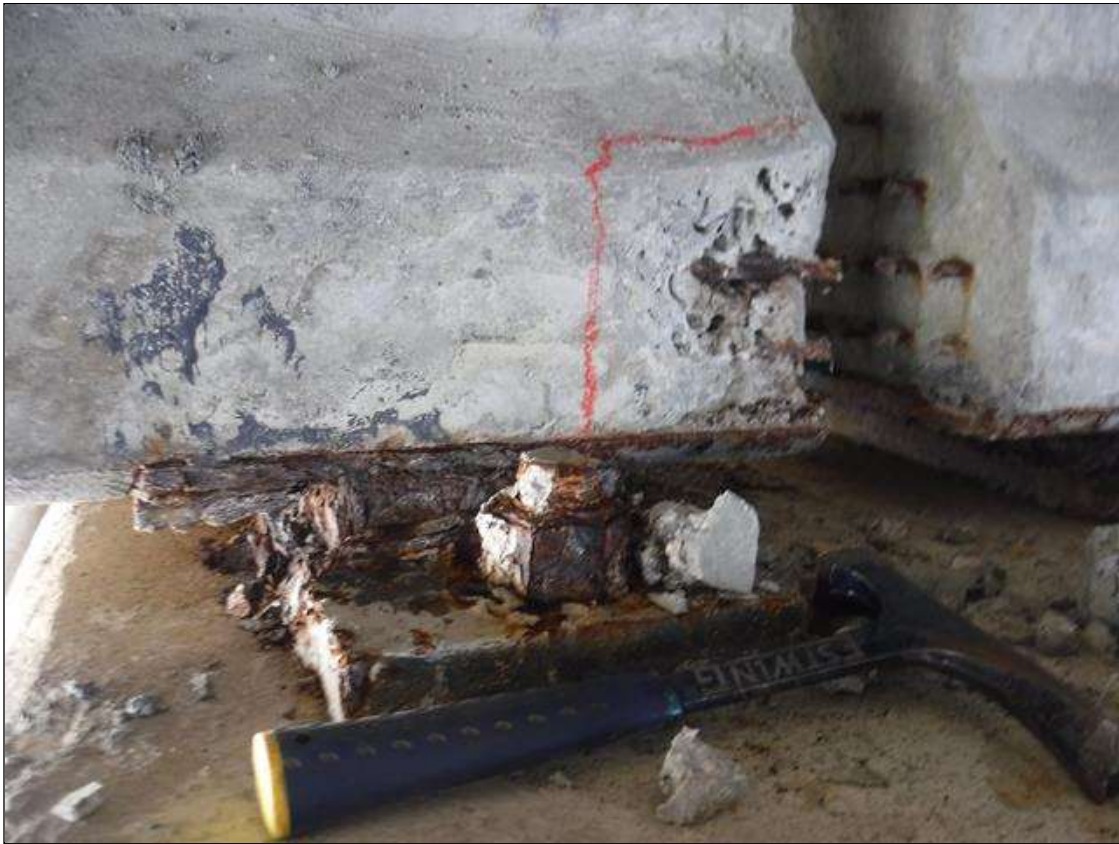
Span 206 Beam 3: 4" DIAMETER SPALL WITH EXPOSED REBAR IN WEB AT BENT 206

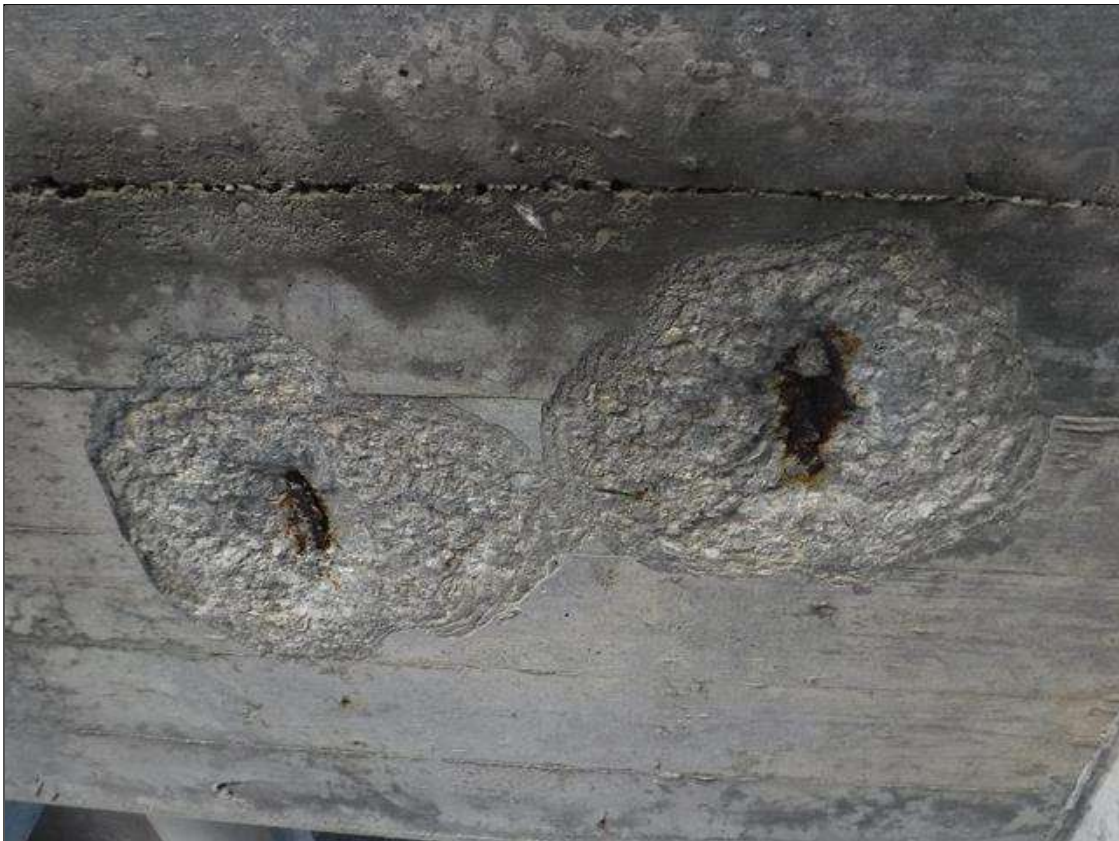
Span 207 Beam 3: (PAR) 6" X 6" X 2" DEEP SPALL WITH EXPOSED STRANDS IN BOTTOM FLANGE, NORTH FACE AT BENT 206

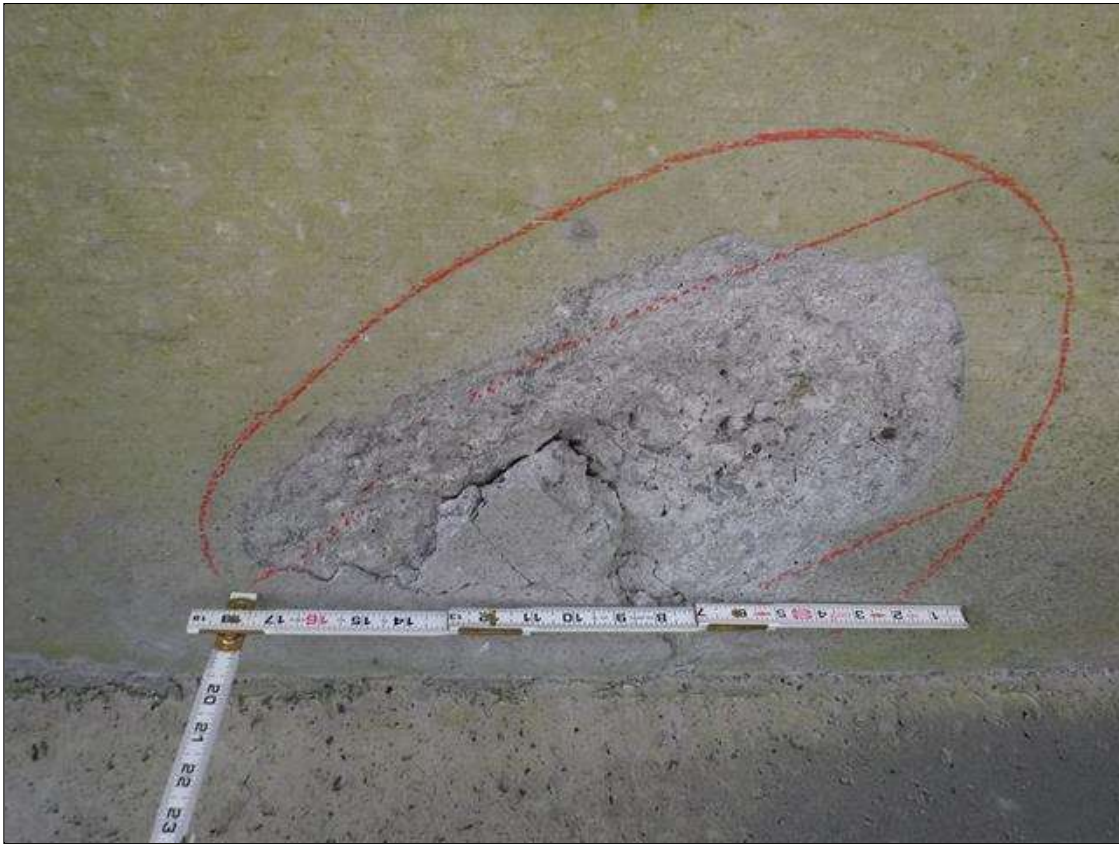
Bent 207 Cap 1: (PAR) (2) 12" DIAMETER SPALLS WITH EXPOSED REBAR ON BOTTOM OF CAP AT MIDSPAN. REBAR HAS 10% SECTION LOSS

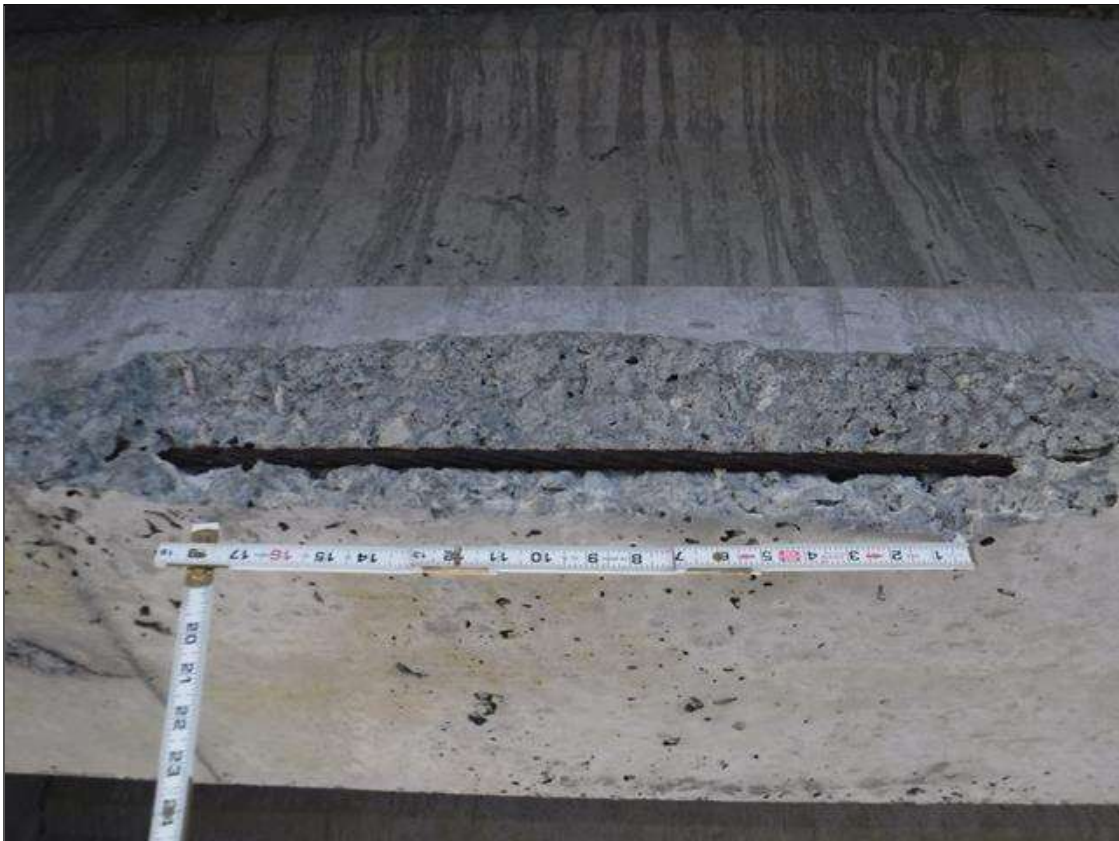
Span 208 Deck: 16" DIAMETER X 2" DEEP SPALL IN UNDERSIDE OF DECK, 5' FROM BENT 207, ADJACENT TO BEAM 4

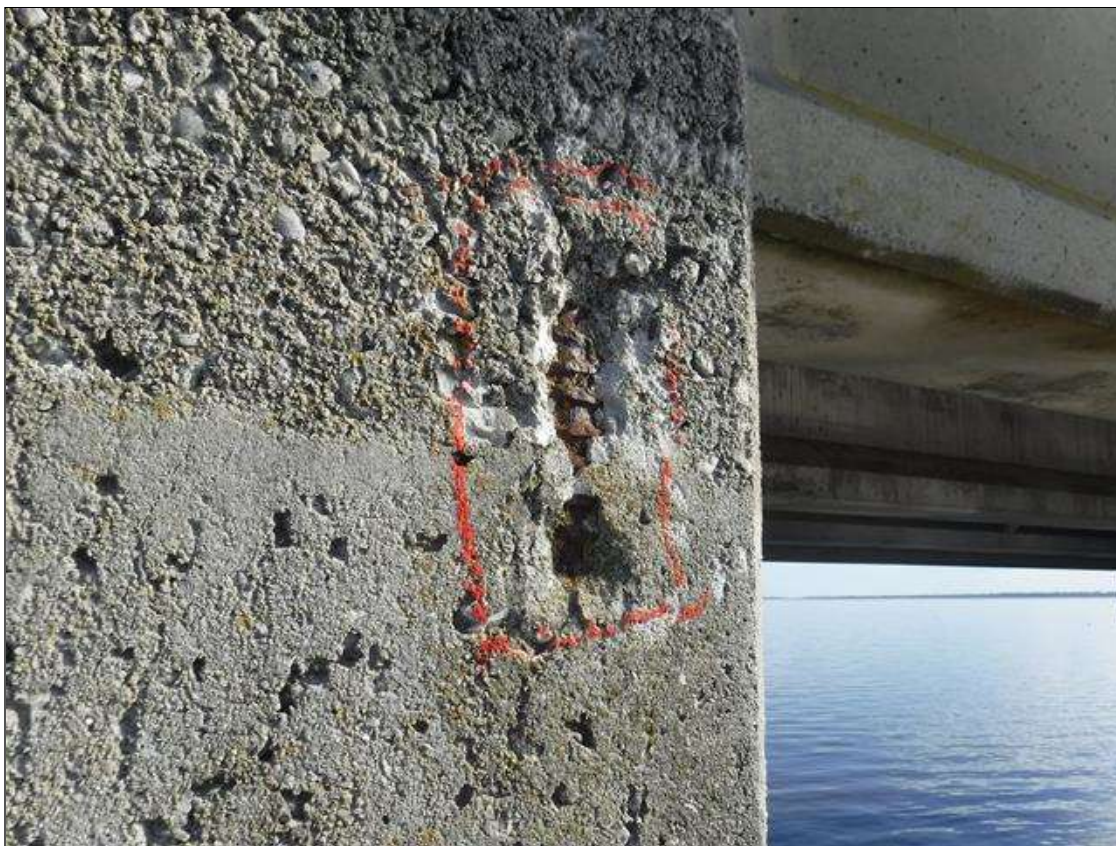
Span 209 Beam 2: (PAR) 32" X 3 X 3" CORNER SPALL, WITH EXPOSED STRAND, BOTTOM NORTH CORNER, 20' FROM BENT 208.

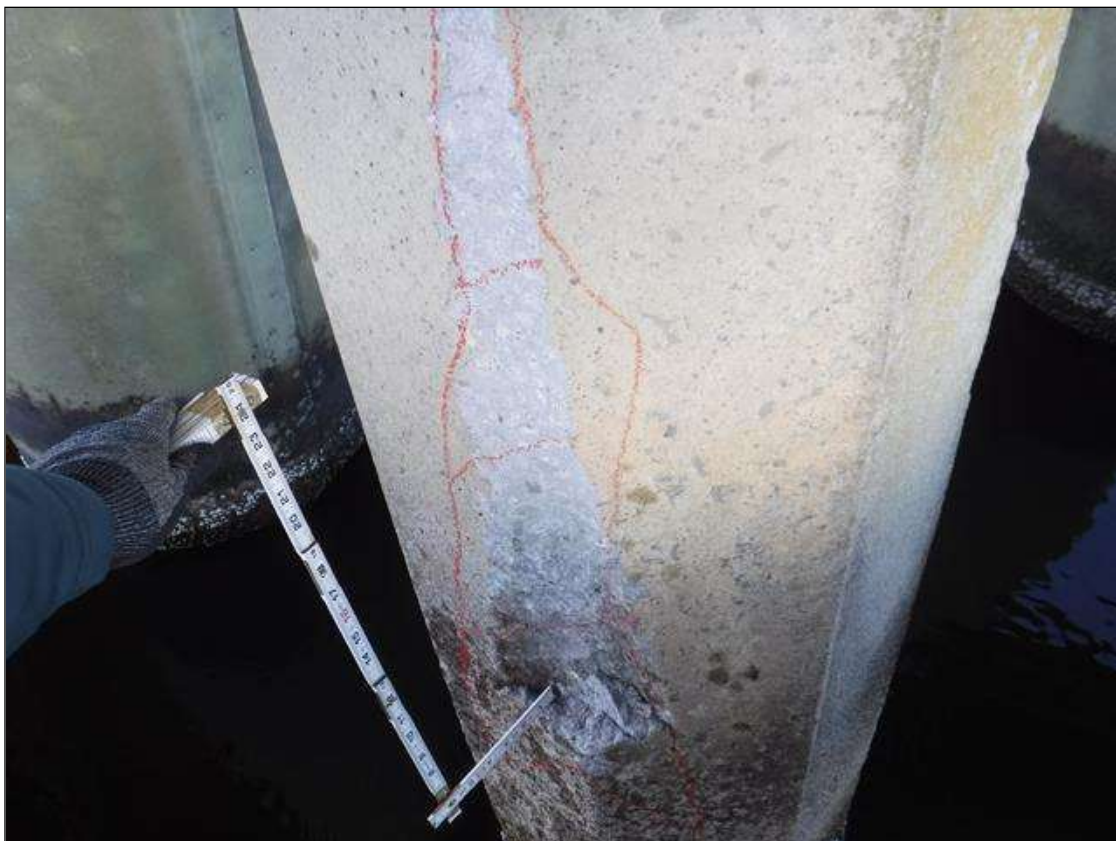
Bent 211 Cap 1: 6" X 3" X 3/4" SPALL, WITH EXPOSED PRIMARY REINFORCING, SOUTH FACE.

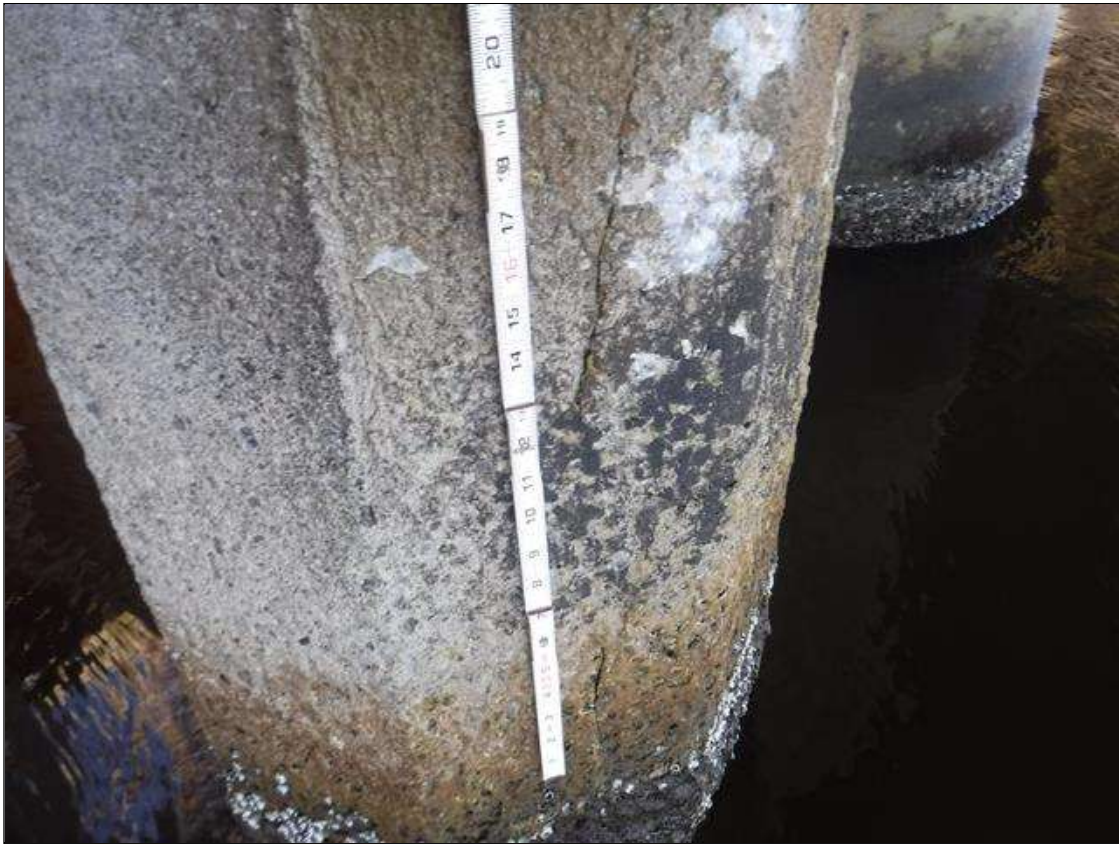
Bent 211 Pile 5: (PAR) 4' HIGH X 16" WIDE X 2" DEEP SPALL ON SOUTH FACE 8' BELOW CAP

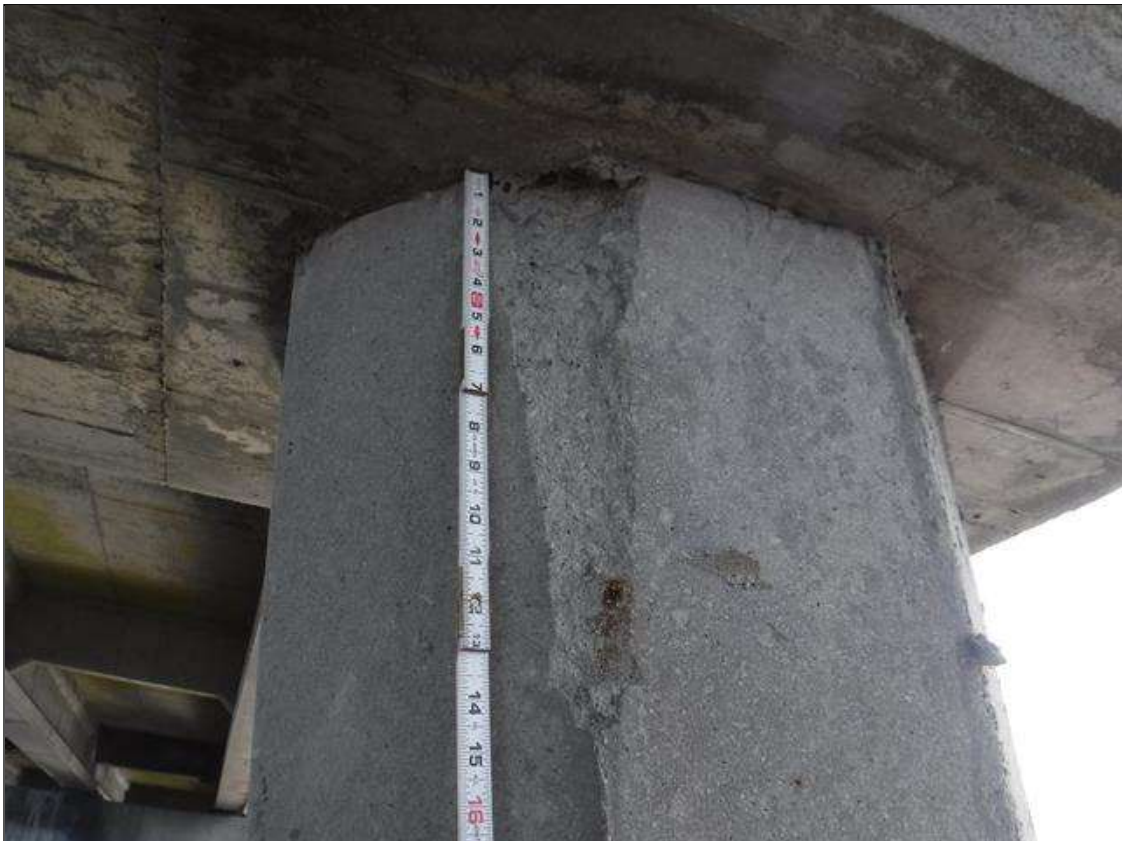
Bent 212 Pile 4: (PAR) 3' LONG HAIRLINE TO 1/8" CRACK, 8' BELOW CAP, DOWN 4' , MULTIPLE FACES. SCALING TO 1" DEEP WITH LOOSE AGGREGATE FROM WATERLINE TO MUDLINE.

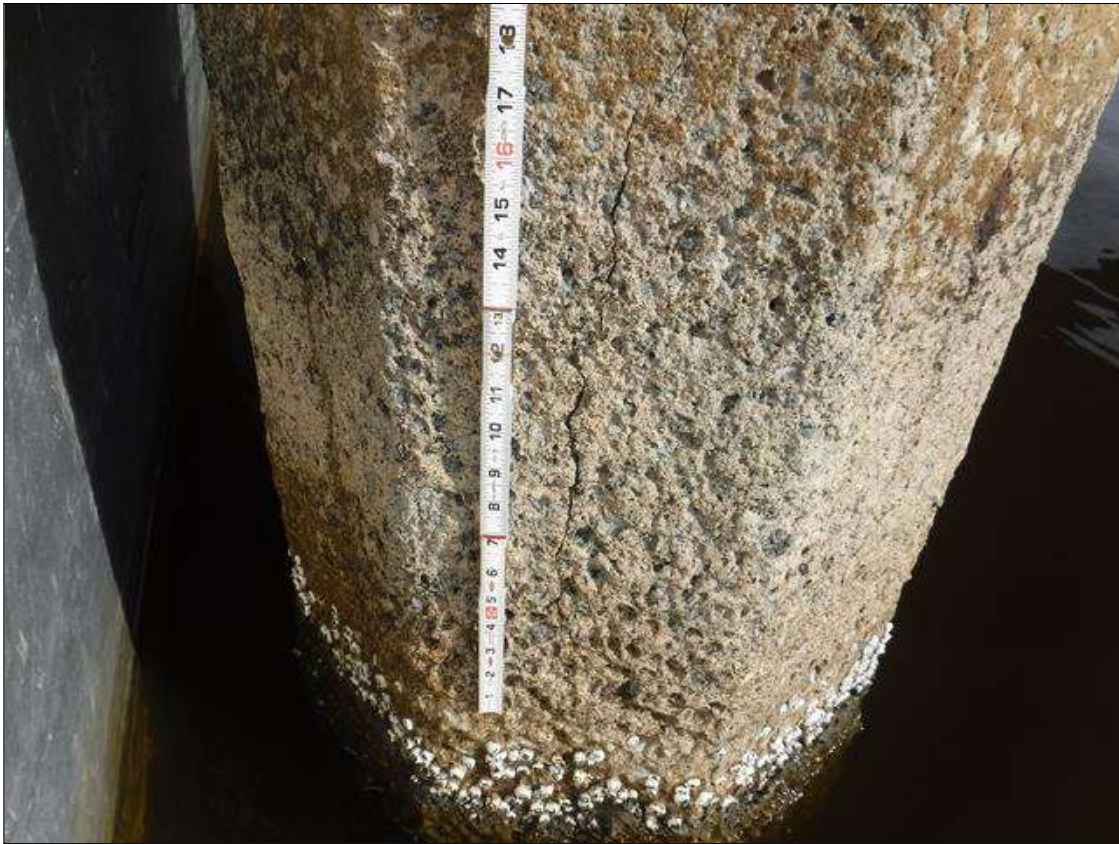
Bent 215 Pile 6: 14" X 4" X 1/2" DEEP SPALL ON WEST FACE BELOW CAP

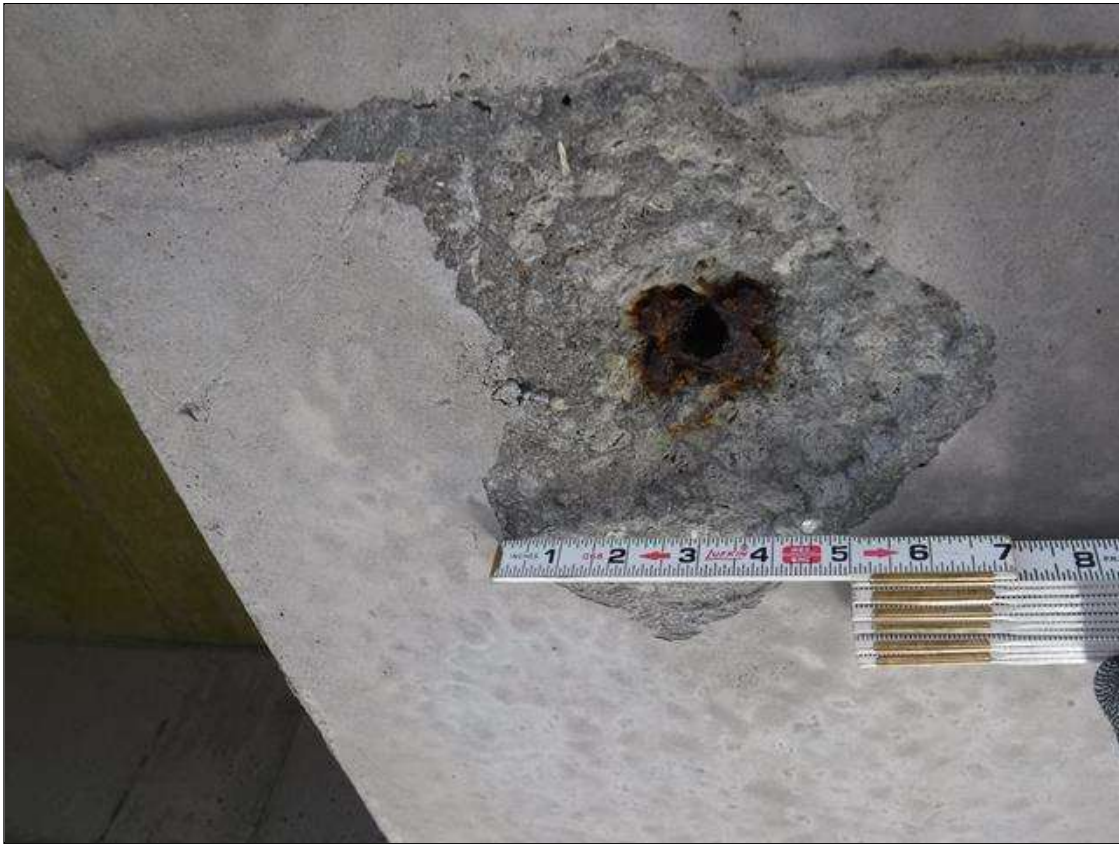
Span 216 Beam 1: 6" DIAMETER X 1/2" DEEP SPALL WITH EXPOSED REBAR ON BOTTOM FACE AT MIDSPAN

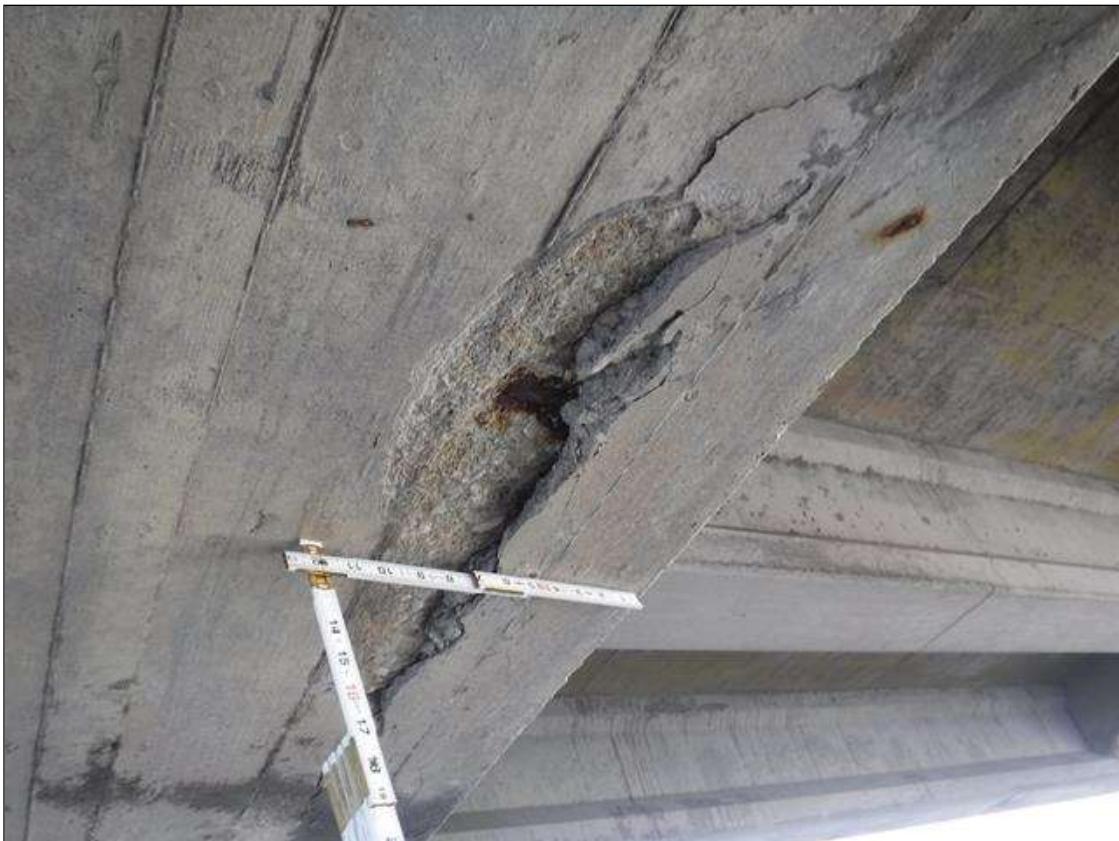
Span 217 Beam 3: 1' DIAMETER X 1/2" DEEP SPALL ON BOTTOM FACE AT MIDPOINT OF SPAN.

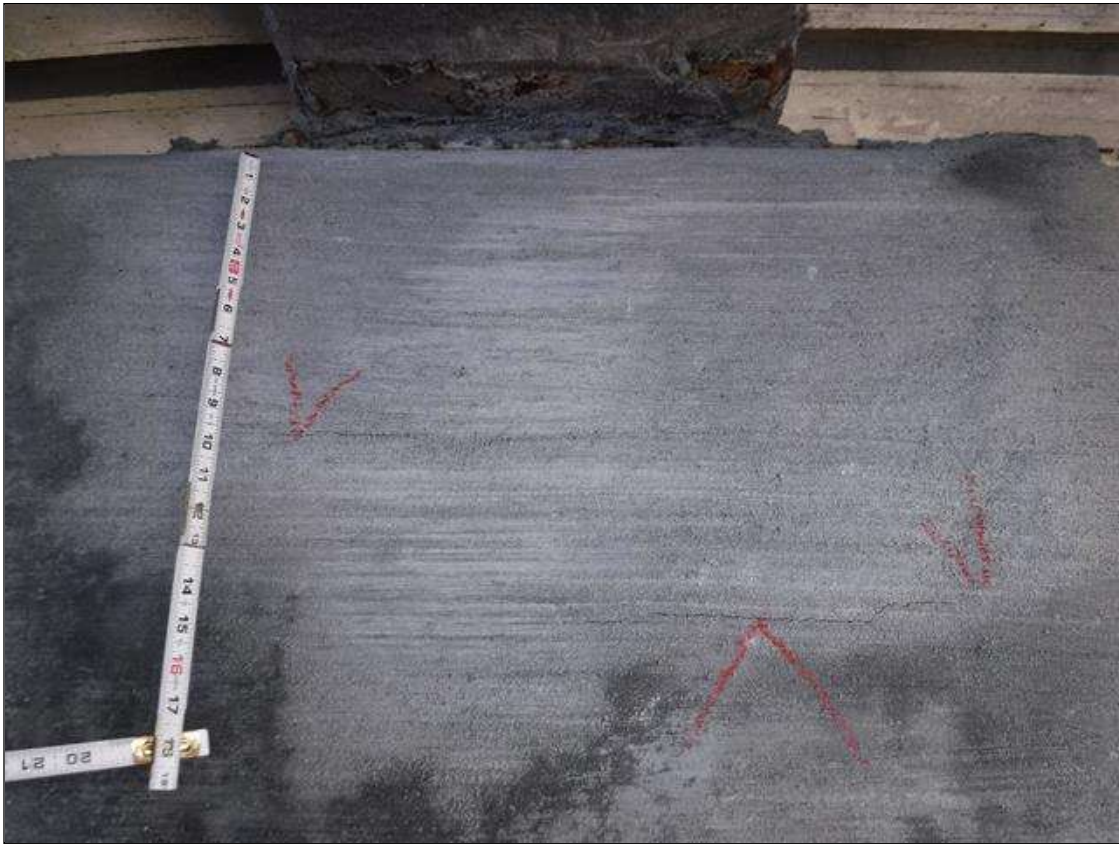
Bent 217 Cap 1: 24" X UP TO 6" X 1" SPALL WITH EXPOSED REINFORCING, BOTTOM OF CAP, BETWEEN PILES 2 AND 3.

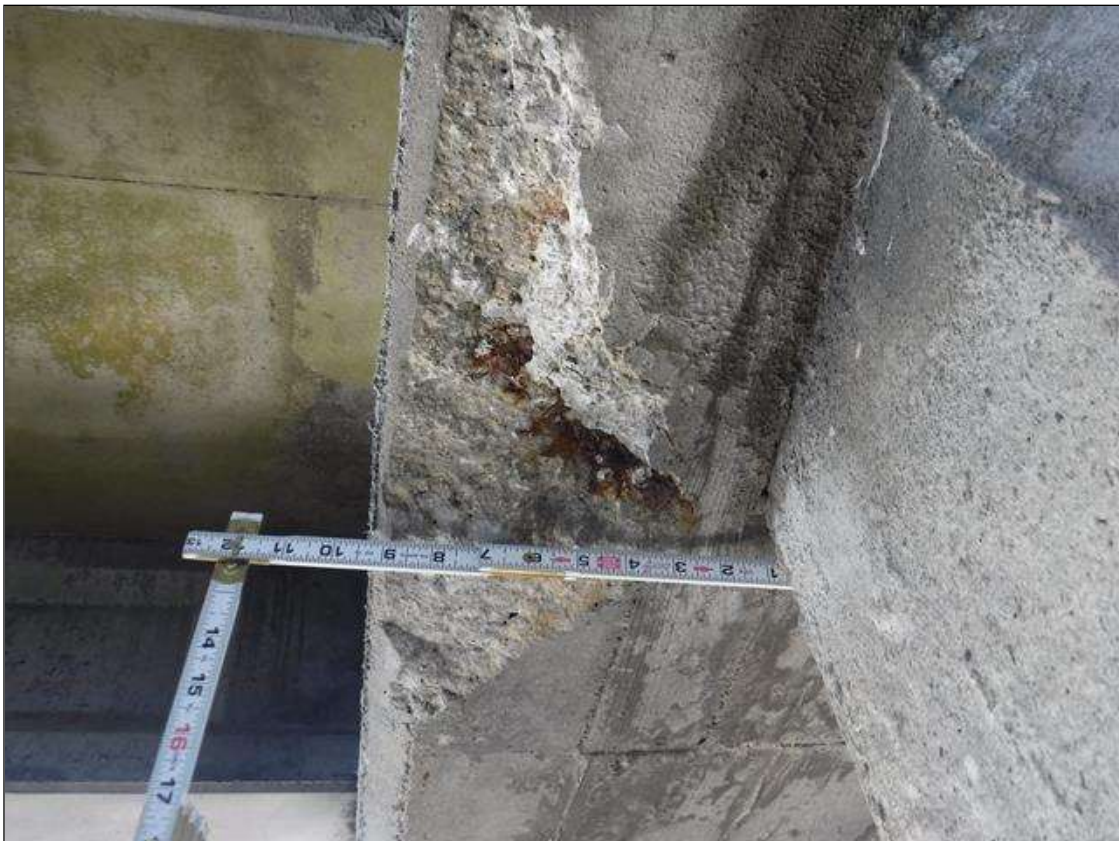
Bent 217 Cap 1: 2' PATCH WITH 1/32" CRACK BELOW BEAM 3 WEST FACE

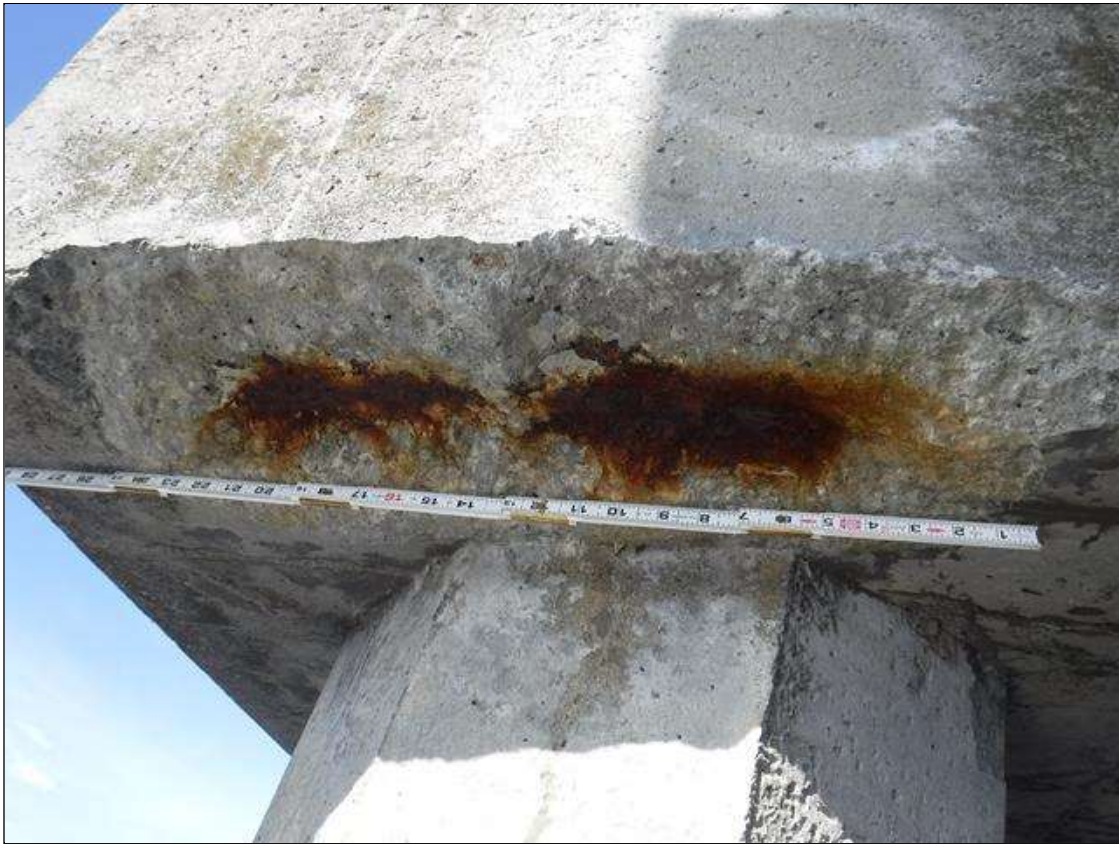
Bent 218 Cap 1: (PAR) 18" X UP TO 7" X 1.5" SPALL, WITH EXPOSED PRIMARY REINFORCING, BOTTOM OF CAP, AT PILE 3. REBAR HAS MINOR SECTION LOSS.

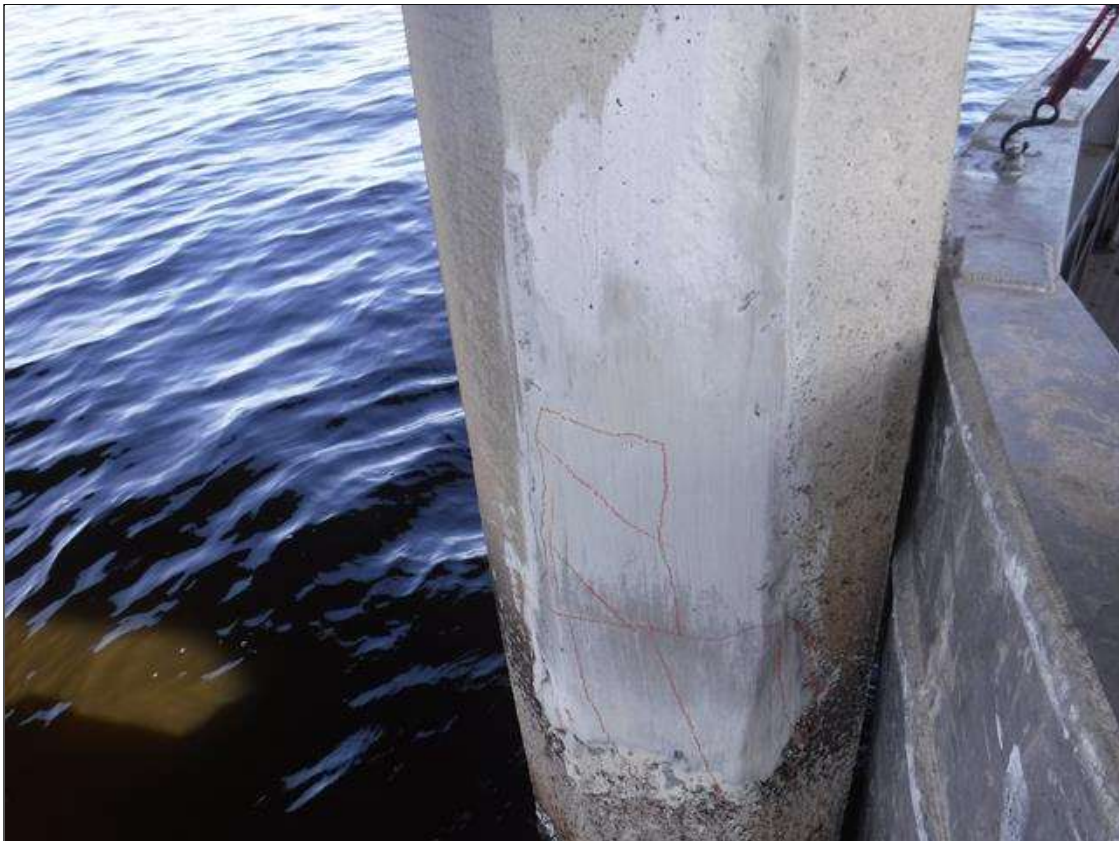
Bent 218 Cap 1: (PAR) 2.5' X UP TO 10" X 2.5" SPALL, WITH EXPOSED REBAR, EAST FACE, AT PILE 4. REBAR HAS 10% SECTION LOSS.

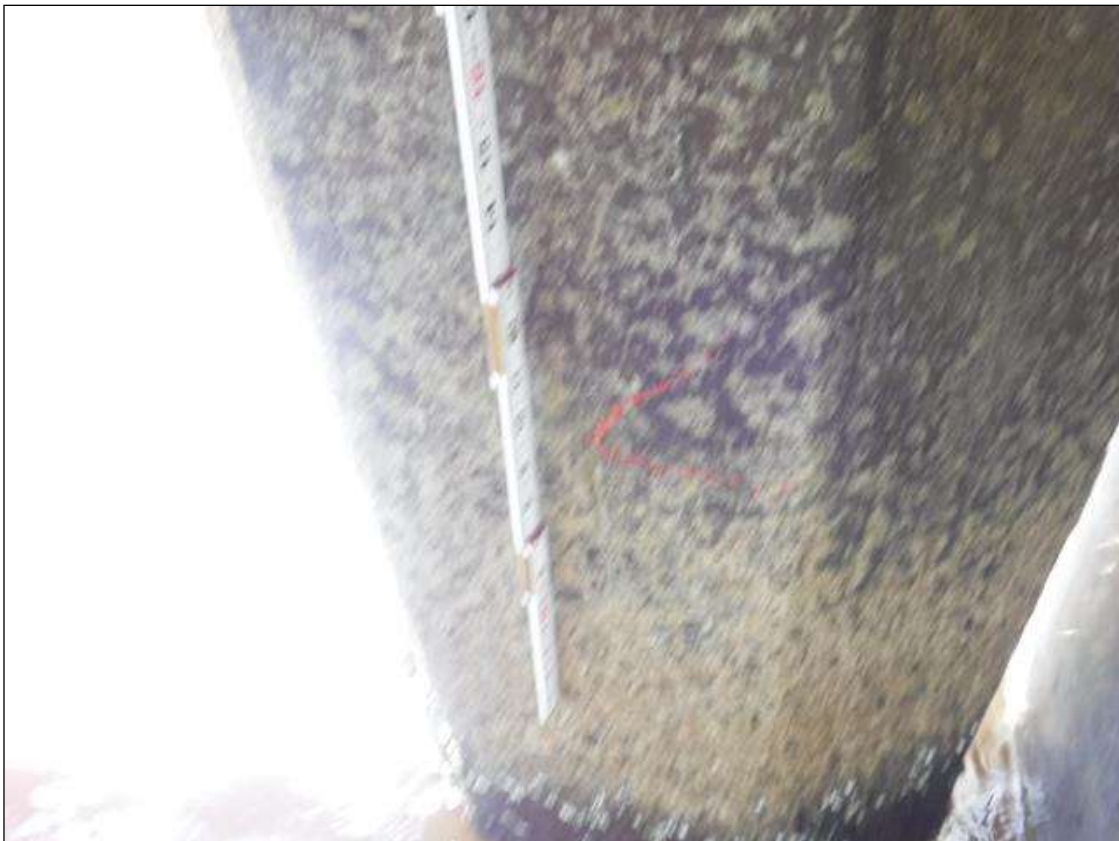
Bent 223 Pile 6: (PAR) 4' X UP TO 16" FAILED PATCH ON SOUTH FACE, 7' FROM BOTTOM OF CAP.

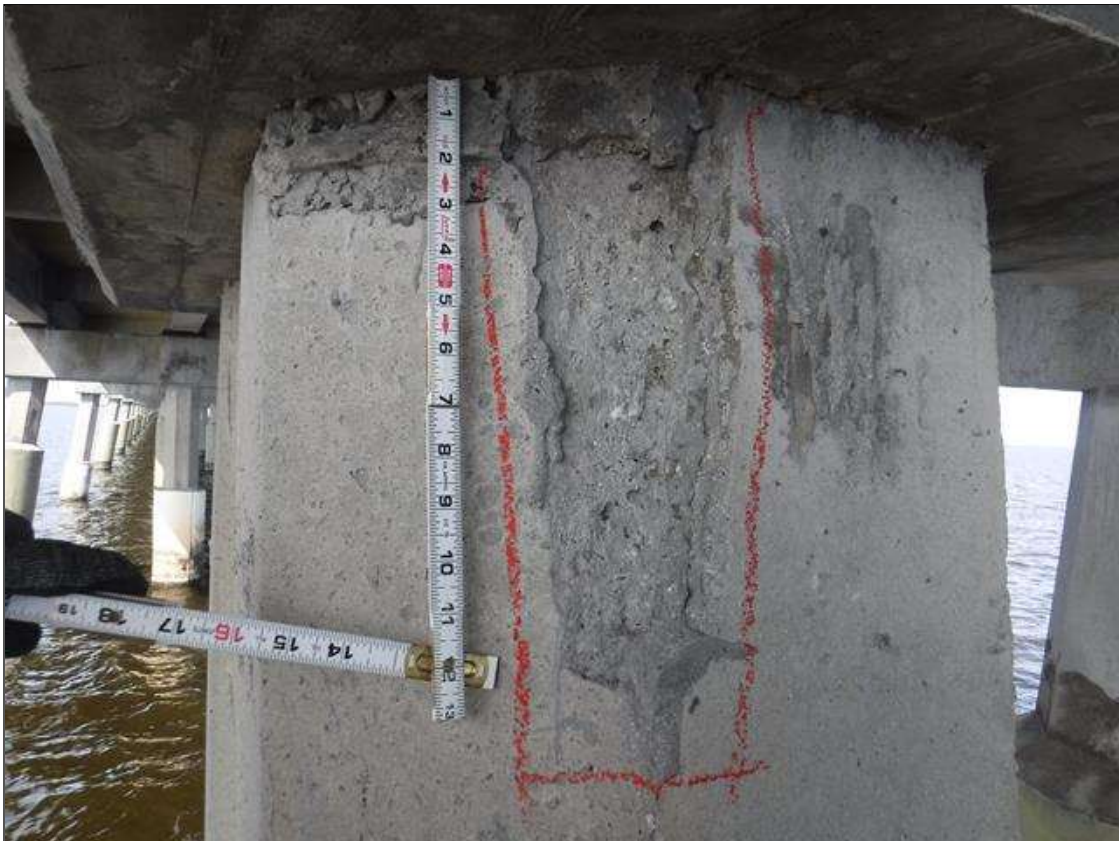
Bent 223 Cap 1: 2' X 6" X 16" DEEP DELAMINATION WITH UP TO 3" DEEP SPALL ON BOTTOM OF EAST FACE AT PILE 6

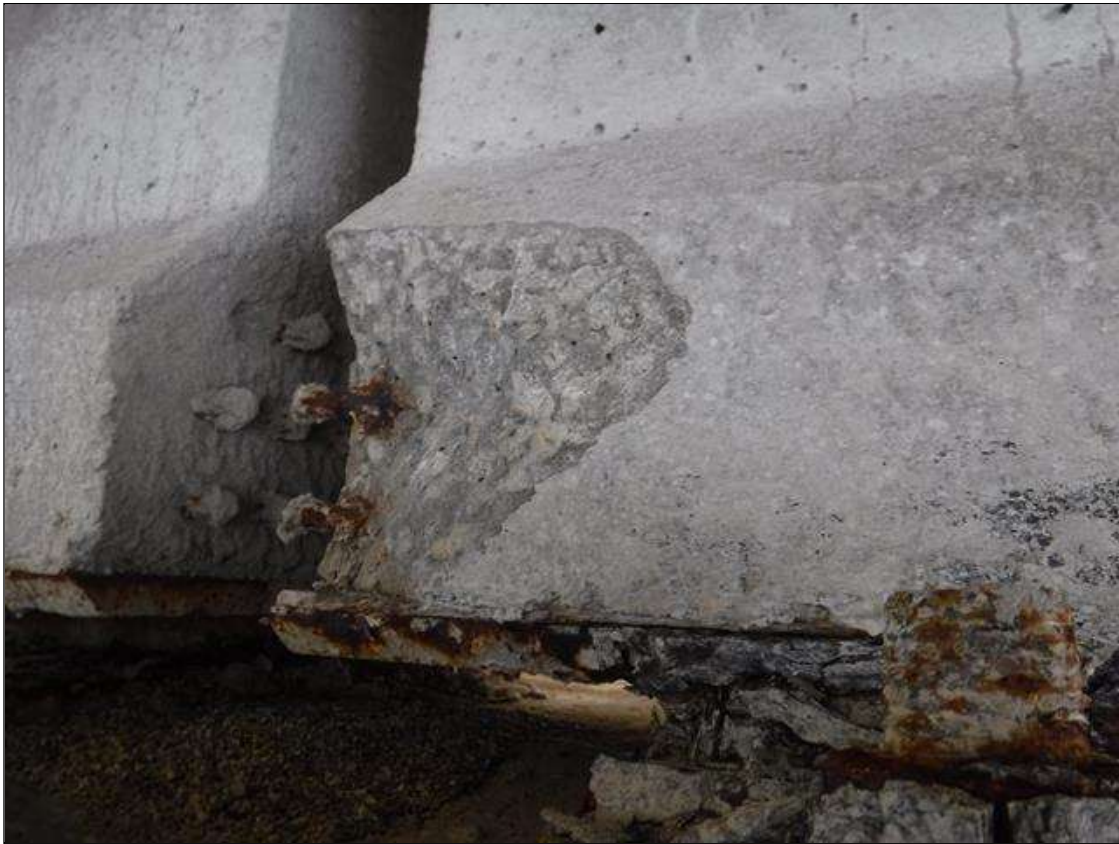
Bent 223 Pile 5: 12" X UP TO 4" X 1/2" SPALL, EAST FACE, AT BOTTOM OF CAP.

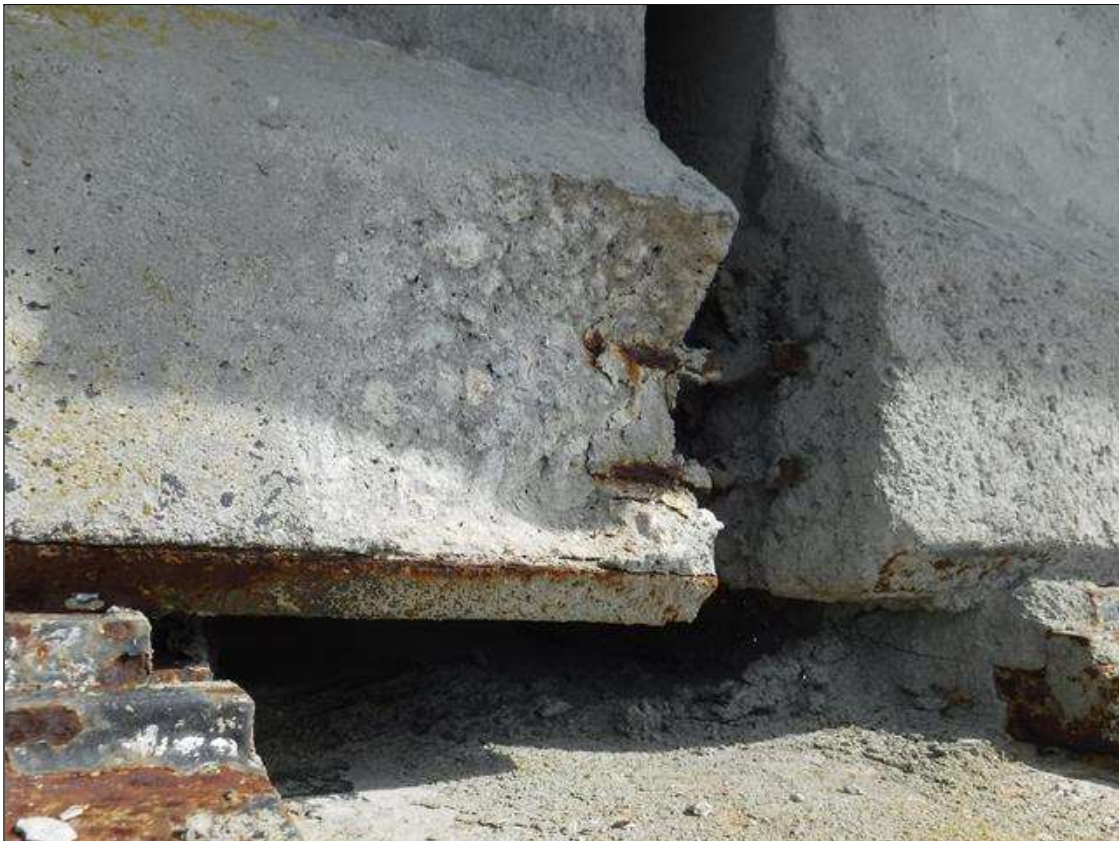
Span 224 Beam 3: (PAR) 6" X 6" X 3" DEEP SPALL WITH EXPOSED STRAND ON BOTTOM FLANGE NORTH FACE AT BENT 224

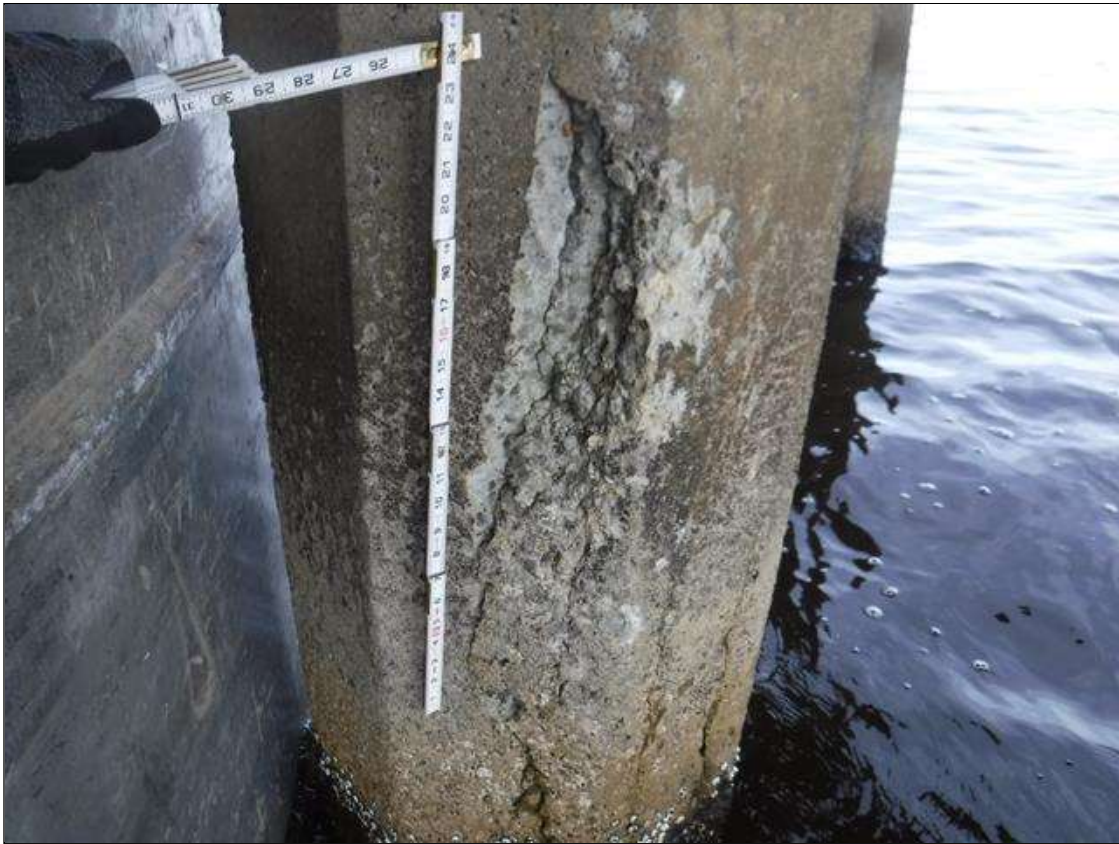
Bent 226 Pile 2: (PAR) HAIRLINE TO 1/8" CRACKS WITH ADJACENT 2' X 2' DELAMINATION, 8' BELOW CAP, DOWN 4', MULTIPLE FACES. SCALING TO 1" DEEP WITH LOOSE AGGREGATE FROM WATERLINE TO MUDLINE.

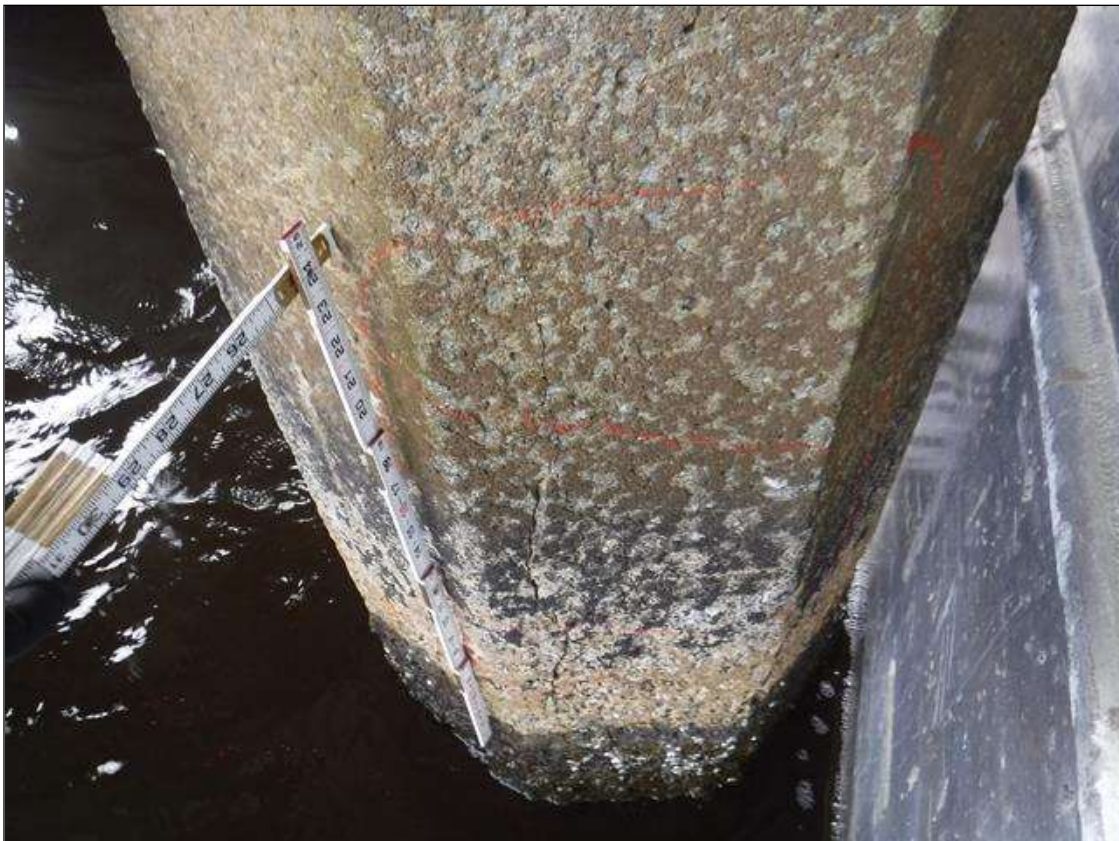
Bent 227 Pile 2: (PAR) 3' X 10" X 1" DEEP SPALL, SOUTH FACE, 8' FROM BOTTOM OF CAP.

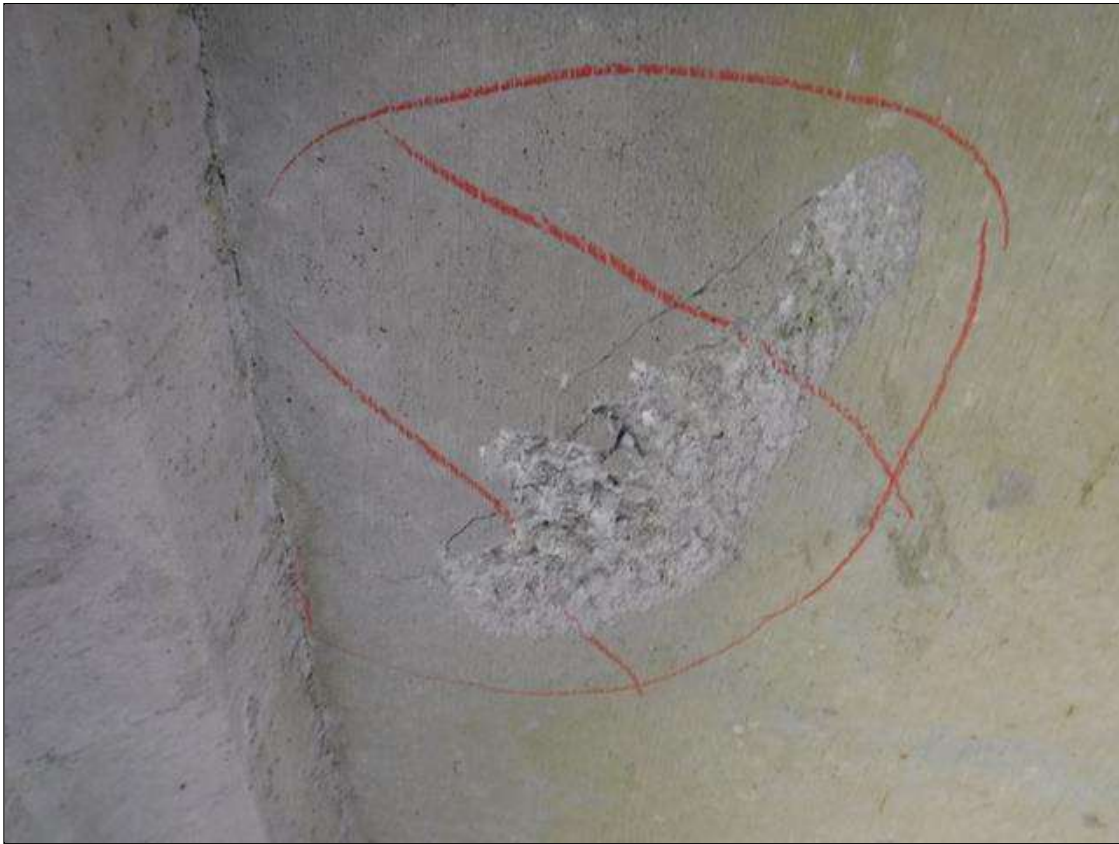
Bent 227 Pile 2: (PAR) (3) UP TO 2' X 0.04" VERTICAL CRACKS, NORTH FACE, 8' FROM BOTTOM OF CAP, WITH ADJACENT 2' X 2' DELAMINATION.
