NC DEPARTMENT OF TRANSPORTATION
DIVISION OF HIGHWAYS
STRUCTURE MANAGEMENT UNIT

Structure Safety Report

Routine Element Inspection - Contract

FEATURE INTERSECTED: ALLIGATOR RIVER

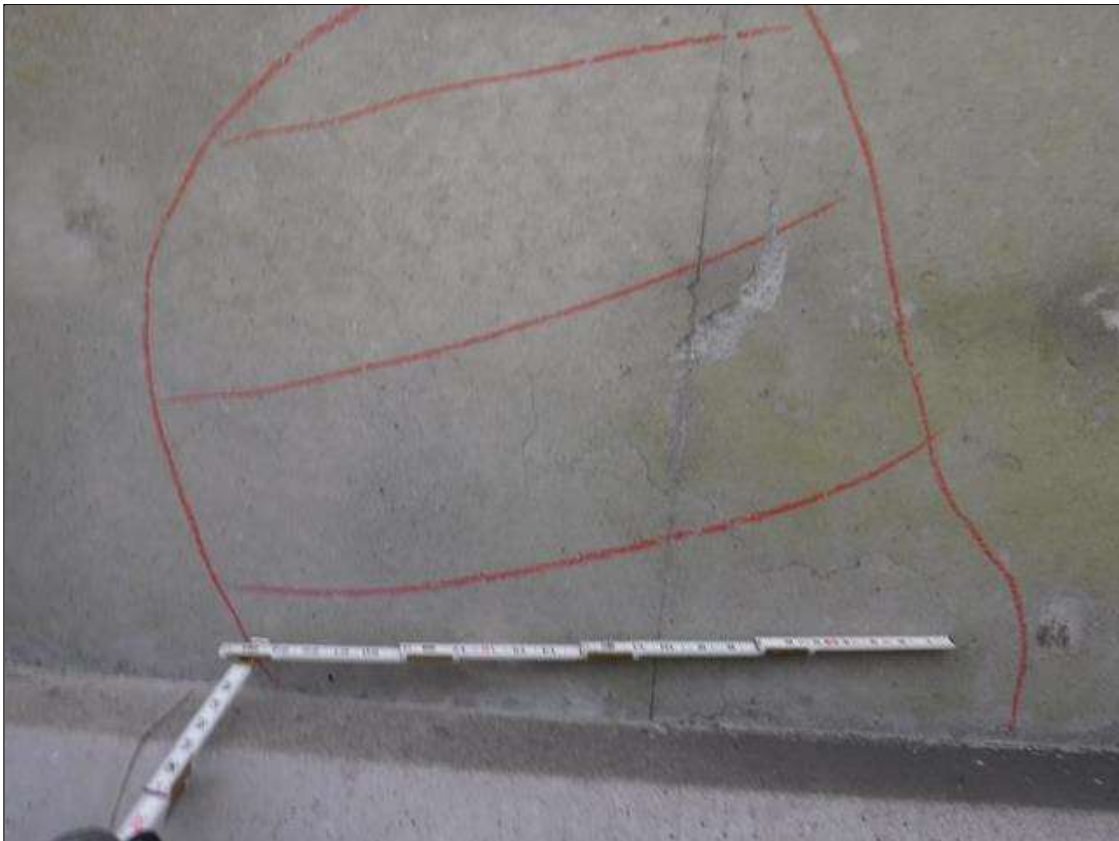
Span 228 Deck: 18" DIAMETER X 3/4" SPALL, DECK UNDERSIDE, BETWEEN BEAMS 3 AND 4, 6' FROM BENT 227, WITH ADJACENT 1' X 1' DELAMINATION.

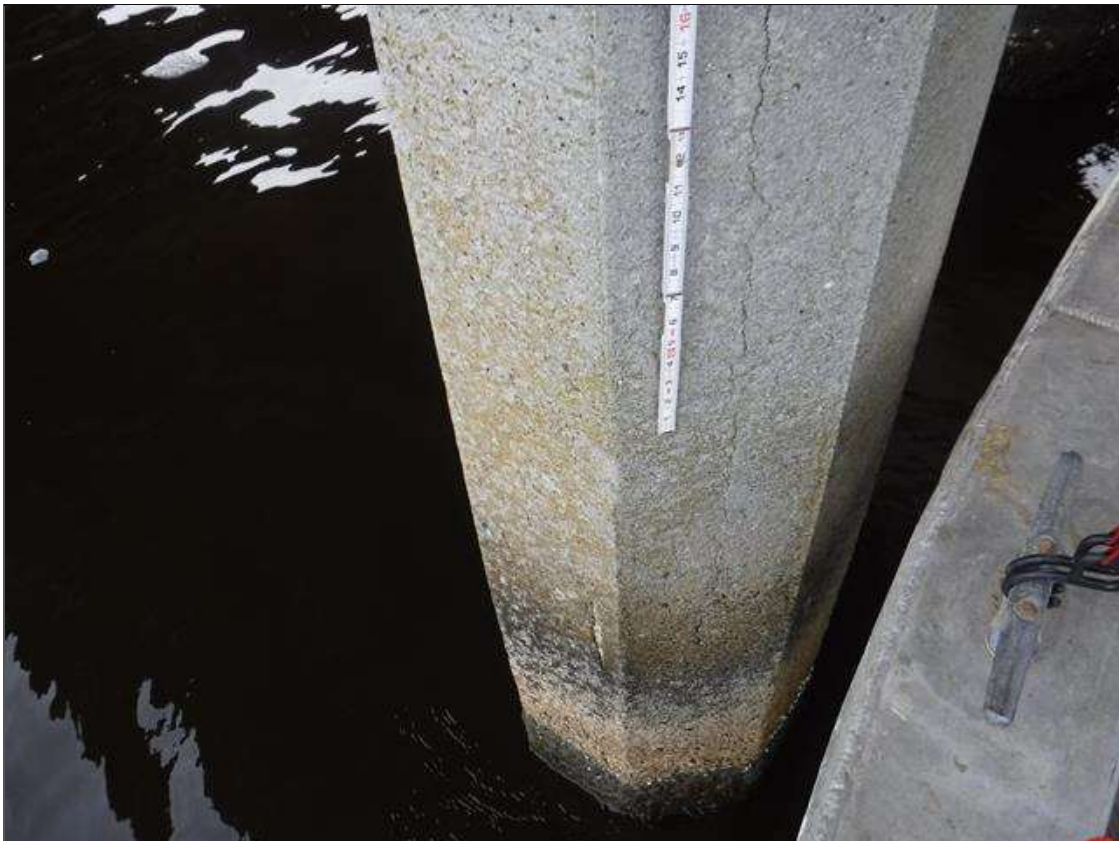
Bent 229 Pile 4: (PAR) (4) UP TO 6' X 0.03" VERTICAL CRACKS, AT RANDOM THROUGHOUT, BEGINNING 5' FROM BOTTOM OF CAP, WITH ADJACENT 2' X 1' DELAMINATION ON NORTH AND EAST FACE

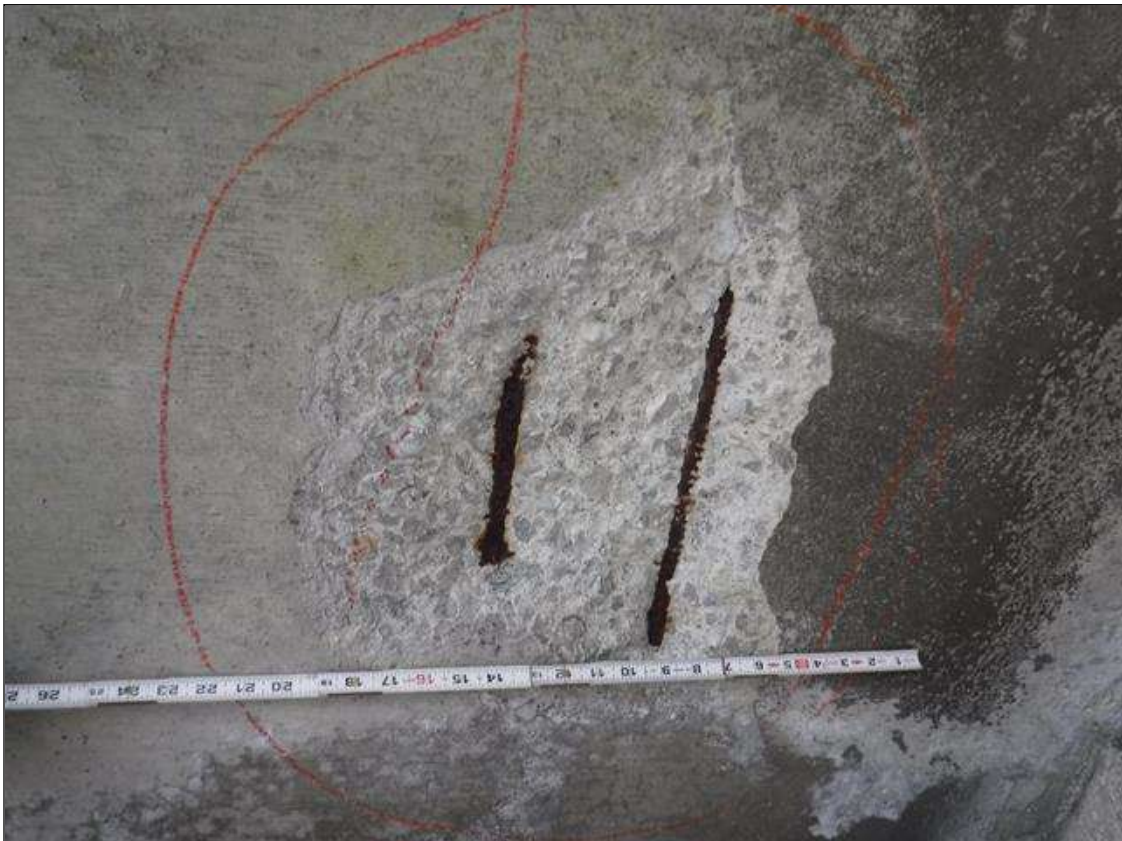
Span 230 Beam 2: 18" DIAMETER DELAMINATION ON END DIAPHRAGM BETWEEN BEAMS 2 AND 3 AT BENT 230

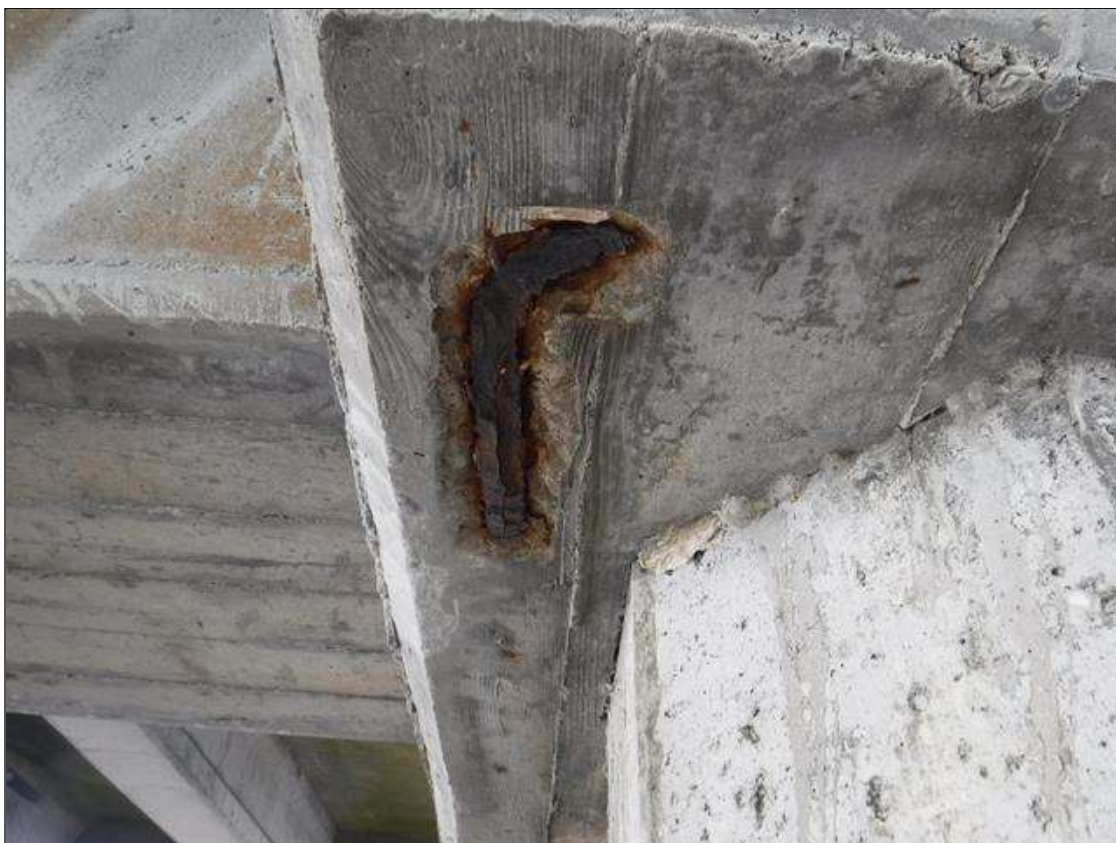
Bent 231 Pile 4: UP TO 3' CRACKED PATCHED AREA WITH 2' X 8" DELAMINATION AROUND THE PILE, WITH RUST STAINING, 5' FROM BOTTOM OF CAP.

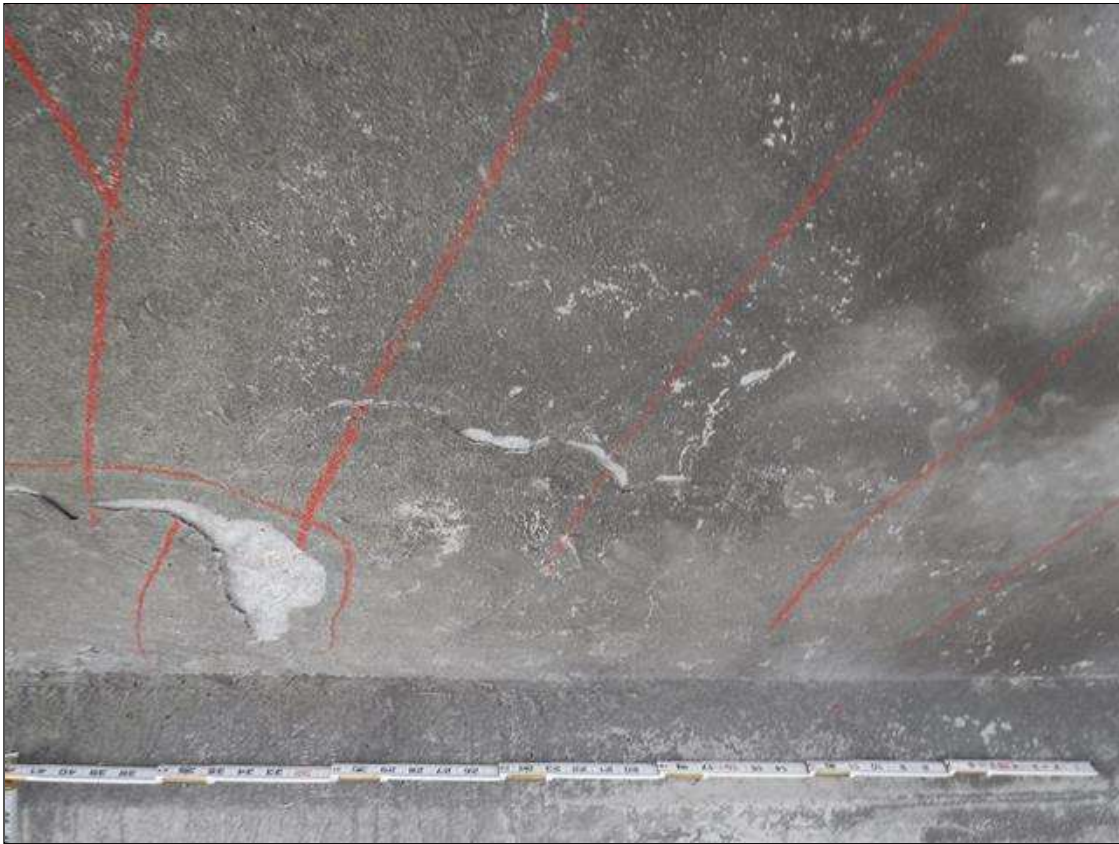
Bent 231 Cap 1: 3' X 8" X 3/4" SPALL, WITH EXPOSED REINFORCING, BOTTOM FACE, BENEATH BEAM 2.

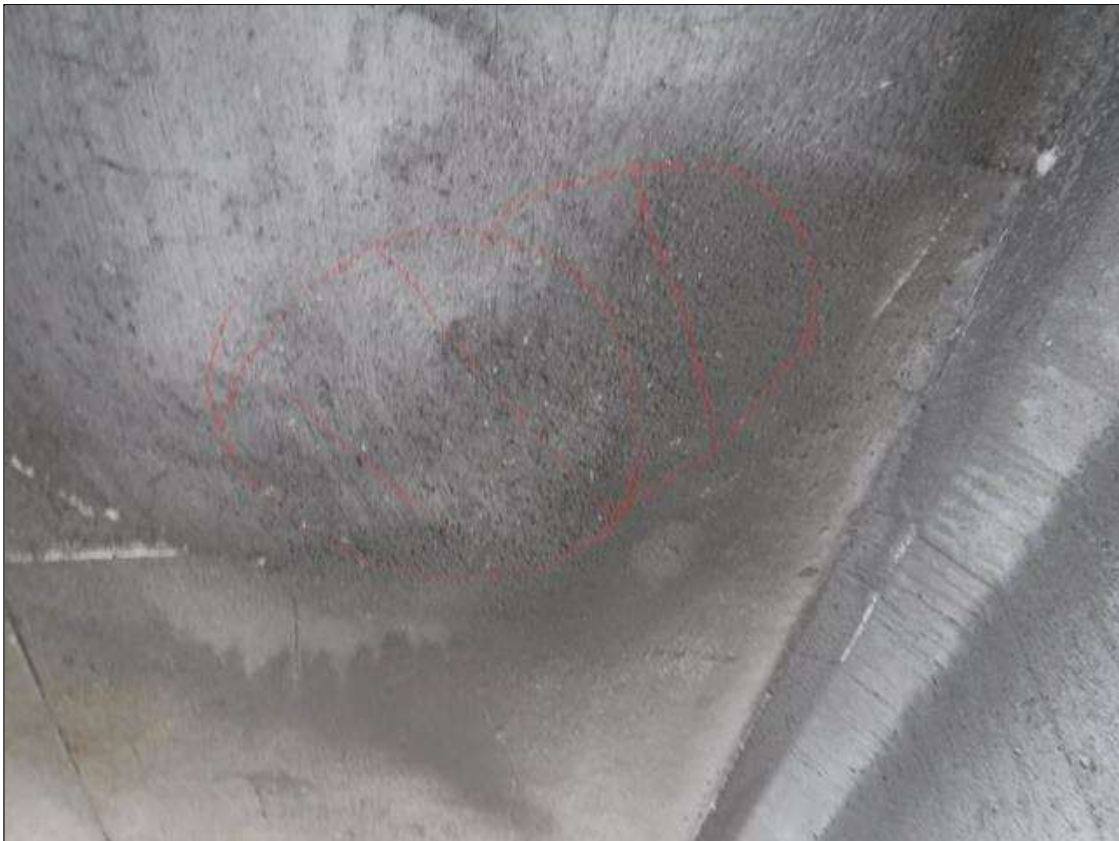
Span 232 Deck: (PAR) 6' X 4' AREA OF DELAMINATION, DECK UNDERSIDE, BETWEEN BEAMS 1 AND 2, NEAR BENT 231.

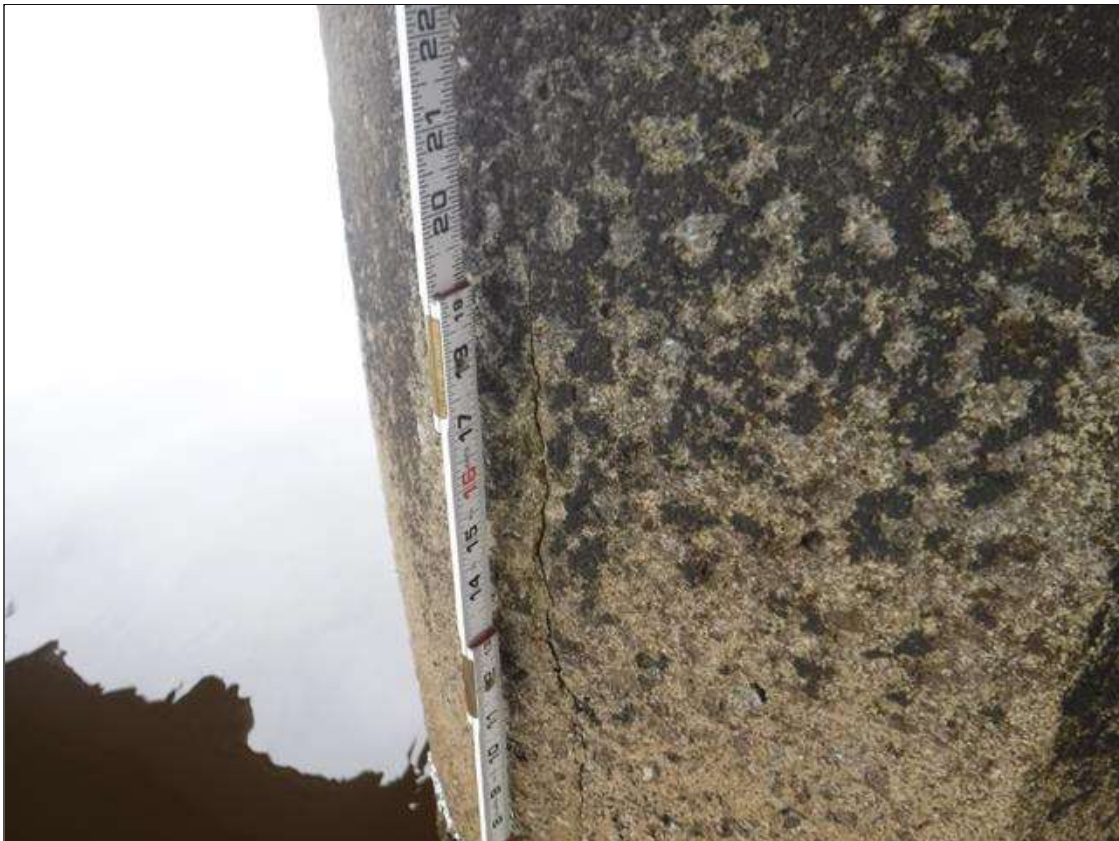
Bent 233 Pile 4: (PAR) 36" X 36" FAILED PATCHED AREA WITH UP TO 1/8" WIDE VERTICAL CRACK, WEST AND NORTH FACE, BEGINNING FROM BOTTOM OF CAP.

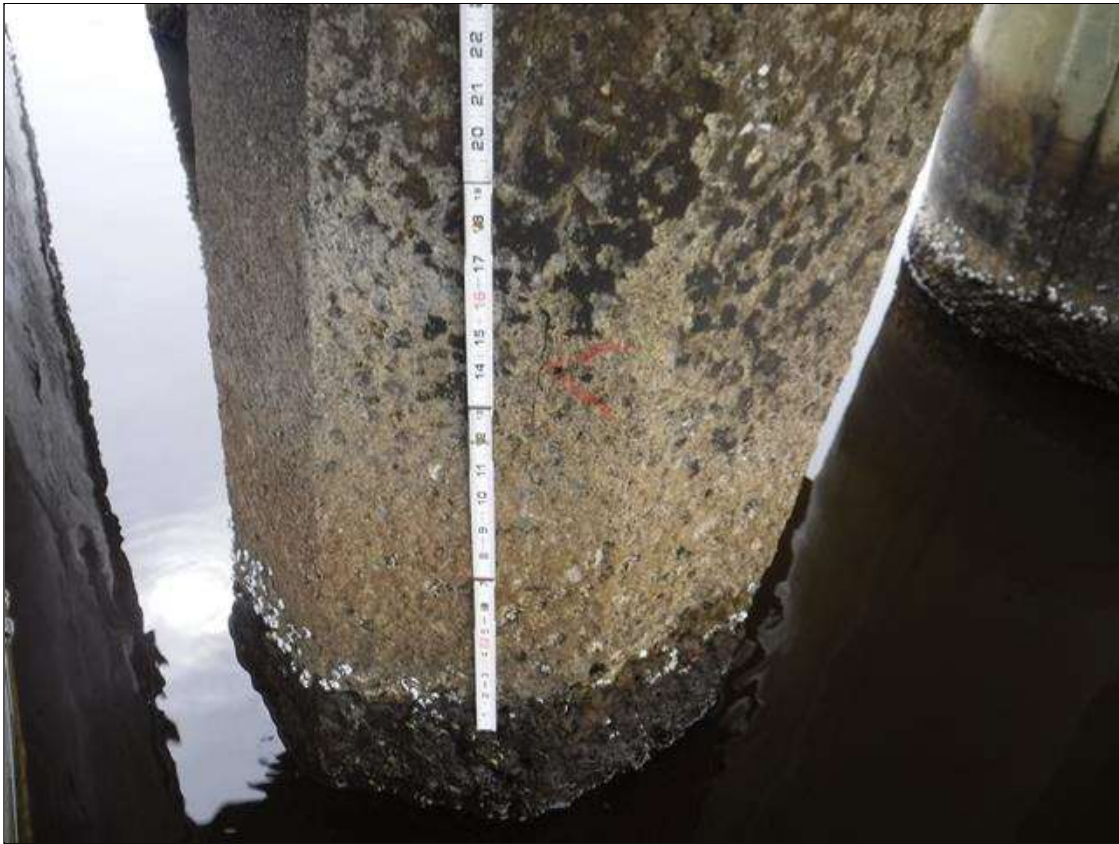
Bent 234 Pile 4: (PAR) (3) UP TO 3' X 0.25" VERTICAL CRACKS, BEGINNING 7' FROM BOTTOM OF CAP, AT RANDOM THROUGHOUT. WITH ADJACENT 3' X 2' DELAMINATION ON NORTH FACE

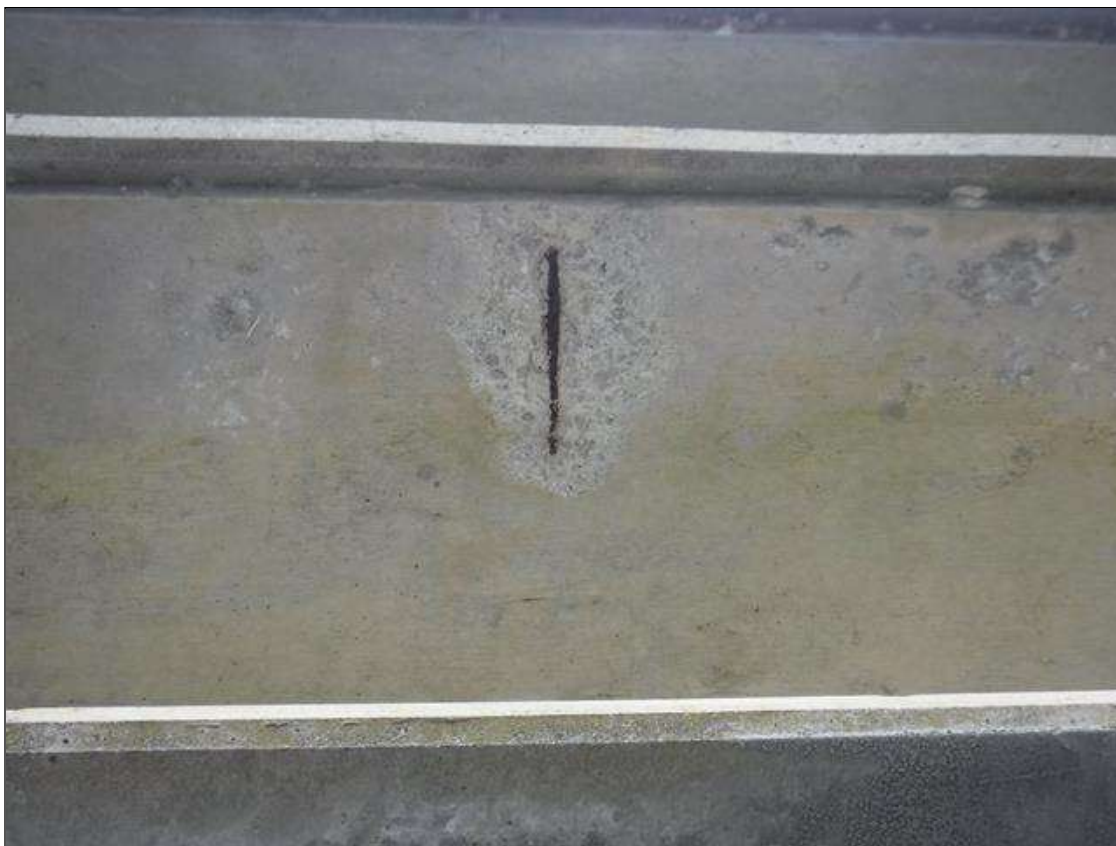
Span 236 Deck: (PAR) 2' DIAMETER X 1" DEEP SPALL WITH EXPOSED REINFORCEMENT IN DECK UNDERSIDE BAY 2, 5' FROM BENT 235

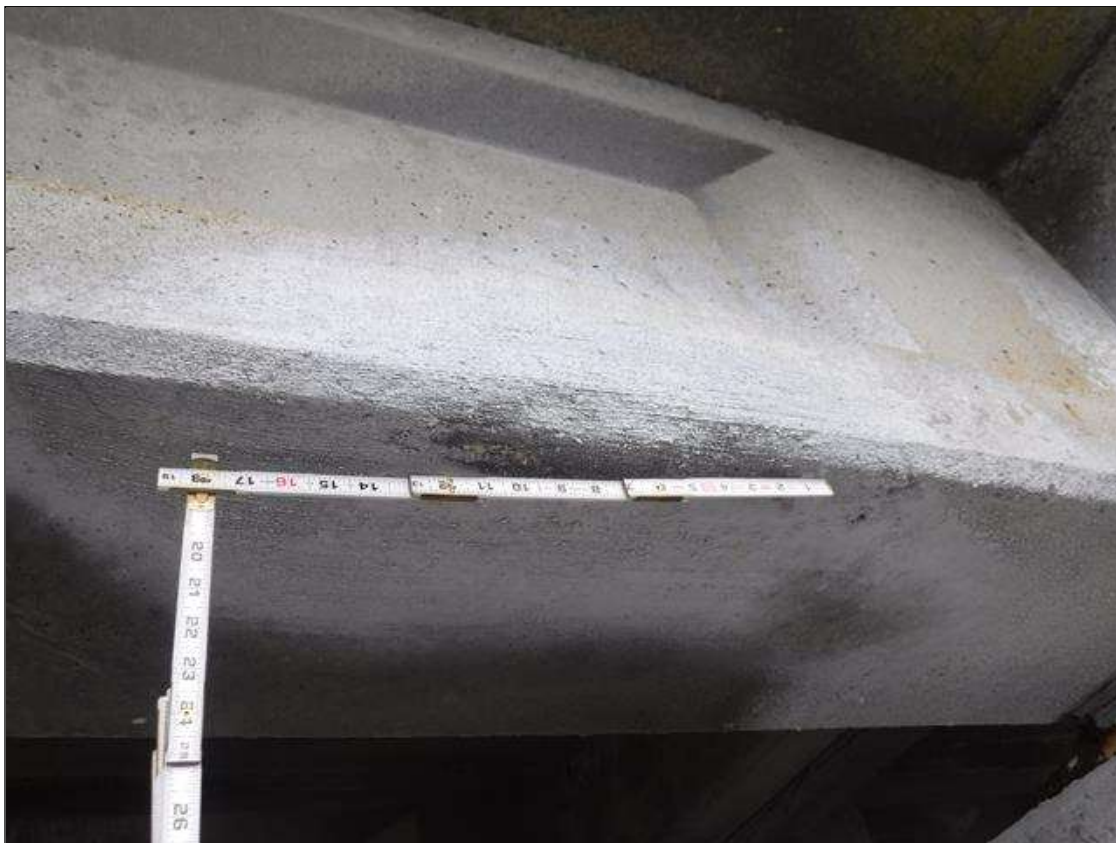
Span 236 Deck: (PAR) 16" DIAMETER X 1" DEEP SPALL WITH EXPOSED REINFORCEMENT IN DECK UNDERSIDE RIGHT OVERHANG, 15' FROM BENT 235

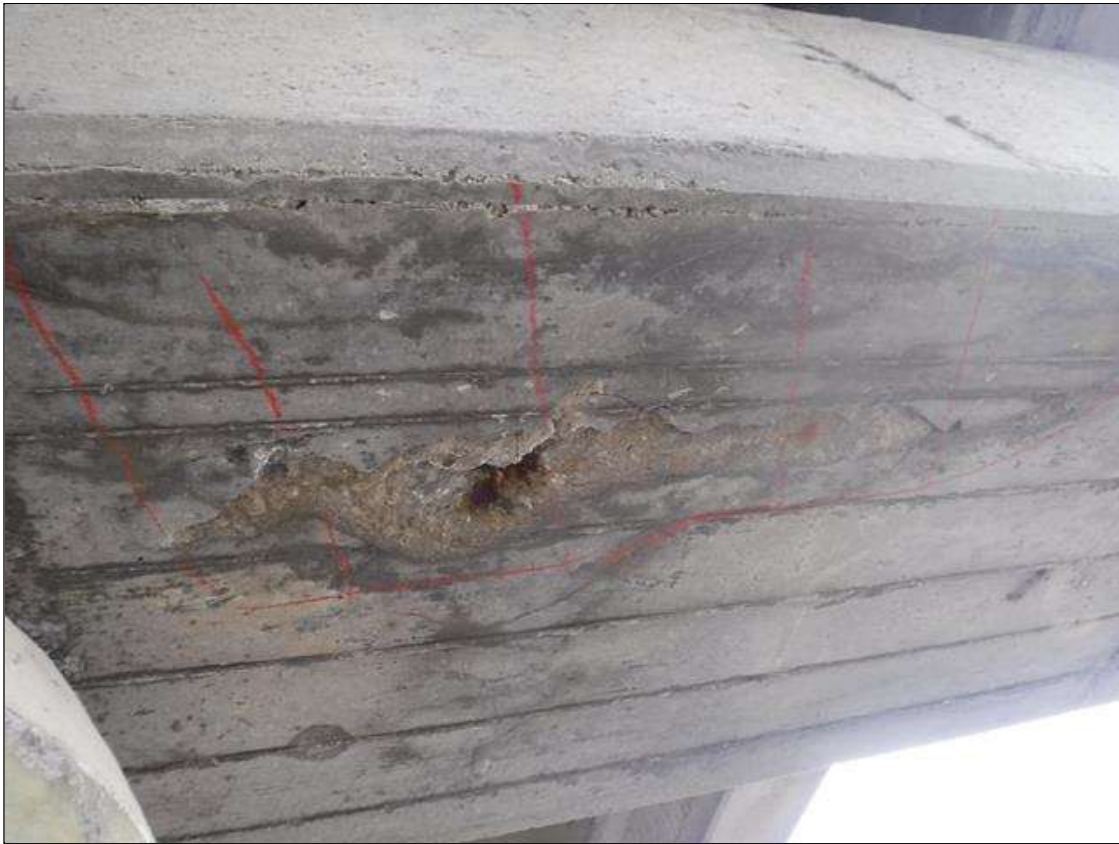
Bent 238 Cap 1: (PAR) 12" X 12" X 1.5" SPALL, WITH EXPOSED REINFORCING, WITH ADJACENT 12" X 6" DELAMINATION, BOTTOM FACE, BENEATH BEAM 1.

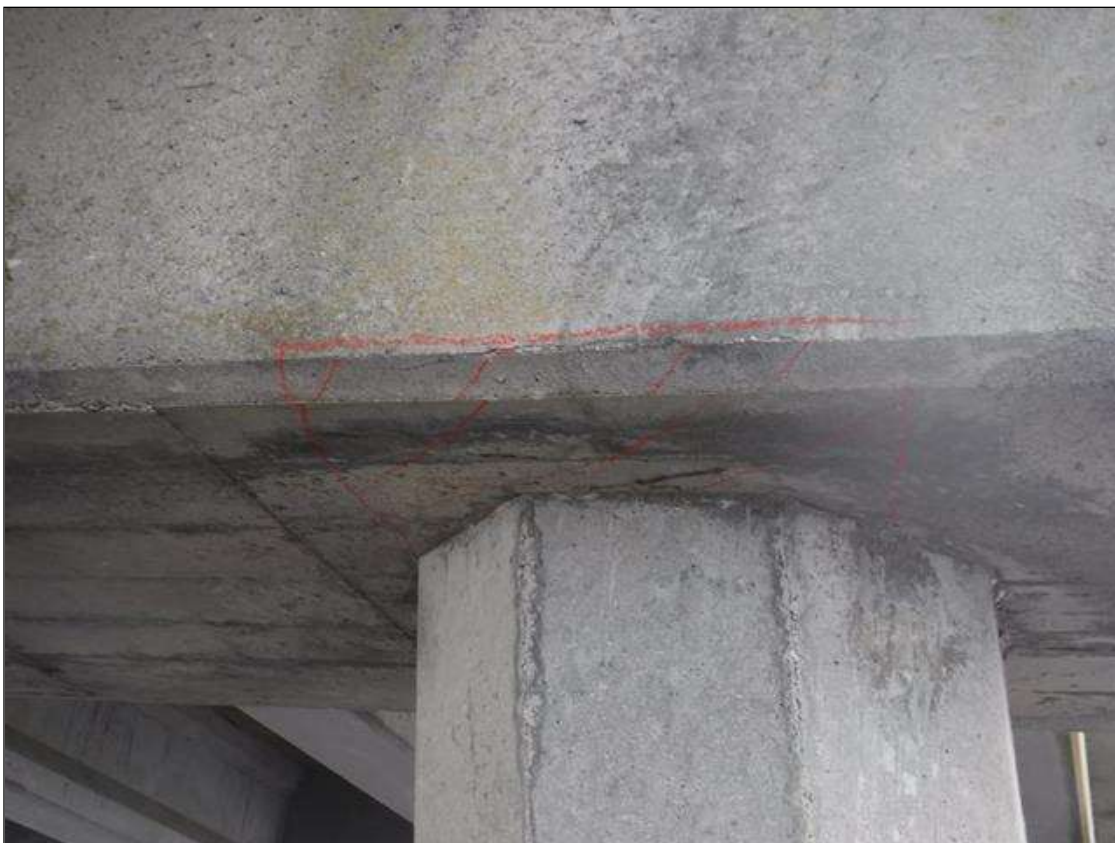
Span 242 Deck: (PAR) 2' X 1' X 2" DEEP SPALL IN DECK UNDERSIDE LEFT OVERHANG AT MIDSPAN

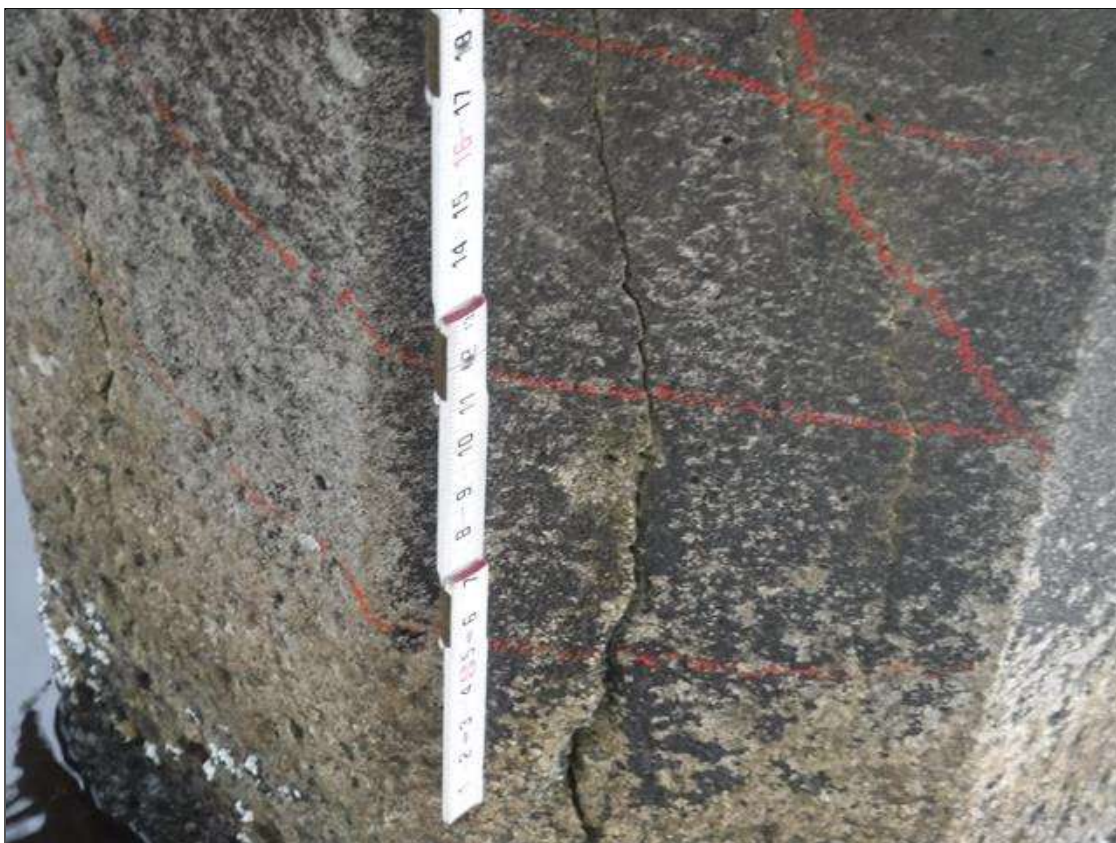
Bent 242 Pile 1: (PAR) HAIRLINE TO 1/8" CRACKS, 8' BELOW CAP, DOWN 4' , MULTIPLE FACES. SCALING TO 1" DEEP WITH LOOSE AGGREGATE FROM WATERLINE TO MUDLINE.

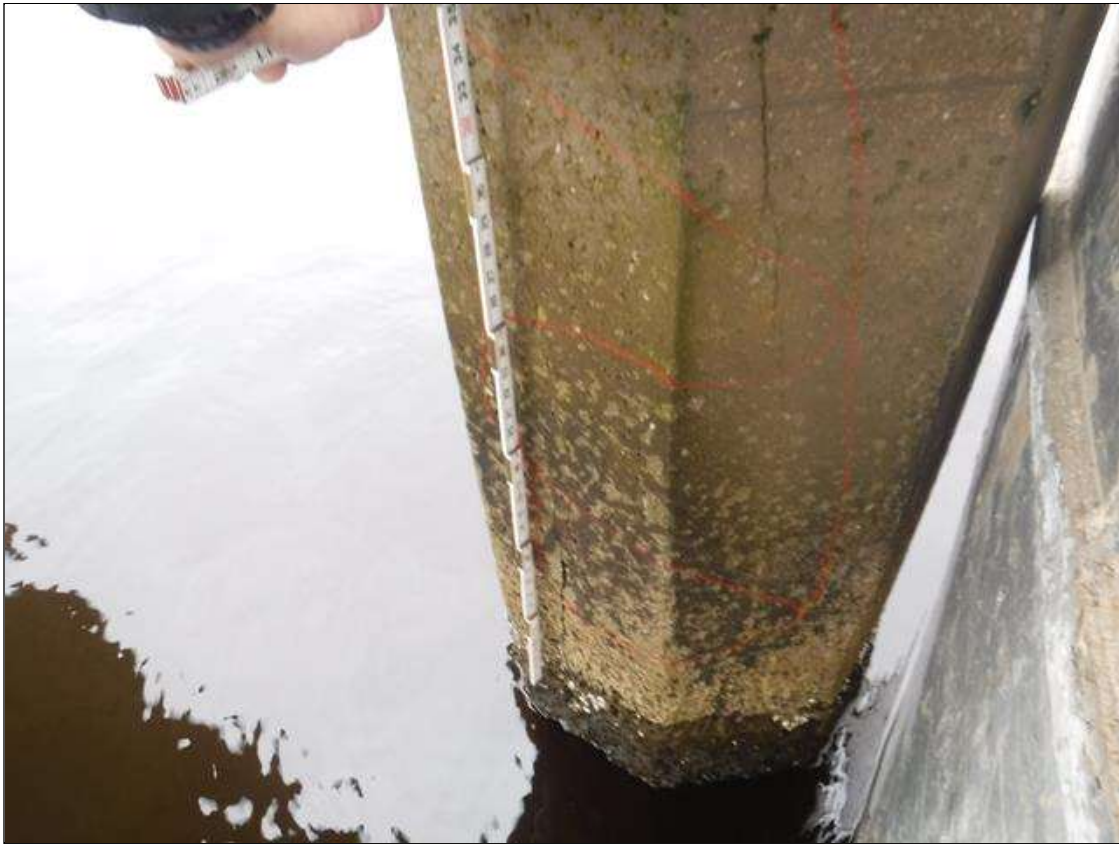
Bent 242 Pile 1: (PAR) 48" X 1" DELAMINATION, SOUTH FACE, 6' FROM BOTTOM OF CAP.

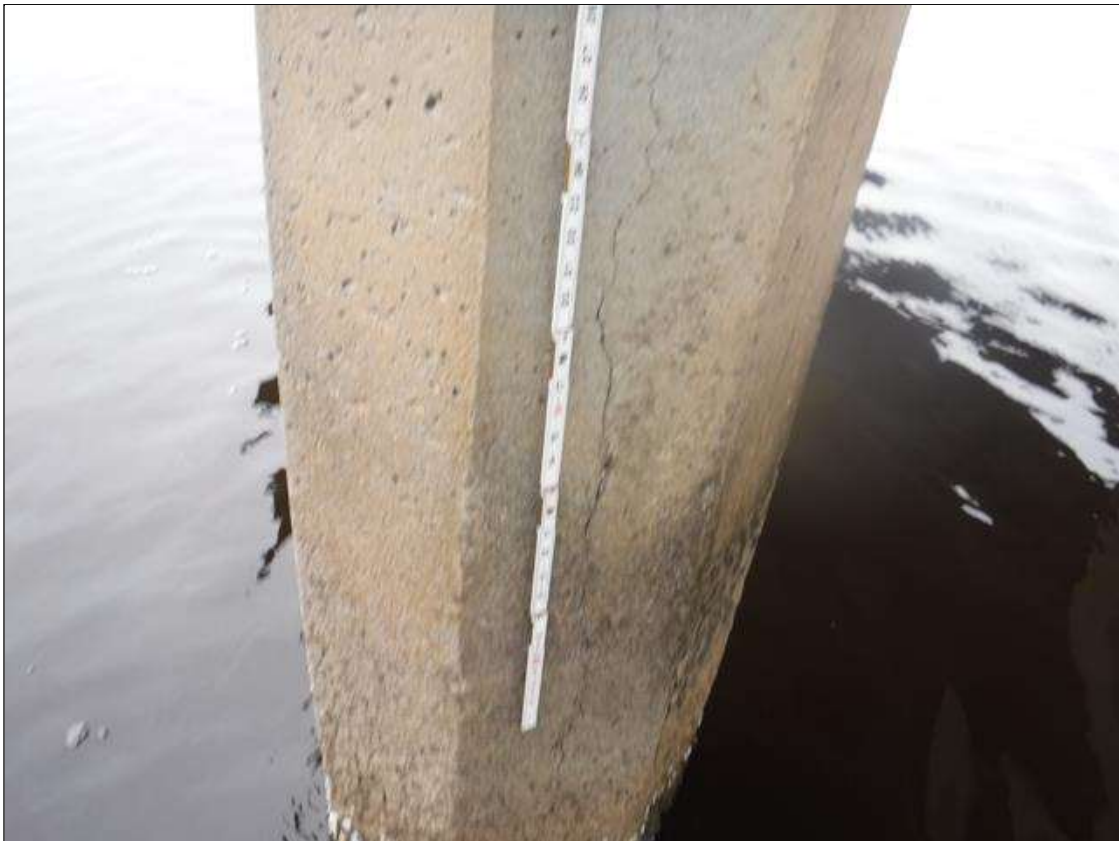
Bent 243 Pile 6: (PAR) HAIRLINE TO 1/16" CRACKS, 8' BELOW CAP, DOWN 4', NORTH FACE. SCALING TO 1" DEEP WITH LOOSE AGGREGATE FROM WATERLINE TO MUDLINE.

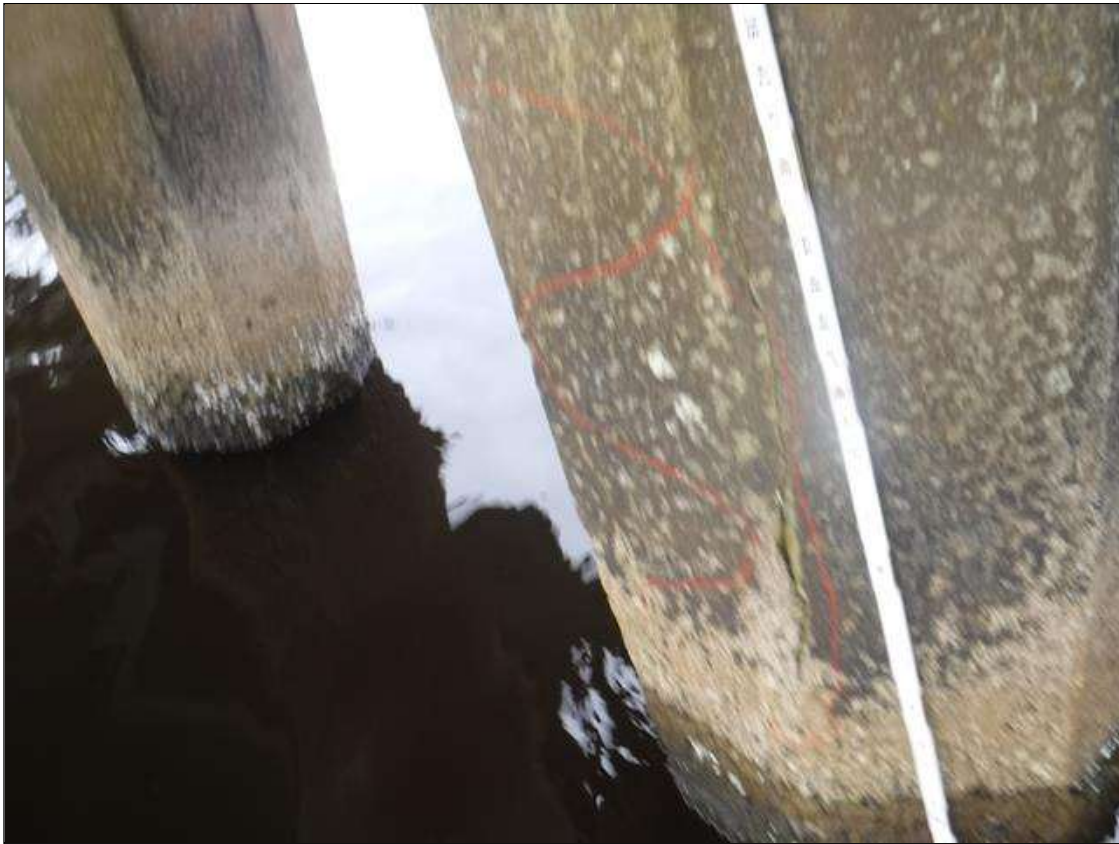
Bent 243 Pile 6: (PAR) (2) UP TO 10' X 0.03" VERTICAL CRACKS, EAST FACE, BEGINNING AT BOTTOM OF CAP.

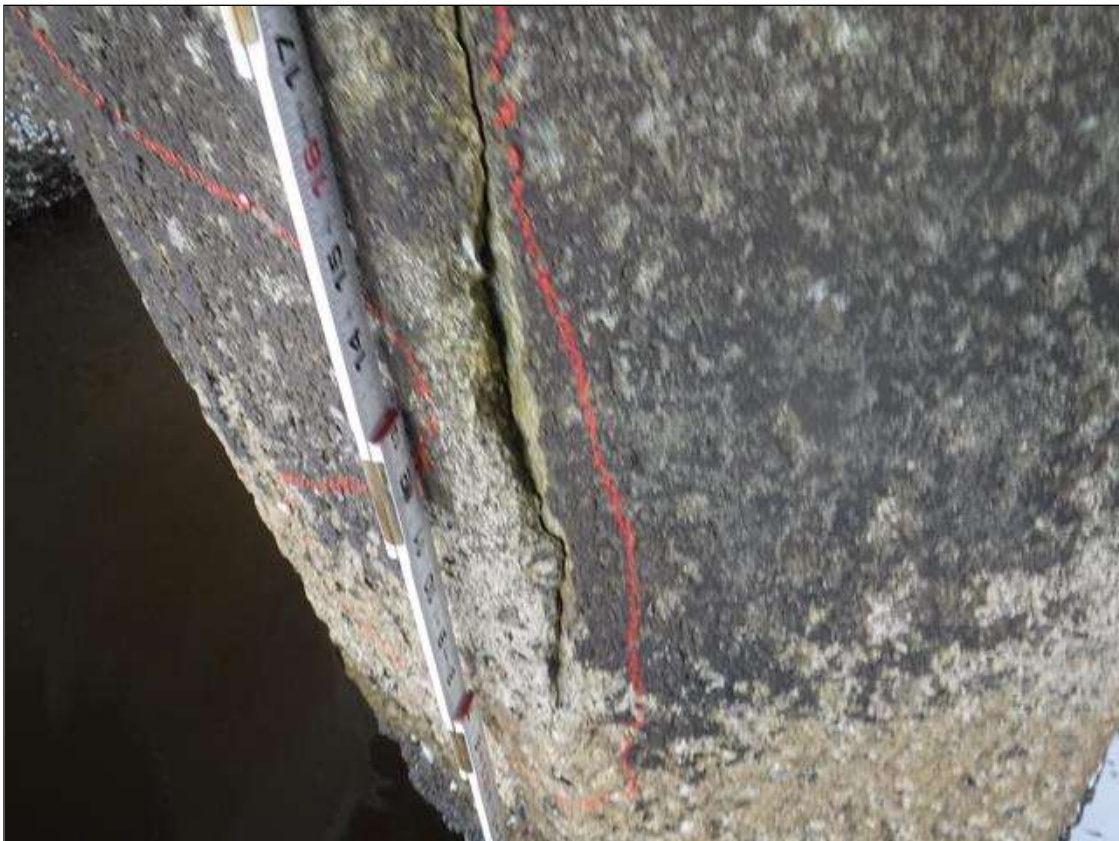
Bent 243 Pile 4: (PAR) 24" X 12" DELAMINATION, NORTH FACE, 8' FROM BOTTOM OF CAP.

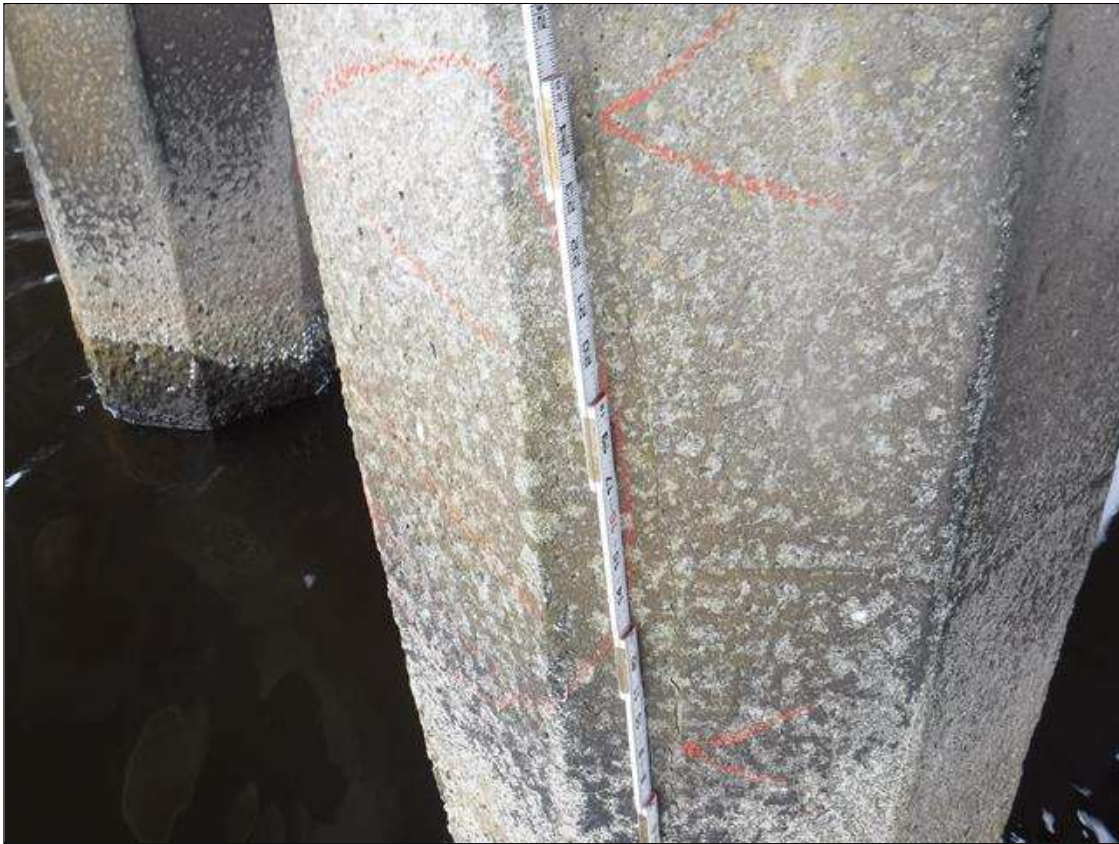
Bent 243 Pile 4: (PAR) HAIRLINE TO 1/4" CRACKS, 8' BELOW CAP, DOWN 4' , MULTIPLE FACES. SCALING TO 1" DEEP WITH LOOSE AGGREGATE FROM WATERLINE TO MUDLINE.

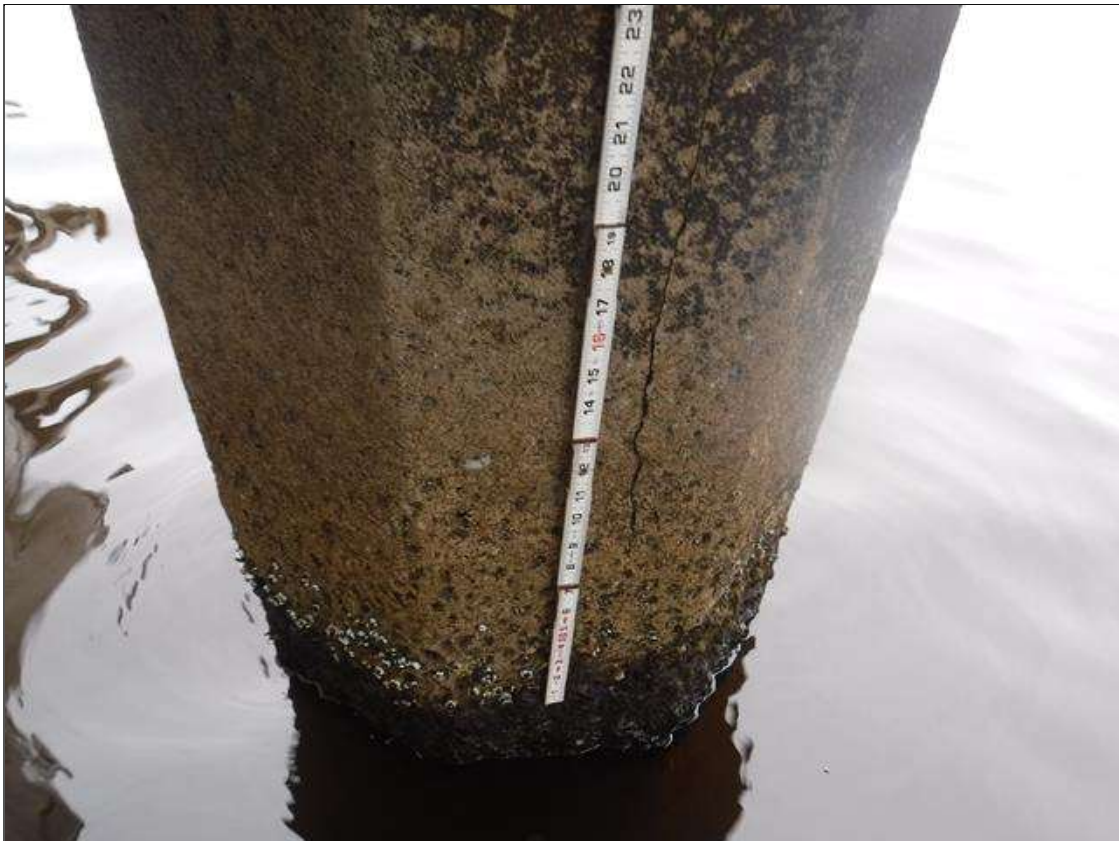
Bent 243 Pile 2: (PAR) (2) UP TO 3' X 0.03" VERTICAL CRACKS WITH SURROUNDING DELAMINATION ON NORTH FACE, BEGINNING 7' FROM BOTTOM OF CAP.

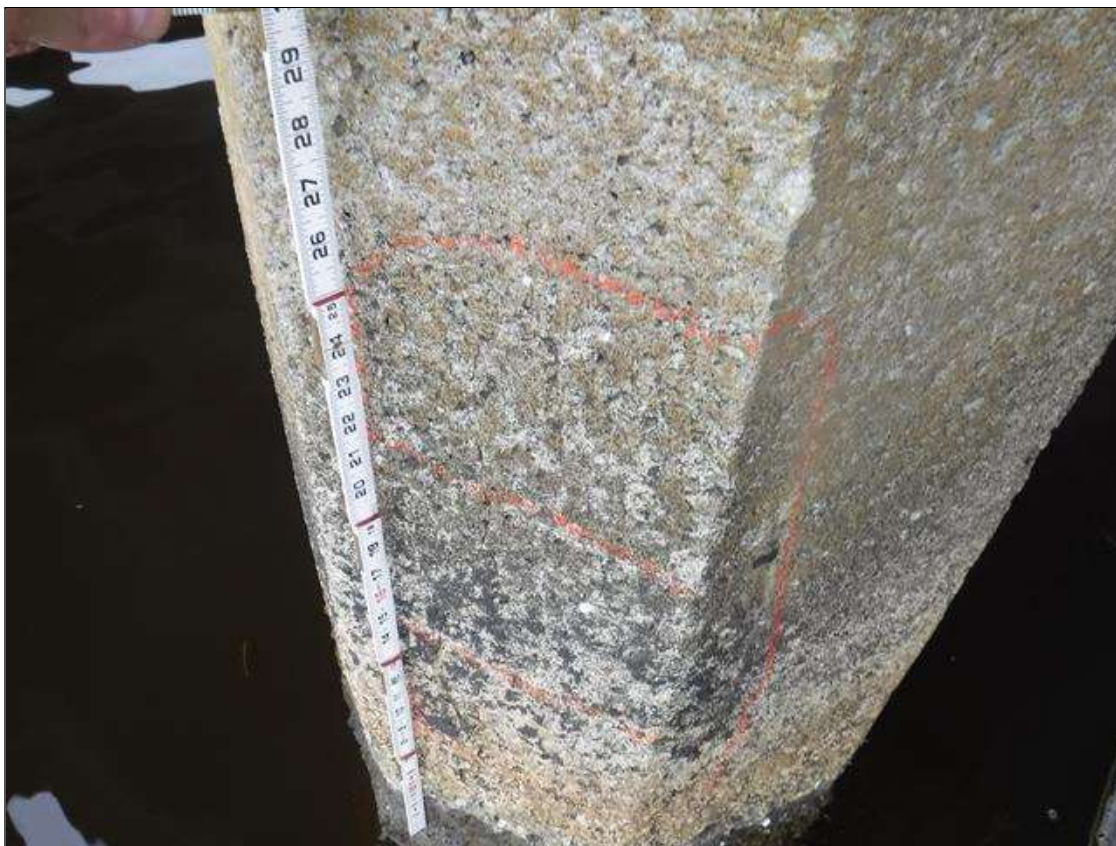
Bent 243 Pile 1: (PAR) 3' X 1/16" CRACKS WITH SURROUNDING DELAMINATION ON SOUTH FACE 7' FROM BOTTOM OF CAP

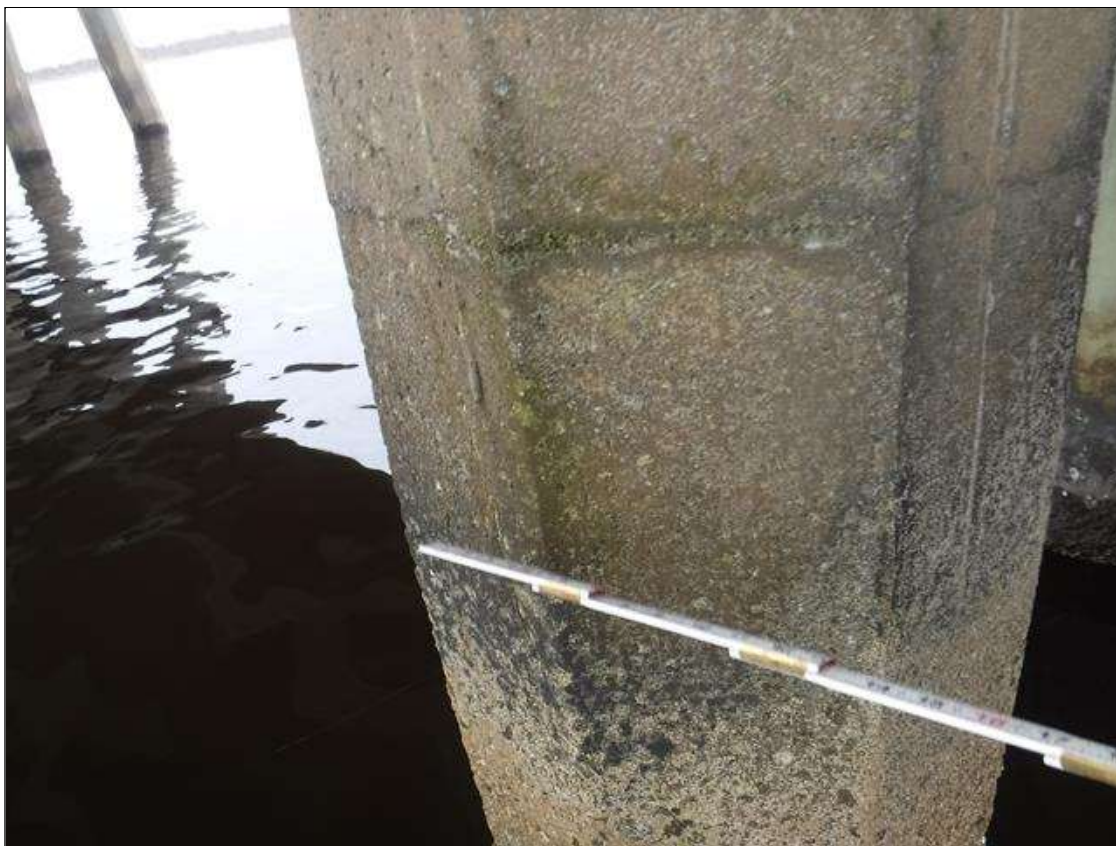
Bent 244 Pile 1: (PAR) (2) UP TO 3' X 0.03" VERTICAL CRACKS WITH 2' X 1' SURROUNDING DELAMINATION ON NORTH FACE, BEGINNING 7' FROM BOTTOM OF CAP, AT RANDOM THROUGHOUT.

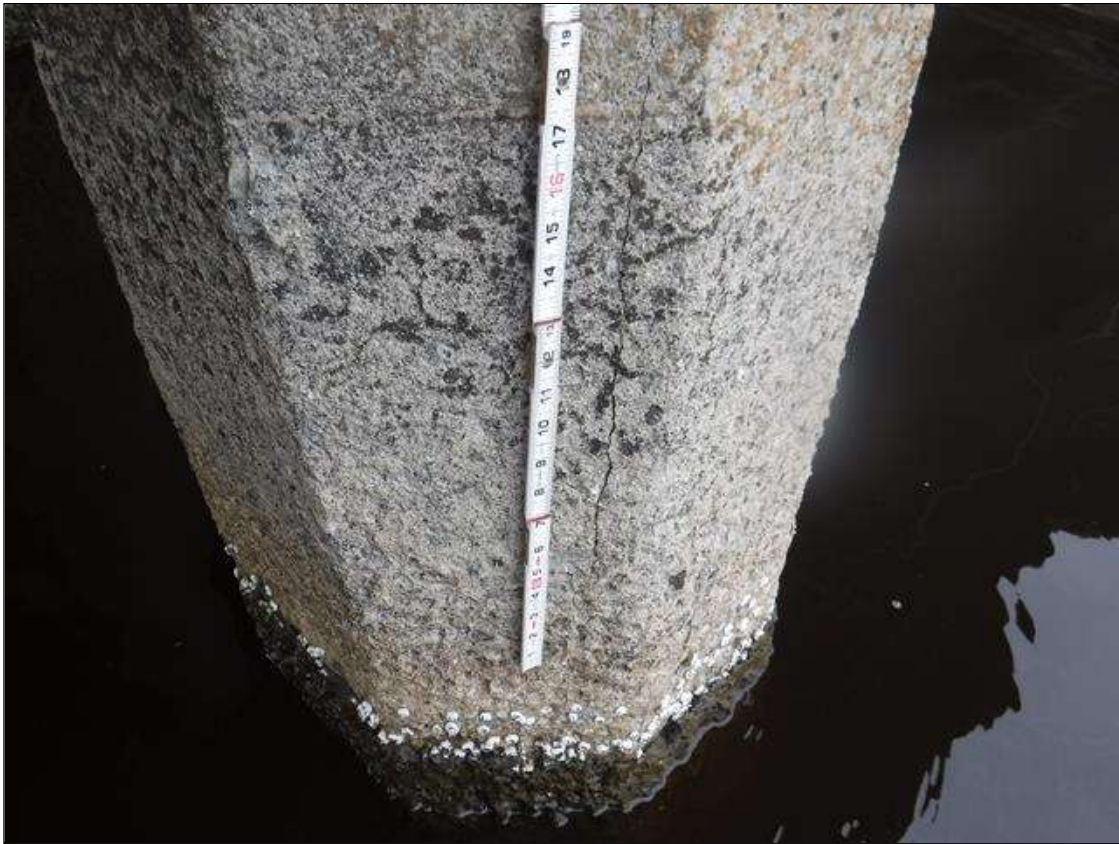
Bent 244 Pile 3: (PAR) HAIRLINE TO 1/16" CRACKS WITH SURROUNDING 36" X 8" DELAMINATION ON NORTH FACE, 8' BELOW CAP, DOWN 4', MULTIPLE FACES. SCALING TO 1" DEEP WITH LOOSE AGGREGATE FROM WATERLINE TO MUDLINE.

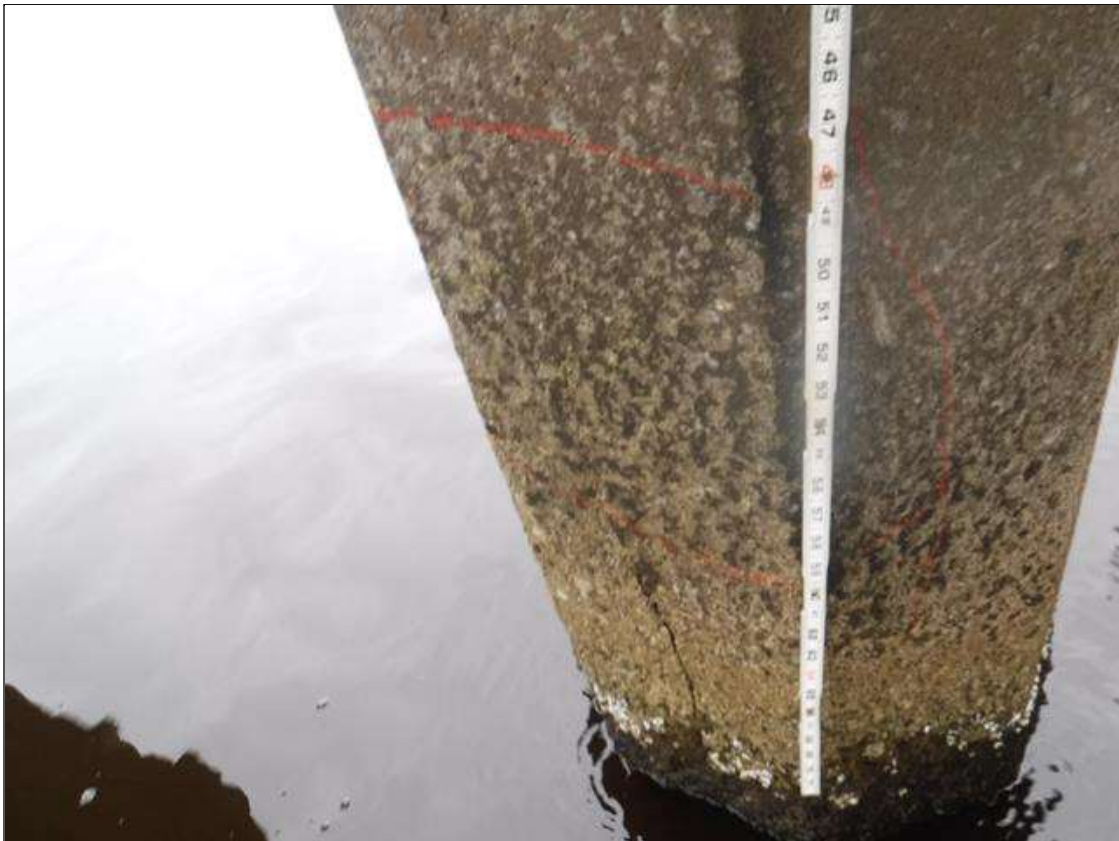
Bent 244 Pile 6: (PAR) (2) UP TO 2' X 0.03" VERTICAL CRACKS ON SOUTH FACE, BEGINNING 8' FROM BOTTOM OF CAP, AT RANDOM THROUGHOUT.
