NC DEPARTMENT OF TRANSPORTATION
DIVISION OF HIGHWAYS
STRUCTURE MANAGEMENT UNIT

Structure Safety Report

Routine Element Inspection - Contract

FEATURE INTERSECTED: ALLIGATOR RIVER

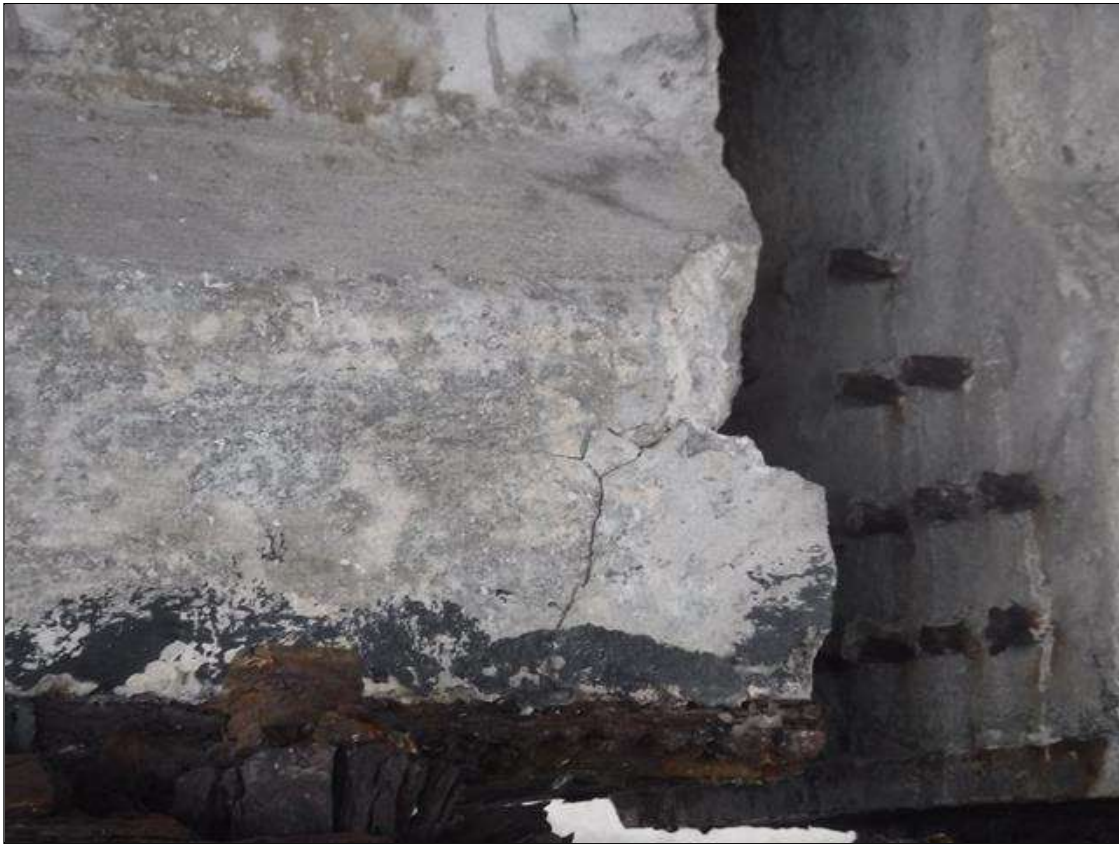
Span 246 Beam 3: (PAR) 6" X 6" X 3" DEEP SPALL WITH EXPOSED STRANDS ON NORTH FACE AT BENT 245

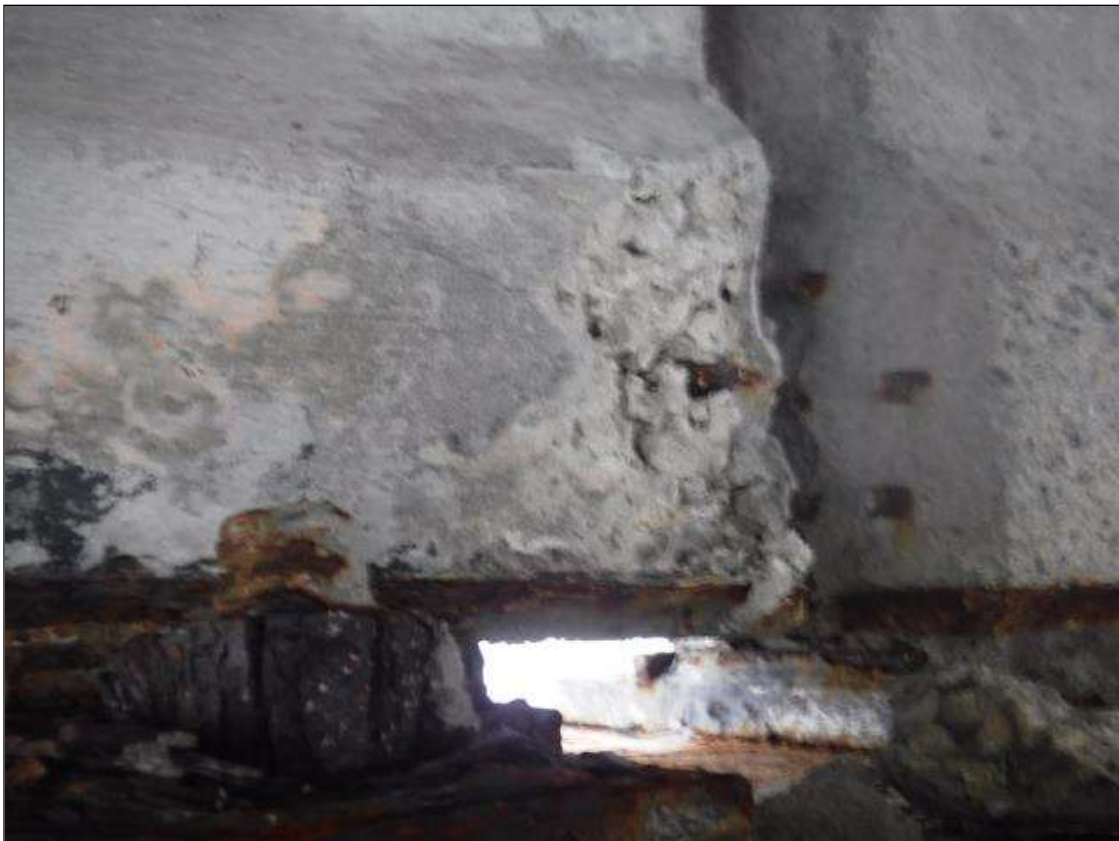
Span 246 Beam 4: (PAR) 6" X 6" X 3" DEEP SPALL WITH EXPOSED STRANDS ON NORTH FACE AT BENT 245

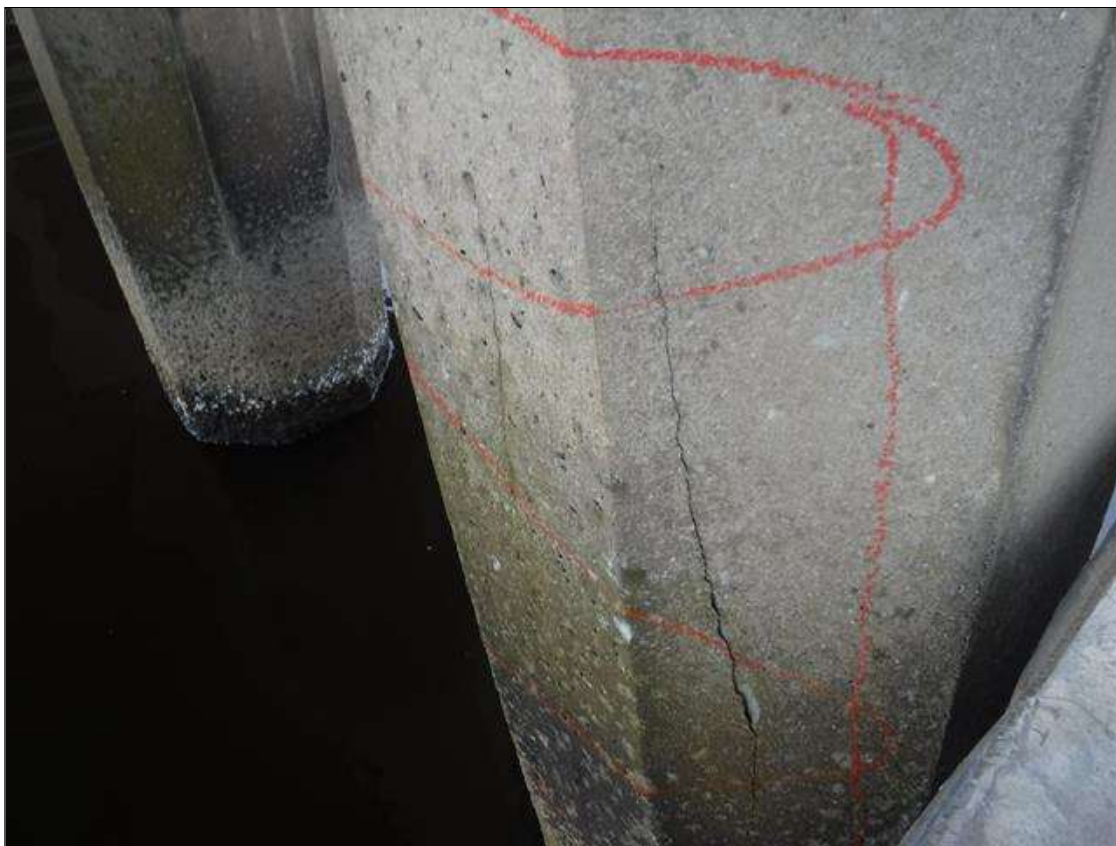
Bent 247 Pile 4: (PAR) HAIRLINE TO 1/8" CRACKS WITH 48" X 24" SURROUNDING DELAMINATION ON NORTH FACE, 8' BELOW CAP, DOWN 4' , MULTIPLE FACES. SCALING TO 1" DEEP WITH LOOSE AGGREGATE FROM WATERLINE TO MUDLINE.

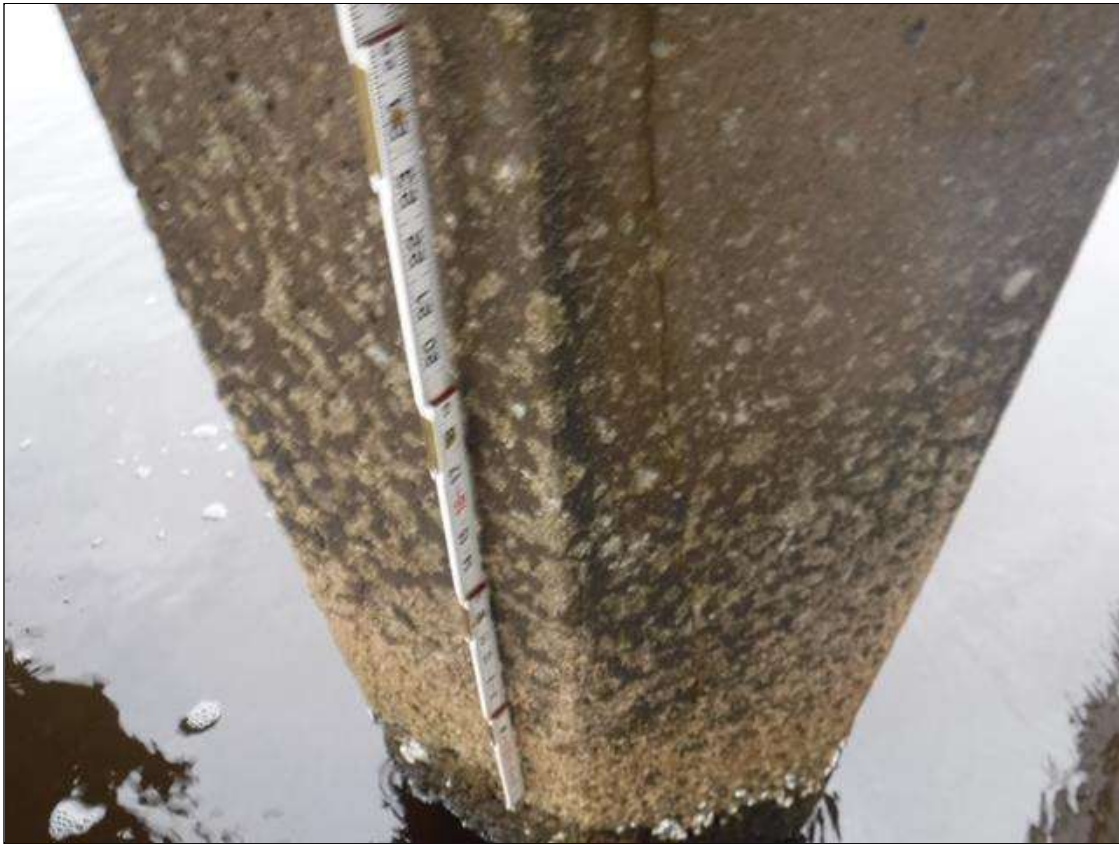
Bent 248 Pile 4: (PAR) 3' X 1/16" VERTICAL CRACK WITH SURROUNDING 36" X 8" DELAMINATION ON NORTH FACE, 7' FROM BOTTOM OF CAP.

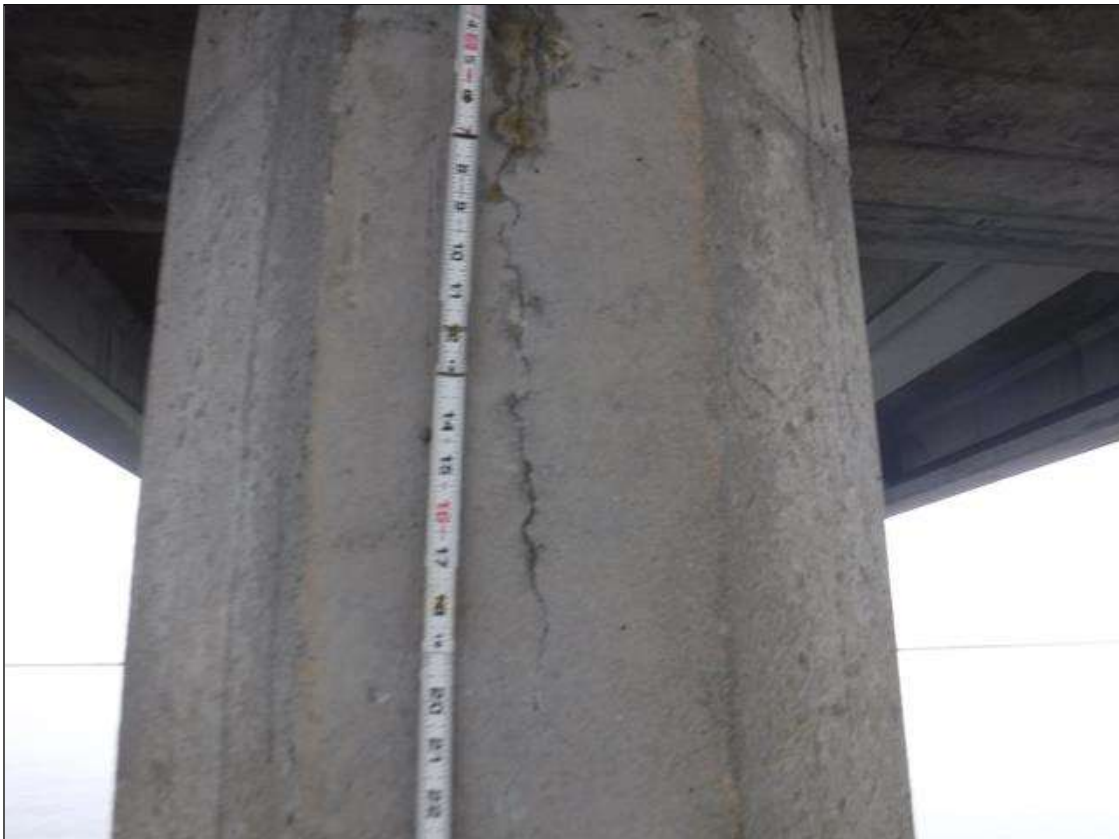
Bent 248 Pile 3: (PAR) HAIRLINE TO 1/16" CRACK FROM BOTTOM OF CAP DOWN 4' ON EAST FACE. SCALING TO 1" DEEP WITH LOOSE AGGREGATE FROM WATERLINE TO MUDLINE.

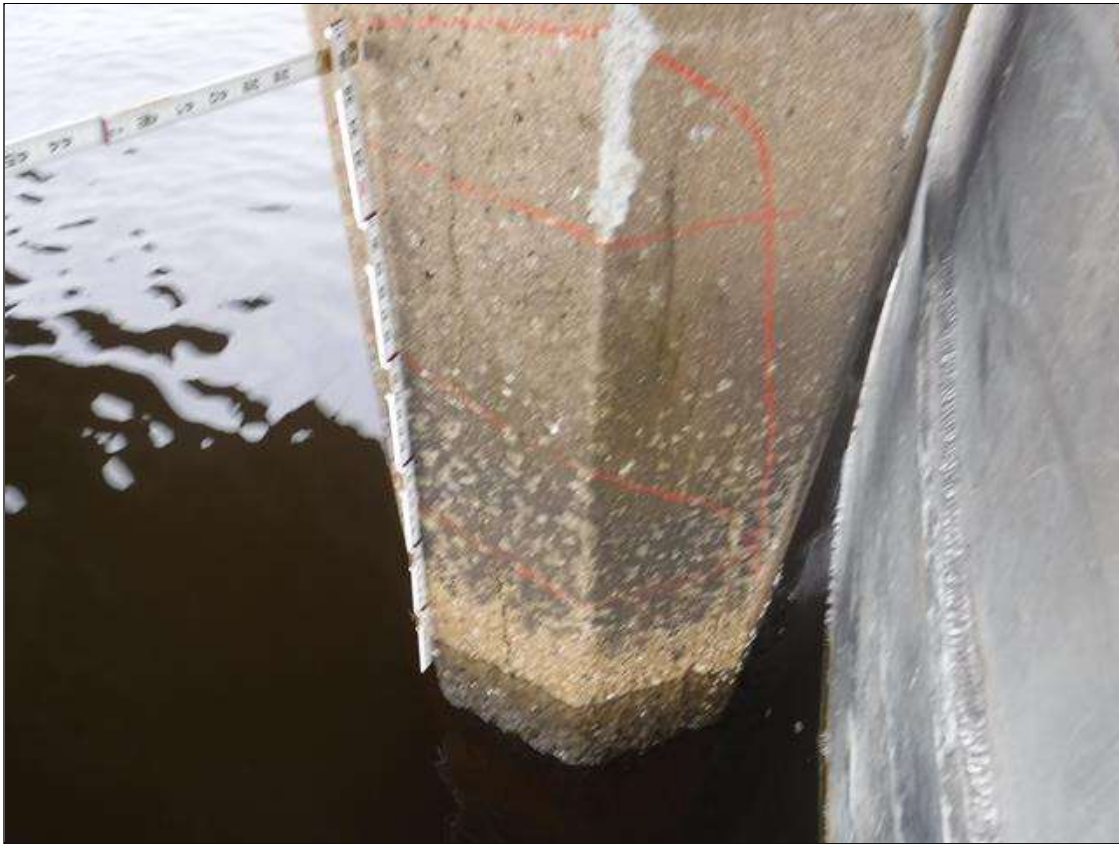
Bent 249 Pile 3: (PAR) (3) UP TO 4' X 0.25" VERTICAL CRACKS WITH 4' X 2' SURROUNDING DELAMINATION ON NORTH FACE, BEGINNING 6' BOTTOM OF CAP

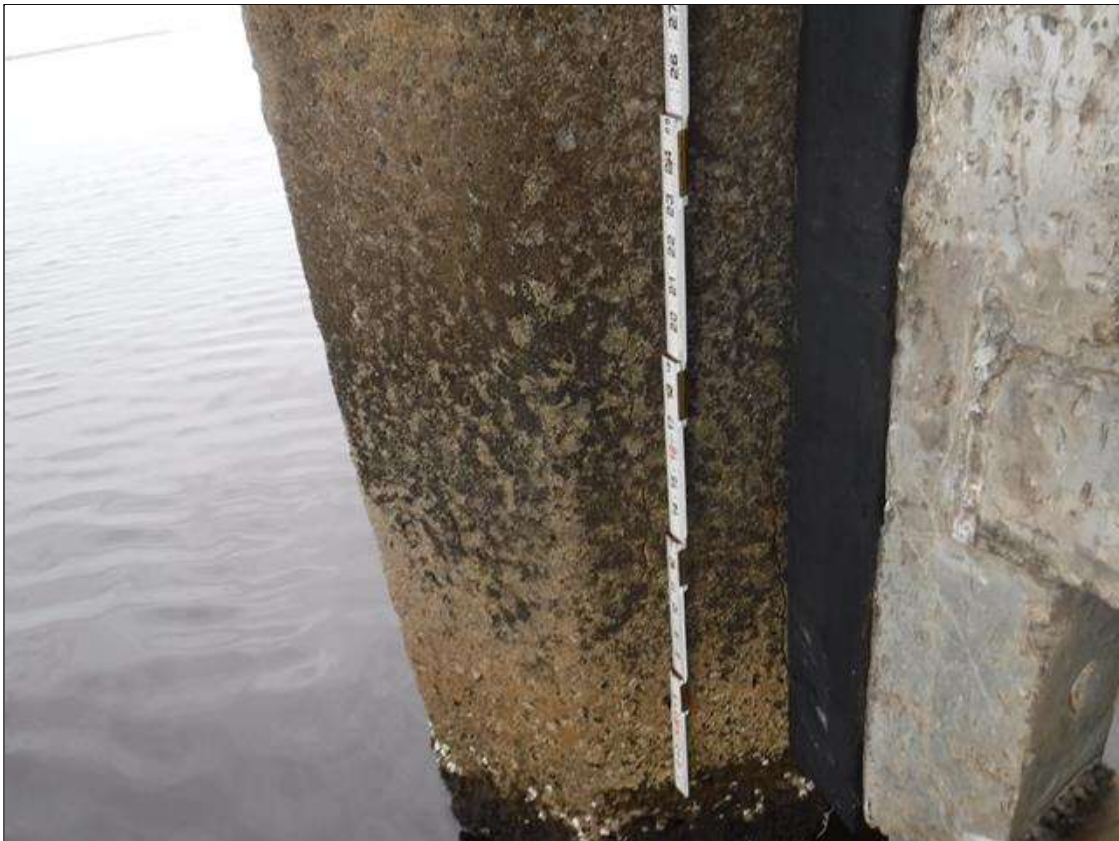
Bent 249 Pile 4: (PAR) (2) UP TO 3' X 0.03" VERTICAL CRACKS ON NORTH FACE, BEGINNING 7' BOTTOM OF CAP

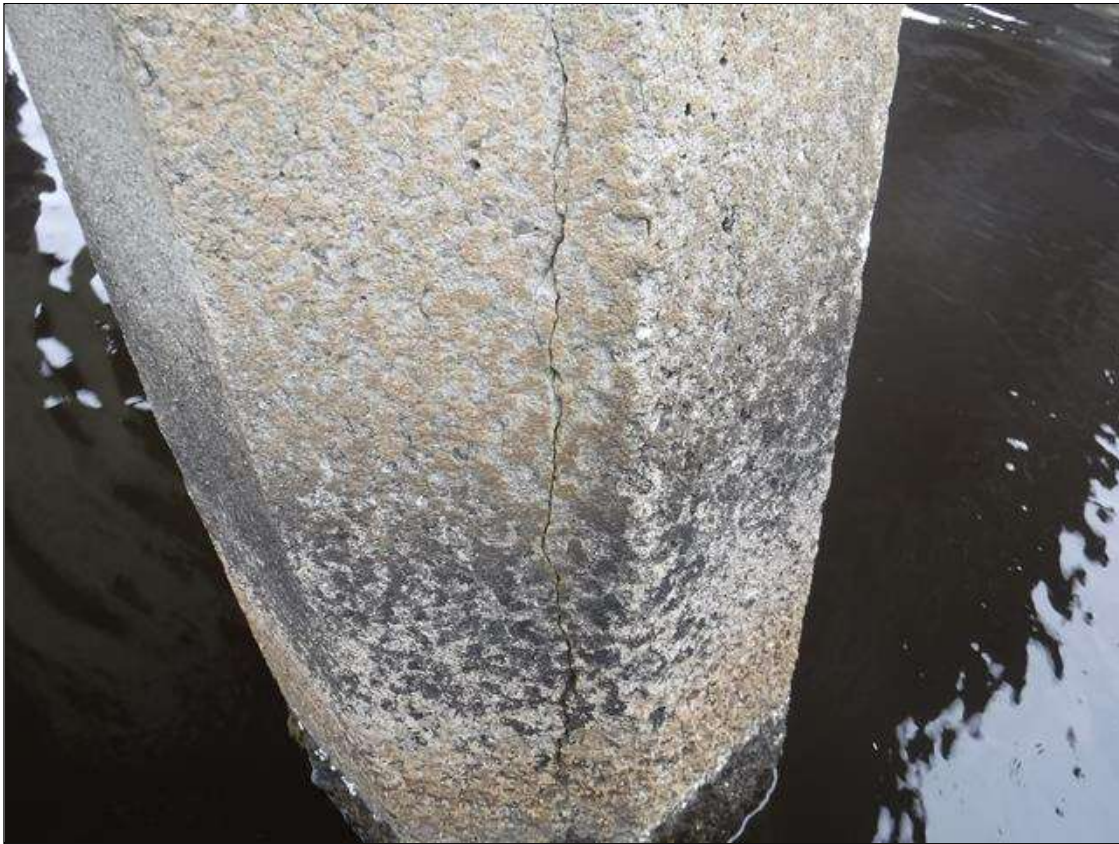
Bent 250 Pile 1: (PAR) UP TO 4' X 0.016" VERTICAL CRACK, NORTH FACE, 7' FROM BOTTOM OF CAP.

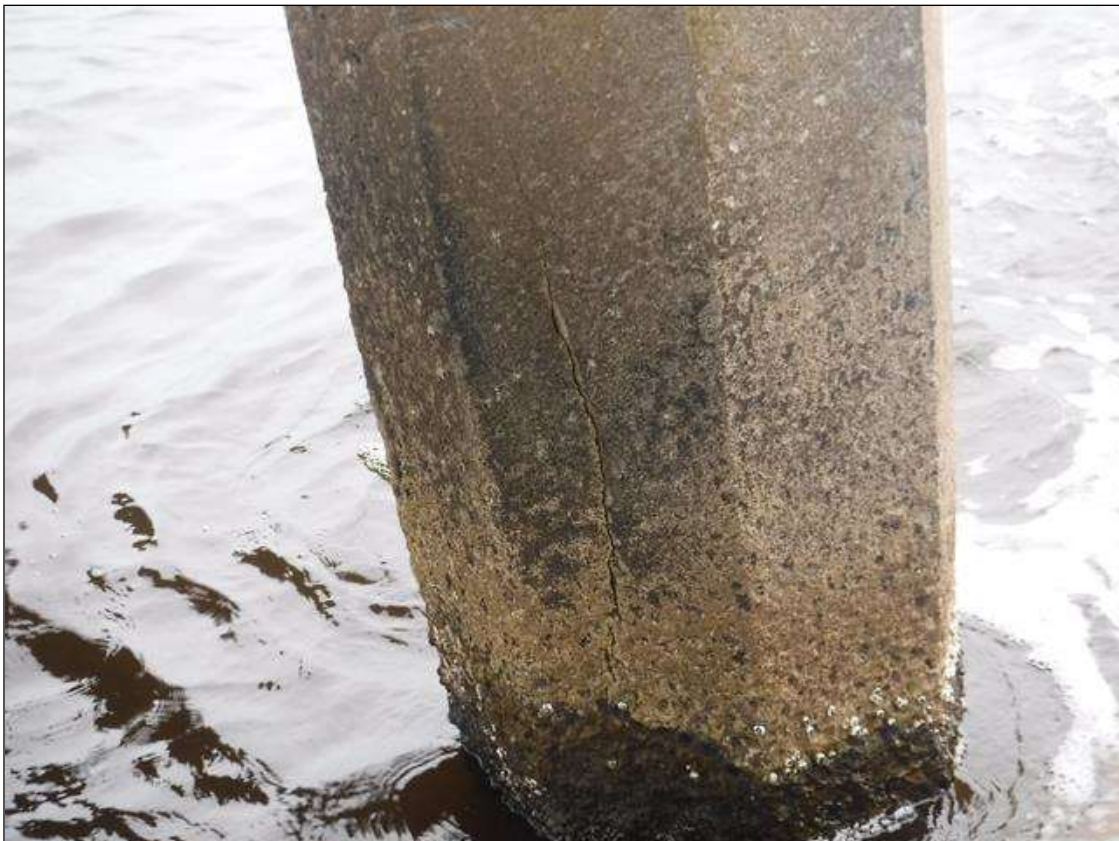
Bent 252 Pile 4: (PAR) (2) UP TO 2' X 0.016" VERTICAL CRACKS, NORTH FACE, 8' FROM BOTTOM OF CAP, WITH ADJACENT 2' X 1' DELAMINATION.

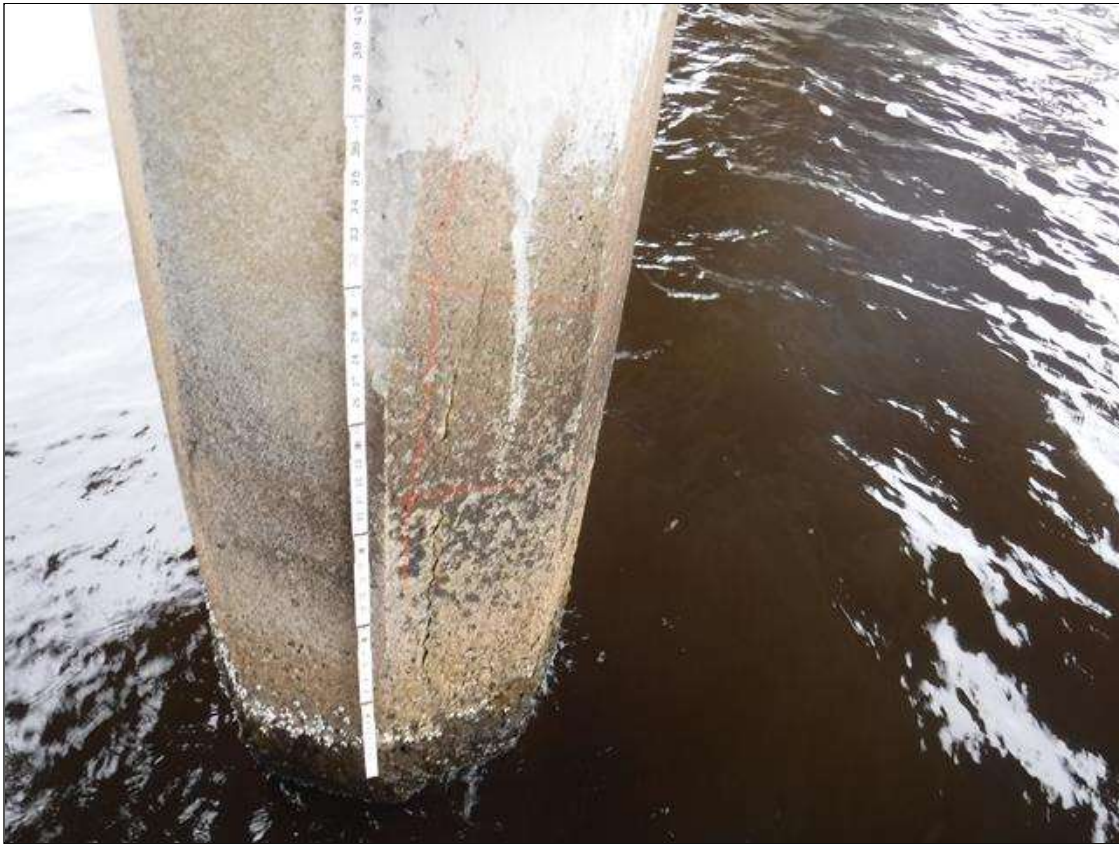
Bent 252 Pile 3: (PAR) (2) UP TO 2' X 0.0125" VERTICAL CRACKS, NORTH FACE, 8' FROM BOTTOM OF CAP, WITH ADJACENT 2' X 3' DELAMINATION.

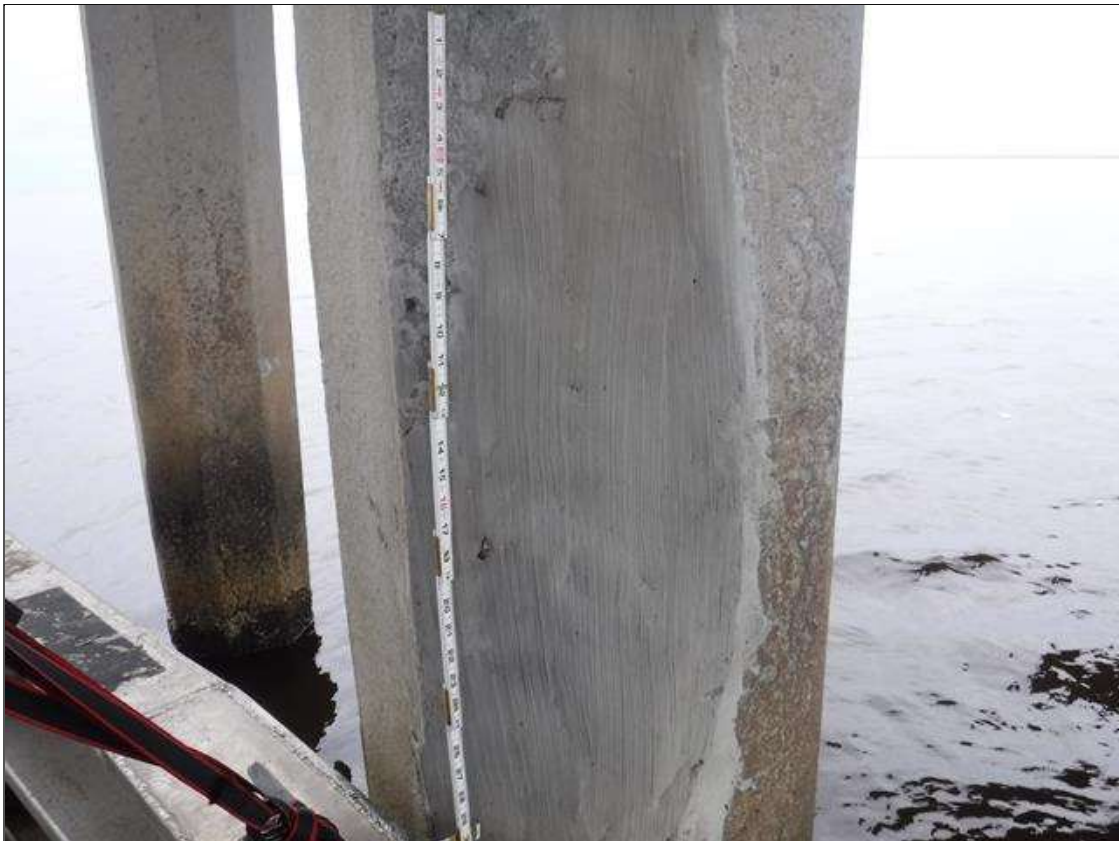
Bent 252 Pile 3: 4' X 14" PATCHED AREA ON NORTH FACE, BEGINNING 4' FROM BOTTOM OF CAP.

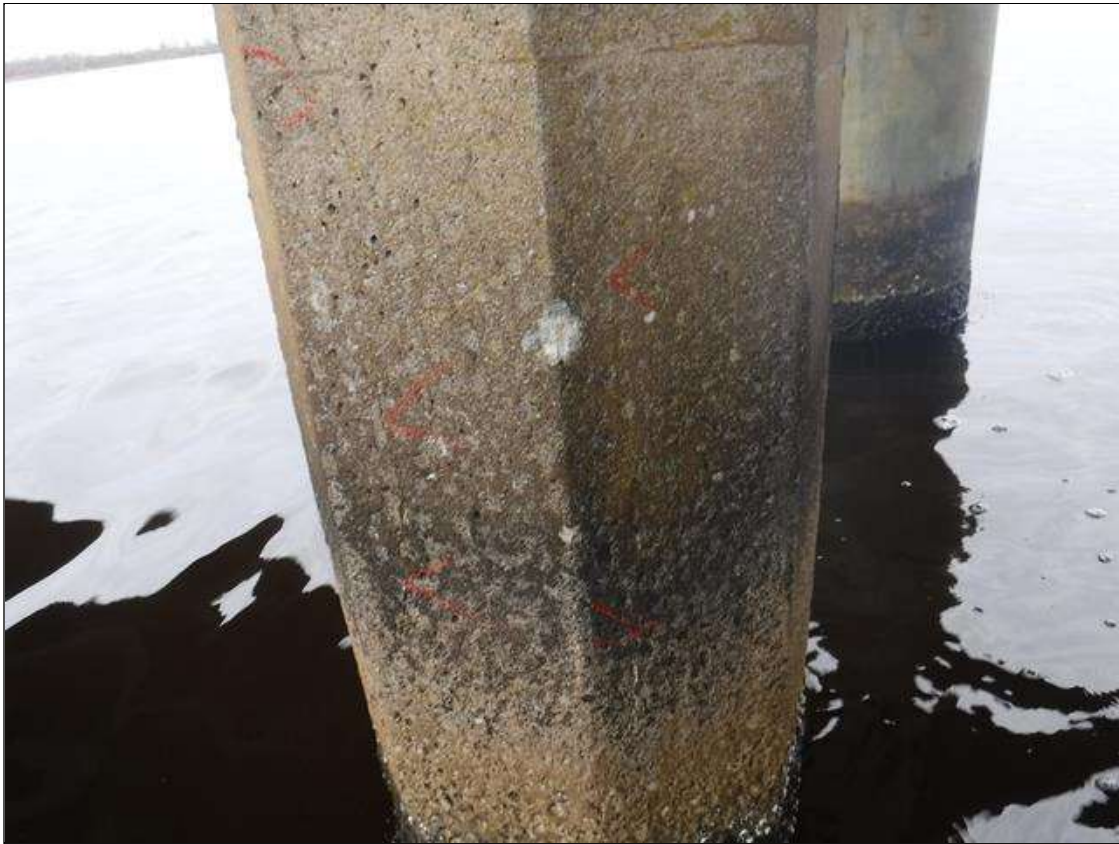
Bent 254 Pile 2: (PAR) (4) UP TO 4' X 0.02" VERTICAL CRACKS, EAST AND NORTH FACES, 7' FROM BOTTOM OF CAP, WITH UP TO 4' X 1' DELAMINATIONS.

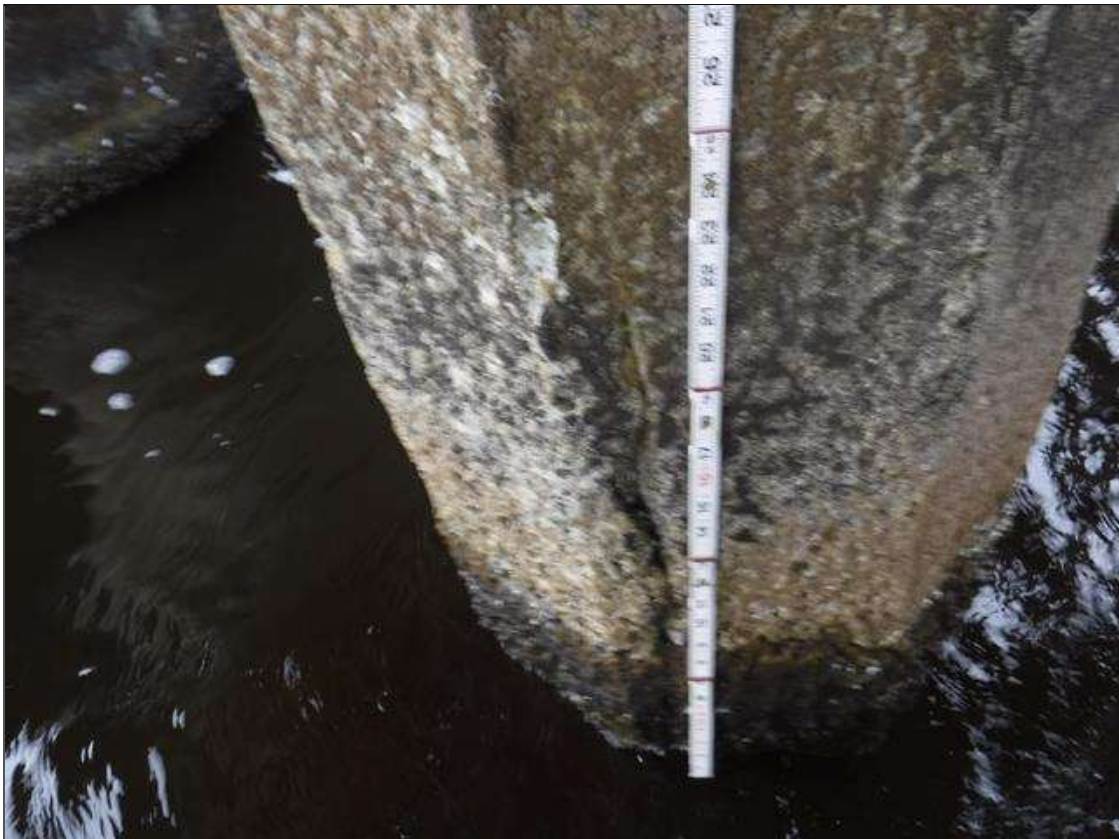
Bent 255 Pile 2: (PAR) 4' X 1/4" TO 1/2" CRACK ON NORTH FACE, 8' BELOW CAP, DOWN 4'. SCALING TO 1" DEEP WITH LOOSE AGGREGATE FROM WATERLINE TO MUDLINE.

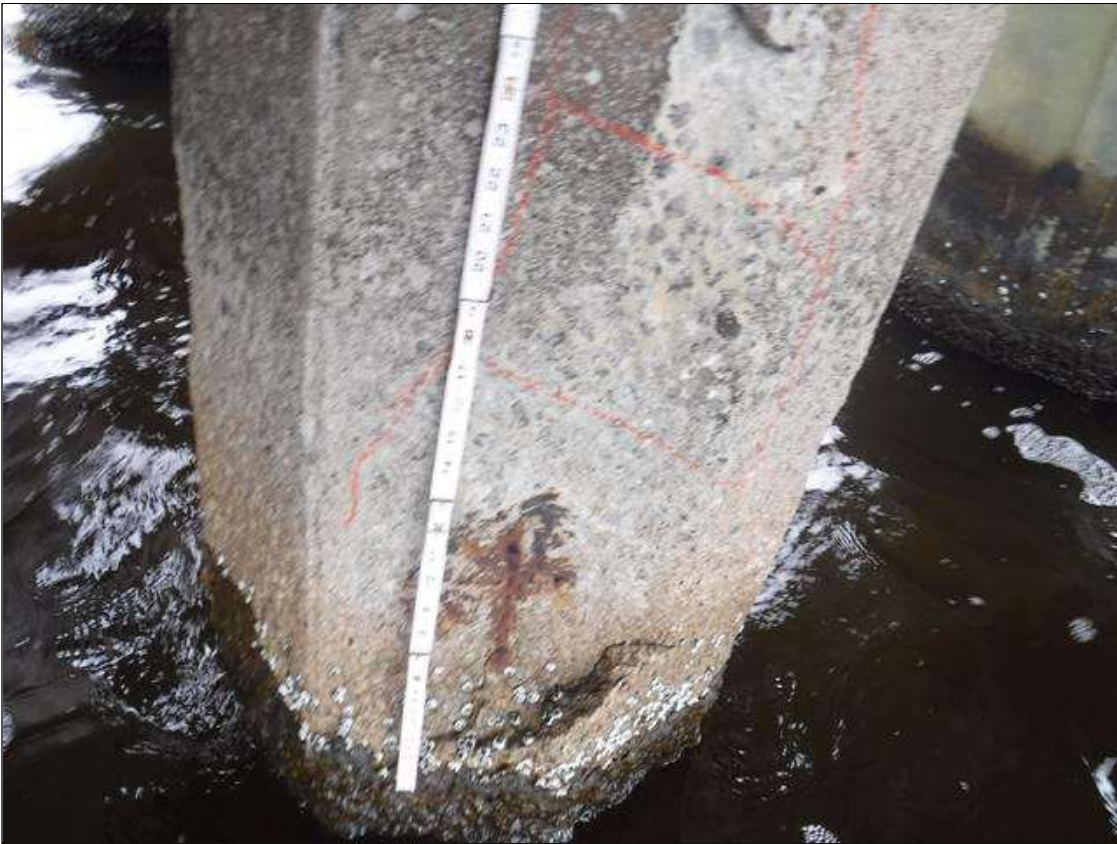
Bent 255 Pile 2: (PAR) 2' X UP TO 1' X 2.5" DEEP SPALL, WITH EXPOSED STRAND, SOUTH FACE, 8' FROM BOTTOM OF CAP.

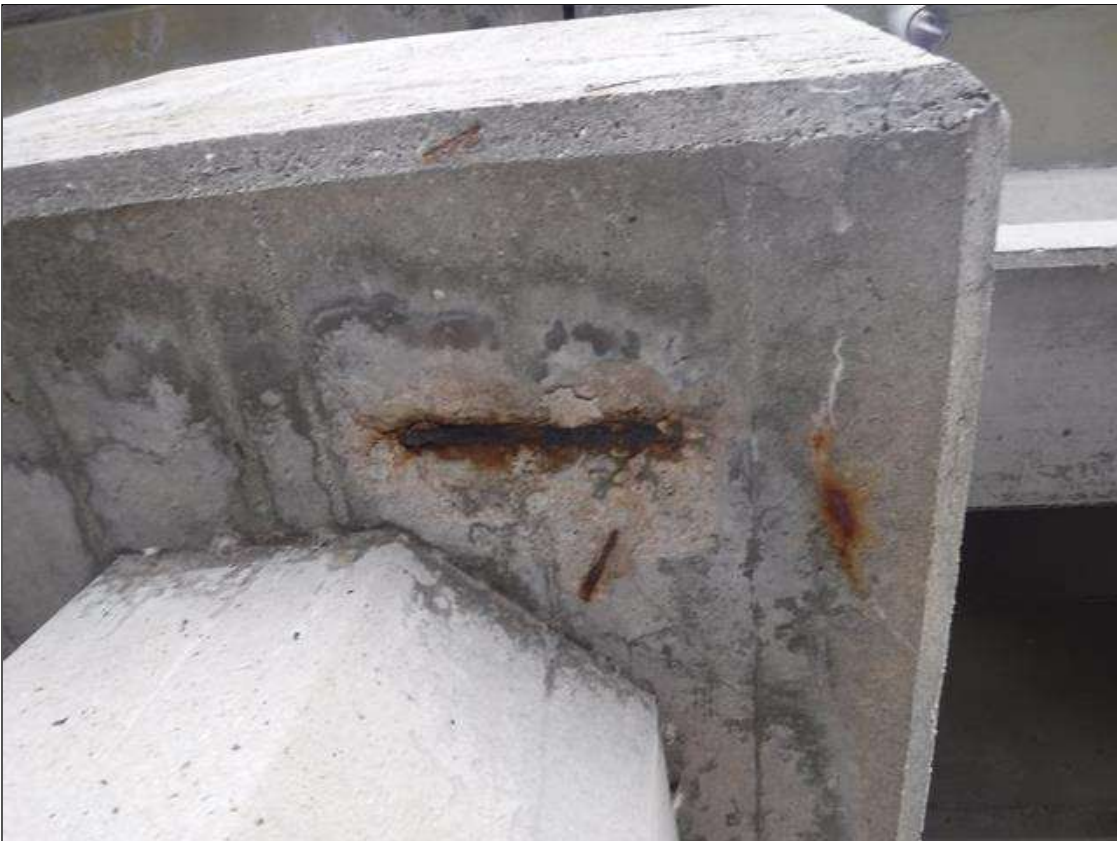
Bent 255 Cap 1: (PAR) 4" LONG, 9" WIDE AND 1" DEEP SPALL WITH EXPOSED REBAR IN BOTTOM OF RIGHT OVERHANG.

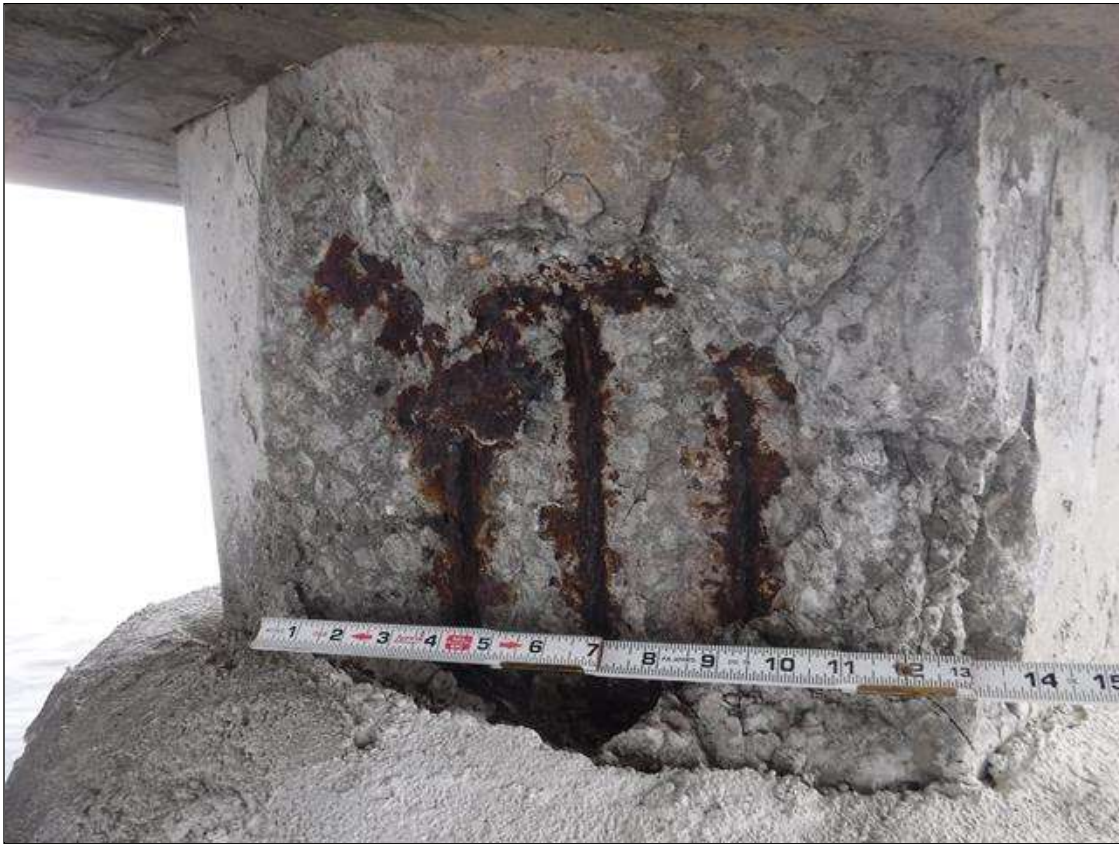
Bent 261 Pile 1: (PAR) 12" X 15" X 3" SPALL, WITH (3) EXPOSED STRAND WITH 50% SECTION LOSS ON SOUTHEAST FACE, AT BOTTOM OF CAP.

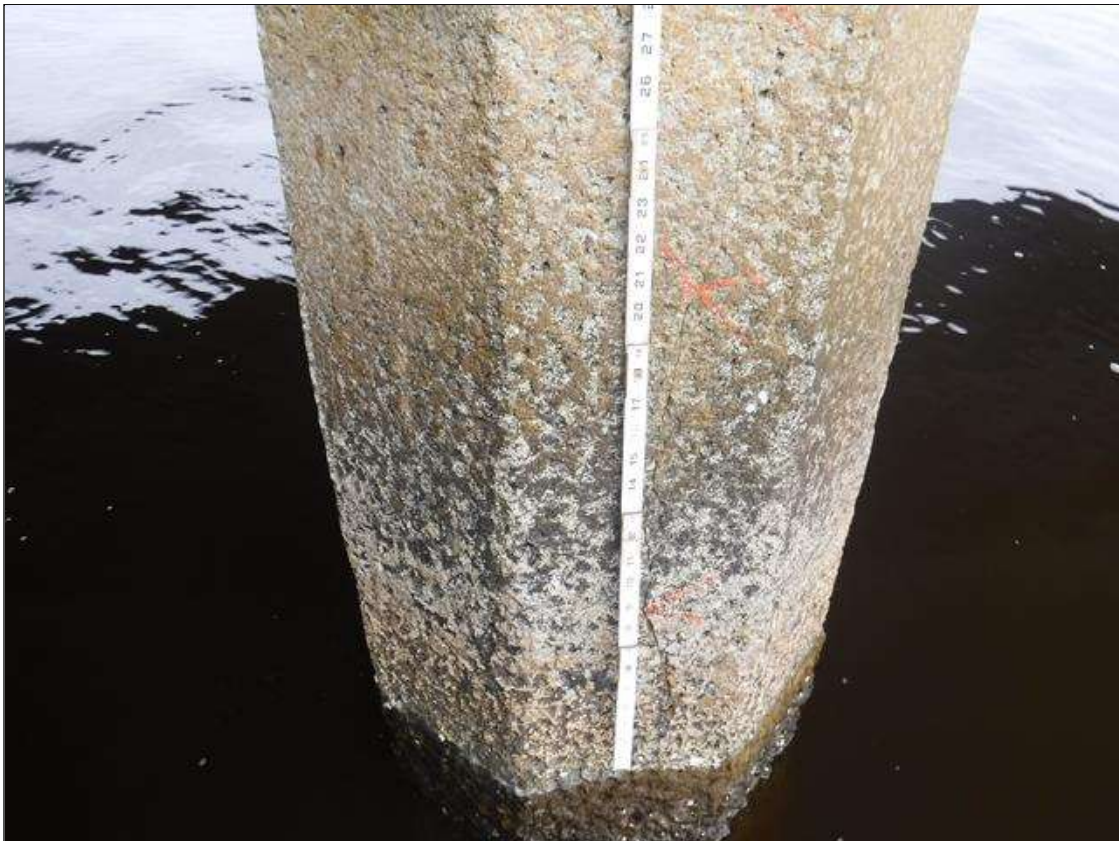
Bent 266 Pile 1: (PAR) HAIRLINE TO 1/16" CRACK, 8' BELOW CAP, DOWN 4', NORTH FACE. SCALING TO 1" DEEP WITH LOOSE AGGREGATE FROM WATERLINE TO MUDLINE.

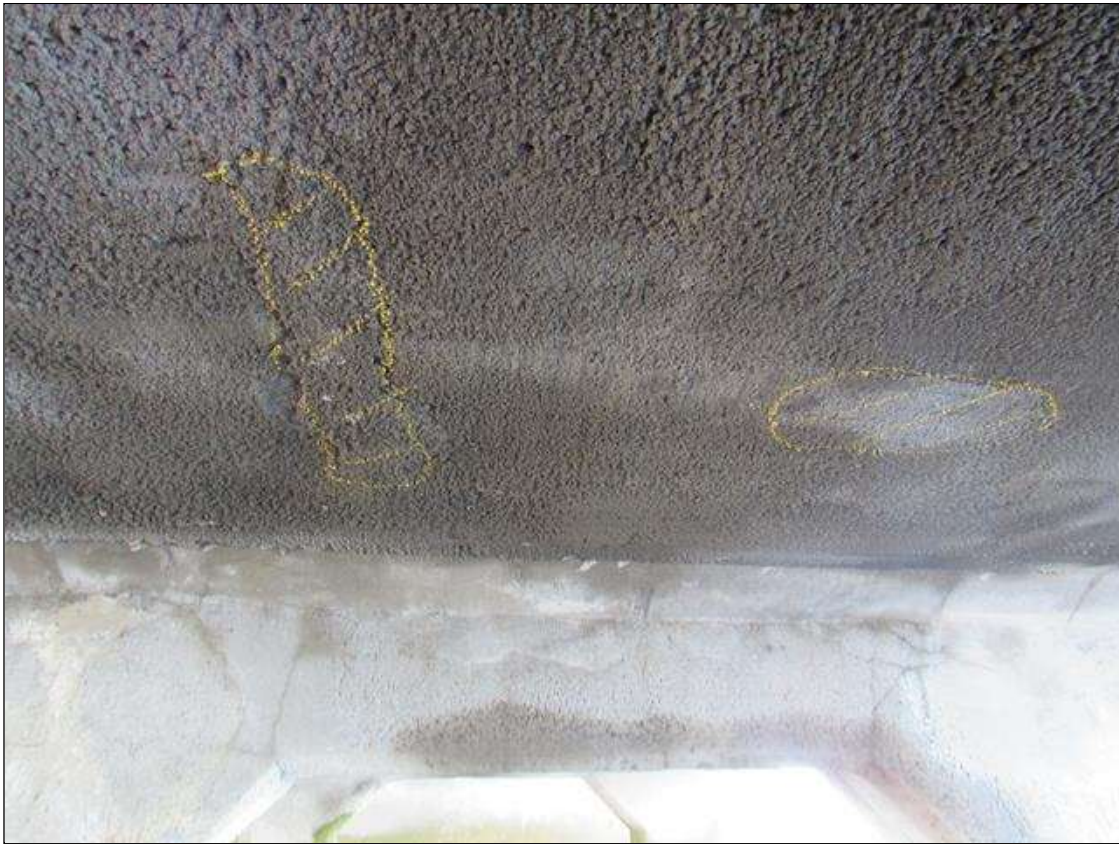
Span 280 Deck: (2) DELAMINATIONS UP TO 6" X 32" ON BOTTOM FACE LOCATED NEAR BENT 279 BETWEEN PILES 1 AND 2

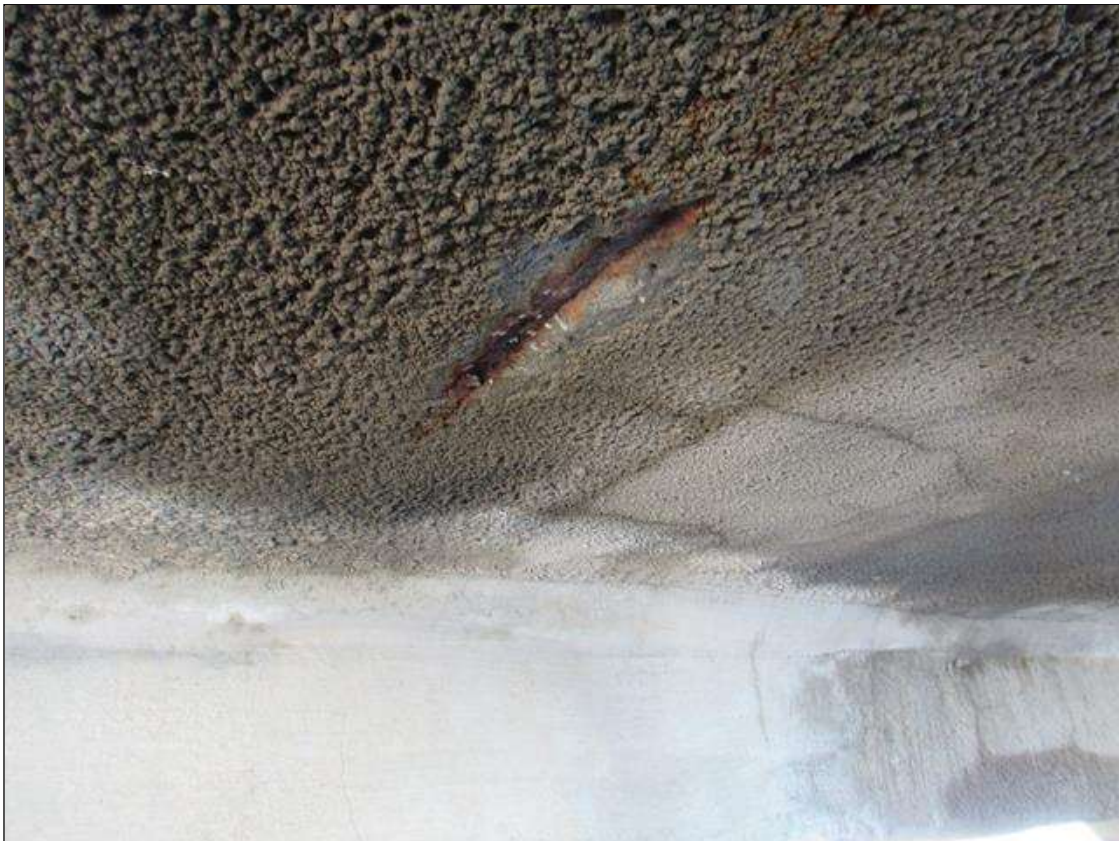
Span 281 Deck: (PAR) 3" X 12" X 1/2" DEEP SPALL WITH EXPOSED REBAR ON BOTTOM FACE LOCATED NEAR BENT 280, PILE 2

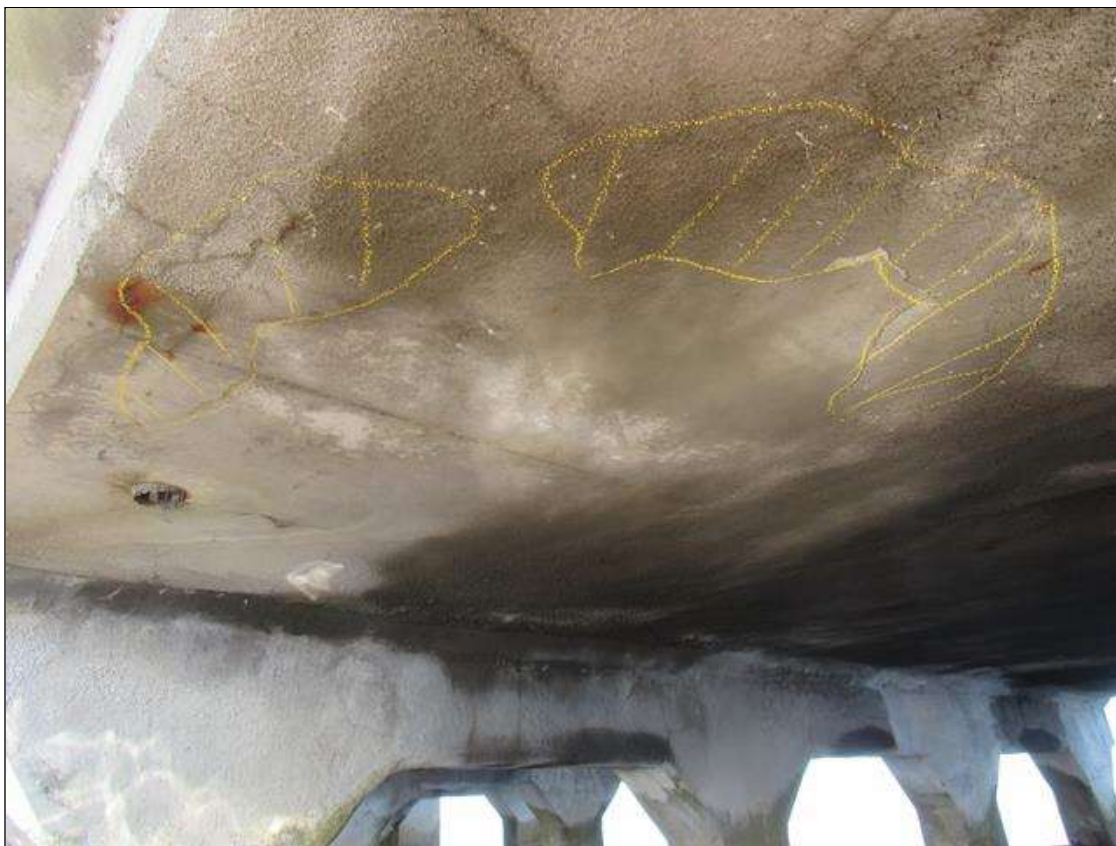
Span 281 Deck: 44" X 42" DELAMINATION ON BOTTOM FACE LOCATED RIGHT SIDE NEAR MID-SPAN

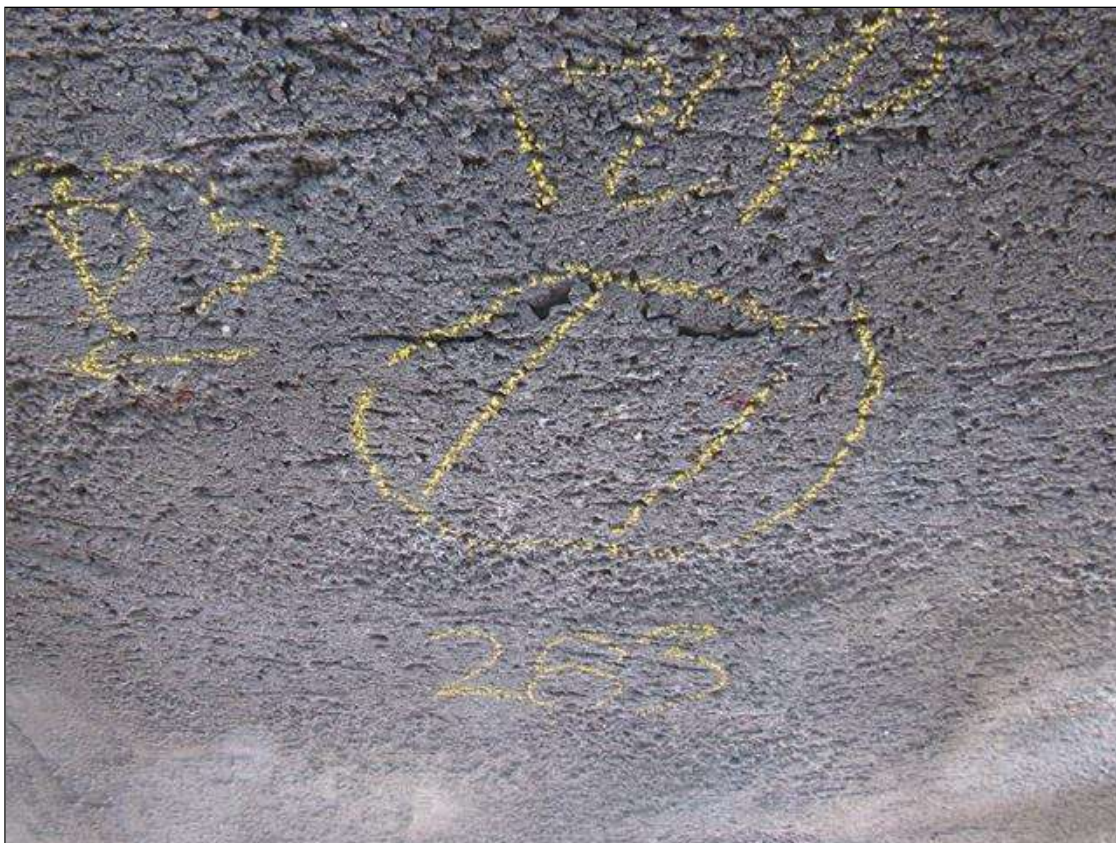
Span 283 Deck: 12" DIAMETER DELAMINATION ON BOTTOM FACE AT MID-SPAN NEAR PILE 3

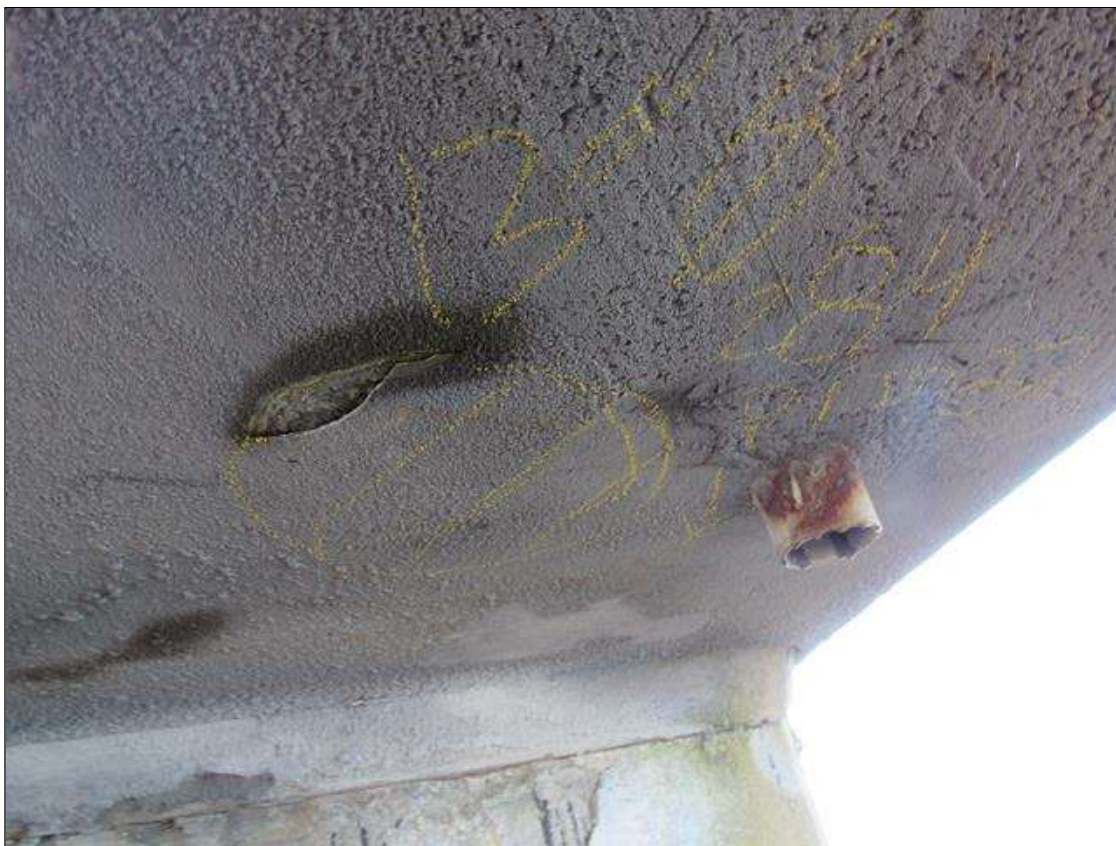
Span 284 Deck: 13" DIAMETER DELAMINATION ON BOTTOM FACE LOCATED NEAR BENT 283 PILE 1

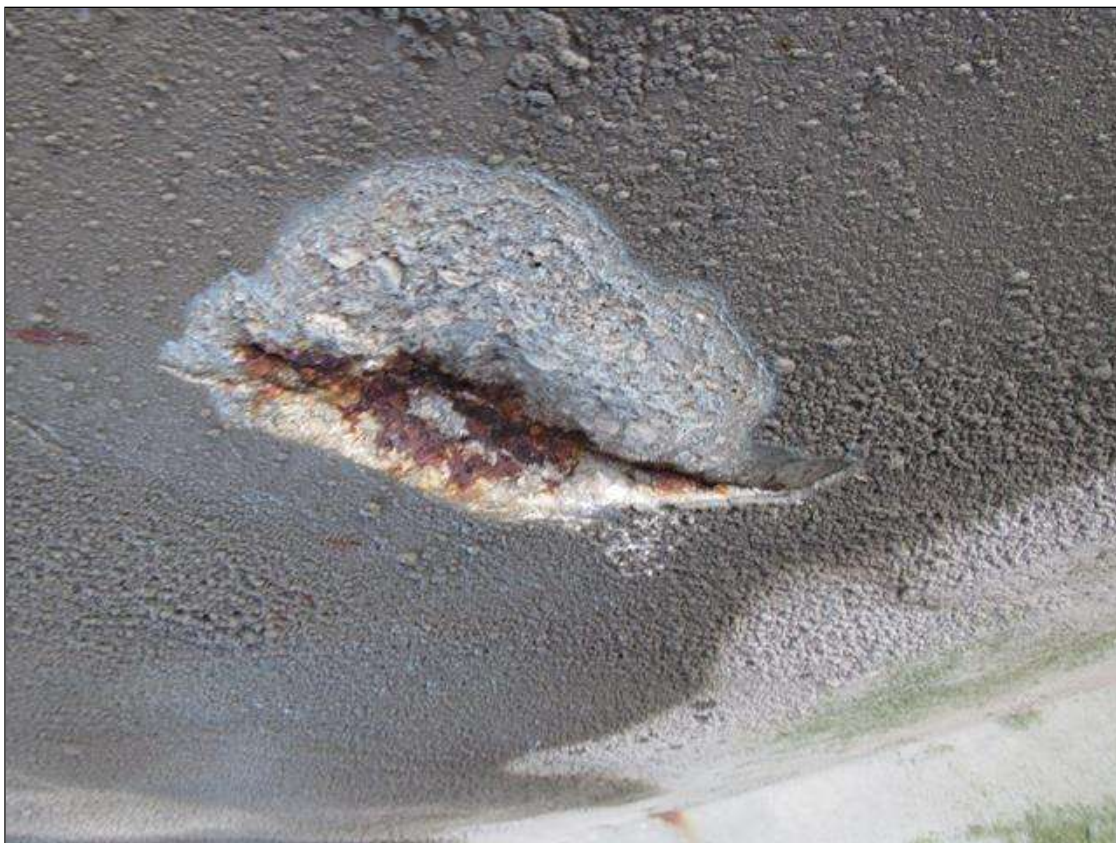
Span 285 Deck: (PAR) 12' DIAPHRAGM X 1/2" DEEP SPALL WITH EXPOSED REBAR ON BOTTOM FACE
LOCATED NEAR MID-SPAN AND PILE 3
