NC DEPARTMENT OF TRANSPORTATION
DIVISION OF HIGHWAYS
STRUCTURE MANAGEMENT UNIT

Structure Safety Report

Routine Element Inspection - Contract

FEATURE INTERSECTED: ALLIGATOR RIVER

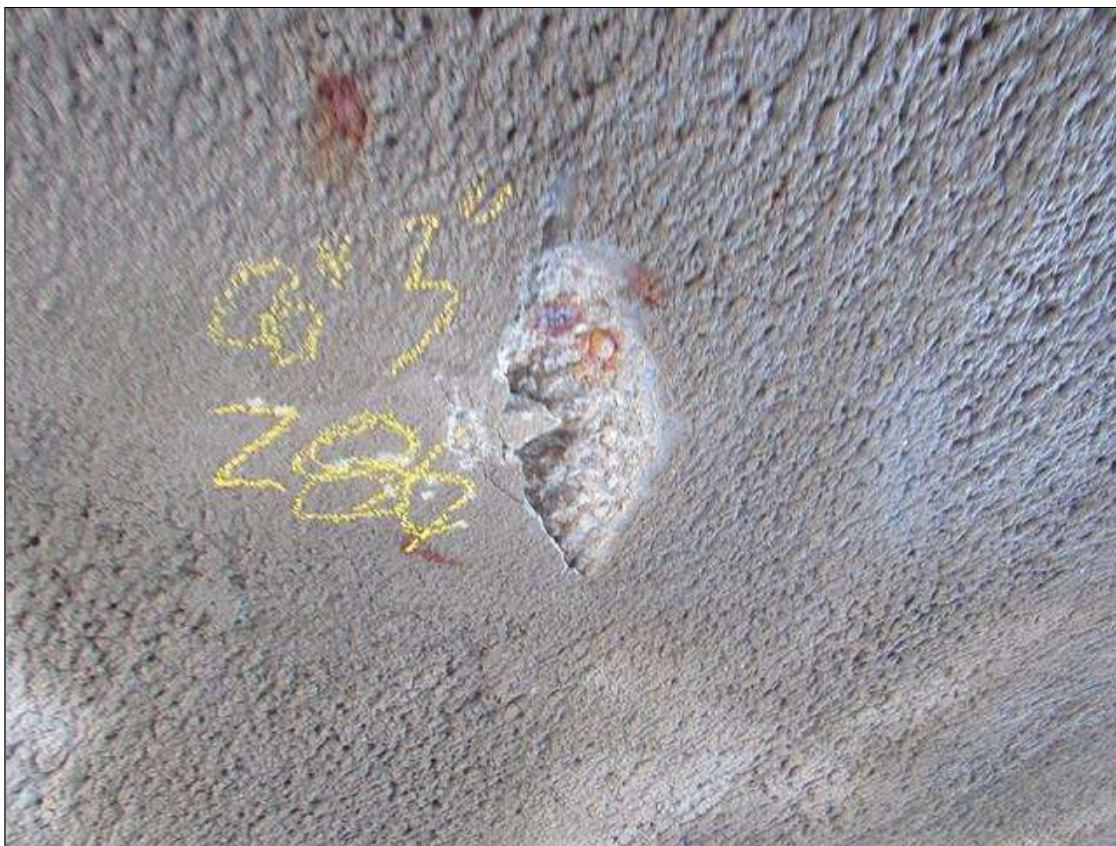
Span 286 Deck: 8" X 3" X 1/2" DEEP SPALL ON BOTTOM FACE LOCATED AT MID-SPAN NEAR PILE 2

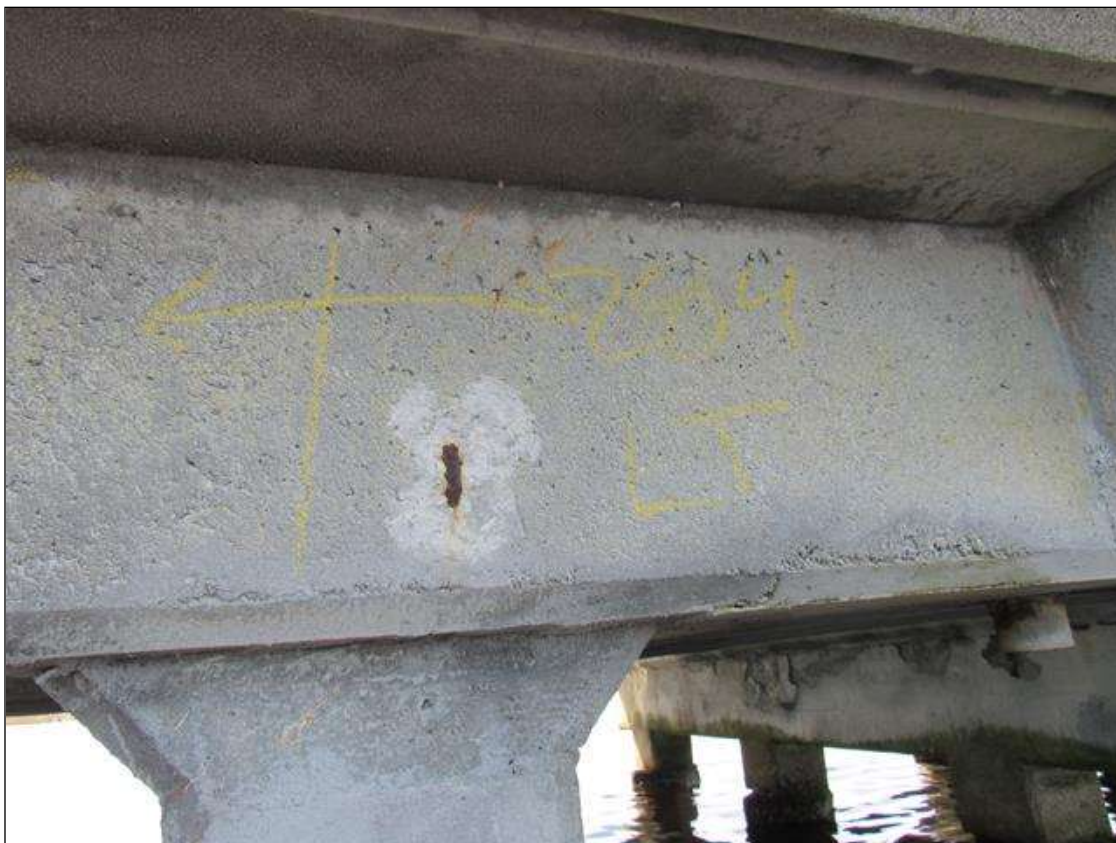
Span 284 Deck: 4" DIAMETER X 1/2" DEEP SPALL WITH EXPOSED REBAR ON LEFT FACE LOCATED ABOVE BENT 284

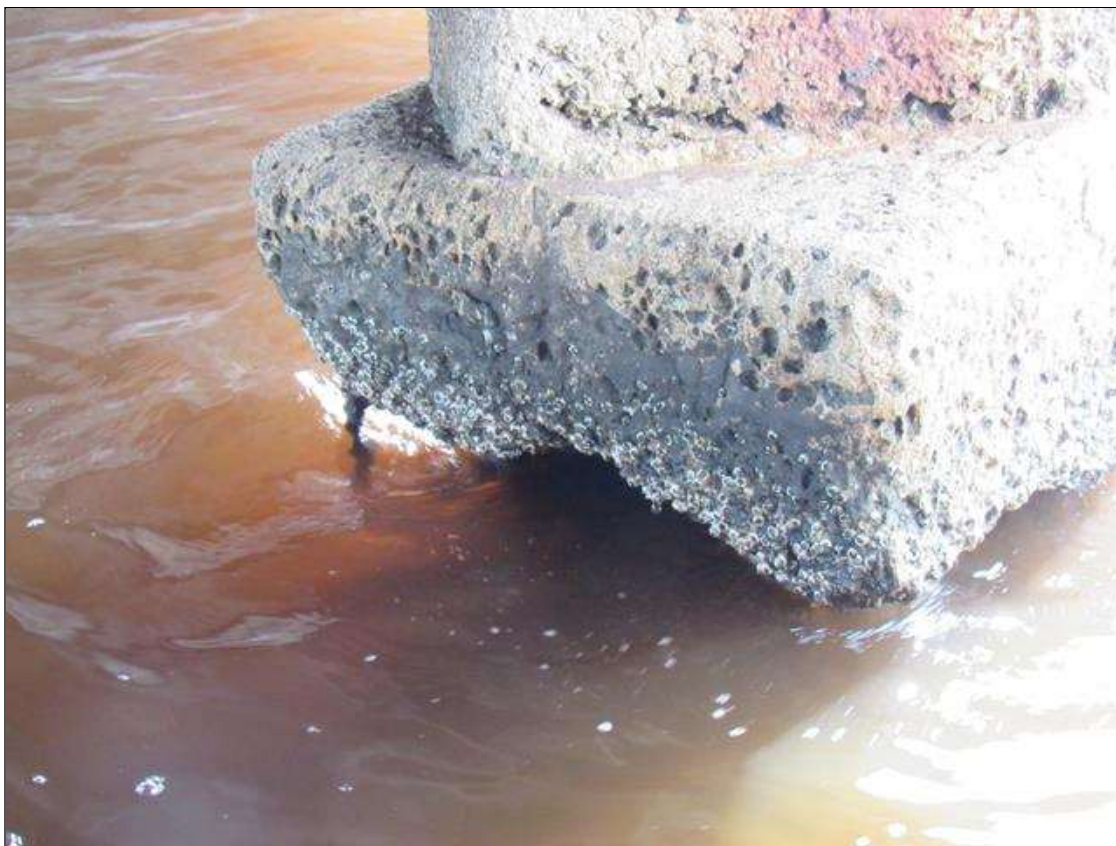
Bent 280 Pile 4: (PAR) 24" X 24" X 8" SPALL WITH EXPOSED REINFORCING ON EAST FACE

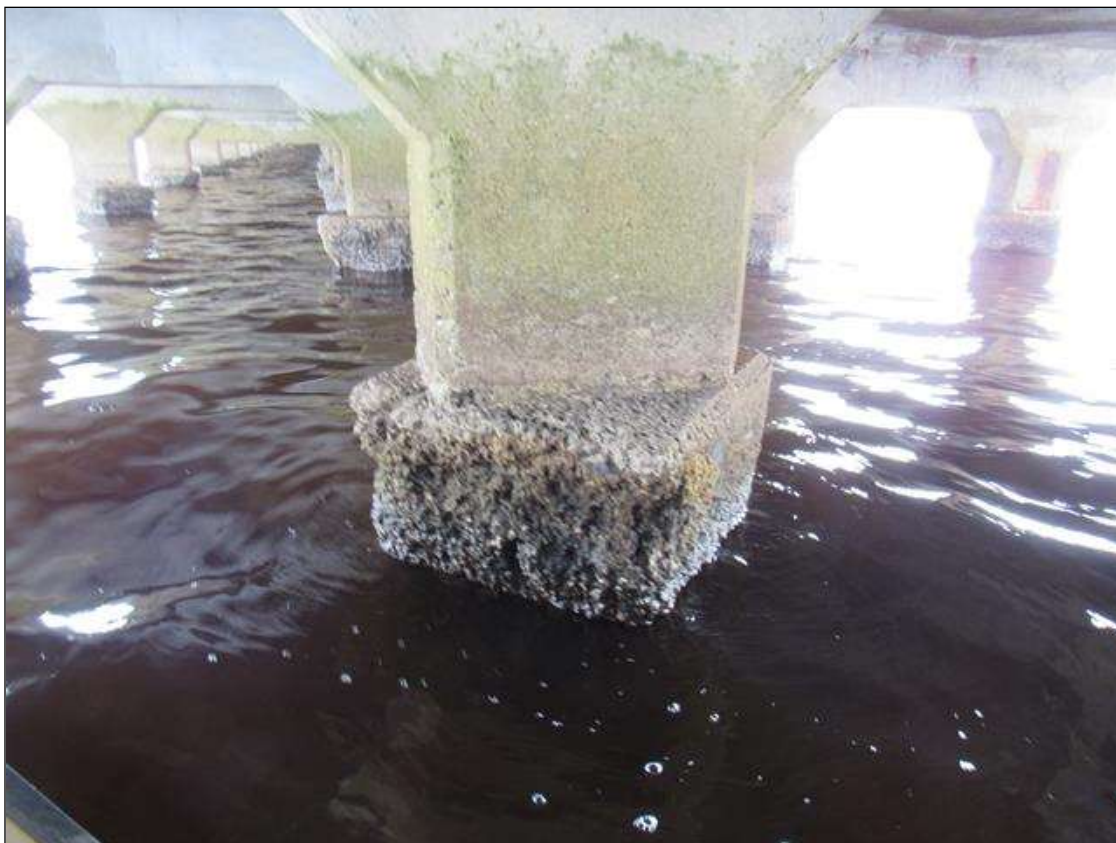
Bent 279 Pile 2: (PAR) 24" X UP TO 12" X UP TO 6" DEEP SPALL WITH EXPOSED REINFORCING ON WEST FACE
ON PILE 2 FOOTING

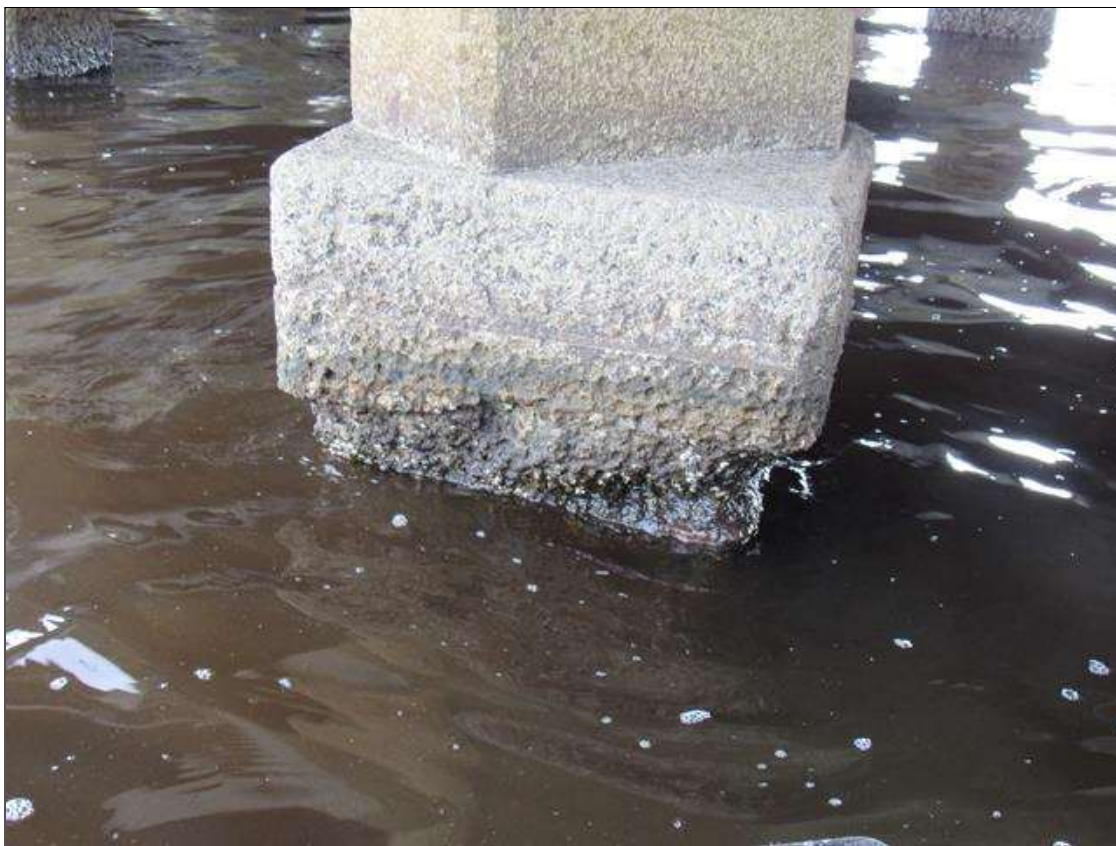
Bent 278 Pile 1: (PAR) 8' X 1' X 8" DEEP SPALL WITH EXPOSED REINFORCING LOCATED ON ALL FACES

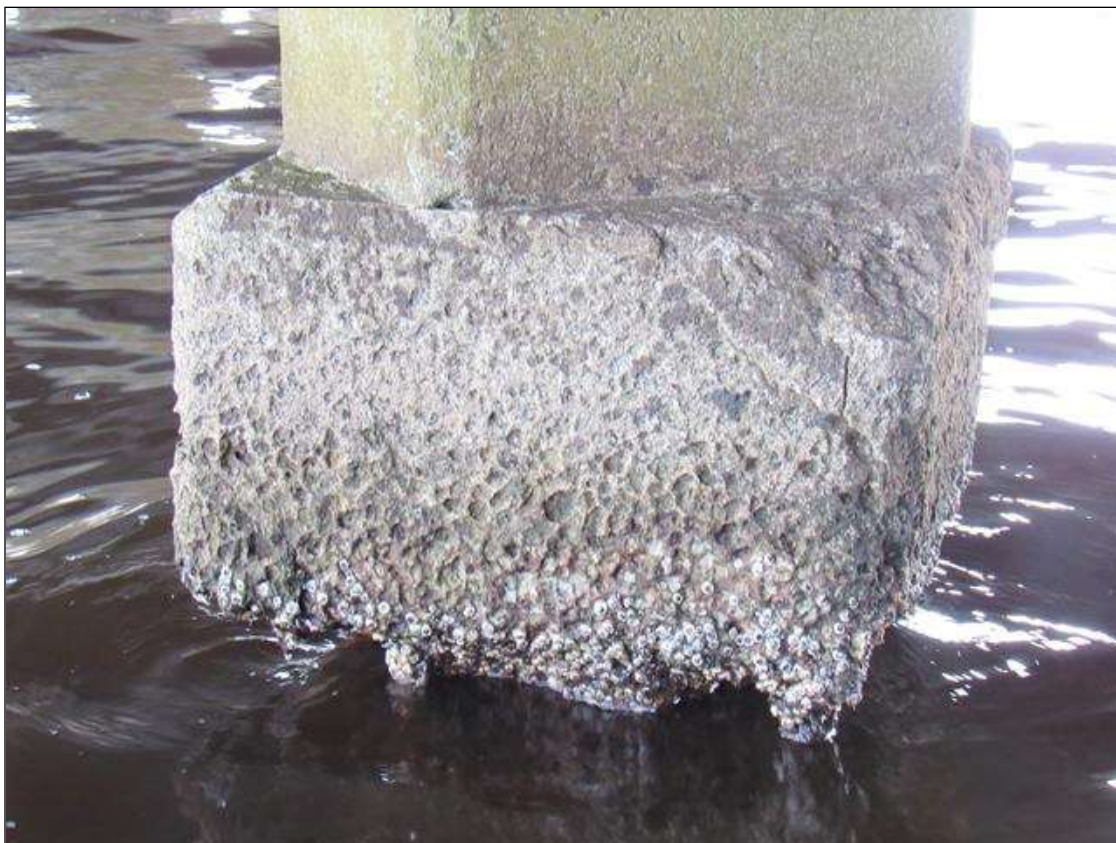
Bent 278 Pile 2: (PAR) 8' X 1' X 8" DEEP SPALL WITH EXPOSED REINFORCING LOCATED ON ALL FACES

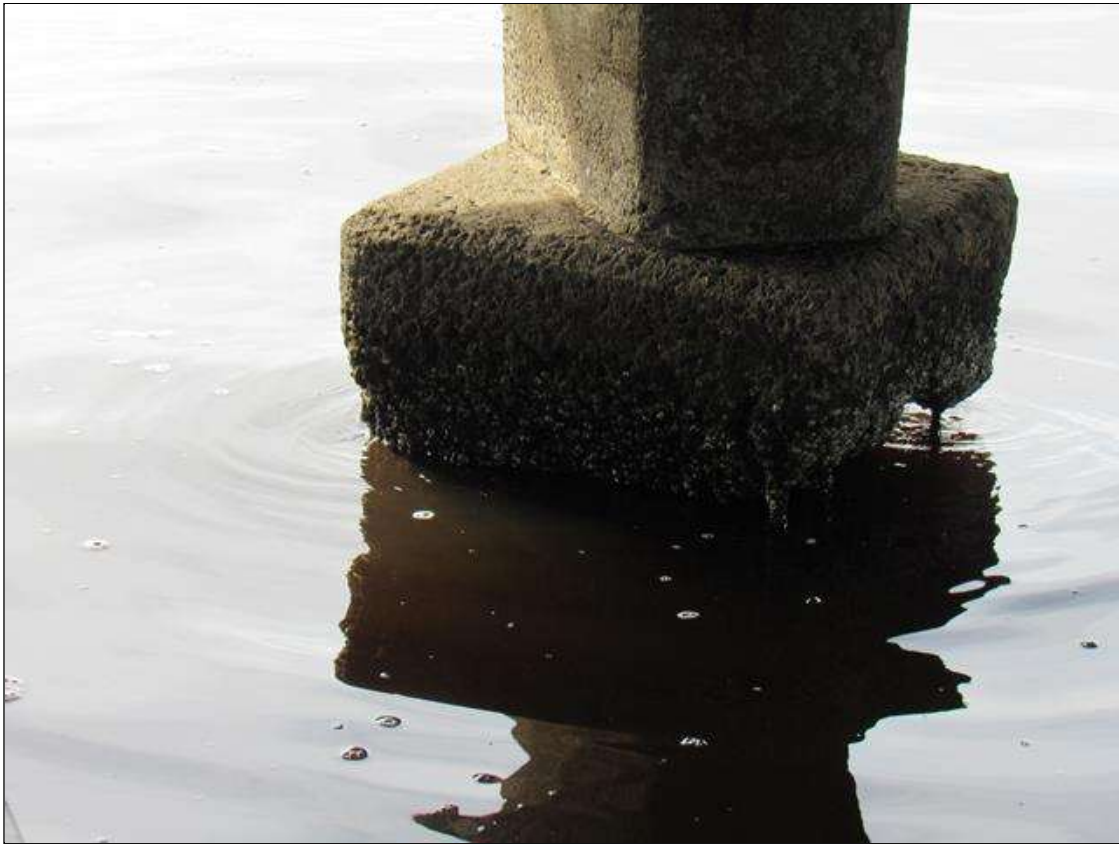
Bent 280 Pile 4: (PAR) 8' X 1' X 8" DEEP SPALL WITH EXPOSED REINFORCING LOCATED ON ALL FACES

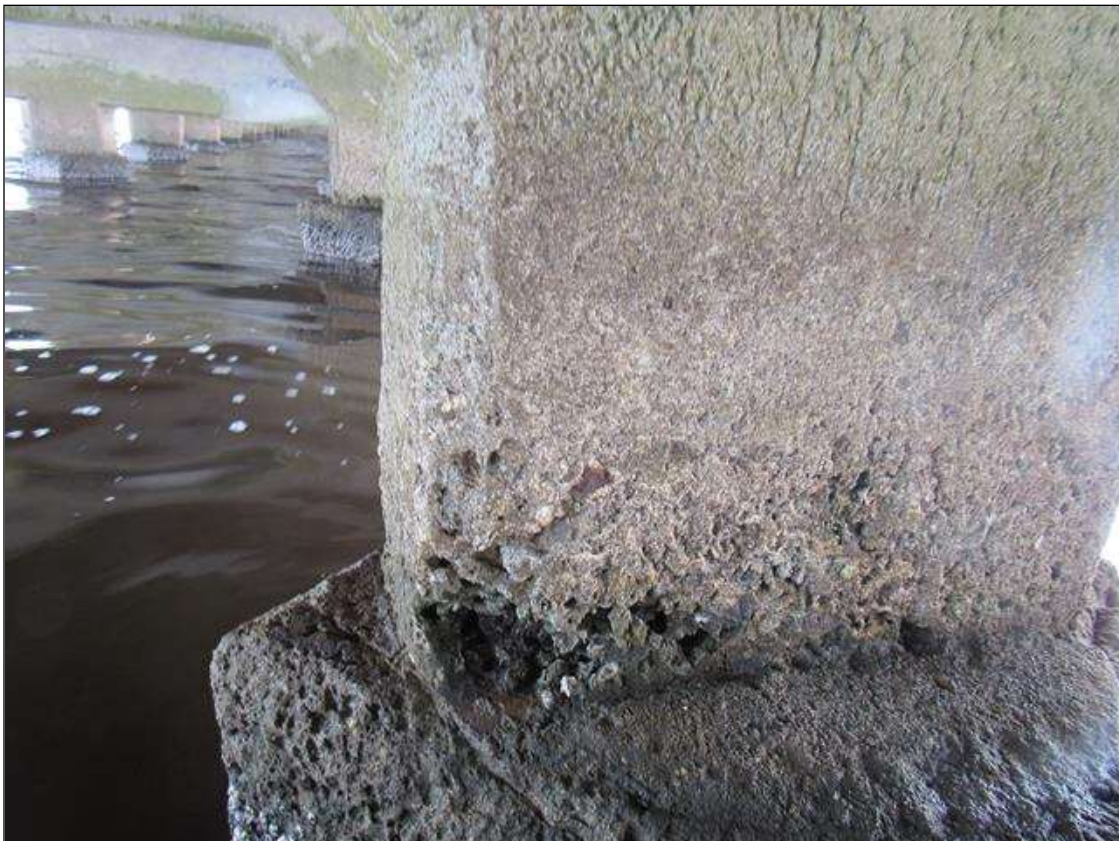
Bent 281 Pile 3: 4" X 4" X 4" DEEP SPALL ON WEST FACE AT COLUMN FOOTING INTERFACE

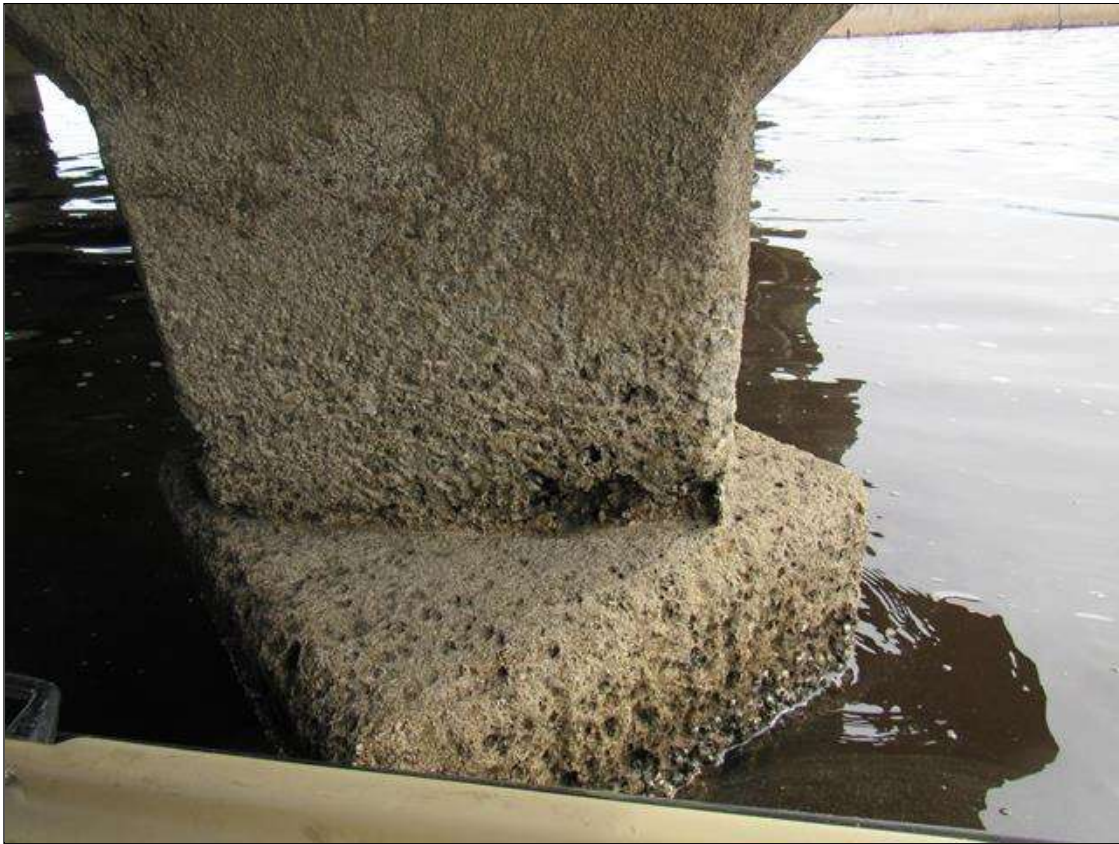
Bent 281 Pile 4: 7" X 3" X 2" DEEP SPALL ON WEST FACE LOCATED AT BOTTOM OF PILE

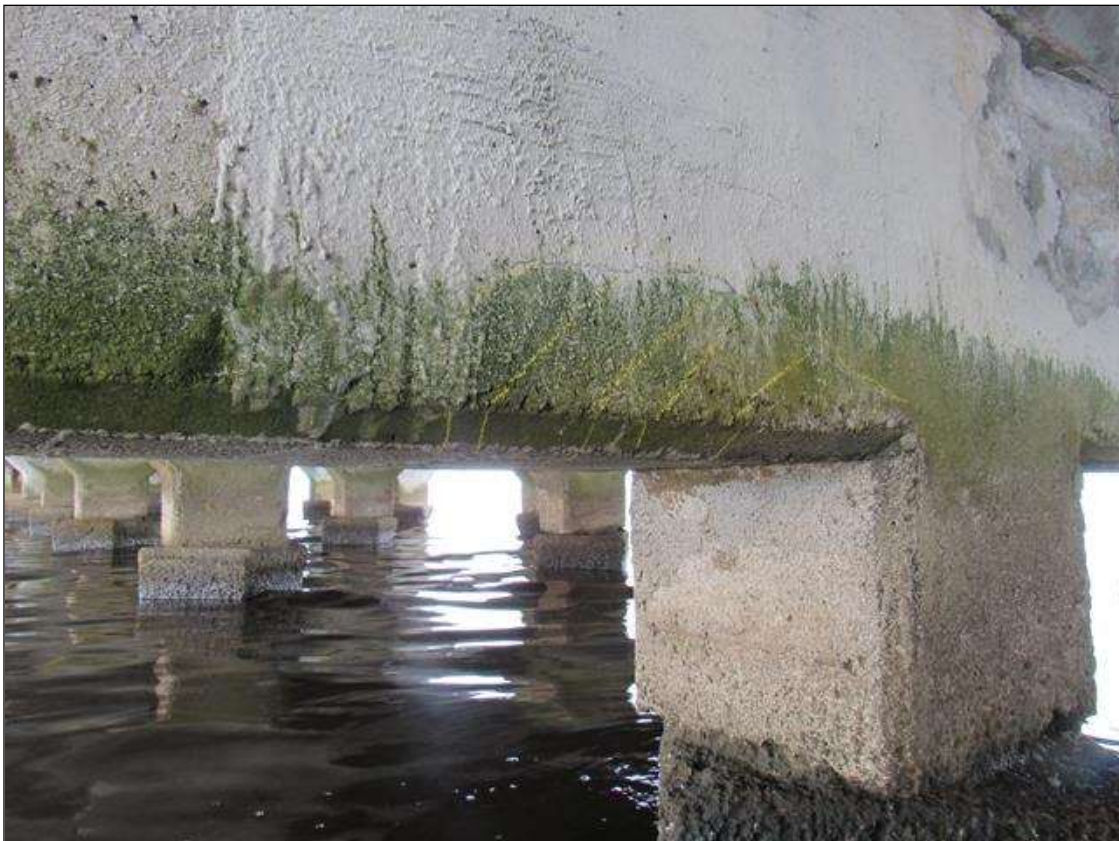
Bent 283 Cap 1: 8" X 22" DELAMINATION ON EAST FACE AT BOTTOM CORNER, BAY 3

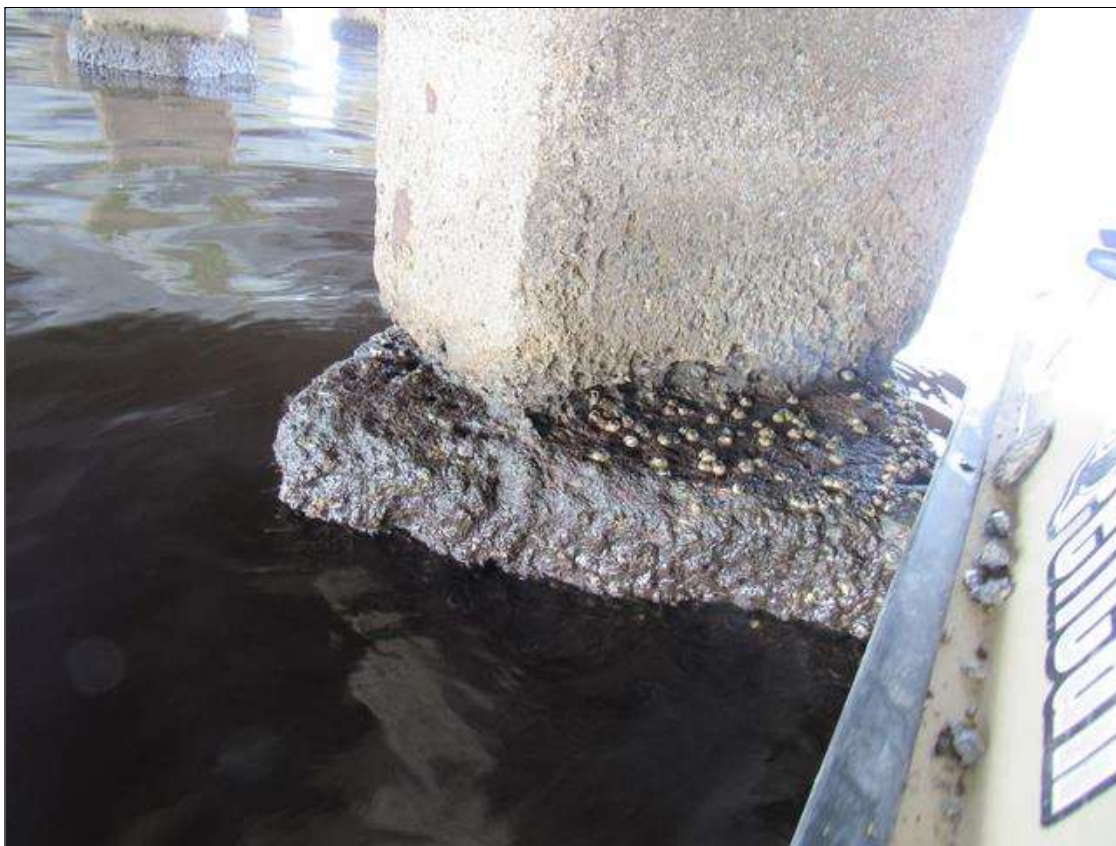
Bent 285 Pile 2: FULL PERIMETER OF PILE X 2" DEEP SPALL WITH EXPOSED REINFORCING ON EAST AND RIGHT FACE

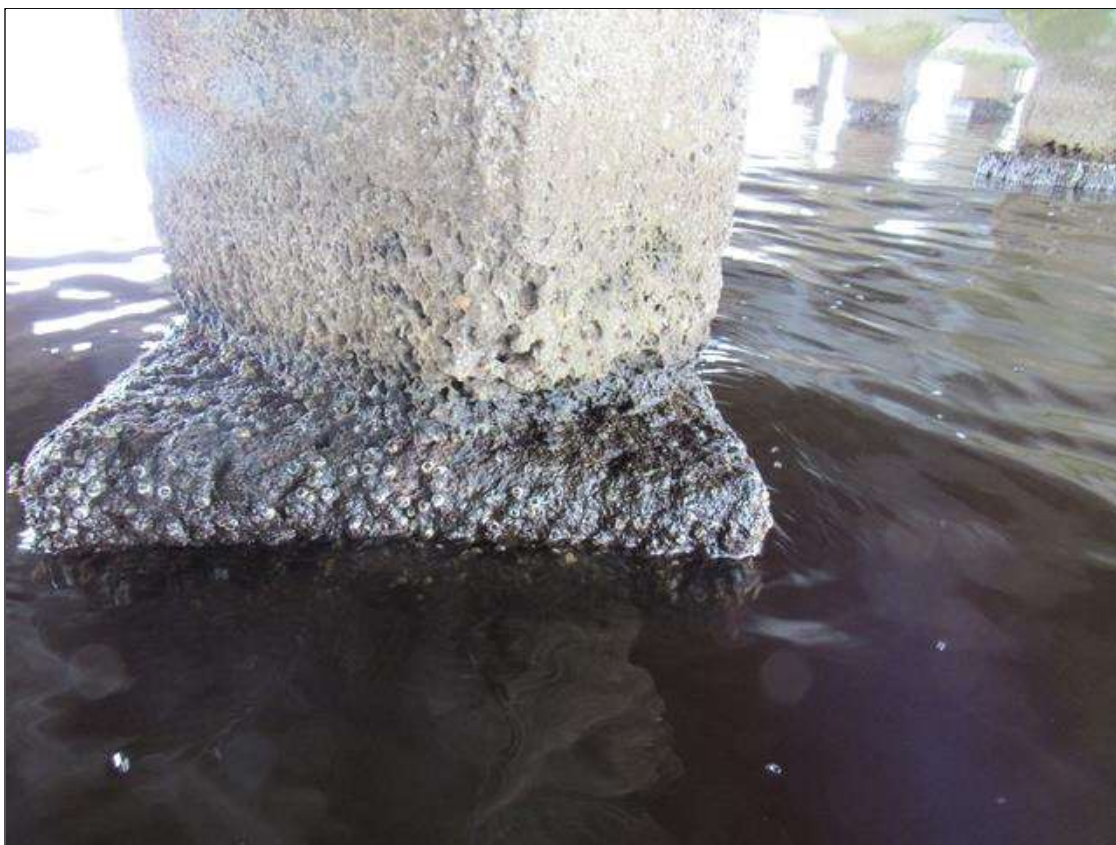
Bent 286 Pile 2: 12" X 2" X 2" DEEP SPALL WITH EXPOSED REINFORCING ON NORTH FACE LOCATED AT BOTTOM OF PILE 2

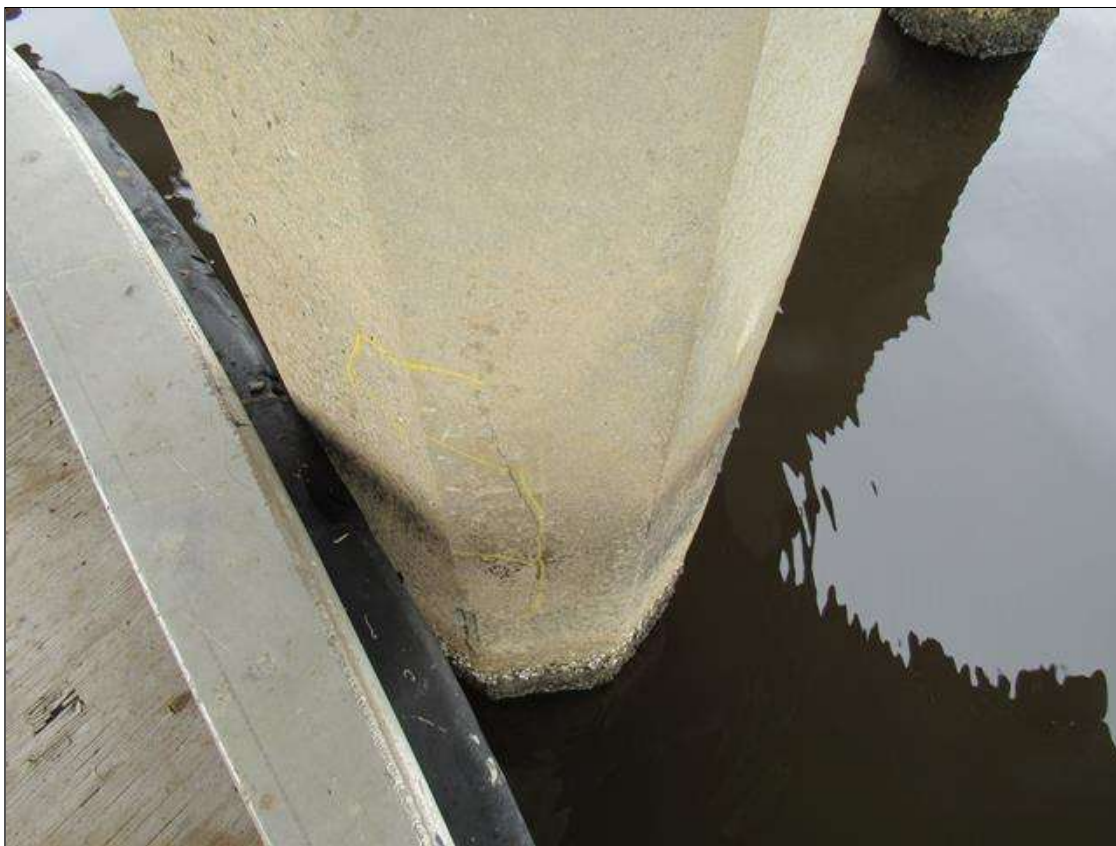
Bent 31 Saved Pile 2: 1' X 3' DELAMINATION ON SOUTH FACE LOCATED 7' FROM BOTTOM OF CAP

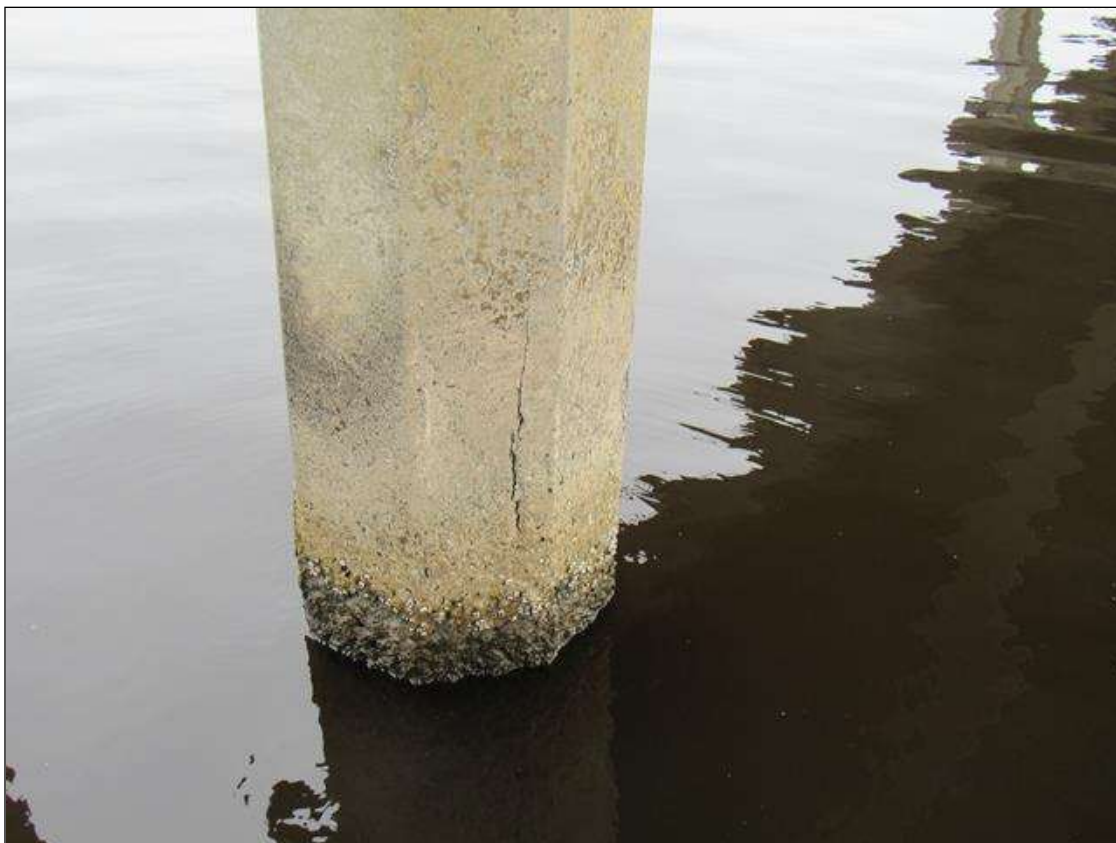
Bent 31 Saved Pile 2: (PAR) UP TO 1/4" VERTICAL CRACK, 8' BELOW CAP, DOWN 6', SOUTH FACE. SCALING TC 1" DEEP FROM WATERLINE TO MUDLINE.

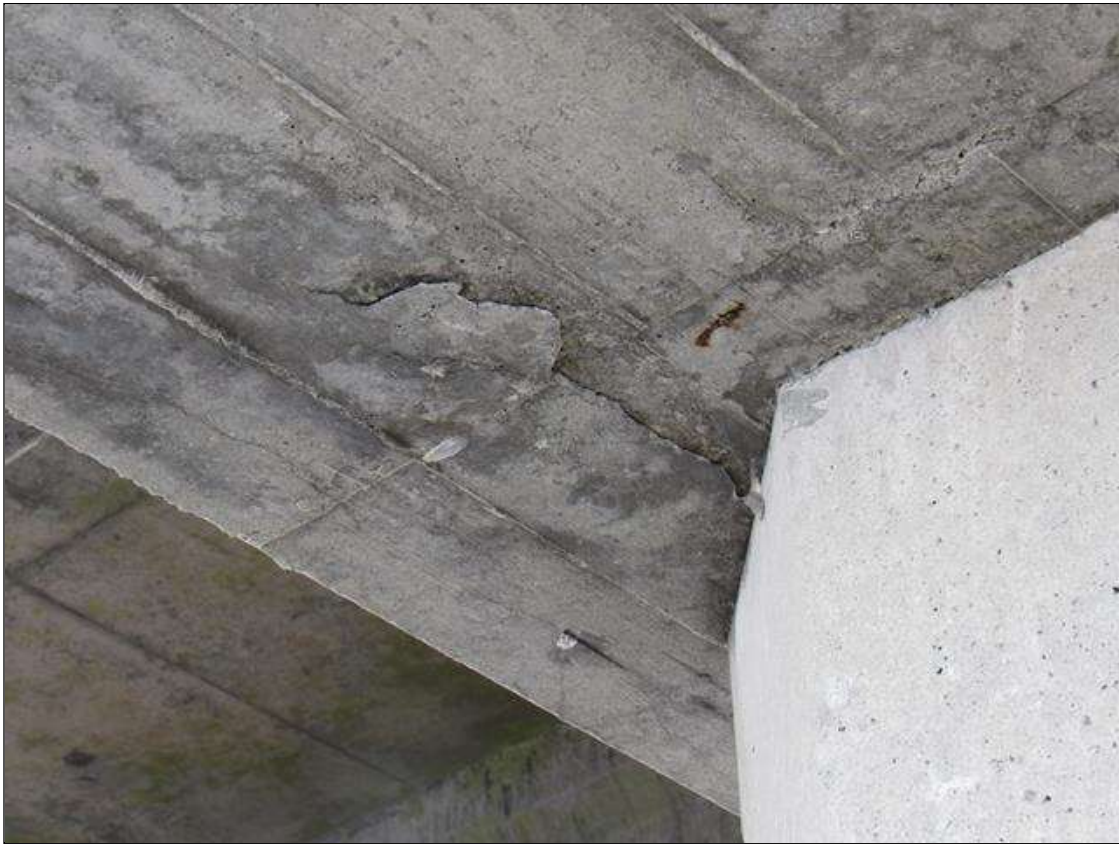
Bent 31 Cap 1: 8" X 14" DELAMINATION ON EAST FACE AT BOTTOM OF CAP NEAR PILE 3

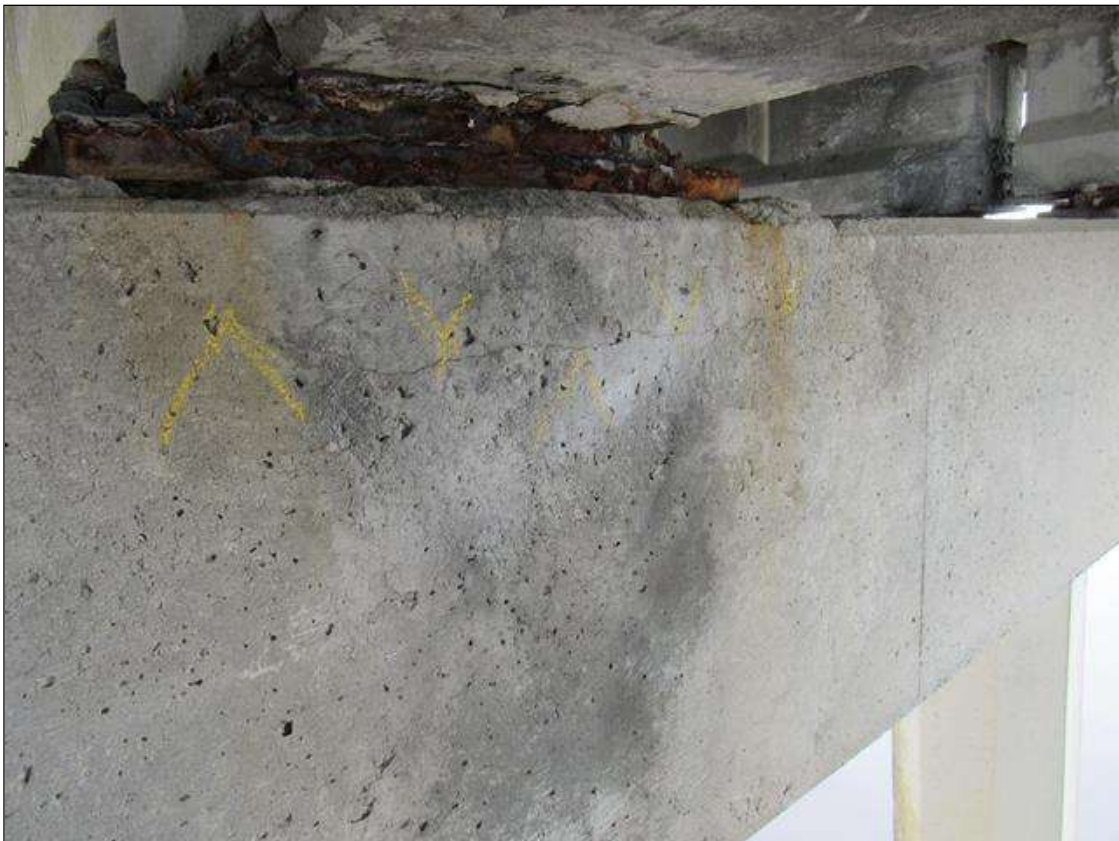
Bent 31 Cap 1: 30" LONG X 1/32" WIDE HORIZONTAL CRACK ON EAST FACE LOCATED BELOW BEAM 2

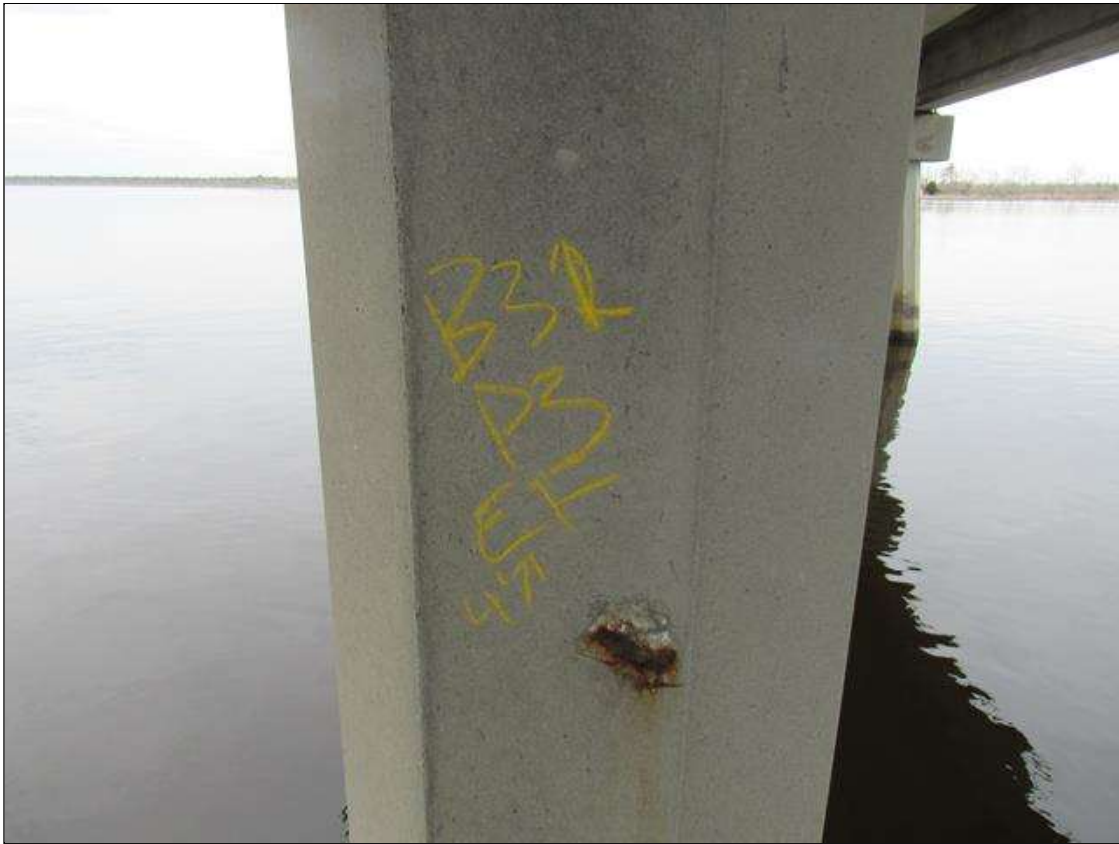
Bent 32 Saved Pile 3: 3" DIAMETER X 1/4" DEEP SPALL ON EAST FACE LOCATED 3' FROM BOTTOM OF CAP

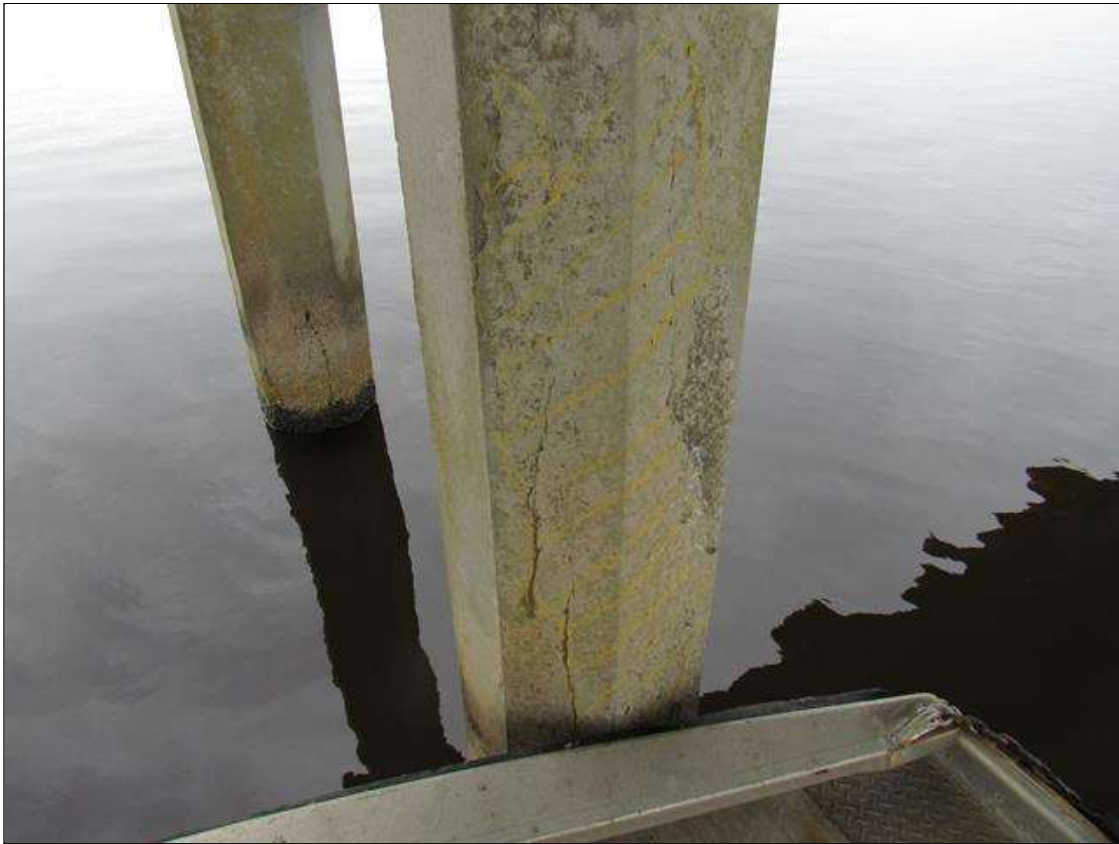
Bent 33 Saved Pile 2: (PAR) HAIRLINE TO 1/16" CRACK WITH ADJACENT DELAMINATION, 8' BELOW CAP, DOWN 6', SOUTH FACE. SCALING TO 1" DEEP WITH LOOSE AGGREGATE FROM WATERLINE TO MUDLINE.

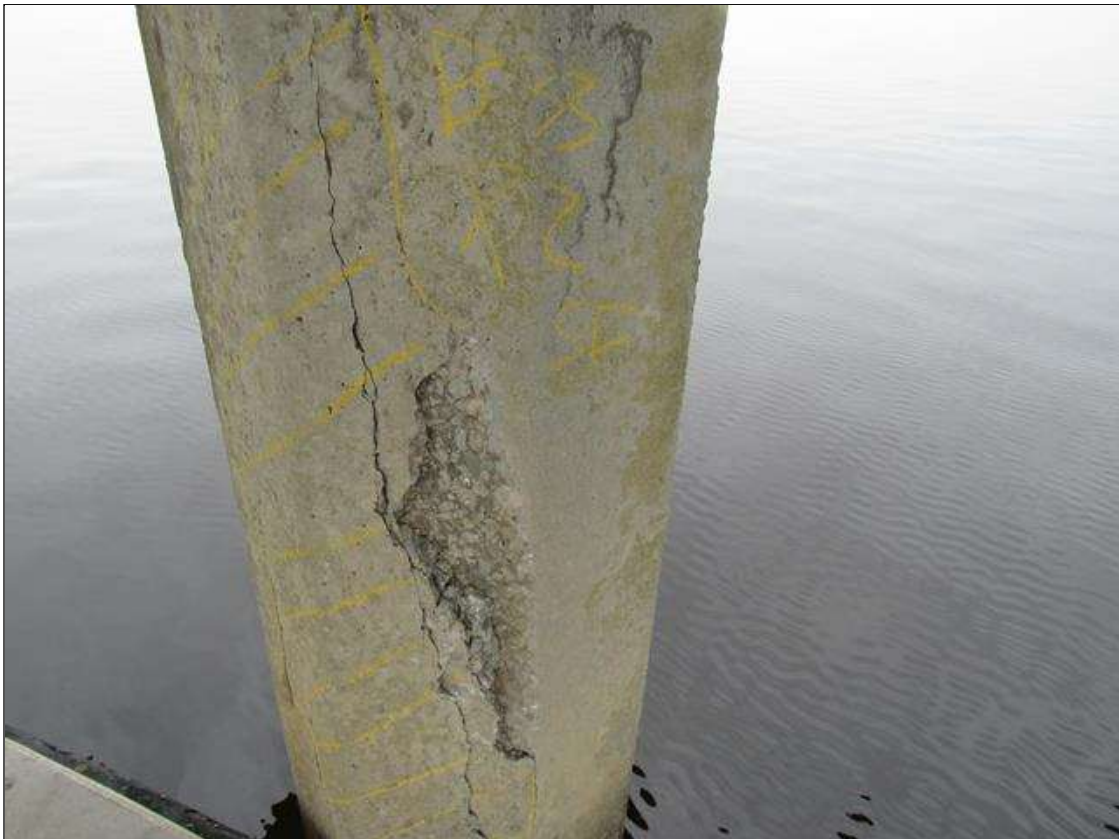
Bent 34 Saved Pile 2: (PAR) HAIRLINE TO 1/8" CRACK WITH 7' X 16" ADJACENT DELAMINATION, 6' BELOW CAP, DOWN 8', SOUTH FACS. SCALING TO 1" DEEP WITH LOOSE AGGREGATE FROM WATERLINE TO MUDLINE.

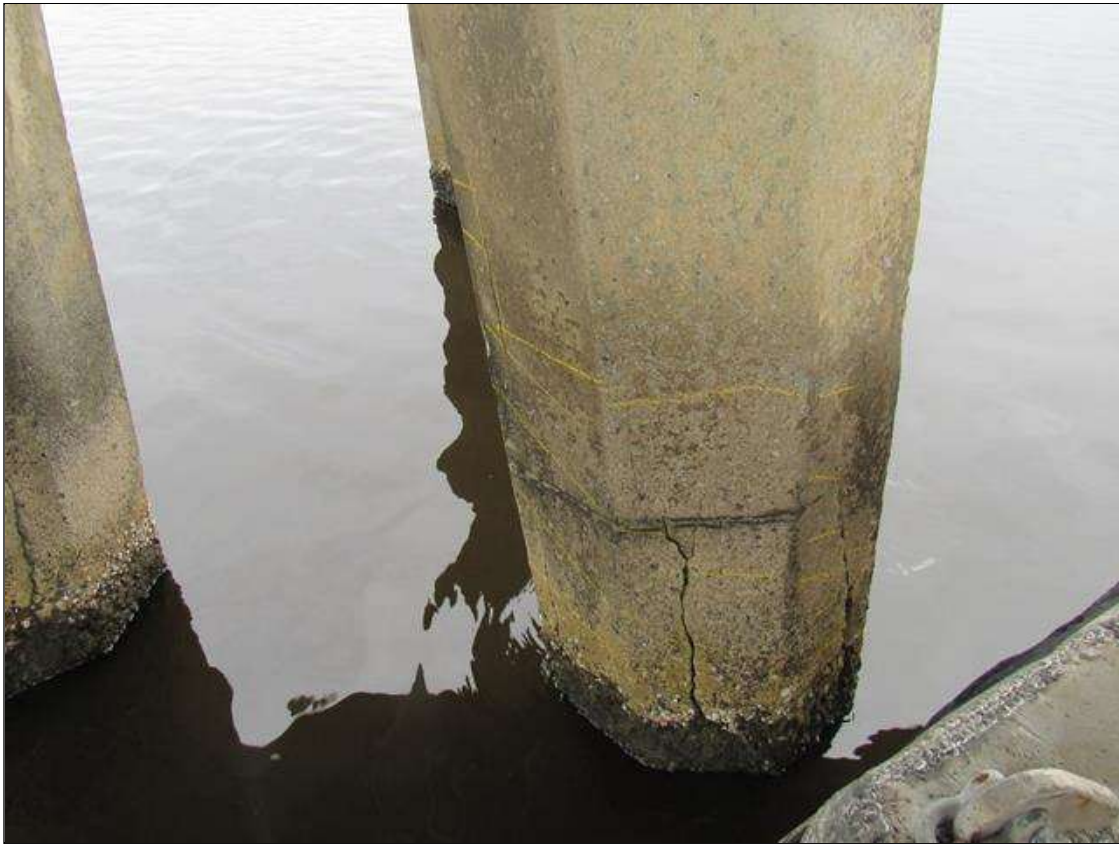
Bent 34 Saved Pile 3: (PAR) 2' X 6" X 1/2" DEEP SPALL WITH 1/16" CRACK, SOUTH FACES, 5' FROM BOTTOM OF CAP.

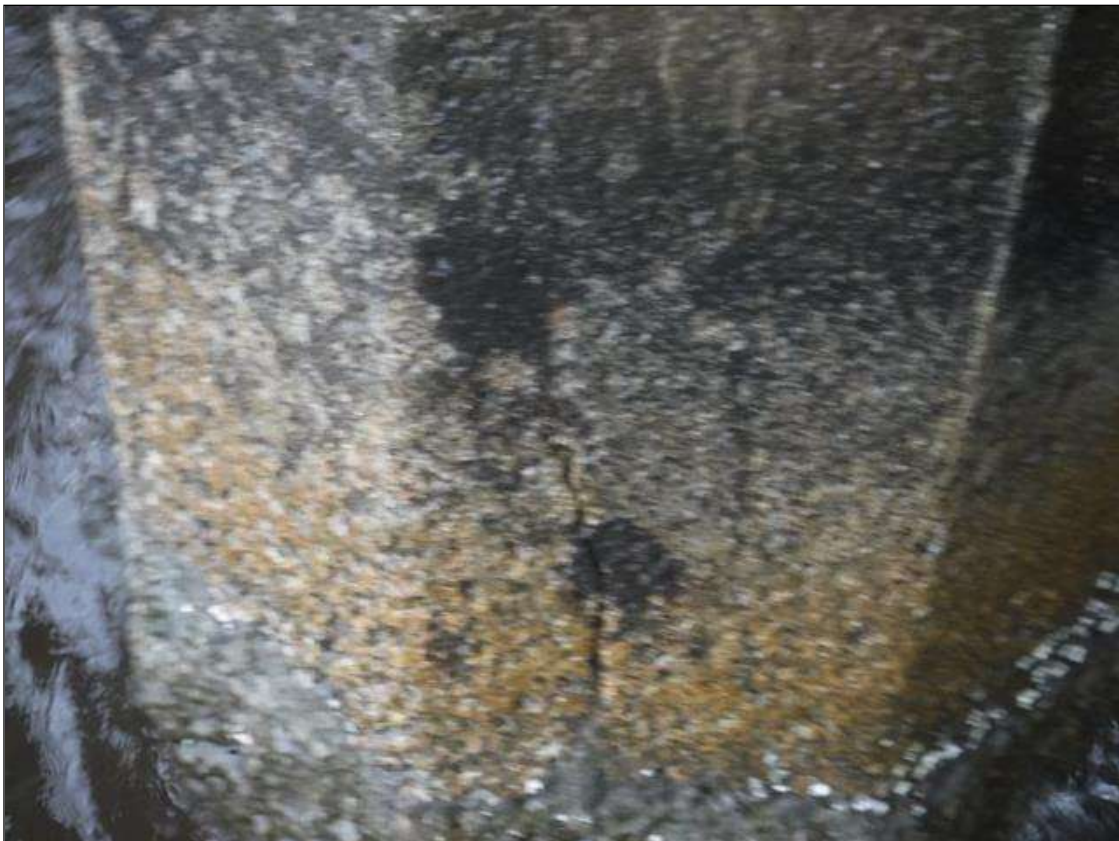
Bent 37 Saved Pile 4: 42" X 36" DELAMINATION ON NORTH AND WEST FACE, 7' FROM BOTTOM OF CAP

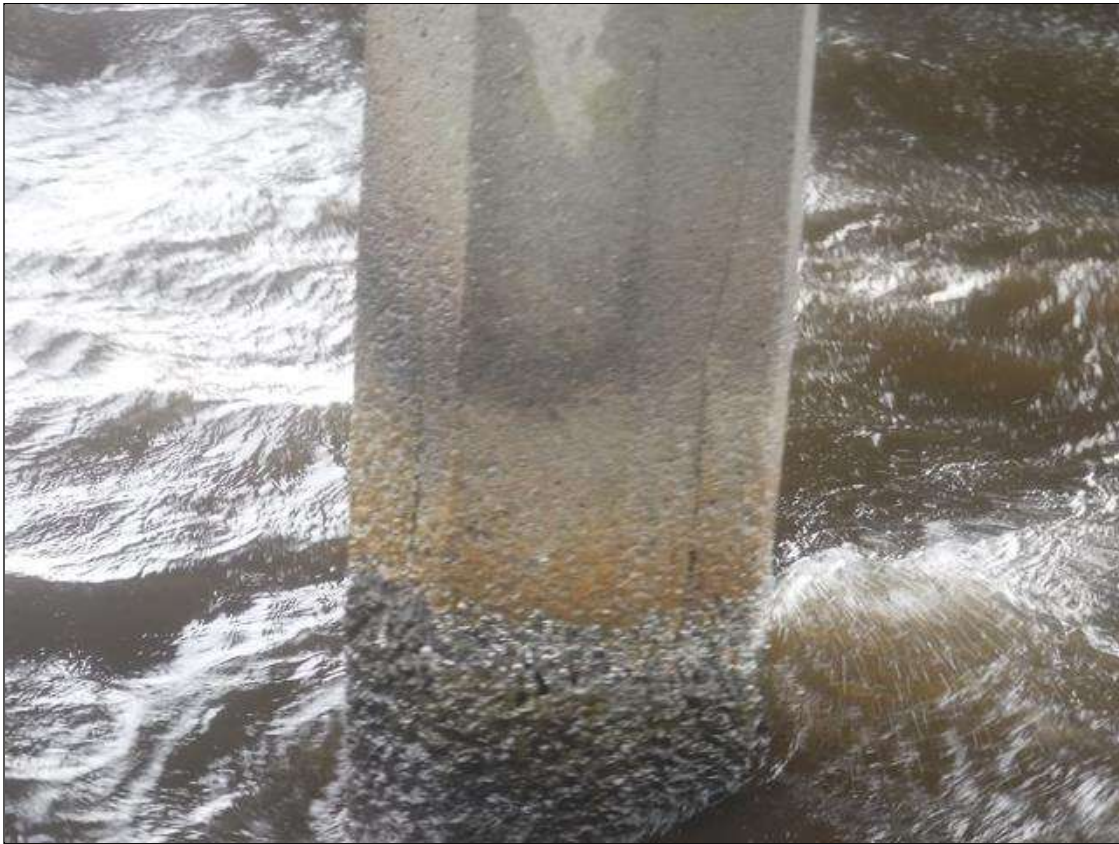
Bent 86 Pile 1: (PAR) (2) UP TO 3' X 0.03" VERTICAL CRACKS, BEGINNING 8' BOTTOM OF CAP, AT RANDOM THROUGHOUT.

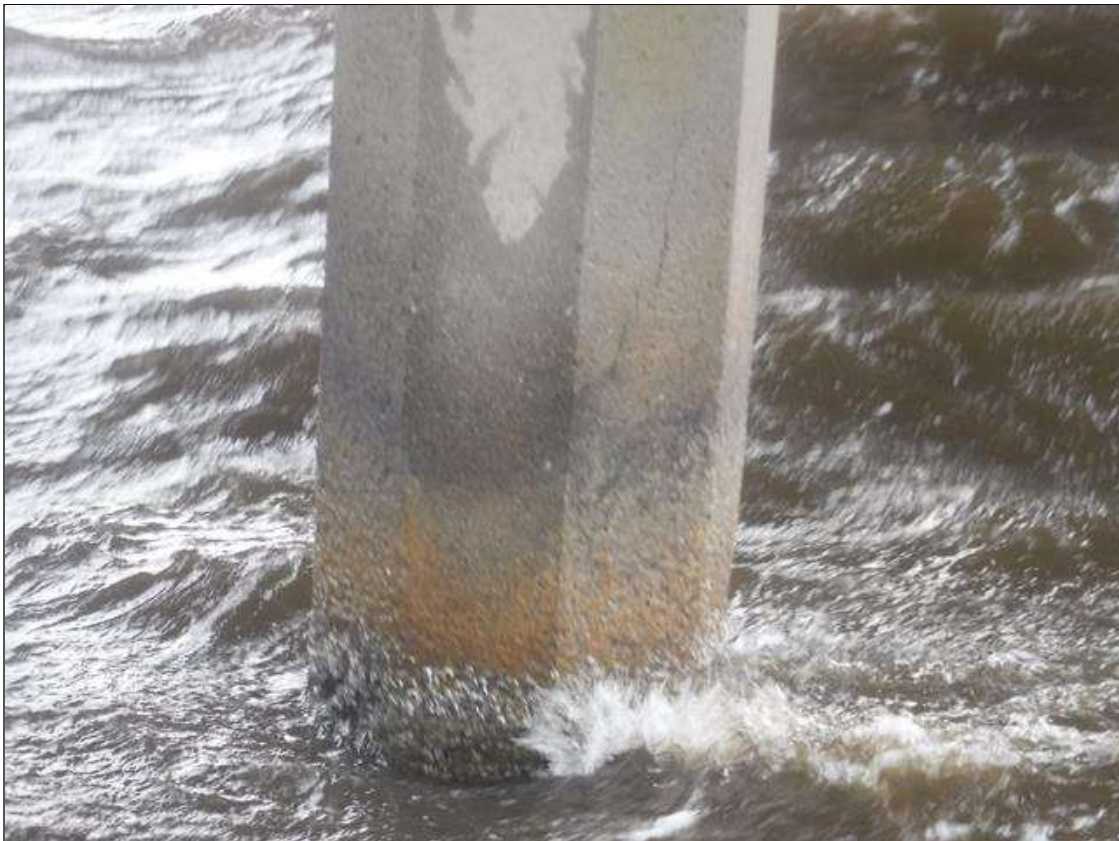
Bent 88 Pile 2: (PAR) UP TO 3' X 0.06" VERTICAL CRACK WITH SURROUNDING 4' X 2' DELAMINATION ON WEST FACE, BEGINNING 8' BOTTOM OF CAP, AT RANDOM THROUGHOUT.

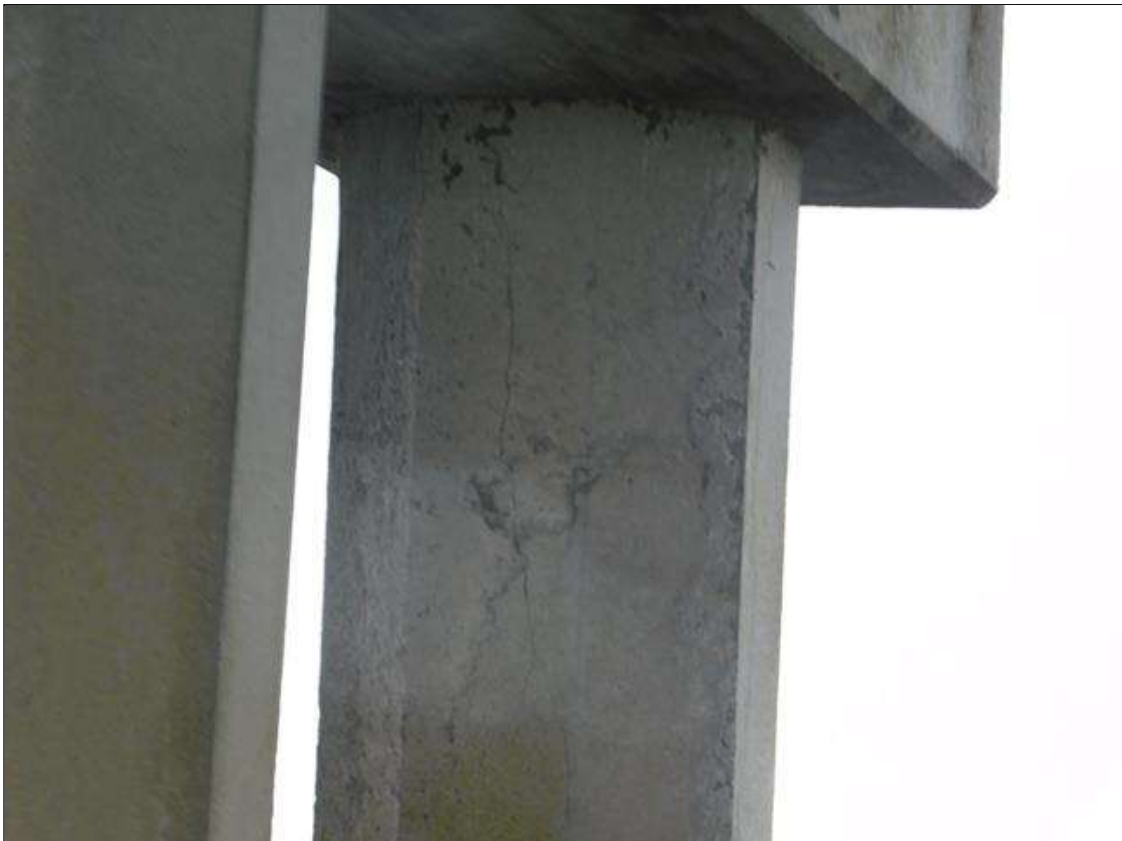
Bent 88 Pile 1: (PAR) UP TO 3' X 0.06" VERTICAL CRACKS WITH 4' X 2' DELAMINATION ON NORTH AND WEST FACE, BEGINNING 8' BOTTOM OF CAP.
