NC DEPARTMENT OF TRANSPORTATION
DIVISION OF HIGHWAYS
STRUCTURE MANAGEMENT UNIT

Structure Safety Report

Routine Element Inspection - Contract

FEATURE INTERSECTED: ALLIGATOR RIVER

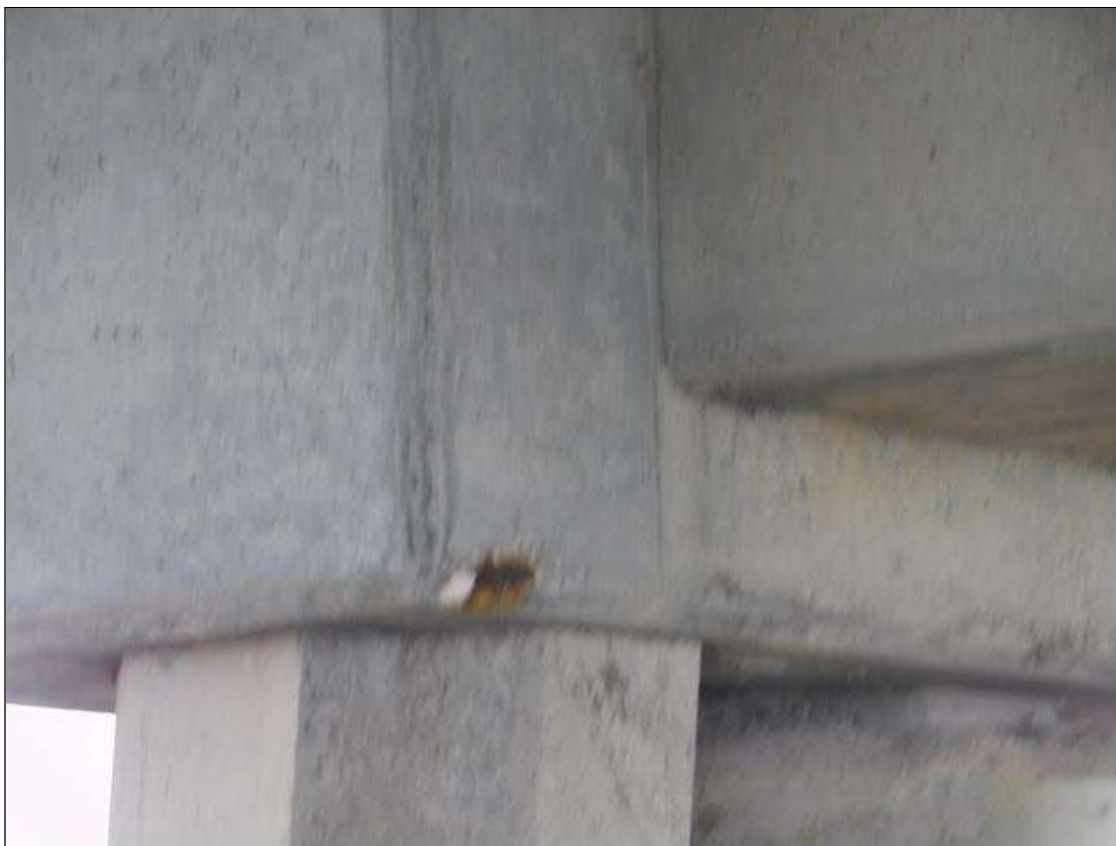
Bent 91 Saved Pile 1: (PAR) (2) UP TO 3' X 0.014" VERTICAL CRACKS, SOUTH FACE, BEGINNING AT BOTTOM OF CAP, WITH ADJACENT 3' X UP TO 1' DELAMINATION.

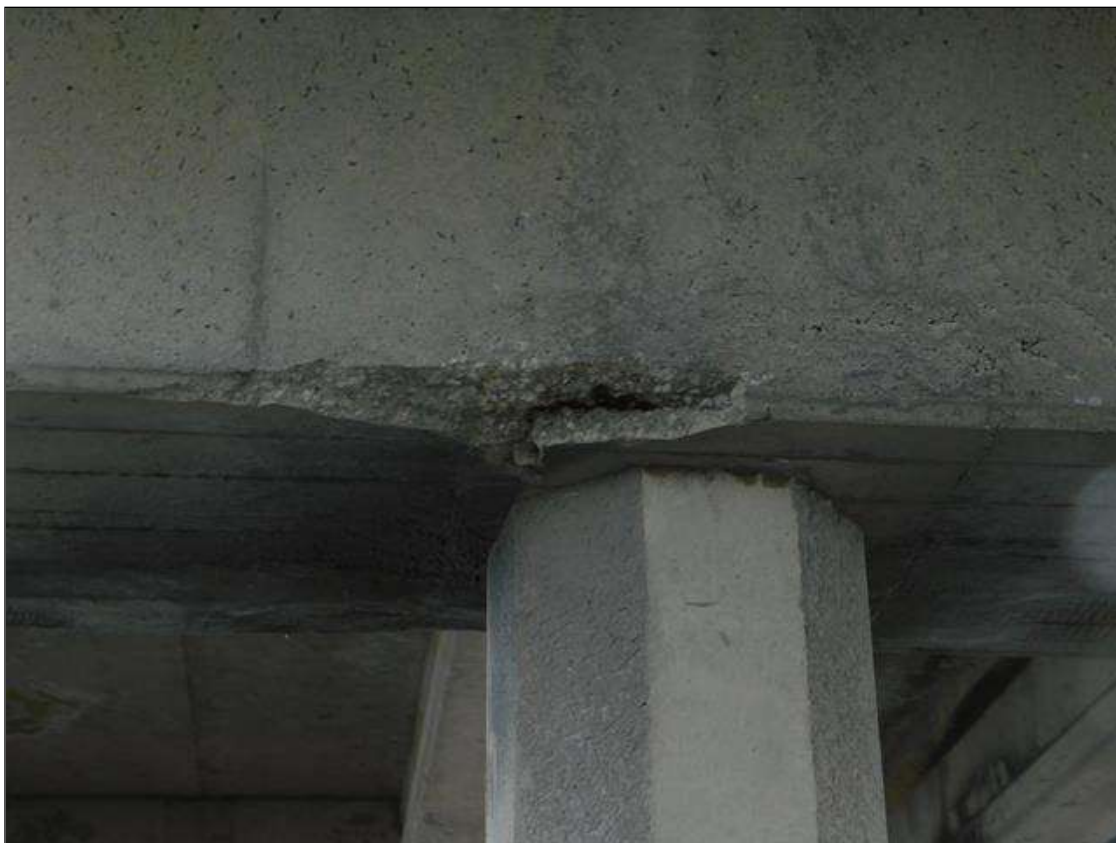
Bent 93 Cap 1: 8" X UP TO 3" X 2" SPALL, WITH EXPOSED REINFORCING, WEST FACE, TOP OF PILE 2.

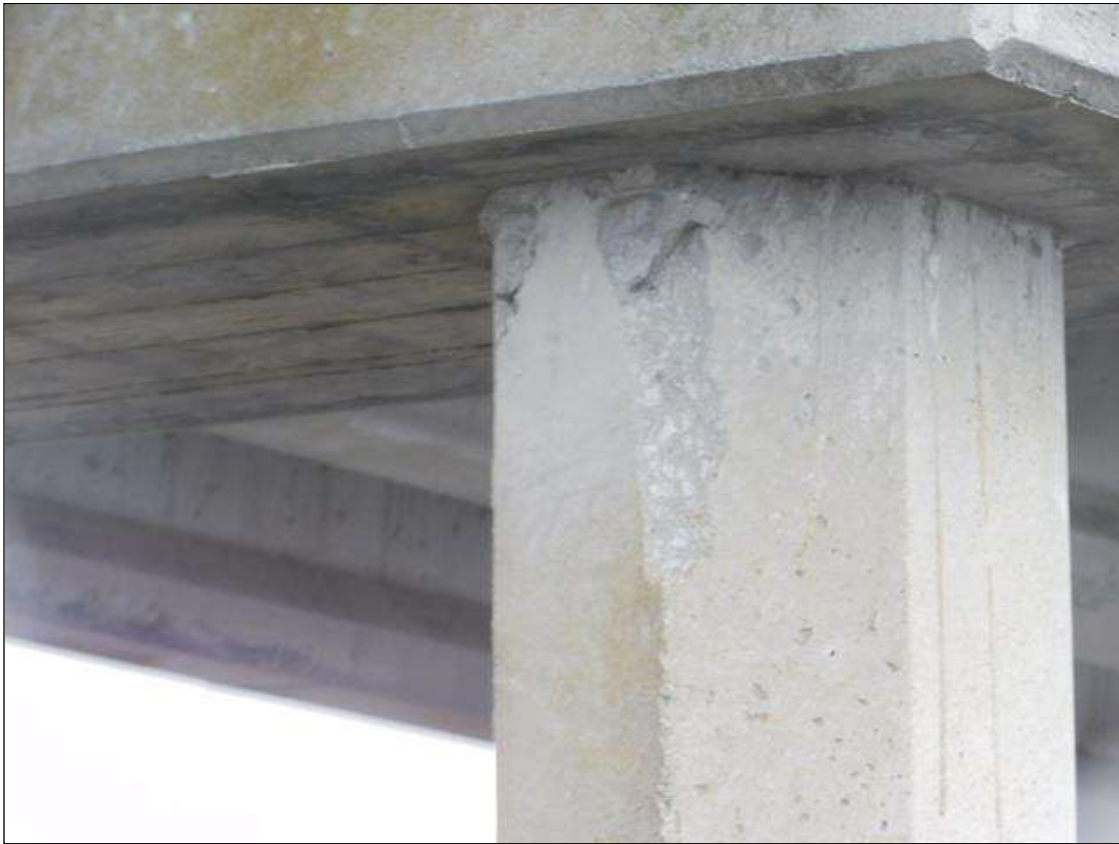
Bent 94 Cap 1: (PAR) 3' X UP TO 11" X 3" SPALL, WITH EXPOSED PRIMARY REINFORCING, BOTTOM OF CAP, BENEATH BEAM 2.

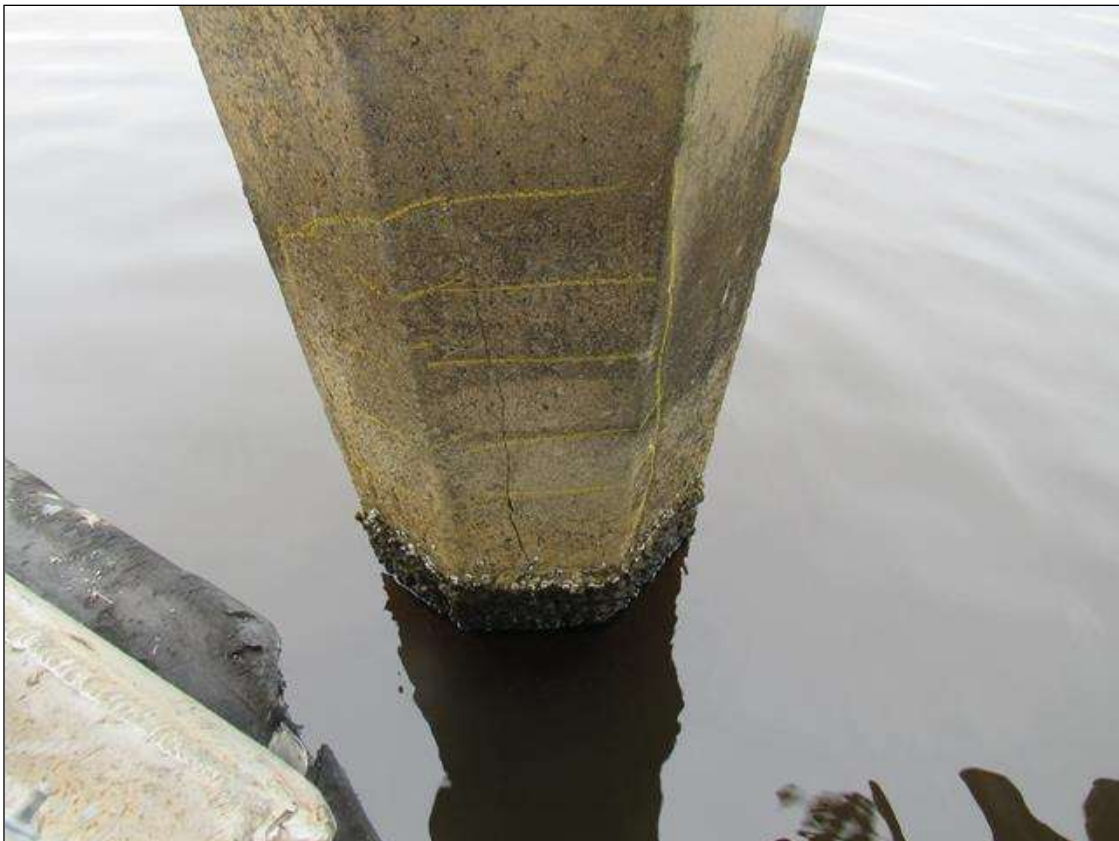
Bent 95 Saved Pile 4: 16" X 4" X 3/4" SPALL, WEST FACE, AT BOTTOM OF CAP.

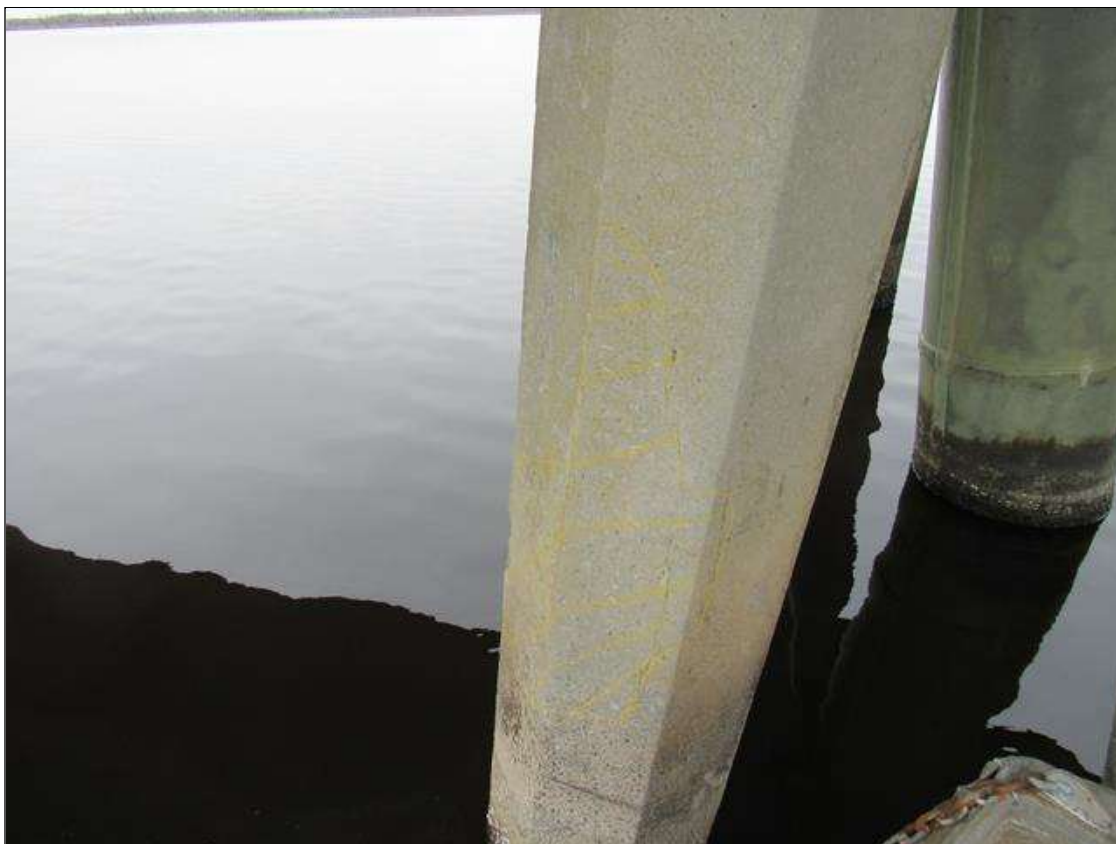
Bent 37 Saved Pile 1: 32" X 19" DELAMINATION ON SOUTH FACE LOCATED 8' FROM BOTTOM OF CAP

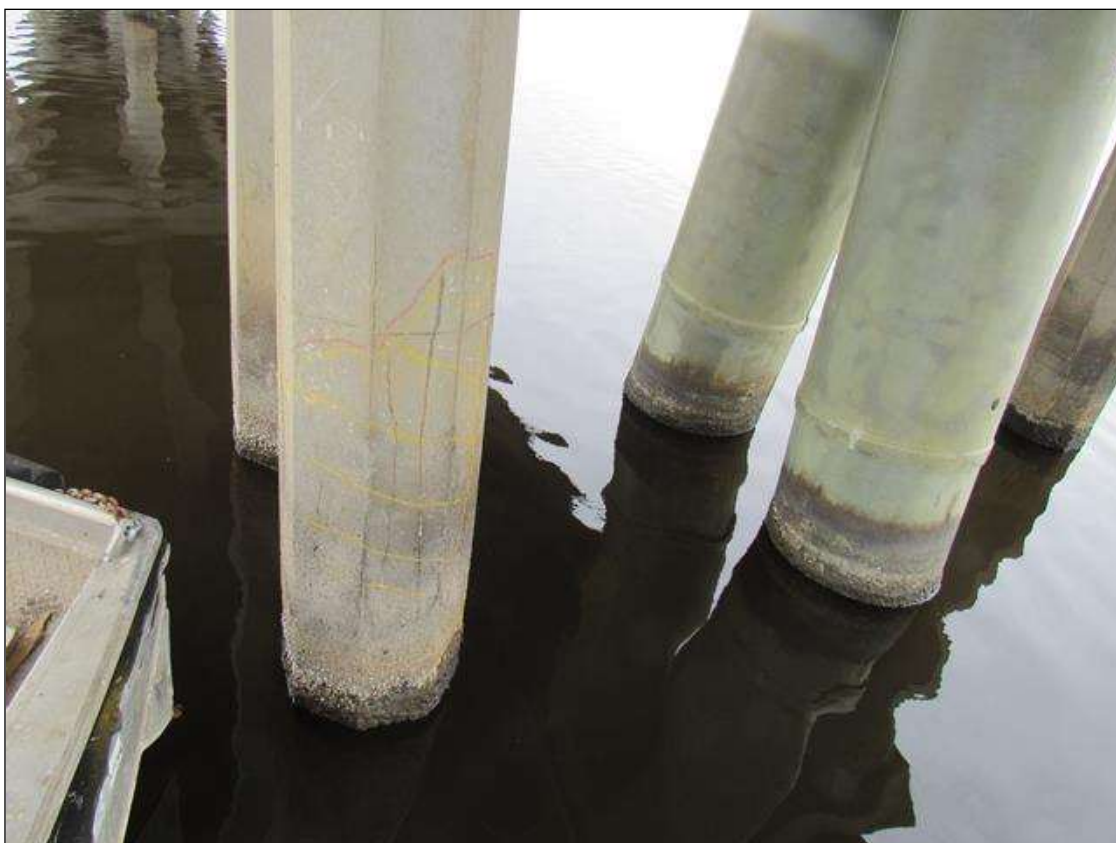
Bent 37 Saved Pile 4: 5' X 18" DELAMINATION, SOUTH FACE, 5' FROM BOTTOM OF CAP.

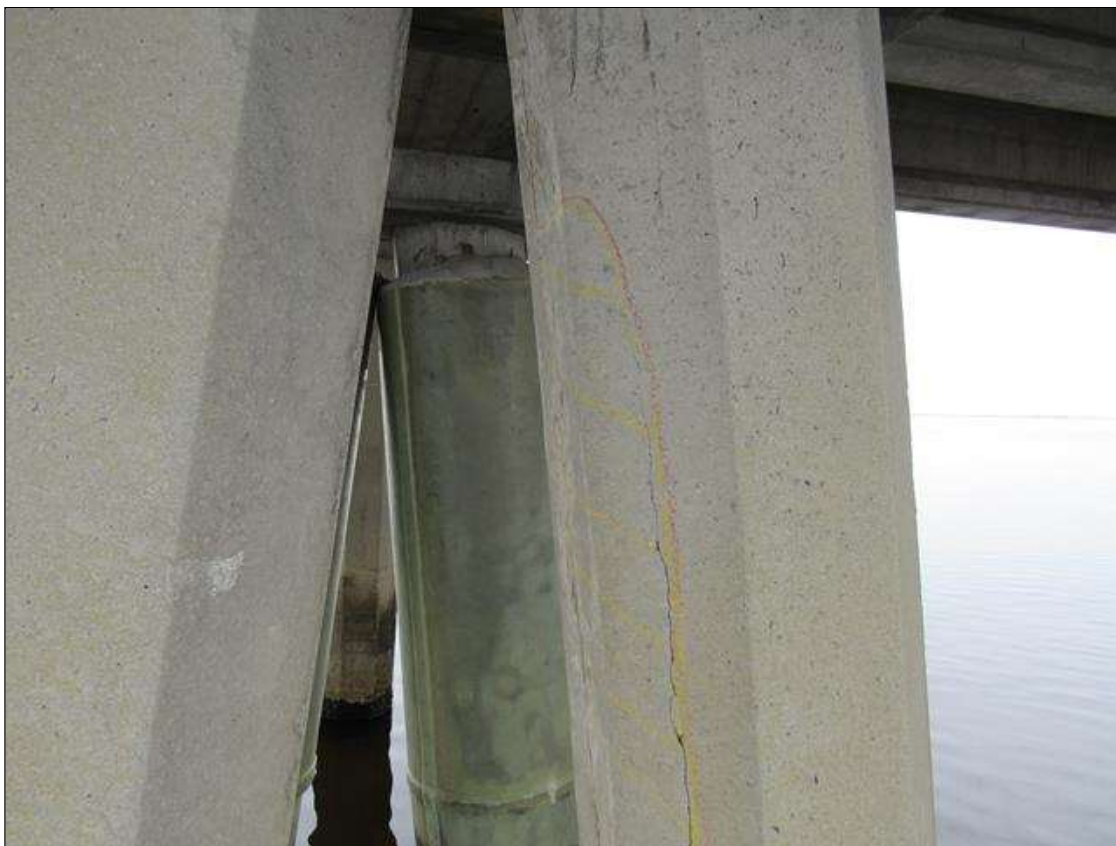
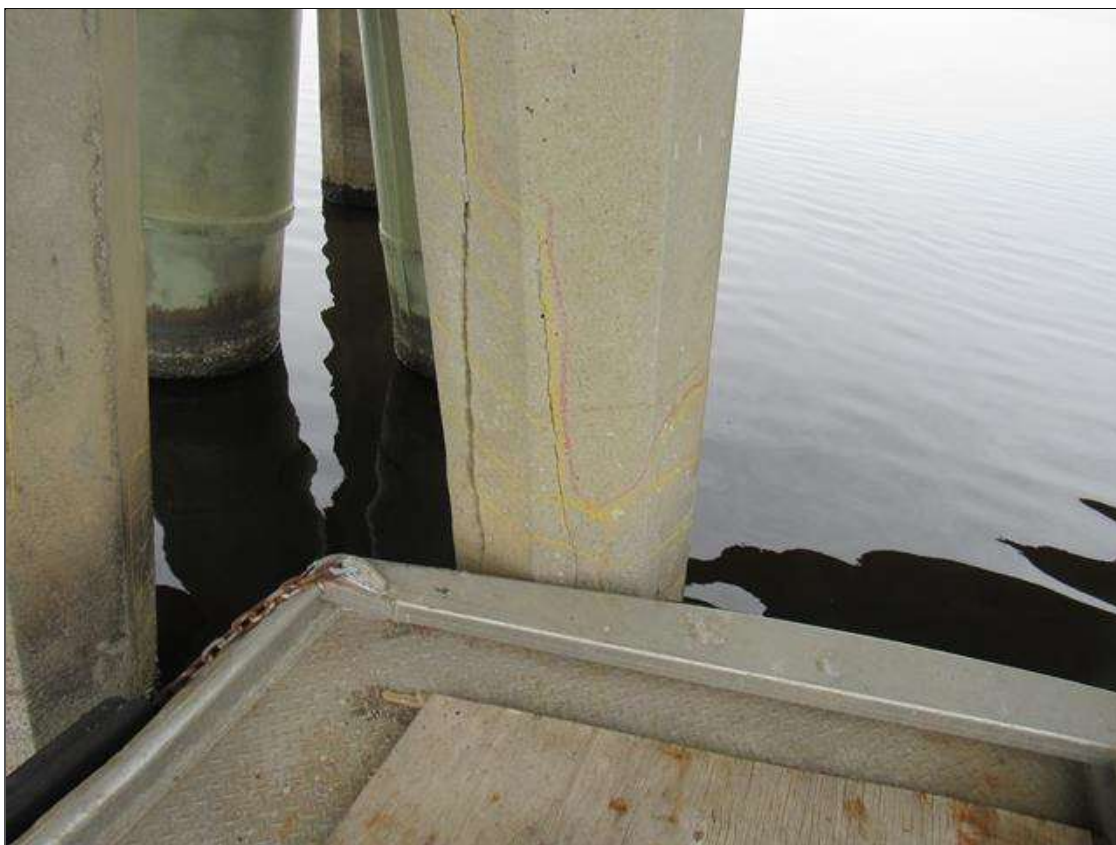
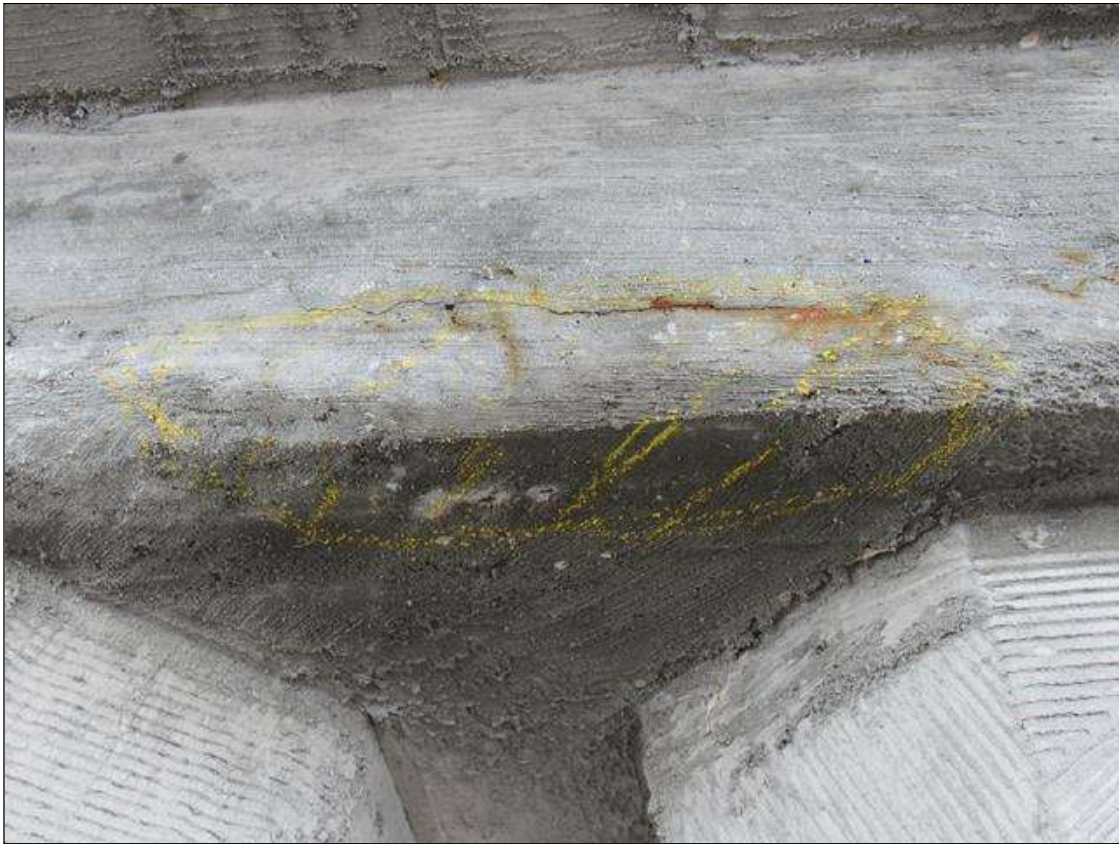
Bent 37 Saved Pile 5: 9' X UP TO 4' WIDE DELAMINATION ON WEST, SOUTH AND EAST FACES LOCATED AT 18' FROM BOTTOM OF CAP

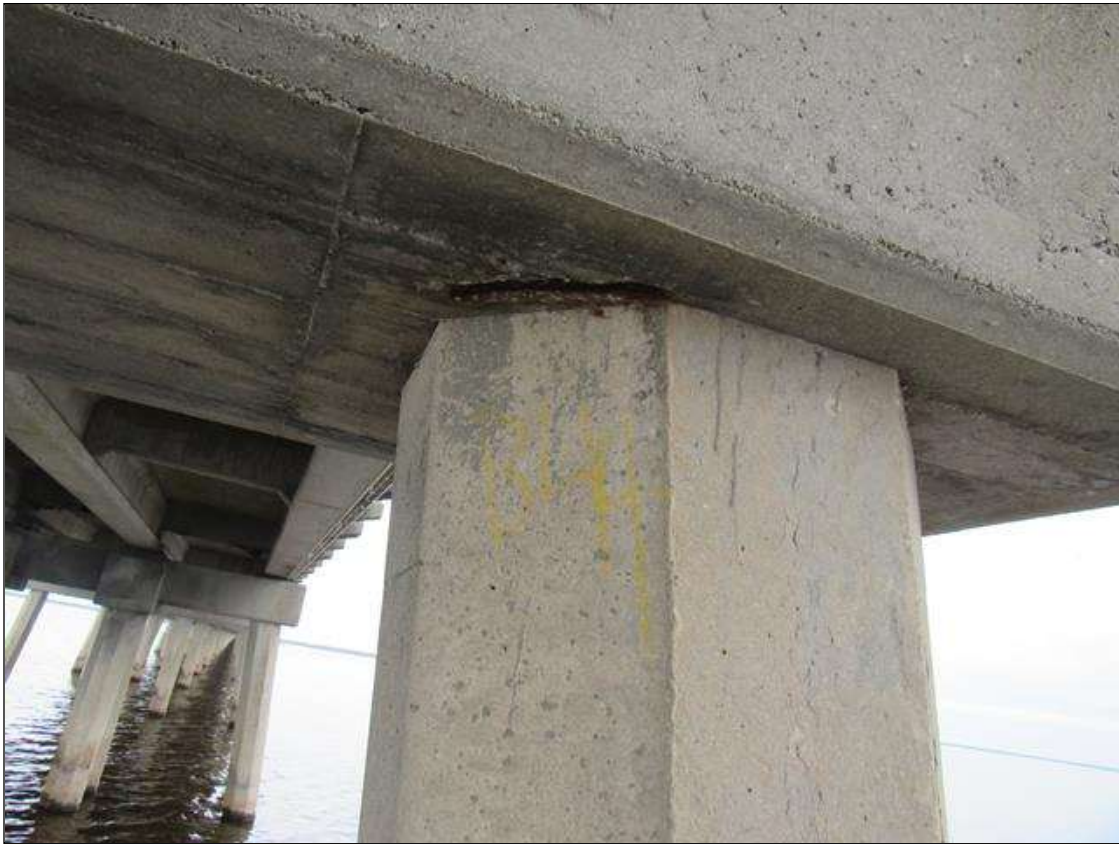
Bent 42 Saved Pile 2: 38" X 9" WIDE DELAMINATION ON SOUTH FACE 22" FROM BOTTOM OF CAP

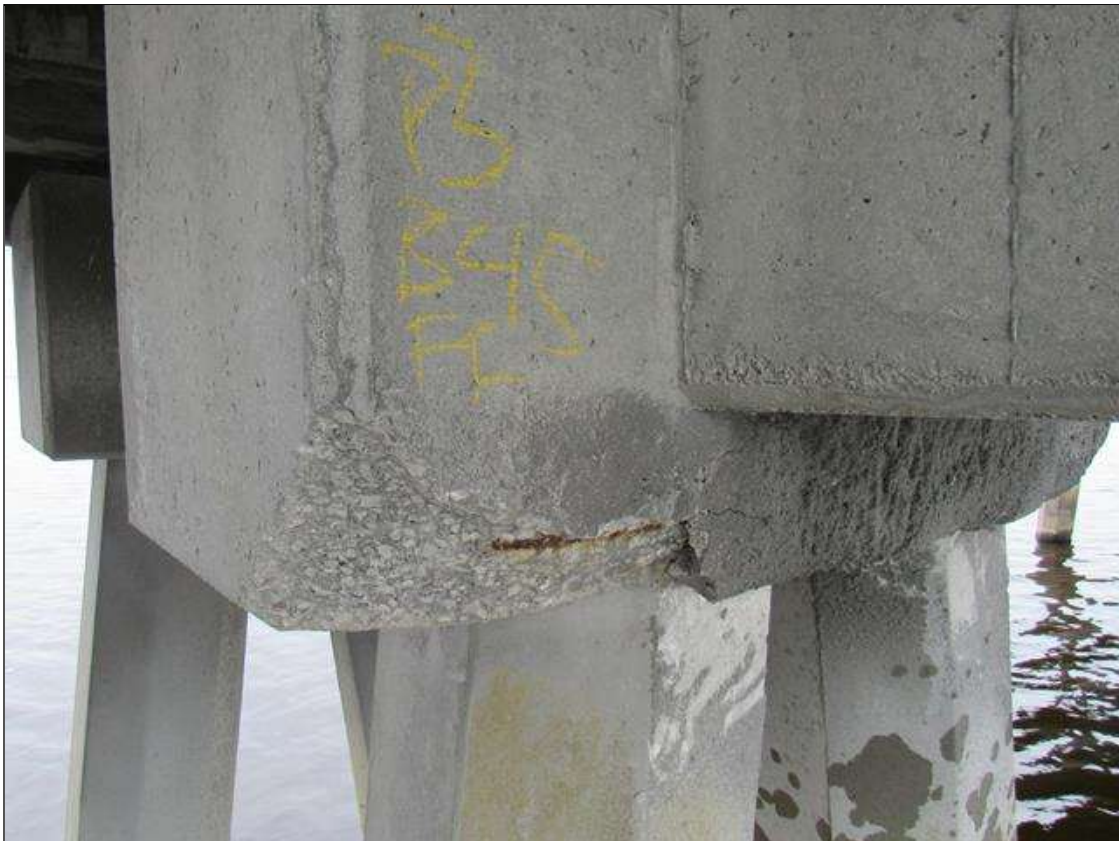
Bent 44 Cap 1: 8" X 1.5" X 3/4" DEEP SPALL WITH EXPOSED REINFORCING ON BOTTOM WEST CORNER LOCATED AT TOP OF PILE 4

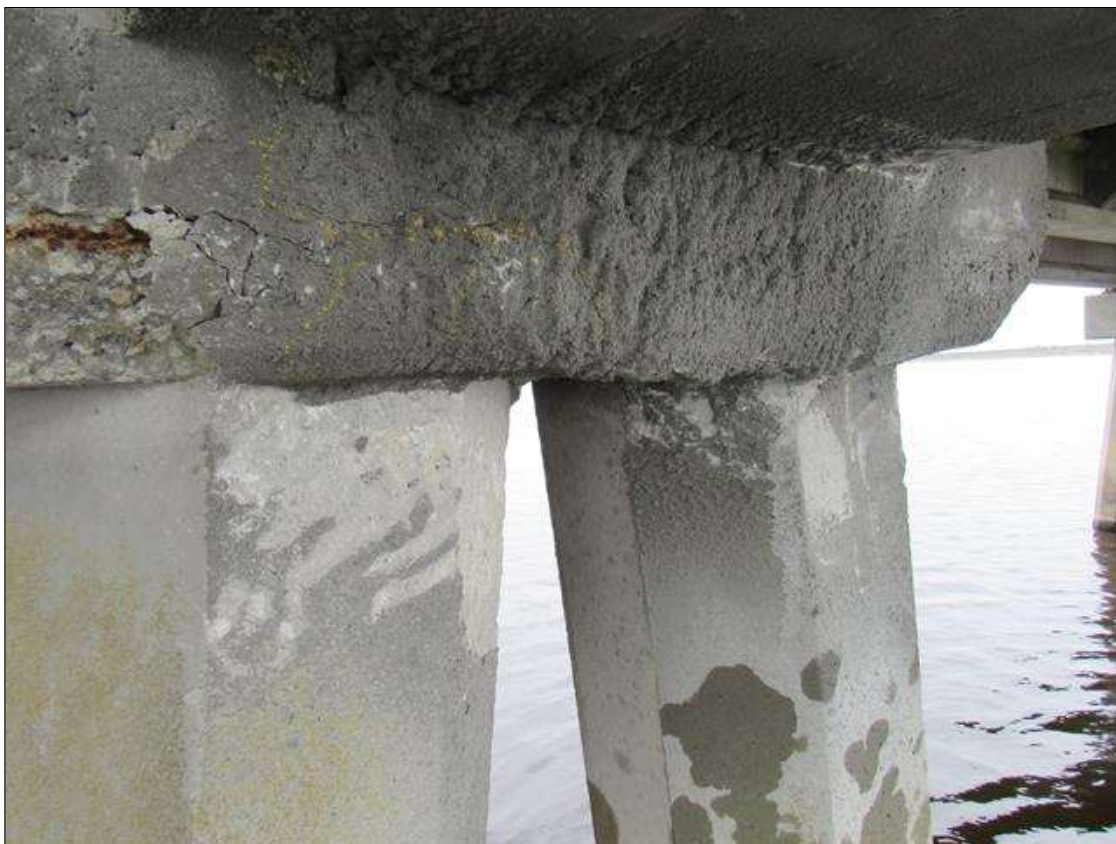
Bent 45 Cap 1: (PAR) 17" X 8" X UP TO 11" DEEP SPALL WITH 9" OF EXPOSED REBAR ON EAST FACE LOCATED LEFT OF PILE 3. REBAR HAS 10% SECTION LOSS

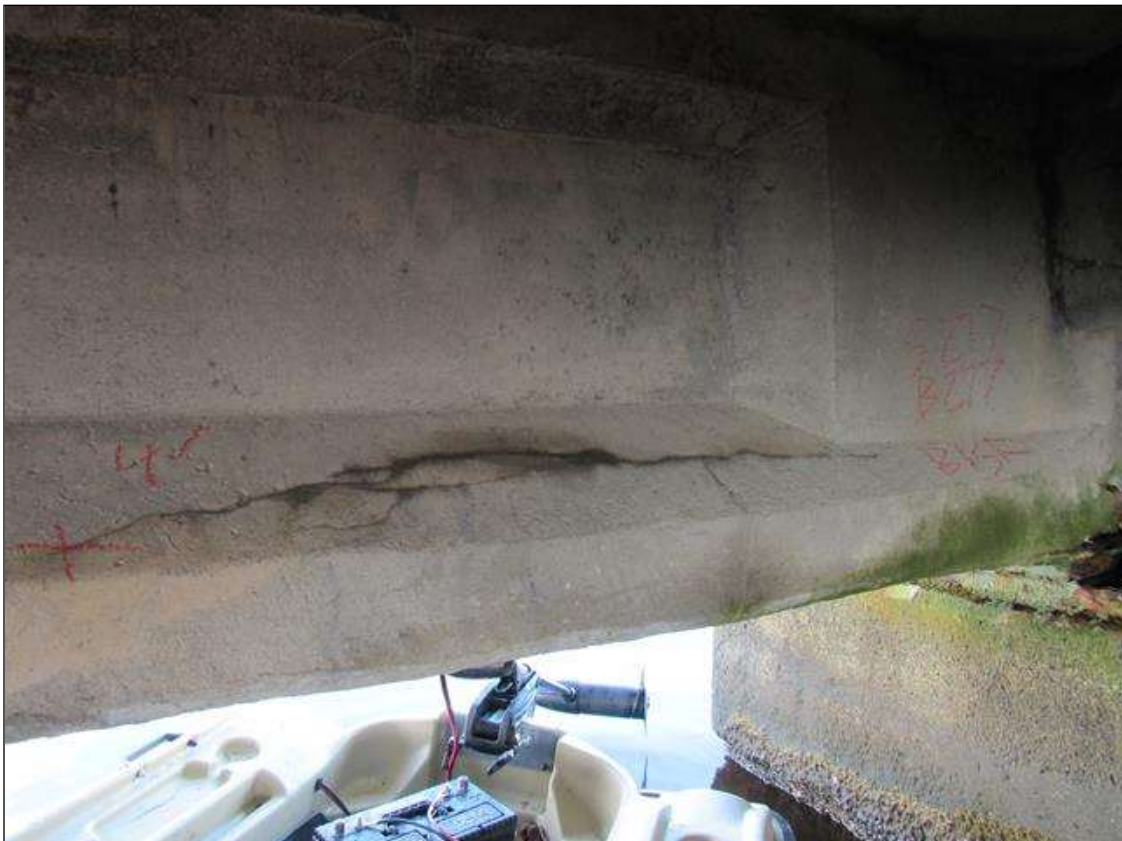
Span 277 Beam 3: UP TO 24" X 8" CRACKED DELAMINATION ON NORTH AND SOUTH FACES, AT BENT 277.

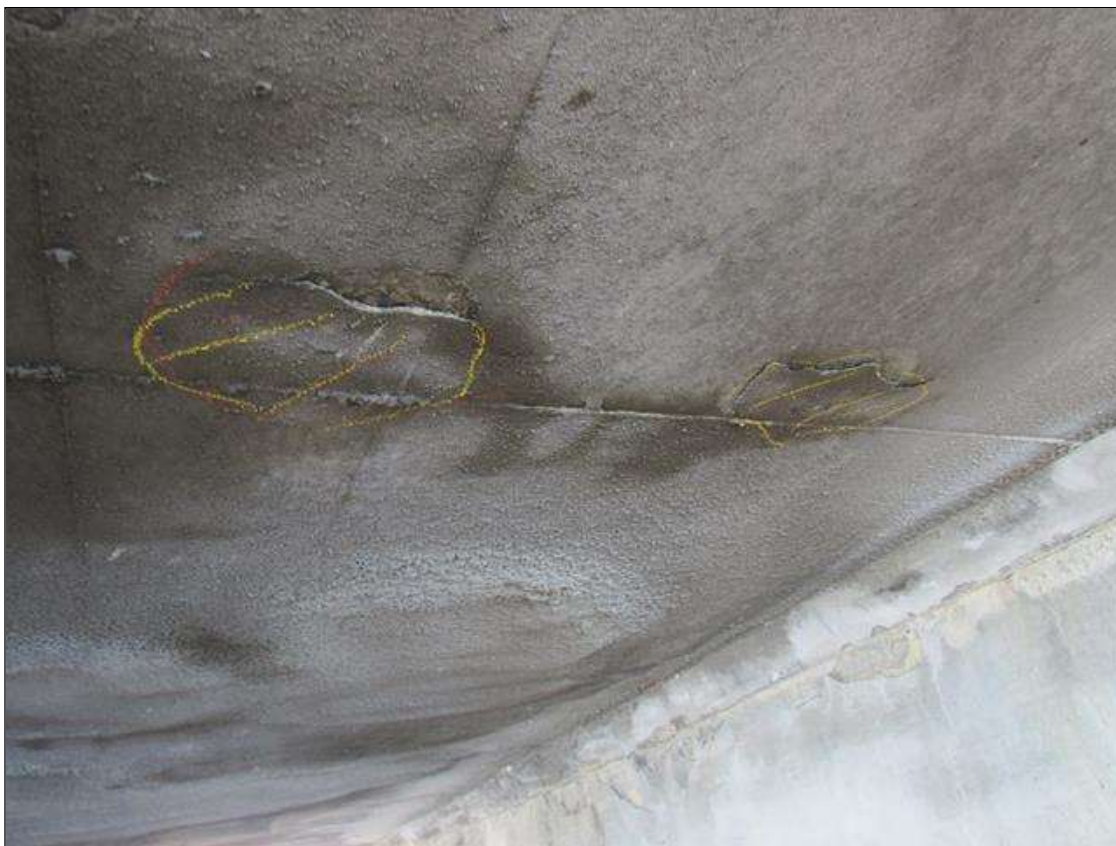
Span 277 Beam 1: (PAR) 4' LONG X 1/16" WIDE HORIZONTAL CRACKS WITH SURROUNDING DELAMINATION ON SOUTH FACE, 4' FROM BENT 277.

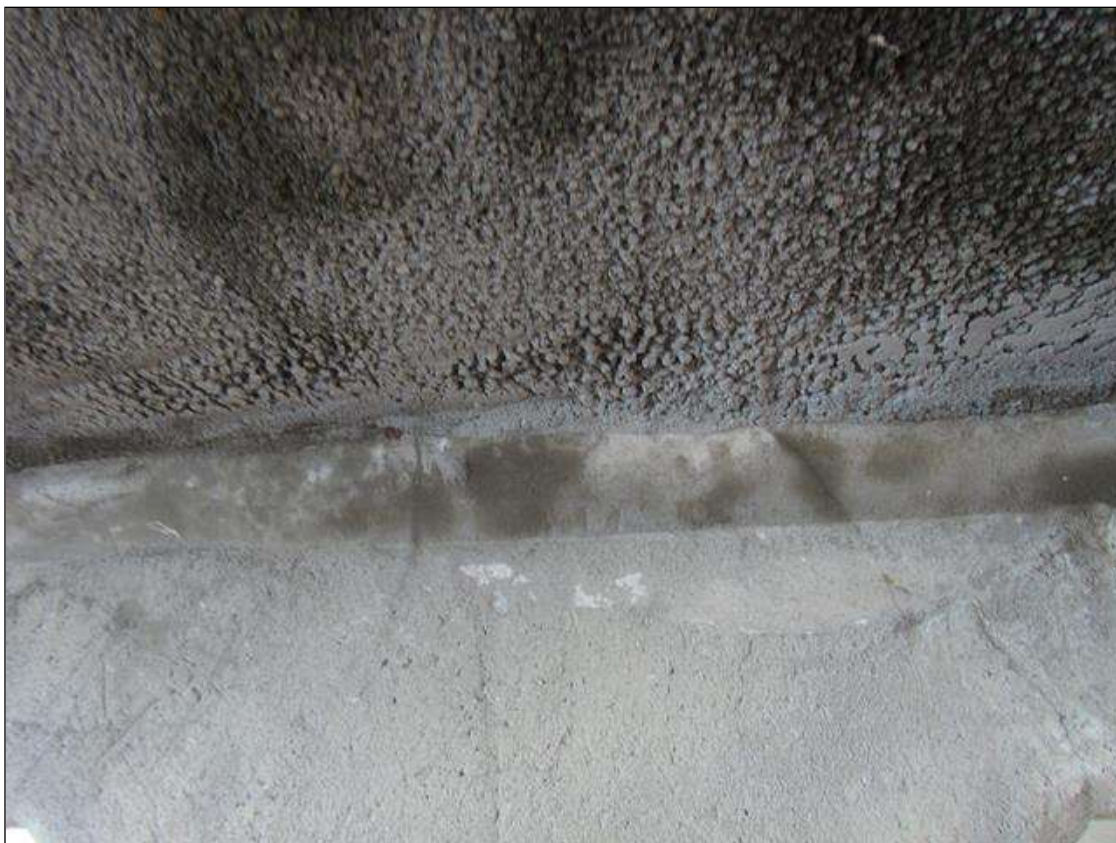
Span 278 Deck: 5 SF OF DELAMINATION ON DECK UNDERSIDE, AT RANDOM THROUGHOUT

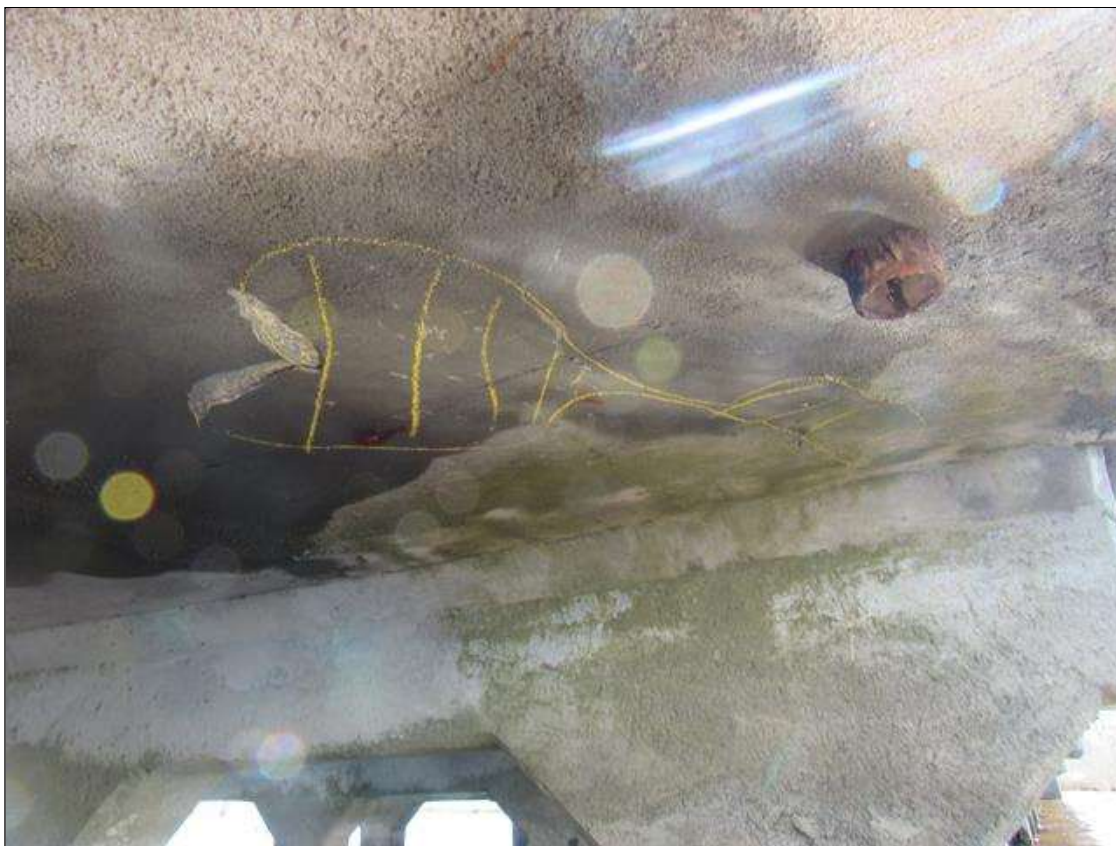
Span 279 Deck: 12" X 6" PATCHED AREA ON DECK UNDERSIDE, NEAR BENT 280.

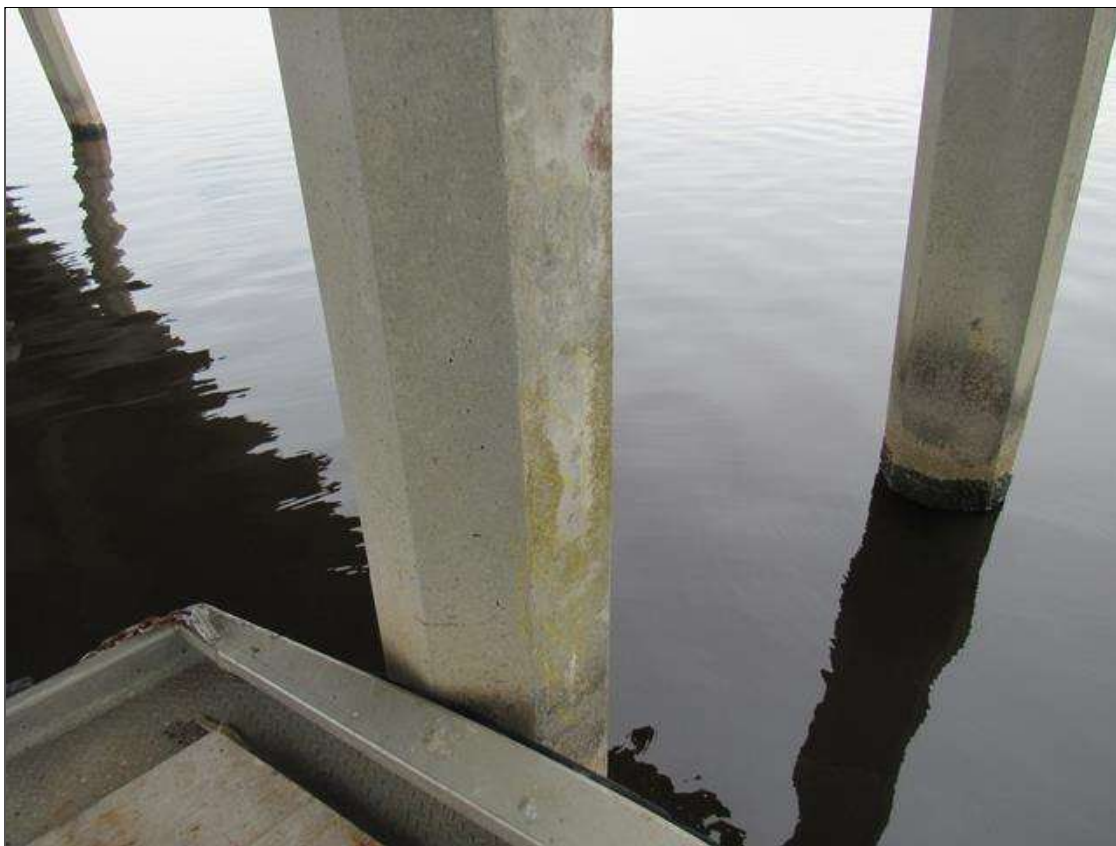
Bent 31 Saved Pile 1: 2' X 1' DELAMINATION, SOUTH FACE, 8' FROM BOTTOM OF CAP.

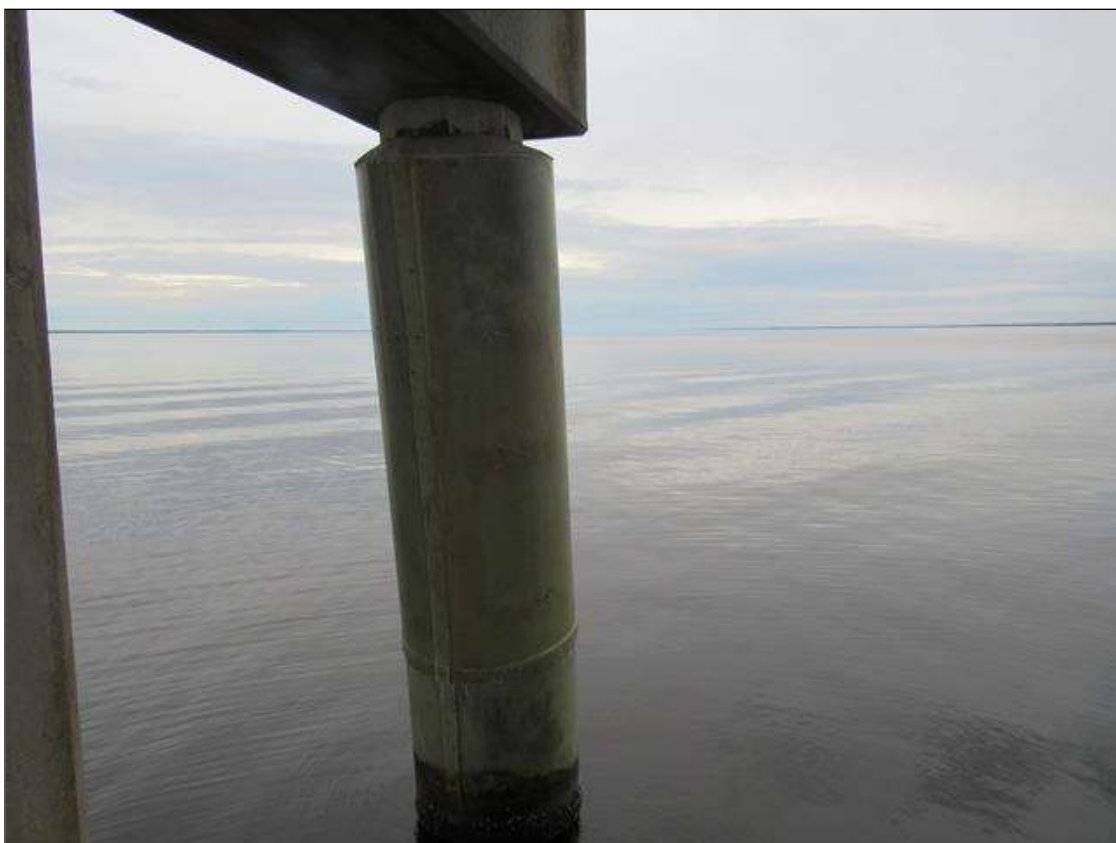
Bent 31 Saved Pile 3: 4' X UP TO 1' DELAMINATION, WEST FACE, 5' FROM BOTTOM OF CAP.

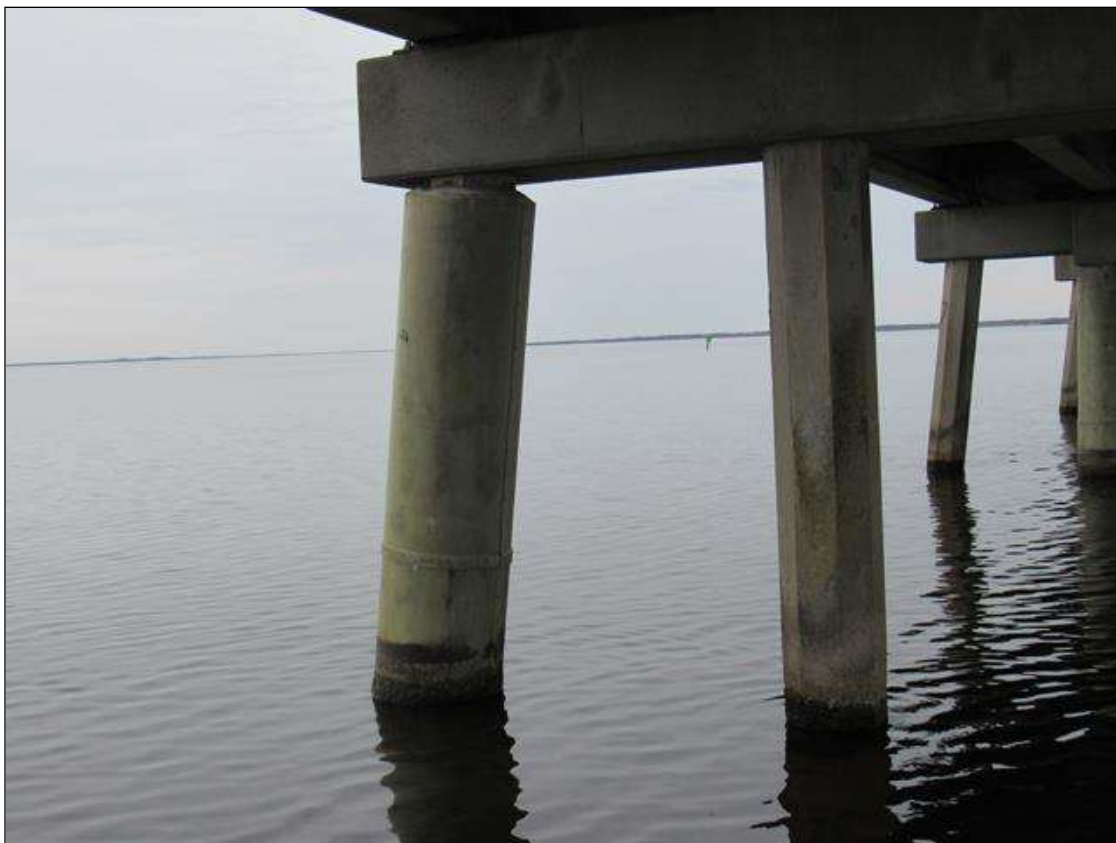
Bent 35 Saved Pile 1: 3' X 40" DELAMINATION, EAST AND WEST FACES, 8' FROM BOTTOM OF CAP.

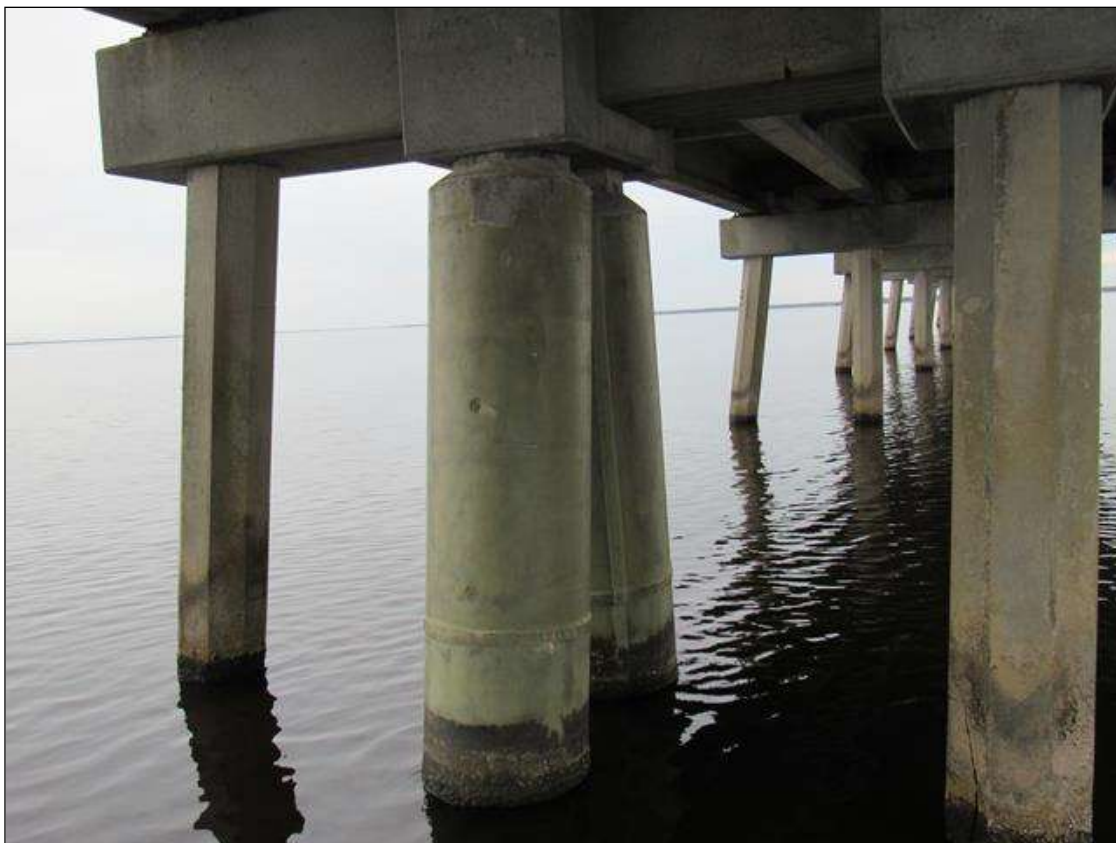
Bent 36 Saved Pile 2: (2) UP TO 4" X 4" X 1" SPALLS, NORTH FACE, 8' FROM BOTTOM OF CAP.

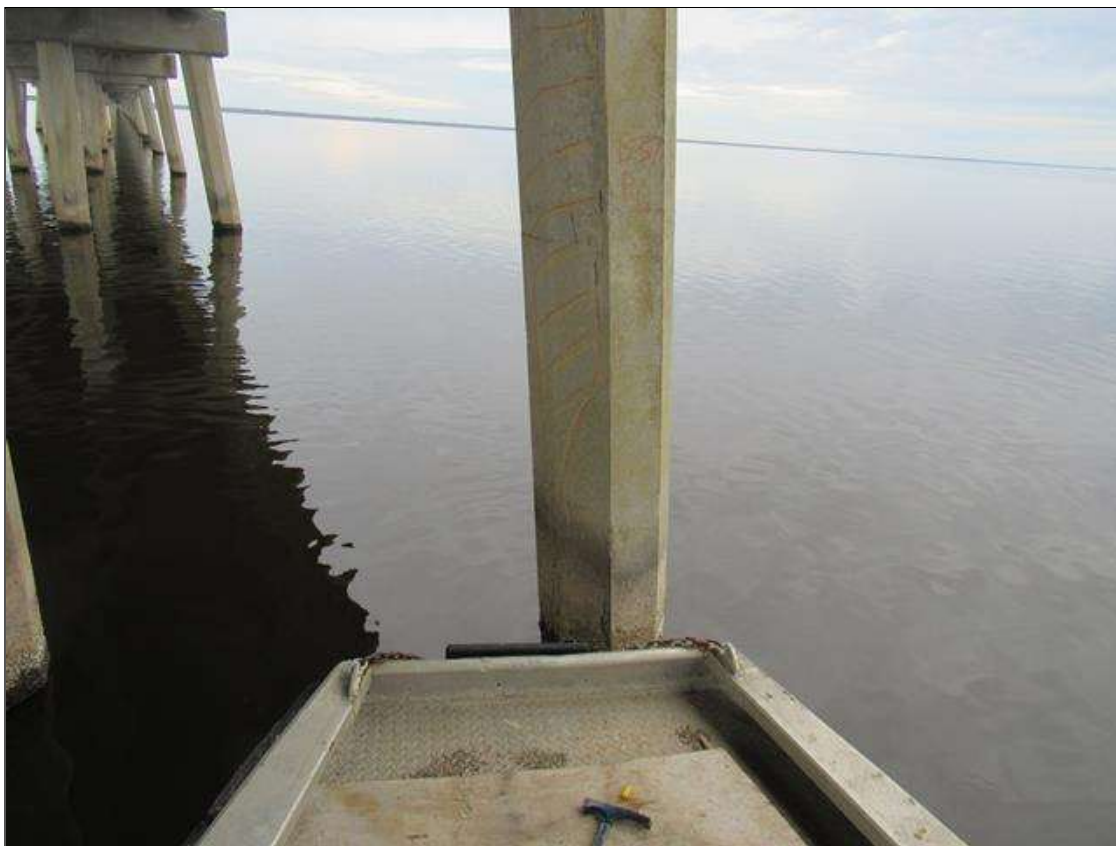
Bent 37 Saved Pile 2: PILE HAS BEEN JACKETED, BEGINNING 1' FROM BOTTOM OF CAP AND EXTENDING BELOW WATERLINE.

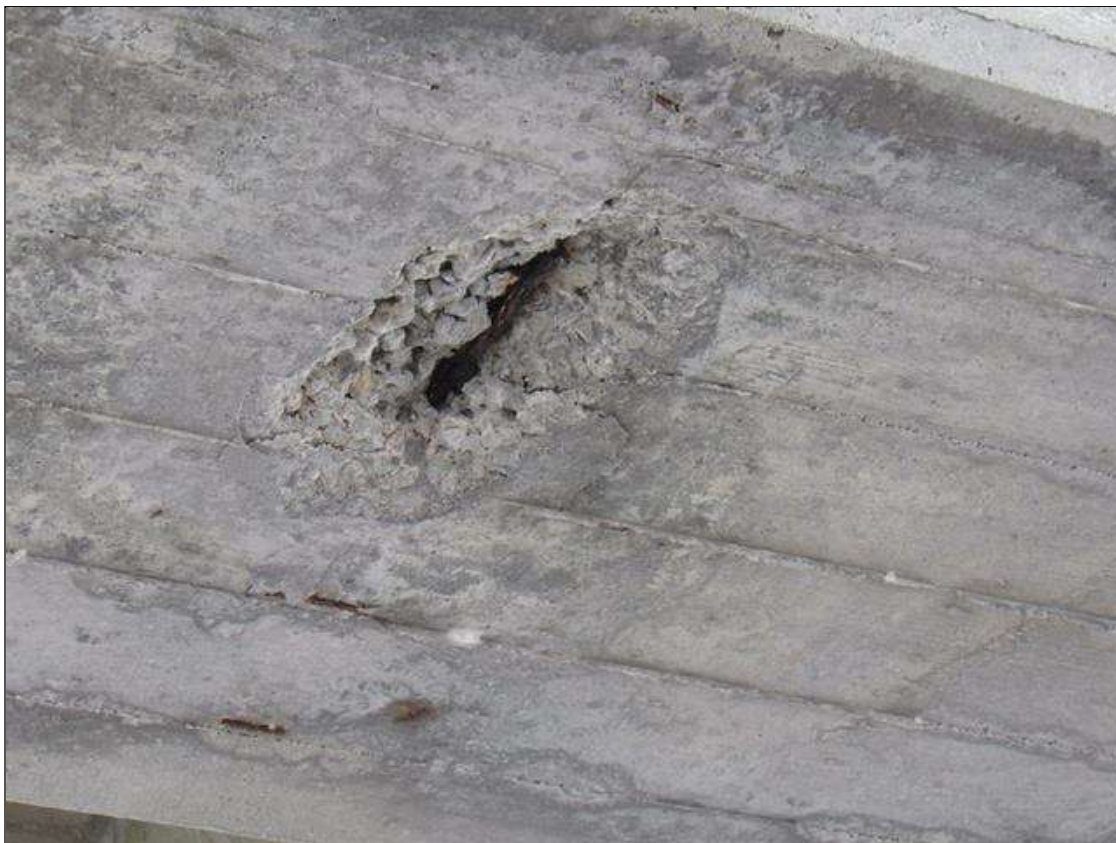
Bent 37 Saved Pile 6: 9.5' LONG X UP TO 22" WIDE DELAMINATION ON NORTH FACE, 3' FROM BOTTOM OF CAP.

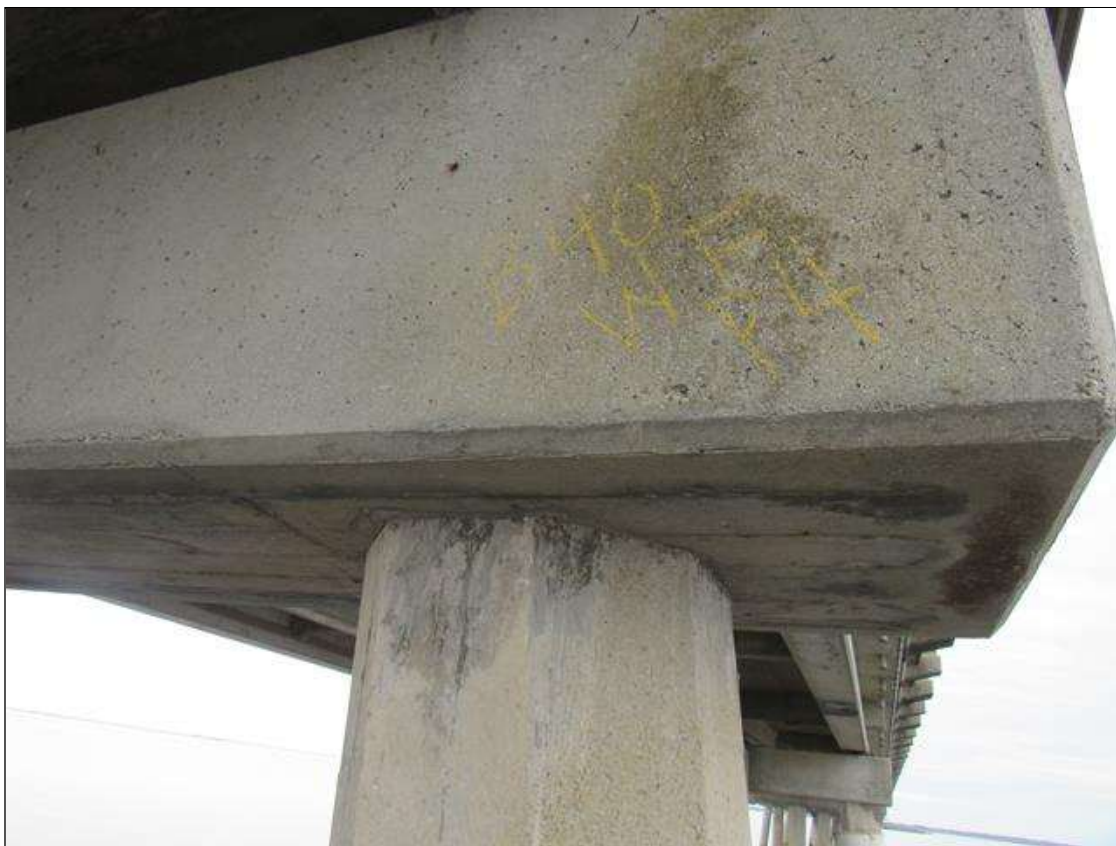
Bent 40 Cap 1: 9" X UP TO 12" X 1" SPALL, WITH EXPOSED REINFORCING, BOTTOM OF CAP, BETWEEN PILES 2 AND 3.

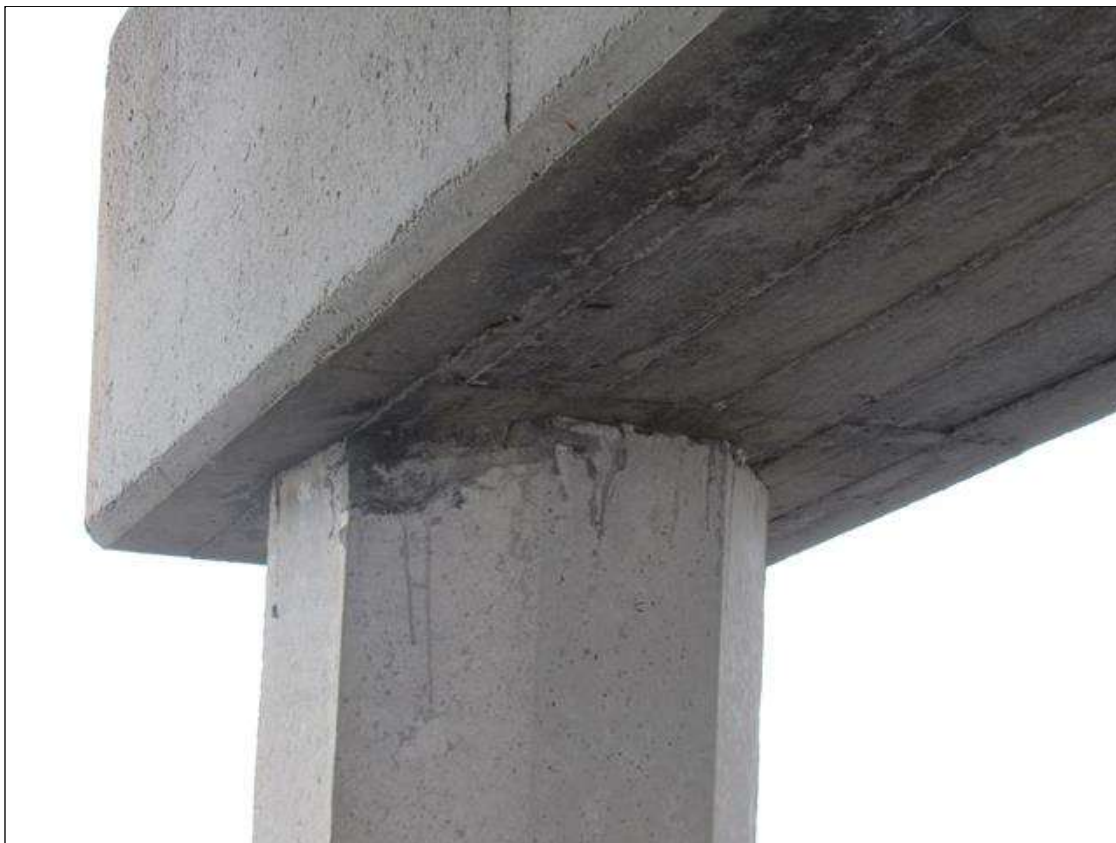
Bent 40 Cap 1: 3' X 14" DELAMINATION, BOTTOM OF CAP, AT PILE 4, EXTENDING 6" ONTO WEST FACE. NOT OBSERVED IN 2020 INSPECTION
