NC DEPARTMENT OF TRANSPORTATION
DIVISION OF HIGHWAYS
STRUCTURE MANAGEMENT UNIT

Structure Safety Report

Routine Element Inspection - Contract

FEATURE INTERSECTED: ALLIGATOR RIVER

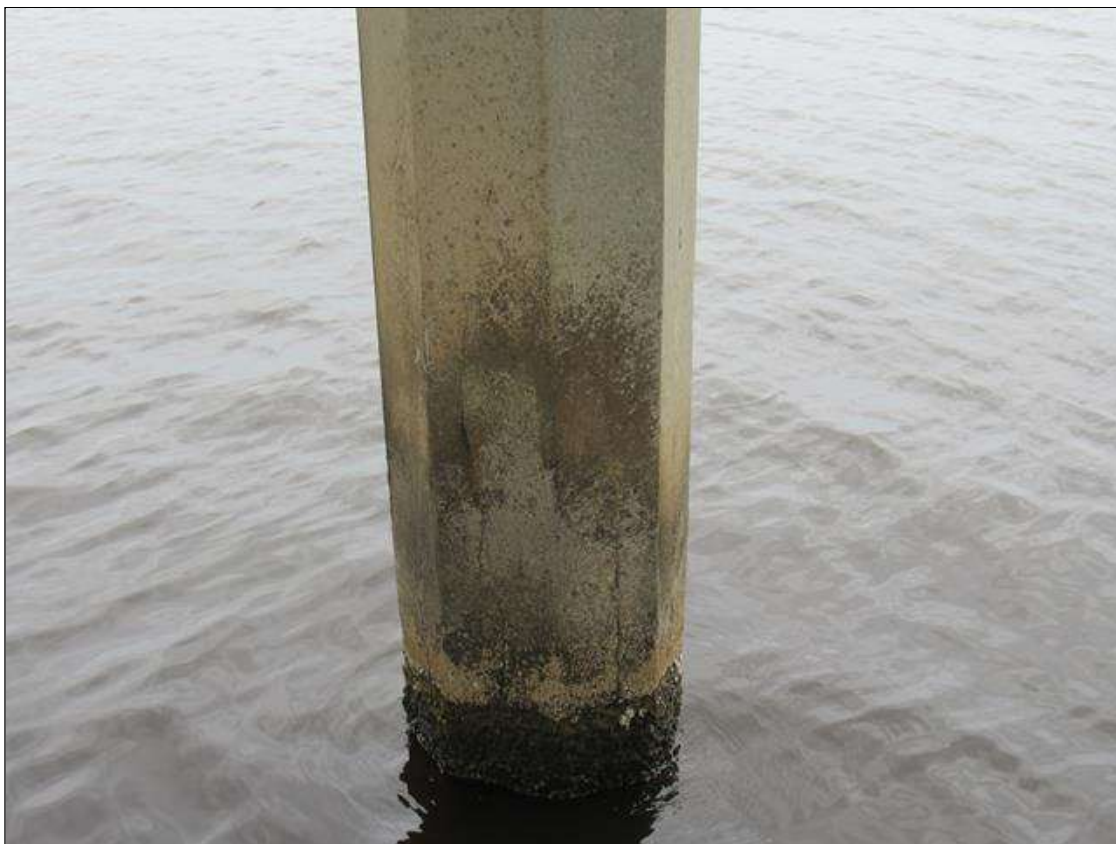
Bent 48 Saved Pile 1: 3" X 5" PATCHED AREA, SOUTH AND WEST FACES, AT BOTTOM OF CAP.

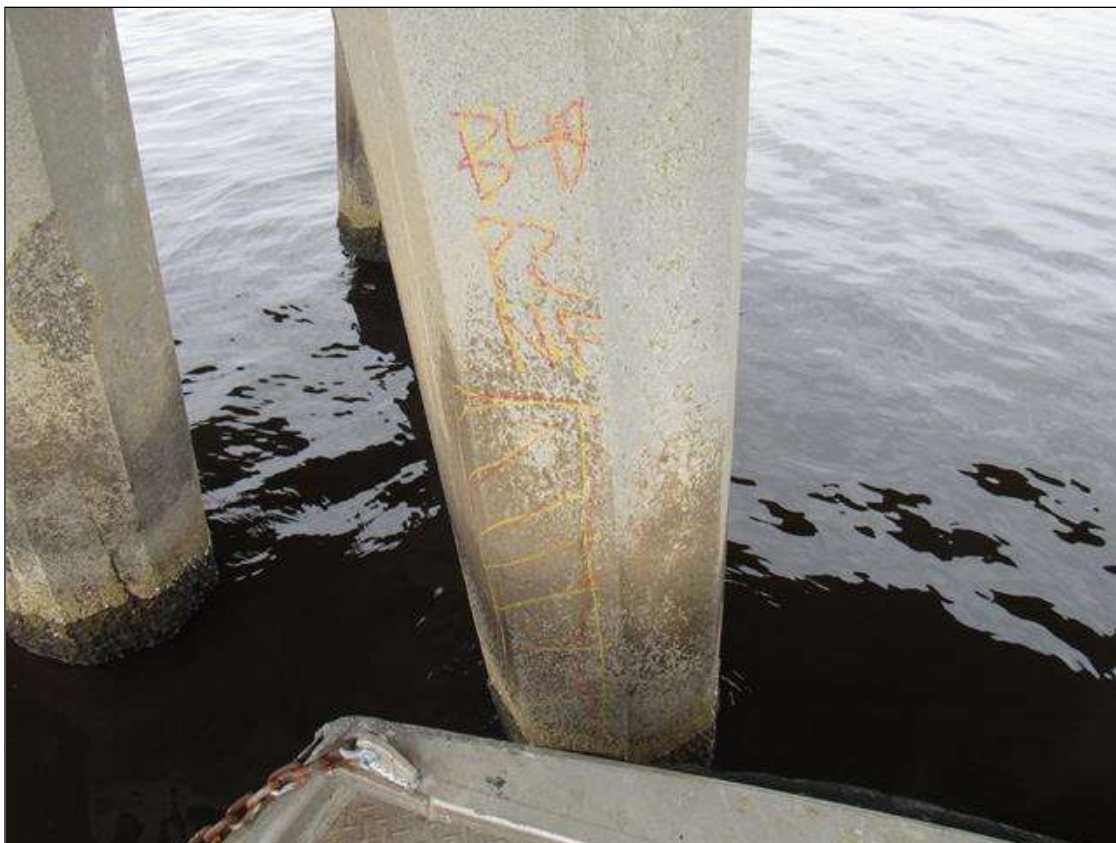
Bent 47 Saved Pile 4: 3' X 1' DELAMINATION, NORTH FACE, 7' FROM BOTTOM OF CAP.

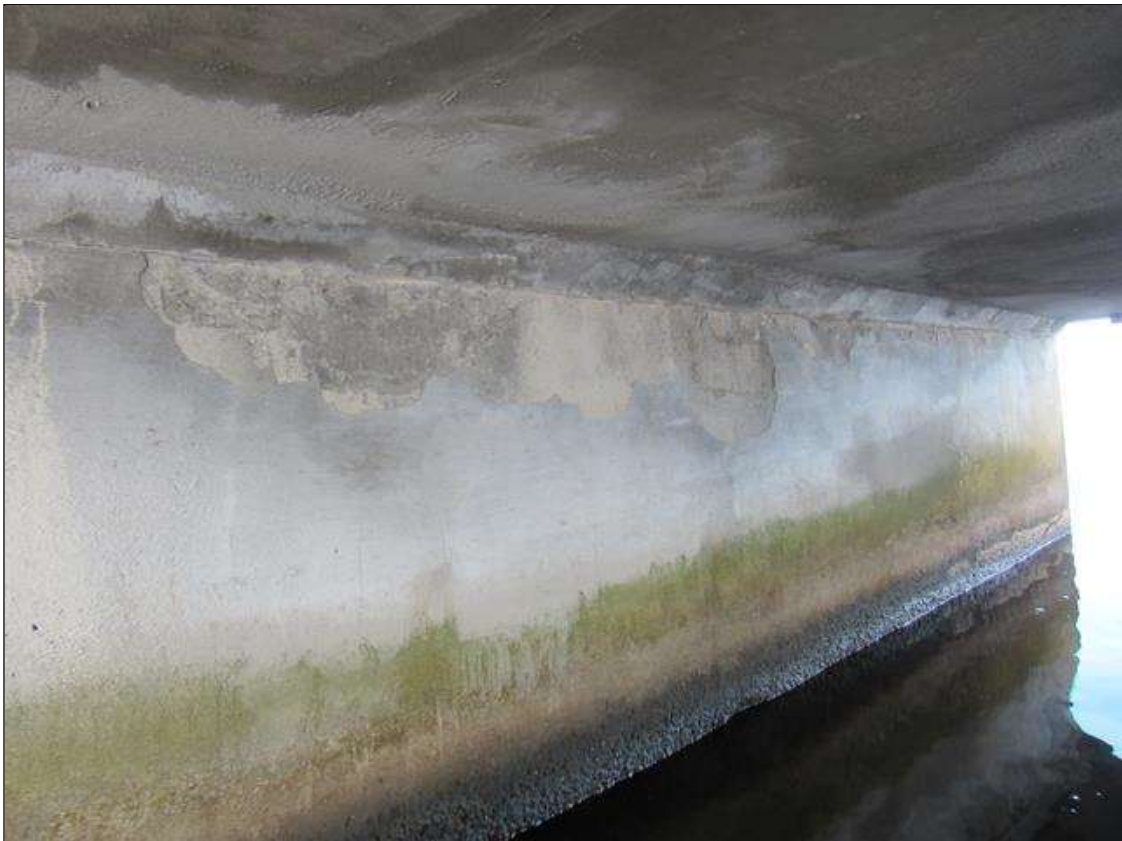
Bent 277 Cap 1: (PAR) 12' LONG X 18" HIGH X 2.5" DEEP SPALL LOCATED ON TOP EDGE OF EAST FACE, BEGINNING 8' FROM SOUTH END. SPALL CAUSING LOSS OF BEARING AREA IN SLAB.

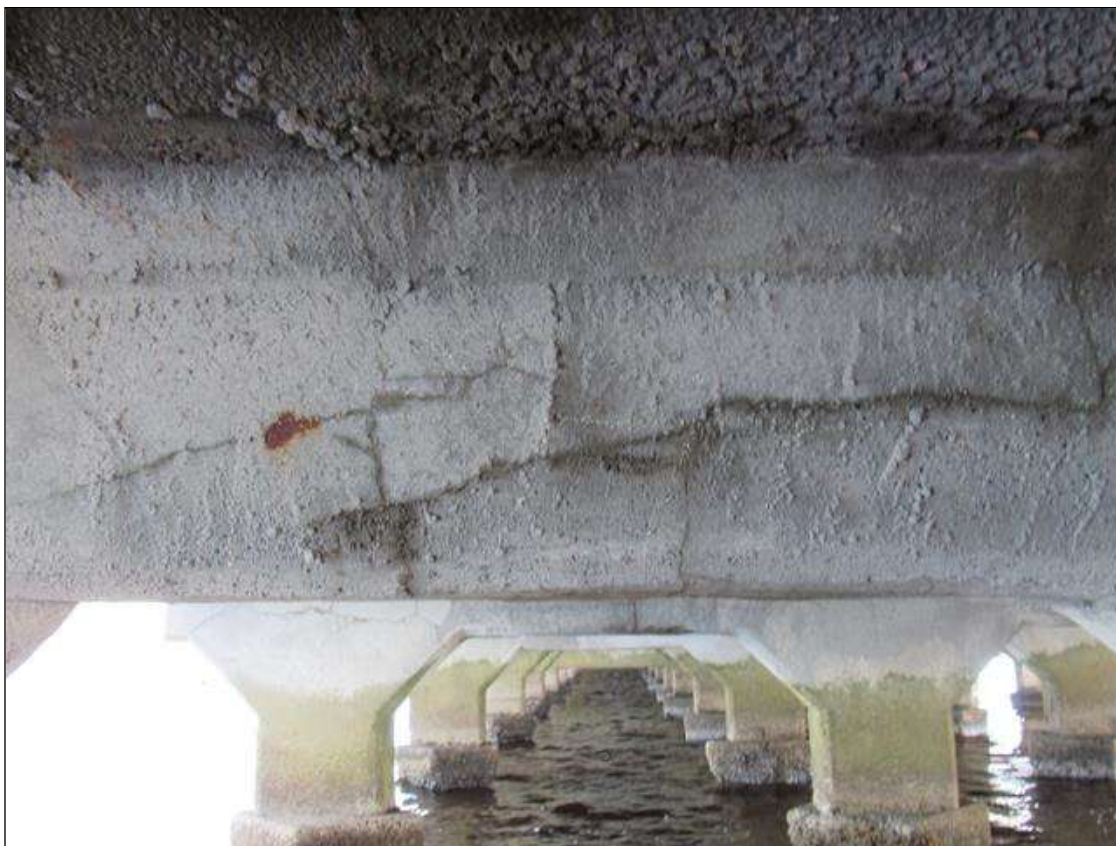
Bent 277 Cap 1: (PAR) 12' LONG X 18" HIGH X 2.5" DEEP SPALL LOCATED ON TOP EDGE OF EAST FACE, BEGINNING 8' FROM SOUTH END. SPALL CAUSING LOSS OF BEARING AREA IN SLAB.

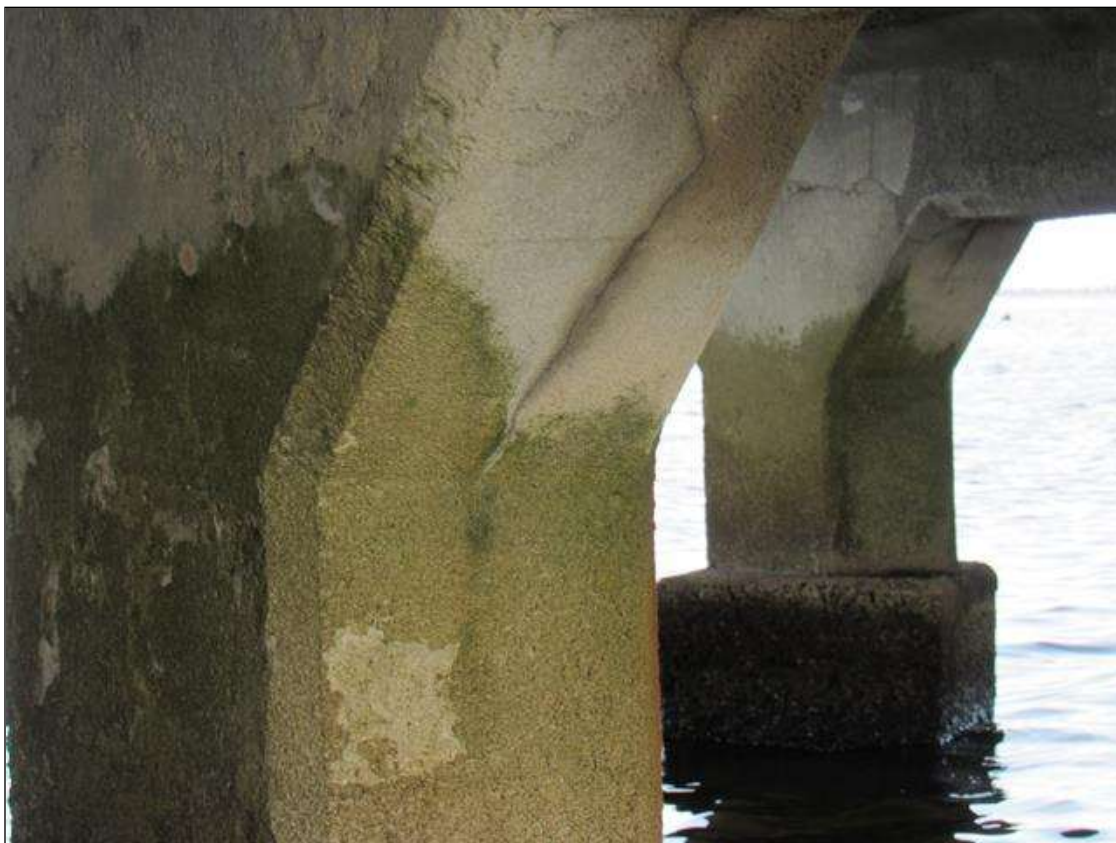
Bent 278 Cap 1: 3' X 1' CRACKED PATCHED AREA, WITH RUST STAINING, WEST FACE, BAY 1.

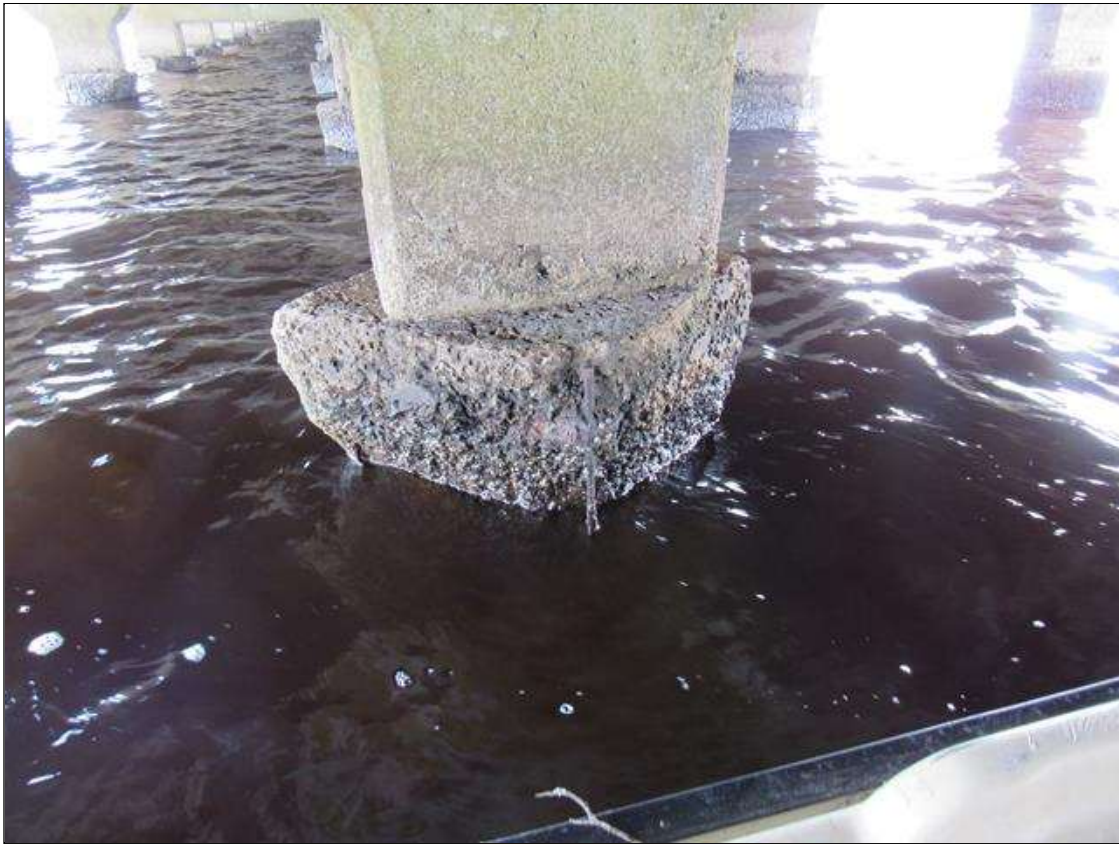
Bent 280 Pile 1: (PAR) 24" X 24" X 24" SPALL, WITH EXPOSED REBAR WITH COMPLETE SECTION LOSS, NORTH FACE OF COLUMN FOOTING.

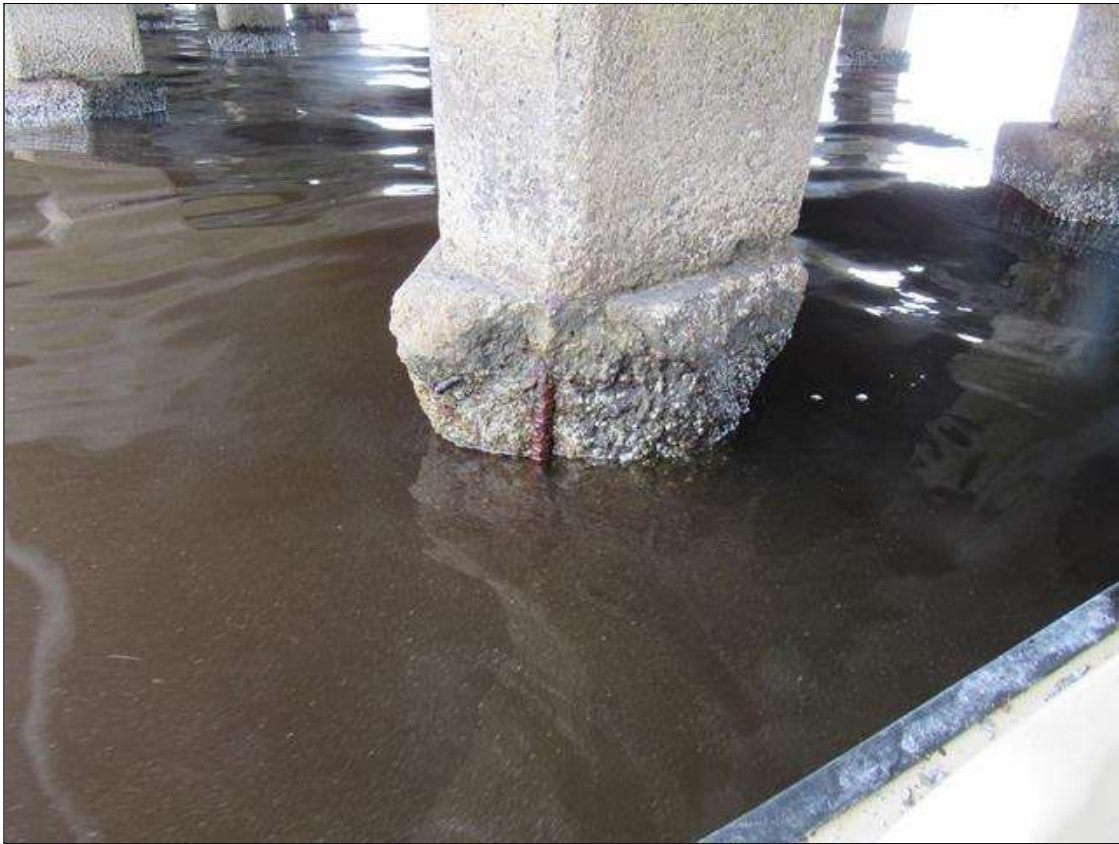
Bent 281 Pile 1: (PAR) 18" X 24" X 24" SPALL, WITH EXPOSED REINFORCING AND COMPLETE SECTION LOSS TO VERTICAL BARS, WEST FACE OF COLUMN FOOTING.

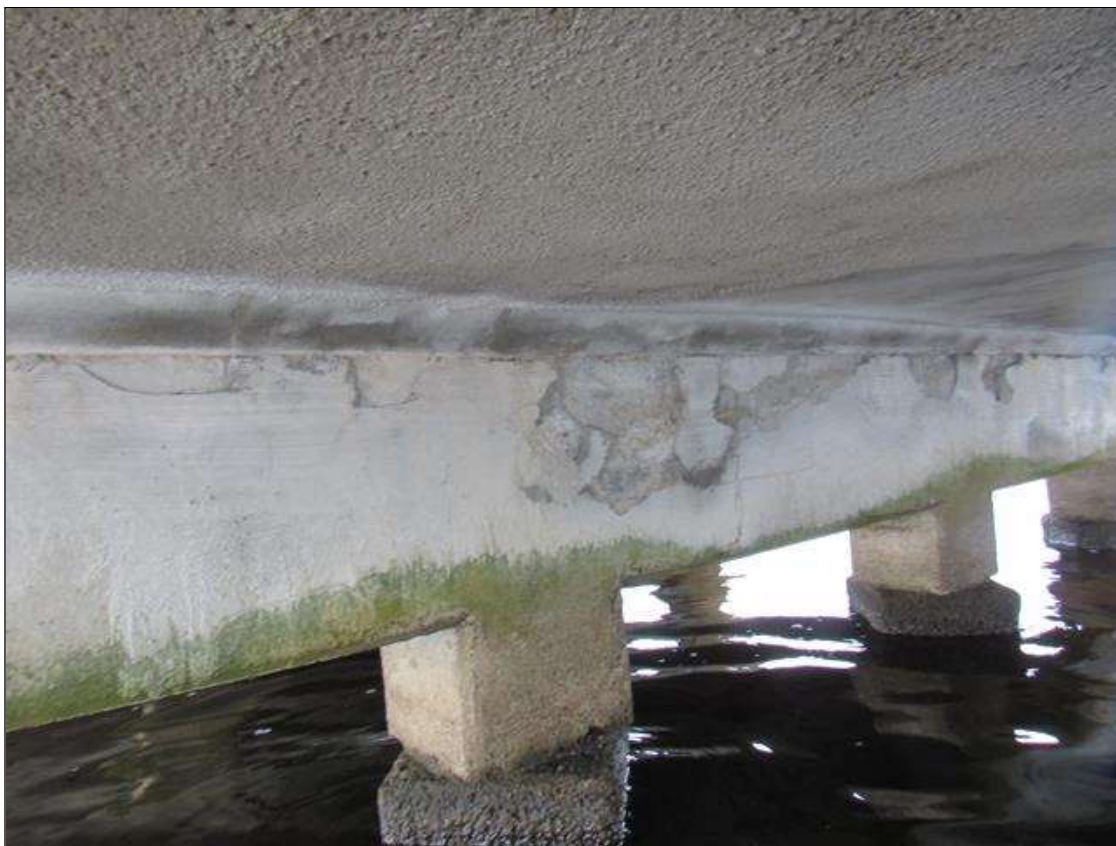
Bent 283 Cap 1: (PAR) 12' X UP TO 17" X 2" DEEP SPALL, EAST FACE, BAYS 2 AND 3. SPALL IS CAUSING 2" LOSS OF BEARING AREA IN SLAB.

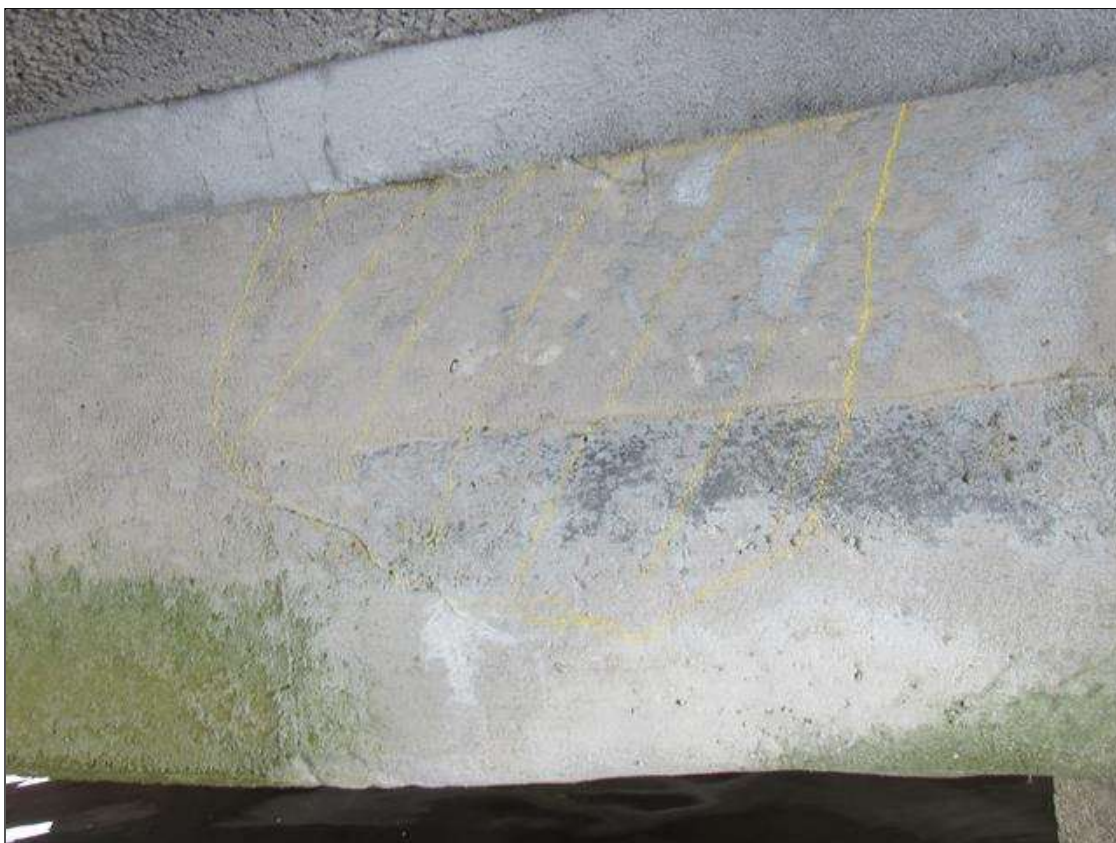
Bent 283 Cap 1: (PAR) 12' X UP TO 17" X 2" DEEP SPALL, EAST FACE, BAYS 2 AND 3. SPALL IS CAUSING 2" LOSS OF BEARING AREA IN SLAB.

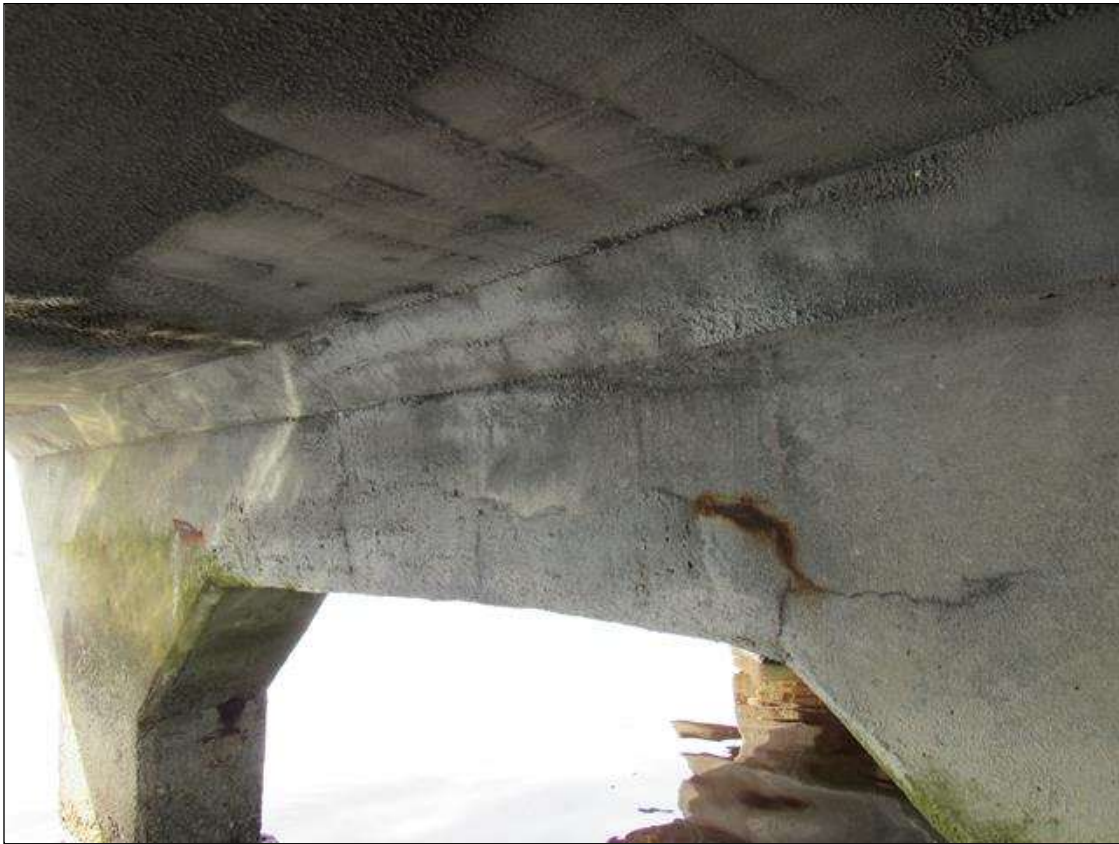
Bent 283 Cap 1: 3' X 1.5' DELAMINATION, WEST FACE, BAY 2.

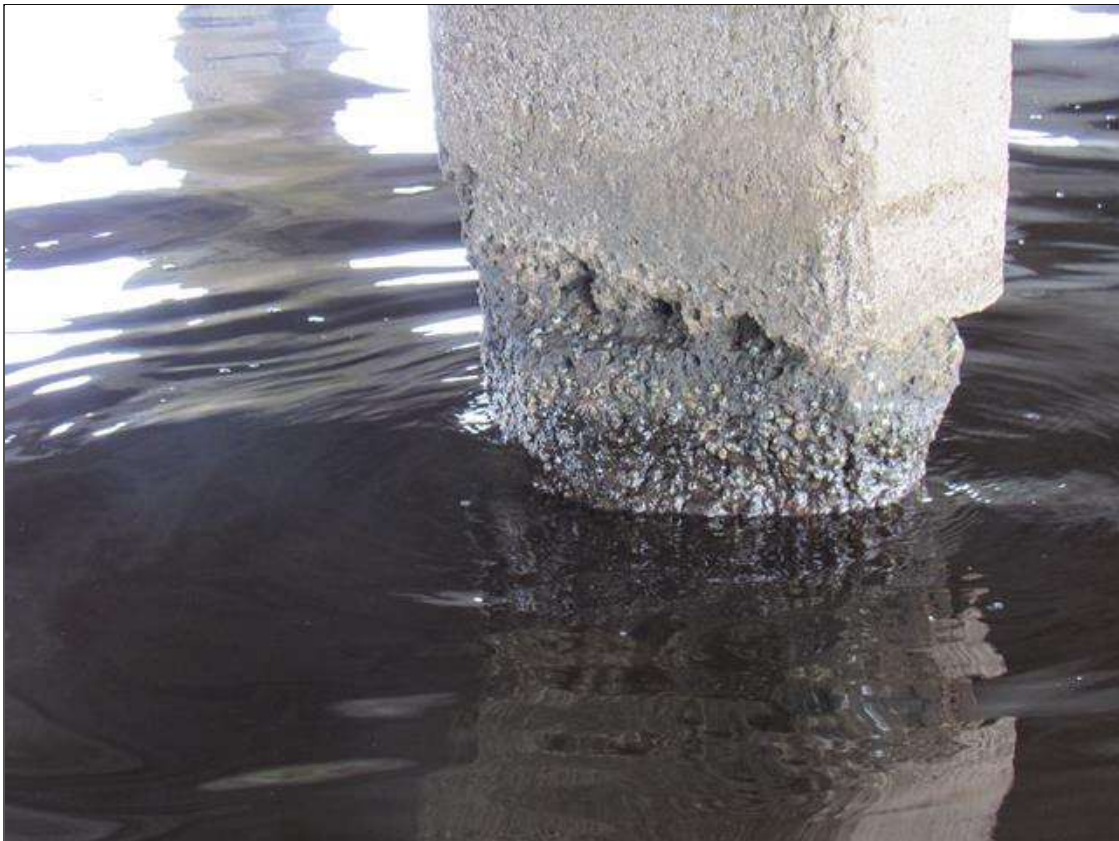
Bent 284 Cap 1: 6' OF LONGITUDINAL CRACKS UP TO 1/16", WITH RUST STAINING, AT RANDOM THROUGHOUT EAST AND WEST FACES.

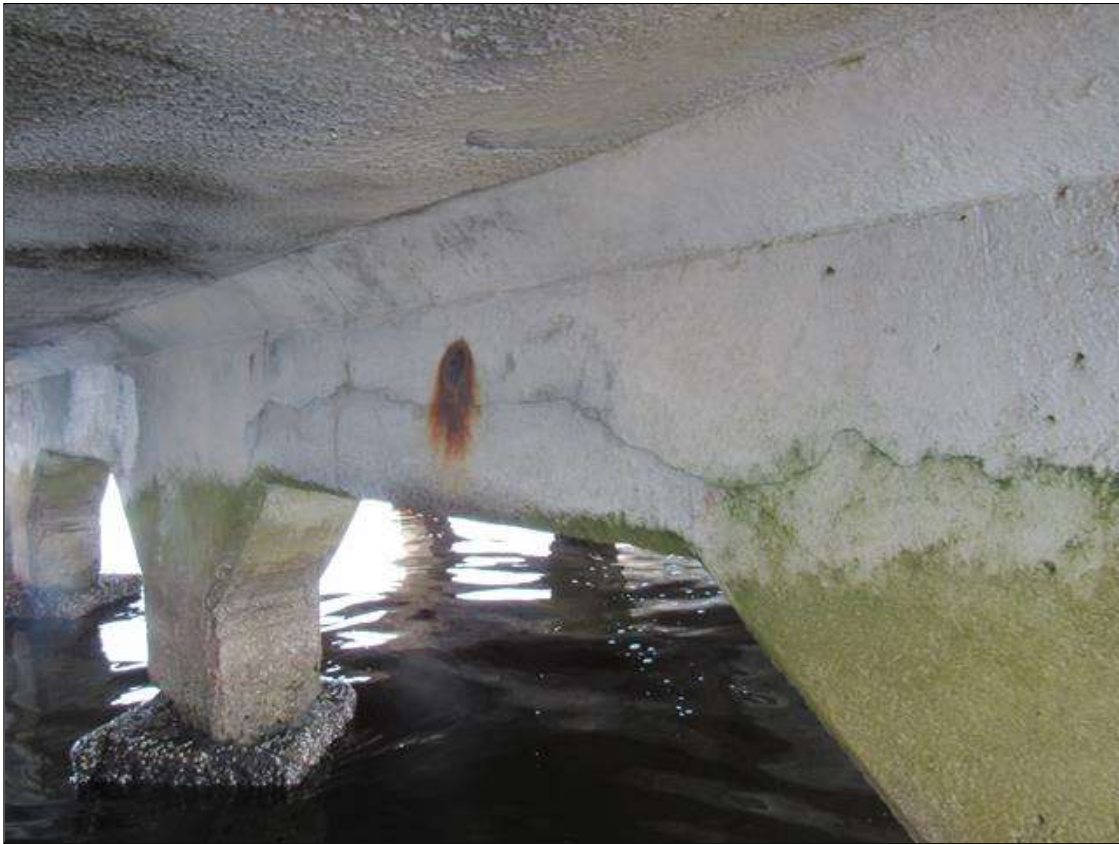
Bent 284 Pile 3: (PAR) 24" X 24" X 24" SPALL, WITH EXPOSED REBAR WITH COMPLETE SECTION LOSS, WEST FACE OF COLUMN FOOTING.

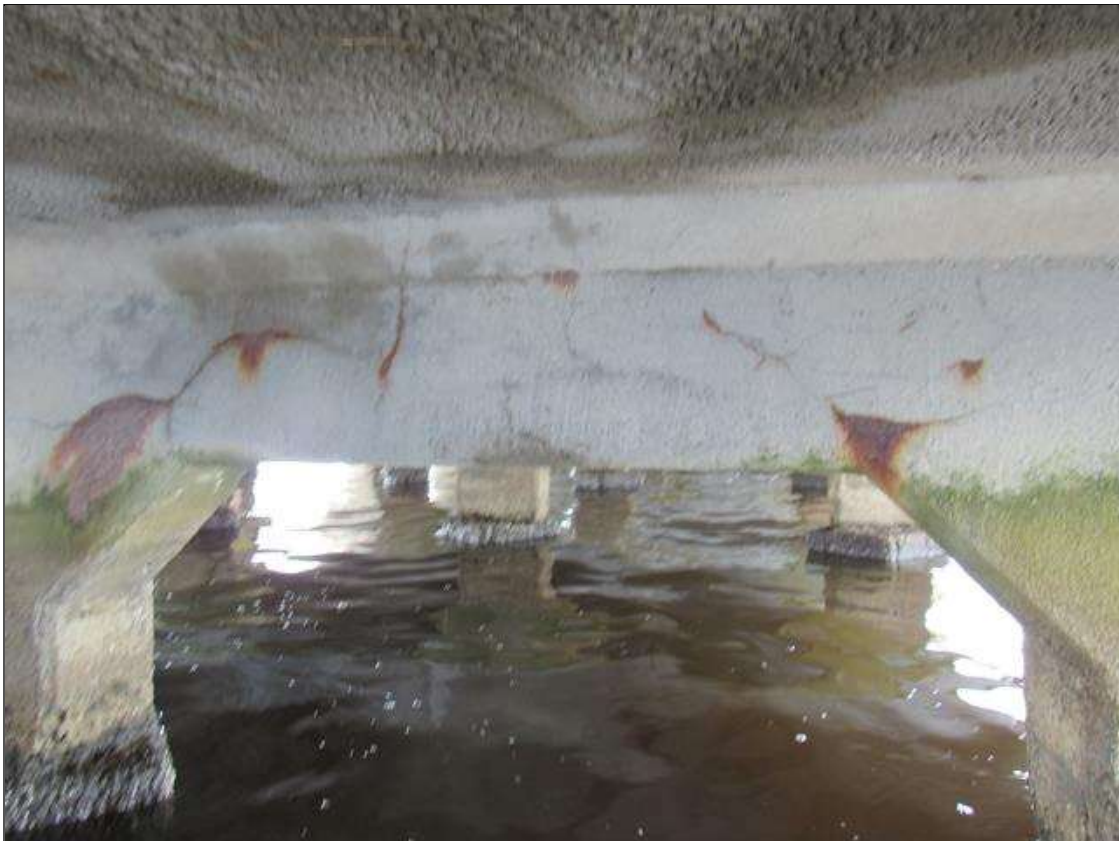
Bent 285 Cap 1: (PAR) 9' OF UP TO 1/16" TRANSVERSE AND LONGITUDINAL CRACKS WITH RUST STAINING, AT RANDOM THROUGHOUT EAST AND WEST FACES.

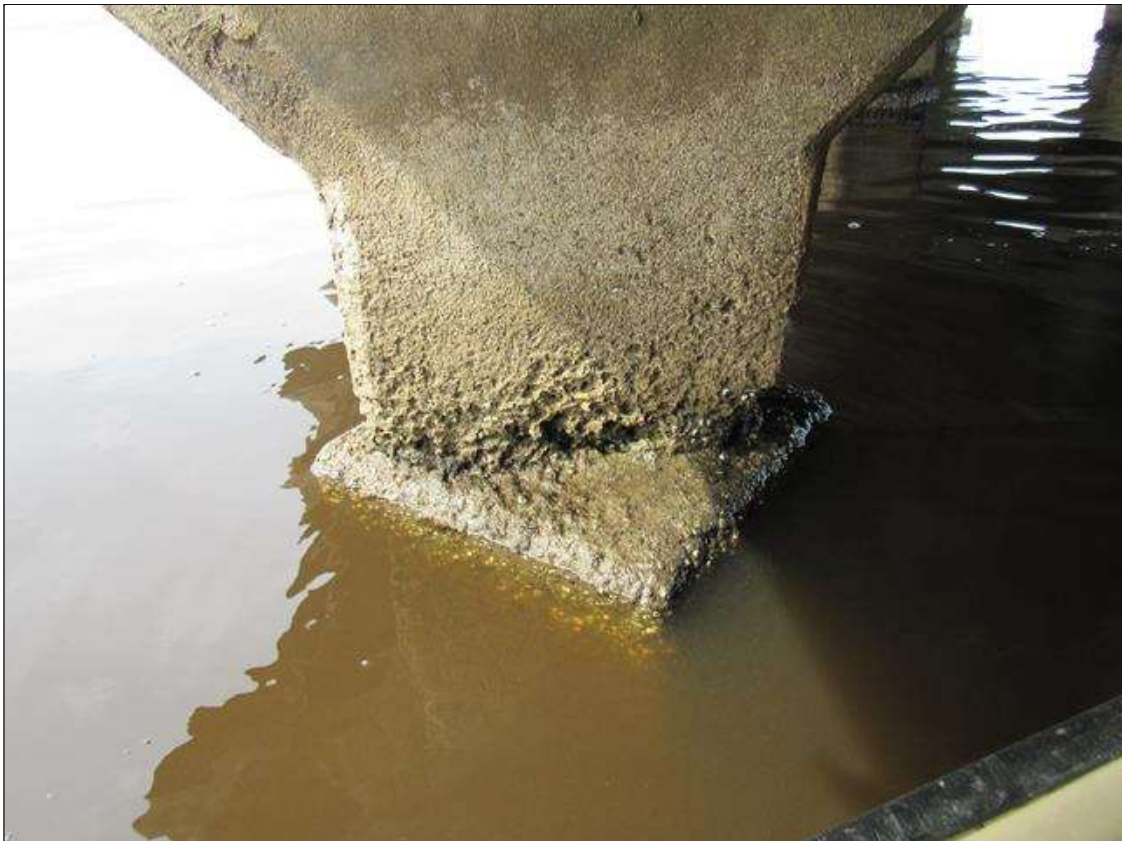
Bent 287 Cap 1: (PAR) 4' OF HAIRLINE TRANSVERSE AND LONGITUDINAL CRACKS, WITH RUST STAINING, AT RANDOM THROUGHOUT EAST FACE.

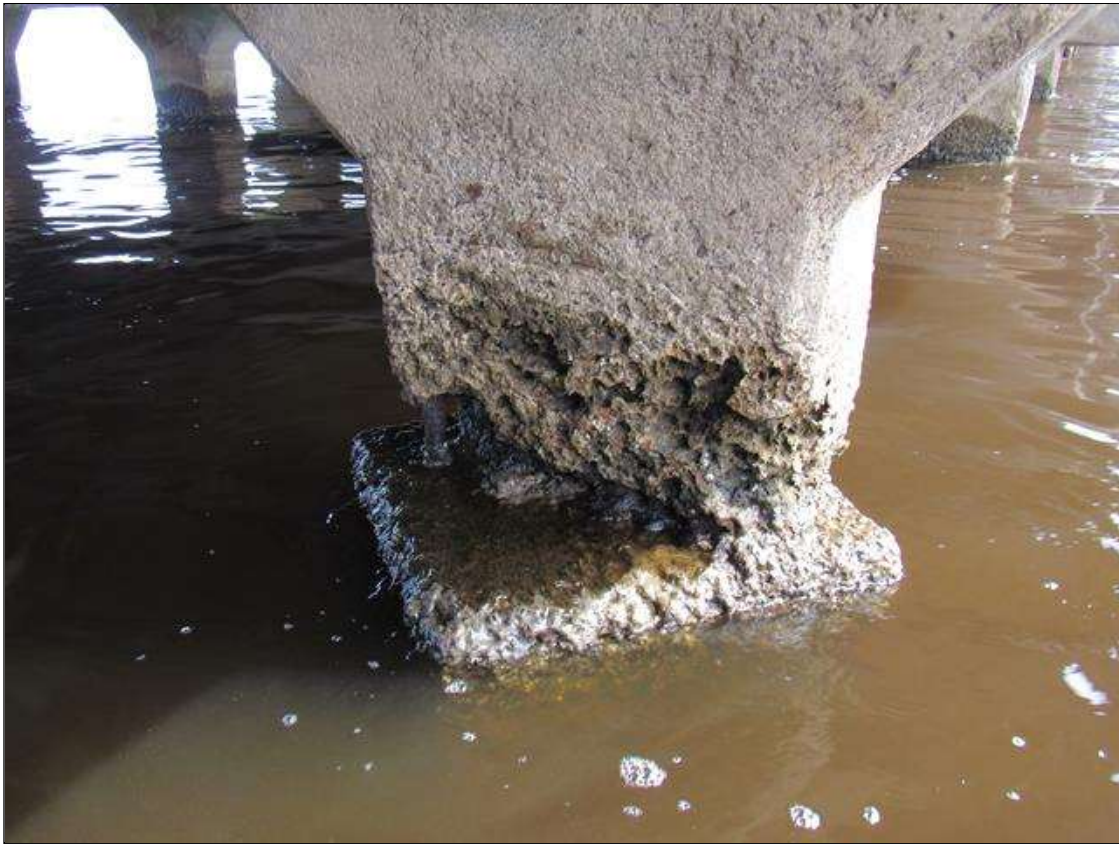
Bent 287 Pile 4: (PAR) 6" X 12" X 20" SPALL, WITH EXPOSED PRIMARY REBAR, NORTH FACE, 2' FROM BOTTOM OF CAP.

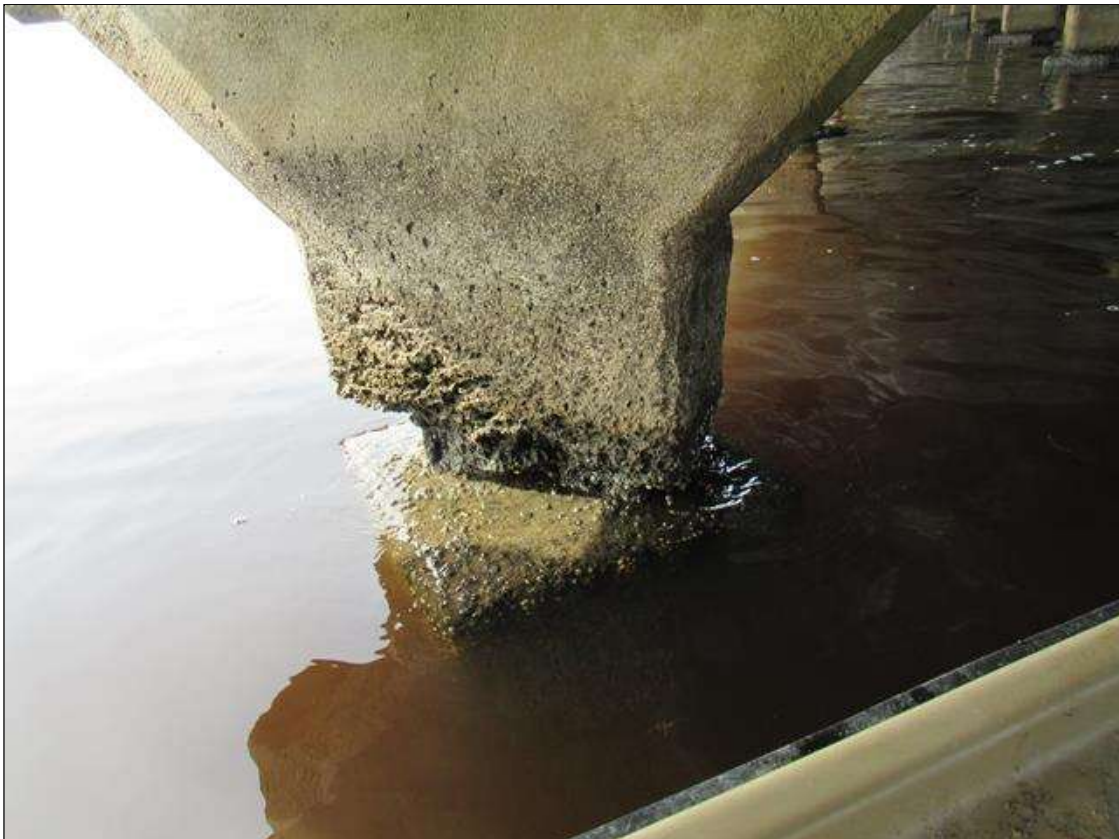
Bent 287 Pile 4: (PAR) 6" DEEP X 8" HIGH X FULL WIDTH SPALL WITH EXPOSED REBAR WITH 25% SECTION LOSS AROUND BASE OF COLUMN AND TOP OF FOOTING

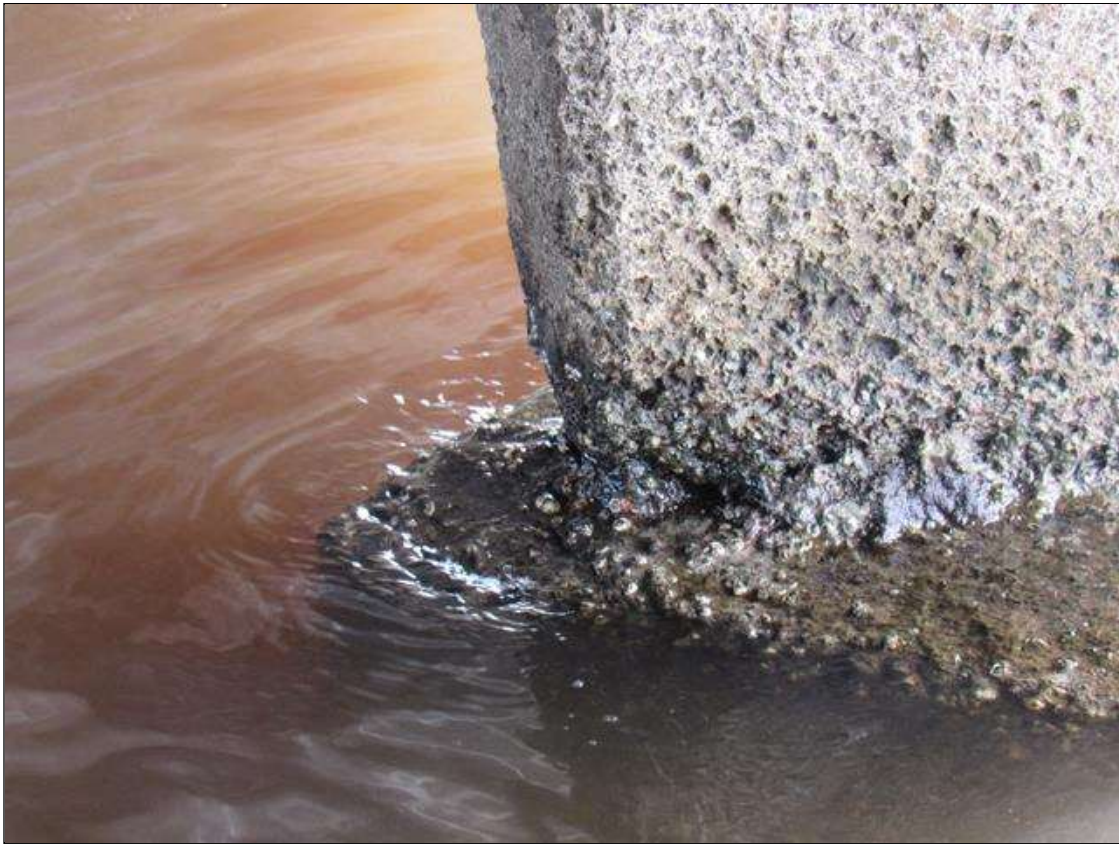
Bent 288 Pile 4: (PAR) 12" X 20" X 10" SPALL, WITH EXPOSED REBAR, EAST FACE, 2' FROM BOTTOM OF CAP.

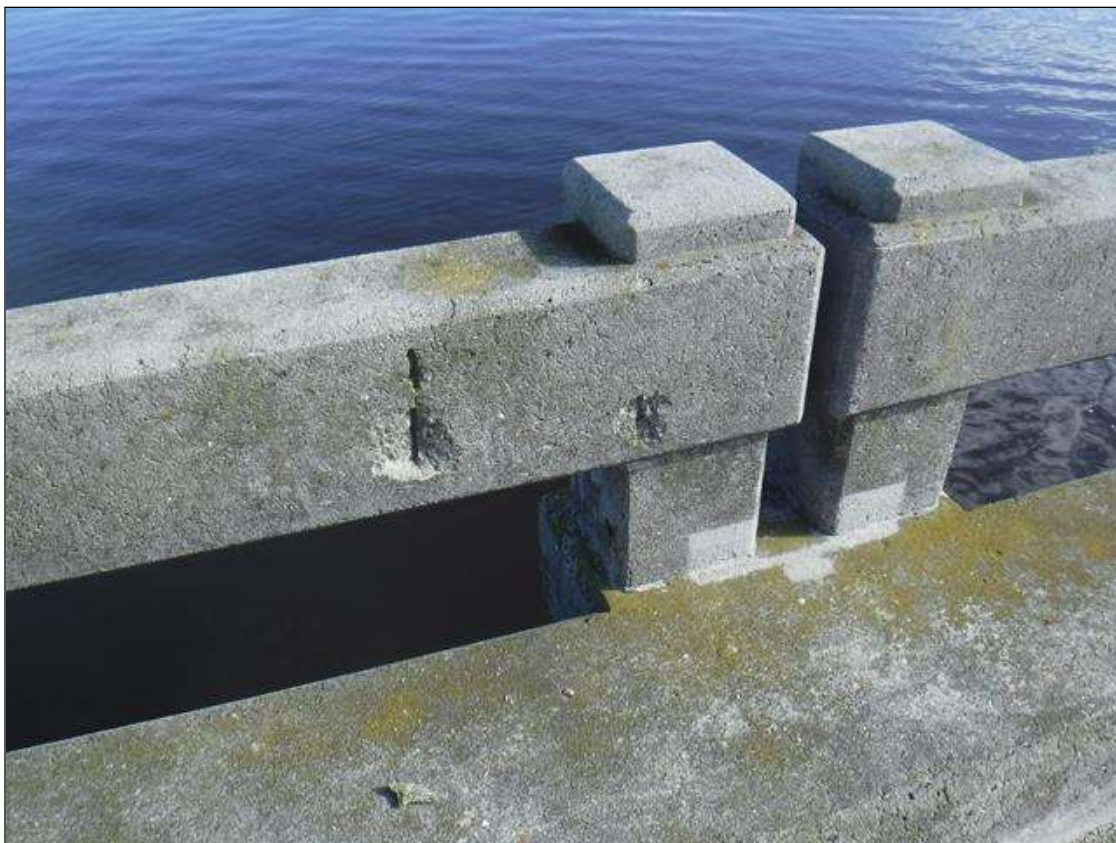
25' OF DAMAGE TO FAR LEFT GUARDRAIL BEGINNING AT END BENT 2

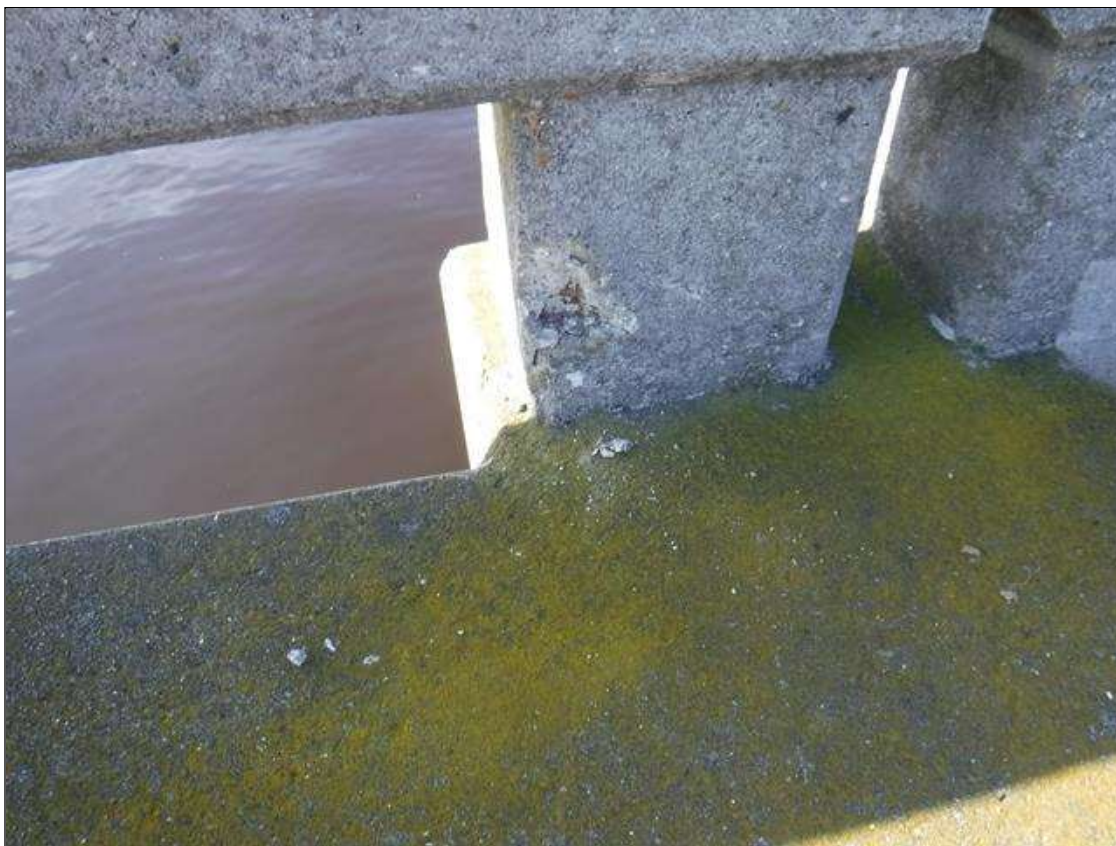
Span 264 Left Bridge Rail: (2) UP 4" X 8" X 3/4" SPALLS WITH EXPOSED REBAR ON RIGHT FACE LOCATED 1' BEFORE POST 3

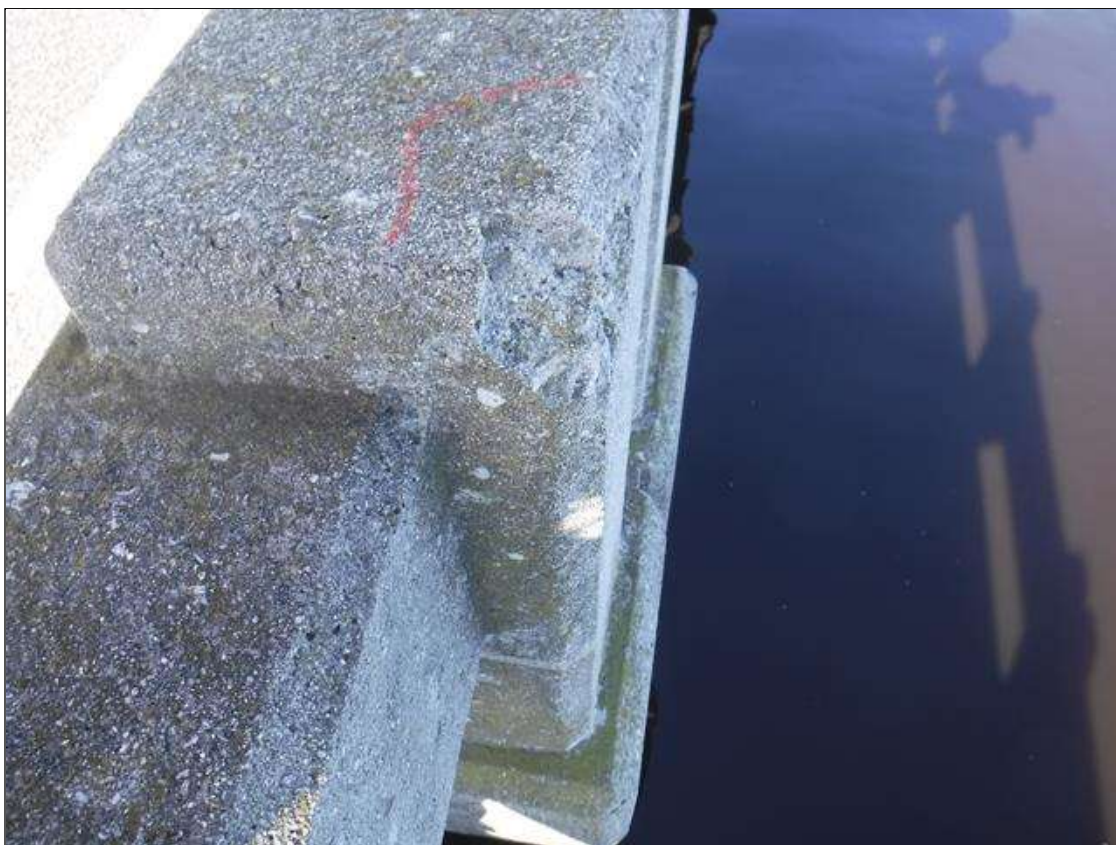
Span 265 Right Bridge Rail: 8" X 3" X 3" SPALL WITH EXPOSED REBAR AT BOTTOM LEFT CORNER LOCATED ON POST 4

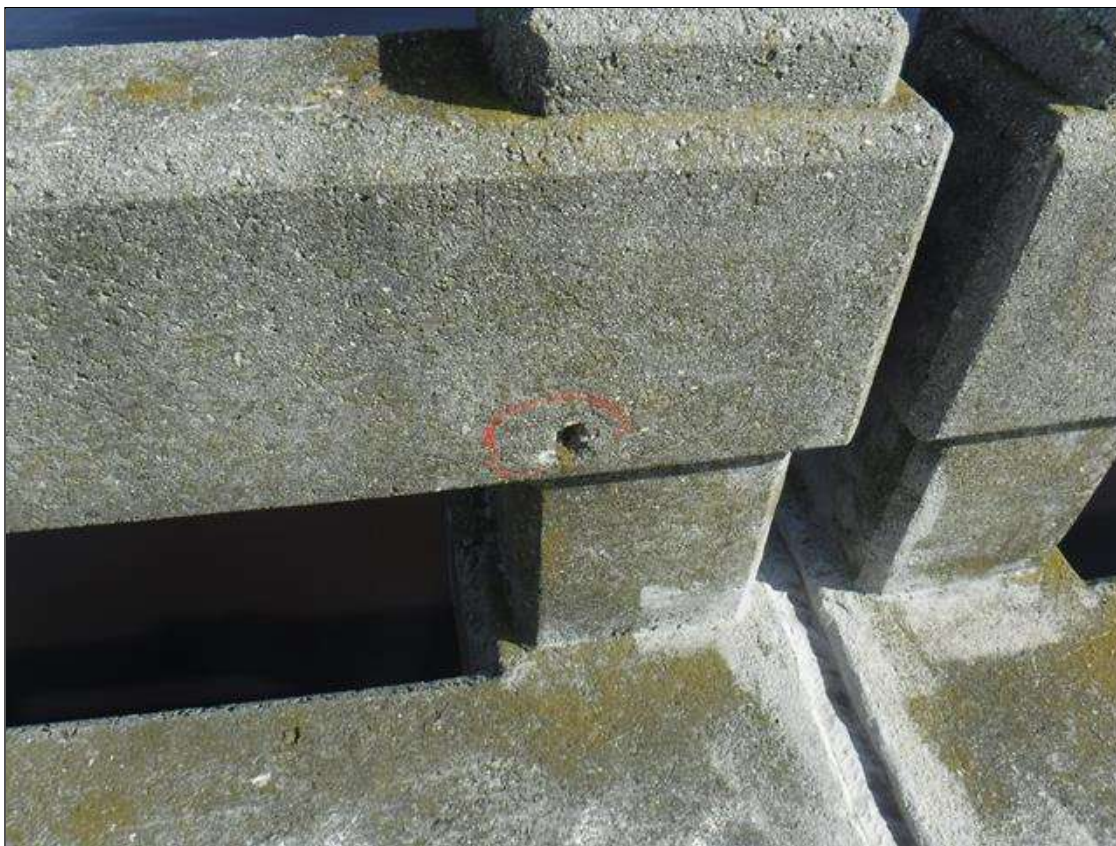
Span 268 Left Bridge Rail: 4" X 3" X 4" SPALL ON LEFT FACE ON POST 7

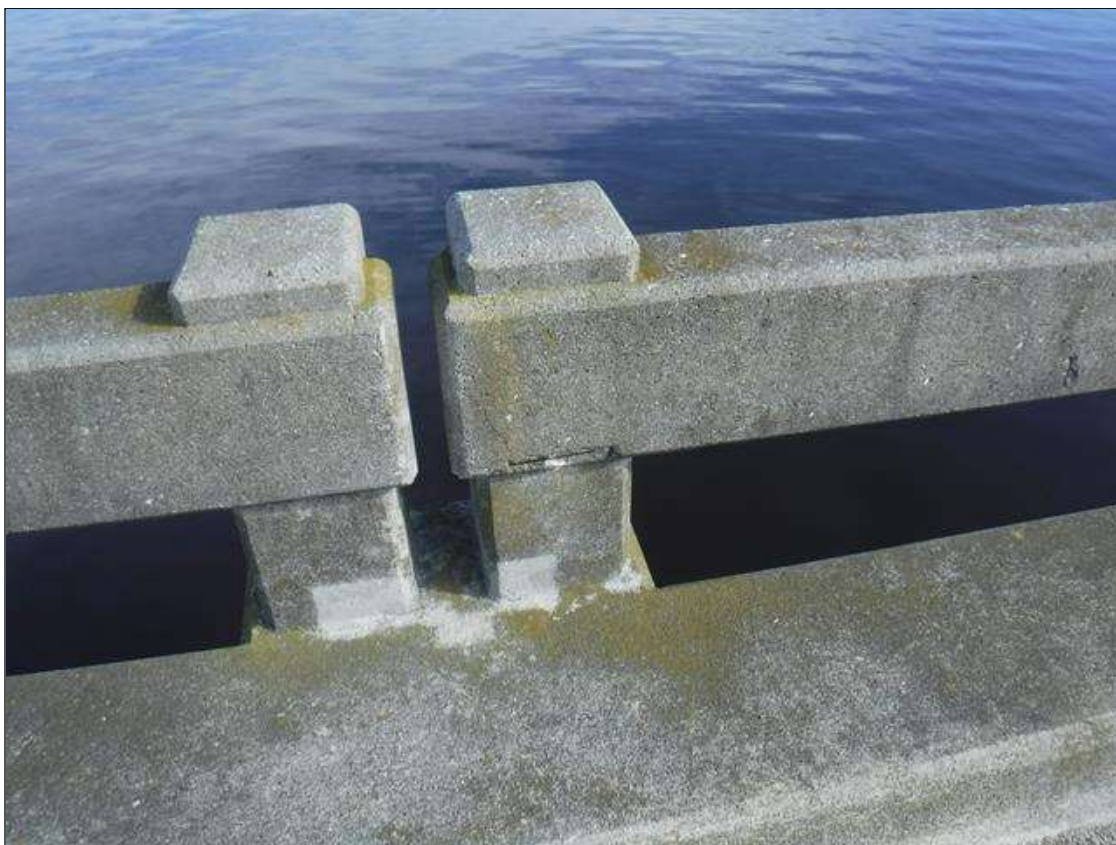
Span 268 Left Bridge Rail: 2" DIAMETER X 1/2" DEEP SPALL WITH EXPOSED REBAR ON RIGHT FACE ON POST
9

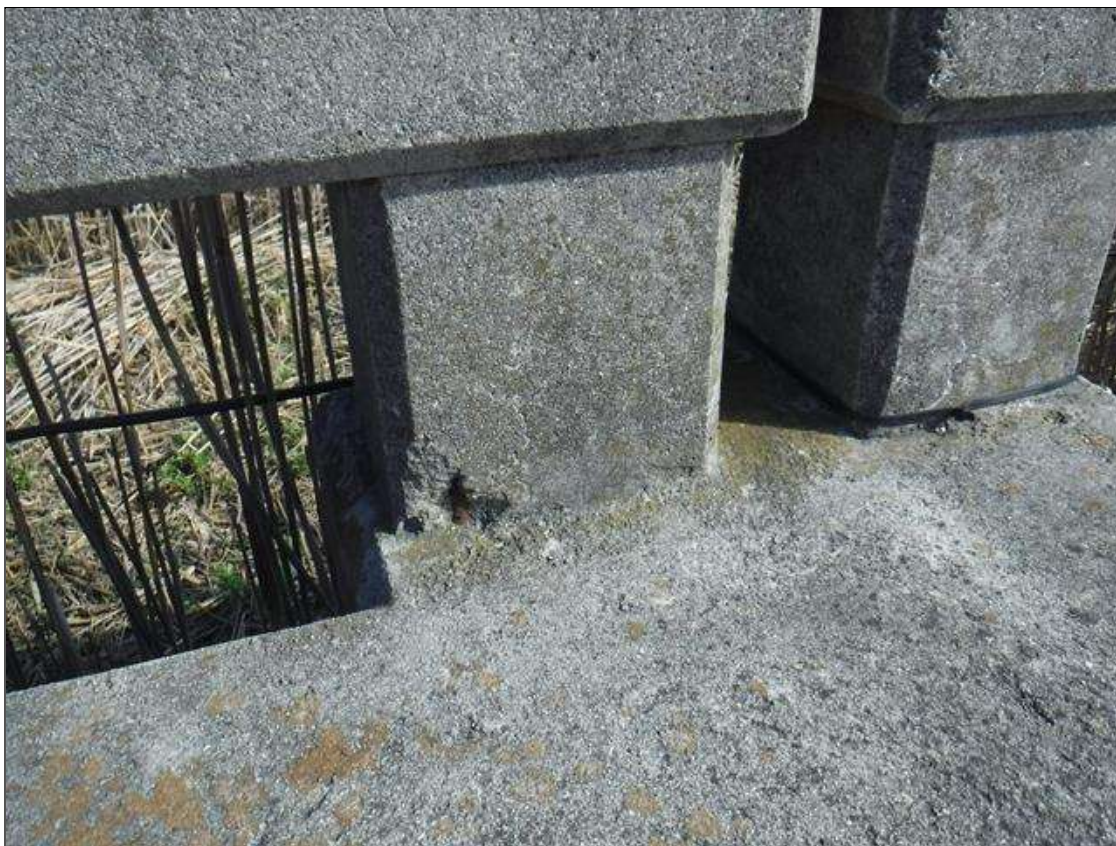
Span 269 Left Bridge Rail: 7" X 2" X 1" DEEP SPALL WITH EXPOSED REBAR ON RIGHT FACE ON POST 7
