NC DEPARTMENT OF TRANSPORTATION
DIVISION OF HIGHWAYS
STRUCTURE MANAGEMENT UNIT

Structure Safety Report

Routine Element Inspection - Contract

FEATURE INTERSECTED: ALLIGATOR RIVER

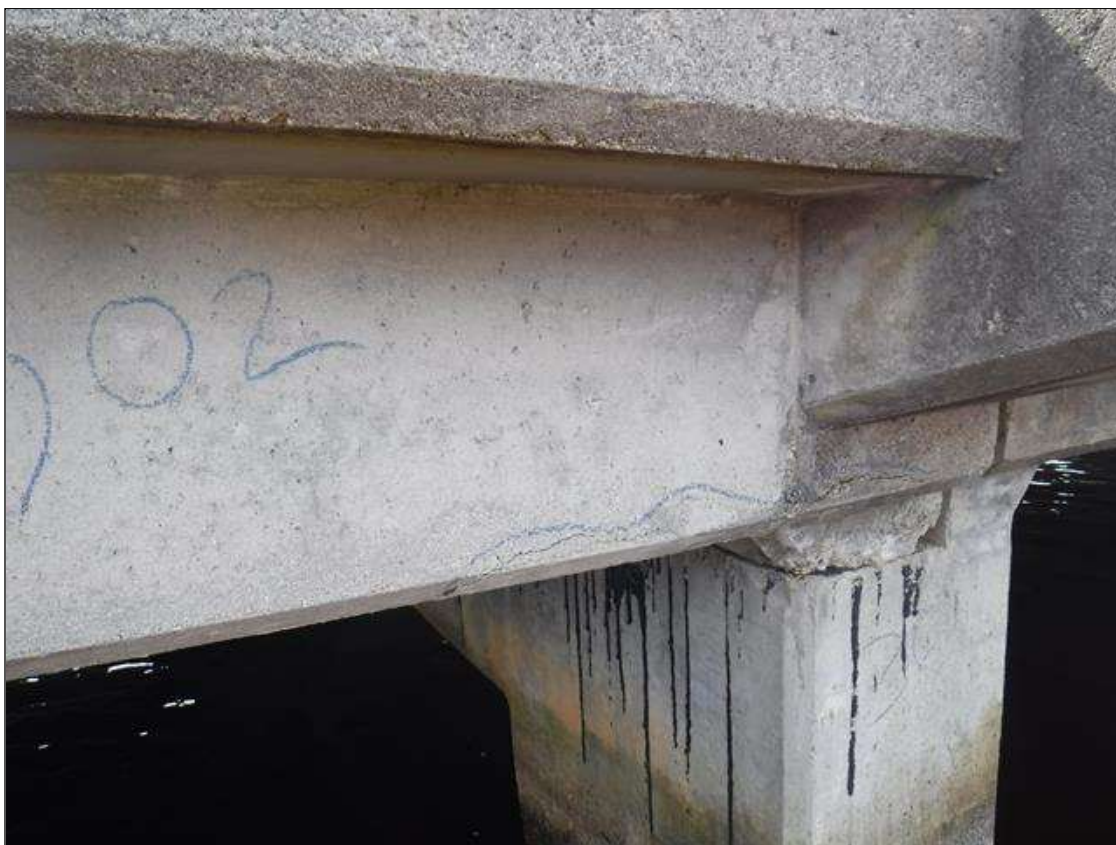
Span 312 Left Bridge Rail: 2" X 2" X 1" DEEP SPALL WITH EXPOSED REBAR AT BOTTOM RIGHT CORNER AT MID SPAN POST

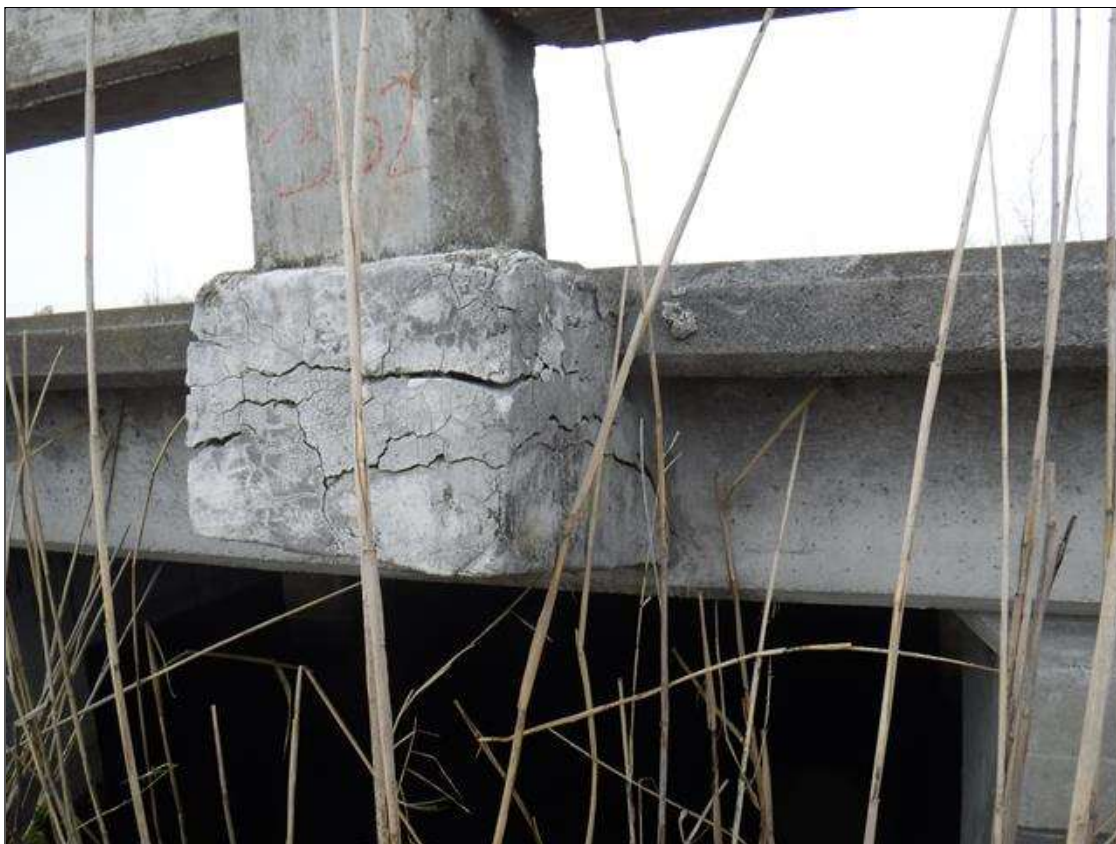
Span 302 Left Bridge Rail: 2' X UP TO 1/16" WIDE LONGTINUAL CRACK AT BOTTOM LEFT CORNER AT BENT 301

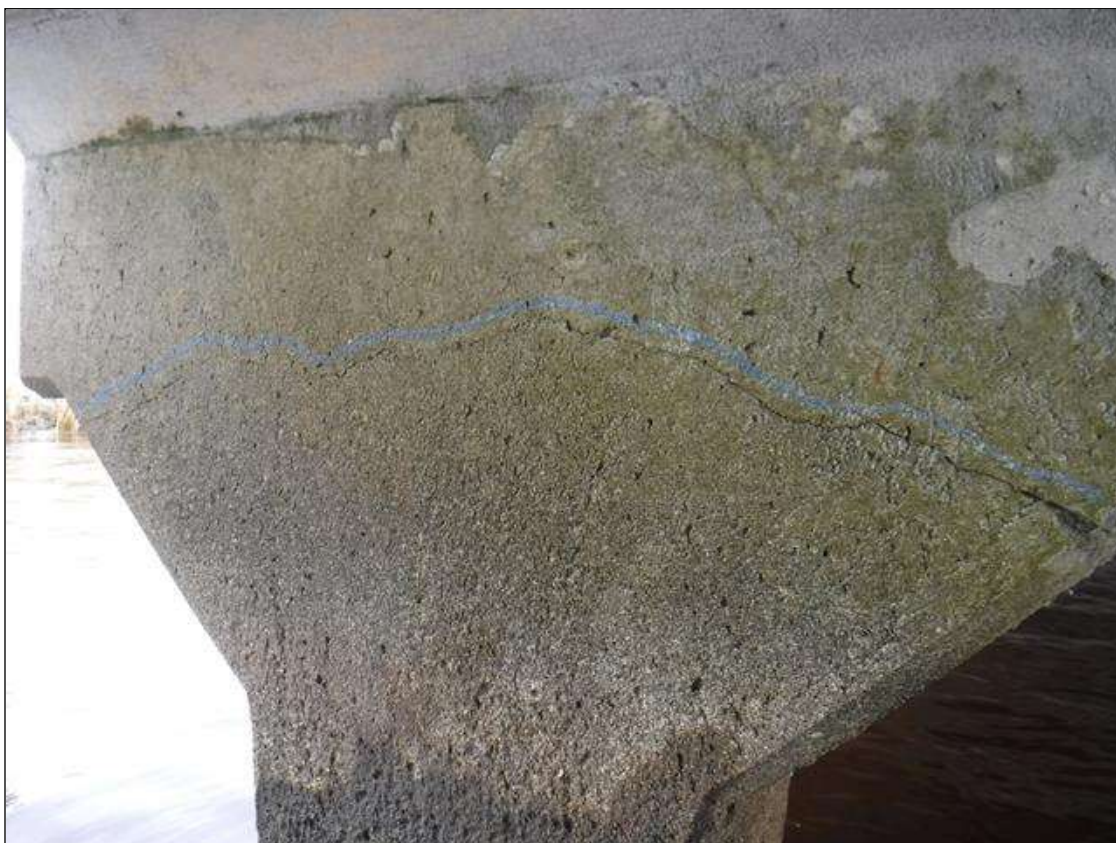
Span 332 Right Bridge Rail: (PAR) 14" X 11" X 23" DELAMINATION AT BOTTOM RIGHT CORNER ON OUTSIDE EDGE OF POST AT MID SPAN

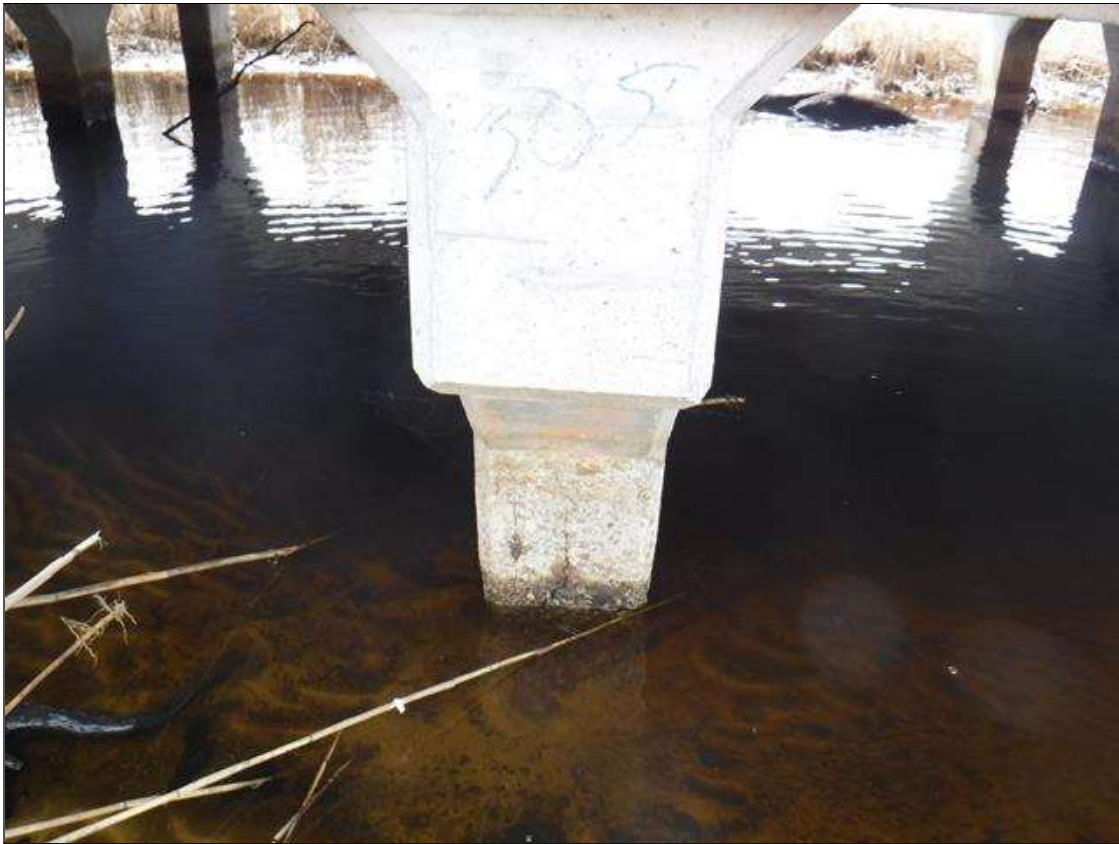
Bent 296 Cap 1: 3' X UP TO 1/16" WIDE LONGITUDINAL CRACK ON WEST FACE LOCATED ABOVE PILE 1

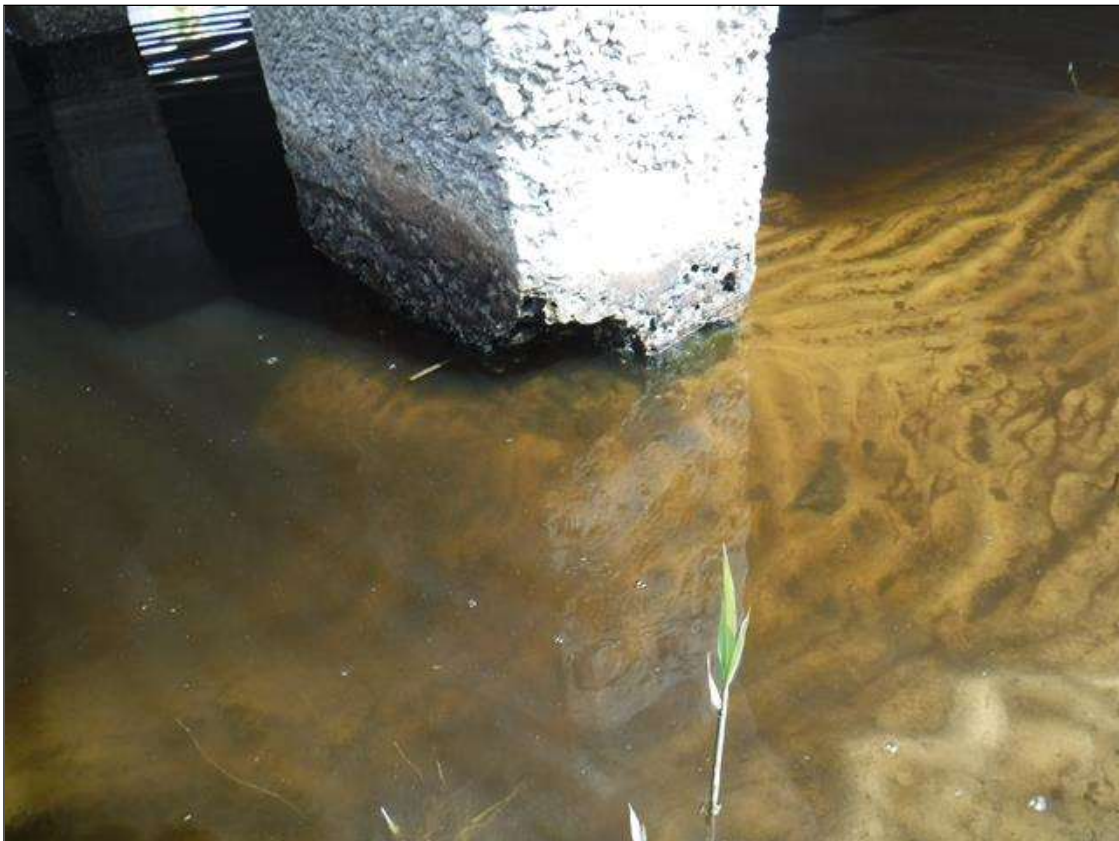
Bent 305 Pile 1: (2) 2' X UP TO 1/16" WIDE VERTICAL CRACKS ON SOUTH FACE LOCATED ON PILE 1

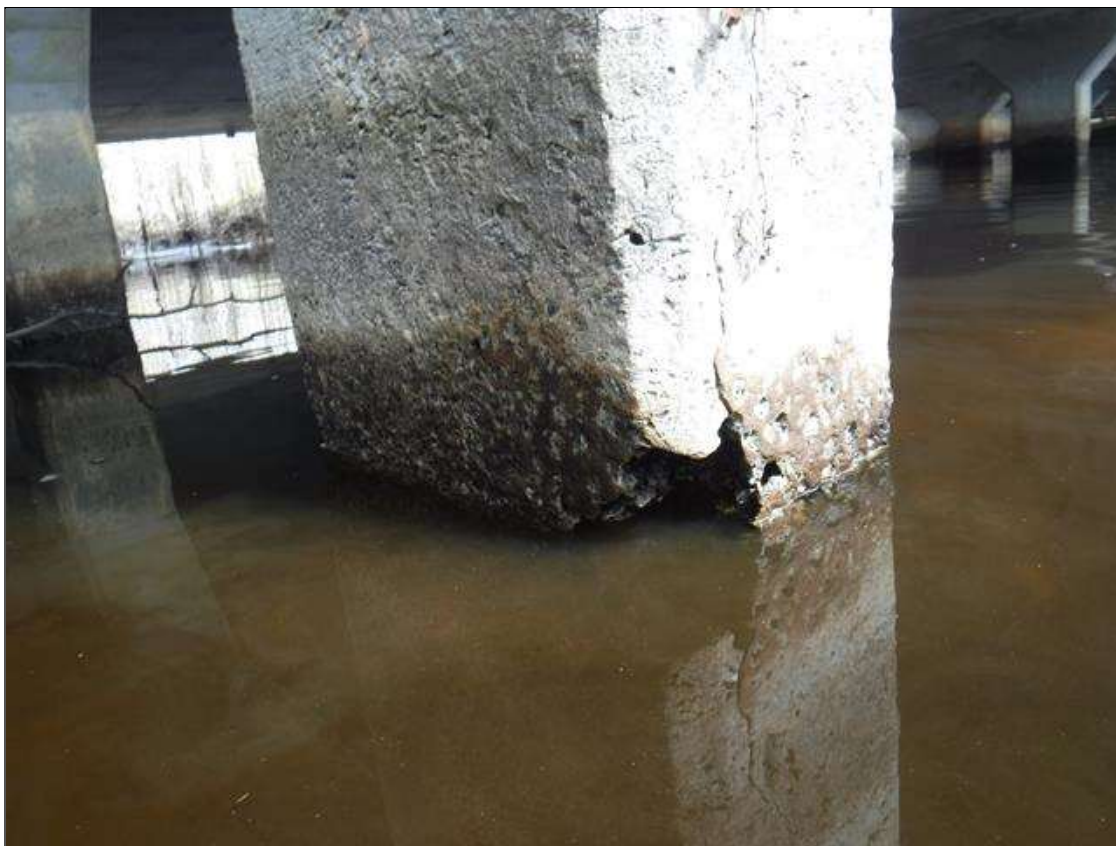
Bent 306 Pile 4: 8" X 8" X 8" SPALL AT BOTTOM SOUTH CORNER

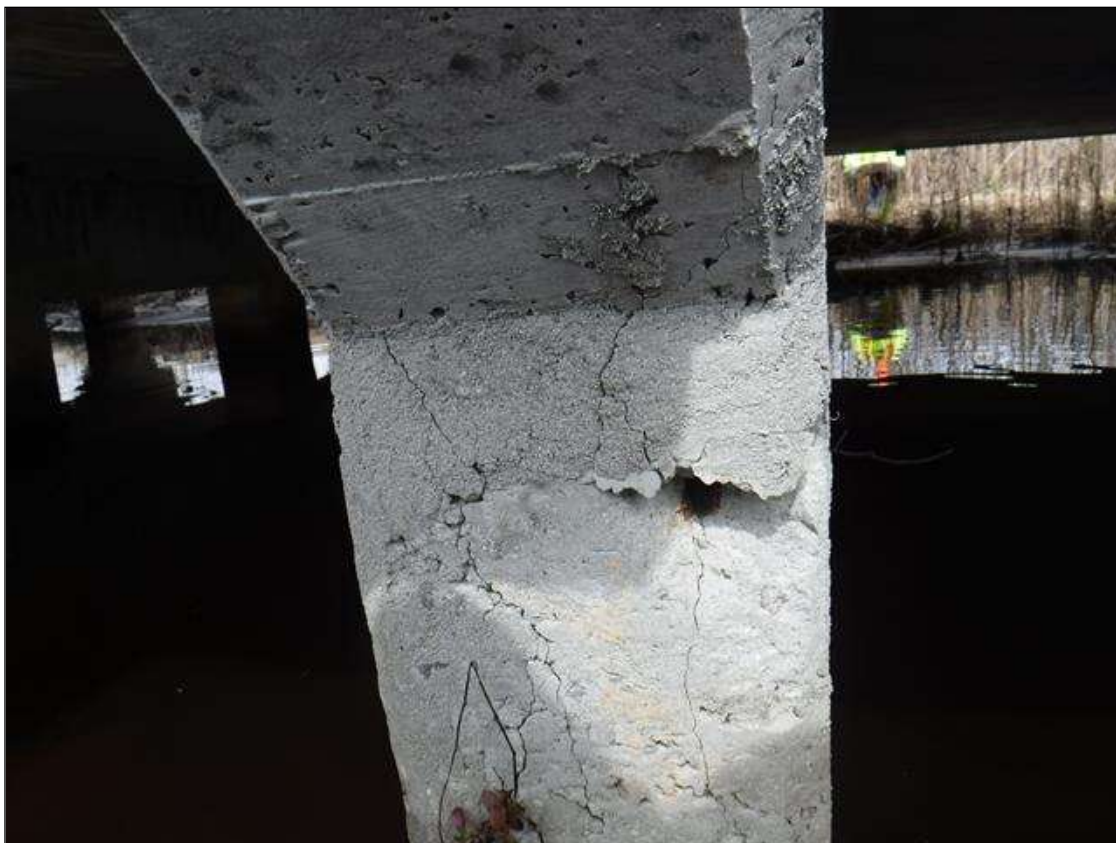
Bent 308 Pile 4: 12" X 8" X 8" SPALL AT BOTTOM EAST CORNER

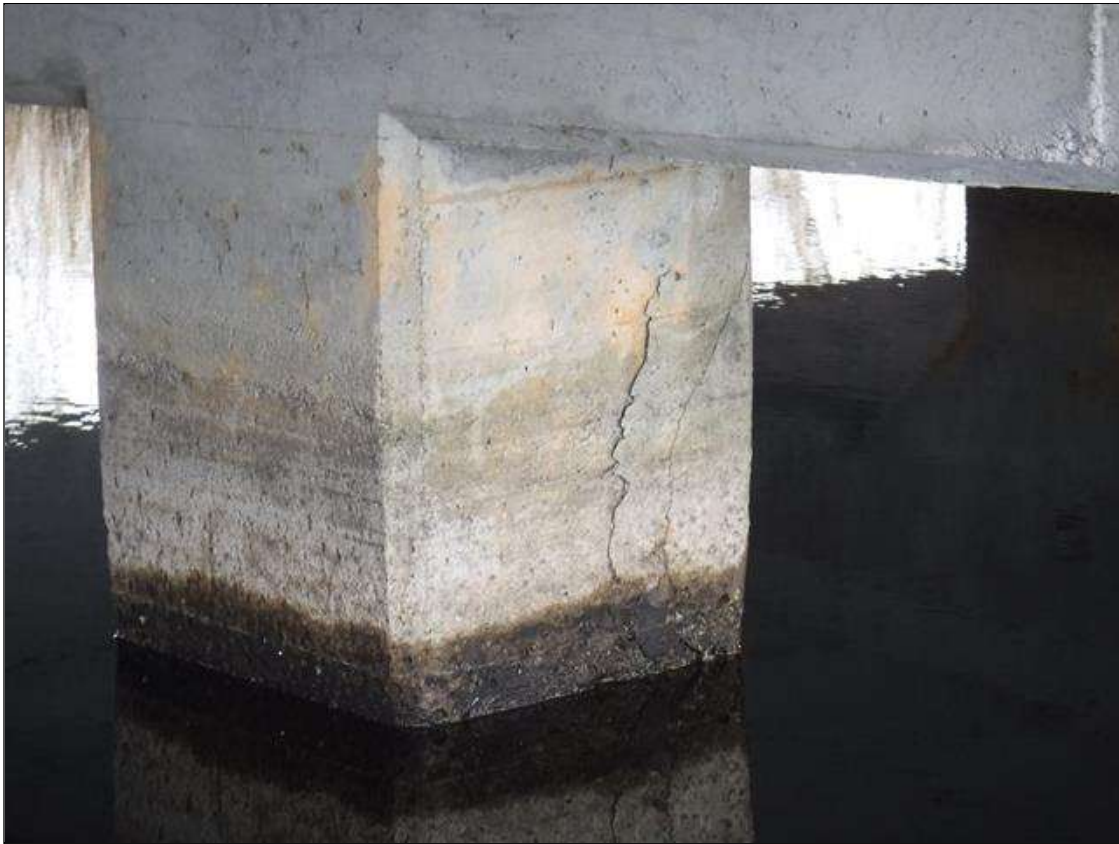
Bent 308 Pile 4: 5" X 8" X 4" FAILED PATCH AT BOTTOM SOUTH CORNER

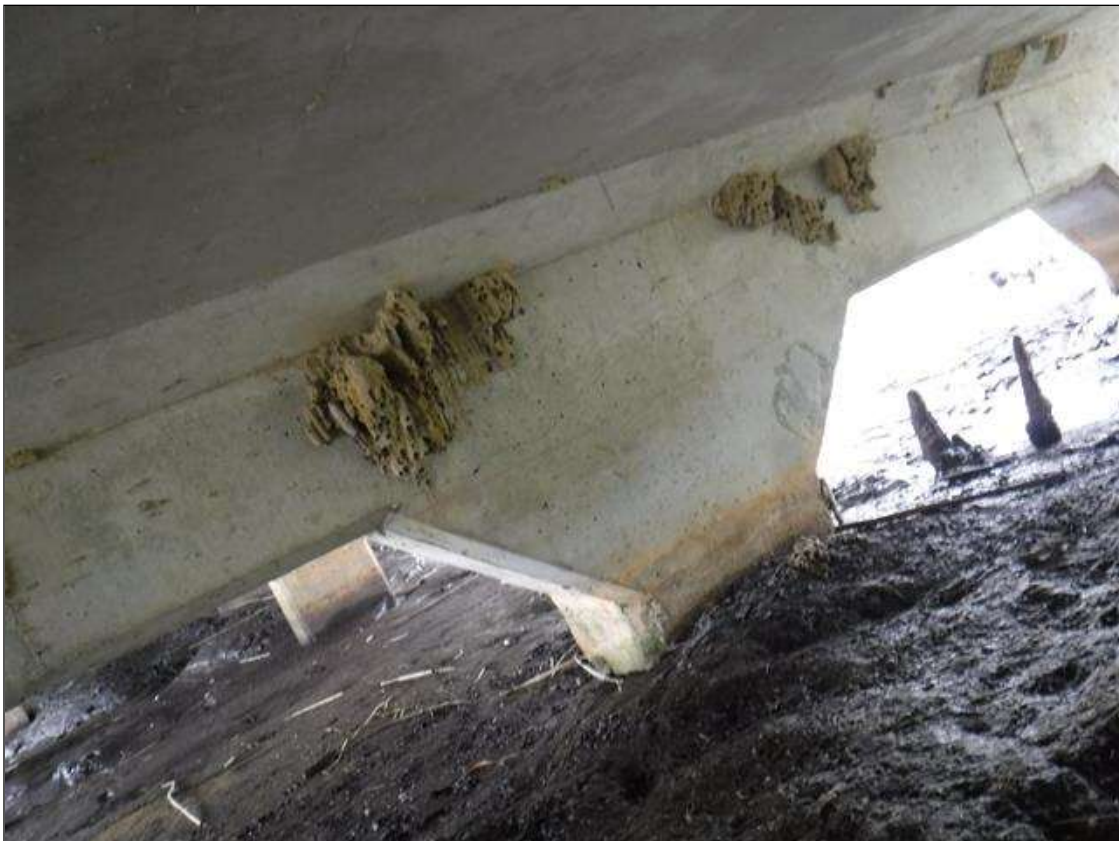
Bent 337 Pile 3: 24" X 12" X 10" DELAMINATION AT BOTTOM SOUTH CORNER

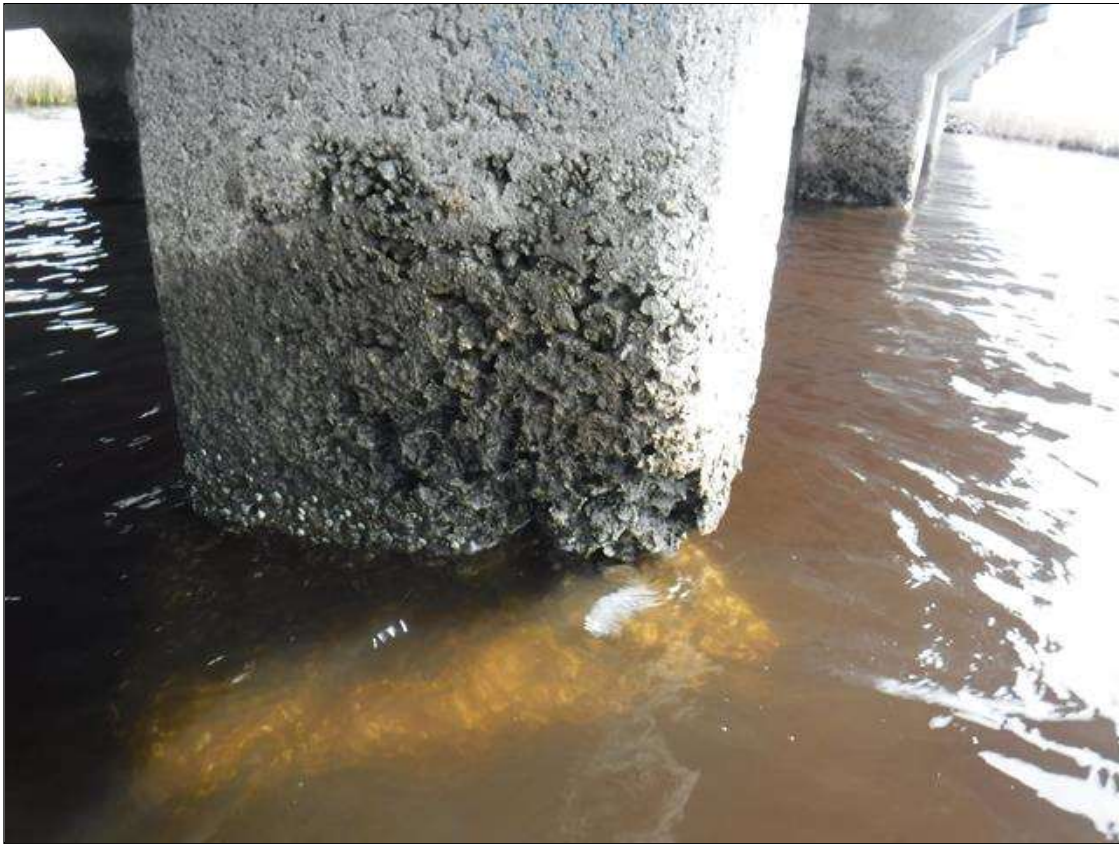
Bent 296 Pile 3: (PAR) 8" X 5" X 5" SPALL, WITH EXPOSED PRIMARY REINFORCING, NORTHWEST CORNER, 2' FROM BOTTOM OF CAP. REBAR HAS 5% SECTION LOSS

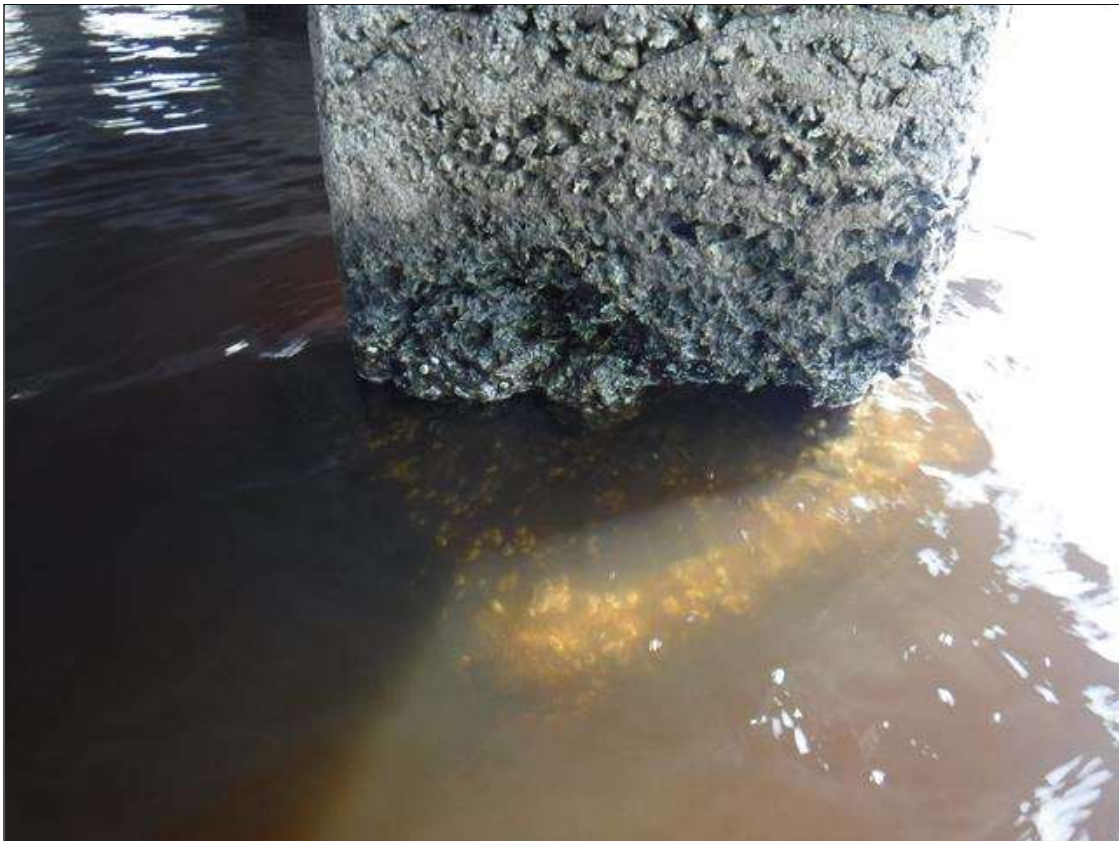
Bent 296 Pile 4: (PAR) 12" X 10" X 10" SPALL, WITH EXPOSED REBAR, SOUTHWEST CORNER, 2' FROM BOTTOM OF CAP. REBAR HAS UP TO COMPLETE SECTION LOSS

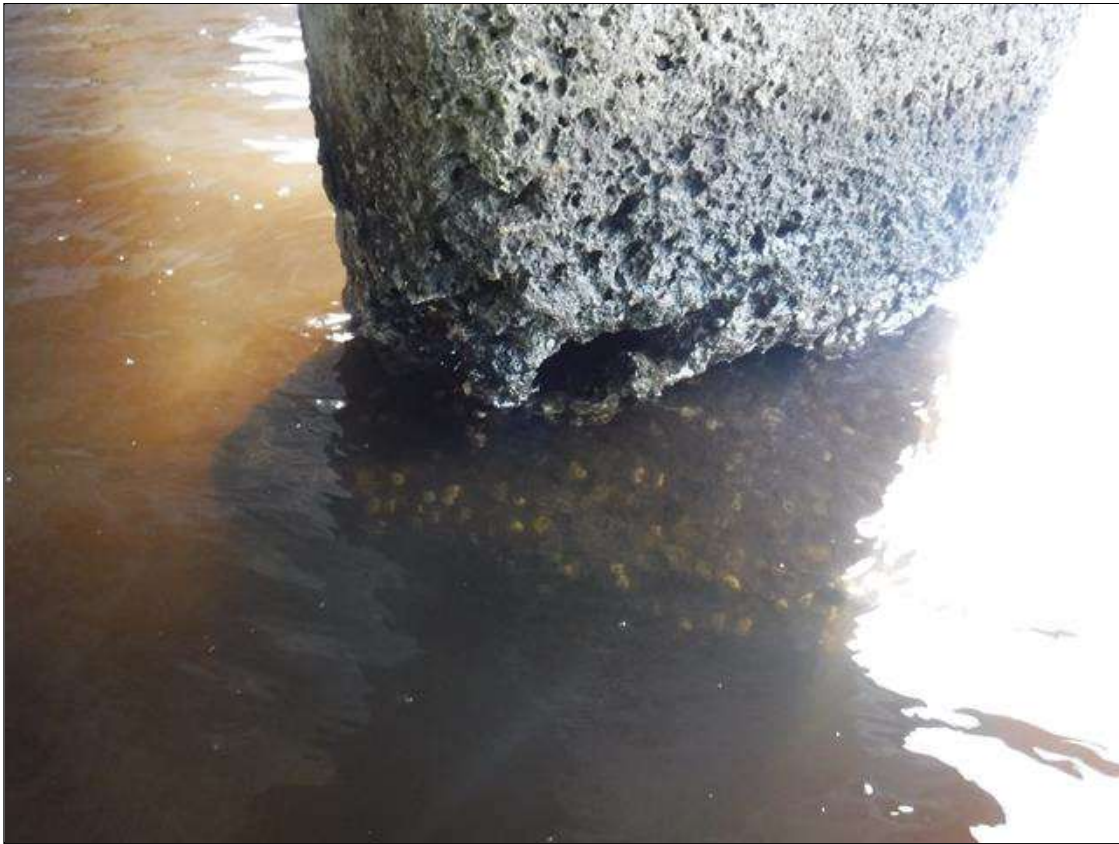
Bent 297 Pile 4: (PAR) 12" X 20" X 6" SPALL, WITH EXPOSED REBAR ON NORTH FACE, 2' FROM BOTTOM OF CAP. REBAR HAS UP TO COMPLETE SECTION LOSS

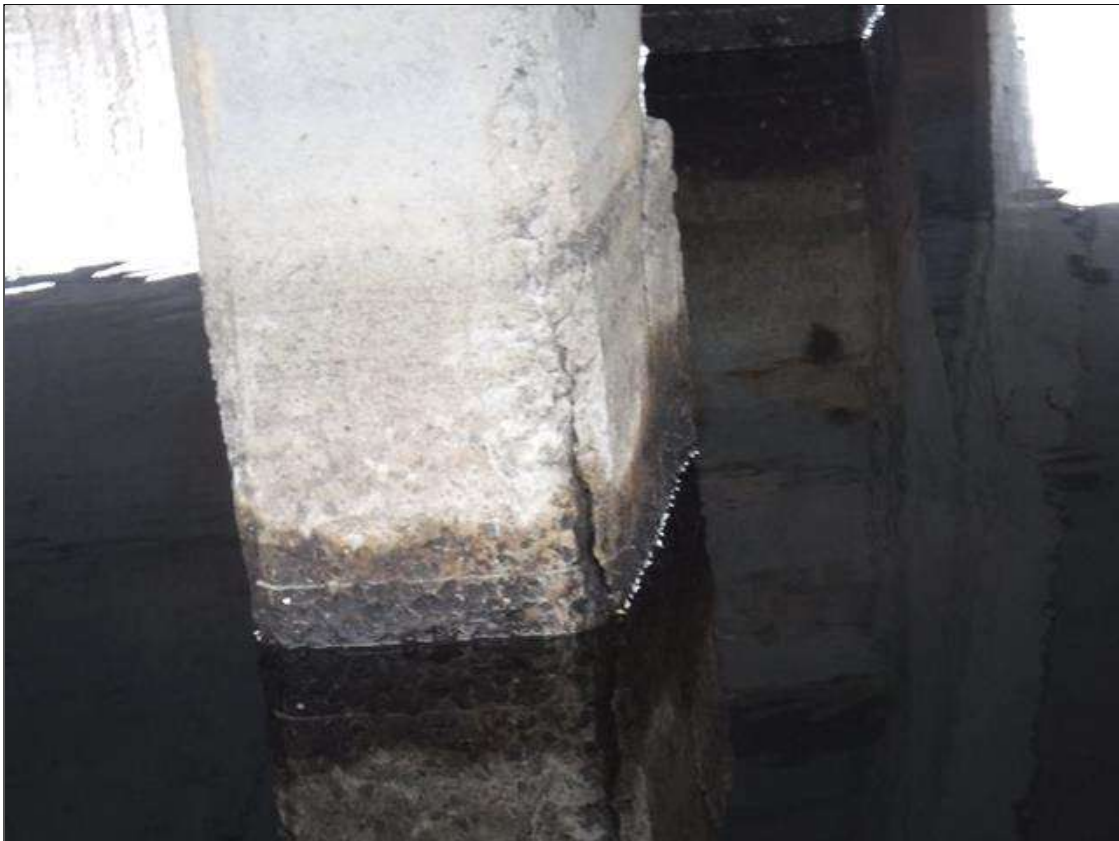
Bent 298 Pile 4: (PAR) 6" DEEP X 8" HIGH X FULL WIDTH SPALL WITH EXPOSED REBAR WITH 25% SECTION LOSS AROUND BASE OF COLUMN AND TOP OF FOOTING

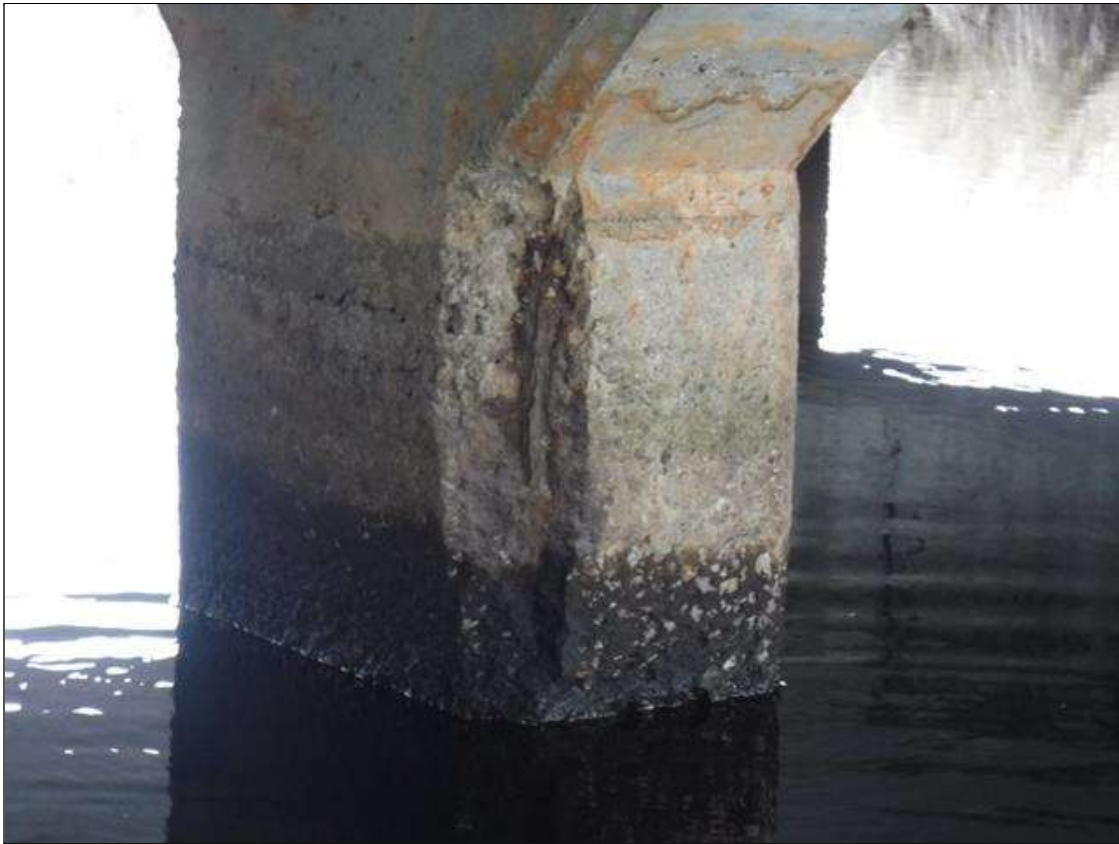
Bent 336 Pile 3: 18" X 4" X 1" SPALL, WITH EXPOSED REINFORCING, NORTHEAST CORNER.

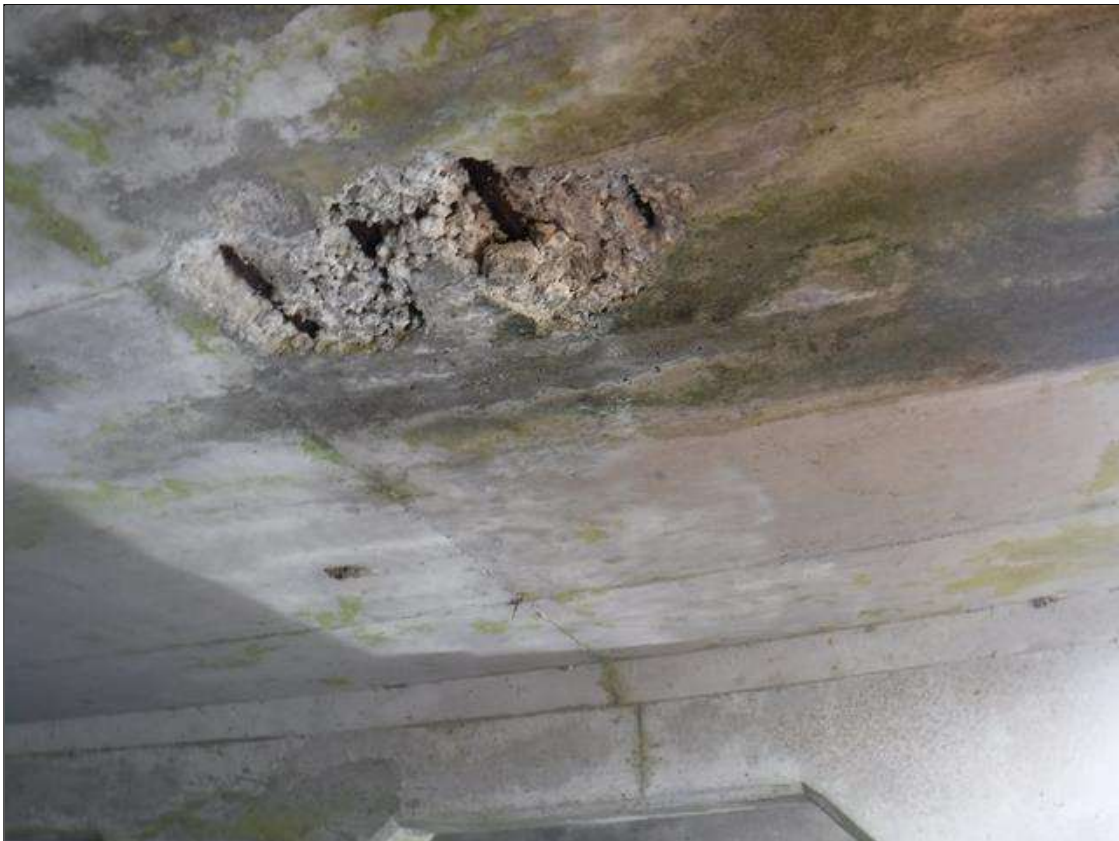
Bent 338 Pile 2: (PAR) 18" X 4" X UP TO 1" DEEP SPALL WITH EXPOSED REBAR, NORTHEAST CORNER. REBAR HAS 25% SECTION LOSS

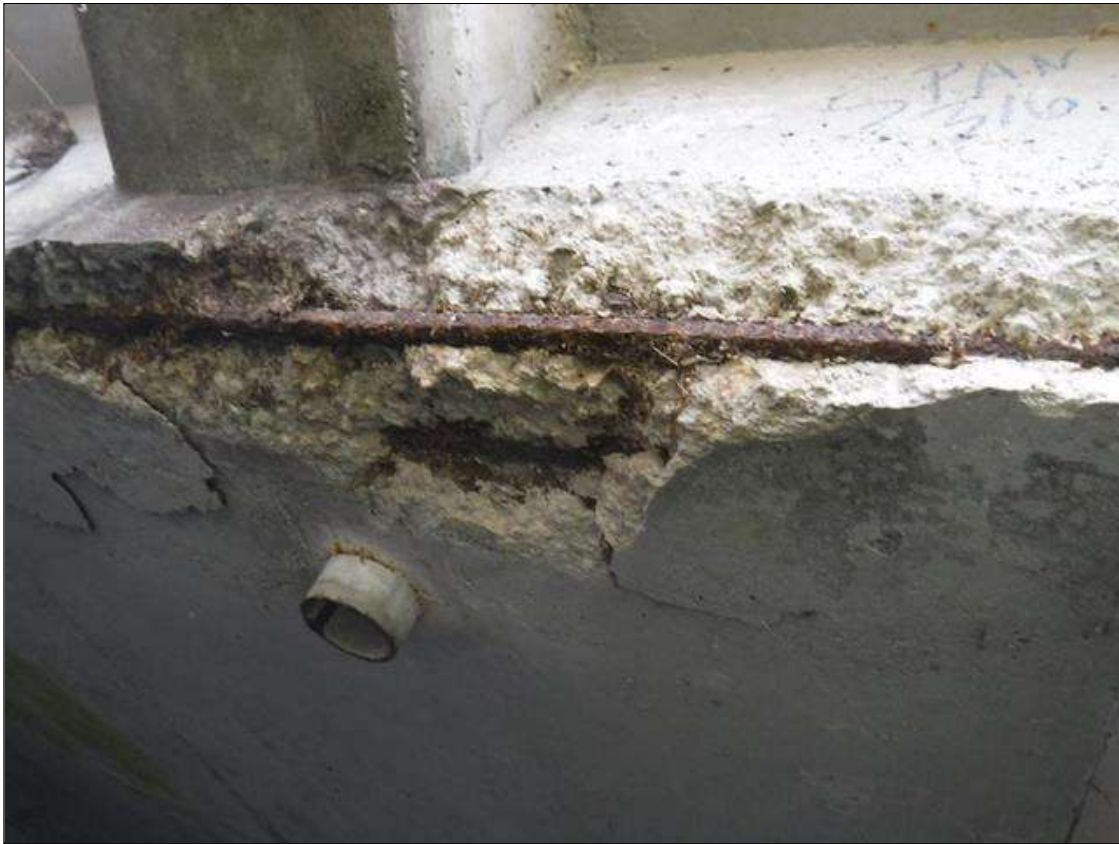
Span 309 Deck: (PAR) 20" X 10" X 1" SPALL WITH EXPOSED REBAR, DECK UNDERSIDE, 4' FROM SOUTH EDGE, NEAR MIDSPAN.

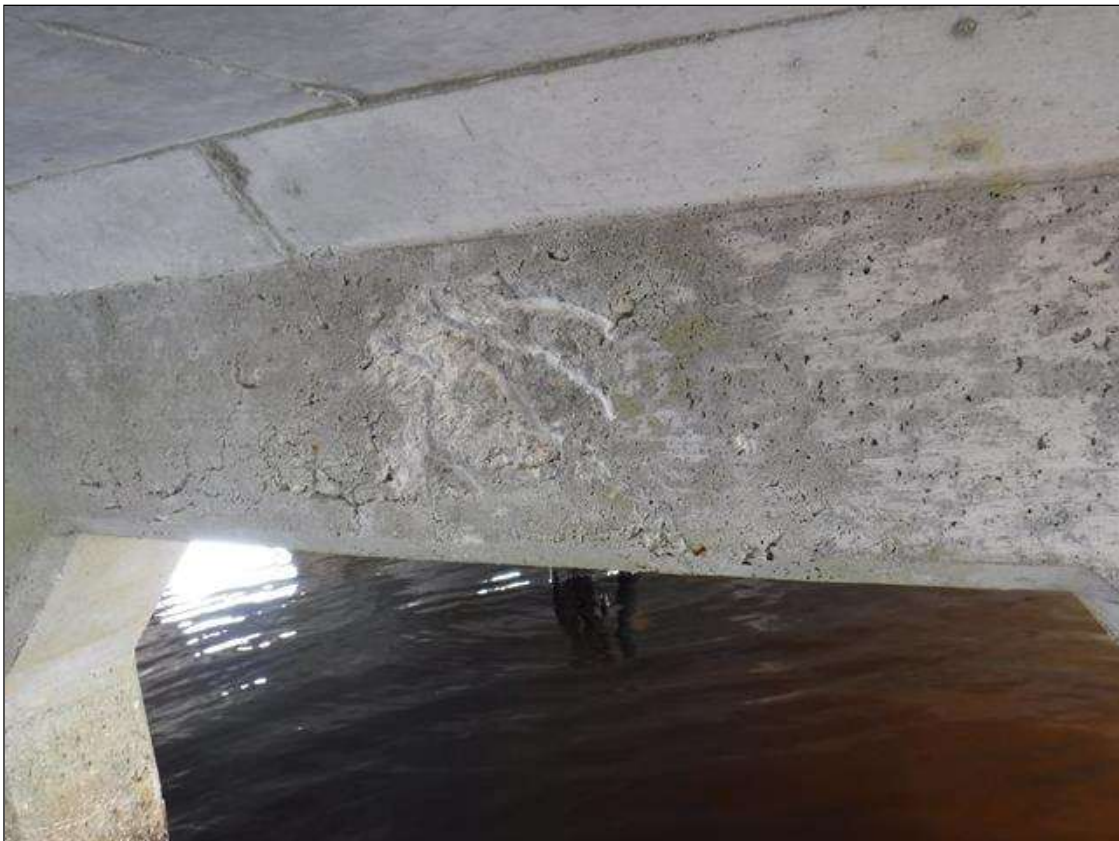
Bent 298 Pile 2: 16" X 2" DELAMINATION, NORTH FACE, AT BOTTOM OF CAP.

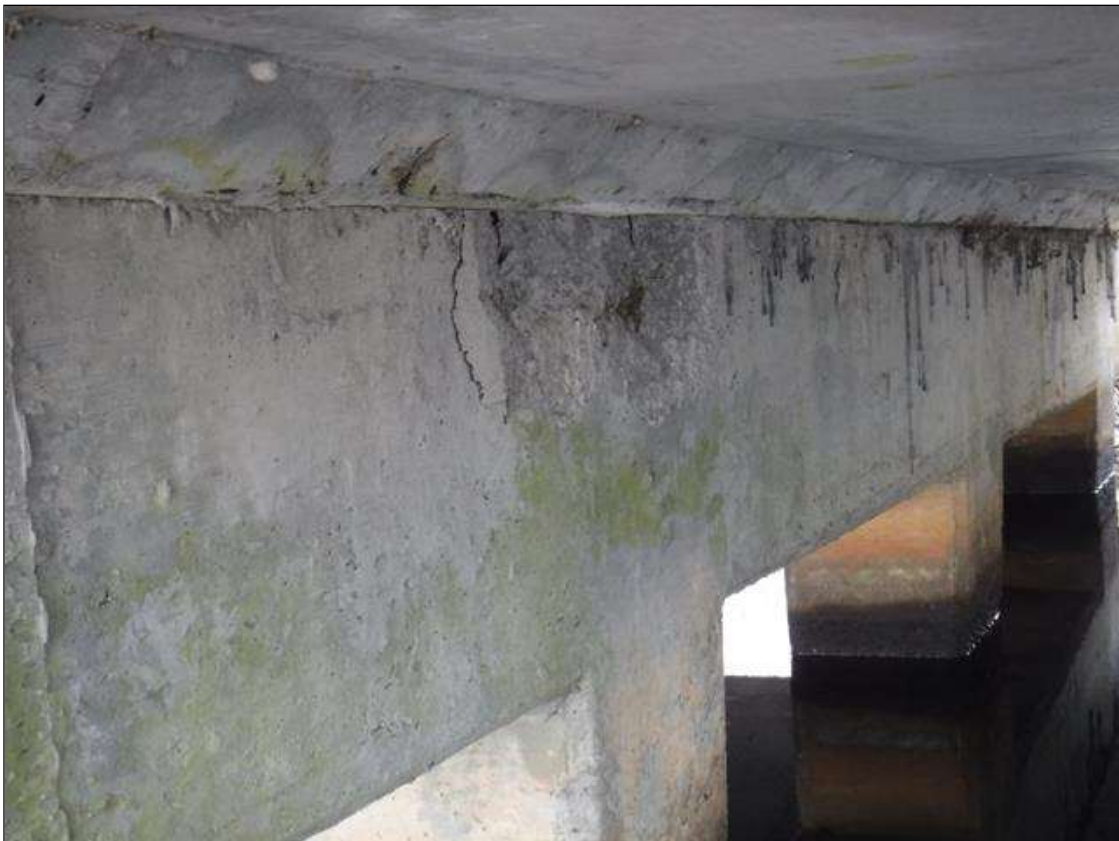
Bent 312 Pile 2: (2) 16" X 6" PATCHED AREAS, SOUTH FACE.

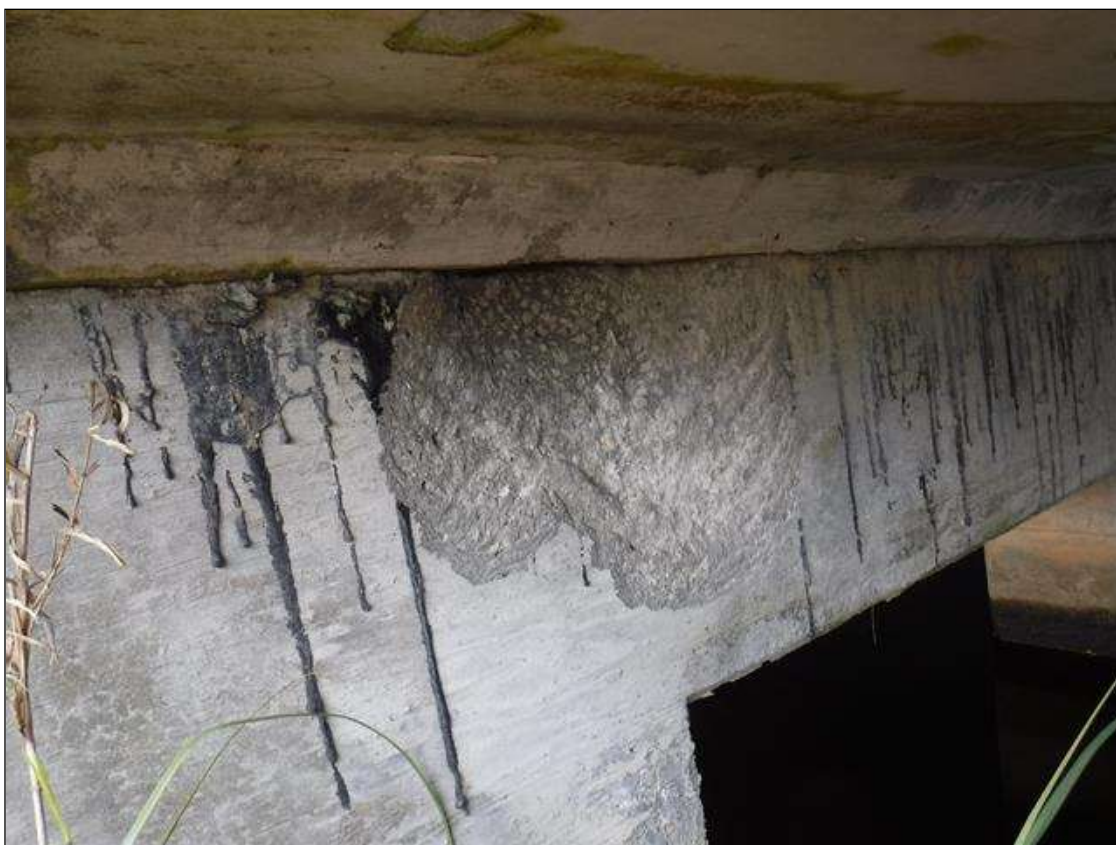
Bent 323 Pile 2: (2) UP TO 18" X 3" DELAMINATIONS, NORTH AND SOUTH FACES, AT BOTTOM OF CAP.

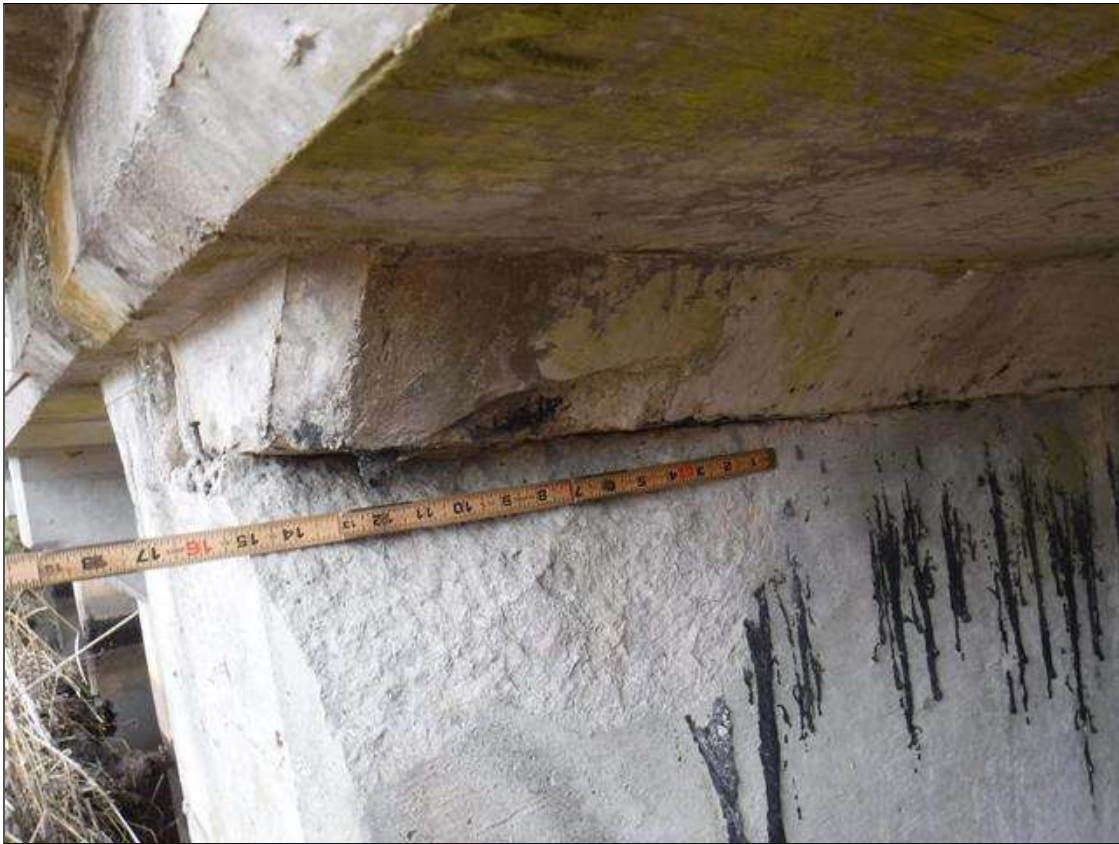
Bent 325 Cap 1: 24" X 24" X 2" SPALL, EAST FACE, ABOVE PILE 4.

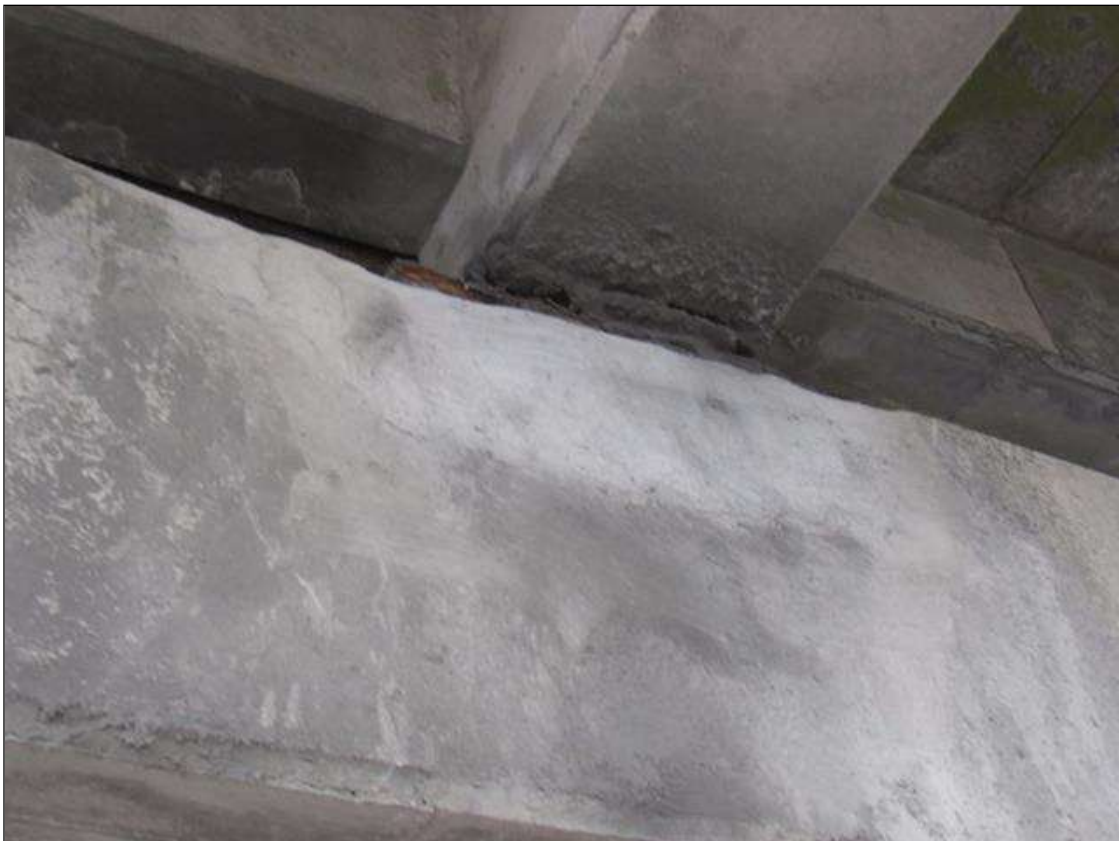
Bent 331 Cap 1: 15" X 7" X 4" SPALL, EAST FACE, SOUTH END OF CAP.

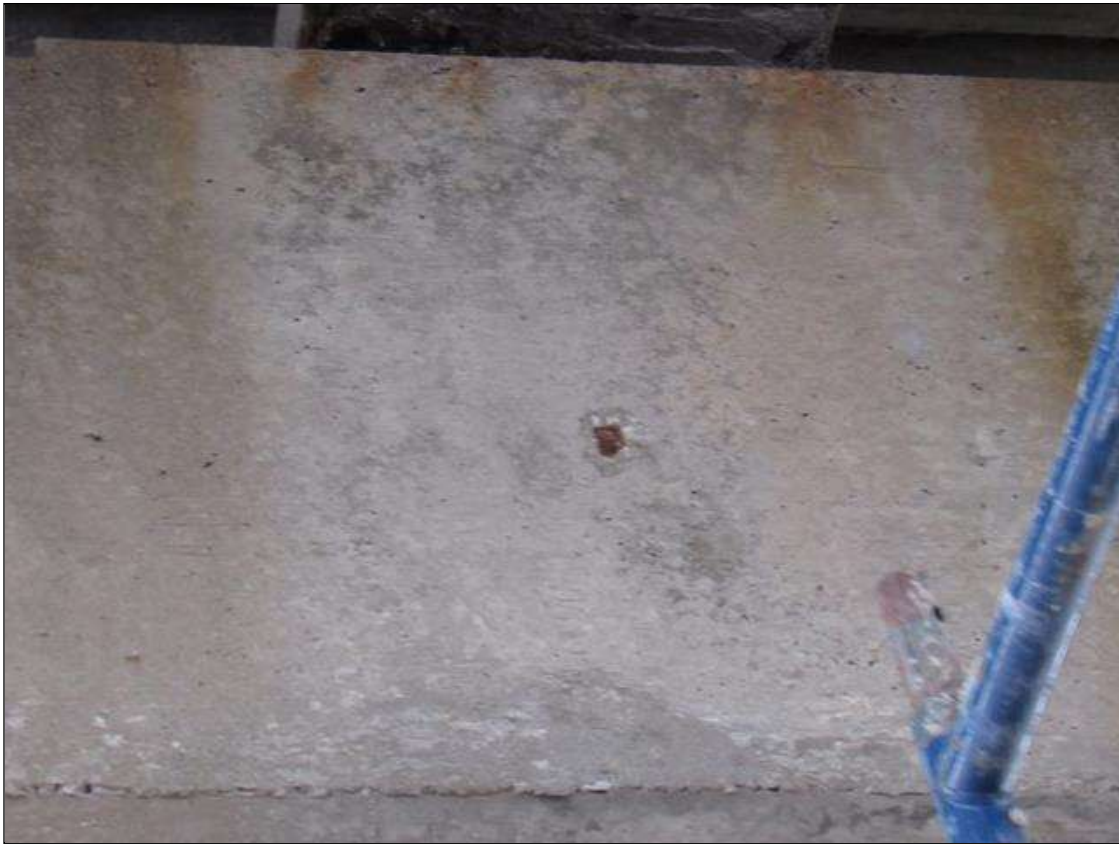
Bent 55 Cap 1: 48" X 12" FAILED PATCHED AREA, EAST FACE, BENEATH BEAM 3.

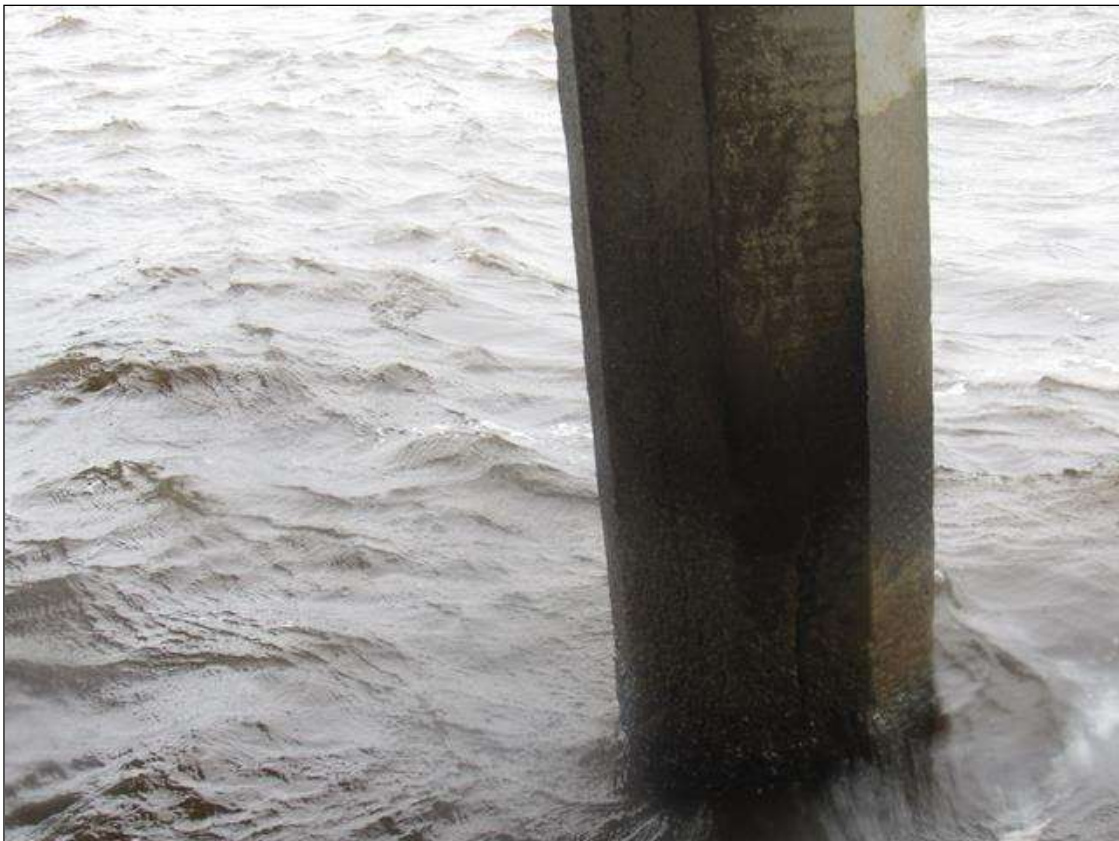
Bent 56 Cap 1: 2" DIAMETER SPALL WITH EXPOSED REINFORCING, EAST FACE, BENEATH BEAM 3.

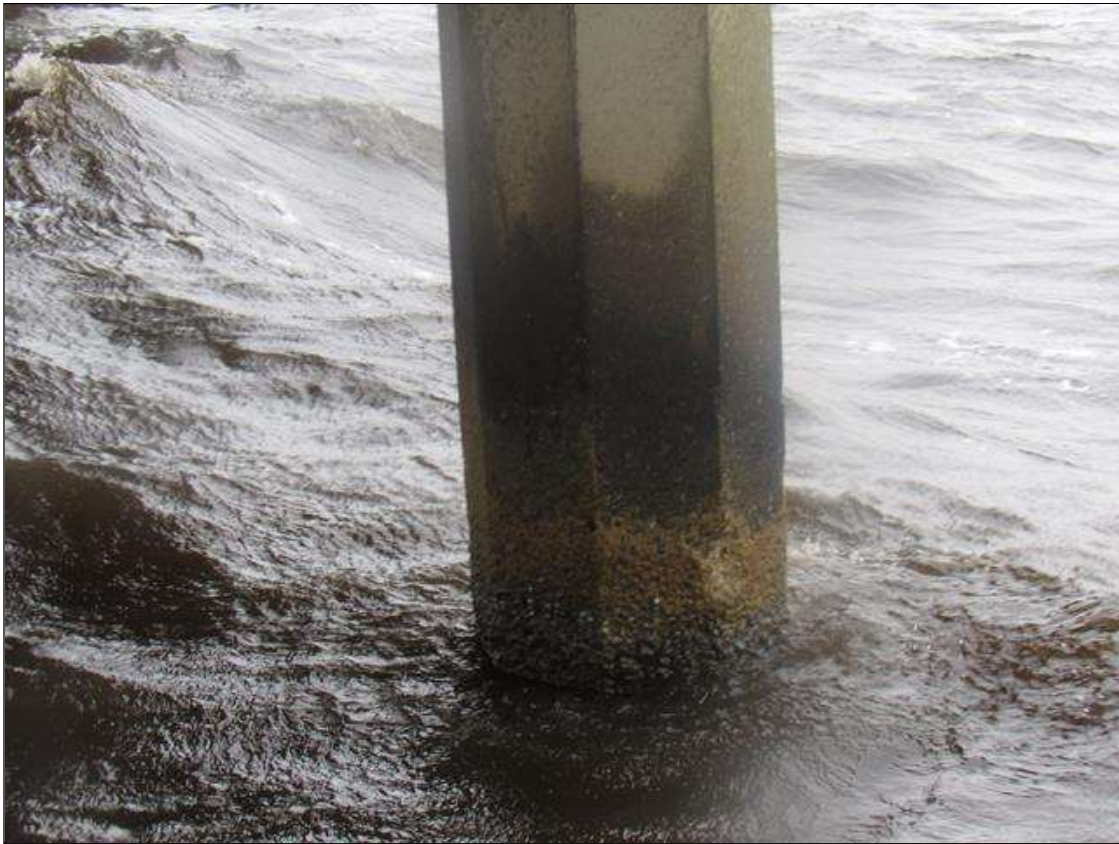
Bent 63 Pile 4: 4' X 1' DELAMINATION, NORTH FACE, 8' FROM BOTTOM OF CAP.
