NC DEPARTMENT OF TRANSPORTATION
DIVISION OF HIGHWAYS
STRUCTURE MANAGEMENT UNIT

Structure Safety Report

Routine Element Inspection - Contract

FEATURE INTERSECTED: ALLIGATOR RIVER

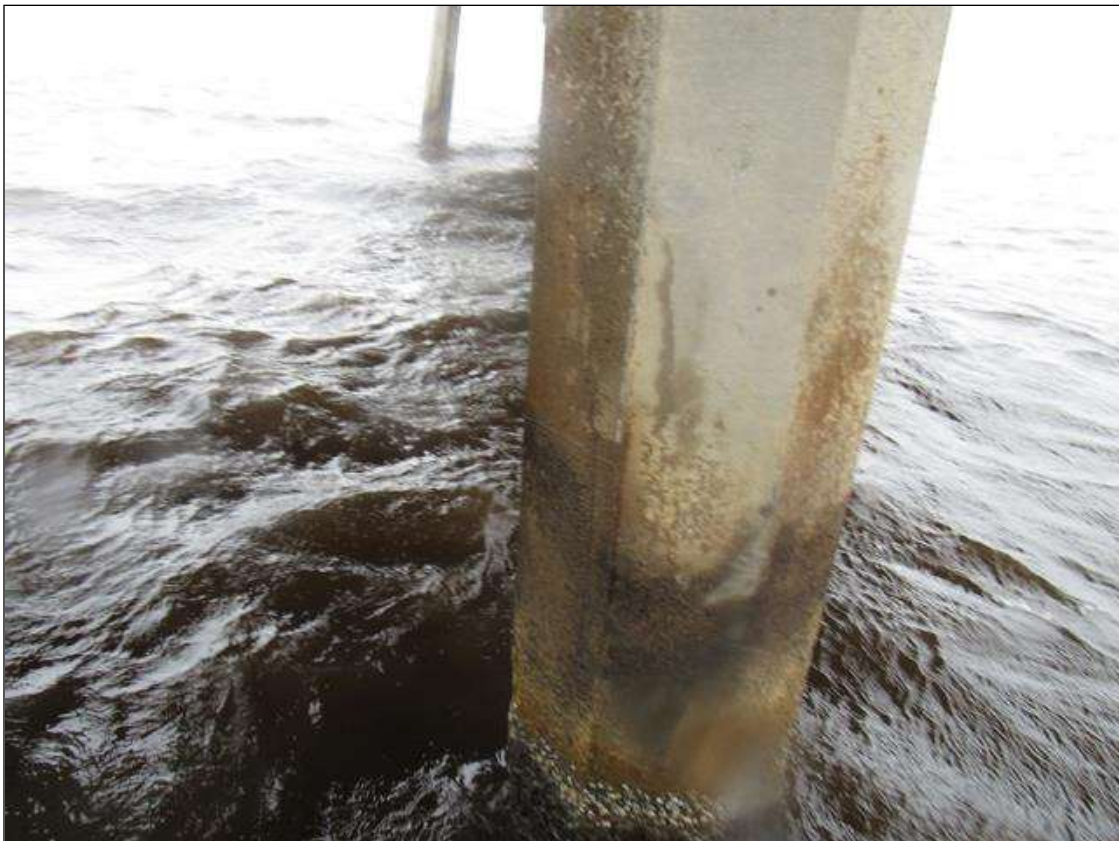
Bent 64 Pile 1: 6" X 4" X 1" SPALL, EAST FACE, 8' FROM BOTTOM OF CAP.

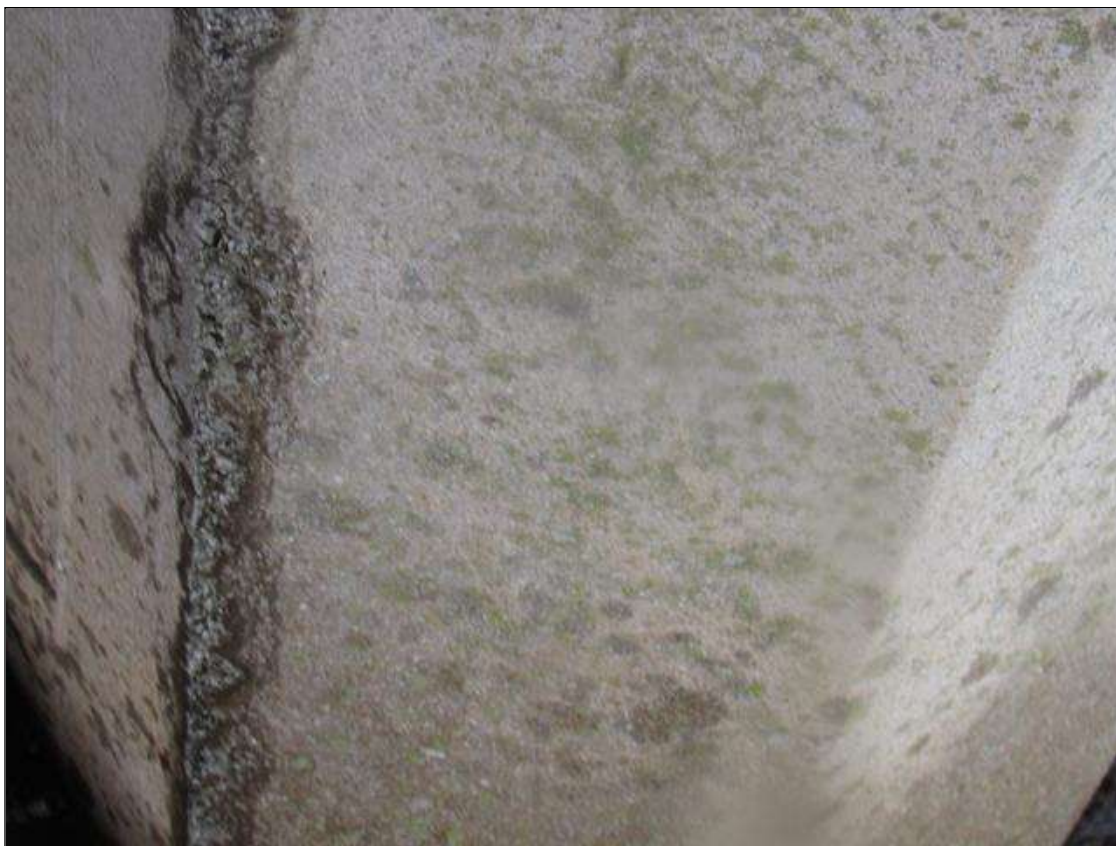
Bent 65 Cap 1: 12" DIAMETER DELAMINATION ON BOTTOM FACE AT PILE 4

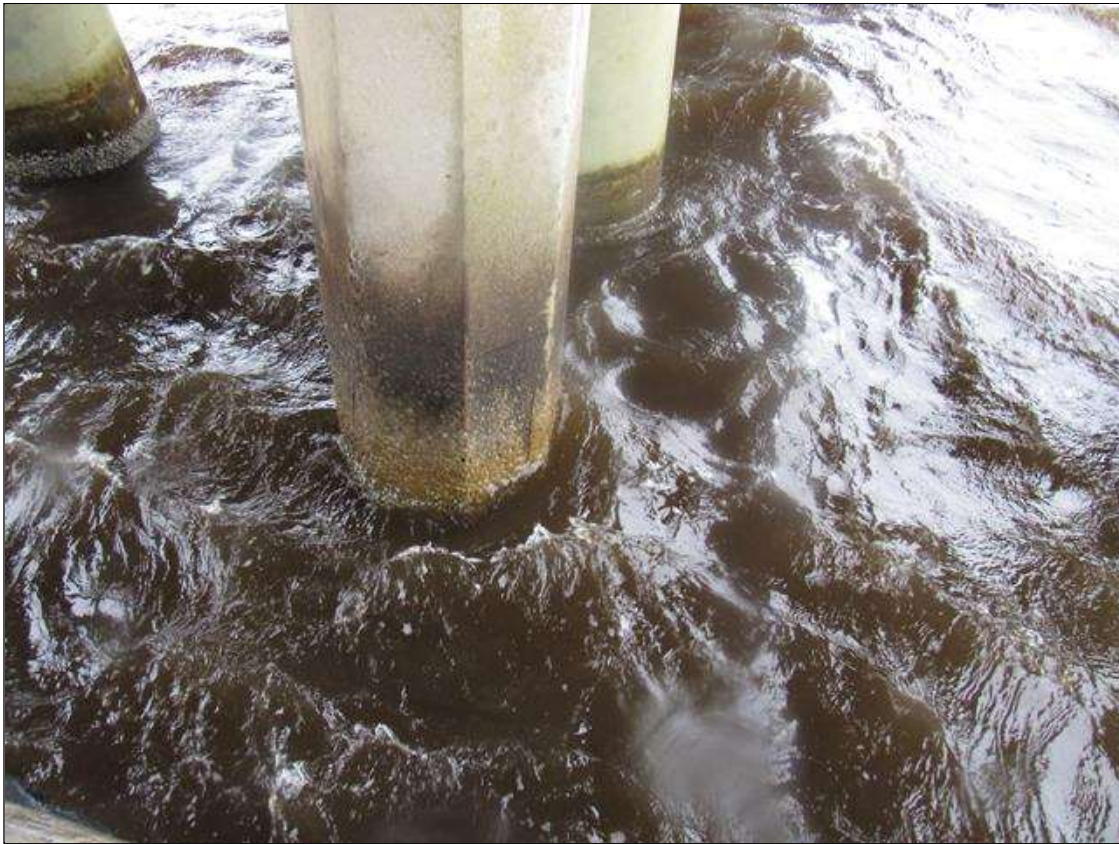
Bent 70 Pile 2: DELAMINATION 3' X 1' ON NORTH AND SOUTH FACES 8' FROM BOTTOM OF CAP

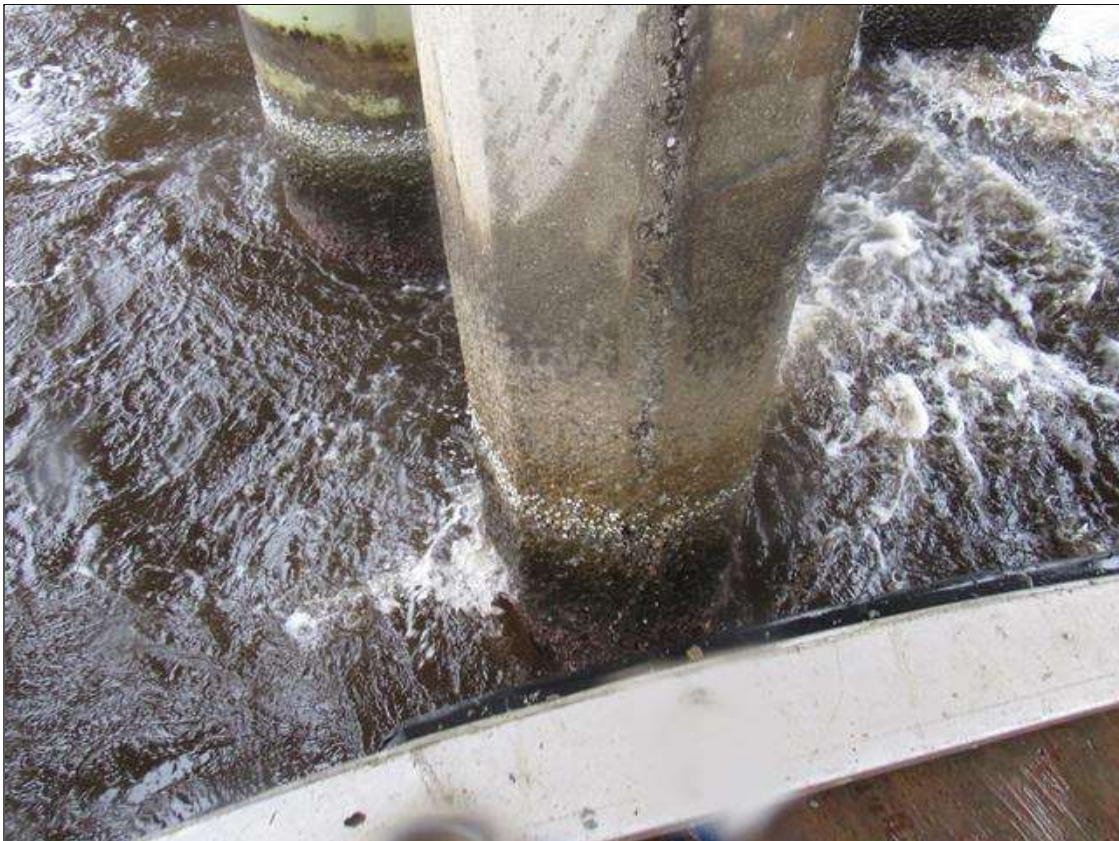
Bent 73 Pile 3: (PAR) (3) UP TO 2' X 0.25" VERTICAL CRACKS WITH RUST STAINING AND SURROUNDING DELAMINATION, BEGINNING 8' FROM BOTTOM OF CAP, AT RANDOM THROUGHOUT.

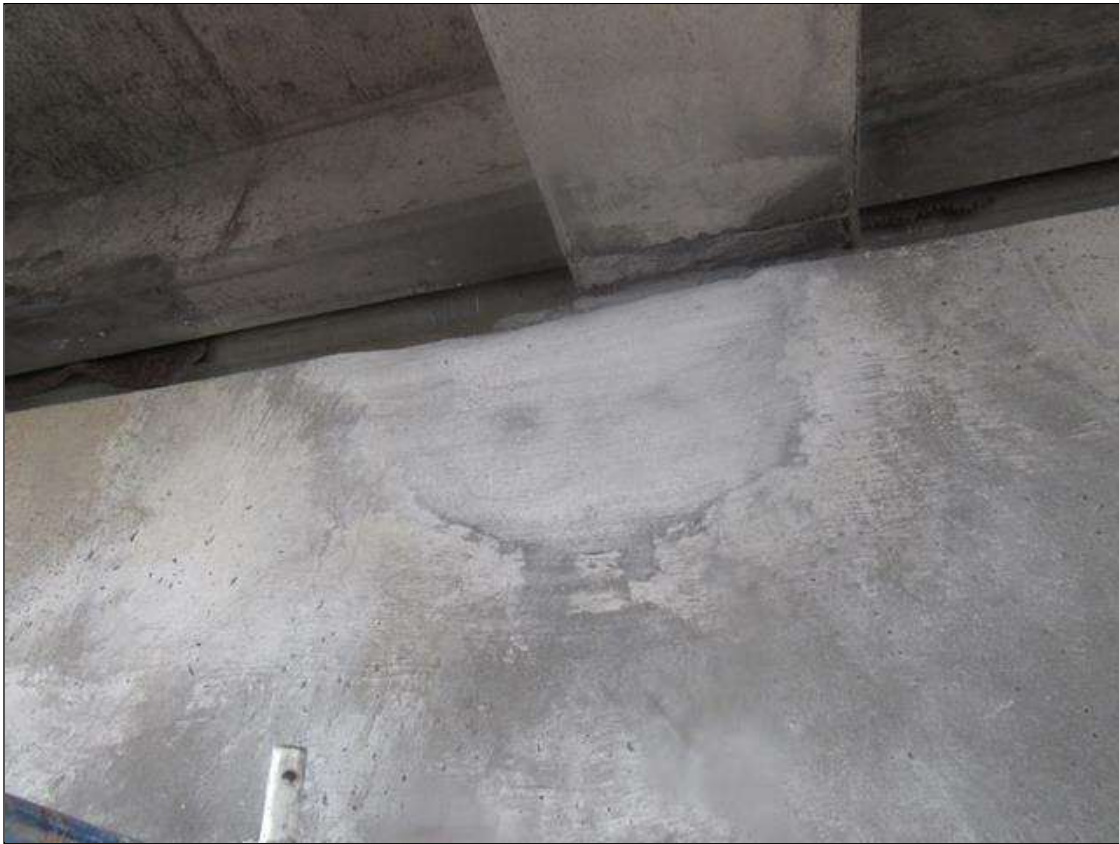
Bent 73 Pile 5: (PAR) (3) UP TO 3' X 0.25" VERTICAL CRACKS WITH SURROUNDING 3' X 1' DELAMINATION, BEGINNING 8' FROM BOTTOM OF CAP, AT RANDOM THROUGHOUT.

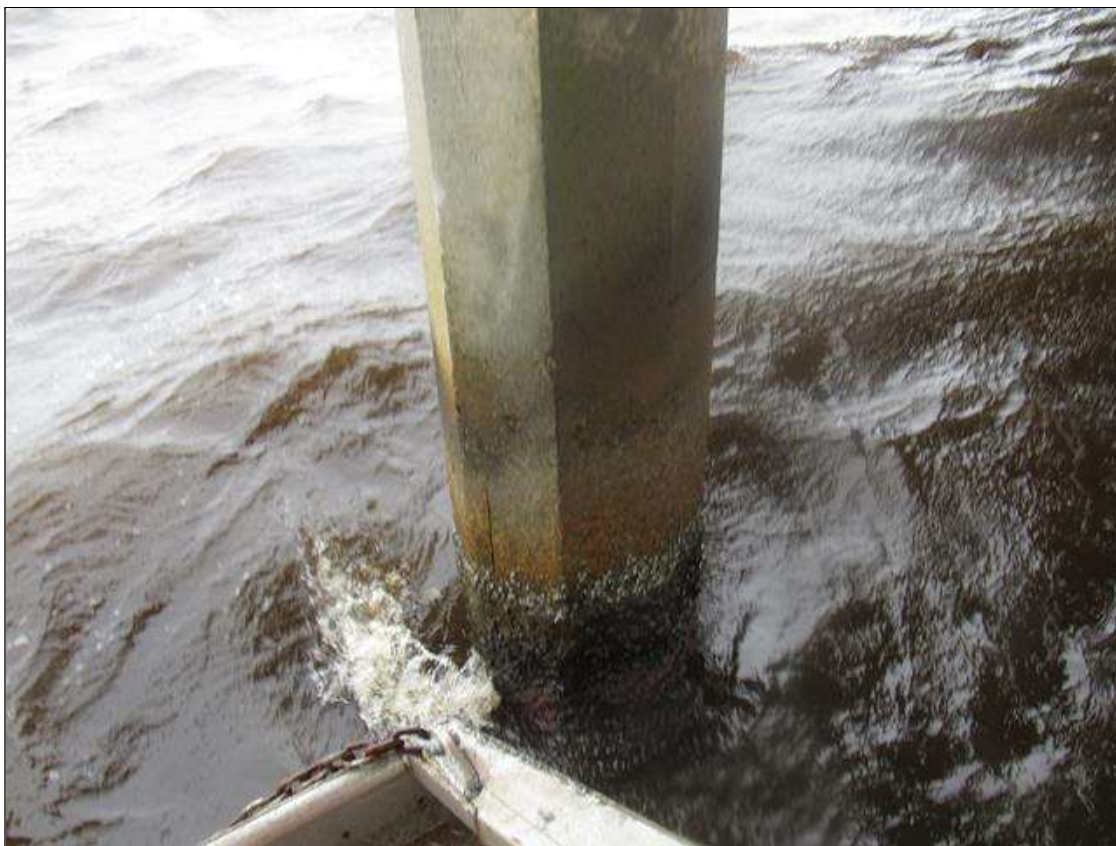
Bent 74 Pile 1: (PAR) (4) UP TO 3' X 0.06" VERTICAL CRACKS WITH SURROUNDING 3' X 1' DELAMINATION, BEGINNING 8' FROM BOTTOM OF CAP, AT RANDOM THROUGHOUT.

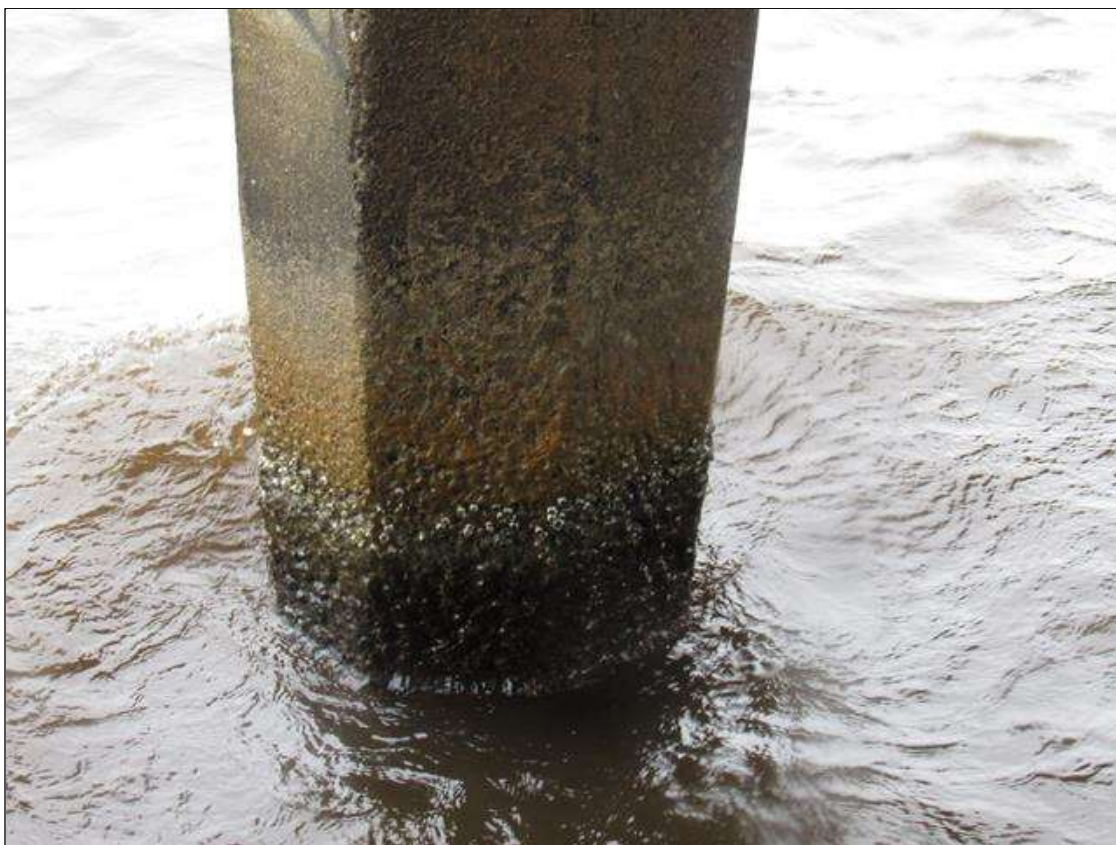
Bent 75 Pile 1: (PAR) UP TO 18" X 0.06" VERTICAL CRACKS, WEST FACE, BEGINNING 10' FROM BOTTOM OF CAP.

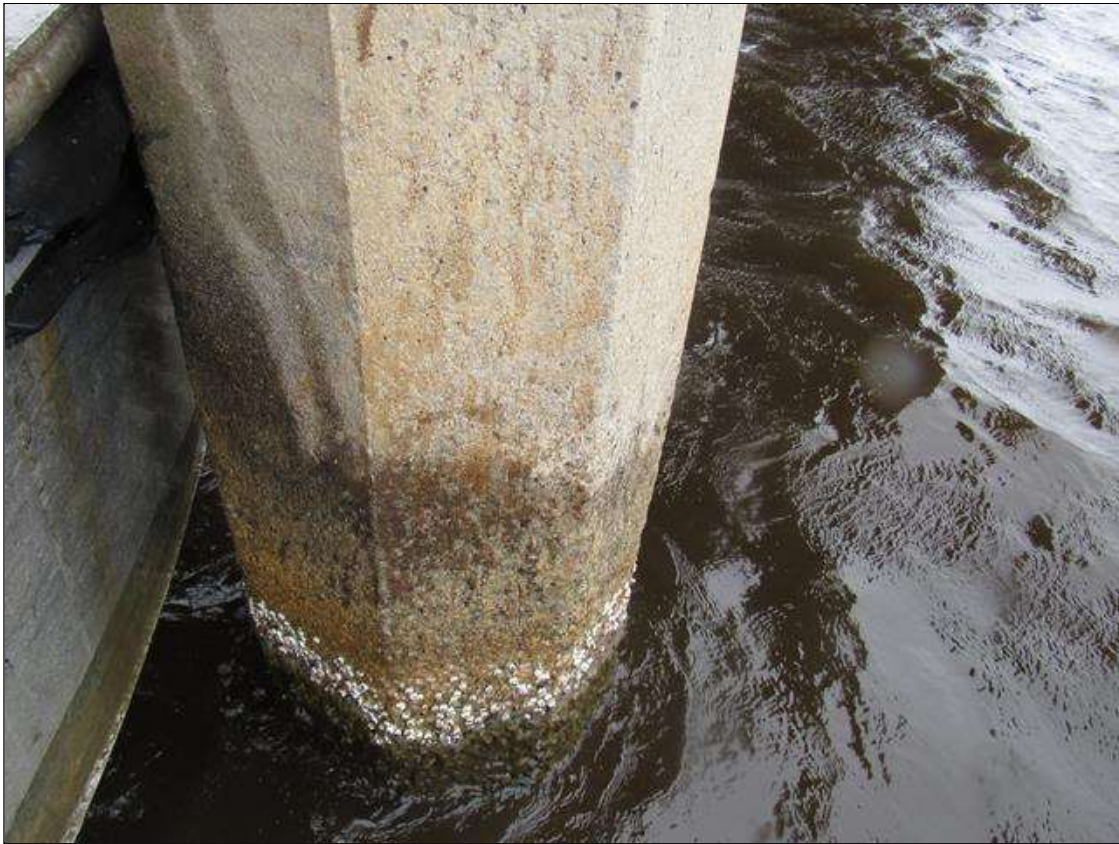
Bent 77 Pile 1: (PAR) (3) UP TO 2' X 0.03" VERTICAL CRACKS, BEGINNING 10' BOTTOM OF CAP, AT RANDOM THROUGHOUT.

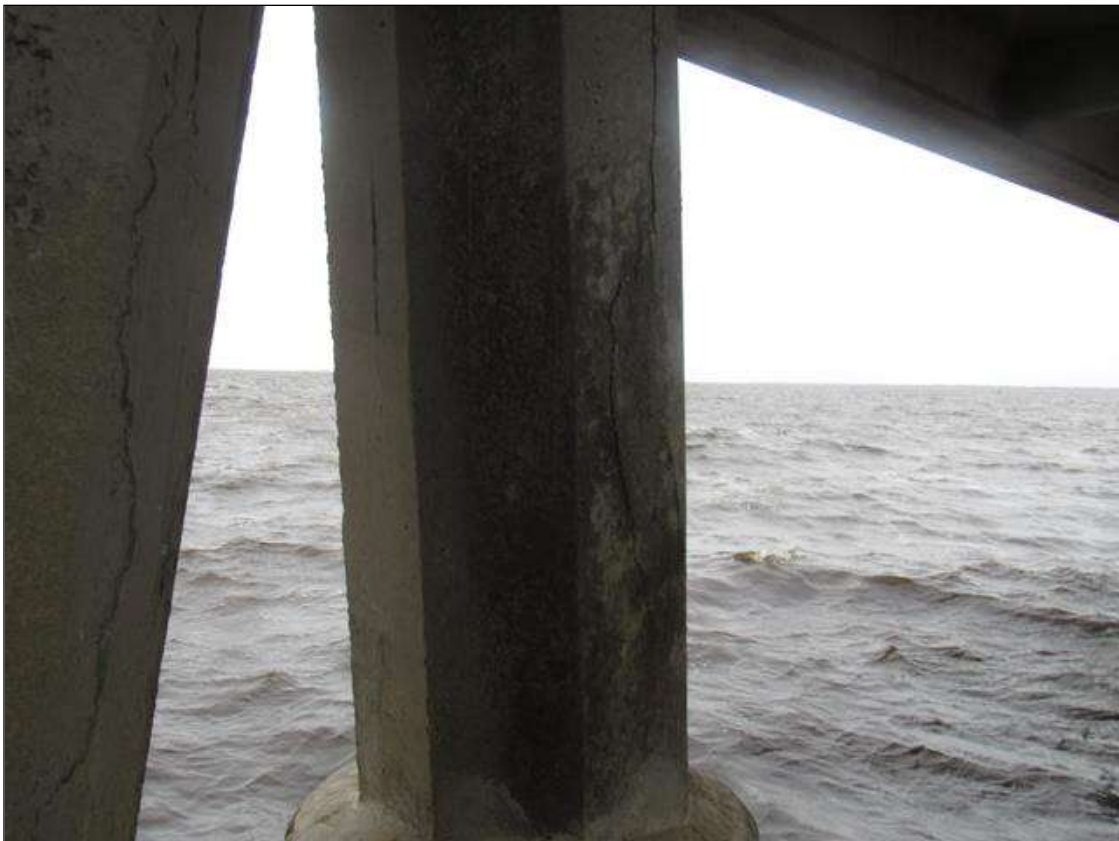
Bent 77 Pile 6: (PAR) UP TO 1' X 0.06" VERTICAL CRACK, SOUTH FACE, BEGINNING 9' FROM BOTTOM OF CAP.

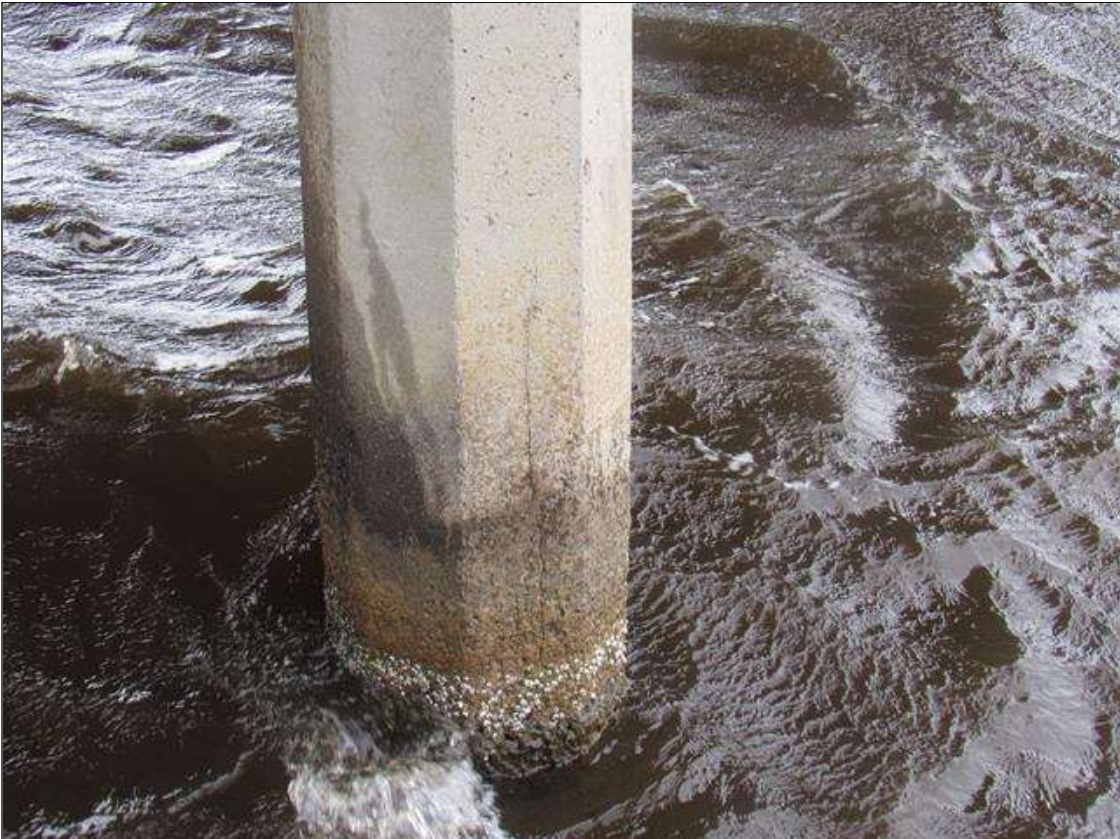
Bent 81 Pile 6: (PAR) 4' X 0.25" VERTICAL CRACK WITH SURROUNDING DELAMINATION ON NORTH FACE, BEGINNING 8' FROM BOTTOM OF CAP

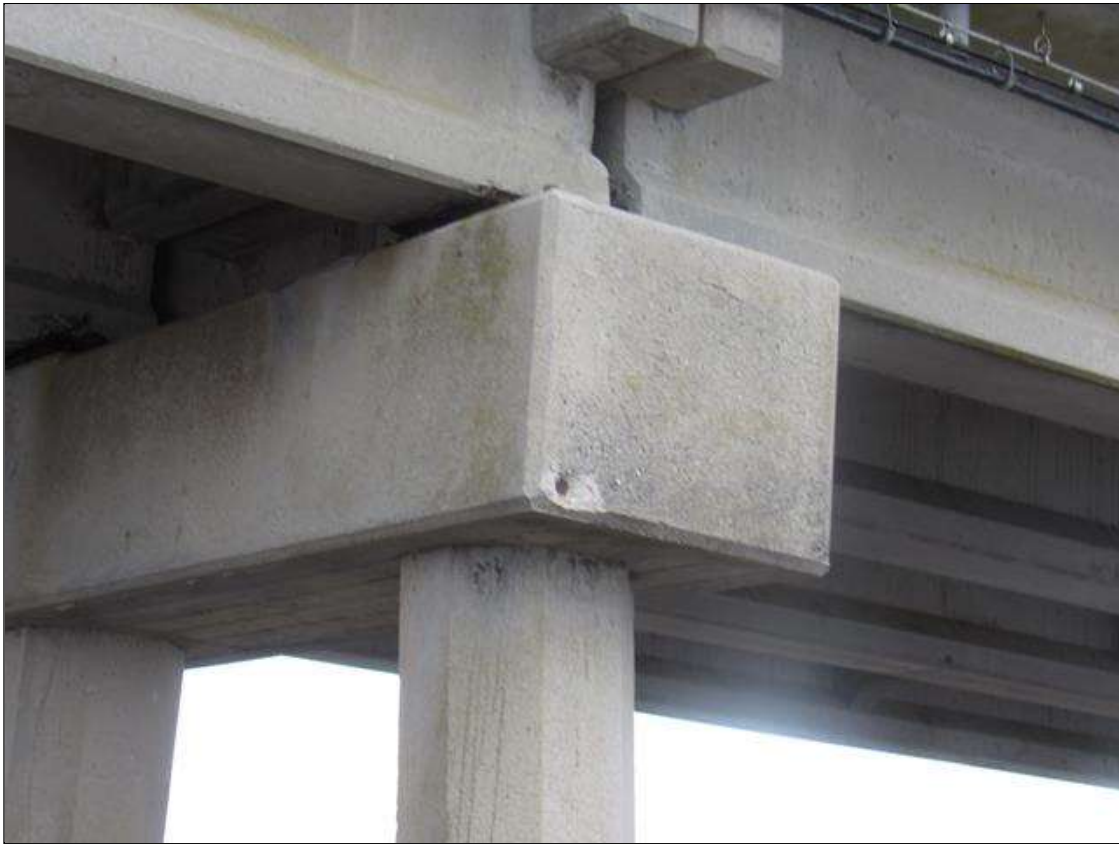
Bent 98 Pile 4: (PAR) 2' X 0.012" VERTICAL CRACK, SOUTH FACE, 9' FROM BOTTOM OF CAP, WITH ADJACENT 2' X 1' DELAMINATION.

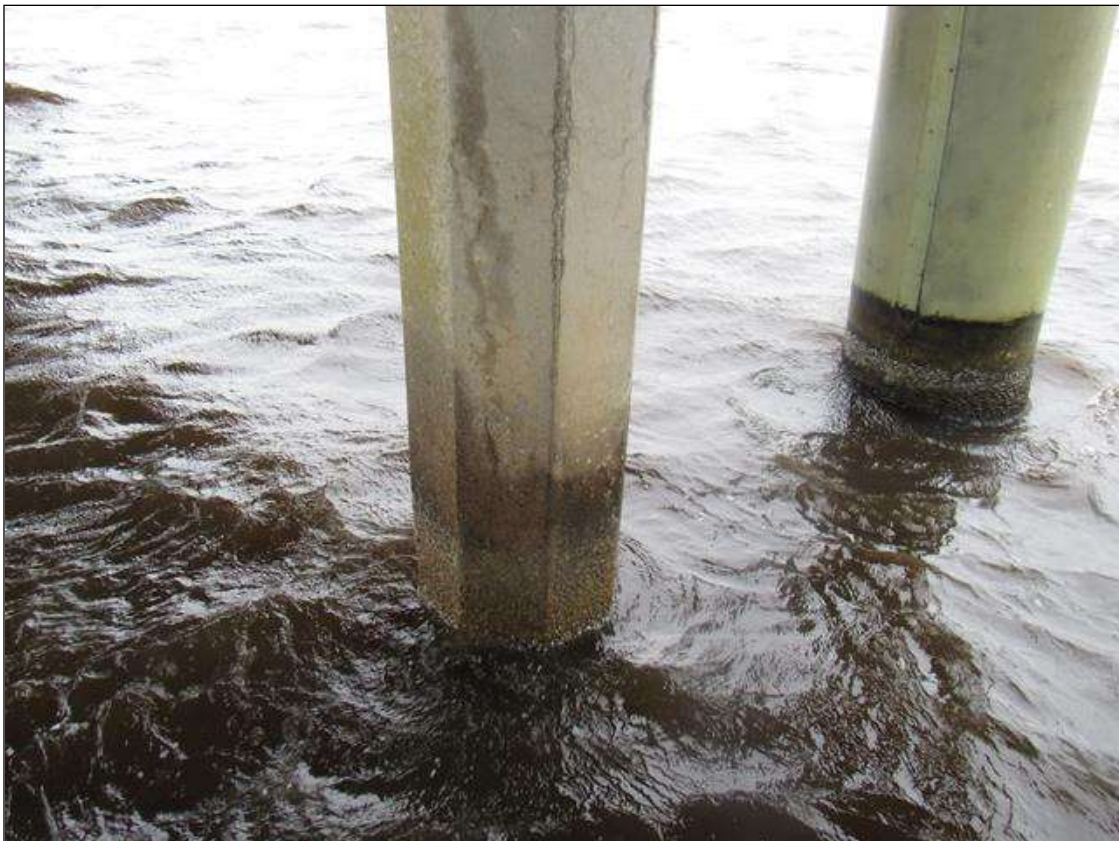
Bent 99 Cap 1: 6" X 5" X 1" DEEP SPALL WITH EXPOSED REINFORCEMENT ON SOUTH END OF CAP

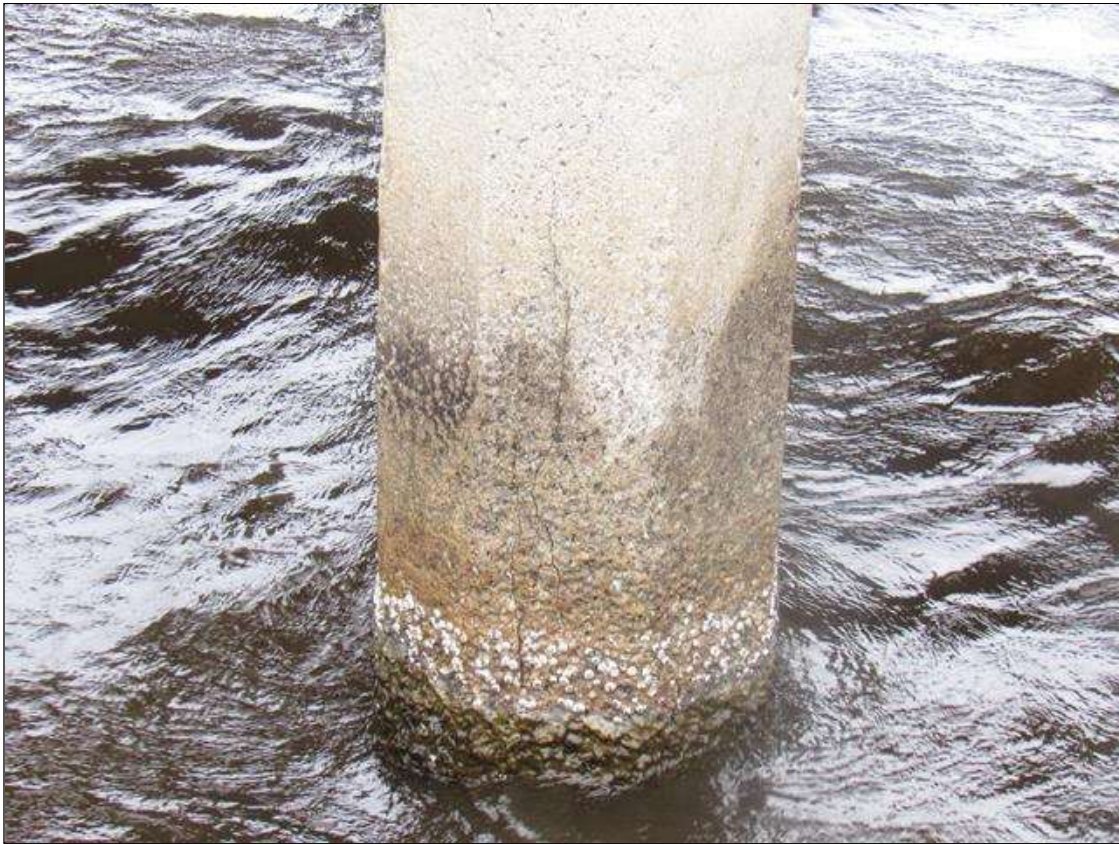
Bent 100 Pile 2: (PAR) 3' X UP TO 0.012" VERTICAL CRACKS, EAST FACE, BEGINNING 9' FROM BOTTOM OF CAP, WITH ADJACENT 3' X UP TO 2' DELAMINATION.

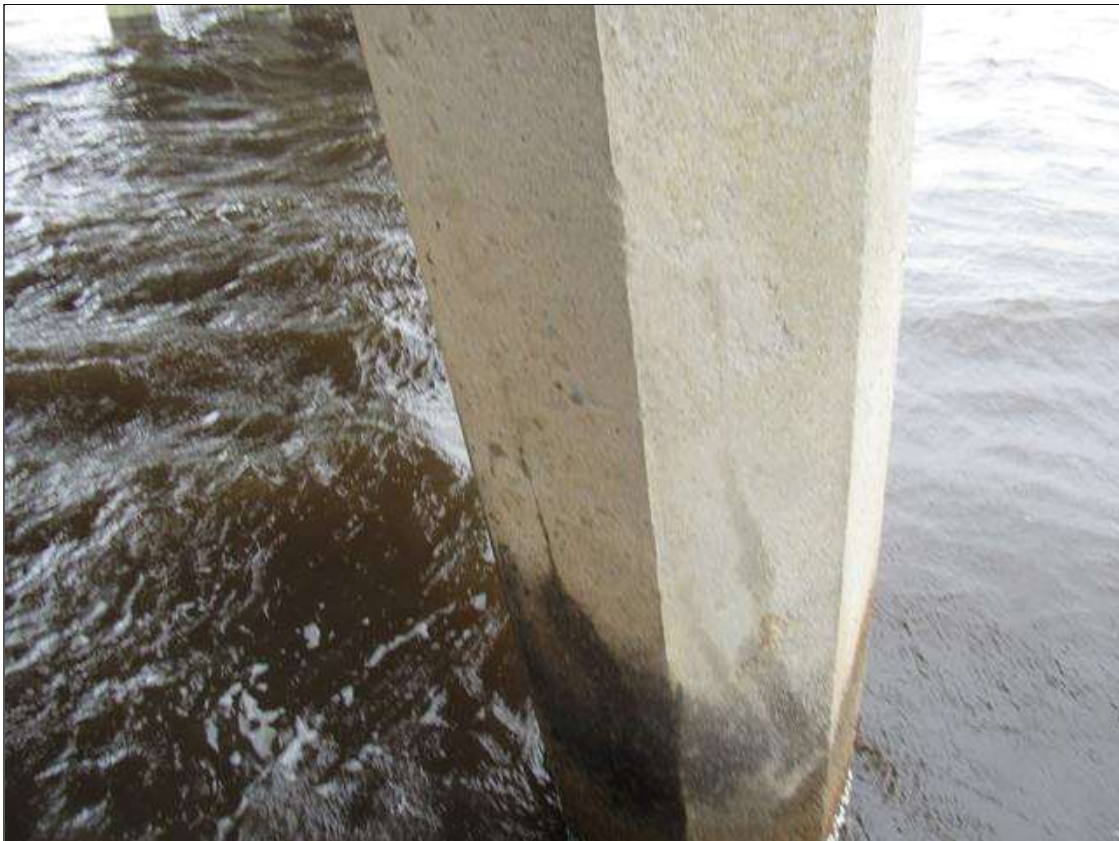
Bent 100 Pile 4: 2' X UP TO 0.007" VERTICAL CRACKS, WEST FACE, BEGINNING 9' FROM BOTTOM OF CAP, WITH ADJACENT 2' X UP TO 1.5' DELAMINATION.

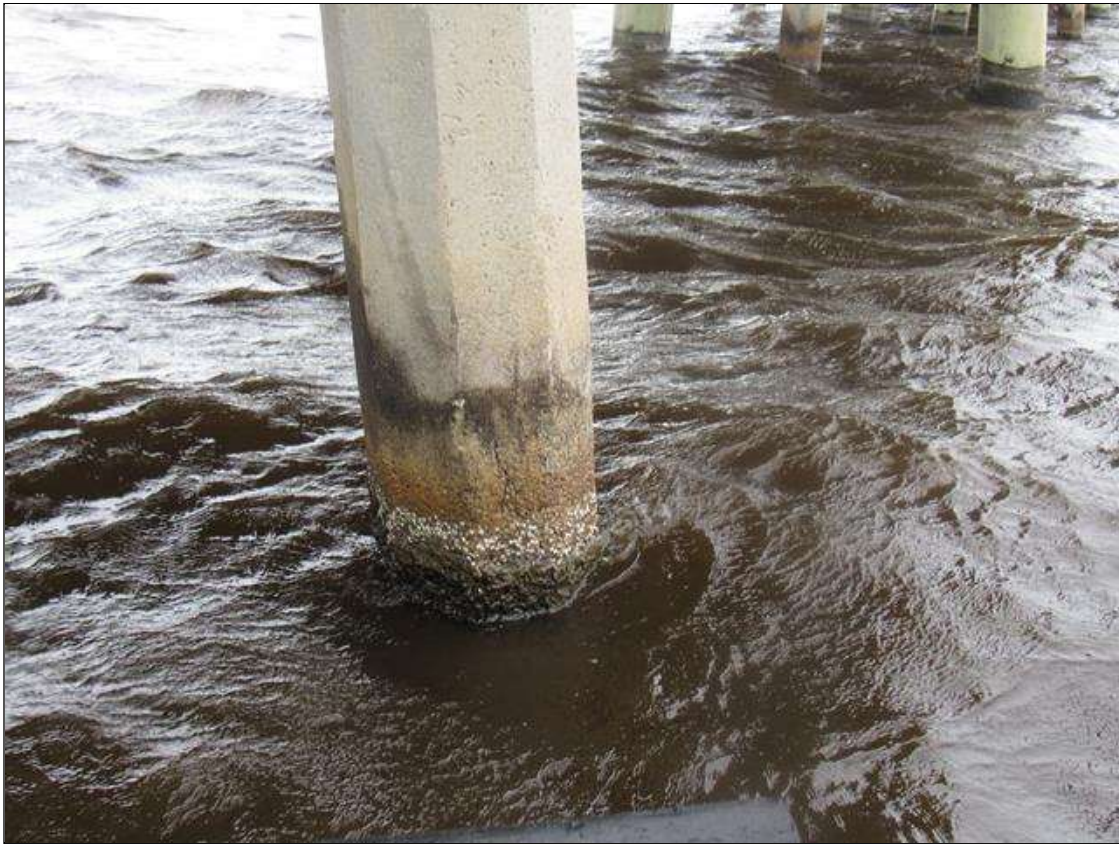
Bent 101 Pile 6: (PAR) 3' X 1/8" CRACKS ON NORTH FACE WITH SURROUNDING DELAMINATION 3' X 1', 10' FROM BOTTOM OF CAP

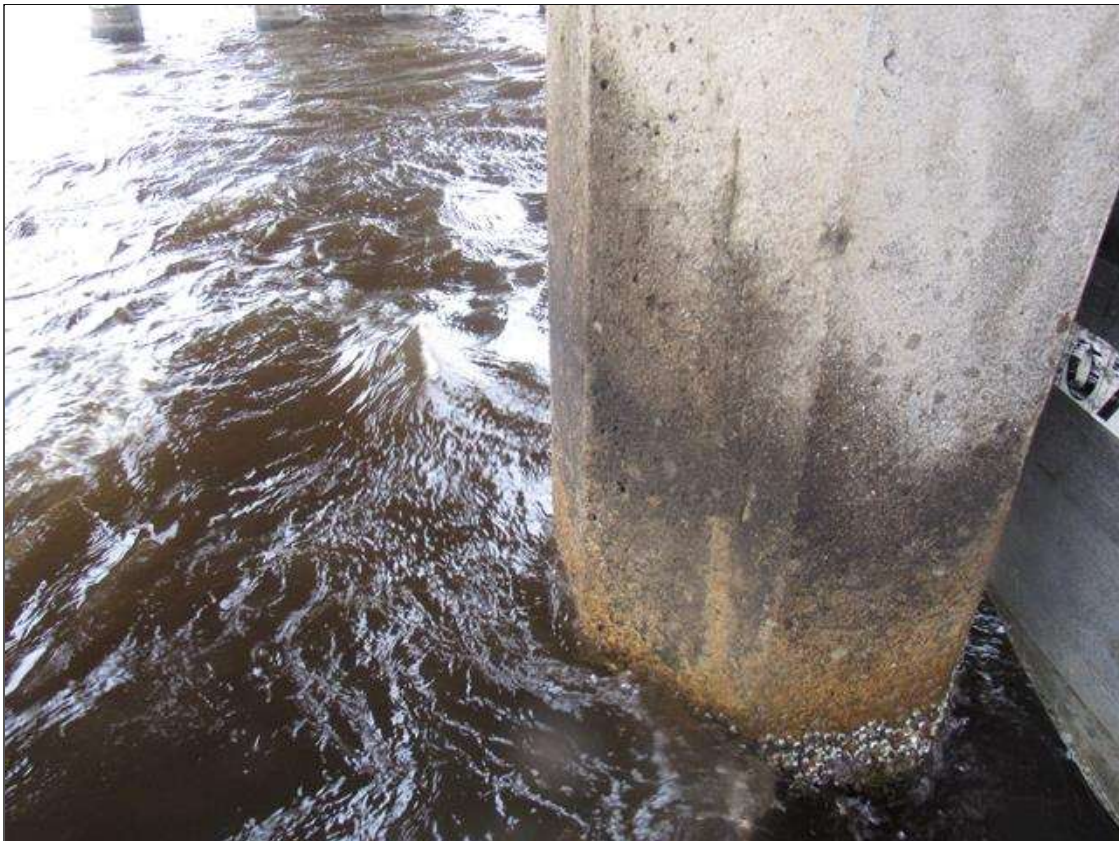
Bent 102 Pile 4: (PAR) UP TO 3' X 0.014" VERTICAL CRACKS, NORTH AND SOUTH FACES, BEGINNING 9' FROM BOTTOM OF CAP, WITH ADJACENT 3' X UP TO 2' DELAMINATION.

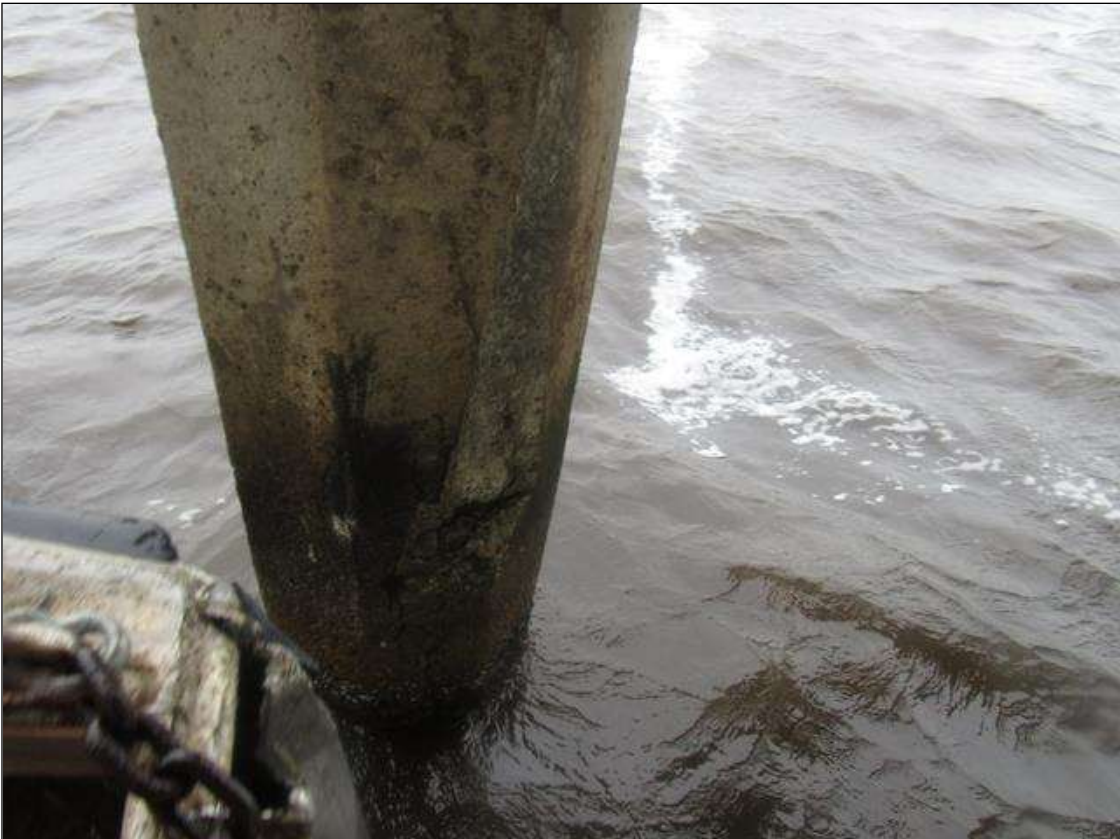
Bent 104 Pile 1: 5' X 9' AREA OF UP TO 0.009" MAP CRACKING, WEST FACE, BEGINNING AT BOTTOM OF CAP.

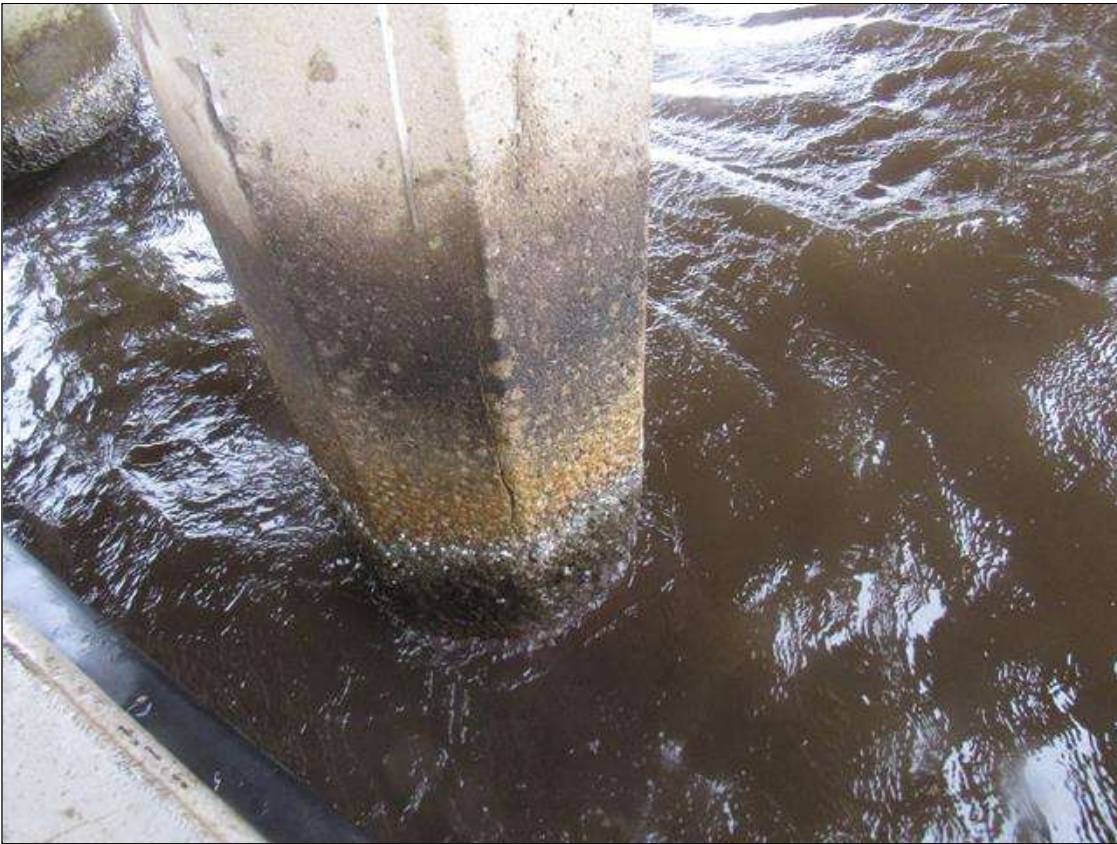
Bent 105 Pile 1: (PAR) 3' X UP TO 10" X 2" SPALL WITH EXPOSED REINFORCING AND SURROUNDING 3' OF DELAMINATION, SOUTH FACE, 9' FROM BOTTOM OF CAP.

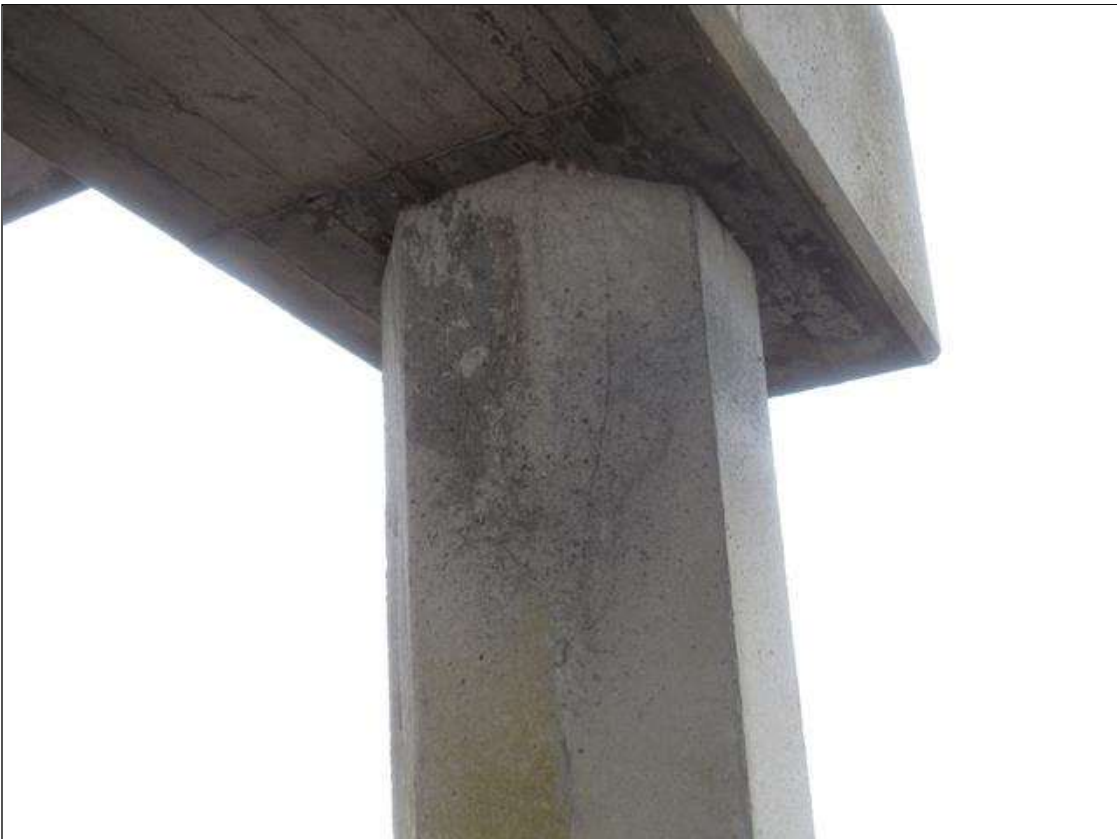
Bent 106 Pile 2: (PAR) (5) UP TO 3' X 1/8" VERTICAL CRACKS, NORTH AND SOUTH FACES, BEGINNING 9' FROM BOTTOM OF CAP, WITH ADJACENT 3' X UP TO 1' DELAMINATION.

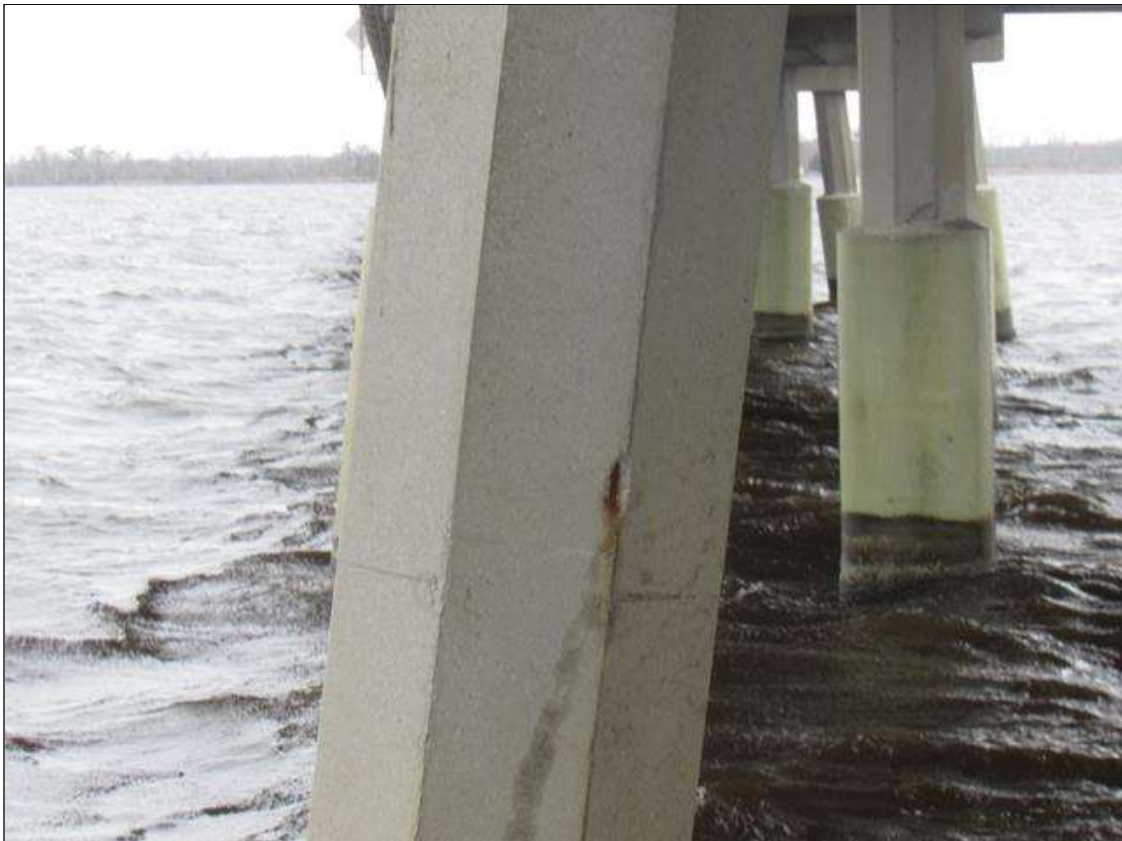
Bent 107 Pile 4: (PAR) (2) UP TO 3' X 0.02" VERTICAL CRACKS, SOUTH FACE, BEGINNING 9' FROM BOTTOM OF CAP, WITH ADJACENT 2' X UP TO 1' DELAMINATION.

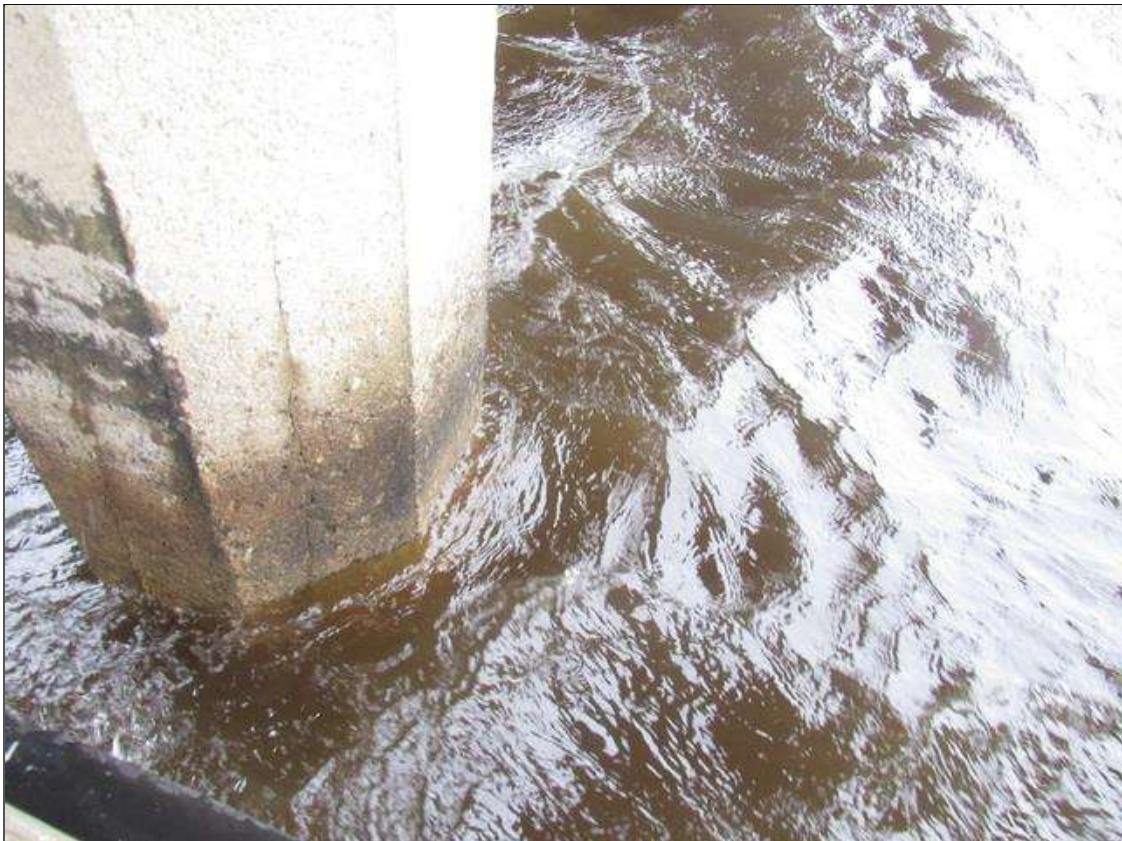
Bent 110 Pile 3: 2' X UP TO 6" X 1 1/2" DEEP SPALL ON SOUTH FACE WITH SURROUNDING DELAMINATION, AT BOTTOM OF CAP, SOUTH FACE.

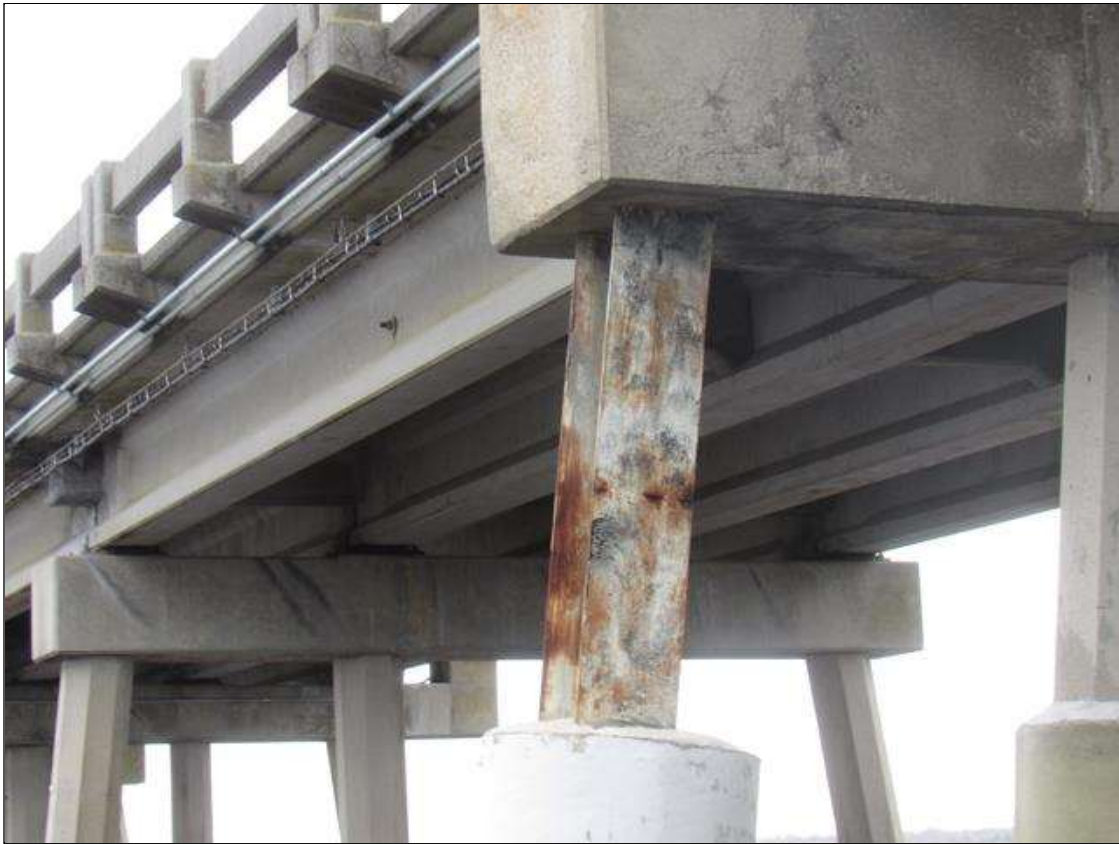
Bent 111 Pile 2: (3) 3' X 1' DELAMINATIONS, 8' FROM BOTTOM OF CAP, NORTH, EAST AND WEST FACES.

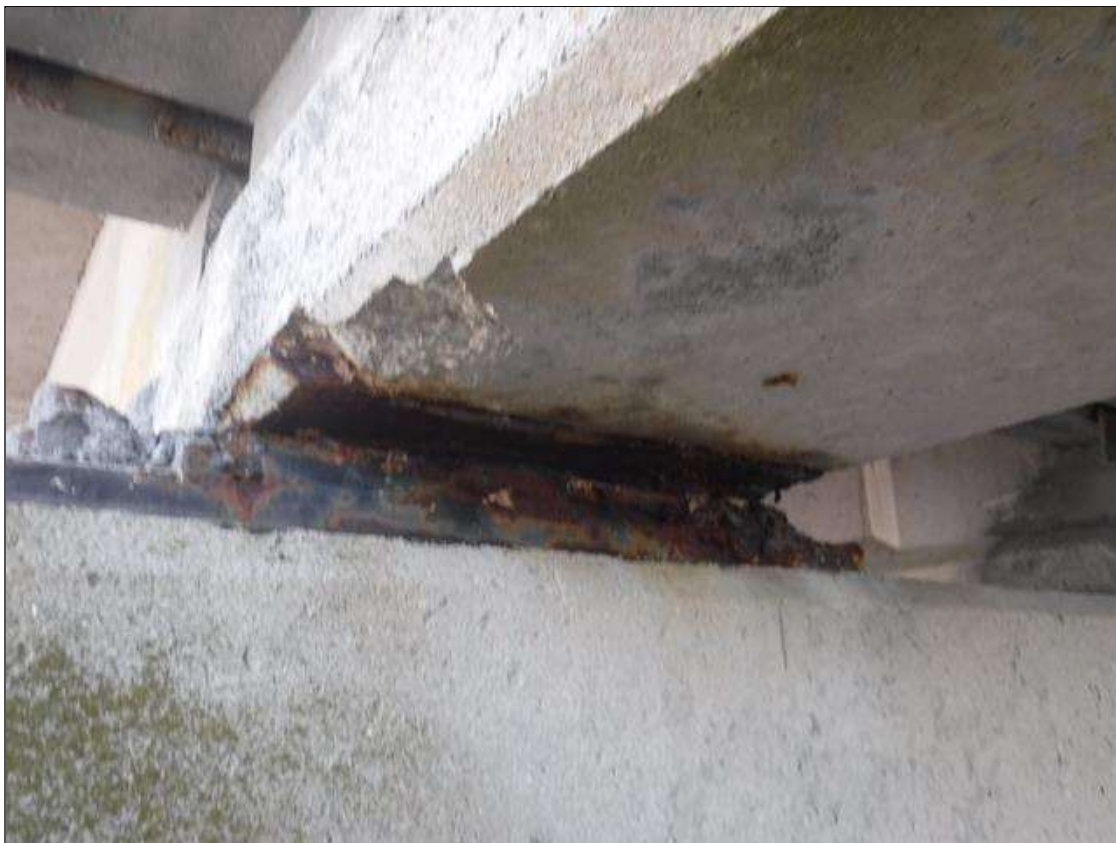
Bent 115 CAP REST PIER 1: 1' X 1' X 1" DEEP SPALL WITH EXPOSED REBAR AND 2' AREA OF SURROUNDING DELAMINATION BOTTOM FACE NEAR PILE 10
