NC DEPARTMENT OF TRANSPORTATION
DIVISION OF HIGHWAYS
STRUCTURE MANAGEMENT UNIT

Structure Safety Report

Routine Element Inspection - Contract

FEATURE INTERSECTED: ALLIGATOR RIVER

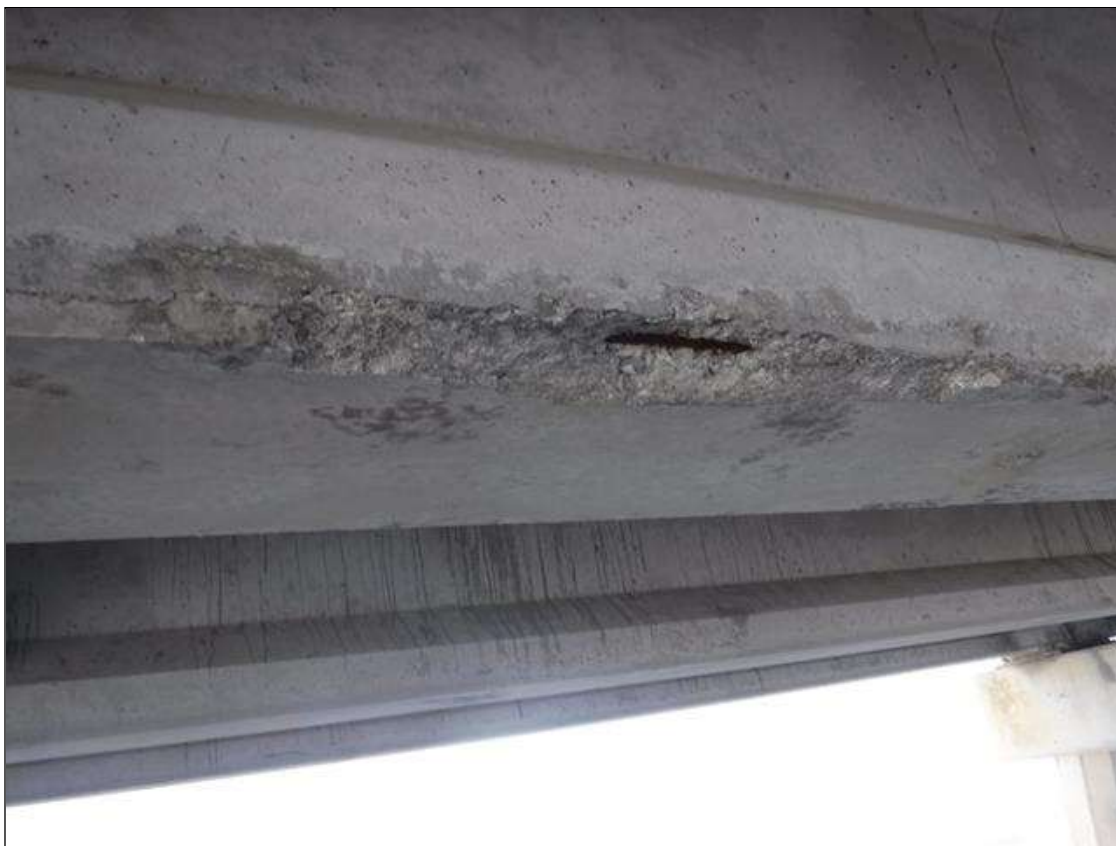
Span 72 Beam 1: 6" X UP TO 5" X 1.5" DEEP SPALL, BOTTOM FACE, AT BENT 72.

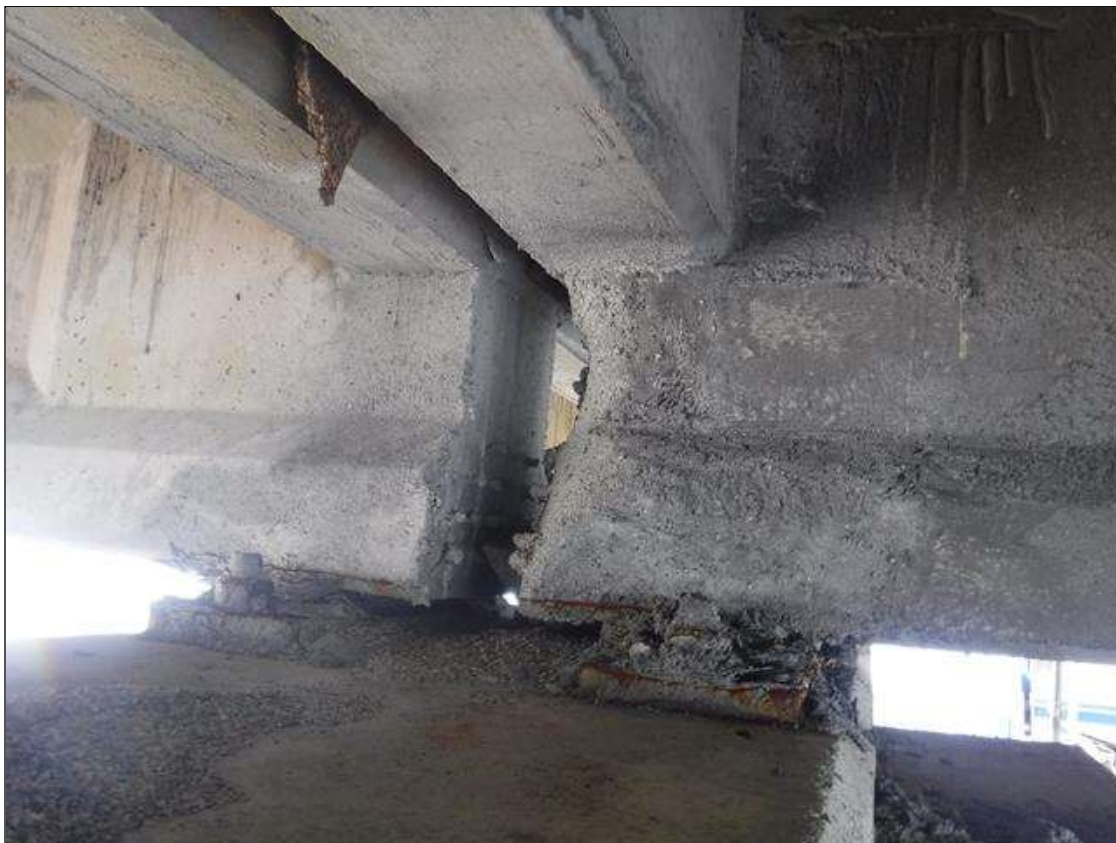
Span 73 Beam 2: (PAR) 3' X 2" HIGH X 4" DEEP SPALL WITH EXPOSED STRAND ON BOTTOM AND NORTH FACE AT MIDSPAN

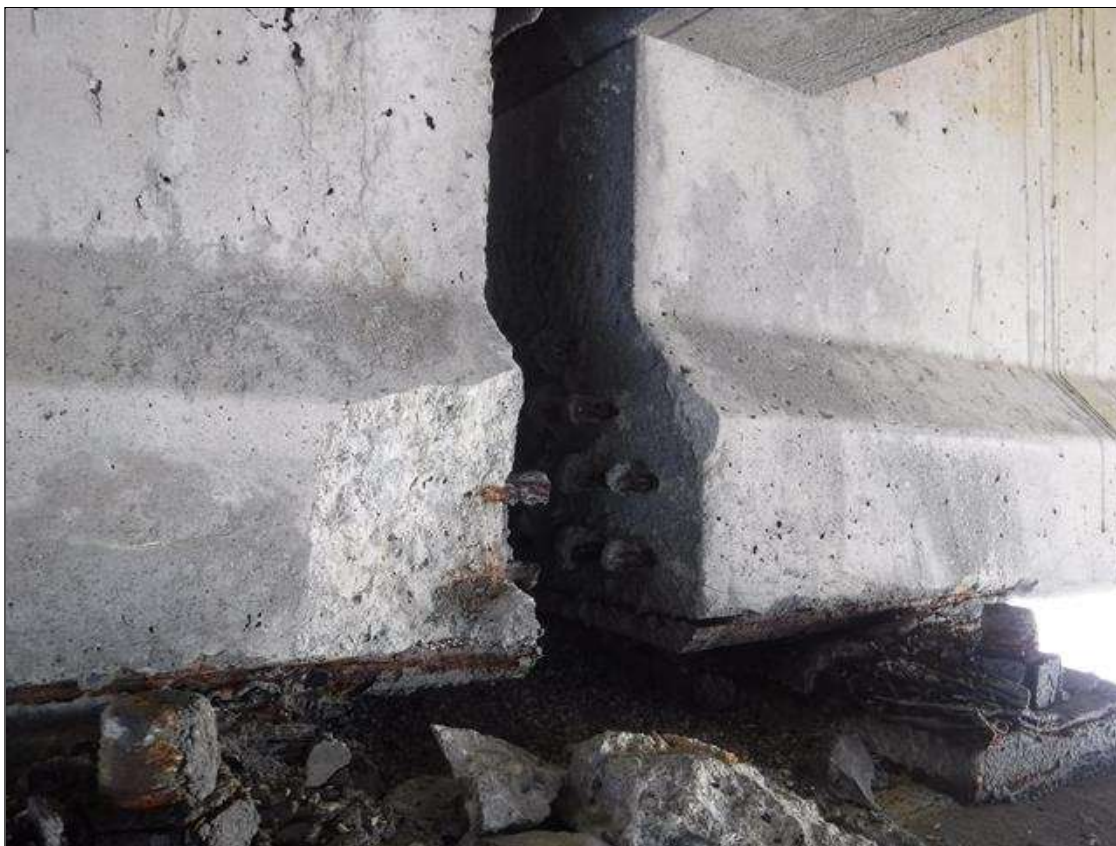
Span 73 Beam 4 Far Bearing: CORROSION WITH LESS THAN 1/16" LOSS. (2" REMAINING).

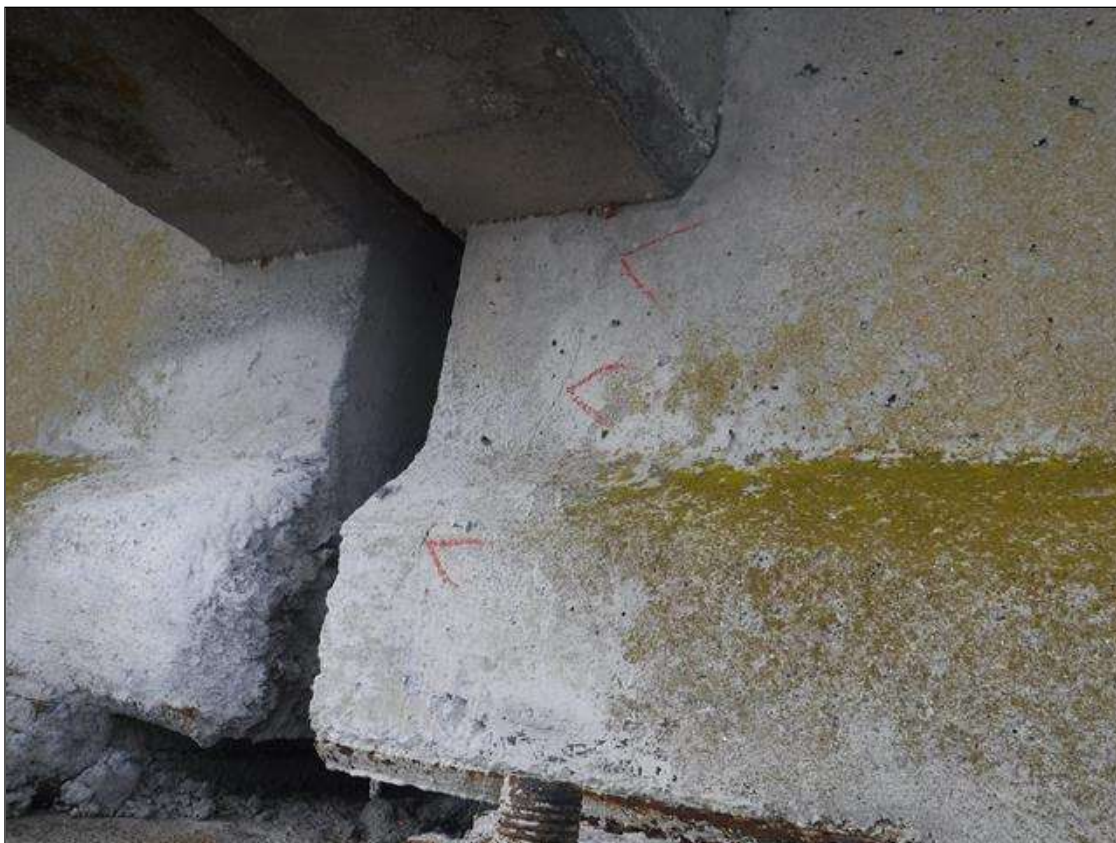
Span 74 Beam 3: (PAR) 6" X 6" X 3" DEEP SPALL WITH EXPOSED STRAND ON SOUTH FACE AT BENT 74

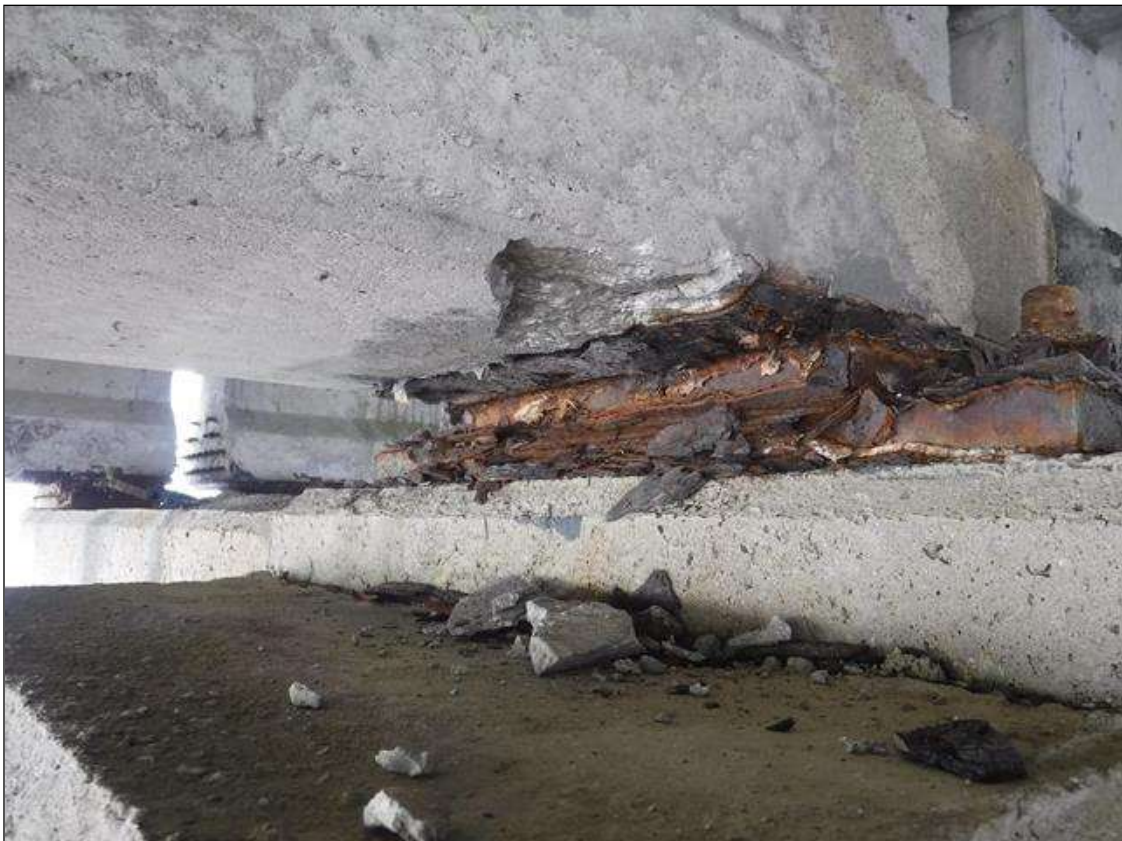
Span 76 Beam 3: (PAR) 15" X 6" X 3" DEEP SPALL WITH EXPOSED STRAND ON SOUTH FACE AT BENT 76

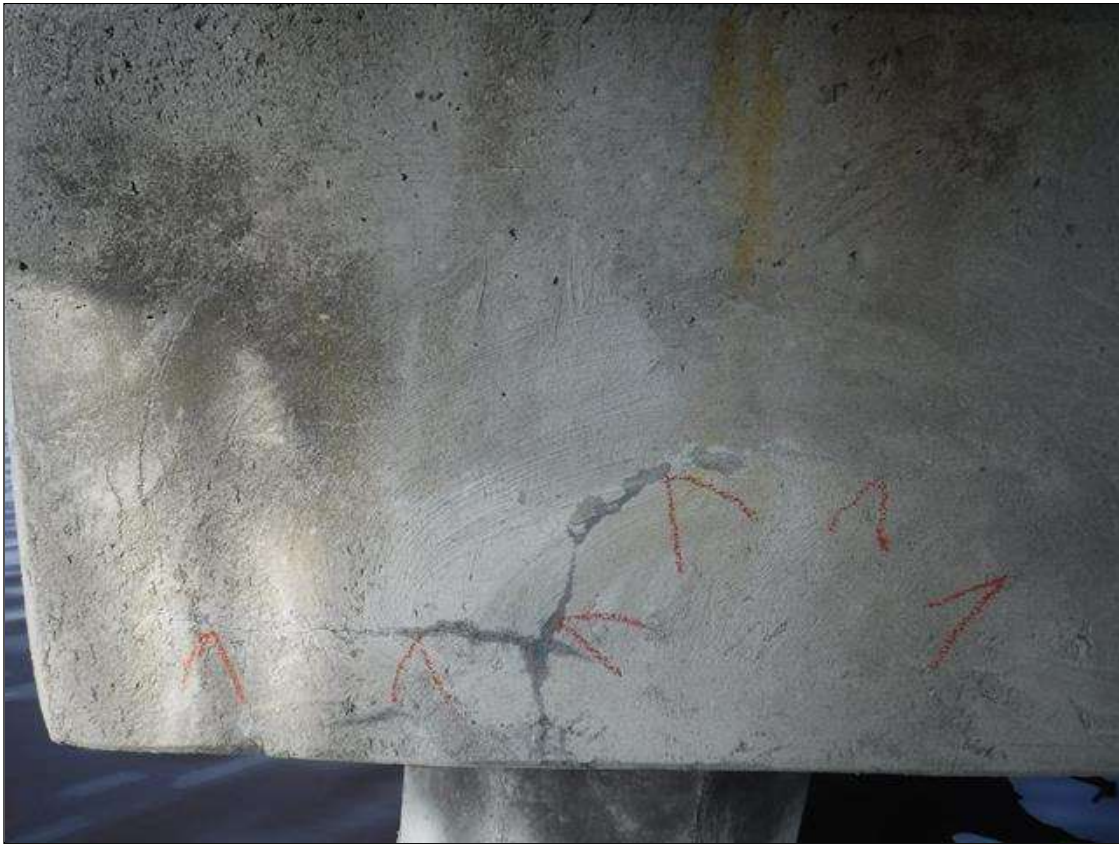
Span 78 Beam 3: 6" X 6" X 1/2" DEEP SPALL, NORTH FACE, AT BENT 77.

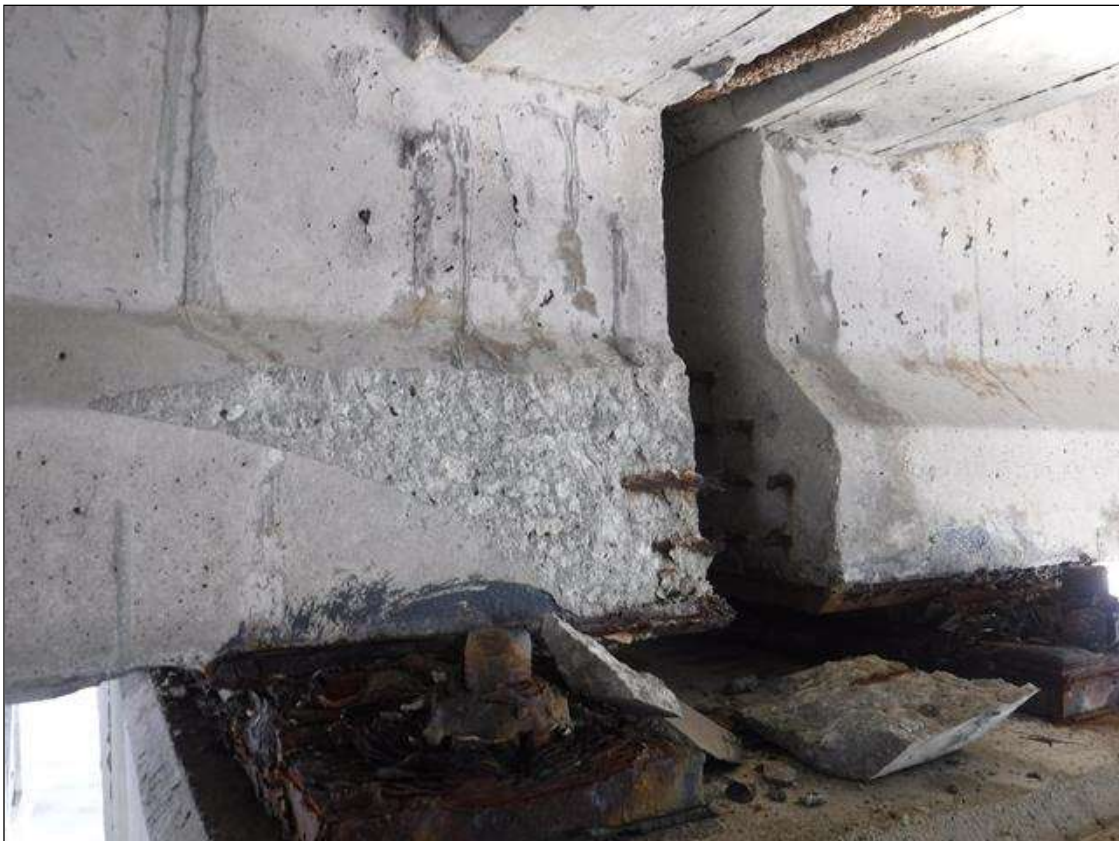
Bent 78 Cap 1: 3' HAIRLINE CRACK ON EAST FACE OVER PILE 4

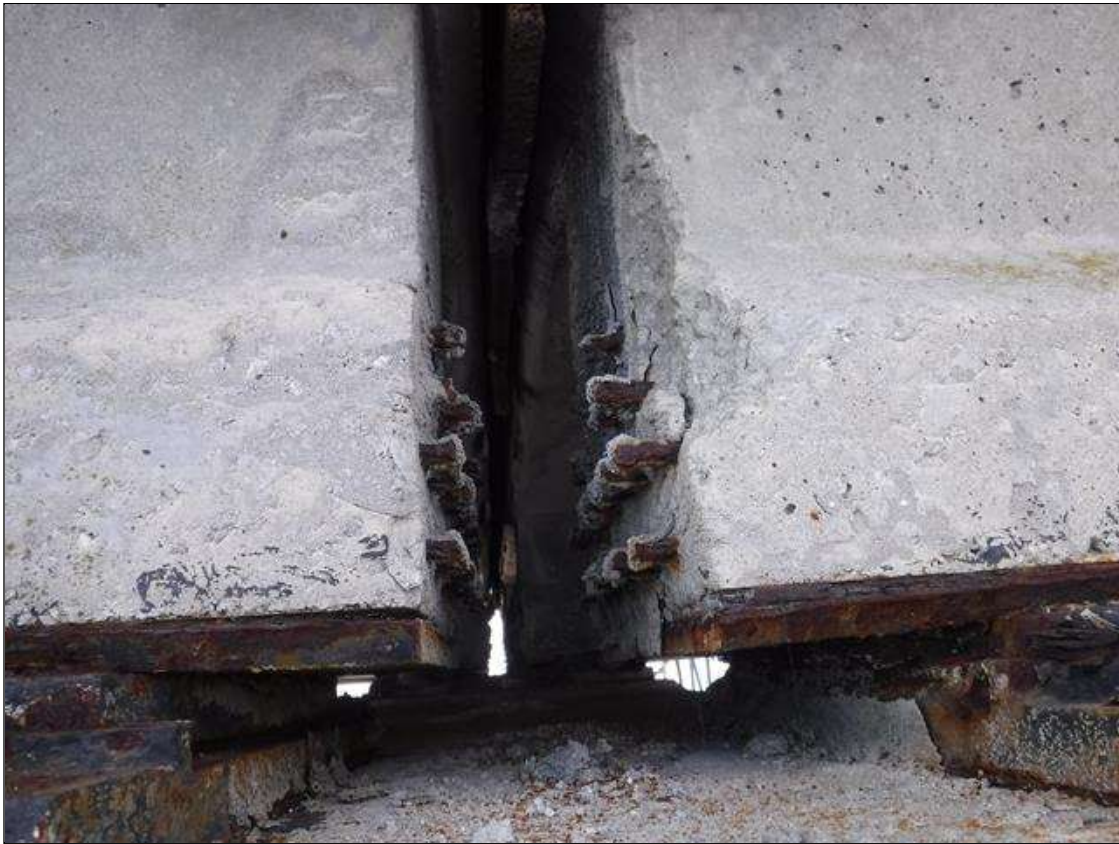
Span 79 Beam 3: (PAR) 15" X 8" X 2" DEEP SPALL WITH EXPOSED STRANDS ON SOUTH FACE AT BENT 79

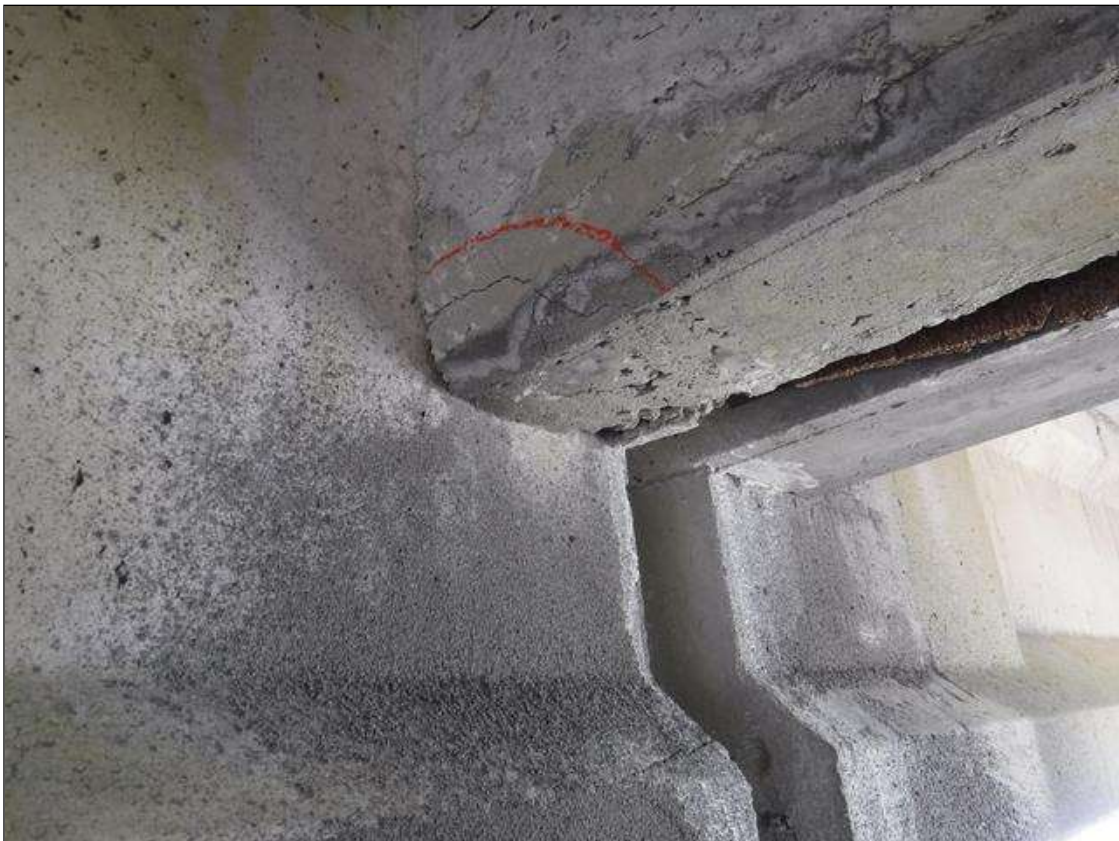
Span 81 Beam 1: 2" X 12" X 1" CORNER SPALL, NORTH FACE, AT BENT 81.

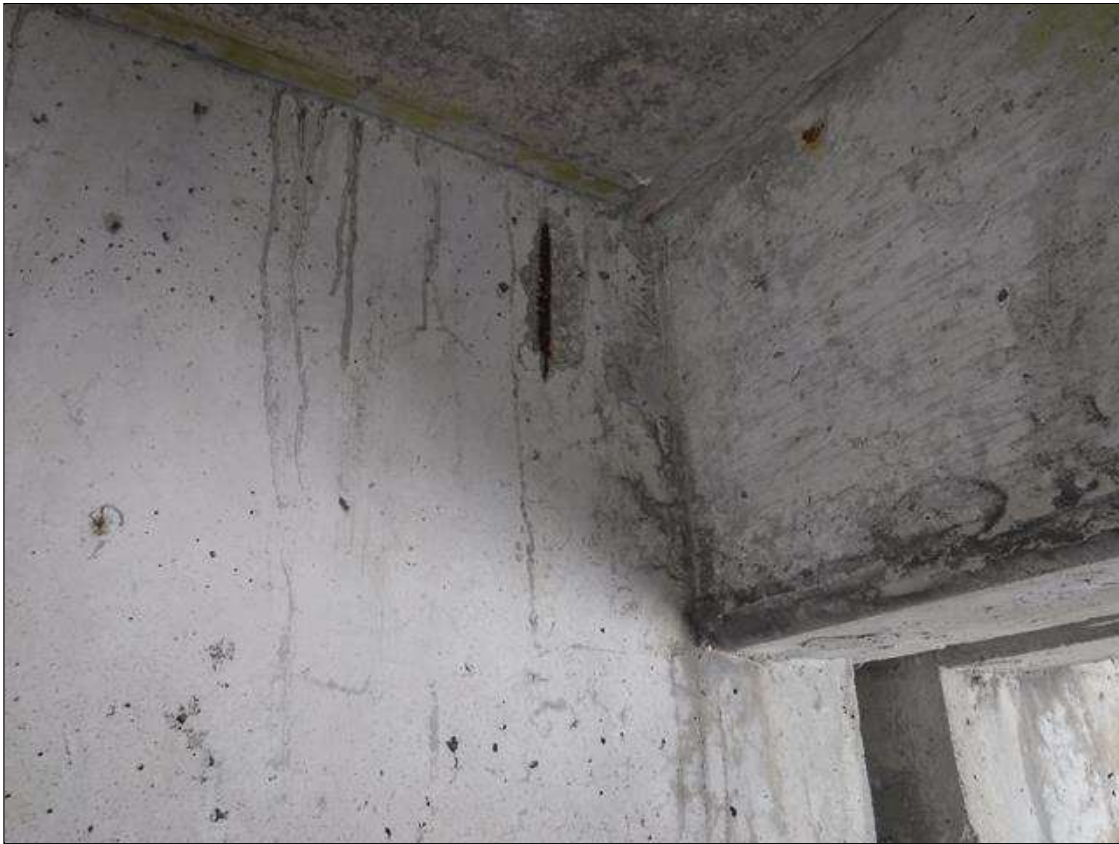
Span 83 Beam 2: 6" X 4" DELAMINATION IN BAY 2 DIAPHRAGM AT BENT 83

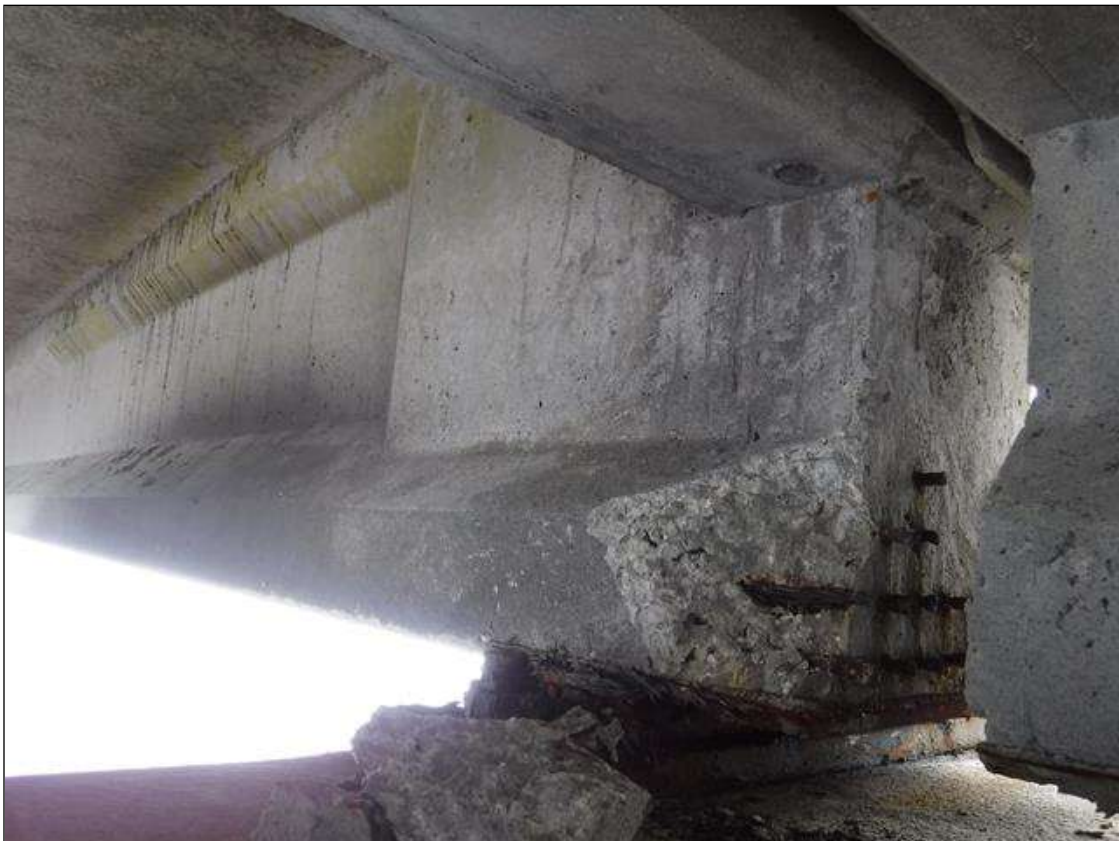
Span 86 Beam 2: 9" X 2" X 1/2" DEEP SPALL WITH EXPOSED REBAR ON SOUTH FACE IN WEB AT BENT 86

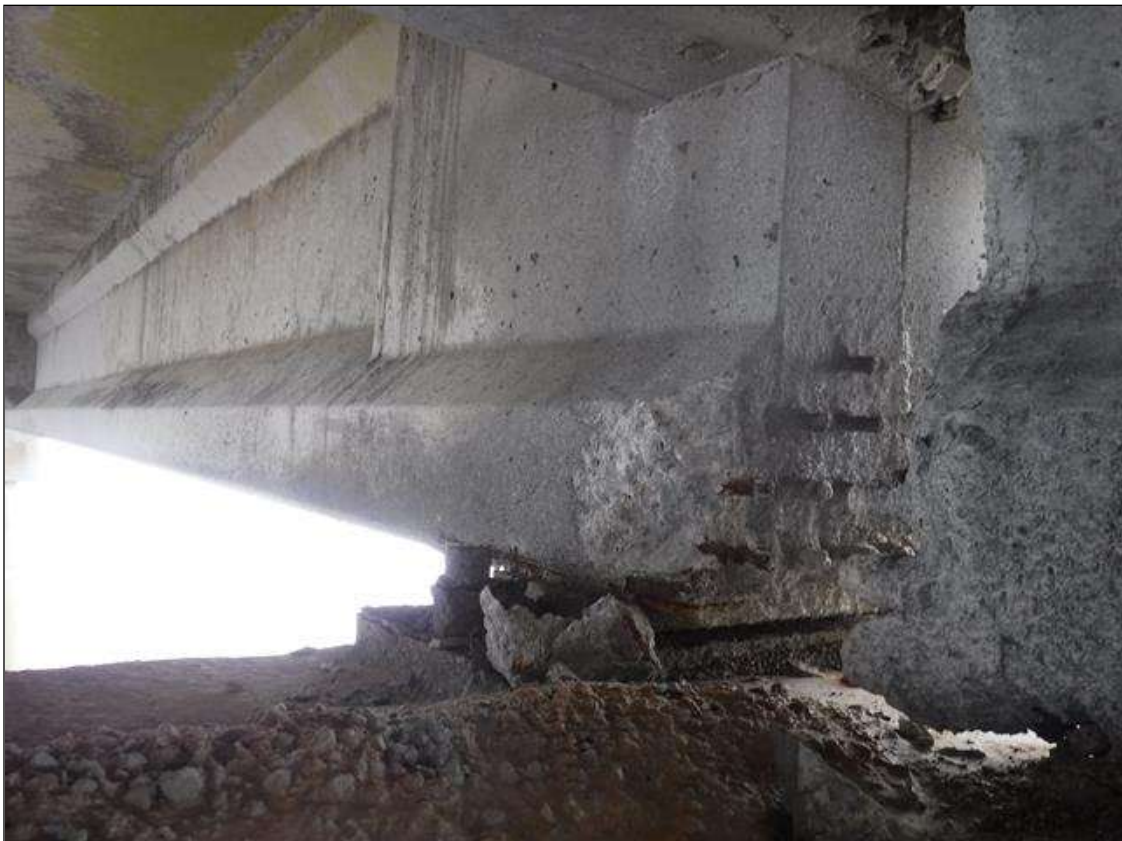
Span 89 Beam 1: (PAR) 3' X 3" X 6" SPALL WITH EXPOSED REBAR IN BAY 1 DIAPHRAGM AT BENT 88

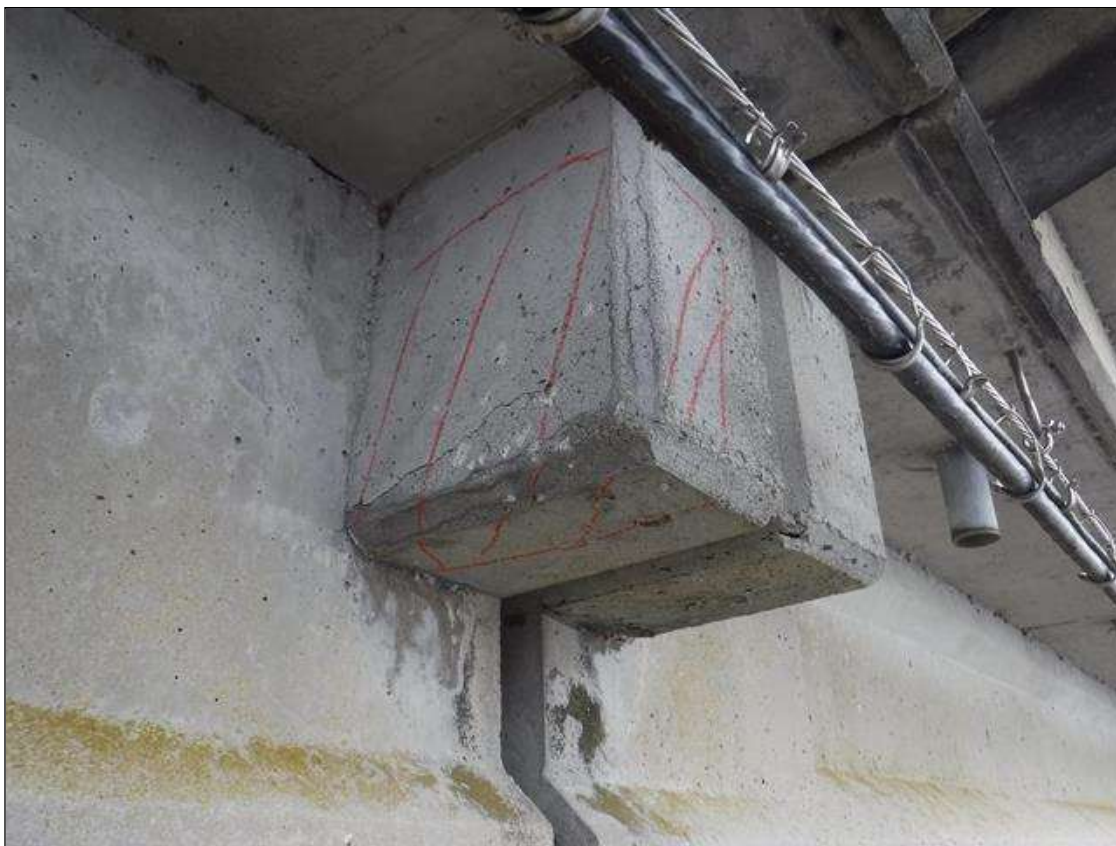
Span 90 Beam 4: (PAR) 6" X 6" X 2" DEEP SPALL WITH EXPOSED STRAND ON NORTH FACE AT BENT 89

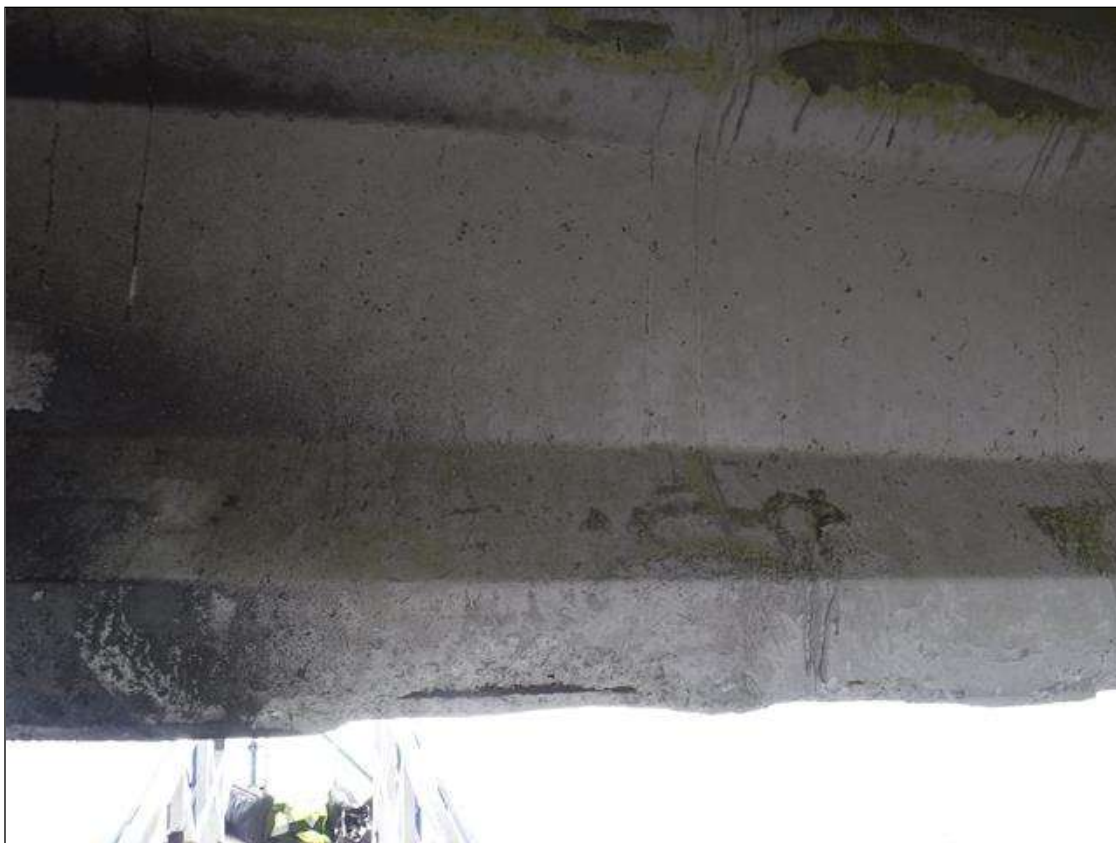
Span 91 Beam 4: 1' X 1' DELAMINATION, END DIAPHRAGM, RIGHT OVERHANG, AT BENT 91.

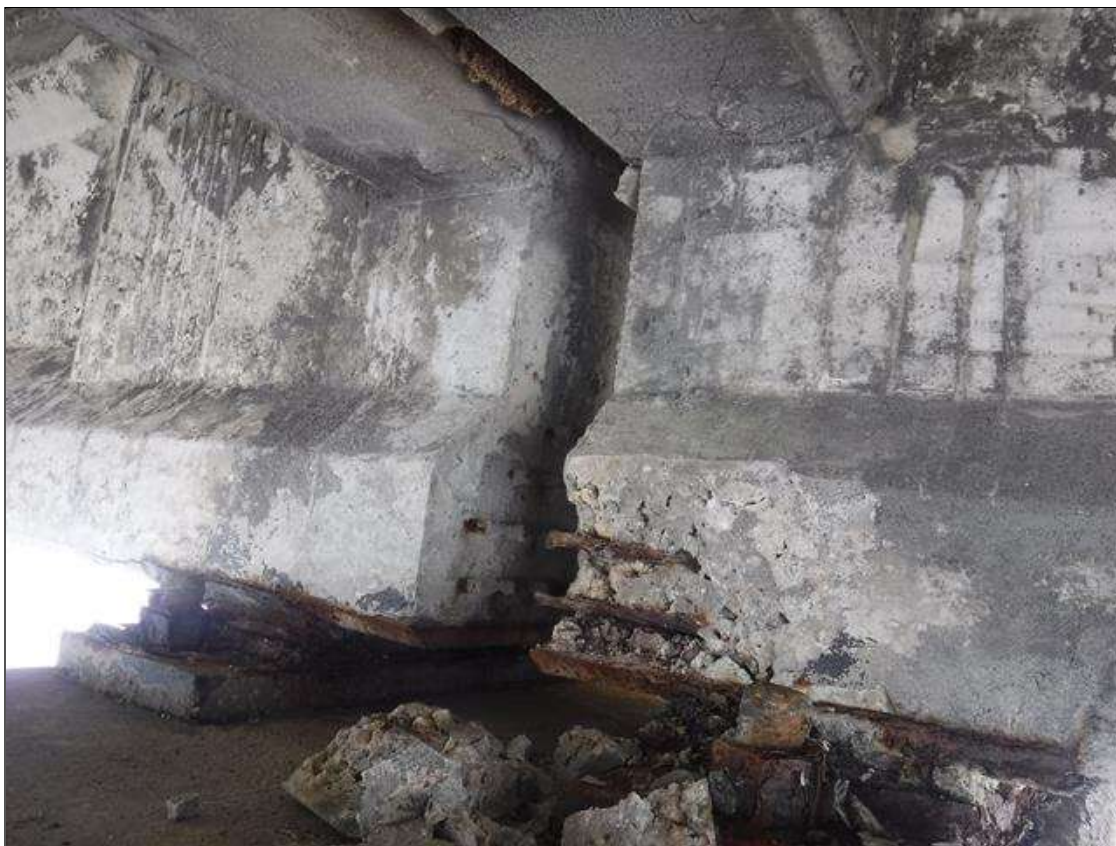
Span 97 Beam 3: (PAR) (3) UP TO 18" LONG X 5" WIDE X 6" SPALL WITH EXPOSED STRANDS ON NORTH FACE
25' FROM BENT 97

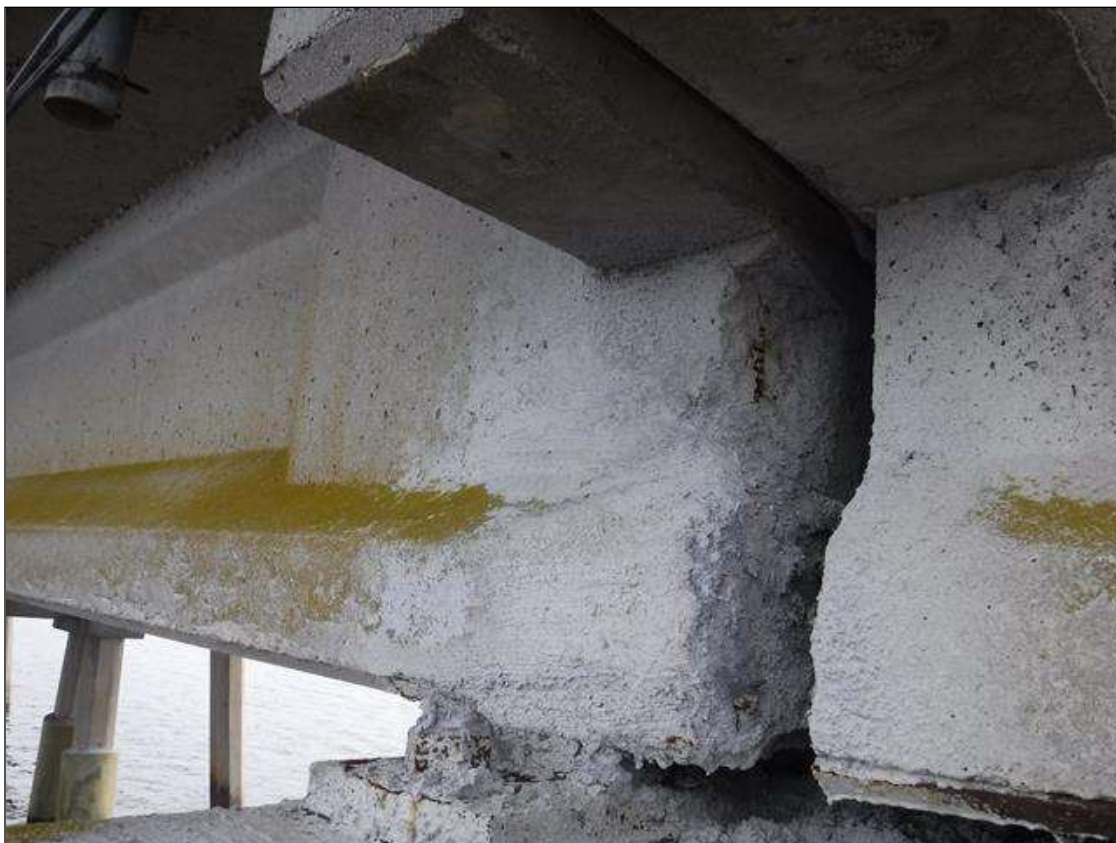
Span 98 Beam 3: (PAR) 6" X 6" X 2" DEEP SPALL WITH EXPOSED STRAND ON SOUTH FACE AT BENT 98

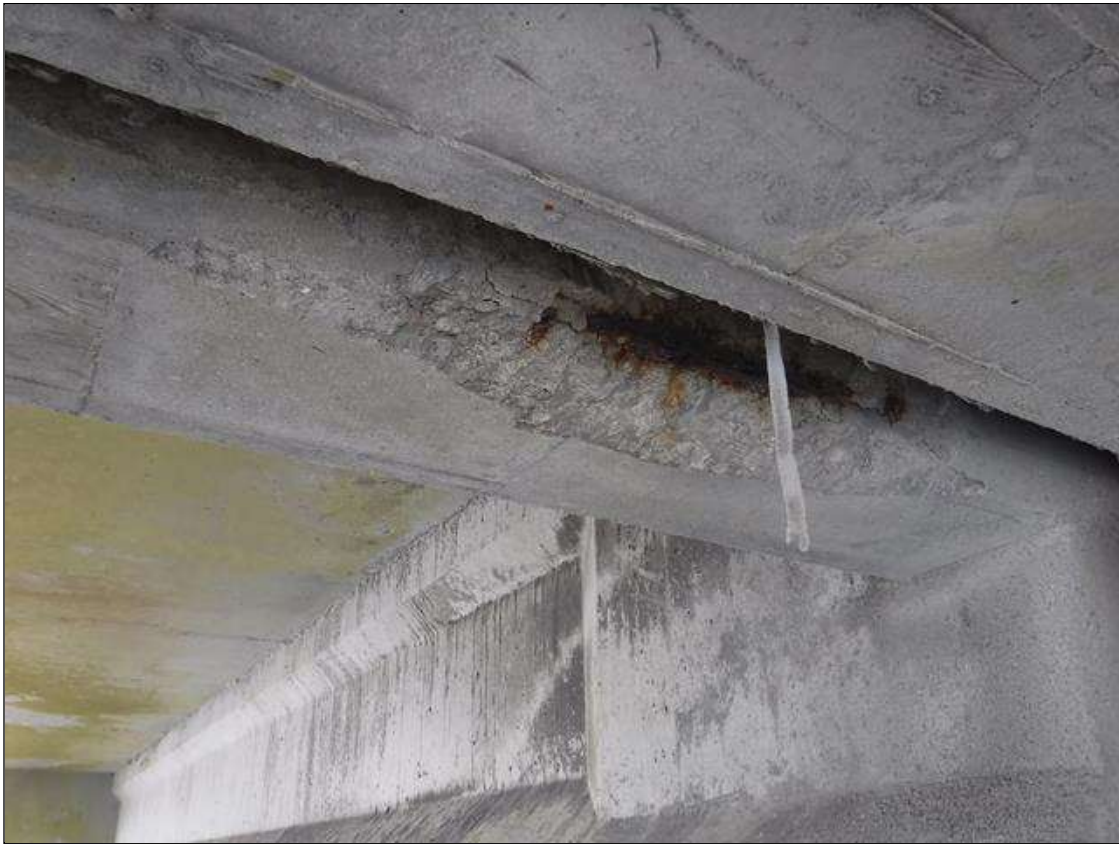
Span 101 Beam 1: 1' X 1' PATCHED AREA WITH EXPOSED REBAR, NORTH FACE, AT BENT 100.

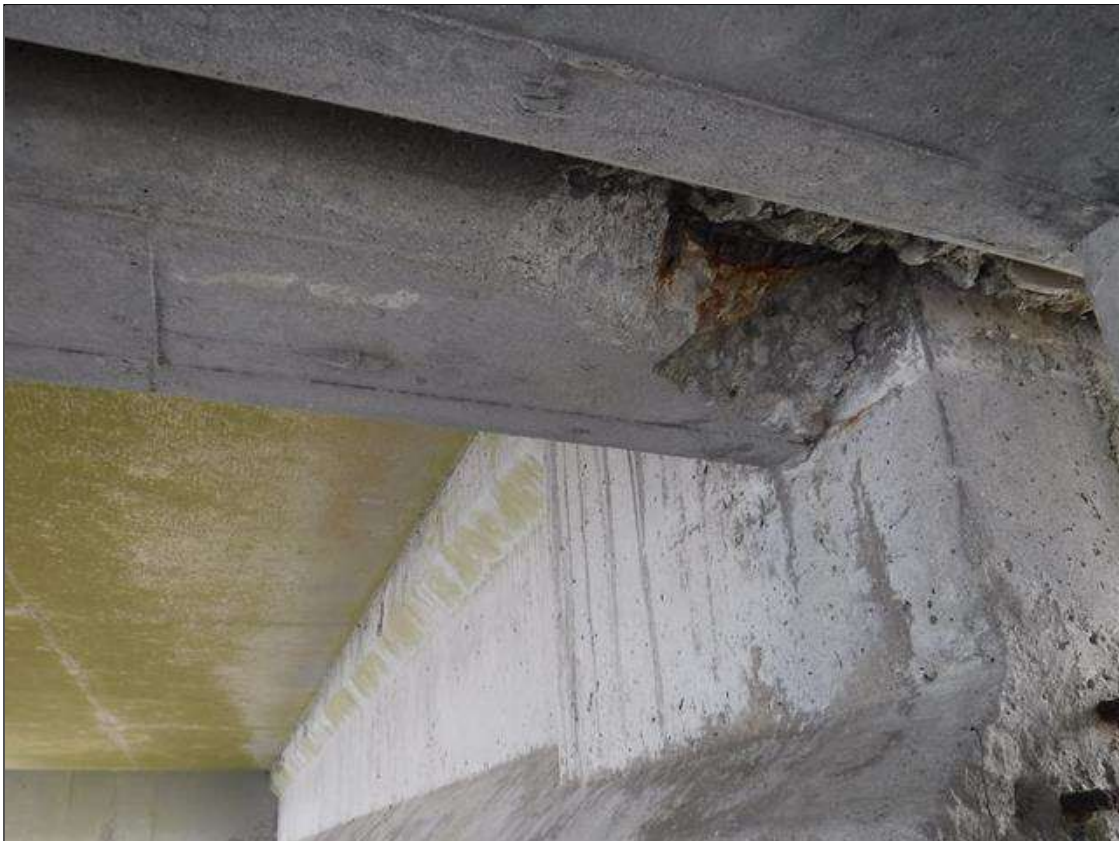
Span 107 Beam 1: (PAR) 2' X 6" X 4" DEEP SPALL WITH EXPOSED REBAR AND 10 PERCENT SECTION LOSS IN BAY 1 DIAPHRAGM AT BENT 106

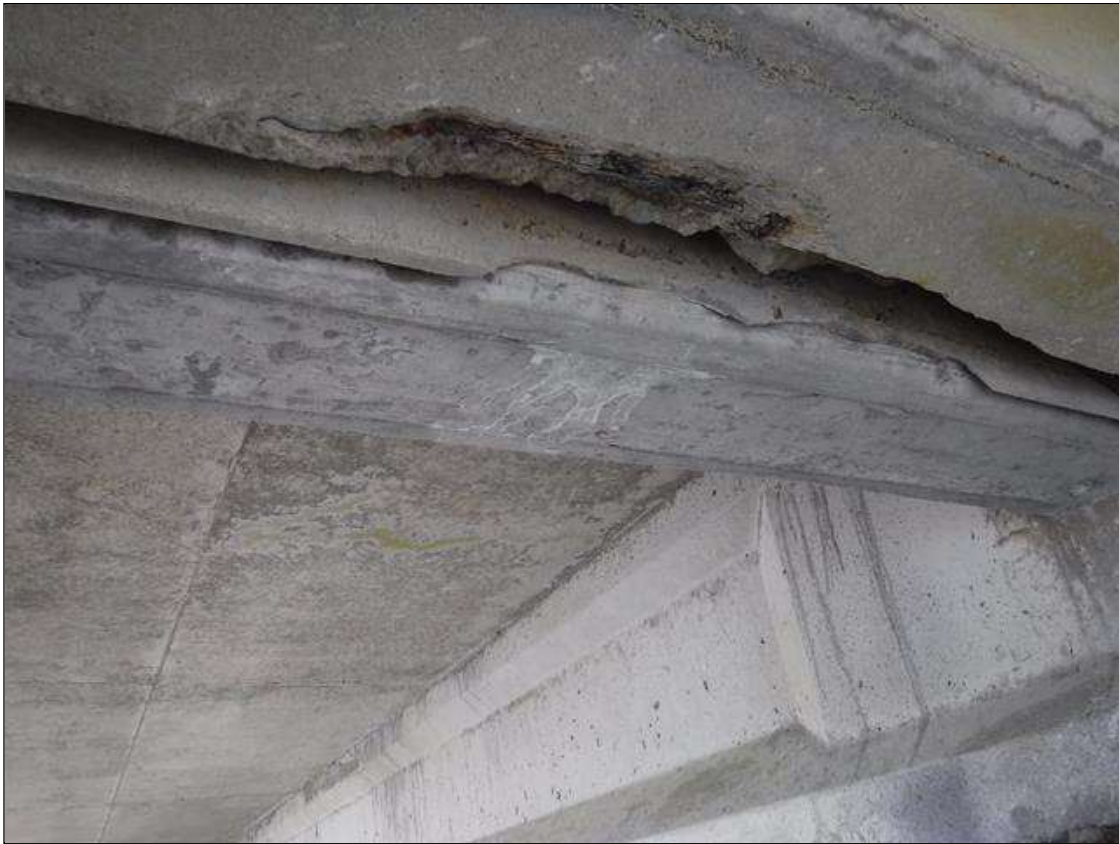
Span 107 Beam 3: (PAR) 1' X 6" X 4" DEEP SPALL WITH EXPOSED REBAR AND 10 PERCENT SECTION LOSS IN BAY 3 DIAPHRAGM AT BENT 106

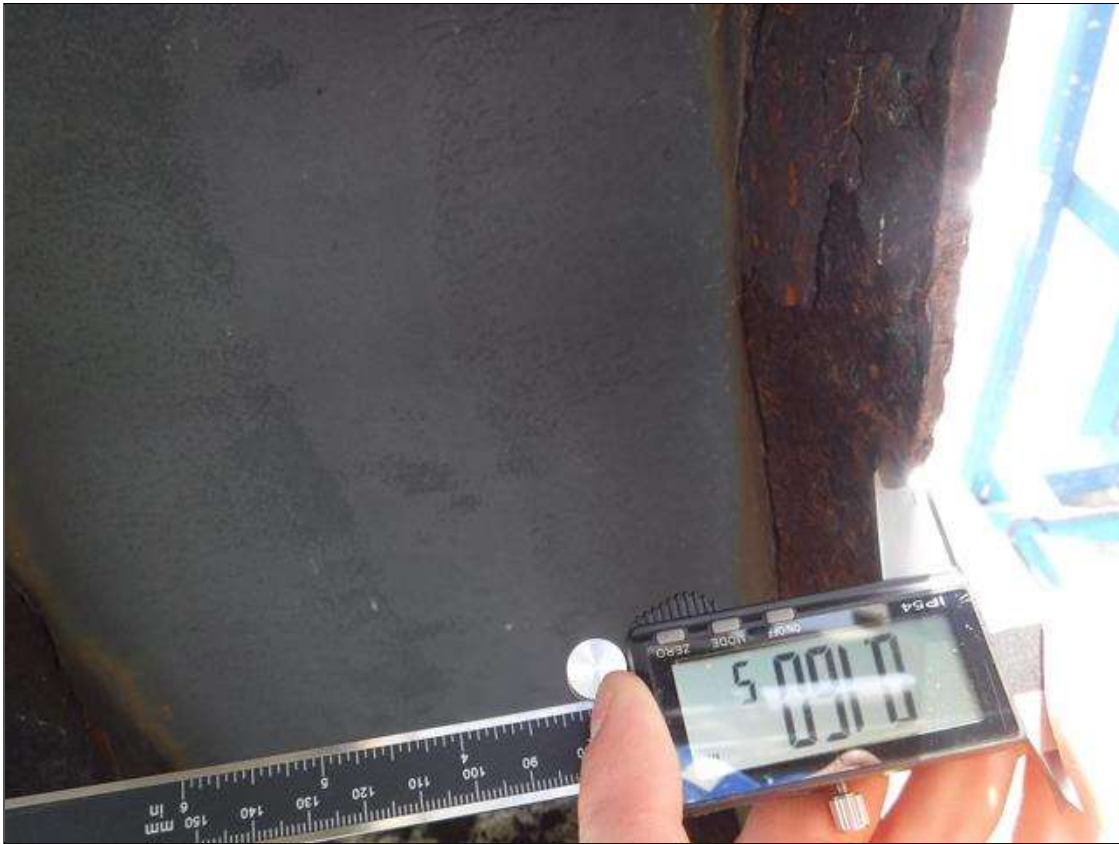
Bent 109 Pile 7: (PAR) 5' RUST SCALE, 0.218" REMAINING, EAST FLANGE, 0.16" REMAINING ON WEST FLANGE, WITH (4) HOLES UP TO 3" X 2" ON EAST FLANGE.

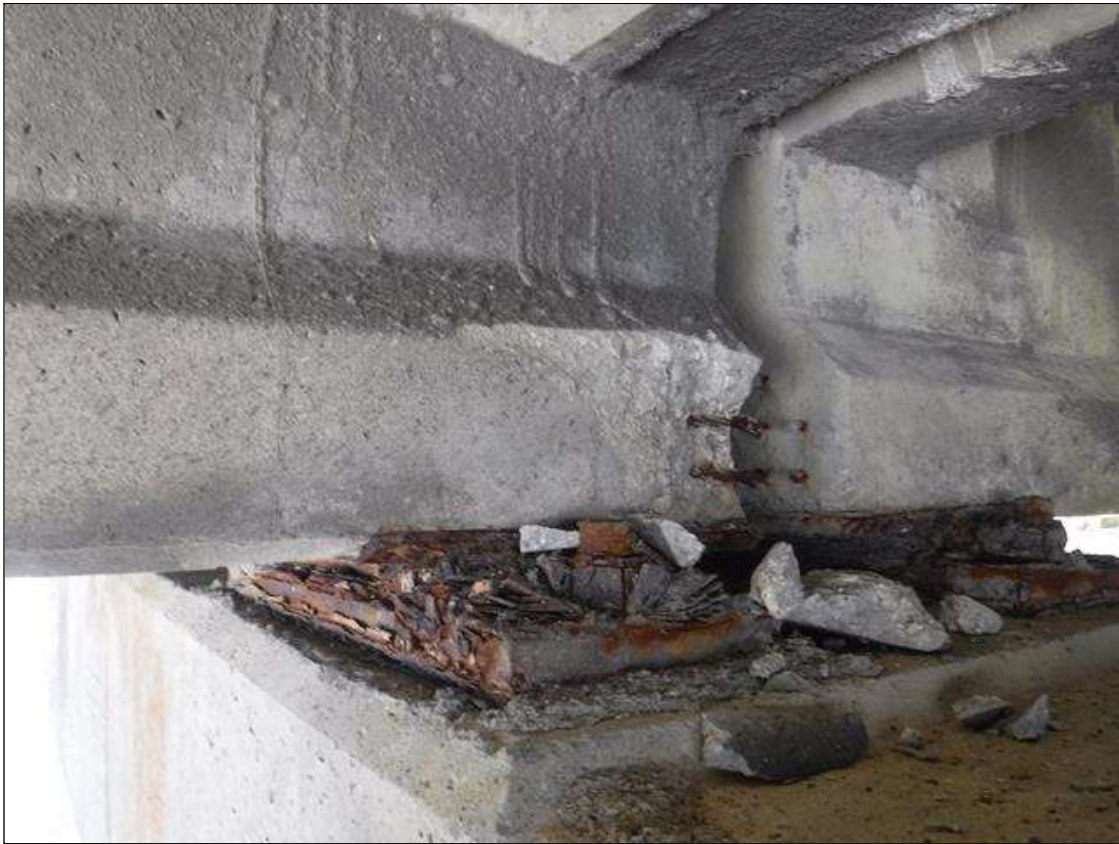
Span 112 Beam 1: 6' X UP TO 1.5' PATCHED AREA, 2" DEEP SPALL REMAINS, EAST FACE OF BENT 112 DIAPHRAGM, BETWEEN BEAMS 1 AND 2.

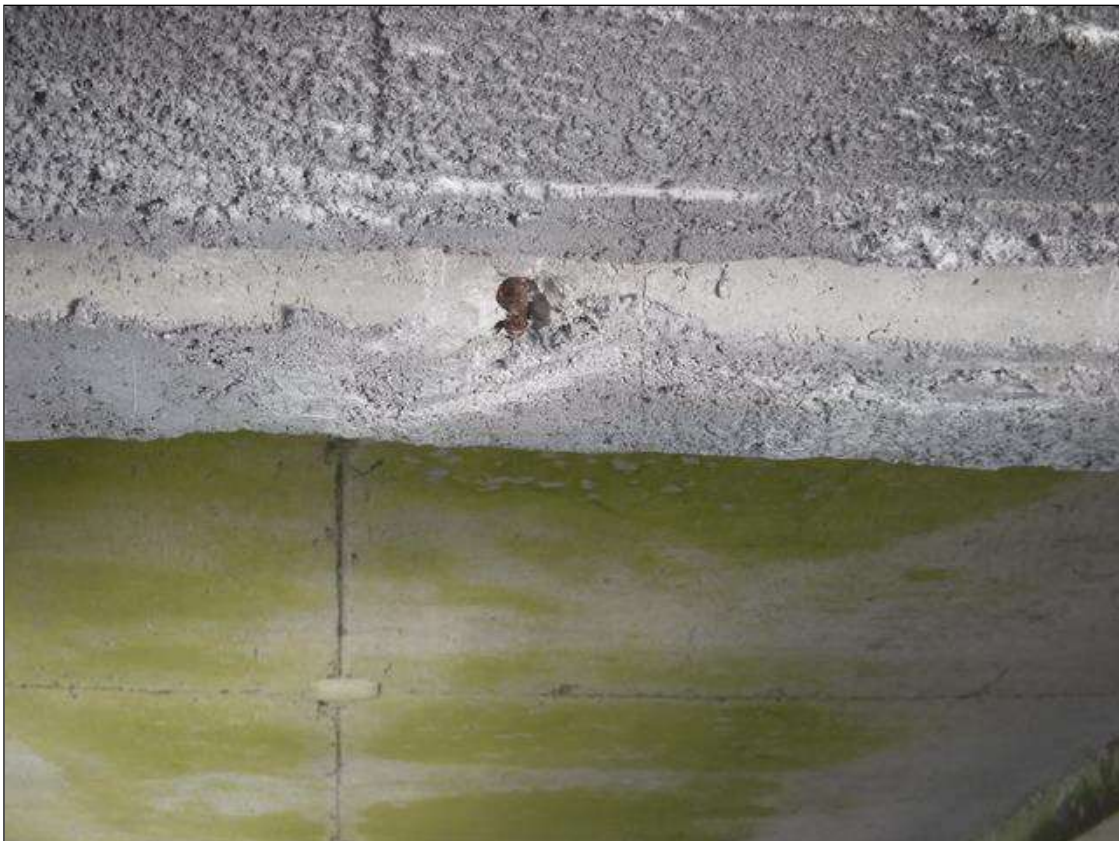
Span 114 Beam 3: (PAR) 8" X 6" X 2" DEEP SPALL WITH EXPOSED STRANDS ON SOUTH FACE AT BENT 114

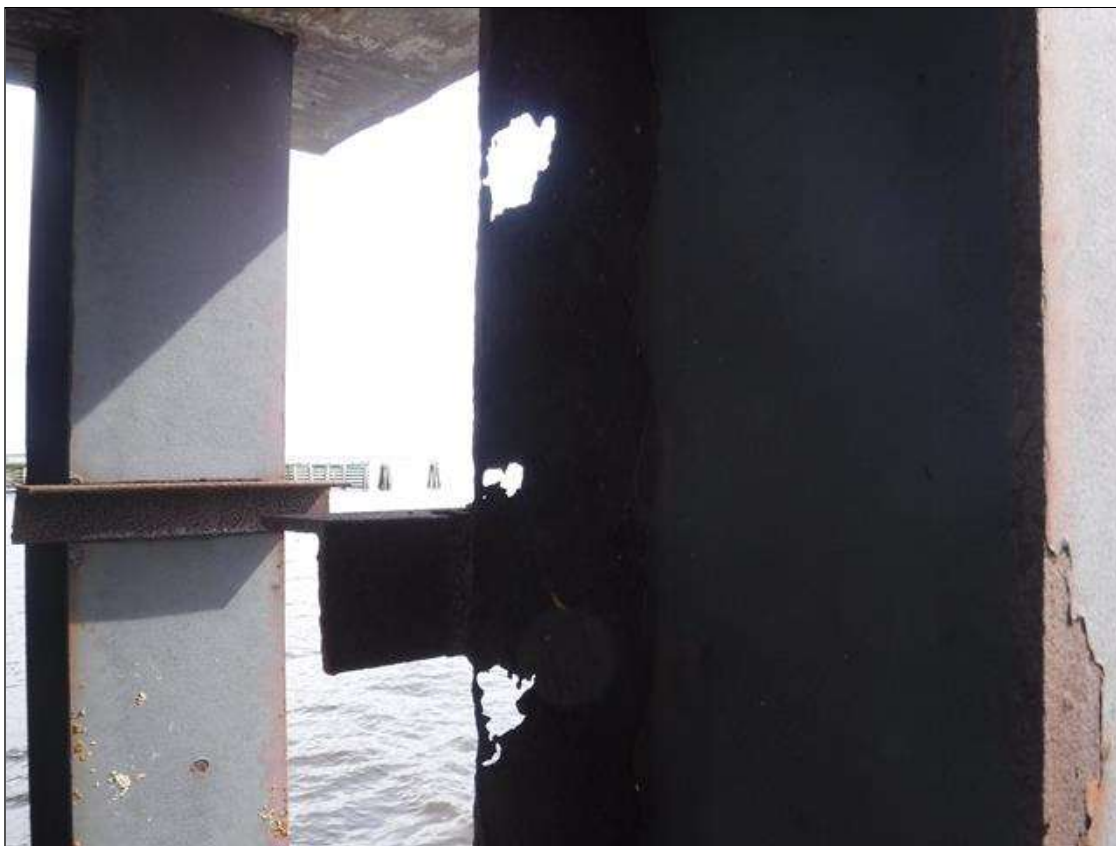
Span 115 Beam 3: 3' X UP TO 1' PATCHED AREA WITH 6" AREA OF EXPOSED REBAR, WEST FACE OF BENT 114 DIAPHRAGM, BETWEEN BEAMS 3 AND 4.

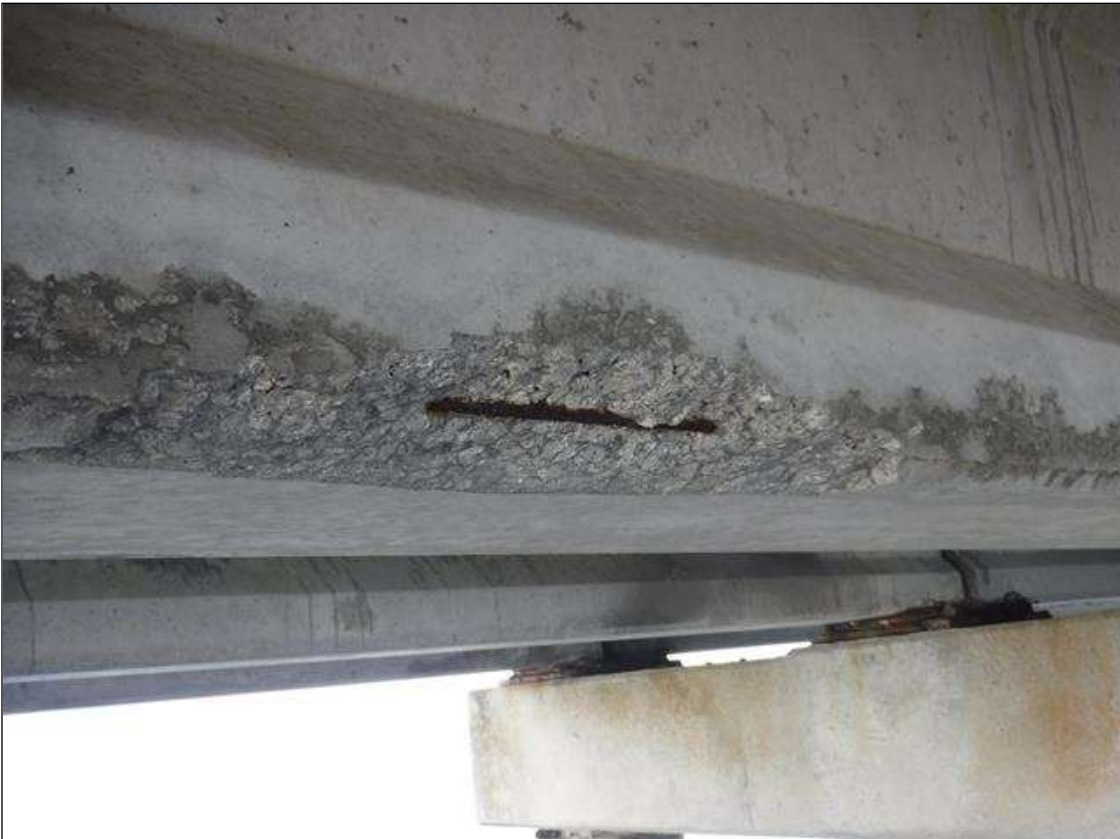
Span 118 Beam 2: (PAR) 6" X 6" X 2" DEEP SPALL WITH EXPOSED STRAND ON SOUTH FACE AT BENT 118
