NC DEPARTMENT OF TRANSPORTATION
DIVISION OF HIGHWAYS
STRUCTURE MANAGEMENT UNIT

Structure Safety Report

Routine Element Inspection - Contract

FEATURE INTERSECTED: ALLIGATOR RIVER

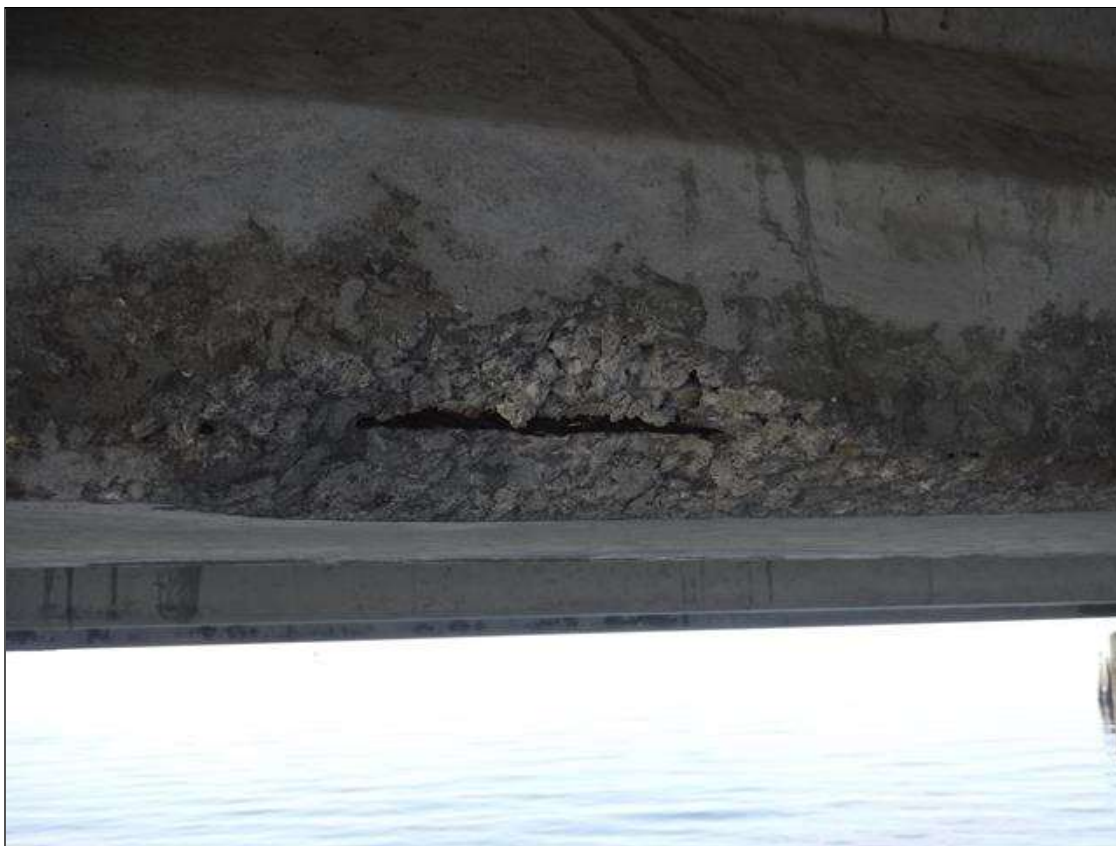
Span 121 Beam 2: (PAR) 30" X 3" X 3" EDGE SPALL, WITH EXPOSED STRAND, BOTTOM NORTH CORNER, 12' FROM BENT 120.

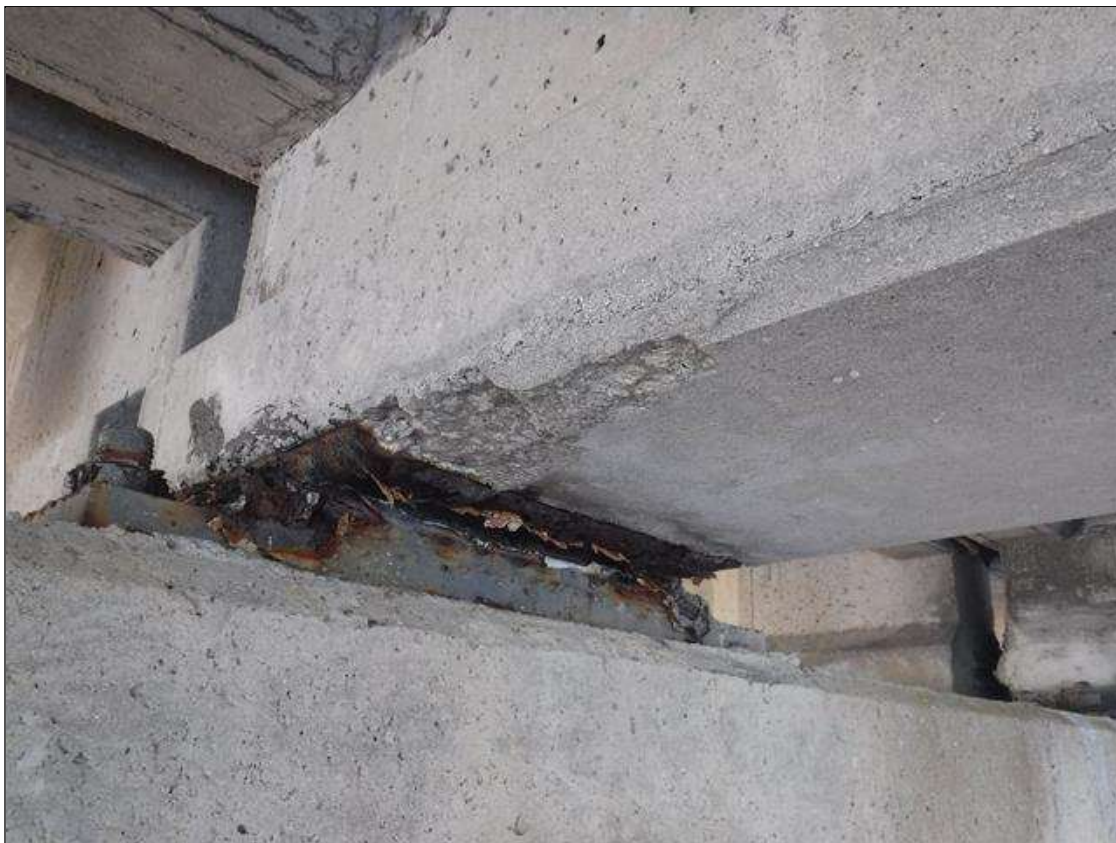
Span 121 Beam 2: (PAR) 20" X 3" X 1" EDGE SPALL, WITH EXPOSED STRAND AND 10 PERCENT SECTION LOSS, BOTTOM NORTH CORNER, 16' FROM BENT 120.

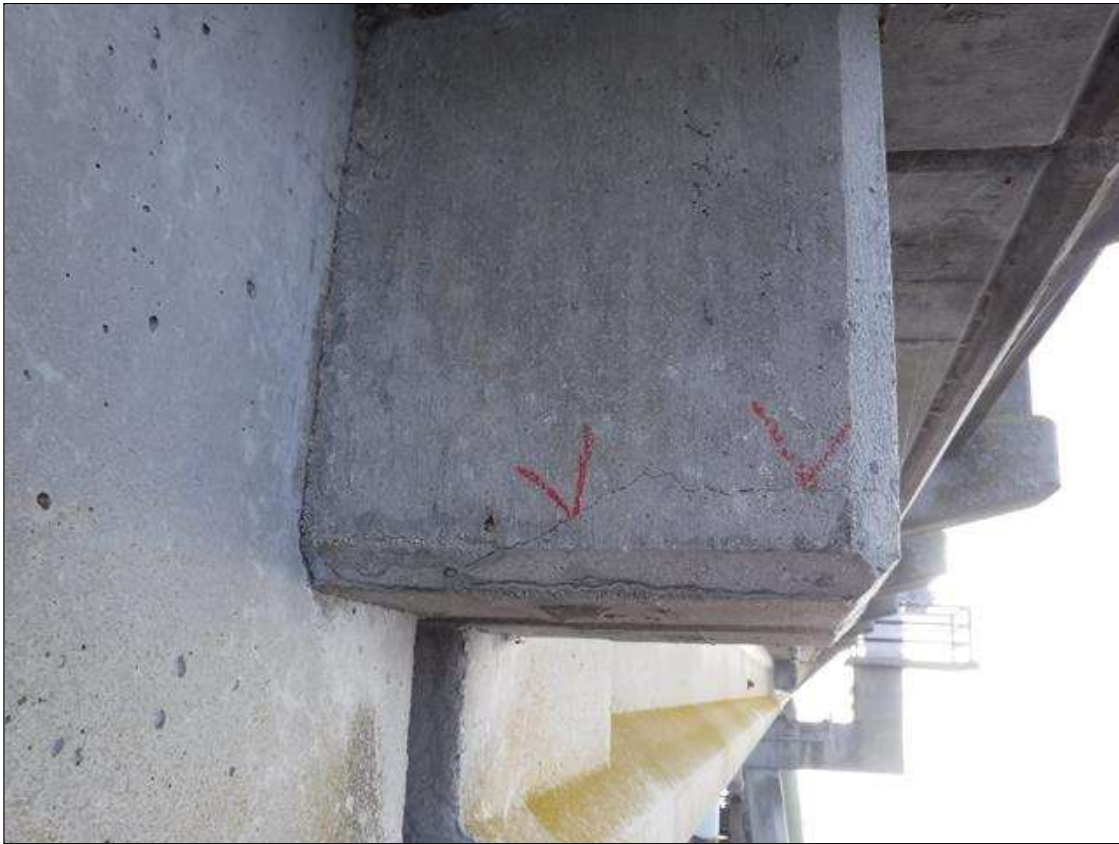
Span 121 Beam 2: 10" X 3" X 1/2" DEEP SPALL ON BOTTOM NORTH FACE AT BENT 121

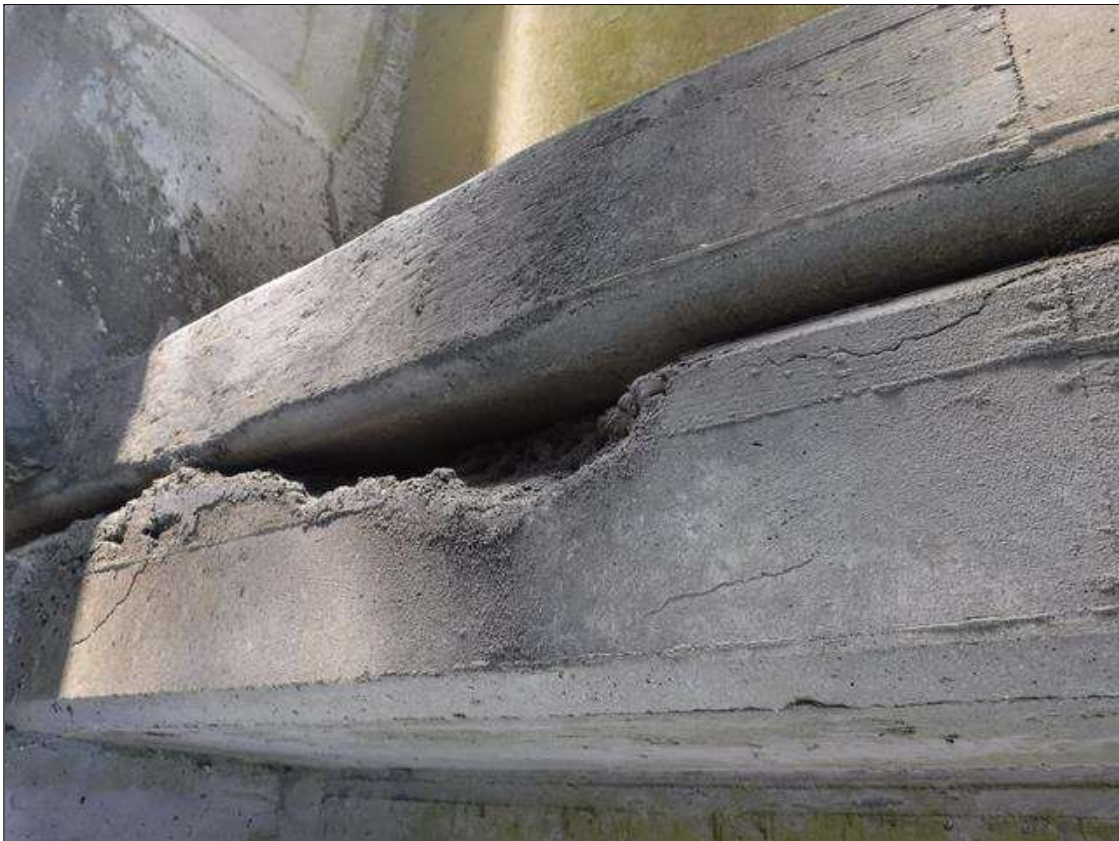
Span 122 Beam 4: 2' X 3" X 3" DEEP SPALL WITH EXPOSED REBAR ON EAST FACE OF BAY 3 DIAPHRAGM AT BENT 122

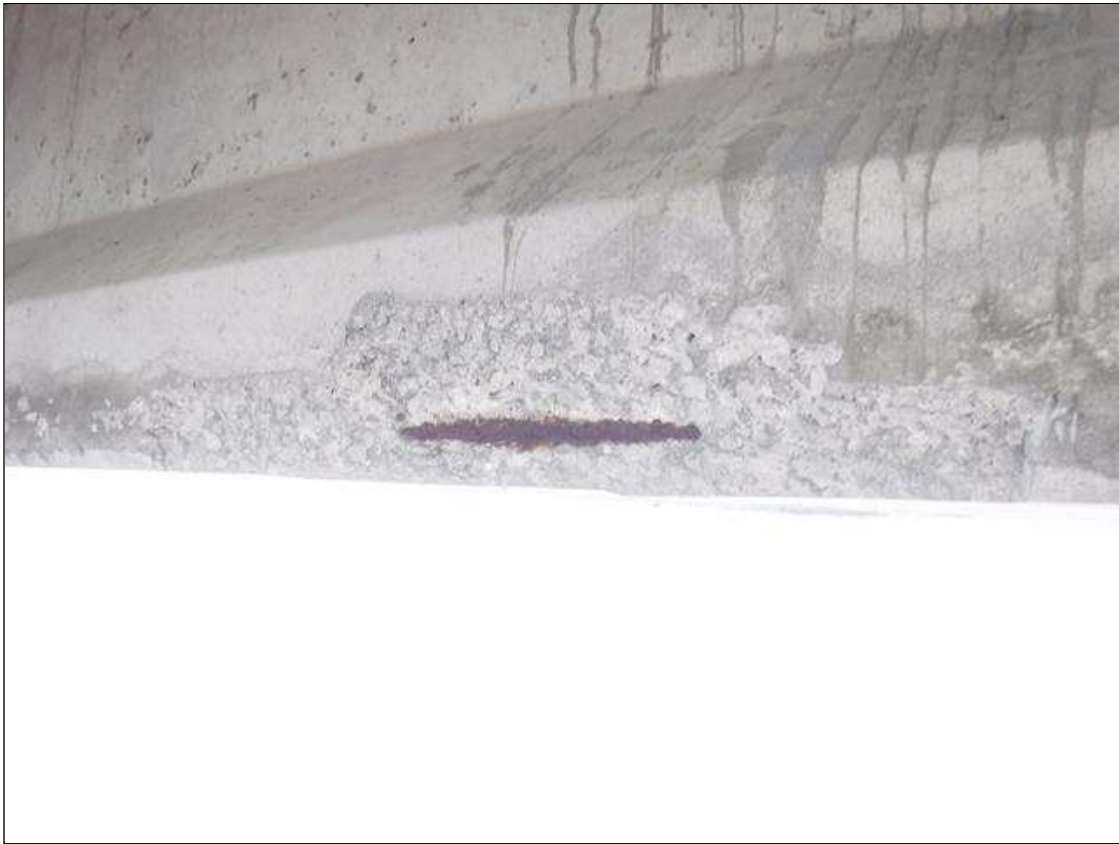
Span 125 Beam 1: (PAR) 2' X 6" X 4" DEEP SPALL WITH EXPOSED STRAND ON SOUTH FACE AT MIDSPAN

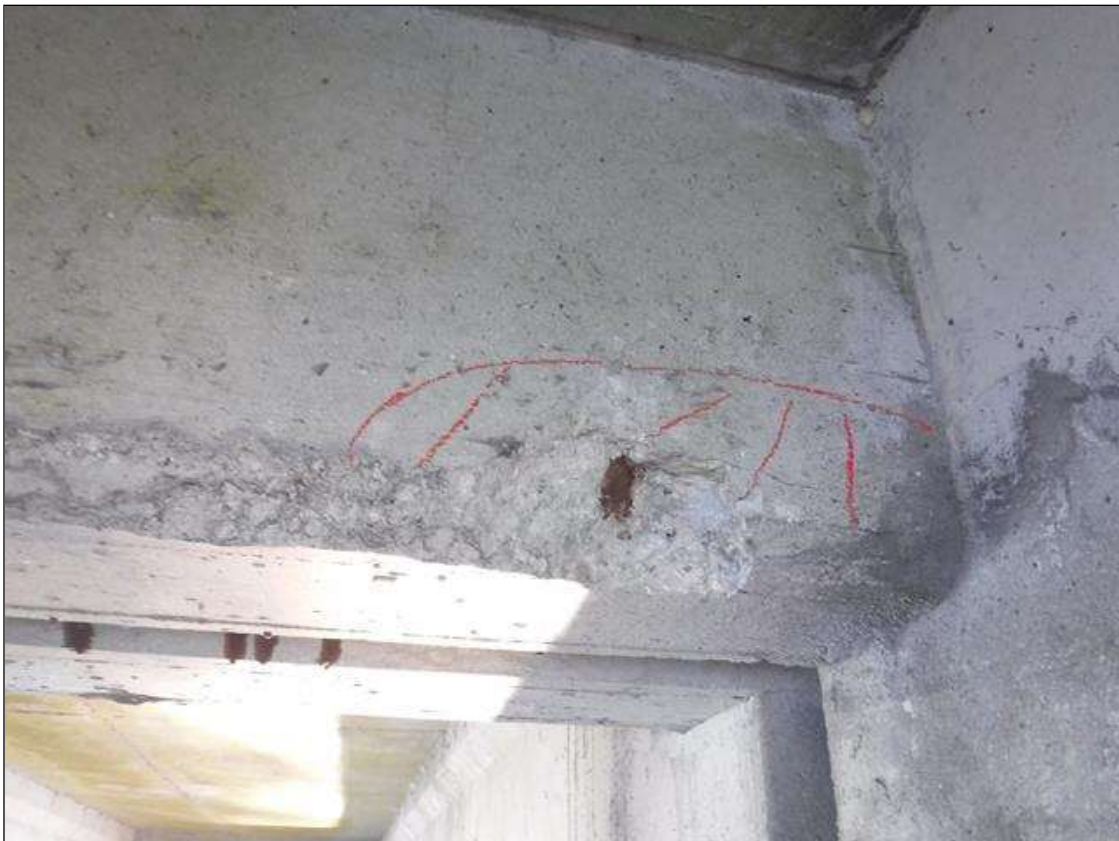
Span 126 Beam 2: 6" DIAMETER X 2" DEEP SPALL WITH 1' DELAMINATION, WEST FACE OF BENT 126 DIAPHRAGM, BETWEEN BEAMS 2 AND 3.

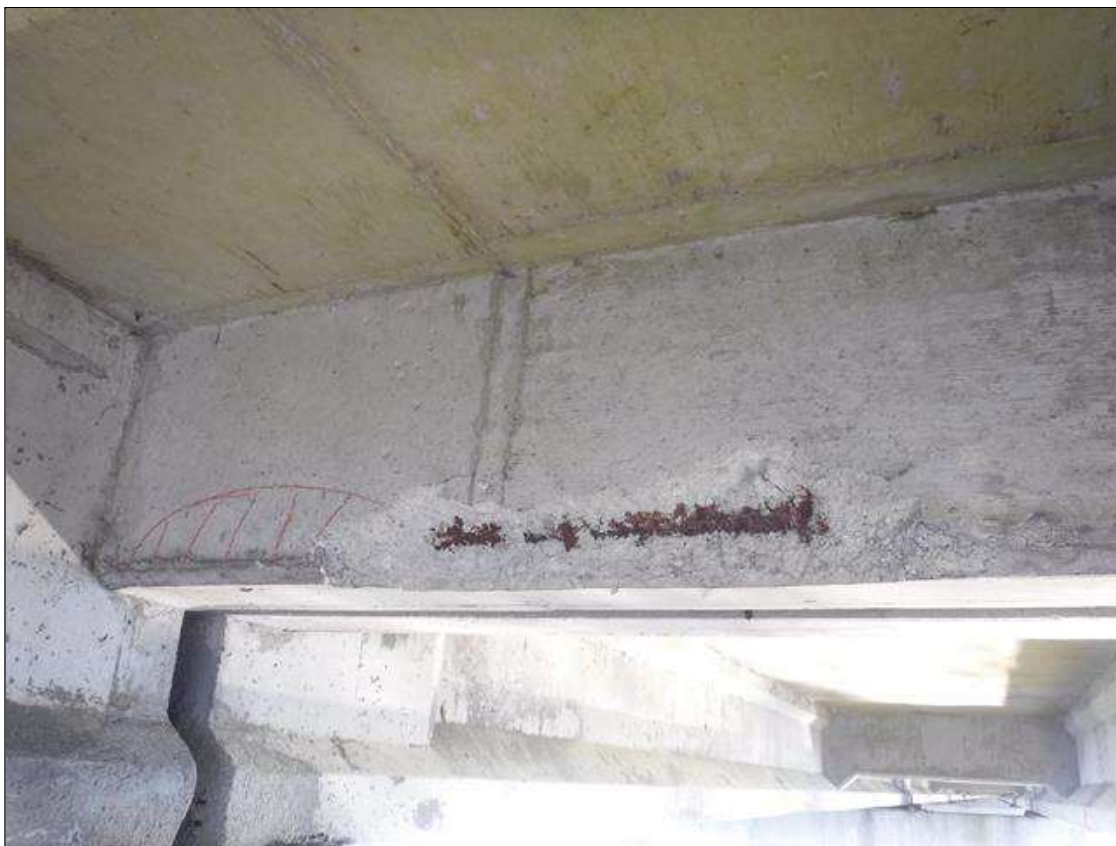
Span 127 Beam 3: (PAR) 5' X 1' X 2" DEEP SPALL WITH EXPOSED REBAR, WEST FACE OF BENT 127 DIAPHRAGM, BETWEEN BEAMS 3 AND 4

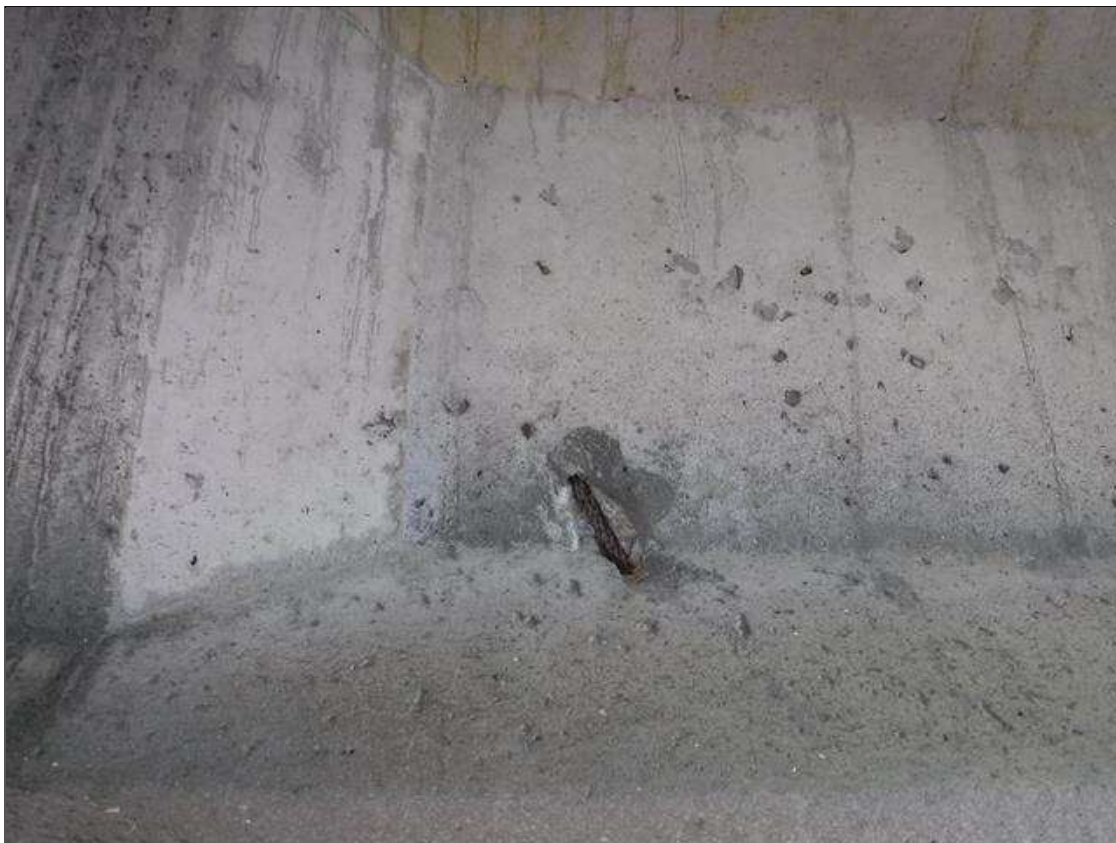
Span 128 Beam 4: (PAR) 2" DIAMETER X 1/2" SPALL, WITH EXPOSED STRAND, NORTH FACE, 3' FROM BENT 128.

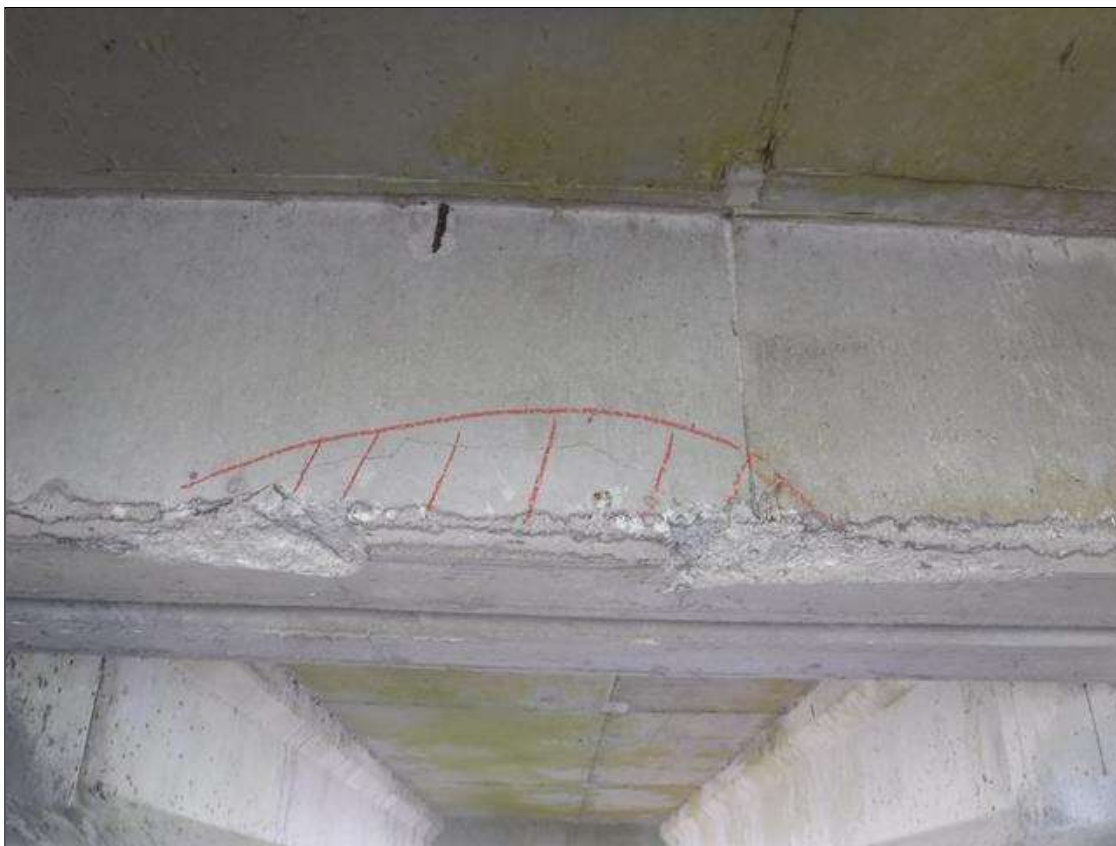
Span 129 Beam 1: 4' X 1' X 4" DEEP SPALL WITH SURROUNDING DELAMINATION, EAST FACE OF BENT 128 DIAPHRAGM, BETWEEN BEAMS 1 AND 2

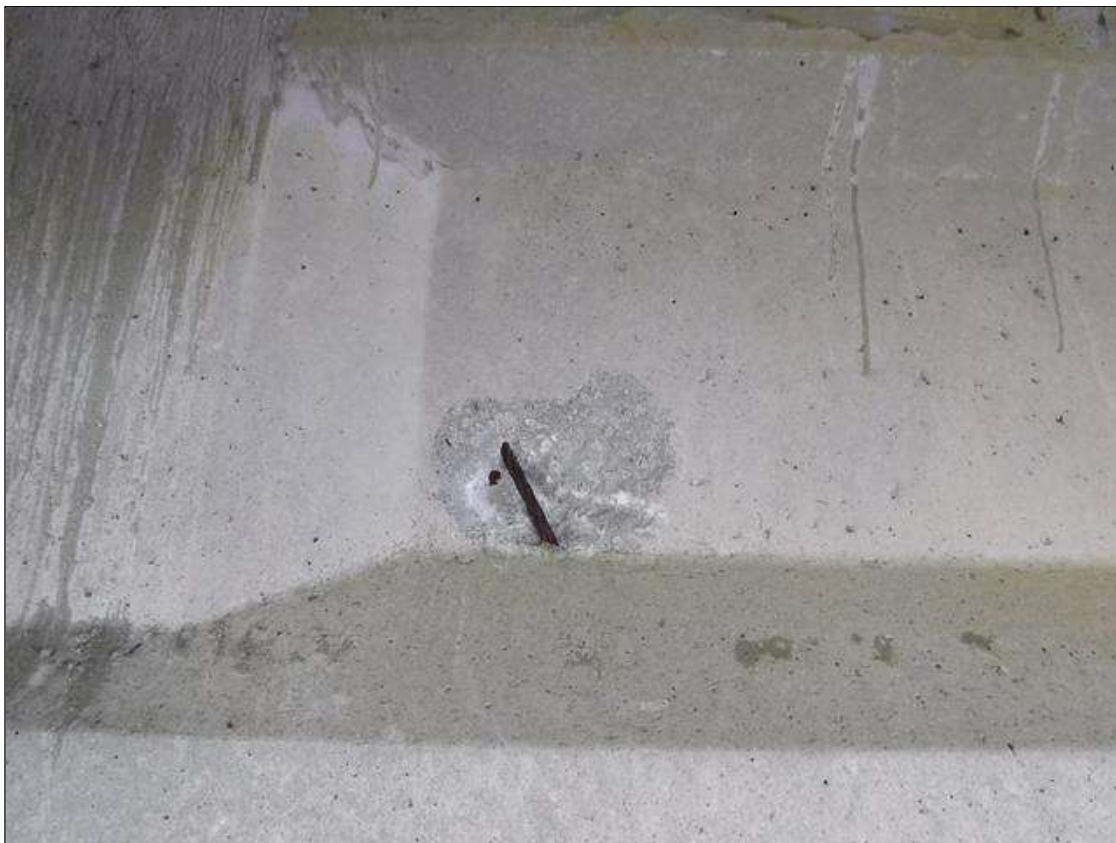
Span 130 Beam 2: (PAR) 9" X 6" X 1.5" DEEP SPALL, WITH EXPOSED STRAND, NORTH FACE, 3' FROM BENT 130.

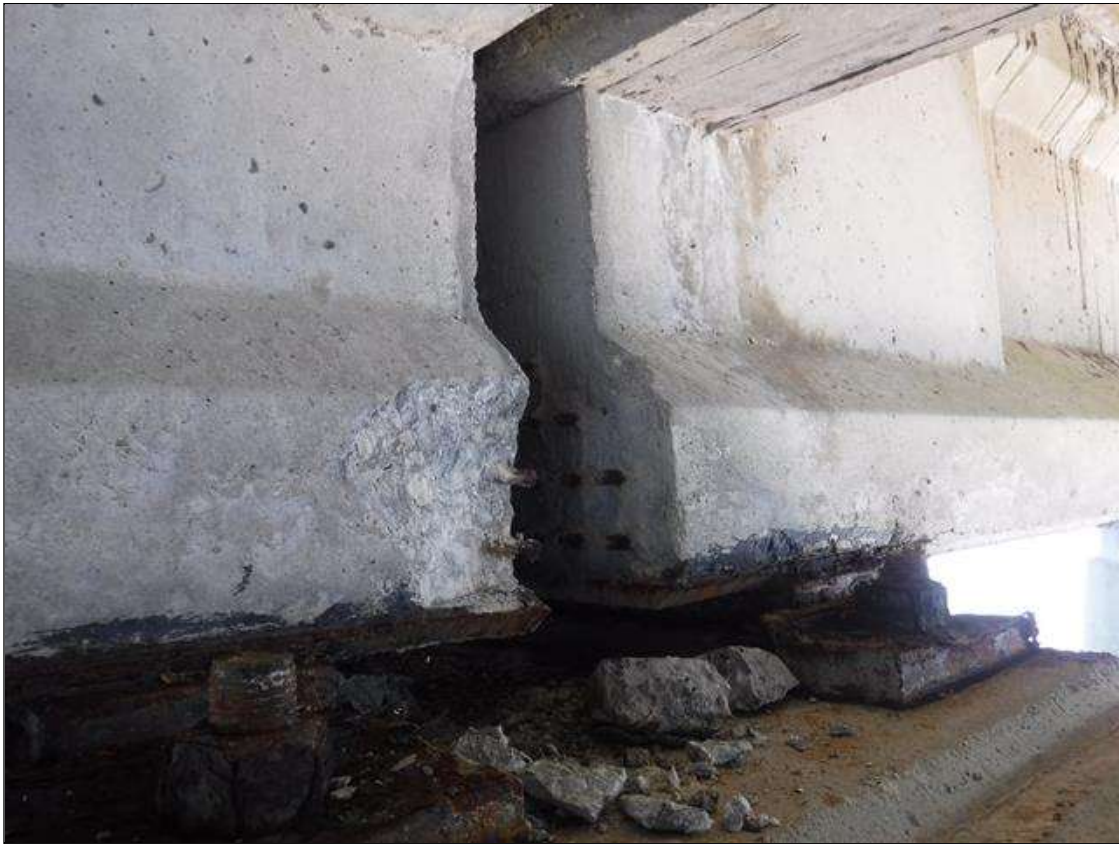
Span 132 Beam 3: (PAR) 6" X 6" X 2" DEEP SPALL WITH EXPOSED STRAND ON SOUTH FACE AT BENT 132

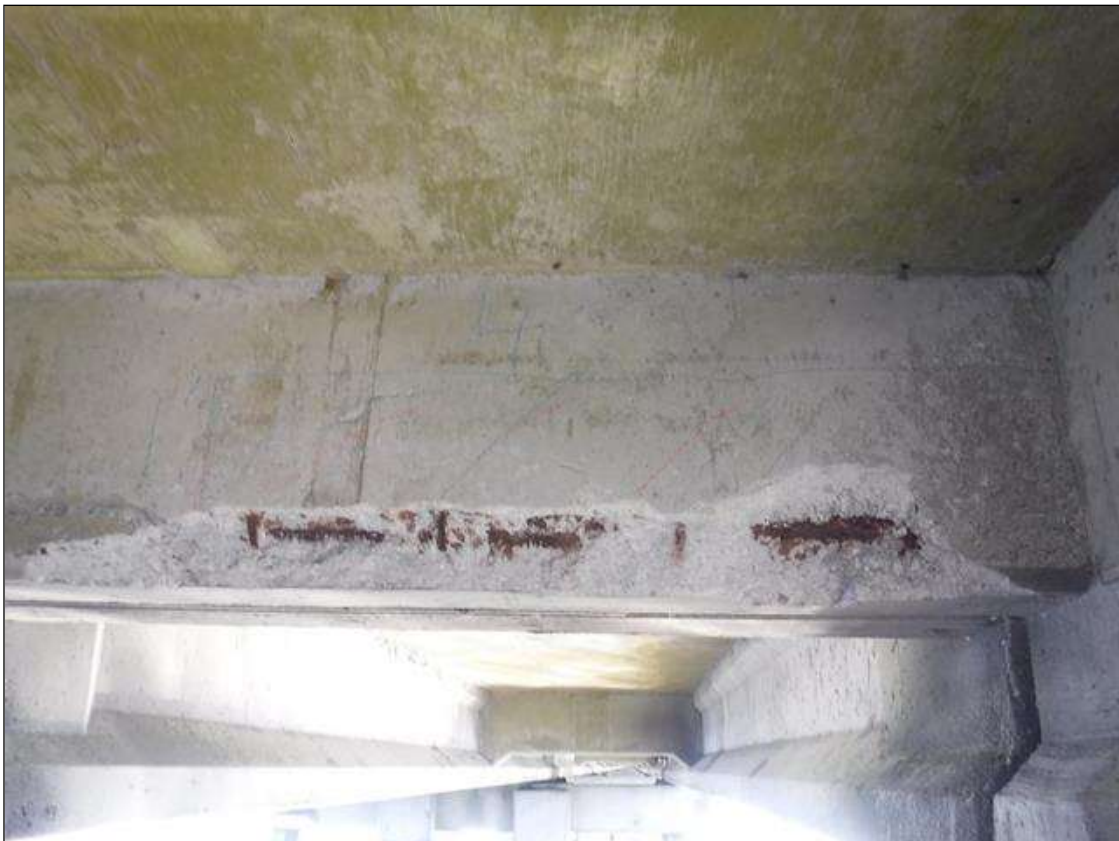
Span 134 Beam 3: (PAR) 5' X 10" X 3" DEEP SPALL WITH EXPOSED REBAR AND 4' X 1' SURROUNDING DELAMINATION ON WEST FACE BAY 3 DIAPHRAGM AT BENT 134

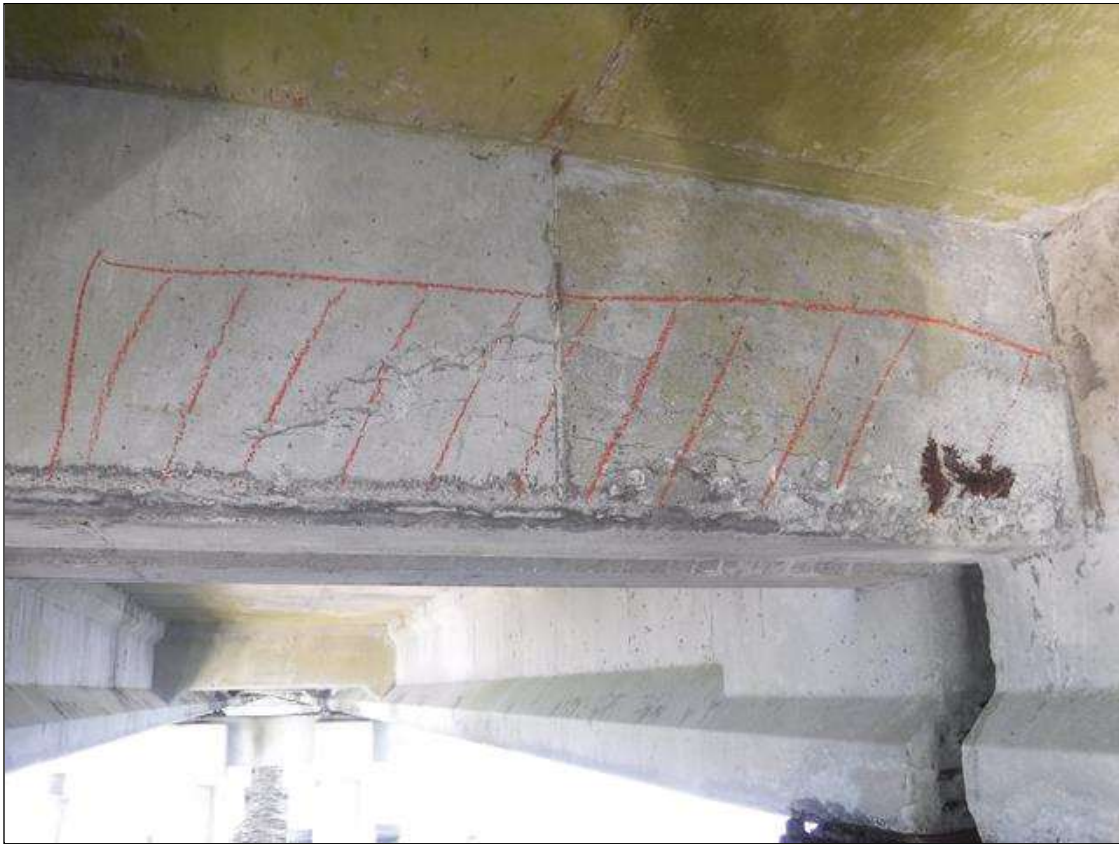
Span 137 Beam 2: (PAR) 18" X UP TO 12" X 1" SPALL, WITH EXPOSED REINFORCING, EAST FACE, BENT 136 DIAPHRAGM, BETWEEN BEAMS 2 AND 3, WITH 4' X 12" DELAMINATION.

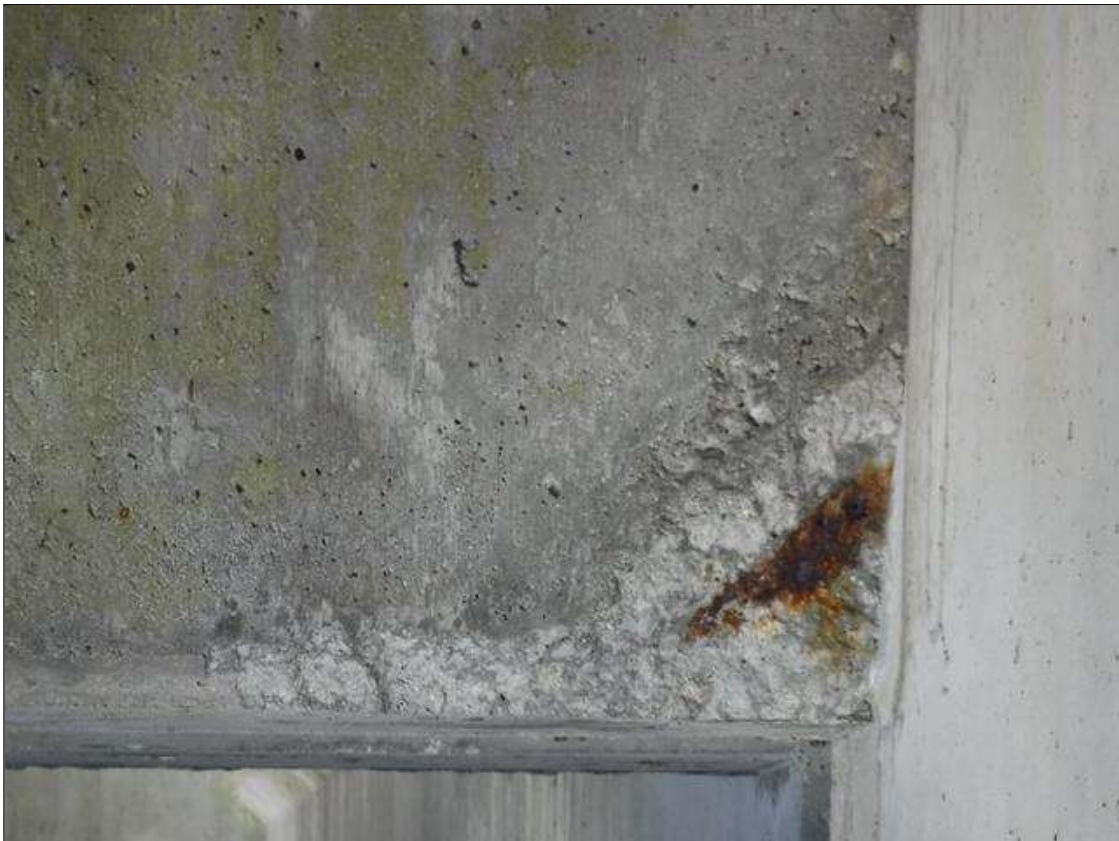
Span 137 Beam 3: 1' DIAMETER X 1" DEEP SPALL WITH EXPOSED REBAR ON EAST FACE BAY 3 DIAPHRAGM

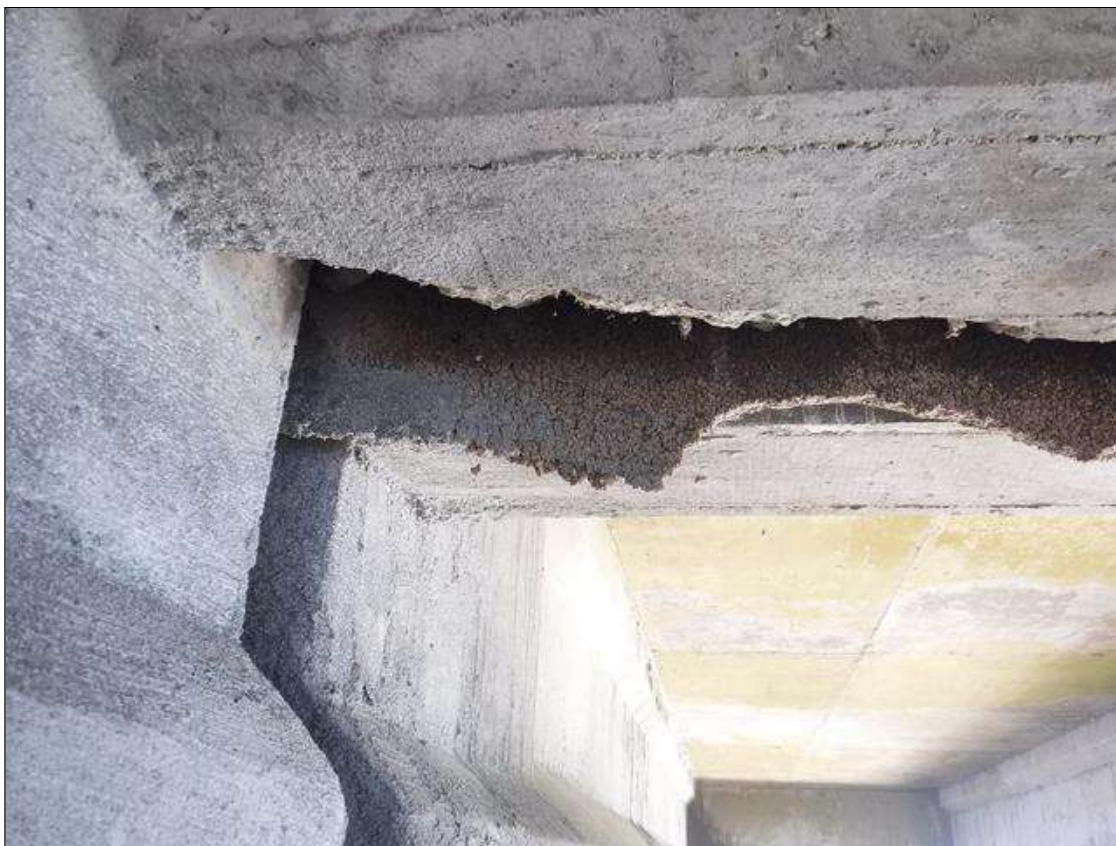
Span 137 Beam 3: 1.5' X 6" X 4" DEEP SPALL WITH EXPOSED REBAR ON EAST FACE BAY 3 DIAPHRAGM

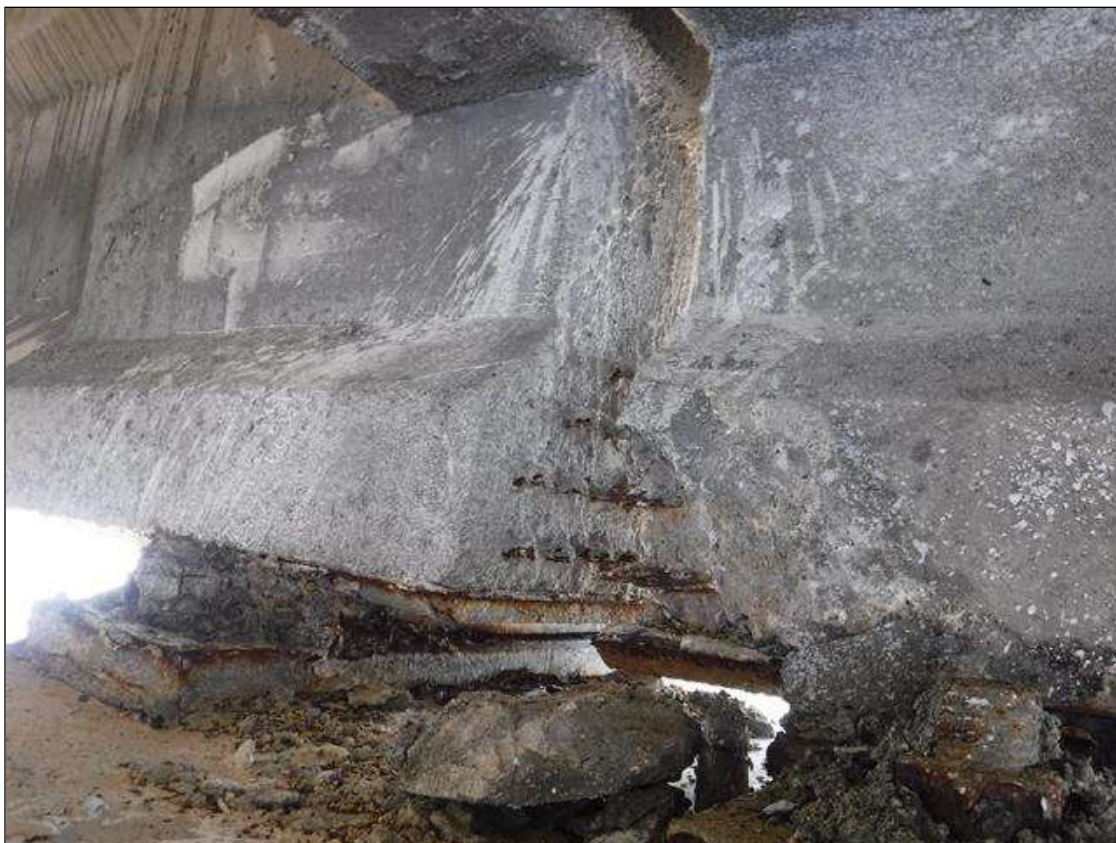
Span 138 Beam 4: (PAR) 6" X 6" X 2" DEEP SPALL WITH EXPOSED STRAND ON NORTH FACE AT BENT 138

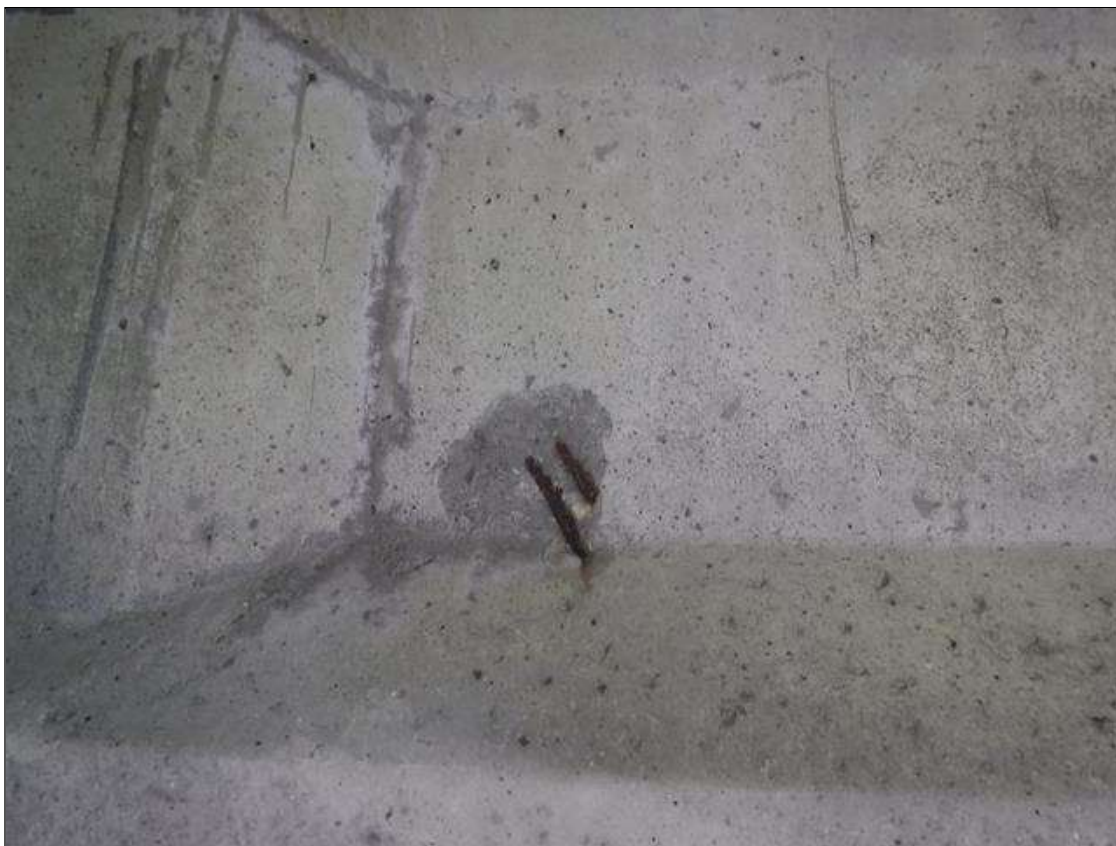
Span 139 Beam 4: (2) 3" DIAMETER X 1/2" SPALL, WITH EXPOSED REBAR, NORTH FACE, 3' FROM BENT 139

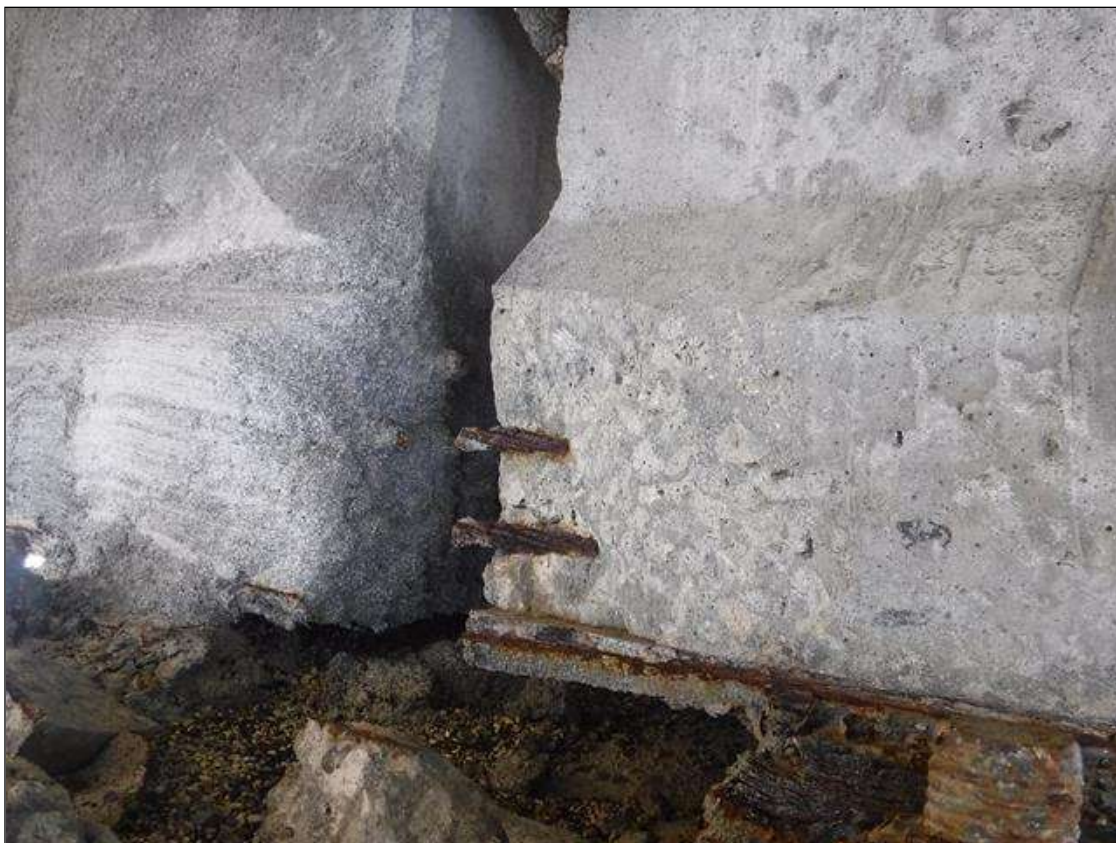
Span 140 Beam 3: (PAR) 8" X 8" X 3" SPALL, WITH EXPOSED STRAND, NORTH FACE, AT BENT 140.

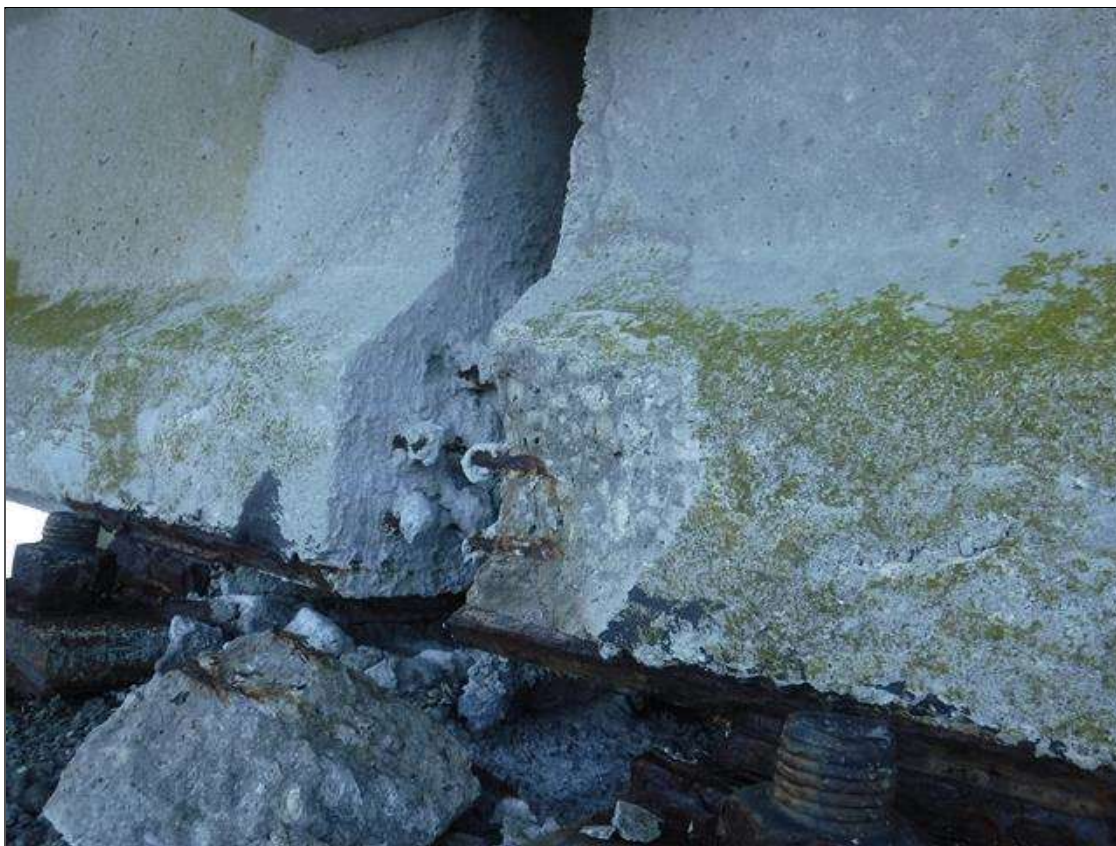
Span 141 Beam 1: (PAR) 6" X 6" X 2" DEEP SPALL WITH EXPOSED STRAND ON NORTH FACE AT BENT 141

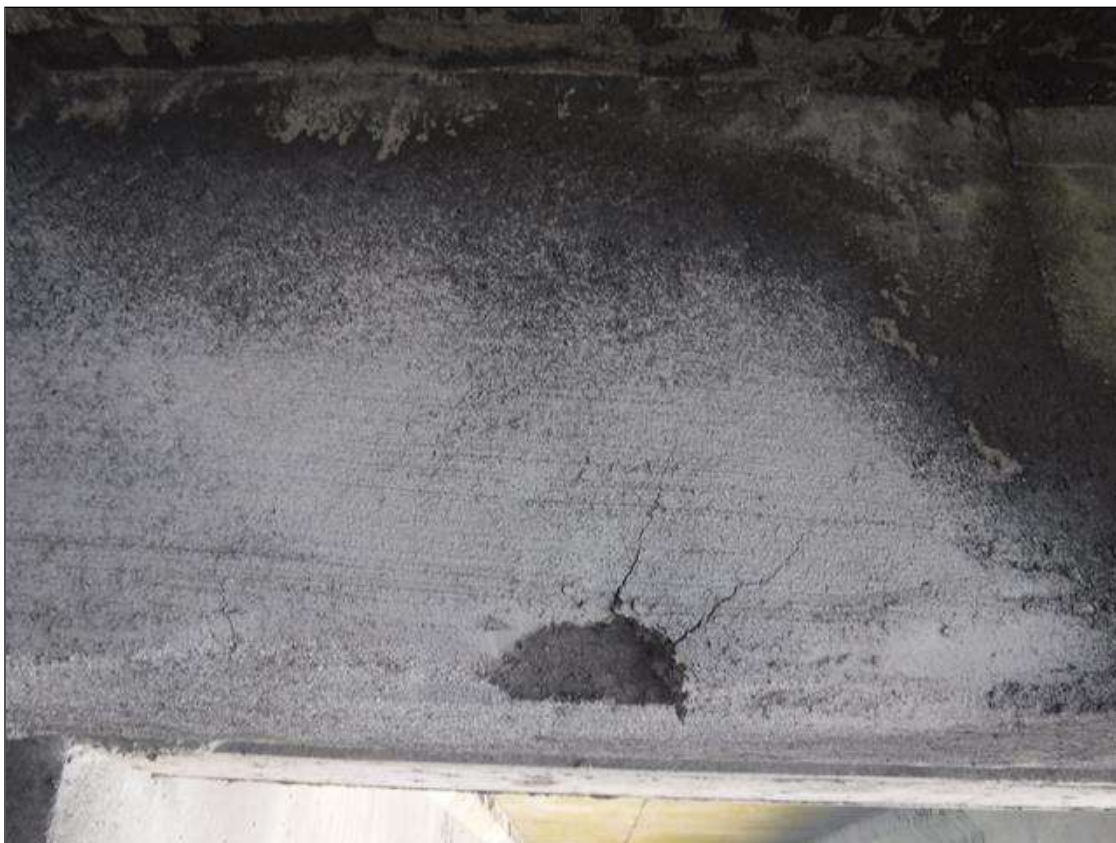
Span 141 Beam 2: 2' X 1' SPALLED PATCHED AREA, WEST FACE, BENT 141 DIAPHRAGM, BETWEEN BEAMS 2 AND 3.

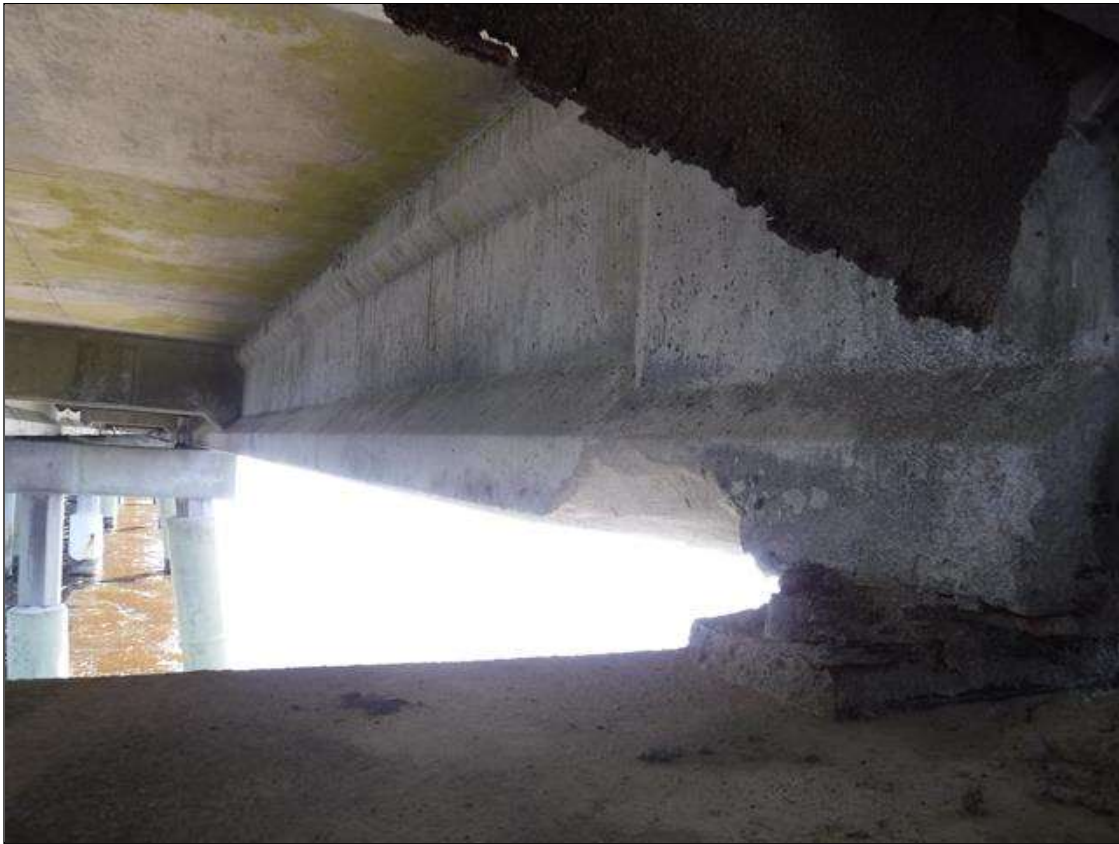
Span 142 Beam 4: 36" X 8" PATCHED AREA, NORTH FACE, AT BENT 141.

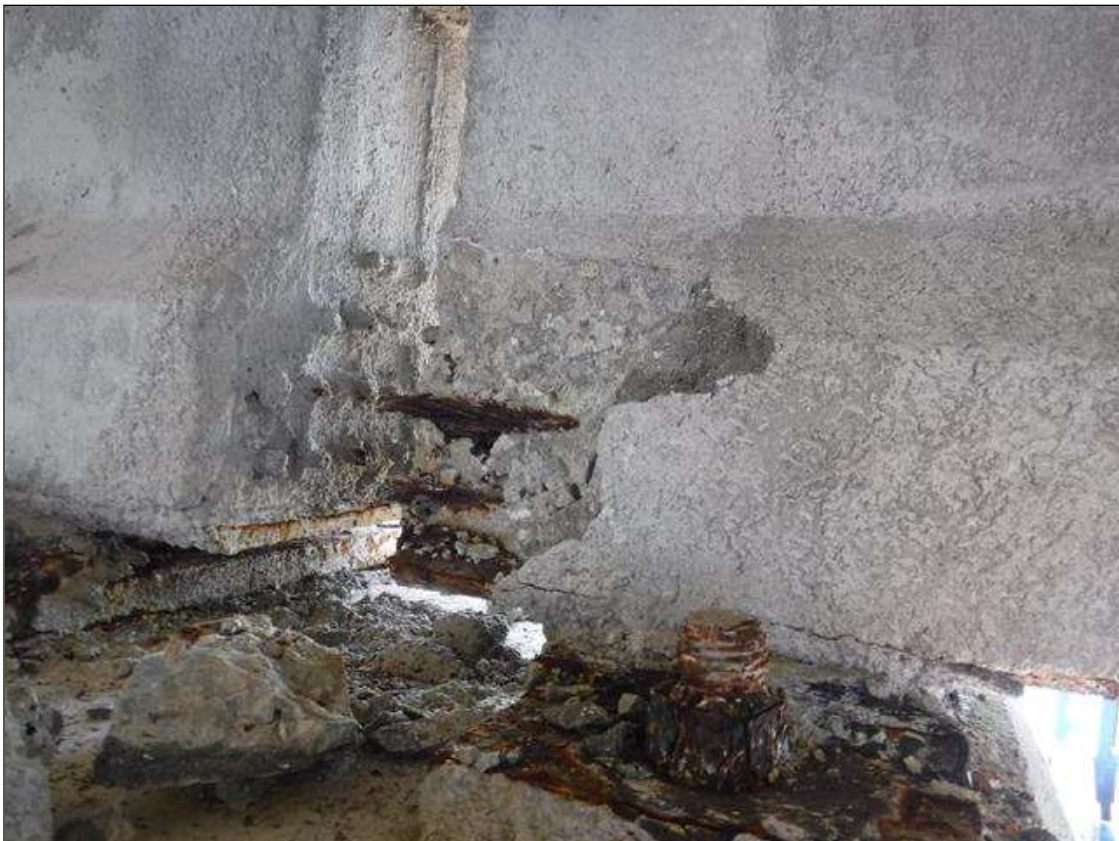
Span 145 Beam 4: (PAR) 6" X 10" X 2" DEEP SPALL WITH EXPOSED STRAND ON NORTH FACE AT BENT 145

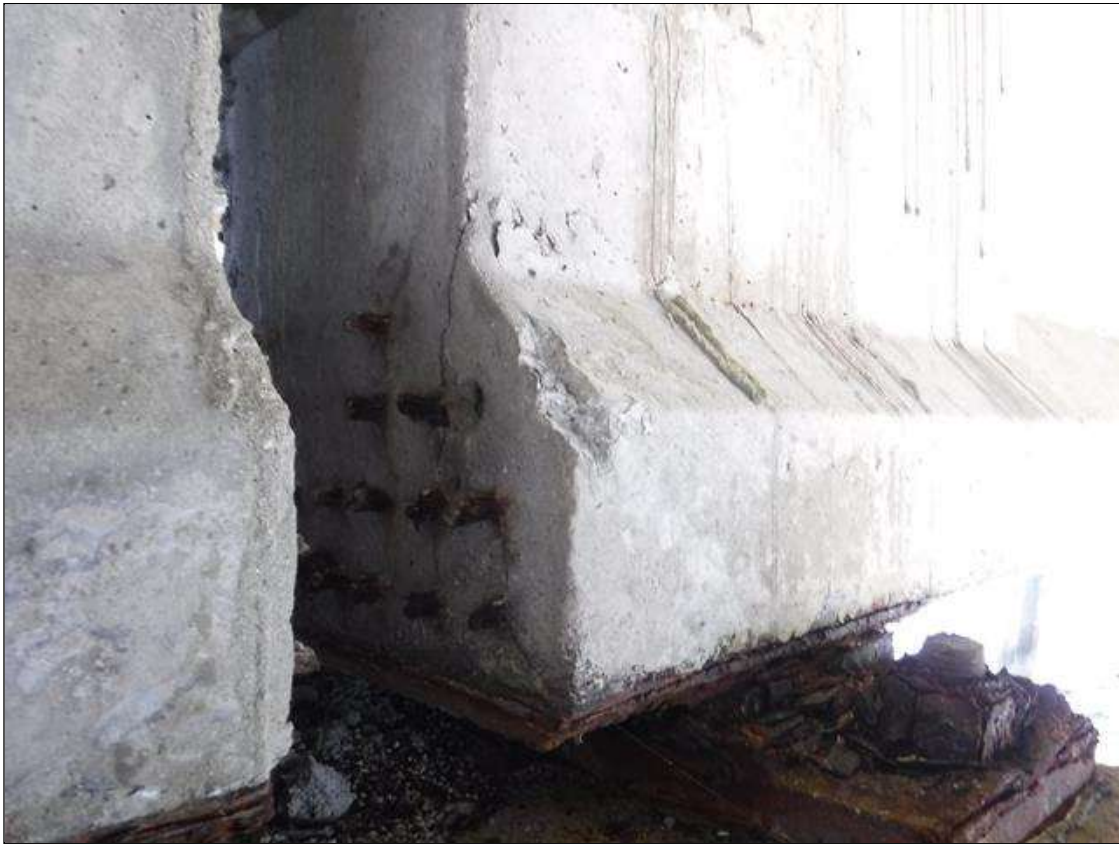
Span 146 Beam 3: 6" X 6" DELAMINATION ON SOUTH FACE AT BENT 146

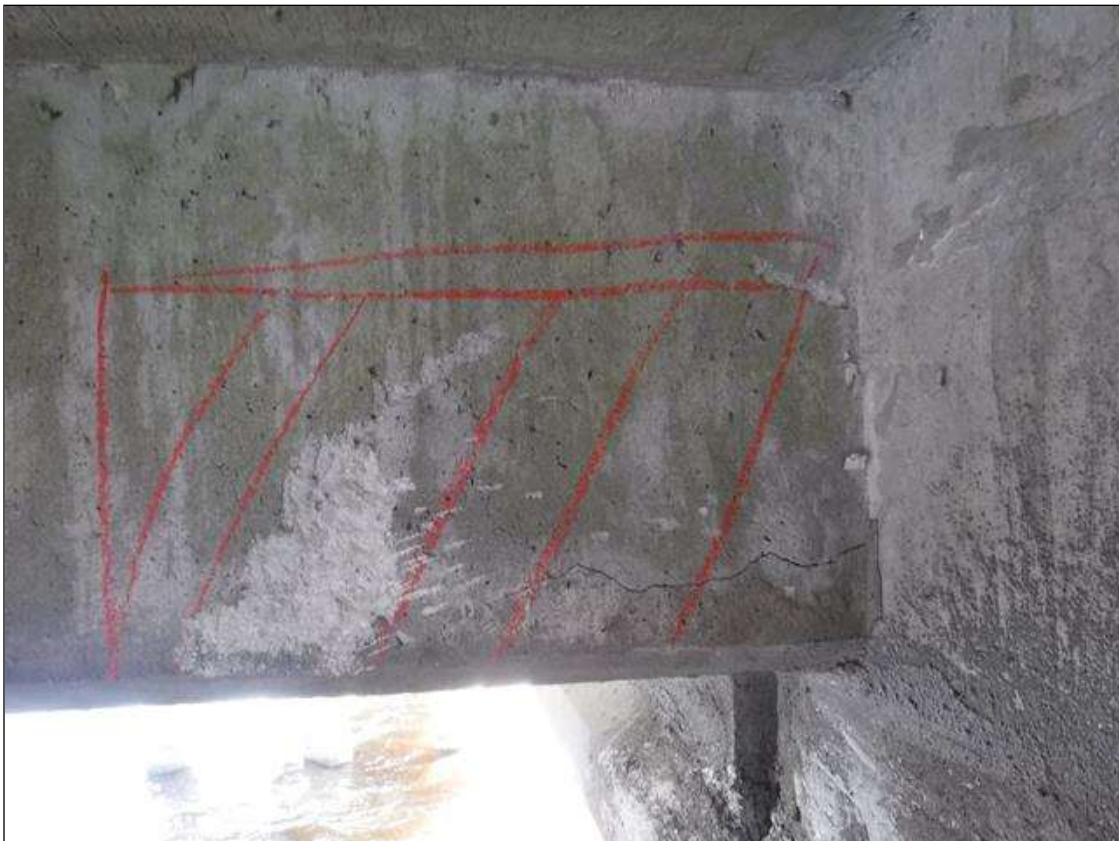
Span 147 Beam 3: 2' X 2' DELAMINATION, WEST FACE OF BENT 147 DIAPHRAGM, BETWEEN BEAMS 2 AND 3
