NC DEPARTMENT OF TRANSPORTATION
DIVISION OF HIGHWAYS
STRUCTURE MANAGEMENT UNIT

Structure Safety Report

Routine Element Inspection - Contract

FEATURE INTERSECTED: ALLIGATOR RIVER

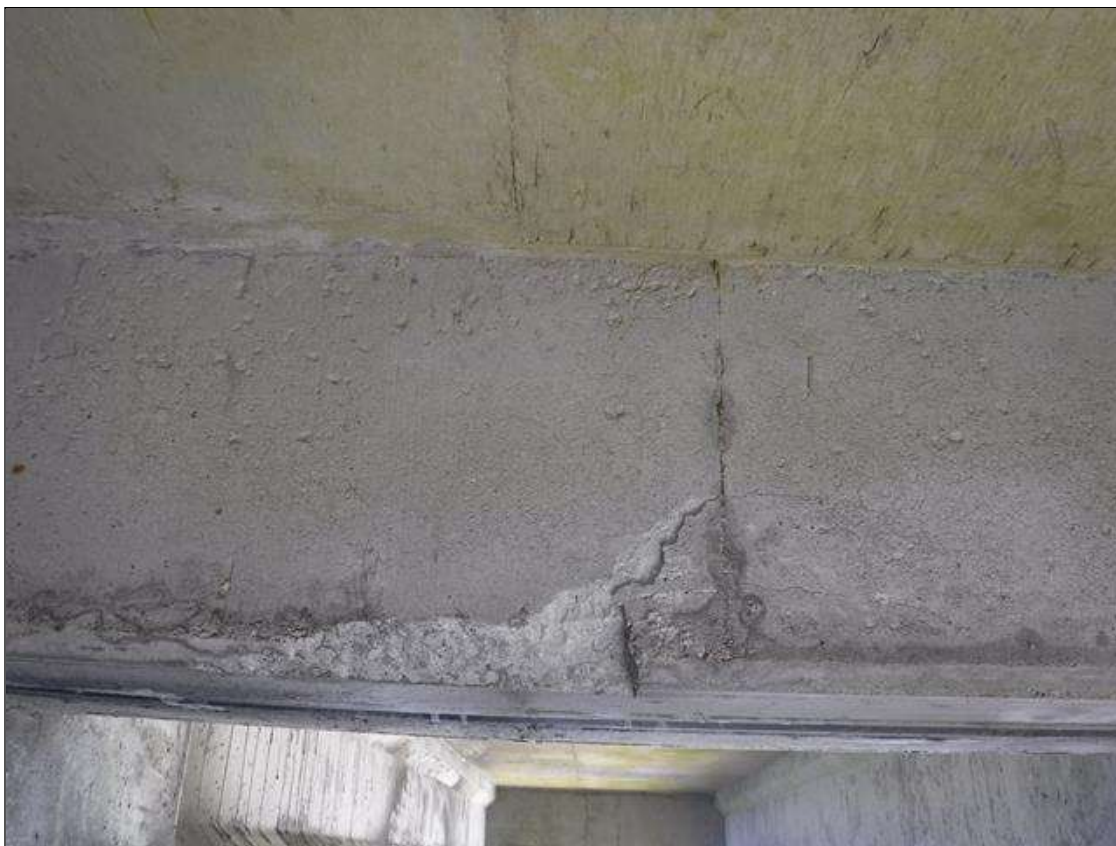
Span 147 Beam 4: 18" X 6" X 2" DEEP SPALL, WEST FACE OF BENT 147 DIAPHRAGM, BETWEEN BEAMS 3 AND 4

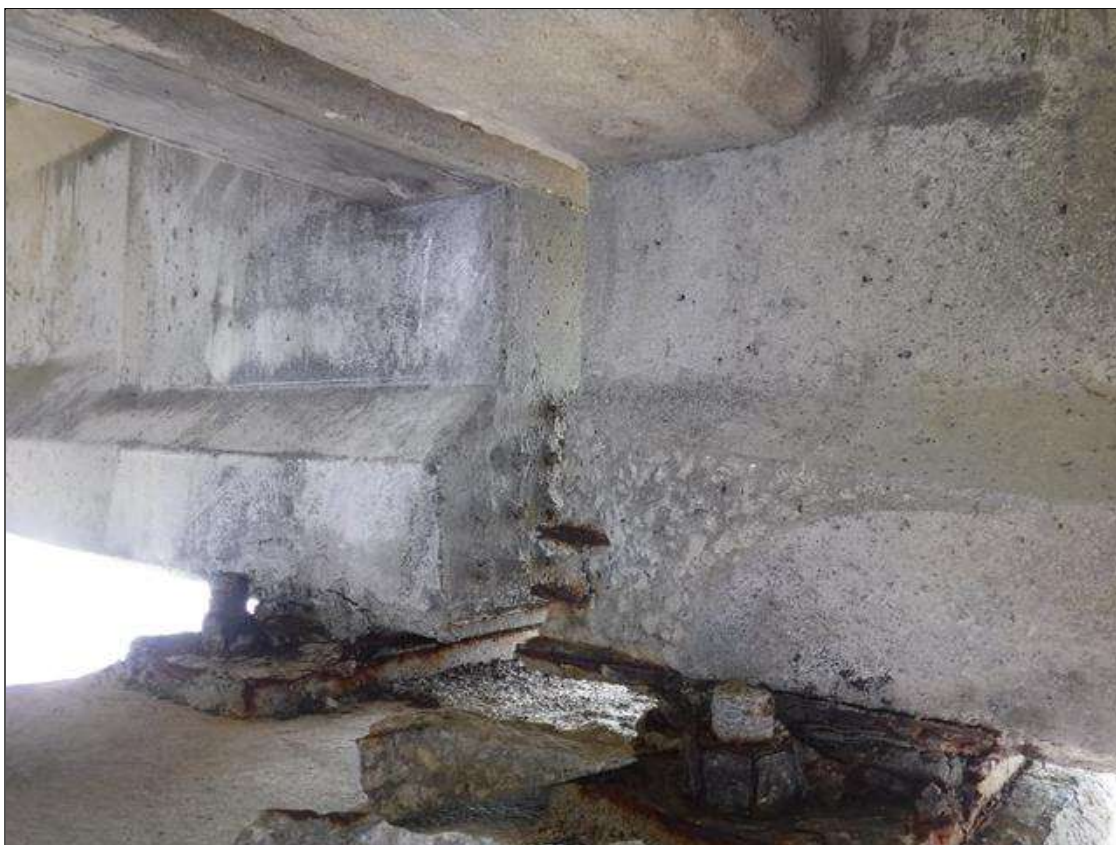
Span 147 Beam 4: (PAR) 6" X 6" X 2" DEEP SPALL WITH EXPOSED STRAND ON NORTH FACE AT BENT 147

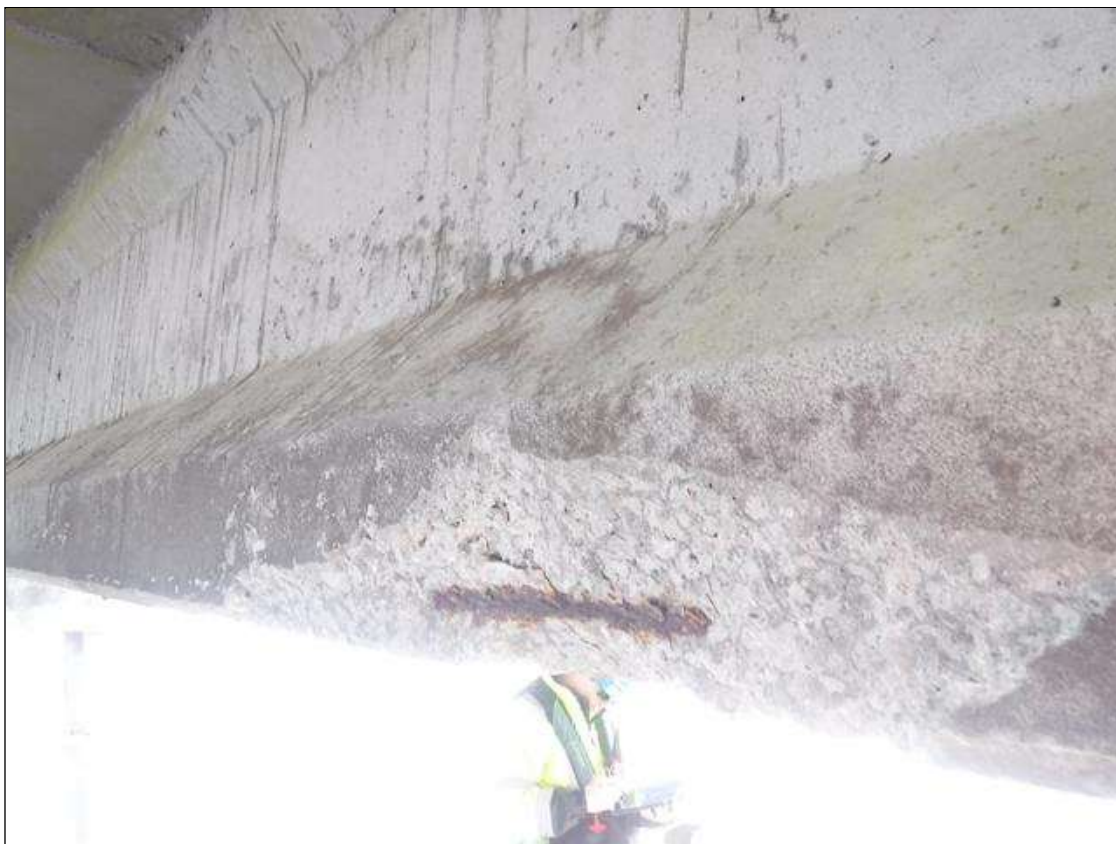
Span 148 Beam 3: (PAR) 3' X 6" X 6" CORNER SPALL, WITH EXPOSED STRAND, BOTTOM FACE, 17' FROM BENT

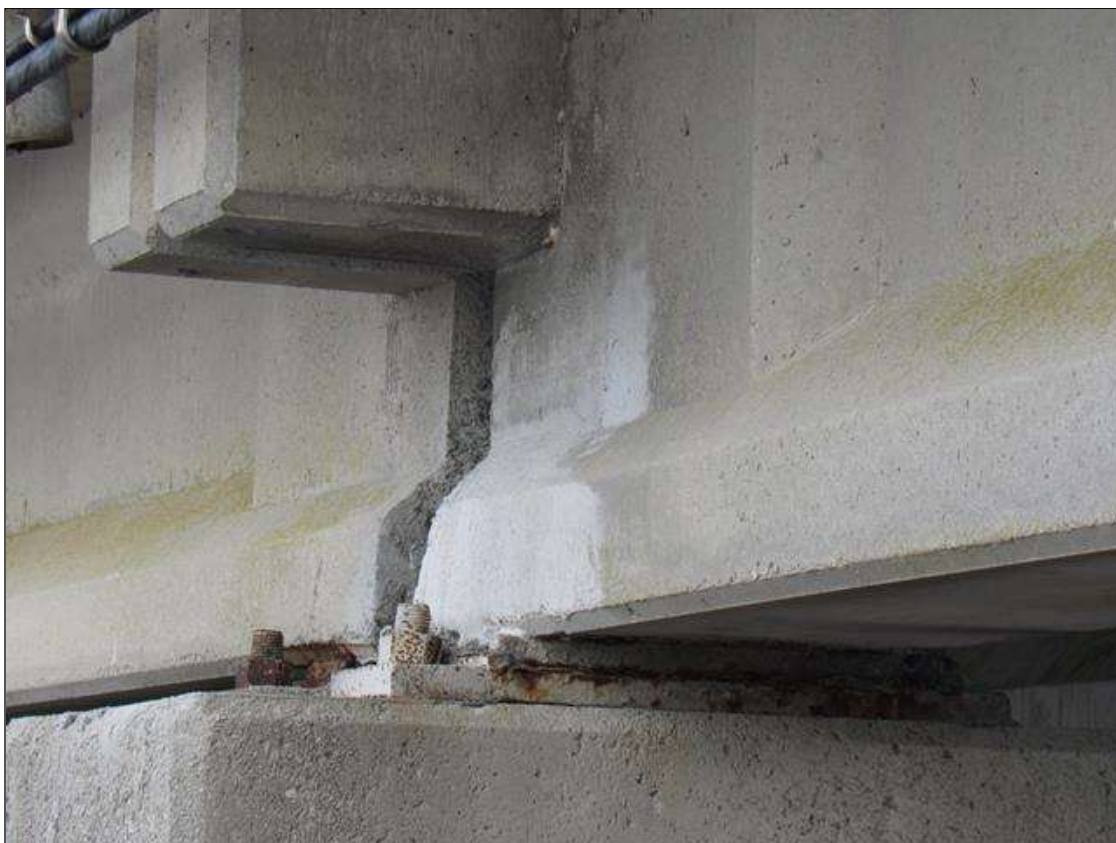
Span 32 Beam 4: 1' X 1' PATCHED AREA, NORTH AND SOUTH FACES, AT BENT 31.

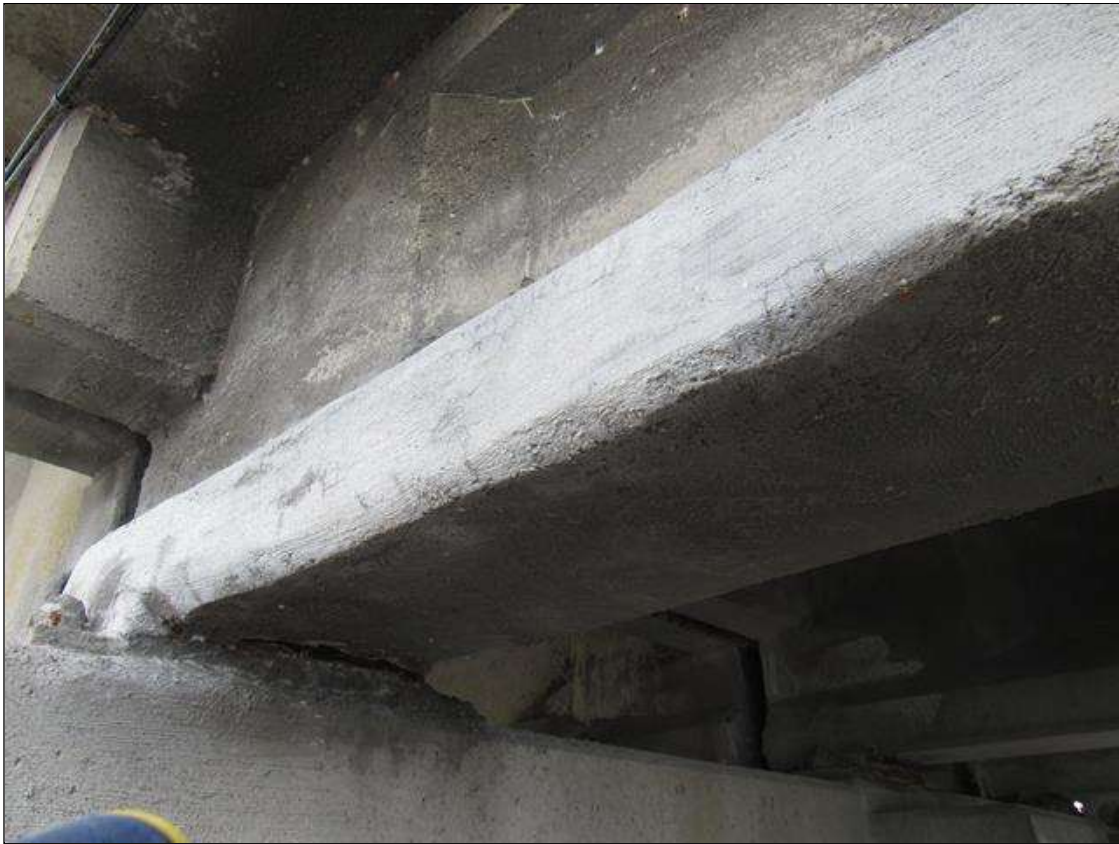
Span 33 Beam 1: 4' X 1' PATCHED AREA, NORTH FACE, AT BENT 33.

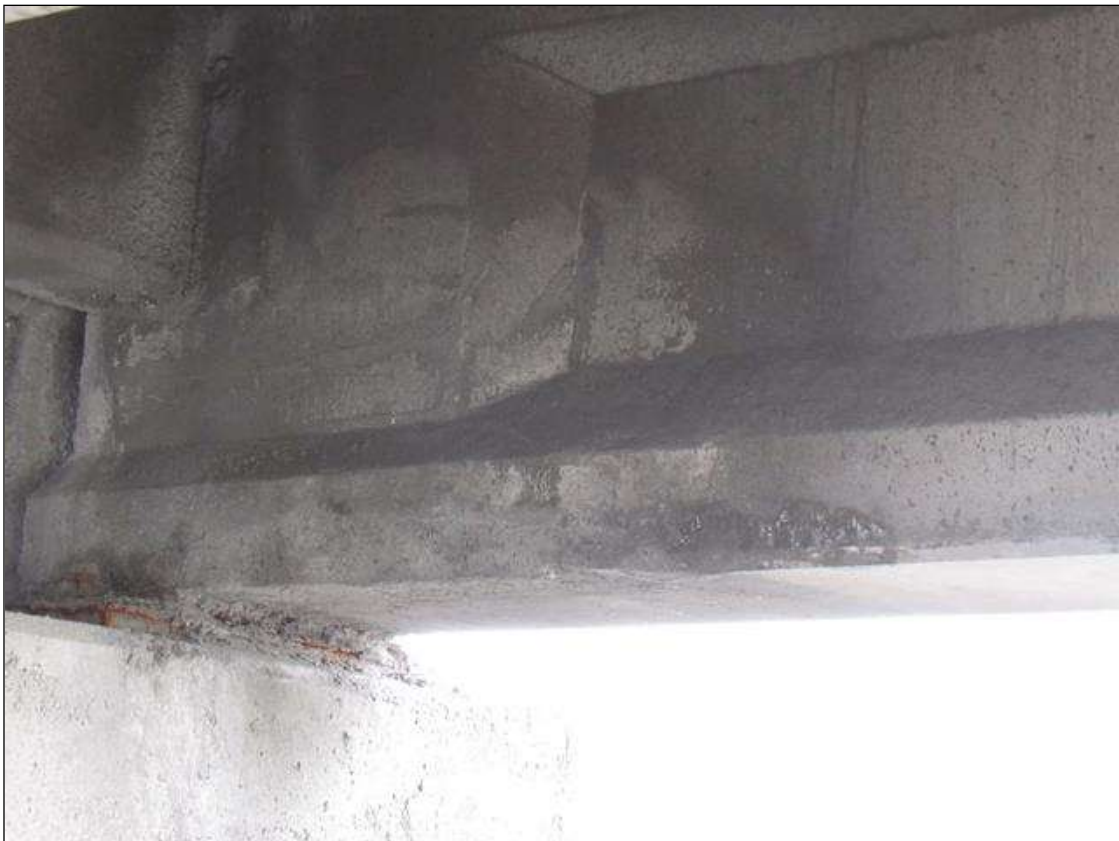
Span 33 Beam 1: 4' X UP TO 6" PATCHED AREA, BOTTOM FACE, EXTENDING 4" ONTO NORTH FACE, AT BENT 32.

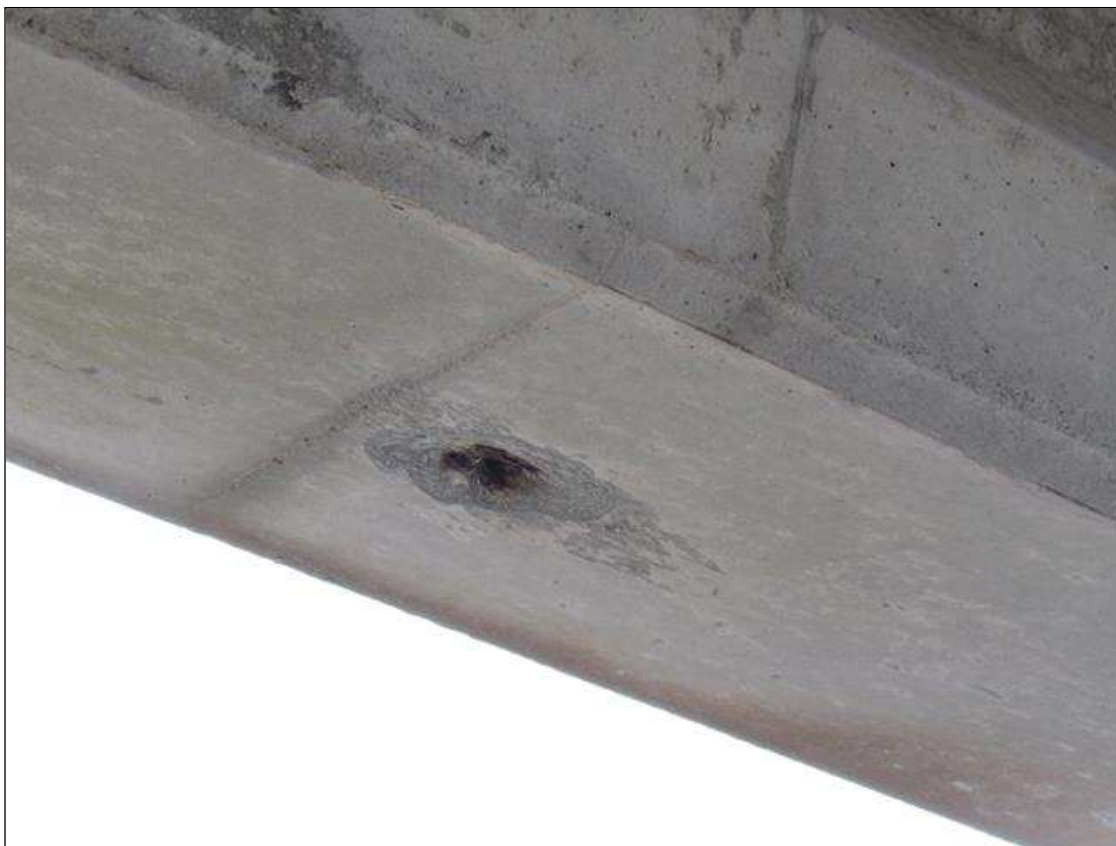
Span 33 Beam 1: 3" DIAMETER X 1/2" DEEP SPALL ON BOTTOM FACE AT MIDSPAN

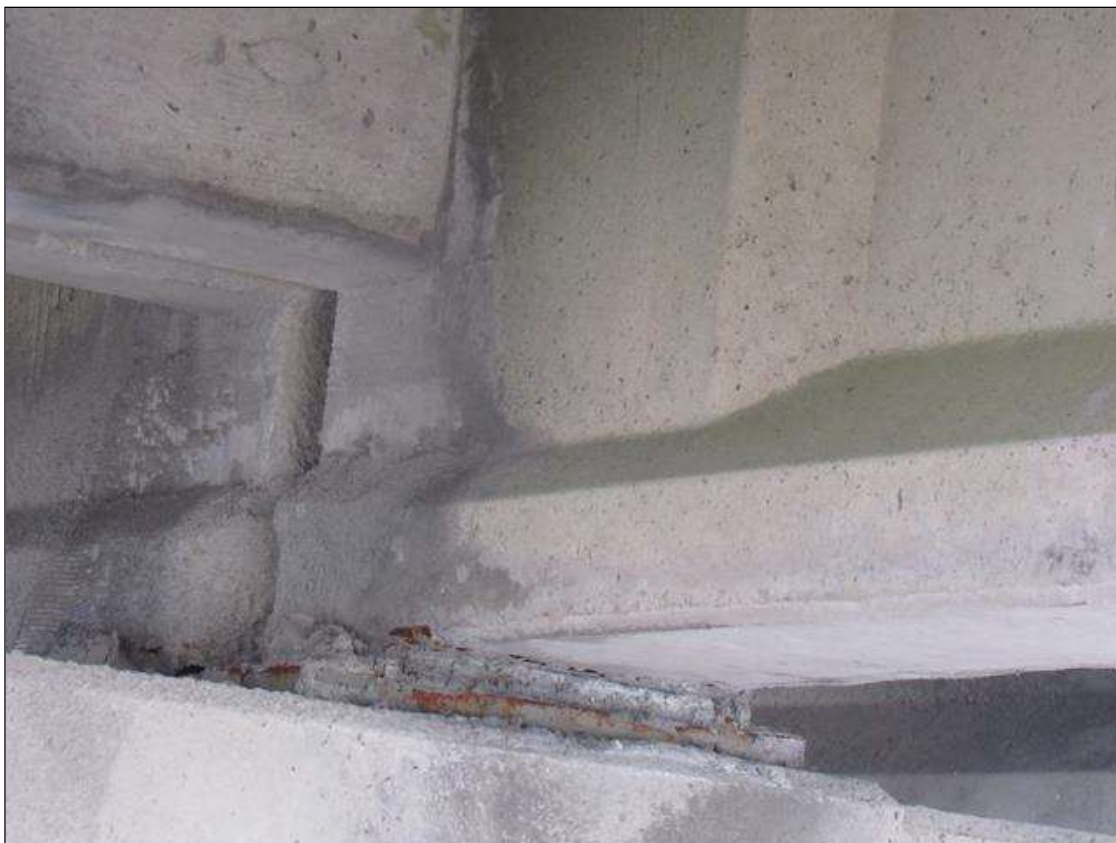
Span 33 Beam 2: 1' X 1' PATCHED AREA, SOUTH FACE, AT BENT 32.

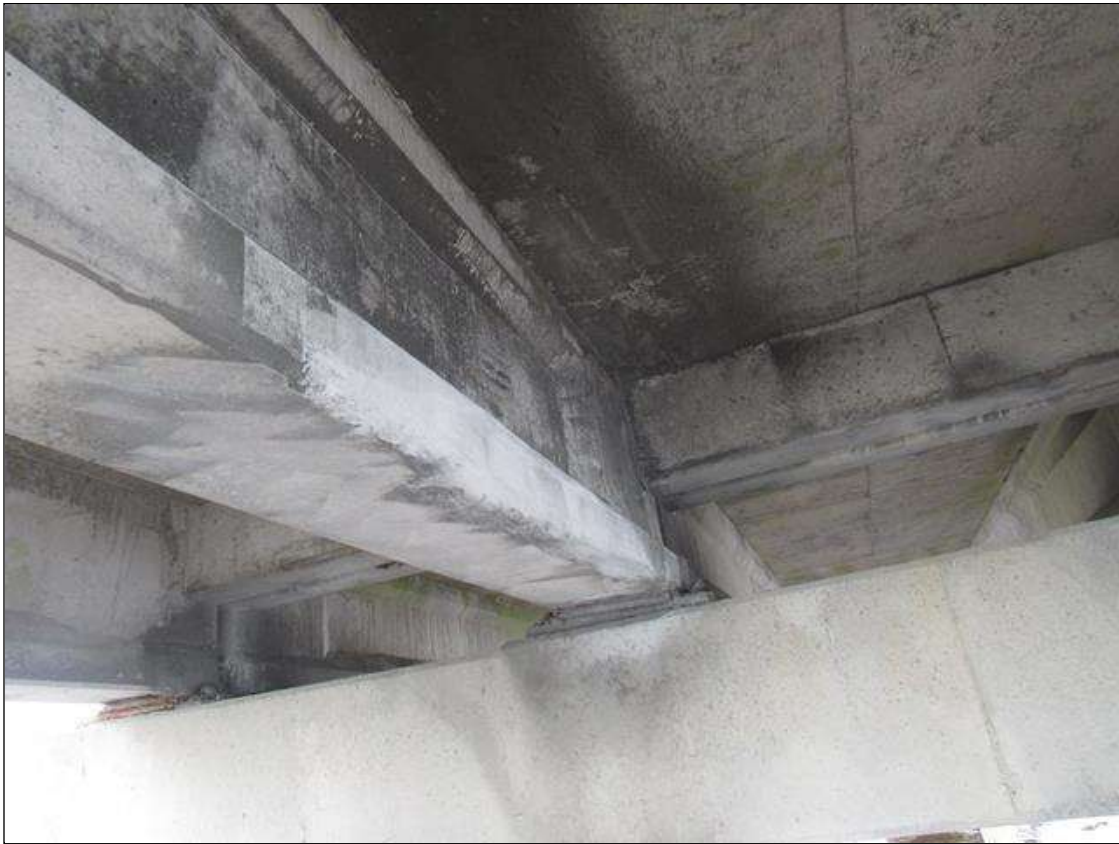
Span 33 Beam 3: 7' X UP TO 6" PATCHED AREA, BOTTOM FACE, EXTENDING 1' ONTO NORTH FACE, AT BENT 32.

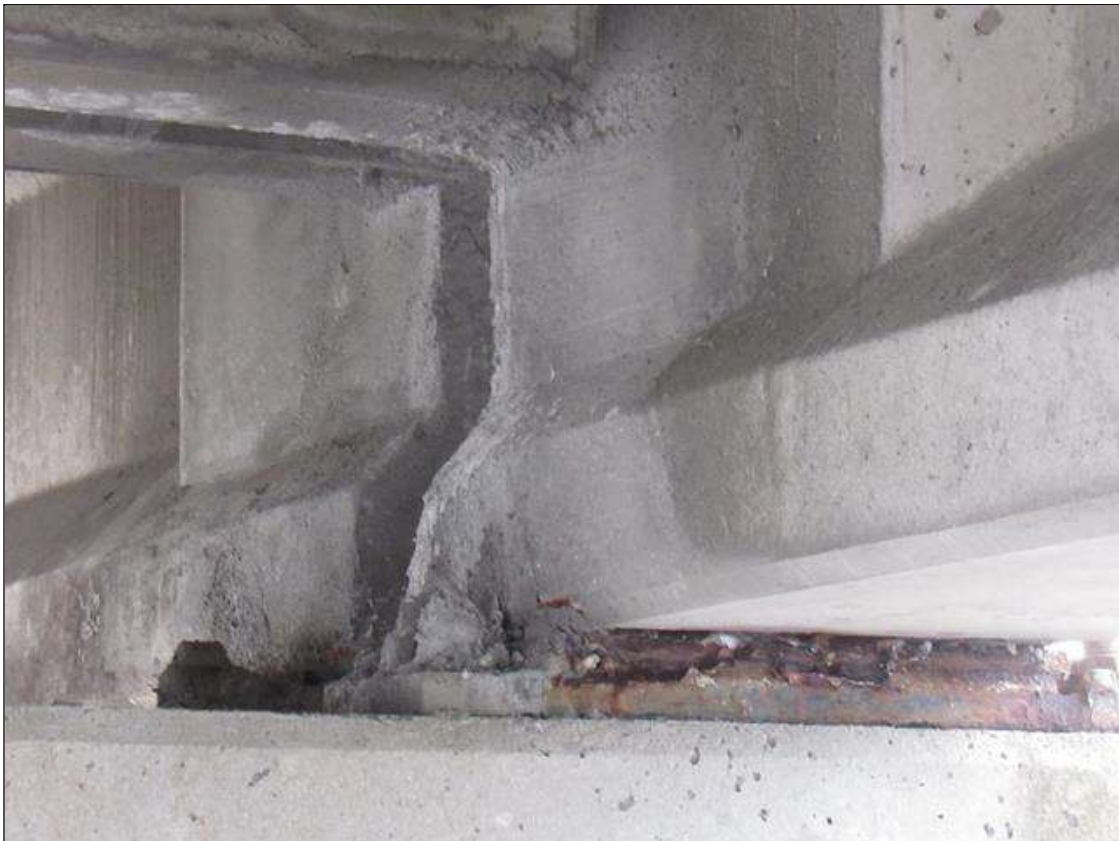
Span 33 Beam 4: 10" X 1' PATCHED AREA, NORTH FACE, AT BENT 33.

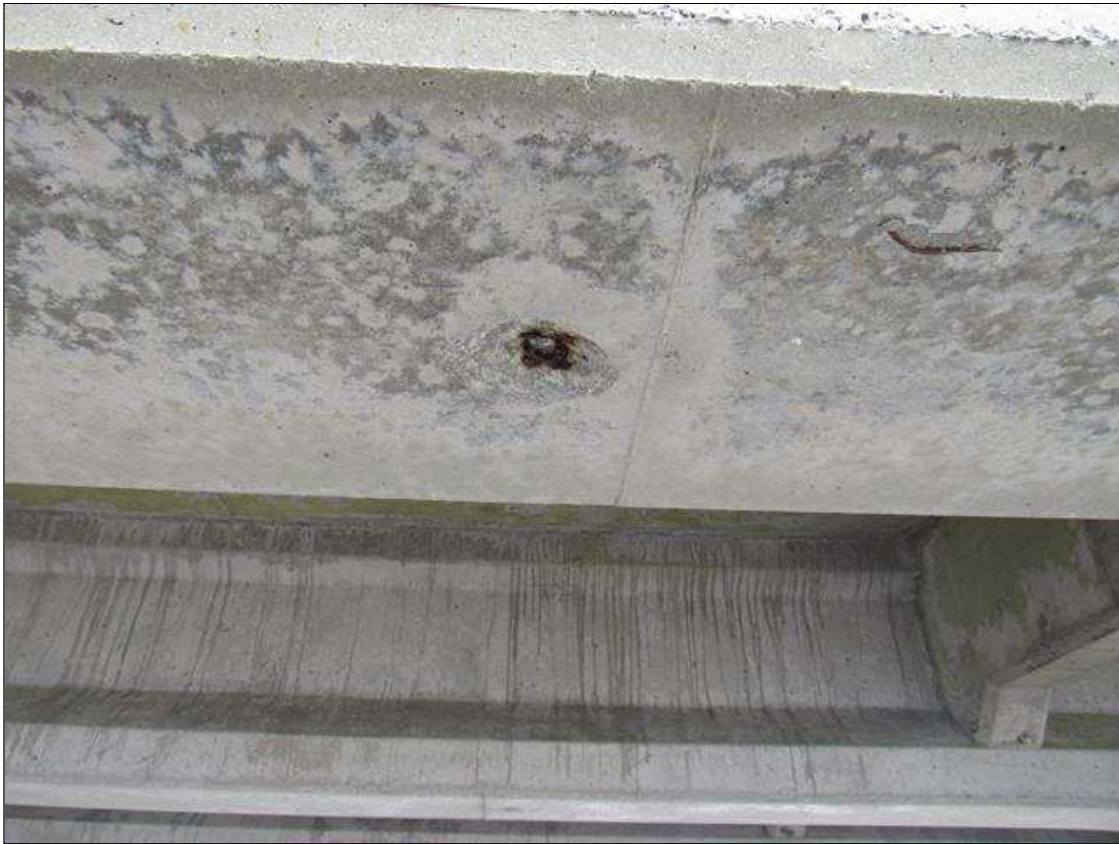
Span 33 Beam 4: 3" DIAMETER X 1/2" DEEP SPALL ON BOTTOM FACE AT MIDSPAN

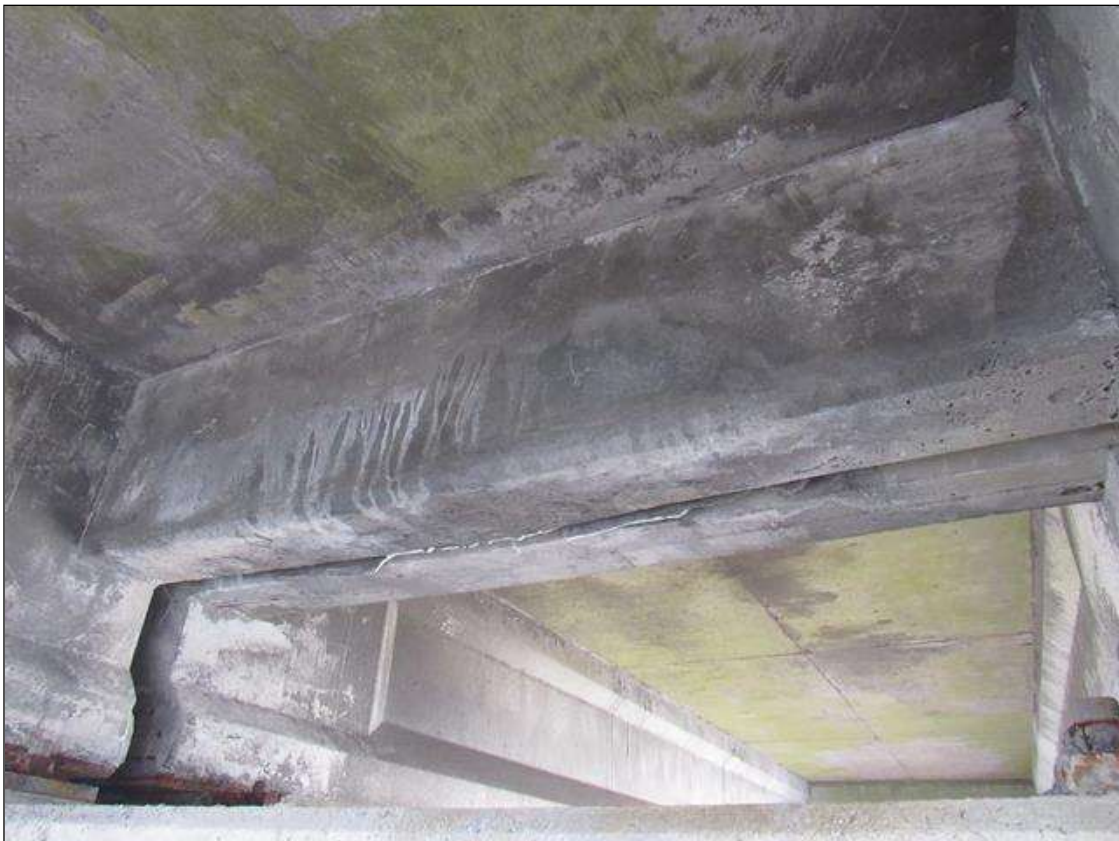
Span 34 Beam 3: 7' X UP TO 9" X 1' PATCHED AREA, END DIAPHRAGM, BETWEEN BEAMS 3 AND 4, AT BENT 34.

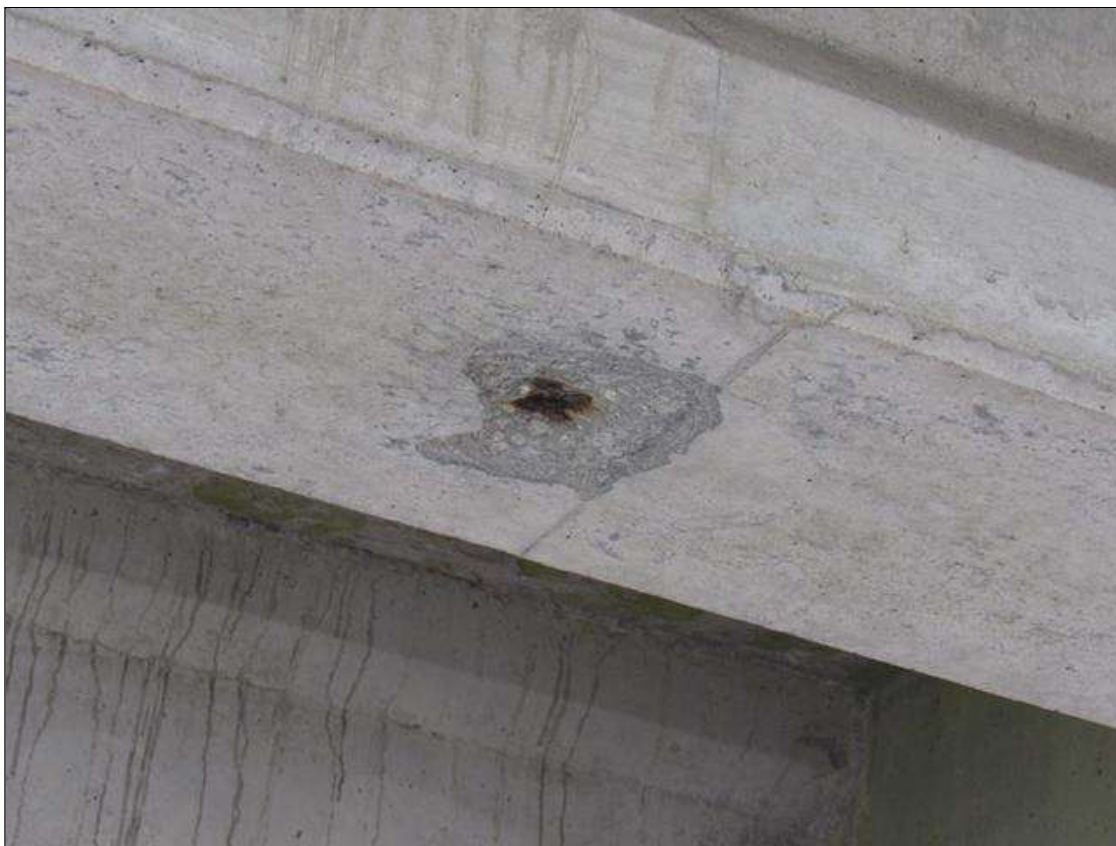
Span 35 Beam 3: 5" DIAMETER X 1/2" DEEP SPALL ON BOTTOM FACE AT MIDSPAN

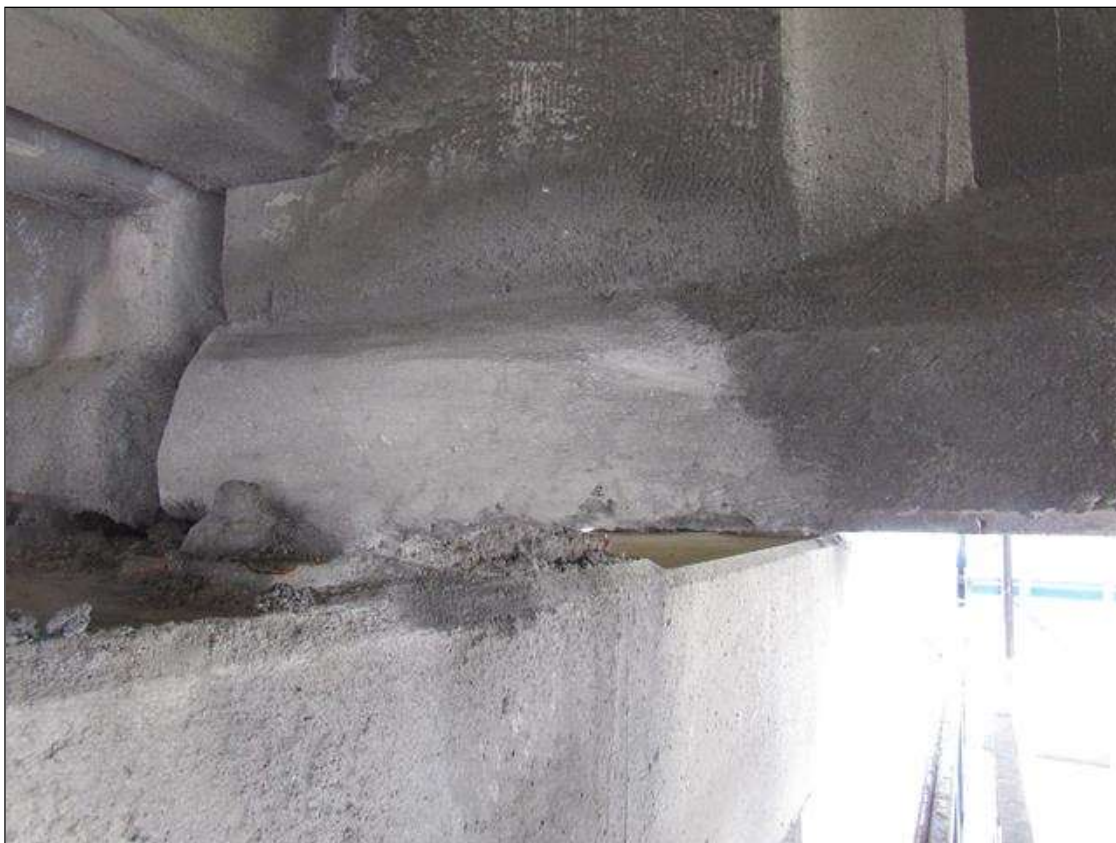
Span 36 Beam 3: 2' X 1" PATCHED AREA, BOTTOM FACE, EXTENDING 1' ONTO SOUTH FACE, AT BENT 36.

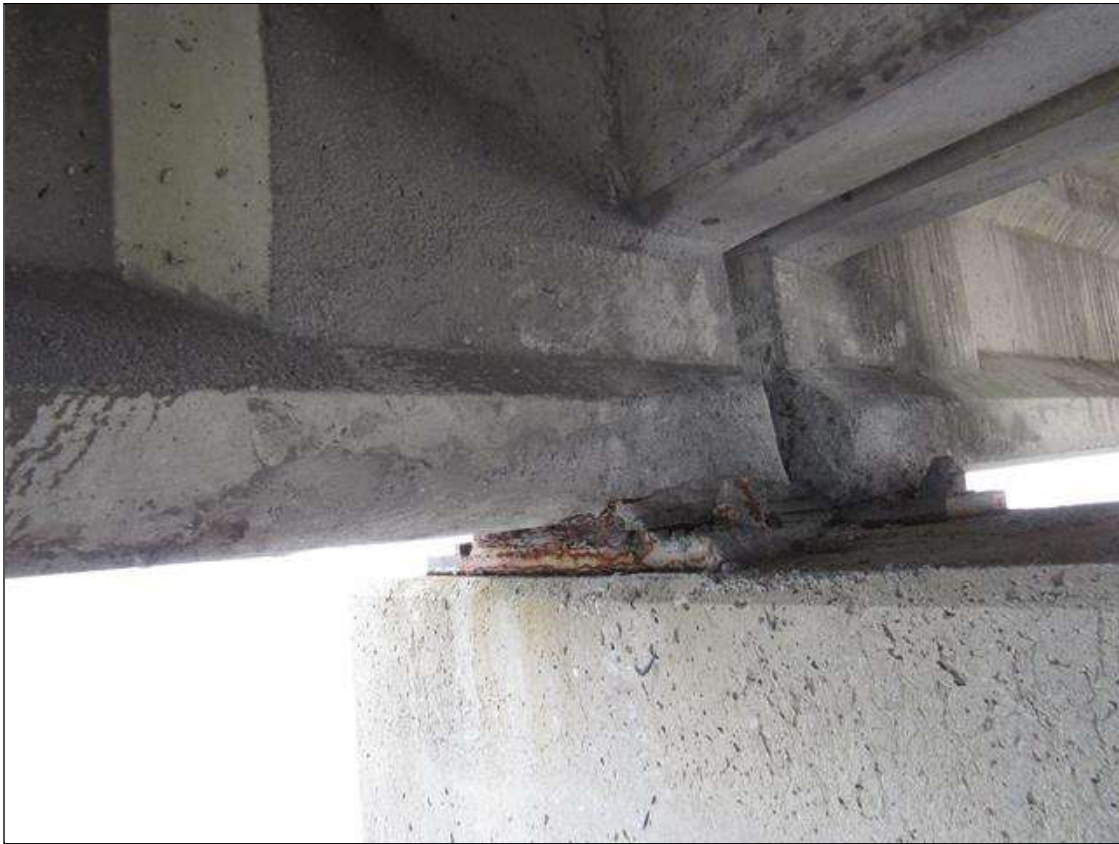
Span 37 Beam 1: 2' X UP TO 6" FAILED PATCHED AREA, BOTTOM FACE, EXTENDING 10" ONTO SOUTH FACE, AT BENT 37.

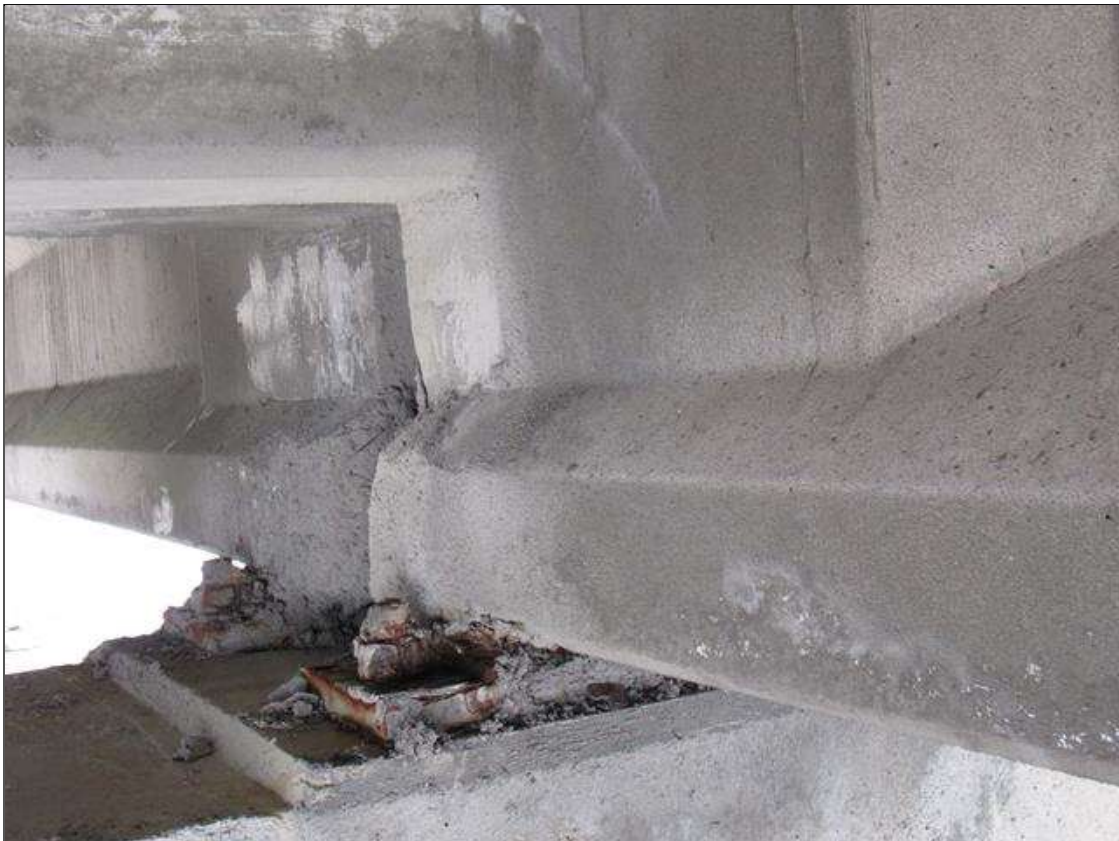
Span 37 Beam 3: 4' X UP TO 18" PATCHED AREA, BOTTOM FACE, EXTENDING 10" ONTO NORTH AND SOUTH FACES, AT BENT 36.

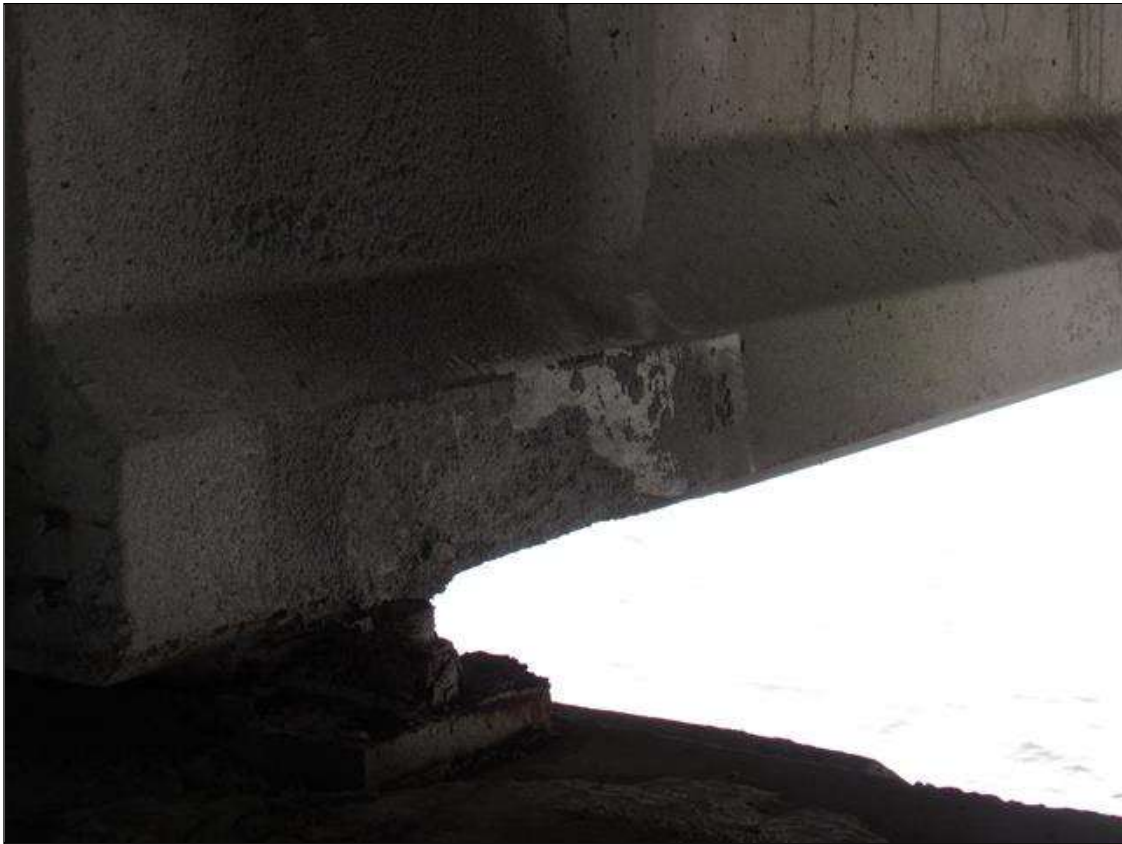
Span 38 Beam 2: 1' X 1' PATCHED AREA, SOUTH FACE, AT BENT 37.

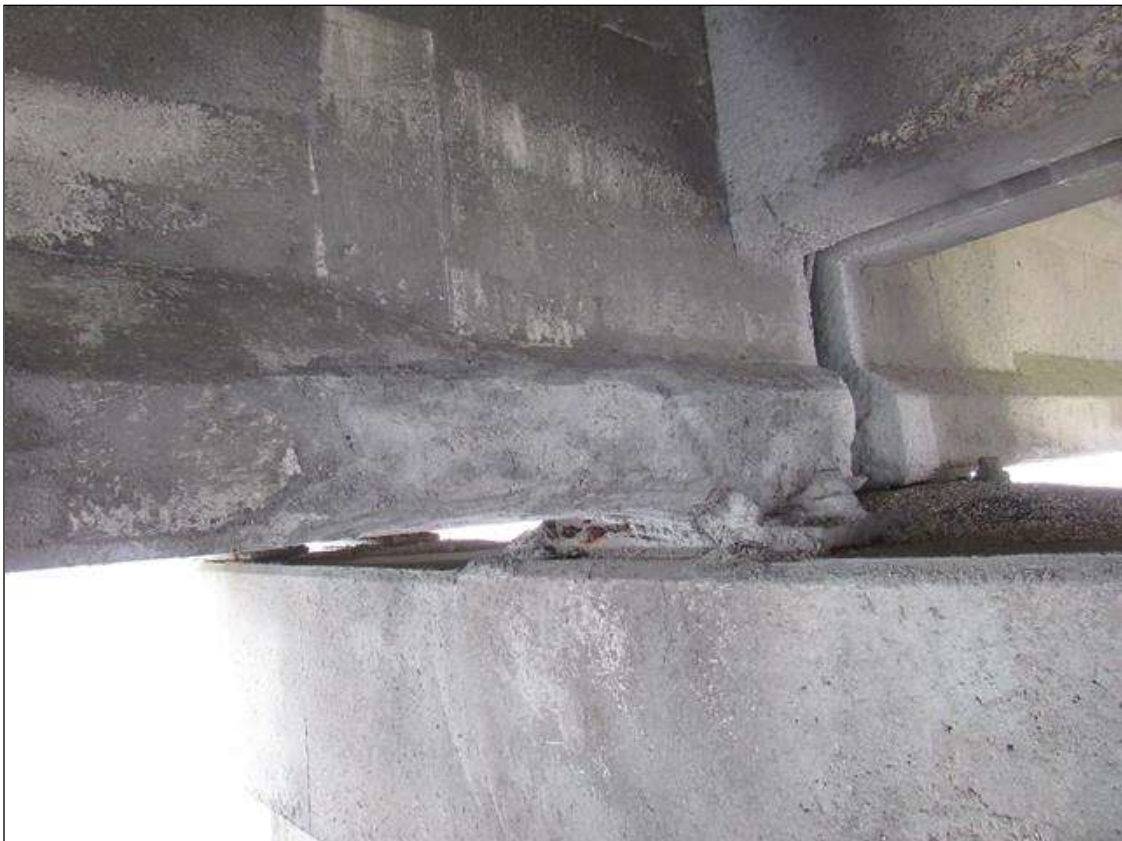
Span 38 Beam 2: 4' X UP TO 8" PATCHED AREA, BOTTOM FACE, EXTENDING 10" ONTO NORTH AND SOUTH FACES, AT BENT 38.

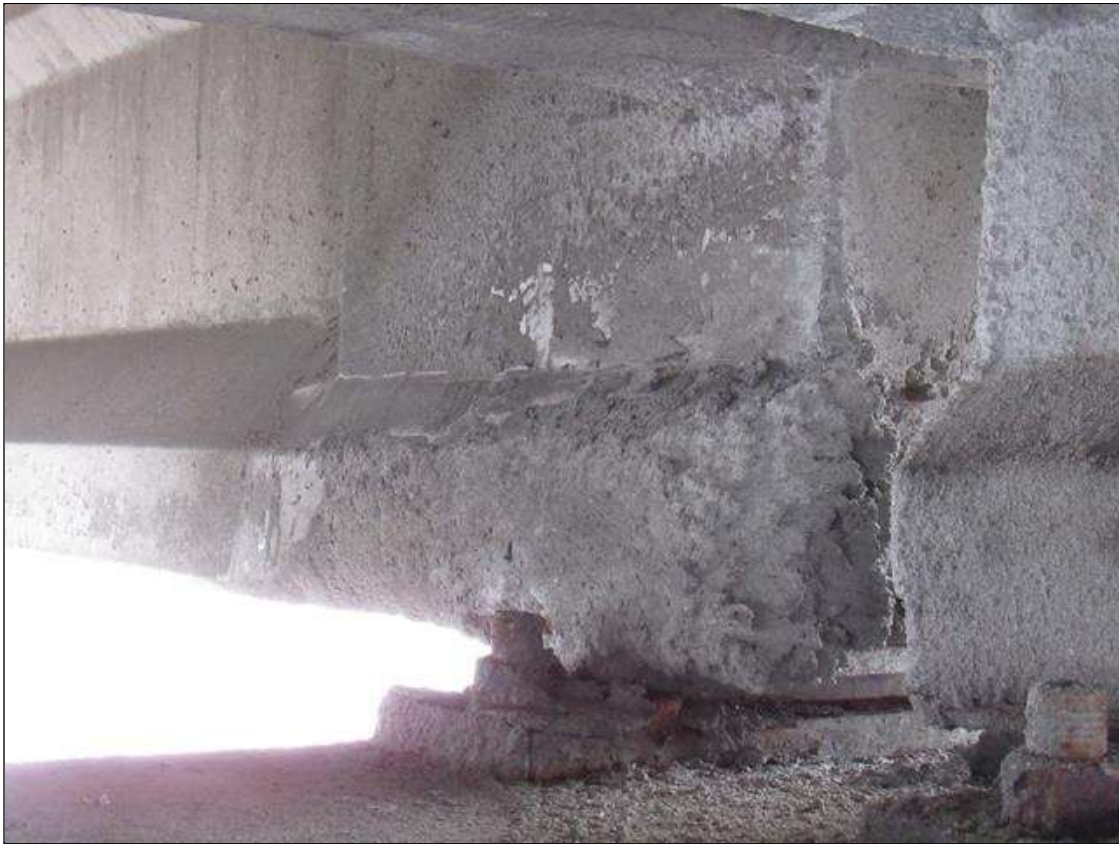
Span 38 Beam 4: 2.5' X UP TO 8" PATCHED AREA, BOTTOM FACE, EXTENDING 10" ONTO NORTH FACE, AT BENT 37.

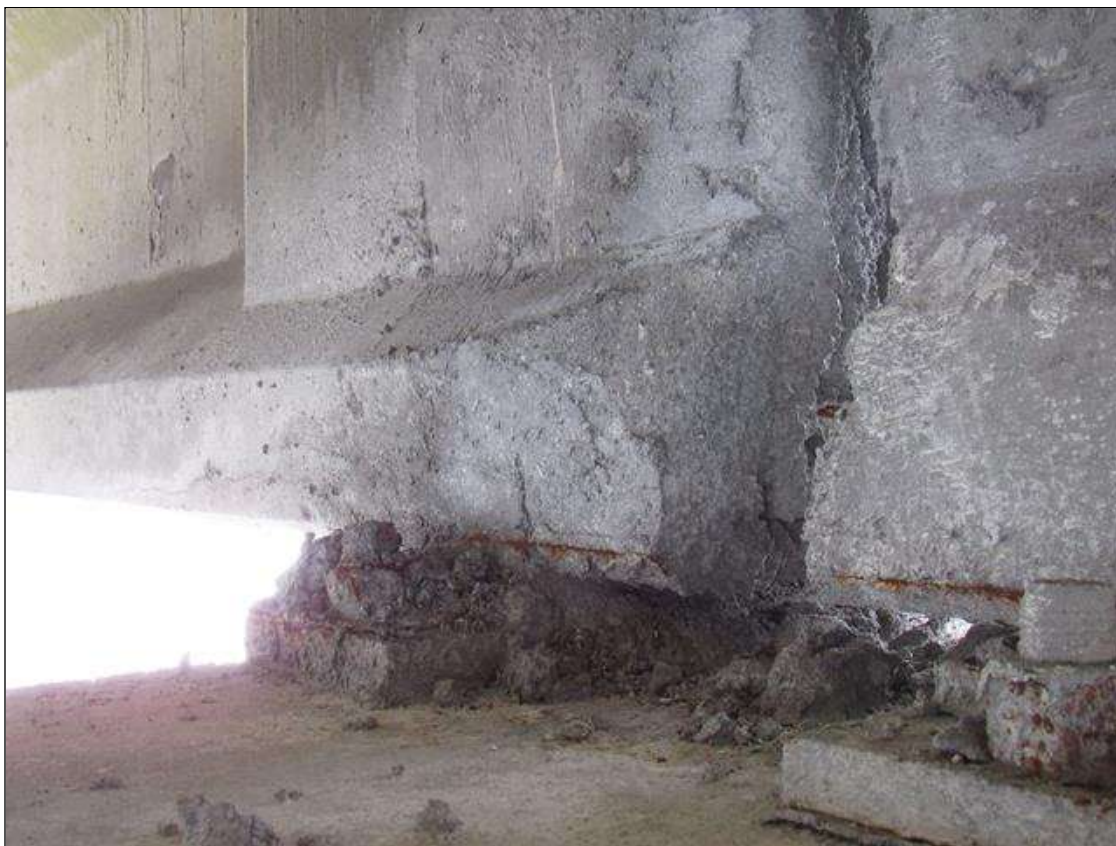
Span 39 Beam 4: 7' X UP TO 7" PATCHED AREA, BOTTOM FACE, EXTENDING 8" ONTO NORTH FACE, 18' FROM BENT 38.

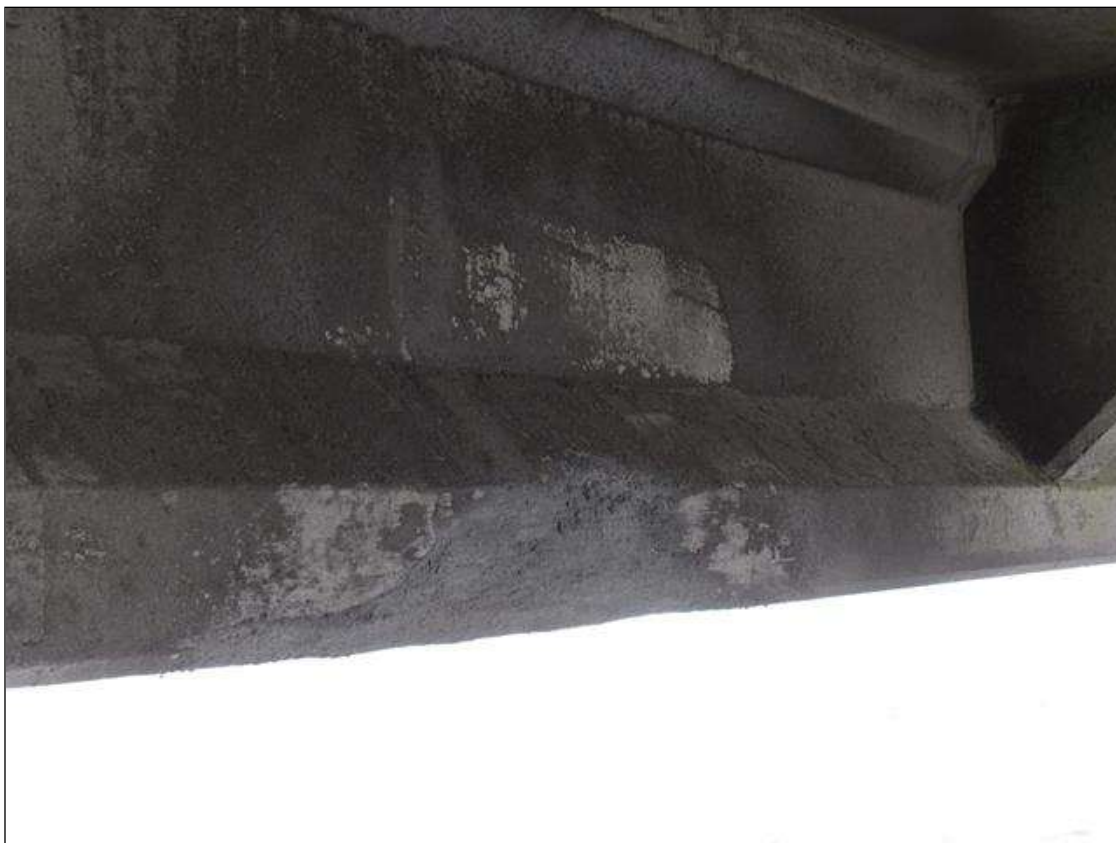
Span 40 Beam 4: 9" X 18" PATCHED AREA, NORTH FACE, AT BENT 39.

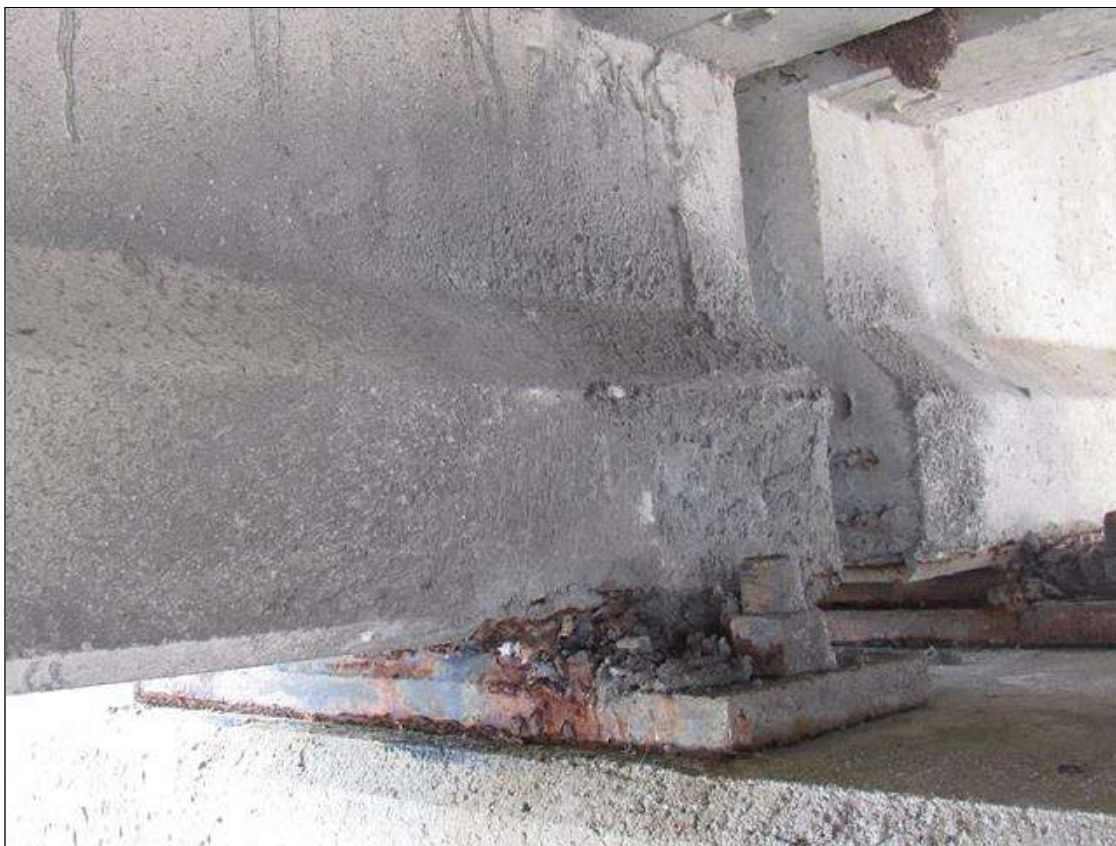
Span 41 Beam 4: 2.5' X UP TO 5" PATCHED AREA, BOTTOM FACE, EXTENDING 7" ONTO NORTH FACE, 18' FROM BENT 41.

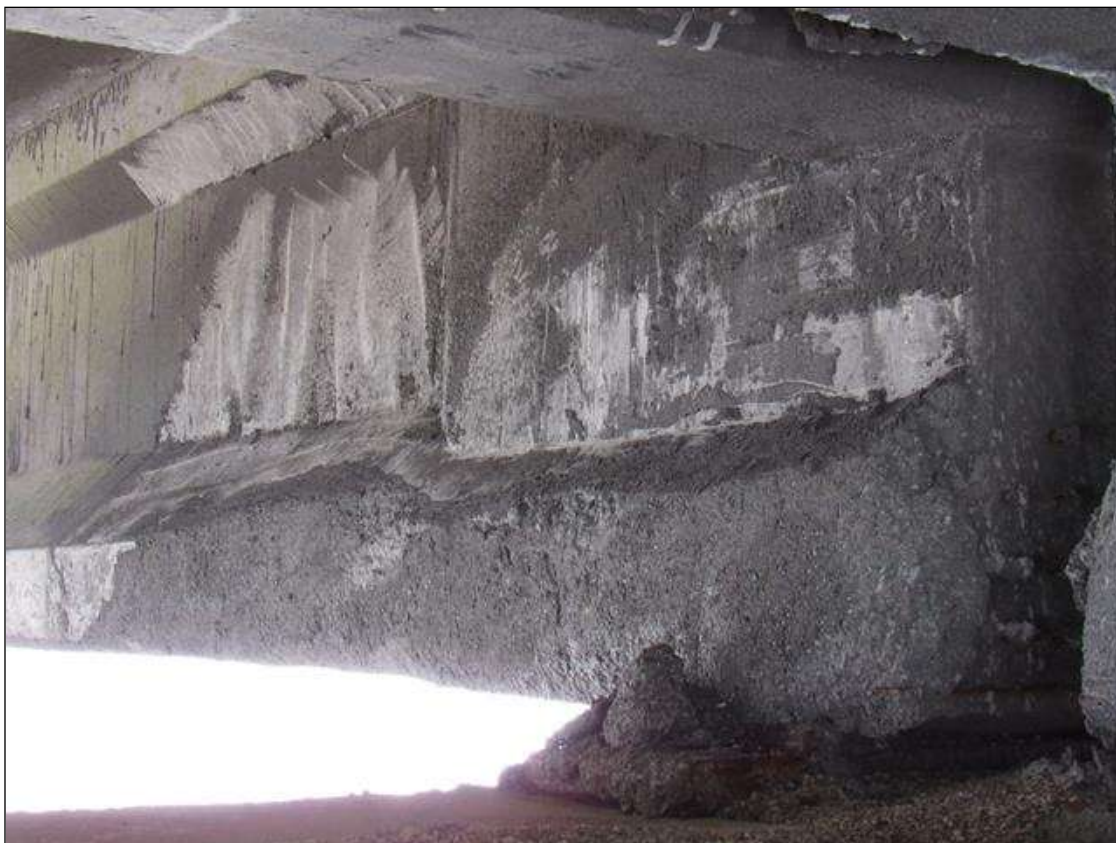
Span 44 Beam 1: 10" X 10" PATCHED AREA, SOUTH FACE, AT BENT 44.

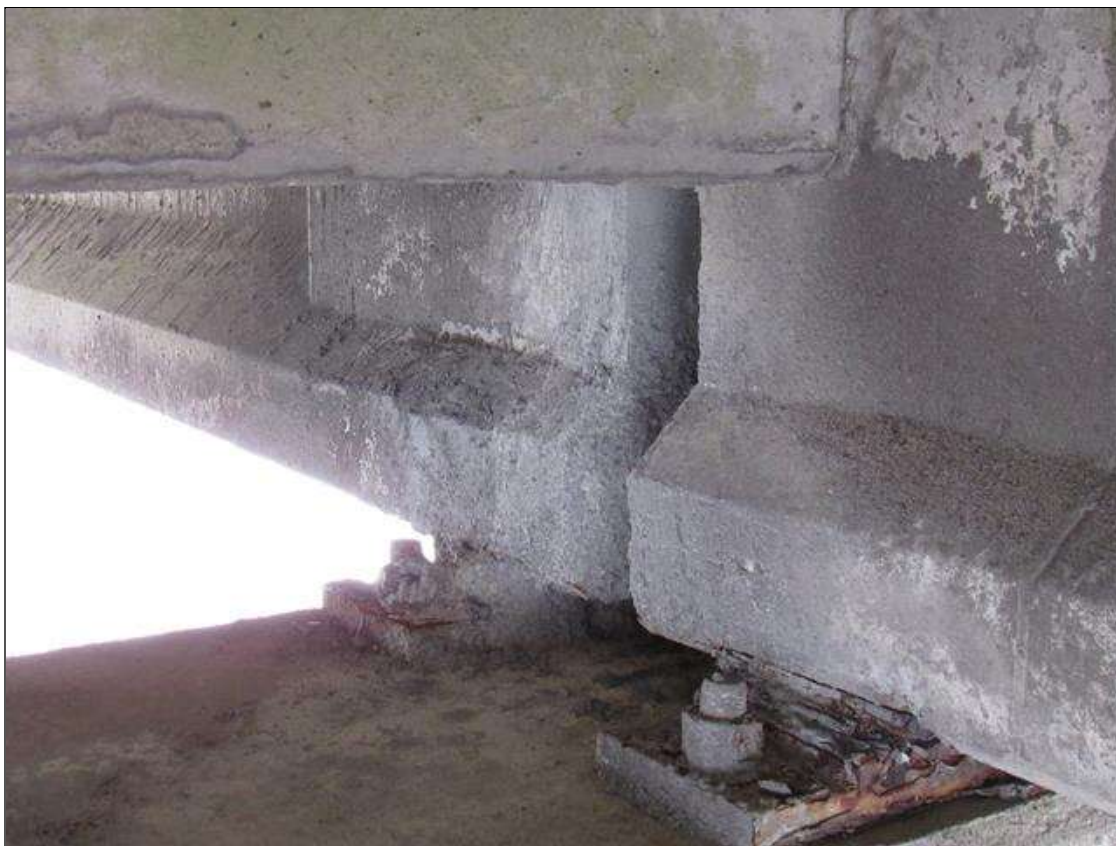
Span 44 Beam 2: 5' X UP TO 10" PATCHED AREA, BOTTOM FACE, EXTENDING 6" ONTO NORTH FACE, AT BENT 43.
