NC DEPARTMENT OF TRANSPORTATION
DIVISION OF HIGHWAYS
STRUCTURE MANAGEMENT UNIT

Structure Safety Report

Routine Element Inspection - Contract

FEATURE INTERSECTED: ALLIGATOR RIVER

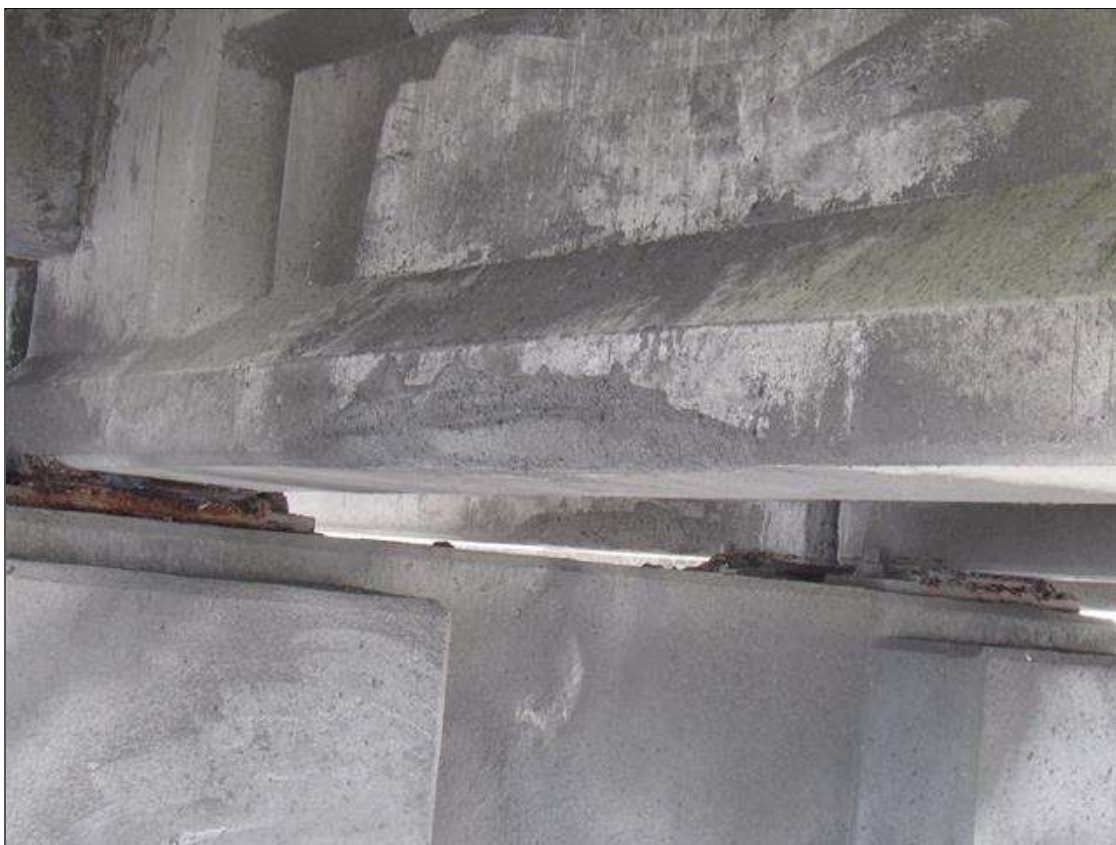
Span 44 Beam 3: 3' X UP TO 5" PATCHED AREA, BOTTOM FACE, EXTENDING 1' ONTO NORTH FACE, AT BENT 43.

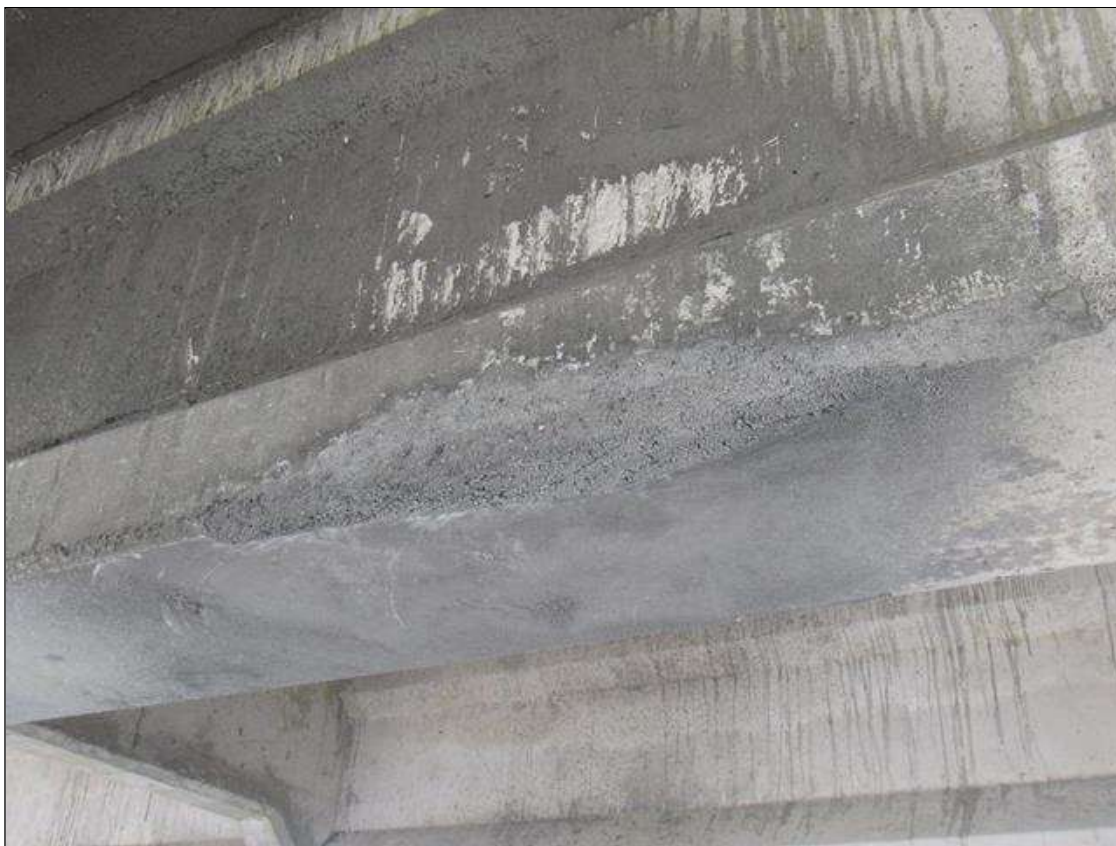
Span 45 Beam 2: 3.5' X UP TO 6" PATCHED AREA, BOTTOM FACE, EXTENDING 5" ONTO NORTH FACE, 5' FROM BENT 45.

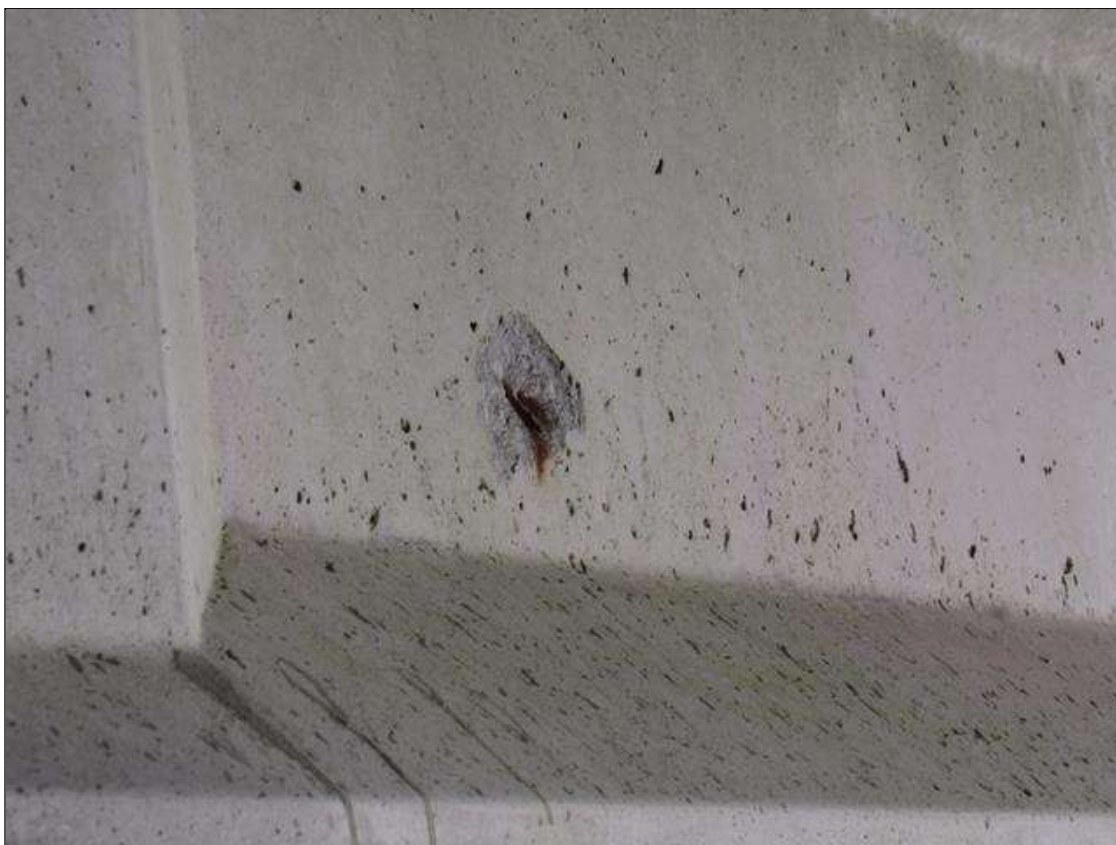
Span 45 Beam 2: 2.5' X UP TO 3" PATCHED AREA, BOTTOM FACE, EXTENDING 3" ONTO SOUTH FACE, 15' FROM BENT 45.

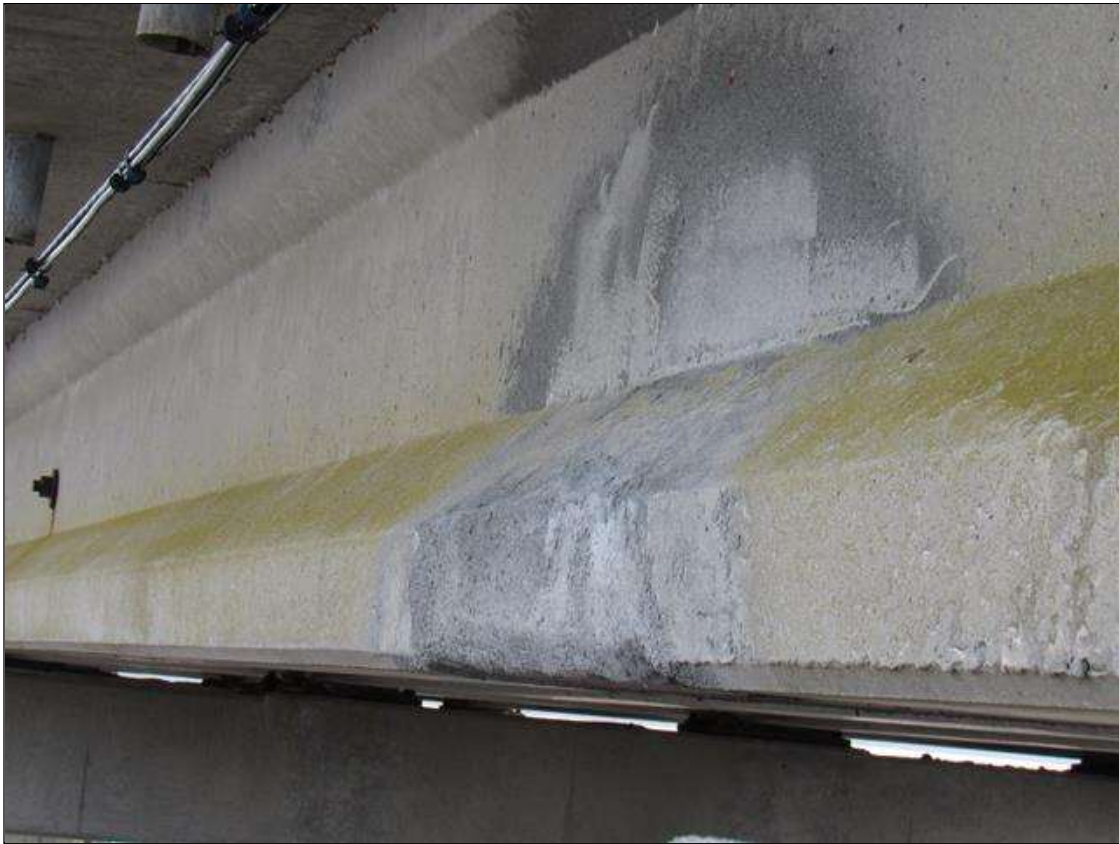
Span 46 Beam 1: 3" DIAMETER SPALL IN WEB, 5' FROM BENT 45.

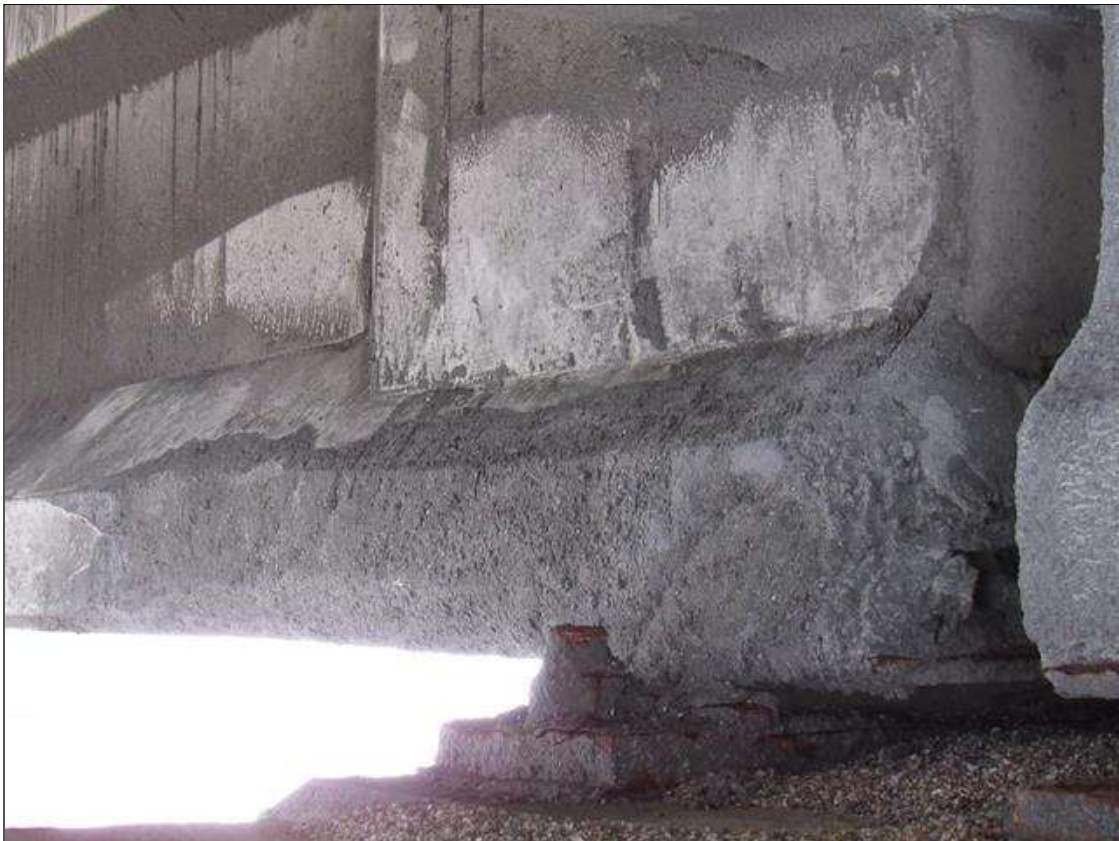
Span 47 Beam 1: 4' X UP TO 5" PATCHED AREA, BOTTOM FACE, EXTENDING 12" ONTO NORTH FACE, 6' FROM BENT 46.

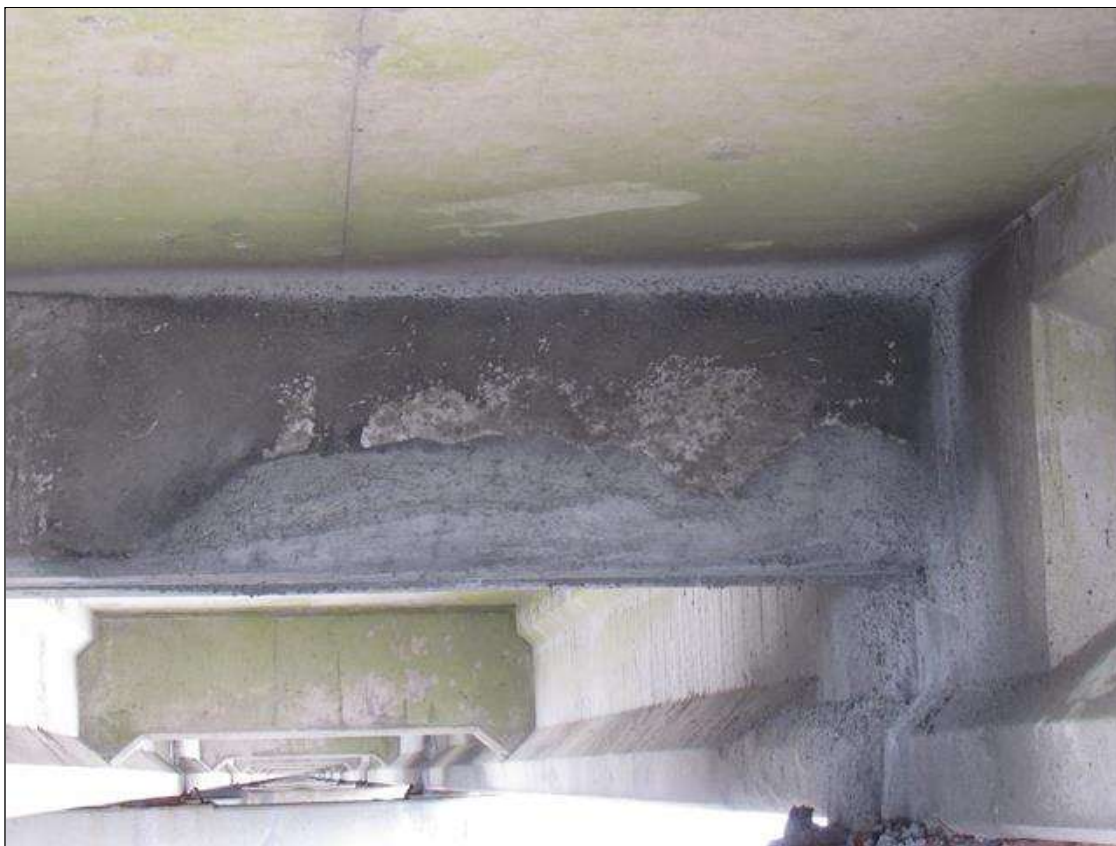
Span 47 Beam 2: 5' X UP TO 6" PATCHED AREA, BOTTOM FACE, EXTENDING 1' ONTO NORTH FACE, AT BENT 46.

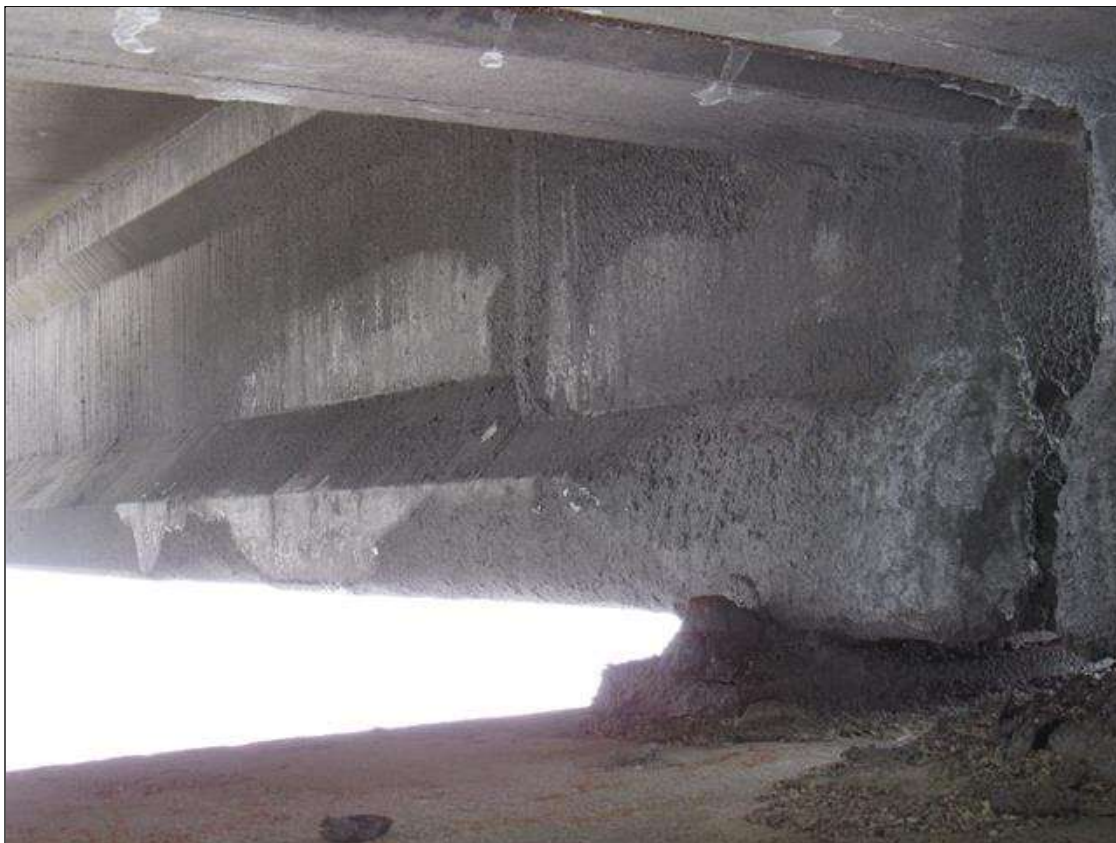
Span 47 Beam 3: 5' X UP TO 10" X 1' PATCHED AREA, WEST FACE, END DIAPHRAGM, BETWEEN BEAMS 3 AND 4, AT BENT 47.

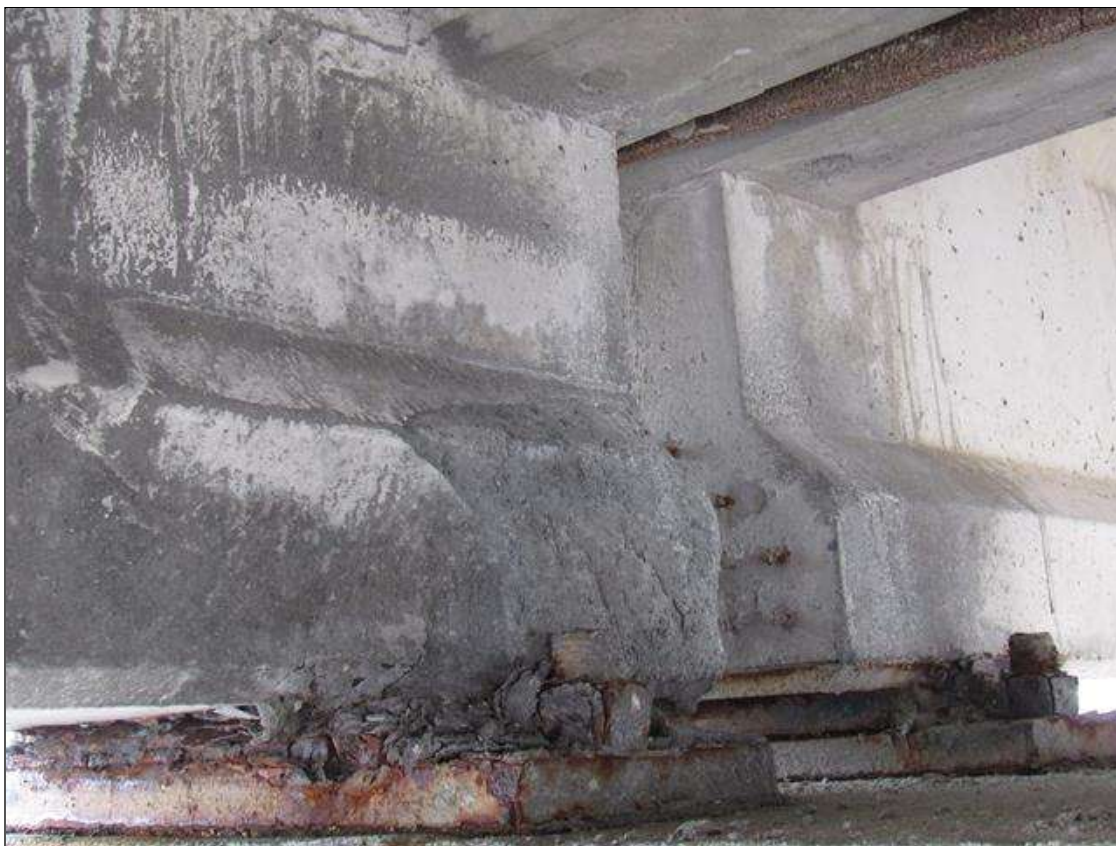
Span 47 Beam 4: 5' X UP TO 5" PATCHED AREA, BOTTOM FACE, EXTENDING 1' ONTO NORTH FACE, AT BENT 46.

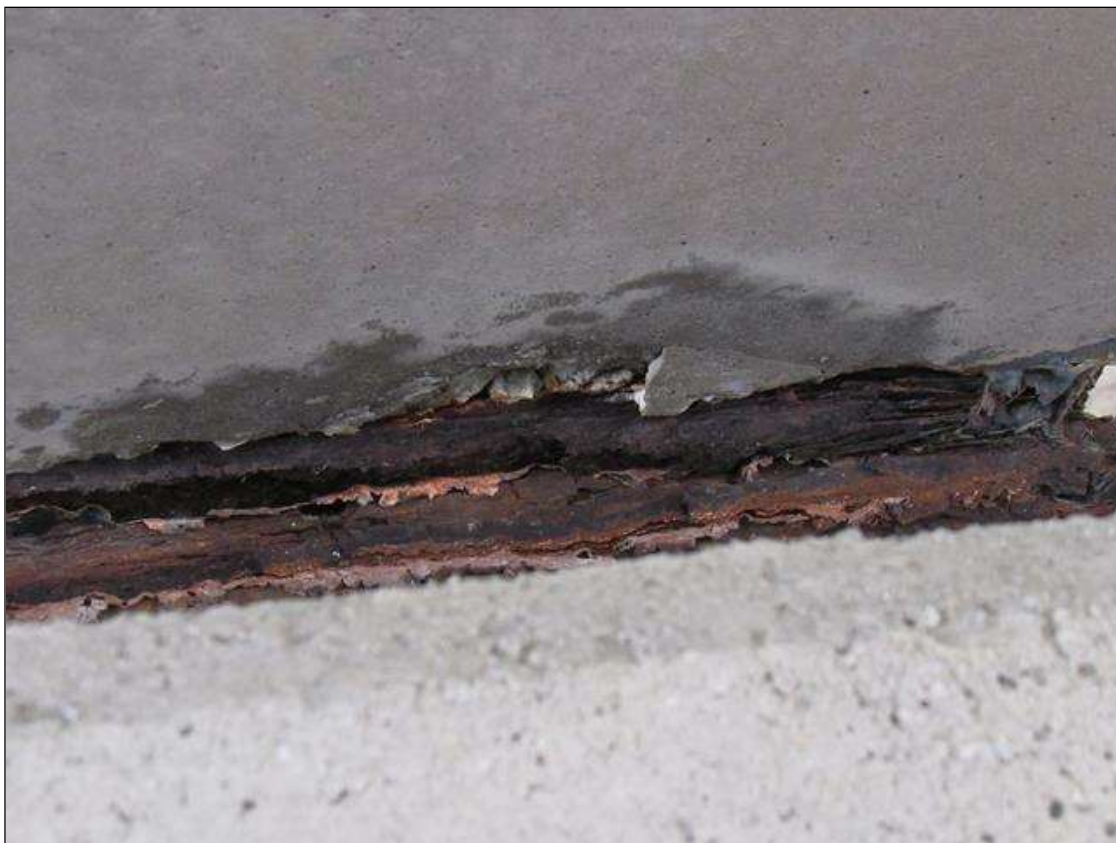
Span 48 Beam 1: 12" X 8" PATCHED AREA, NORTH FACE, 4' FROM BENT 48.

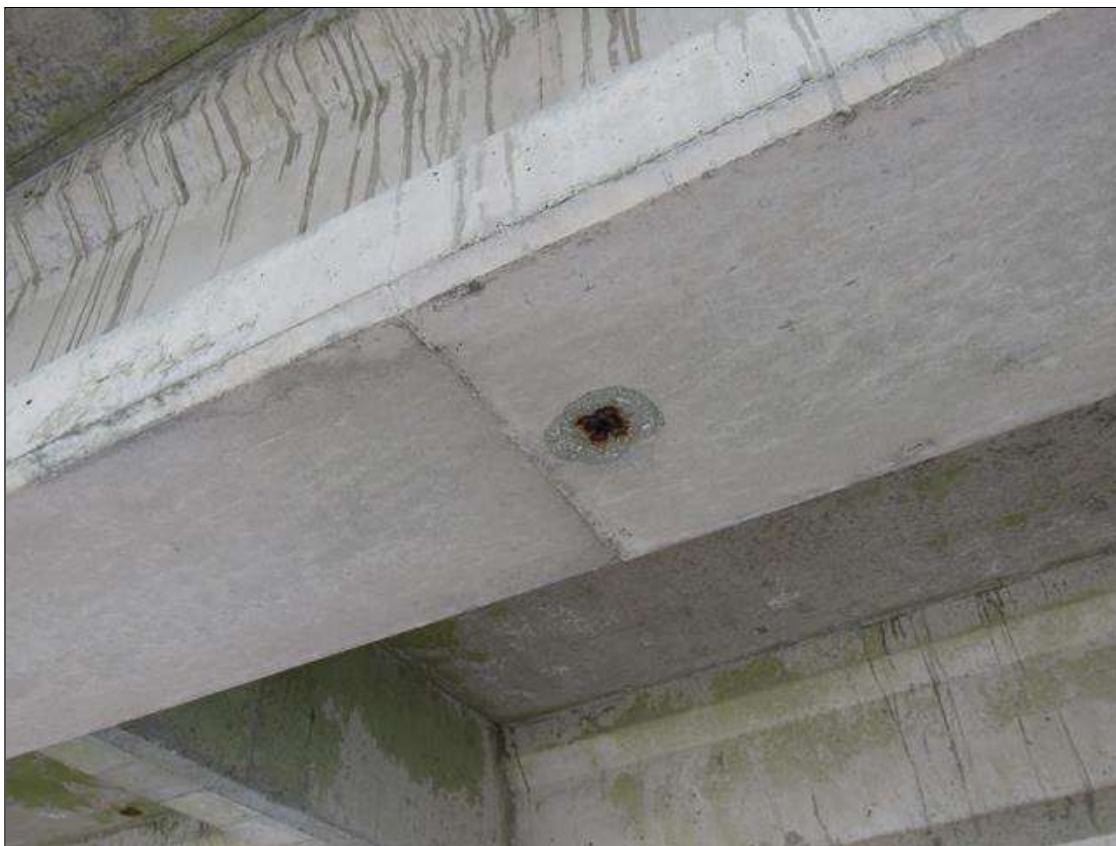
Span 49 Beam 2: 6" LONG X 1" HIGH SHALLOW SPALL WITH DELAMINATION ON BOTTOM EDGE AT BENT 49 BEARING

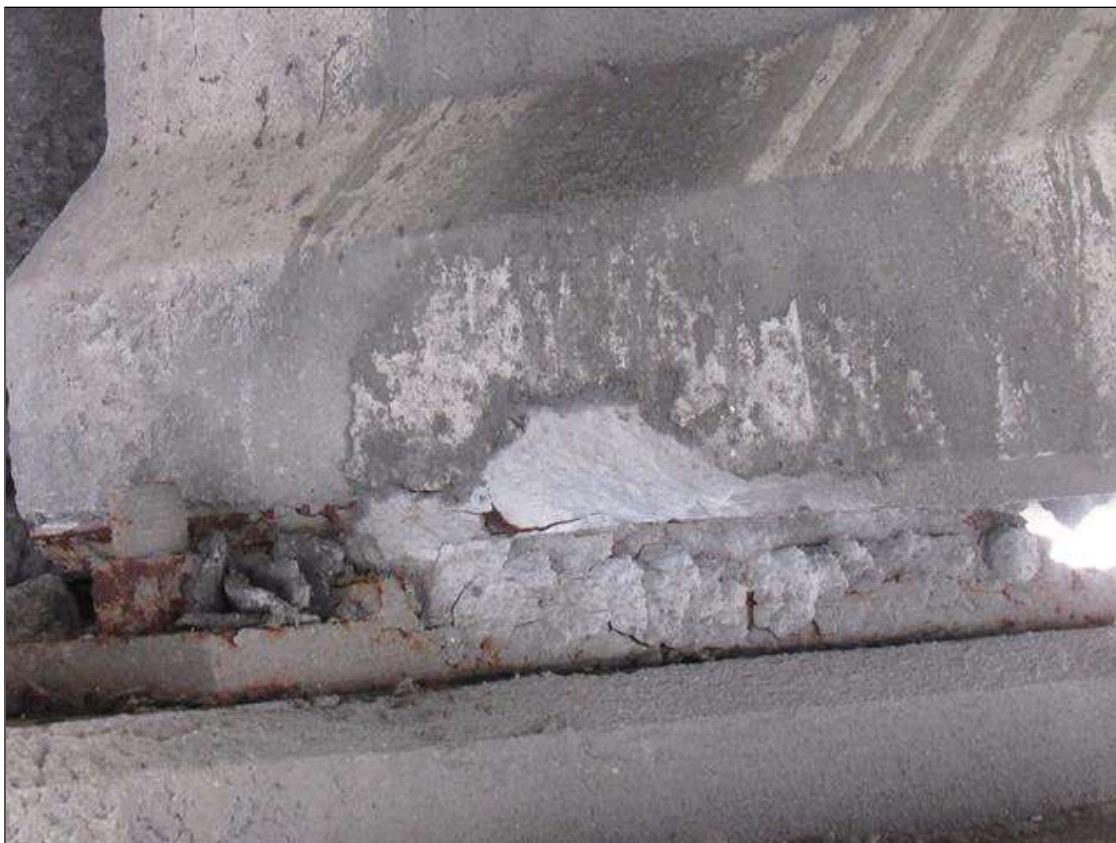
Span 49 Beam 3: 3" DIAMETER SPALL, 5' EAST OF MID SPAN

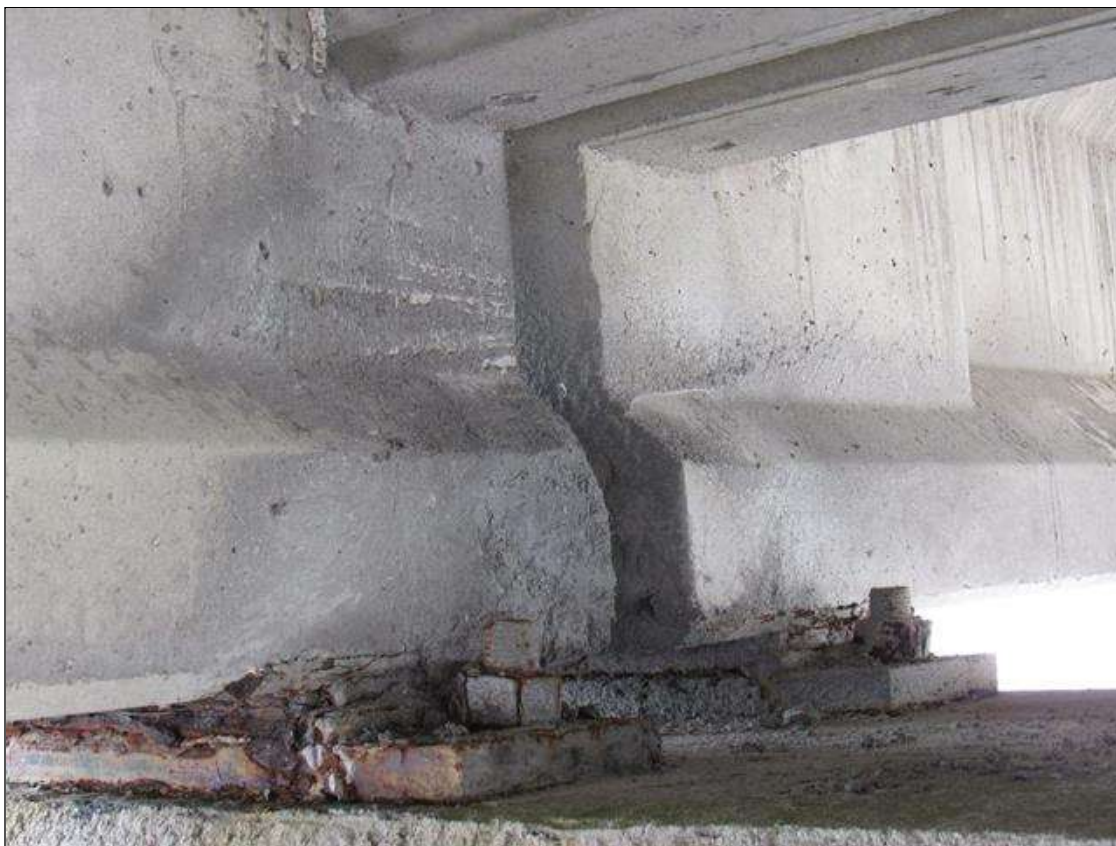
Span 49 Beam 3: 1' X UP TO 6" X 3" SPALL, BOTTOM FACE, AT BENT 49.

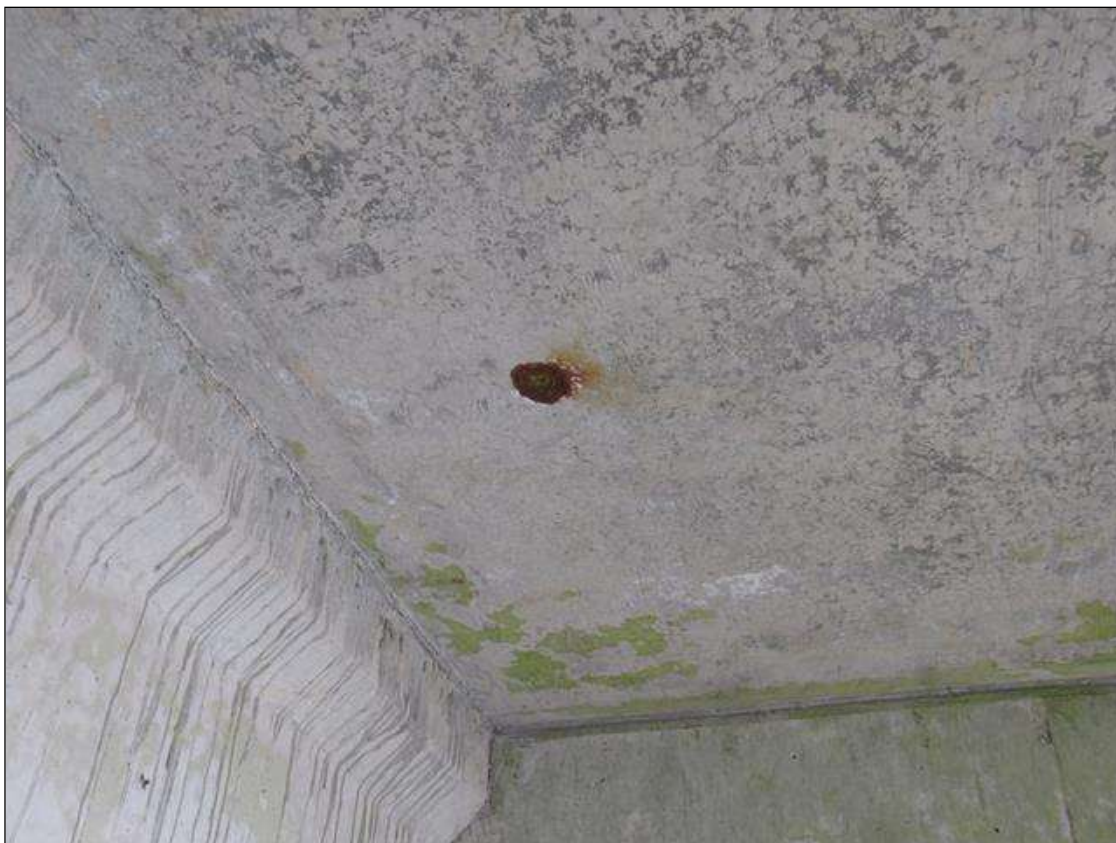
Span 50 Beam 1: 12" X 12" PATCHED AREA, SOUTH FACE, AT BENT 50.

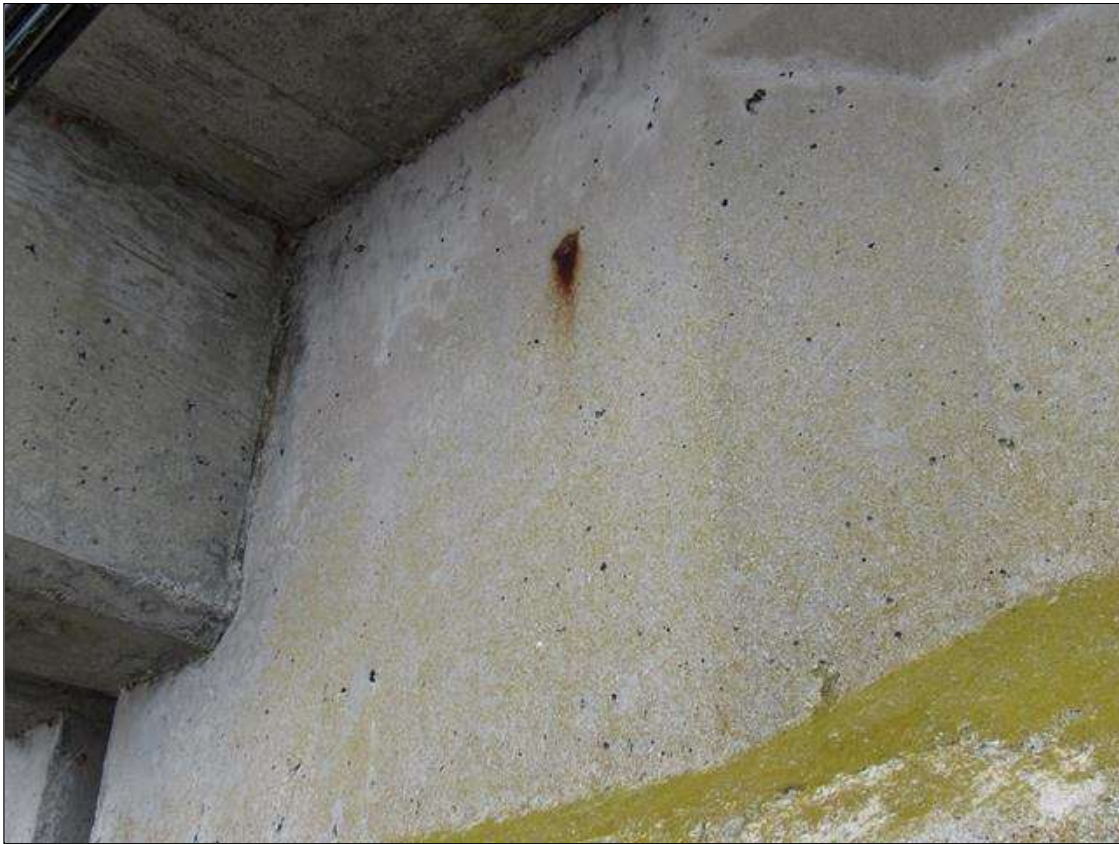
Span 50 Deck: 2" X 2" AREA OF RUST STAINING, UNDERSIDE OF DECK, BETWEEN BEAMS 1 AND 2, 30' FROM BENT 50.

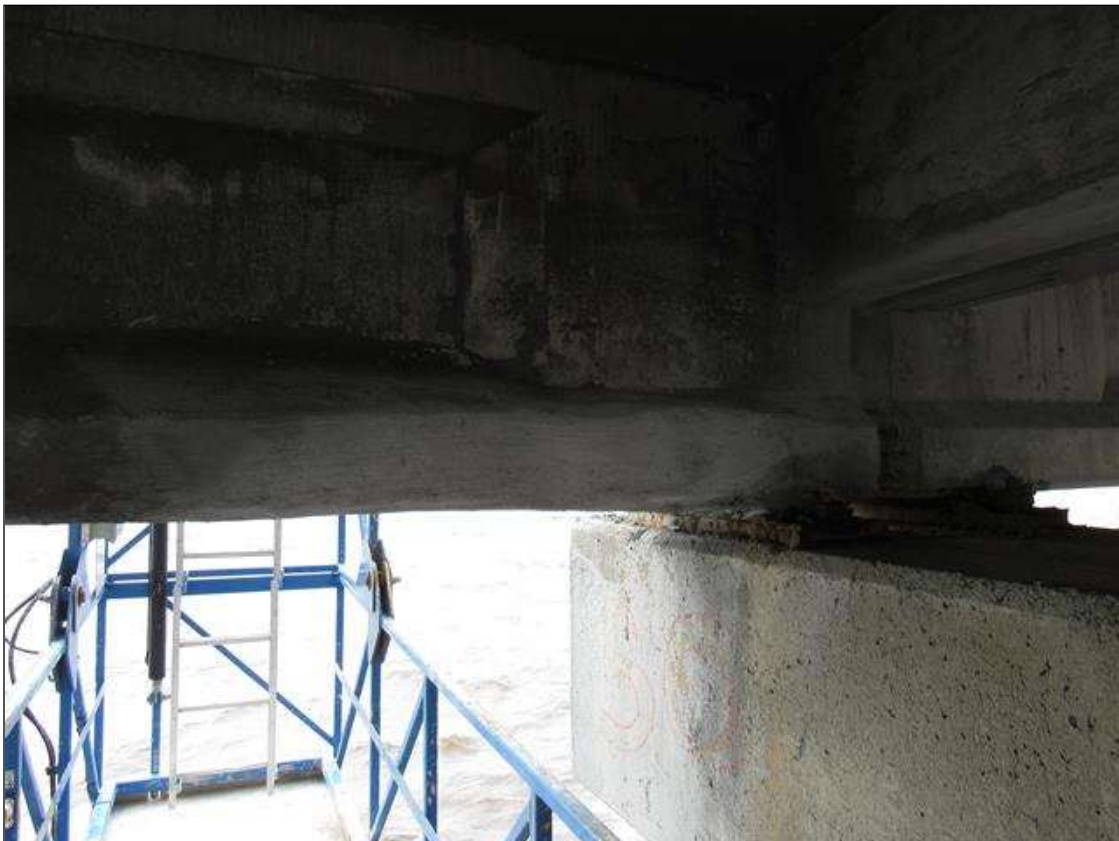
Span 51 Beam 1: 1" X 2" AREA OF RUST STAINING, NORTH FACE, 1' FROM BENT 51.

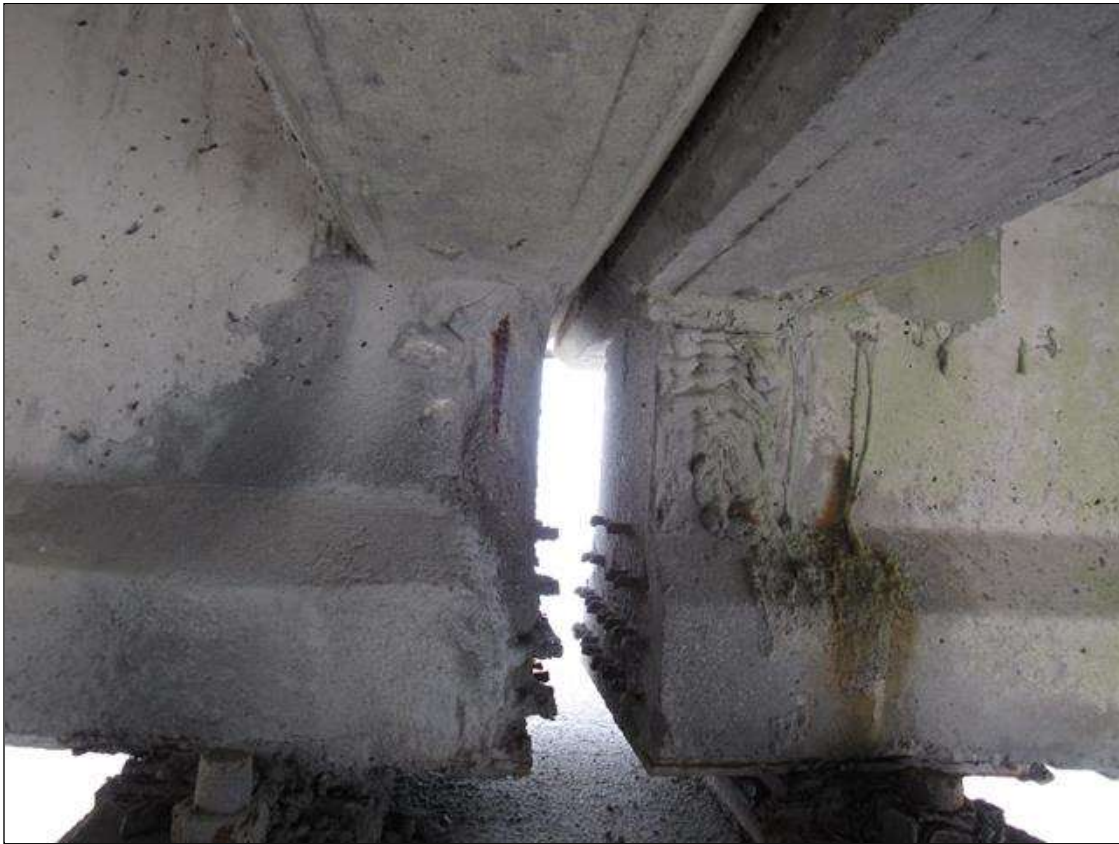
Span 51 Beam 4: 54" X 12" X 12" CORNER PATCHED AREA, NORTH FACE, AT BENT 50.

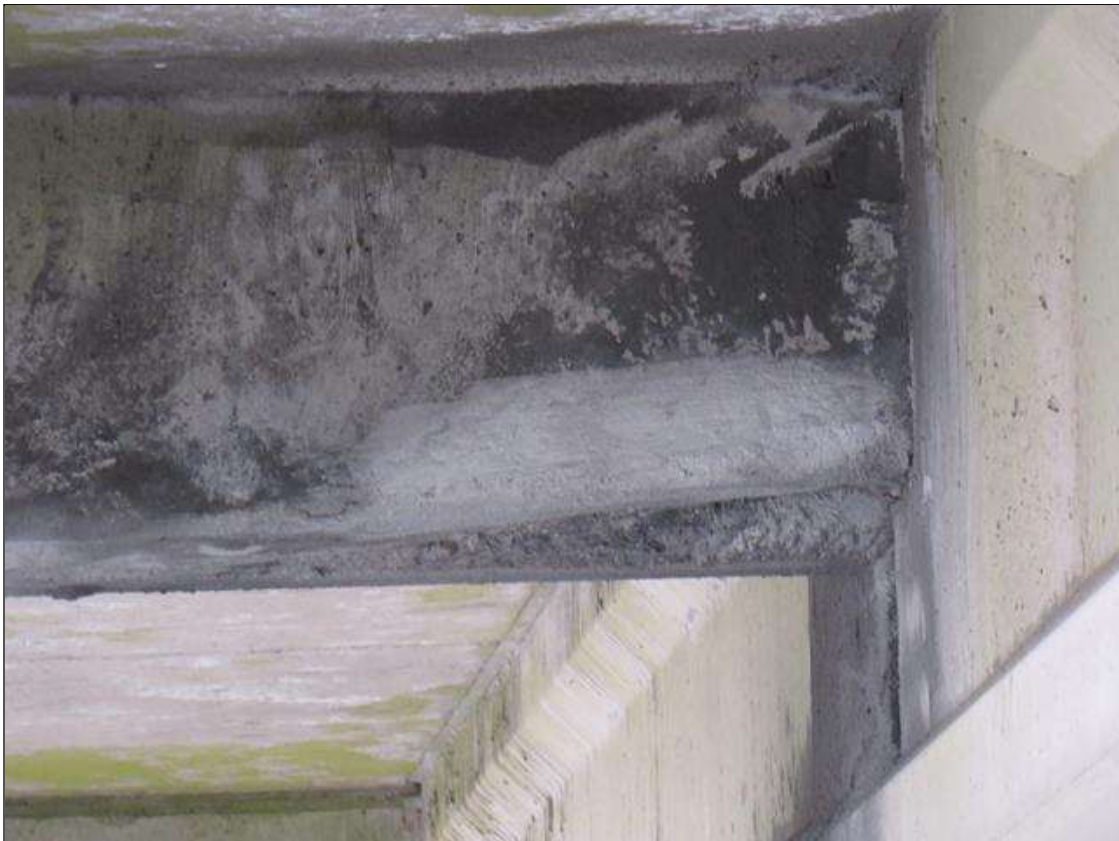
Span 52 Beam 1: 12" X 24" FAILED PATCHED AREA, WITH 6" OF EXPOSED REINFORCING, SOUTH FACE, AT BENT 52.

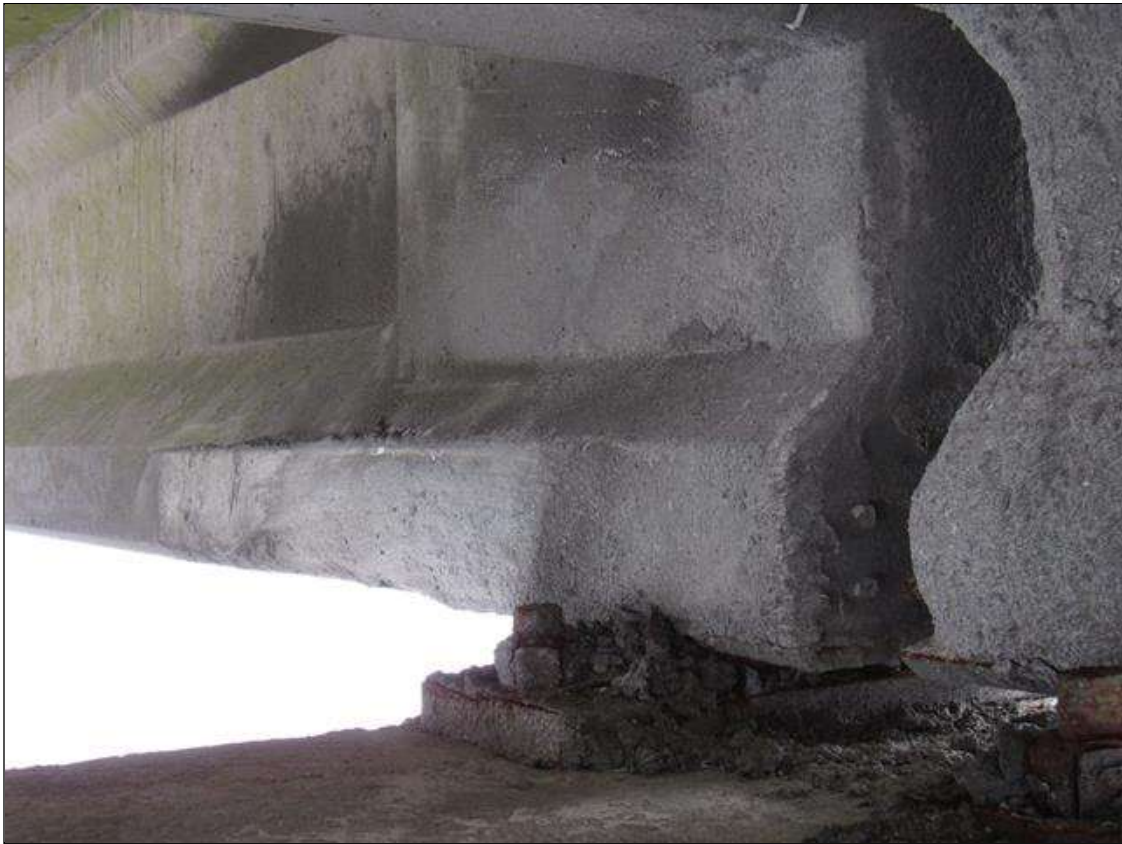
Span 52 Beam 1: 18" X 12" X 12" CORNER PATCHED AREA, END DIAPHRAGM, BETWEEN BEAMS 1 AND 2, EAST

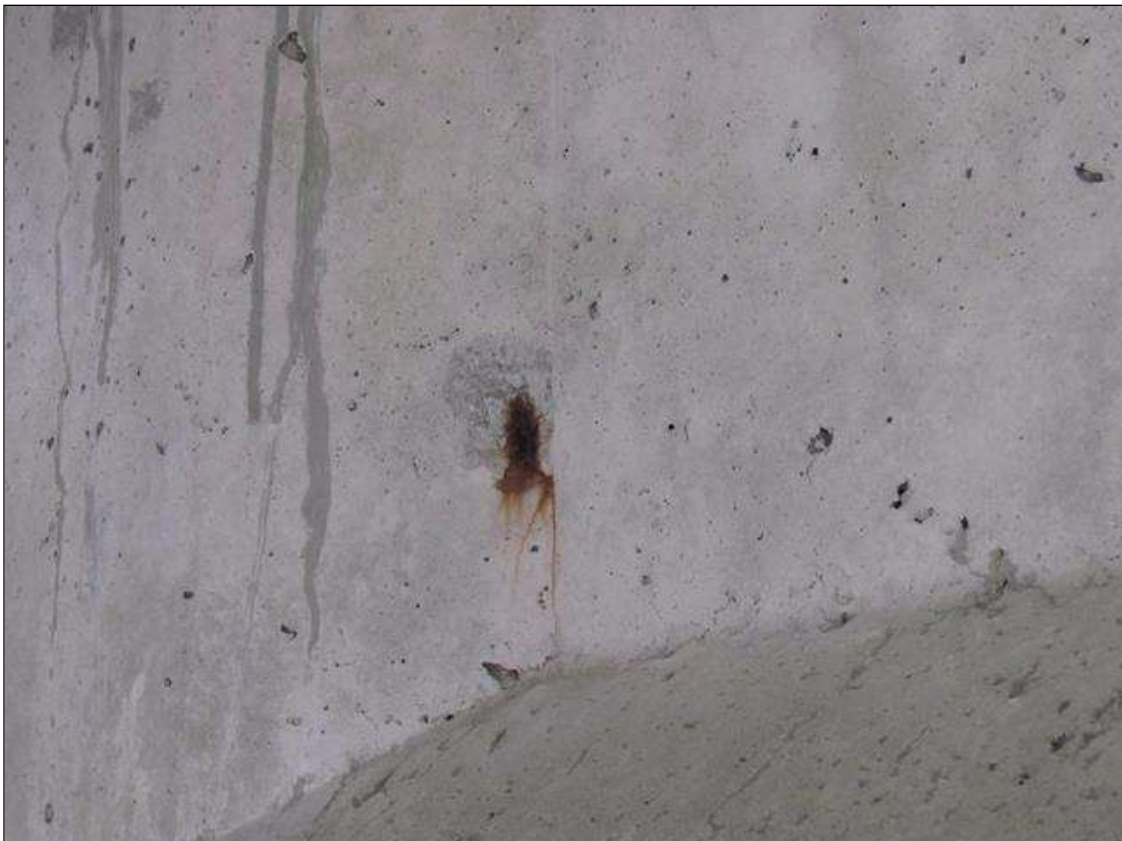
Span 52 Beam 4: 48" X 12" X 12" CORNER PATCHED AREA, NORTH FACE, AT BENT 51.

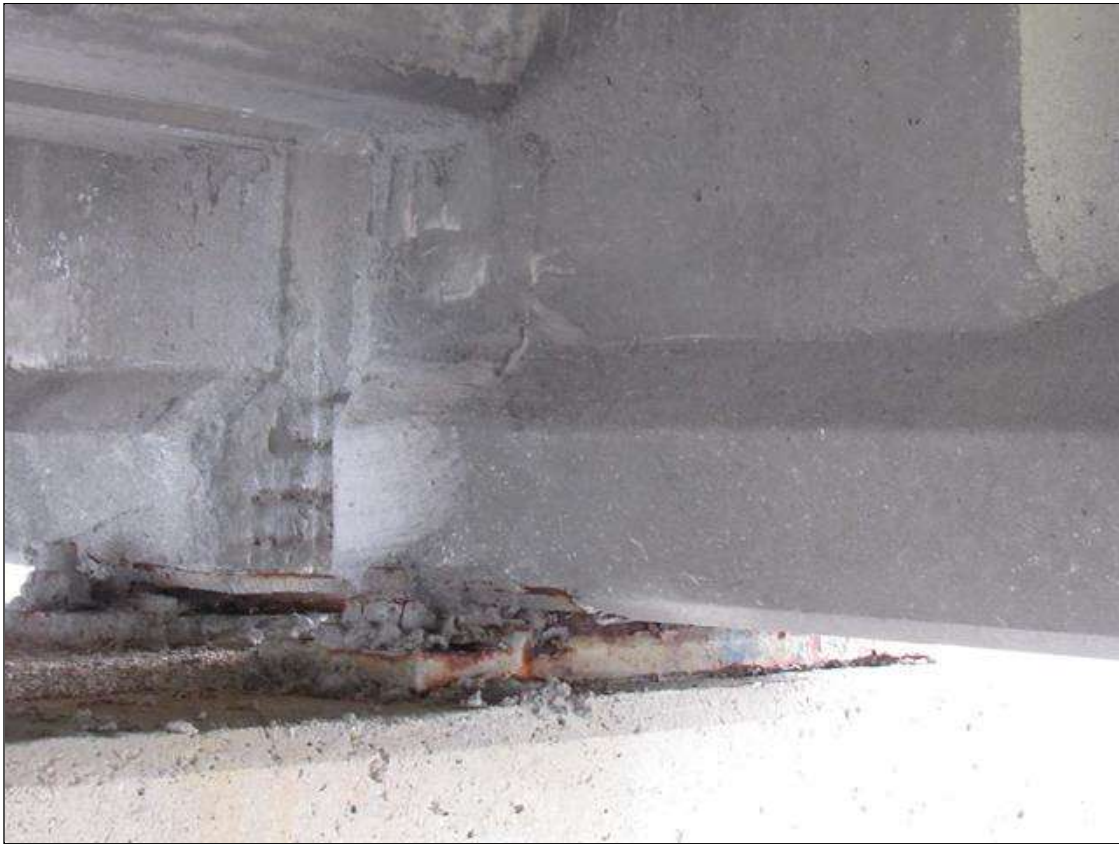
Span 53 Beam 3: 2" DIAMETER X 1/4" DEEP SPALL WITH EXPOSED REBAR, NORTH FACE, 2' FROM BENT 53.

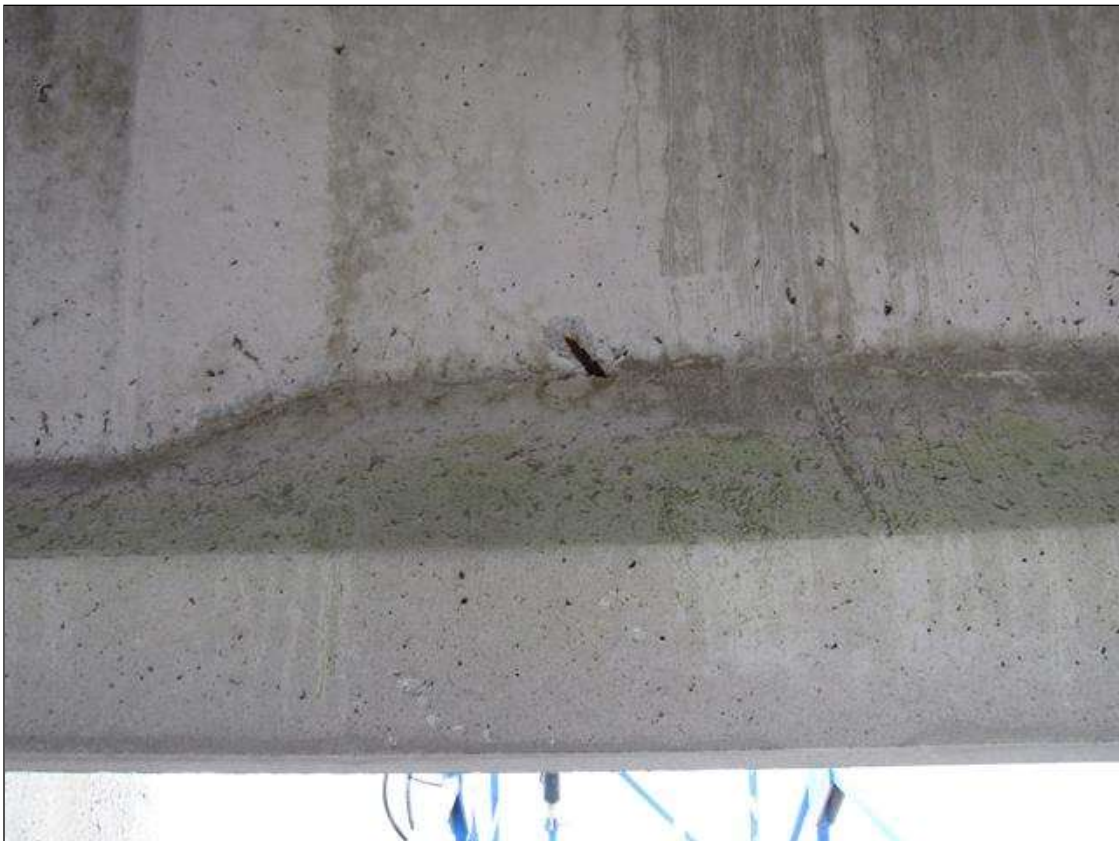
Span 53 Beam 4: 12" X 12" PATCHED AREA, NORTH FACE, AT BENT 53.

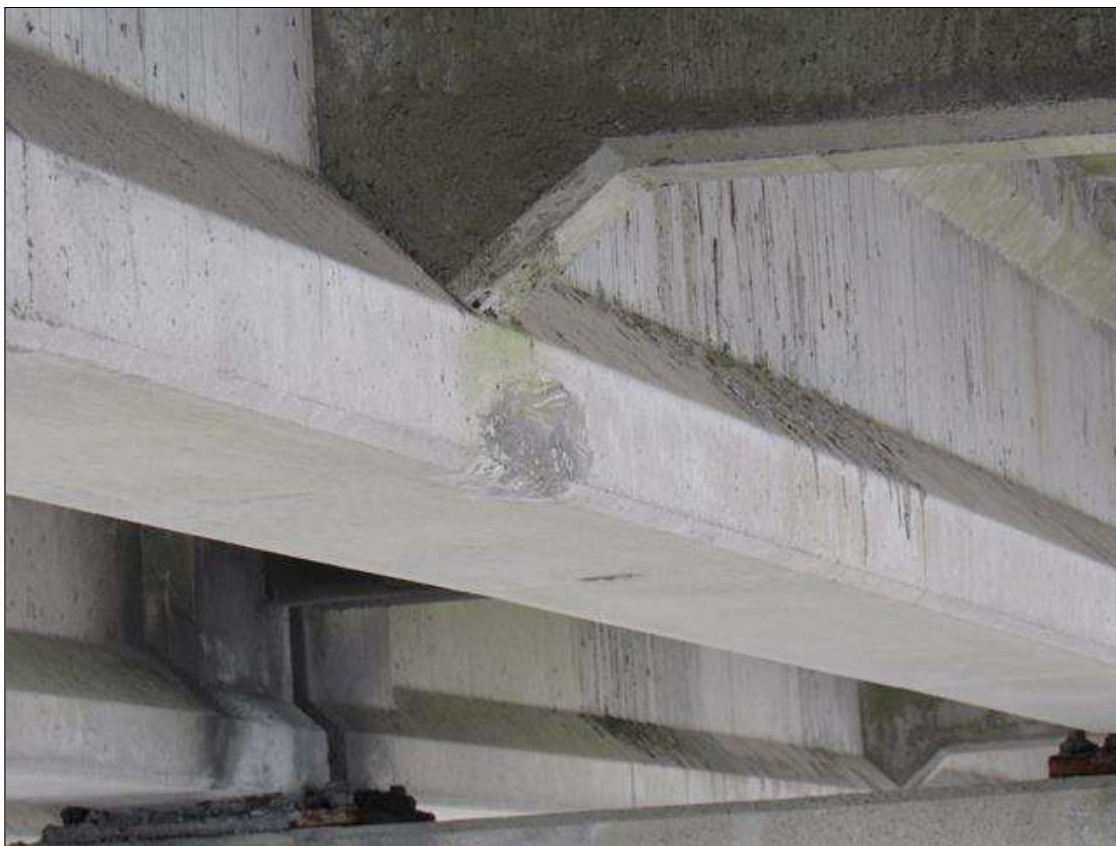
Span 54 Beam 4: (1) LOCATION OF EXPOSED REBAR, NORTH FACE, 5' FROM BENT 54.

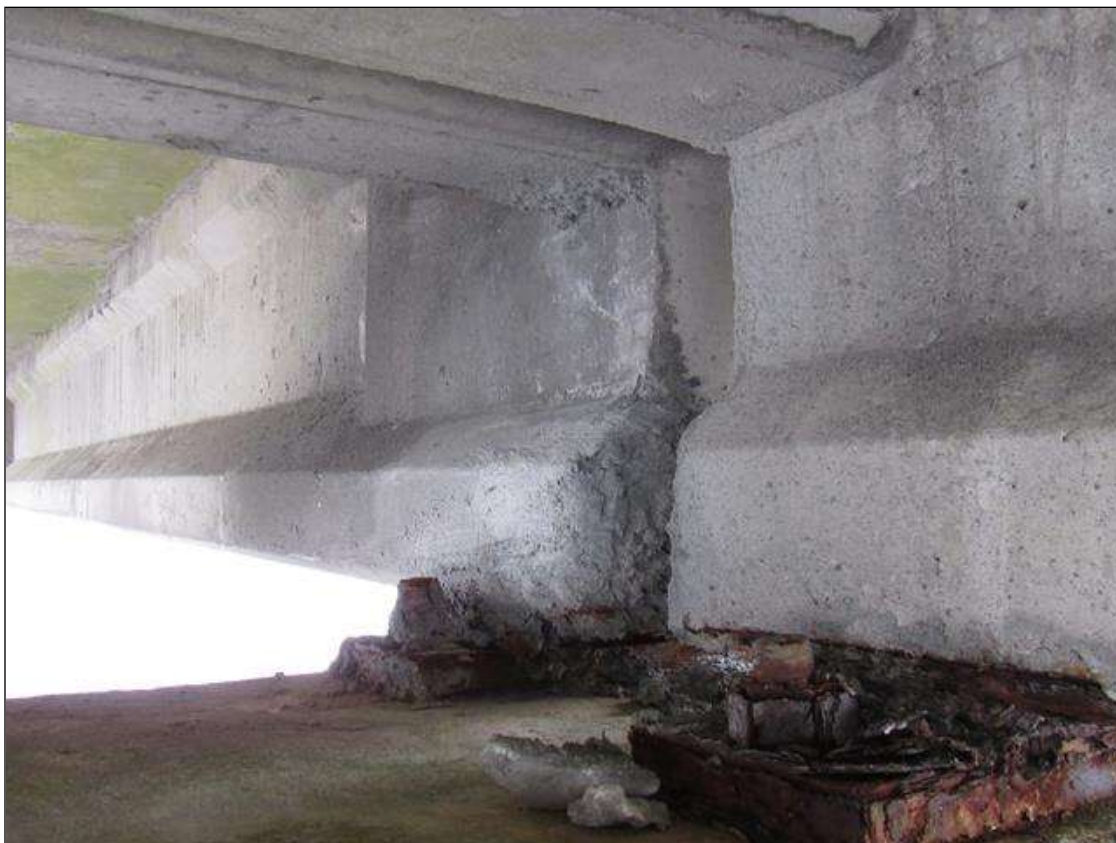
Span 55 Beam 2: 18" X 12" PATCHED AREA, NORTH FACE, AT BENT 55.

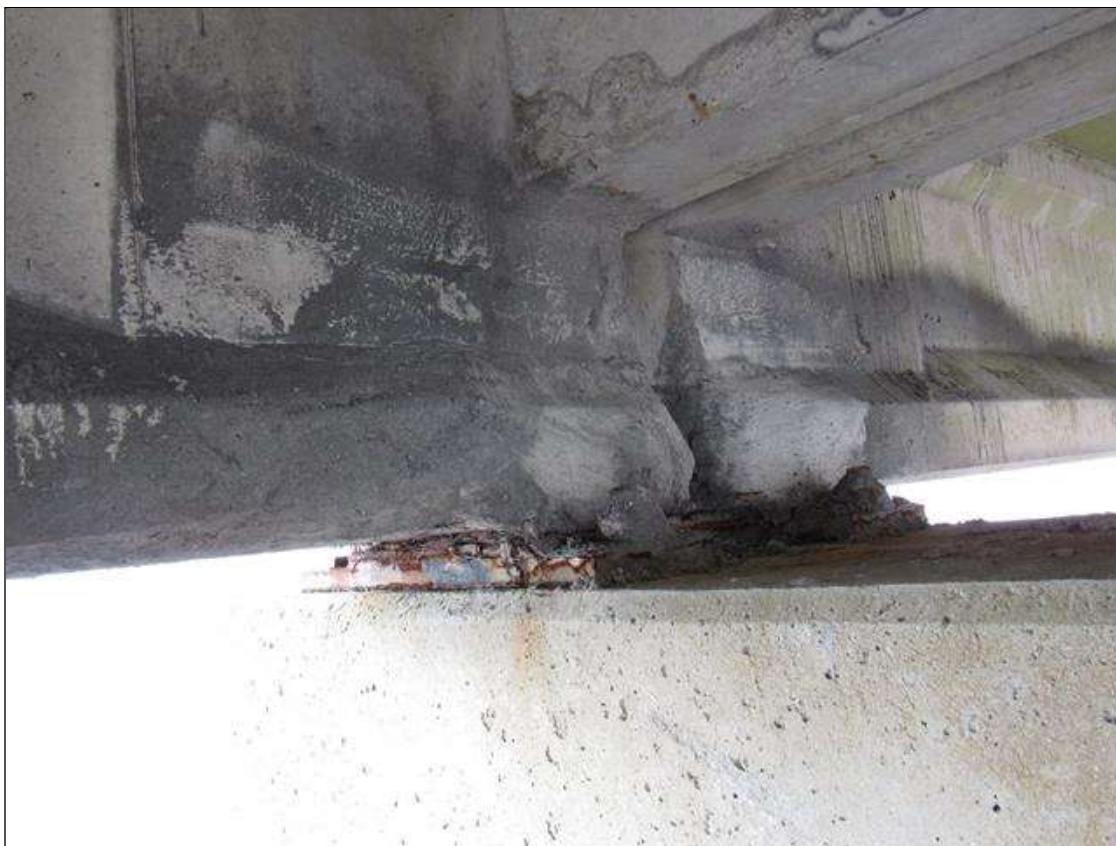
Span 55 Beam 4: 12" X 12" PATCHED AREA, NORTH FACE, AT BENT 54.
