NC DEPARTMENT OF TRANSPORTATION
DIVISION OF HIGHWAYS
STRUCTURE MANAGEMENT UNIT

Structure Safety Report

Routine Element Inspection - Contract

FEATURE INTERSECTED: ALLIGATOR RIVER

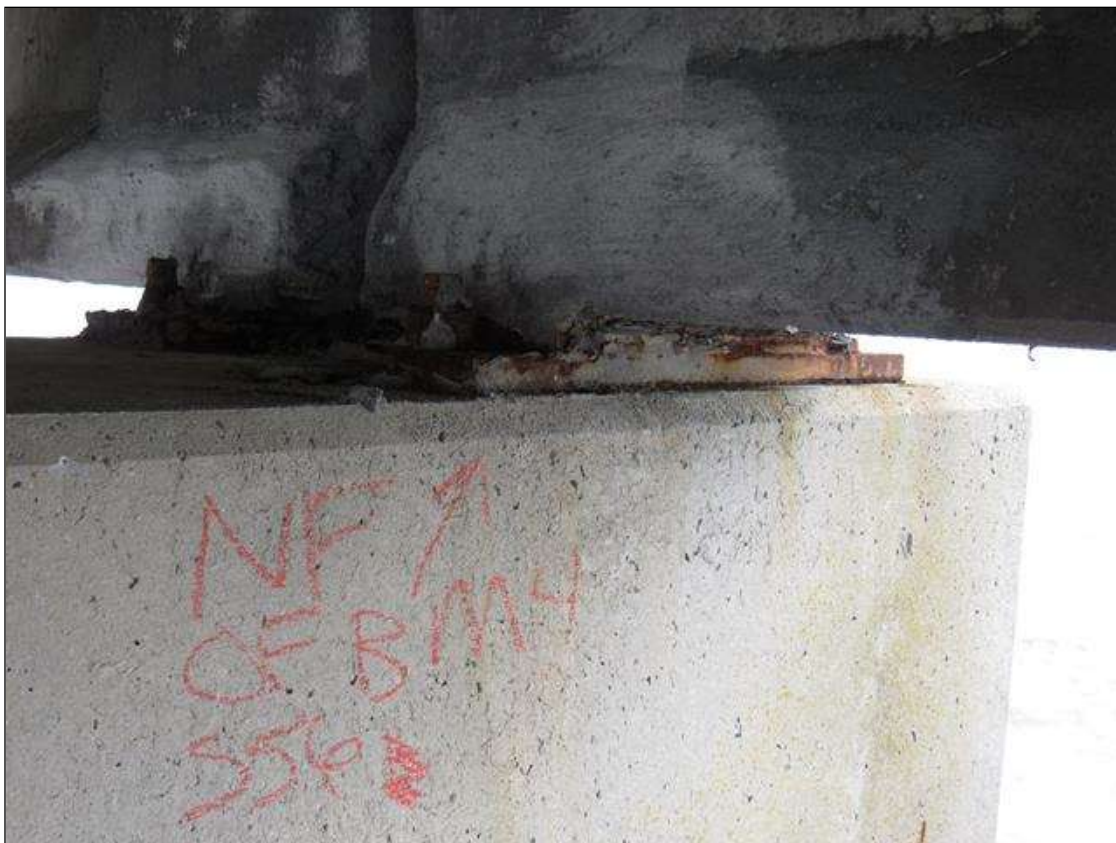
Span 56 Beam 1: 48" X 18" X 6" CORNER PATCHED AREA, SOUTH FACE, AT BENT 56.

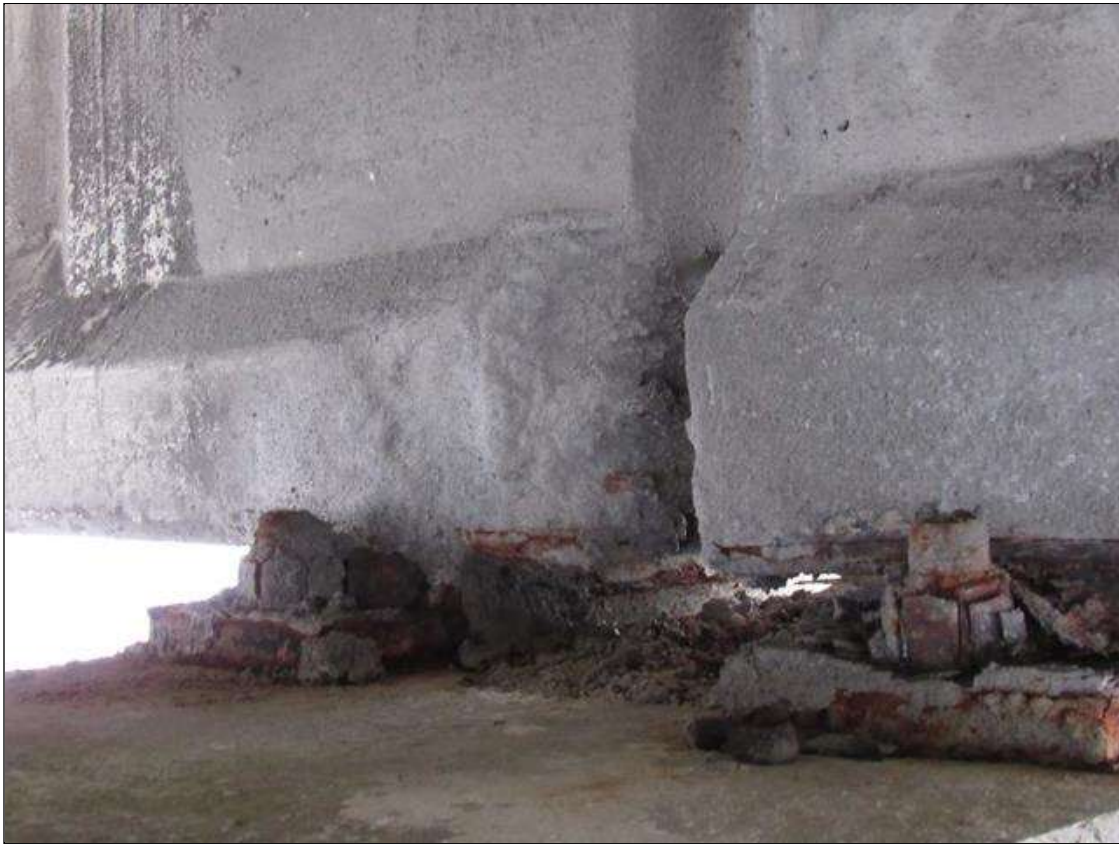
Span 56 Beam 4: 24" X 12" PATCHED AREA, NORTH FACE, AT BENT 56.

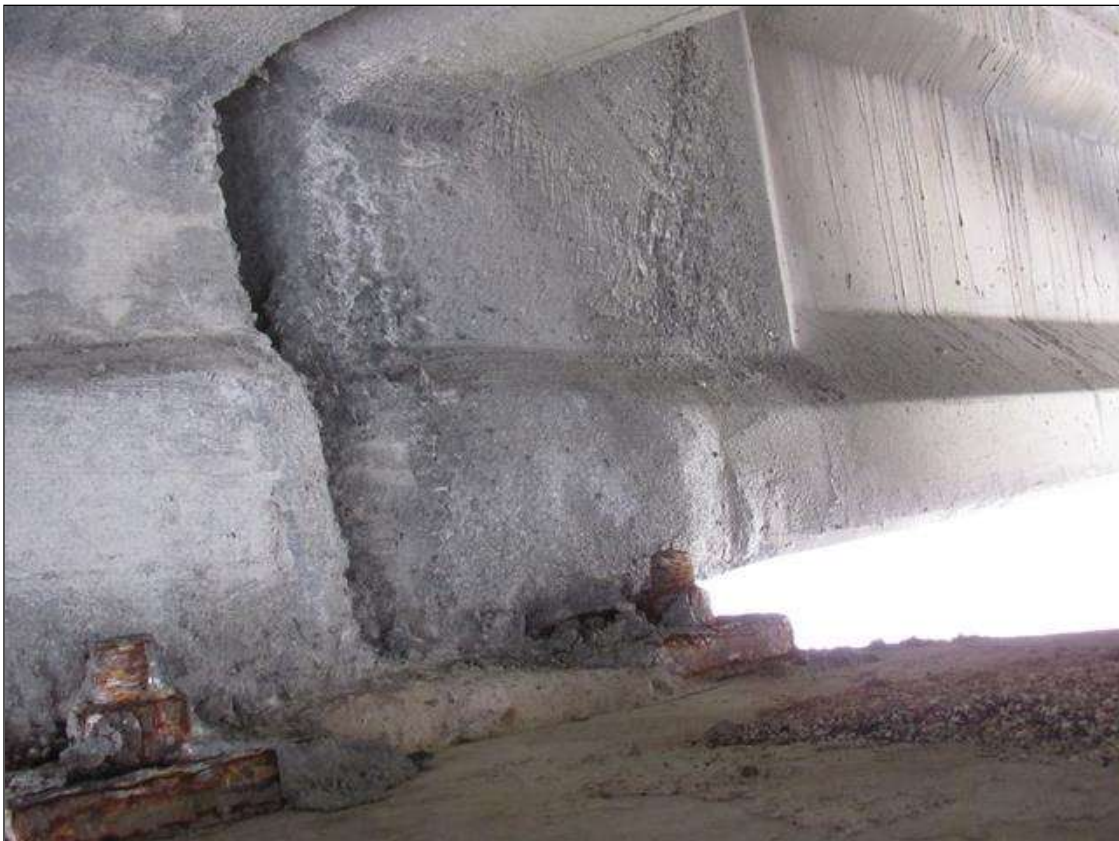
Span 56 Beam 4: 12" X 12" PATCHED AREA, NORTH FACE, AT BENT 55.

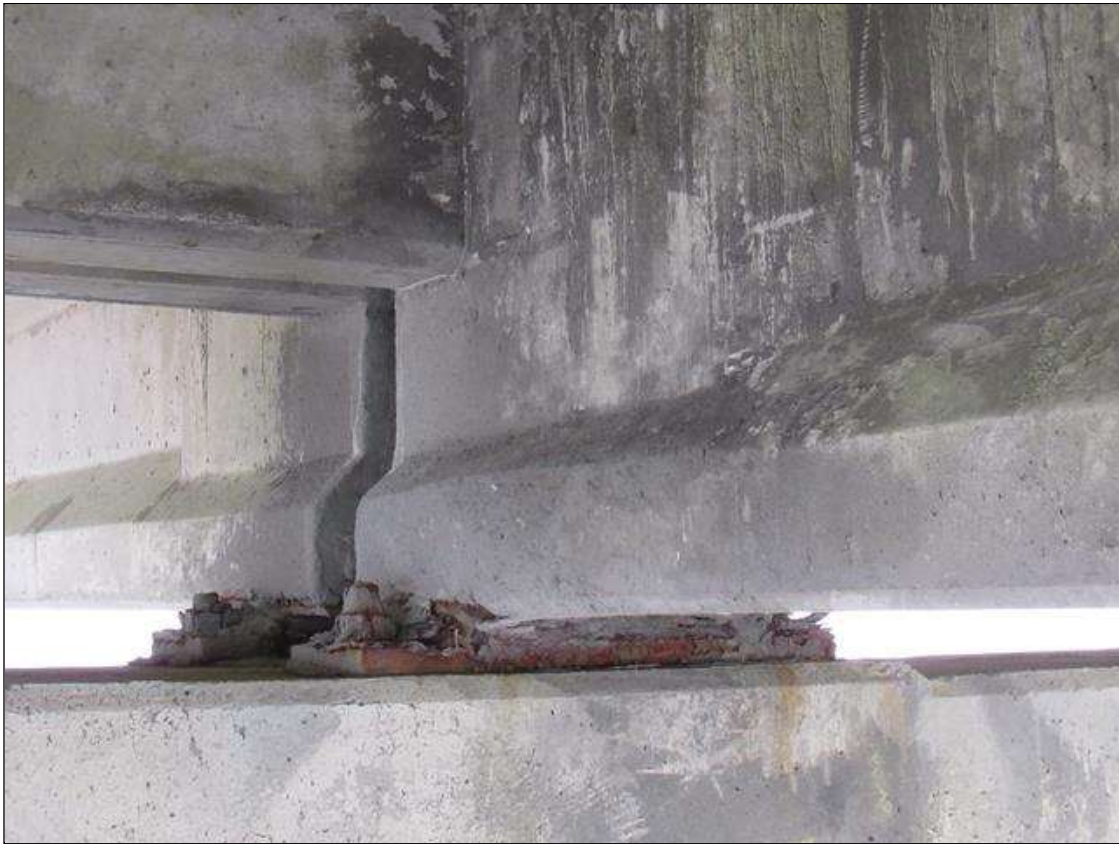
Span 57 Beam 2: (2) UP TO 24" X 12" PATCHED AREAS, NORTH AND SOUTH FACES, AT BENT 56.

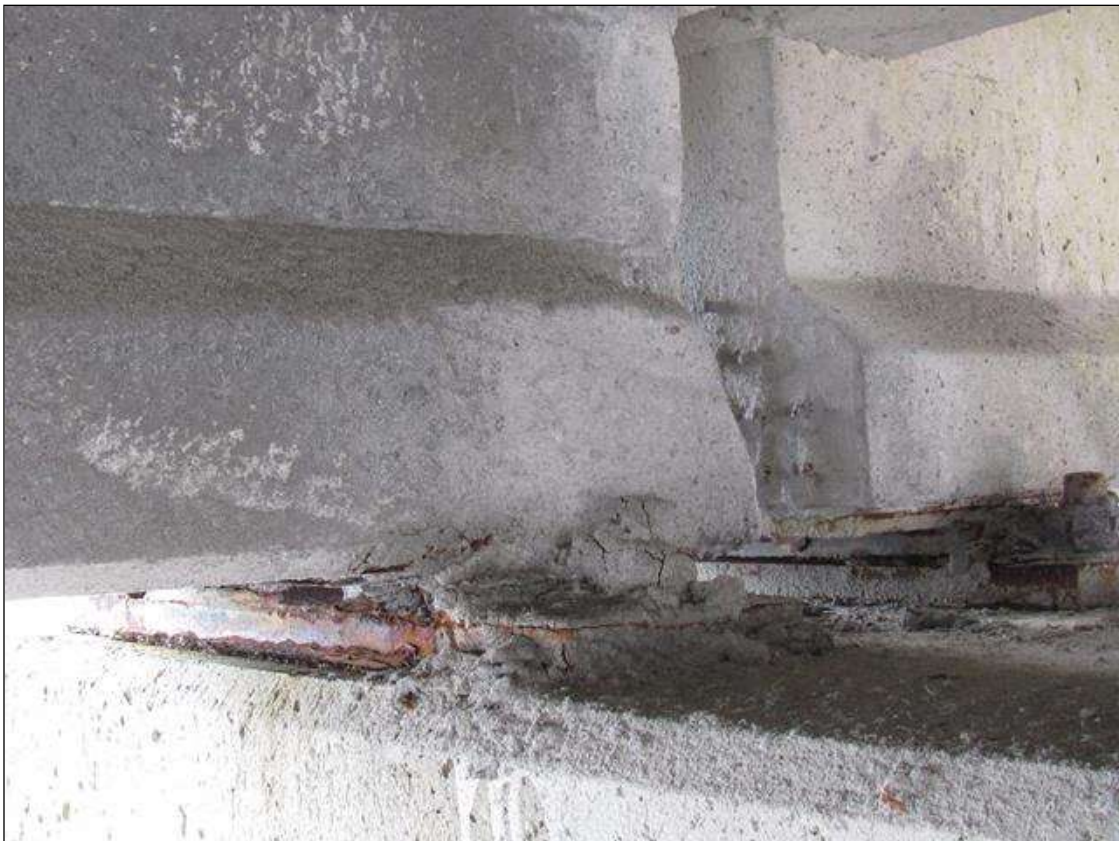
Span 58 Beam 3: 24" X 12" PATCHED AREA, NORTH FACE, AT BENT 58.

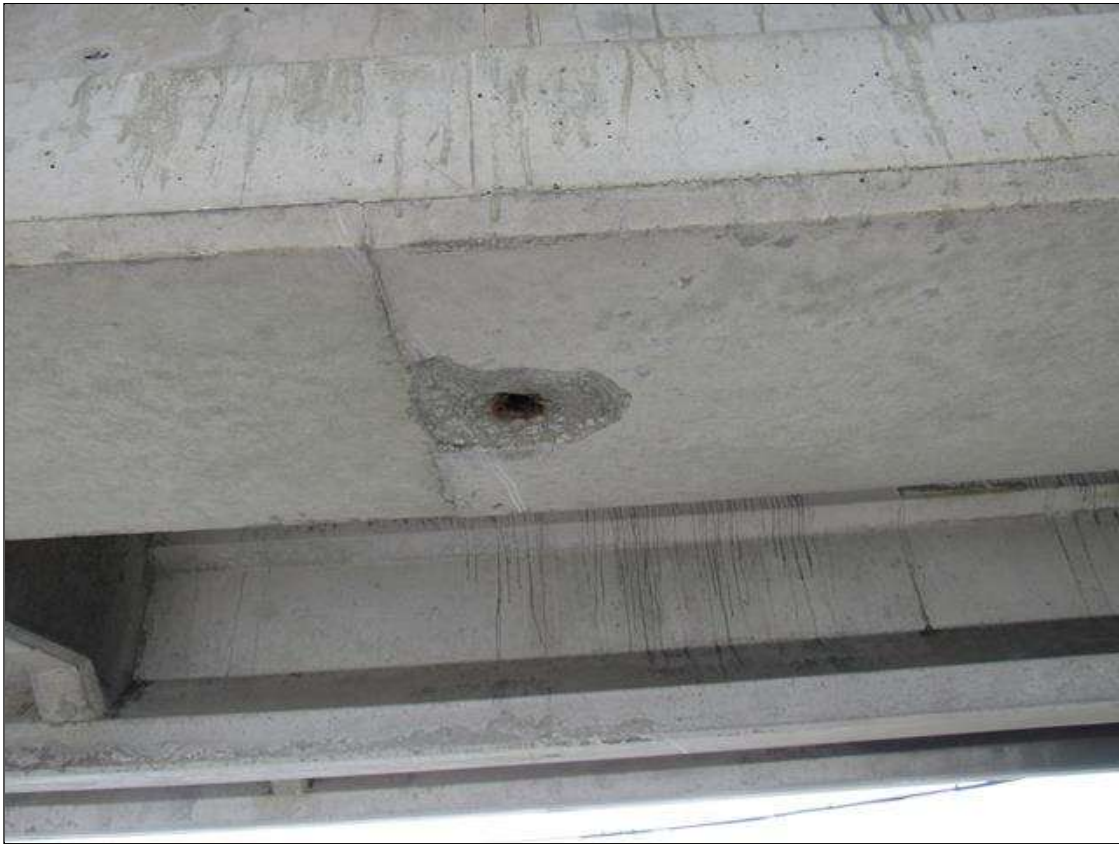
Span 59 Beam 1: 7" X 10" PATCHED AREA, SOUTH FACE, AT BENT 59.

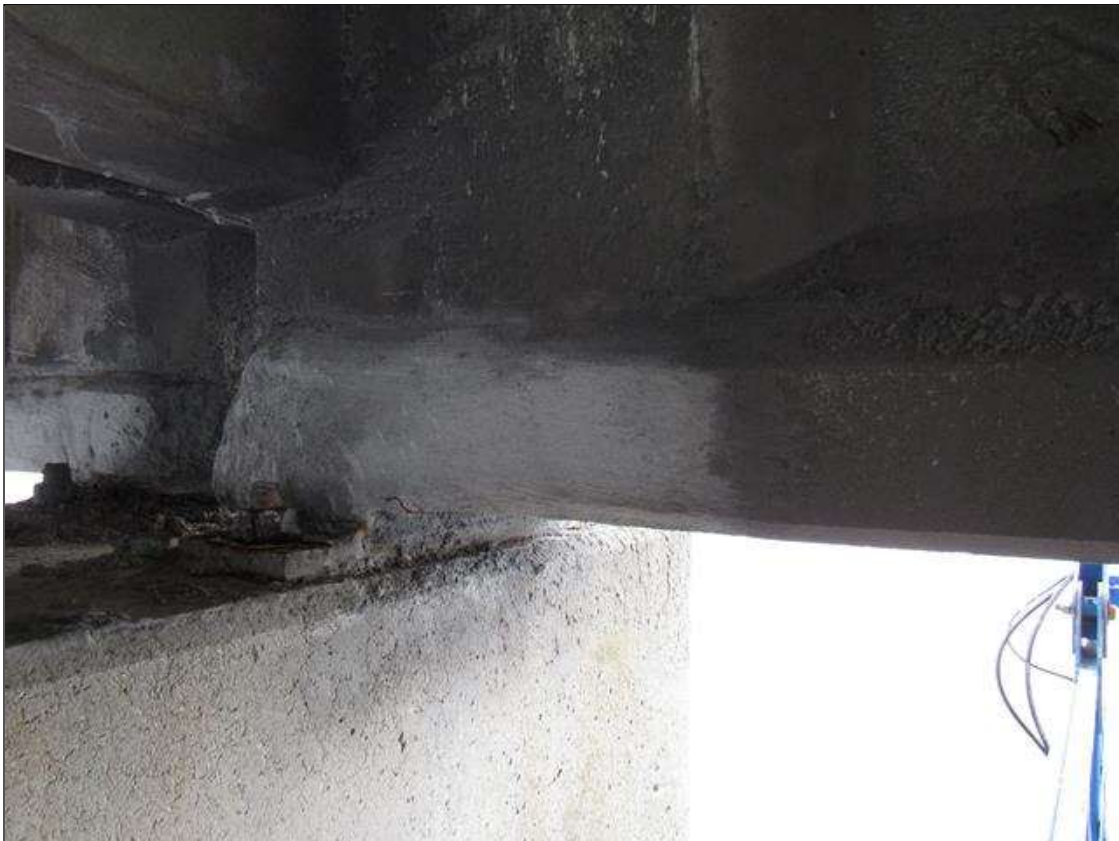
Span 59 Beam 3: 7" X 5" X UP TO 1" SPALL, WITH EXPOSED REINFORCING, BOTTOM FACE, 5' EAST OF MID SPAN.

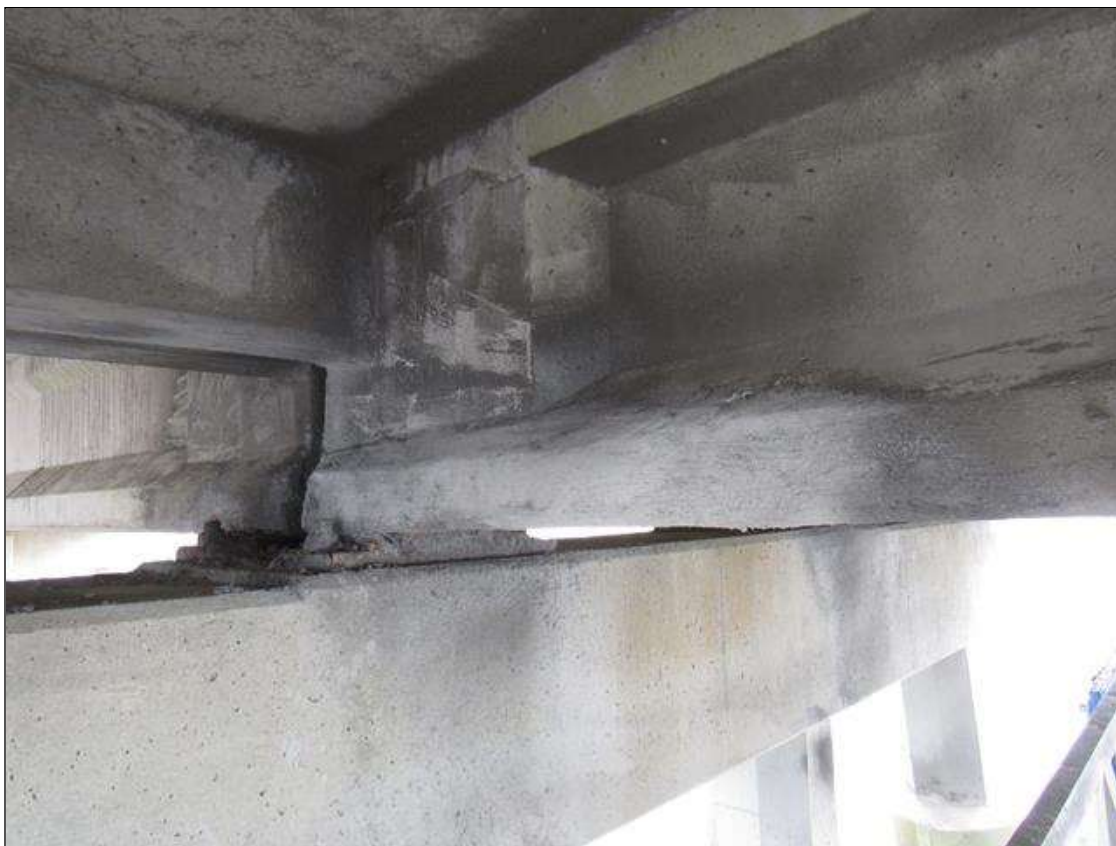
Span 59 Beam 4: 30" X 12" PATCHED AREA, NORTH FACE, AT BENT 59.

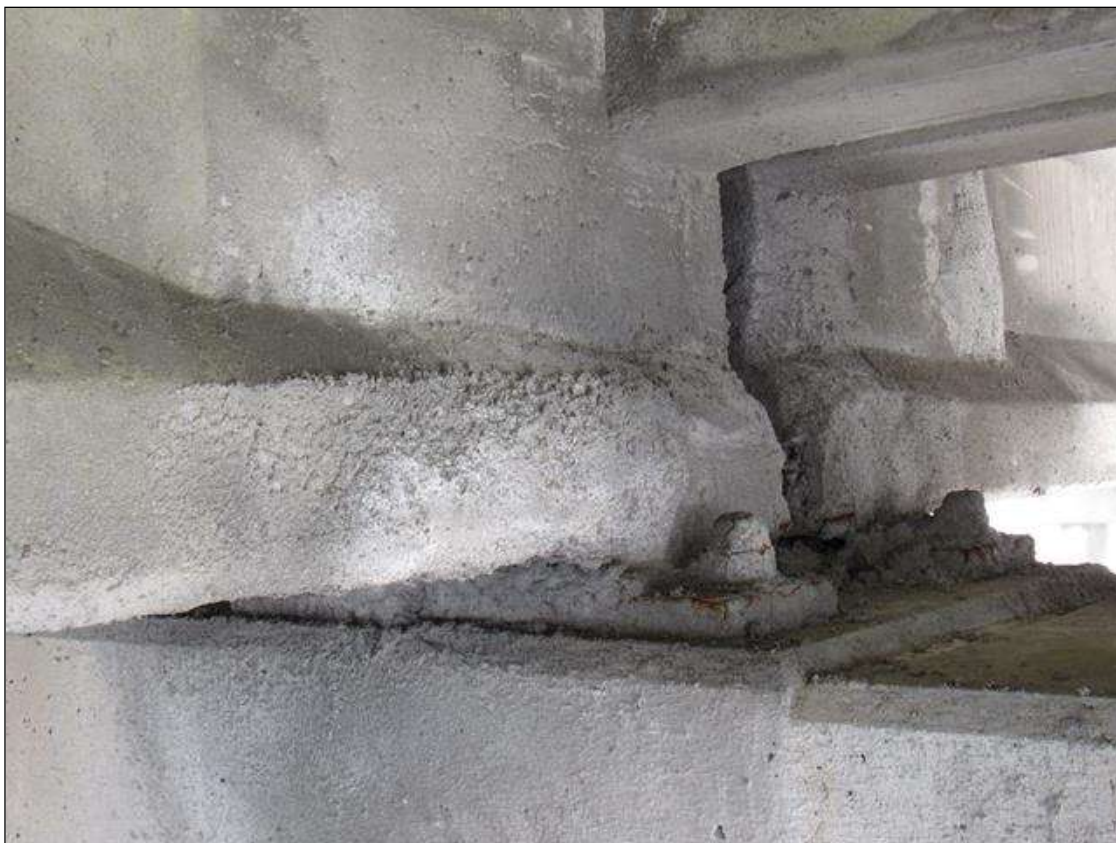
Span 60 Beam 2: (2) UP TO 55" X 12" X 6" CORNER PATCHED AREAS, NORTH AND SOUTH FACES, AT BENT 60.

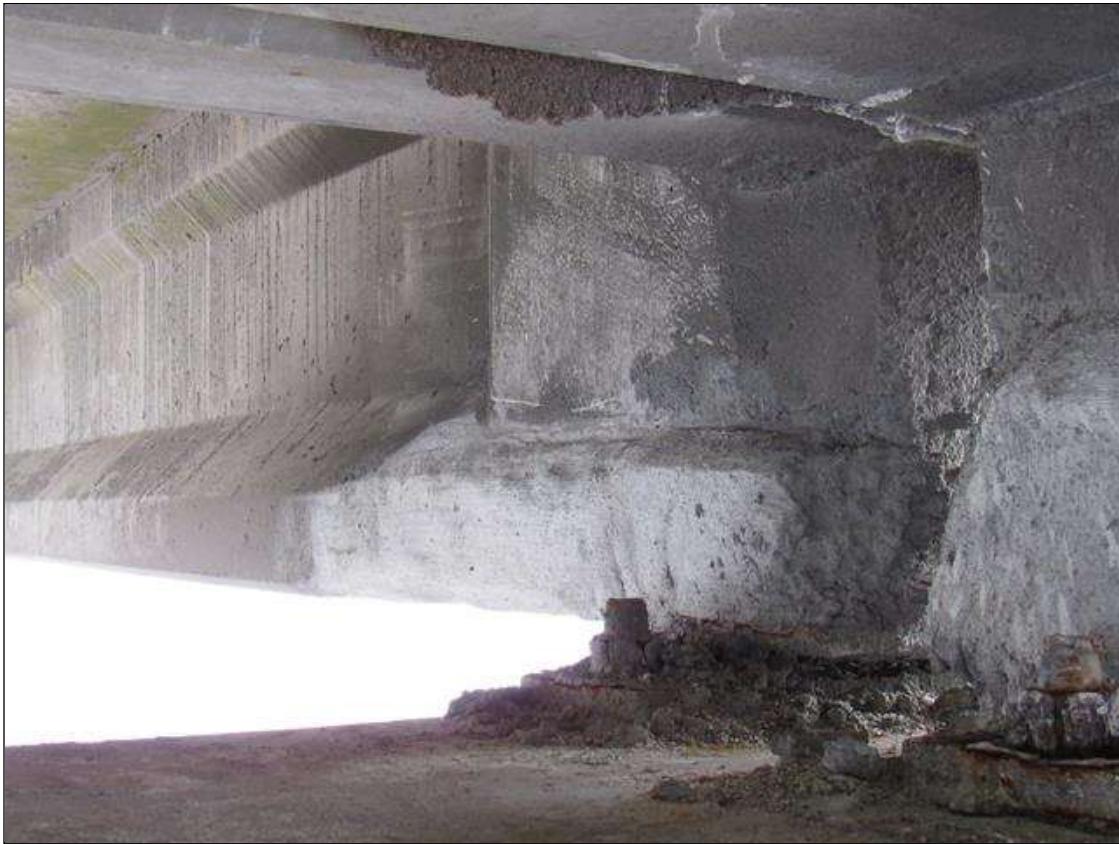
Span 60 Beam 3: (2) UP TO 24" X 12" X 4" CORNER PATCHED AREAS, NORTH AND SOUTH FACES, AT BENT 60.

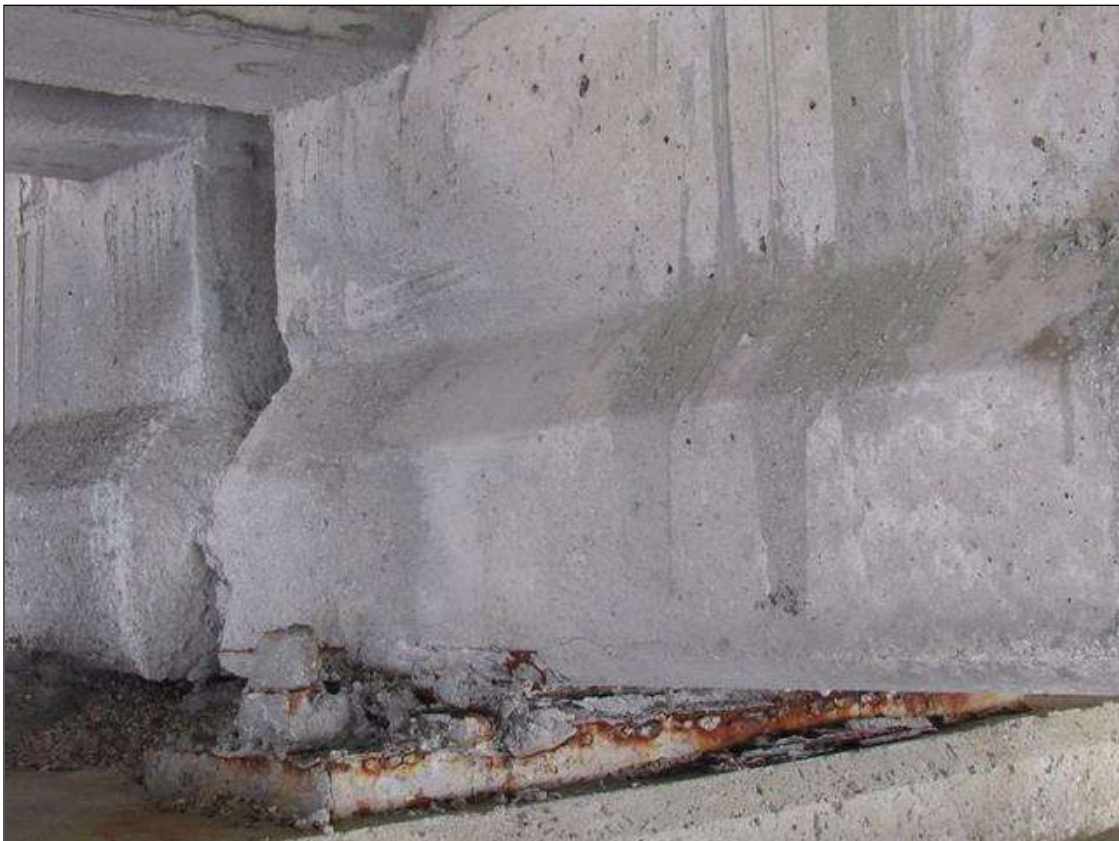
Span 60 Beam 4: 5' X 12" X 12" CORNER PATCHED AREA, NORTH FACE, AT BENT 59.

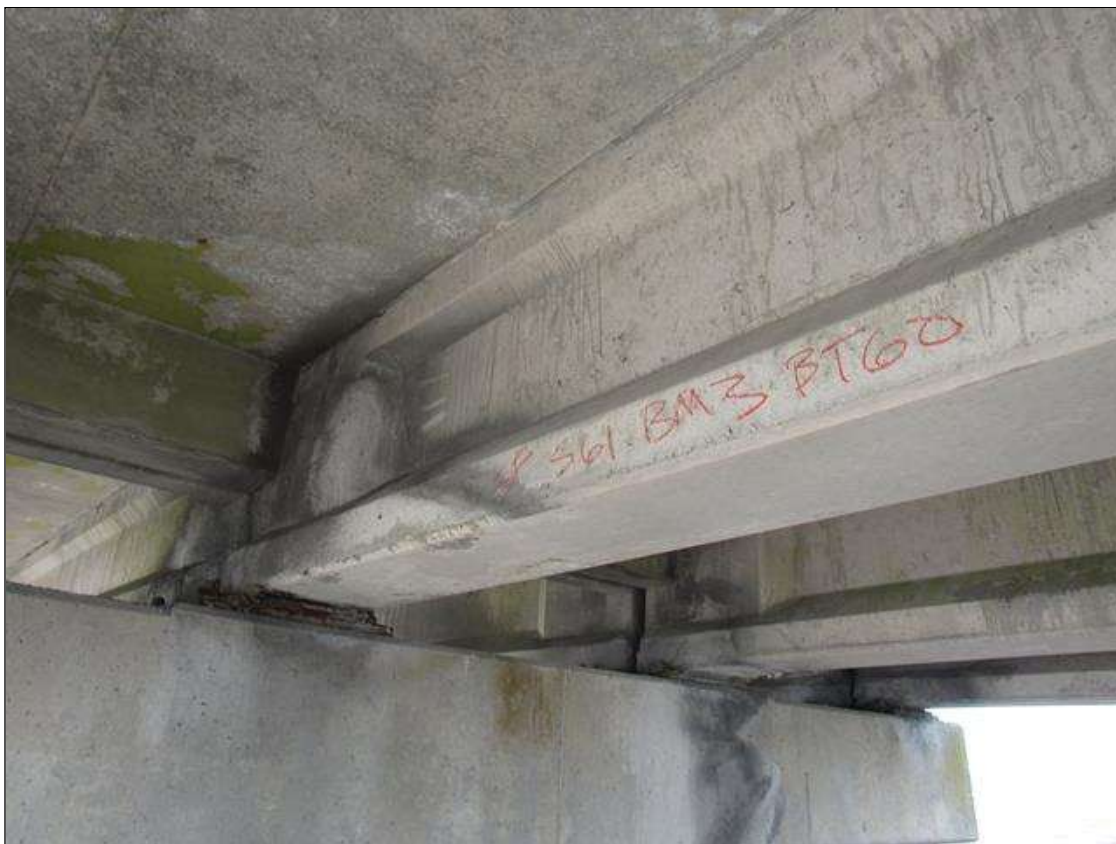
Span 61 Beam 3: (2) UP TO 12" X 12" PATCHED AREAS, NORTH AND SOUTH FACES, AT BENT 61.

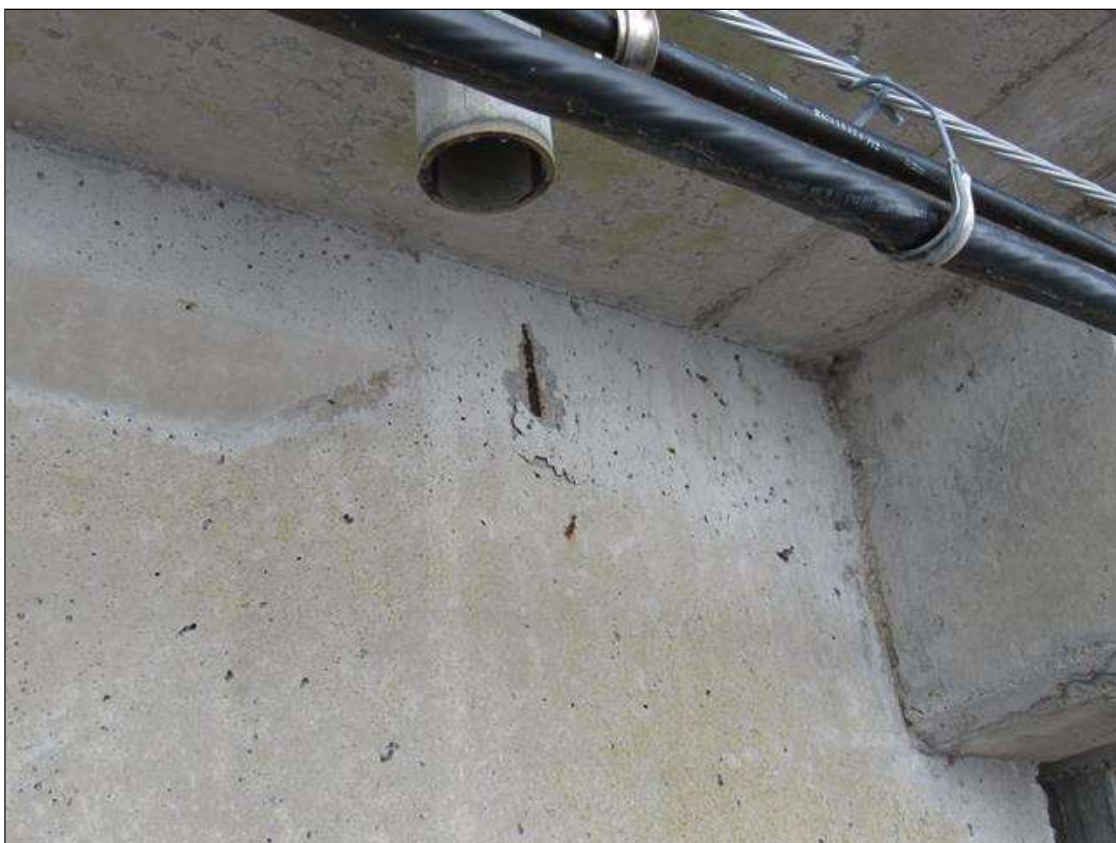
Span 61 Beam 3: 12" X 18" PATCHED AREA, SOUTH FACE, 2' FROM BENT 60.

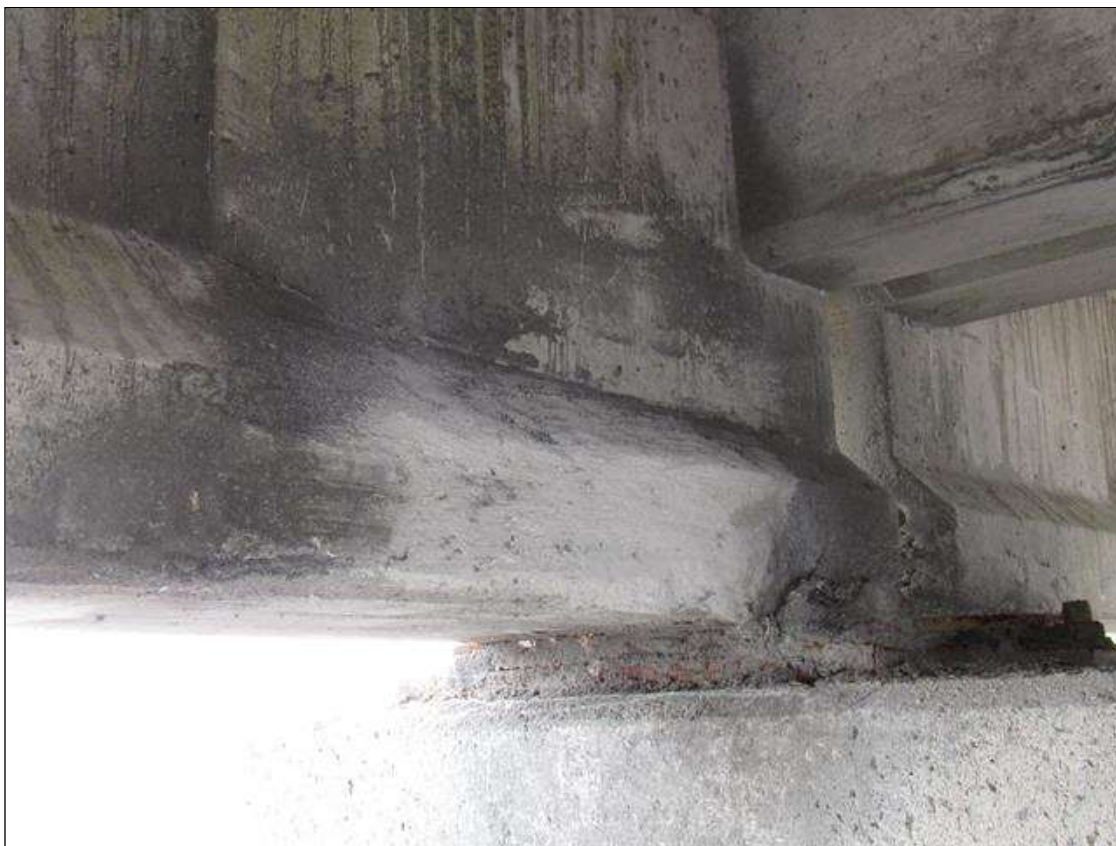
Span 61 Beam 4: 2" X 4" X 1/8" SPALL, WITH EXPOSED REINFORCING, TOP OF SOUTH FACE, 2' FROM BENT 61.

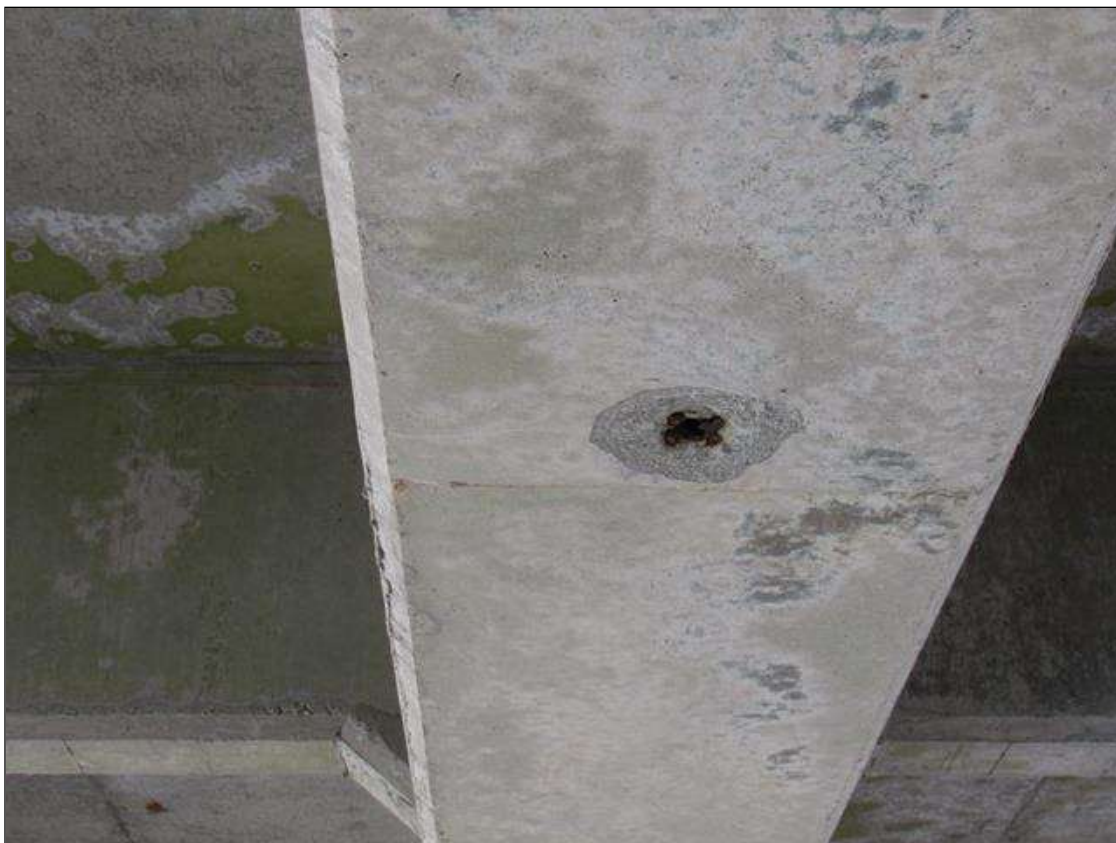
Span 62 Beam 4: 2' X 8" X 12" CORNER PATCHED AREA, NORTH FACE, AT BENT 61.

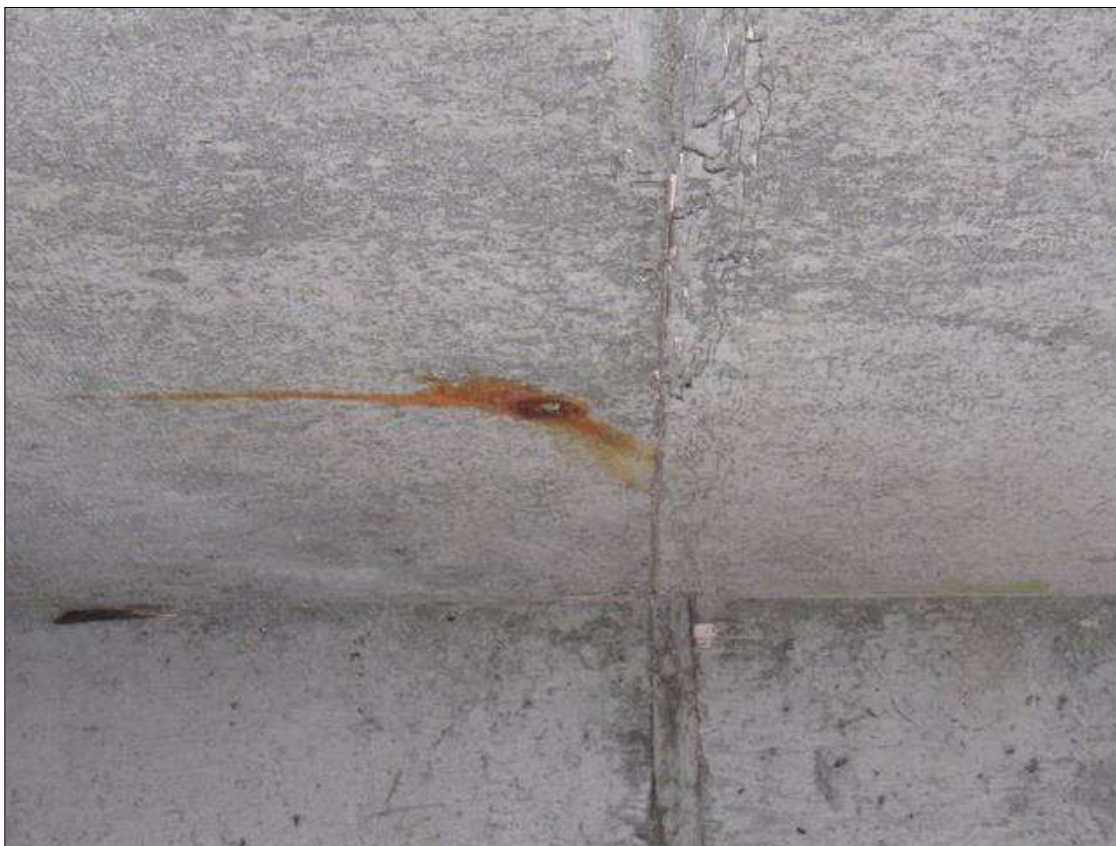
Span 63 Beam 3: 5" DIAMETER X UP TO 1/2" SPALL, WITH EXPOSED REINFORCING, BOTTOM FACE, 5' EAST OF MID SPAN.

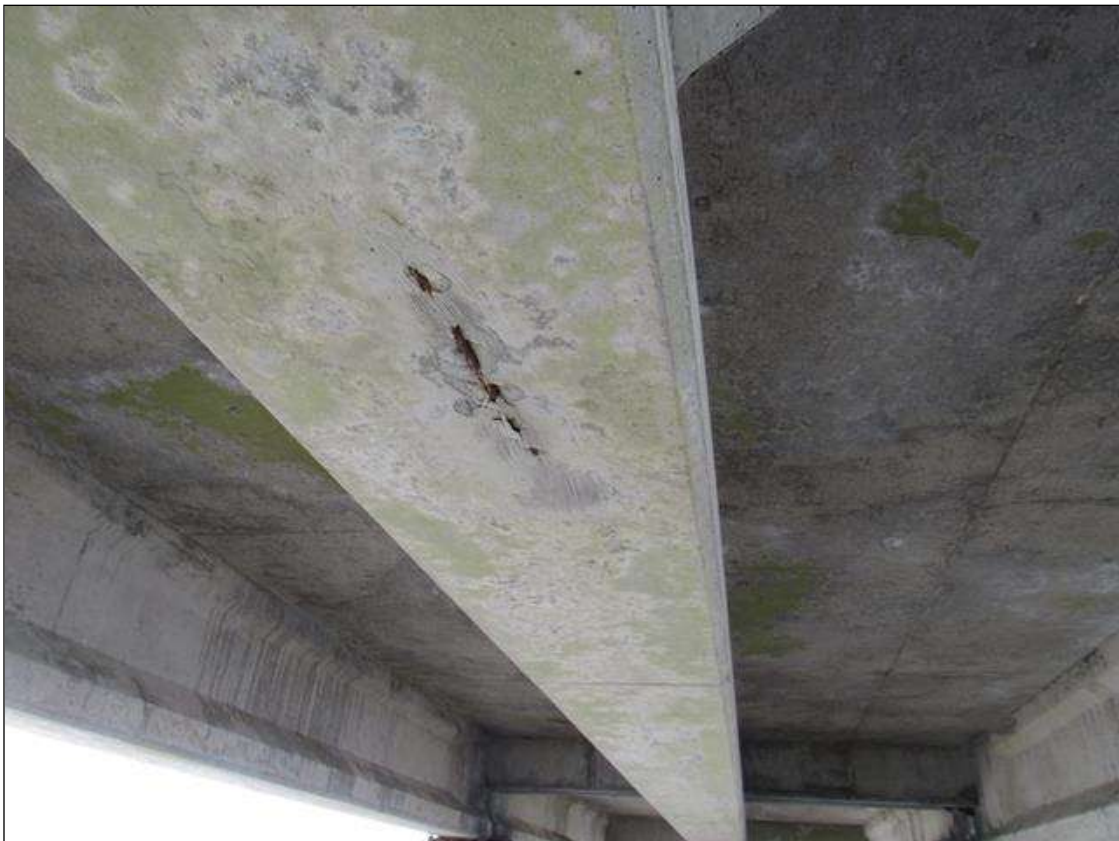
Span 65 Beam 1: 18" X 12" PATCHED AREA, SOUTH FACE, AT BENT 65.

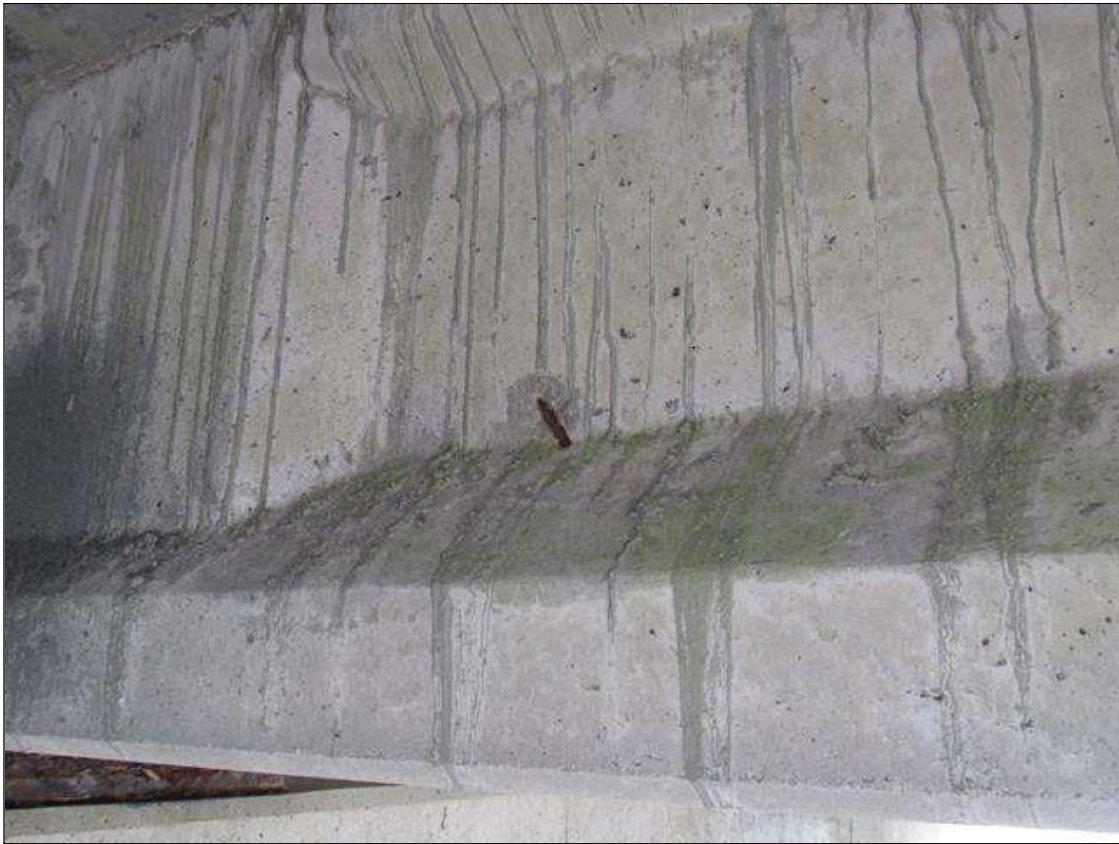
Span 66 Beam 1: 9" X 8" PATCHED AREA, SOUTH FACE, AT BENT 66.

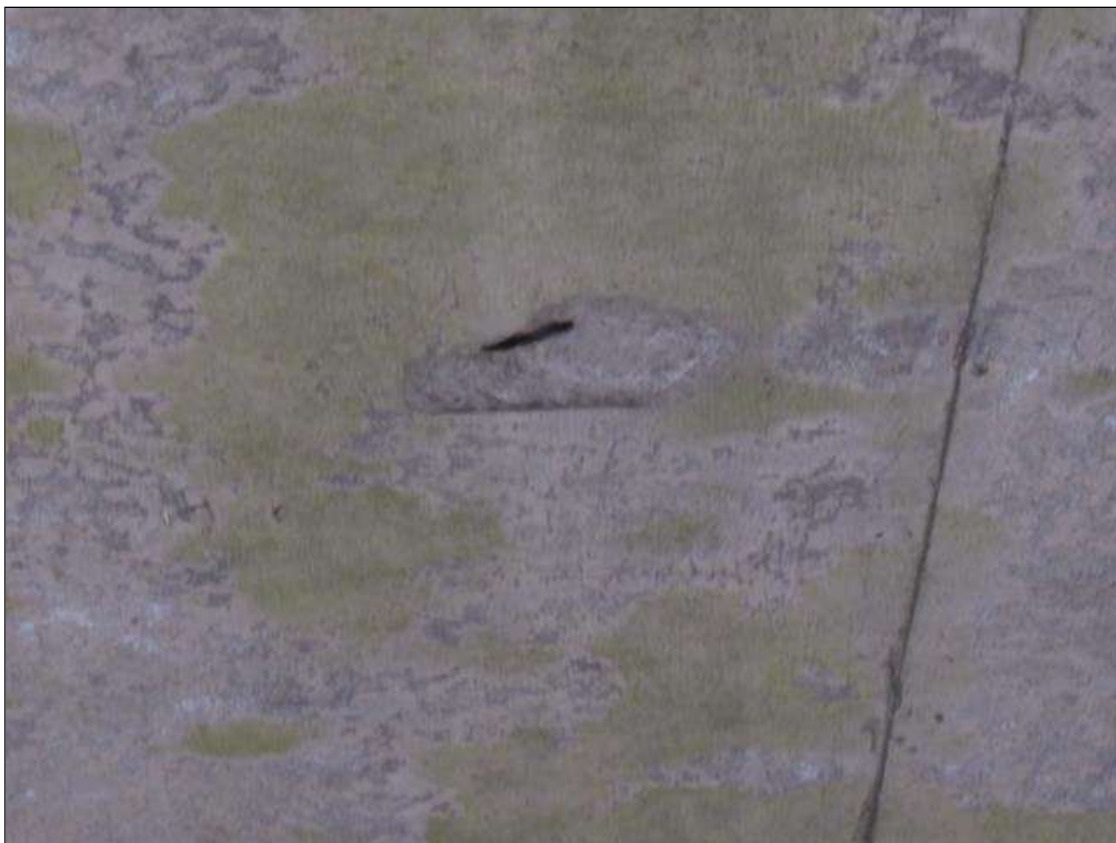
Span 68 Beam 4: 3" HIGH X 1" WIDE CORNER SPALL AT BENT 68

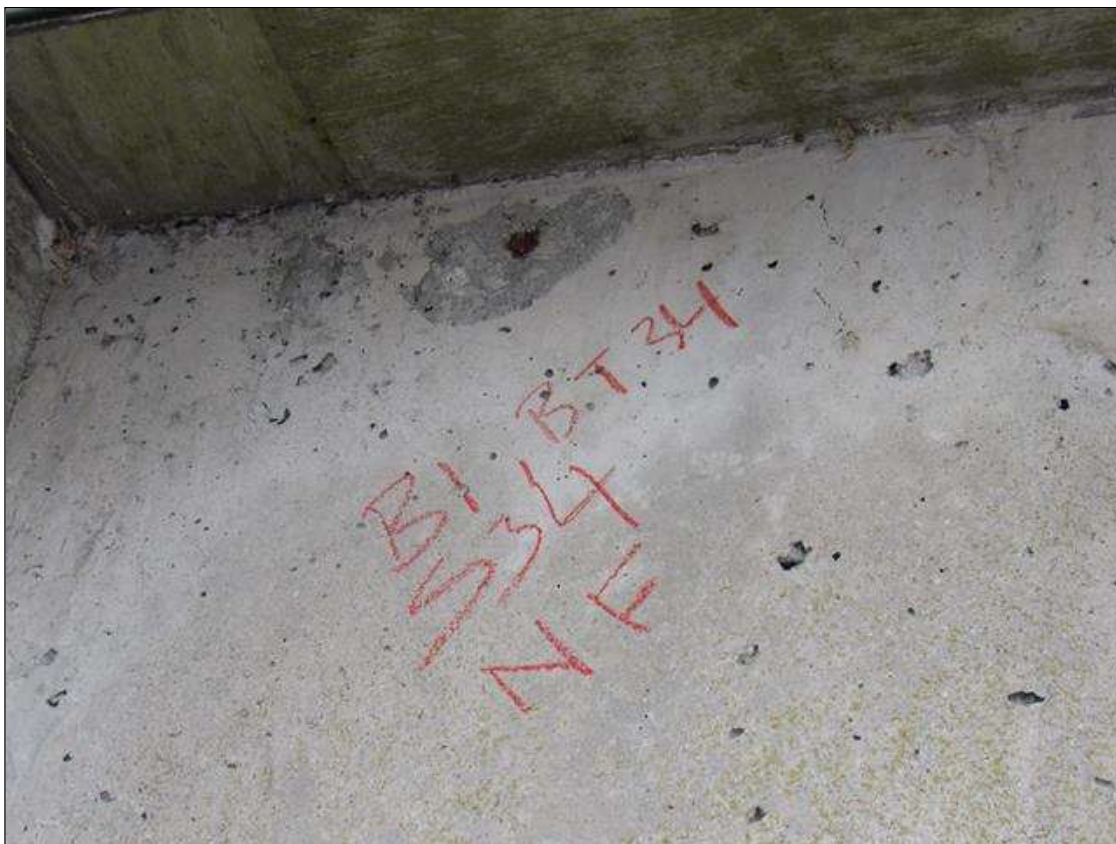
Span 31 Deck: 8" DIAMETER X 1" DEEP SPALL WITH EXPOSED REBAR ON BOTTOM FACE LOCATED ON BAY 2, 20' FROM BENT 30

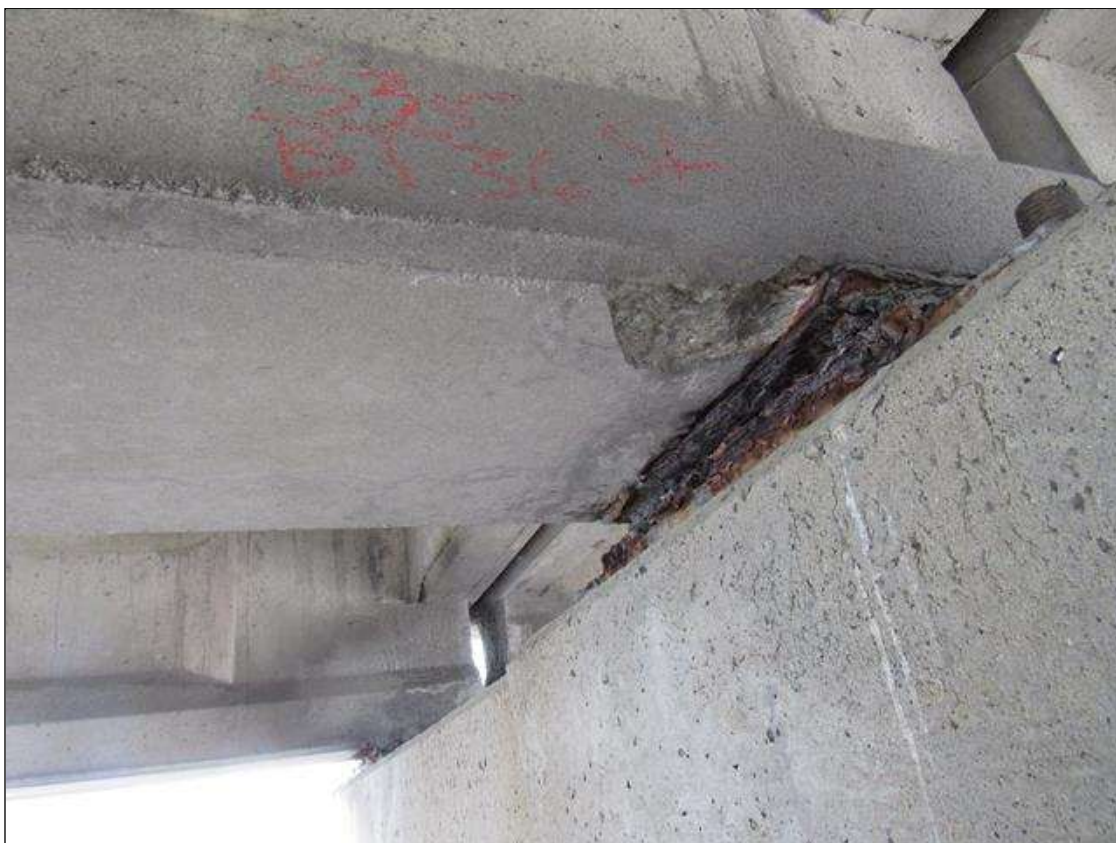
Span 34 Beam 1: 5" DIAMETER X 1/2" DEEP DELAMINATION WITH EXPOSED REBAR ON NORTH FACE OF WEB AT BENT 34

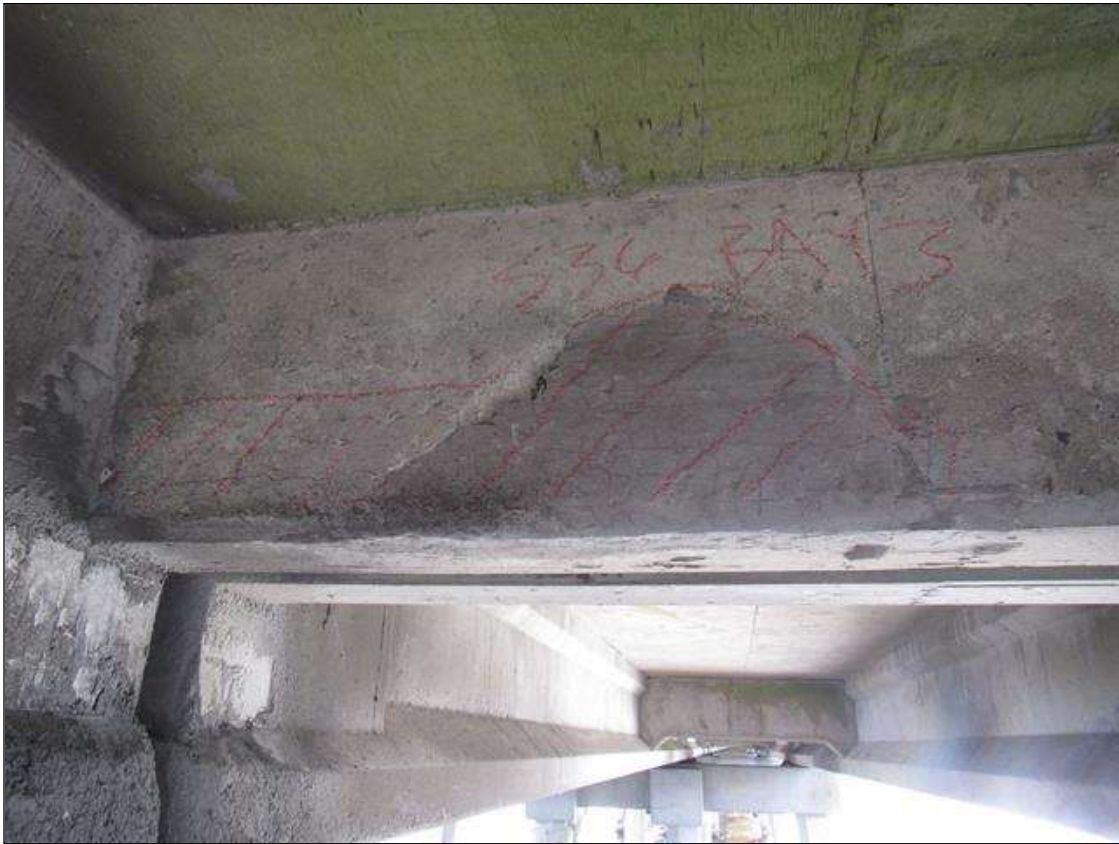
Span 36 Beam 2: 5" DIAMETER X 1" DEEP SPALL ON BOTTOM FACE LOCATED AT BENT 36

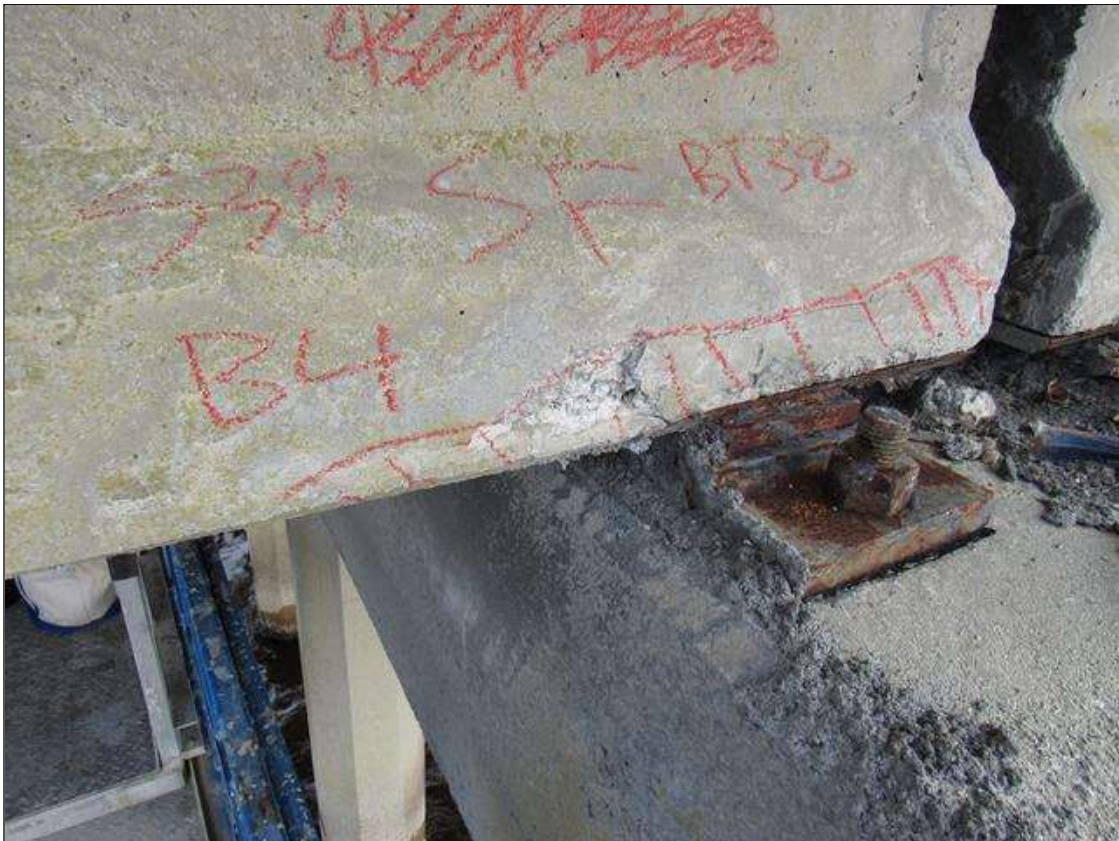
Span 36 Beam 3: 3' X UP TO 10" X 1' CRACKED PATCHED AREA, WEST FACE, END DIAPHRAGM, BETWEEN BEAMS 3 AND 4, AT BENT 36.

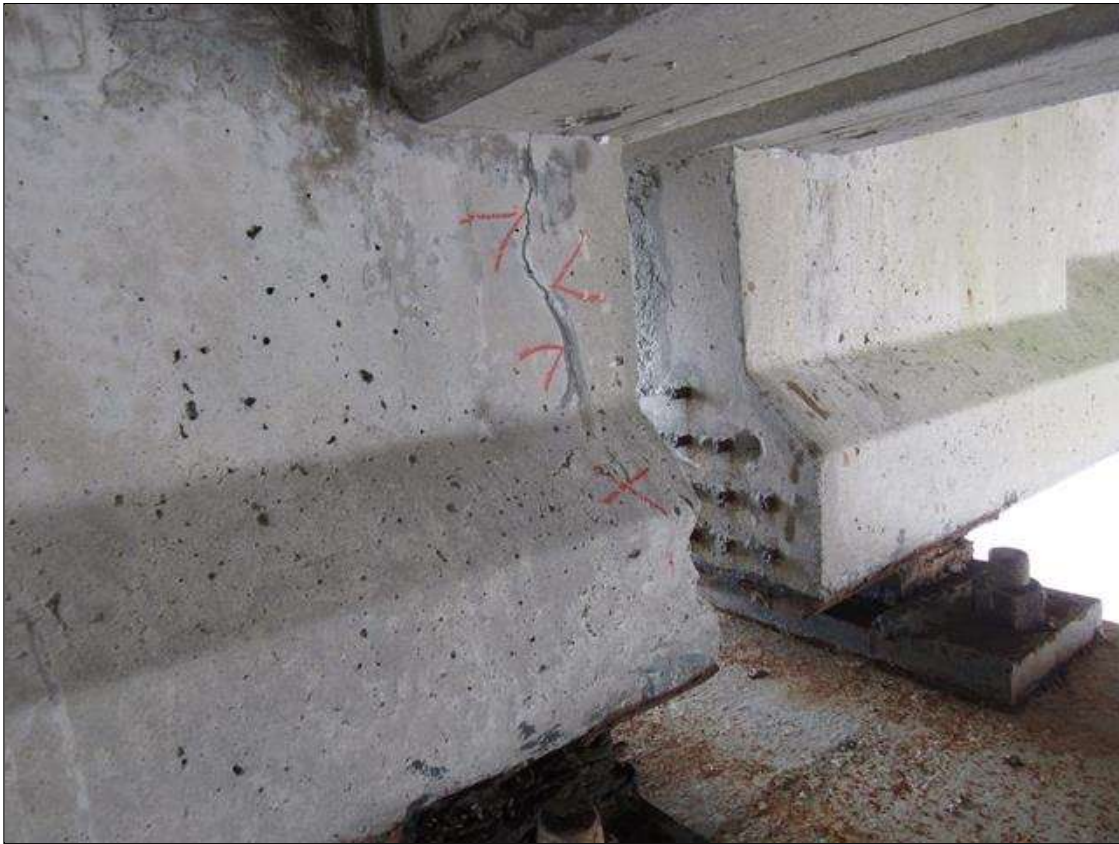
Span 38 Beam 4: 24" X UP TO 4" DELAMINATION ON SOUTH FACE LOCATED AT BENT 38
