NC DEPARTMENT OF TRANSPORTATION
DIVISION OF HIGHWAYS
STRUCTURE MANAGEMENT UNIT

Structure Safety Report

Routine Element Inspection - Contract

FEATURE INTERSECTED: ALLIGATOR RIVER

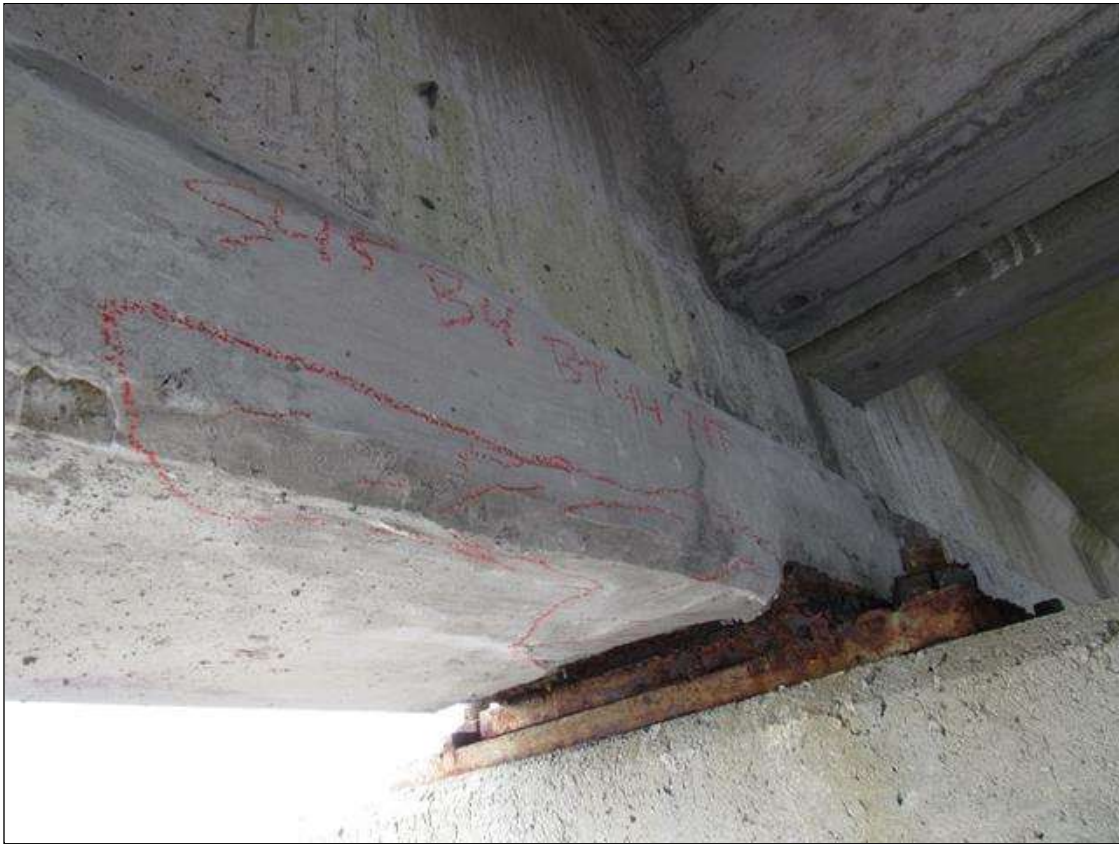
Span 44 Beam 3: 20" X 6" X 4" DEEP SPALL WITH EXPOSED REBAR ON END DIAPHRAGM IN BAY 3, AT BENT 44

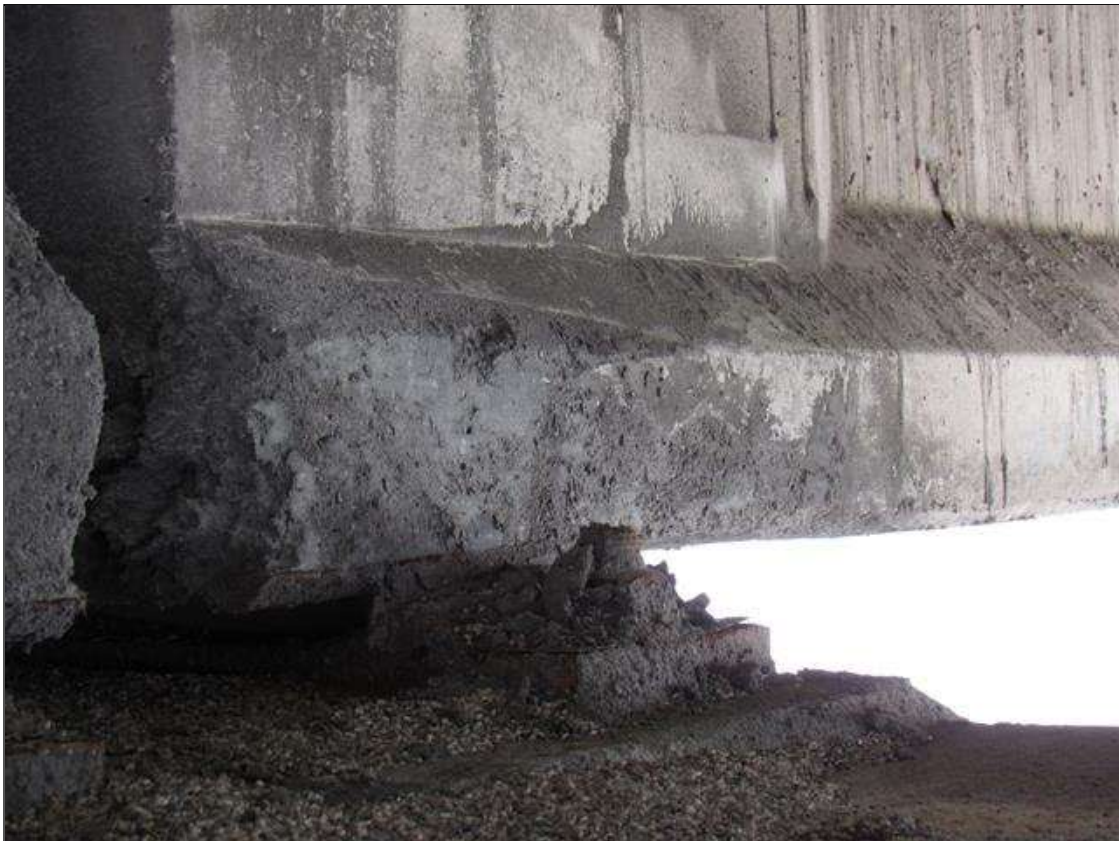
Span 45 Beam 4: 3' X UP TO 9" PATCHED AREA WITH 22" X 11" OF DELAMINATION, BOTTOM FACE, EXTENDING 10" ONTO NORTH FACE, AT BENT 44.

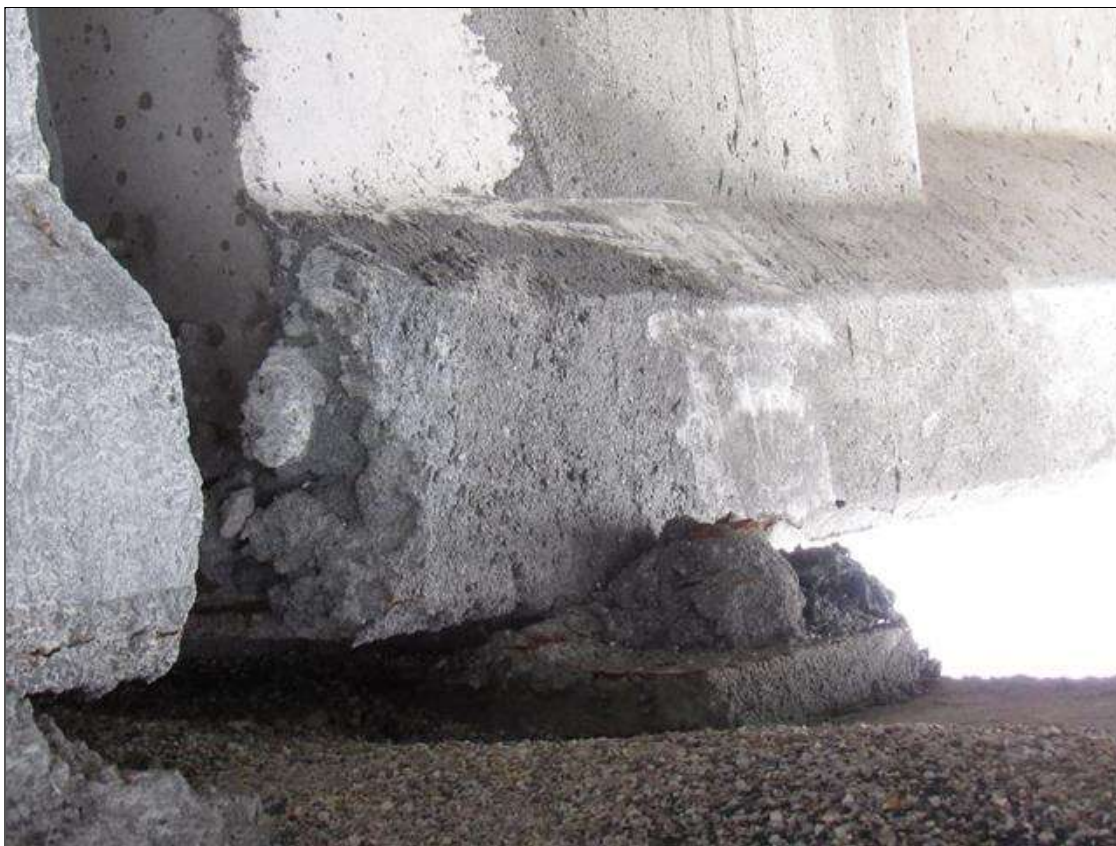
Span 47 Beam 3: 6' X UP TO 18" PATCHED AREA, BOTTOM FACE, EXTENDING 10" ONTO NORTH AND SOUTH FACES, AT BENT 46.

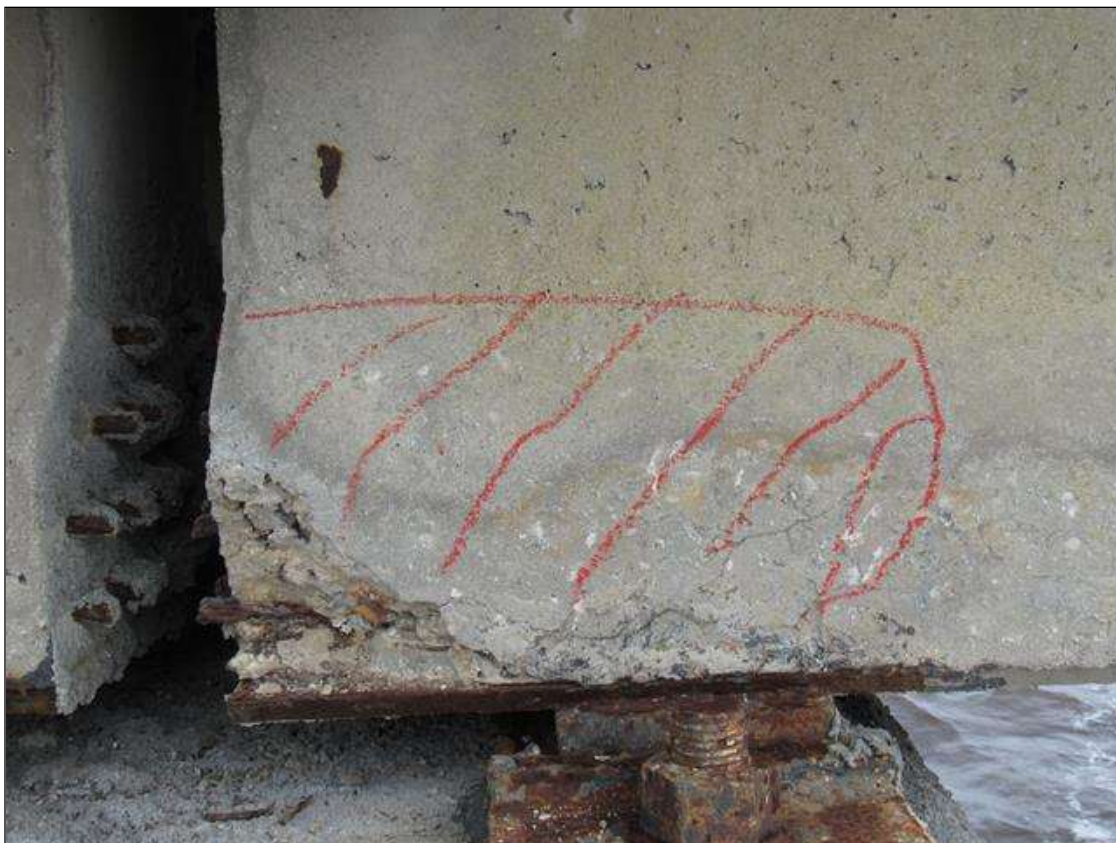
Span 47 Beam 2: 9" X 10" PATCHED AREA, SOUTH FACE, AT BENT 46.

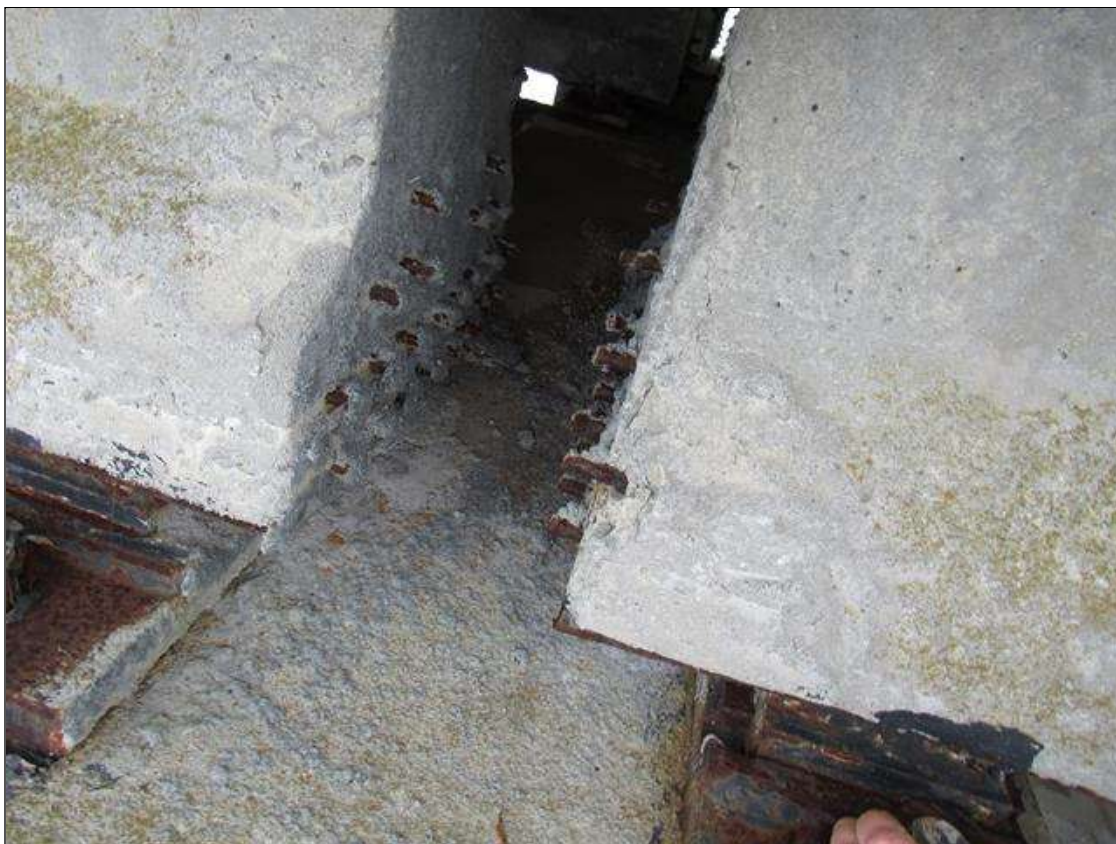
Span 48 Beam 4: (PAR) 9" X UP TO 5" X 2" DEEP SPALL WITH SURROUNDING DELAMINATION AND EXPOSED PRESTRESSING STRAND ON SOUTH FACE AT BENT 47

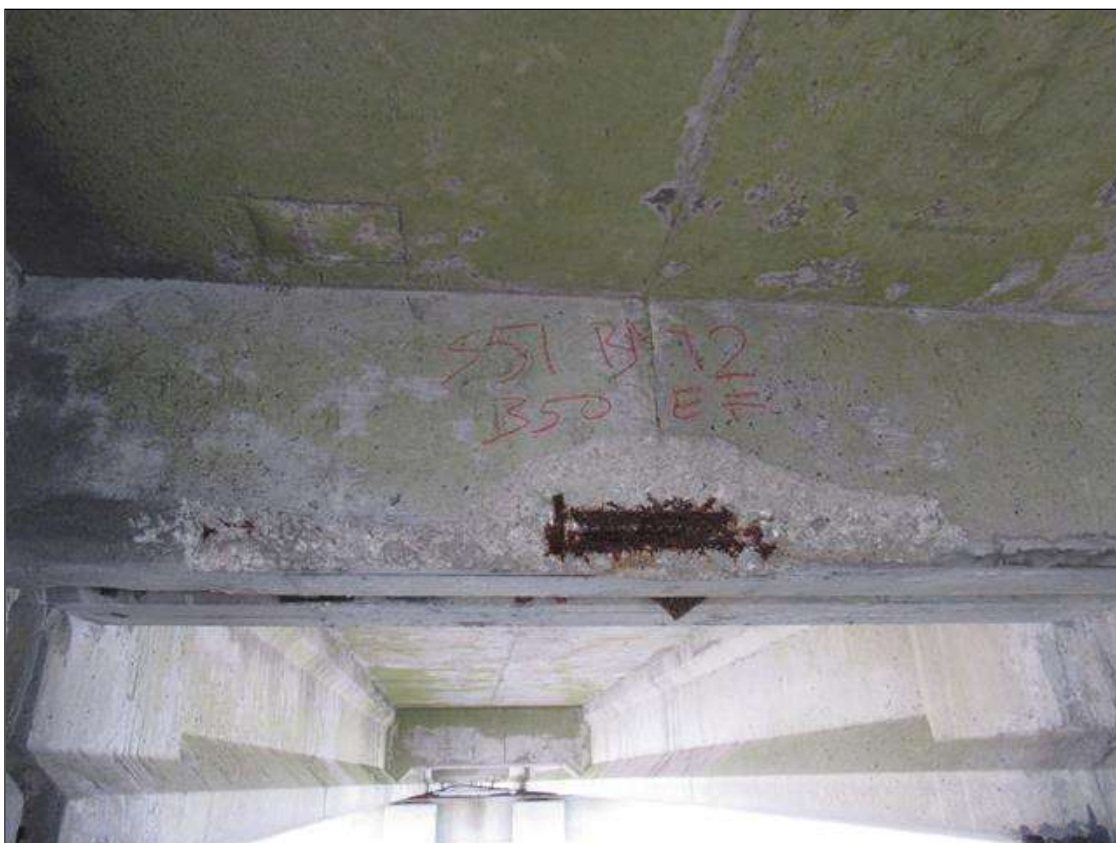
Span 69 Beam 1: 2" X 6" HIGH X 2" CORNER SPALL, NORTH FACE, AT BENT 69.

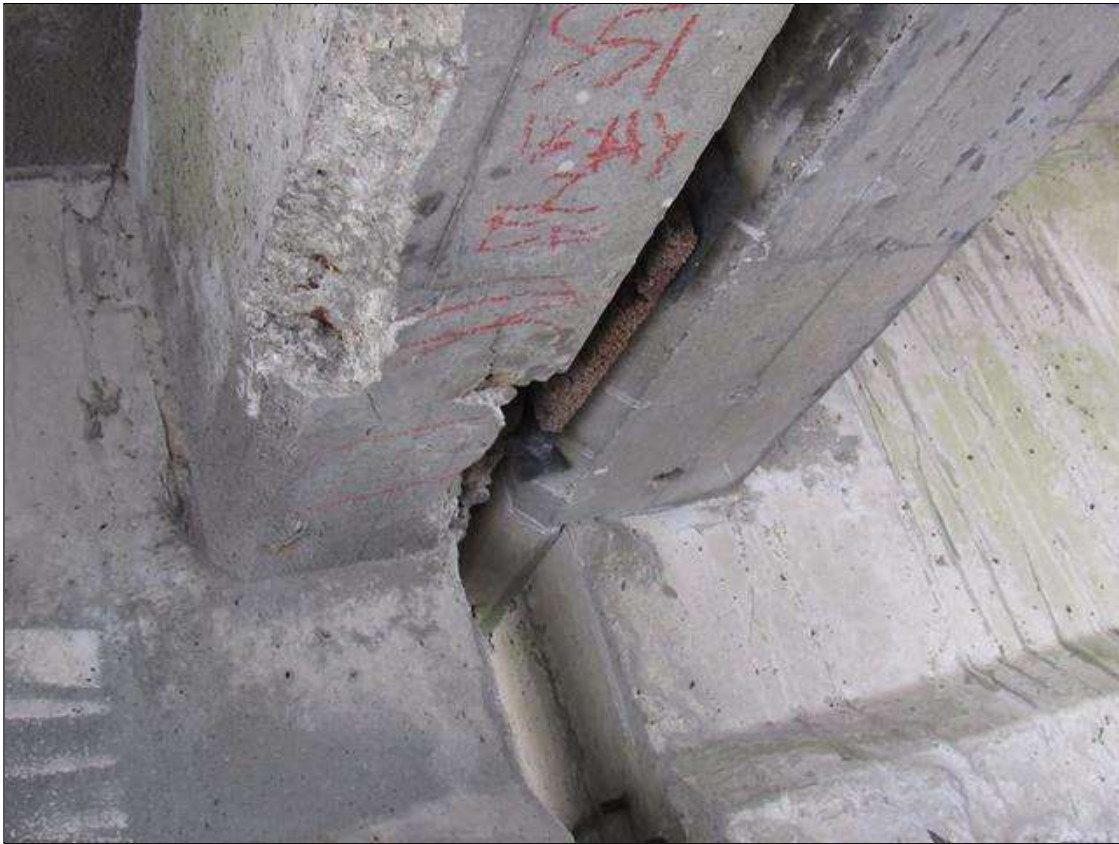
Span 51 Beam 2: 45" X 7" HIGH x 4" DEEP SPALL WITH 12" OF EXPOSED REBAR ON END DIAPHRAGM IN BAY 2
AT BENT 50

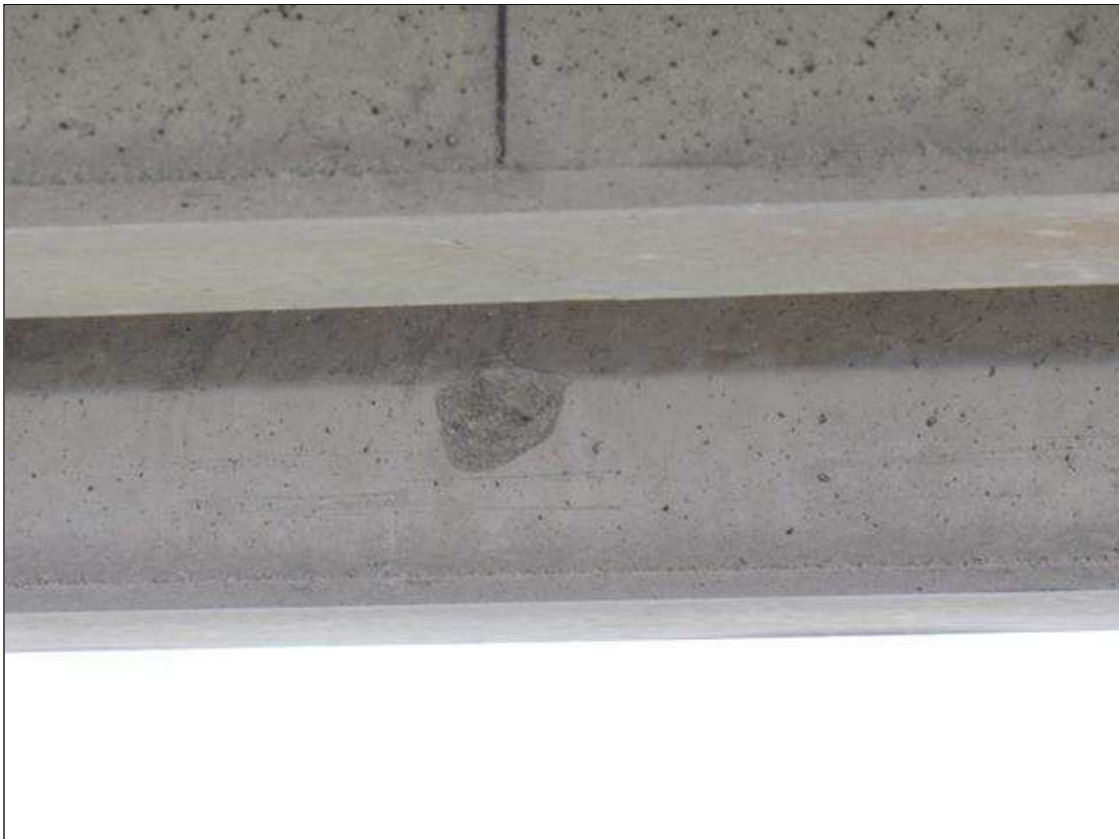
Span 51 Beam 2: 9" X UP TO 12" X 3" DEEP SPALL WITH SURROUNDING DELAMINATION AT BOTTOM WEST CORNER OF END DIAPHRAGM IN BAY 2 AT BENT 50

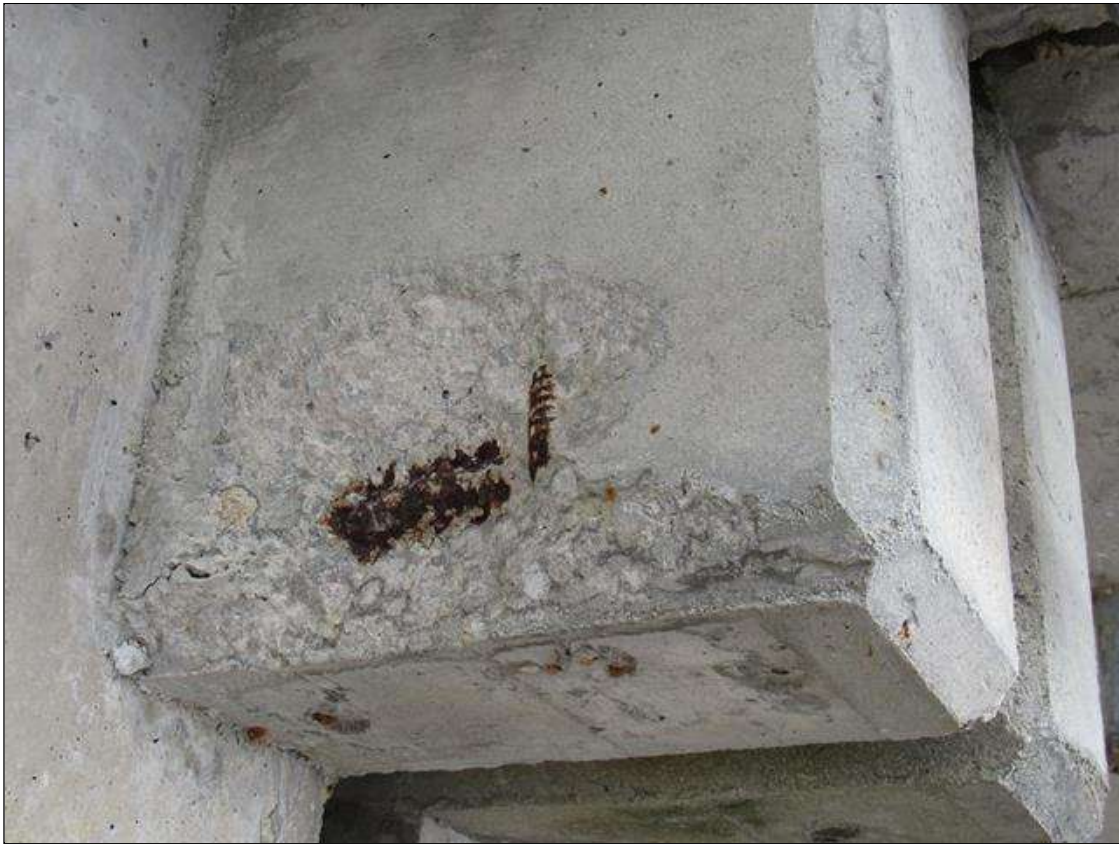
Span 51 Beam 1: 3" DIAMETER X 1" DEEP SPALL ON SOUTH FACE OF BOTTOM FLANGE LOCATED 15' FROM BENT 51

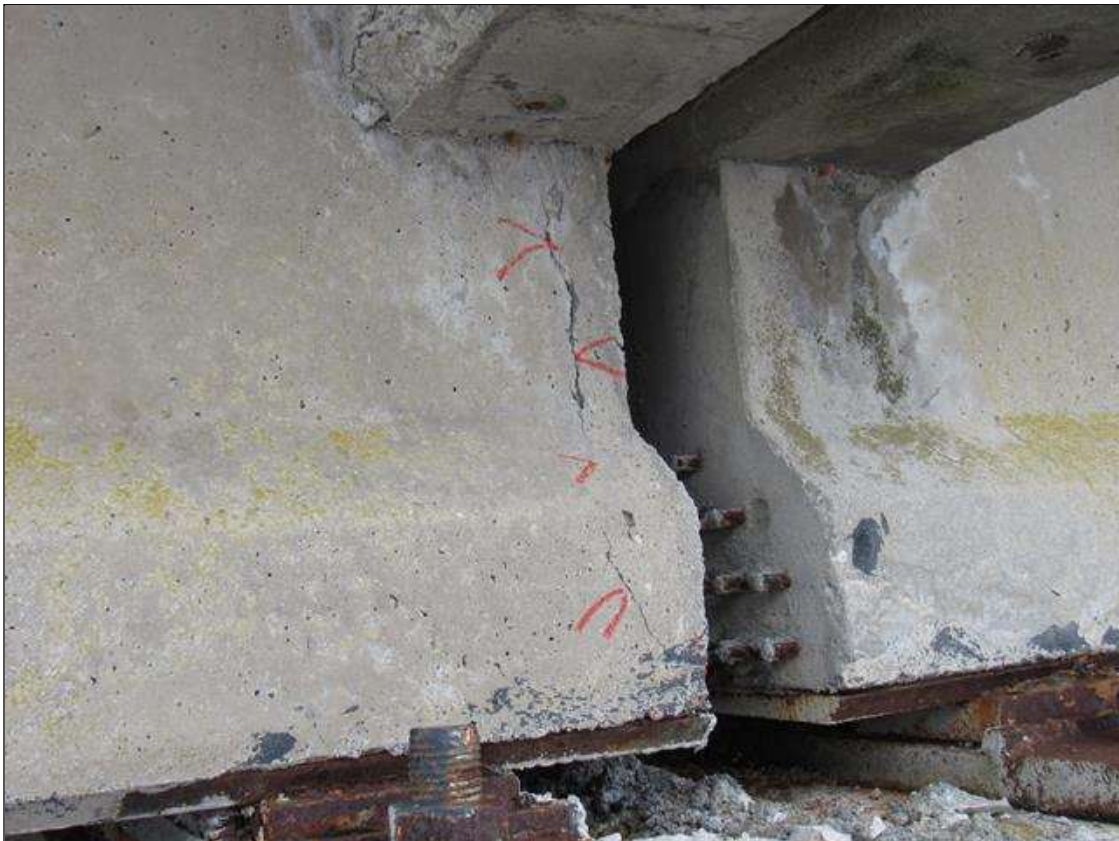
Span 55 Beam 4: 12" X 8" X 1" DEEP SPALL WITH EXPOSED REBARS ON END DIAPHRAGM AT SOUTH OVERHANG AT BENT 55

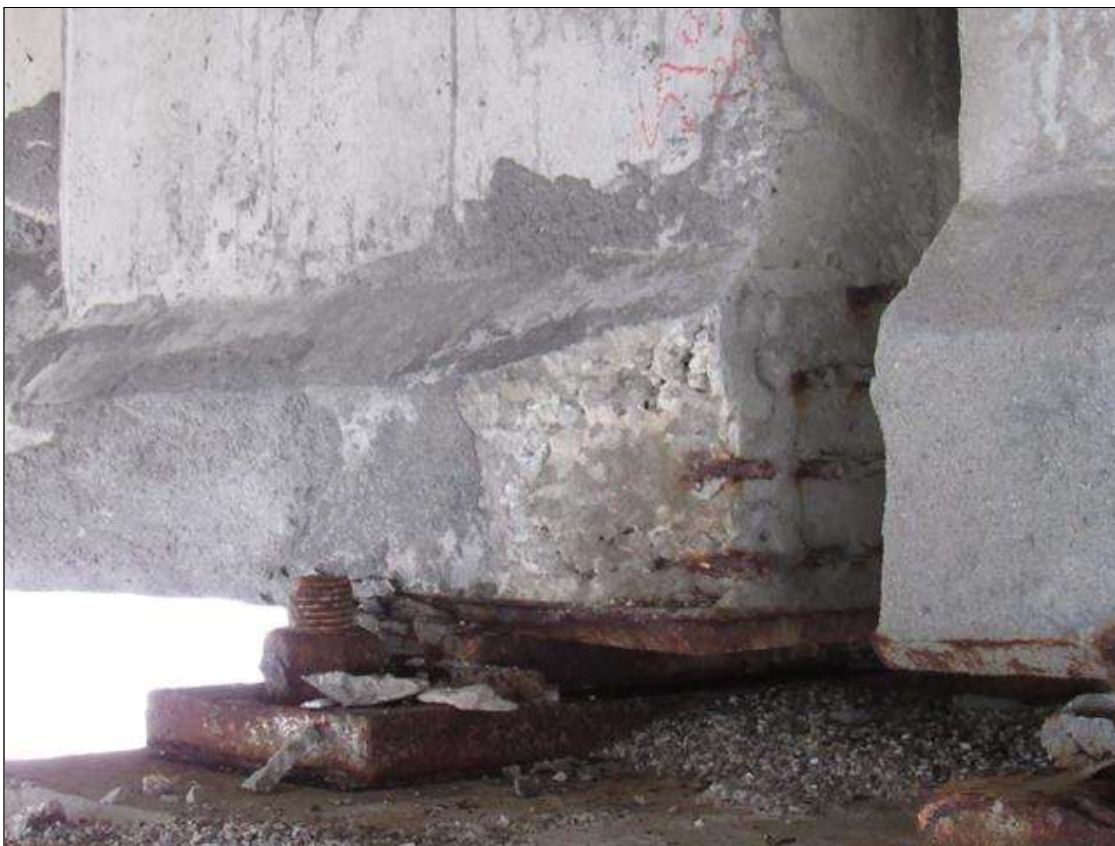
Span 55 Beam 4: (PAR) 16" LONG X UP TO 1/16" WIDE VERTICAL CRACK ON SOUTH FACE AT BENT 55

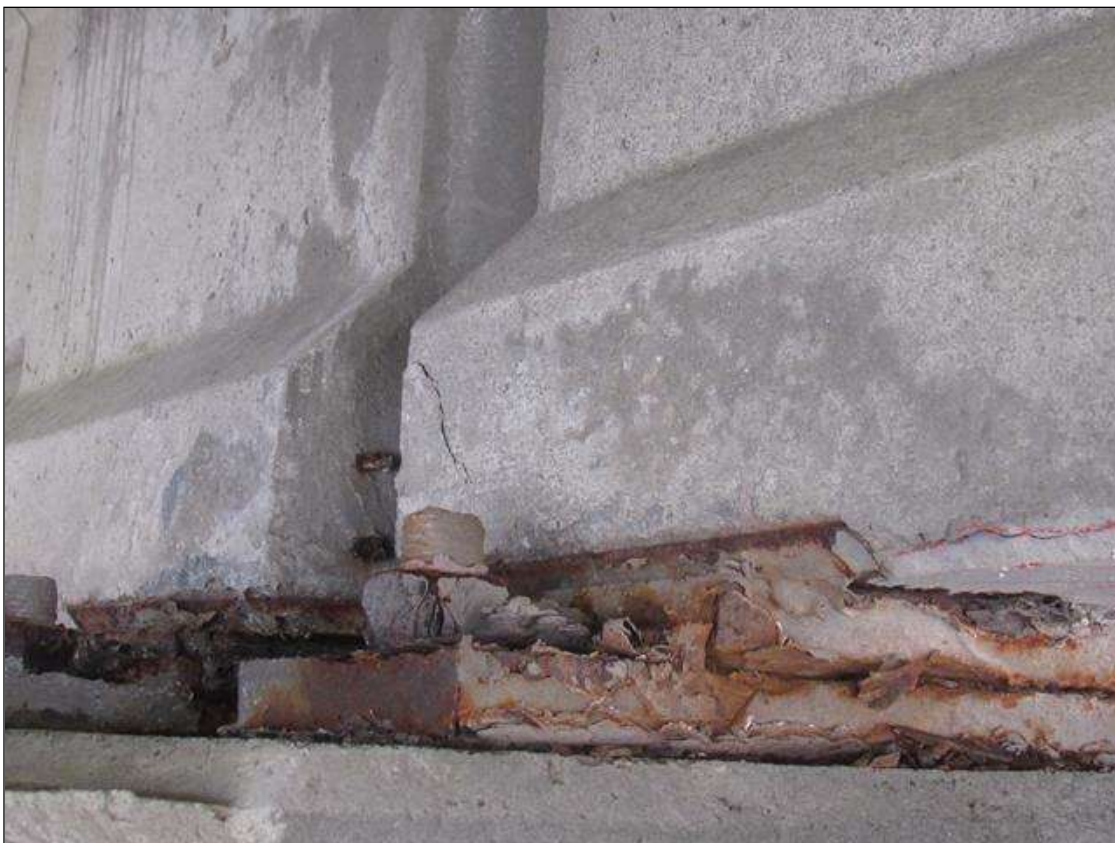
Span 70 Beam 2: 12" X 12" FAILED PATCH ON NORTH FACE AT BENT 69

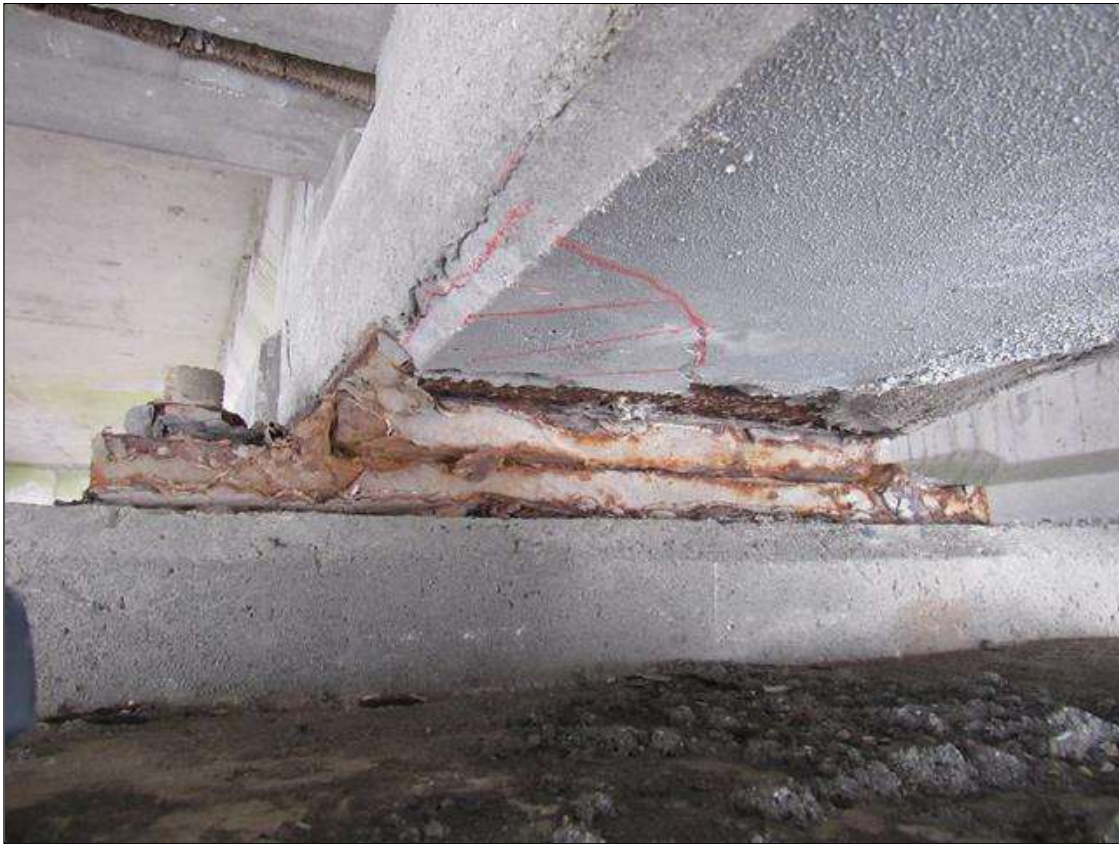
Span 34 Beam 3: 4" X 4" DELAMINATION ON SOUTH FACE AT BENT 33

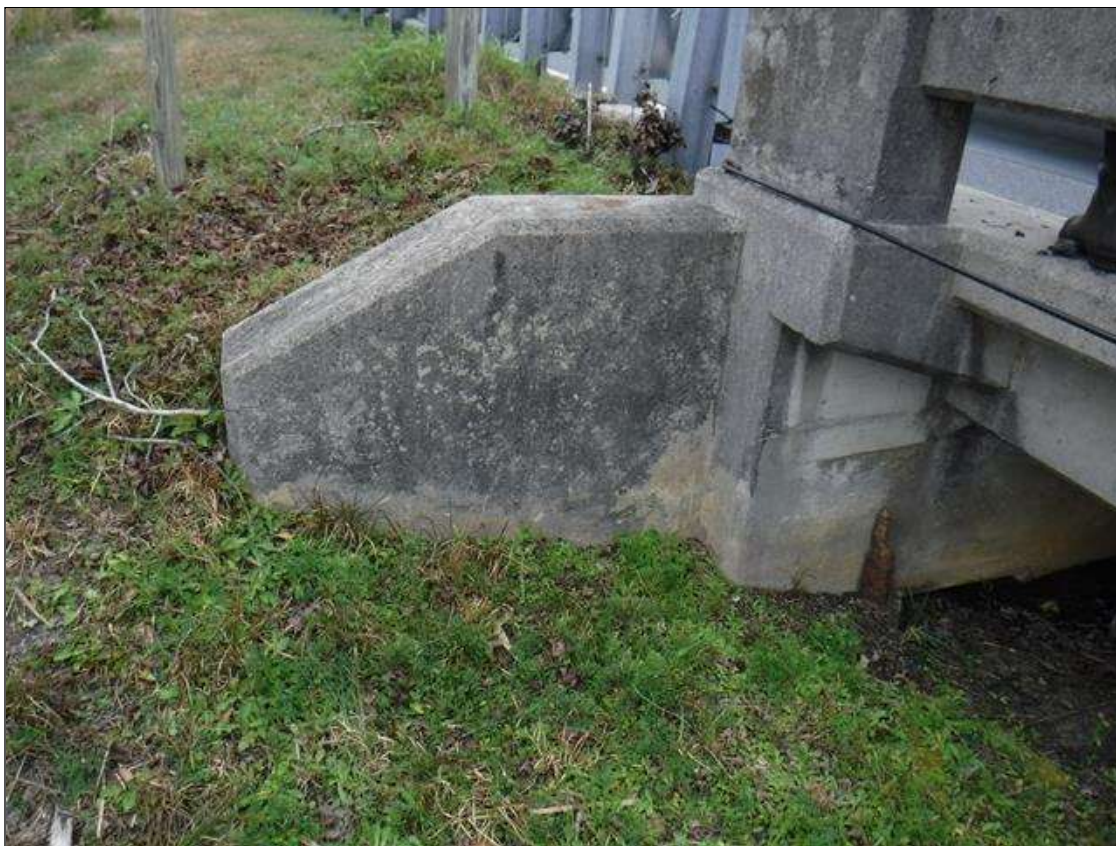
END BENT 2 RIGHT WINGWALL

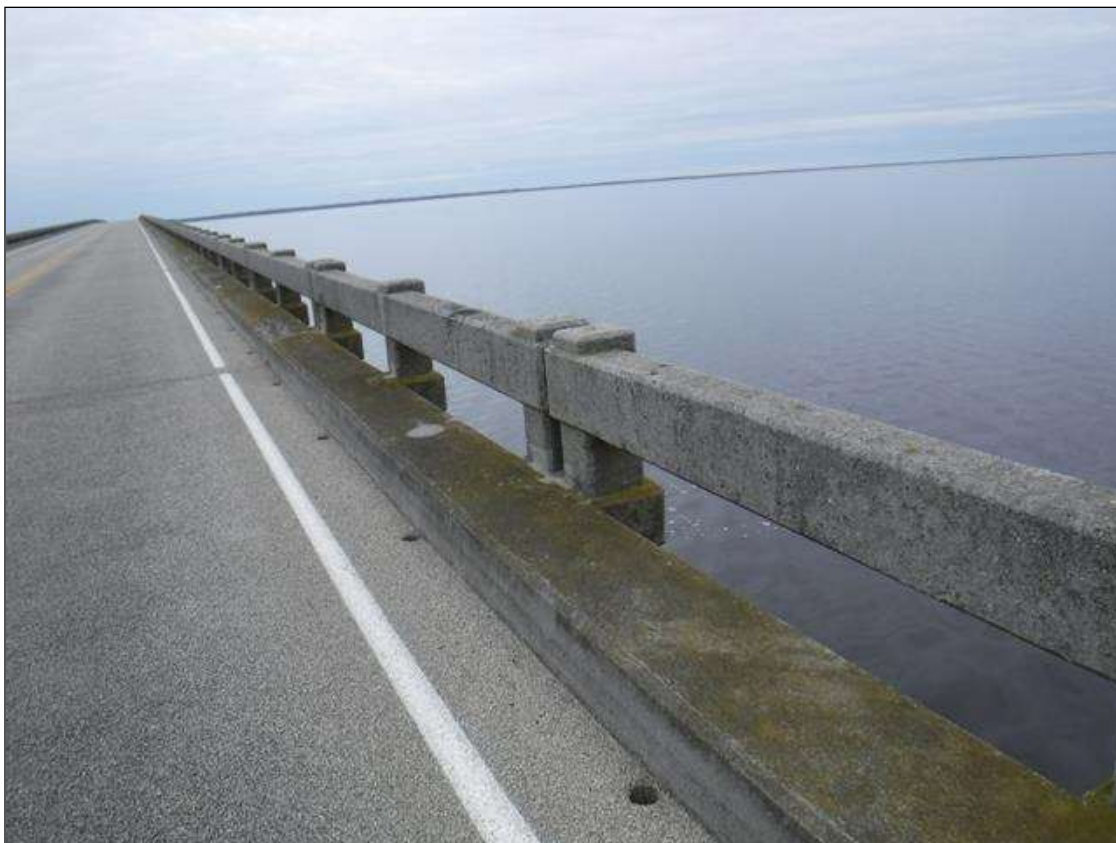
TYPICAL JOINT, BENT 2 JOINT SHOWN

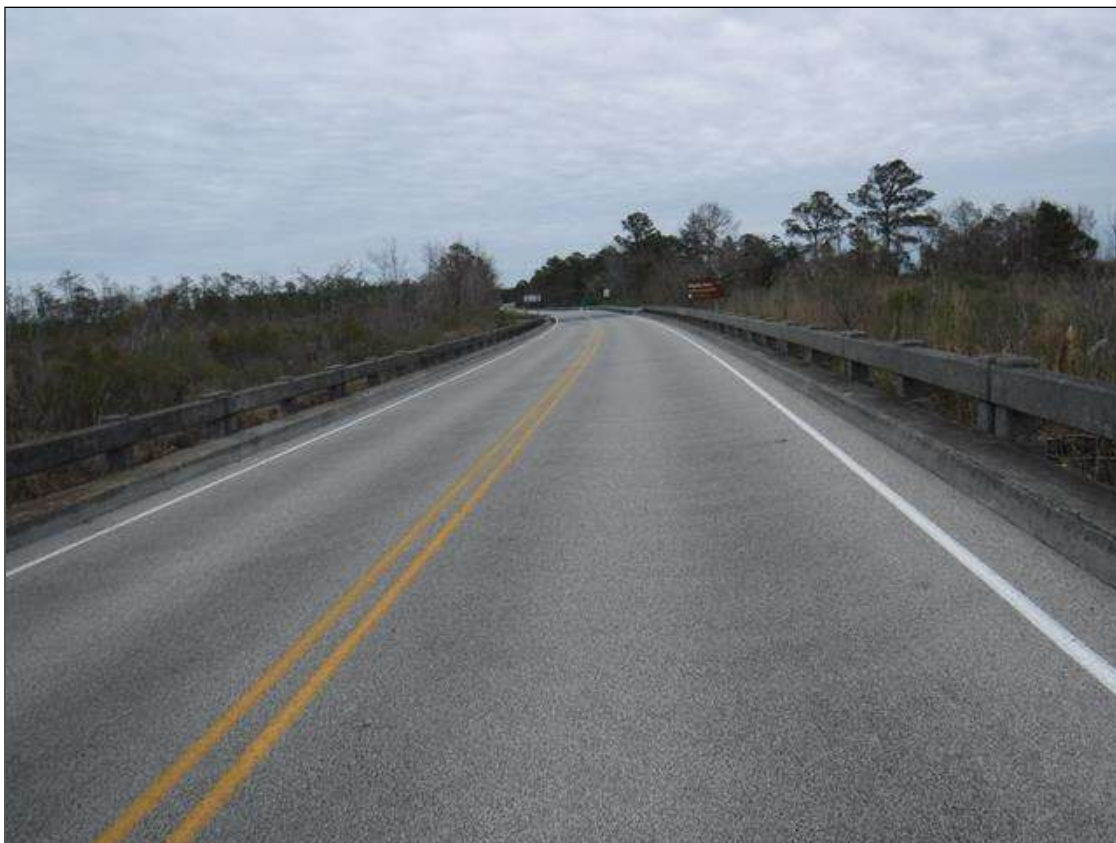
JOINT OVER BENT 113

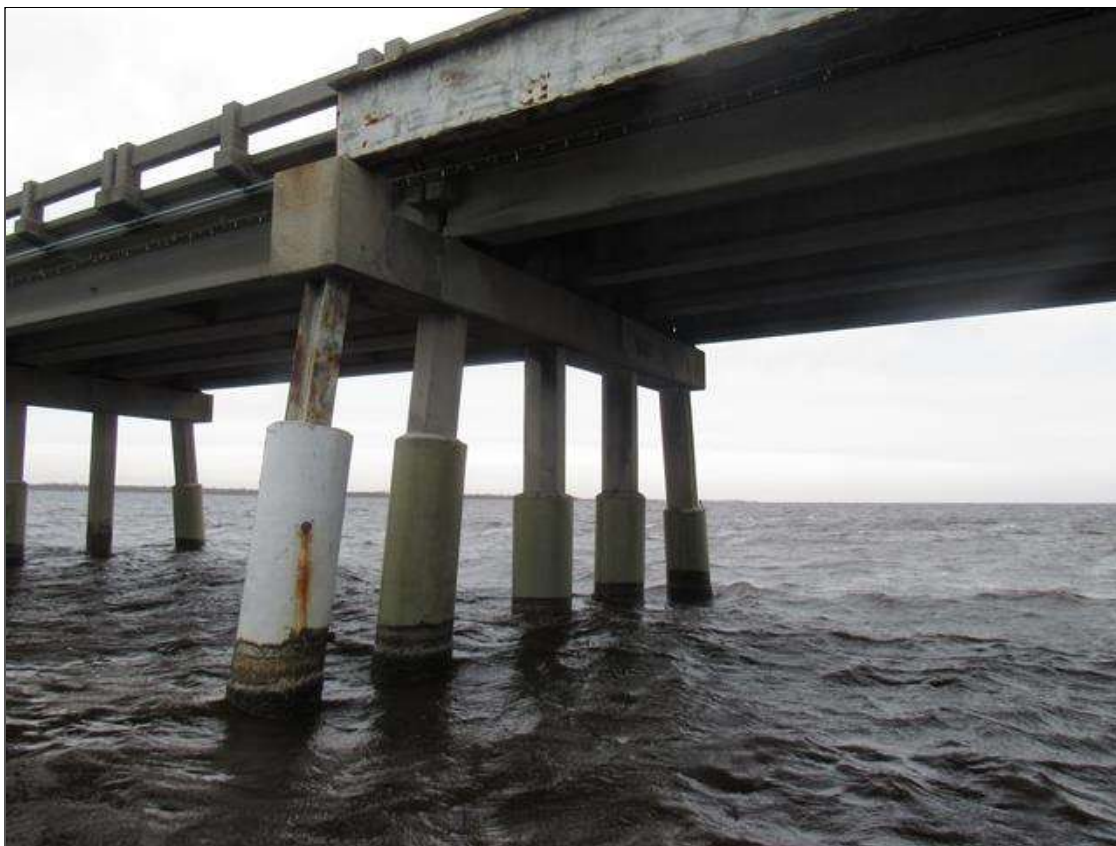
UTILITIES ATTACHED TO RIGHT SIDE OF BENTS 108, 109, AND 110

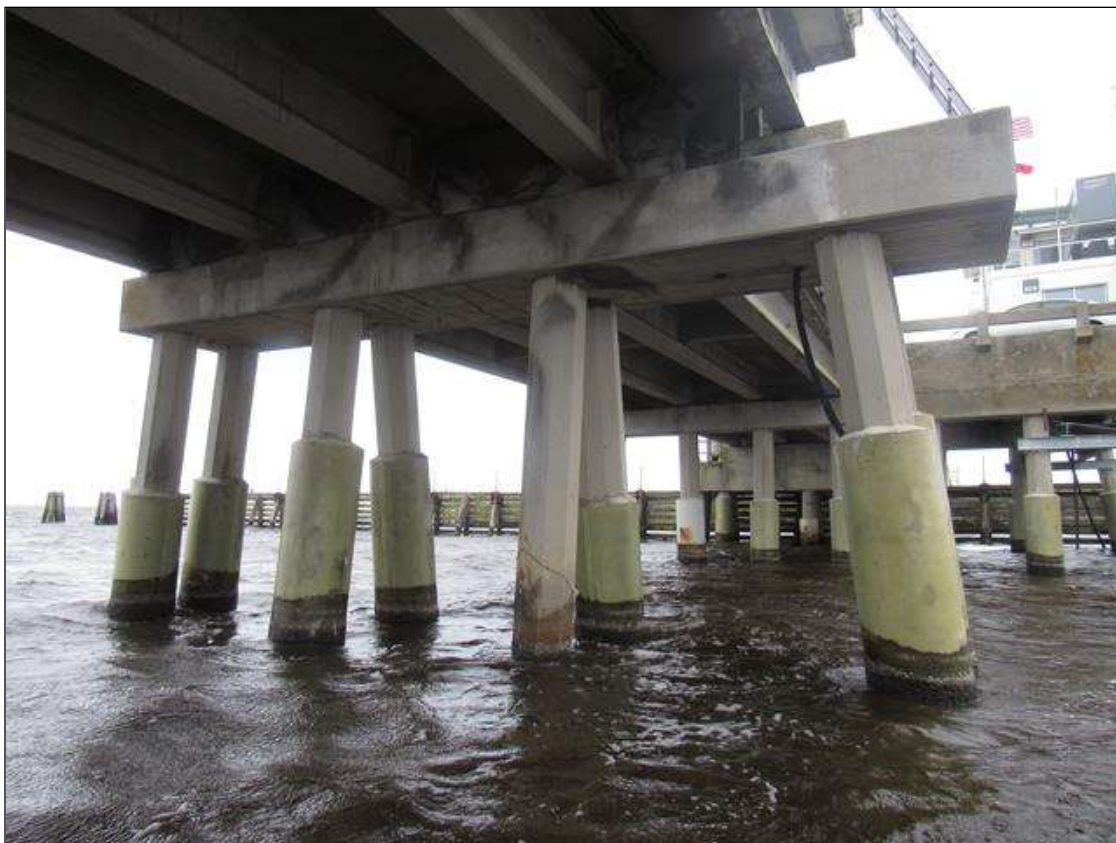
SUBSTRUCTURE TYPE 12, BENT 112 EAST FACE SHOWN

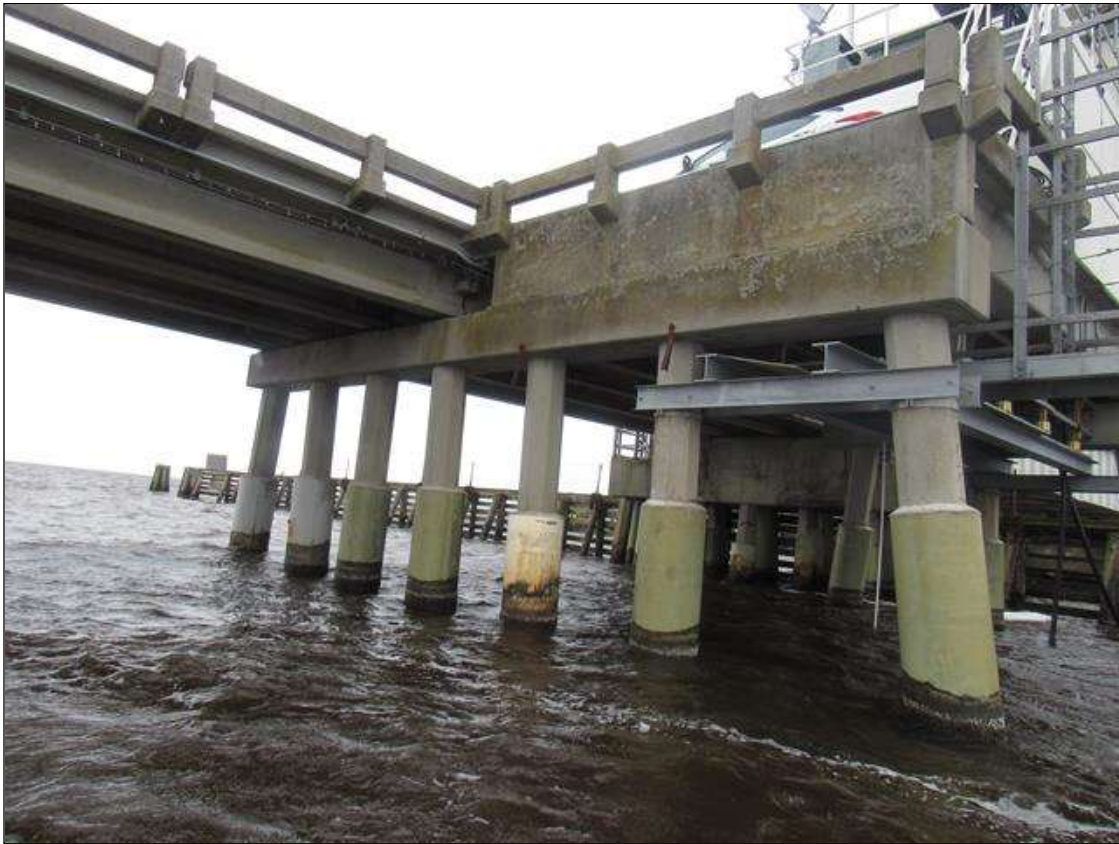
SUBSTRUCTURE TYPE 7, BENT 113 EAST FACE SHOWN

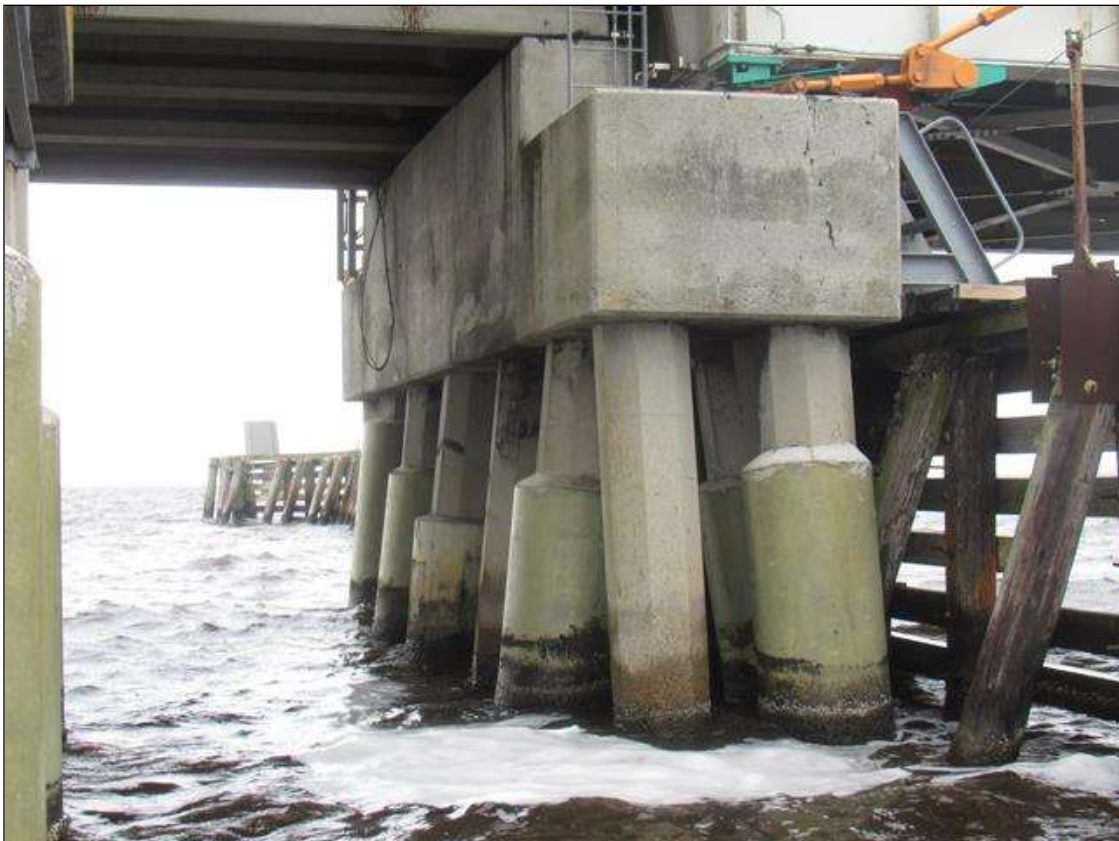
SUBSTRUCTURE TYPE 8, BENT 114 WEST FACE SHOWN

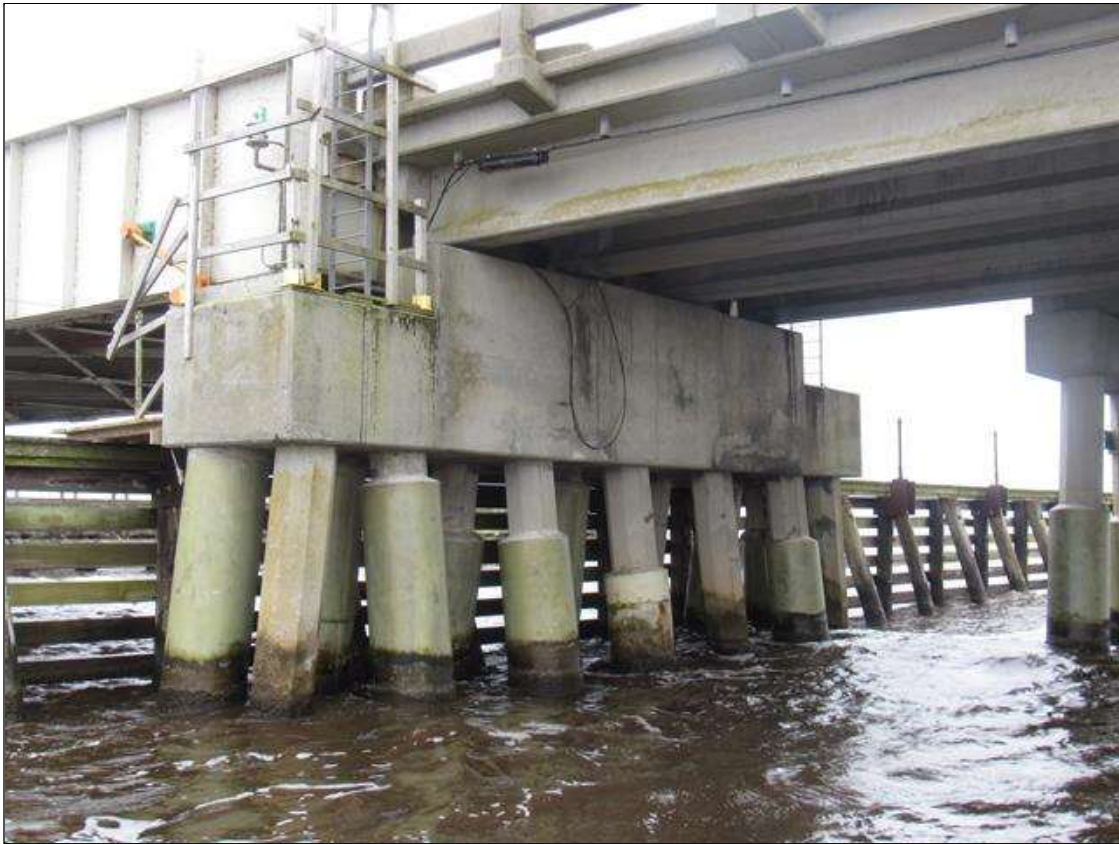
SUBSTRUCTURE TYPE 9, BENT 115 SOUTH FACE SHOWN

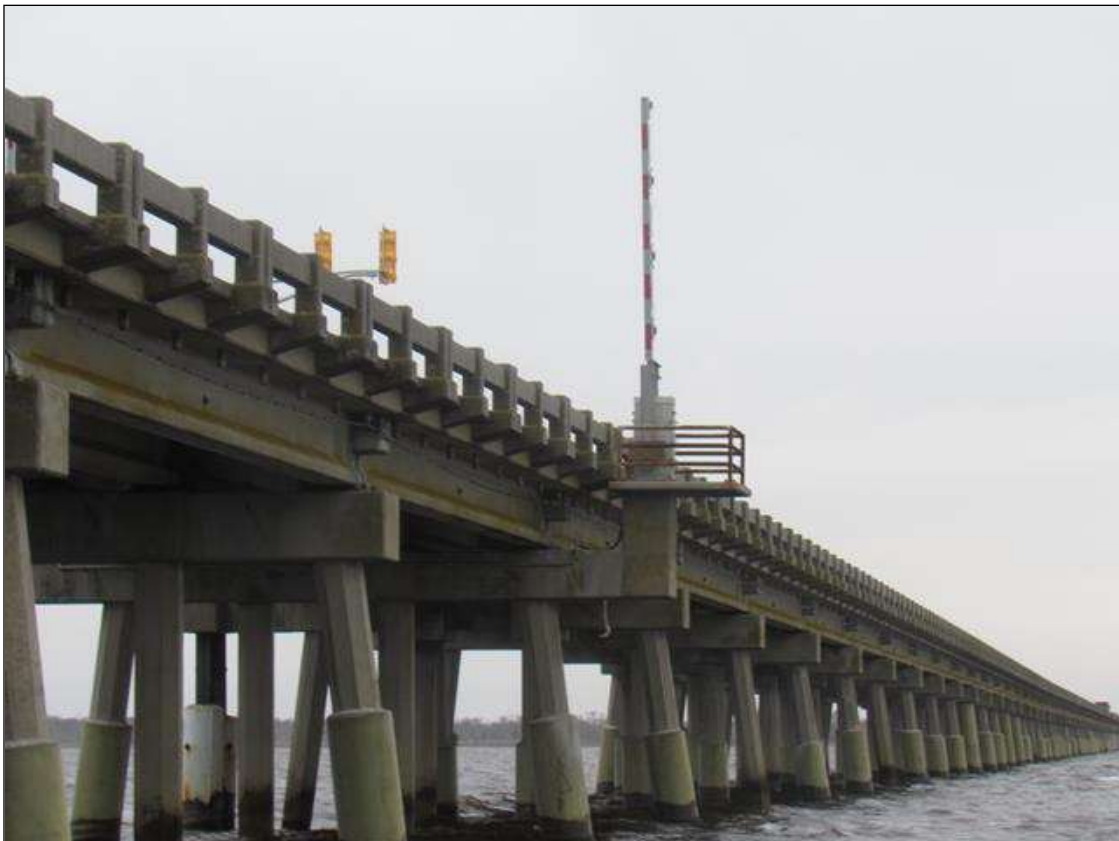
SUBSTRUCTURE TYPE 8, BENT 115 WEST FACE SHOWN
