NC DEPARTMENT OF TRANSPORTATION  
DIVISION OF HIGHWAYS  
STRUCTURE MANAGEMENT UNIT

## Structure Safety Report

### 4 Year Underwater Element Inspection

DIVISION: 1 COUNTY: TYRRELL STRUCTURE NUMBER: 880007 FREQUENCY: 48 MONTHS

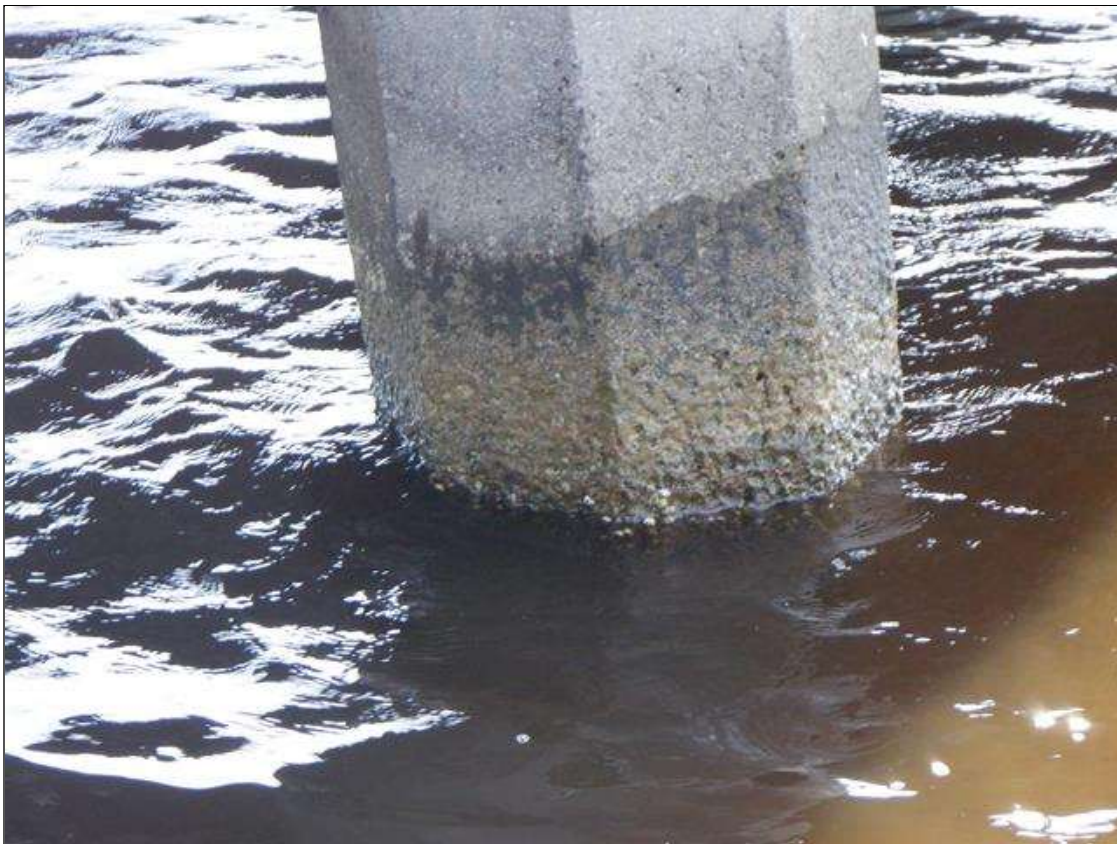
SCALING DETAIL
