NC DEPARTMENT OF TRANSPORTATION  
 DIVISION OF HIGHWAYS  
 STRUCTURE MANAGEMENT UNIT

# Structure Safety Report

## Routine Element Inspection - Contract

DIVISION: 13 COUNTY: MADISON STRUCTURE NUMBER: 560149 FREQUENCY: 24 MONTHS

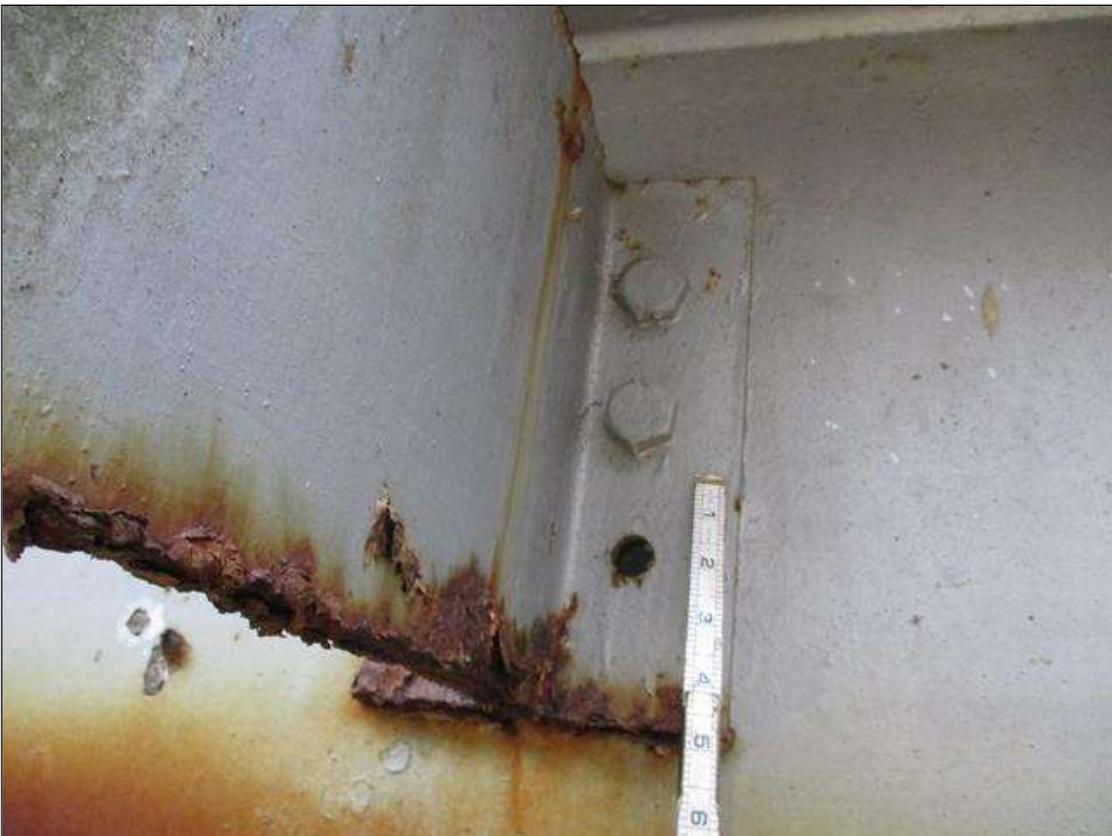
Priority Level	Defect Type	Quantity	Defect Description
2	Connection	2	Span 2 Left Bridge Rail: (PAR) RAIL POSTS 5 AND 6, TWO (2) MISSING BOLTS AT

Span 2 Left Bridge Rail: (PAR) RAIL POSTS 5 AND 6, TWO (2) MISSING BOLTS AT CONNECTION TO BEAM 1

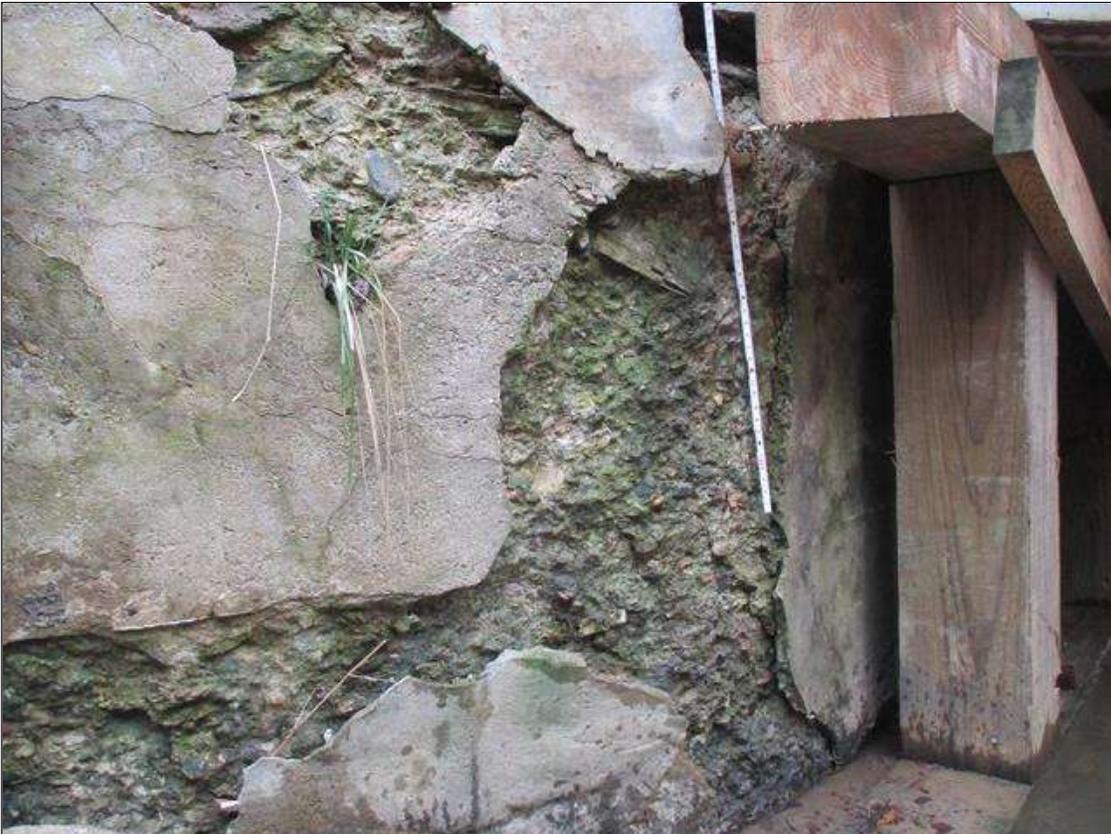
End Bent 2 Abutment: (PAR) NORTHEAST WINGWALL EXTENSION, 11'x 5" AREA OF DELAMINATION FOUR (4) SPALLS UP TO 3'x 3'x 5" DEEP WITH UP TO 1/8" MAP CRACKING WITH EFFLORESCENCE IN FACE

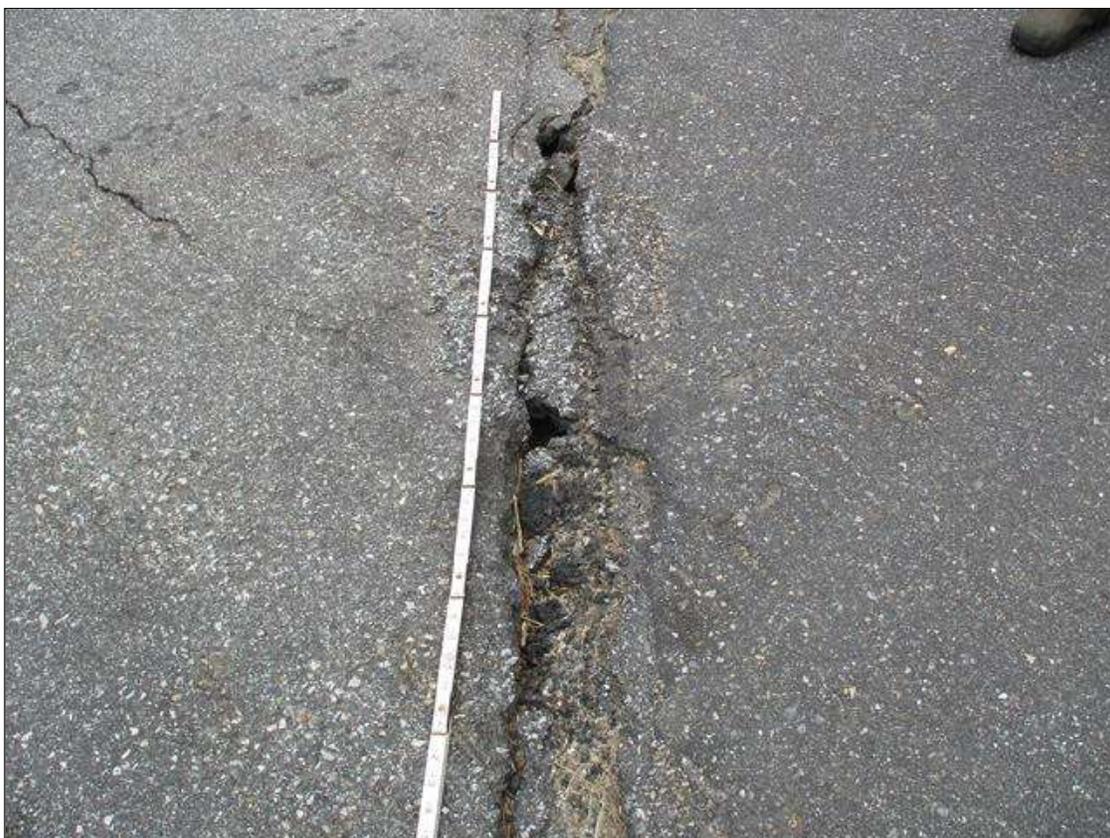
Span 2 Wearing Surface: POTHOLE ALONG ABUTMENT 2 FILL FACE, APPROXIMATELY 5' FROM RIGHT EDGE OF ROADWAY

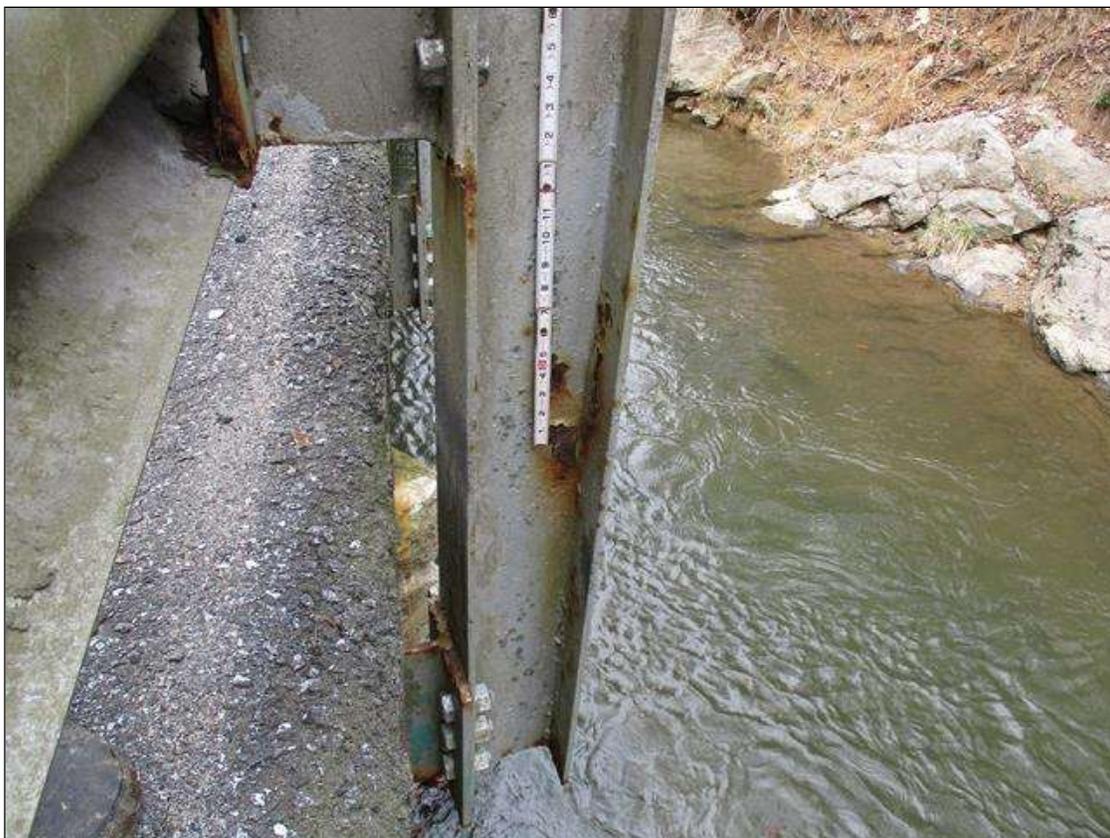
Span 2 Left Bridge Rail: 16" X 1" DEEP DISTORTION IN TOP OF RAIL, APPROXIMATELY 10' FROM PIER

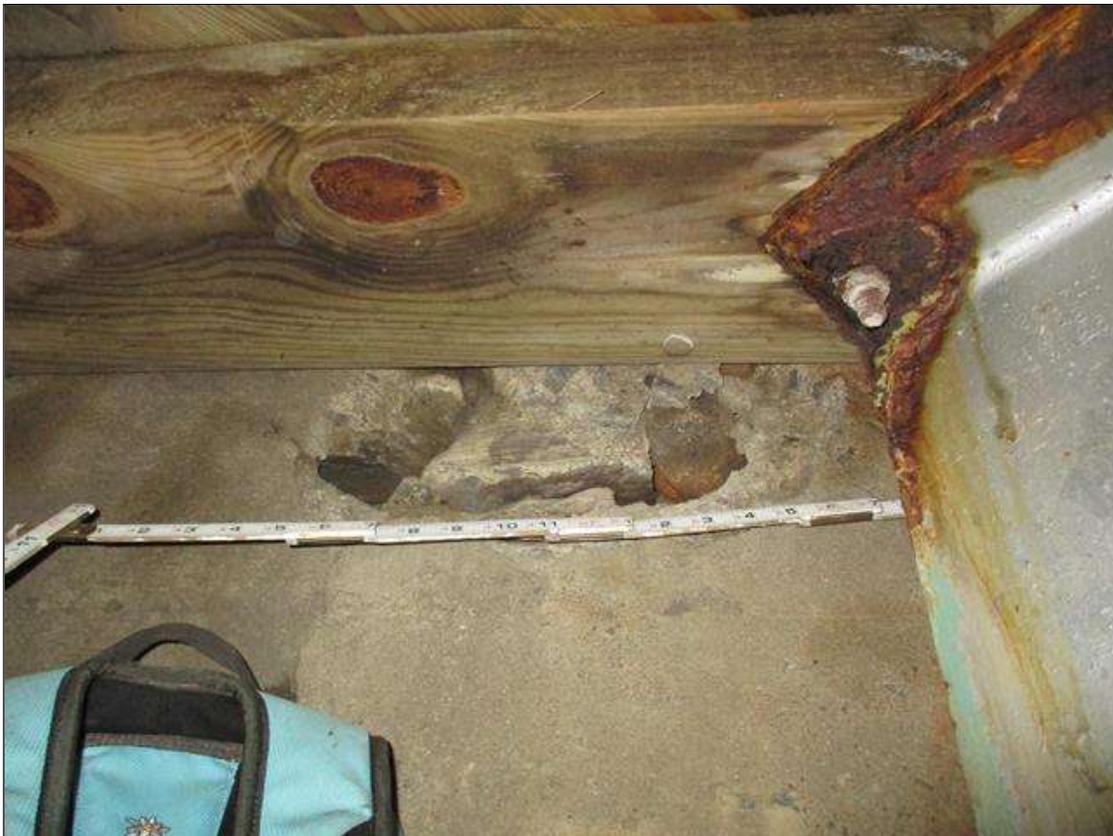
End Bent 1 Abutment: 32" X 16" X UP TO 1" DEEP SPALL IN FACE OF CAP BENEATH BAY 7; NO LOSS OF BEARING NOTED

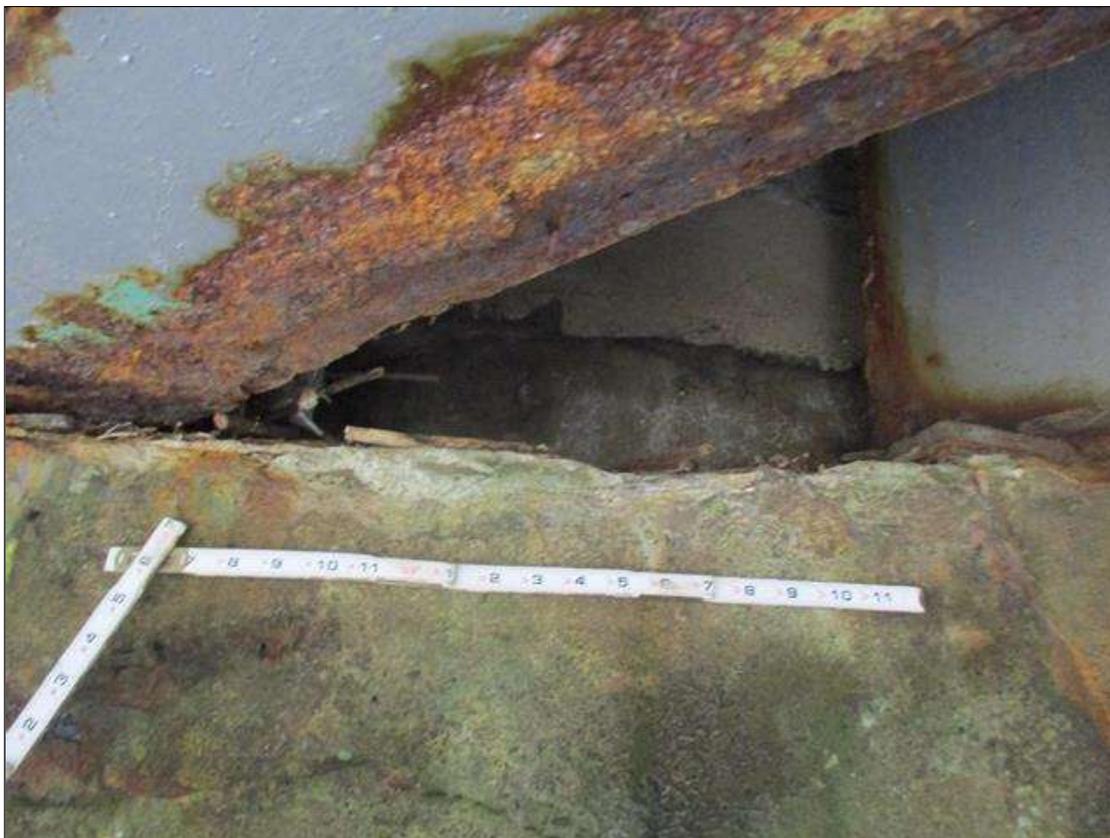
End Bent 1 Abutment: 9" X 5" X 2" DEEP SPALL IN FACE OF BACKWALL IN BAY 6

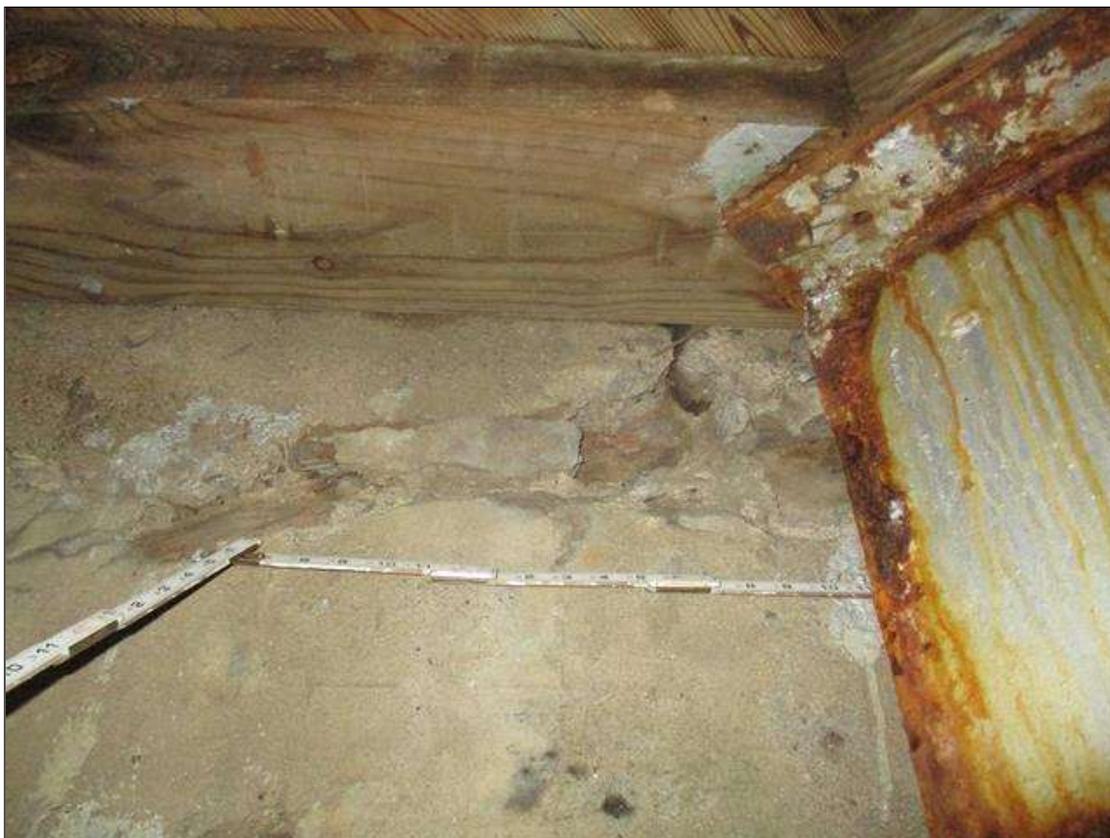
End Bent 1 Abutment: 14" X 2" X 1" DEEP SPALL IN FACE OF CAP BENEATH BAY 5

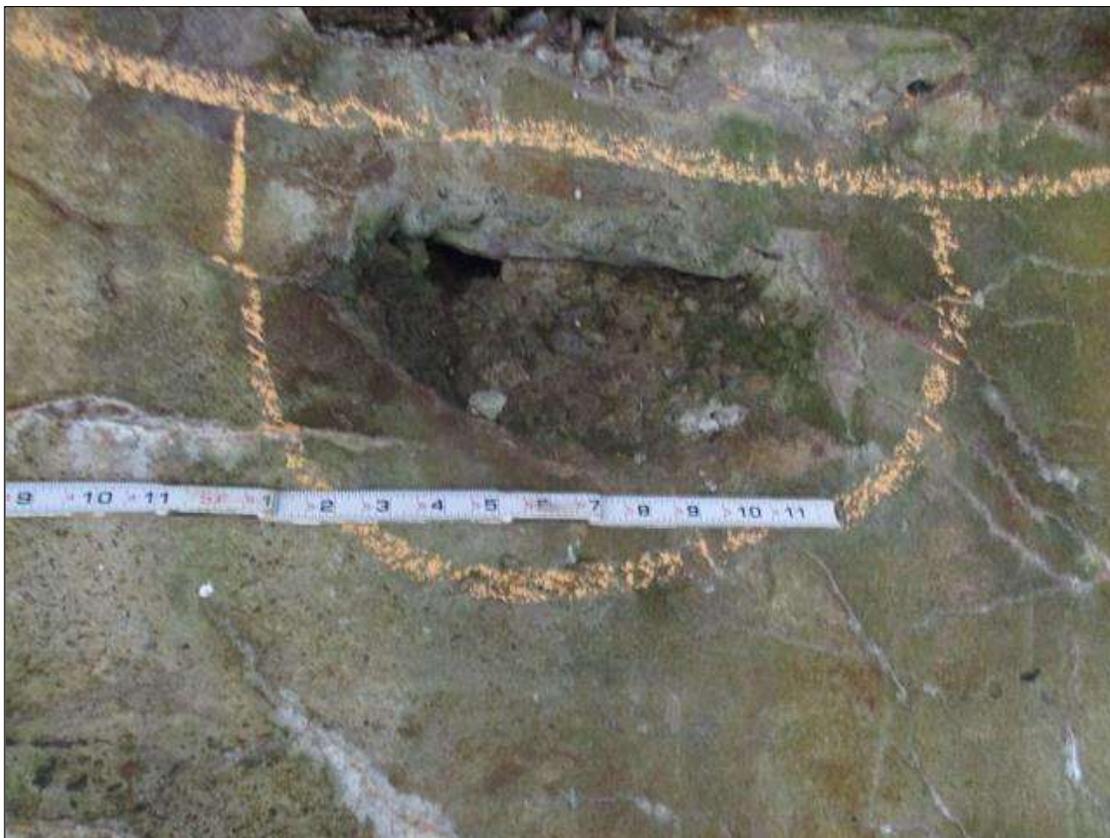
End Bent 1 Abutment: 6" DIAMETER X 2" DEEP SPALL IN FACE OF BACKWALL IN BAY 4

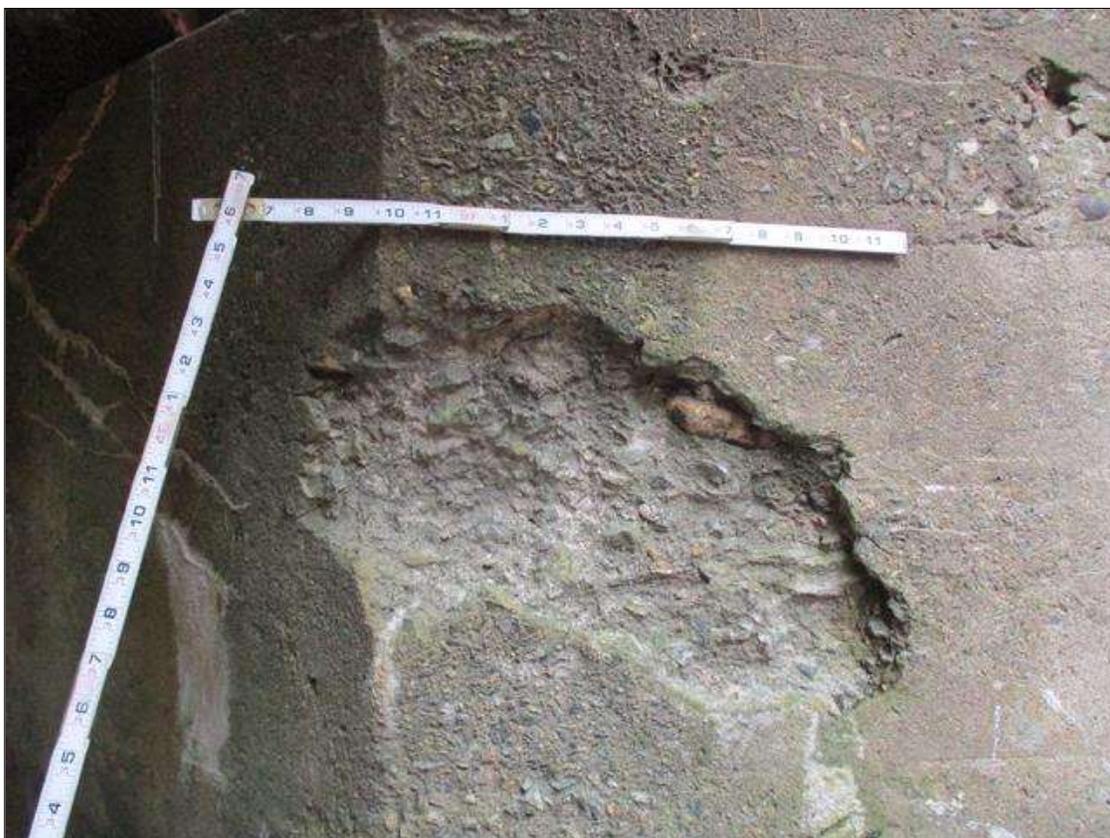
End Bent 1 Abutment: 10" X 5" X 1" DEEP SPALL IN FACE OF BREASTWALL BENEATH BAY 1 NEAR BOTTOM OF CAP

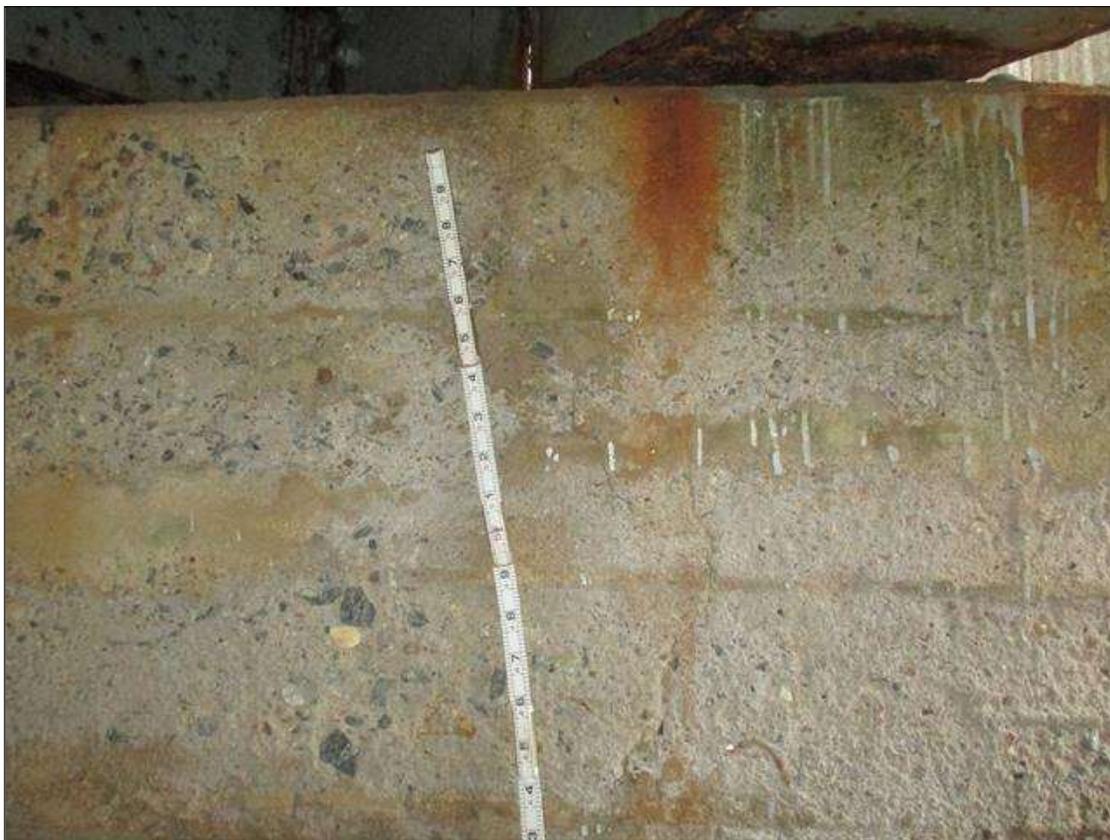
End Bent 1 Abutment: BELOW LEFT OVERHANG NEAR BOTTOM OF BREASTWALL, SPALL 16" X 8" X 1" DEEP

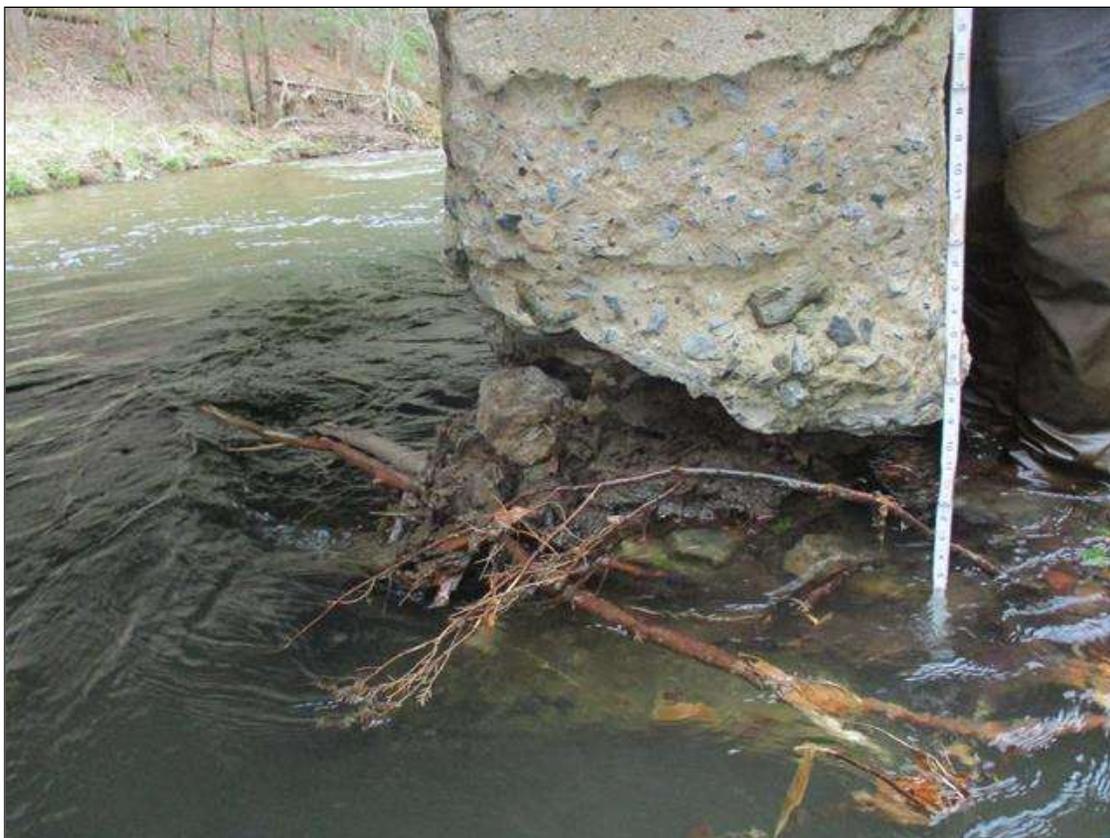
Bent 1 Cap: VERTICAL AND HORIZONTAL HAIRLINE CRACKS IN BOTH FACES OF CAP IN VARIOUS LOCATIONS

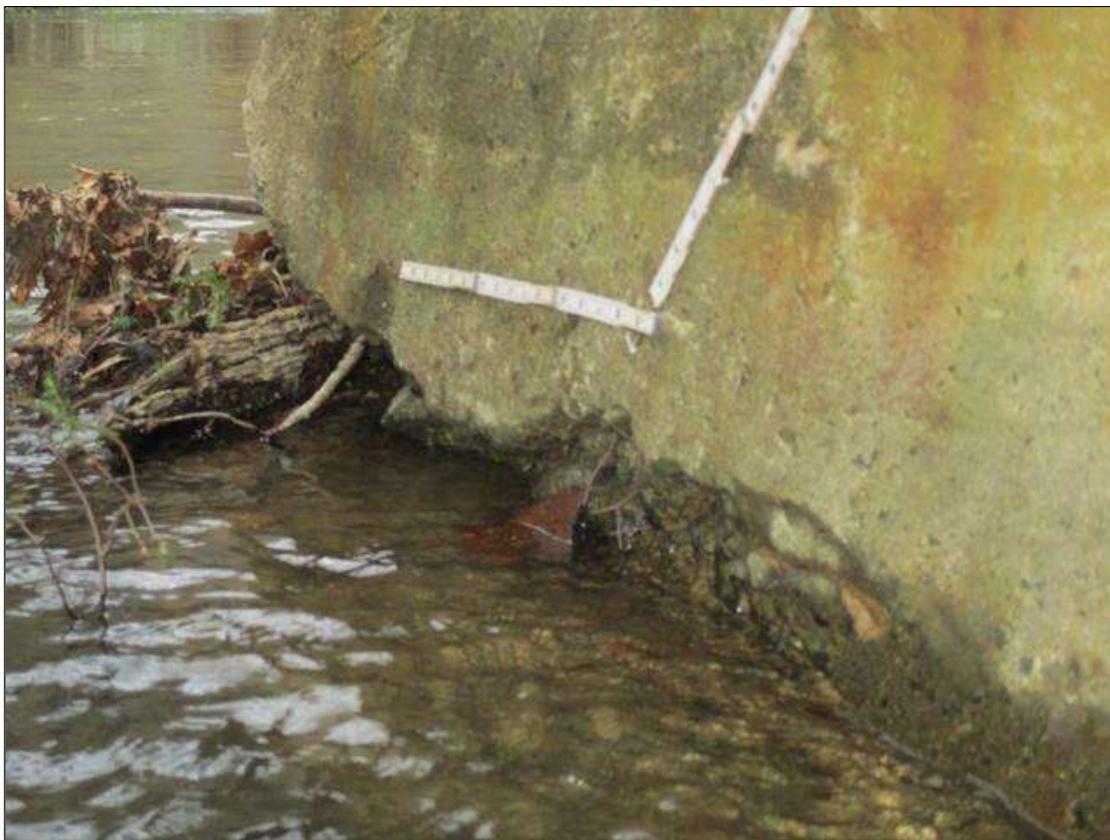
Bent 1 Pier: 48" LONG X 16" HIGH X 7" DEEP SPALL IN SPAN 1 FACE OF PIER AT WATER SURFACE AT UPSTREAM END

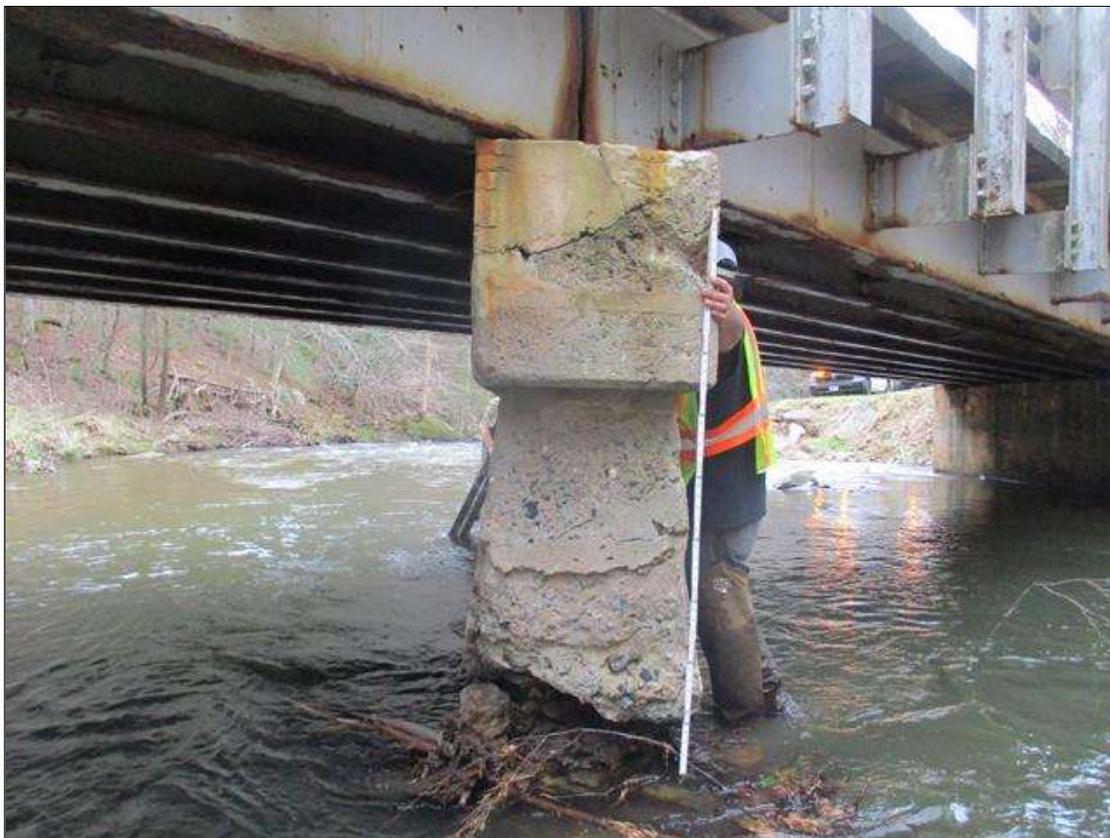
Bent 1 Pier: 48" LONG X 16" HIGH X 7" DEEP SPALL IN SPAN 1 FACE OF PIER AT WATER SURFACE AT UPSTREAM END

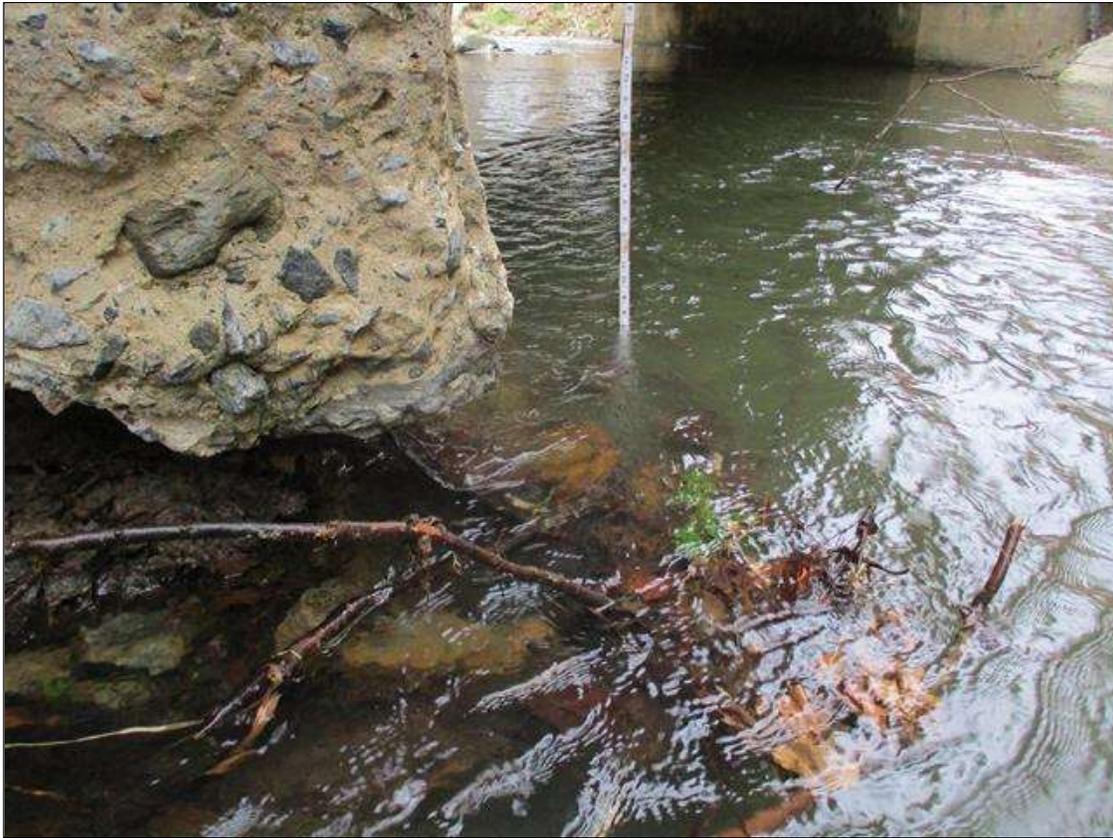
Bent 1 Pier: 30" WIDE X 33" HIGH X 7" DEEP SPALL IN UPSTREAM FACE OF PIER AT WATER SURFACE

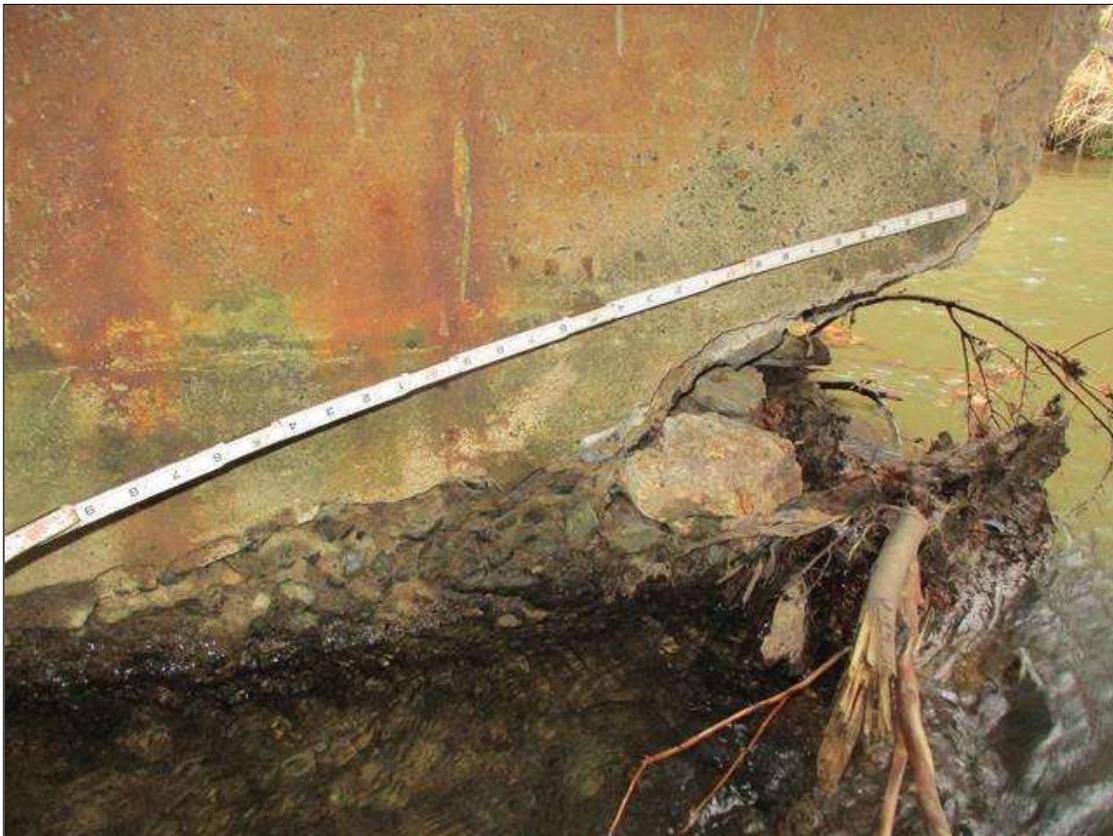
Bent 1 Pier: 25' OF UP TO 36" DEEP SCOUR ALONG BOTH FACES AND UPSTREAM END OF PIER, NO UNDERMINING NOTED

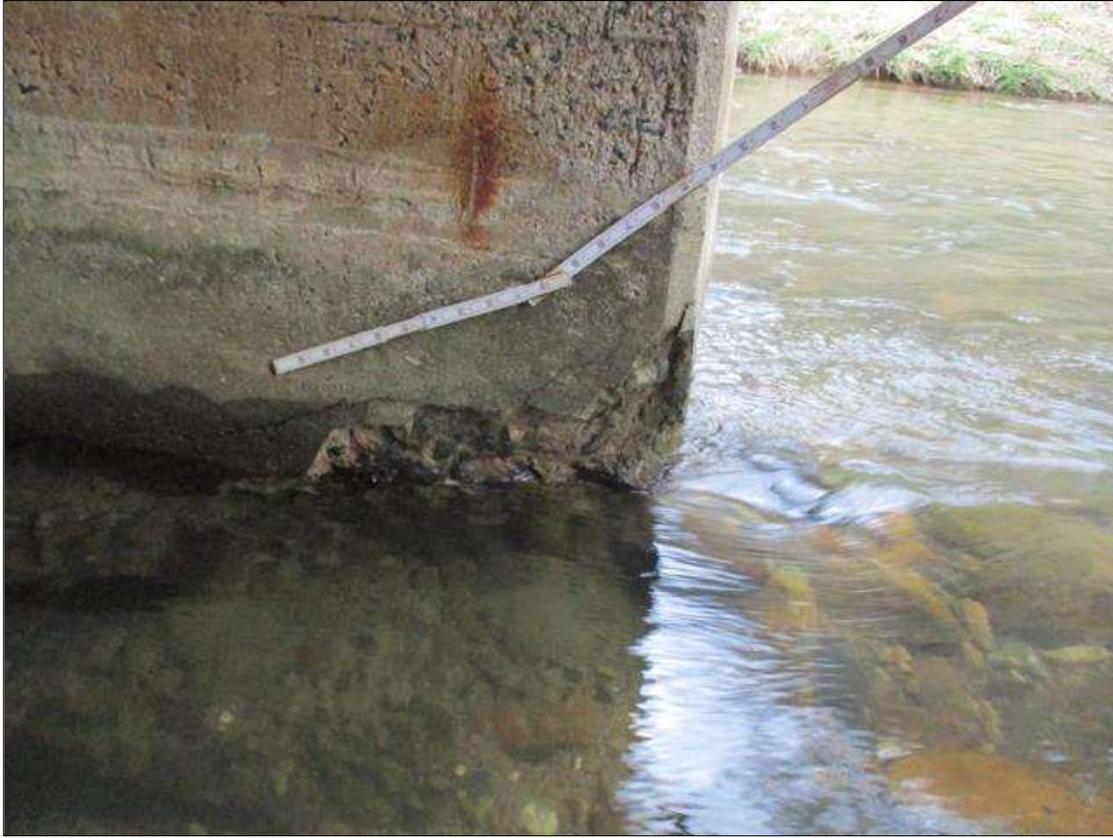
Bent 1 Pier: SPAN 2 FACE AT WATER SURFACE EXTENDING FROM UPSTREAM END, 15' LONG X 12" HIGH X 3" DEEP SPALL

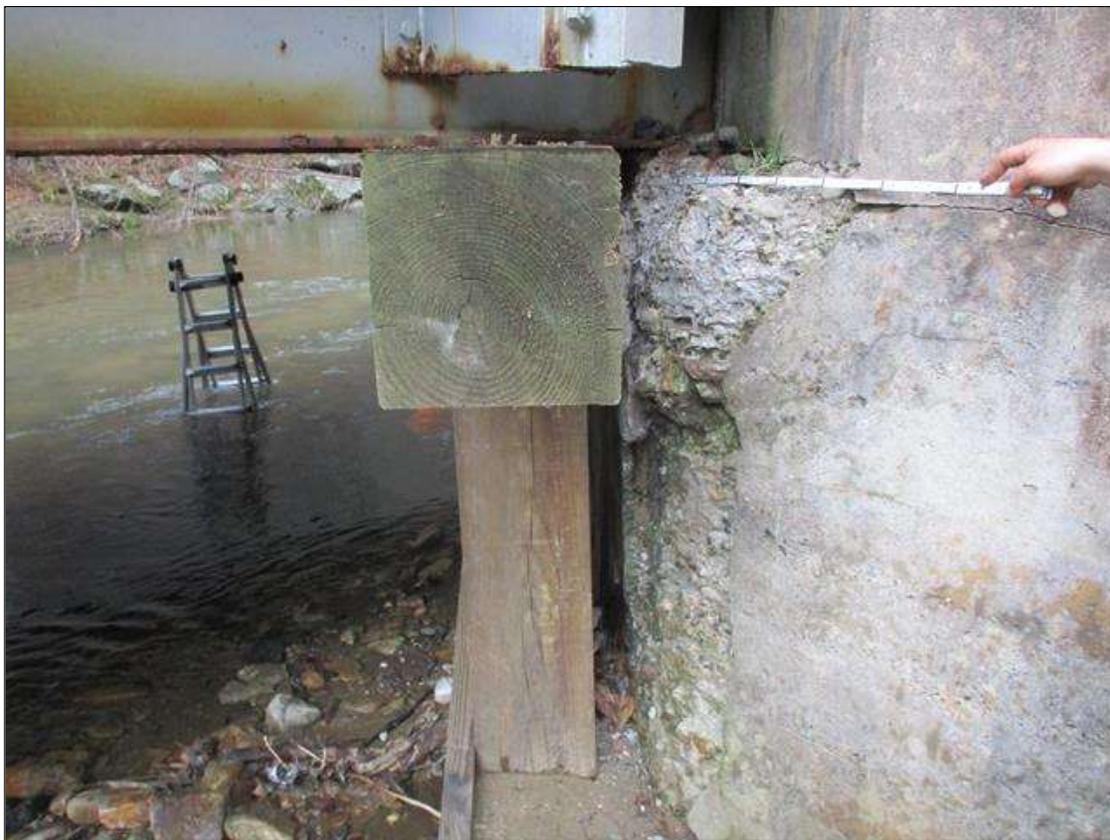
End Bent 2 Abutment: UP TO 24" LONG X 1/4" WIDE VERTICAL CRACKS IN FACE OF BACKWALL IN BAYS 5 AND

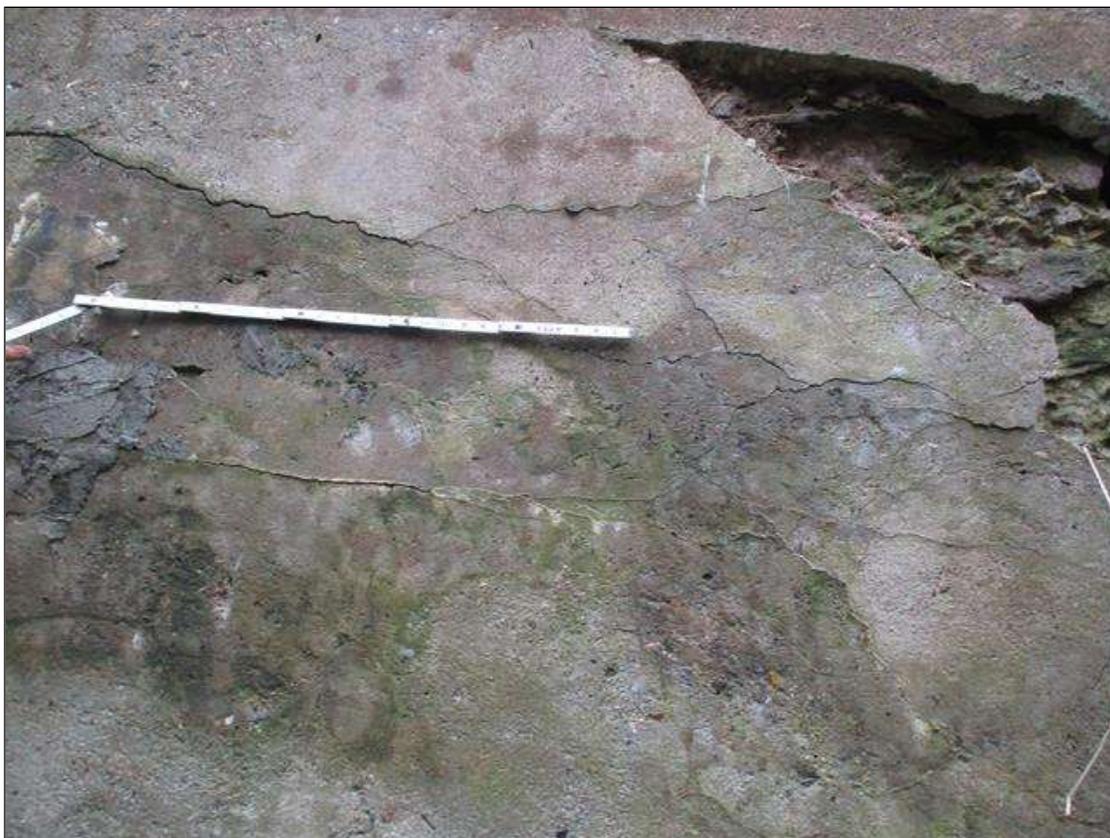
End Bent 2 Abutment: 36" LONG X 60" HIGH X UP TO 8" DEEP SPALL IN FACE OF BREASTWALL AT RIGHT END
